River Anton – Goodwood Clatford

An advisory visit carried out by the Wild Trout Trust – September 2008

1. Introduction

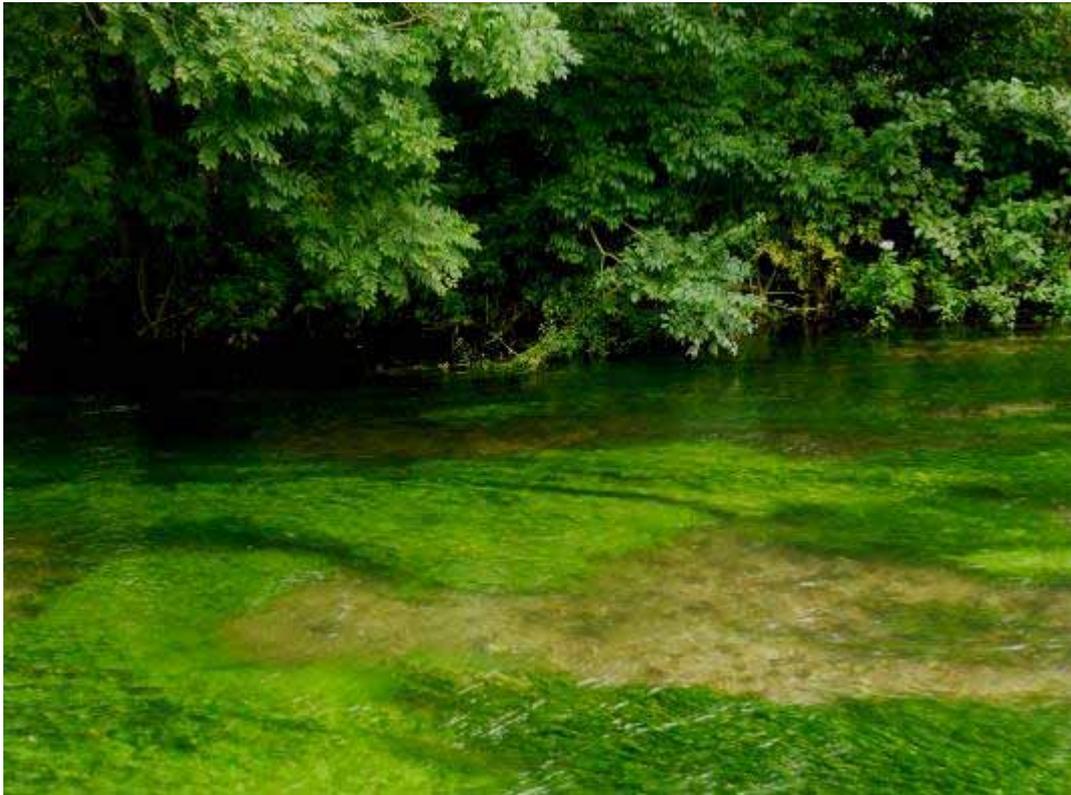
Far RB left unmanaged with lots of low scrubby cover creating ideal trout holding habitats.

- Move the compost heap at least 10 metres away from any river bank.
- Retain the low scrubby marginal cover. This is particularly important in the winter months. Autumn strimming of marginal dead annuals is often undertaken, resulting in damage to juvenile trout habitat.

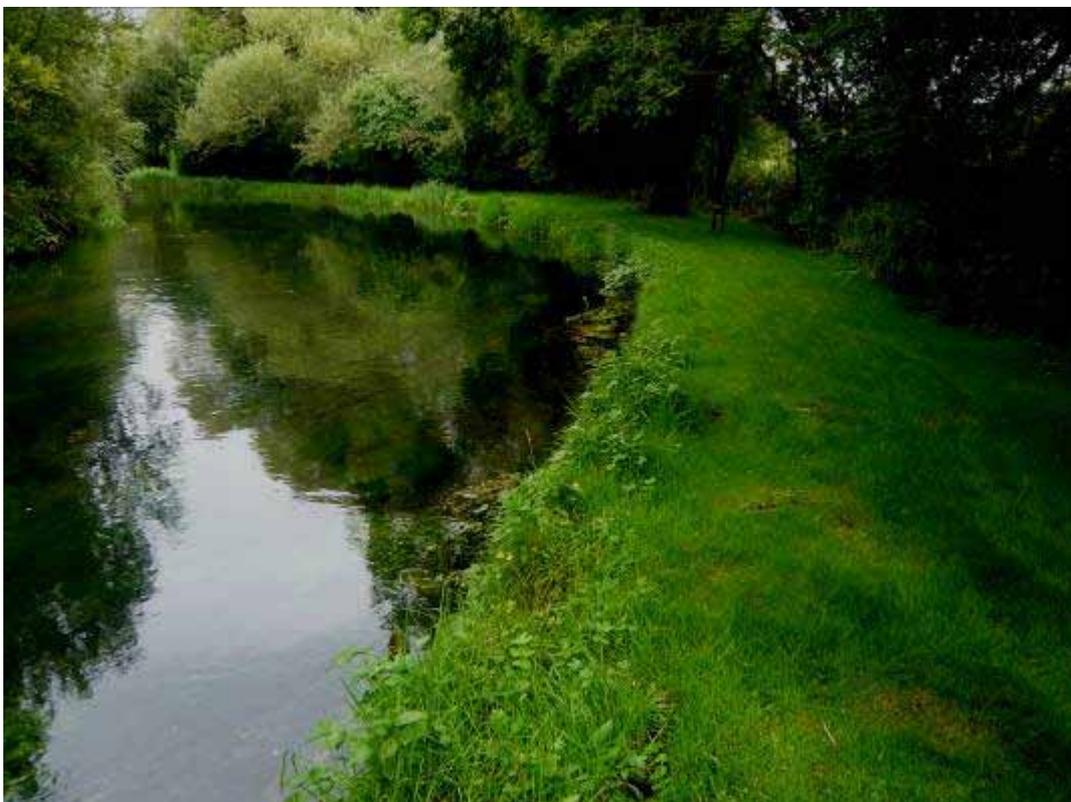
LB managed for access

Most of the LB was heavily managed. Much of the bank appears to have been made-up or consolidated with imported material, top dressed and sown with grass seed. Although this makes for a pleasant area to walk and fish from it is not conducive to high quality chalkstream habitat. Margins on the whole should be low, soft and supporting a thick fringe of native plants and herbs. The margins or ecotones of any river are a crucially important habitat for a wide range of species, including juvenile trout. Maintaining a shallow margin that gradually gives way to a soft squashy bank not only provides valuable habitat for plants, invertebrates' and fish, but also buffers the harder bank areas from the erosive forces of the river.

Some thought needs to be given to the future management and maintenance of the bank on the LB of the main channel. Establishing a soft natural margin will reduce the requirement for expensive maintenance and create marginal habitats suitable for juvenile fish as well as enhancing fly life.

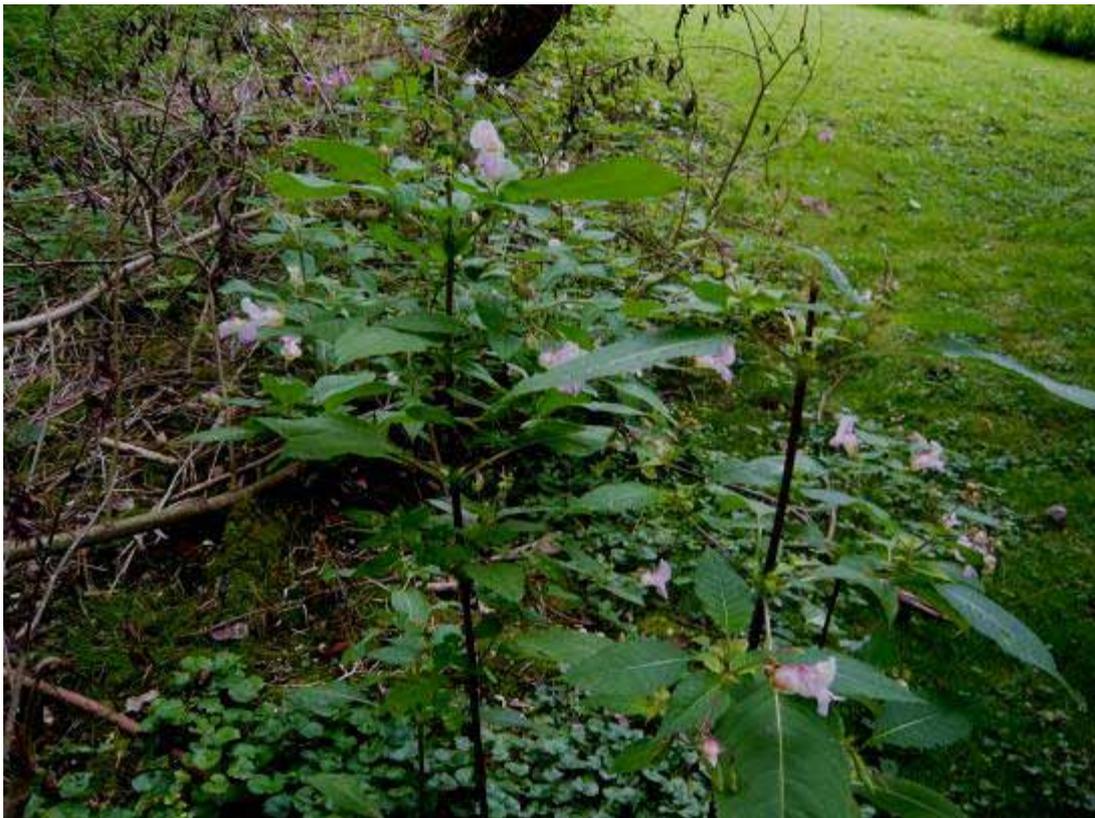
One area of concern relates to the presence of non native plants. Himalayan balsam (*Impatiens glandulifera*) was observed on the LB near the top end of the fishery. It is a relative of the Busy Lizzie and is known by a wide variety of common names, including Indian balsam, jumping jack and policeman's helmet. It is a tall, robust, annual producing clusters of purplish pink (or rarely white) helmet-shaped flowers. These are followed by seed pods that open explosively when ripe, shooting their seeds up to 7m (22ft) away. Each plant can produce up to 800 seeds. Himalayan balsam tolerates low light levels and, in turn, tends to shade out other vegetation, impoverishing habitats. In the autumn, the plants die back, leaving the banks bare of vegetation and vulnerable to erosion.

Clumps of Himalayan balsam were seen near the top end of the fishery. This is an undesirable plant that can be difficult to control.

- Control Himalayan balsam. This can be achieved by physical or chemical means:

The main method of control, and usually the most appropriate, is pulling or cutting plants before they flower and set seed (usually in June or July).

Himalayan balsam can be controlled with a weedkiller based on glyphosate, such as Roundup. Glyphosate is a non-selective, systemic weedkiller that is applied to the foliage. It is inactivated on contact with the soil, so there is no risk of damage to the roots of nearby plants, but care must be taken that the spray doesn't drift onto their foliage. Glyphosate is most effective when weed growth is vigorous. This usually occurs at flowering stage but before die-back begins; with most weeds, this is not earlier than mid-summer.

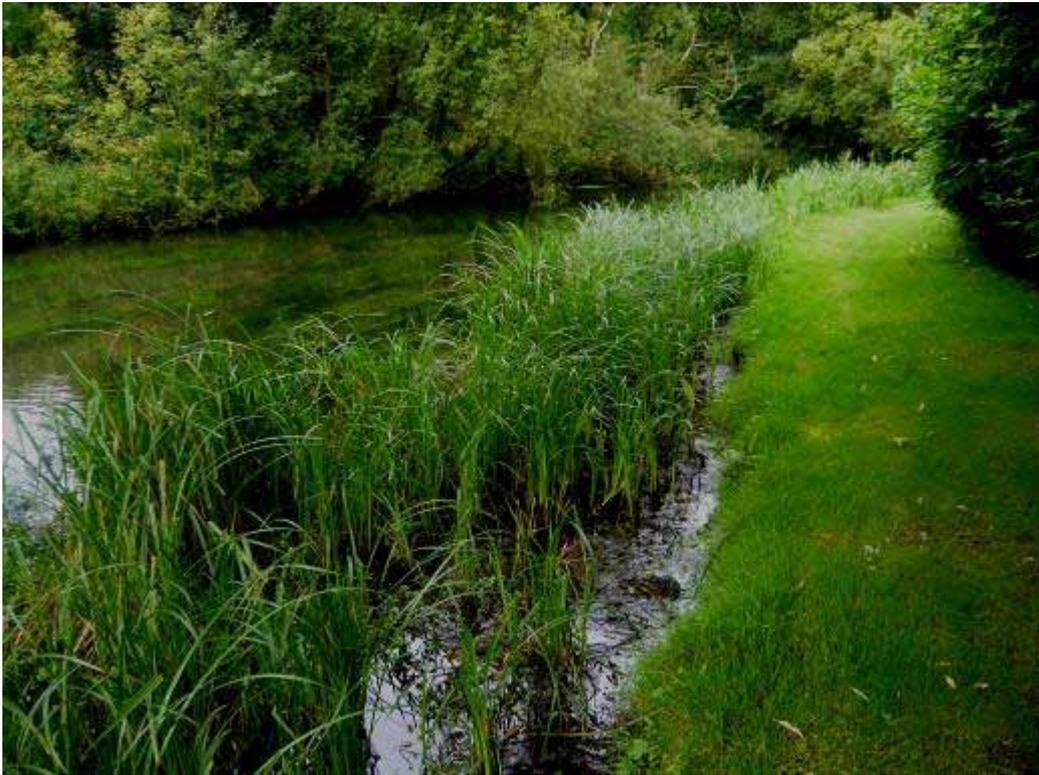
Some work has been carried out to try and create a wider fringe of marginal emergent plants by reveting the existing bank with faggot bundles and allowing the adjacent area to colonise with sedge *Carex sp.*

A new soft margin has been created by reveting the margin with faggot bundles. An excellent enhancement

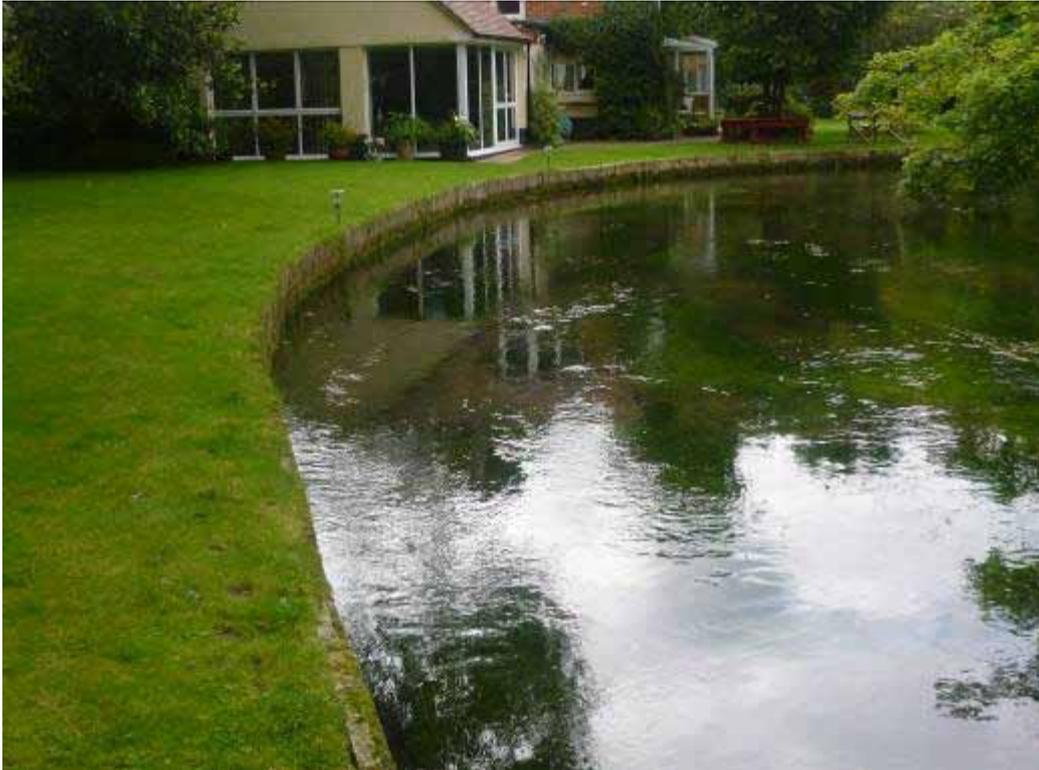
Near the upstream end of the fishery the access gives way to the formal garden of Mr and Mrs Jausas's home. Here the bank has been reveted with toe boarding.

Toe boarding is often used adjacent to formal lawn areas because it is easy to maintain and forms a clean, neat edge. Whilst often attractive to the eye, toe-boarding is a hostile environment for aquatic plants and animals and should only be used sparingly. Toe boarding, even when constructed from expensive hardwoods such as oak usually has a very limited life span. Problems sometimes occur when sediments are eroded away from the inside of the boards leaving the bank to sometimes slump without warning. The hard effect of toe boarding can sometimes be mitigated by staking a pre-planted roll of coir (coconut matting) at the base of the boards. A soft fringe of marginal emergent plants such as sedge or yellow flag iris will make an attractive, as well as biologically useful barrier to the erosive forces of the river and prolong the lifespan of the bank defenses.

The LB adjacent to the garden is formally reveted with toe boarding. A fringe of marginal emergent plants would protect the bank and provide habitat

- Consider enhancing the existing hard bank defences (toe-boards) through the introduction of a soft toe (such as coir rolls) capable of supporting marginal emergent plants.

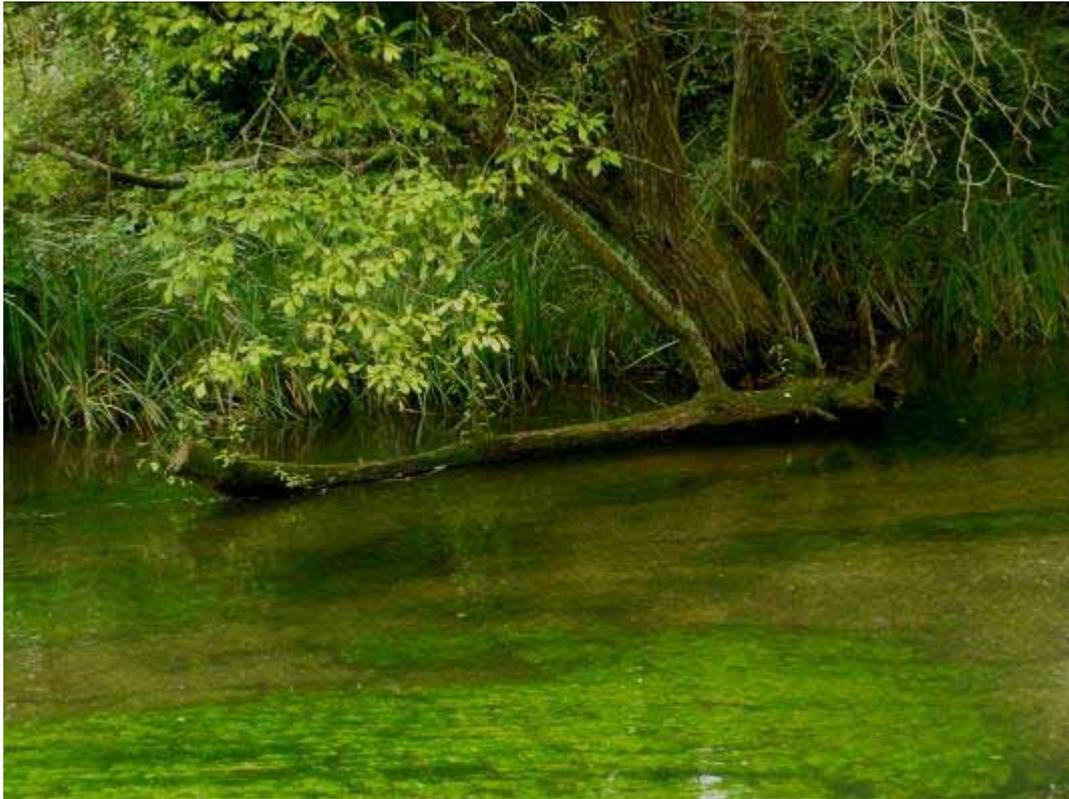
An excellent example of LWD which is acting as a live current deflector

- Use LWD to promote local scour on the wide shallow sections of main river channel.
- Consider introducing imported river gravels to create enhanced spawning opportunities in the small carrier at the head of the fishery.

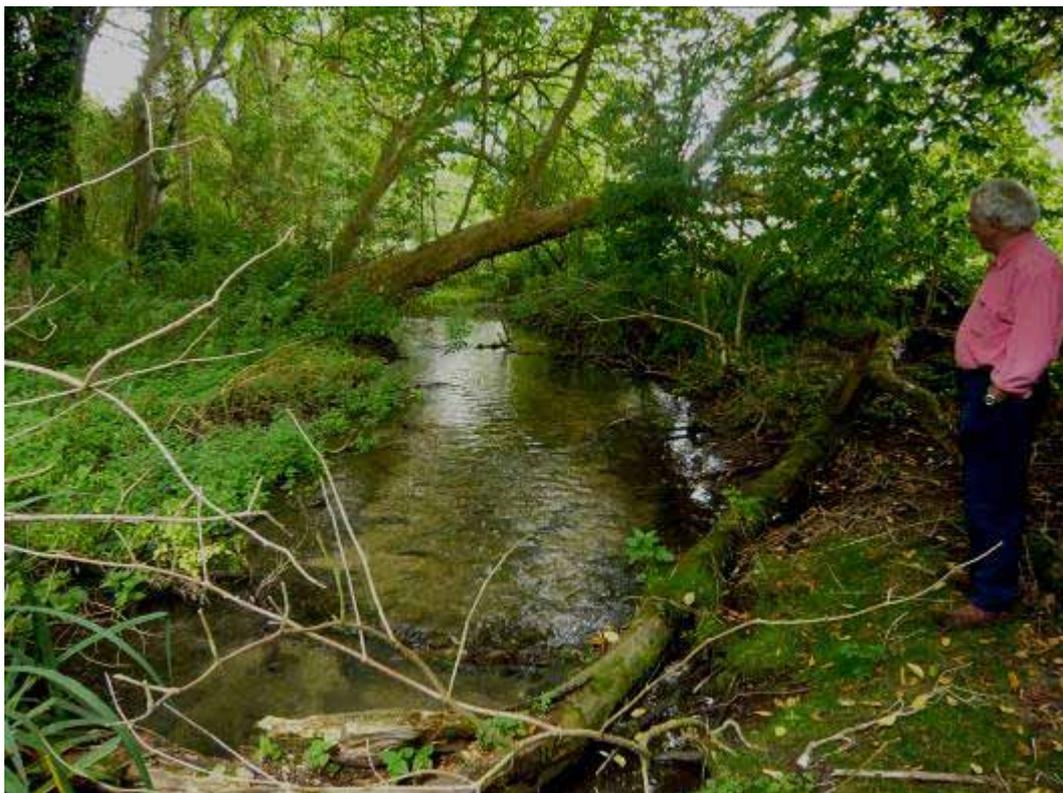
A small carrier joins the main channel on the LB about 200m from the top boundary. Currently the carrier is quite overgrown and shaded with a substrate of silt and thin gravels. The author is of the opinion that this stream has excellent potential as a trout spawning and nursery habitat. Lying as it does near the head of the fishery, any enhancements that can be carried out to improve productivity within the carrier will bring significant benefits to the fishery as a whole.

The top carrier near to its confluence with the main channel. Potentially a superb spawning and nursery habitat.

A comparatively cheap and simple enhancement would be to create one or two spawning riffles by importing some fresh aggregates (gravel) from a local river

valley source. The bed of the stream is currently dominated by soft silts. Reducing the bed level by pressure jetting the sediments and then importing gravel to raise the bed and create a shallow spawning riffle would enhance the aesthetic appeal as well as the providing a valuable spawning and nursery habitat.

Constructed riffles should ideally be no less than 20m in length, with longer lengths increasing the feature's value as a spawning and nursery zone, although on such a small carrier a riffle of half this length will still be a useful addition.

The riffle should comprise of a depth of at least 30cm of spawning gravel (mixed 15-40mm diameter gravel) with a sub-layer of larger cobbles.

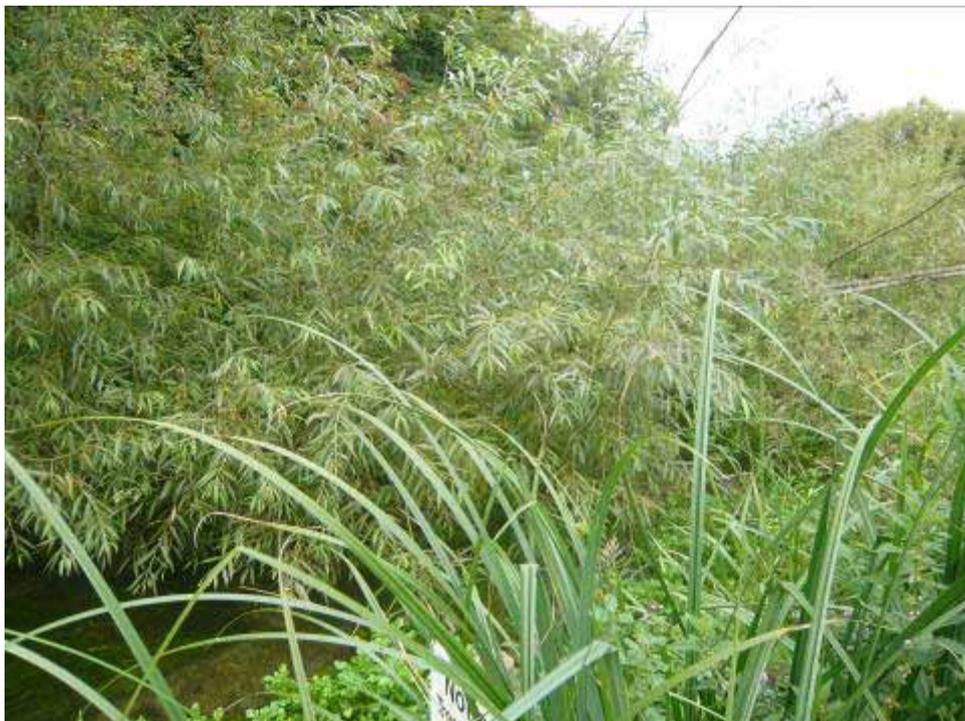
Back carrier with heavy growth of willow scrub

It is thought that this area lies within the SINC boundary and any plans to undertake works here should be shared with the Hampshire County Council. The channel is completely blocked over a substantial length and would benefit from some sensitive tree maintenance, but not large scale clearance.

The initial objective is to re-establish some open areas and allow sunlight into sections of the channel. This will enable in river plants such as crowfoot and starwort to re-establish, and so support more fly life and trout. Once the channel has been opened up, it will be easier to identify if any further work is required.

There are also some large willows which are in need of pollarding before the tree completely splits

- Carry out some sensitive tree management on the back carrier to re-establish the channel form and allow more light penetration. Material gained from the work can be used within the channel to consolidate banks and promote local scour.

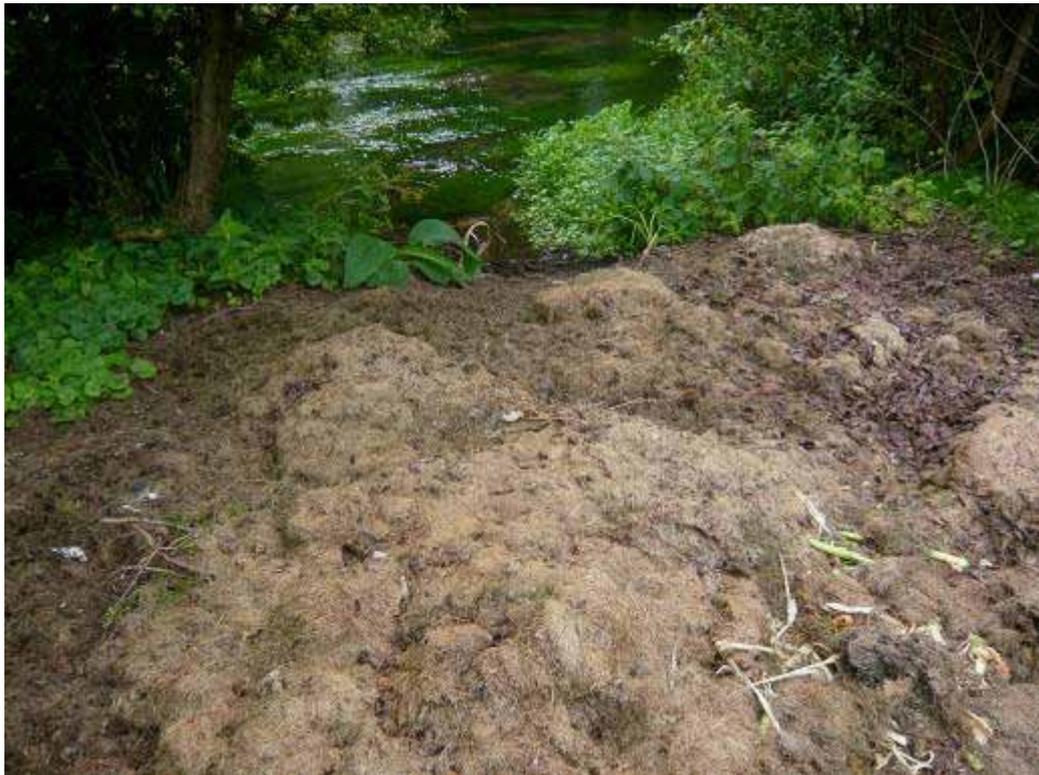
It was noted while inspecting the area between the main channel and the carrier that an area was being used to store composted grass cuttings. The liquor that is derived from cut grass or composting piles is known to be very polluting. When allowed to leach into a watercourse has the capacity to significantly reduce dissolved oxygen levels and impact both fish and insect life. It is therefore recommended that the compost area be moved well away from the bank of the river or carrier.

Area of grass cuttings stored too close to the river
