**HABITAT ADVISORY VISIT TO A
BACKSTREAM OF THE RIVER AVON AT
AMESBURY,
UNDERTAKEN BY VAUGHAN LEWIS,
WINDRUSH AEC LTD ON BEHALF OF THE
LIVING RIVERS PROJECT AND THE
ENVIRONMENT AGENCY**

MARCH 2008

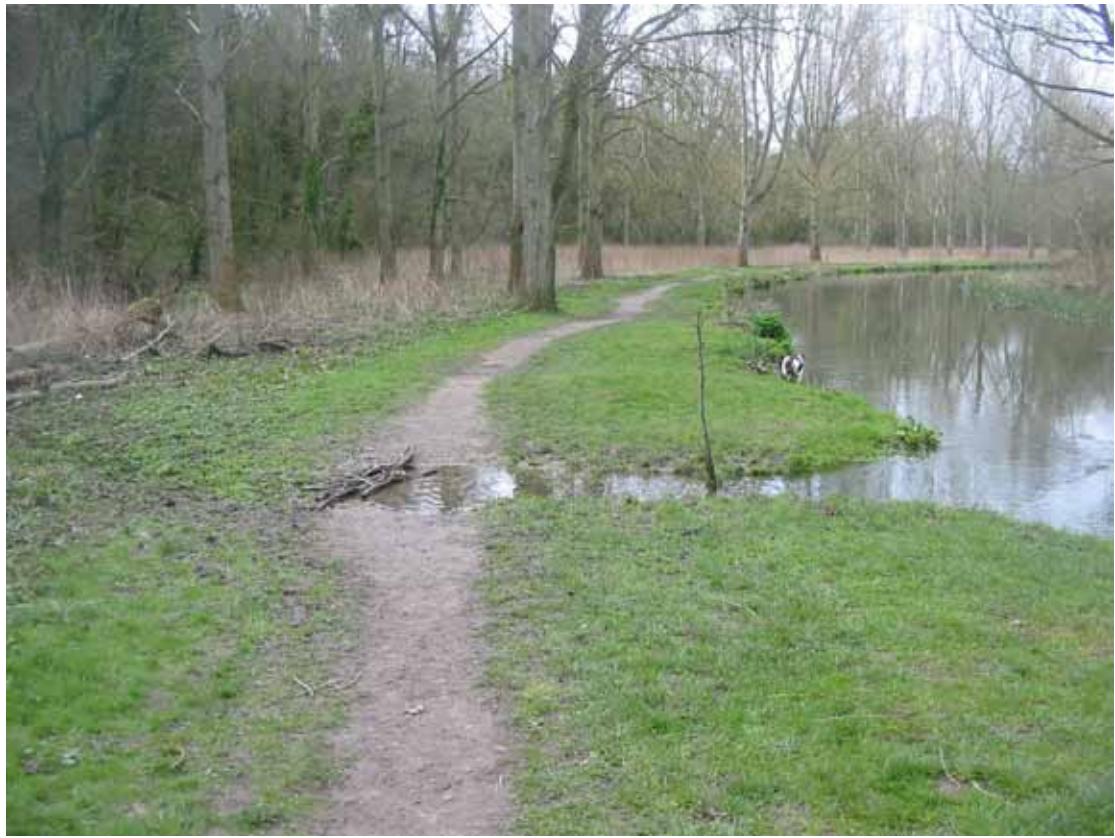
The two breaches in the LB of the main River Avon provided a flow of water into the backstream some 50m downstream of the A303 bridge. On the day of the site visit, the upper breach was still running, whilst the lower breach was dry. River levels were relatively high for the time of year.

Upstream bank breach showing flow still entering the backstream

In order to increase the security of water supply into the backstream, it is recommended that the two existing natural breaches in the LB of the main Avon should be allowed to remain. Their edges should be carefully graded to create a shallow, safe gradient. It will be necessary to provide a simple crossing of these in order to allow access along the footpath at the breach locations. It should be a relatively simple matter to provide a sleeper (or similar) bridge, provided that adequate provision is made for Health and Safety of people using the crossing. The

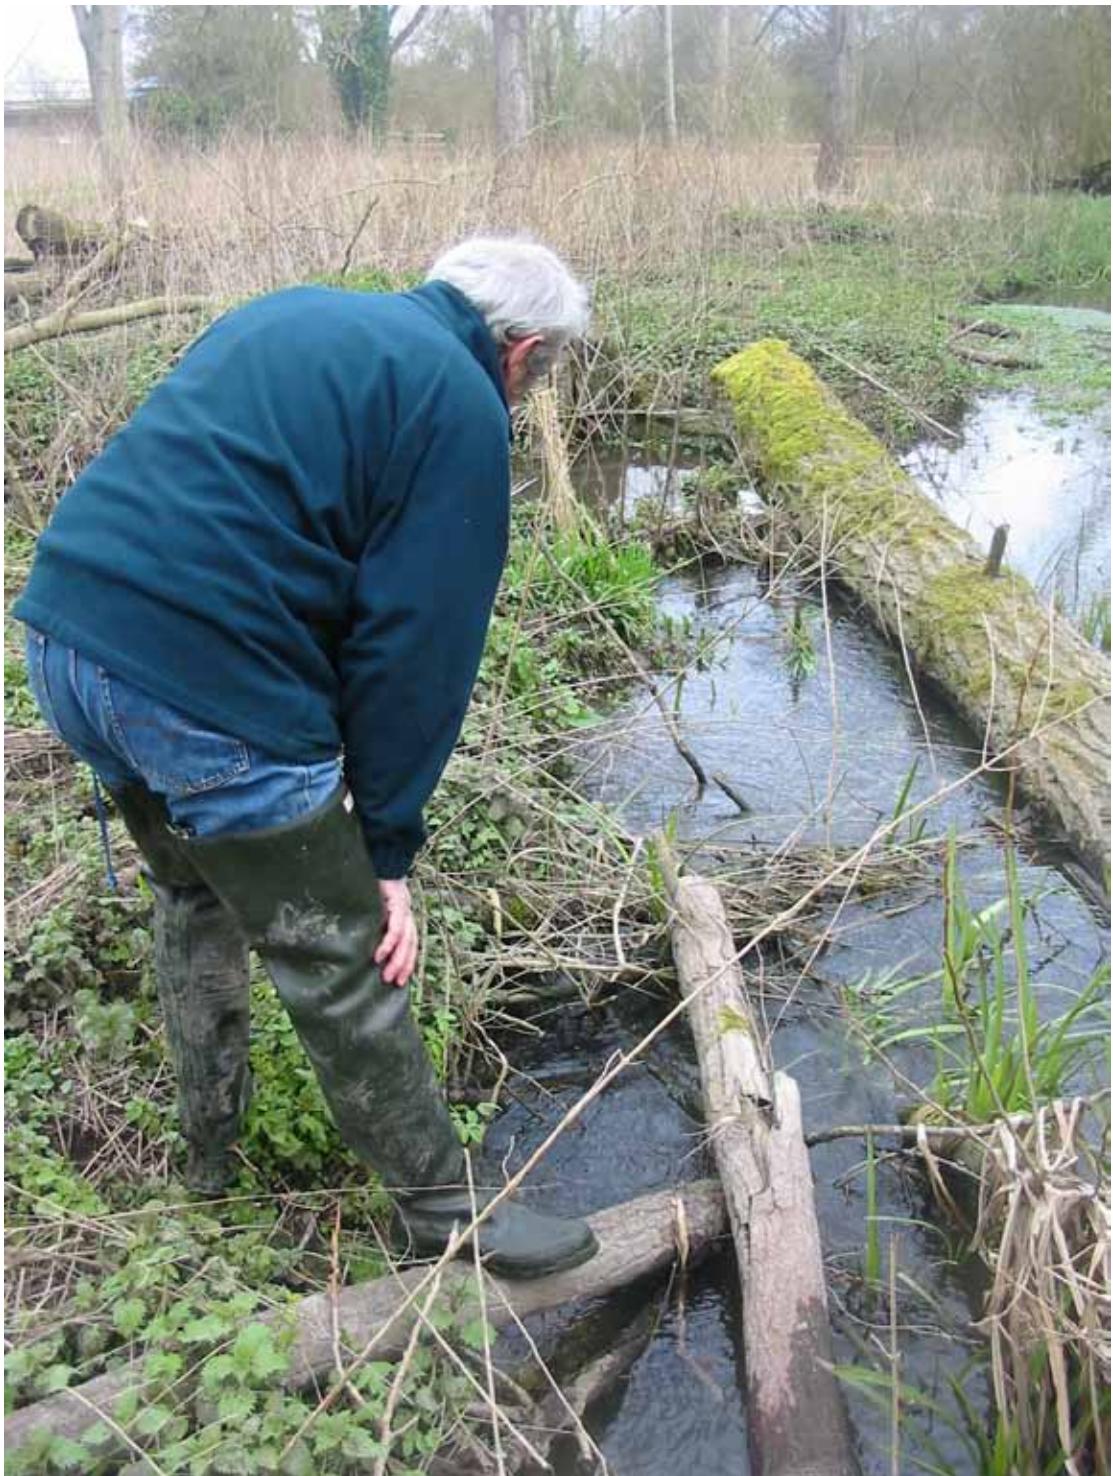
There was an additional flow into the backstream via an underground bank breach (there may be an old pipe present that has been exposed by recent erosion?). A very substantial volume of water was passing through this breach, and was upwelling in the margins of the backstream, replicating a deep spring input.

Upwelling flow visible by right boot

In addition, no attempt should be made to reduce the underground flow provided to the backstream from main Avon. There was no evidence of bank erosion issues connected to this water source, and hence no obvious reason why it should not be permitted to continue to supply water to the backstream.

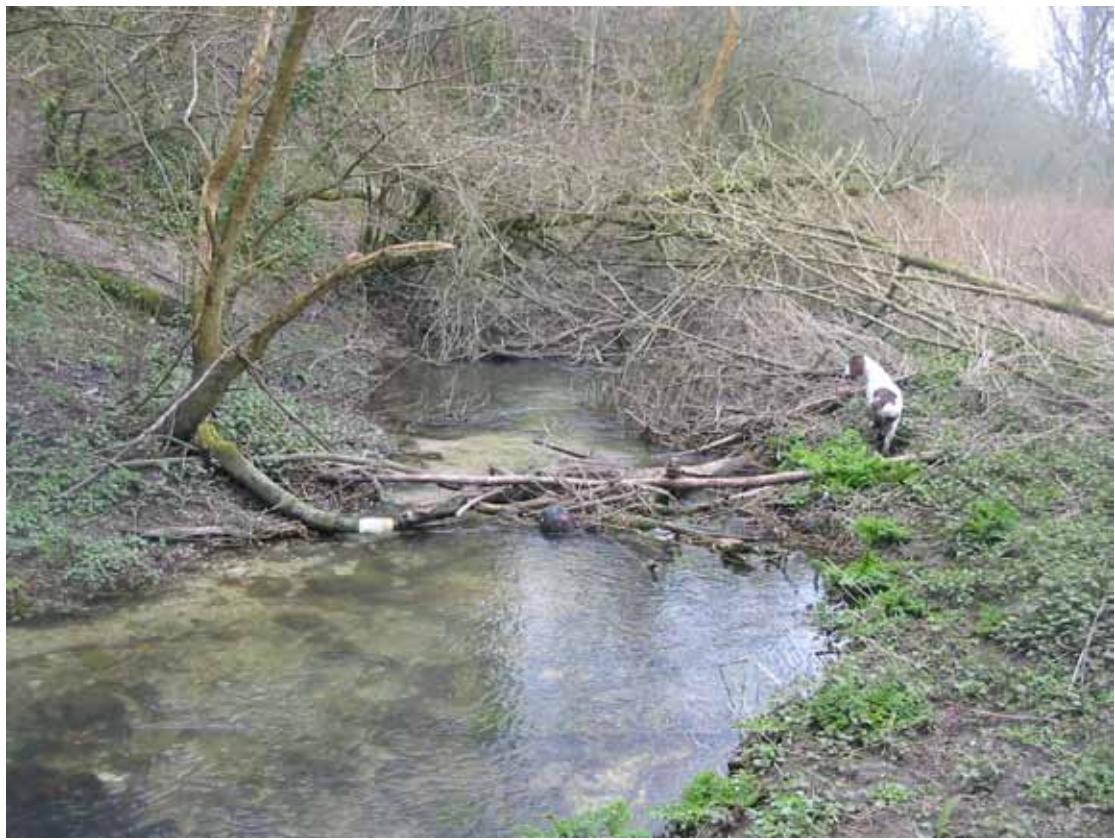
There were some sections of Large Woody Debris present in the channel. These provide excellent cover for juvenile trout and coarse fish, particularly during the winter period.

Typical length of channel with LWD visible.

- The large amount of LWD present was of great benefit to the stream. It provided excellent cover for a range of species, including fish. It concentrated flow, thus helping to shape the river’s morphology, by scouring and sorting the substrate, and causing differential deposition of sediment. The stable LWD dams also act to detain leaf litter that is the basic foodstuff of many ‘shredding’ species of macroinvertebrates. There should thus be a general policy of retaining LWD in the channel, except where it poses an unacceptable flood risk or prevents access along the channel for migrating fish. LWD should be stabilised within the channel by the use of stakes and wire if necessary.

- Trimming of branches and local realignment of LWD can be usefully undertaken, in order to optimise its beneficial impact on river processes. This can include scouring out of new pools or maintaining the depth of existing pools. LWD can also

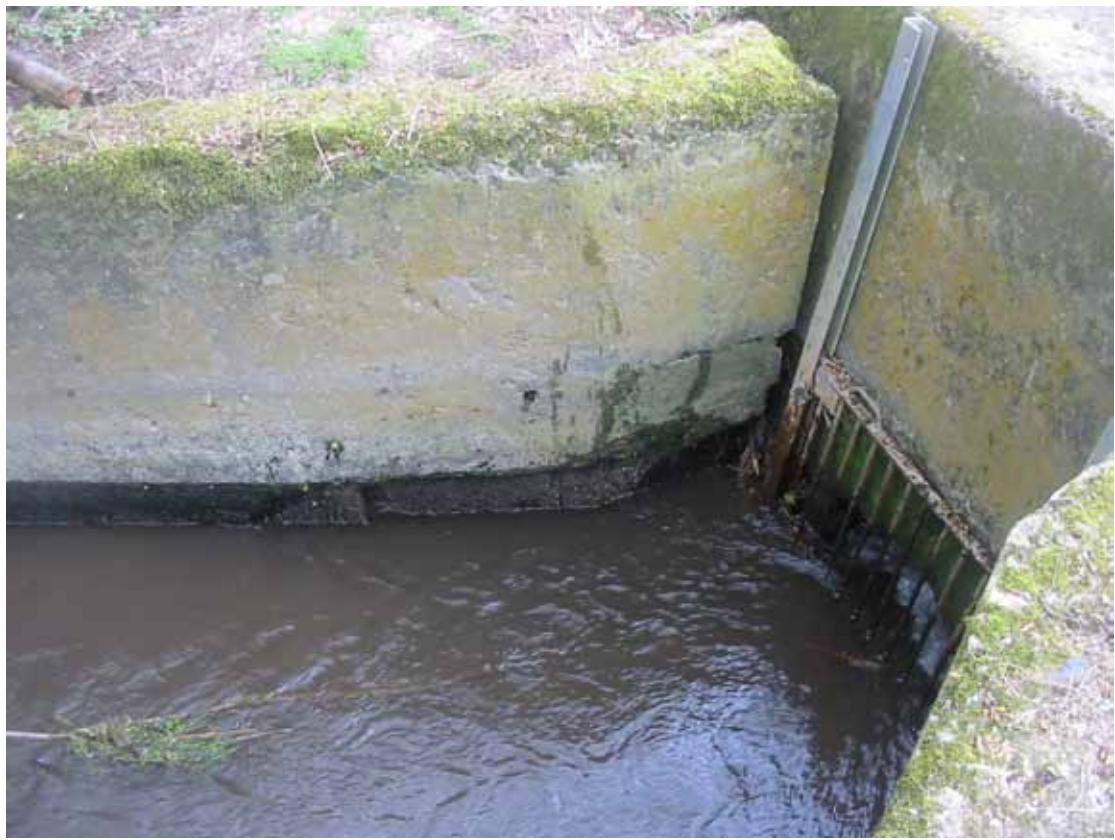
The downstream limit of the backstream was marked by its passage into a culvert, and hence under the main River Avon via a siphon. The channel then rejoined a second arm of the Avon at a lower level some 300m downstream. This area of the river is a well-used spawning area for both brown trout, and Atlantic salmon *Salmo salar*. On the day of the advisory visit, the screen across the upstream face of the culvert was blocked with debris. Removal of this lowered the upstream water level by around 150mm-200mm with a noticeable and beneficial impact on habitat quality.

Screened culvert. Note dark mark on wall showing level of water before unblocking culvert.

- Access for fish into the channel is currently limited by the screen across the culvert. The relatively narrow bar spacing leads to the screen blocking with debris, limiting fish migration, and raising the upstream water level, adversely affecting habitat quality. In order to reduce the incidence and impact of this, it is recommended that a new screen be fitted. This should slope backwards at an angle of around 45°, thus building in a degree of ‘self-cleaning’; accumulated debris will tend to be driven up the screen by flow, reducing blockage of the culvert. Bar spacing of the screen should be considered, with the widest spacing deemed acceptable for Health and Safety purposes adopted. Finally, it would be desirable if the screen could be cleaned at least once a week, either by a paid employee or by volunteers.

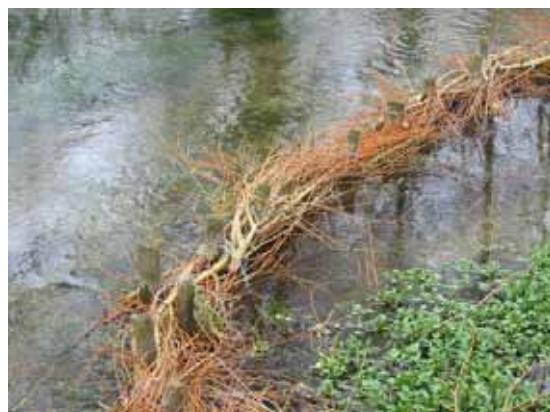
Faggot narrowing

- In locations where the channel was clearly overwide, large amounts of sediment had been deposited across the channel width. In order to narrow the channel, faggot bundles constructed from the brushwood risings from coppicing could be installed in marginal areas and secured using driven wooden stakes. This is a job that could easily be performed by volunteer labour, with each section of faggot narrowing undertaken as a separate and short project.

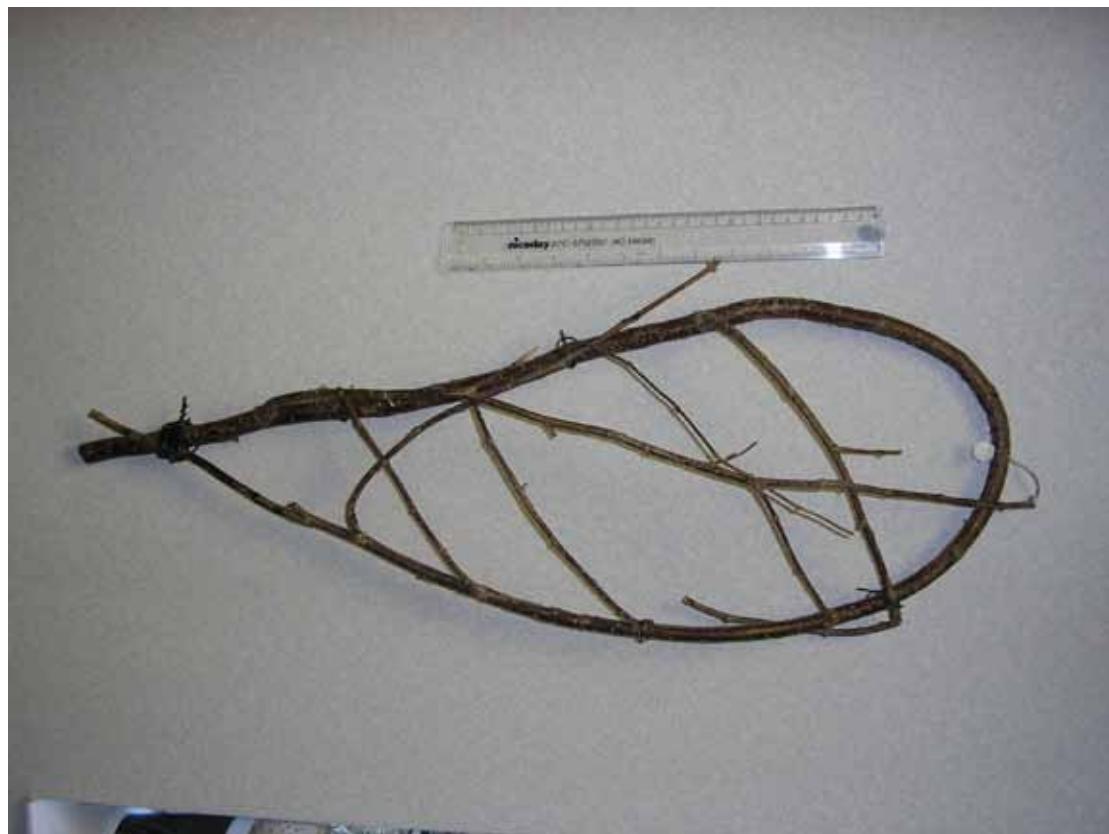
Constructed snowshoe prior to installation.

- It might be possible to introduce water crowfoot *Ranunculus* Spp to the backstream following the introduction of gravel. Simply translocating large fronds and ‘heeling’ them into the gravel with protection from grazing wildfowl may be adequate. Additional holdfasts can be provided by the use of wooden ‘snowshoes’. These are simple structures constructed from pliable fine twigs (often willow) that are then secured onto the bed where they collect strands of submerged vegetation encouraging it to root.

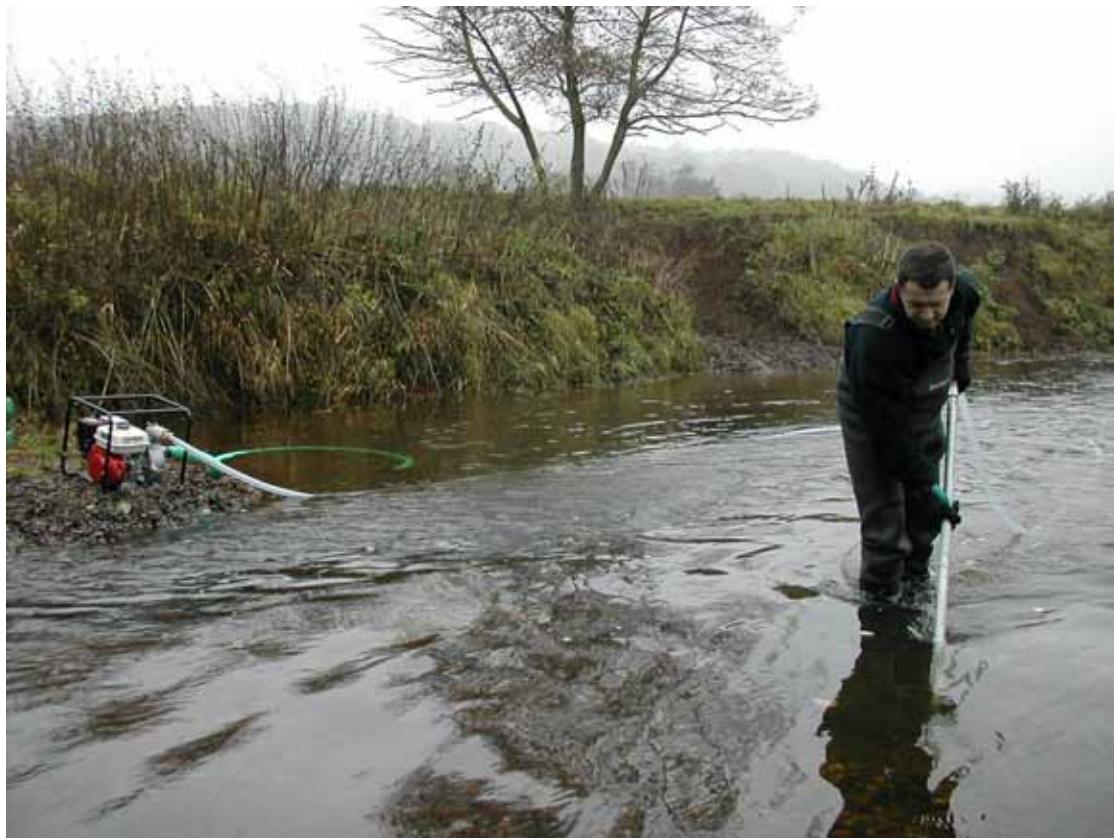
Gravel cleaning

- The gravel already present in channel appeared to be moderately imbedded (compacted). In order to increase trout spawning success, it is important that the consolidated gravel ‘pan’ is broken up. This can be achieved by the use of LWD groynes (see above). Additional benefit can be obtained by utilising gravel washing using water pumps with a modified outlet. Starting at the upstream limit of the gravel riffles, the pressurised water jet is played over the gravel, loosening it and removing much of the silt trapped within it. This would make an ideal training exercise for students, perhaps as part of the WTT Practical Visit (see below) or in conjunction with the Environment Agency.
