## River Avon – Middle Woodford

An advisory visit carried out by the Wild Trout Trust – April 2009

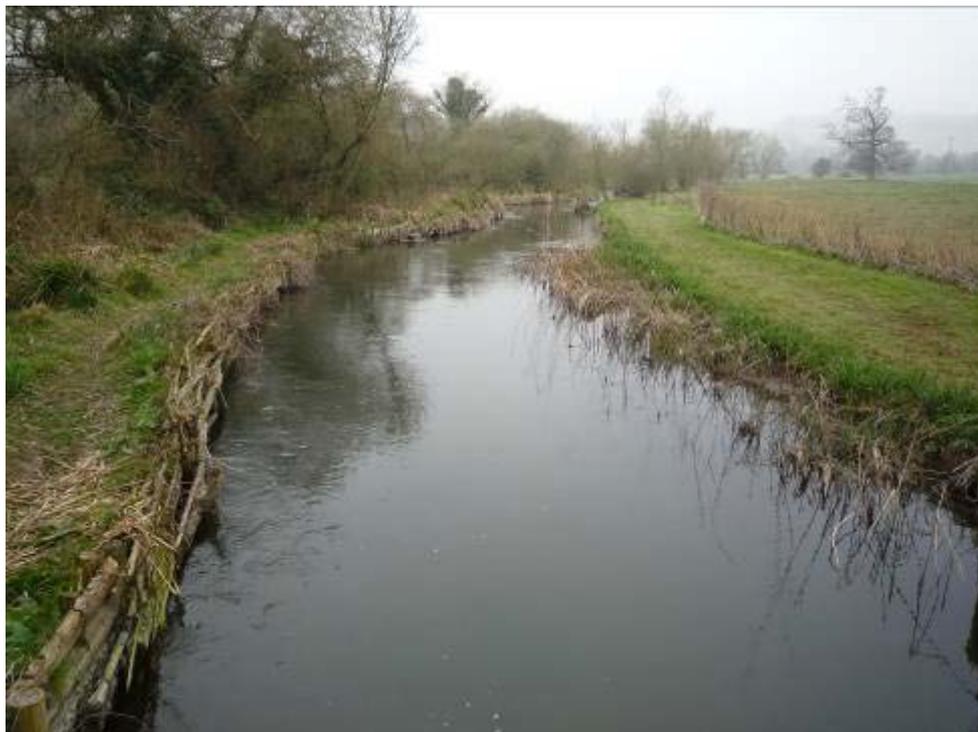
The banks are relatively low and soft along substantial lengths of the carrier. Low, soft banks on most chalk rivers usually support a diverse and rich flora of chalk river herbs and emergent plants, which provide great habitat and protect banks from excessive erosion. On the outside of some bends, there was evidence of bank-side erosion where the emergent fringe was thin and the wetted margin deep. Attempts to arrest this are on-going with a mixture of live willow spiling and parallel pole revetment.

Low banks, deep margins and bank repairs on the outside of a gentle bend

Where banks are eroding a very clear plan needs to be developed to tackle the problem. A combination of spilling on the outside of deep bends and developing wet shelves with a thick fringe of true aquatic emergent plants along straighter sections will provide enhanced bank protection and improve the ecology of the channel.

- Have a clear plan for dealing with erosion problems on all reaches. A wet fringe made up of emergent plants will be the best option on all but the deepest margins.

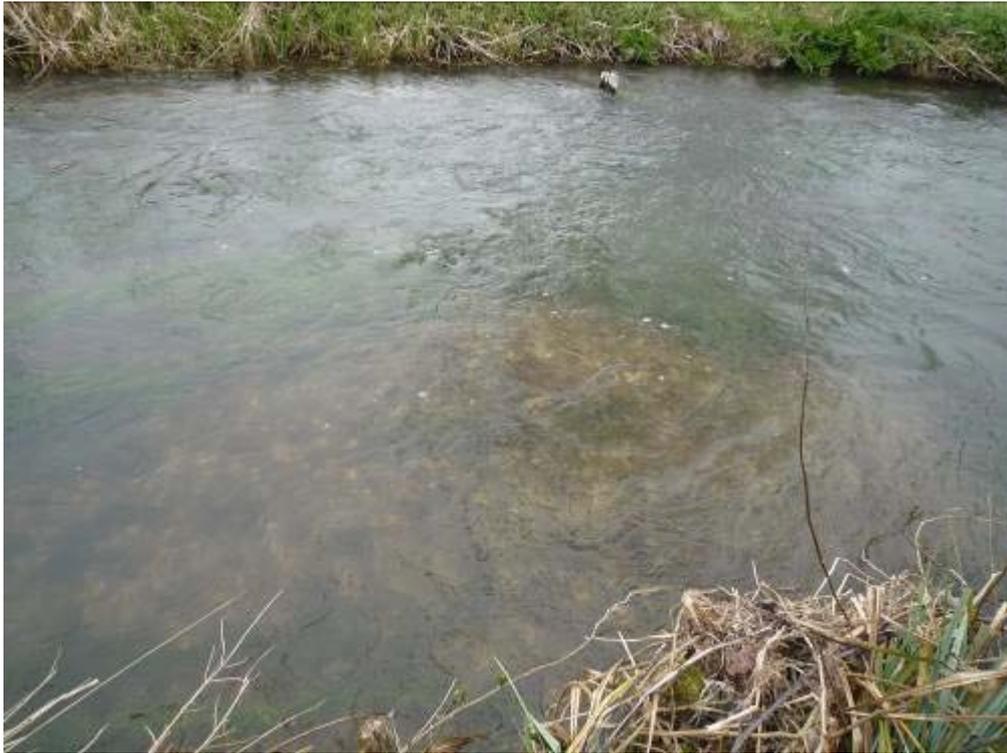
Strong flows can promote valuable habitat. Evidence of salmon spawning activity

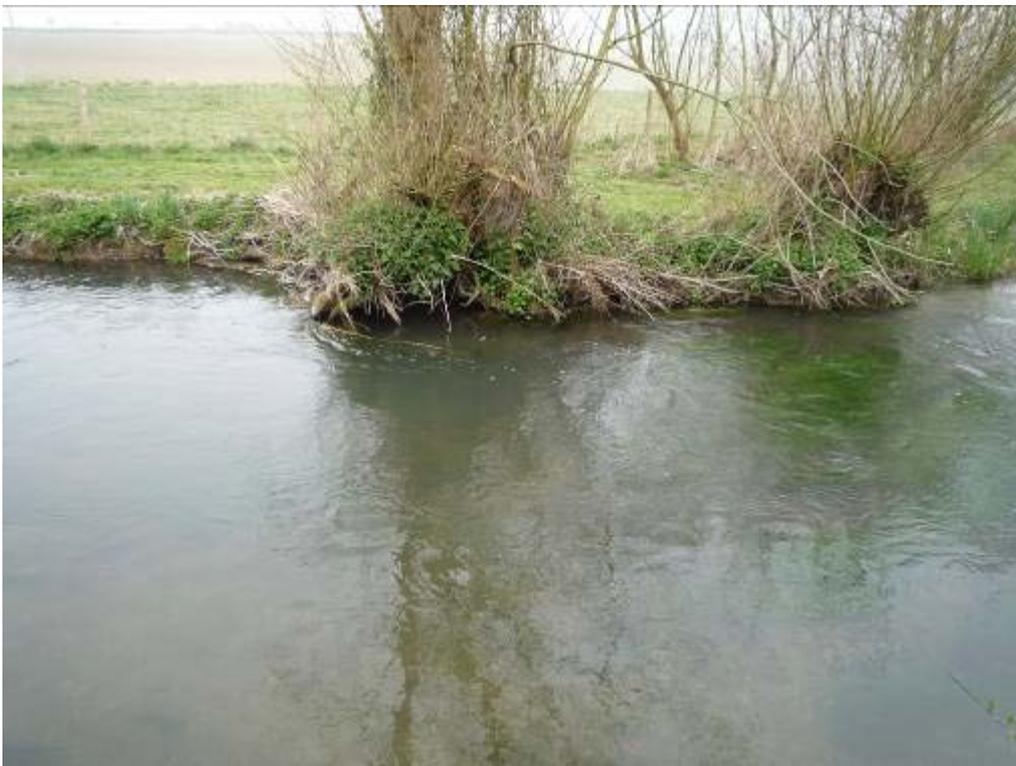
An old willow root system promoting some local bed scour and providing a great lie for a trout

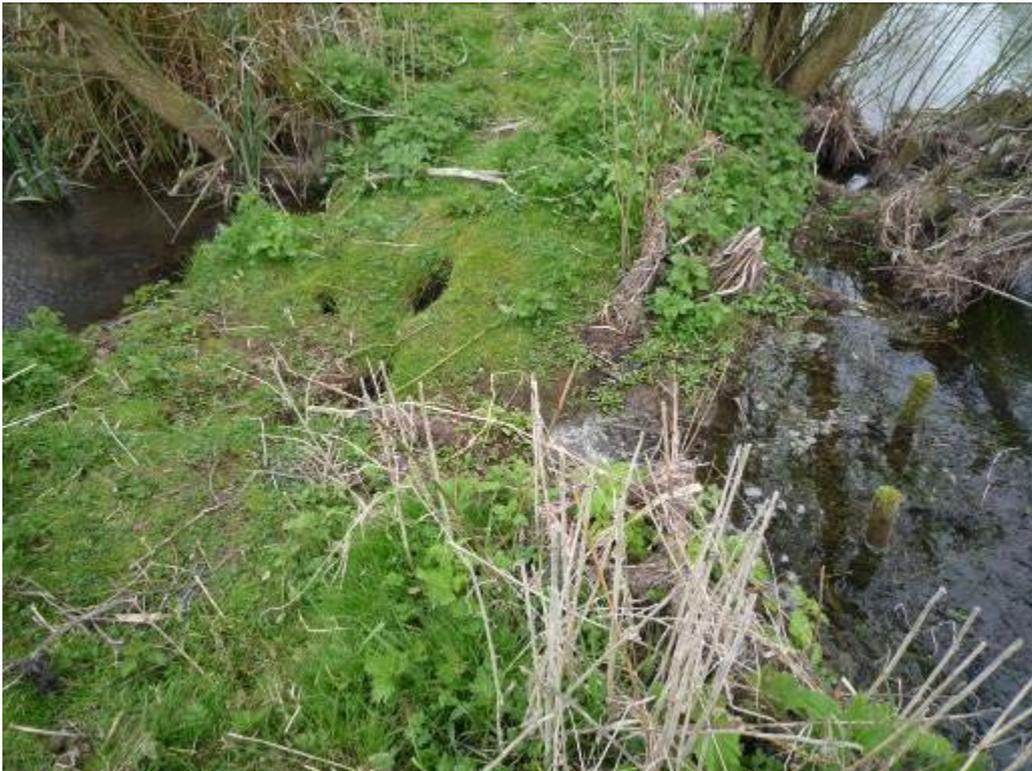
At the head of the carrier where the channel diverts off from the main river there is no formal structure. Currently the main river bank adjacent to this area is in very poor condition and there were several spots where water was beginning to breach through the bank. It is understood that flows in recent years have substantially increased via the carrier route and attempts are going to be made to repair the weak bank. It is imperative that this work is successful otherwise the trend of increased flows via this route will continue, potentially causing massive erosion along the carrier and depriving the main channel of valuable flows.

Main river bank a few meters upstream from the carrier take-off point. Hugely vulnerable to a major breach.

A clear strategy for managing flow splits between the main river and the carrier is required. Urgent action is needed to limit the erosion at the take-off point where banks are extremely vulnerable to a major breach. The main river hatches could be manipulated to draw more water through via the main river route.

- Throttle the flow running into the carrier by defending the bank adjacent to the take-off point.
- Investigate the potential for drawing the main river hatches fully to reduce flow in the carrier.

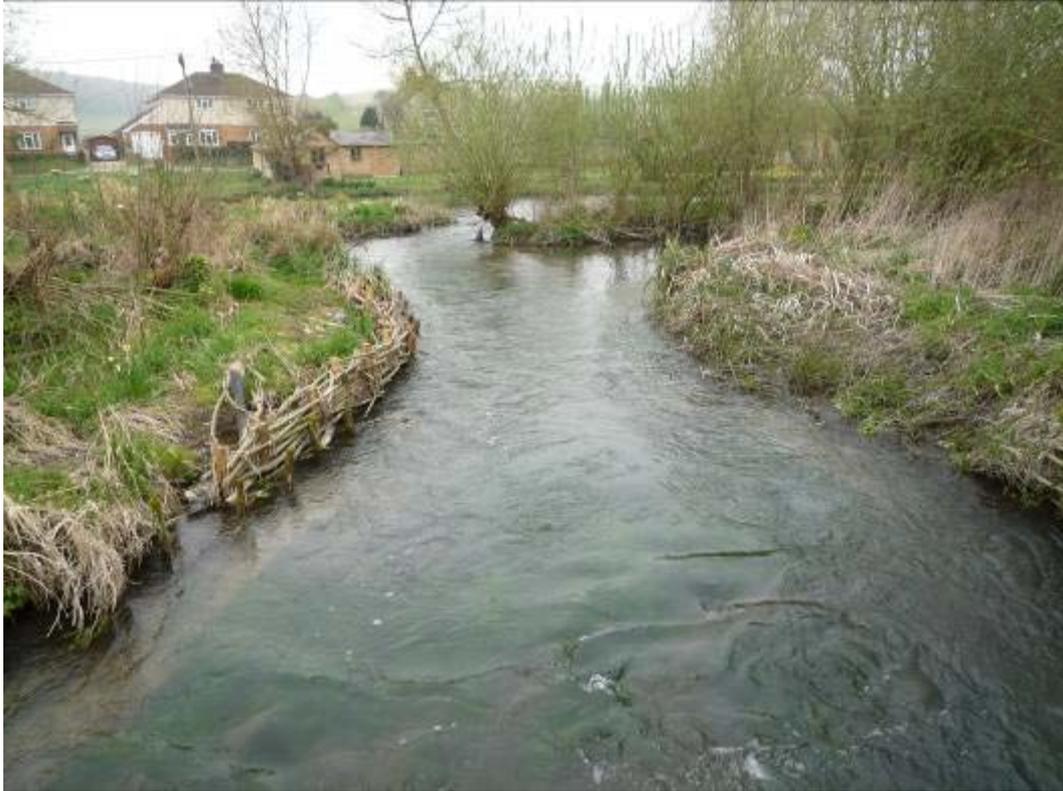
Twenty meters or so below the take-off area another section on the RB of the carrier has subjected to spiling work. It is essential that all materials used are live willow as a combination of live willow and dead willow or hazel will result in only partial protection. Willows that do take off will tie the bank together, however, they will also shade out the development of any local marginal emergent plant such as sedge (*Carex sp*) and will need to be tightly knitted together. Long sections of thick willow spiling will also require considerable maintenance in the future. If the bank defences are designed more to provide a temporary revetment, as in the case of using parallel trunks or poles then it is absolutely crucial to ensure that the margin behind the revetment is low, wet and sticky and planted up with a thick fringe of marginal emergent plants as soon as possible.

[A woven revetment on the RB – Is this live willow designed to grow or as bank revetment?](#)

A thick fringe of emergent plants has the capacity to absorb energy from the river, provide habitat and can knit the vulnerable bank soils together.

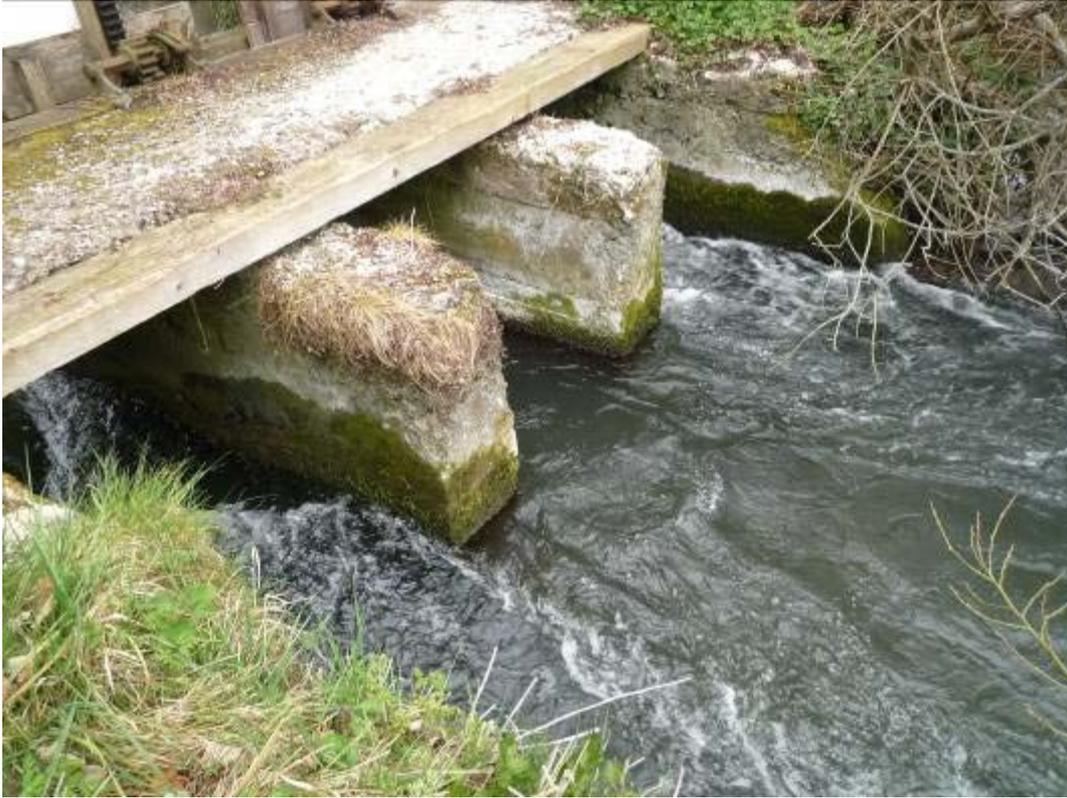
One possible option which may take some of the pressure off the carrier is to explore the back-watering impact of the hatch structure located on the main channel where it joins the bottom end of the carrier. This under shot hatch potentially enables the main river levels to be lowered. If the hatches were to be fully drawn this may enable more flow to be pulled down the main river route and throttle flows via the carrier. In doing so this will also reduce water levels in the lower milling channel (unless there is a structure at the bottom which could potentially be used to restore levels but not flow).

Undershot hatches on the main channel could be drawn and may reduce flows through the carrier thus reducing erosion pressures

An added benefit of drawing the hatches fully will be to locally increase water velocities in the main channel which in turn will potentially promote better quality habitats for trout.

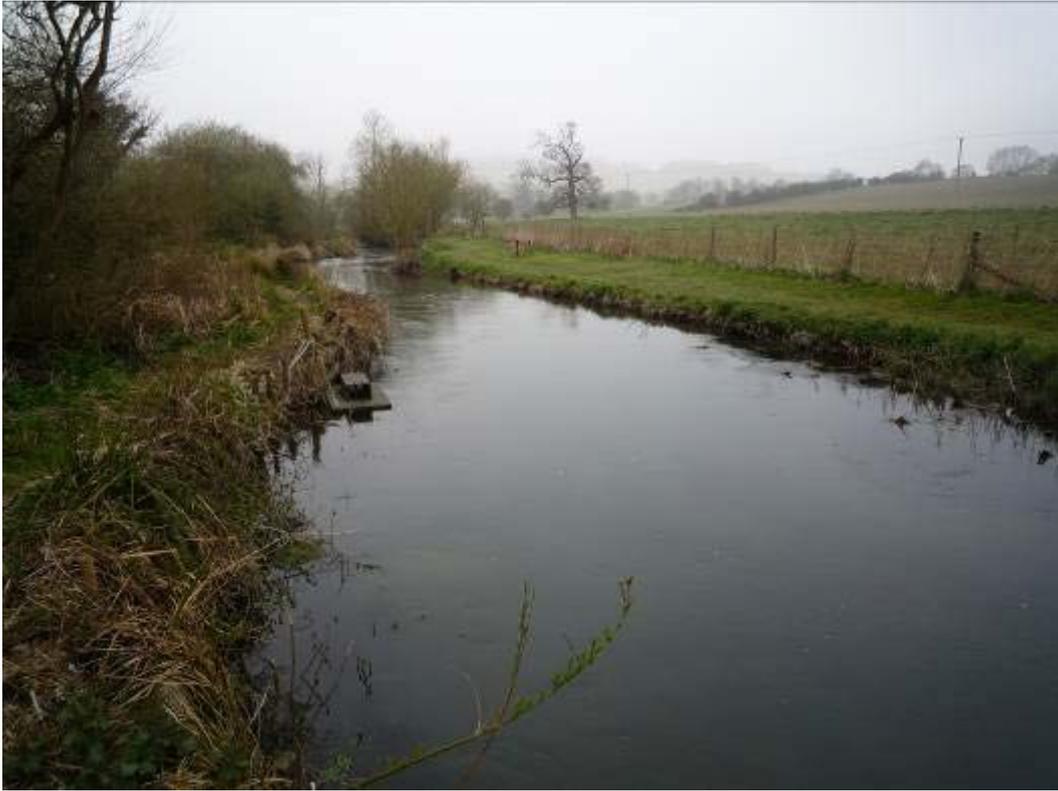
A section of the carrier where access for angling is maintained from both banks. Planting a few scrubby willows on the LB and restricting angling access to the RB would cut down on maintenance requirements and improving habitat for trout.

To enhance the channel further as a holding habitat for trout it would be sensible to restrict angling access to one bank. Dotted low scrubby willows along some of the more open margins will also help to improve its trout holding potential.

Restricting angling to one bank on such a narrow channel would seem to be a sensible option for reducing maintenance costs and improving habitat.

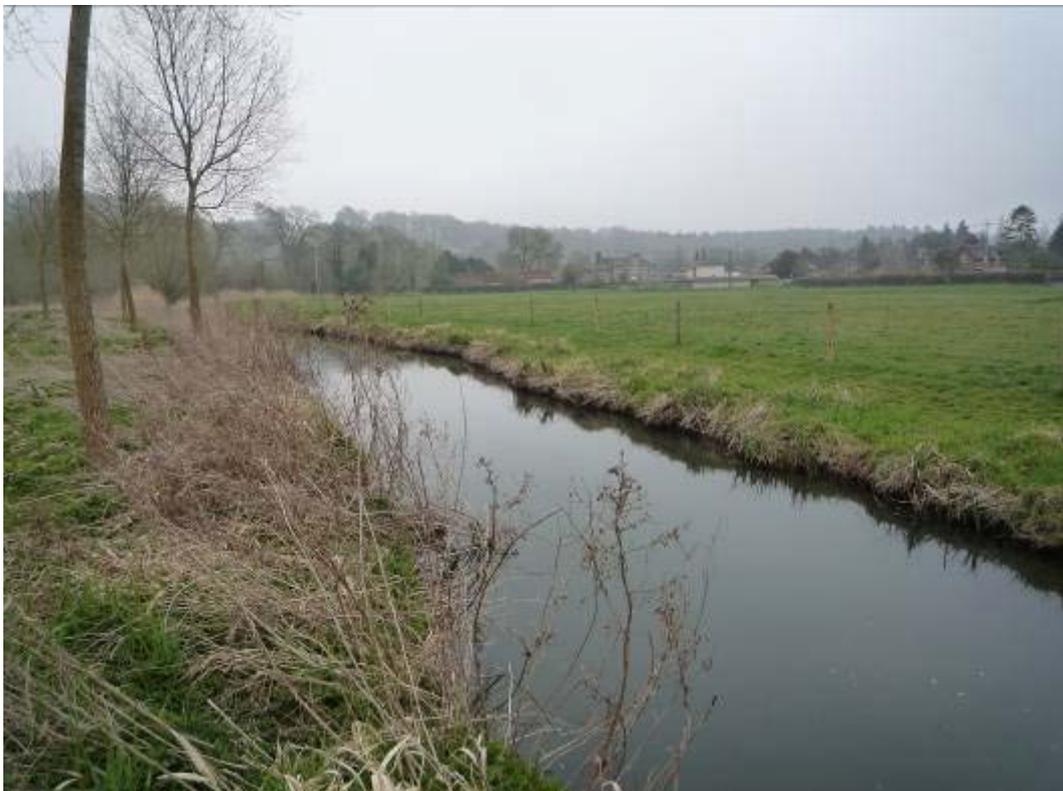
The mill channel at present only provides limited habitat for trout, being comparatively deep and slow flowing. It may well be that low densities of larger fish might drop back into a reach like this and perhaps the addition of more marginal cover on the RB would help to enhance its potential for fish holding.

A section of the mill channel which would benefit from some low scrubby cover on the RB

- Undertake a programme of tree planting with the odd willow or goat willow (*Salix caprea*) on long open sections of main river, carrier and mill stream to provide improved holding habitat.

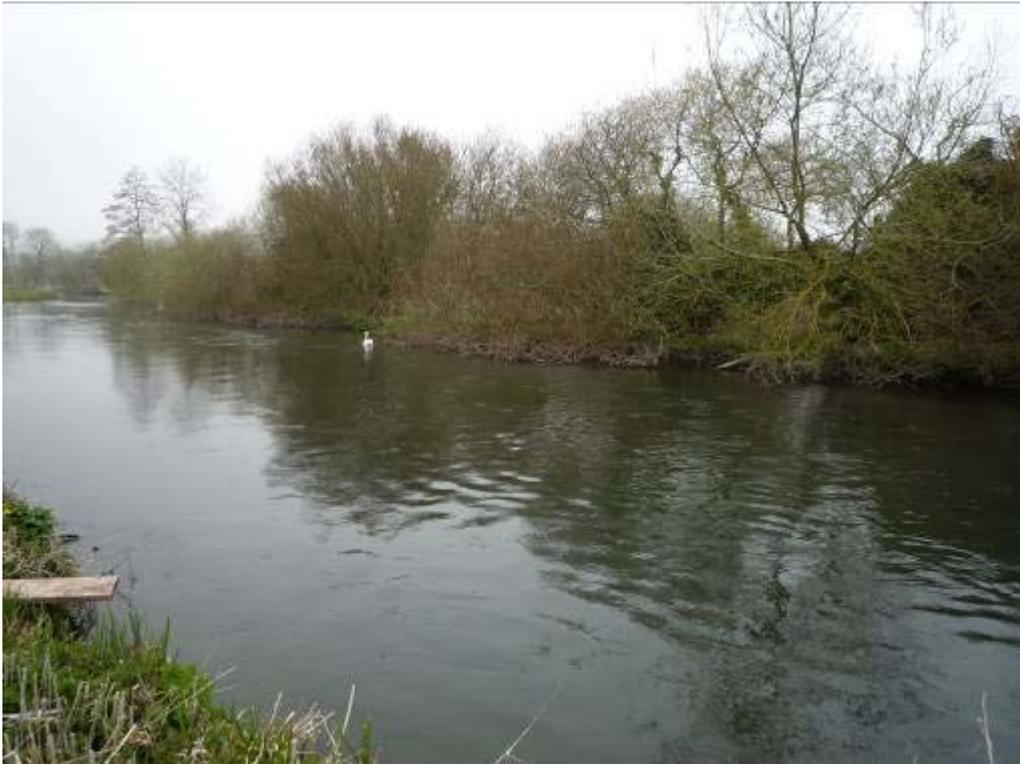
Much of the main channel running parallel with the carrier was in very good order with the LB margin largely unmanaged. The wide channel was not too deep to support some excellent beds of water crowfoot (*Ranunculus spp*) which provides numerous holding stations for both wild and stocked trout.

Main river channel with a wonderful wild margin proving a superb refuge for fish

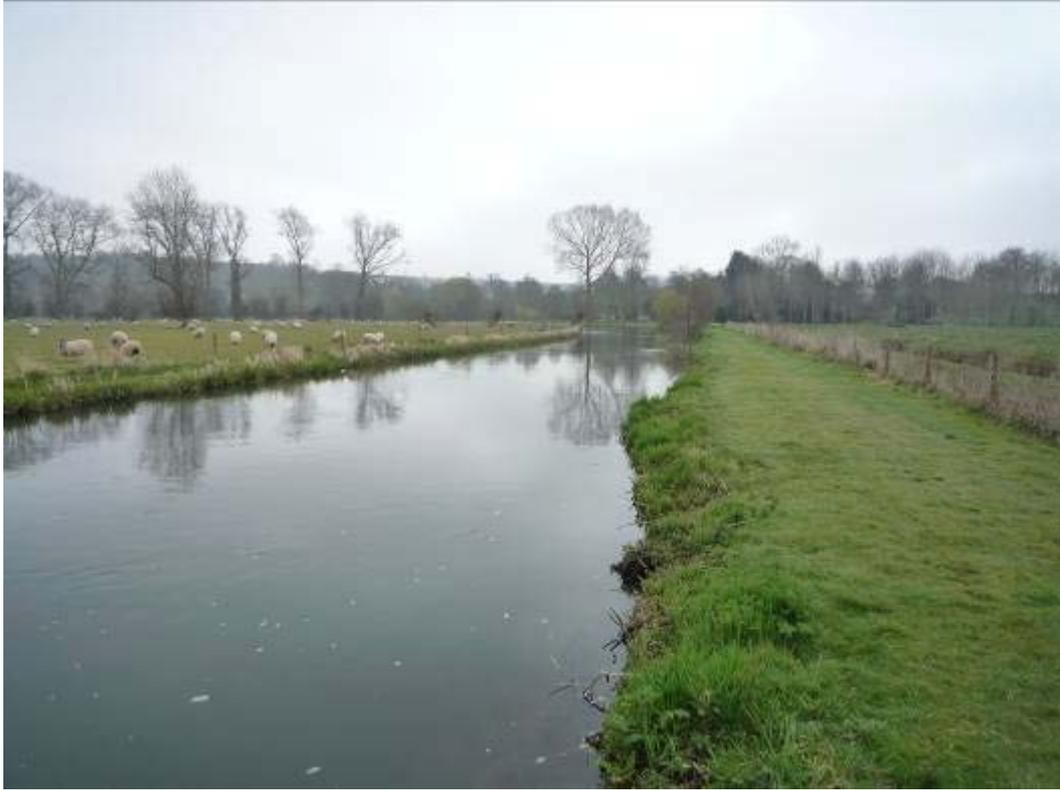
The most scope for improvement on the main channel lies in the top reach where there is precious little in the way of marginal cover and lots of evidence of bank erosion. Attempts to stabilise the banks with wooden toe boarding and some faggot work have largely failed. This is mainly due to the lack of any substantial fringe of suitable aquatic emergent plants. Most of the banks have been made up well above river level leading to normally dry conditions where only terrestrial plants can flourish. The slightly flashy nature of the Avon can mean that following long periods of heavy winter rain the river will rise up onto these areas and rip out unsuitable vegetation and nibble away at bare soils. A solution to this problem would be to re-revet the margin; but this time using faggot bundles set very low i.e. just above summer water levels. A one meter strip of the current bank should then be pushed down with a machine bucket to form a low wet backfill. It will be crucial to immediately plant this area with a thick assortment of locally procured emergent plants such as sedge, iris and reed.

Poor habitat for fish and fly life and no protection from bank erosion

The LB margin on the very top end of the main channel can be easily improved. A low squishy berm could be created by pushing the existing high margin into the river behind a low revetment. Planting the fringe with suitable aquatic emergent plants will be the key to success. The fringe should be at least a one metre thick, preferably two, and not subject to topping or mowing.

- On the upstream section of main river consider creating a low wet berm by using an excavator to push the dry bank down behind a low faggot revetment to form a better quality environment for marginal emergent plants. This will improved habitats for trout and fly-life and provide sustainable protection from erosion.

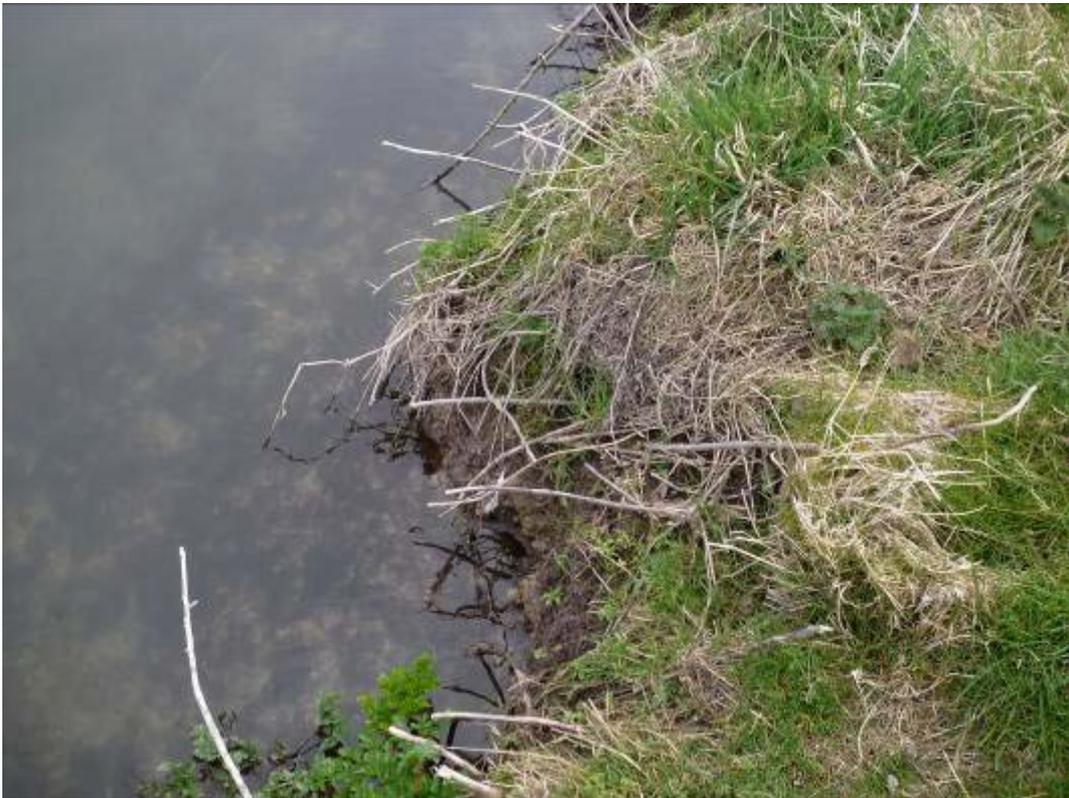
A margin of mown or strimmed grass over a steep slope of bare soil just waiting to be eroded by strong winter flows

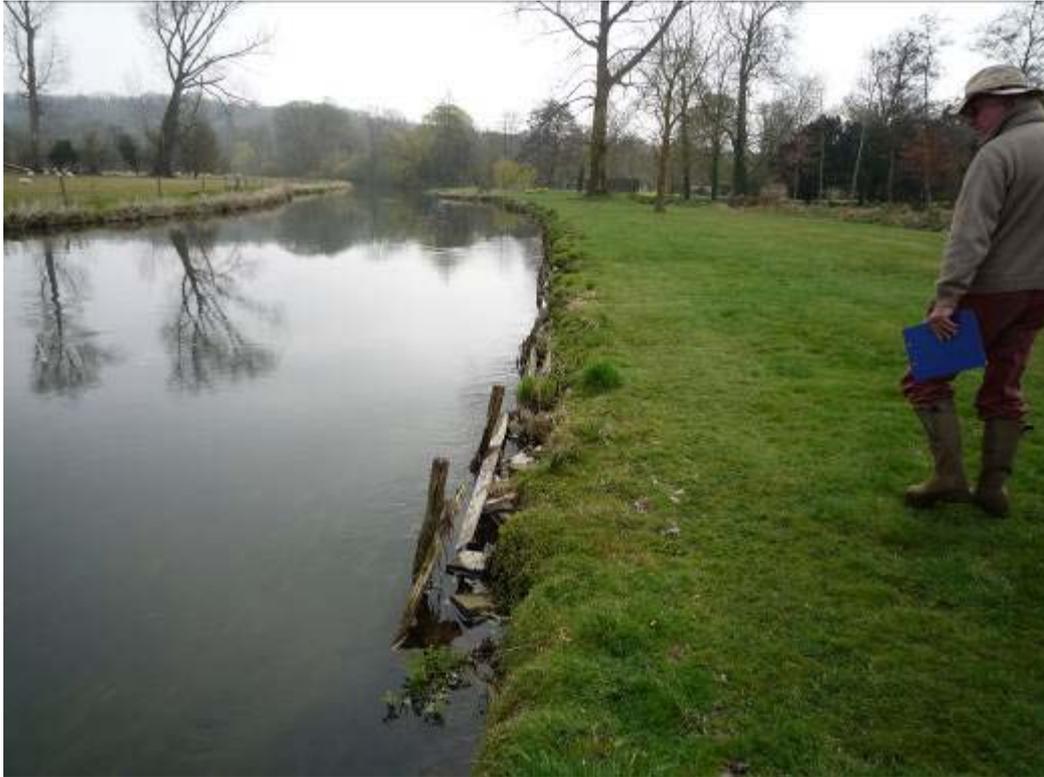
Area adjacent to the formal gardens where attempts to protect the bank have largely failed.

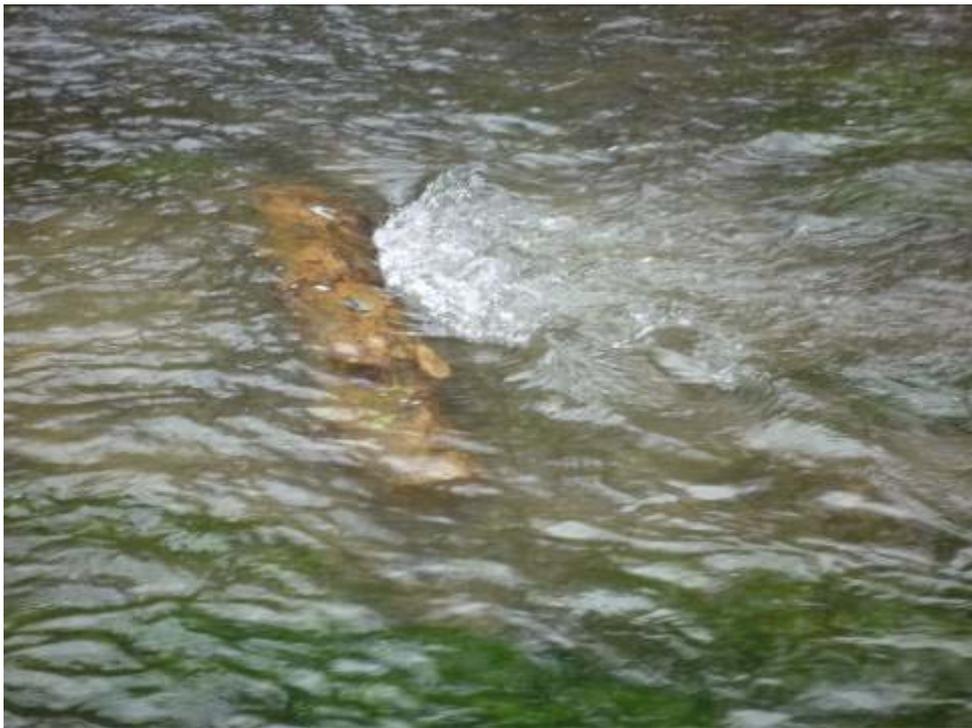
On a few of the shallower sections of main river and carrier it will be beneficial to consider pegging down some large pieces of woody debris (LWD) to help to locally scour and sort river bed gravels. This simple technique enables fresh spawning substrate to be blown up into bars which creates both good holding pots but also ramps of loose gravel ideal for salmonid spawning.

An example of a trunk section pegged to the river bed with steel re-enforcing bar. An easy way to create good spawning habitat

- On shallower, gravelly sections peg down the odd section of large woody debris (LWD) to locally scour and sort river bed gravels and improve spawning potential.
