River Avon (Bristol) – Sommerfords Fishing Association

An advisory visit carried out by the Wild Trout Trust – March 2012

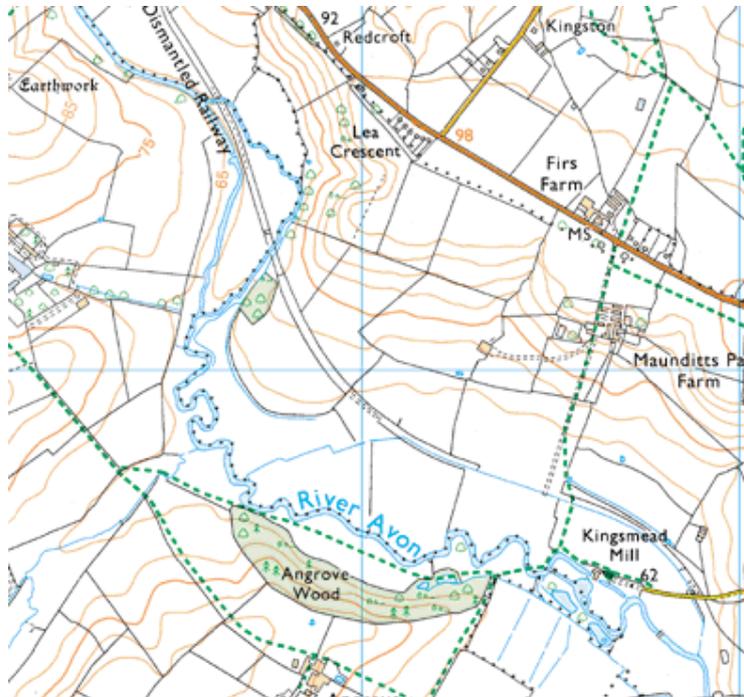
Sommerfords FA beat above Kingsmead Mill

This report is the output of a Wild Trout Trust advisory visit undertaken on a stretch of the River Avon on waters controlled by the Sommerfords Fishing Association. The club has approximately 11Km of fishing but the advisory visit was restricted to the top beat, above Kingsmead Mill NGR ST 956844.

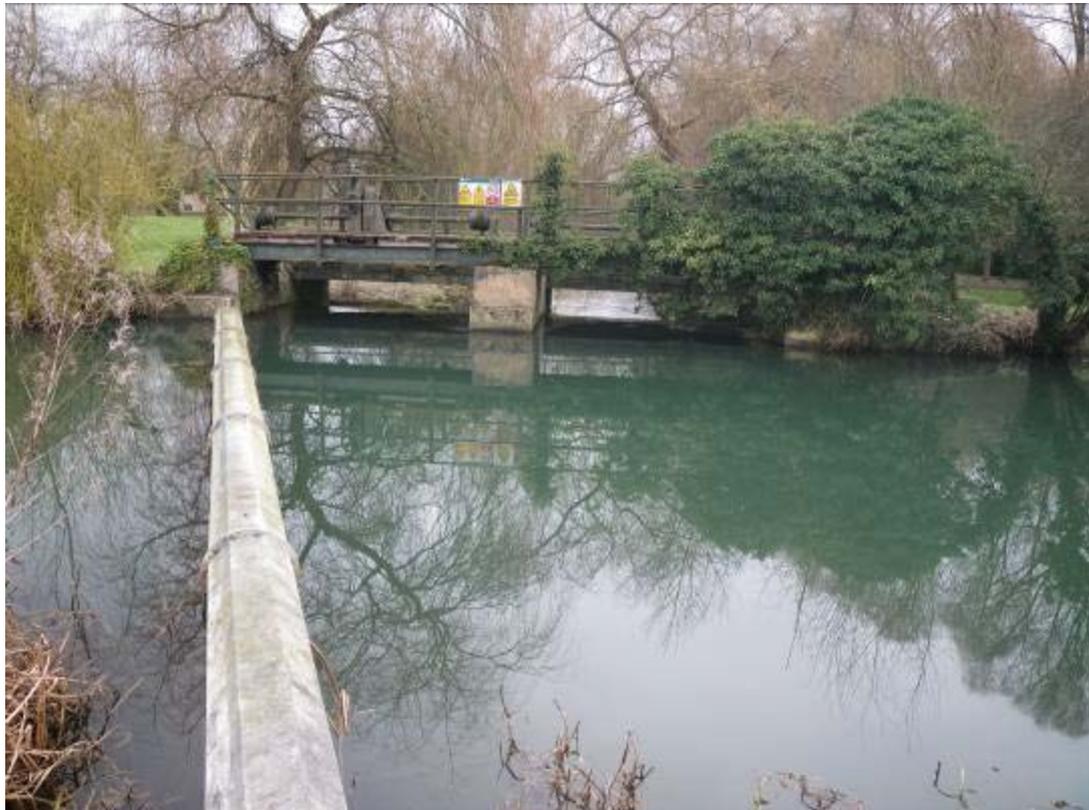
The river upstream of the Kingsmead Mill is very heavily influenced by the large impounding weirs (photo1) located at this site. It was not possible to closely inspect the structures but it is assumed that there are no fish passes, or bypass channels. The lack of any usable access route for fish isolates the top beat from fish wishing to migrate upstream. Fish species such as trout, barbel and dace are known to migrate significant distances upstream to find high quality habitat for spawning and then drop back downstream after spawning. Juvenile fish will be washed downstream over the weir, particularly following summer spates with no hope of re-colonising sections upstream. The lack of connectivity is an issue for many rivers and is one that is usually flagged up in local River Basin District Management Plans.

Photo 1. Kingsmead Mill (main weir)

The impact of the hatches at Sommerfords weir on upstream habitat quality and fish connectivity cannot be over stated. Options for reducing the impacts should be explored with the EA and Mill owner.

- Explore options with the EA and Mill owners for modifications to the operation and management of the weir structure a Kingmead Mill.
- Open up a dialogue with the local land owner to negotiate wider buffer zones between the banks and cultivated meadows.

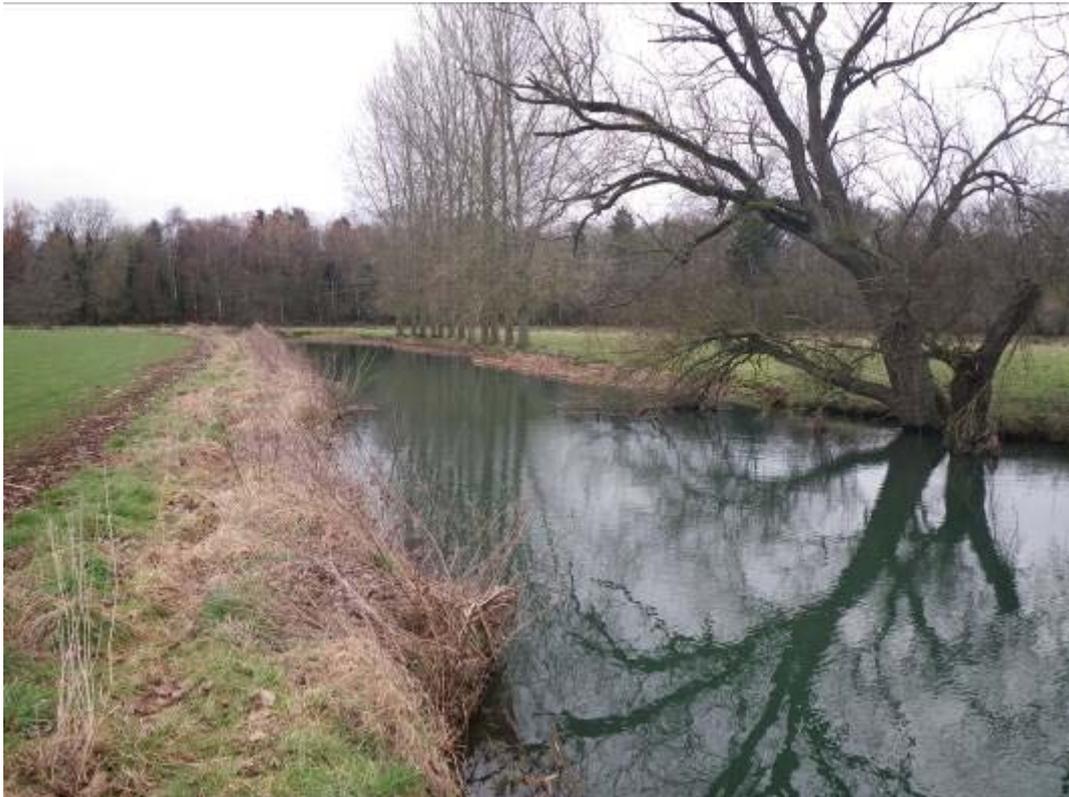
Upstream of the weir, the river does have a gently meandering planform. However, any natural variations in river bed topography are completely drowned by the impounding effect of the weir, resulting in long, slow, deep glide habitat (photo 2) dominating the first kilometre of channel. It was not possible to see the river bed but it is highly likely to be predominantly soft deposited sediments. Opportunities for enhancing this lower section of the top beat are dependent upon modifications to the weir, either simply through management of hatches or gates, or via a capital project to modify or remove the structure altogether. This issue is discussed further in the conclusions section of this report.

Photo 2. Hundreds of metres of deep glide upstream of the weir. A poor environment for flow-loving fish species such as barbel, trout and dace.

- Consider tree planting on the open impounded sections of the lower reach.

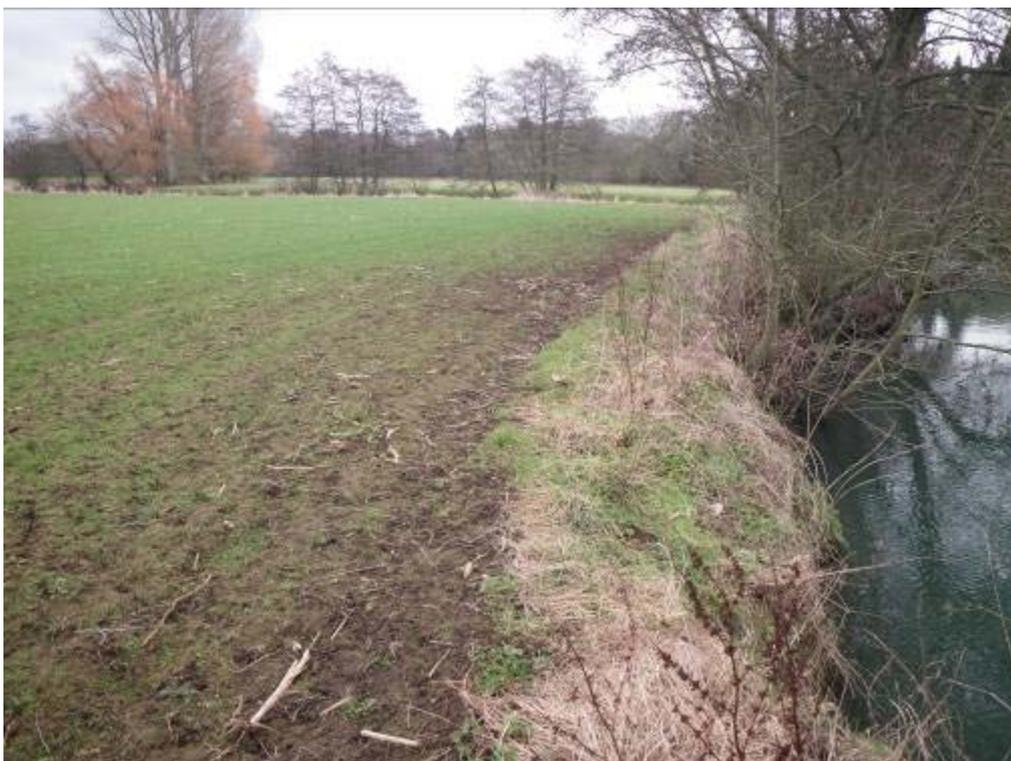
Further pressure is put on the river from arable land use (photo 3) adjacent to the LHB, also visible in photo 2 above. It appears that some of these meadows are now seeded for permanent pasture but they may well be part of a crop rotation scheme which extends in places to virtually the top of the bank. Some narrow uncultivated buffer strips between the top of the bank and the edge of the fields exist, however, they are far too small to be of any significant value. Wide buffer zones are critically important for filtering out nutrients, for preventing excessive sediments reaching the river and for bank protection during out-of-bank flood events.

Photo 3. A recent maize field reseeded for pasture. Note the vulnerable top soils within a couple of metres of the river

Negotiate with the adjacent land owners for wider buffer zones between the top of the river banks and the edge of fields and meadows. Currently the river is failing WFD targets for phosphates and actions to improve diffuse pollution are a priority.

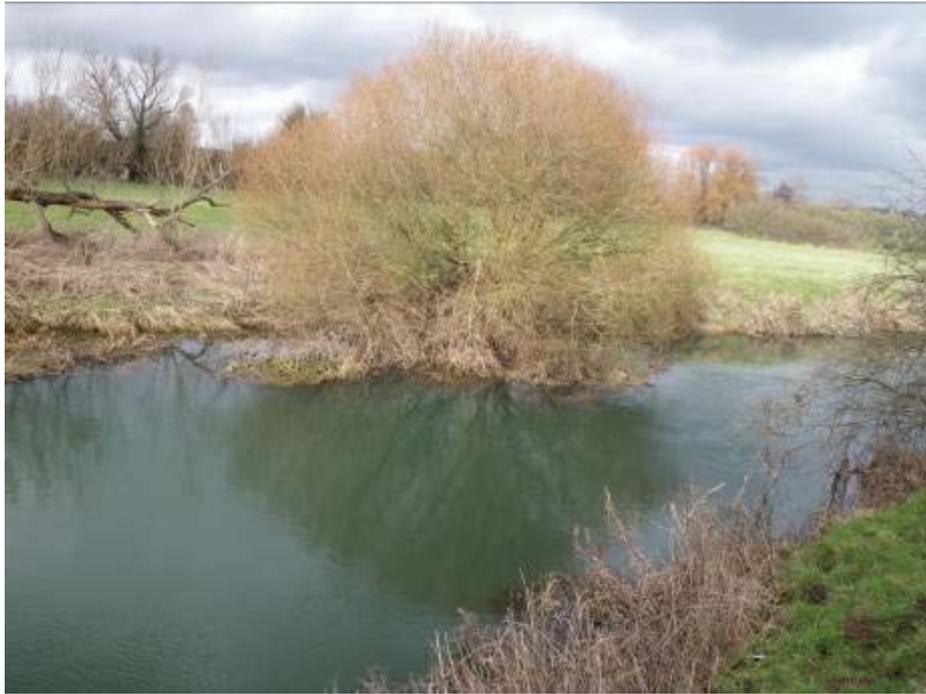
Bankside cover throughout the middle and upper reaches is much more luxuriant and fish-friendly with good examples of valuable marginal trees (photo 4) and fallen large woody debris (LWD) having been left in the channel. Both large and coarse woody debris are critical components of good river habitat. Leaving as much material in the channel as possible helps to promote active river bed scour, sorting of spawning gravels, the provision of safe predator-proof lies and a primary source of food for many grazing invertebrates. The banks of the Avon are often soft and friable and leaving fallen trees without any intervention may cause some bank erosion (photo 5). In such cases, whole trees, trunks, or large branches can be moved, re-positioned and secured to promote bed scour rather than bank erosion. Indeed woody debris can be used to protect banks from erosion as well as provide habitats for fish. If woody debris is causing an issue the key message is 'move it but don't remove it!' Photo 6 shows a good example of where fallen woody debris is likely to create some excellent habitat.

Photo 4 A great example of a willow providing superb habitat and also acting as a flow deflector

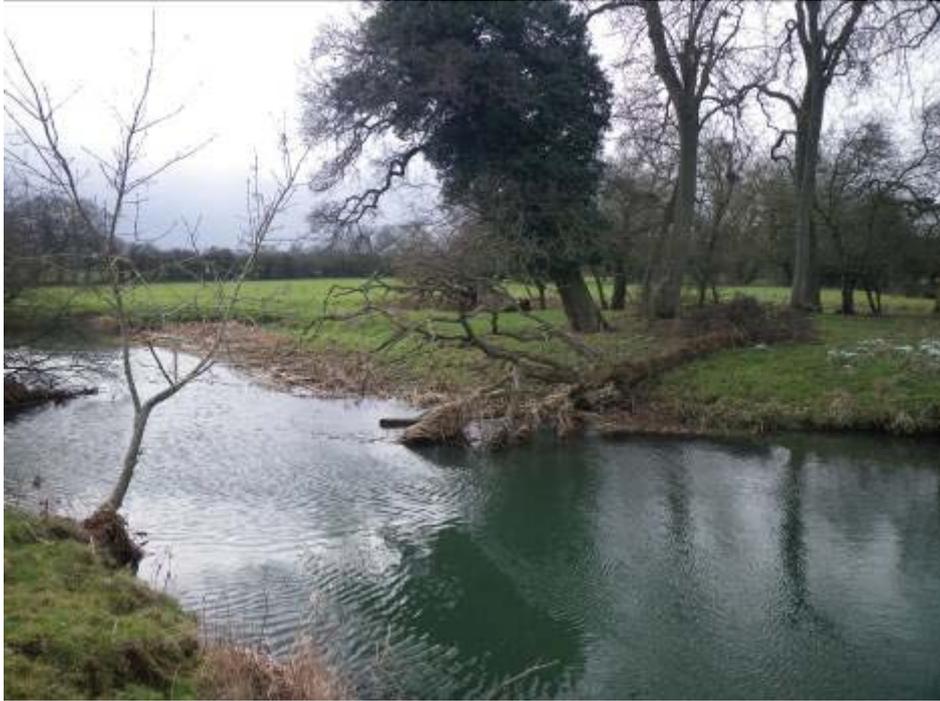
Photo 6 Valuable habitat

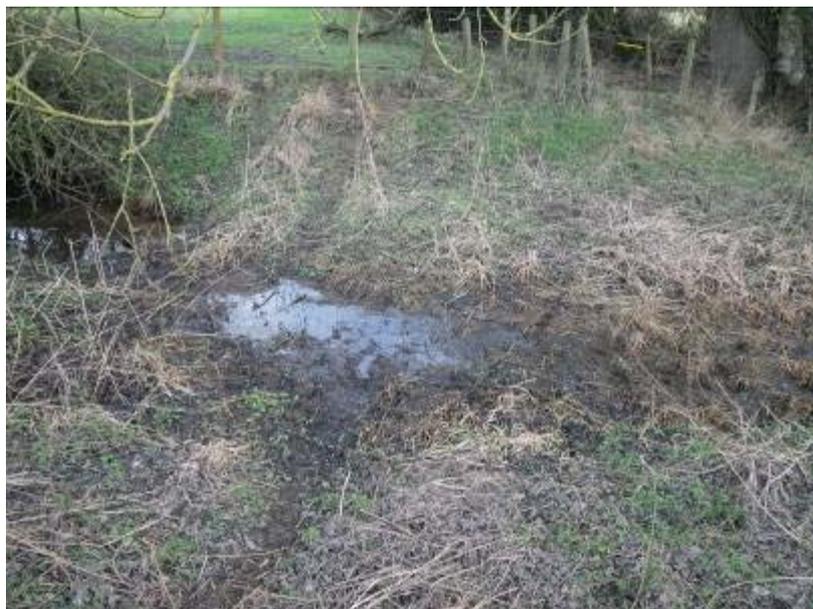
Photo 9. Central section of the backwater where the channel has virtually filled in already

There are options, however, for developing the back channel so that it does provide some habitat likely to benefit local fish communities by plugging the central section (photo 9) so that the channel becomes in effect two, connected oxbows. The top (photo 10) and bottom connections with the main river could be deepened and widened with a machine to create two significant backwater features. The banks could be battered back to create an ideal shallow shelving margin, perfect for summer fry and the backwaters would also make excellent winter refuge for many coarse fish during big winter flood events.

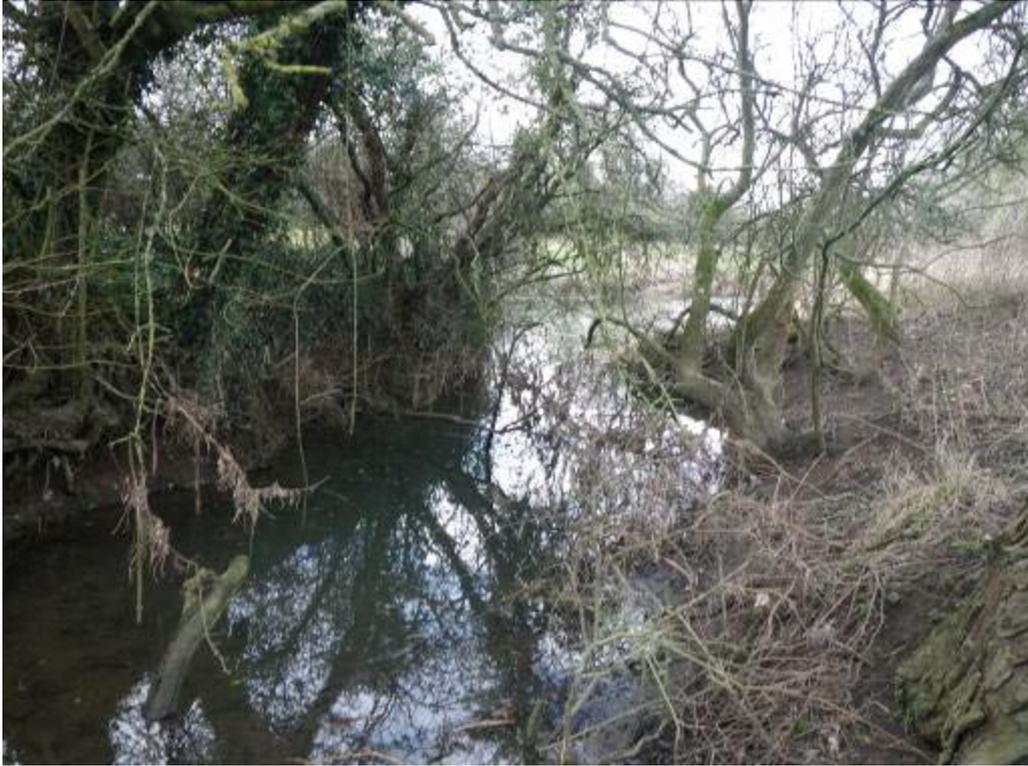
Photo 10. The entrance and exit to the backwater could be substantially enlarged to create two large backwater habitats ideal for summer coarse fish fry and provide improved winter holding habitat.

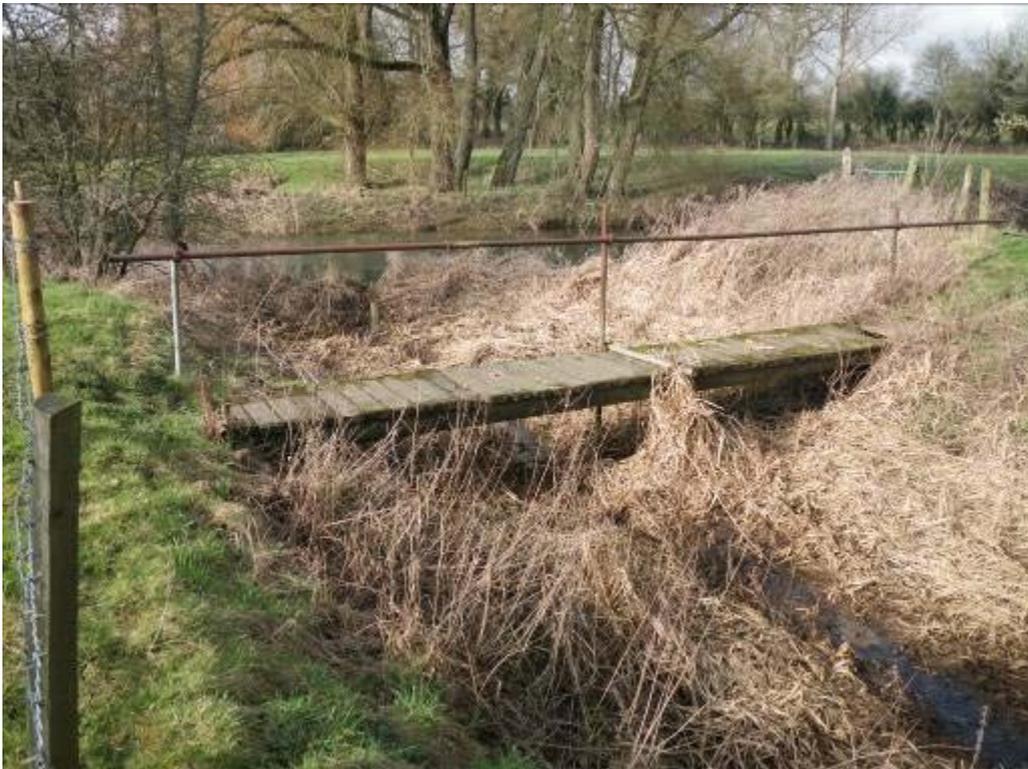
Photo 11 Backwater confluence with the main channel.

Any connected backwater will be prone to settling sediments and will require periodic maintenance (every 3 to 5 years) to keep the habitat in optimum condition. Connected backwater habitats on many of our rivers are rare habitats and are often not recognised as being crucial for maintaining healthy populations of coarse fish.

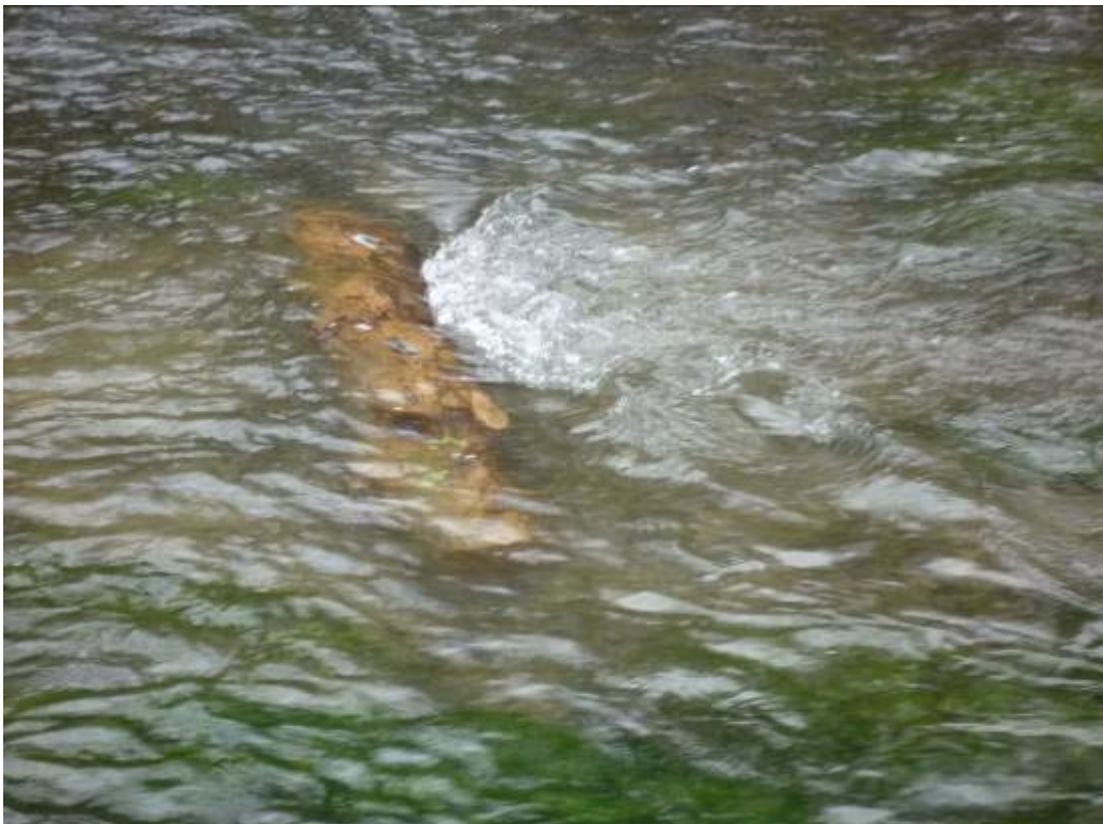
Photo 12. A section of tree trunk pegged at right angles to the flow to promote score of bed gravels and improved spawning opportunities for spawning.

- Implement a programme of gravel enhancements by pegging in sections of LWD to promote local bed scour and breaking up of the gravel crust with fencing spikes or gravel cleaning pumps.

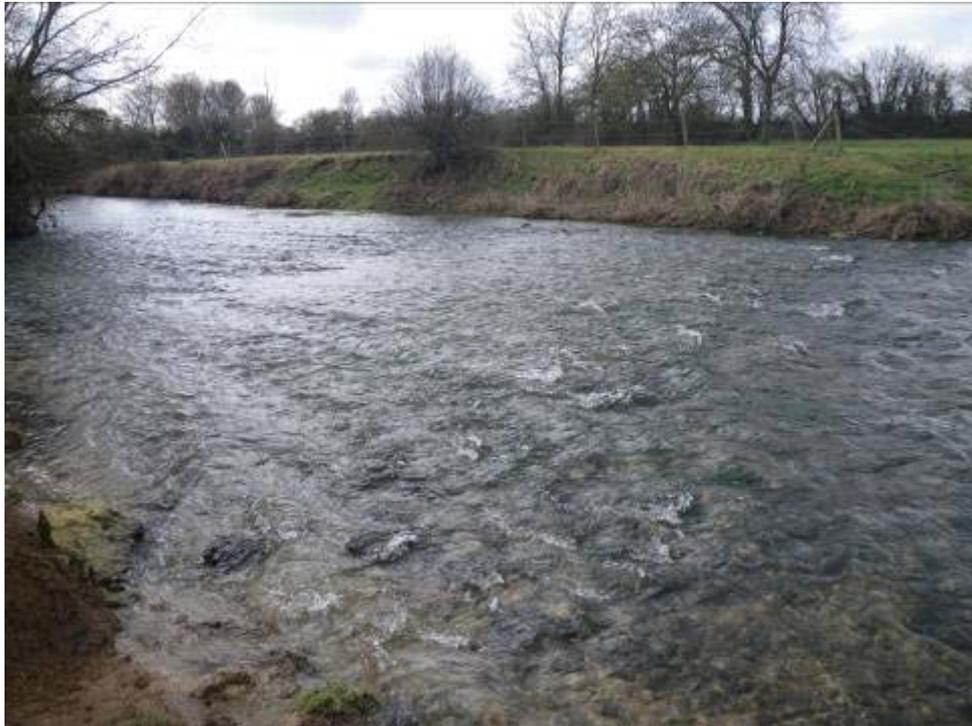
On one long section of potentially good trout juvenile habitat (photo 13) there is a chronic lack of marginal cover. This could easily be rectified by securing a line of whole felled thorn trees or large brash bundles layed into the margins and wired, or cabled to the odd driven post.

Photo 13. Habitat for fry could be provided by introducing brash cover into the RHB margin

- Look at options for the provision of shallow backwater habitat at the mouth of joining backwaters.
- Use hinged trees or tethered brash bundles installed in the margins, especially in the margins of shallow runs to provide enhance winter cover.

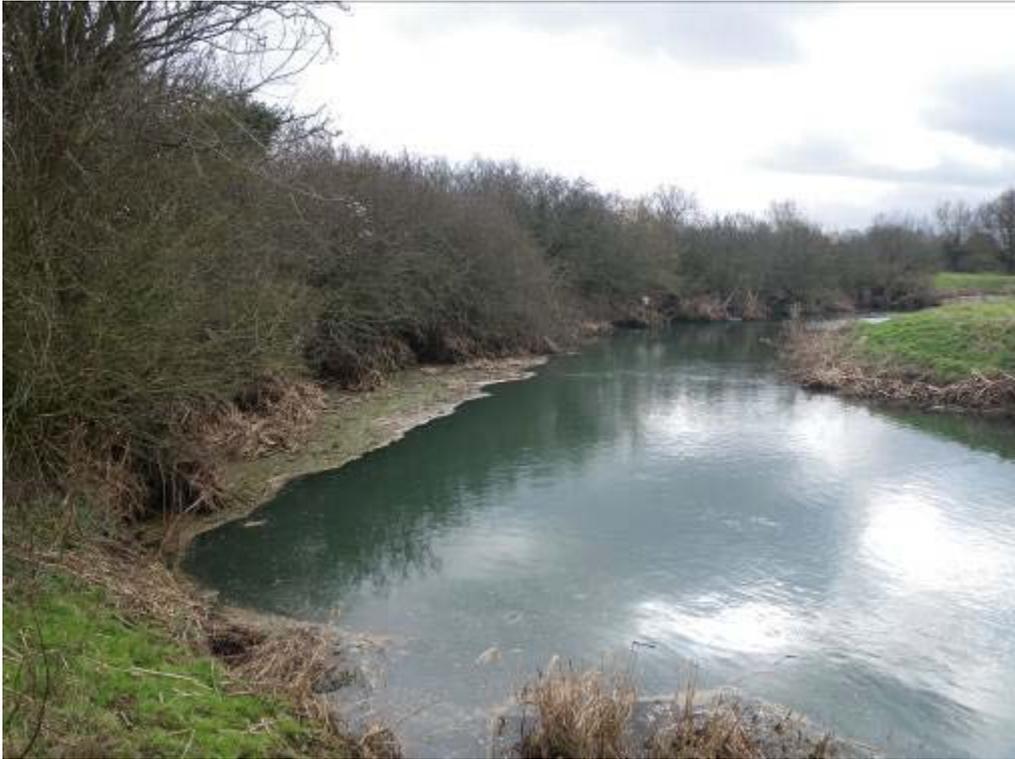
In some sections there is plenty of high quality marginal tree cover. In one or two areas (photo 14), the odd tree could be hinged into the margins to create fantastic predator-proof cover and also provide a living flow deflector that will locally sweep sediments away from the central river bed locations.

Photo 14. The left bank tree cover provides opportunities for folding in the odd hinged tree to create improved habitat within the channel.

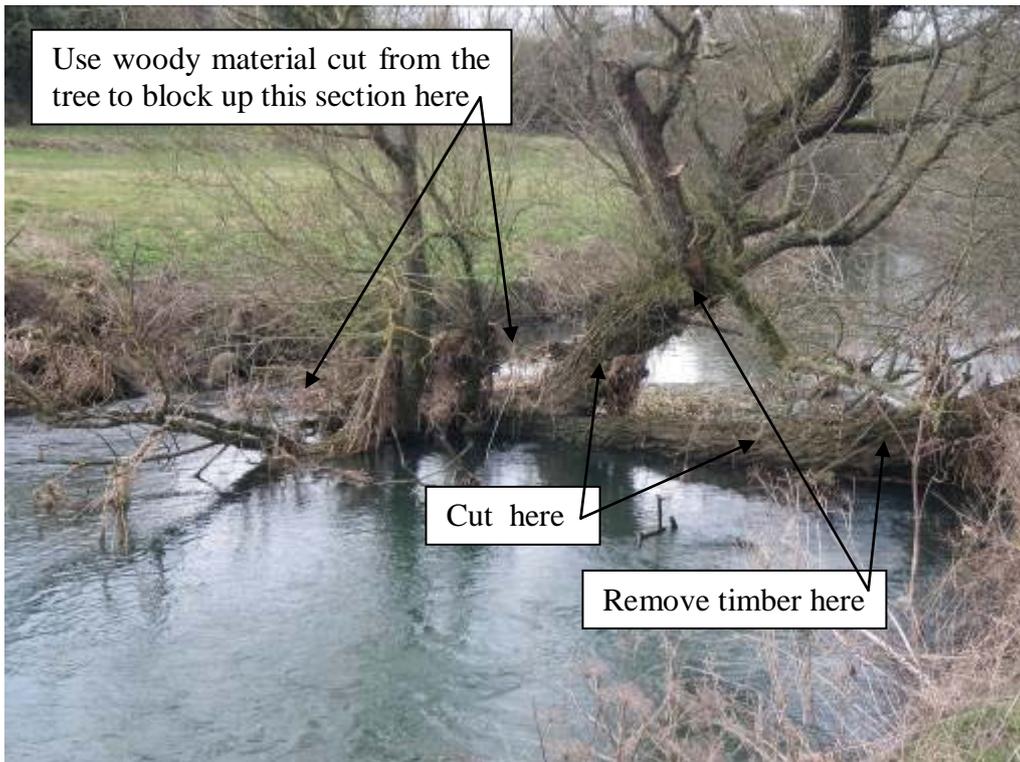
Photo 15. Sensitive management of fallen trees is essential.

- Keep control of invasive in-channel emergent plants by cutting narrow channels to avoid any "back up" effects.
- Undertake sensitive management of fallen woody debris and use it to create enhanced in-channel habitats.
