River Avon (Devon) – Avon Fishing Association

An advisory visit carried out by the Wild Trout Trust – April 2011

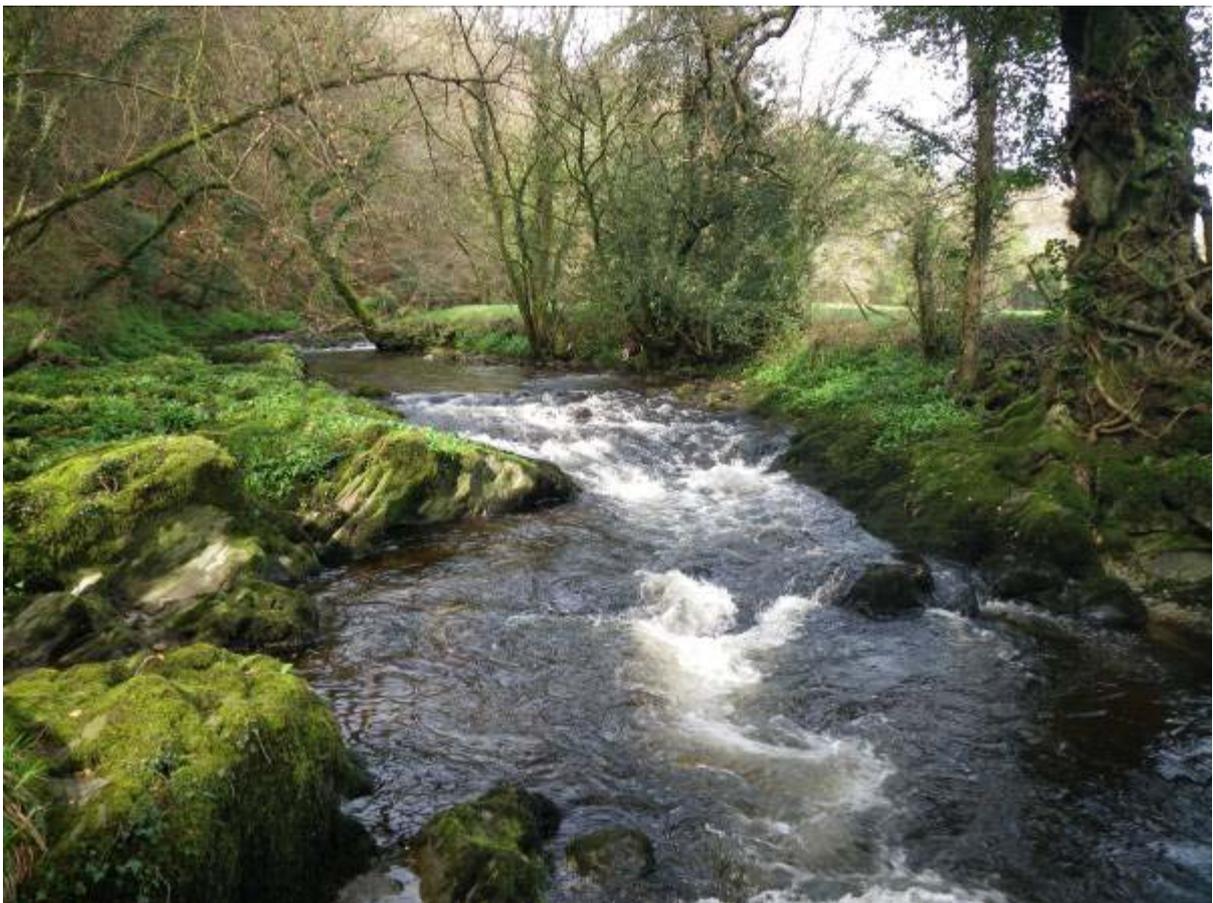
The first section inspected was the Kerrydowns beat (cover photo) which starts a short distance below the A38 road bridge and flows south, picking up the Glaze Brook tributary.

The river here runs down a comparatively steep gradient over a substrate mainly composed of outcrops of hard Devonian sandstone and granite. Large boulders and cobbles are plentiful and provide excellent parr cover on the numerous shallow glides, while the "mini" gorge type pools create wonderful lies for adult salmonids. The whole reach affords a good balance of light and shade, with a range of mature broad leafed trees providing the shade regime which looks to be very near to ideal. Shading will be particularly important during comparatively dry years, when the flows will rapidly drop away. Keeping suitable holding pools cool will be of paramount importance for salmonids under such conditions.

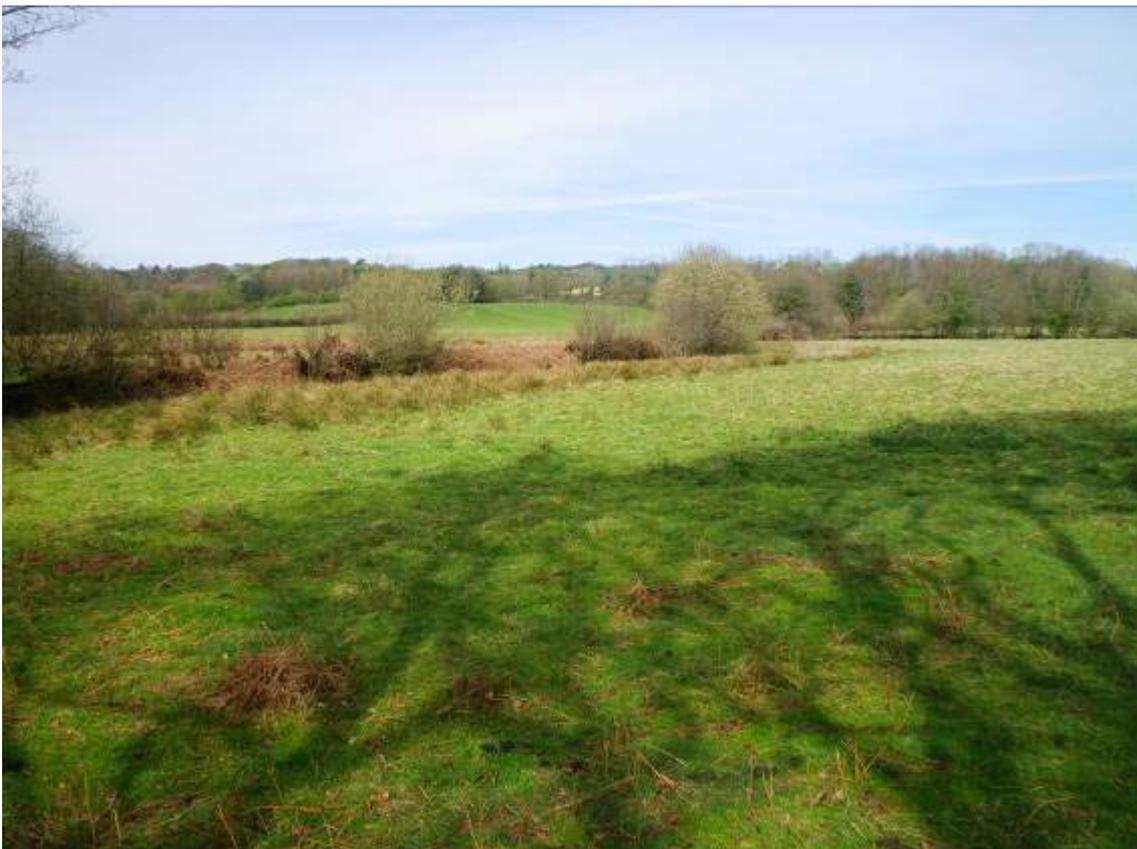
A typical Avon valley scene. Small, low density grazing meadows interspersed with blocks of deciduous woodland. A “river and fish friendly” valley

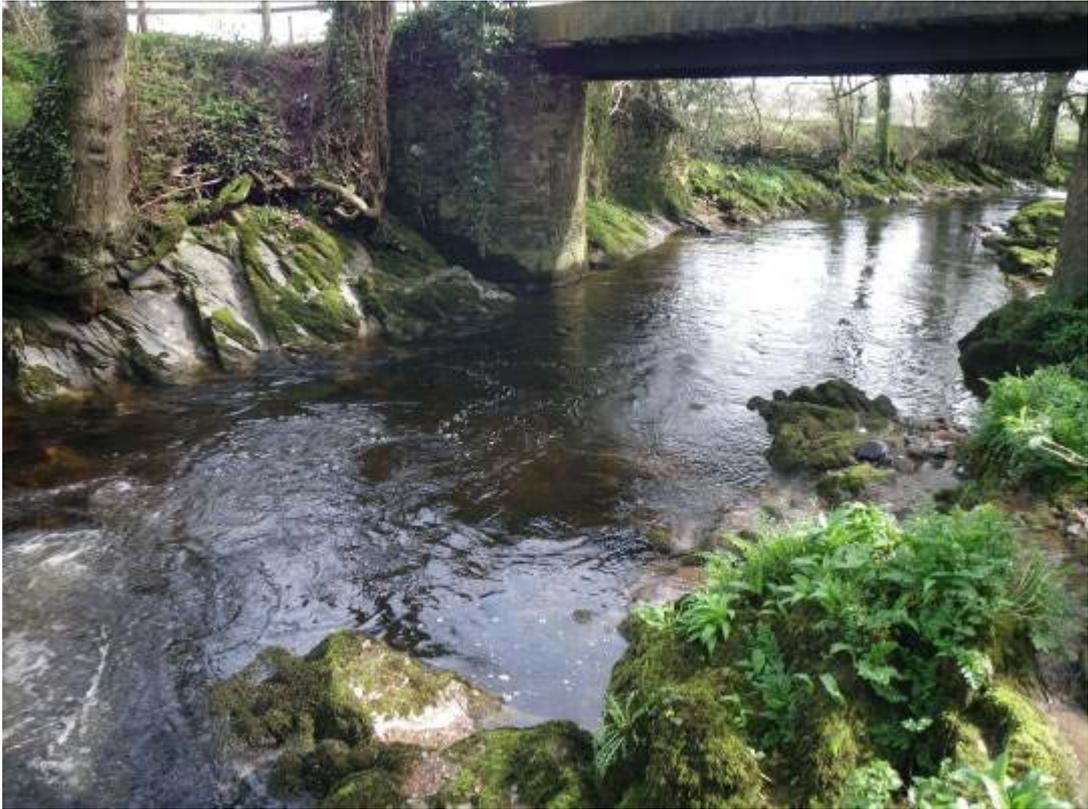
"Mini" gorge providing great holding habitat for adult salmonids

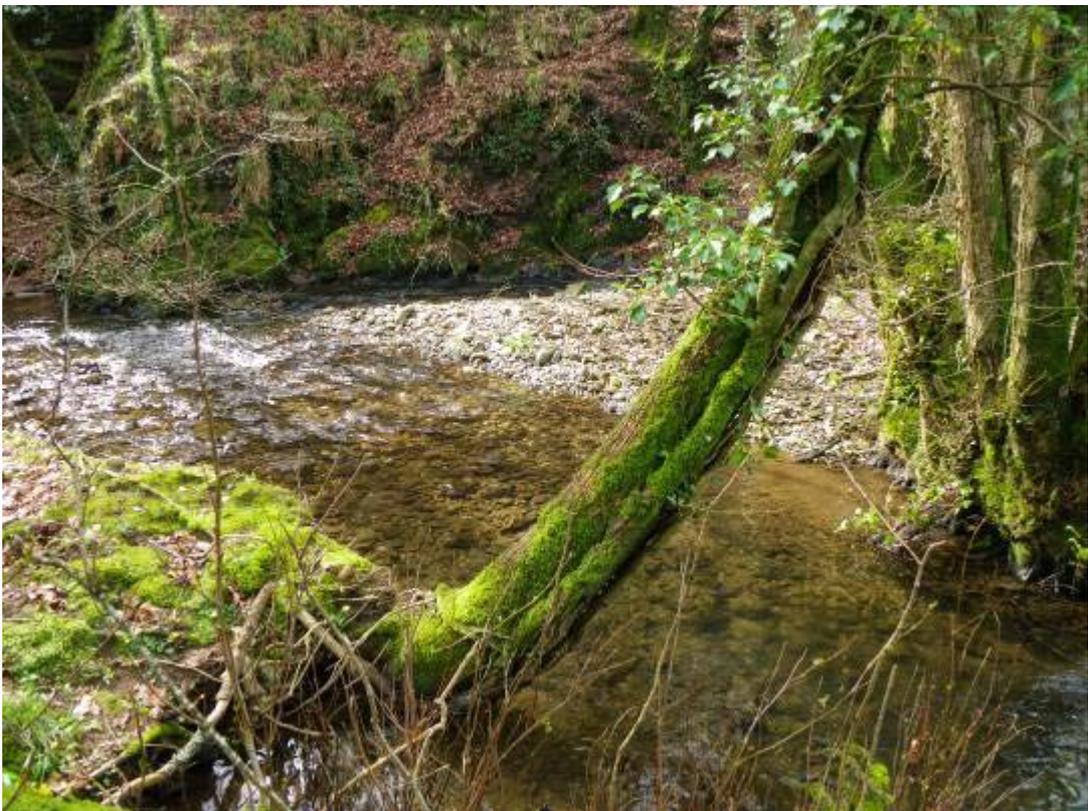
First impressions of the Glaze Brook suggests that it will be ideal as a spawning and nursery site with plenty of suitable gravels available for a range of differently sized brood fish to spawn. Suitably sorted and graded substrate ideal for spawning is often found on side streams and tributaries as opposed to main stem sites, where the erosive forces generated by the large water volumes and steep gradient can sometimes blow gravels away from glide habitat. This can be quite a common occurrence on rivers with a hard underlying rock bed, where the erosion of fresh gravels can be a limited resource. Suitably sized gravels for spawning were seen on the main stem but on this particular reach were not widespread.

The tail of a glide on the Glaze Brook – a good spawning site for trout.

Walking the tributaries in late November and December will also enable the AFA to become acquainted with spawning sites. Understanding where these sites are and checking to ensure that both gravel quality and cover is in optimum condition is well worth the effort. This will enable the Association to get a better feel for the relative importance of tributaries and provide an assessment of the overall habitat quality available for Avon fish stocks.

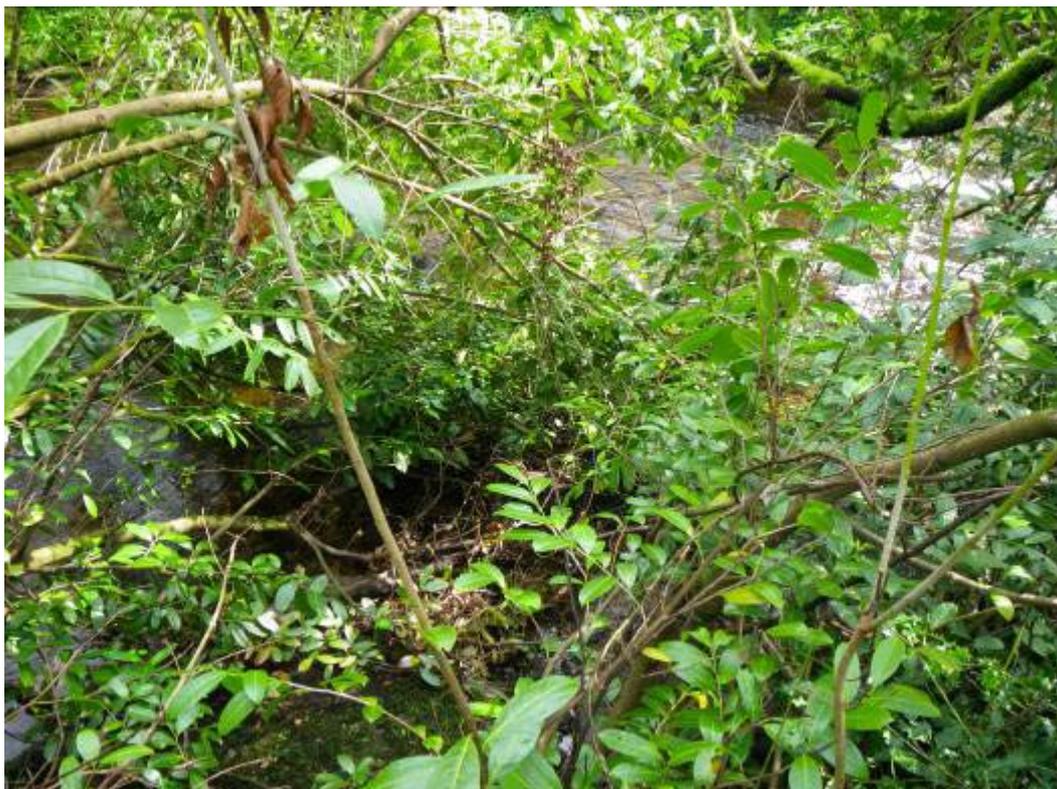
Laurel trees are not recommended as an ideal riverside plant. The leaves of laurel bushes are known to produce toxins, which although will not be having a measurable impact on river water quality, will be restricting the development of other marginal plants.

A laurel mat which has flopped into the RB margin

Although not ideal, the laurels have, in places, provided some much needed cover in shallow marginal areas. A tangled mass of brash like this often provides an important refuge area for small fish to escape from larger fish and avian predators.

One option is to gradually cut back the laurel and plant with native trees such as willow (*Salix caprea* and *S. cinerea*) or the odd thorn bush which can also provide a low tangled matrix of branches.

- If not total removal then at least punch some significant holes in the laurel/rhododendrons below Avonwick Bridge and replant with low goat willows to create low, brashy cover over shallow margins.

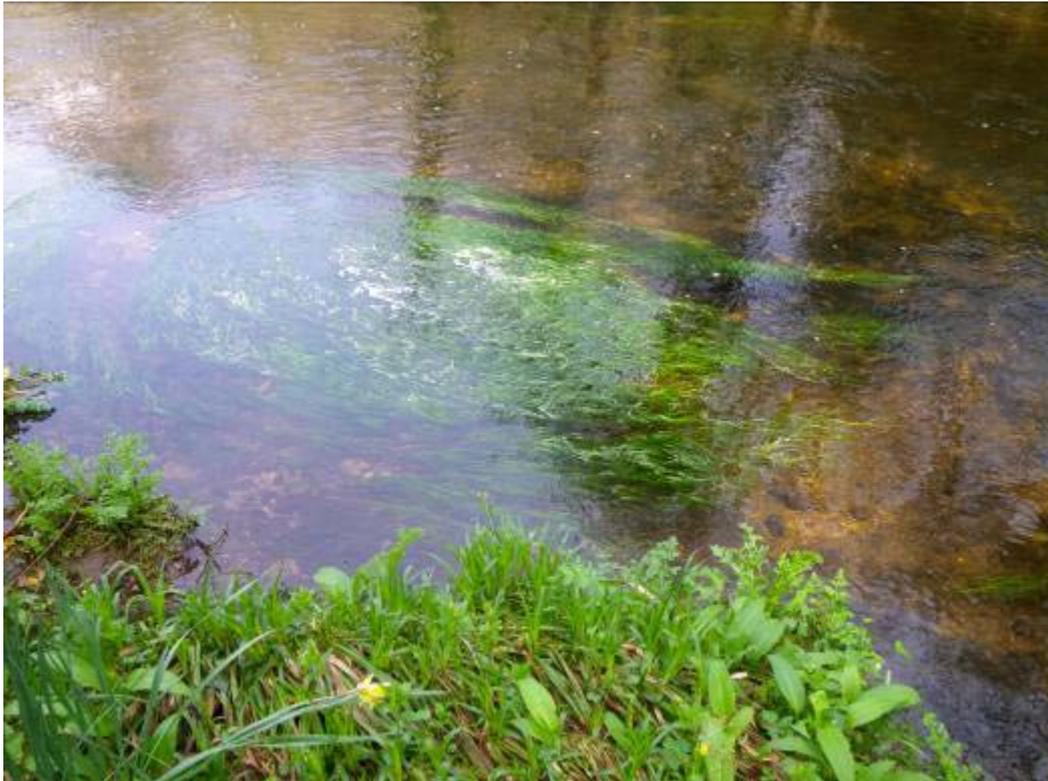
Where holes puncture the canopy and light reaches the river bed, small beds of water crowfoot (*Ranunculus spp*) have established. This is a very important plant for many rivers as it provides great cover for fish and is also an important habitat for numerous invertebrate species, many of which are valued by the fly fisher.

Below Avonwick bridge the gradient is slightly more gentle and where sufficient light penetrates the canopy beds of water crowfoot can be found. Good trout habitat.

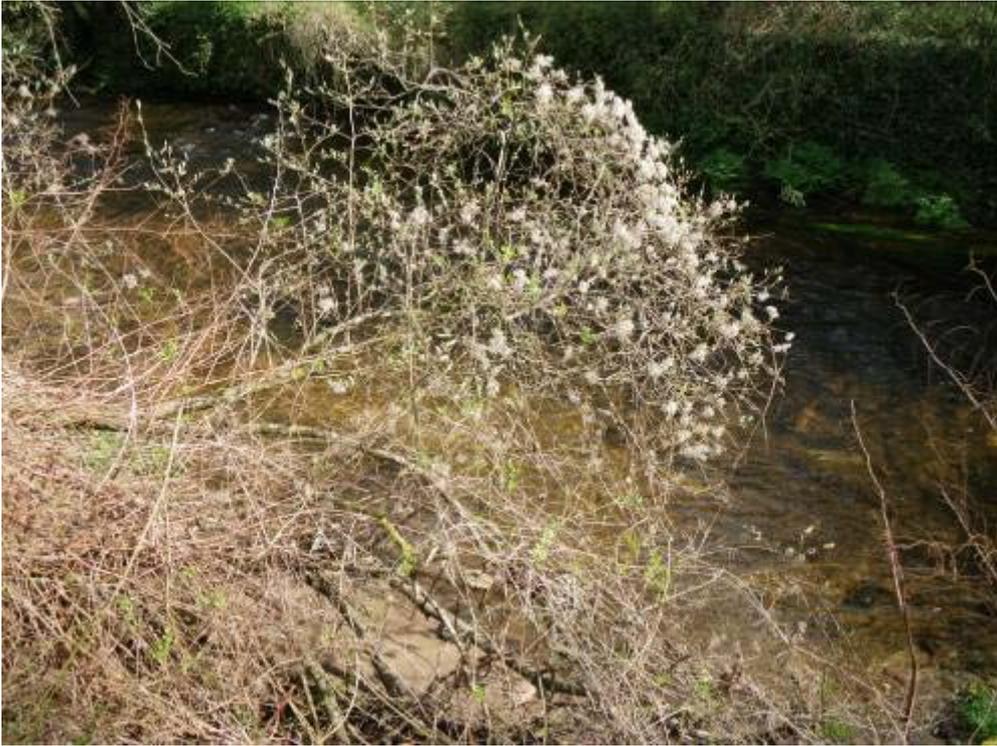
A low willow providing a bankside refuge for juvenile fish. Replacing the laurel with goat willow or low thorns will improve habitat and allow more light to reach central channel locations.

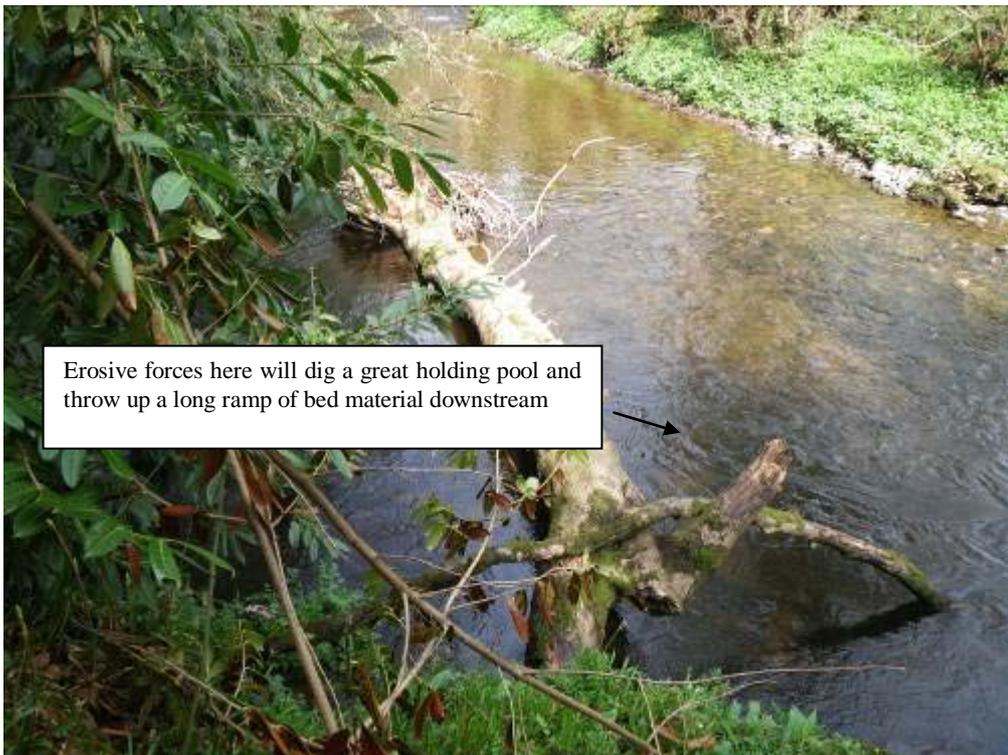
The gradient throughout this section appears to be gentler than the top beat and it is likely that it supports good numbers of trout throughout the reach. Some excellent quality habitat has been formed by the river, which has in places been energised by fallen trees acting as flow deflectors. In sections where the river bed is comparatively flat, the presence of large woody debris can help to carve out superb holding habitat as well as throwing up ramps of loose, well sorted gravel, ideal for winter spawning.

A whole tree has come to rest in a central channel location. The orientation of the tree is unlikely to cause any serious bank erosion but it will help to dig a fantastic holding pool.

If a fallen tree is in danger of causing a severe blockage and unacceptable flood risk, or if it is orientated in a way that puts severe erosive pressure on a vulnerable bank then the best course of action is to winch it into a position where it will enhance in-channel habitat. Move it – don't remove it.

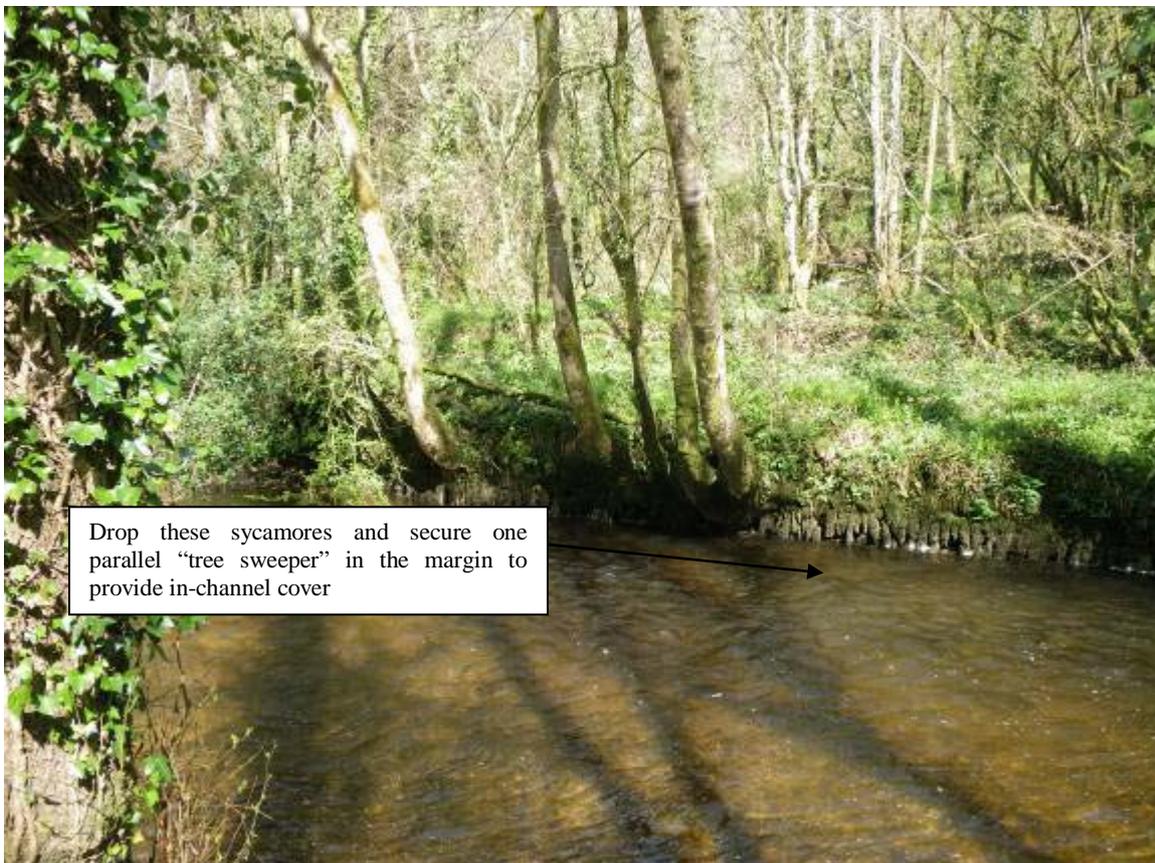
The section of river upstream of Gara bridge supports some interesting and varied habitat. The top of the beat runs through a fairly shaded, steep sided valley where the river displays classic pool/riffle/glide formation. Some concern was expressed regarding the growth of sycamore trees adjacent to a disused railway line. In bygone years, trees here would have been routinely managed by the railway company but all maintenance has now ceased and the section of river is now much more shaded. The balance of light to shade still looks to be very favourable for supporting good quality salmonid habitat. A ratio of 60% shade to 40% direct sunlight is always an ideal to aim for. When choosing trees to thin, coppice or pollard, make sure that random blocks are treated rather than one individual and choose less valuable riverside trees such as the sycamore over the ash or alder which often has well developed root systems that defend the bank and the soils in place.

Five "leggy" sycamores growing out of the old stone revetment. Coppice these to the ground to protect the integrity of the wall but lay in a whole tree on the river bed parallel to the margin to provide a shelf and cover for fish.

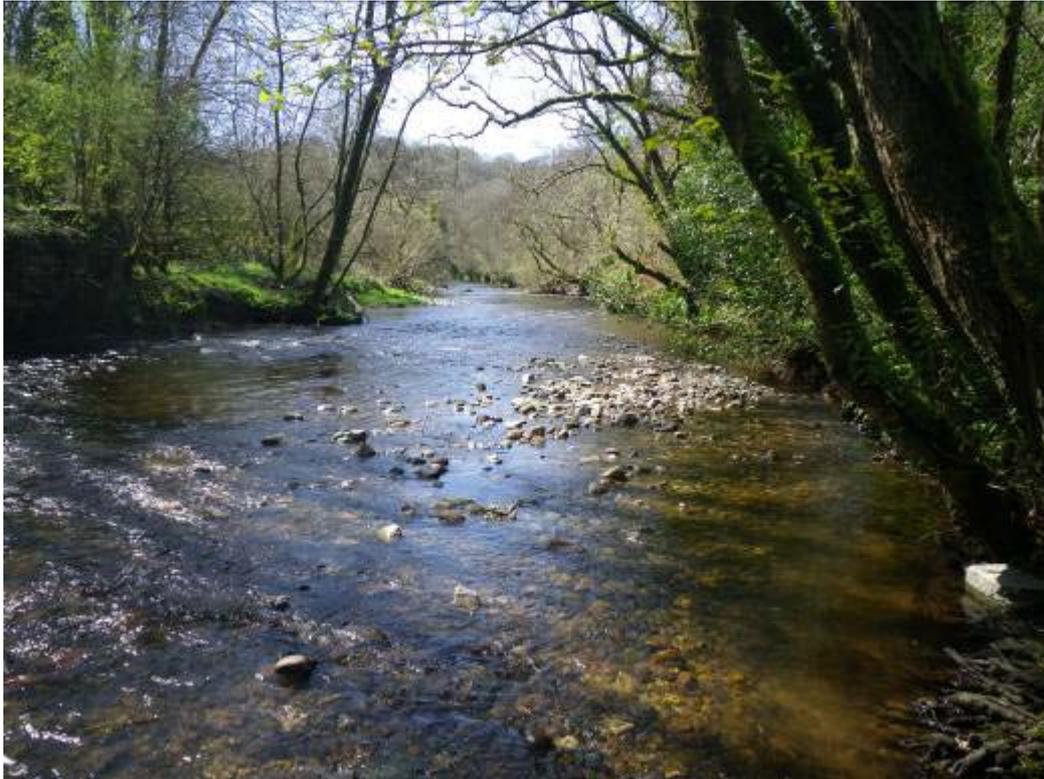
Long sections of the beat supported first class trout habitat. The combination of riffle habitat with lots of scattered boulders and cobbles provides pocket water for adult browns and plenty of micro holding lies for parr.

Good parr habitat with lots of cobbles and large stones scattered over riffle habitat.

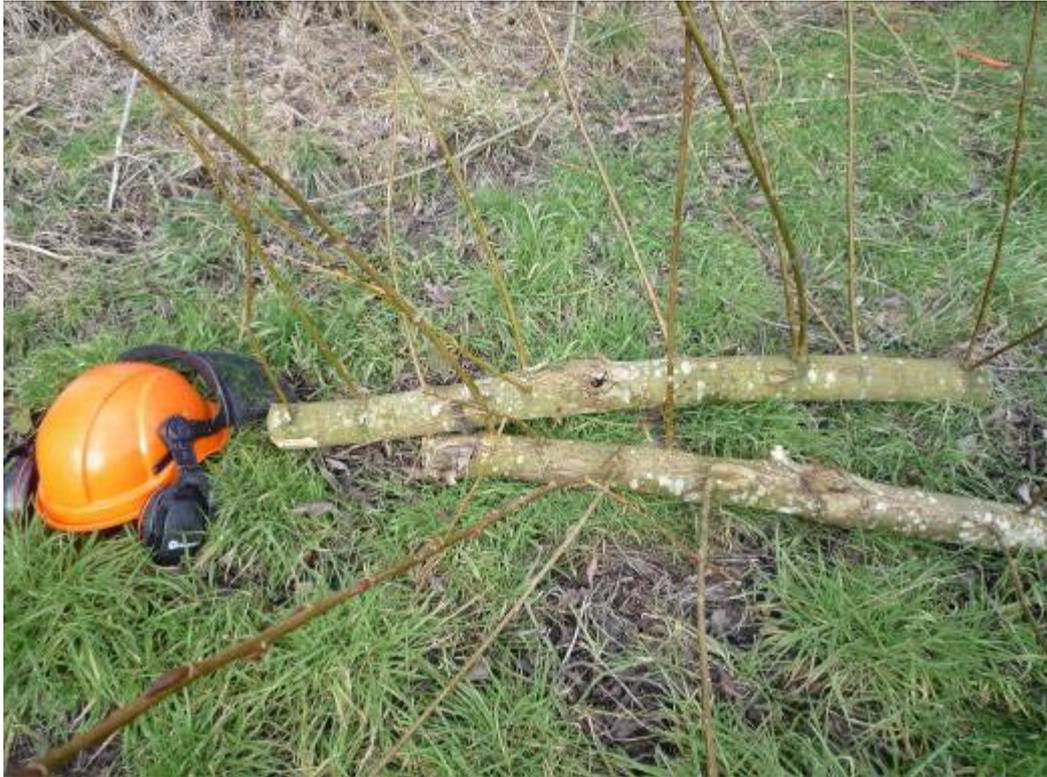
A section of live willow which can be pegged and wired down onto the wet toe of a slumped margin. The willow will set root and protect the face of the eroded bank.

Further downstream the canopy opens up and the river starts to meander through an open meadow. Some evidence of minor bankside erosion could be seen on this section but it is not a cause for major concern. When the outside of a bend erodes, often the face of the bank slumps into the margin to create new "toe" to the bank. If a toe is present then the best way to stabilise the bank is to plant up the toe with a series of willow whips, or willow branches laid flat and secured with live stakes.

If a toe does not form then it might be appropriate to take some action to slow the rate of erosion by using a tree sweeper or brush mattress, wired down to the face of the bank. An alternative method, where applicable, is to hinge whole live trees down parallel with the eroding bank. All of these techniques will slow down the erosive forces of the river by absorbing energy and by gathering sediments that slough off the bank face and also by collecting materials washed down with the flow. The whole face can also be planted up to tie in the soft vulnerable soils.

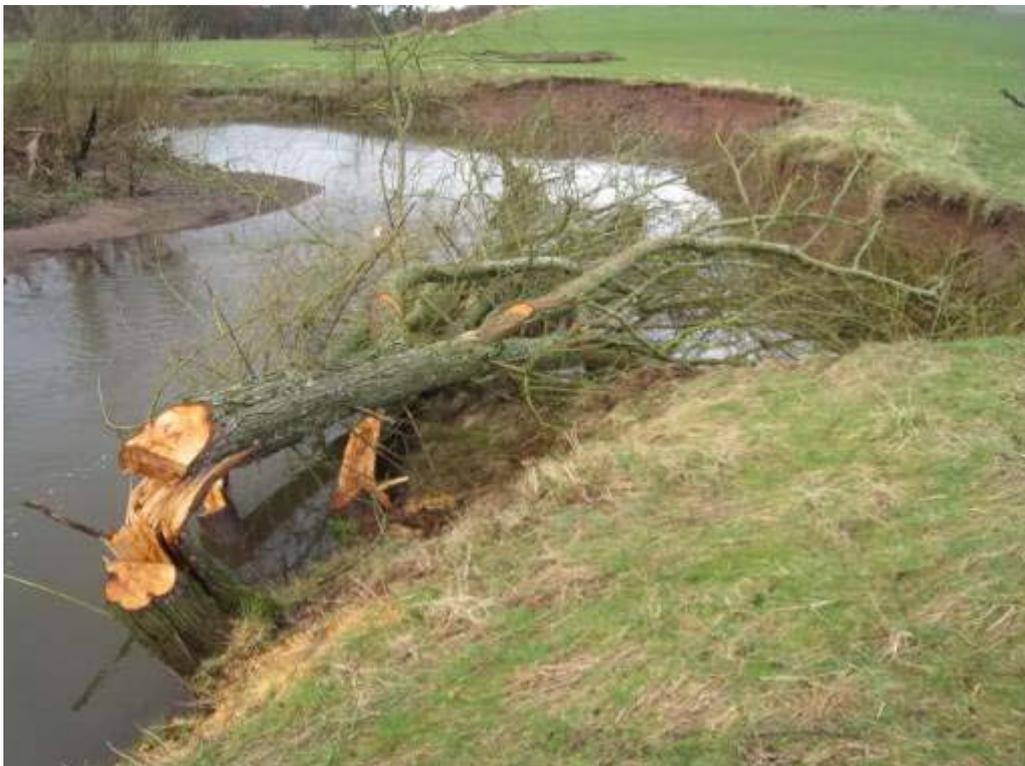
Live hinged Alder used to protect an eroding bank on the River Monnow.

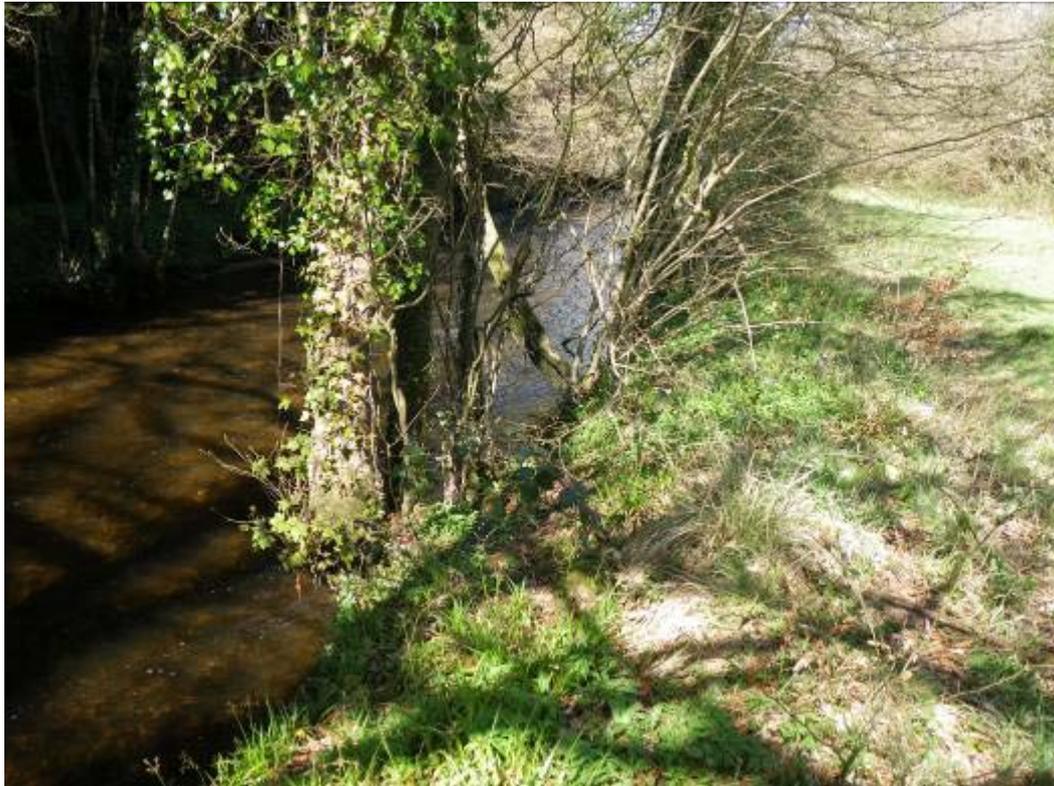
The beat below Gara Bridge was also inspected. Channel form was good, although holding pools were at a premium and the section is slightly over shaded, caused in part by the high bank on the RB rather than excessive tree growth. Some coppicing, however, would be beneficial and material won could usefully be used to enhance habitats within the channel.

The section of channel below Curtis Mill is quite shallow and shaded. Coppicing out blocks of sycamore in particular and pegging the material into the channel is recommended.

Coppicing out long tracks of bank-side trees should be avoided as this will result in a maintenance liability and unless regularly managed will result in an even greater level of channel shading. Small 10 to 30m blocks of coppicing is sufficient and any large landscape trees should be left to provide dappled light and shade, as well as a method of slowing down the re-growth of adjacent coppiced trees.

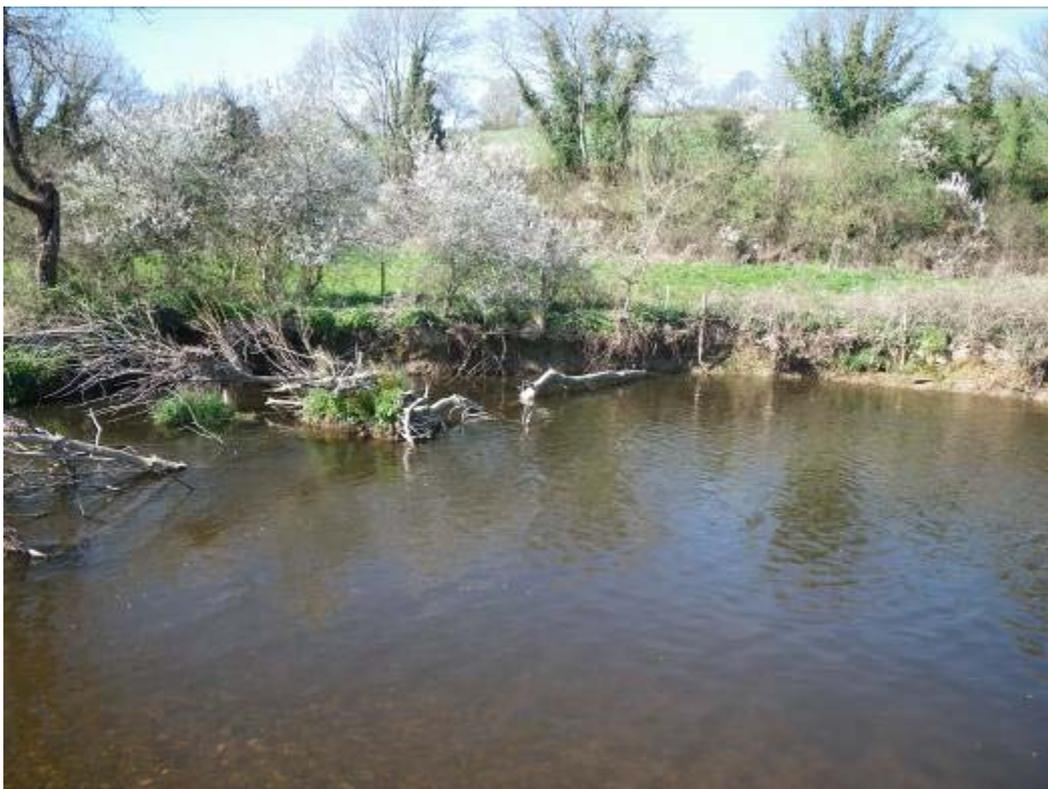
alluvial deposits. As a consequence the river is “active” and with no hard banks, or steep gradient to force a straight channel, the river kinks and bends in response to any slight impediment to flow. The consequences are that it simply re-carves a line where it once deposited material many years before.

Although this process causes considerable anxiety, particularly when a loved sea trout pool is lost, or a section of river is given over to become a redundant oxbow, the process is entirely natural and one that is hugely expensive and difficult to fight. The secret is to be relaxed when one good holding pool is about to be lost, confident in the knowledge that a brand new one is in the process of being formed. They just need to be explored and will soon have the reputation as a new “hot spot”.

An eroding bank on the lower beat at Knap Mill. Some good holding pools will be lost but others will also be created.

If bank side erosion is deemed unacceptable then it is possible to manipulate this wandering of the channel through the intelligent use of LWD flow deflectors. Pressure can be taken off of an eroding bank, just as easily as erosion can be encouraged to maintain a desired course. Our advice would be that if the landowners are relaxed about the way the river moves then the fishing club should be as well.

- Raise awareness amongst the membership over the importance of catch and release for wild salmonid conservation.
- Take a relaxed approach to natural river processes, particularly on the very bottom beat where the river has naturally meandered for thousands of years.
