Salisbury Avon – Chisenbury Syndicate

An advisory visit carried out by the Wild Trout Trust – December 2011

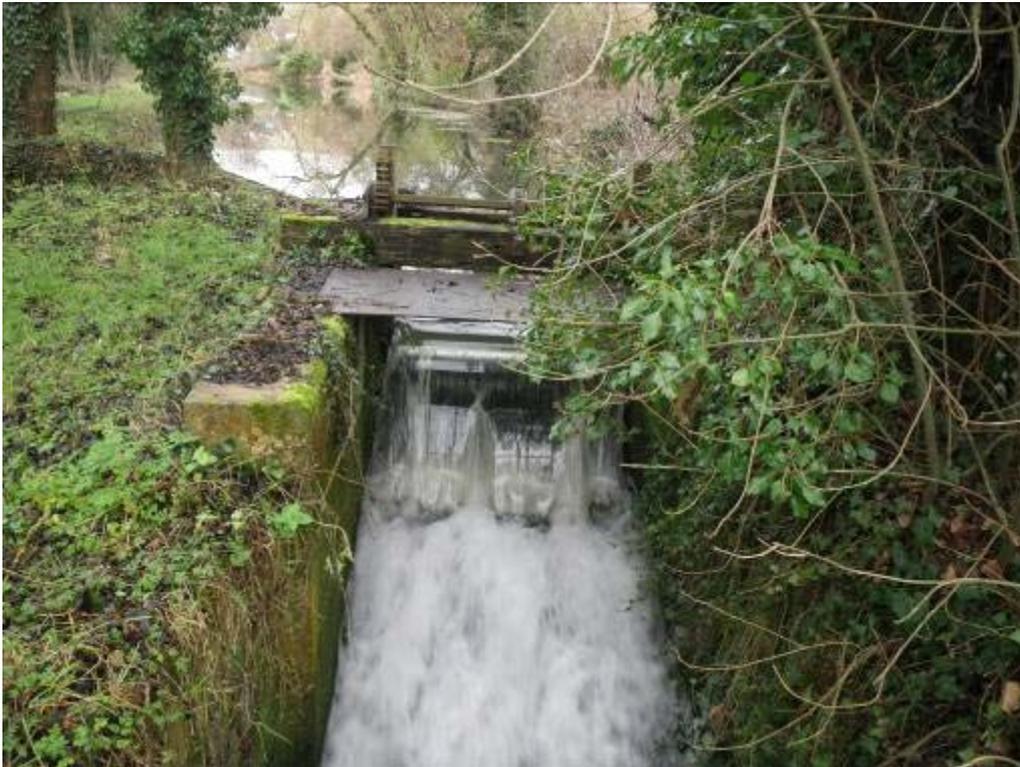
The section upstream of the hatch pool in the village was the first section to be inspected. The weir itself looks to be an old milling structure and the hatches currently impound a long section of river channel up above the village. The impoundment also enables water to be pushed down an old leat which feeds the Chisenbury manor. The leat itself was not inspected but it is understood that the channel feeds into an ornamental garden within the grounds of the manor, before discharging back into the main river just below the village.

As with most structures located on low gradient chalk rivers, the upstream impounding effect of the structure has significantly impacted the physical characteristics of the channel, resulting in a long reach of sluggish glide, flowing over a mainly thin gravel and sediment river bed.

One of two hatch structures on the weir in East Chisenbury

Immediately downstream of the weir there is some excellent quality spawning and nursery habitat on both channels. The weir itself looks to be a complete barrier for fish migration and it is understood that the EA have identified this weir as a significant obstruction requiring at the very least the construction of a suitable fish pass.

- Lobby the EA for action on the impoundment at East Chisenbury, ideally lowering the height of the impoundment, or as a minimum, the installation of a fish pass.
- Actively preserve the top section above the tank crossing as wild trout water.
- Develop a spawning and nursery habitat project focused on the section adjacent to the tank crossing. A WTT PP might help.
- Carry out more work like the brash shelf and flow deflector already installed.
- Provide more overhead low scrubby cover by planting willows near to the toe of the bank and at shallow angles so that they grow out over the water rather than upwards; ensure their subsequent maintenance as small trees
- Talk to your neighbours about sympathetic fringe management and stocking

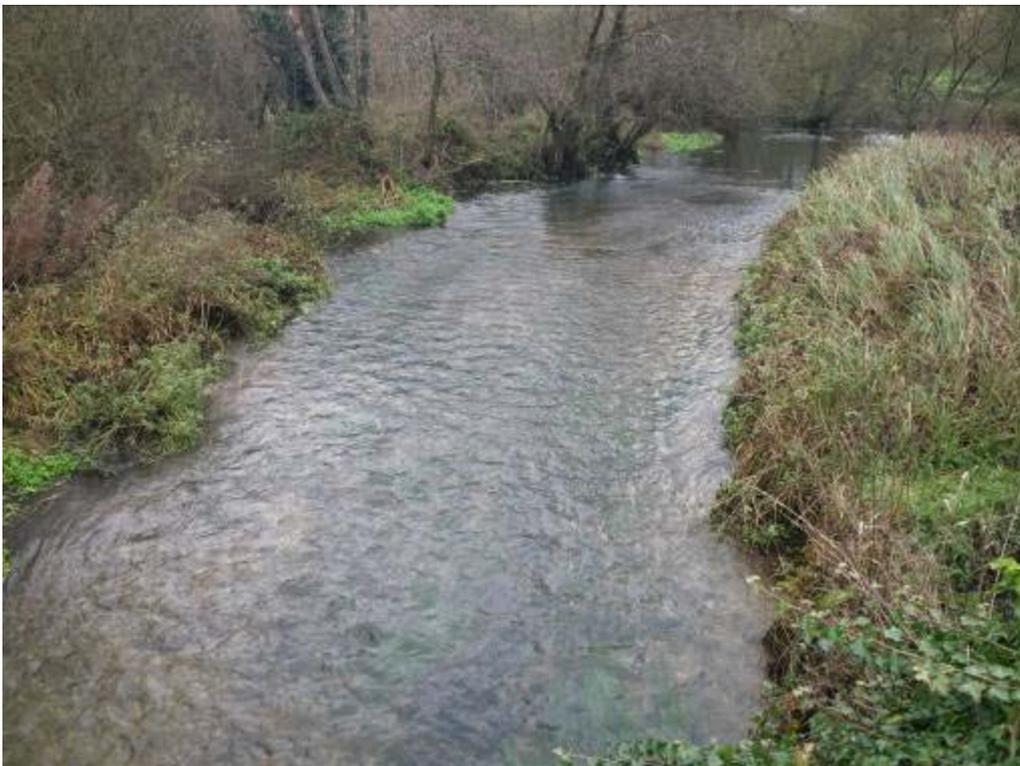
High quality spawning and nursery habitat immediately downstream of the weir

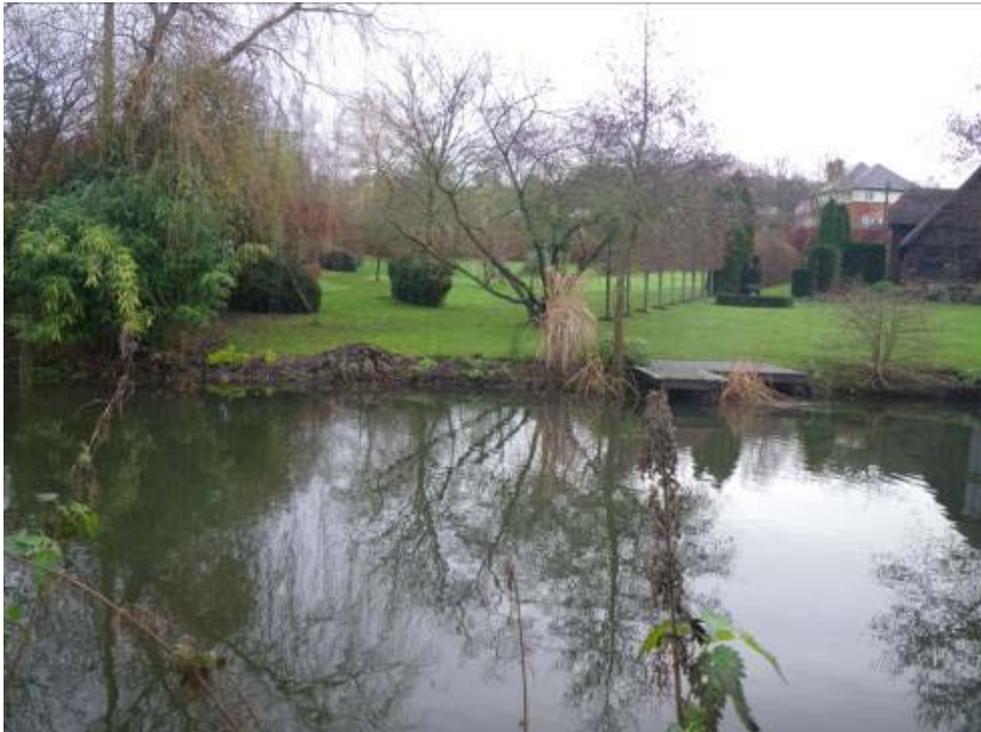
A section of the impounded reach within the village

Along the first section inspected there were several properties backing onto the river, one or two of which have incorporated the bank of the river into part of the formal managed garden. Unfortunately mown lawns, toe boarding and platforms are not robust bank defences. When river banks are formally managed there are real dangers of erosion and bank failure. Inappropriate riverside planting can also result in the spread of undesirable non-native plants that in some cases result in damage to local ecosystems. There may be some scope to engage with the householders to discuss appropriate treatment of river margins, such as encouraging a fringe of emergent vegetation to protect the hard bank from erosion and to provide invaluable habitat at all times of year for a range of fish and invertebrate species.

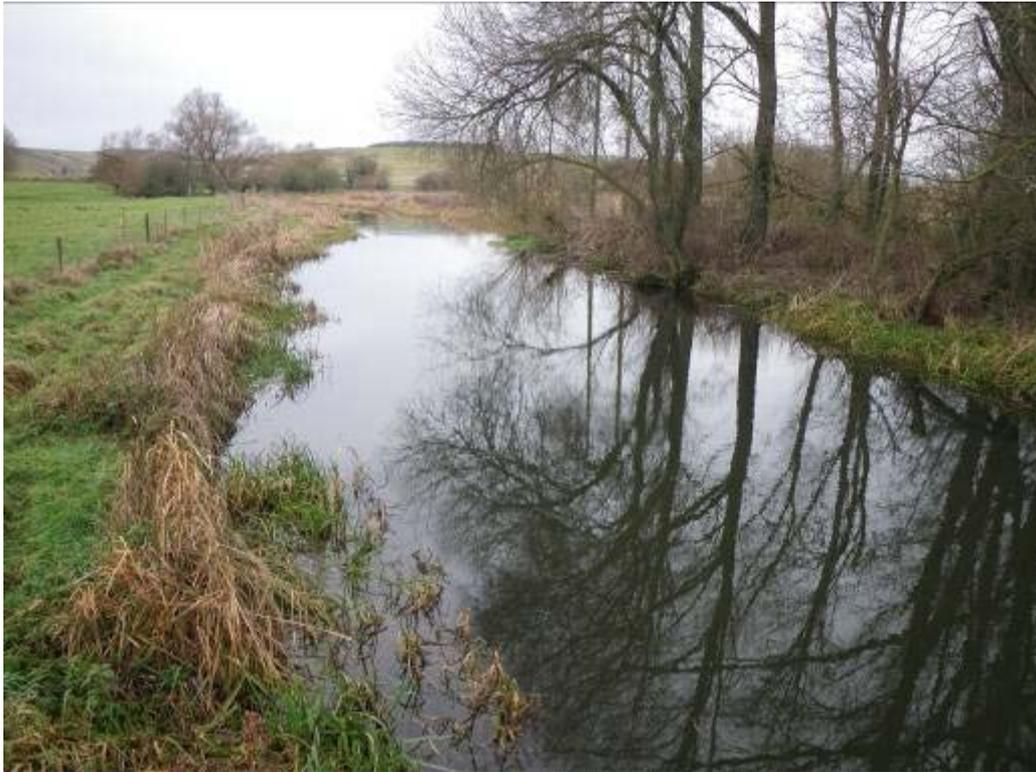
A typical section of the channel on the reach above the village.

The RB margin is typical chalkstream, with a low boggy fringe dominated by reed sweet grass (*Glyceria maxima*), providing excellent bank protection and habitat for adult river flies. Where the fringe had formed floating mats of vegetation there is also good cover available for fish.

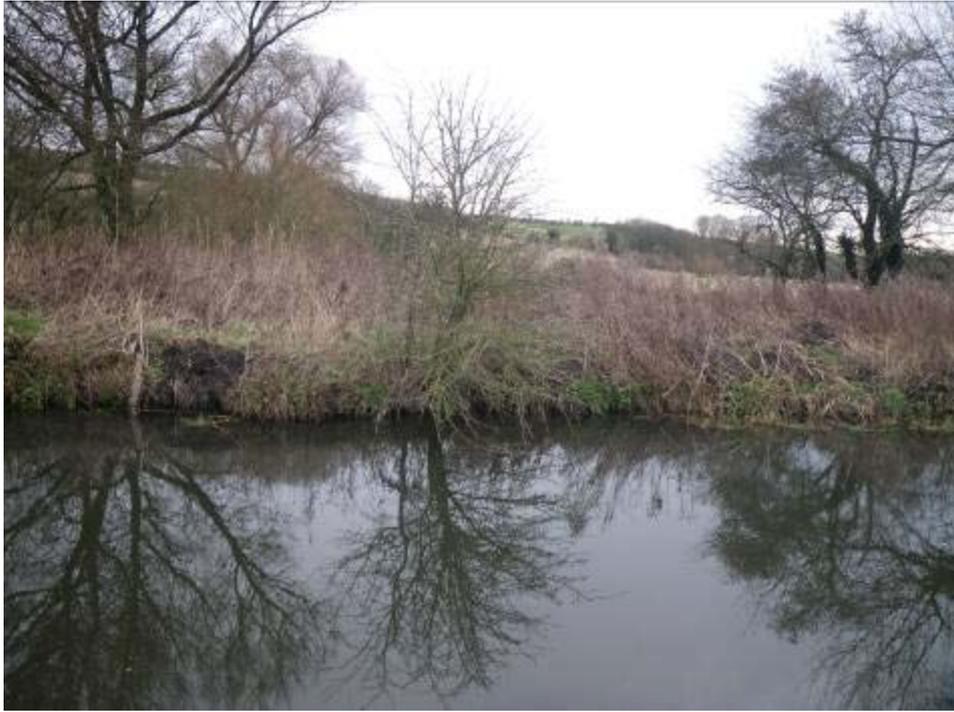
A small thorn tree that when in leaf will provide a comfortable lie for a trout in a reach where marginal cover is at a premium

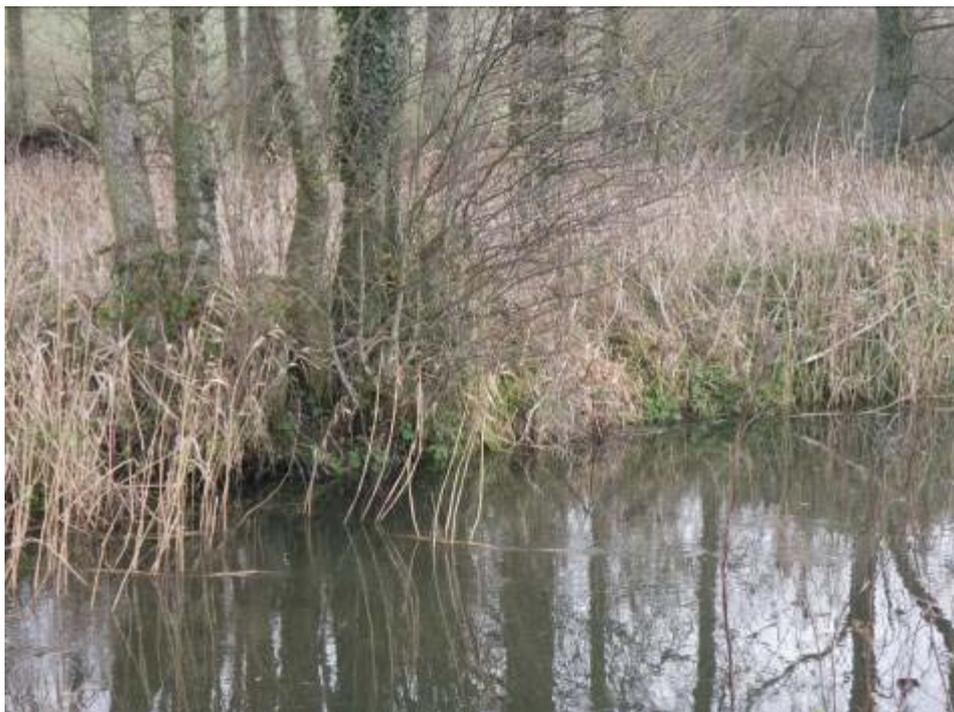
Alder trees can also provide some low cover when coppiced. Note the fringe of Norfolk reed (*Phragmites sp*) on the LB which provides good habitat for fish and invertebrates.

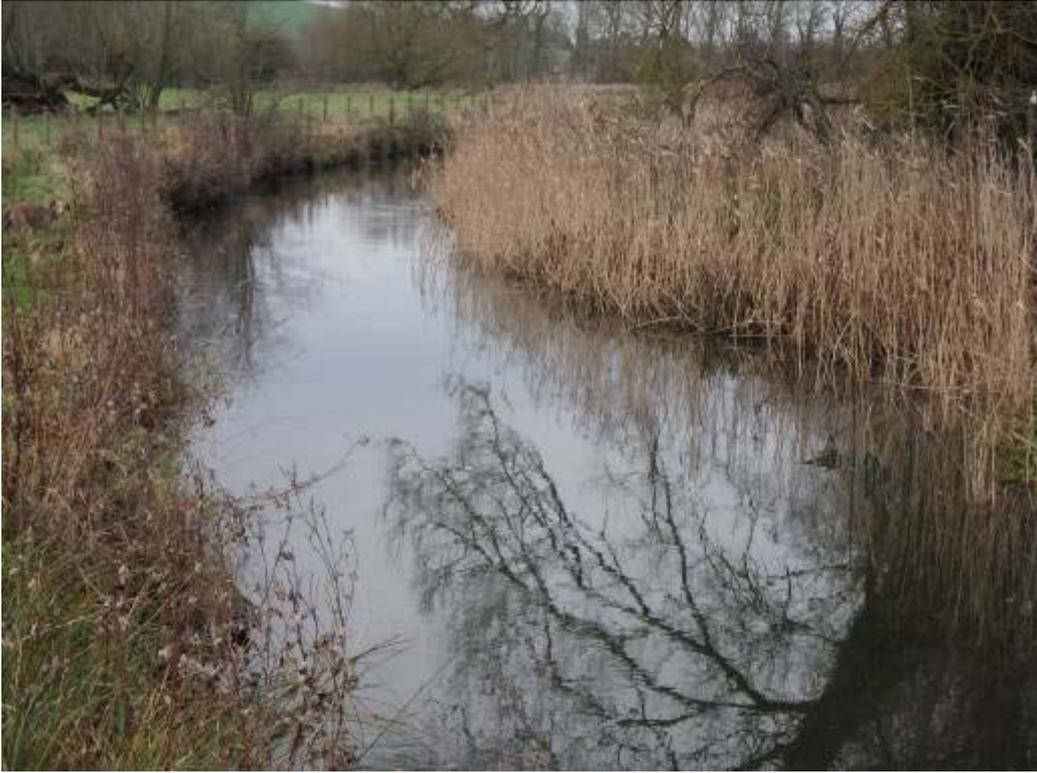
A little further upstream the channel has been naturally narrowed slightly by beds of encroaching Norfolk reed (*Phragmites australis*). These plants are also extremely valuable. They will help to accrete sediments in the margins around the roots of the plants, as well as acting a natural flow deflector, squeezing the channel slightly which in turn helps to sweep sediments away from central channel locations.

A fringe of Norfolk reed pinching the channel width and elevating in-channel water velocity.

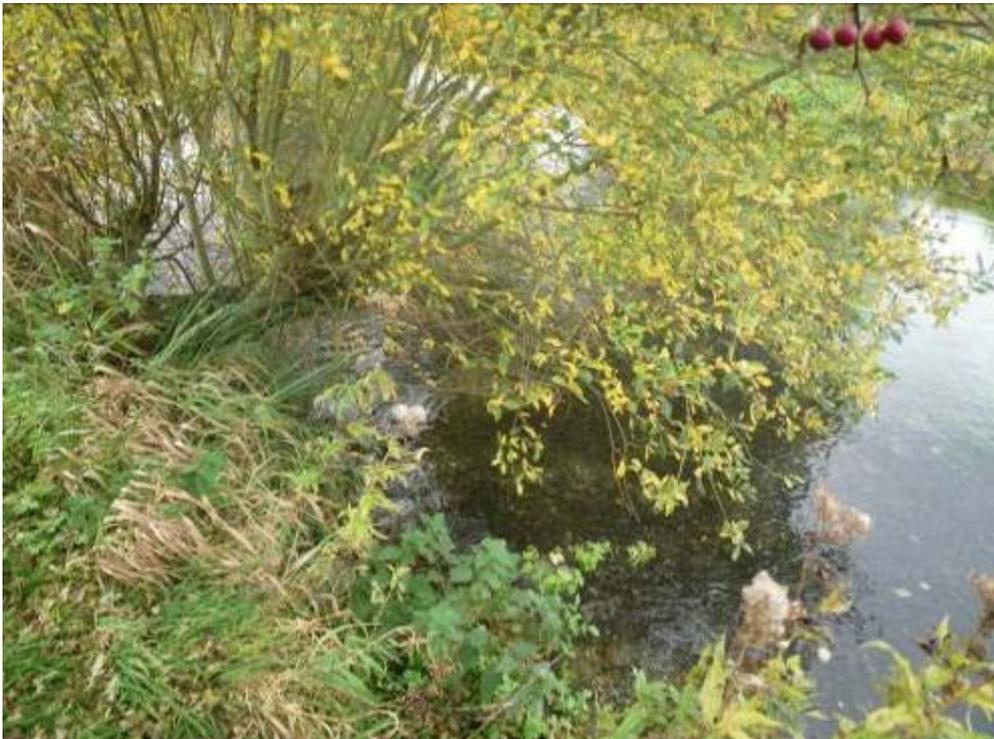
A low goat willow overhanging a carrier on the Test. Trees like this provide a valuable refuge area for juvenile trout over shallow runs, or adult trout over deeper pool habitat.

Scope exists for cutting whips from goat willows and planting them in at a shallow angle in the toe of the bank to create a series of high quality lies. Scrubby cover such as this is particularly useful for over-wintering trout, providing good cover from fish eating birds such as heron and cormorant, despite the obvious management requirements such tree cover necessitates.

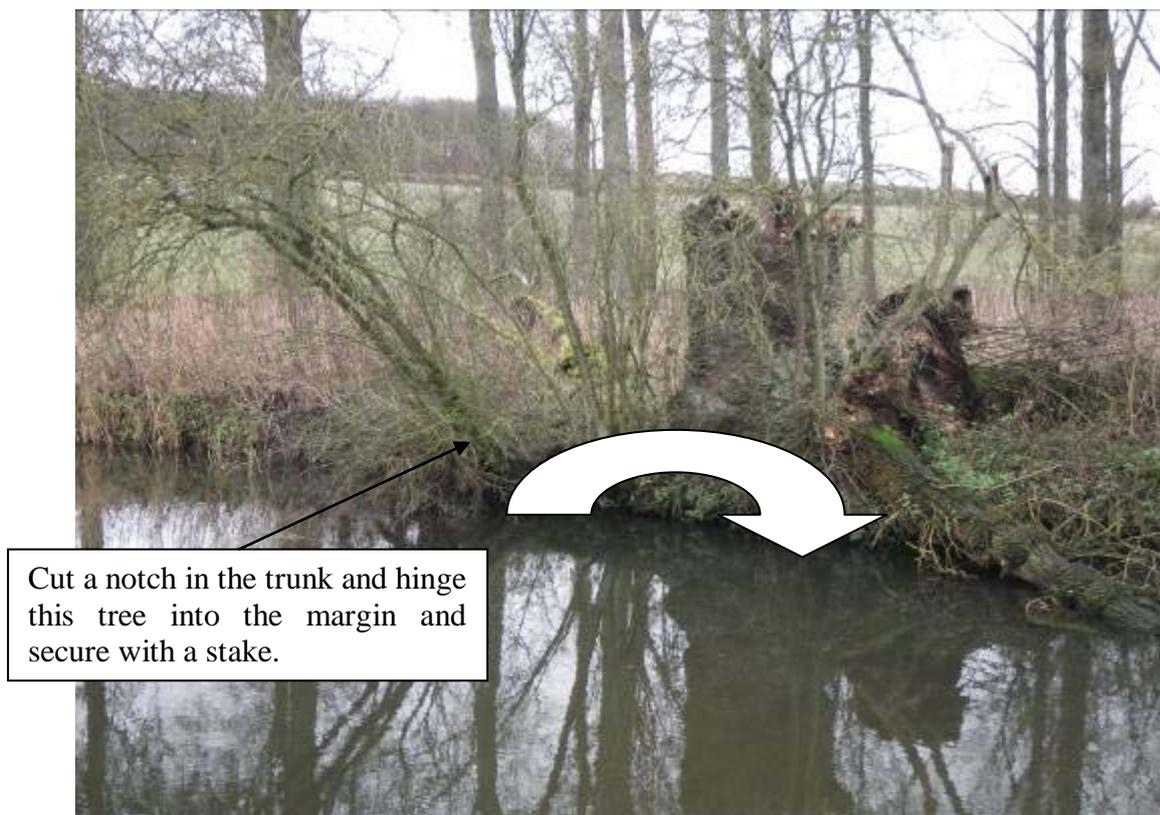
In a few areas the club have deliberately left some large fallen trees that have dropped in parallel to the margins. Some of these are creating excellent habitat by providing direct overhead cover for adult trout and by promoting some variations in flow patterns. There is lots of scope to be more radical when the next tree blows over by trimming and securing the trunk to create improved lies for trout.

The fallen trunk on the right could be complemented by hinging the small tree upstream

Cut a notch in the trunk and hinge this tree into the margin and secure with a stake.

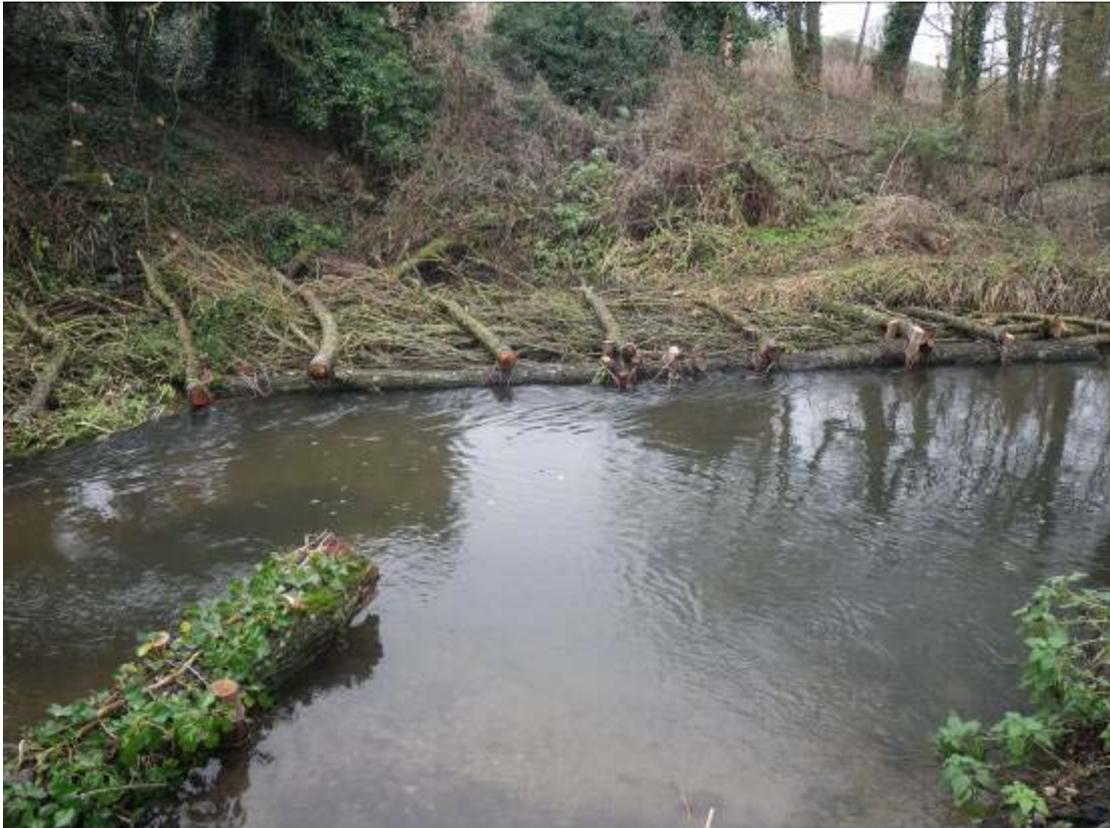
Towards the top end of the beat the channel starts to regain its natural gradient and some decent trout habitat is available. At one location the club's keeper has built a log and brash shelf, in order to protect an eroding bank. The work has slightly pinched the channel width and the keeper has skilfully used an upstream facing LWD deflector to harness the elevated velocities which in turn will help to scour sediments from the channel bed. An excellent piece of work, which could be extended to other reaches where the channel is over wide and the river is a flat, shallow glide.

A log and brush shelf with a LB flow deflector – super job.

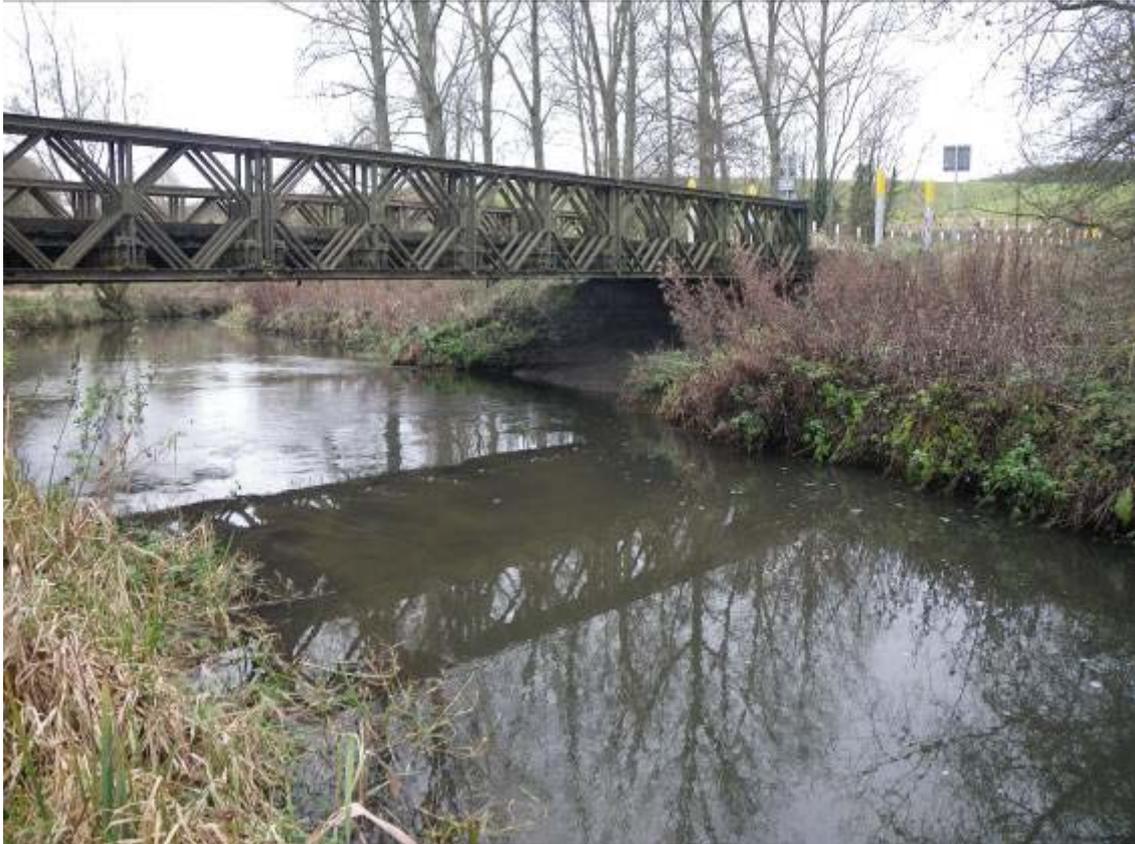
The section immediately adjacent to the tank crossing has potential, and could be improved by either introduction of fresh gravels, or pegging in short sections of LWD across the channel to encourage local bed scour and promote a more varied bed topography. Where ramps of gravel on a gentle upslope already exist, it is well worth arranging some late September work parties to break up the tufa crust with a steel spike and give the gravels a vigorous rake, or jet with a lance and pump. Details of how to undertake effective gravel cleaning are highlighted

The section either side of the tank crossing has potential to develop improved spawning and nursery habitat

The river bed immediately under the bridge (the bridge invert) is raised and there is scope to create a new spawning glide by introducing a gravel riffle/glide on the section immediately upstream of the invert. Any riffle should be two to three times as long as the channel width and stabilised by first lining the bed with large stones or cobbles and then top dressing with 20-50mm angular river gravels. There is scope here to raise the bed by 200-300mm without backing up the channel too much. It is estimated that approximately 100 m³ of material would be required at 1.8 metric tonne/m³. Approximate costs for materials would be £6000 and a further £1000 for design, plant and manpower. This option is discussed in further detail in the recommendations section of this report.

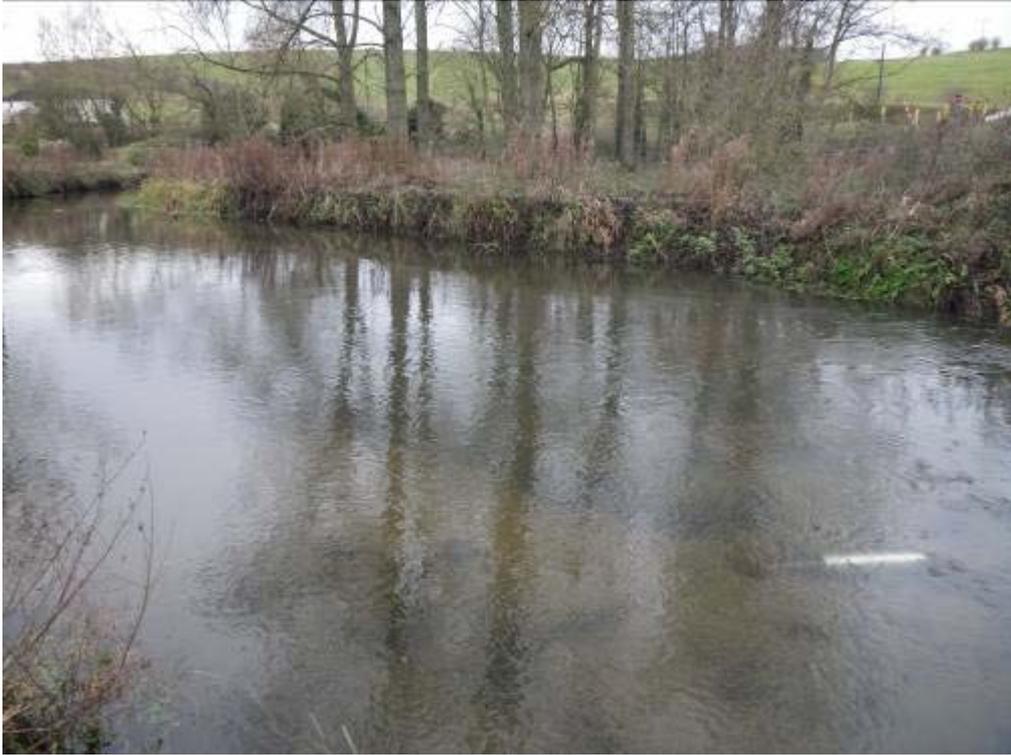
The section immediately downstream of the crossing could be developed as a trout nursery habitat

The section immediately downstream of the bridge could also be improved by raising the bed slightly to provide some shallow nursery habitat and then packing both margins with a matrix of loose brush bundles and cobbles. Connecting good spawning habitat to a significant area of shallow, well covered juvenile habitat will significantly boost wild trout production.

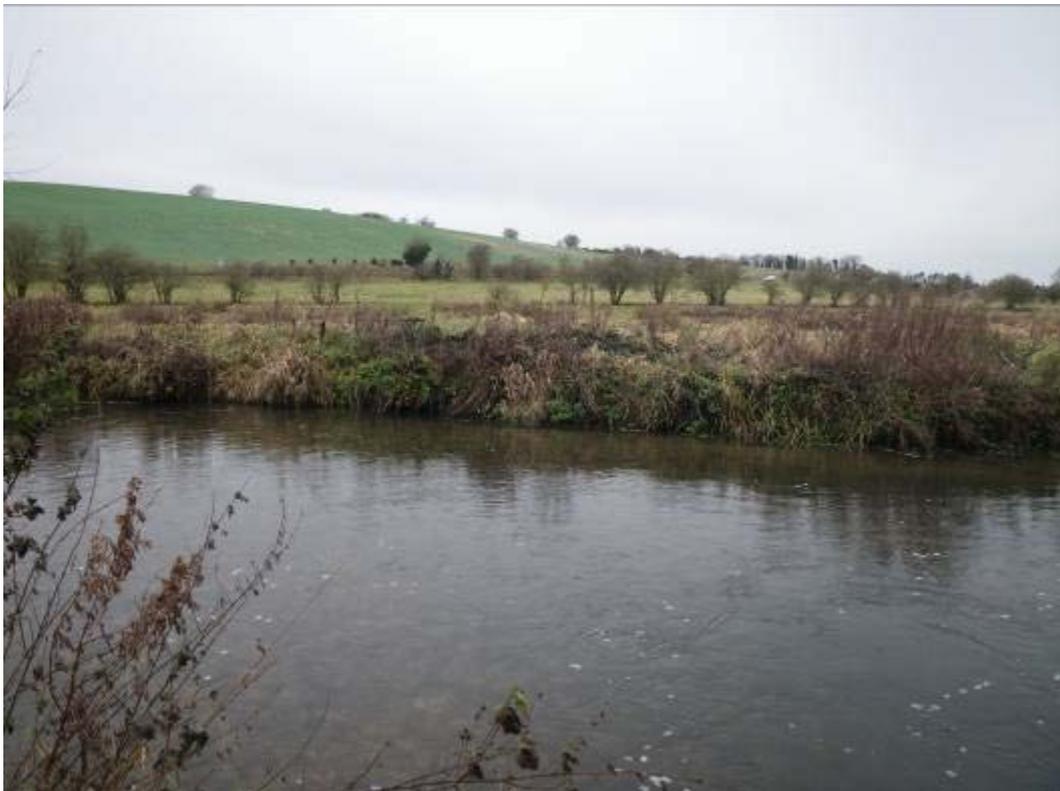
A lovely section of trout water near the top boundary could be further improved by planting the odd sallow on the RB.

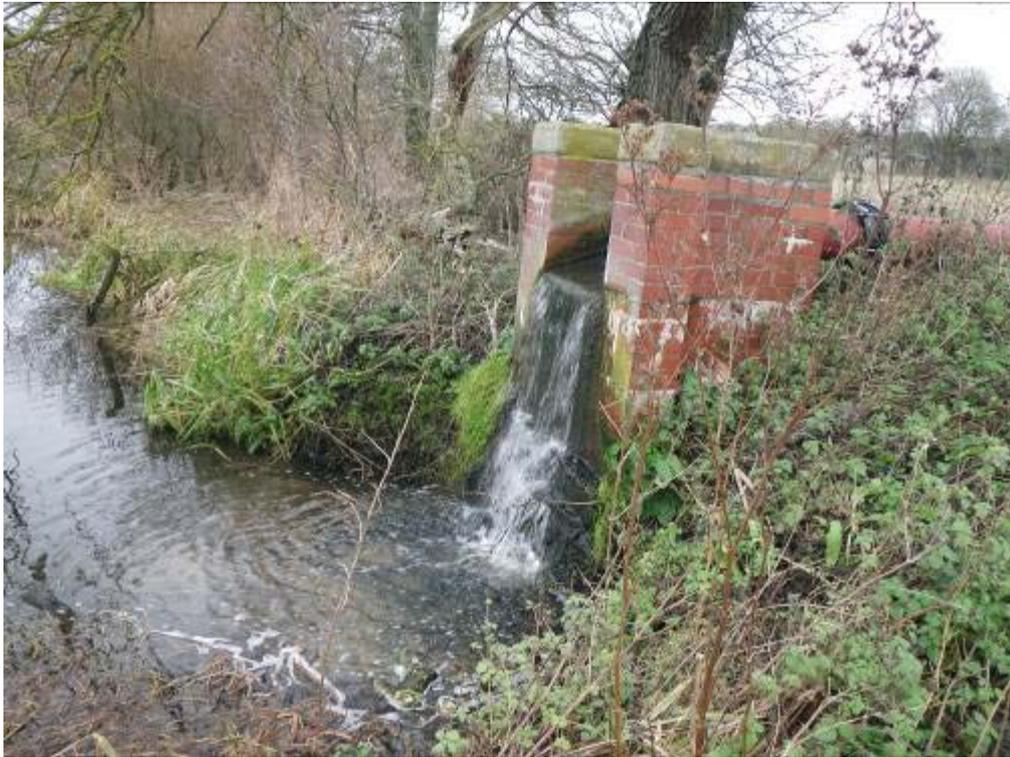
Near to the top boundary there is a discharge point from the local waste water treatment works. No information is available as to how this particular works is performing but it is understood that CS undertake some of their own monitoring via the Anglers Monitoring Initiative. This relies on undertaking a survey of river bugs using a 3 minute "kick sweep" technique. It is important to select sites based on where threats to WQ exist and it is recommended that a site near the tank crossing is included in the clubs monitoring programme.

A waste water discharge near to the fishery top boundary. It is essential that this works performs well at all times. The presence or absence of pollution sensitive invertebrates will give the CS the opportunity for monitoring the performance of the works.

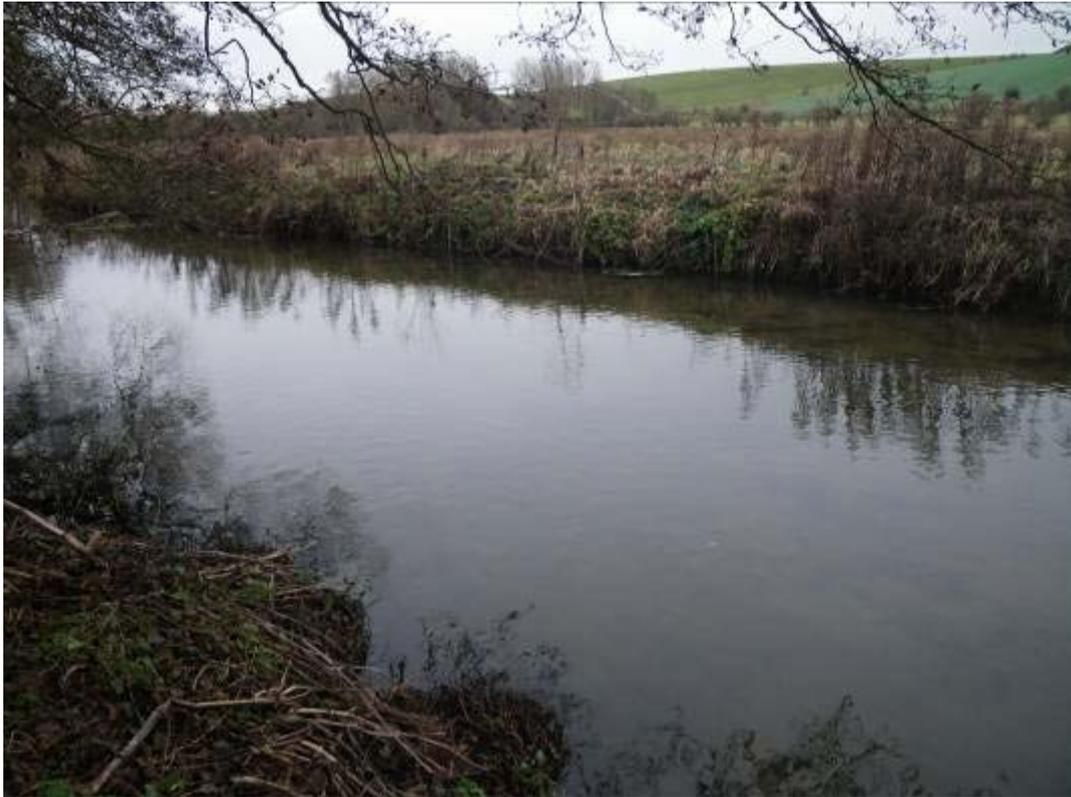
Scope exists for improving a fairly shallow glide habitat that flows beneath a dense canopy of alder cover. Coppicing out random clumps and using the material to peg into the channel will promote more weed growth and a more varied bed shape. It should be remembered that coppiced alder will require repeat coppicing on a 5 to 10 year rotation to avoid the development of intense shading.

A section of shaded channel where some coppicing and pegging in of flow deflectors would work well

The LWD deflectors can be temporary and can be strategically located to promote bed scour exactly where it is likely to be most useful.

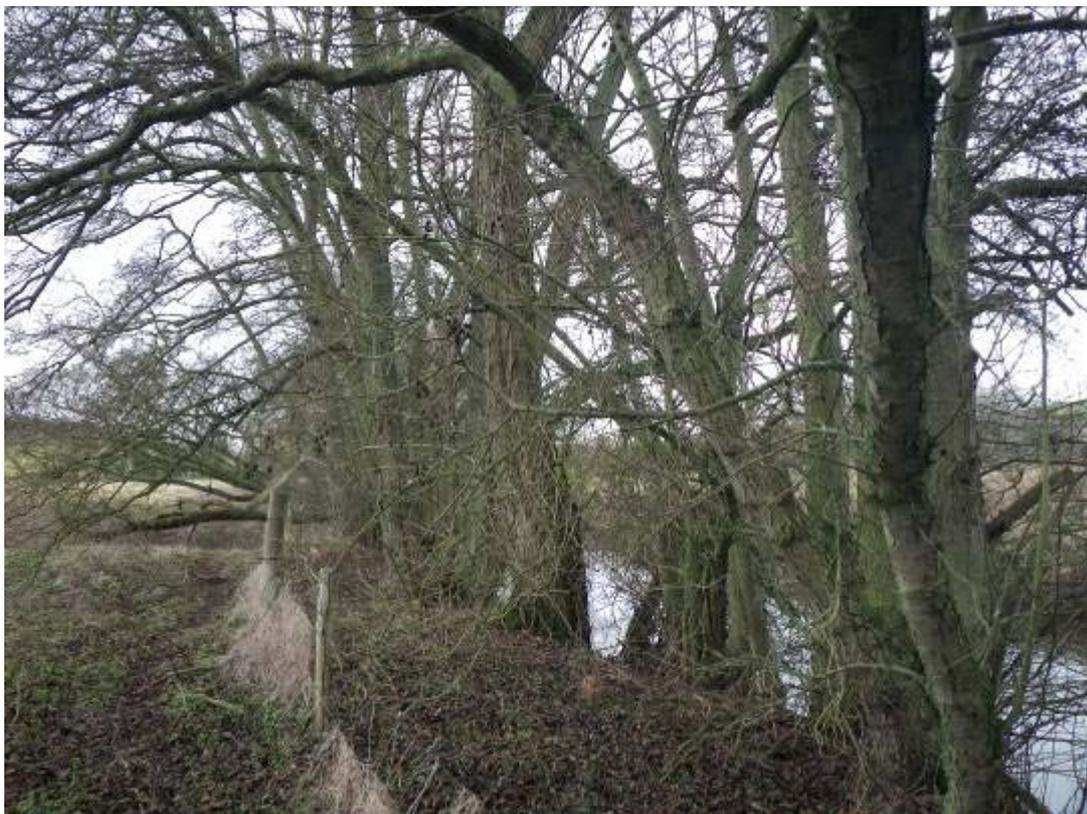
A section where some coppicing would be appropriate.

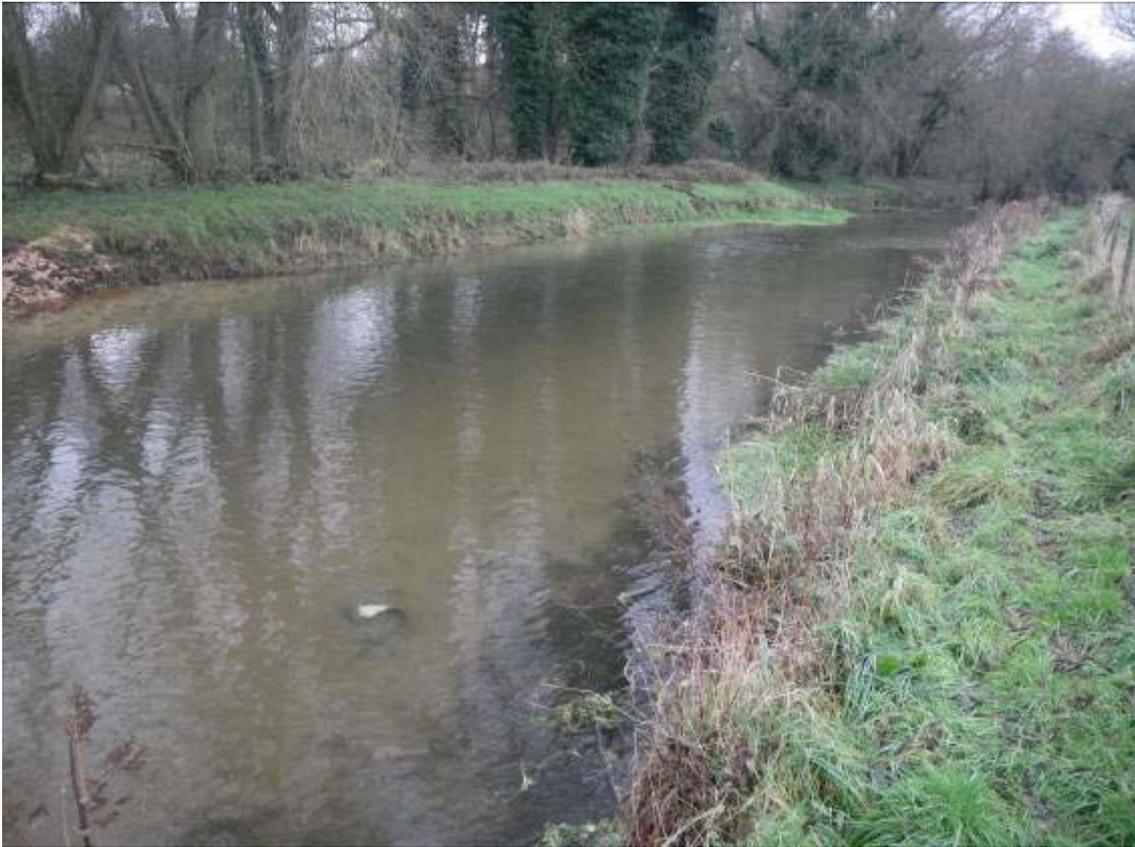
Section of channel on the bottom beat where a combination of shading and over enthusiastic maintenance of margins has resulted in an over wide channel devoid of useful cover for trout.

One particular section (photo above) was ripe for enhancement. A combination of shading and an over wide channel has resulted in significant silt deposition, a lack of in-channel weed and virtually no cover for trout. If letting in more light to this section is not an option then improvements could be made by pegging in some flow deflectors, or possibly creating a brash shelf out from the LB. Pushing water over to a heavily strimmed RB margin is likely to cause erosion and so the RB margin should also be defended by promoting a low squidgy toe to develop with a fringe of sedge or reed. There is no reason why this could not be established even in a comparatively shaded margin.

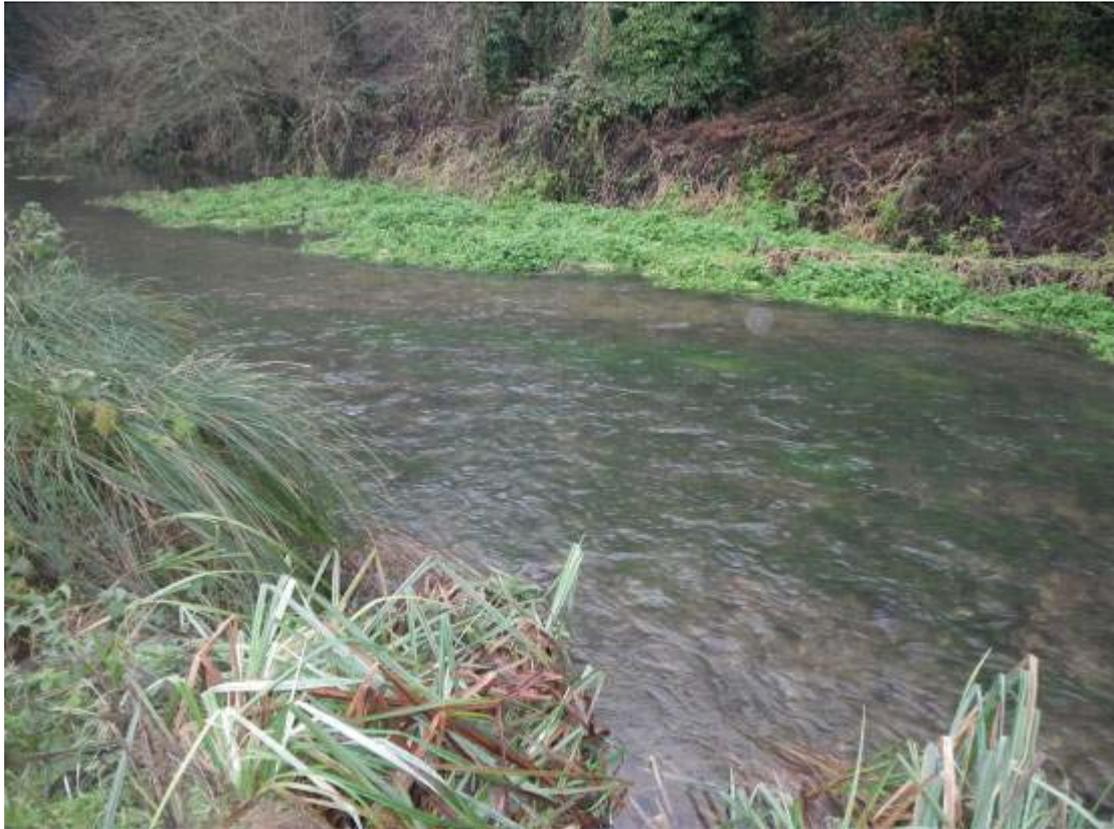
A fine section of trout juvenile habitat with well covered sedge fringe on the LB and a cross shelf on the RB. The weedy riffle provides first class habitat for parr

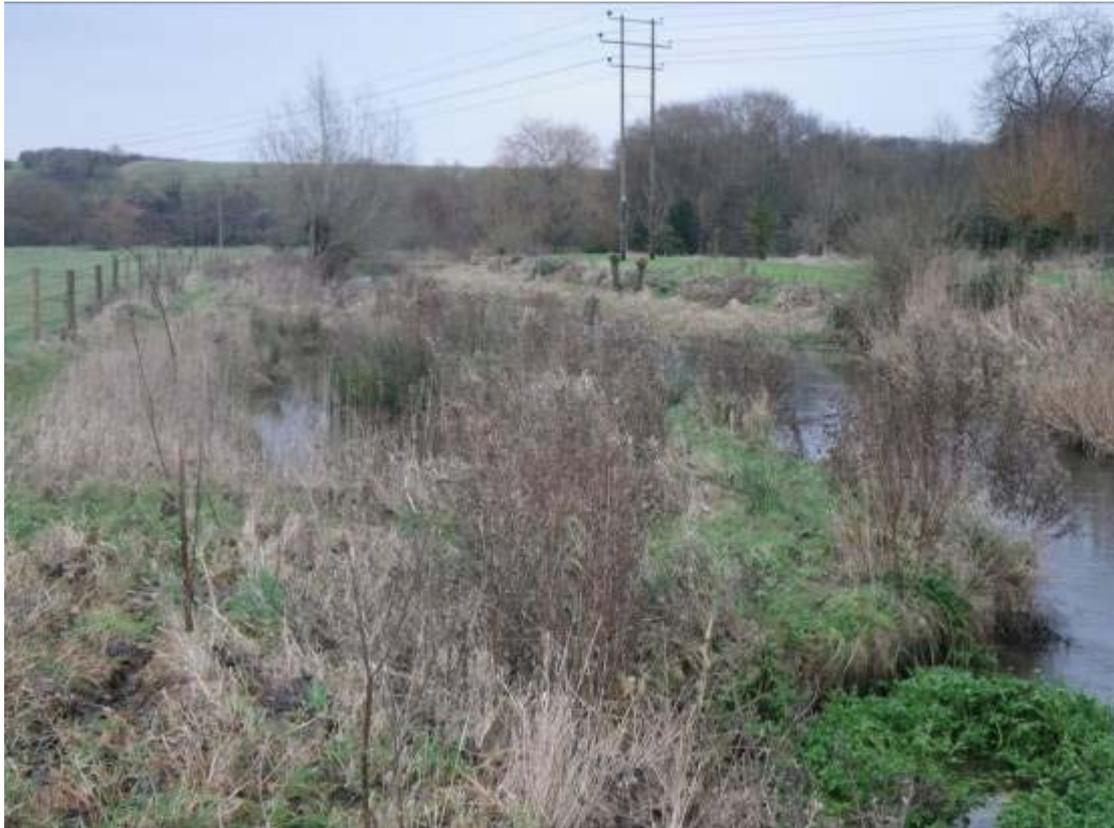
The section of river on beat 4 that was the site of the enhancement works looks to be settling down well. The use of the perpendicular faggot bundle bars is a technique I have not seen used before. I have reservations as to how effective these will be over the long term, but I do believe that the way the channel has been squeezed by winning adjacent bank material to create bunds and backwaters is a triumph. The luxuriant water crowfoot found in this reach reflects the elevated water velocities that have been generated by pinching the channel. This plant is synonymous with healthy chalk streams and is a favoured habitat for several important river flies, including the blue winged olive.

Section of channel enhanced as part of the Avon STREAM project. The riparian habitat created is of equal value to the fly fisherman as the improved in-channel habitat.

There is room to extend the scope of these works to some of the sections further downstream and resources might be available via the Catchment Restoration Fund which is being rolled out by DEFRA and is available for charitable organisations such as the Wessex Chalk Stream and Rivers Trust to bid into; see <http://www.environment-agency.gov.uk/research/planning/136182.aspx>

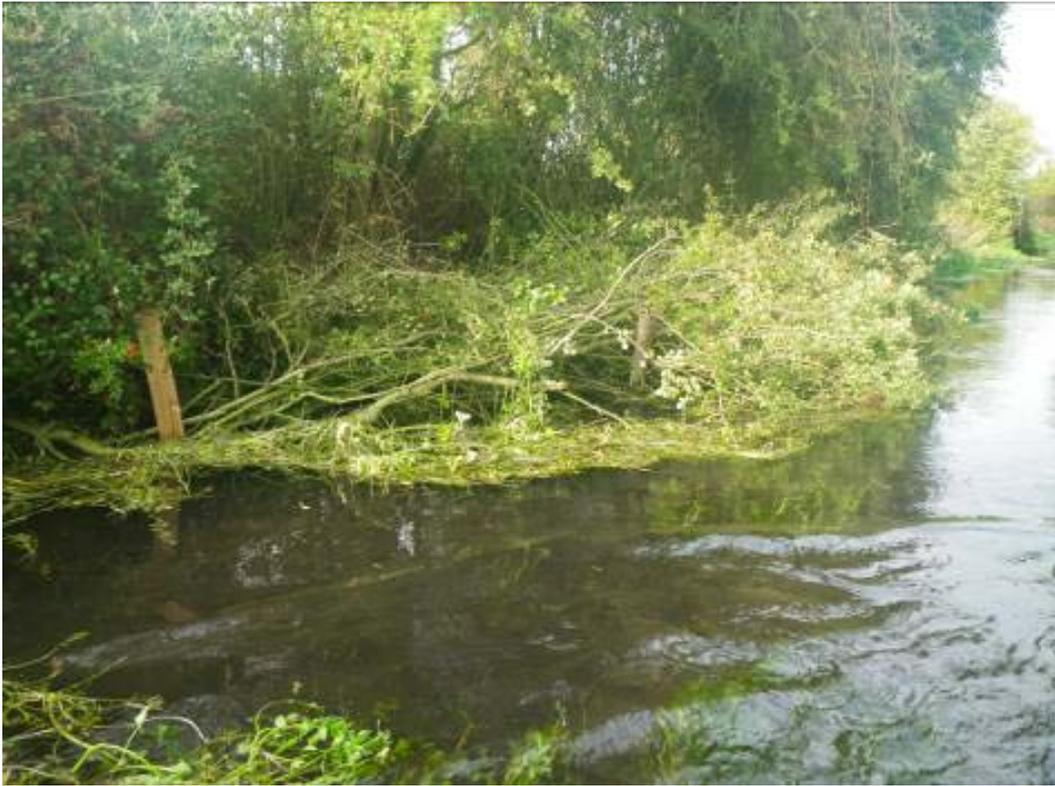
A thorn tree hinged into the channel – brilliant winter cover

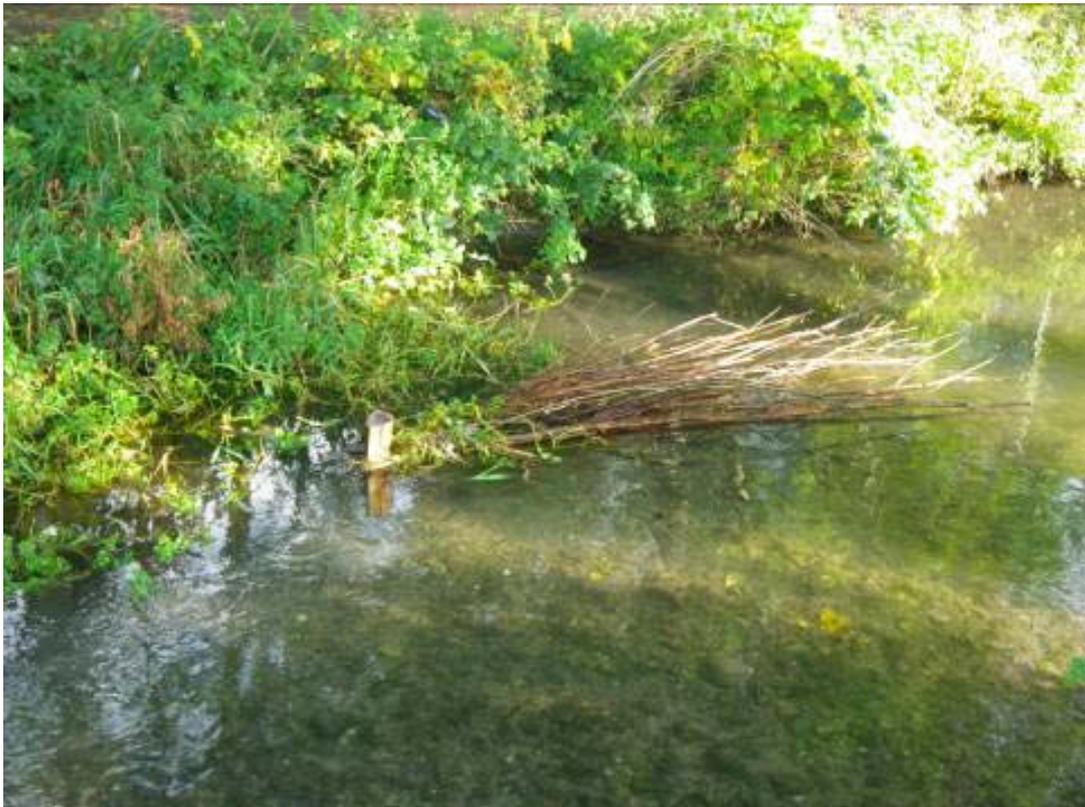
A brush bundle tethered to a stake. A method to use where temporary cover might be more desirable.

- Use tethered brush bundles installed in the margins either permanently or temporarily for winter cover on bare shallow margins.
- Find a volunteer to undertake the Anglers Monitoring Initiative. More information at www.riverflies.org
- Experiment with your trout stocking programme to find optimum densities that still provide high quality sport without impacting wild stocks and provide value for money for the CS syndicate.
- Undertake some end of season maintenance works to likely spawning spots through a programme of gravel cleaning. Details available via the WTT Chalkstream Habitat manual.

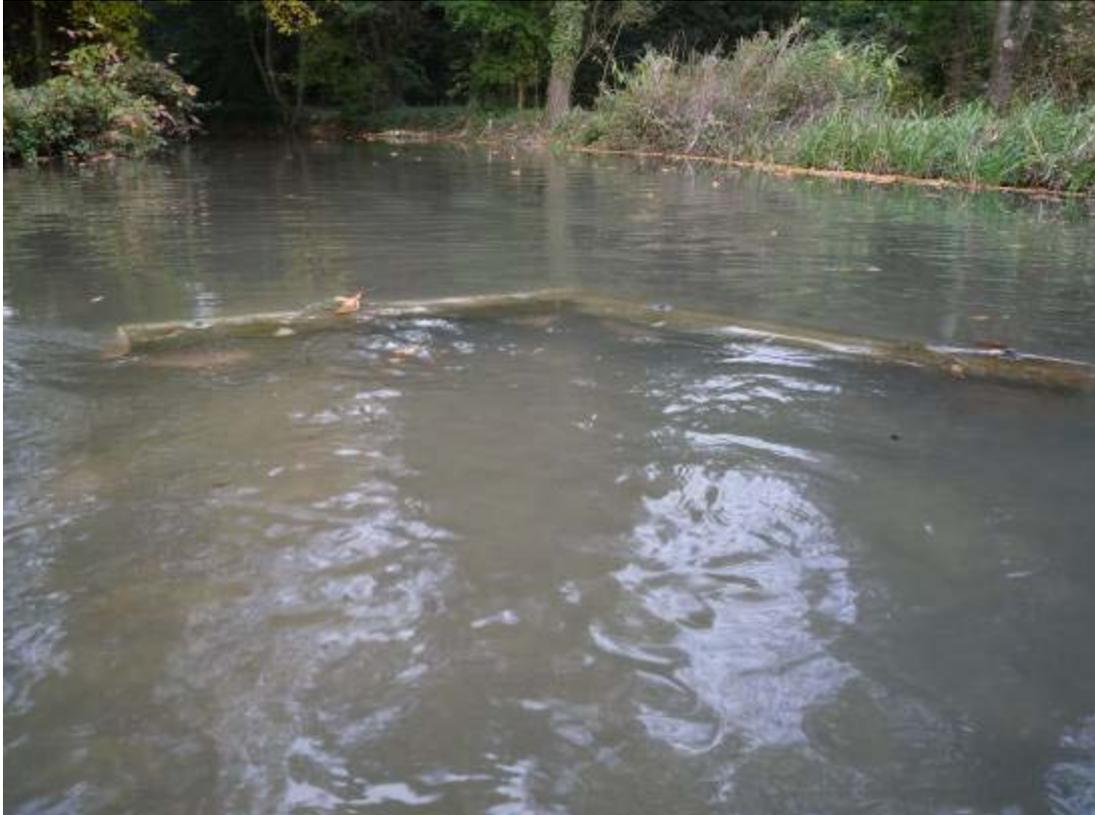
An upstream "V" deflector set up on log spacers to promote undershot bed scour. These work well on flat shallow glides to promote variety in depth
