**Advisory Visit**

**River Avonmore, Co. Wicklow, Ireland**

**5<sup>th</sup> July, 2010**

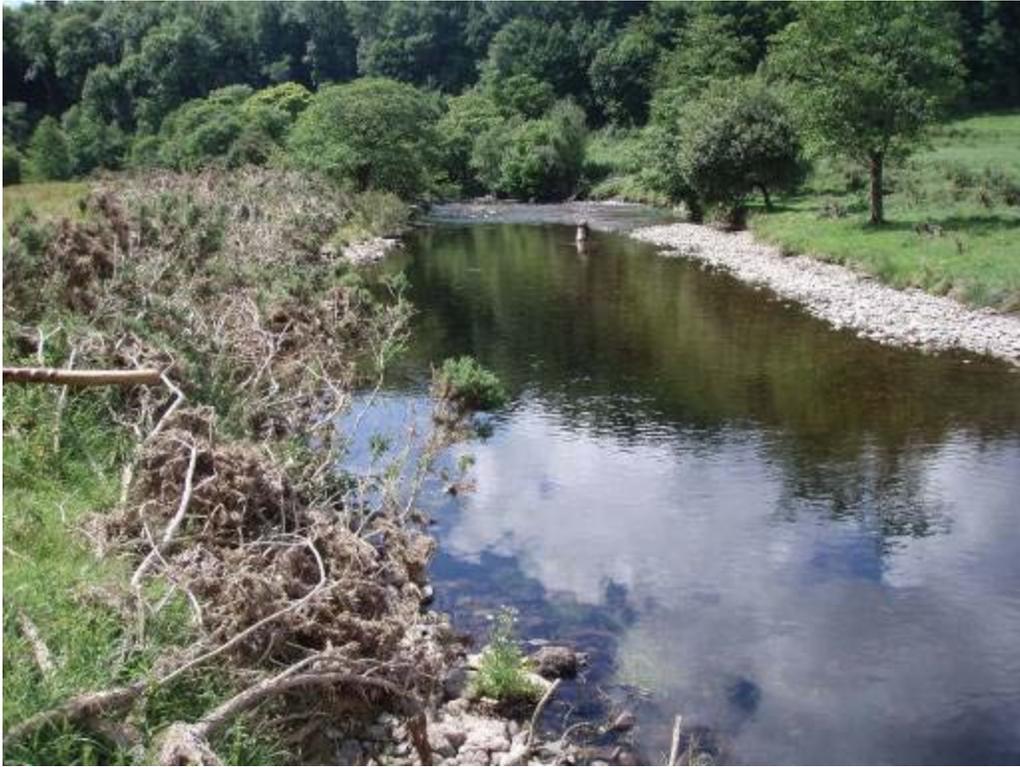
**Photo 1**

In Rathdrum, the river was walked downstream from the main road bridge to a footbridge. In-stream habitat was excellent with a variety of pools, riffles and glides and gravel point bars (Photo 1). A kick-sample for

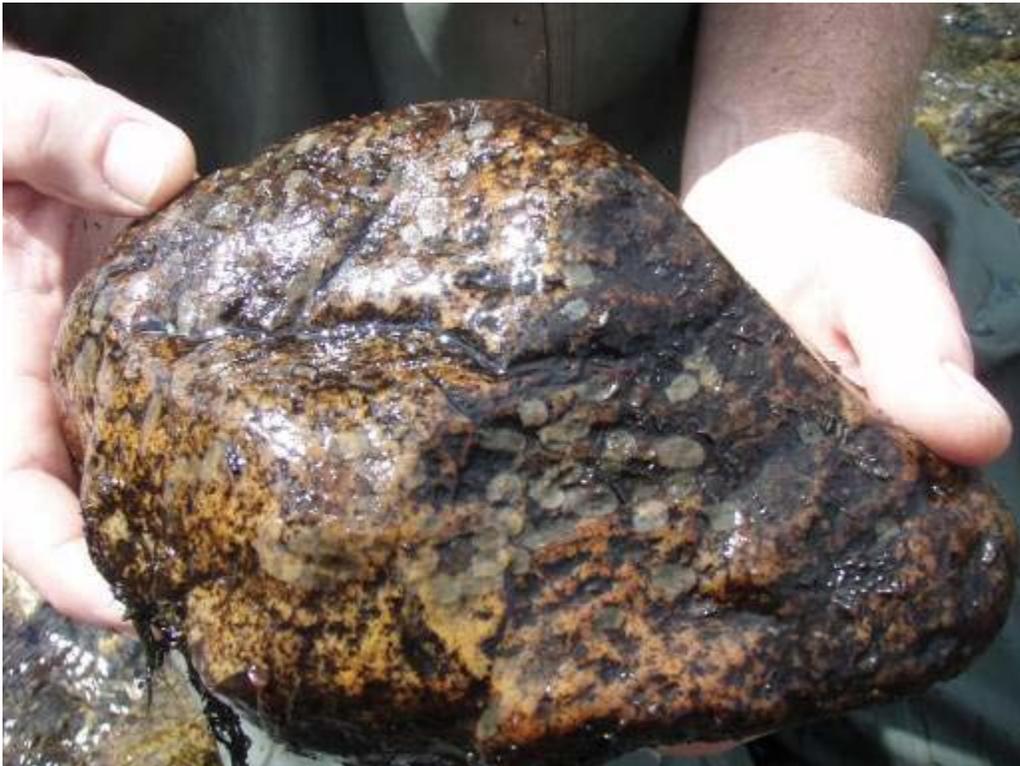
**Photo 2**

invertebrates was taken which revealed a good variety of species indicating good water quality, but relatively low numbers overall indicating a naturally unproductive system. The types of invertebrates caught were cased caddis (<10), caseless caddis (<100), blue-winged olives (<100), olives (Baetidae, <100), stoneflies (<10) and freshwater shrimp (<10). A small eel was also caught in the sample. Turning stones revealed good numbers of egg masses from upwinged flies (Photo 2).

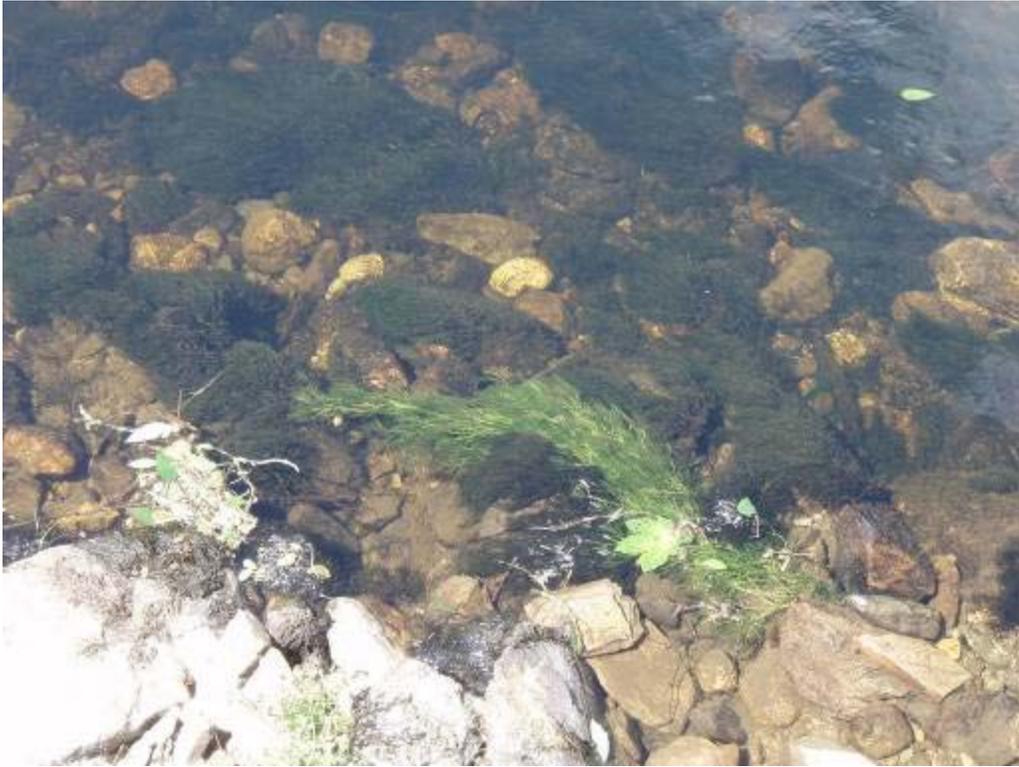
There was some aquatic vegetation within the river channel in the form of moss (*Fontinalis* sp.) and odd clumps of water crowfoot (*Ranunculus* sp.) (Photo 3). Compared with other river systems however, the weed growth is sparse and productivity within the river channel is low. Inputs from outside the river channel (e.g. leaf litter) probably provide a lot of the nutrients which support the food chain and are therefore very important.

**Photo 3** Water crowfoot (*Ranunculus* sp.) and moss growing on stones

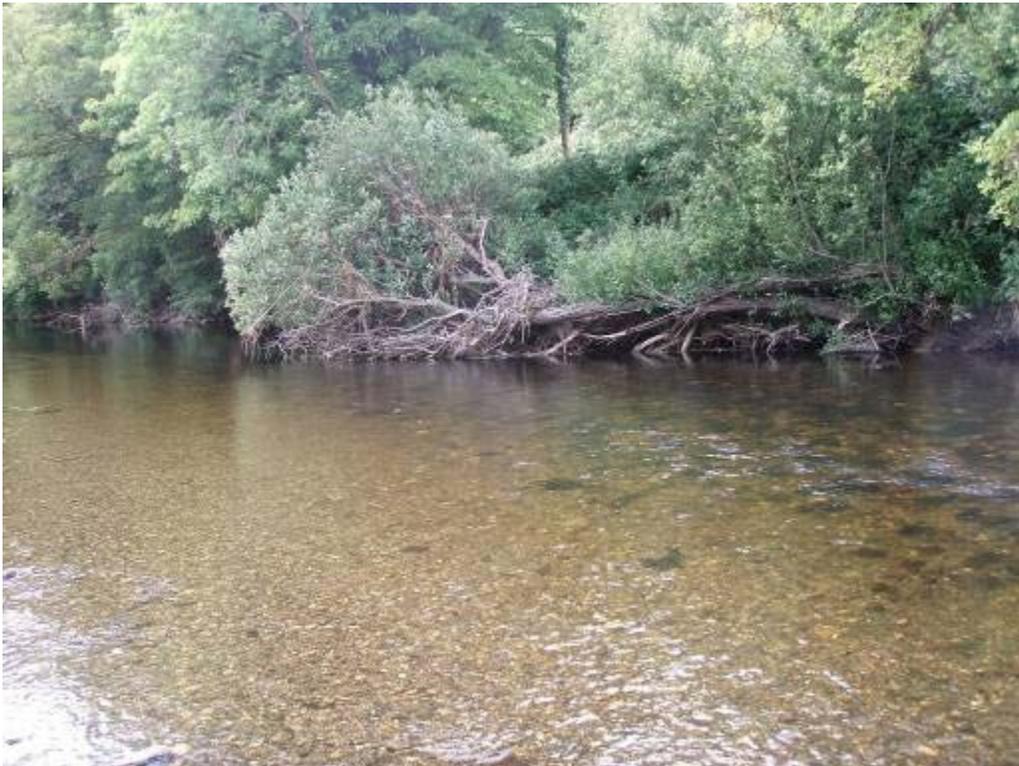
There were some good examples of stable large woody debris (LWD) in the river (Photo 4). LWD has been shown to be very important to the ecology of river systems for a number of reasons. These include:

**Photo 4** Stable large woody debris – a very valuable habitat

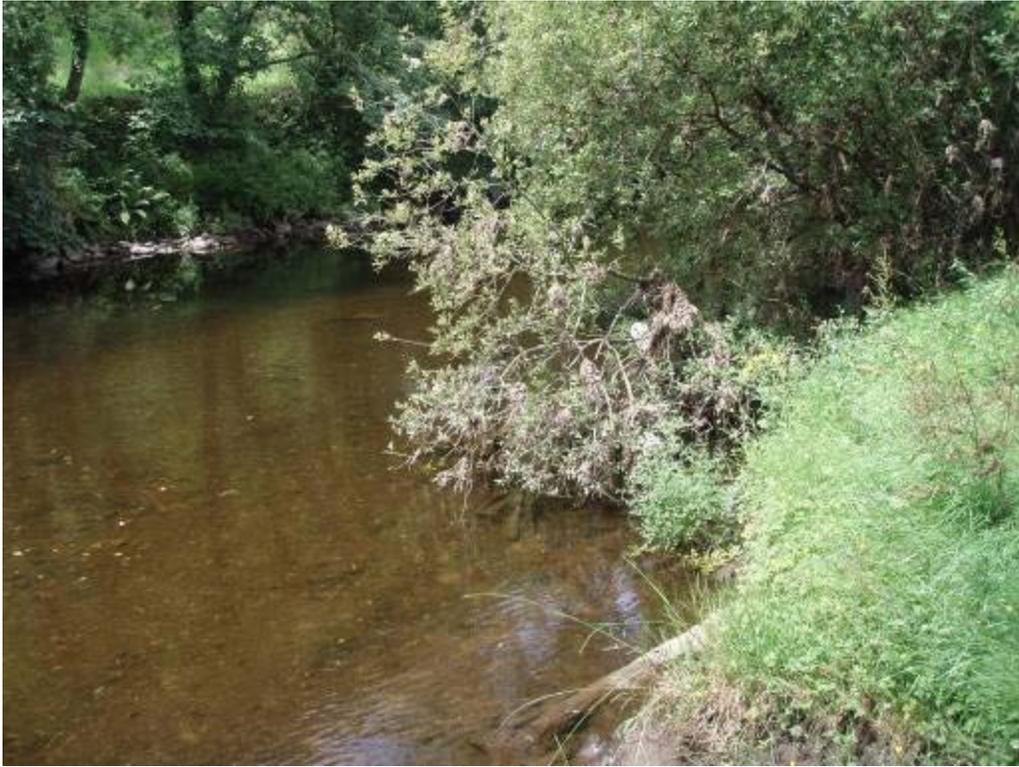
**Photo 5** Low cover over the water provided by a sallow tree – valuable fish habitat, particularly if combined with deeper water than shown in this photo.

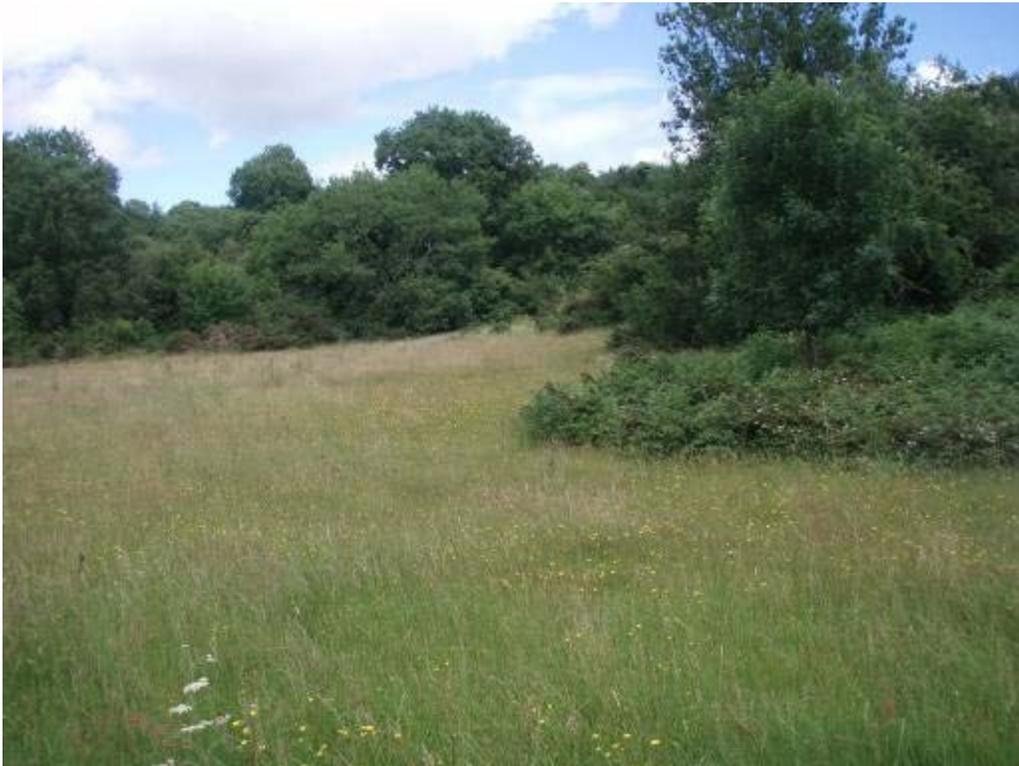
**Photo 6** Low intensity land use alongside the river – very important in protecting water quality and regulating run-off.

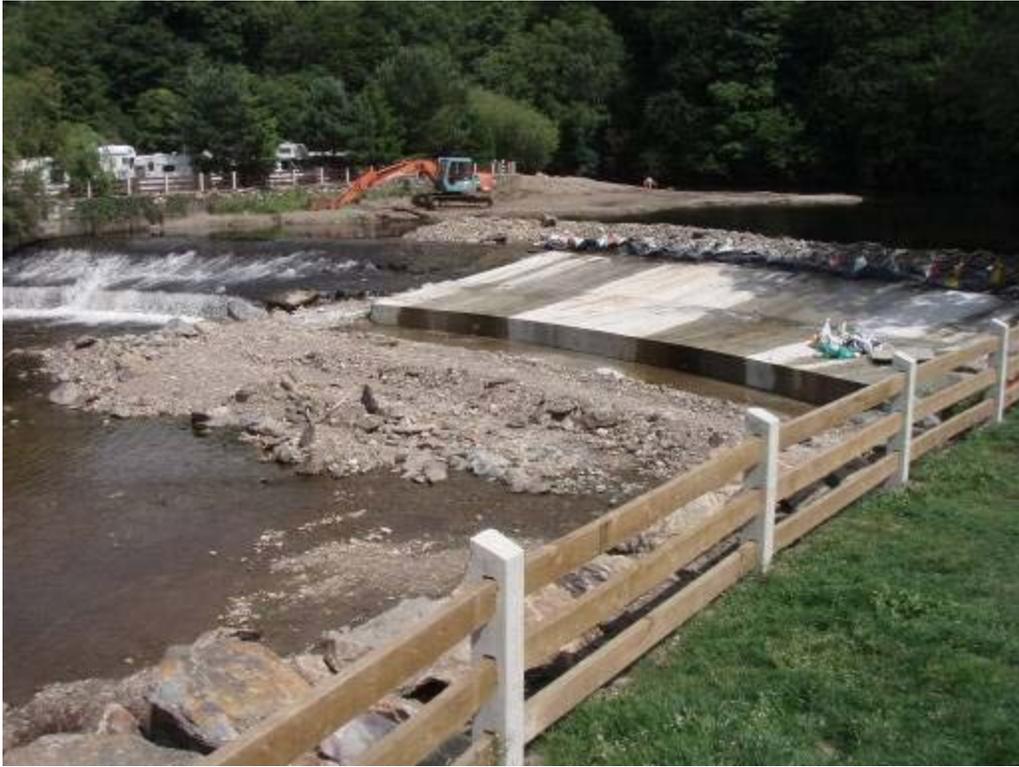
In addition to these works, a large weir has been repaired and the broken sill has been replaced with new concrete (Photo 7). It is reported that there are plans to install a hydropower turbine on the weir to generate power for the campsite. Whilst this is to be applauded for creating renewable energy, there are a number of points that need to be considered to ensure that the project does not create problems for fish stocks and the ecology of the river generally. These include:

**Photo 7 Weir repairs at the camp site**

- Fish passage upstream past the weir. Both salmon and trout migrate upstream to spawn, and eels also colonise rivers from the sea. The rebuilding of the weir will hinder this unless provision is made for a suitable fish pass. Ideally the downstream entrance to this needs to be located close to the discharge from the hydropower turbine so fish are attracted to that location.

- Fish passage downstream. Salmon and sea trout smolts and silver eels migrate downstream to the sea. Certain types of turbine (propeller types) cause heavy mortality rates to fish passing through them and need to be screened and an alternative route provided to bypass the turbine. The Archimedes screw turbine is far less damaging to downstream migrating fish and can be used with much coarser (or no) screening, reducing the screen maintenance requirement.

- Location of the turbine. The preferred location for the turbine would be within the weir itself, rather than any bypass channel (e.g. old mill channels) which would leave a stretch of river depleted of water.

RTAEC raise a formal query with the relevant authority regarding the provision of fish passage at this site; it would be far cheaper to construct a fish pass during the installation of hydropower facilities rather than trying to retrofit something afterwards.

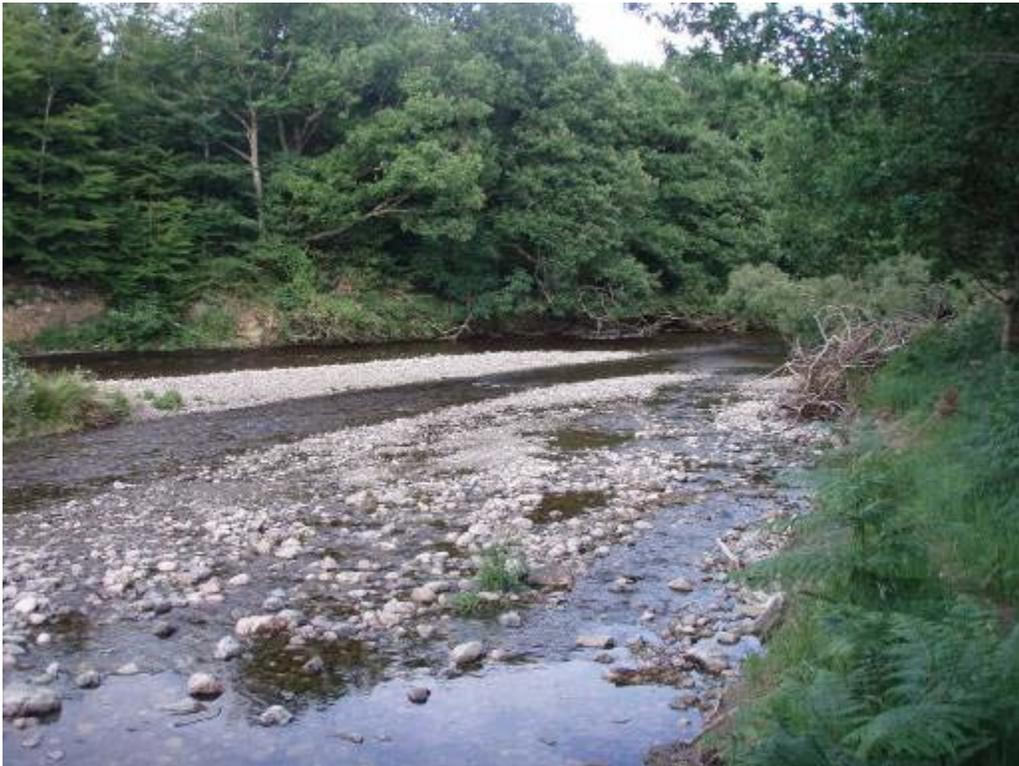
Upstream of Rathdrum Rugby Club the river had more areas of deep slow glide habitat separated by gravel shoal areas with some excellent habitat for juvenile trout and salmon and for salmon spawning. There were some good examples of large woody debris and many fish were seen rising in the glides.(Photos 8, 9).

**Photo 8 Gravel shoals upstream of the rugby club**

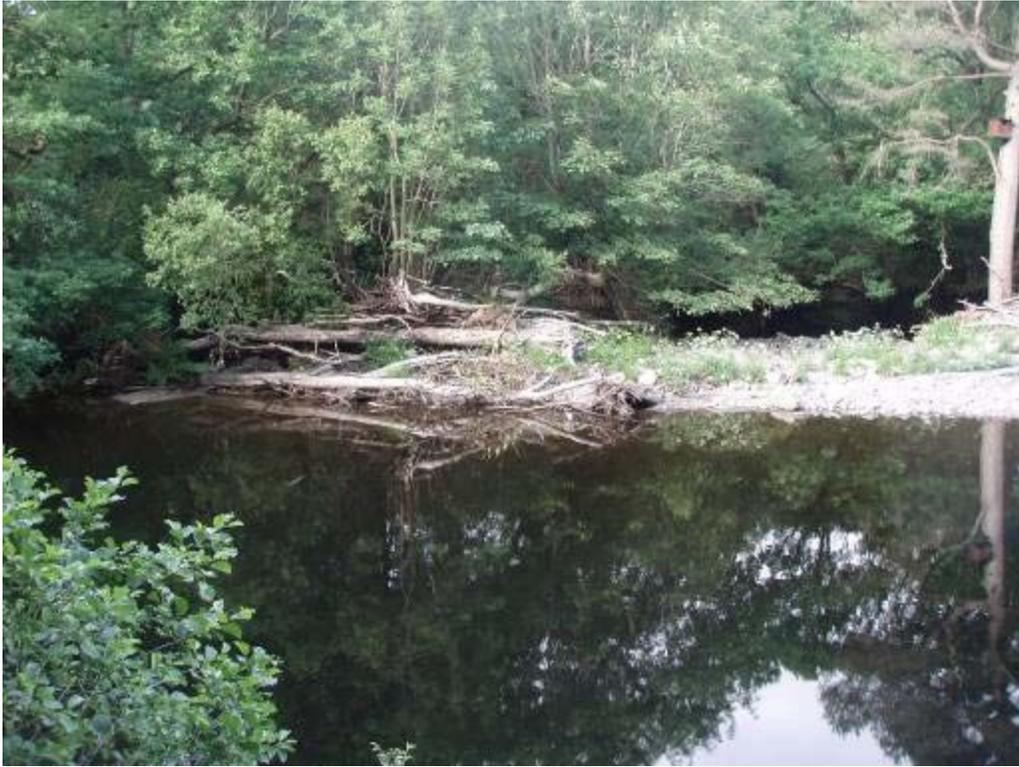
**Photo 9 Large woody debris and glide habitat upstream of the rugby club**

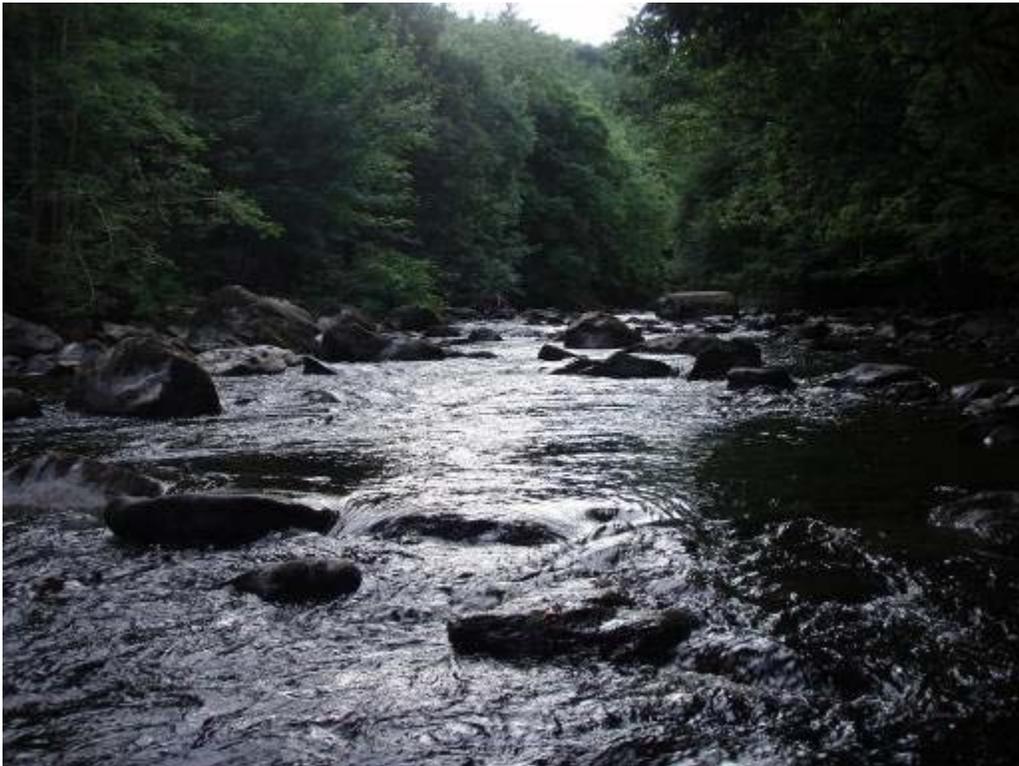
The river was visited at Dan Morrissey's quarry and the habitat here is spectacularly good. Set in a steep-sided, wooded valley the river has a steep gradient and is studded with large boulders (Photo 10).

**Photo 10 The Avonmore alongside Dan Morrissey's – habitat heaven!**

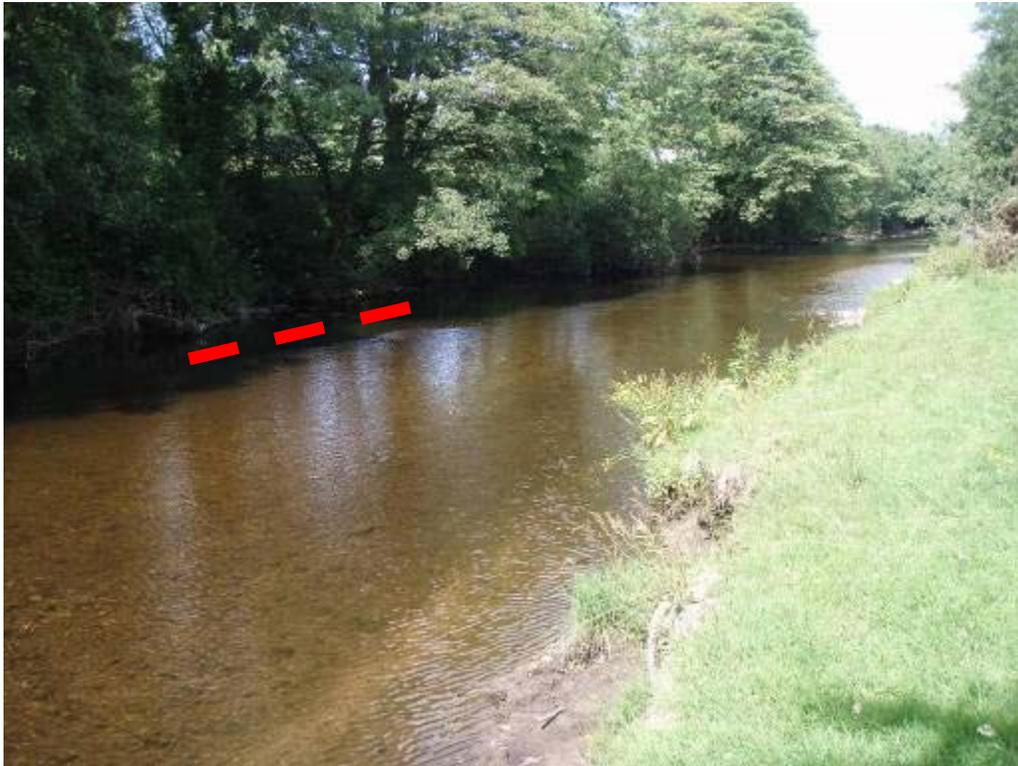
**Photo 11 Possible location for tree sweeper**

These are introduced by felling trees and fixing them parallel to the river banks as shown in the above diagram. The sites for installation can be on the outside of a meander or along a straight section of channel; a suggested location is on some of the straight glide habitats where there is currently little in-stream cover (Photo 11, 12).

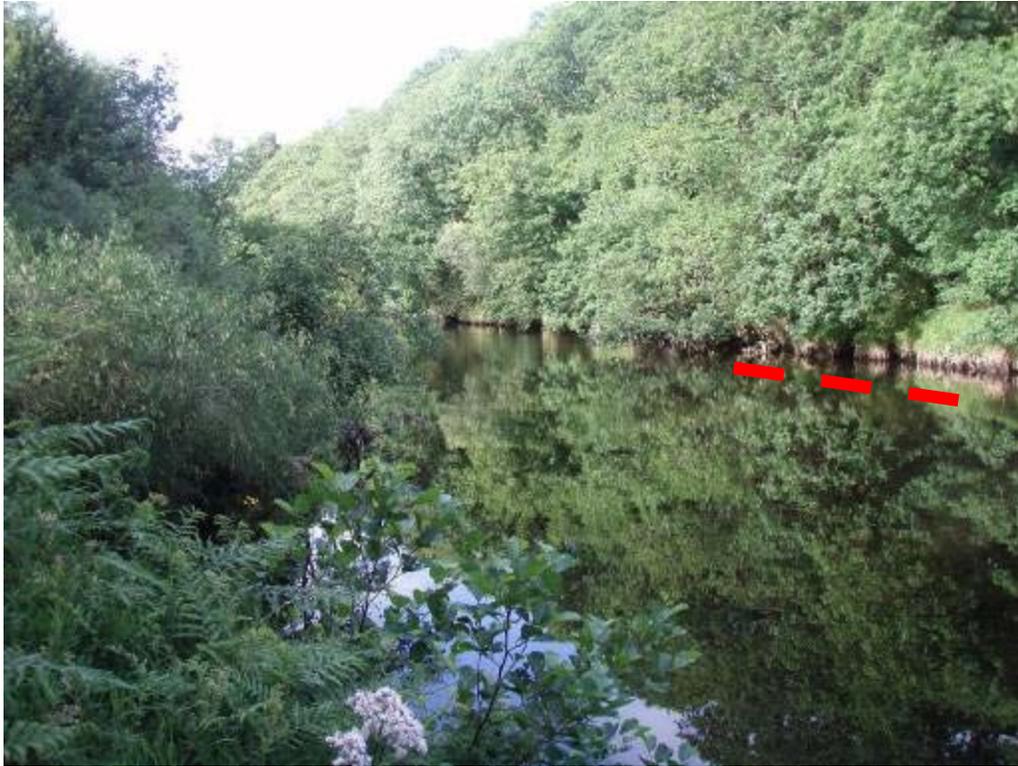
**Photo 12 Possible location for tree sweeper**

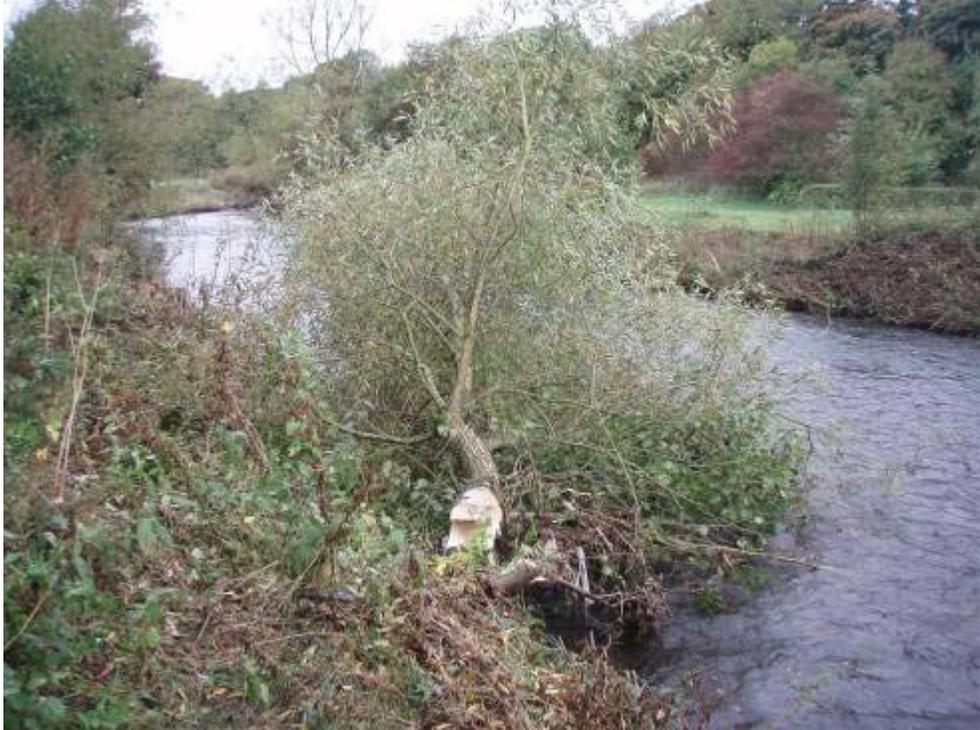
**Photo 13 Tree sweeper formed by hinging**

The trees can be fixed by hinging (partially cutting through the trunk to retain a hinge fixing it to the stump – Photo 13); this is suited to tree species like willow. An alternative is drilling and fixing to the stump with steel cable (Photo 14); this should be done at a level between low flow and bank-full water levels to prevent the sweeper being lifted onto the bank by flood waters. By preference, the sweepers should be positioned so a good proportion of them are submerged at low water levels.

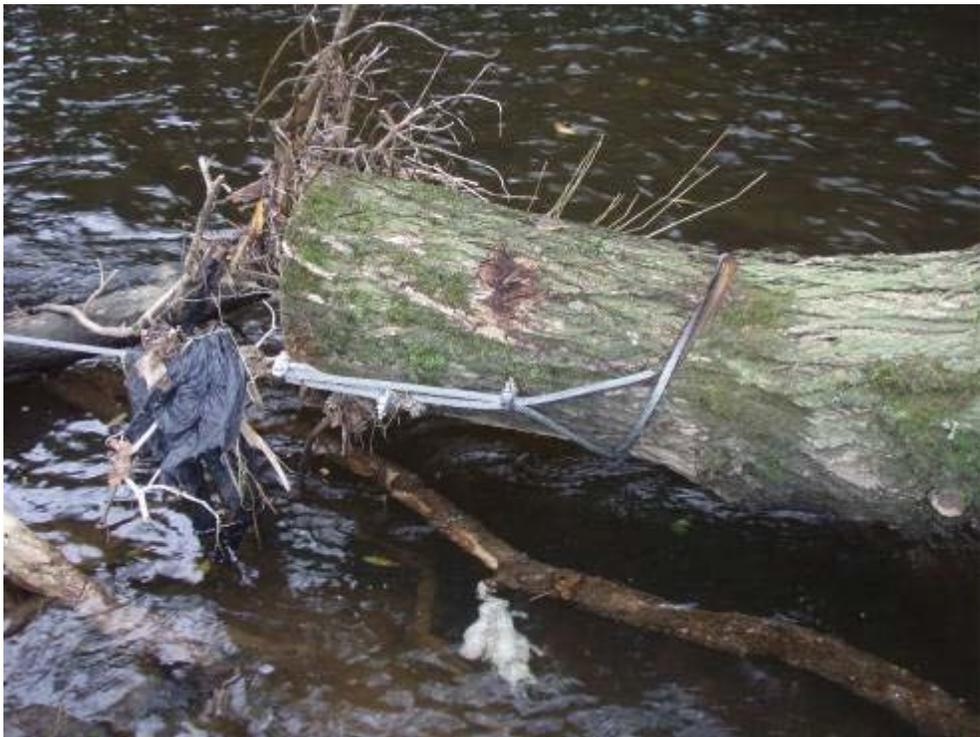
**Photo 14 Cable attachments – these can be largely concealed from view by drilling holes with an auger and keeping the cable as short as possible.**
