Advisory Visit

River Ure, Bradford City Angling Association

09/01/2017

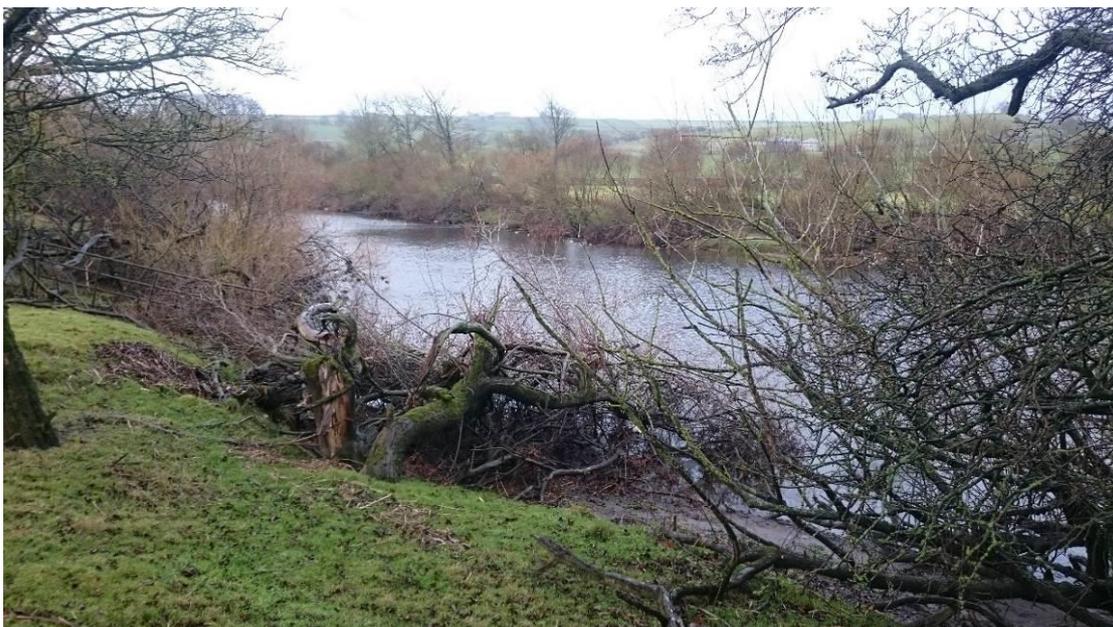
Fig 1. A short walk along the LB to examine willow fringe which presents good low cover over and in the water on both banks for the lowest ~250m of BCAA Aysgarth waters. See Fig 2.

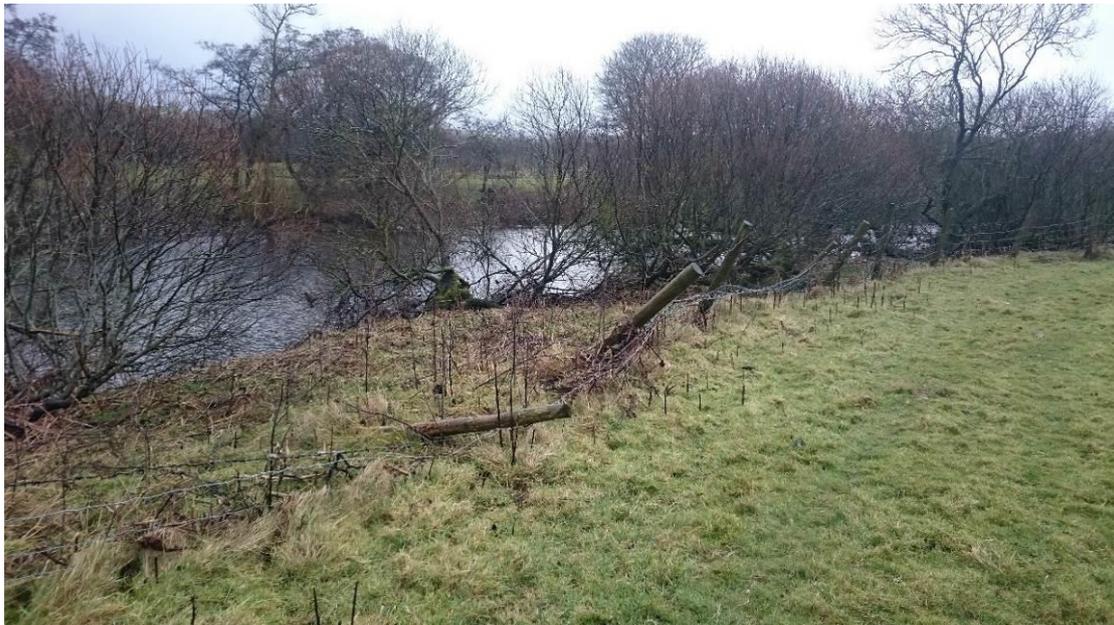
Fig 2. Almost opposite Fig 1, taken from the RB. Fencing requires reinstatement to prevent livestock access. Where there is adequate depth of water in the wetted channel, strategic laying of some well protected willow stems could provide low cover for fish holding. Furthermore, it may be possible to insert some woody debris between the abundant living stems and cable into position to introduce more heterogeneity to the instream habitat. NB: laying does not require consent; installation of fixed woody material may require consent dependent upon dimensions.

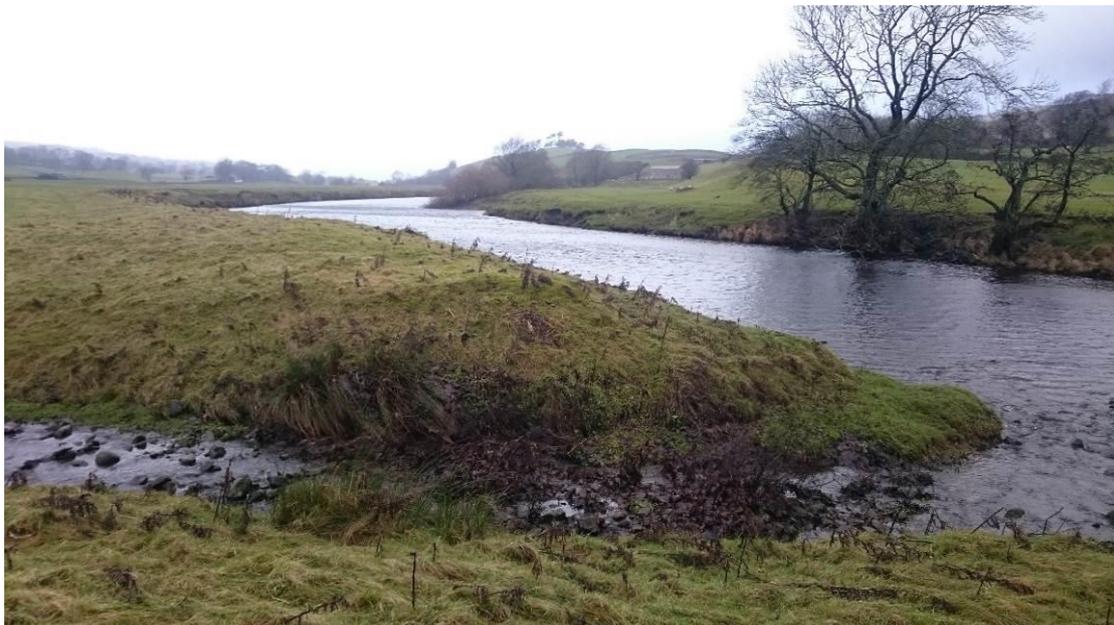
Fig 3. Looking u/s from the last of the willow in Fig 2, exemplifying the bare, grazed banks (lacking tree and vegetation regeneration), and long sweeping bends created by channel realignment and bank toe reinforcement with stone, presumably to prevent the river meandering too close to the railway line (now defunct). Unfettered access to Gill Beck (foreground) has resulted in a shallow, uniform channel completely devoid of cover. Such becks will be important for spawning and fry habitat and hence are worth protecting. Engagement with YDRT could provide an avenue for improvements to be made beyond the immediate sphere of influence of BCAA.

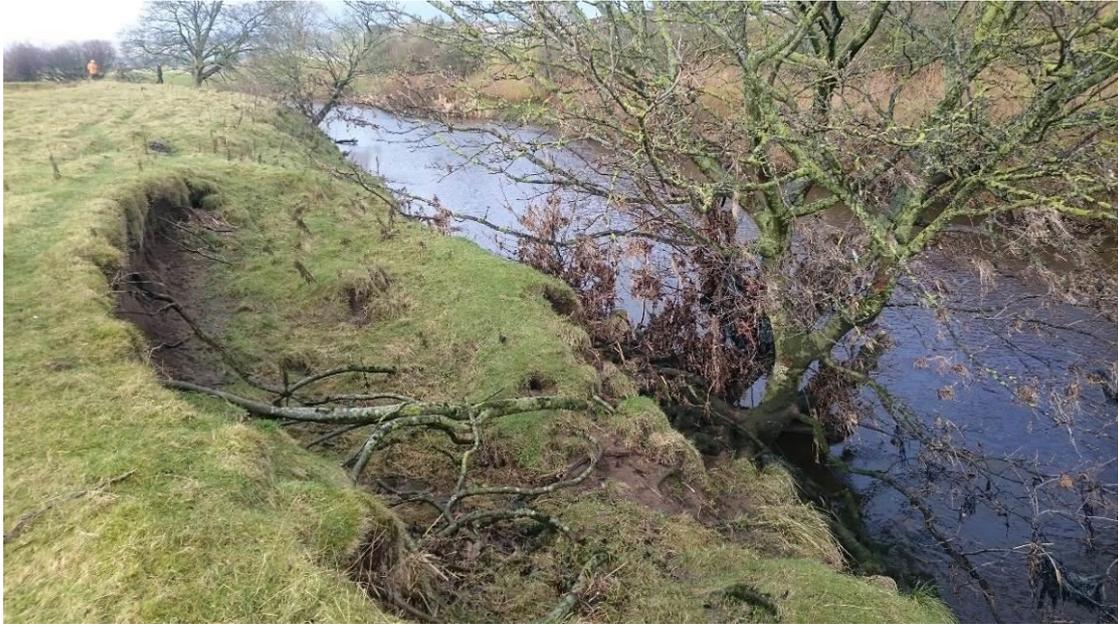
Fig 4. A slumped section of bank at SD 98420 89306 which would have been long lost if not for the extensive root mass holding it in position. However, continued livestock access is exacerbating erosion around the remaining horizontal roots via trampling and grazing. Fencing would be beneficial here to allow riparian regeneration and development.

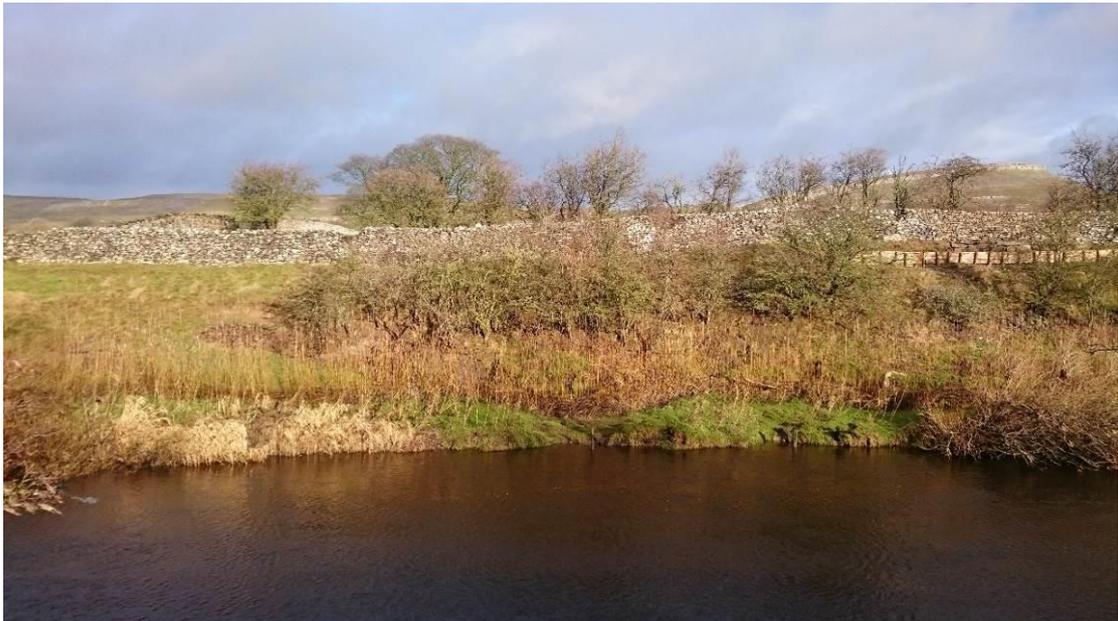
Fig 5. Line of willow spiling (on the outside of a bend and ~ 1m above the waterline) which appears to have taken well. Evidence that willow techniques will work on the Ure and can be applied as actual habitat creation rather than just bank erosion.

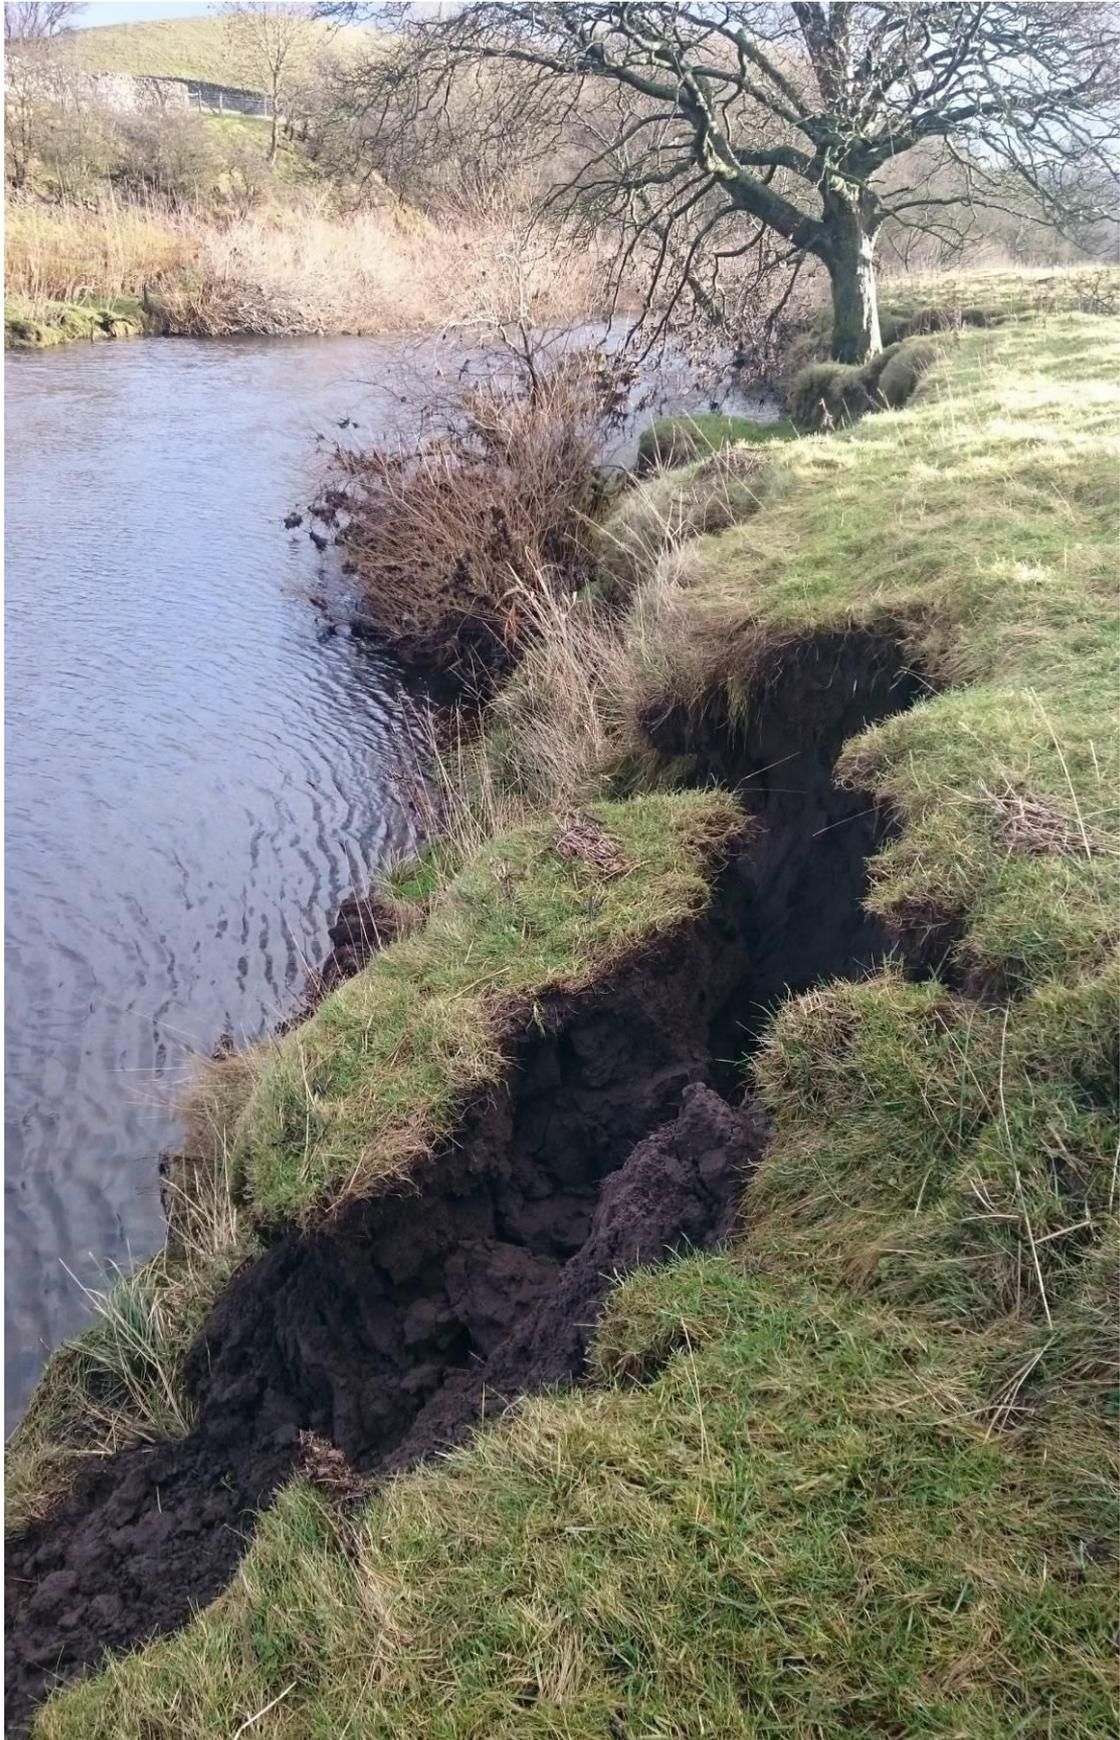
Fig 6. Block failure of bank. Sheep grazing greatly reduces the diversity of vegetation and the extent of associated root matrices within the soil; as a result, only the surface layer is bound together. Continued loss of such blocks will eventually lead to the loss of the tree in the background and further widening of the channel, which will become shallower and entrain soil / silt.

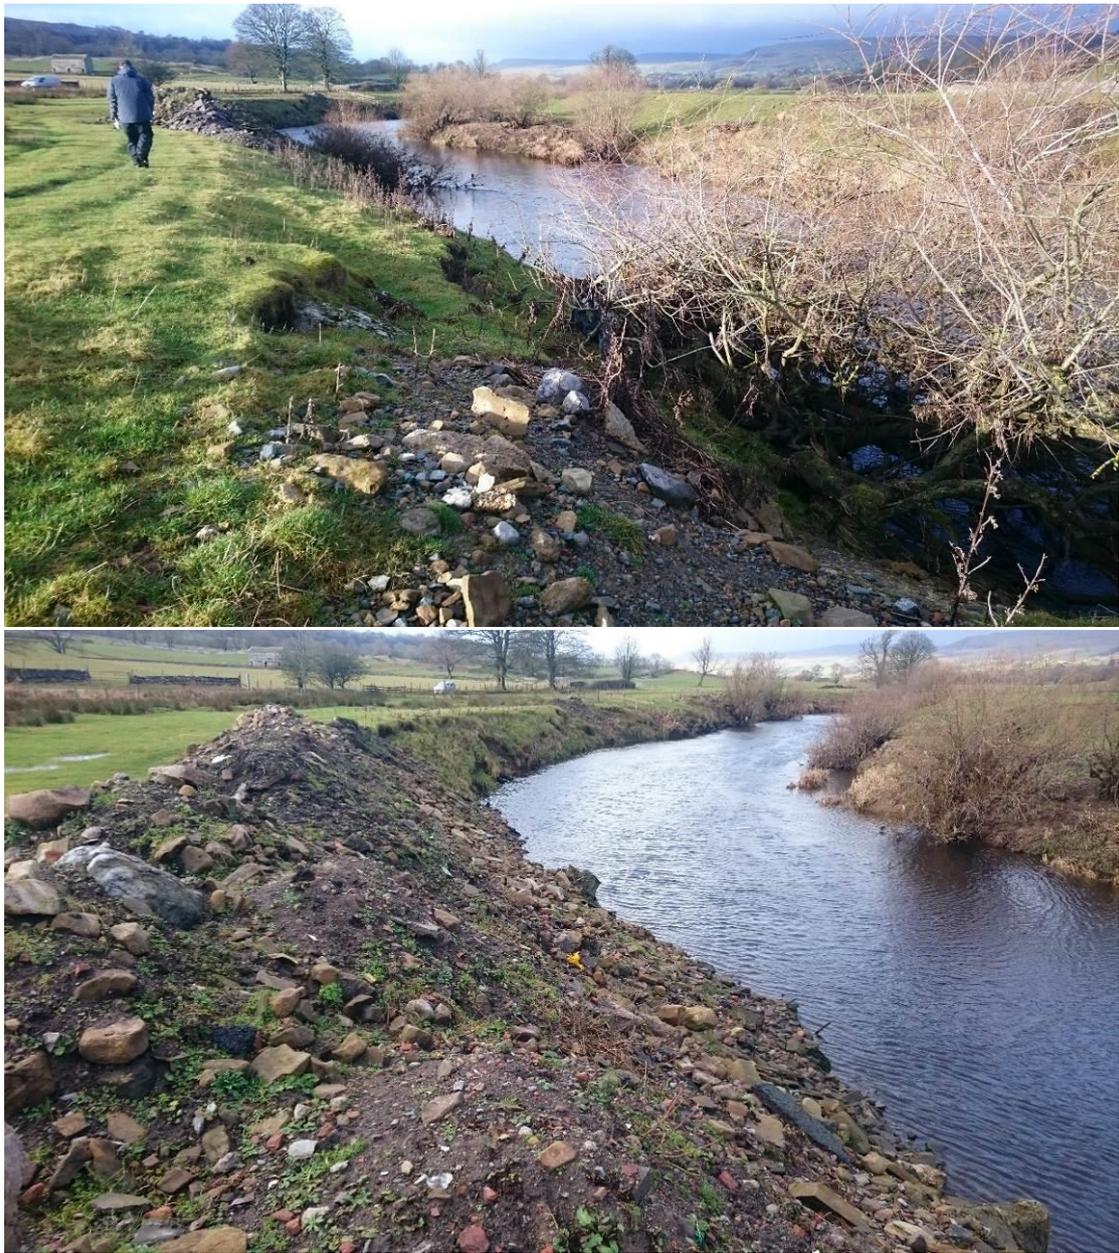
Fig 7. Upper & lower panels: assorted rubble and unconsolidated material illegally dumped onto the river bank (and sloughing into the channel) in a misguided attempt to curtail erosion on this bend (SD 97770 89513). It will be worth engaging with YDRT to instigate a farm visit and where possible, encouraging the use of willow whips and stakes to create a softer, green engineering solution to preventing bank erosion. However, for any green engineering techniques to be effective, livestock must be excluded from the bank.

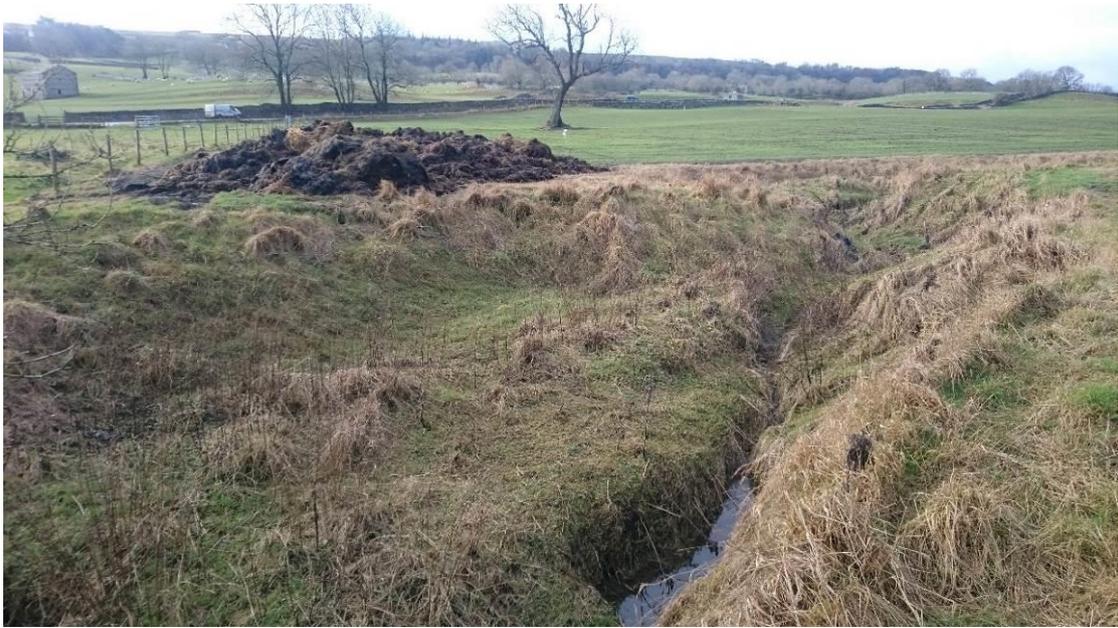
Fig 8. Dumping of manure / old silage – a pollution hazard perilously close to a small tributary and less than 25m from the mainstem Ure bank (SD 97606 89612). As this decomposes, the liquor is likely to seep into the beck causing pollution and eutrophication.

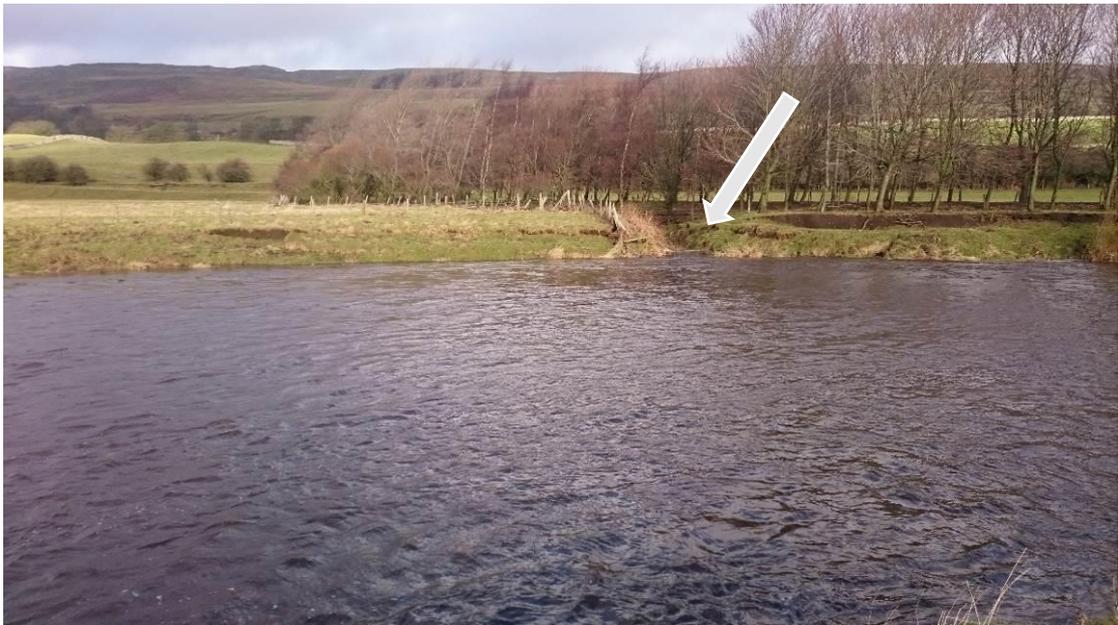
Fig 9. Confluence of Sister Ings Beck with the Ure (white arrow) viewed from opposite on the RB. BCAA have fishing rights at least until the old railway line along the tributary. It appears fenced and with a wooded riparian fringe on one bank at least and so may well be worth further investigation into its suitability as a spawning beck. Its confluence with the Ure is also on the outside of a bend (on the main river) and hence should always be accessible from relatively deep water.

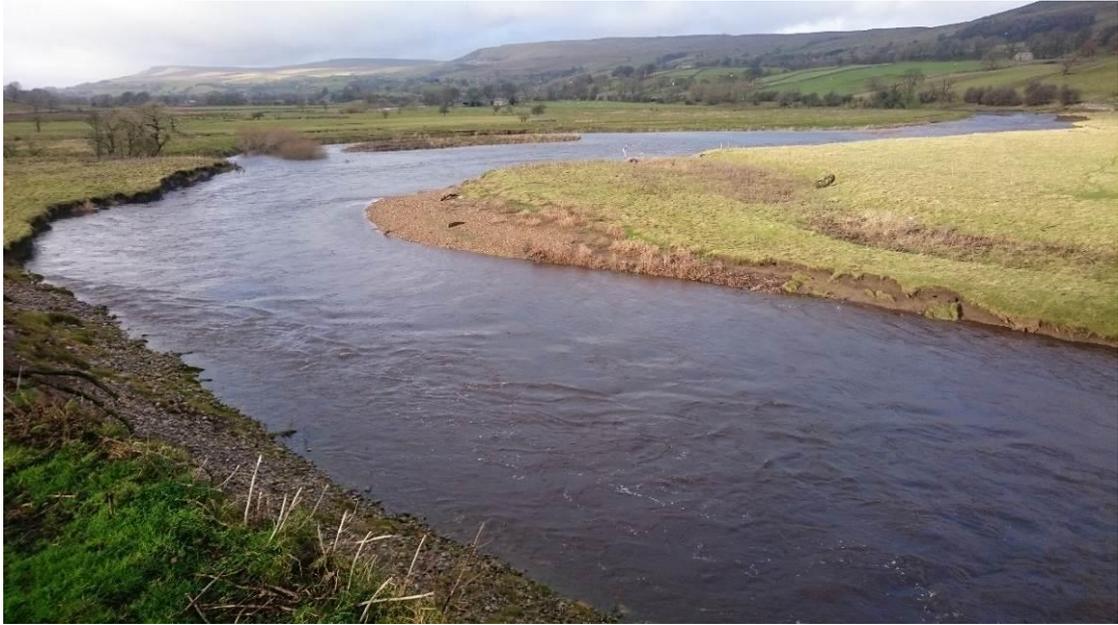
Fig 10. Image taken at the top of the BCAA Aysgarth beat as the river was rising rapidly! Exemplifies typical bare banks which would benefit from restriction of livestock access and tree planting.

Quick and easy wins could be achieved by willow whip and peg / stake insertion at appropriate points in the toe of the banks, but is only worthwhile in areas that sheep cannot access. The further upstream, the more willow is available (aside from the very lowest banks), and more could be done to lay some of that into and over the water surface (angled d/s so as not to cause undue stress under spate flows) to provide cover (e.g. around Worton). Sister Ings Beck (Fig 9) could also be a target for protecting / rehabilitating / creating spawning habitat, especially as the Club has the fishing rights and hence access there; the land management further u/s also appears to be more sympathetic than along the becks entering from the Ure RB.
