Advisory Visit

River Bain, Donington, Lincolnshire

4th November, 2008

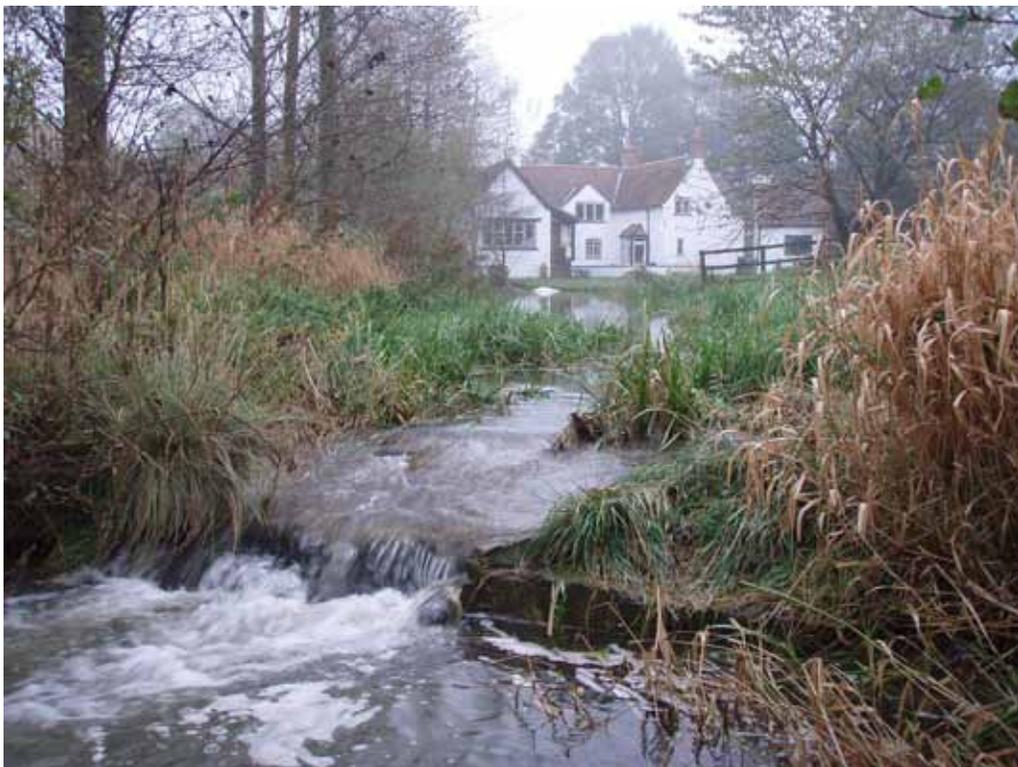
Just above the road bridge two channels converge, meeting at a weir (Photo 2). The right channel takes the main flow, and the left channel (cover photograph) takes the flow from the pool outside the mill house (this pool is fed by a pipe from the main channel). A crayfish trap was found just below the weir, containing a live signal crayfish (*Pacifastacus leniusculus*); these are known to be present in large numbers in this part of the river.

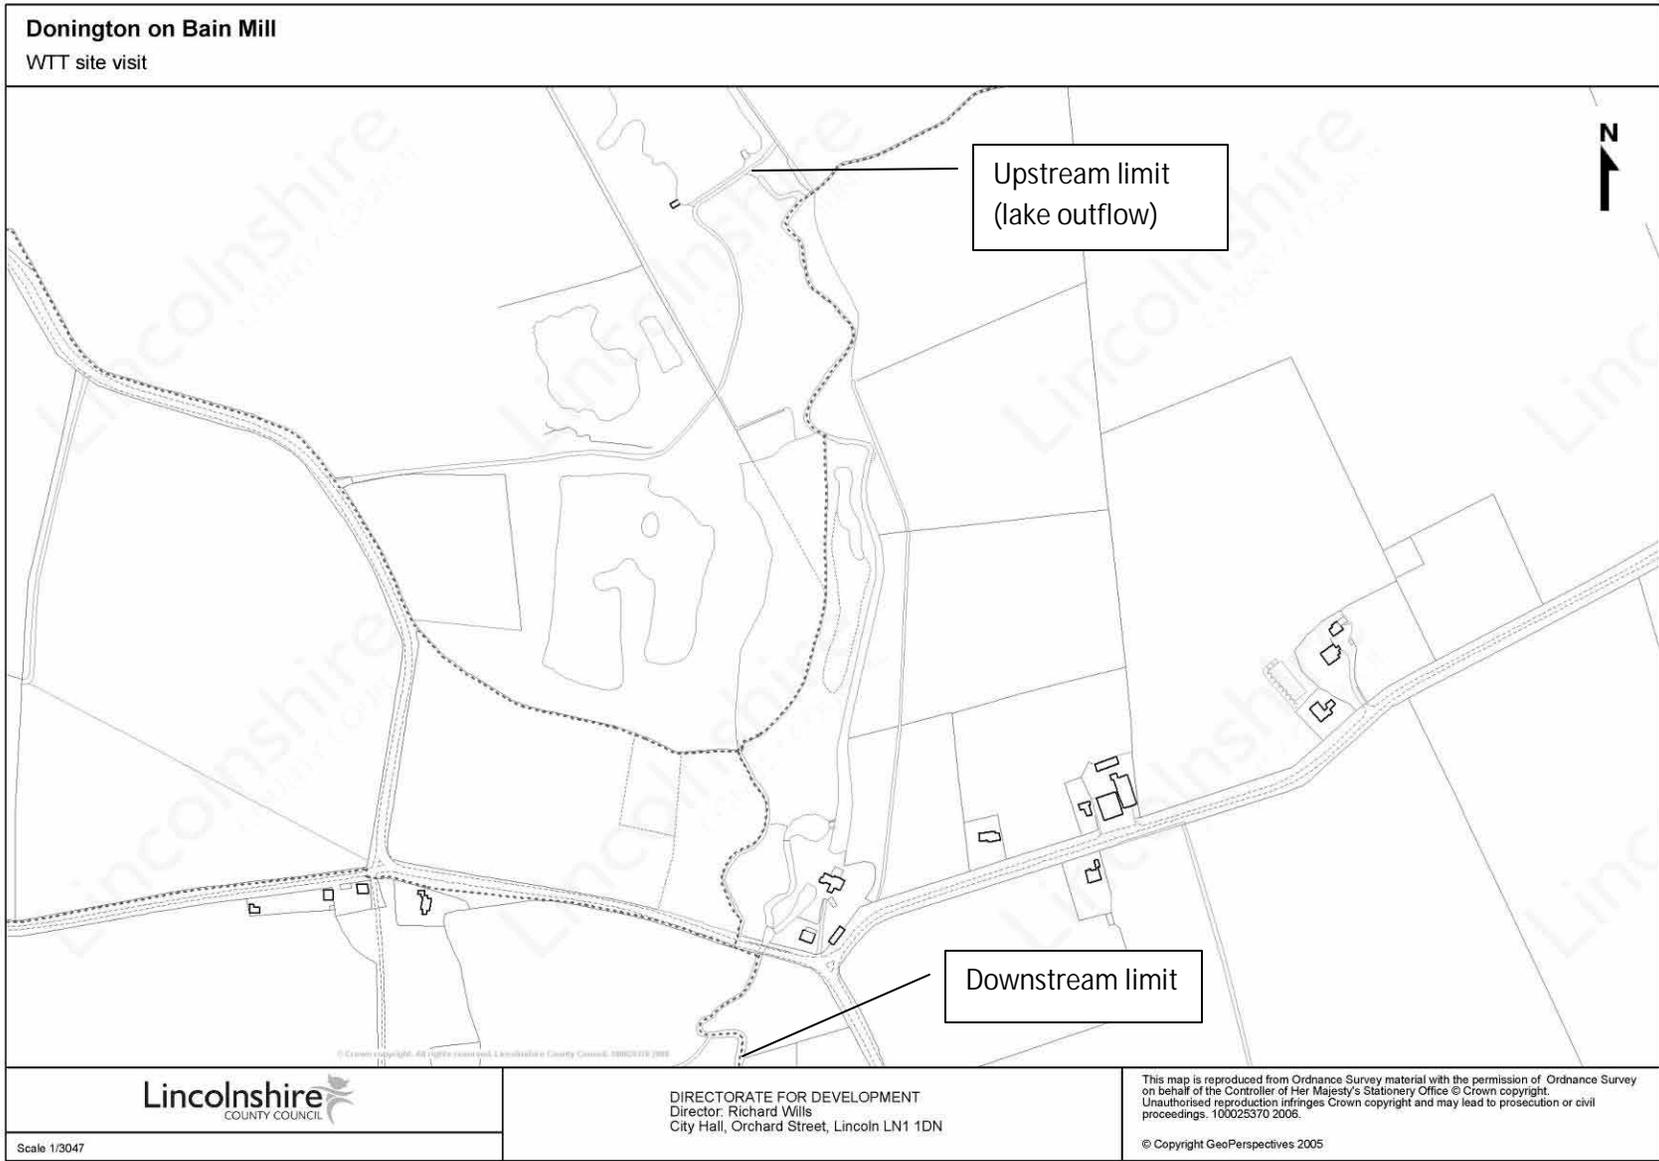
Figure 1 Site Map

The River Bain is a small chalk river rising in the Lincolnshire Wolds close to Ludford, flowing south through Horncastle and Coningsby, and joining the River Witham at Dogdyke. This visit was at Donington-on-Bain, near Louth (TF 233 834), on an approximately 850-m stretch of river alongside the Old Mill House (Figure 1).

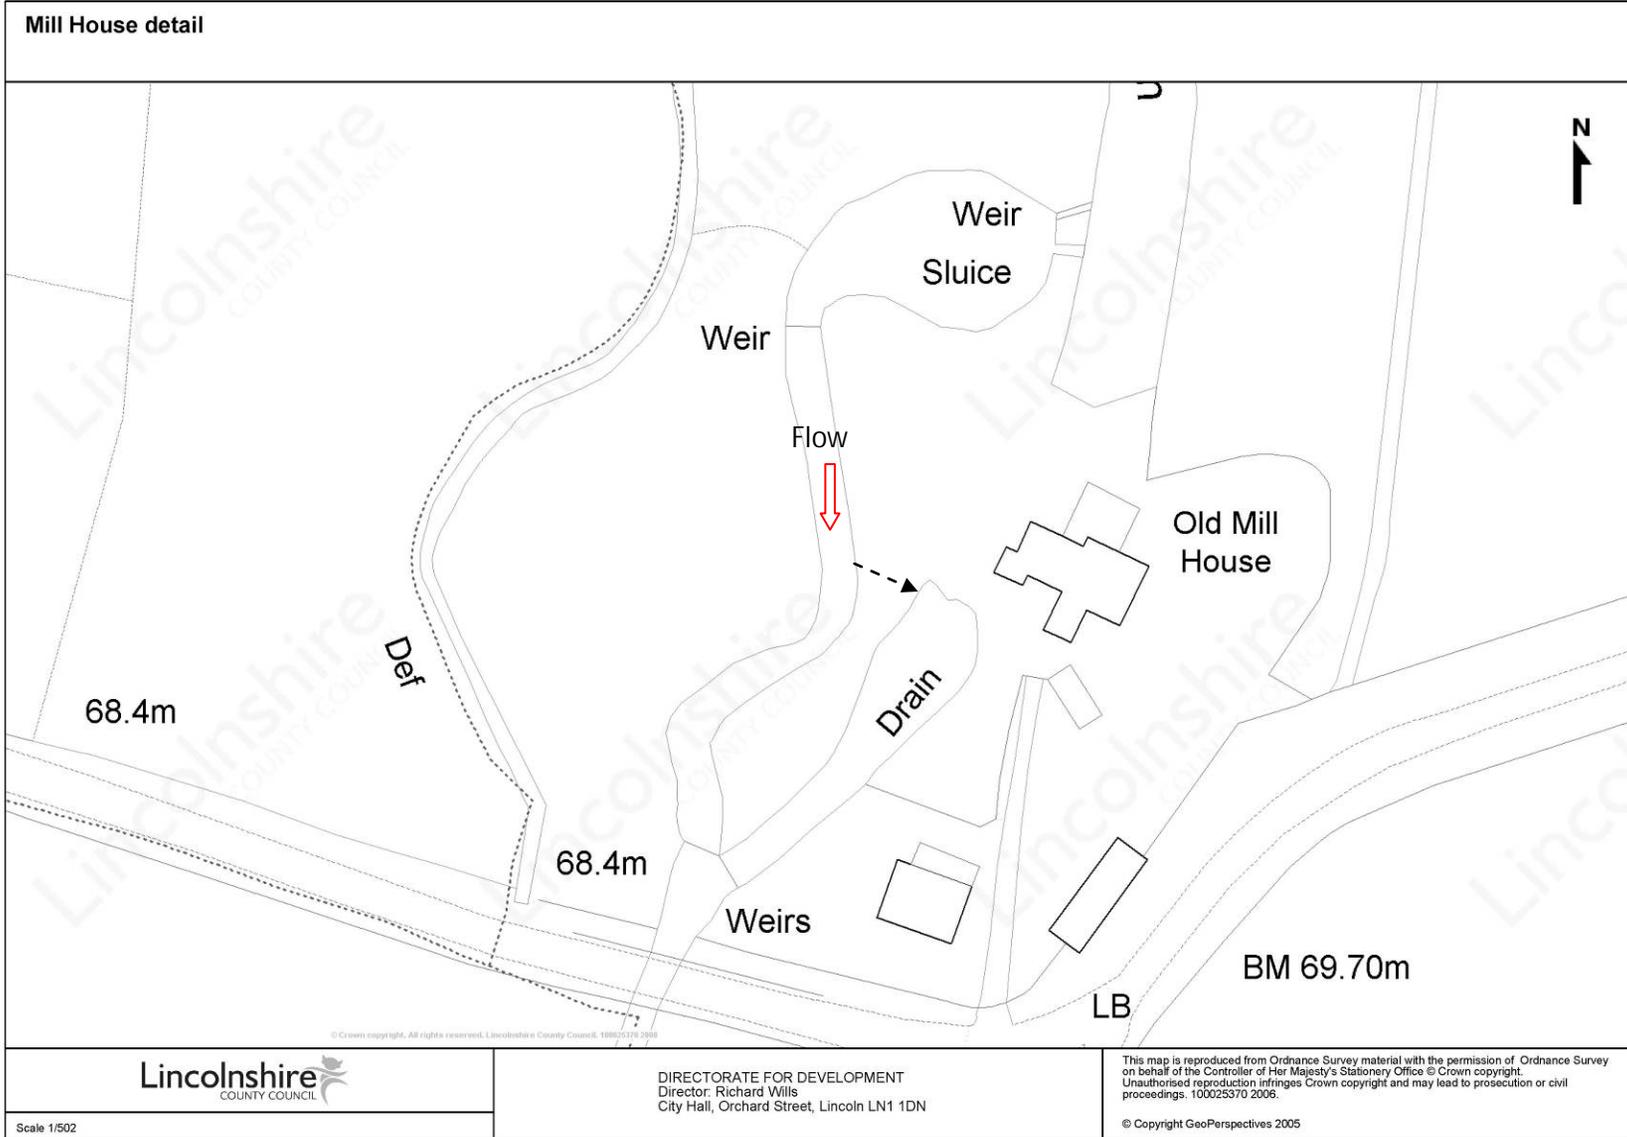
Figure 2

The primary influence on the habitat in this reach of the River Bain is the mill impoundment. The mill is no longer in use, but the diverted river channel upstream of the mill building remains; this is a perched channel which overflows through a sluice and a weir into a weirpool. Upstream of the weir and sluice the river is impounded for a considerable distance upstream (Figure 2).

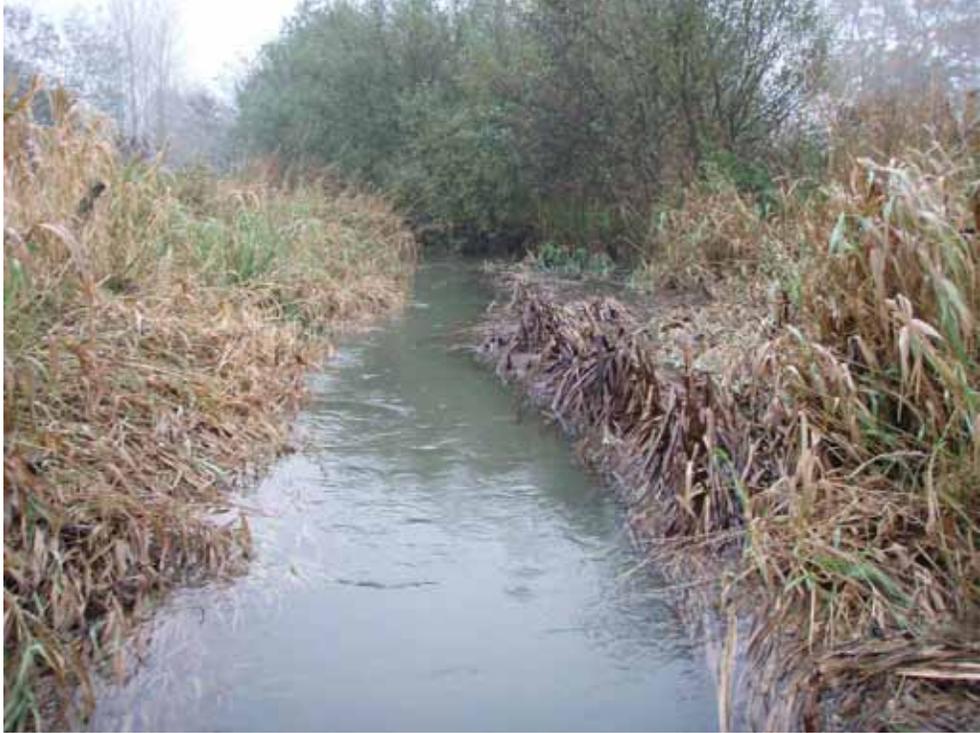
At the downstream end of the reach, below the road bridge the river has a channel width of about four metres, two of which comprise a wet berm along each margin vegetated with grasses, reeds and sedges (*Carex* sp., *Phalaris* sp., *Sparganium* sp.) (Photo 1). There are some young alder and willow trees present, and the river is fenced along both banks; behind the fence, the land use is hay meadow (LHB) and a wet grazing meadow (RHB; this is in Countryside Stewardship).

There is little variation in depth and width in this section of the river; the channel width is approximately 4 m and the depth 0.5 m. The river bed here is poorly sorted and comprises sand and silt; there was little in the way of gravel of a suitable size for spawning.

Photo 1 Downstream of the road bridge

outflow (two riffle areas of 20-m length each), and downstream of the road bridge (one riffle of 20-m length). Further information on the introduction of gravels is provided in the Chalkstream Habitat Manual.

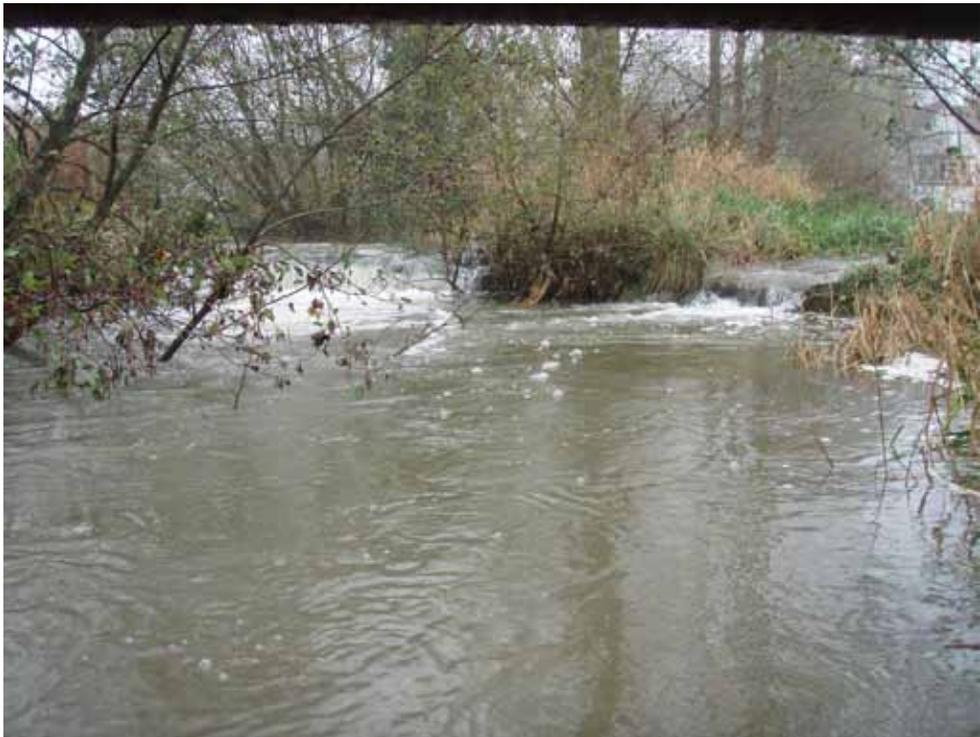
Photo 2 Weirs just upstream of the road bridge

The small weirs could be improved by installing simple pre-barrages; these are lower weirs installed downstream of the obstruction in order to reduce the head loss across it. They are commonly used in conjunction with a notch or gap in the weirs, creating a series of “steps” down below the existing structure (Photo 16). They can be constructed from stone or logs.

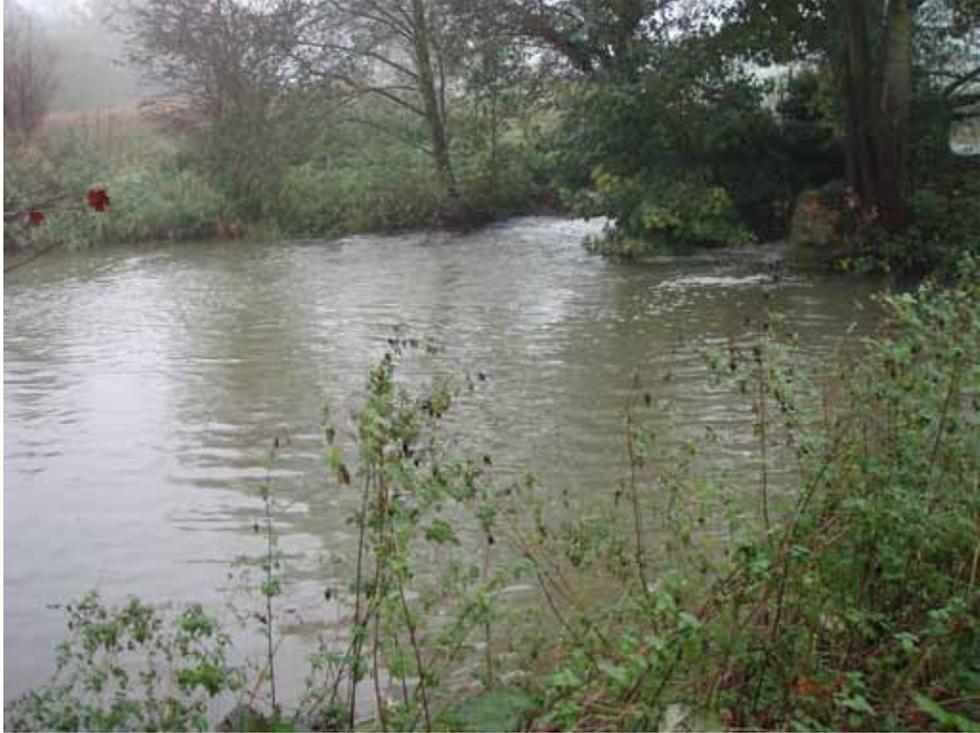
Photo 3 Weirpool with outflow from sluice (nearest) and overflow weir visible top right

Between the weirs next to the road and the weir pool alongside the mill house, the river channel is slow and deep, with a low weir under a footbridge. The weir pool itself receives the flow from the impounded channel upstream of the mill (Photo 3); the flow can be controlled by a sluice gate, and there is also a concrete overflow channel adjacent to the RHB which is showing signs of erosion (Photo 4). The height of the sluice and overflow is such that fish wishing to move upstream would not be able to pass this point.

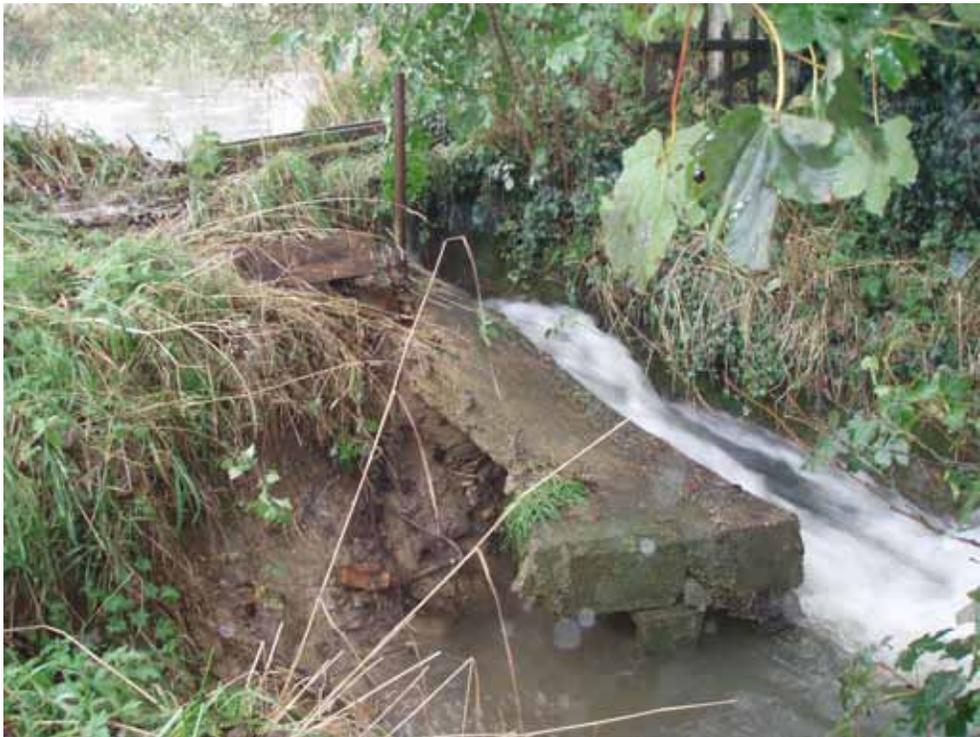
Photo 4 Overflow weir and eroding embankment

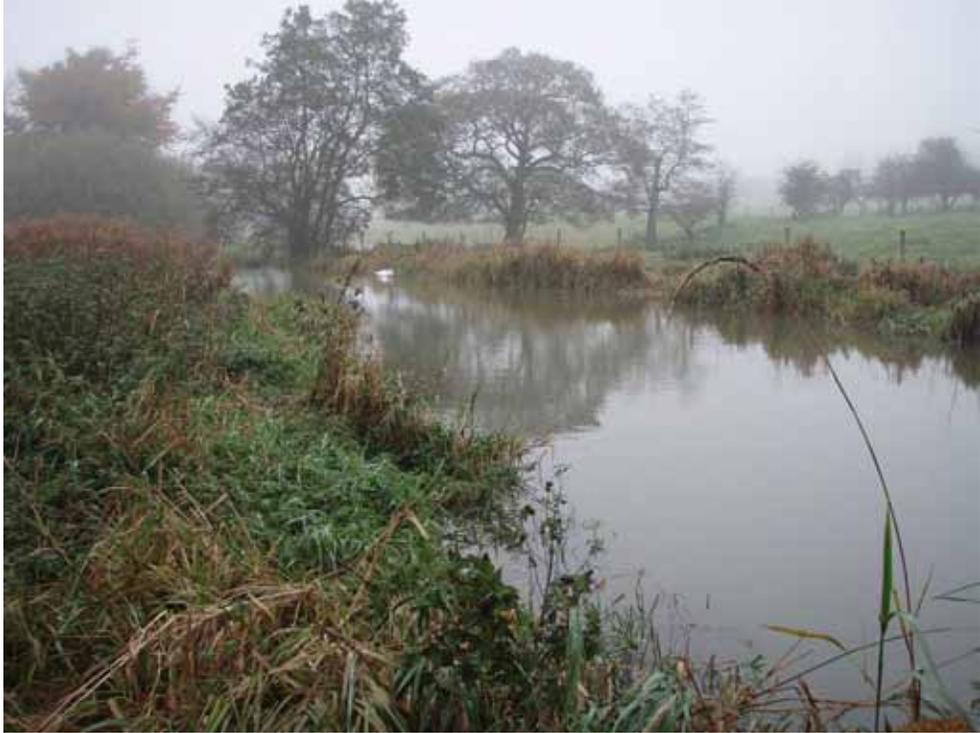
Upstream of the mill the river is impounded in a deep, wide channel perched above the level of the surrounding land (Photo 5); this was obviously constructed to provide a head of water for milling. The LHB is used for grazing and is traversed by the long-distance public footpath, the Viking Way; the river is fenced on this bank and there is a wide margin of wetland vegetation between the river and the fence. There was an area of standing water in the low lying ground in the field beside the river at the time of the visit (Photo 6).

Photo 5 The slow-flowing mill channel

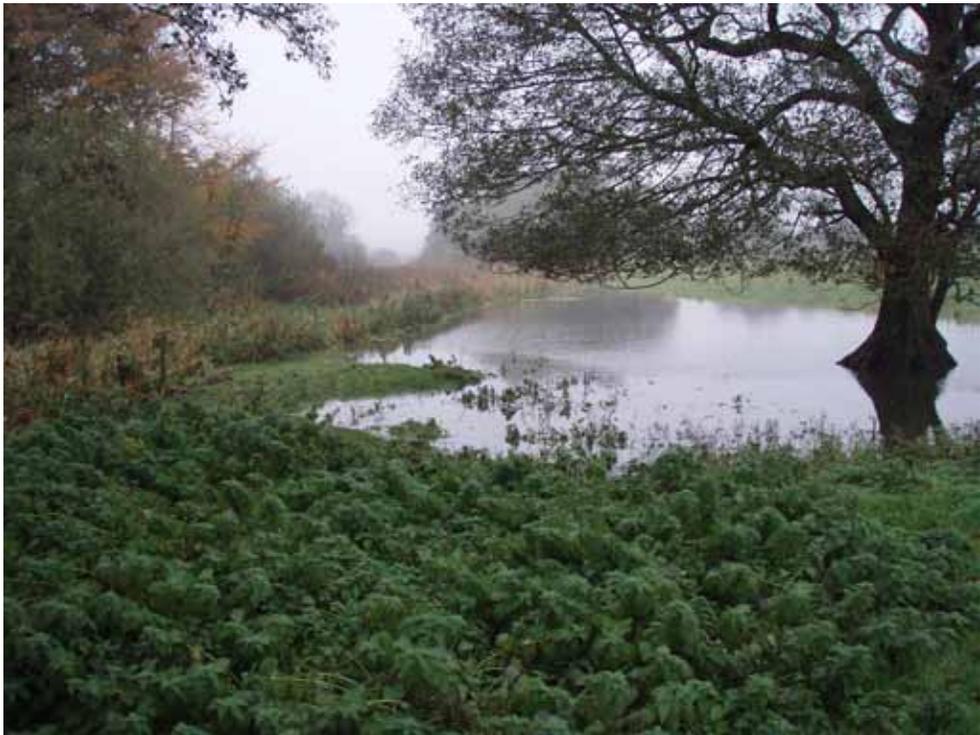
Photo 6 Standing water on the LHB having overflowed from the perched mill channel

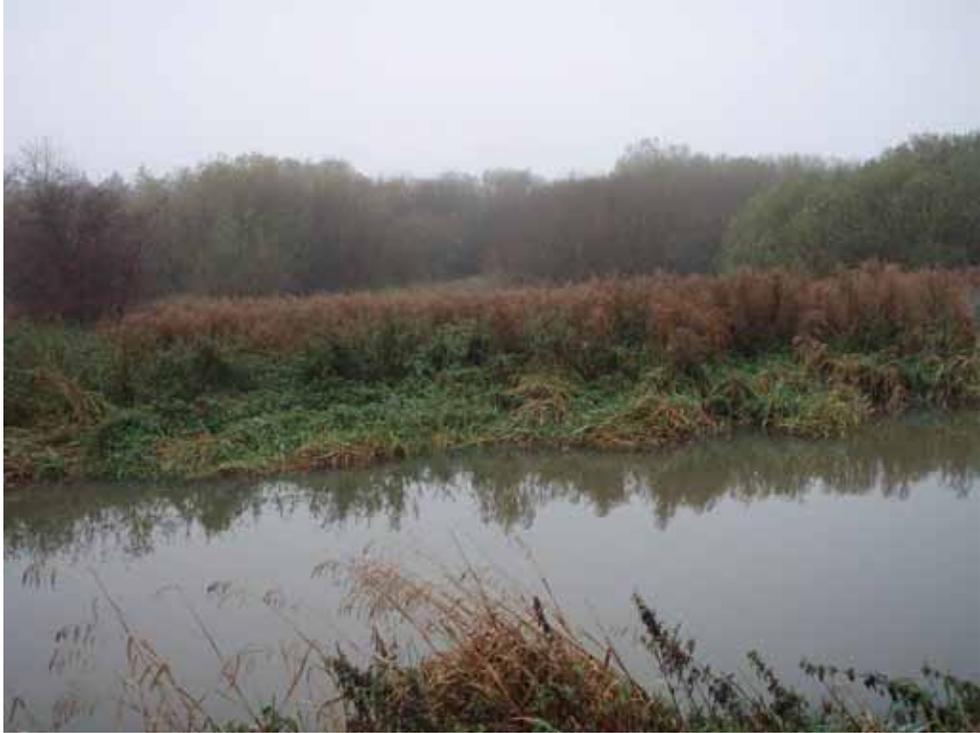
The RHB here is an extensive area of wet, marshy ground with wetland vegetation, willow and sallow, and ponds and duck flights; an area of high value for wildlife, and probably where the original river channel was found prior to the construction of the mill (Photo 7).

Photo 7 Low-lying wetland area on the RHB

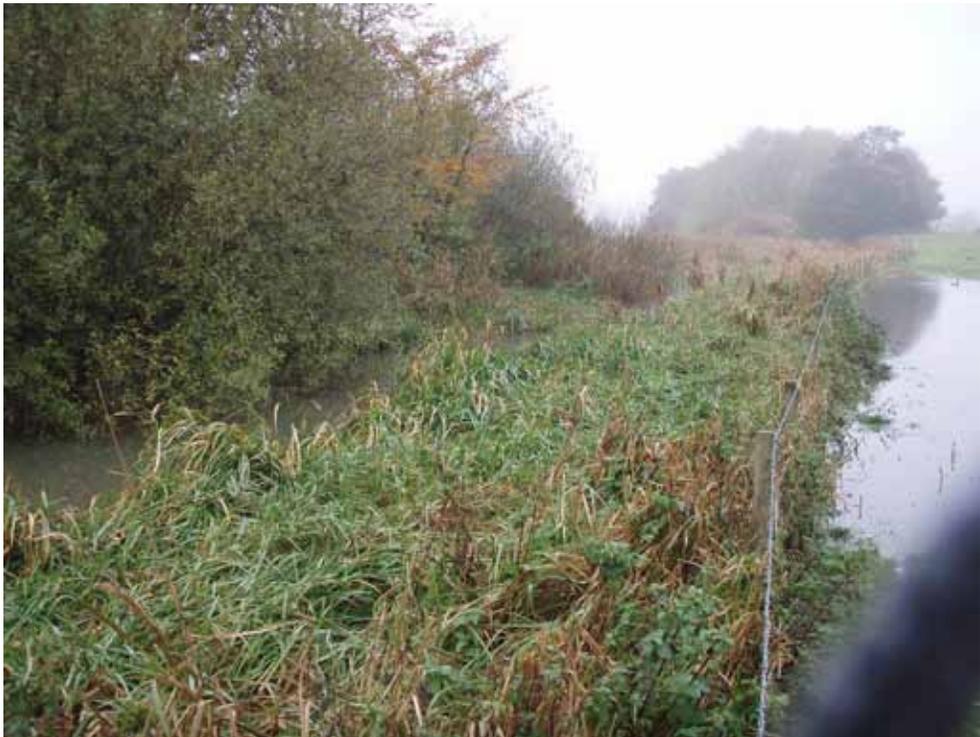
The impounded nature of the channel here limits its value as trout habitat, although the wet, vegetated margins and low overhanging cover provided by willow bushes make it suitable for holding adult trout (Photo 8).

Photo 8 Wet margins and good low overhead cover alongside the mill channel

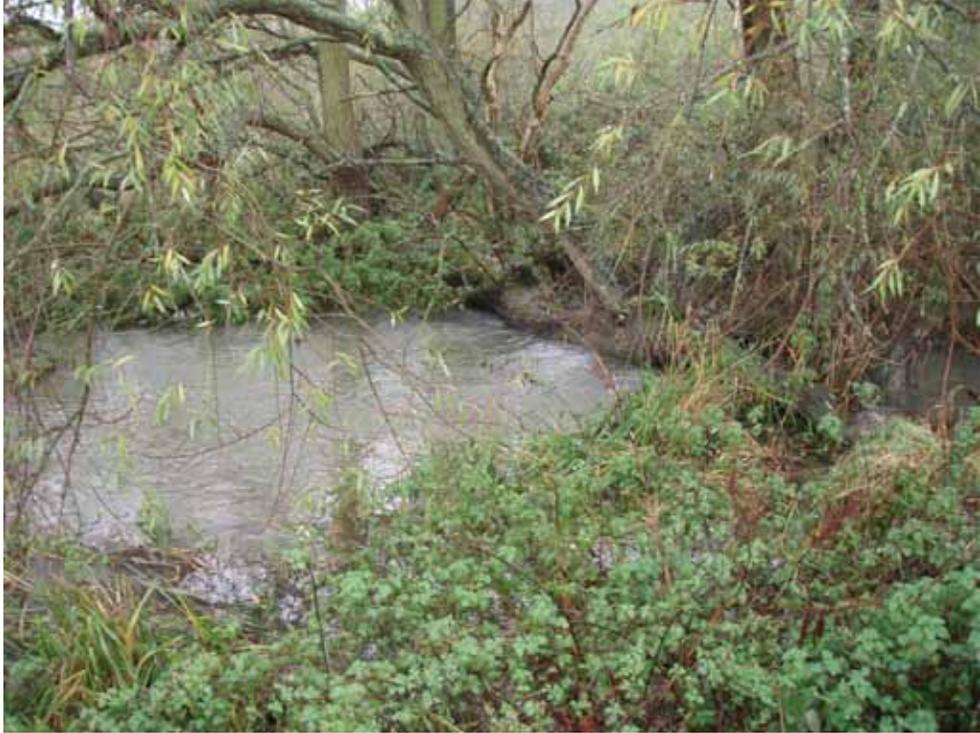
Progressing upstream, the river channel enters a copse of trees (willow, beech, alder, sycamore, larch, sweet chestnut) and is quite heavily shaded. There is a fallen willow across the channel at one point, providing a good example of large woody debris (LWD) in the river channel (Photo 9). The importance of LWD in streams is described fully in the WTT Chalkstream Habitat Manual.

Photo 9 A fallen willow providing valuable large woody debris in the channel

- Large woody debris should be retained in the channel and should be introduced to promote localised scour of the river bed and create a greater variety of depths and sorting of river bed materials. This would be most appropriate in the section of river downstream of the road and between the copse and the lake. The Chalkstream Habitat Manual provides details on the use of LWD and in-stream structures.
- Improving fish passage across the impoundments present on this reach of river is desirable and would benefit fish populations. This would be relatively easy for the smaller weirs, but a significant and expensive undertaking for the larger barriers such as the mill pool and the lake dam.

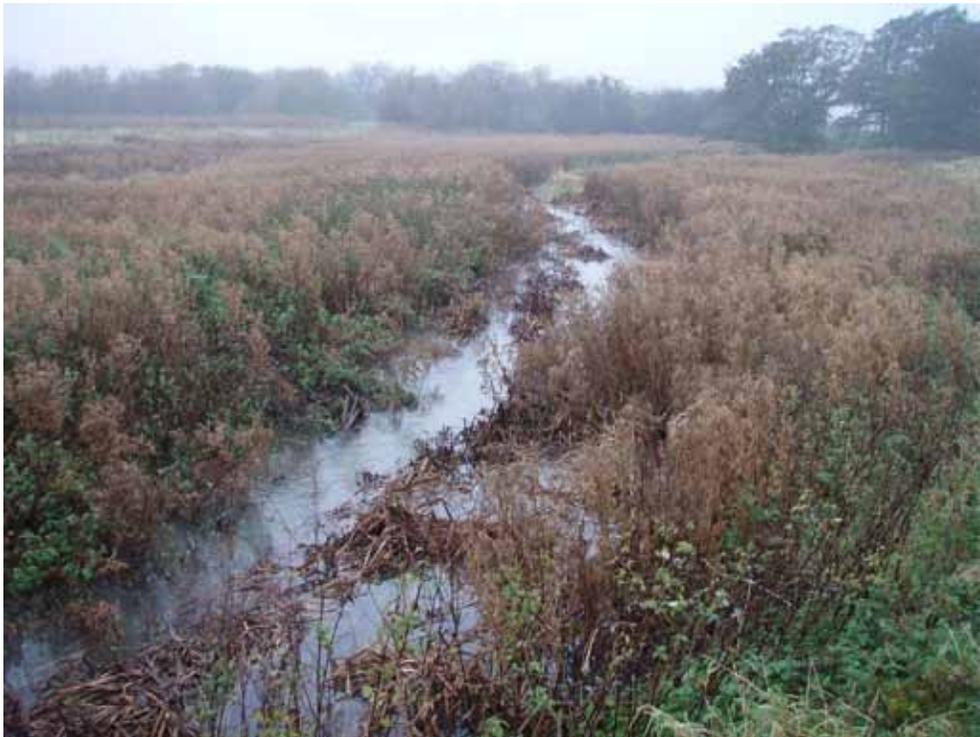
Beyond the copse the river opens out, and the effect of the impoundment at the mill begins to run out. The river is bordered by a low-lying wet floodplain area on the RHB (Photo 10) and a steeper bank with arable fields on the RHB. The water depth here was around 0.9 m, with an additional 0.2 m of soft substrate on the bed.

Photo 10 Upper part of the fishery flowing through a low wetland area

- Introduce some gravel riffle areas to improve trout spawning. These would need to be located in areas of the river which were not affected by the backwater effects of impoundments, so would be best positioned in the section of river between the copse and the lake

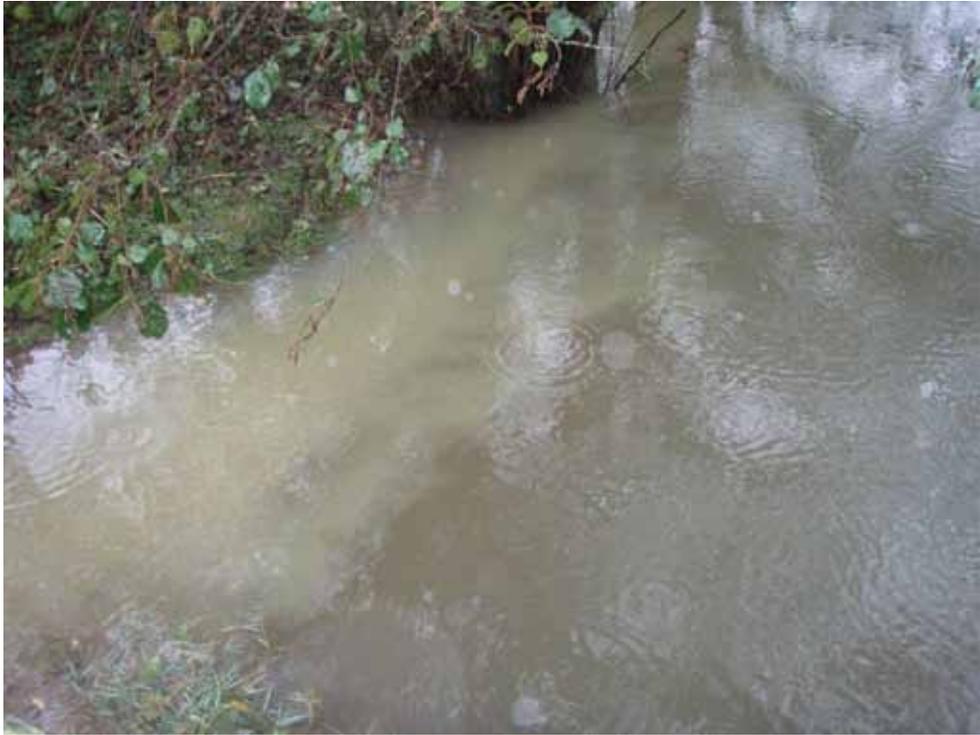
At the upstream limit of the stretch, a ditch enters the river on the LHB. At the time of the visit this was carrying water with a high sediment load, clearly visible at the confluence with the main river; the source of the sediment was undoubtedly run off from arable land (Photo 11). High sediment inputs are detrimental to trout in the river as they will clog the spaces between gravel leading to reduced survival of trout eggs and alevins which spend several weeks incubating there during the winter.

Photo 11 Sediment-laden water entering from a ditch

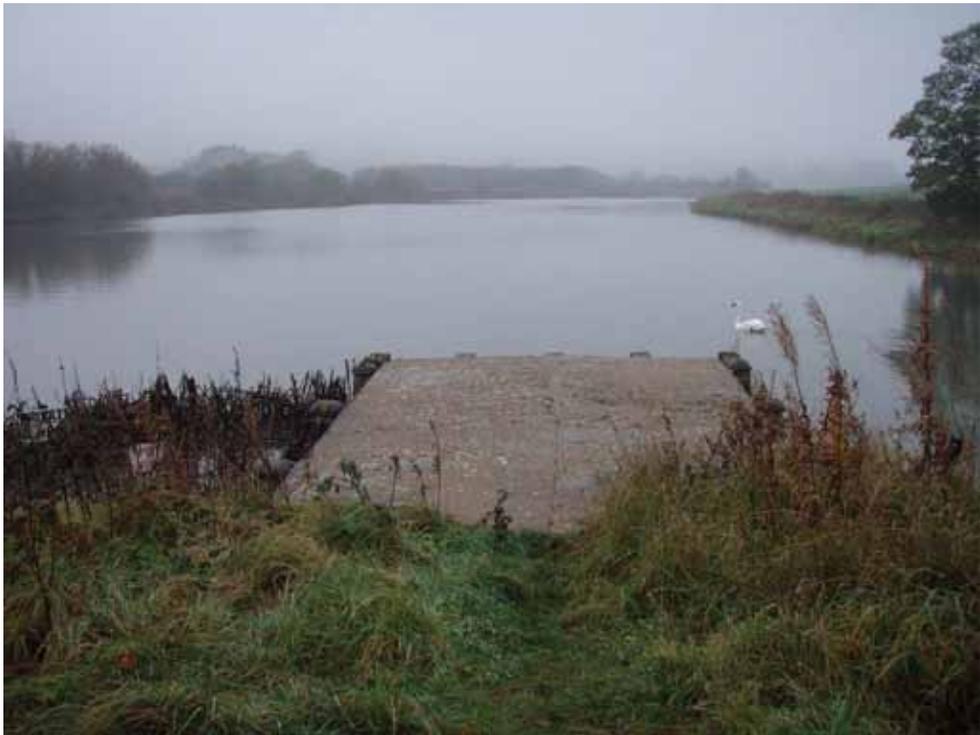
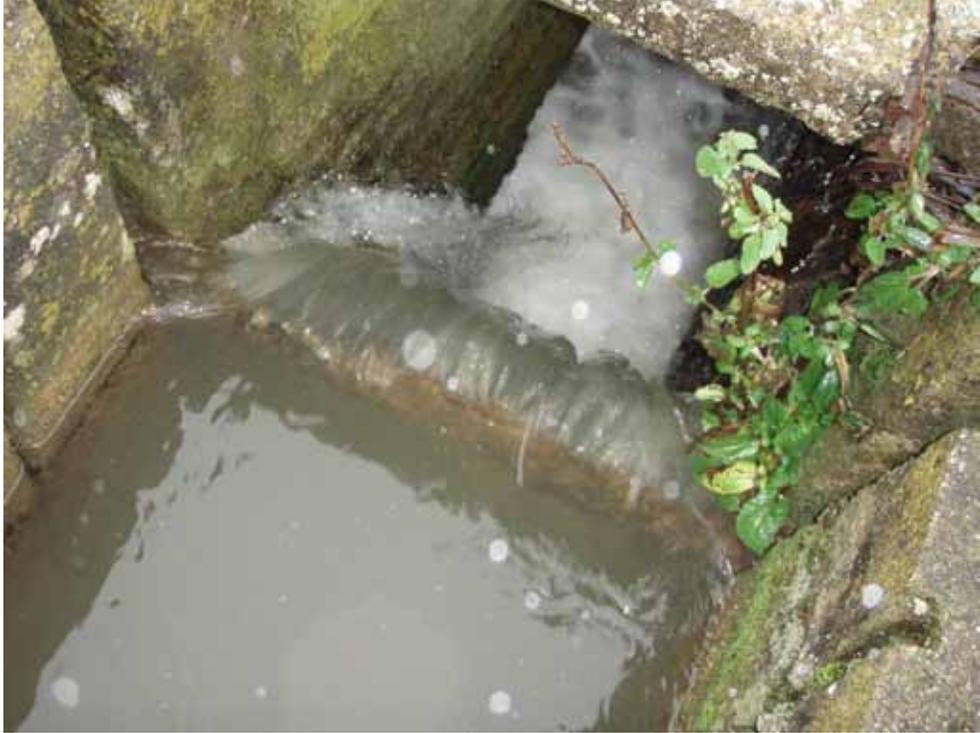
Above this point is the dam forming the online lake. The overflow from the lake prevents fish movement past this point (Photos 12 and 13).

Photo 12 Online lake and overflow structure

Photo 13 Closer view of one of the apertures in the lake overflow structure

For the larger obstructions the simplest solution would probably be a “nature-like bypass channel”. These are low gradient (1:80 – 1:100) channels dug around the obstacle to create a pathway for fish migration. They tend to be less costly than a formal fish pass (or “fish ladder”) and can pass a wider range of species. Appendix 2 gives further information on fish passage and references which give examples and design criteria.

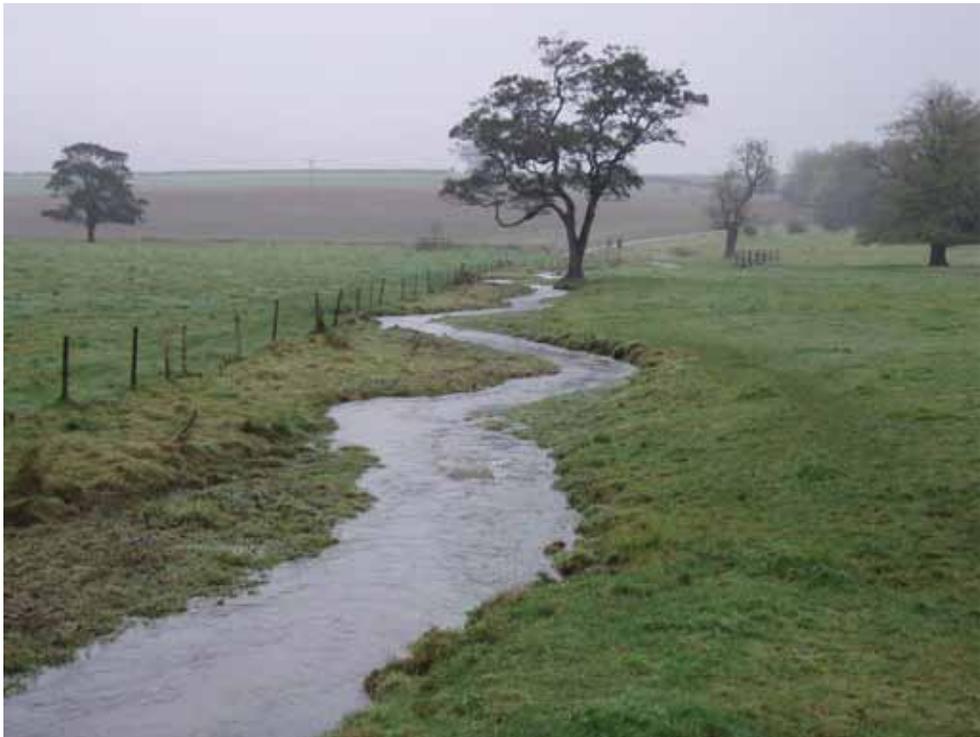
Upstream, at Biscathorpe, the river is formed from two or more small channels coming together in open grassland (grazing being managed under Countryside Stewardship Scheme). The streams have good habitat with a steeper gradient, gravel bed, and a shallow bank profile (Photo 14). There was however grazing access right up to the river, and despite the obviously careful control over grazing pressure, this had resulted in a dearth of marginal habitat which would suit trout, such as emergent aquatic plants and low overhanging cover. A brief kick sample at this site caught Mayfly *Ephemera danica*, shrimp *Gammarus pulex*, and bullhead *Cottus gobio*.

Photo 14 River Bain at Biscathorpe

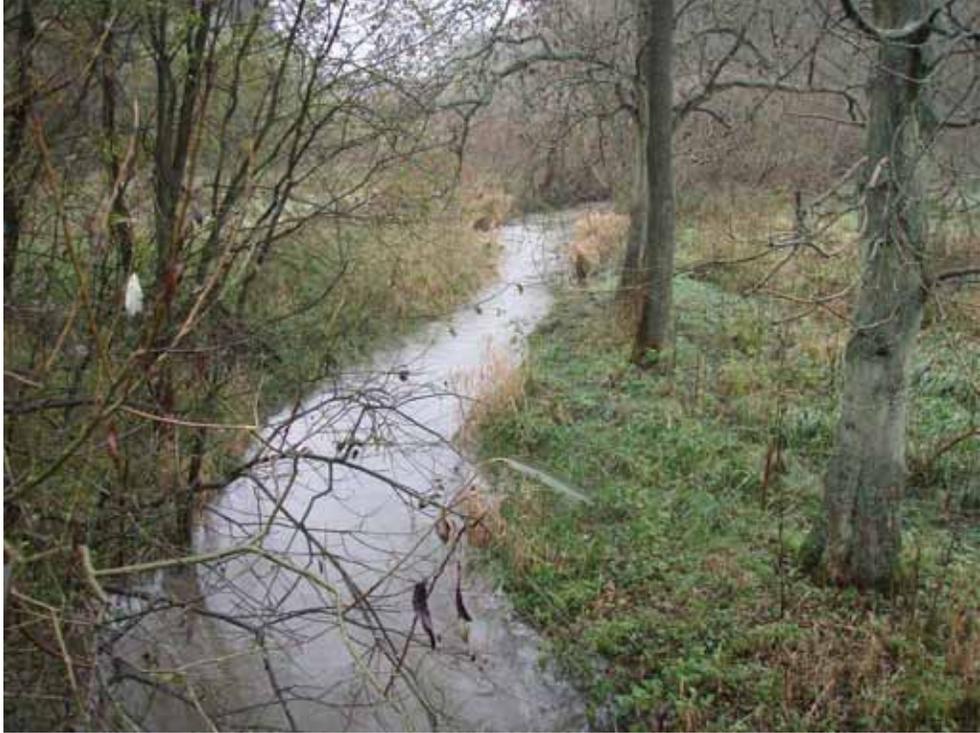
Downstream on the Stenigot Estate, the river is currently being surveyed by Ian Rees of the Lincolnshire Chalk Streams Project. From the road bridge, the in-stream habitat looked reasonably good, with wide, wooded banks between the river and farmed land. The channel width looked quite uniform, so it may also be lacking a diversity of depths and bed substrate composition (Photo 15).

Photo 15 River Bain on the Stenigot Estate

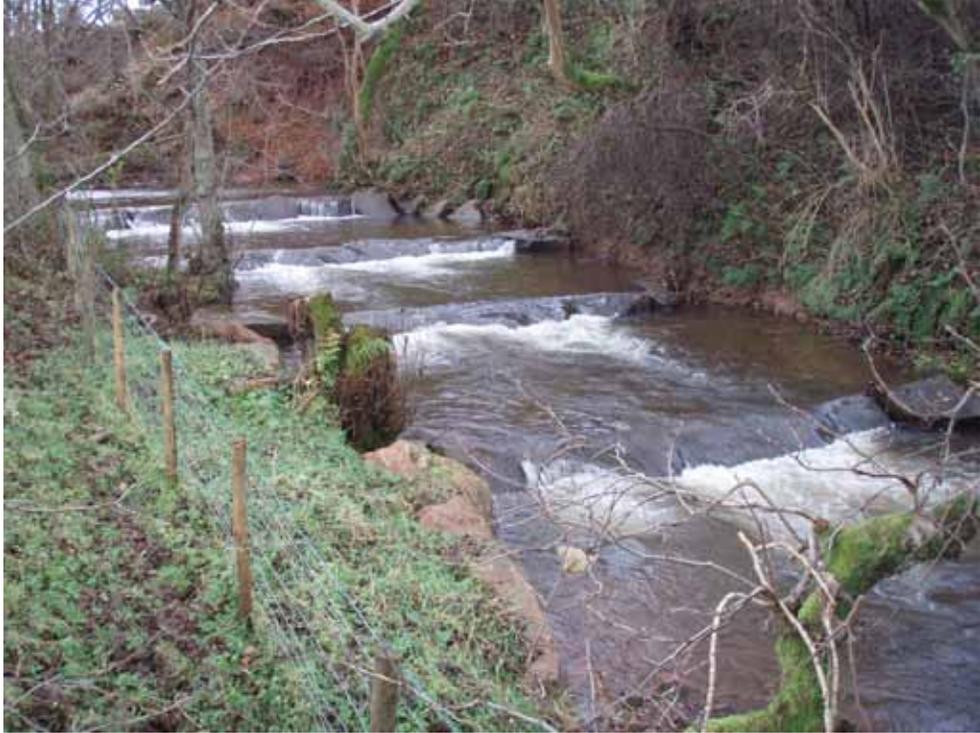
Photo 16 Pre-barrages installed on an upland stream to enable fish passage over a formerly impassable weir (not visible – around the corner at the top left of the picture)

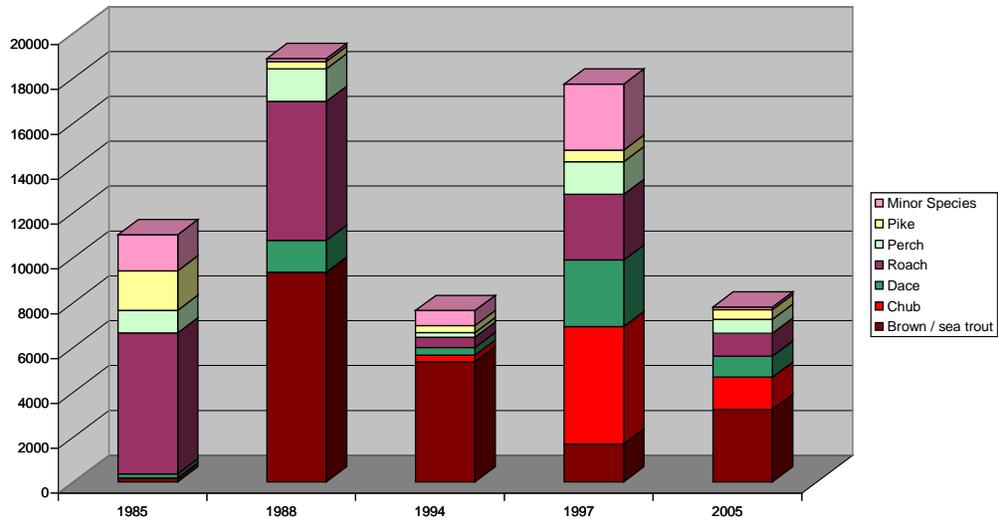
The river here has a good fish population as evidenced by the last Environment Agency electric fishing survey in 2005. This estimated a density of 26.6 fish/100m² (+/- 1.1) and a biomass of 2104 g/100m² (+/- 397). Trout comprised around 40% of the biomass (Appendix 1).

Figure 39 River Bain - Annual trends in total catch since 1985 and the contribution of species to biomass.

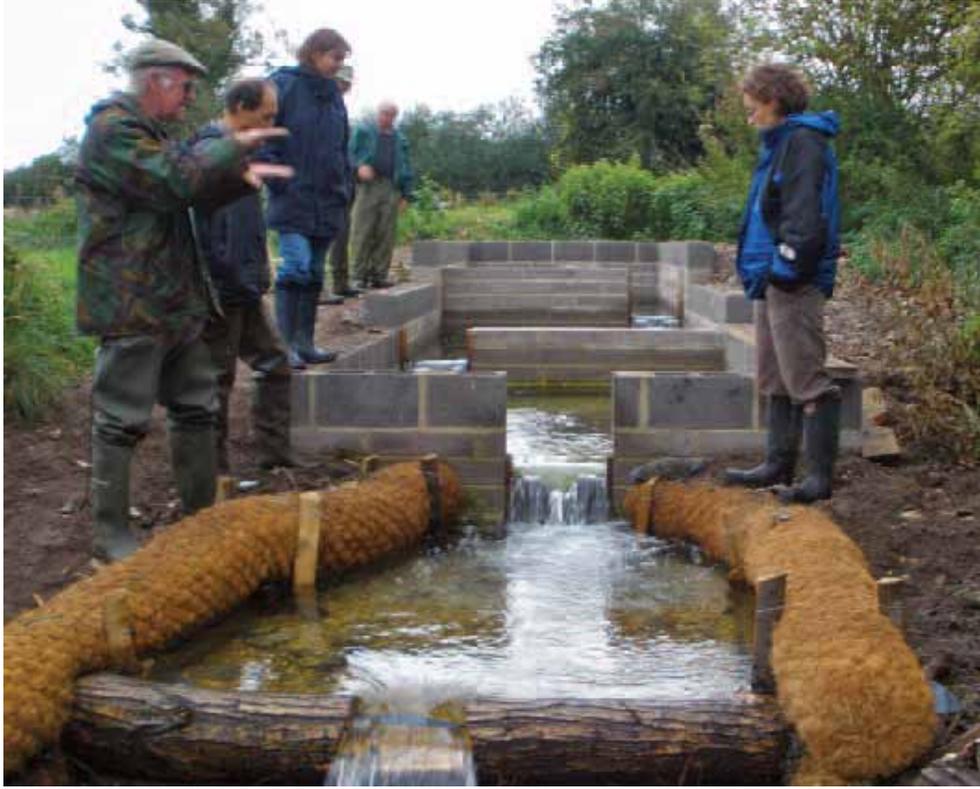
Photo 17 Example of a fish easement by-passing a mill leat on the River Bourne, Wiltshire
