Advisory Visit
Birkin Brook – Cheshire
10/03/2015

1.0 Introduction

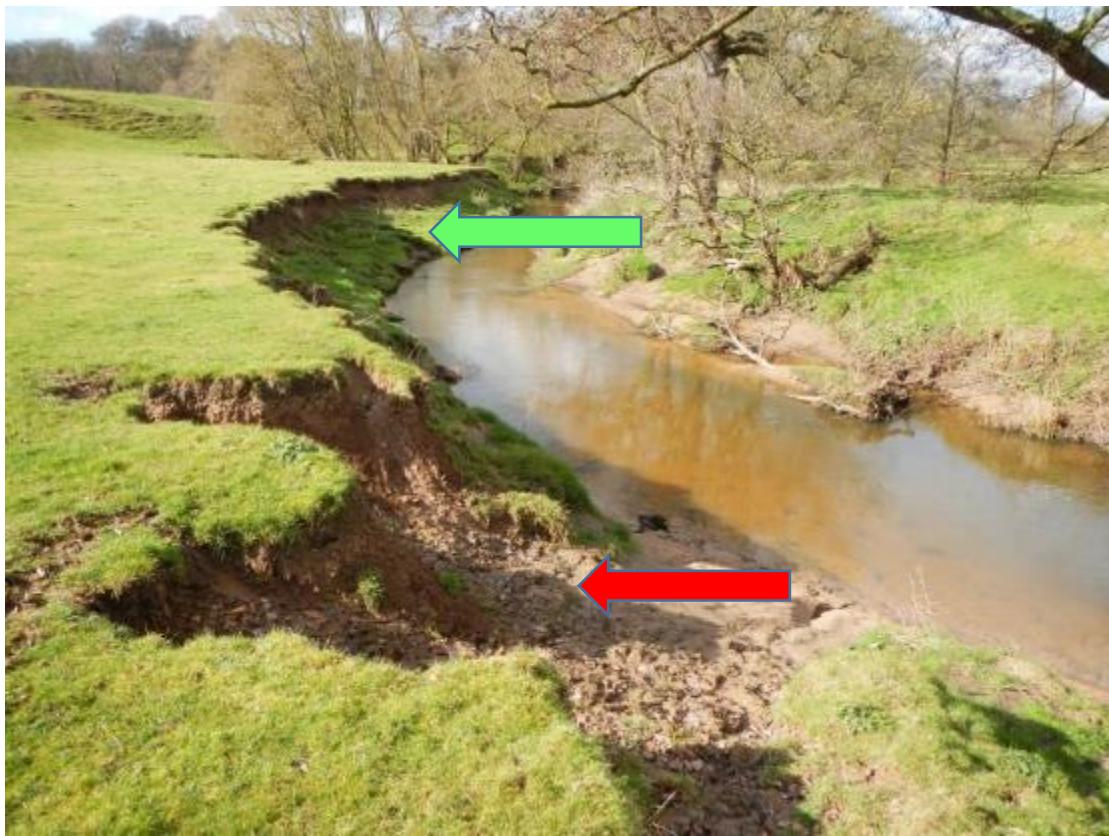
On beats 1 & 2, grazing still appears to the most notable and major negative impact upon the Brook (Photos 1 & 2). This issue is not to be taken lightly, as stock access to the banks and channel is seriously degrading marginal habitat and contributing to the already extensive sedimentation issues. Grazing and browsing, even at relatively low stock density, prevents any herbaceous vegetation from becoming established and halts the natural succession of saplings, primarily alder (*Alnus glutinosa*) and willow (*Salix spp.*), that should replace mature trees that are washed out or die.

Photograph 1. Stock access point (red arrow) and area of slumped bank that should naturally re-vegetate and stabilise if stock are excluded (green arrow).

When the issues of accelerated erosion are combined with the significant physical damage that poaching of the ground by livestock causes, it is not surprising that fine sediment input to the Brook is such an issue. The land loss and serious habitat degradation could, however, be significantly reduced by simply excluding stock from the river bank.

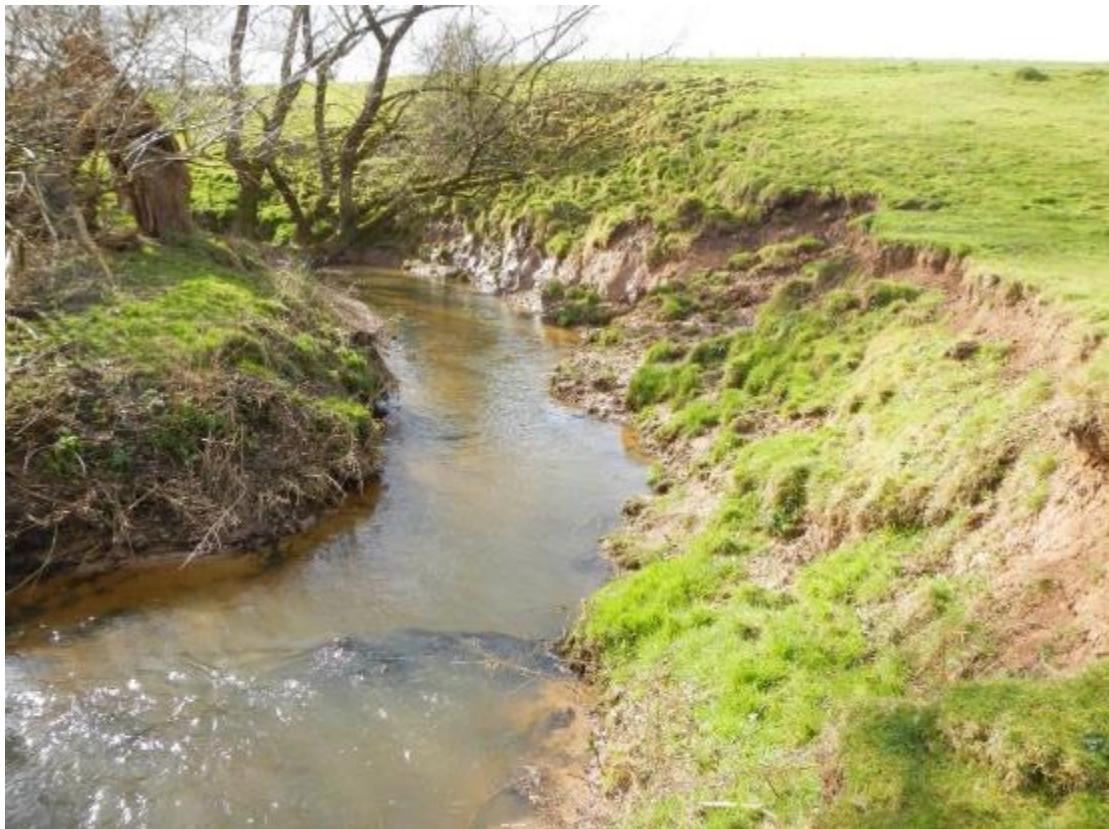
These factors contribute to a significant lack of in-channel structure and low-level cover, both vital aspects of habitat that are required to retain fish within a reach. On friable, sandy soils, as found in this area, the additional root matrix that such shrubs and herbaceous vegetation provide are vital in stabilising the riverbank and reducing erosion rates; they not only help prevent erosion occurring, but can stabilise slumped areas allowing the bank to naturally re-grade and preventing further erosion, as should occur in Photo 2 if stock are excluded.

Photograph 2. Significant bank destabilisation from stock access that could be prevented by linking the downstream and upstream sections of buffer fence.

There are signs of previous attempts at buffer fencing, as detailed in the previous report; however, the fact that the ends of the fence have been left open in most sections has allowed access into the buffer strip, negating their benefit (Photos 3 & 4). A similar problem exists where only one bank has been fenced, as cattle are quite willing to enter and cross a small brook, as evident by the numerous access points (Photos 1 & 2).

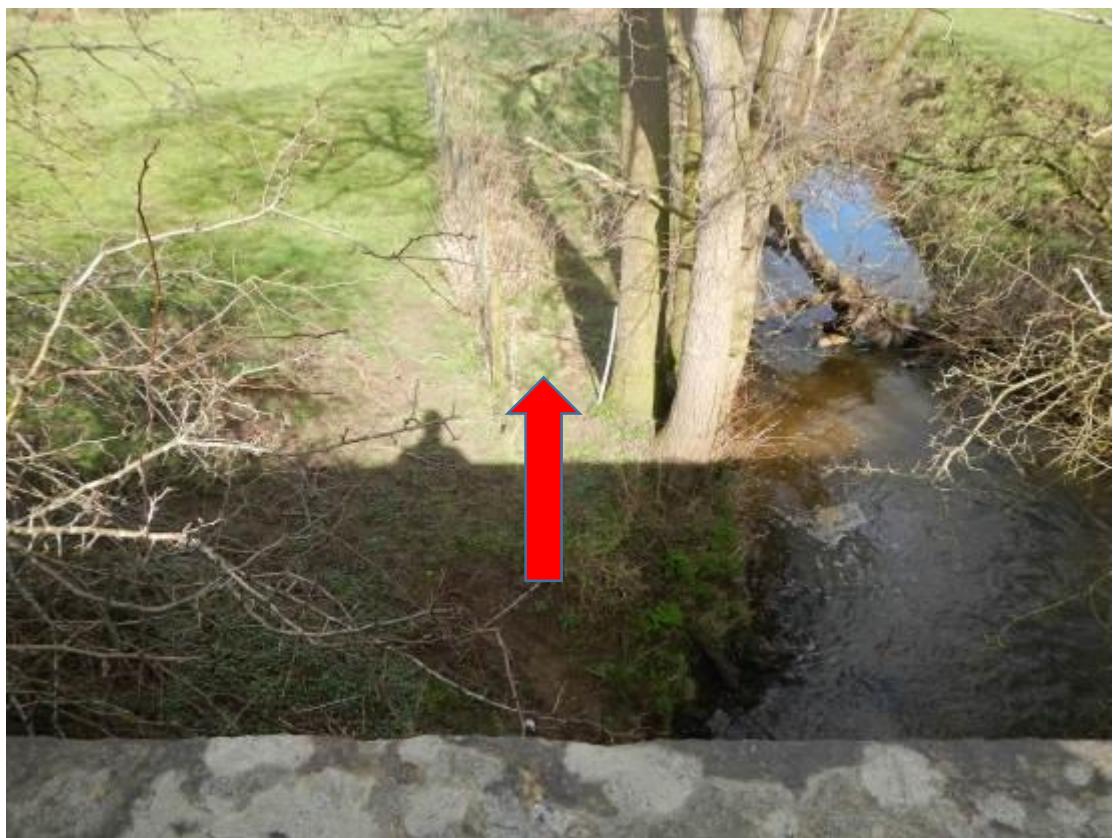
Photograph 3. Open end to buffer fence which allows stock access and completely negates its value.

There are two ways of ensuring stock do not access a buffer strip, one of which must be employed if future fencing is to be successful. The first and most secure method is to maintain continuous fencing along the watercourse, tying it in to the end field boundaries. This is likely to be the best method in this situation as the track bridge will still allow stock access to both banks. Pasture pumps or solar pumps would be required to water the livestock, but the benefits of complete stock exclusion to both the farmer and watercourse ecology would be well worth the increased expense.

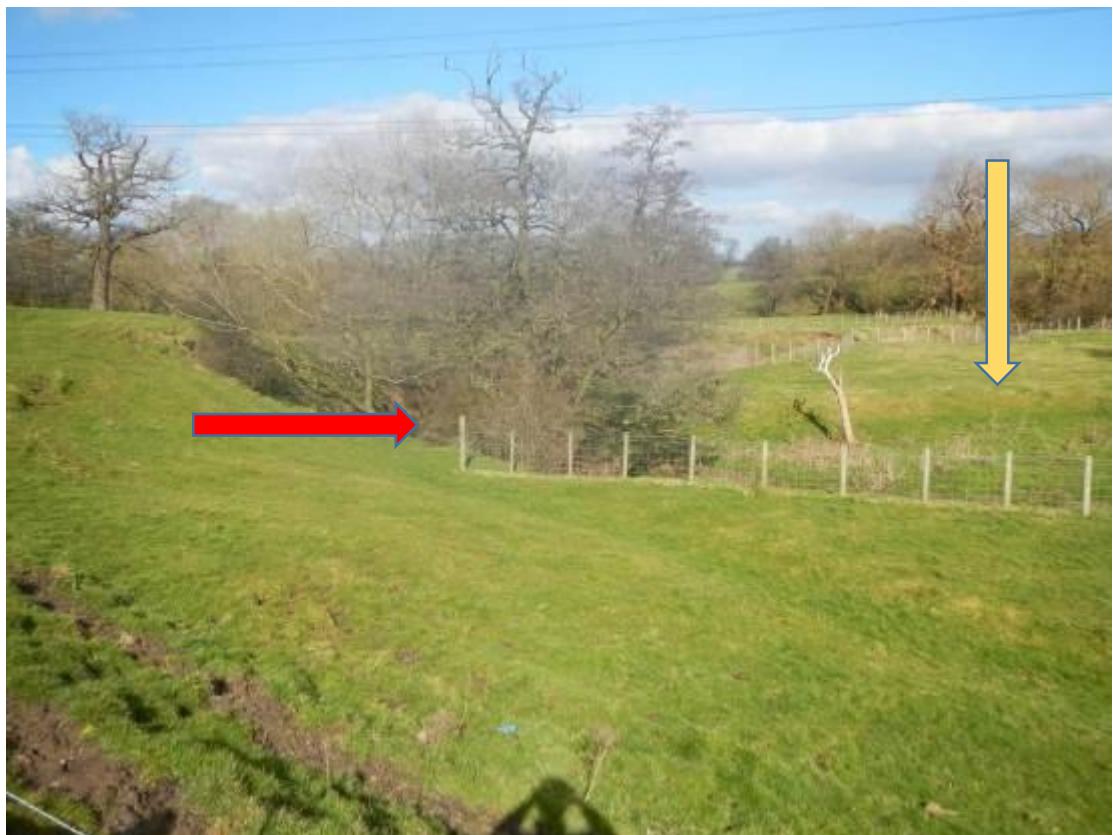
Photograph 4. Downstream end of the fence on Photo 3, where livestock have unrestricted access (red arrow) and can also access from the unfenced RB (orange arrow).

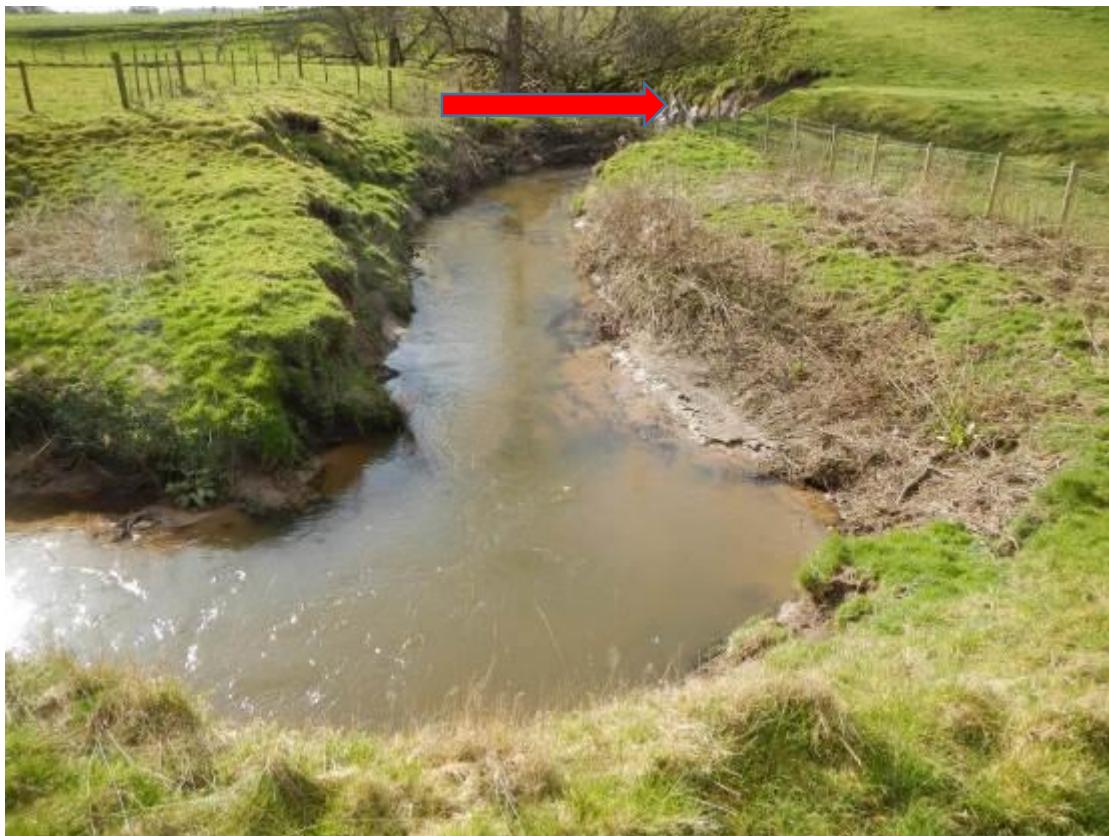
Where a buffer fence is present on both banks, there does appear to have been a slight improvement in marginal vegetation (Photo 5); however, subsequent stock access, as evident by the broken fence at the upstream end has greatly reduced its value. It may well be that the issue stems from livestock becoming trapped within the fence, having entered the buffer via the river. This would trap stock exactly where they are not wanted and be an inconvenience to the farmer who then has the task of getting them out of the buffer. This issue can be prevented by ensuring that the fencing is continuous and secure, and that stock cannot access either end.

Photograph 5. Slightly improved marginal vegetation and bank stabilisation now compromised by stock access (red arrow).

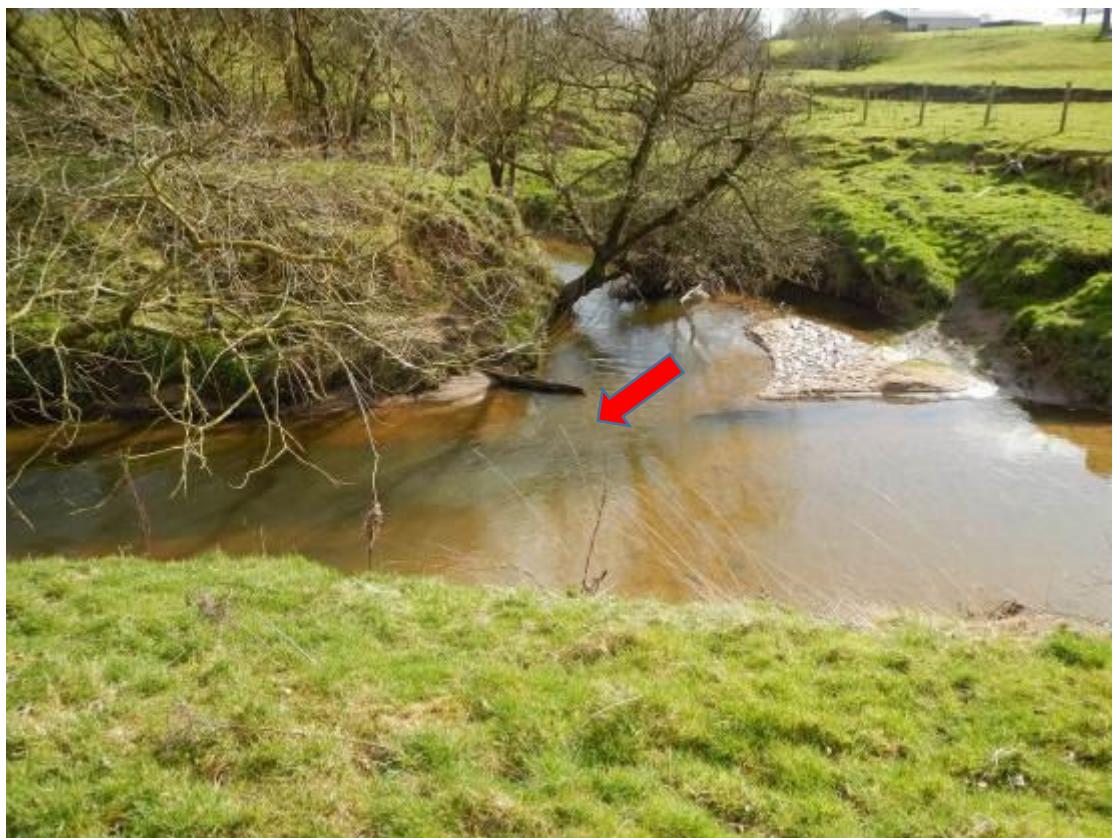
Where Mobberley Brook enters the Birkin, a small area of gravel substrate is present (Photo 6), before becoming smothered by sand, as on the rest of the Birkin Brook visited. This further highlights the scale of the fine sediment issue on Birkin Brook, but also that improvement measures to increase salmonid spawning may be best targeted on less impacted tributaries such as the Mobberley Brook.

Photograph 6. Mobberley Brook inputs some gravel (red arrow) to Birkin Brook, but it is quickly smothered by the high loading of fine sediment.

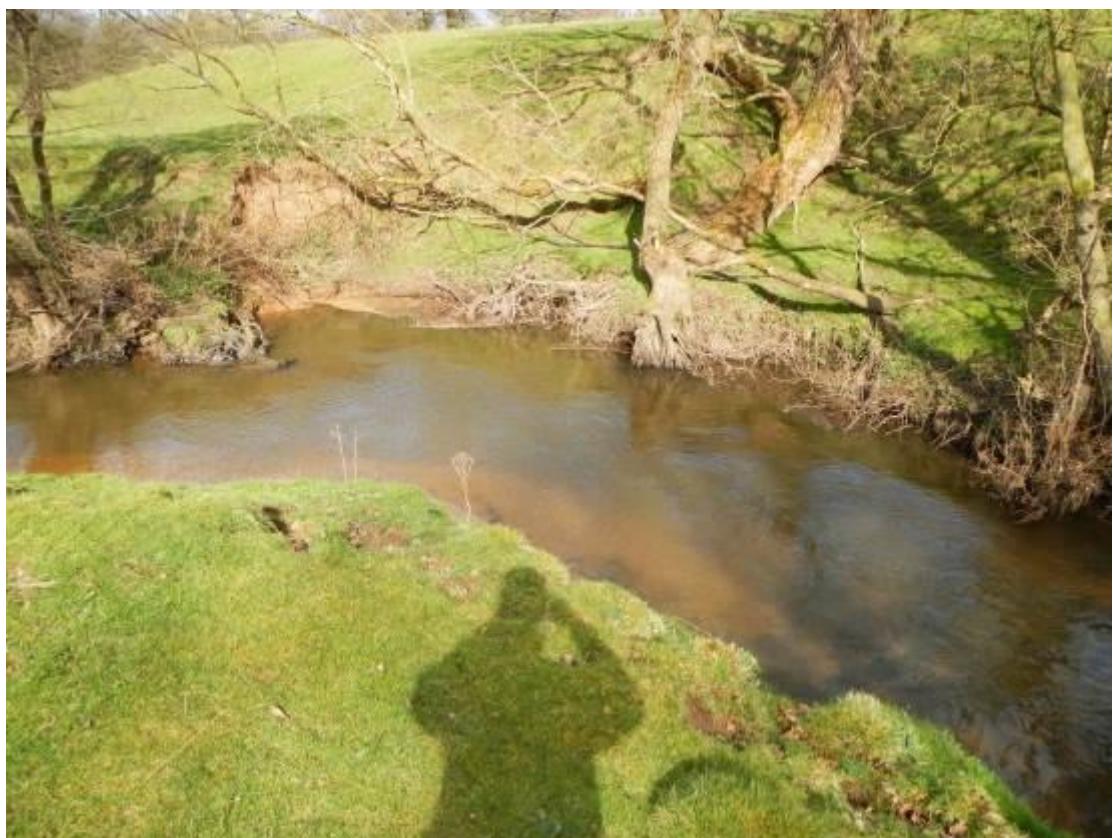
A general lack of low level branches (within 1m of the water) on bankside trees was also noted (Photo 7 - often well-meaning but inappropriate management to improve angling access), which, combined with a lack of bed roughness (smoothed by a coating of sand) makes the Birkin Brook a pretty hostile environment with limited areas to shelter from high flows, particularly for small fish. Root structure provides the only real in-channel habitat or cover in most places. Coppicing the occasional tree to encourage low-level regrowth, planting trees along the river margin (both requiring stock exclusion) and laying branches into the channel (as occurs naturally in Photo 8) are all recommended to disrupt flows and create fish refuge. If undertaken, these measures may make access a bit trickier, but should greatly increase the fish carrying capacity of the Brook, which will ultimately improve the angling – better to have tricky access with plenty of fish than easy access to few or no fish!

Photograph 7. A general lack of low-level cover makes casting easier but greatly reduces the number of fish the river will support and makes habitat heavily reliant upon root structure.

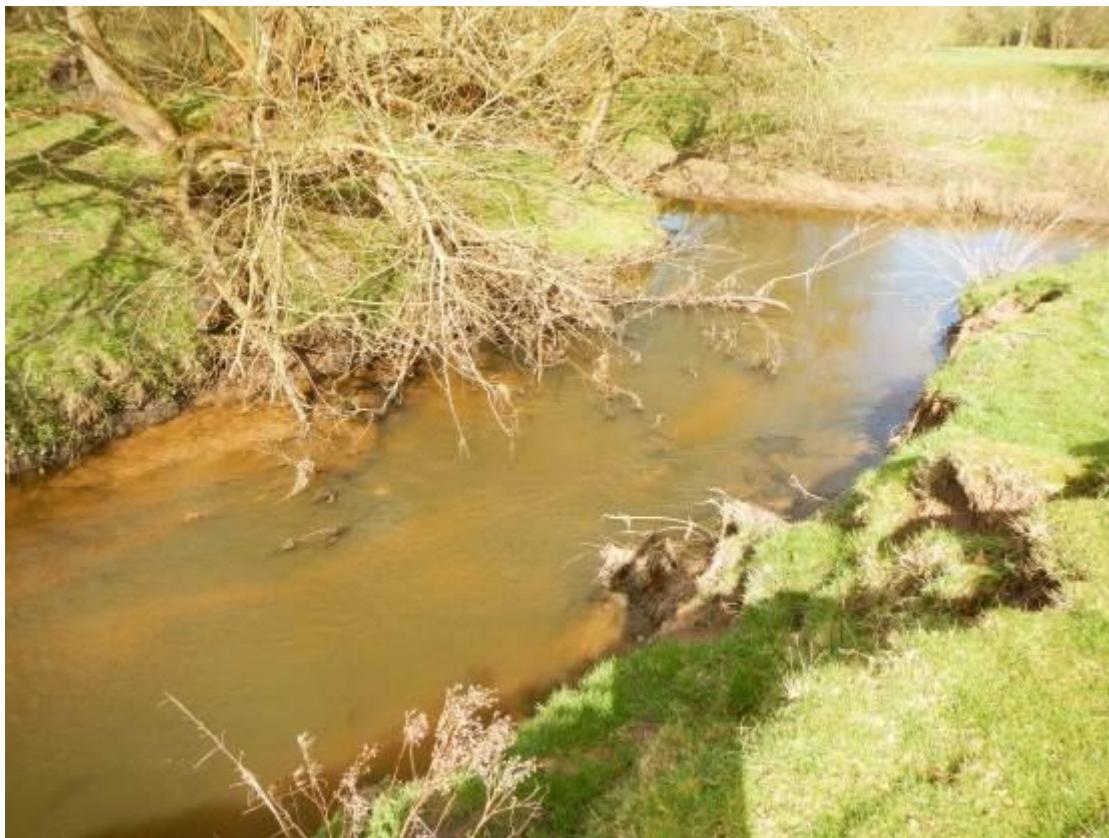
Photograph 8. Highly valuable low-level, trailing cover. This is likely to hold several fish and offers protection from high flows, predators, along with shade from direct sunlight. A great deal more of this type of habitat is required throughout Beats 1 & 2.

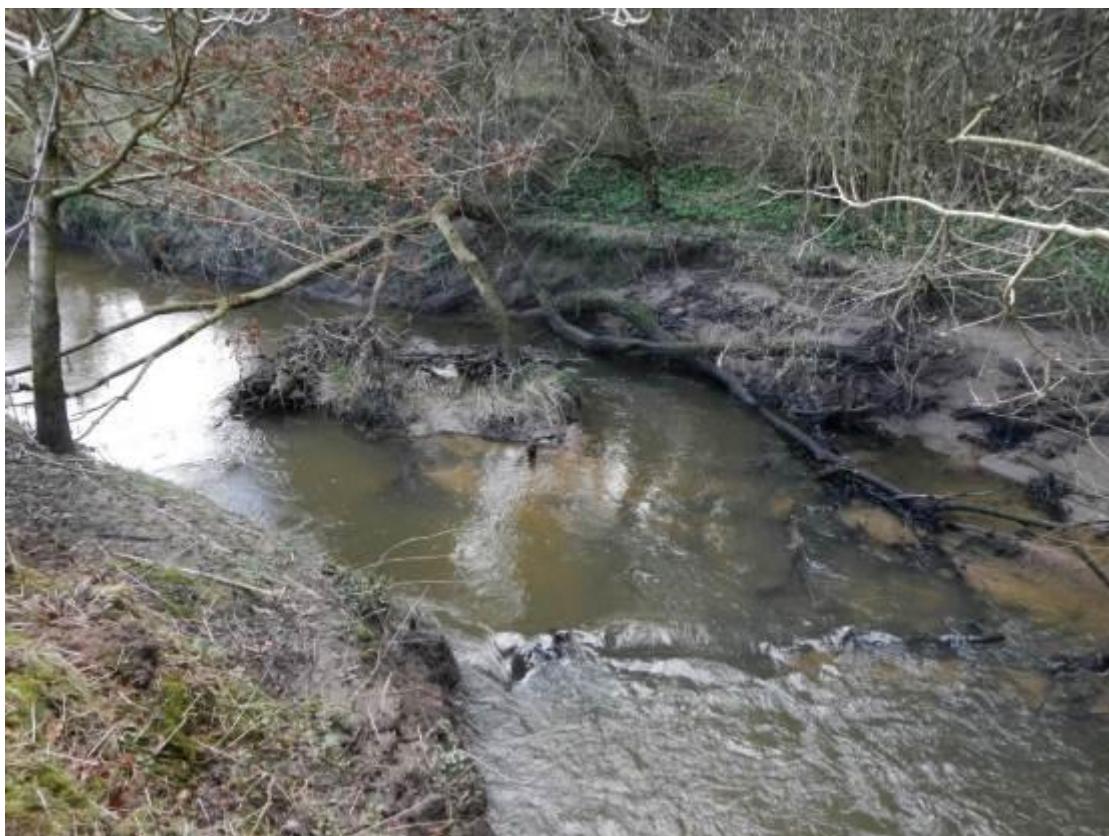
Photograph 9. Valuable LWD creating flow diversity, cover and trapping sediment.

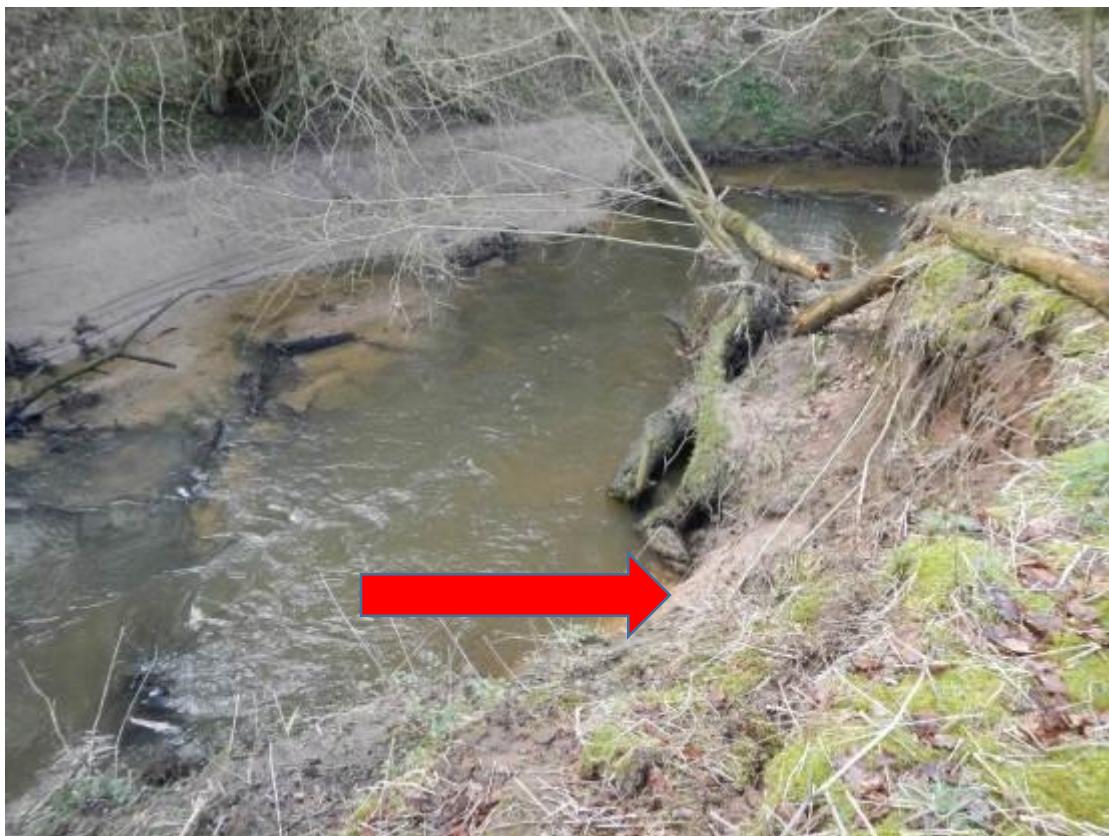
Photograph 10. LWD that has helped to stabilise the bank. Installation of more, or planting of willow around the remaining area of erosion (red arrow) should further increase stability.

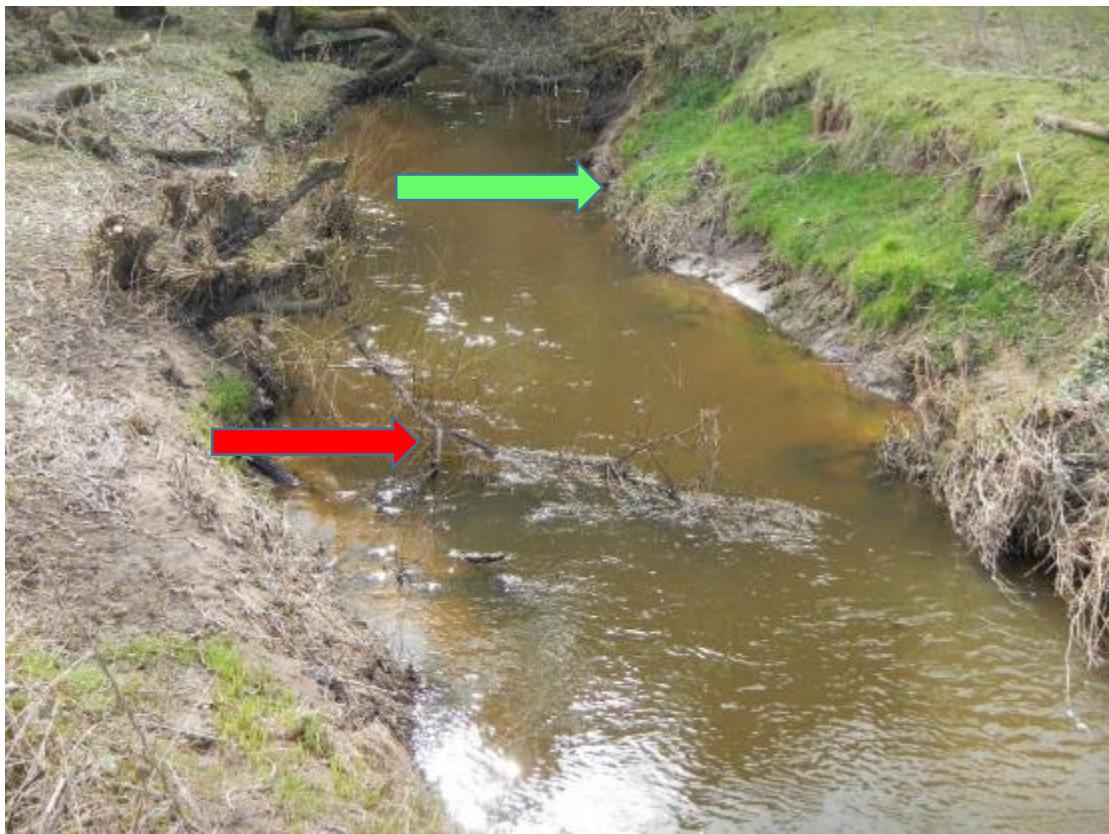
Photograph 11. Willow below the power line that has been pruned for safety. Fortunately, the highly beneficial trailing branch (red arrow) has been retained and provides the only real fish holding feature. Planting a willow on the opposite bank, upstream (green arrow), to grow on and replicate the feature would create further fish-holding capacity.

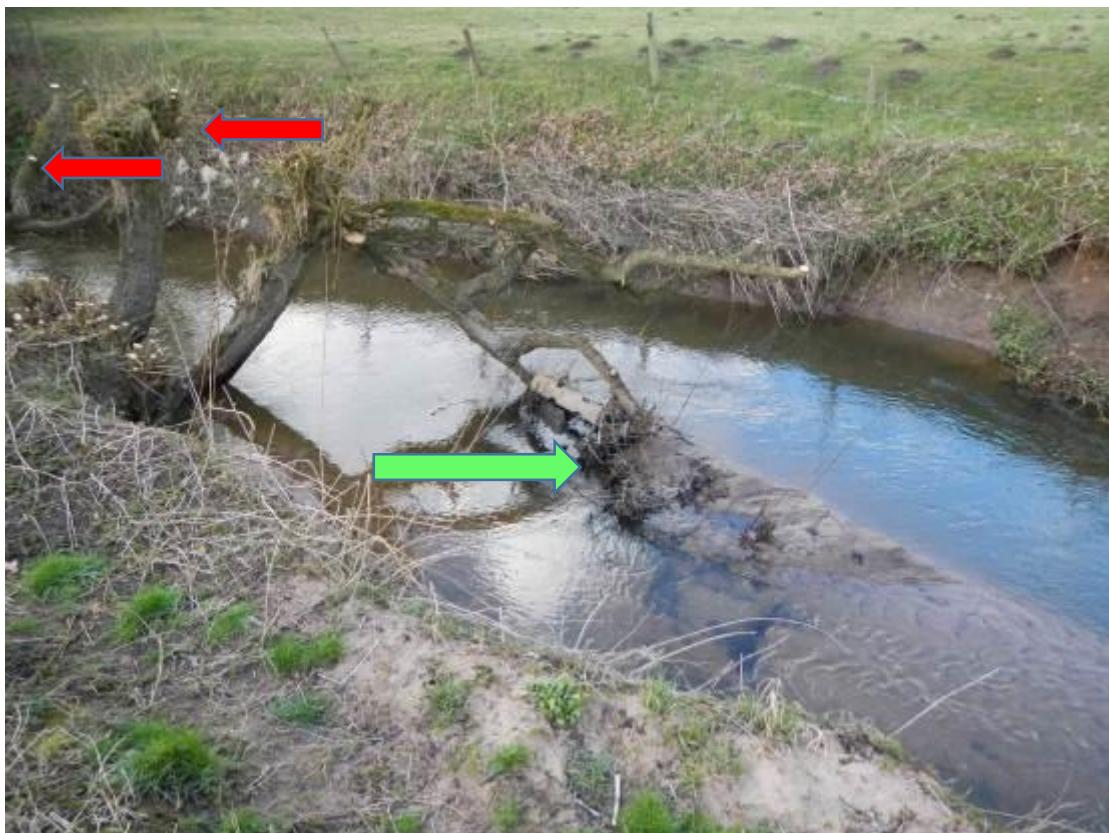
Photograph 12. Another pruned willow with trailing branch providing low cover and shelter from high flows (green arrow). Previous pruning and maintenance has lifted what will be the canopy of several other stems (red arrow). These could be coppiced just above the waterline to encourage regrowth of fish-holding cover.

The water turbidity from fine sediment reduces visibility, but from what was visible, it appears that the high levels of sediment deposition is filling many of the deeper channel areas. For this reason, it is vital to preserve and promote in-channel structures such as the willows (Photos 11 & 12), tree stump (Photo 13) and logjam (Photo 14), that will narrow the channel, focussing flows to scour the bed to maintain areas of deeper water. Photo 15 highlights a willow tree that could be laid into the channel relatively easily to replicate the one naturally occurring in Photo 12.

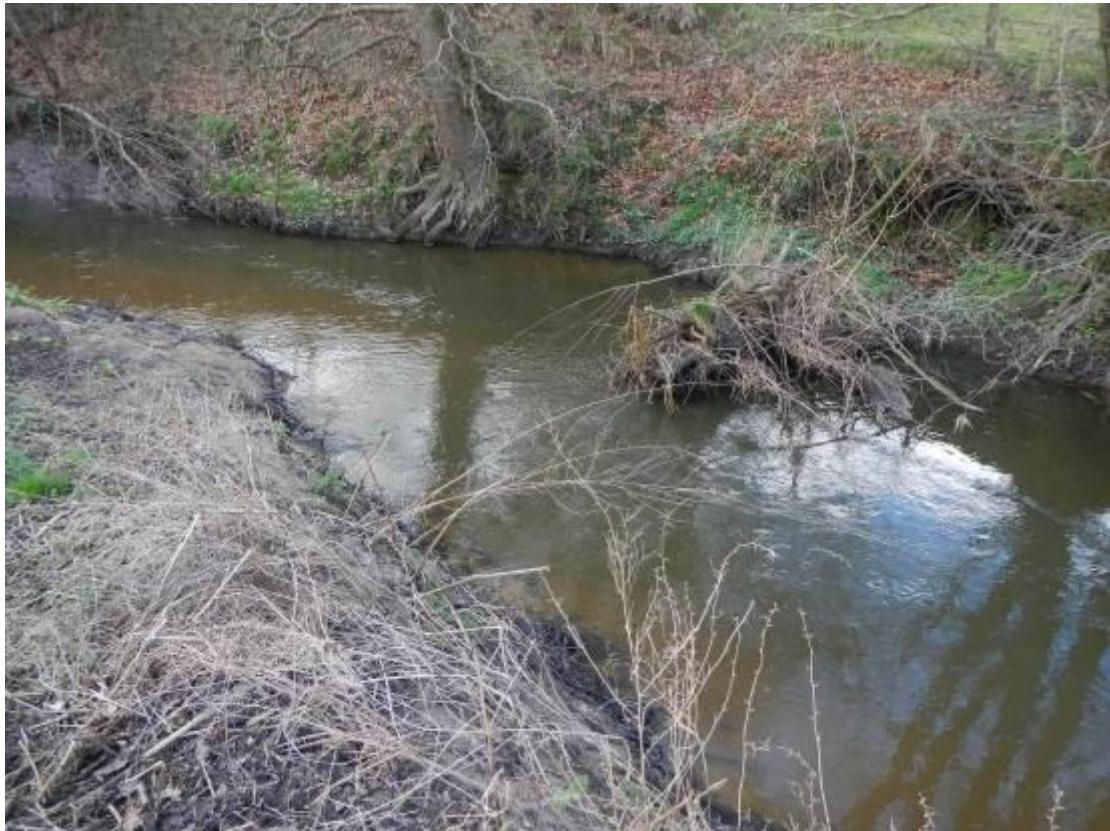
Photograph 13. Highly valuable in-channel tree stump causing scour that should help maintain depth of the pool. Hopefully, small branches sprouting from the stump will further enhance the habitat by providing additional low-level aerial cover. Any branches that do grow should be retained, as the branch causing the slight inconvenience for casting may be the feature that makes the difference between the spot holding a fish or not.

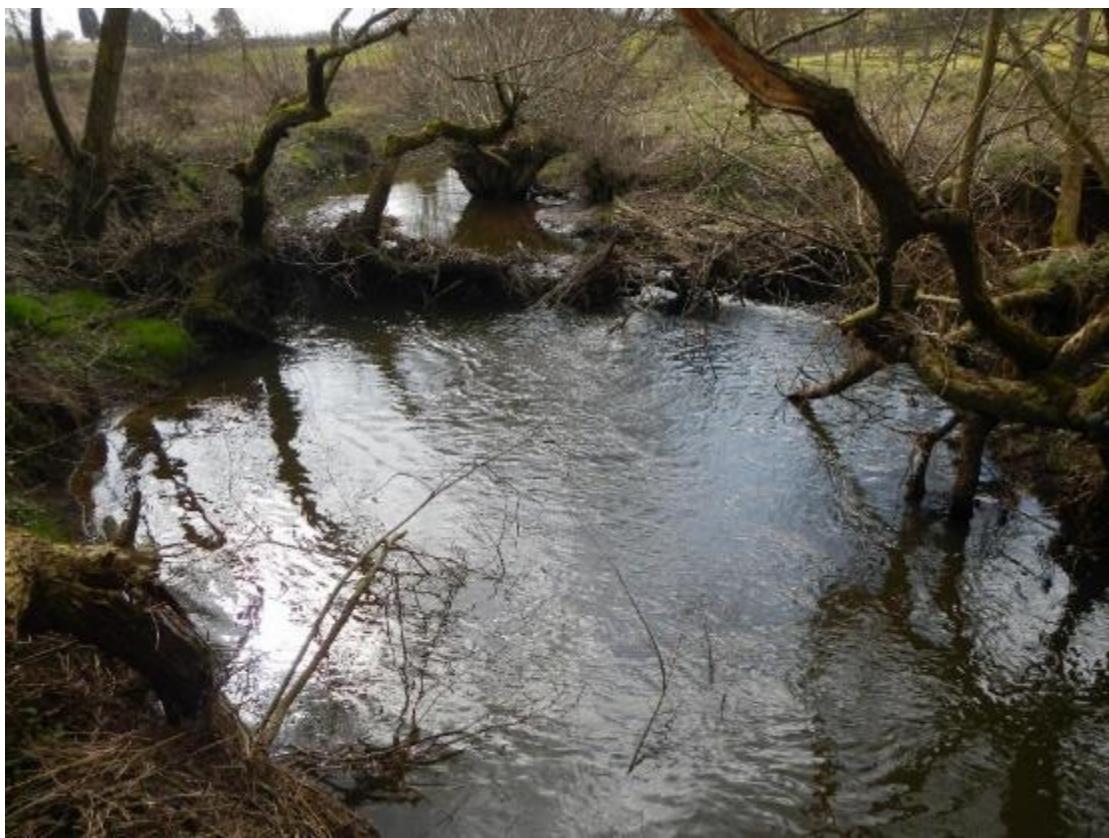
Photograph 14. Highly beneficial LWD/logjam. This will provide areas of scour to maintain the pool, abundant fish cover, and also provide much needed shelter from high flows that will assist fish retention within the reach.

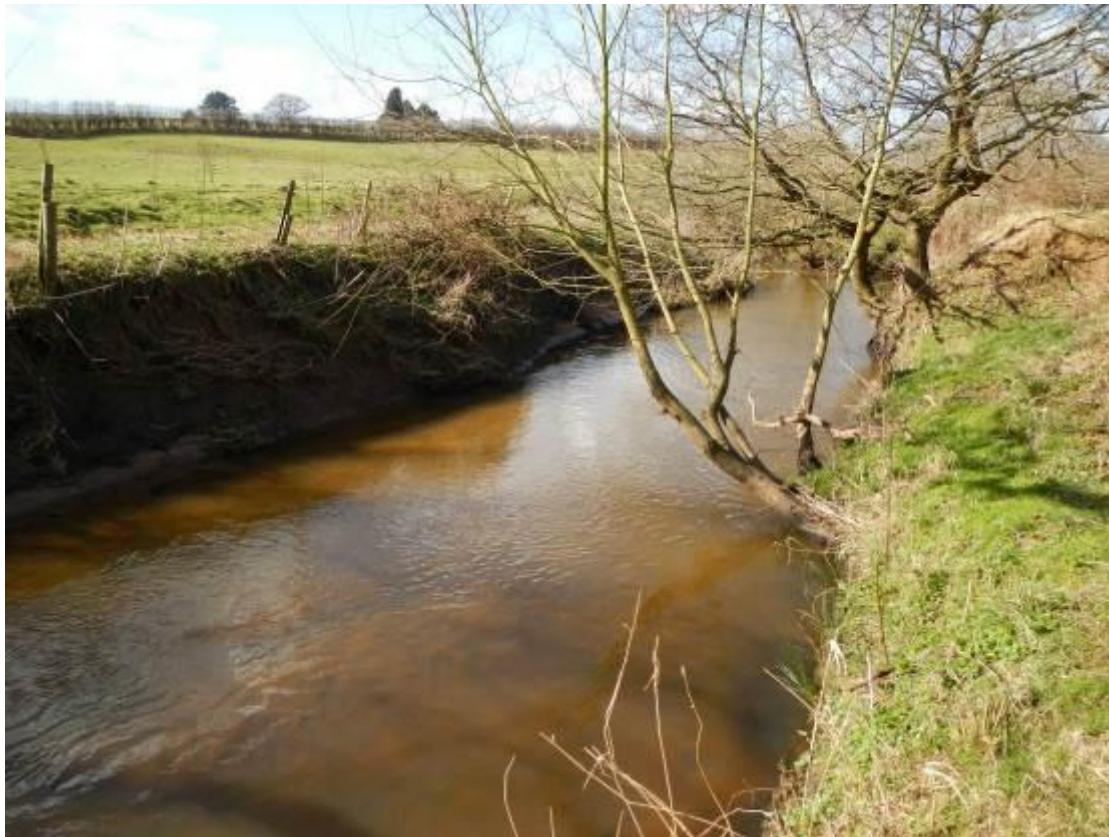
Photograph 15. Willow that can be laid into the channel to increase cover and shelter.

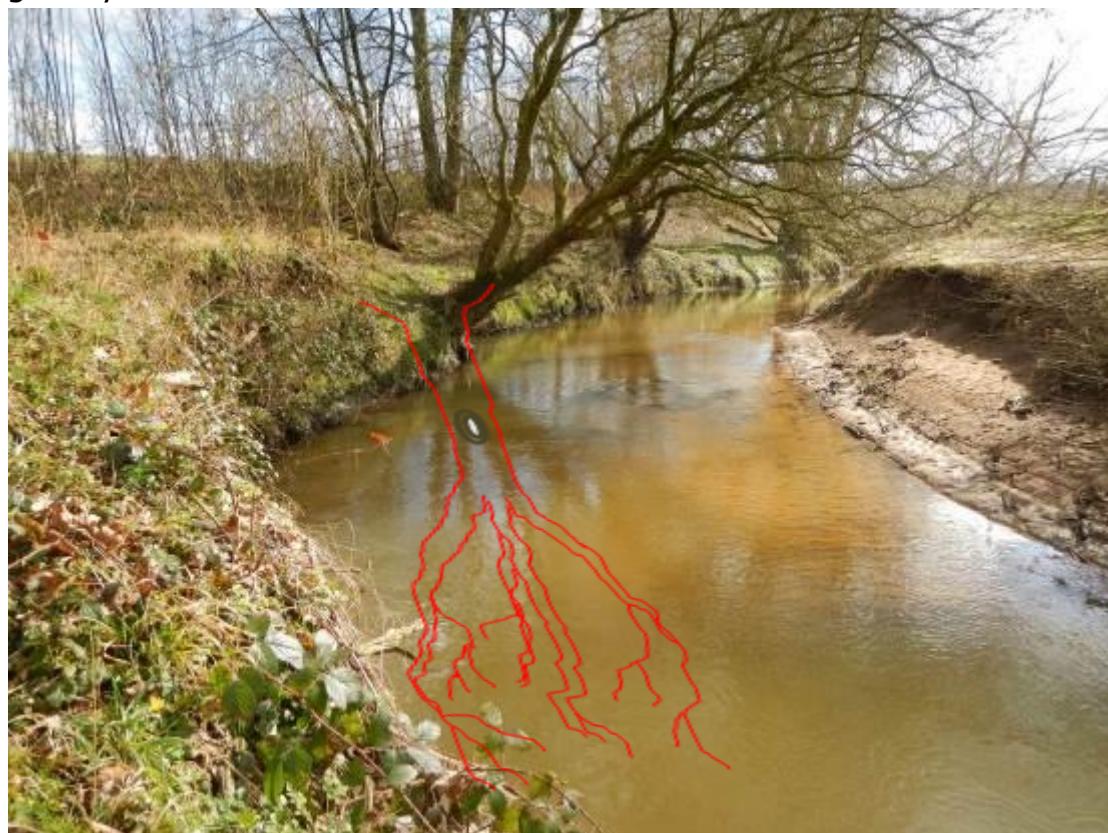
Photograph 16. More low cover should increase the number of resident fish. To achieve this, the willow tree could be laid tight to the bank, as shown by the red tree outline.

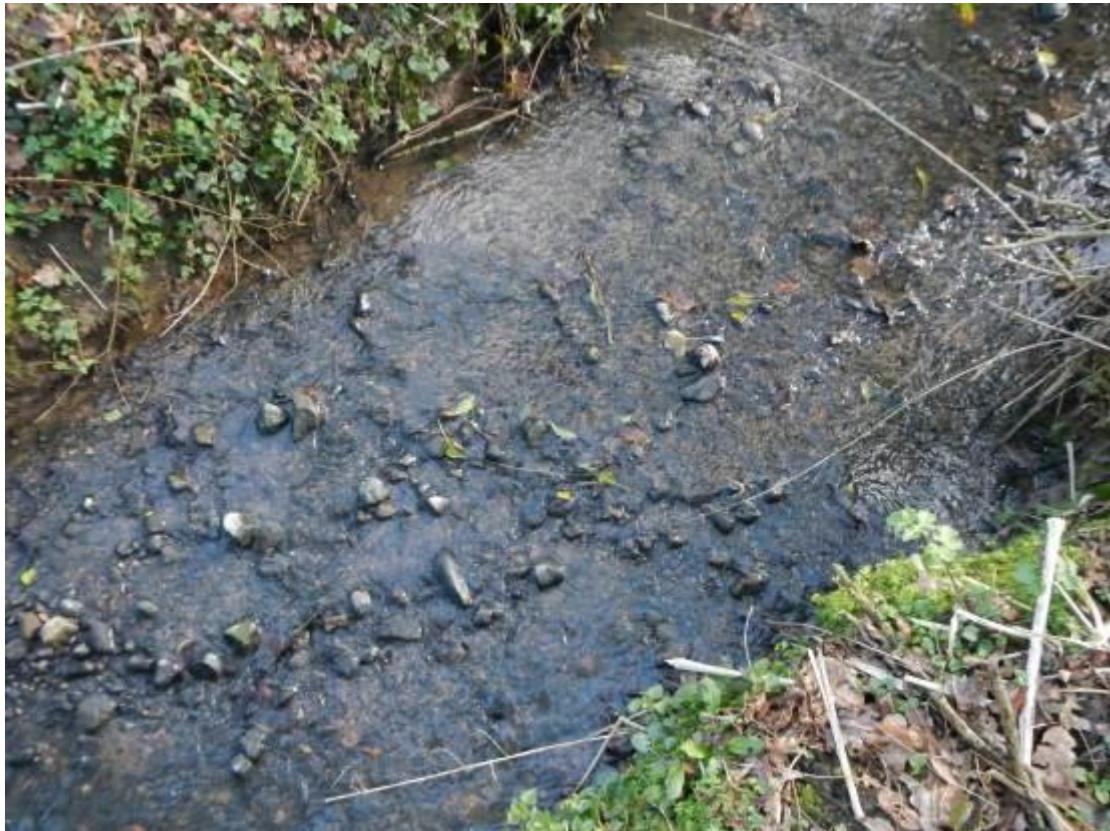
Photograph 17. Small tributary of Mobberley Brook with potential as a spawning and nursery tributary. Sediment input from upstream remains a significant impact.

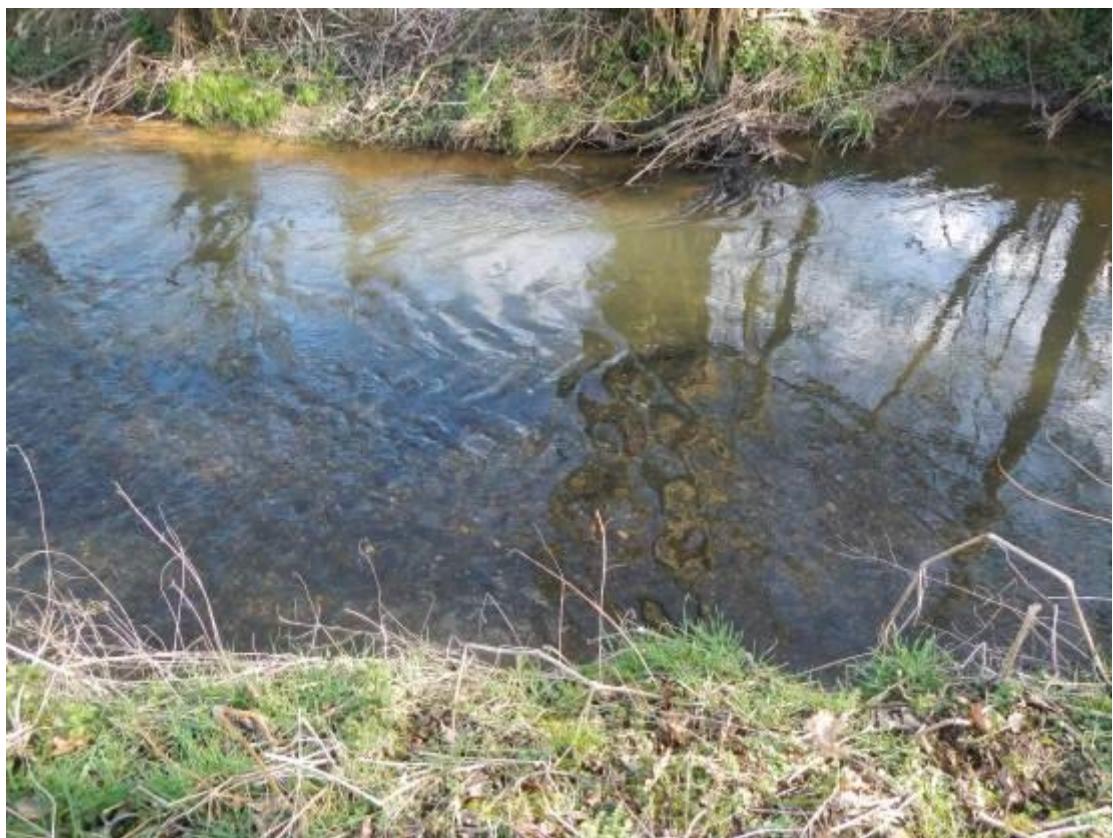
Photograph 17. Mainstream Mobberley Brook suitable flows and gravel size for trout spawning. Signs of redds might be expected here, but none were observed.

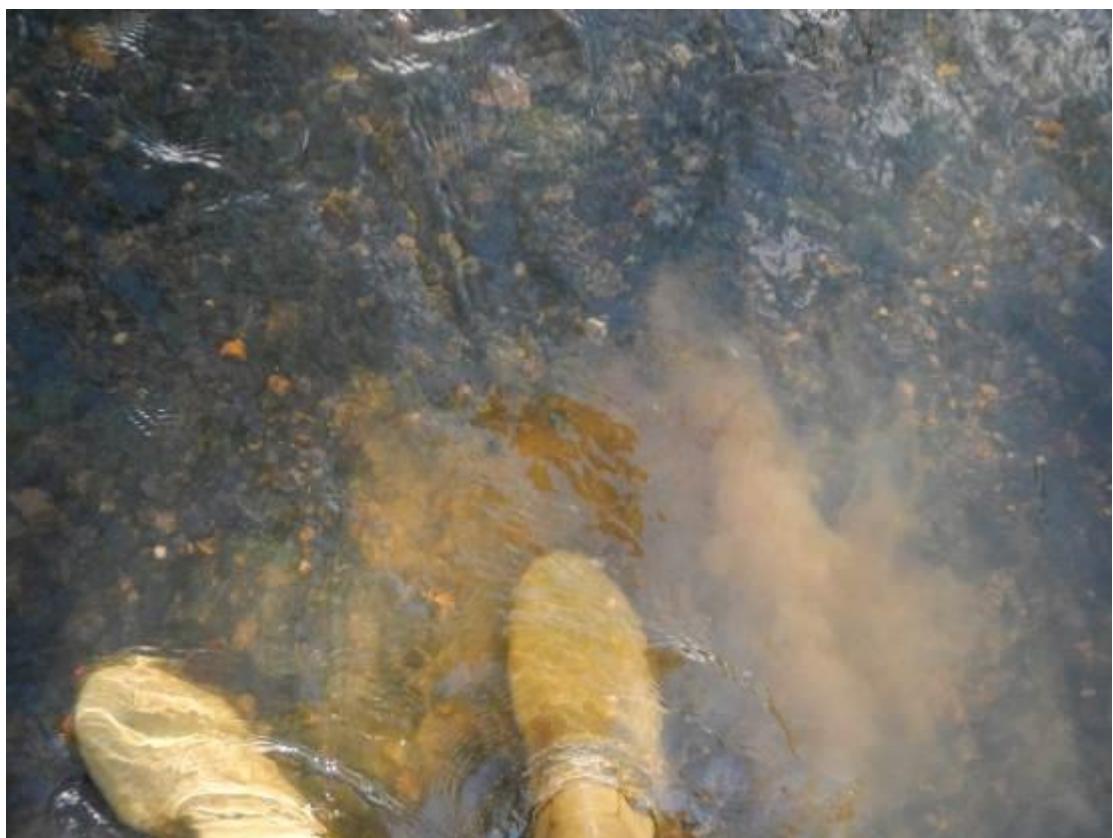
Photo 18. High loading of fine sediment within the gravel.

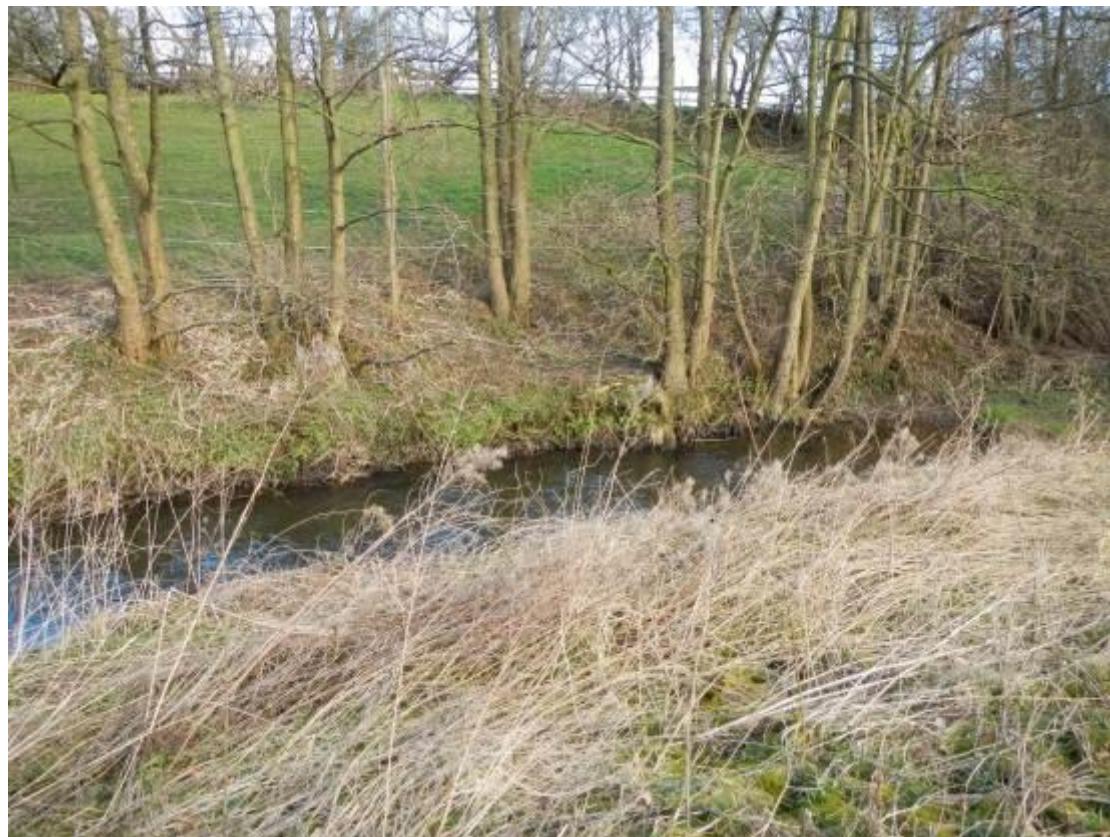
Photograph 19. Sparing alder coppicing to increase low regrowth and planting of willow would benefit this section.

As on other sections, it would be beneficial to increase low-level cover in some areas. Photo 19 shows a section of RB where coppicing and planting could be used to promote valuable low-level cover. Photos 20 & 21 demonstrate great examples of the type of valuable woody debris that is easily overlooked, and all too often ‘tidied up’, to the detriment of fish habitat. In the case of Photo 20, such habitat within a relatively shallow run is often the only feature enhancing the area for juvenile fish. Increasing these features is likely to improve juvenile survival rates and carrying capacity.

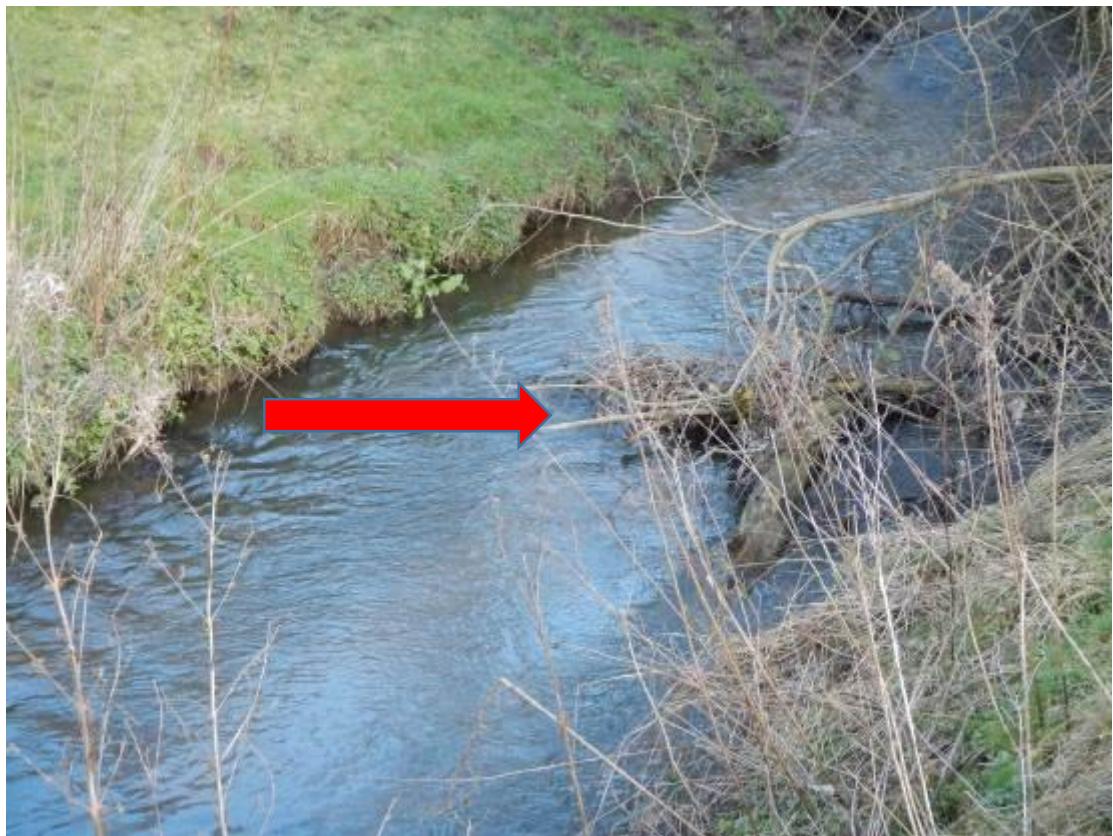
Photo 20. A basic, easily overlooked feature (red arrow) that is actually key habitat for healthy juvenile trout populations.
