Advisory Visit
Birkin Brook – Cheshire
10/03/2015

1.0 Introduction

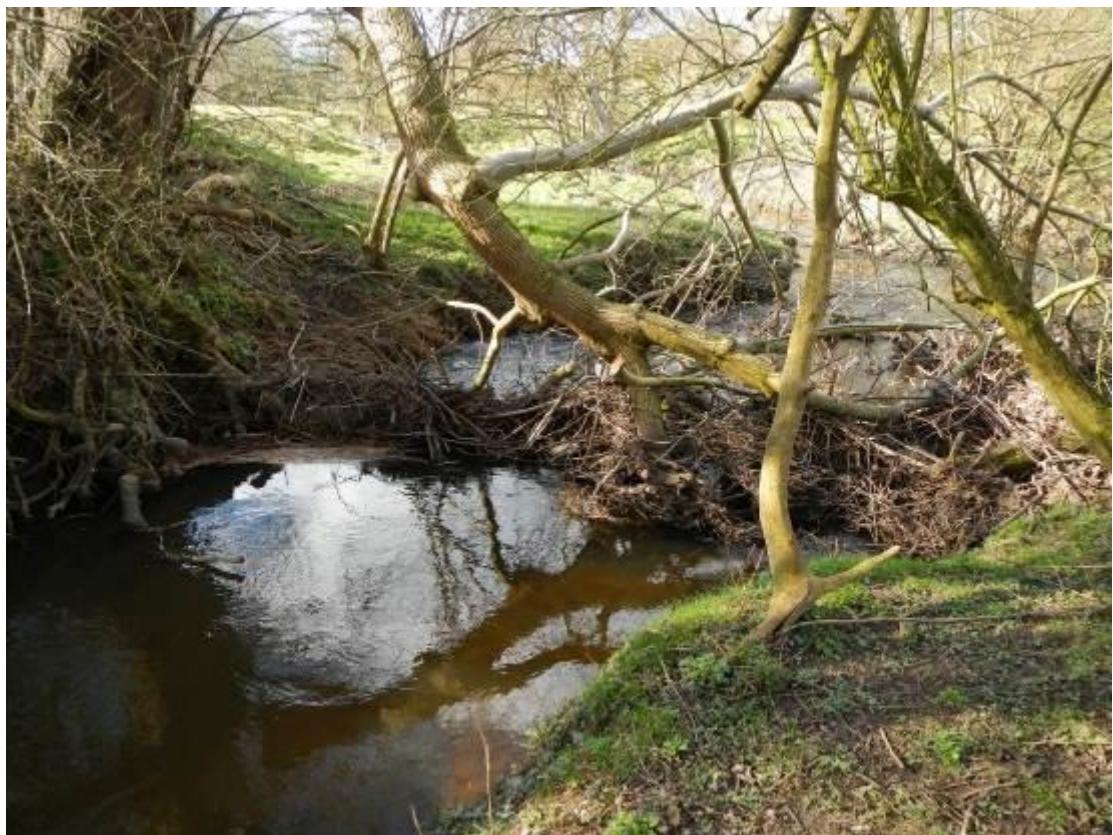
Photograph 21. Valuable woody debris logjam that provides beneficial bed scour and shelters fish from high flows.

The logjam in Photo 20 is a great example of the type of feature that should be retained and can be recreated to force scouring flows into the bed, hopefully reducing sediment loading within the gravels to a state suitable for trout spawning. If such structures are to be recreated, it should be undertaken in areas with stable banks (ideally tree lined) so as not to increase the potential for bank erosion.

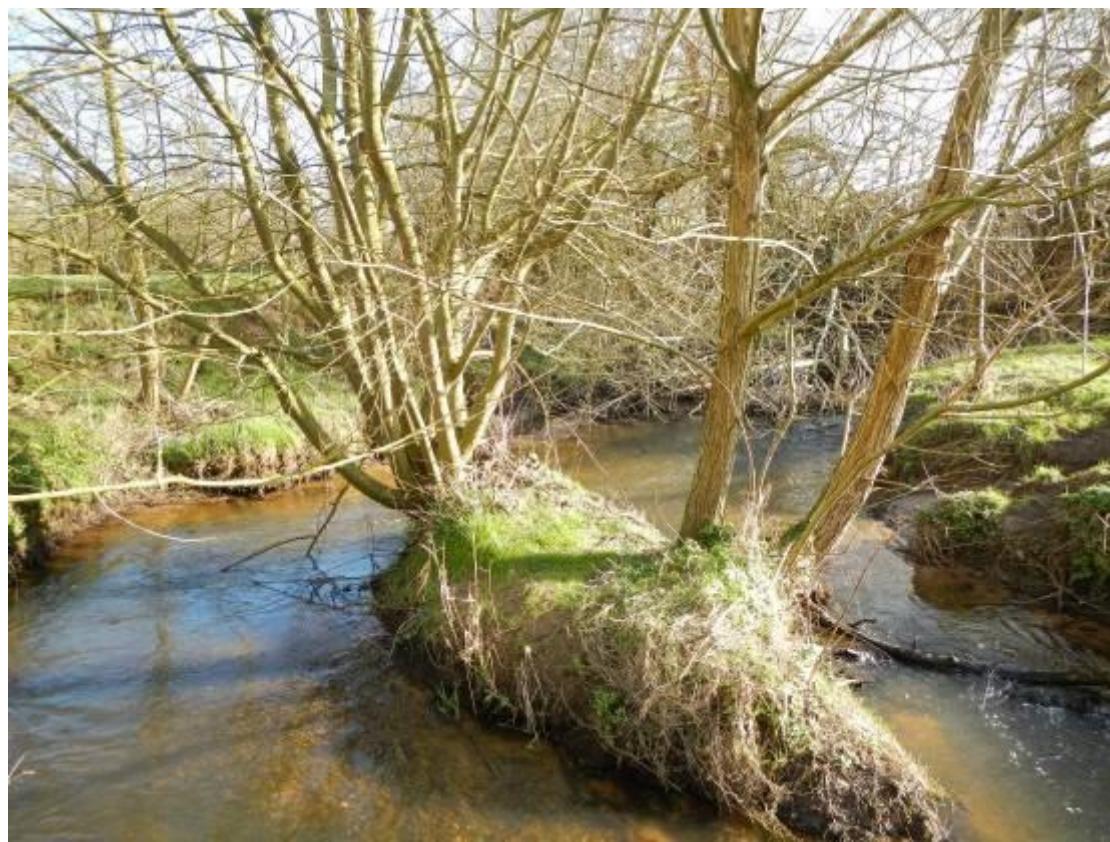
An island within the channel provides a good example of the two predominant willow types present on the Brook and provides guidance as to which should be used for habitat improvements (Photo 22). The two stems on the right are crack willow (*Salix fragilis*), a large fast-growing species that tends to collapse and break under its own weight. This is useful for planned channel obstructions, as the trees will produce that effect if planted then left alone. In other scenarios, however, they often require a greater degree of future maintenance than other species. The willow clump to the left of shot is goat willow (*Salix caprea*), also known as pussy willow or sallow. This is a much smaller species, generally growing to around 4-6 metres, and therefore requiring less maintenance. They also tend to support a denser canopy and so provide a greater degree of low-level cover. Both species can be easily laid into the channel and will take from whip cuttings driven into the ground.

Photograph 22. Crack willow (right of shot) and goat willow (left of shot). Any of the limbs could be beneficially laid into the channel to increase low cover and in-channel structure.

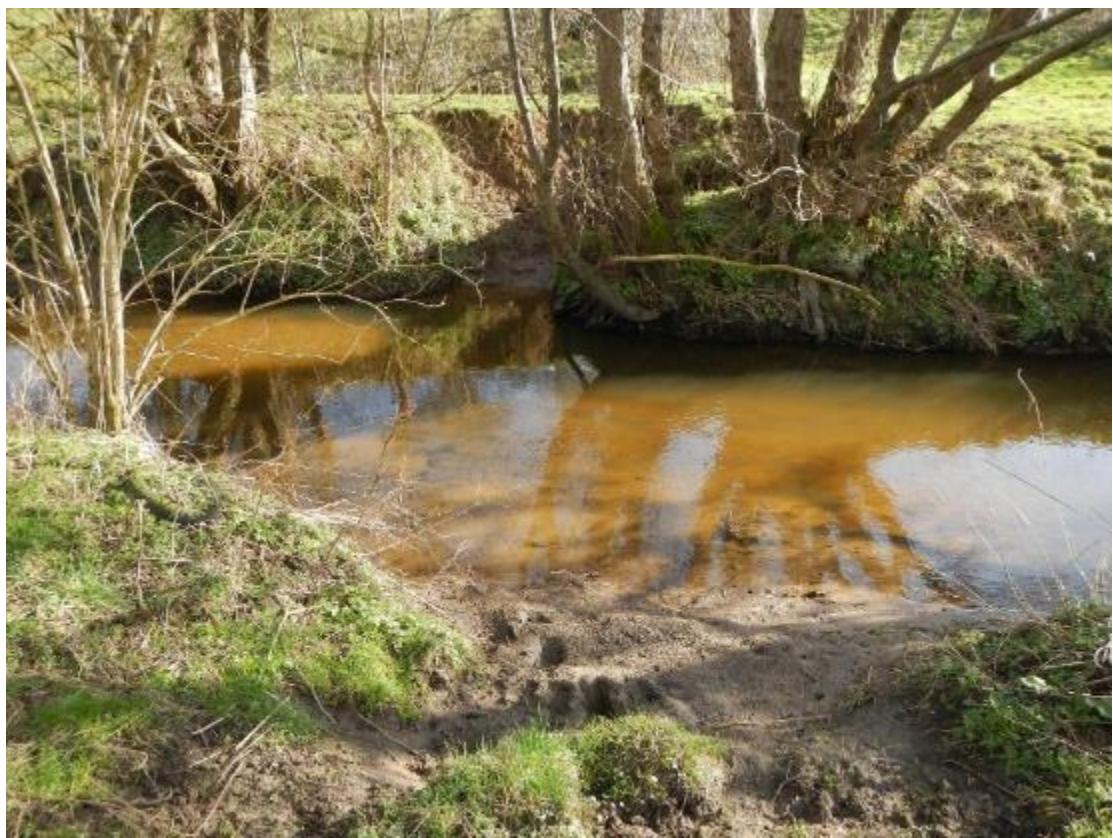
As on other beats, in unfenced areas, grazing is a significant issue, with cattle fording the watercourse and causing significant damage and sedimentation through poaching. Again, options for stock exclusion from the watercourse should be investigated with the landowner and farmer. In this area, coppicing and installation of LWD/'tree kickers' (see Recommendations) to increase cover and bed scour would also be beneficial (Photos 23 & 24).

Photograph 23. Significant sedimentation issues at a cattle fording point. Coppicing here would encourage beneficial low cover but may be eaten by the cattle in the absence of fencing.

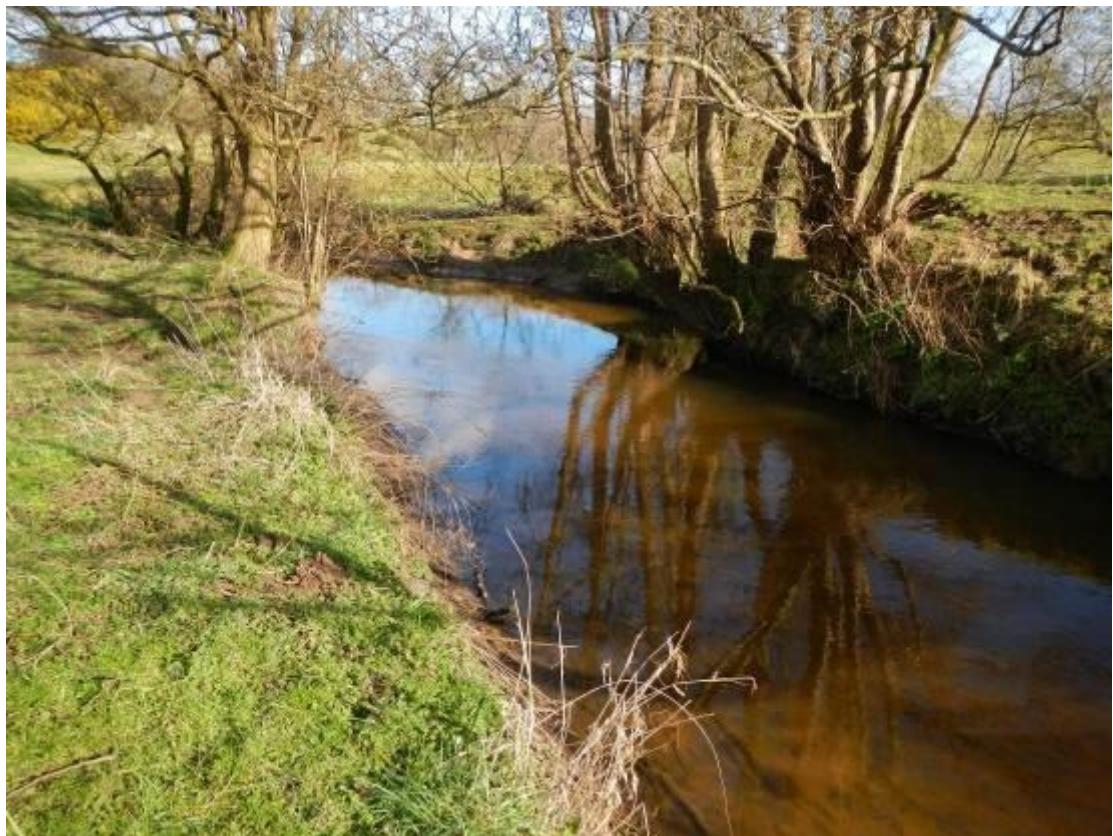
Photograph 24. An open pool, lacking in cover that would benefit from coppicing and utilisation of the trunk material as a 'tree kicker'.

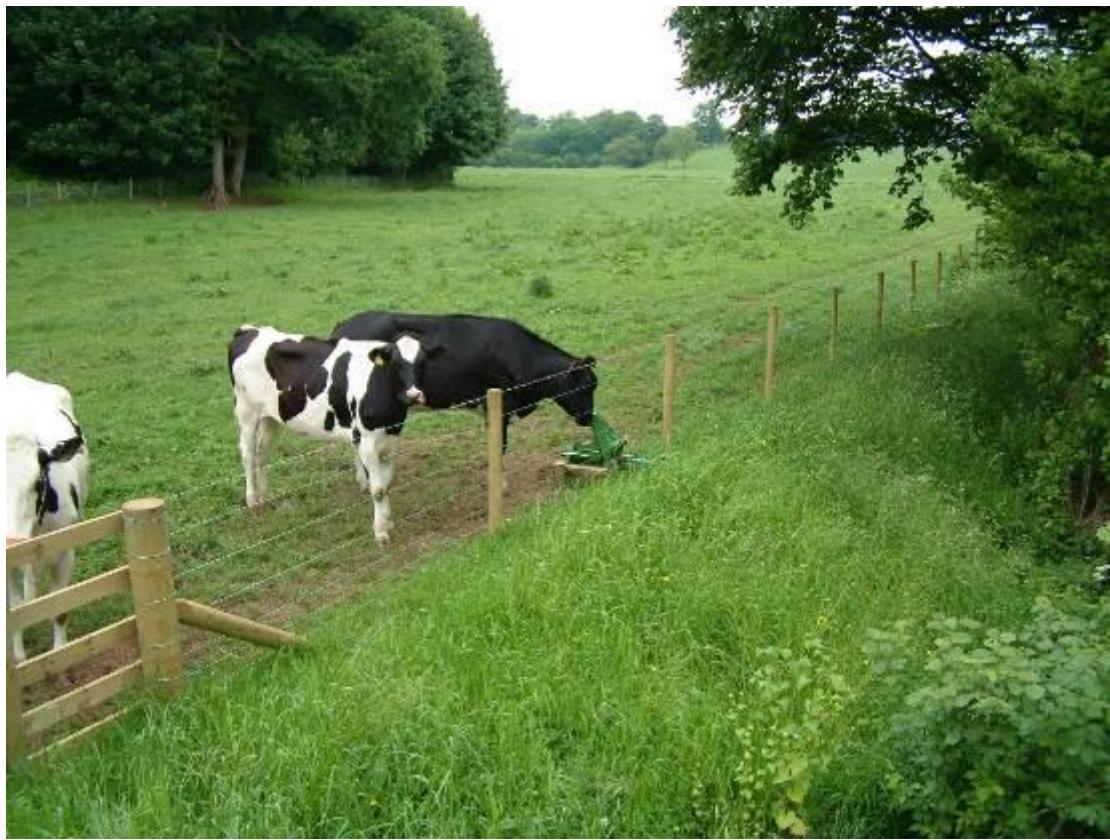
Photograph 25. Cattle excluded from a riverbank and watered via a pasture pump. The cattle draw water from the river through a pump which they activate themselves by pushing it with their nose.

Effective fencing to exclude livestock from the riverbank is one of the most vital measures that could be implemented on BBFFA waters if significant improvements are to be realised, particularly on Beats 1 & 2. If sheep are not grazed in the Brook-side fields, this can be done much more cheaply and more easily than previously attempted, by simply using posts and three or four strands of barbed wire. Ideally, the fencing should completely exclude livestock from the river bank and so would require either solar pumps (Photo 25) to supply water troughs, or pasture pumps (Photo 26) at several locations for stock watering.

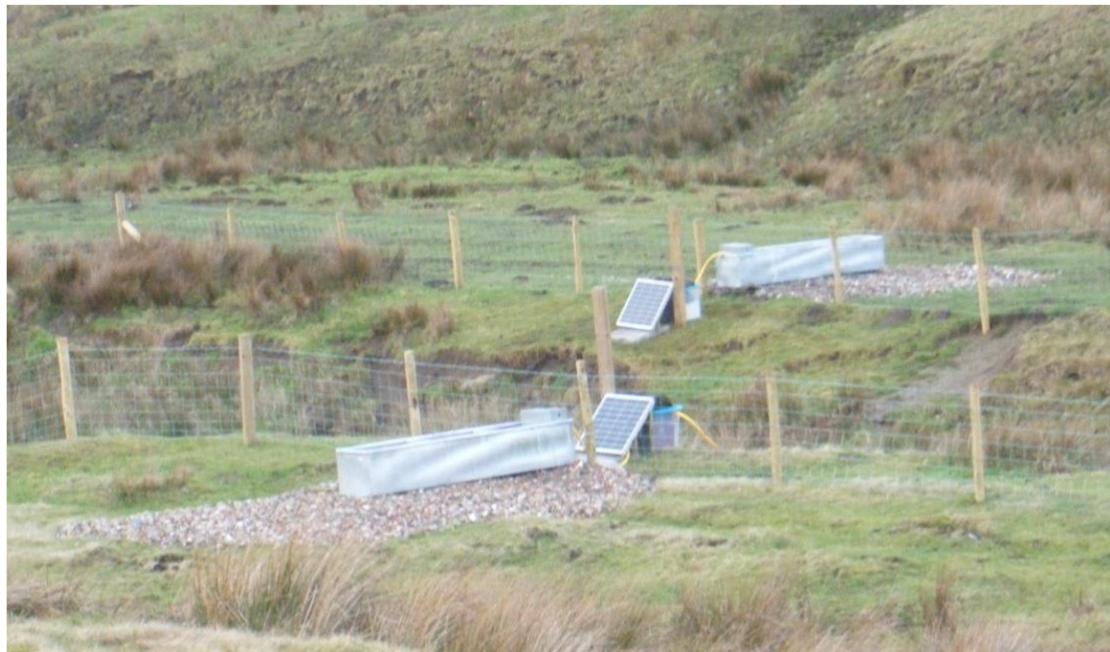
Photograph 26. Solar panel powered pumps employed to fill standard water troughs.
Photograph courtesy of Ribble River Trust.

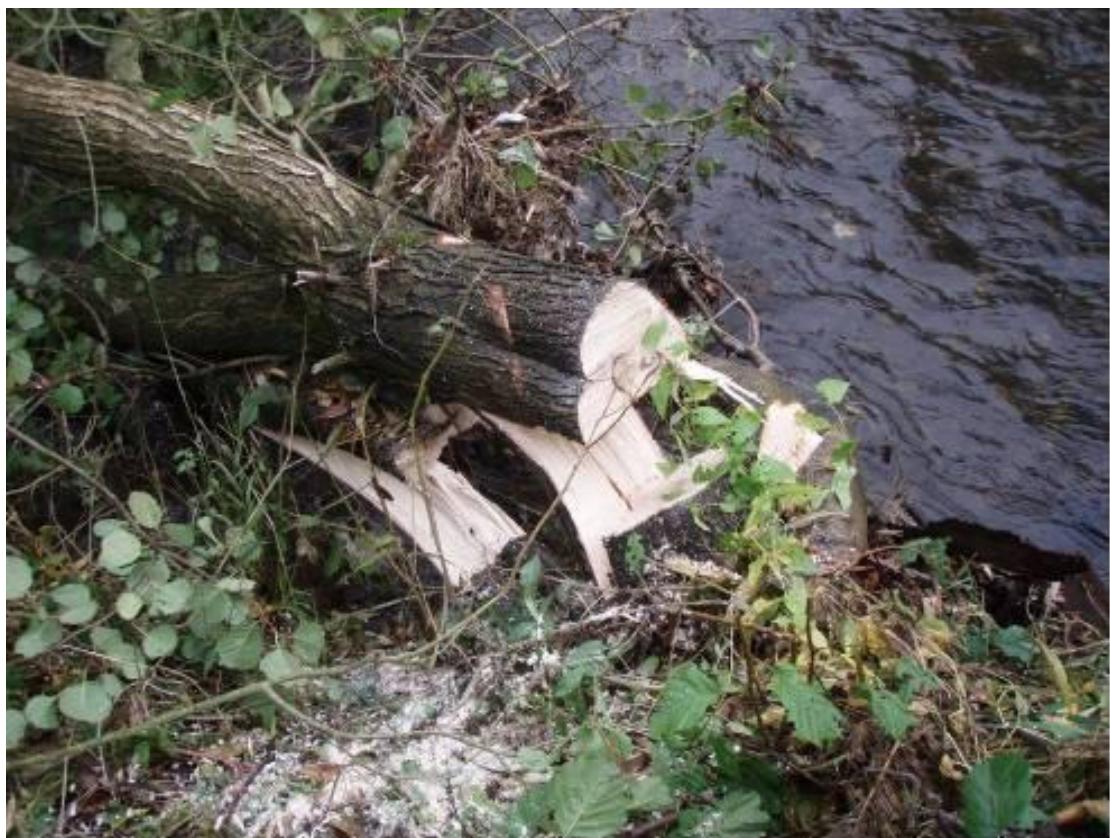
Photograph 27. Hinged willow.

The process involves cutting part way through the stem/trunk, a bit at a time (like laying a hawthorn hedge), until it can be forced over into the channel (Figures 27 & 28). The depth of the cut should be limited to only that which is required to bend the limb over, to retain maximum strength and health of the tree/shrub.

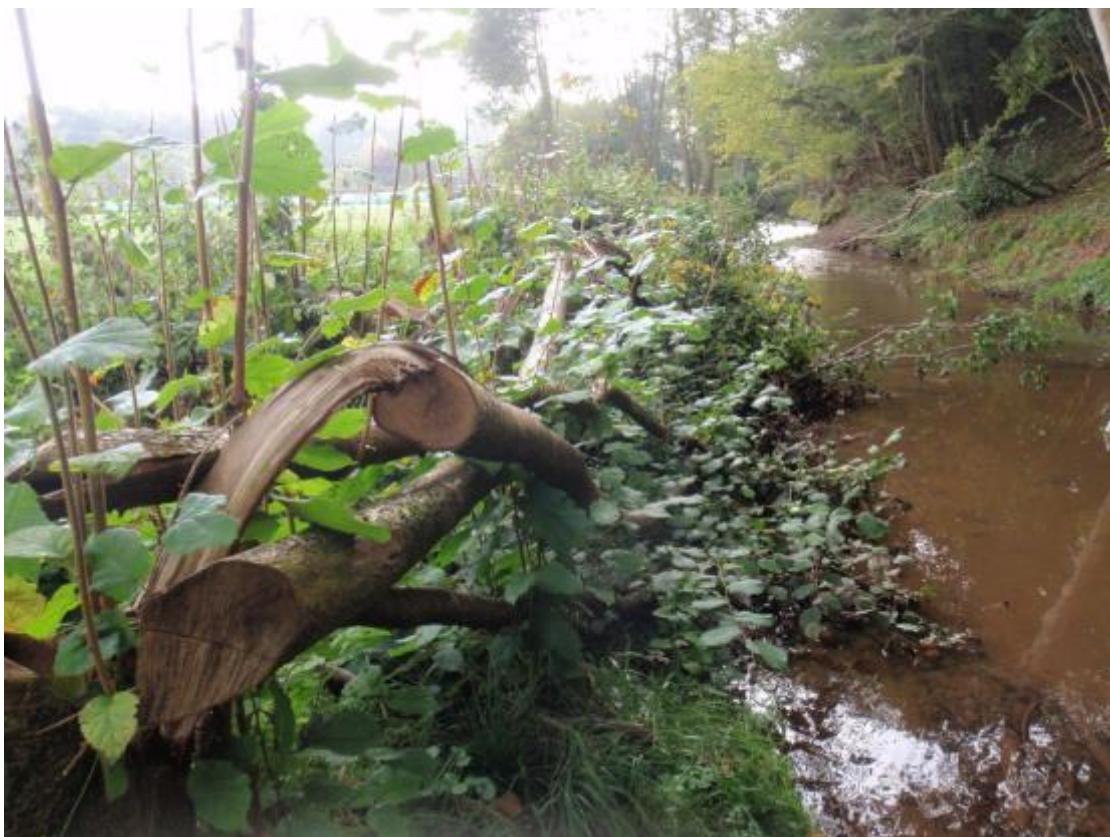
Photograph 28. Hinged hazel.

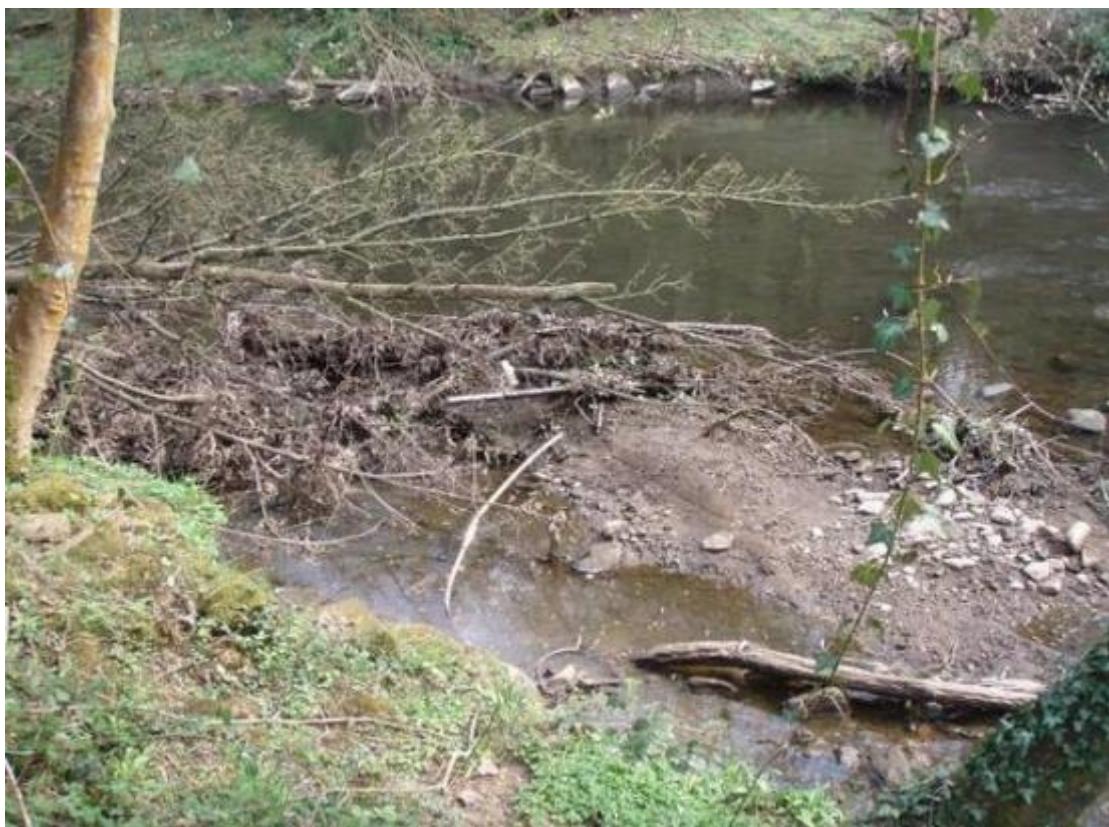
Photograph 29. Note the narrowing effect through significant sediment accumulation (foreground centre and right of shot) in the sheltered area downstream of the tree kicker.

The introduction of additional LWD and structures like tree kickers (live and dead) into the channel can also be used to encourage new areas of scour and deposition. Such structures can also help to concentrate flows in certain areas of the channel (usually towards the centre), and scour deeper pool habitat, while also creating slacker areas within the margins where deposition will increase (Photo. 29). The method simply involves cabling the trunk of a coppiced tree as tightly to its own stump as possible (Photos 30 & 31). (This technique requires a Flood Defence Consent).

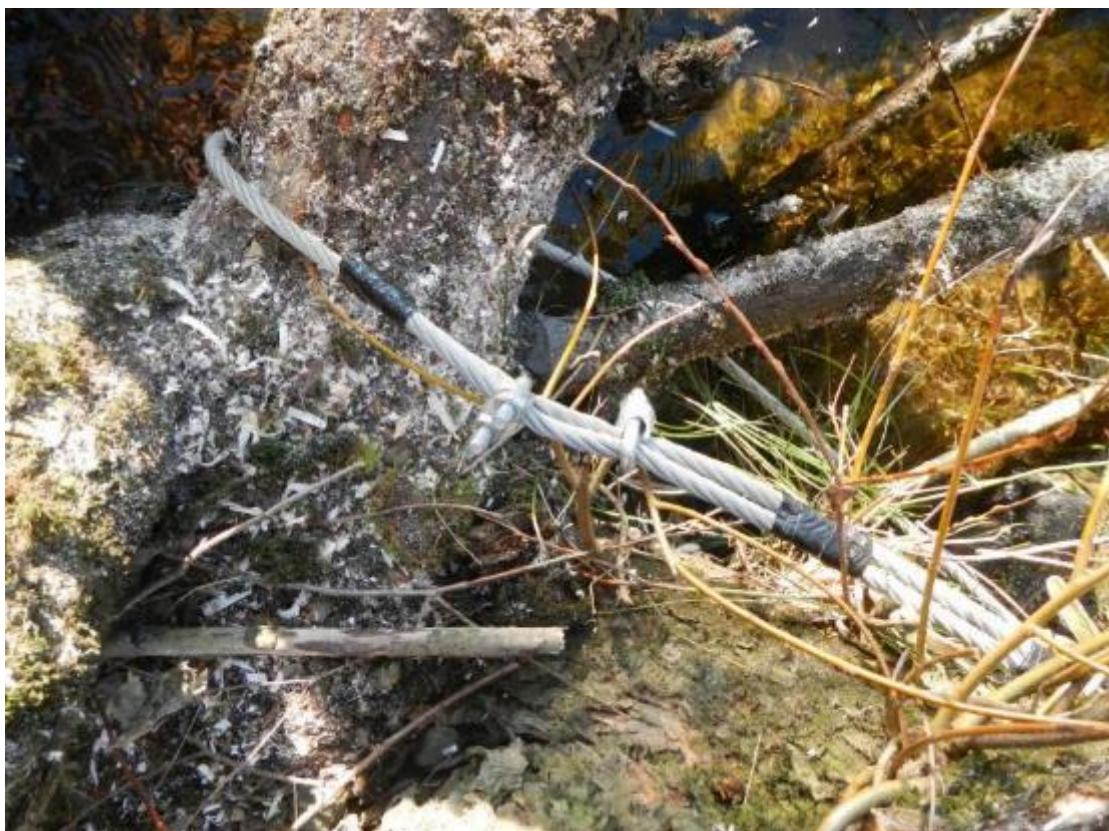
Photograph 30. Stump cabling for a tree kicker.

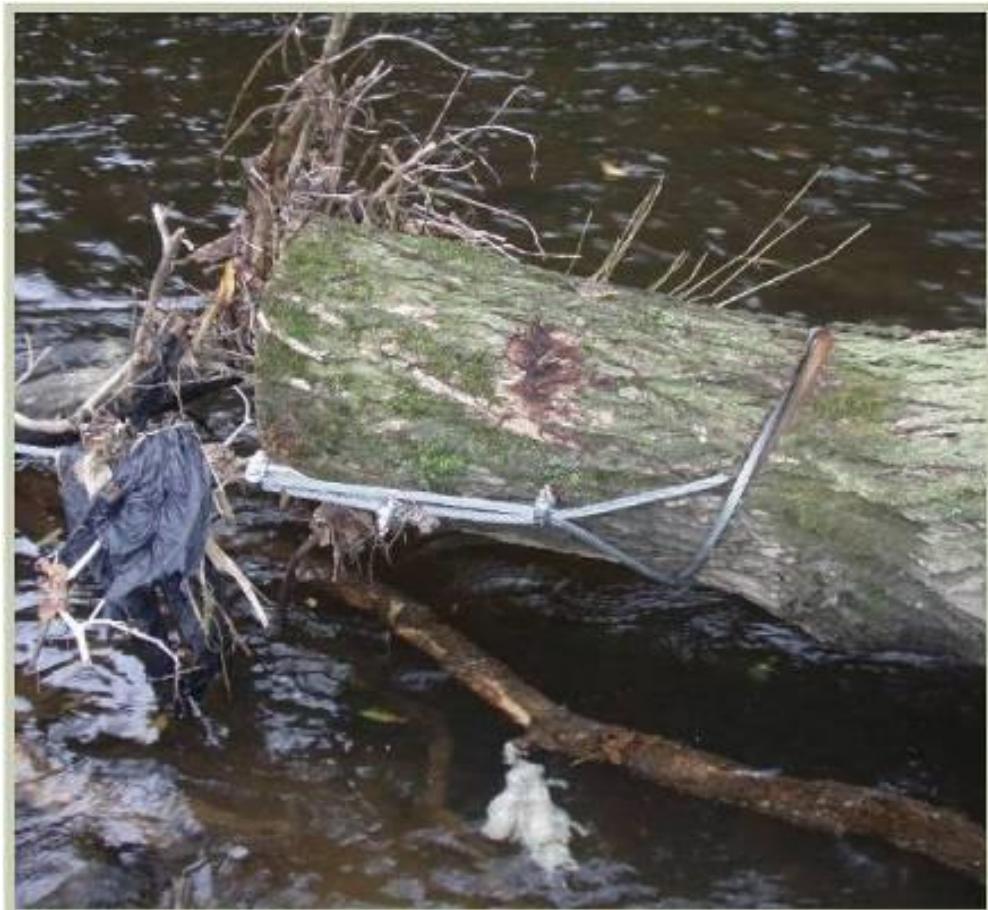
Photograph 31. Trunk cabling for a tree kicker.

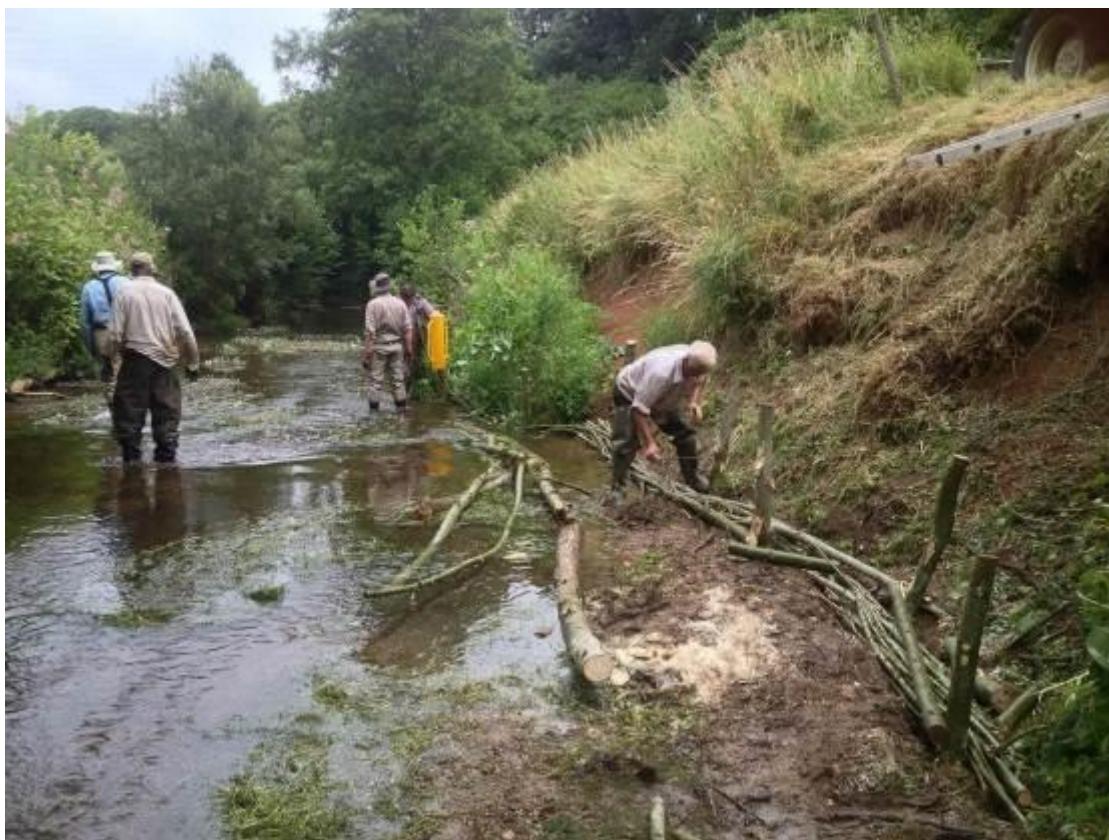
Photograph 32. Creating a line of posts along which brash bank protection can be installed.

In some areas, BBFFA have initiated bank protection measures using willow spilling. These have worked quite effectively, remaining in place and trapping sediment that will ultimately become vegetated and consolidate, demonstrating the potential for this type of work. A quicker method that is likely to achieve similar results is to use brash, rather than spiling (Photo 32 & 33). This simply requires pinning one or more pieces of brash (or brash faggots) into place, in a similar way to spiling, but much quicker and has less chance of washing out in long sections if an area does become destabilised.

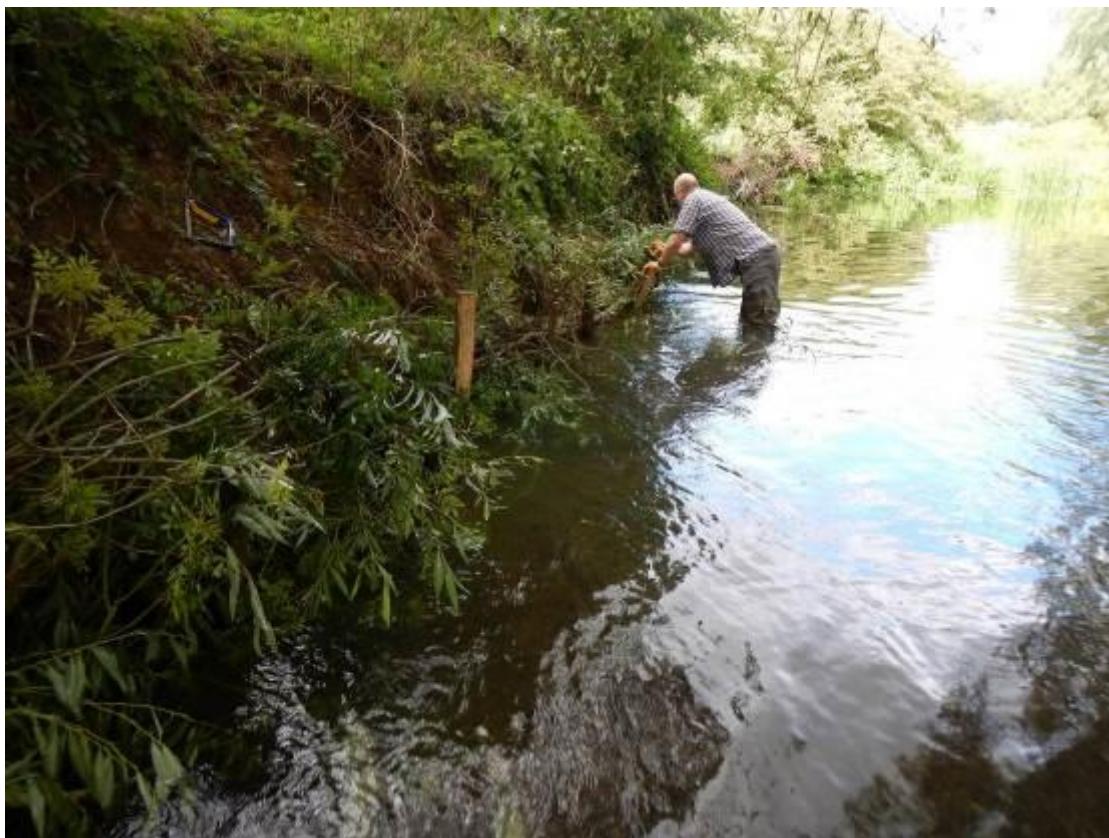
Photograph 33. Willow brash installed along bank toe.
