The Black Bourn

An Advisory Visit by the Wild Trout Trust January 2016

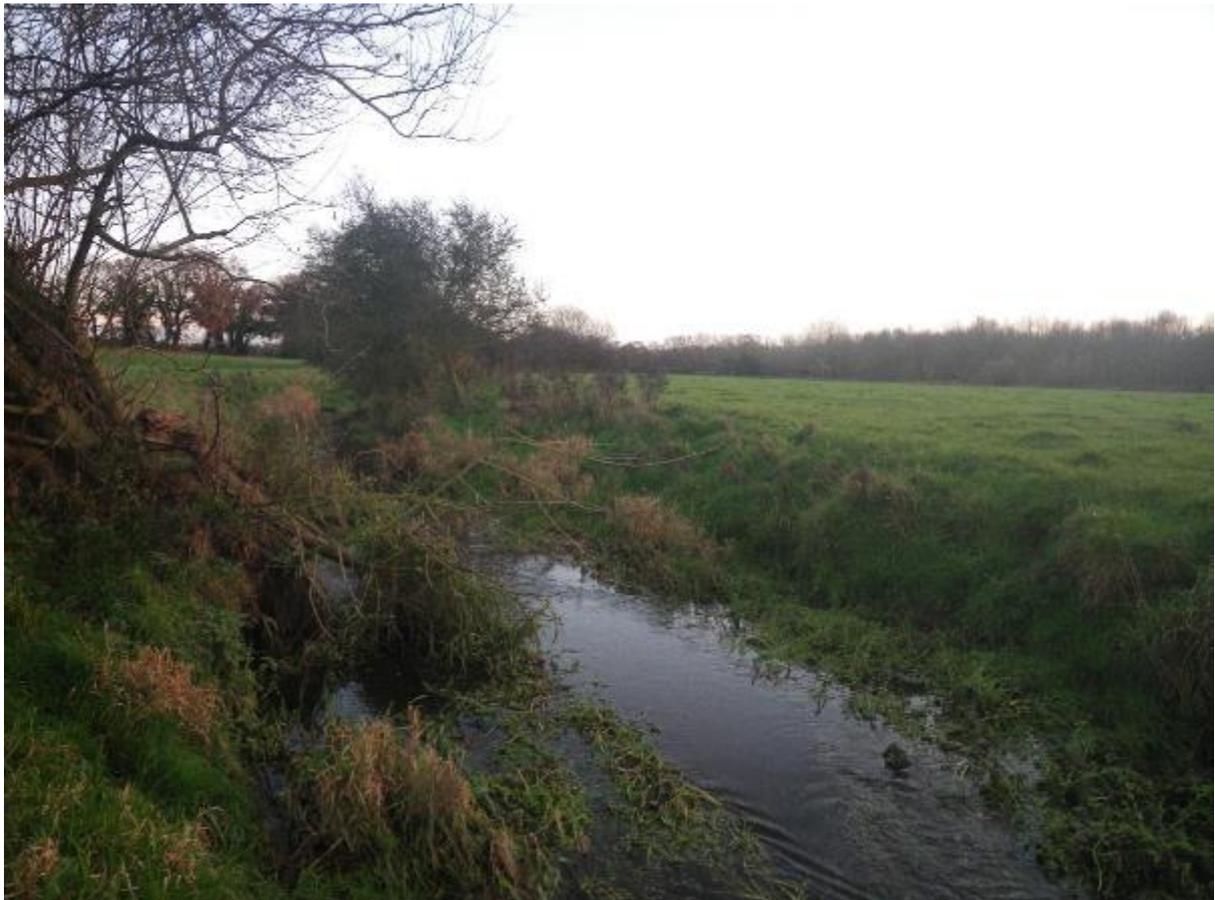
The Black Bourn Valley site includes a length of semi-natural meandering channel (cover photo and photo 1), flowing down from the upstream boundary, followed by a section of heavily modified and straightened river channel. In addition, an old relict channel not currently connected to the main river but located in the flood plain on the eastern side of the valley, forms what is in effect a long linear pond.

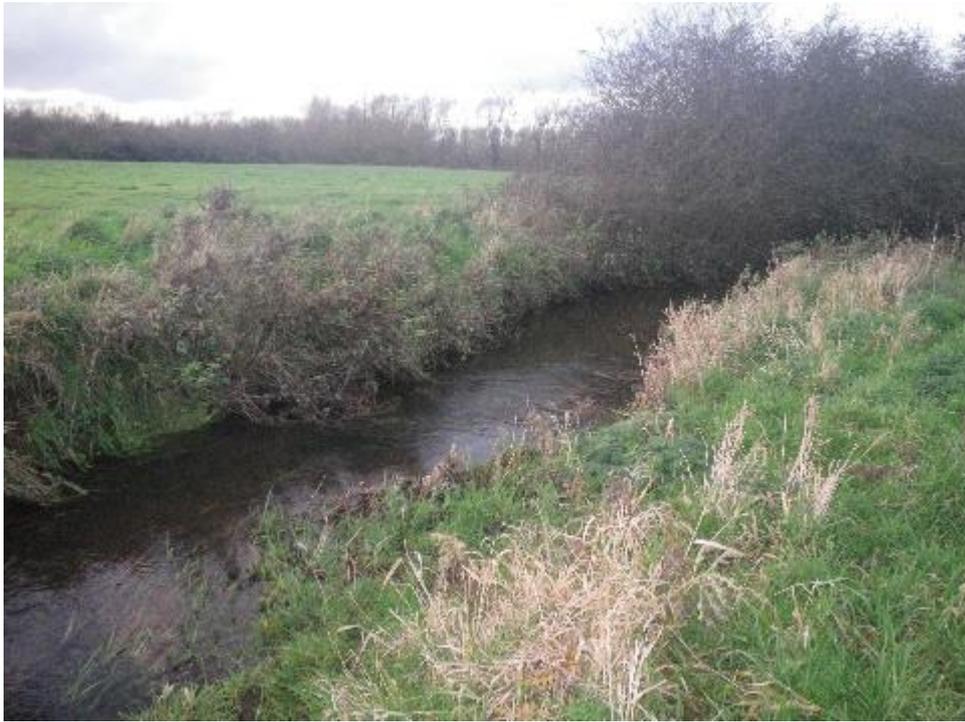
Photo 1. Upstream reach where the river has a healthy gradient and more varied topography enhanced by the low, scrubby marginal cover and occasional tree shading.

The top 200m of natural channel potentially provides the best opportunities for flow loving, gravel spawning fish species. Although not apparently rich in gravel, some small outcrops could be seen on the tail several pools. These areas will be critically important spawning sites and will be used in succession by a range of fish species, with potentially trout spawning in the November to January period, followed by dace in April and chub in May or June.

Gravel quality could be enhanced further by allowing, or even promoting woody material to fall into the channel to generate local bed scour and loosen, sort and clean coarse river bed sediments. There is a wealth of information about the benefits of woody material in river channels on the WTT web site www.wildtrout.org. The WTT regularly provides training and guidance on how to utilise local woody material to create improved spawning conditions and to provide enhanced cover for both fish fry and adult fish alike.

The natural section of channel at the upstream end of the reserve provides spawning opportunities for a range of rheophilic species, including brown trout. Habitat on this upper section could be improved further by installing large woody material to help improve gravel quality and provide in-channel habitat for fish and invertebrate communities.

The upper natural channel should be managed as a shallow flowing stream habitat where a variation in bed topography and a narrow channel is maintained. Priority species here should be mainly submerged macrophytes and marginal chalkstream herbs rather than emergent reeds, sedges, grasses and rushes. Maintaining areas of clean gravel over shallow glides will help to support spawning opportunities for a range of fish species.

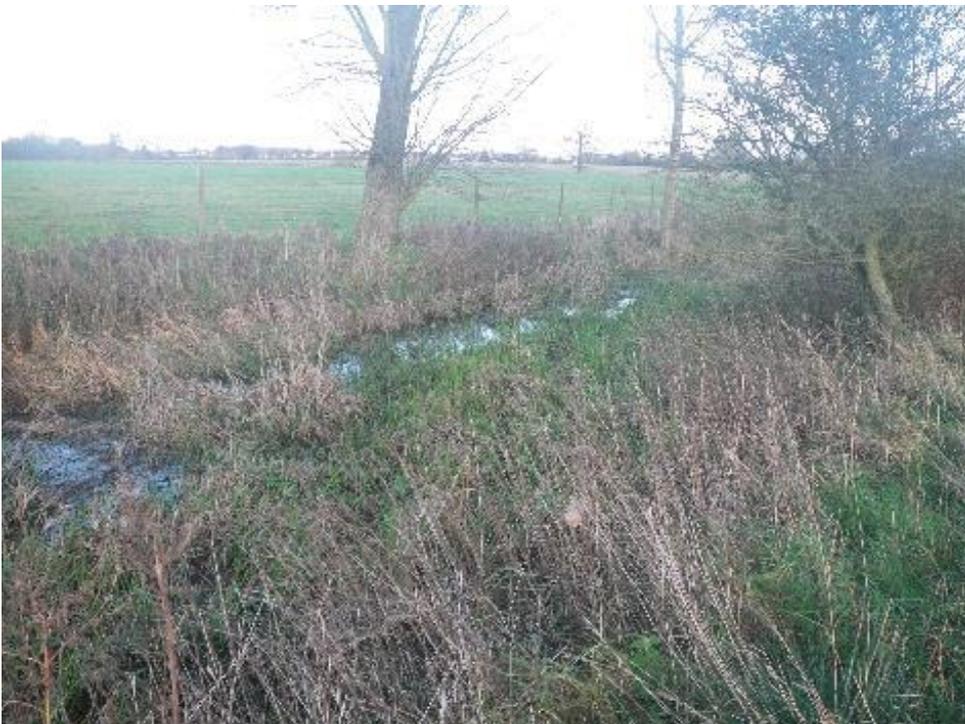
A further section of channel (photo 2), which picks up a small amount of flow from connected ditch systems appears to have once been connected to the old

backwater channel described above and flows north before turning a dog-leg left and joining the main river near the northern (downstream) border of the site.

Photo 2. The downstream "dog-leg" channel which picks up flow from various ditch systems and is connected to the main river at its downstream end.

The lower, silted up backwater near the northern end of the site could be very important as a refuge for fish in high flow conditions. This channel requires some heavy maintenance to remove settled sediment and win back water depth. Digging out the sediments with a tracked 360 excavator from the bottom end up will ensure that the channel remains in continuity with the flowing main river and will help to provide valuable alternative habitat. Research has shown that connected backwater channels, such as relict oxbows, provide critically important refuge during both summer and winter flood events.

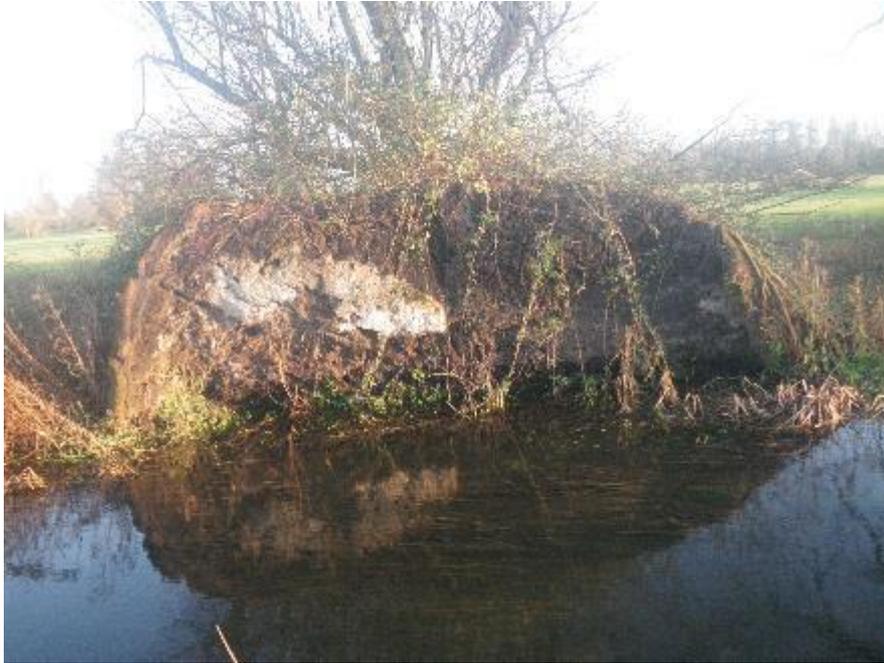
A superb example of a root plate from a fallen tree was noted (photo 3). Trees that fall away from the river channel often create critically important nesting opportunities for kingfishers, as well as often providing an undercut refuge for fish species.

Photo 3. Root wad providing habitat both above and below the water line.
