**Advisory Visit**

**Black Lynn Burn, Argyll (Waterbody ID: 10304)**

**25/06/12**

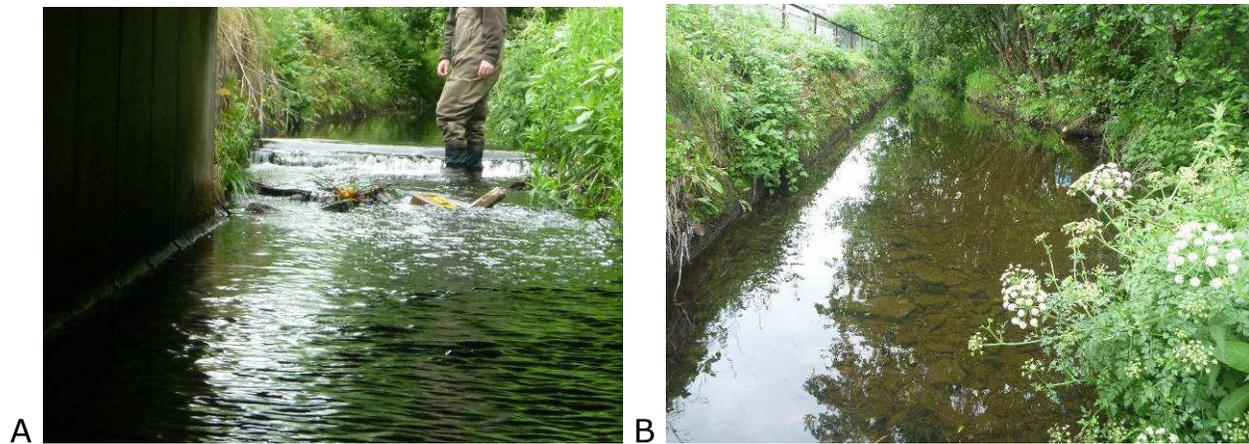
A map of the surveyed reach (Fig. 1) indicates the main focus of the habitat assessment and the reach was walked from an upstream to downstream direction. The first point surveyed was beneath the bridge at Lynn Road (NM86019 29288). A small weir of around 30cm in height was impounding a considerable reach of water (Fig. 2). Assuming that ownership issues and the presence of below-ground services (i.e. sewer pipes, gas mains, electricity/telecommunications cables) could be ruled out – removing at least half of this structure down to stream bed level would have great benefits to upstream habitat diversity.

Figure 2: Low weir upstream of bridge at Lynn Road (A) and impoundment of straightened section upstream of weir (B)

Of equal importance will be the establishment of ownership (and subsequent obtaining of permissions) to make the required alterations to the stream bed as well as the low weir at the top of the inspected reach.

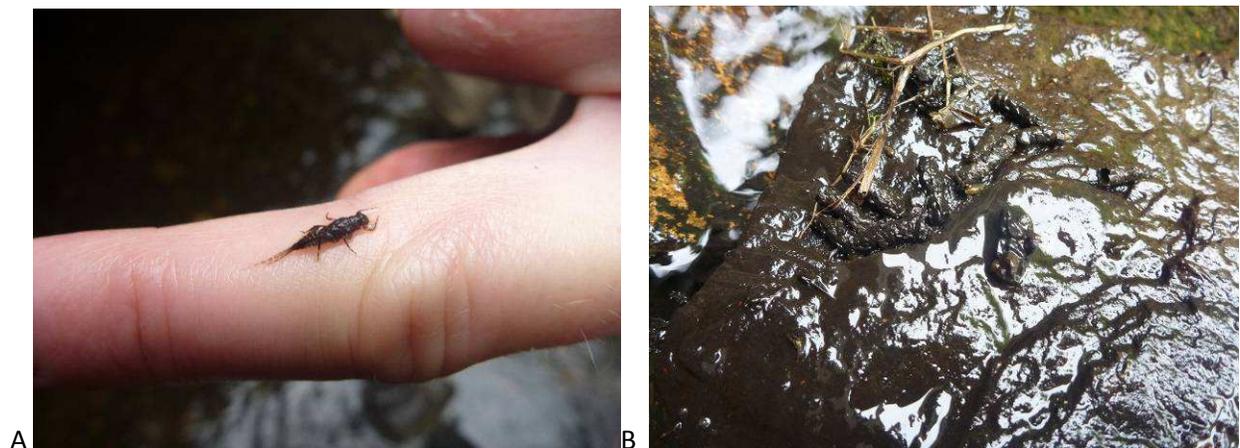
The water quality in the burn is sufficiently good to support a range of pollution-sensitive invertebrate fauna (Fig. 3). Consequently, chemical water quality is not expected to be a primary constraint on biodiversity – including pollution-sensitive salmonid fish.

Figure 3: Organic pollution-sensitive taxa including *Seratella ignita* (A) and a mixture of cased caddis larvae, caseless caddis pupal shelters plus metallic pollution-sensitive *Baetis* and *Gammarus spp.* (B)

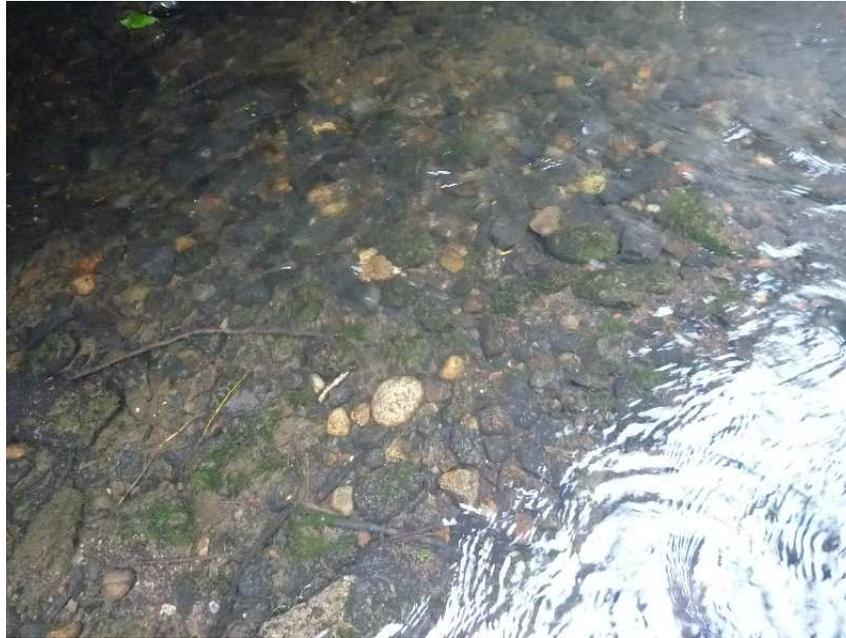
Instead of chemical toxicity, a physical impact of diffuse-source pollution in the form of over-supply (and/or over-retention) of fine silt and sandy sediment was a more prominent concern. The potentially valuable spawning gravels noted at this location – and throughout the visited reach – were heavily infiltrated by fine sediment (e.g. Fig. 4). In some places, cobble and gravel substrate was buried under several inches of sand and silt to a degree that would not be expected in such a small and relatively briskly-flowing burn draining a limited catchment area.

**Figure 4: Even in fast flowing sections, the spaces (interstices) between pebbles were packed with fine sediment. This will reduce the overall number of micro-habitats available for invertebrate species and also significantly reduce the survival of trout eggs laid in these beds.**

As well as reducing micro-scale habitat variation (and consequently invertebrate diversity), the blockage of interstitial spaces between gravels prevents the irrigation of eggs with oxygen-rich water. This dramatically reduces the hatching success of salmonid fish eggs – with the majority suffocating before fry are able to hatch. Spawning fish will also detect and actively avoid areas that offer poor survival prospects for their offspring.

Making contact with the appropriate SEPA personnel that can assist in tracking down the predominant sources of any potential fine sediment over-supply is crucial to removing the spawning success bottleneck. Their involvement will also be instrumental in helping those responsible to meet the requirements of “no deterioration” for ecological potential under the Water Framework Directive (as well as existing legislation governing the accidental pollution of watercourses). As stressed previously, this must be undertaken alongside an assessment of channel geomorphology and potential improvements to sediment transport and deposition processes.

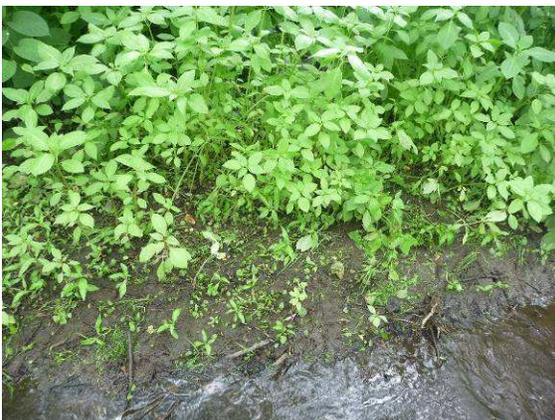
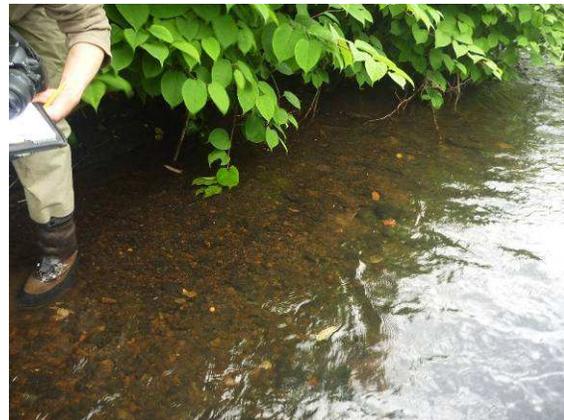
**Figure 5: Himalayan balsam (A) and Japanese knotweed (B) in the reach at NM86021 29330**

The presence of substantial stands of both Himalayan Balsam (*Impatiens glandulifera*; Fig. 5A) and Japanese knotweed (*Fallopia japonica*; Fig. 5B)

will undoubtedly add to the stream bed-load of fine sediment, through wash-in of bankside soils exposed after winter die-back of the plants.

In accordance with guidance offered in the urban rivers restoration guidelines (cited in section 2 of this report) it is recommended that stem injection of Japanese knotweed is carried out by appropriately certified and insured individuals. Himalayan balsam can be tackled by a combination of hand pulling (by volunteers) and strimming below the first stem node (by appropriately qualified personnel). N.B. strimming should NOT be used to control Japanese knotweed – as plants can propagate from fragments as small as the last joint of a thumb. Hand pulling and strimming of balsam must be carried out when plant growth is vigorous, but prior to setting seed. Both Japanese knotweed and Himalayan balsam eradication efforts must be carried out from an upstream to downstream direction to prevent unnecessary efforts to control recolonisation from upstream sources. Spraying of herbicide for either balsam or knotweed (c.f. injection) would not be recommended in the case of the Black Lynn Burn due to its impact on non-target species and because control is feasible by alternative means. Depending on the speed of recovery from the native seedbank, it may be desirable to assist the development of native flora by either seeding with a locally-appropriate mix of species. In situations that the regeneration by both natural and hand-seeded means is poor, it may be advantageous (although more costly) to kick start the process using mature plants.

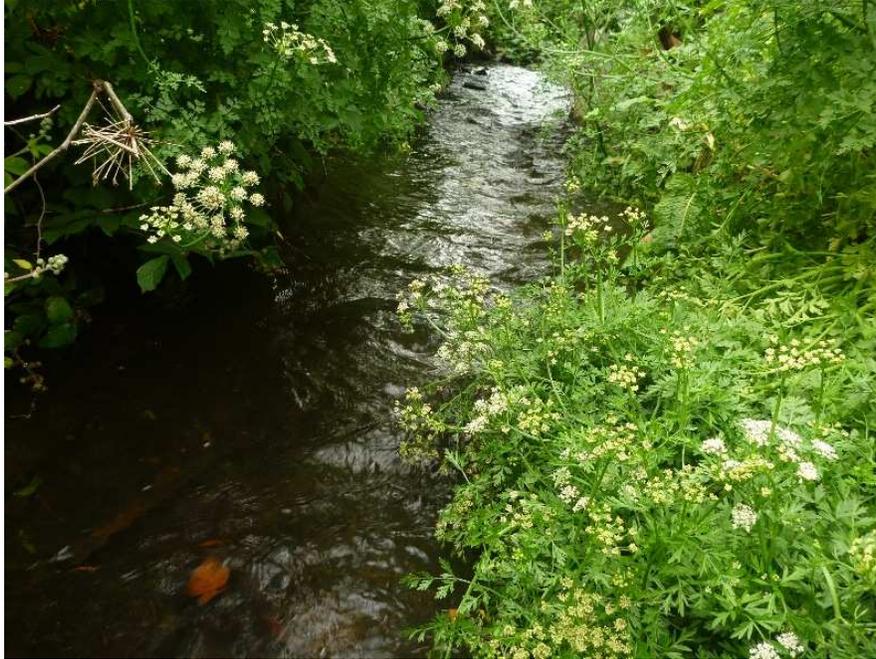
Although there is an obvious constraint on spawning success, there was some high quality juvenile and adult fish habitat within the inspected reach. Excellent examples of suitable flow, pace and depth, coupled with overhanging and partially submerged herbaceous and woody vegetation, were providing superb nursery habitat for fry and parr (e.g. Figs. 6 - 9).

**Figure 6: Overhanging herbaceous cover and gentle marginal flows in the region of NM86010 29341 - ideal for juvenile life stages**

The importance of proactively protecting what is already high quality habitat should not be underestimated. It could be quite easy to place a greater value on the more obvious interventions suggested within this report. This would be highly detrimental to the prospects for wild trout and other river corridor wildlife – especially if it resulted in over-zealous management efforts to “tidy” the highlighted juvenile and adult cover.

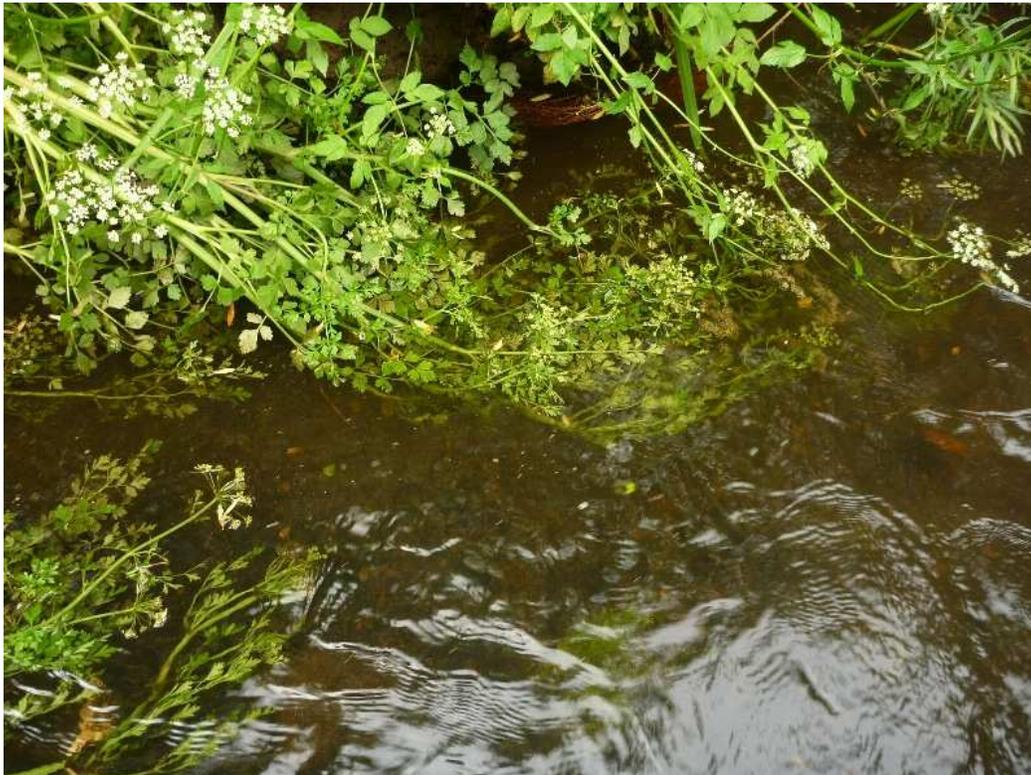
**Figure 7: Ideal shelter for small fry in the region of NM86010 29341**

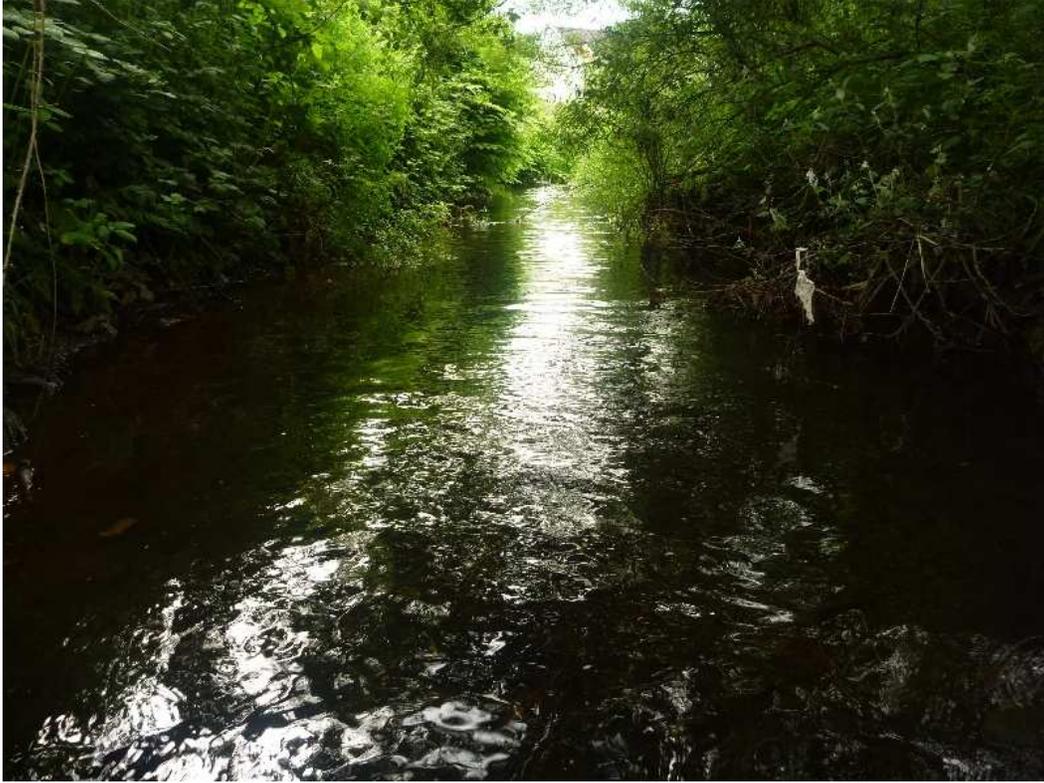
**Figure 8: Glide habitat suitable for parr augmented by good overhead and submerged cover - particularly on the LHB at NM86010 29341 (view is upstream)**

A small number of simple, pegged woody debris structures will generate valuable gravel size “sorting” (or grading) that, in concert with reduced sediment supply, help to maximise egg survival. For example, a simple “upstream V” structure (Fig. 19A) in the reach pictured in Figure 8 at NM86010 29341 would generate “gravel-cleaning” scouring flows in the centre of the channel. Similarly, individual upstream logs (Fig. 19B) would enhance existing marginal deposits of gravel.

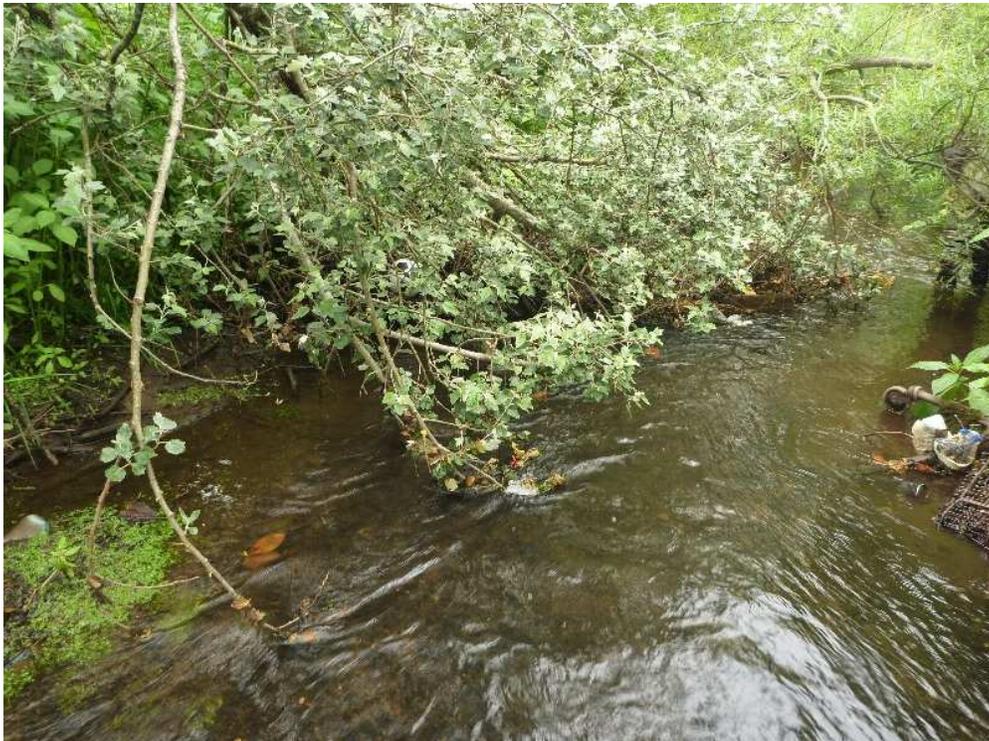
**Figure 9: Superb parr and young adult trout habitat generated by the trailing crown of a naturally hinged bankside tree just downstream of NM86010 29341**

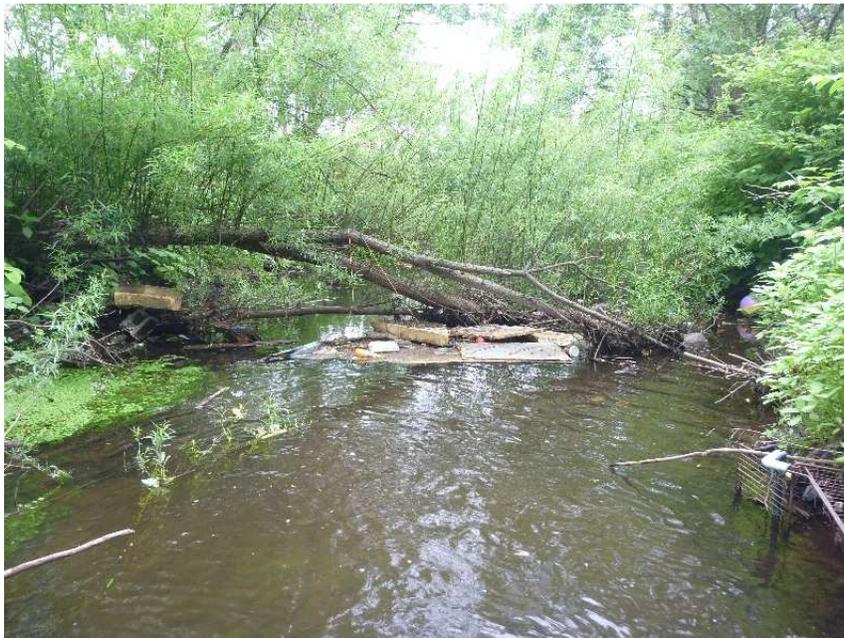
Of comparable, if not greater, value are the substantial scour pool and overhead cover features for adult and larger parr provided by large fallen trees (e.g. Fig. 10). Again, with improvements to spawning success, the retention of these features will provide good opportunities for self-sustaining wild trout/sea trout populations. Retaining some complex and “unkempt” sections, away from extensive public access, gives vital refuge during crucial life cycle stages. Providing sustainable access to other (more appropriate) areas represents the perfect balance between providing for healthy wild fish populations and enabling the community to appreciate and value them.

**Figure 10: Fallen living willow generating excellent bed-scour pool habitat at NM85990 29363. The flow of water funnelled beneath the submerged wood goes some way to mitigating the heavy silt bed-load by "blowing out" localised clean gravel patches.**

Running working parties (with appropriate provision for public health and safety – see Recommendations) would be an ideal way to remove some of the litter (e.g. Figs. 10 and 11) from this section whilst educating participants on the value of the habitat features. Such working parties could also be an ideal vehicle for highlighting the pressures currently faced by the burn. As an example in this reach – the high loading of fine bed-sediment is particularly evident (Fig.12).

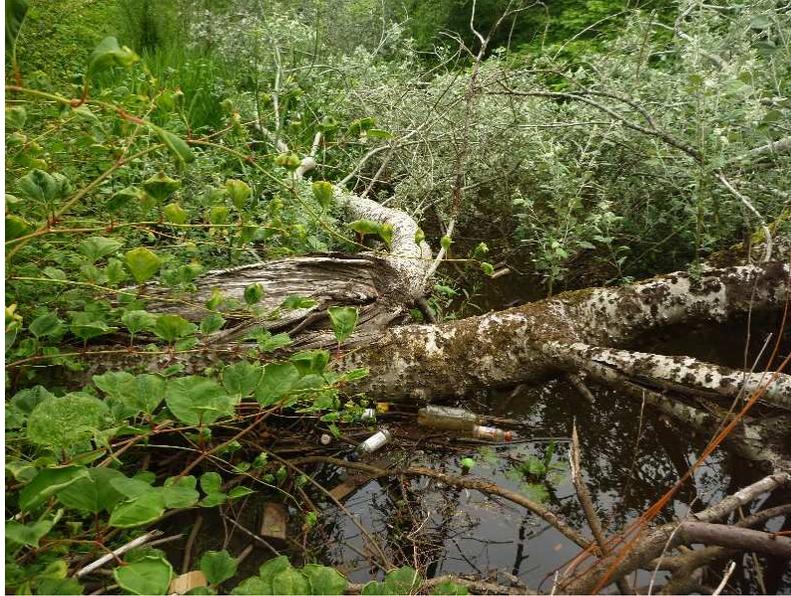
**Figure 11: Fallen woody debris has produced a deep (>1 m) scour pool below the water surface at NM85969 29394. It is also providing superb shelter and habitat for adult fish and a range of invertebrates**

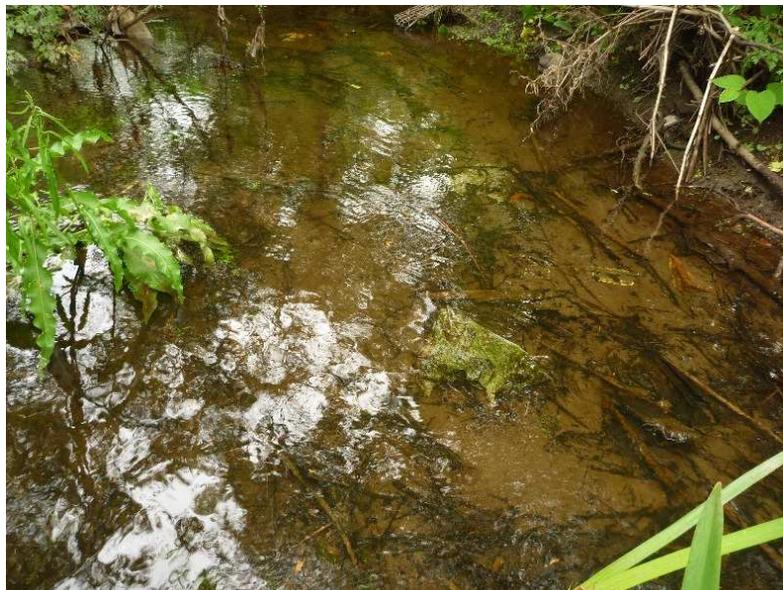
**Figure 12: Cobble and gravel stream bed covered by a layer of sandy/silty sediment many centimetres deep just downstream of NM85990 29363**

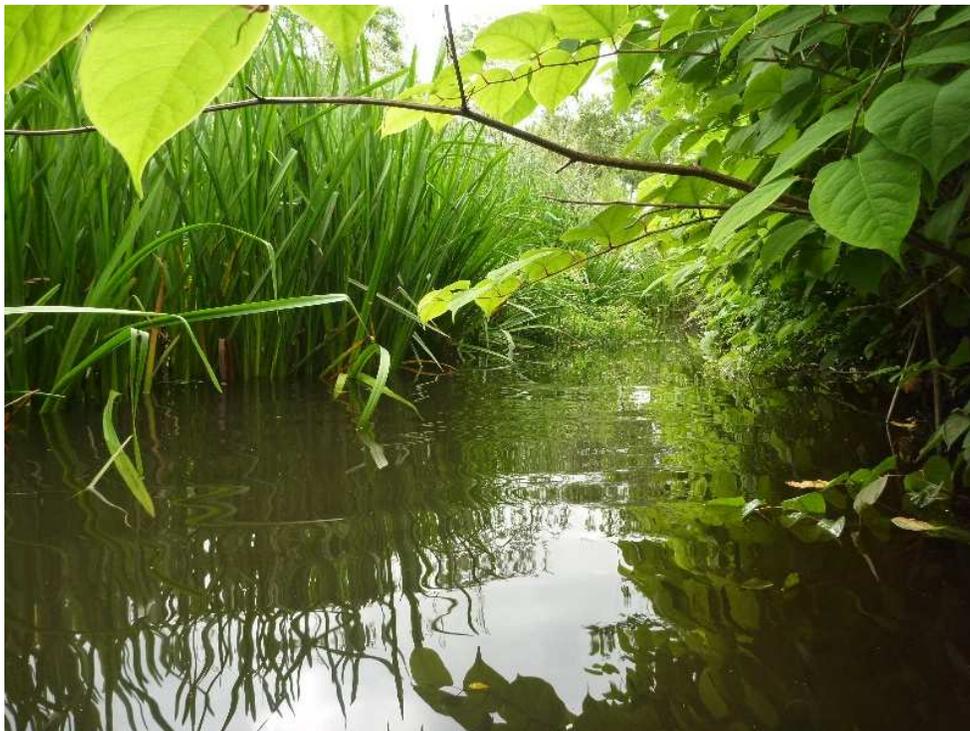
Another very evident combination of pressures can be seen in the section (approx. 80 m in length) alongside the supermarket car park at NM85952 29431. A very dense stand of Japanese knotweed flanks a heavily canalised section of river (Fig. 13). The uniform and canalised nature of the section is a result of engineered straightening of the channel as well as the impounding effect of a downstream structure. Native emergent plant species are still present in the channel itself (Fig. 13), but the banks and surrounding land within the river corridor are dominated by a huge stand of Japanese knotweed. As well as contributing to the bed-load of fine sediments, this domination will dramatically reduce the diversity of both native flora and the fauna that would otherwise be associated with a more varied plant assemblage.

**Figure 13: Japanese knotweed on the LHB with the native *Sparganium sp.* growing in the water along the RHB. Picture taken whilst facing upstream**

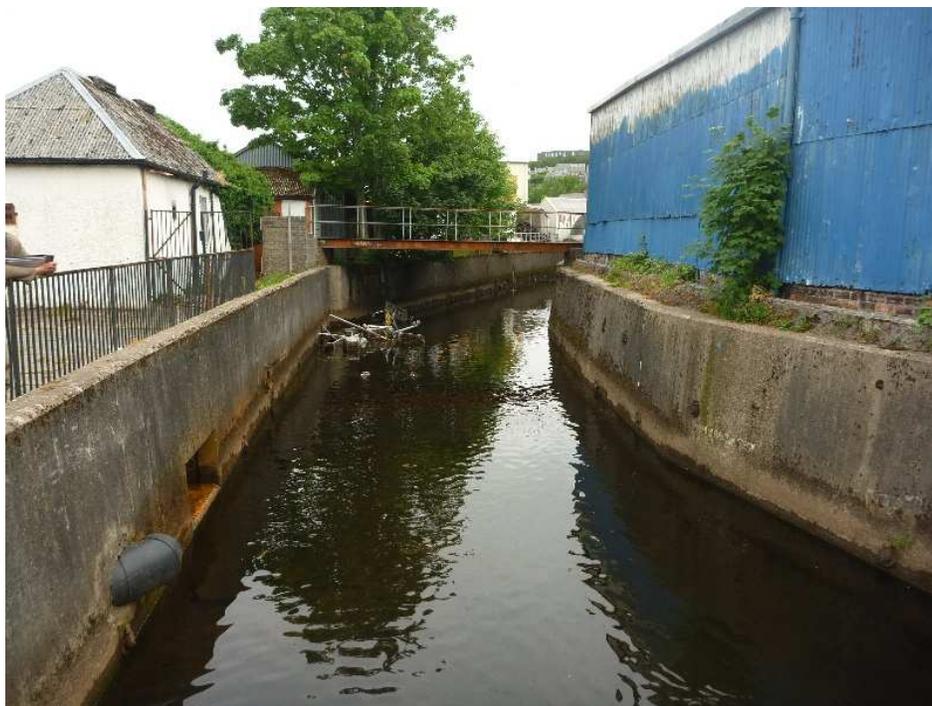
The lower limit of the knotweed-infested section is at the bridge over the burn at NM85972 29560. Below here the channel is entirely artificial – consisting of a concrete bed and retaining walls (Fig. 14). Despite the general lack of cover and diversity within the channel, several small trout and small sea trout (finnock) were visible in this reach. The depth and flow, coupled with debris on the stream bed being just sufficient to meet the needs of a few fish.

**Figure 14: Artificial concrete channel below NM85972 29560. Habitat works combined with a raised walkway and interpretive signage would provide a great boost to the wildlife and community value of the burn. Refurbishment of the existing footbridge and associate access could provide an excellent entry point to a walkway on the RHB. Photo taken whilst facing downstream.**

It would be possible to improve the survival potential for fish using this reach by providing securely anchored marginal brush and also to generate some sinuosity of flow by promoting localised marginal accumulations of bed material (see Recommendations). The use of expansion bolts drilled into the concrete would provide very stable anchor points for such works. The consideration here would be to ensure that the in-channel structures are sited so as to avoid any impedence of the numerous surface-water drain outfalls. These works, when coupled with trash removal initiatives, would improve both the habitat and also the visual amenity value of this section of river. Augmenting these improvements with interpretive signage and also improving public access – for example via installation of a raised walkway – would be excellent means of engaging the local community with the wildlife and aesthetic value of their burn (Fig. 15).

For overwide, straightened concrete sections that already hold some adult fish, it would be ideal to use a combination of suitable imported stone (potentially augmented with timber structures bolted to the concrete) to produce a staggered series of alternating side-berms. In this way a meandering planform of the river flow could be created within the river channel. It is important to make the bank-side edges of such berms the

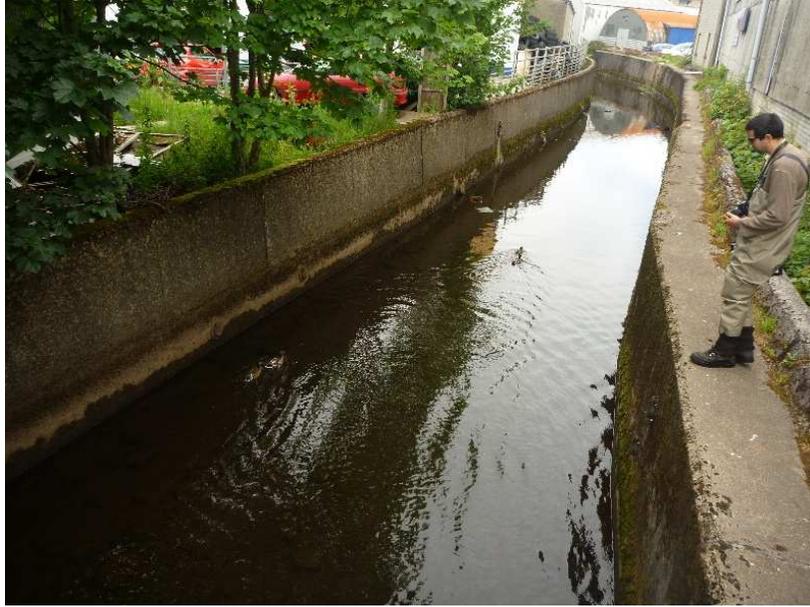
**Figure 15: Installing a hand rail (RHB) and interpretive signs would open up this hidden section of river to sustainable public access.**

With particular reference to points 8 and 9, consideration should be given to a walkway scheme along the heavily modified portion of the burn. The inclusion of signage that explains the rationale and function of specific interventions is a vital component of this engagement. A catalogue of before, during and after photographs is a highly valuable component of such signage. Schemes that have used a comparable approach to increasing the community value of their urban watercourses include the Five Weirs Walk in Sheffield (<http://www.fiveweirs.co.uk/> and Fig. 18, left) and the millennium walkway in New Mills (<http://www.newmillsheritage.com/walkway.htm> and Fig. 18, right).

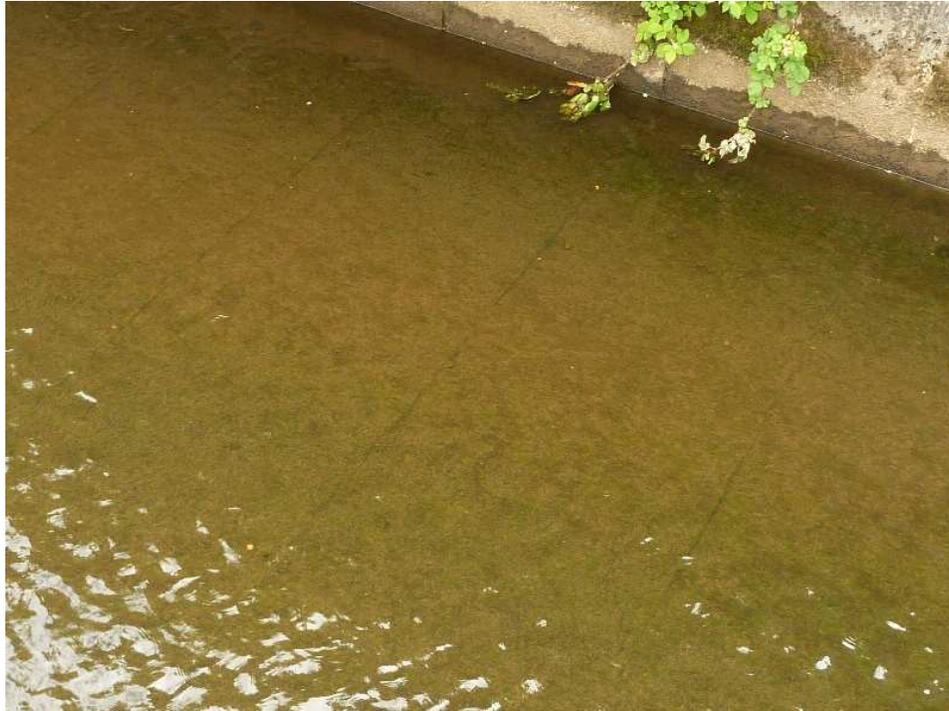
One of the most serious impacts on the burn is the shallow, sloping concreted section of stream bed at NM85975 29720. Not only is the flow extremely shallow across its full width, but there is virtually no natural substrate or debris retained within this section (Fig. 16). In addition, the height of the upstream limit of this concrete ramp is the cause of the impounding effect that homogenises the habitat in the upstream reach. This combination of factors makes the section a serious barrier for fish to ascend (and therefore make use of) to the spawning and juvenile habitat upstream. It is also of virtually zero value in terms of habitat that can be used by fish and the majority of stream invertebrates that are present upstream.

Consequently, one of the greatest opportunities to generate significant ecological status improvements to the Black Lynn Burn lies in tackling the barrier effect of this section. This will allow the upstream reaches to be used to their maximum potential. Moreover, the improvements to fish passage can also be designed so as to improve the intrinsic habitat value of the problem section itself.

**Figure 16: Uniformly very shallow - even after significant rainfall. Very poor habitat and a significant barrier to fish that could otherwise benefit from the good quality habitat upstream**

Creation of a low flow channel could be achieved - N.B. FOLLOWING THOROUGH SERVICES CHECK - by simply breaking up the concrete bed (e.g. via pneumatic drill) to the desired depth, width and planform. An example design given on the Forecaster website ([http://forecaster.deltares.nl/index.php?title=Main\\_Page](http://forecaster.deltares.nl/index.php?title=Main_Page)) is shown below (Fig. 23).

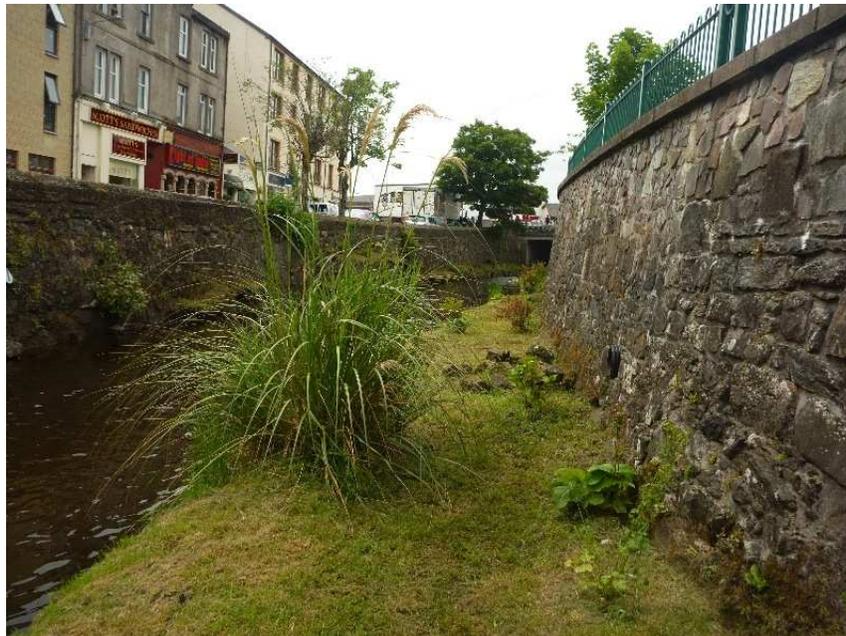
Below this concreted section, the river appears to return to a more natural gradient and recovers some nice natural stream-bed features. It has also benefitted from the addition of aesthetic features along the channel margins (Fig. 17).

**Figure 17: Marginal berms planted and mown for aesthetic improvements to the river corridor between NM85978 29797 and NM85956 29906**

A little less mowing, some appropriate wild vegetation planting and the addition of logs in a similar arrangement to those shown in Figure 22 would add huge habitat value to the works already completed in stream. In addition, the “toe” of the existing berms (the part where the riverbed joins the vertical face of the bank) could be stabilised against erosive flows using dense brush bundle installation (retained with fencing wire attached to steel pins or expansion bolts according to nature of the stream bed). Alternatively (spate flows allowing) a sloping gravel reject toe could be used to the same

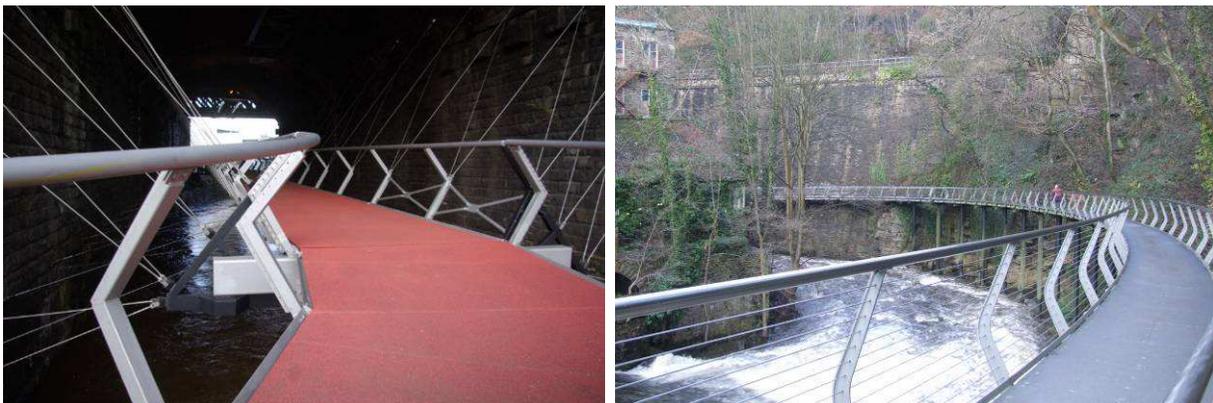
**Figure 18: Cobweb bridge above the waters of the River Don (left) to provide pedestrian crossing beneath a railway line – N.B. achieving a similar effect in Oban may be constrained by the likely heights of flood waters that may make such “under-bridge” walkways non-viable. Millennium walkway (right) providing pedestrian access to an otherwise totally isolated gorge in New Mills, Derbyshire.**

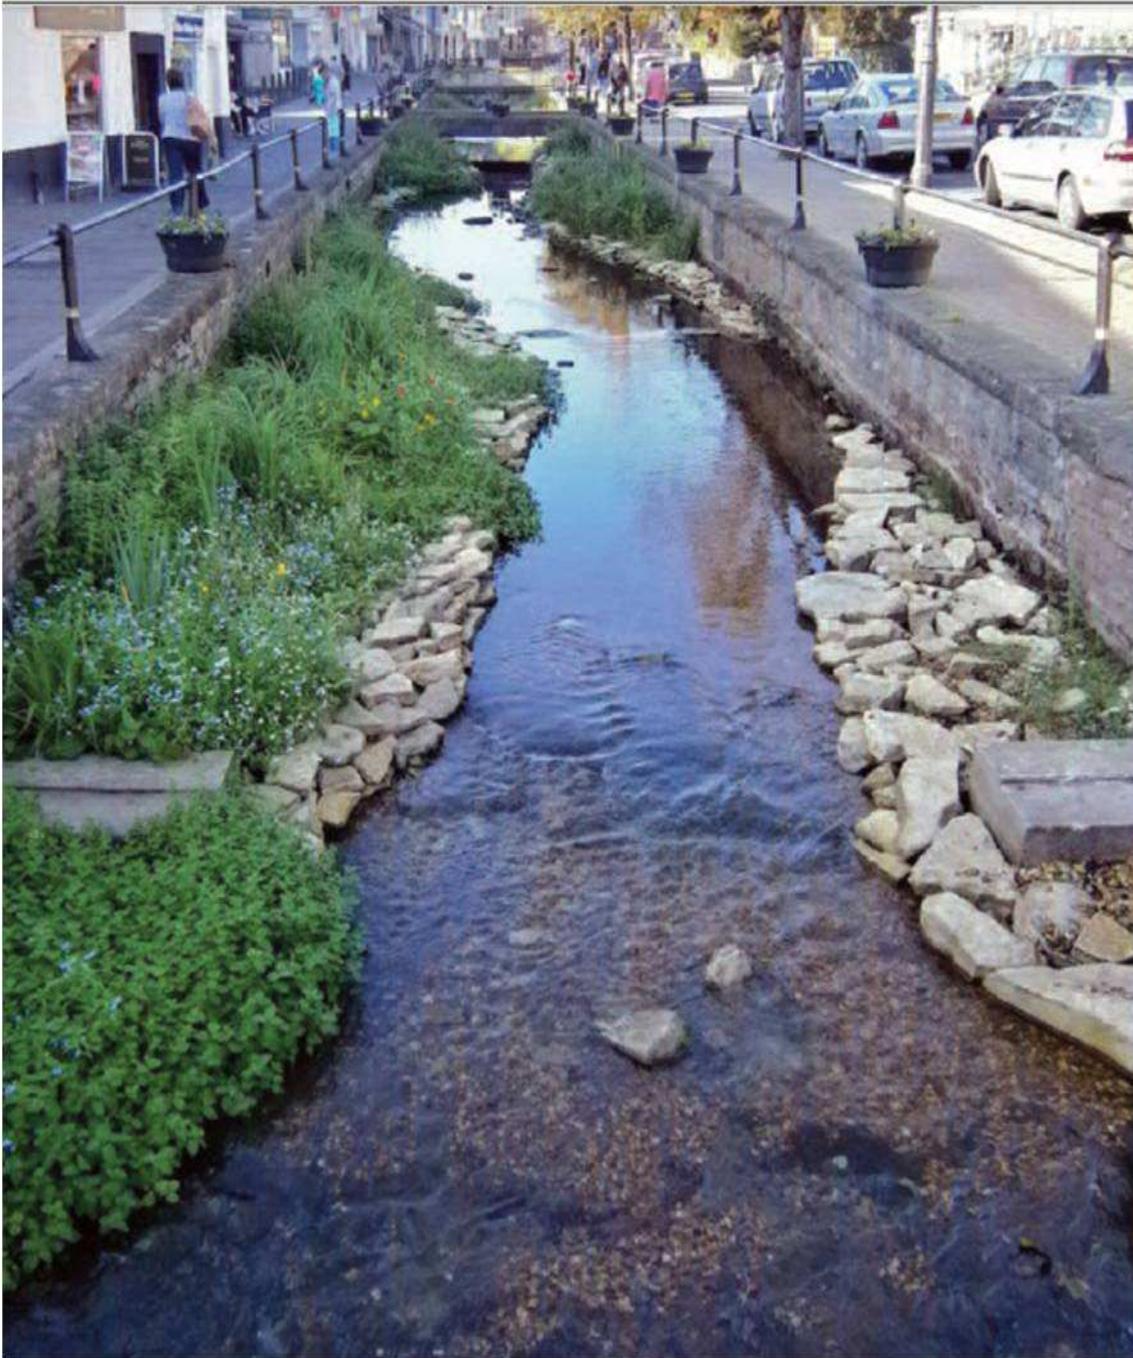
**Figure 20: Meandering planform, aquatic plant establishment and introduced gravels/cobble substrate within retaining walls of an engineered channel.**

It may also be possible and desirable to introduce spawning substrate (gravels in the 20 – 40-mm diameter size range). The additional use of large boulders and pinned logs, would be valuable in grading and retaining such spawning gravels during the natural processes of remobilisation and deposition during spate flows. The logs, in particular, could be fixed in an upstream pointing direction and used to delimit the downstream edges of constructed berms. This arrangement will tend to naturally accumulate any bed materials transported down the channel and re-introduce this natural process back into the artificial channel. This work should also be combined with installing suitably-sized “brashy” tree tops (Fig. 21) that would act to enhance the variation in flow and depth, but also provide vital cover for juvenile and adult fish from the threat of predation. An example schematic of a possible arrangement of these techniques is also given to illustrate a generic layout (Fig. 22).

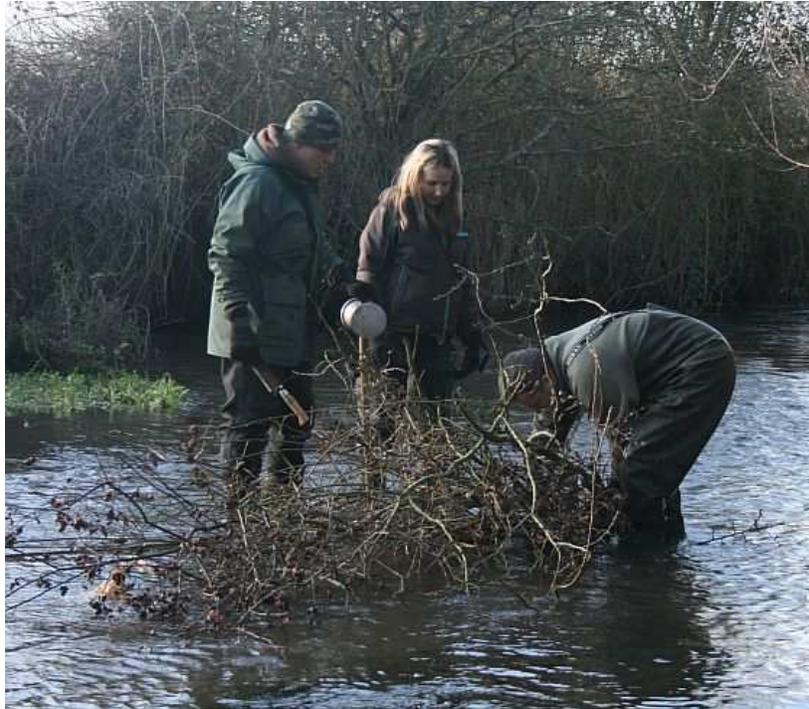
Figure 21: Tree top brashy cover example

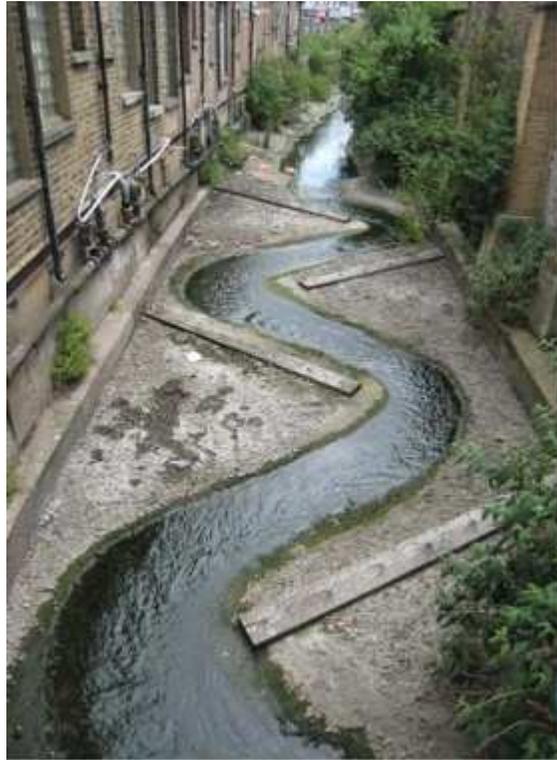
Figure 23: Sinuous low flow channel created in overwide concrete watercourse.

The additional inclusion of imported stone and planting schemes would augment this improvement – both aesthetically and in terms of the habitat value.
