Advisory Visit

River Bollin, Dunham Massey, Cheshire

15th April, 2009

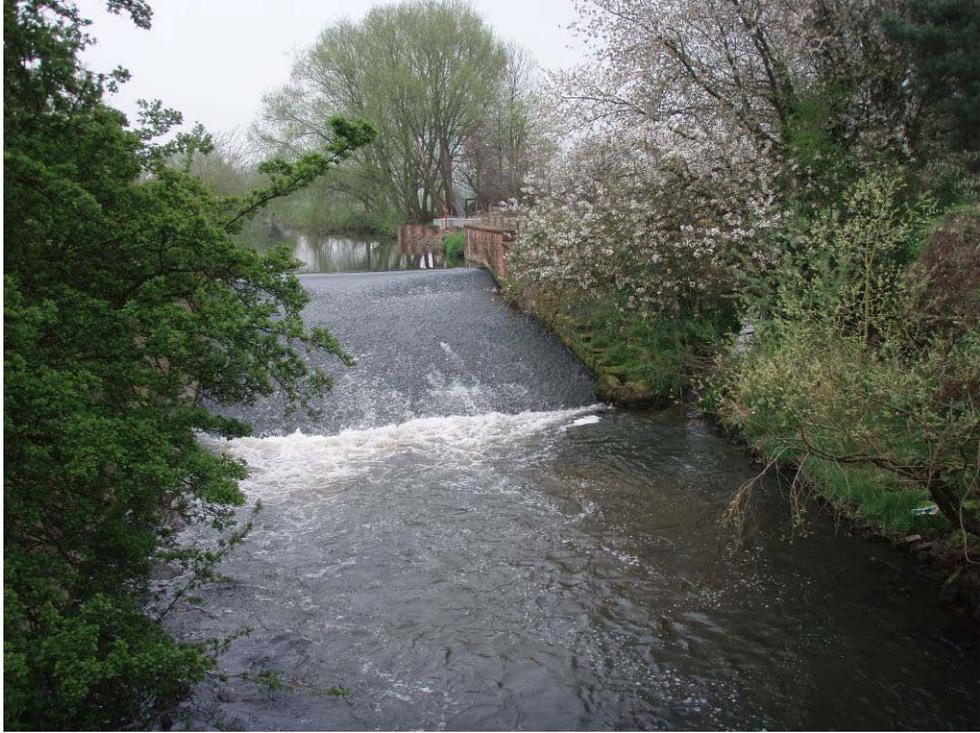
Photo 1 Weir at Bollington Mill

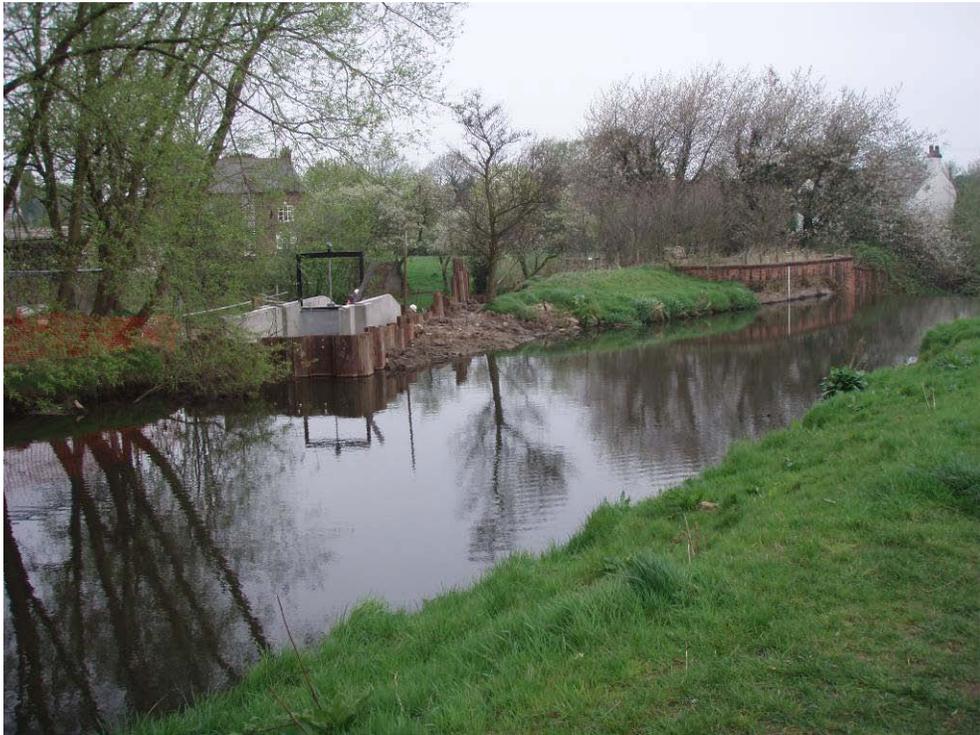
Photo 2 Fish pass construction (LHB) at Bollington Mill weir

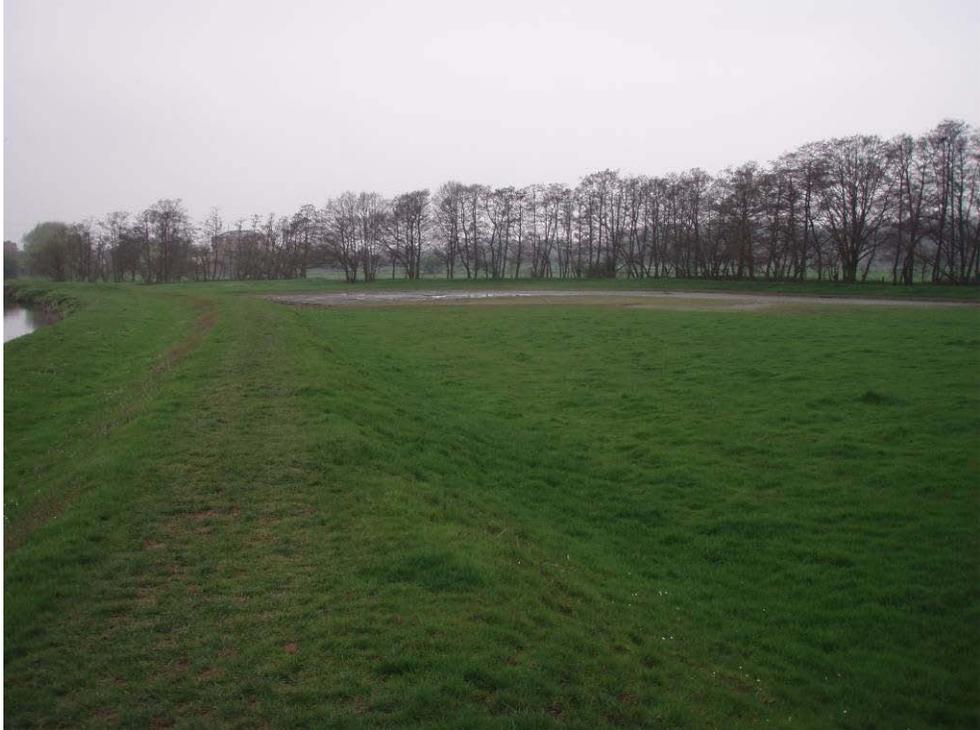
It appears that historically the river channel upstream of the mill was re-aligned to provide a head of water to power the mill, leaving the land adjacent to the channel below water level, and hence prone to standing water following floods (Photo 3). The river has been extensively dredged throughout the reach inspected and embankments are present on one or other of the banks (mostly the RHB) (Photo 4).

Photo 3 Low-lying land behind the embankment is prone to standing water

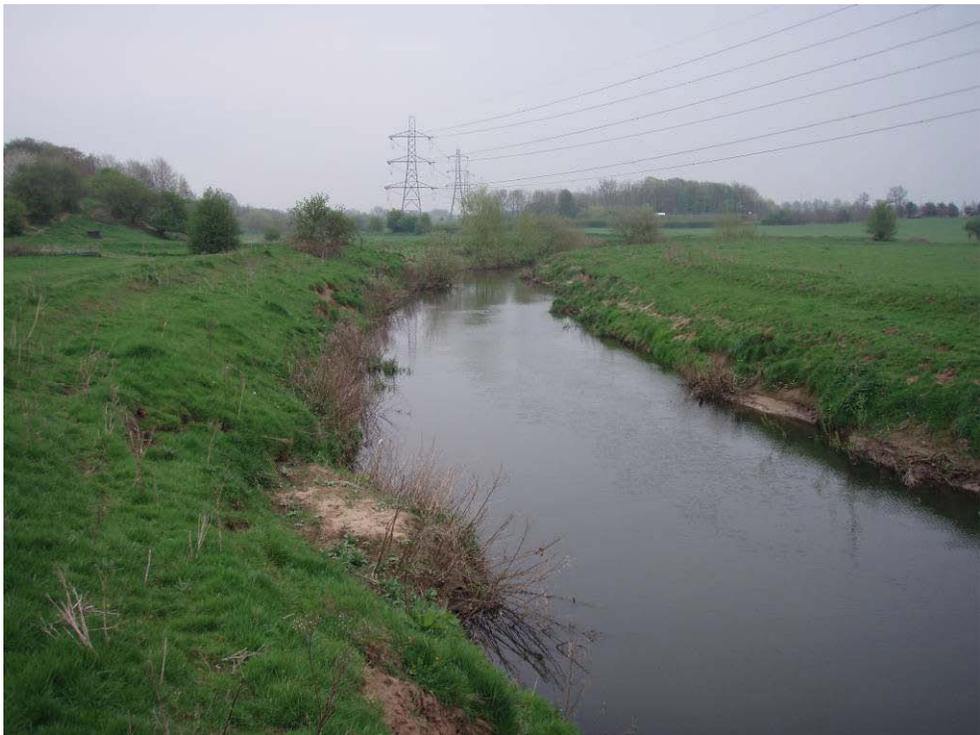
Photo 4 The river has been historically dredged and has steep banks topped with embankments

- Consider re-profiling some sections of the river bank (Photo 11). At present the channel is trapezoidal in cross-section with high banks, topped with embankments on one side of the other. Re-profiling the banks to a shallower gradient with a low berm alongside the river would improve the habitat value, and increase channel capacity; this may lead to a reduced incidence of flooding of adjacent fields and better drainage following flood events (because of the removal of the embankment). The re-profiling should ideally be targeted on the inside of meanders (Figure 1). This type of work would require some detailed planning (including a levels survey), and consideration of where the spoil could be disposed of (off the floodplain).

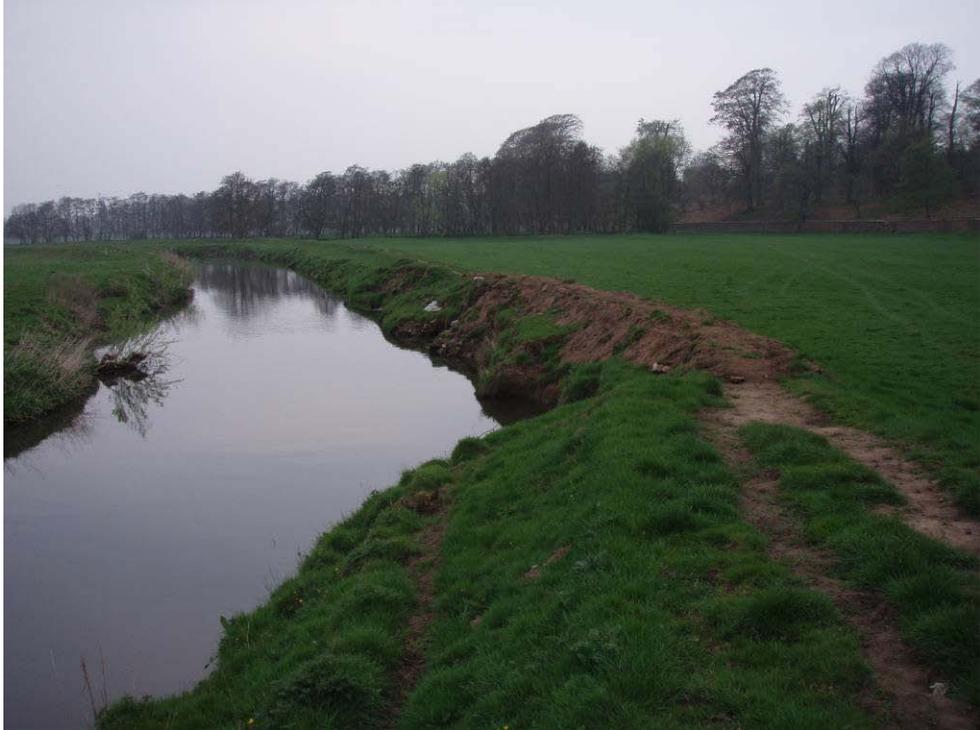
Adjacent land is used for grazing dairy cattle by the tenant farmer, and he actively maintains the embankments to reduce the incidence of flooding (Photo 5). The embankments may however contribute to the retention of floodwater on the land once they have been overtopped. It would be valuable to assess the relative merits of the embankments with respect to flood prevention and water retention on the land.

Photo 5 Recent repairs to the embankment

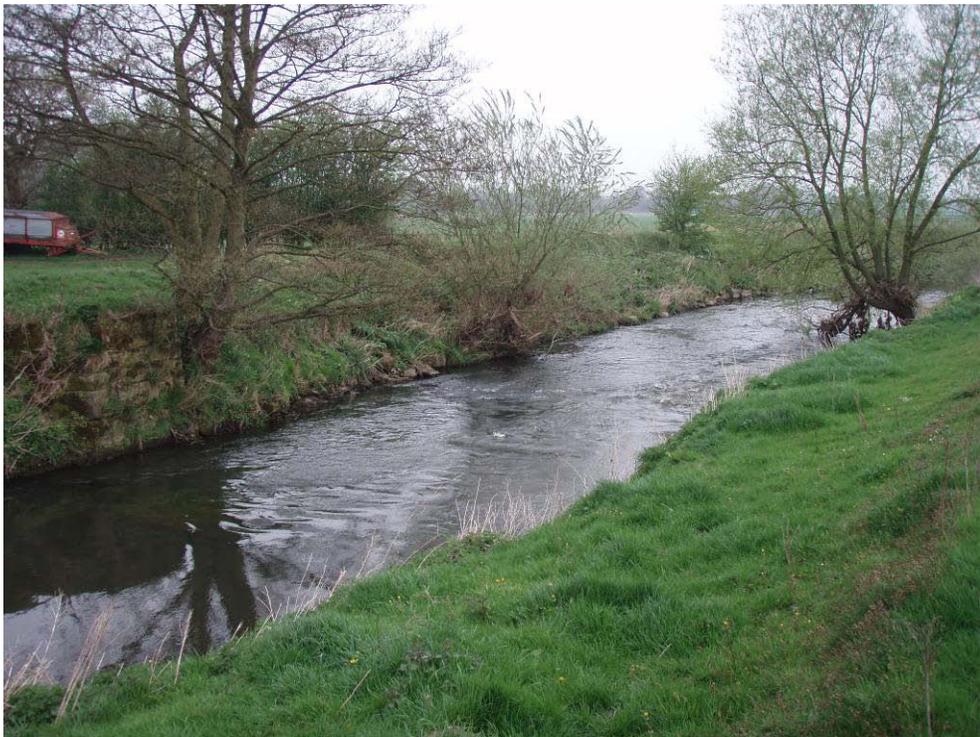
There appears to be little variation in the width and depth of the river channel throughout this reach, with it generally being a deep, slow-flowing glide. The only exceptions to this were faster, broken water at the site of a former bridge (near the upstream end of the reach, Photo 6); below the weir at Bollington Mill; and underneath the canal aqueduct. All these areas appear to be downstream of existing or former impoundments within the channel.

Photo 6 Faster water at the site of a former bridge(?)

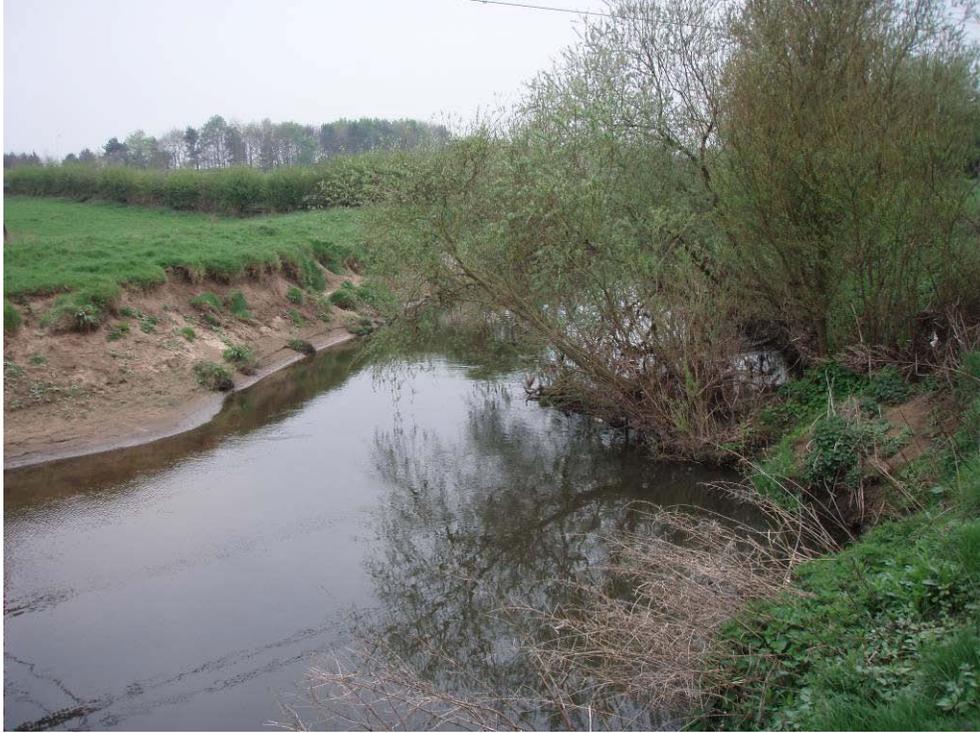
There are very few trees alongside the river along this reach, with the exception of the odd small willow. There is therefore a lack of cover both over and within the channel (from fallen trees / boughs), making it less favourable habitat for adult trout and coarse fish (Photo 7).

Photo 7 Some valuable low cover over and in the water from trees – a rare sight on most of this reach.

- Plant some native trees on the river banks. These would require protection from grazing livestock by fencing, and this would incur a management requirement to control invasive plant species.
- Take steps to control the invasive plant species. Himalayan balsam control can be achieved by physical or chemical means:

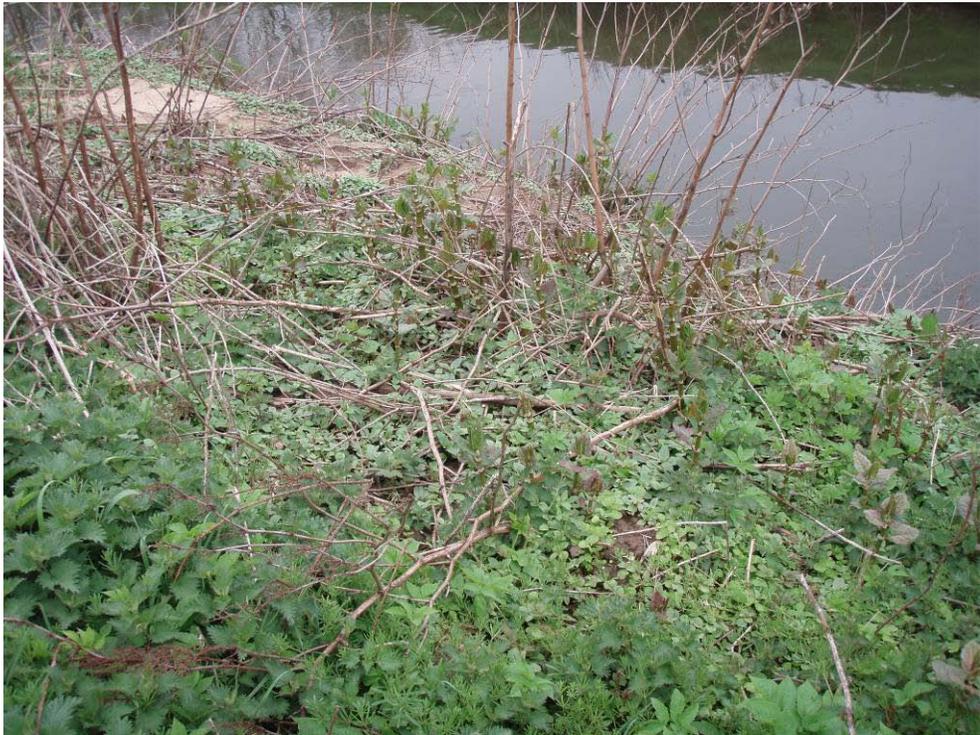
The sandy soils in this area are an ideal medium for the growth of non-native invasive plant species, and there was plenty of evidence of Himalayan balsam, Japanese knotweed and giant hogweed in various locations (Photo 8). Balsam in particular can contribute to bank erosion by shading out native species, but dying back in winter to leave bare banks. National Trust are aware of the issues surrounding these species and are taking steps to control giant hogweed, and encouraging tenants to tackle Japanese knotweed.

Photo 8 Japanese knotweed and Himalayan balsam sprouting on the banks

The main method of control, and usually the most appropriate, is pulling or cutting plants before they flower and set seed.

Himalayan balsam can be controlled with a weedkiller based on glyphosate, such as Roundup. Glyphosate is a non-selective, systemic weedkiller that is applied to the foliage. It is inactivated on contact with the soil, so there is no risk of damage to the roots of nearby plants, but care must be taken that the spray doesn't drift onto their foliage. Glyphosate is most effective when weed growth is vigorous. This usually occurs at flowering stage but before die-back begins; with most weeds, this is not earlier than mid-summer.

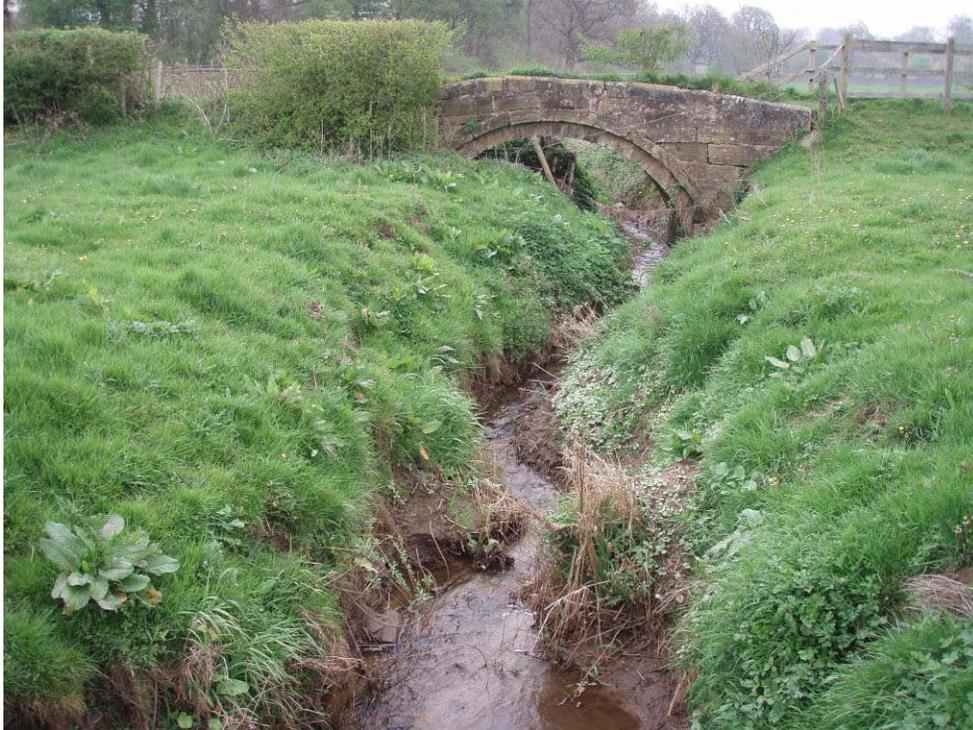
A small channel enters the river on the RHB upstream of the aqueduct which carries water from the historic working mill at Dunham Massey Hall (Photo 9). The channel is regularly maintained by dredging by the tenant farmer to ensure drainage of floodwater from the low lying land adjacent to Bollington Mill. During this maintenance the farmer has reported catching small trout in the digger bucket. If this is the case, then it may be possible that this very small channel is being used for spawning by trout from the main river.

Photo 9 The small side stream draining the Hall grounds

- Investigate whether small trout are present in the small channel draining the Dunham Massey Hall area. Improve the spawning habitat within this channel by introducing gravel spawning areas (Photo 11). This would involve raising the bed level of the channel, and would have to be agreed with the tenant farmer, and his subsequent maintenance regime modified to prevent removal of the gravel.
- Introduce gravel to the main river channel (Photo 12) at a gradient break point, such as the site of the old bridge mentioned in section 3.0 above. This could be done in conjunction with some bank re-profiling to create marginal habitat (low berms), and maintain or improve channel capacity, as described above.

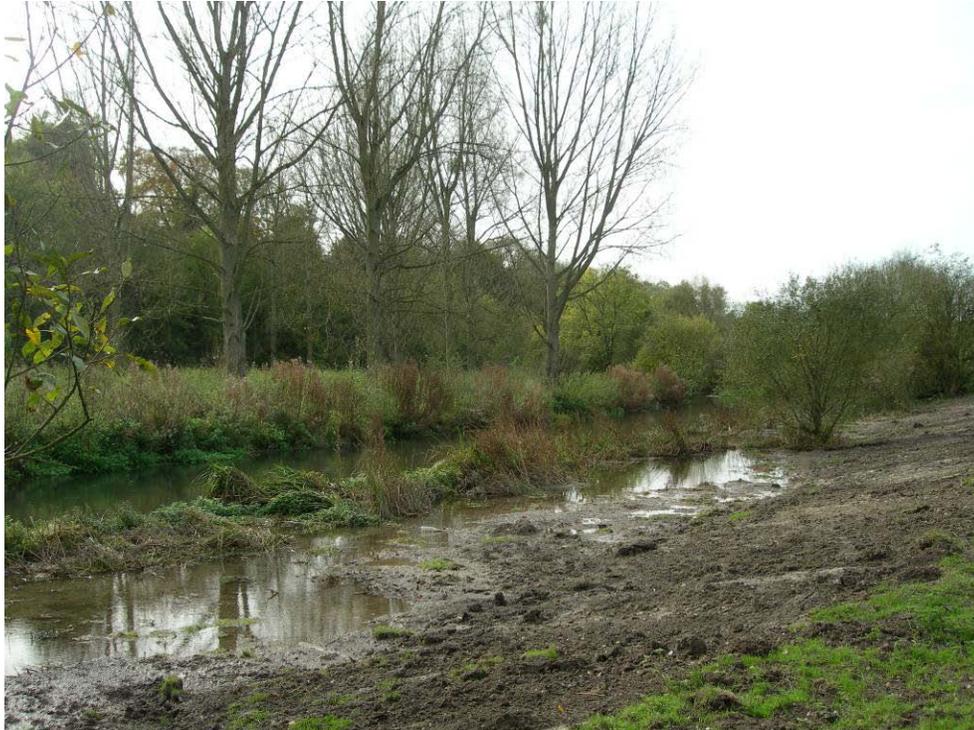
Photo 10 Bank re-profiling (recently completed), R. Avon, Amesbury (Photo: Jenny Wheeldon)

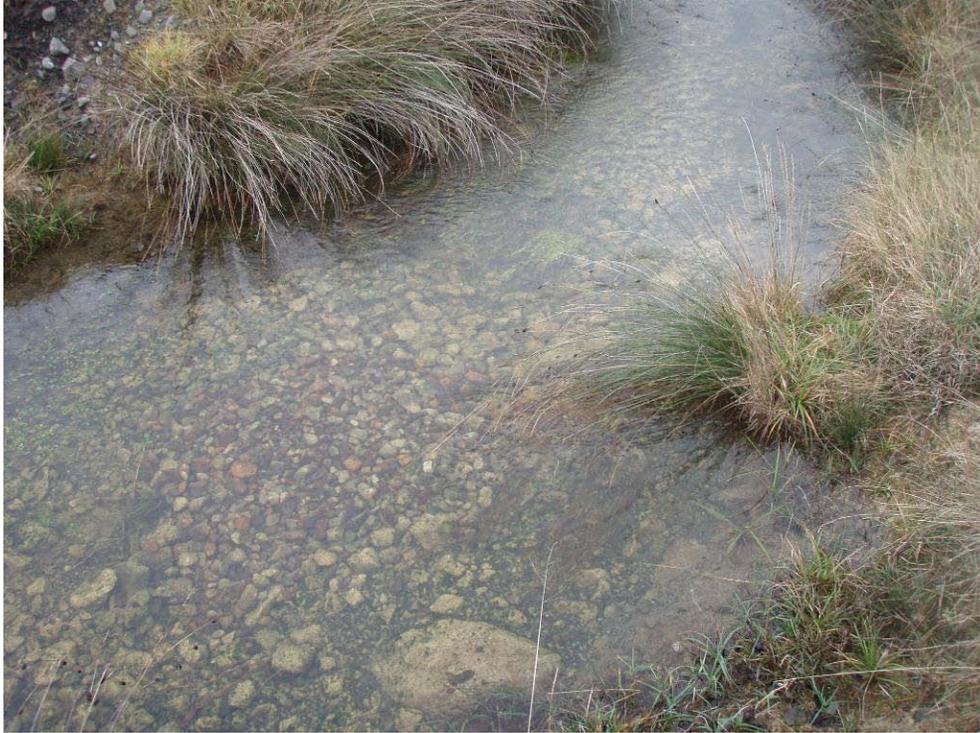
Photo 11 Trout redds on introduced gravel on a small Irish stream

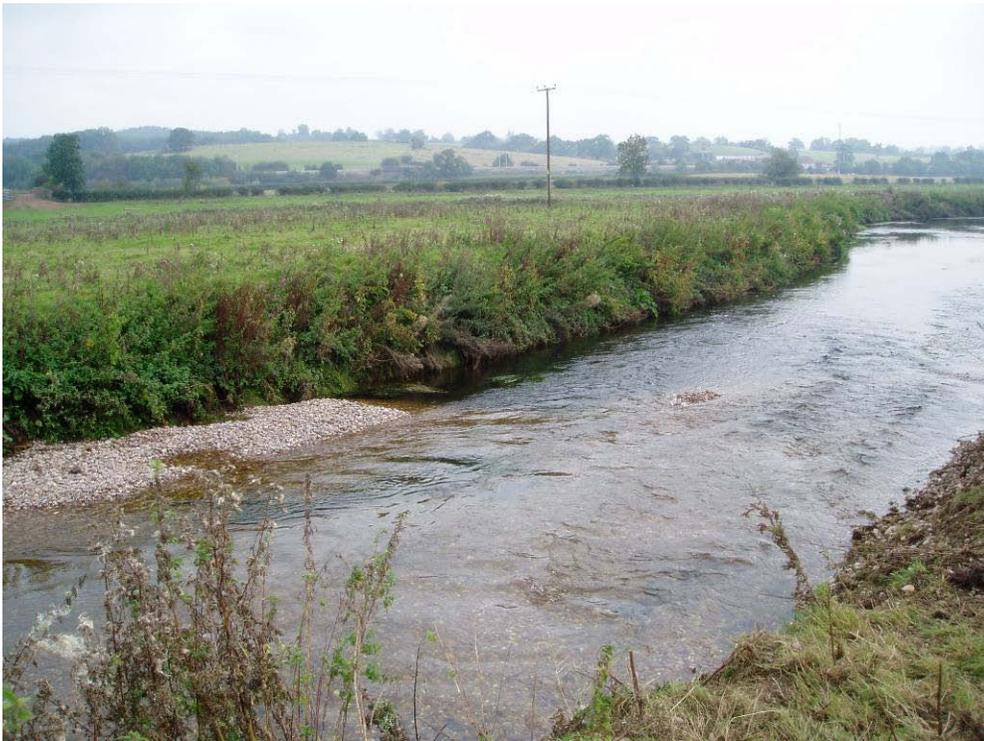
Photo 12 Example of introduced gravel on the upper Trent
