Box Brook – Bathampton AA

An advisory visit carried out by the Wild Trout Trust – June 2008

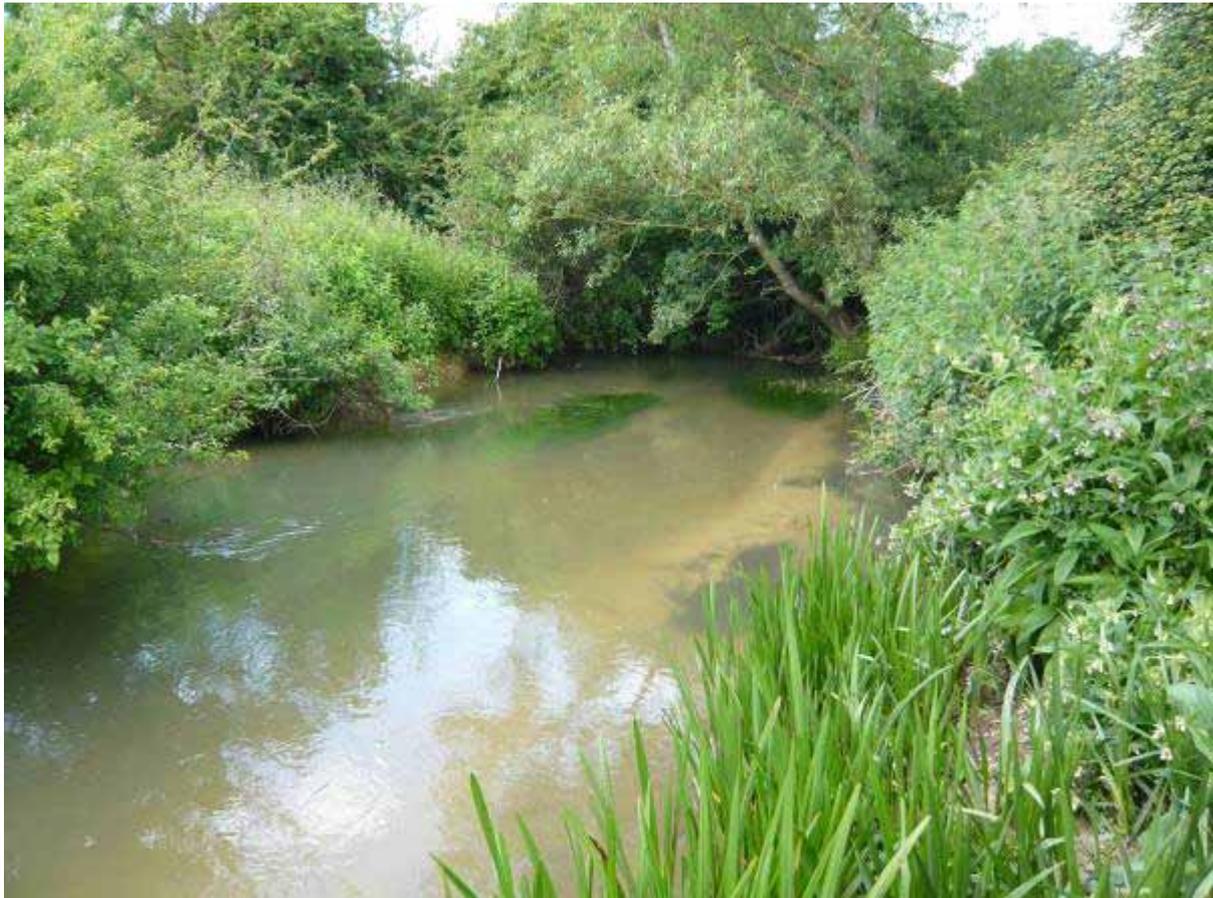
A typical section of the Box brook with good marginal cover and valuable beds of water crowfoot. Note the impenetrable jungle!

Shading on some sections of the Box brook was considered to be excessive. Some simple "sky lighting" to promote a dappled light and shade should be undertaken. In addition some short sections of the Brook were an impenetrable jungle which I suggest are best left alone.

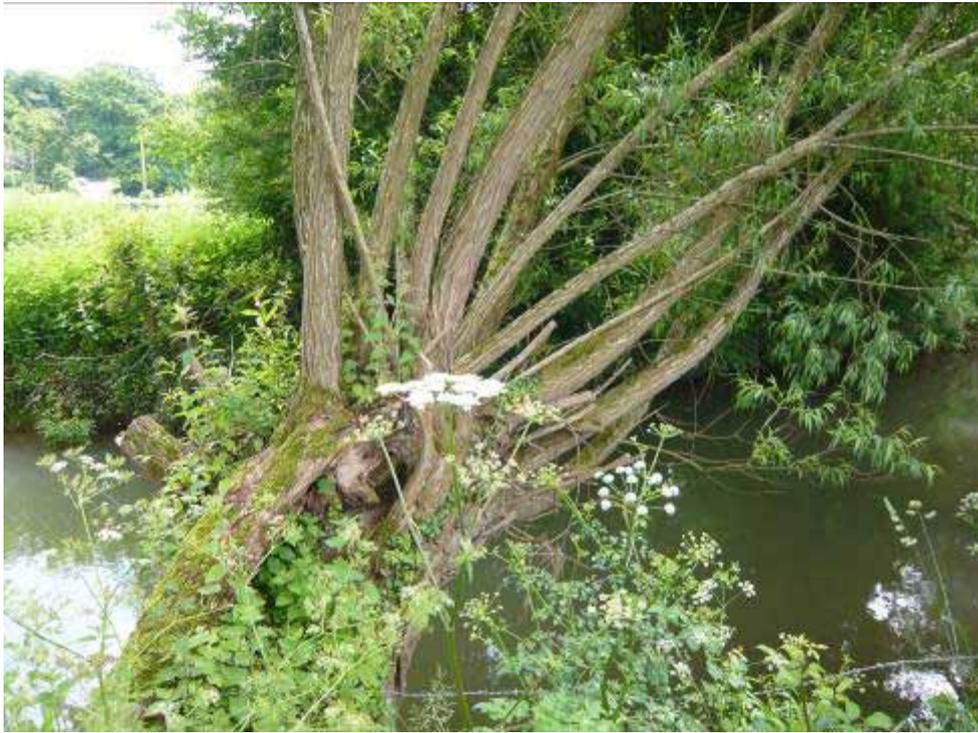
An old willow pollard in need of further work

Riparian tree works should only be undertaken outside the bird nesting season. Mature trees, or those with significant ivy growth, may well support bats which are protected by law. It is recommended that you consult with the local authority before contemplating any significant tree works. Coppicing or pollarding, although often preserving and lengthening the life of trees, can sometimes be controversial in the eyes of the general public.

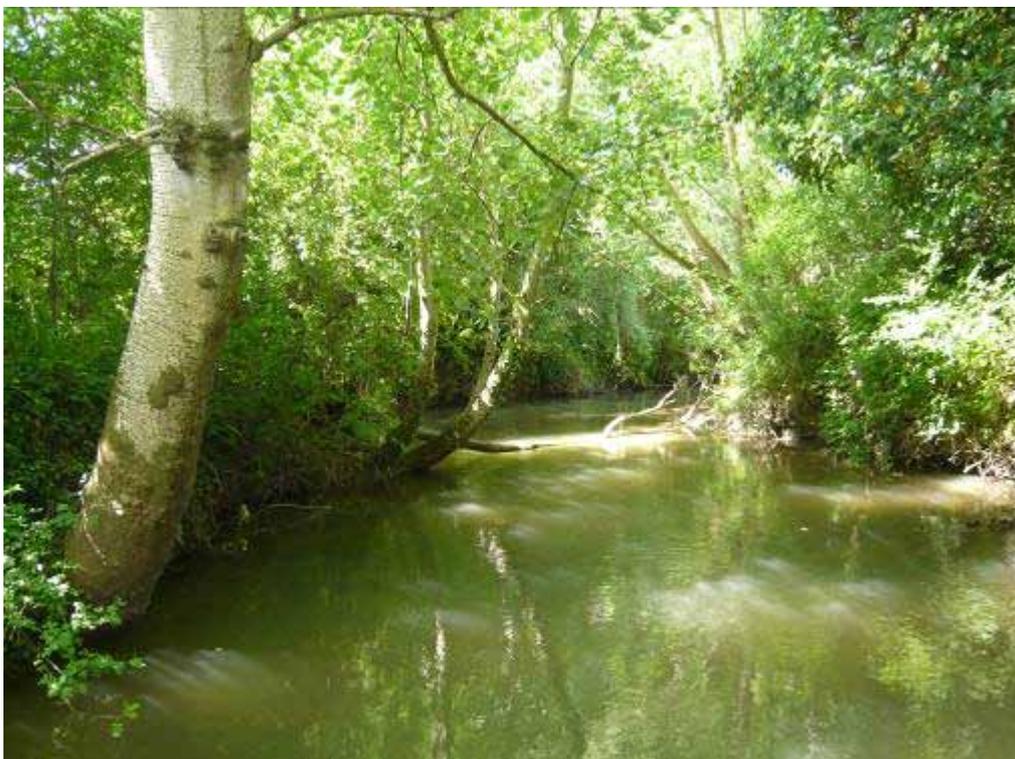
Selective thinning of leggy birch and sycamore would promote increased productivity

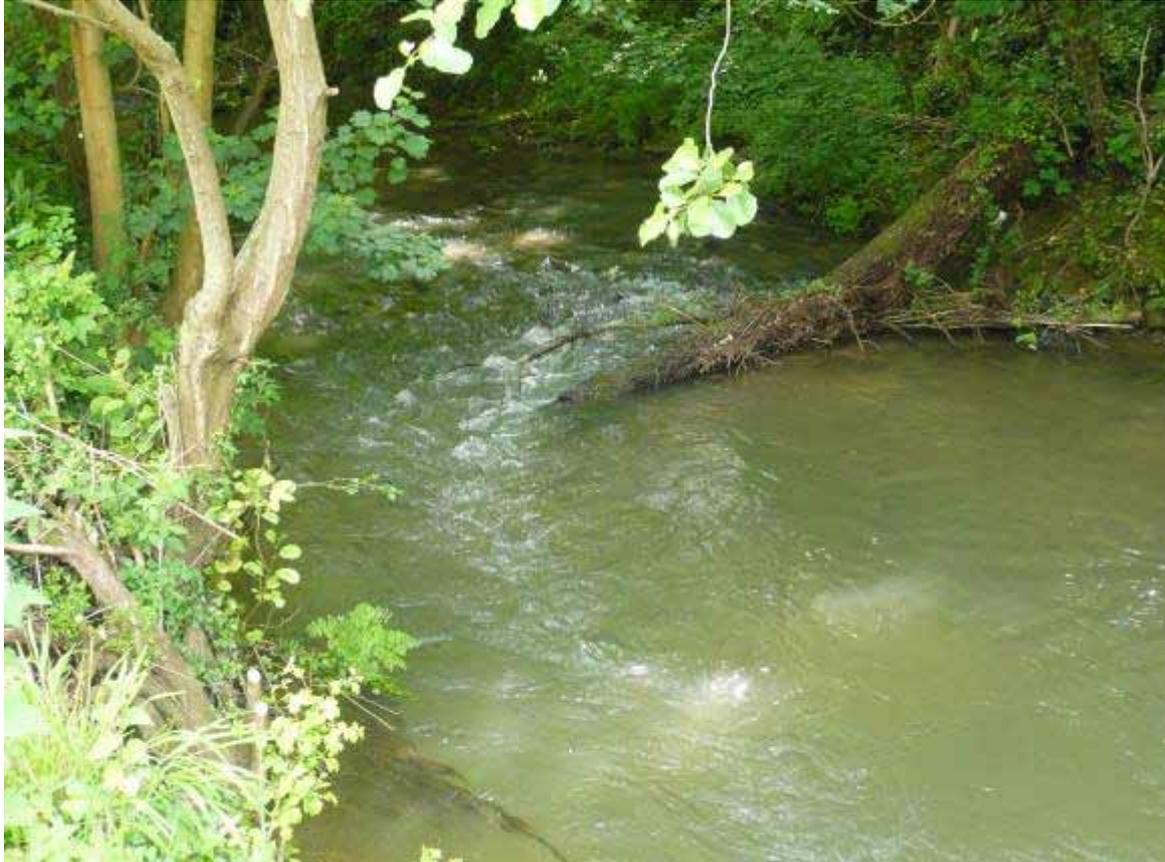
A naturally “hinged” tree has created a superb lie for trout.

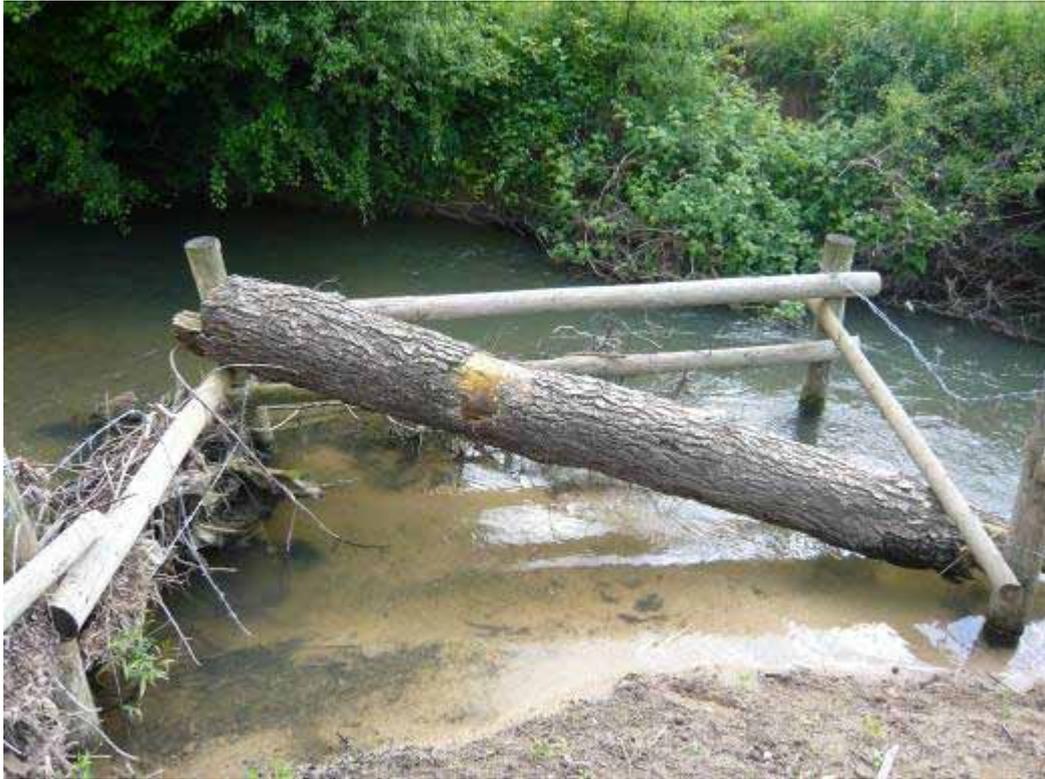
The Box brook has the power to mobilise large trees so it is vital to secure LWD when using it to promote trout habitat

It is important to ensure that any LWD is stable as it was quite evident that the the stream is comparatively flashy in nature. LWD should be wedged into the bank or wired to live trunks to avoid them becoming a flood risk at vulnerable locations such as culverts or bridges further downstream. Pinning the material to the river bed with either chestnut stakes or steel re-inforcing bar is often an effective method.

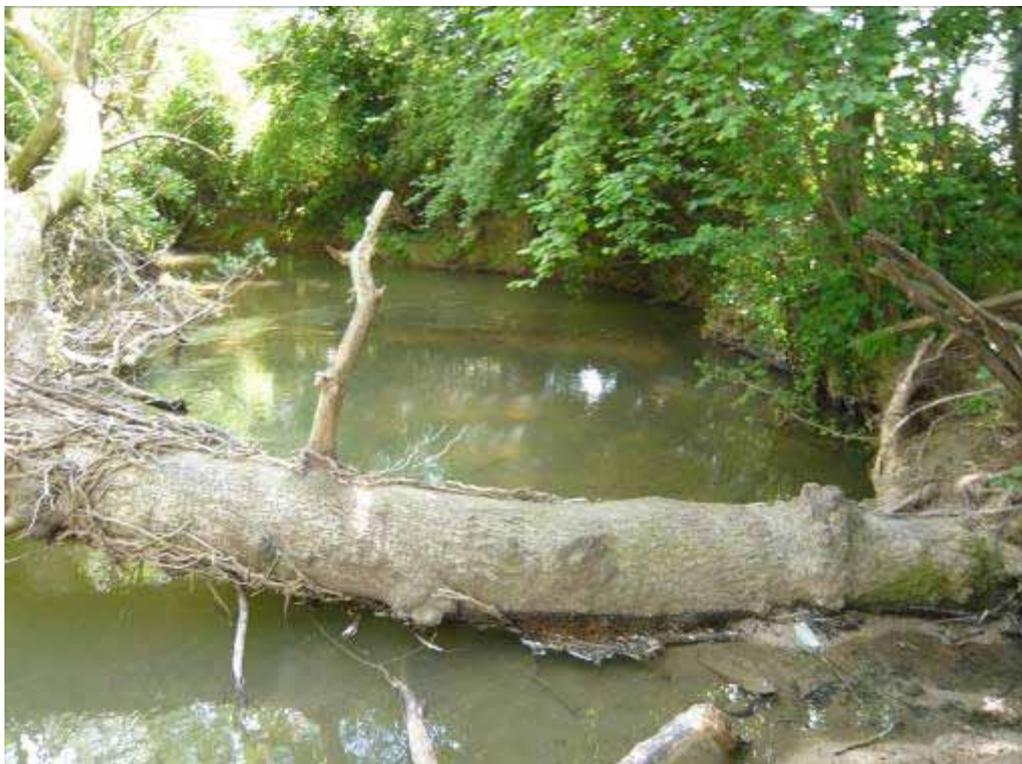
A fallen "rooted" tree promoting pool scour and a gravel riffle – good trout habitat

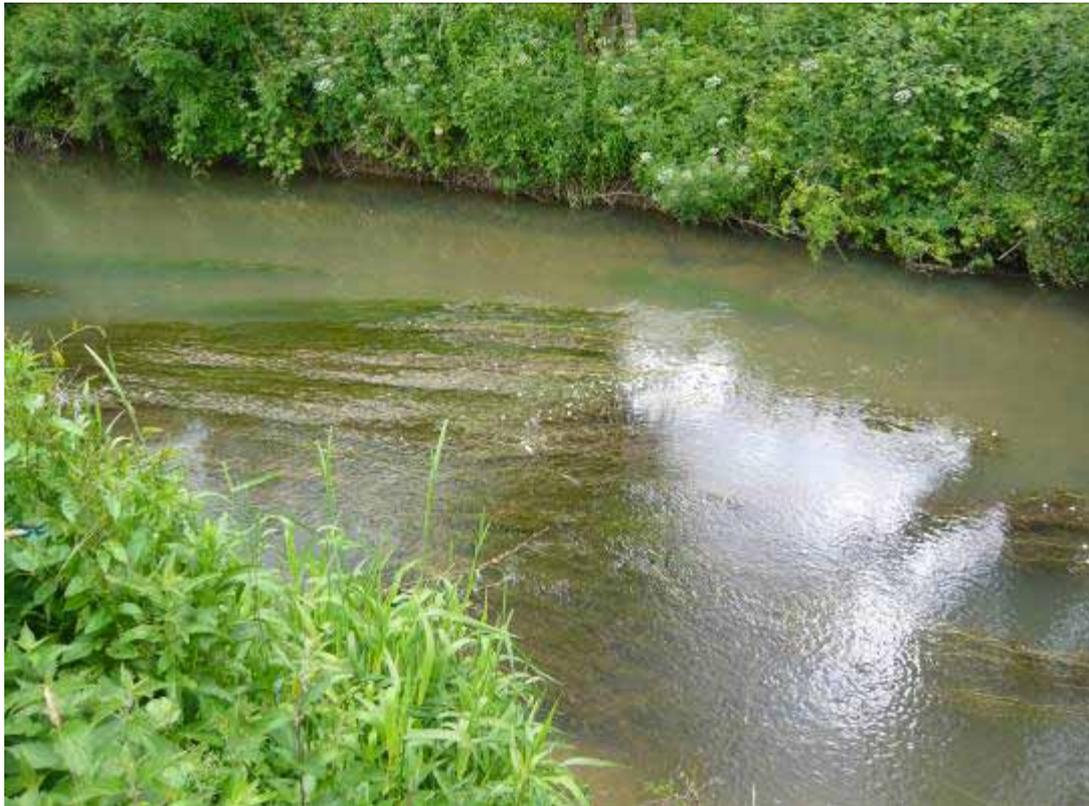
Water crowfoot provides habitat for invertebrates and trout

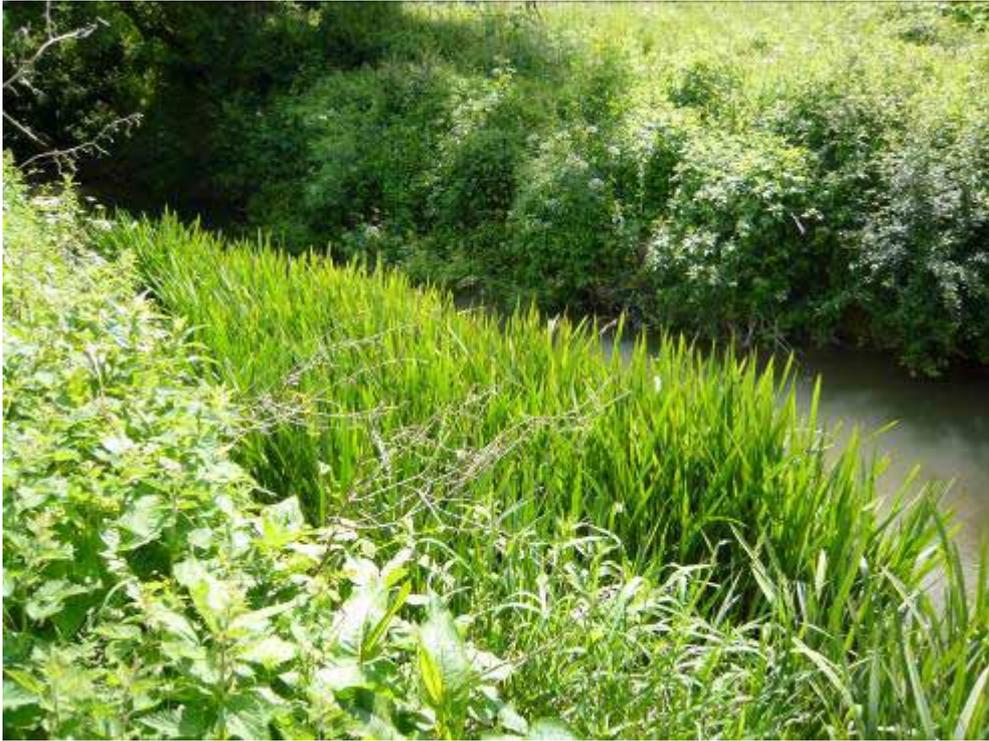
A thick bed of burr reed *Sparganium* sp pinches the channel

Beds of aquatic emergent vegetation were well established in several areas. On one section near the bottom of the fishery, burr reed had established out from a soft margin, pinching the channel and creating an excellent run which was enhanced by a lovely low scrubby fringe on the opposite bank. Fishing access to the fishery is inevitably via wading so it is recommended that habitats like this are left to find their own equilibrium. Mid channel growth of pipe reed (common club rush) may, however, require some light maintenance. A mid channel island can promote excellent habitats although occasionally the plant will spread right across the channel and rather than promoting lateral scour either side of the bed may clog the channel, raising upstream water levels and potentially slowing velocities.

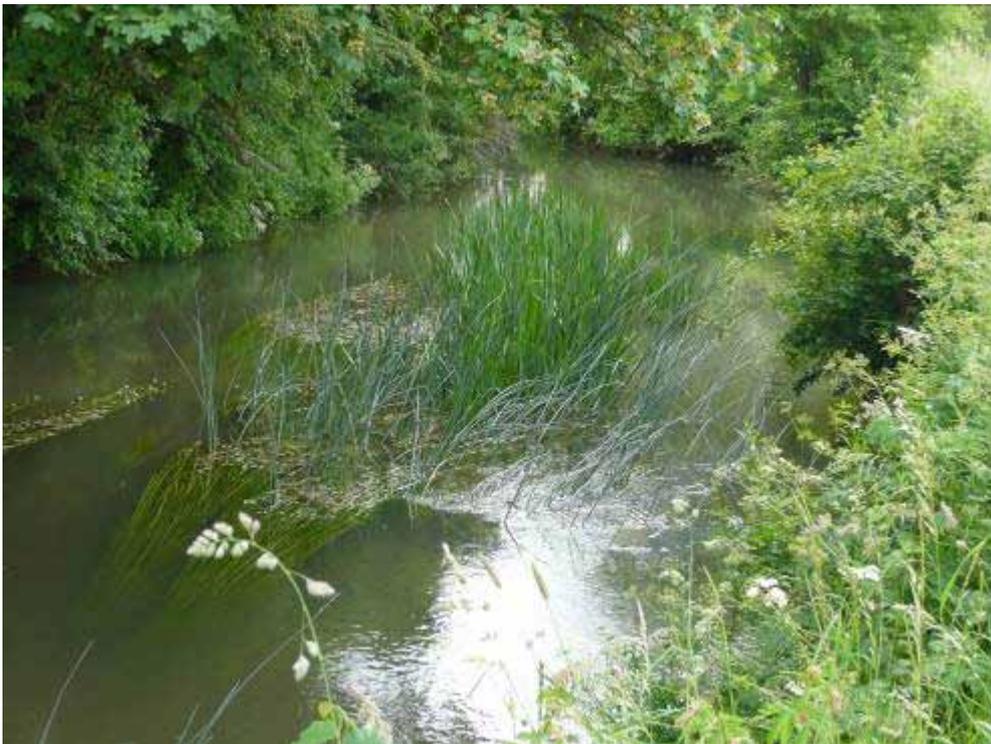
Pipe reed *Schoenoplectus* sp forming a central island

Pipe reed can be grubbed out but it is extremely hard work. It can also be controlled with a contact herbicide although it is recommended that this work should only be undertaken by a qualified specialist. **Environment Agency consents are required for all applications of herbicide within 8 metres of a water course.**

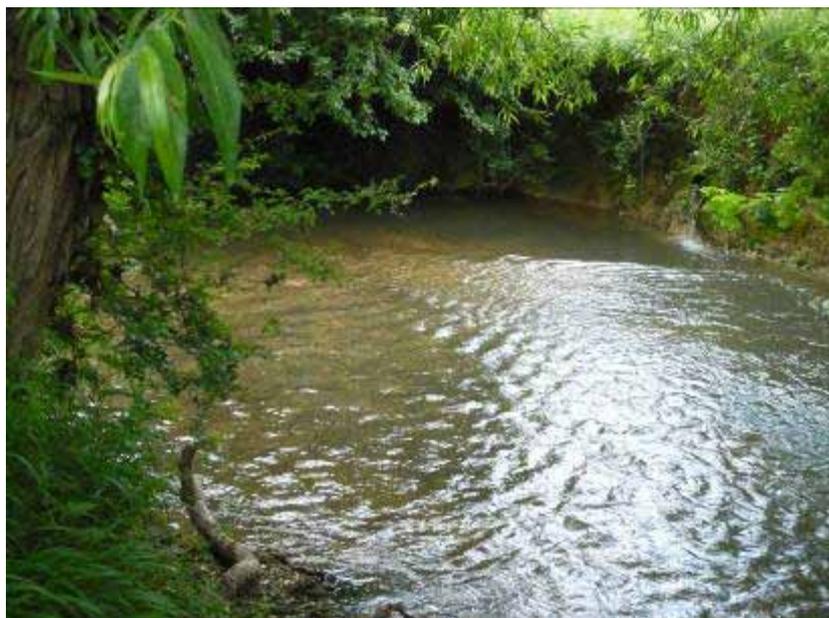
Excellent spawning habitat on the upper half of the fishery just below the gauging weir

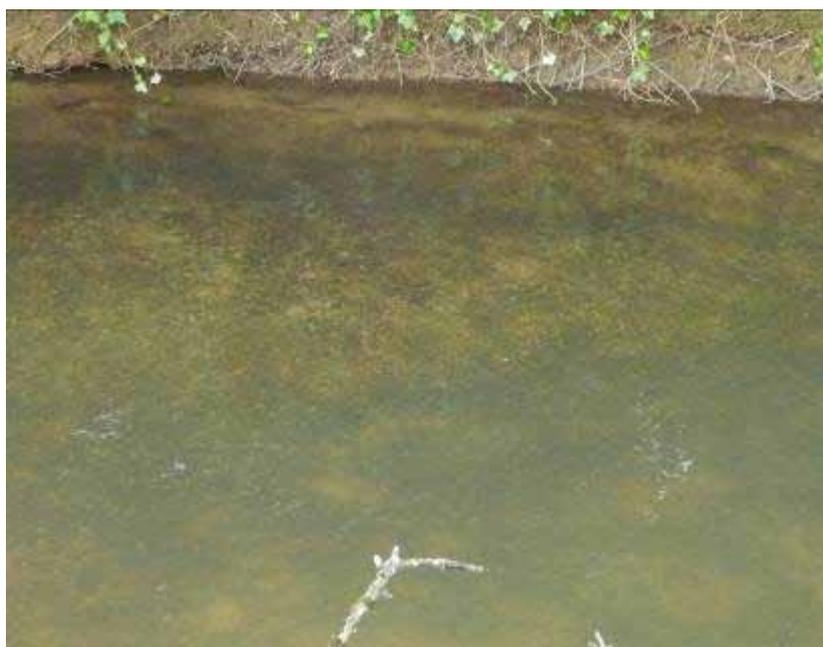
A very thin layer of gravel can potentially be augmented with imported material

One possible course of action that can potentially boost trout production on rivers with limited spawning habitat is to import new spawning substrate. Care must be taken to identify suitable sites as raising river bed levels can adversely effect upstream habitats by backing up the levels and encouraging deposition.

Downstream of the existing weir and on a straight run of channel would be the best site to choose. The spawning riffle should be at least 20m long and have a depth of gravel of at least 30cm with the aim of ending up with a normal summer water depth of approximately 25cm.

The principle is to line the bed initially with large flint rejects and stone and then top dress with mixed angular river gravels of 15 to 50 mm. Ideally the riffle should have a gentle downstream slope but having a slight ramp up to approximately the front third of the riffle and then a gentle slope down over the remainder also works well. The riffle should be very slightly dished in the centre, however, in reality the gravels are often relocated following the first spate. This should not be a concern on a straight run where generally the material will lock and settle into a natural looking riffle.

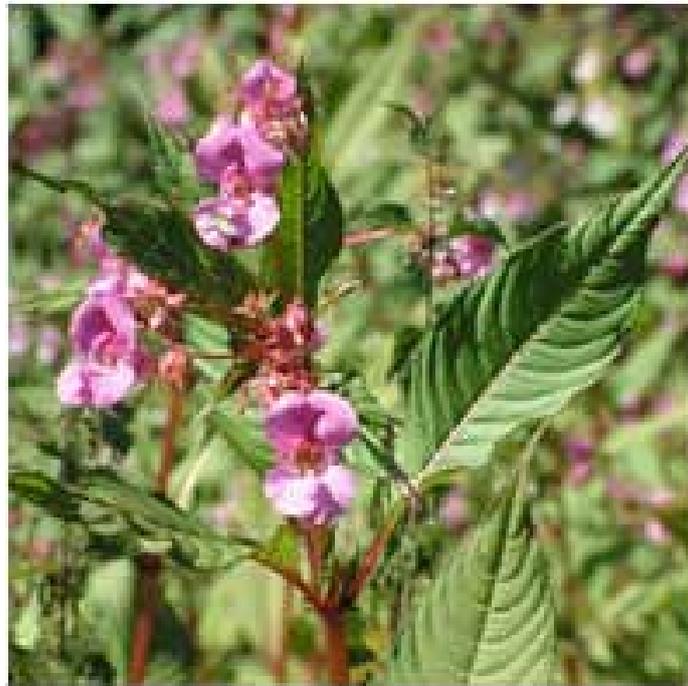
An area of potential concern relates to the presence of non native plants. Himalayan balsam (*Impatiens glandulifera*) was observed on the RB approximately 200m from the bottom boundary. It is a relative of the busy Lizzie and is known by a wide variety of common names, including Indian balsam, jumping jack and policeman's helmet. It is a tall, robust, annual producing clusters of purplish pink (or rarely white) helmet-shaped flowers. These are followed by seed pods that open explosively when ripe, shooting their seeds up to 7m (22ft) away. Each plant can produce up to 800 seeds. Himalayan balsam tolerates low light levels and, in turn, tends to shade out other vegetation, impoverishing habitats. In the autumn, the plants die back, leaving the banks bare of vegetation and vulnerable to erosion.

Highly invasive Himalayan balsam

Currently only very small patches were observed and it is recommended that efforts are made to eradicate the plant before it spreads too widely.

These plants can be easily pulled up by hand or treated with a contact herbicide (Environment Agency consent required).

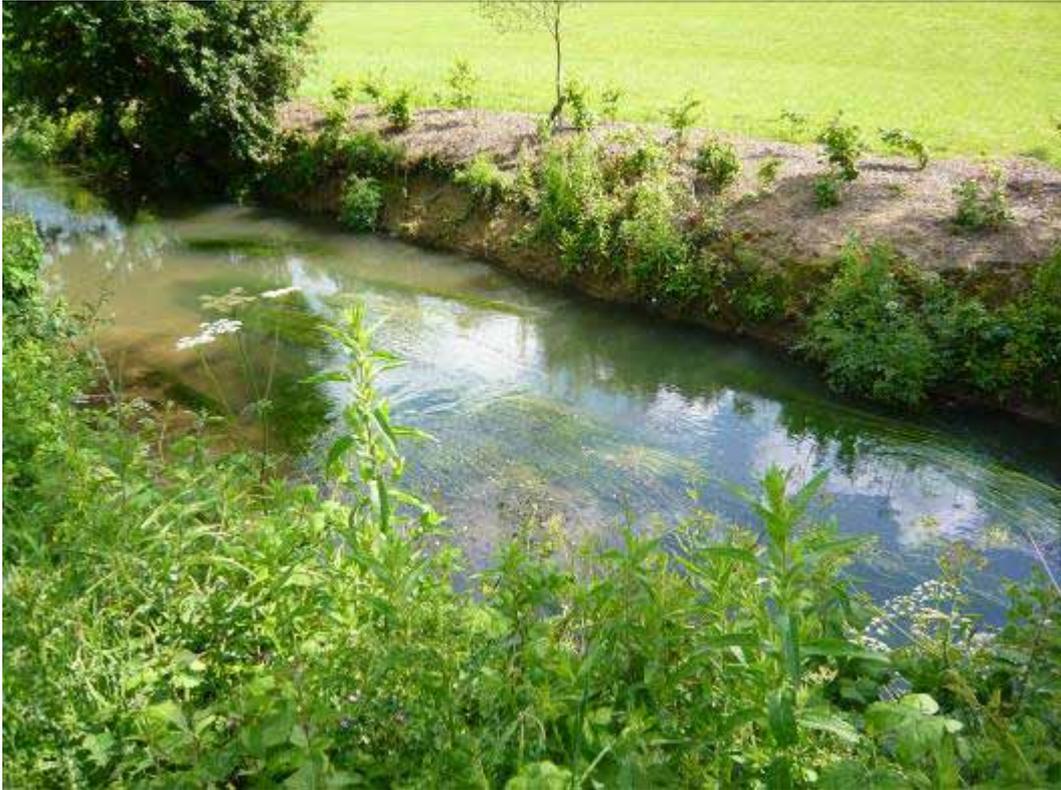
Near the top end of the fishery the club only has access to the RB. The LB is in private ownership and forms the curtilage of a large house. Extensive works have been carried out to the banks including soft engineering in the form of willow spiling. Unfortunately other adjacent sections have been utilised as an extension to the formal grounds with extensive ornamental planting right to the top of the bank. Many of these plants and shrubs will not be suitable for a riverbank environment and could leave the bank vulnerable to excessive erosion.

Unidentified shrubs planted on the LB

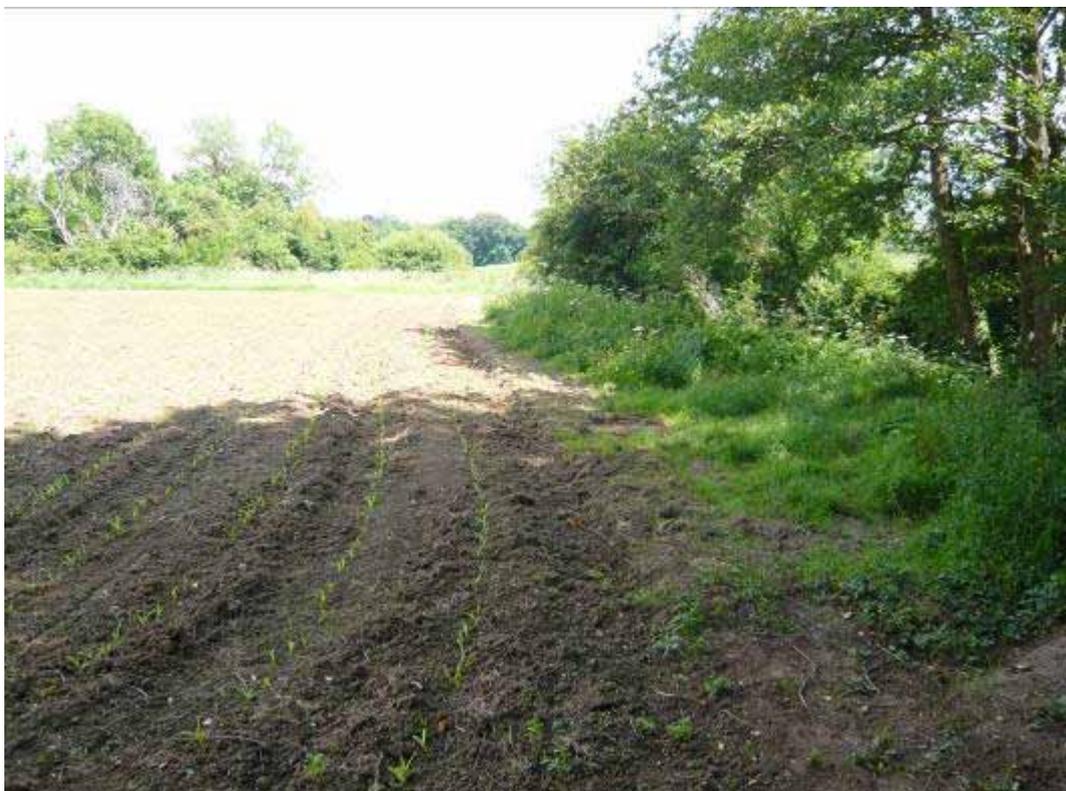
Newly planted crop very close to the RB

No information is available to the author about the wider catchment land use. Most of the land abutting the Box brook was laid to pasture, however two sloping meadows were under arable cultivation with virtually nonexistent buffer zones. Inappropriate land use in river valley meadows has been identified as a key issue on many rivers. Diffuse pollution caused by nutrient rich sediments running off of cultivated valley slopes can be a huge problem.

Raising awareness with local farmers and land owners can help in planning future crop rotation. Many farmers receive subsidies from DEFRA in the form of Single Farm Payments. To qualify for these payments farmers are expected to prepare soil conservation plans and potentially the introduction of substantial buffer strips can save the farmer money as well as protect the river. Details of agri-environment schemes can be obtained from the DEFRA website at <http://www.defra.gov.uk/farm/singlepay/index.htm>

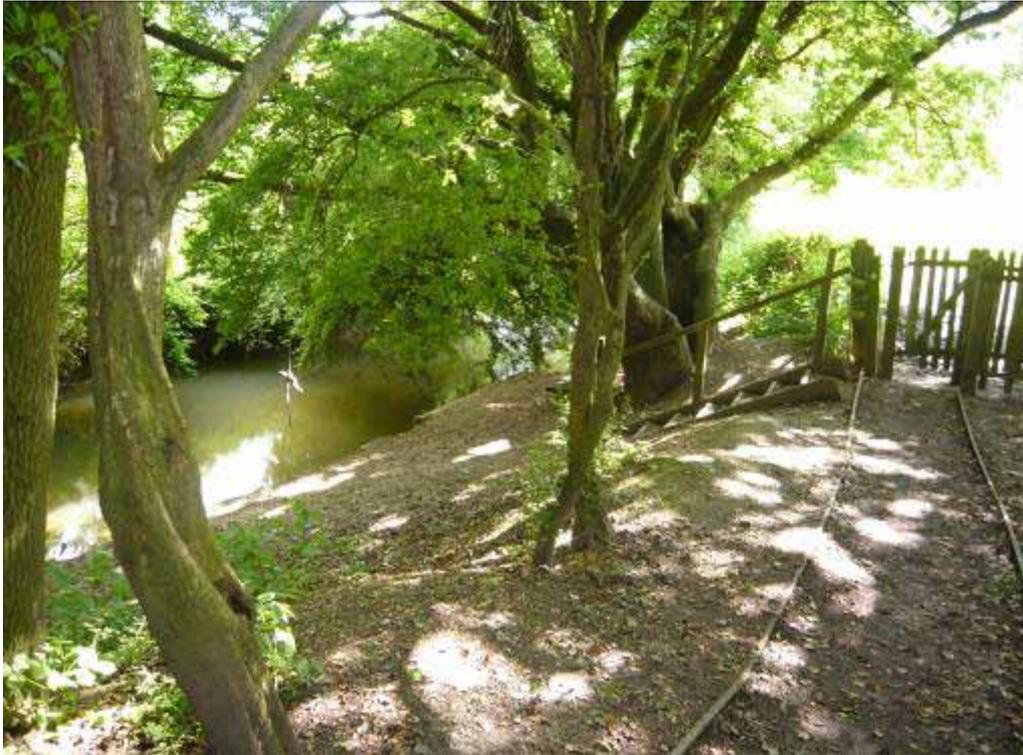
The top boundary. No maintenance work should be carried out on the first 25m

The top boundary of the fishery lies adjacent to a park in the village of Box. This is obviously a very popular site for visitors and locals alike. In order to deter any unwanted guests it may be wise not to open up the first 20 to 30 meters of the RB to act as a screen and a deterrent for would-be poachers. Leaving the short section near the gate for local children to fish and play unchallenged is probably a good idea.
