## Advisory Visit Bradshaw Brook

01/11/2023

<b>River</b>	Bradshaw Brook
<b>Waterbody Name</b>	Bradshaw Brook
<b>Waterbody ID</b>	<a href="#"><u>GB112069064580</u></a>
<b>Management Catchment</b>	Irwell
<b>River Basin District</b>	North West
<b>Current Ecological Status</b>	Moderate (Good for Fish)
<b>U/S Grid Ref inspected</b>	SD73338 12681 (53.610000,-2.4044444)
<b>D/S Grid Ref inspected</b>	SD73499 11877(53.602778, -2.4019444)
<b>Length of river inspected</b>	1.2 km

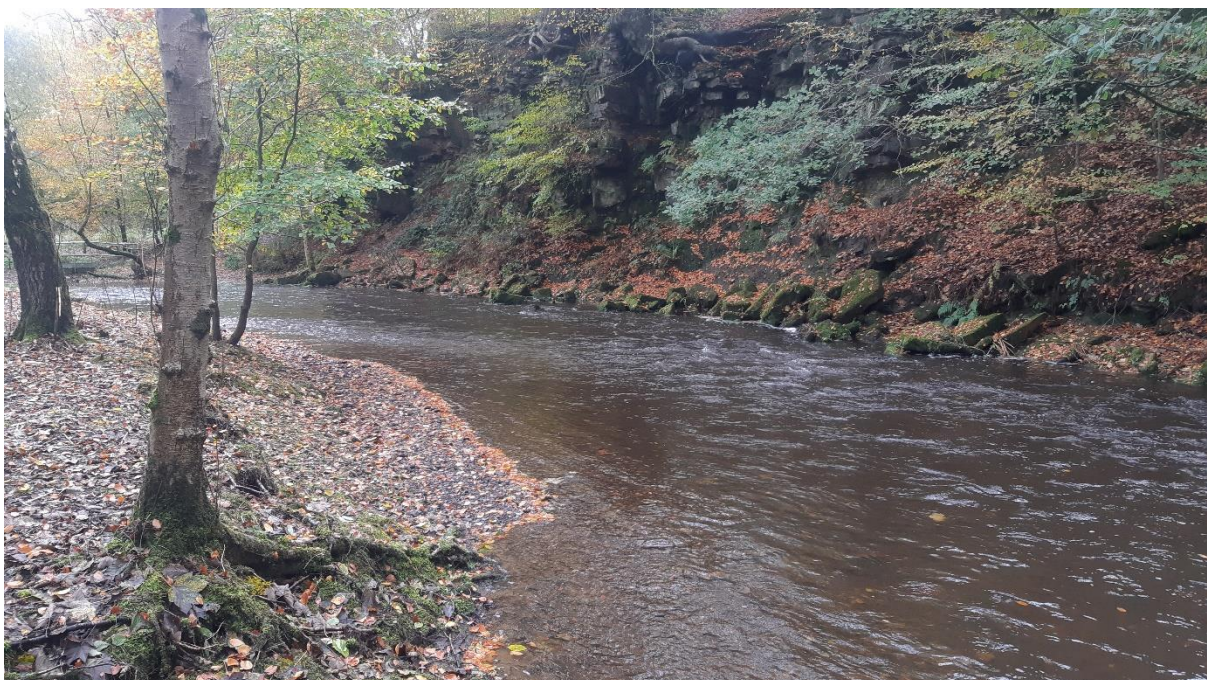
Abundant gravel deposits, in the form of a point-bar deposited on the inside of a bend, were noted at the downstream limit (Fig.1). A significant proportion of those gravel particles were in the 20-50 mm diameter range that trout prefer for spawning (e.g. Fig.2).

Figure 1: Gravel point bar and diverse riparian woodland habitat.

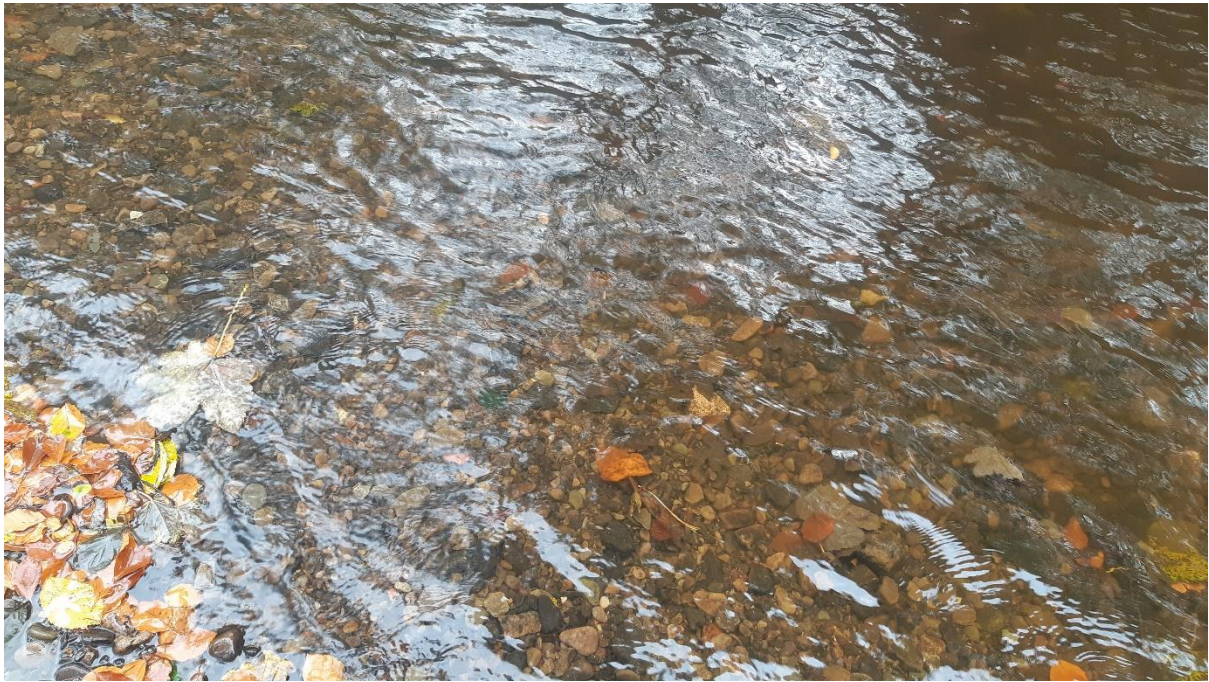
This, coupled with the depth and pace of the current at normal flow, suggests there is good potential for wild trout to spawn within the reach controlled by Bradshaw Brook Fly Fishing Club. Although sometimes described as “riffle-spawning” species, brown trout tend to select clean gravel sites where the flow is consistent but not too turbulent. An important factor determining hatching success is the ability of clean, well-oxygenated water to be drawn through (and not only flow over) gravel beds. In

Figure 2: Point bar gravel particles in the 20-50-mm diameter range.

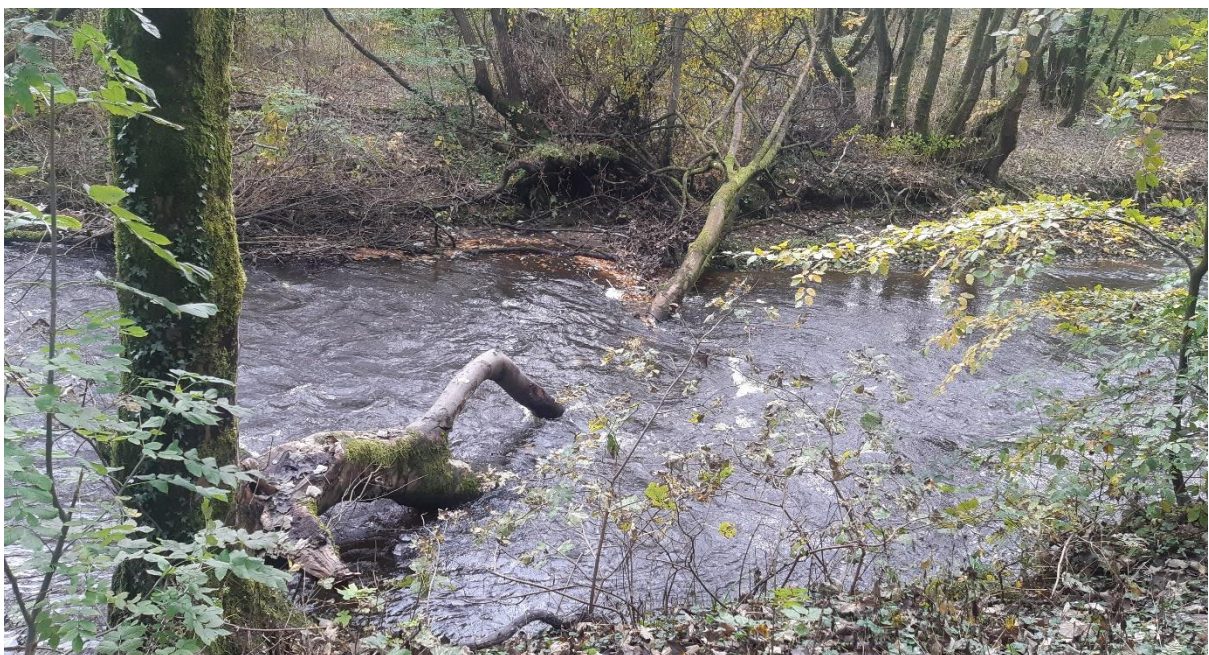
A particularly high value (in ecological terms) example of naturally occurring large woody material was noted at 53.603012, -2.401373 (Fig.3).

Figure 3: Apparently lodged at both ends, the complex trunk shape is promoting undershot scour and is not impounding the flow. This is an extremely valuable habitat feature.

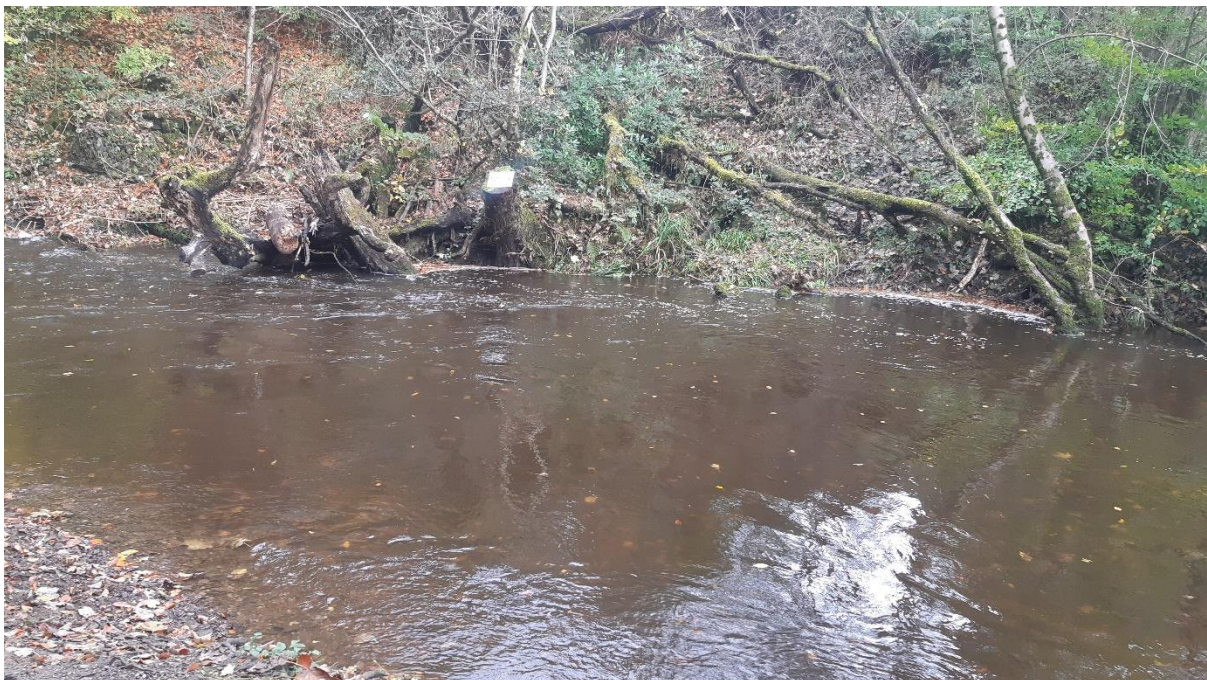
In areas where the channel is able to meander naturally, the combination of bankside trees (and their root systems) with processes of erosion and deposition can create ideal scour pool habitat and cover for adult trout (e.g. Fig.4). The significance of deeper pool habitat containing complex submerged cover such as tangled tree roots is often underestimated. As well as the more obvious times adult trout use these areas as feeding habitat – such habitat also tends to greatly increase overwinter survival of wild trout. Whether trout are hidden away, lying dormant among the complex cover – or actively bolting into that cover to escape predation – tree roots and submerged branches help avoid over-exploitation of prey by predators. The function of this habitat is particularly important during harsh winters when nearby stillwaters become frozen and force piscivorous birds to hunt in rivers and streams.

Figure 4: Leaning trunks and submerged roots on the outside of this scour pool on a bend in the river. Although a mature specimen has been felled – the associated root wad and nearby trunks have been left in place. Ideally, the full tree would have been left in place.

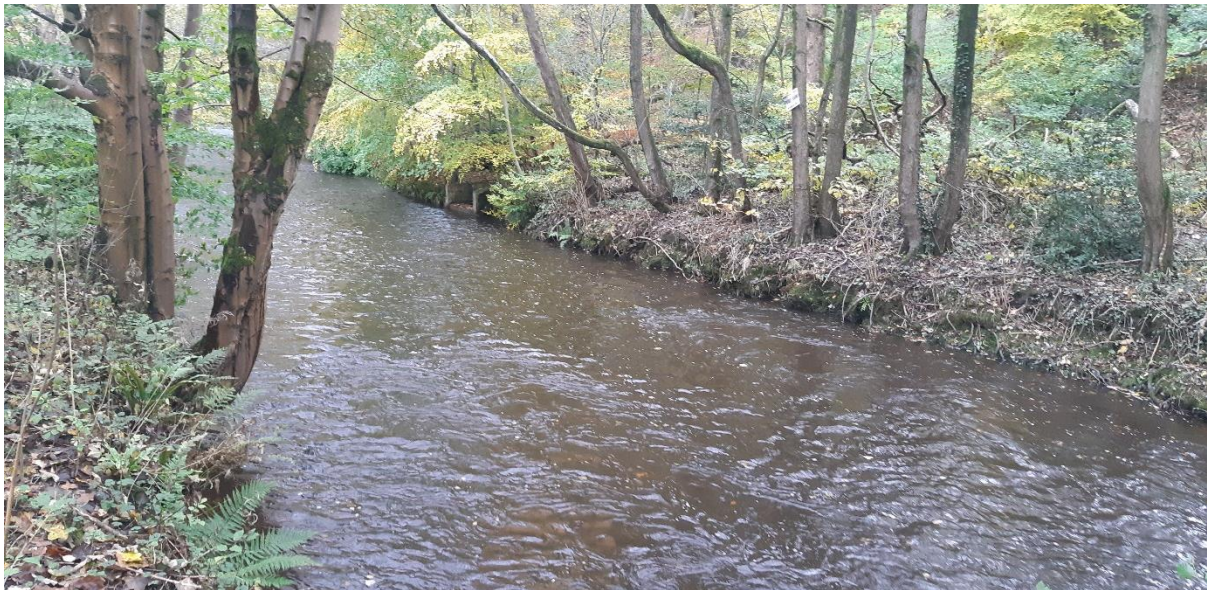
As with many post-industrial rivers, the Bradshaw Brook shows signs of historic straightening of the channel in places (e.g. Fig. 5). In those areas, there is a corresponding reduction in habitat complexity. Lower structural diversity makes habitat suitable only for smaller subset of species.

Figure 5: This section appears to have been straightened in the past. Rock revetments are often stabilised by the roots from a line of riparian trees, as is the case here. However, this does create opportunities for stable, cross-channel large woody material features similar to the naturally arising example shown in Fig.3

The single row of trees of the same age can be used to diversify habitat in two main ways. Firstly, the uniform canopy could be staggered via very light rotational coppicing. Only a very small proportion of trees would be felled at each well-spaced rotation (e.g. taking 5 to 10% of trees once every two to four years). Secondly, trunk and crown material arising from each coppice could span the channel and be lodged on both banks for high stability. Having the trunk and/or limbs only touching the bed at points over the cross-section ensures undershot scour along with space to allow water and a proportion of debris to pass. Thirdly, hanging the v-shape union between main trunk and major limbs around remaining trees would also create stable "tree hanger" habitat features.

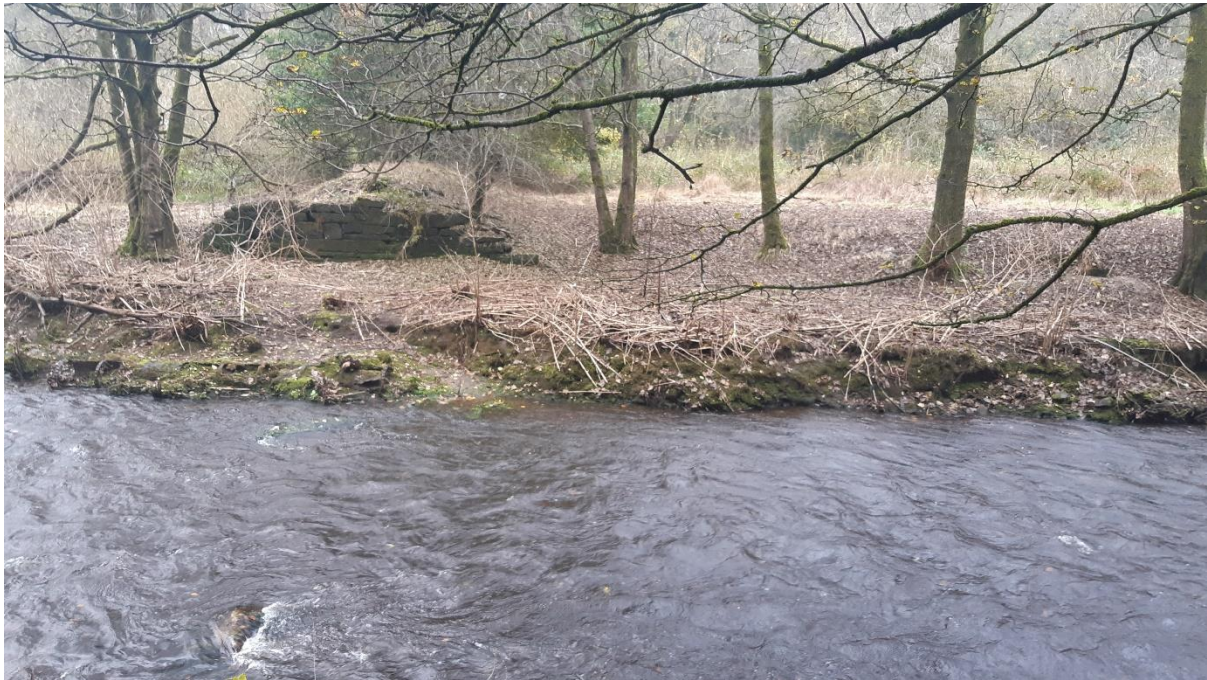
The rigorous and extensive Japanese knotweed control undertaken by the club is extremely valuable (e.g. Fig.6). Re-establishment of a more diverse understory of native vegetation may be helped by extending light rotational coppicing beyond the immediate bankside. Recovery may also be assisted via supportive planting of locally appropriate plug plants.

Figure 6: Extensive area of Japanese knotweed treatment along a historically straightened section of channel a short distance downstream of the A676.

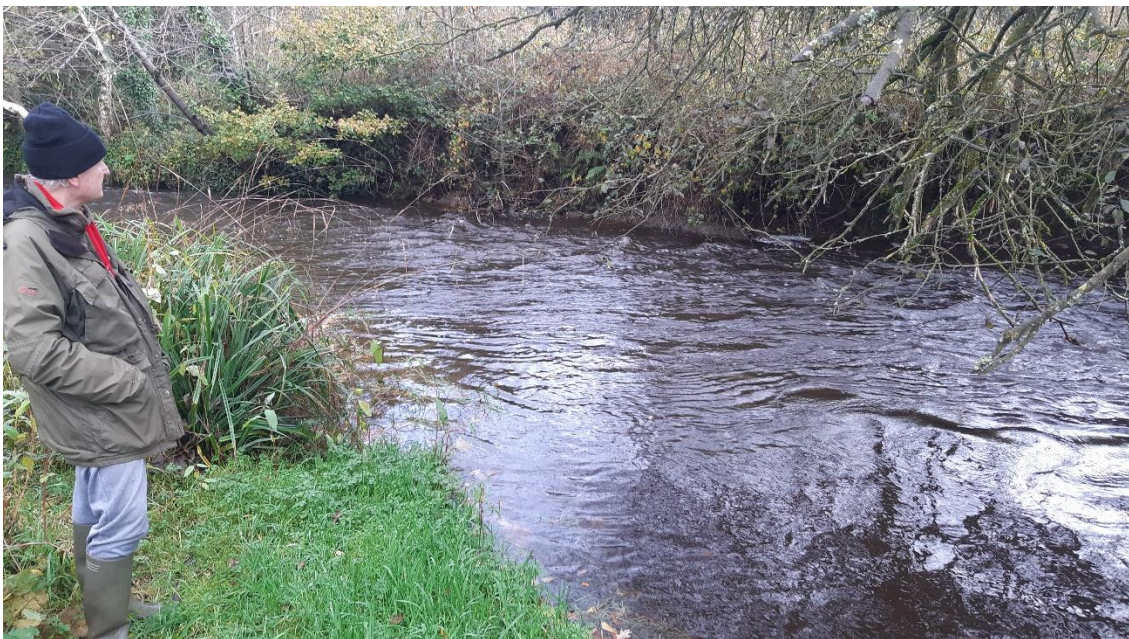
Owing to access, a short section of the Brook from just below to just above the A676, Bolton Road was not surveyed. Upstream of Bolton Road, behind the tennis club around 53.606230, -2.404347, the Brook is more constrained on both sides by riparian land use and infrastructure. However, varied habitat still exists with particular benefits arising from a lack of excessive pruning or removal of riverside trees (e.g. Figs. 7 and 8).

Figure 7: Marginal vegetation on the near bank and valuable overhanging branch cover on the far bank. The combination of fishable water with the probable elevation of fish numbers due to overhanging cover matches with club member reports of good dry fly fishing here.

Retaining cover such as the examples shown in Figs. 7 and 8 is extremely important for high quality trout fishing. Pressure and temptation to excessively tidy up this type of habitat can sometimes be hard to resist. However, without enough of these types of features, there would be far fewer fish to cast a fly at. The presence of these features is a strong sign that the club waters are well managed. Continuing the policy of retaining important structural habitat – including woody material in the channel - is essential for robust, self-sustaining trout populations.

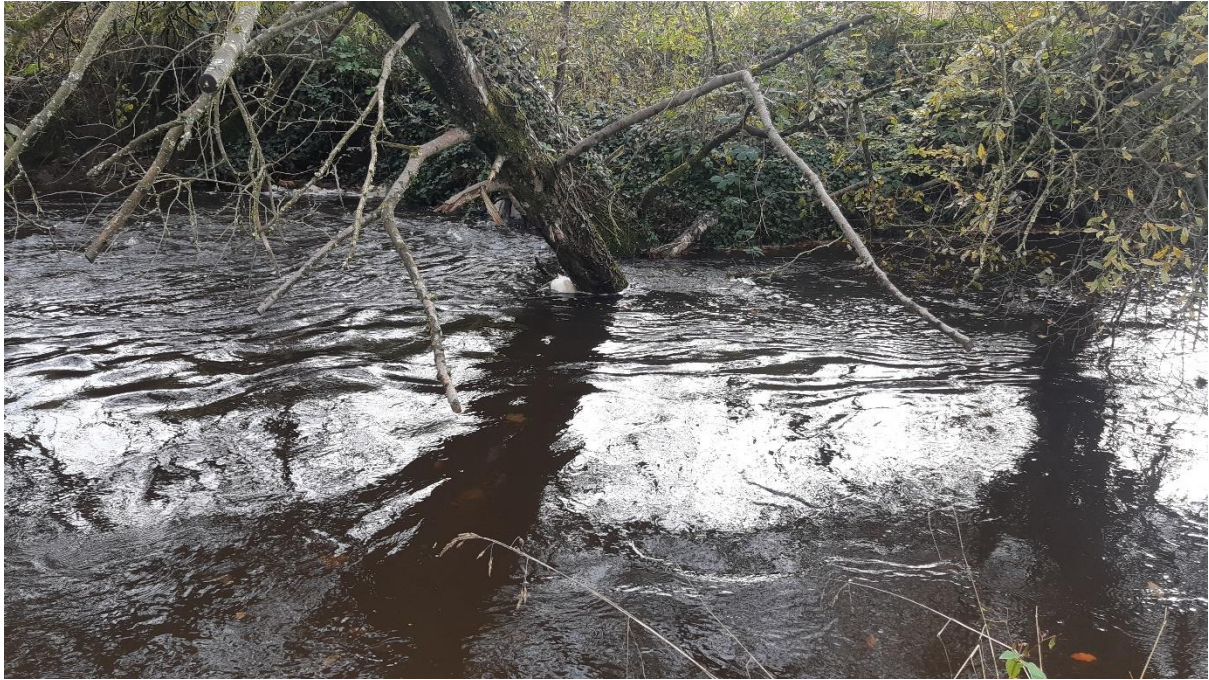
Figure 8: Complex submerged cover on the far bank creating ideal adult trout habitat.

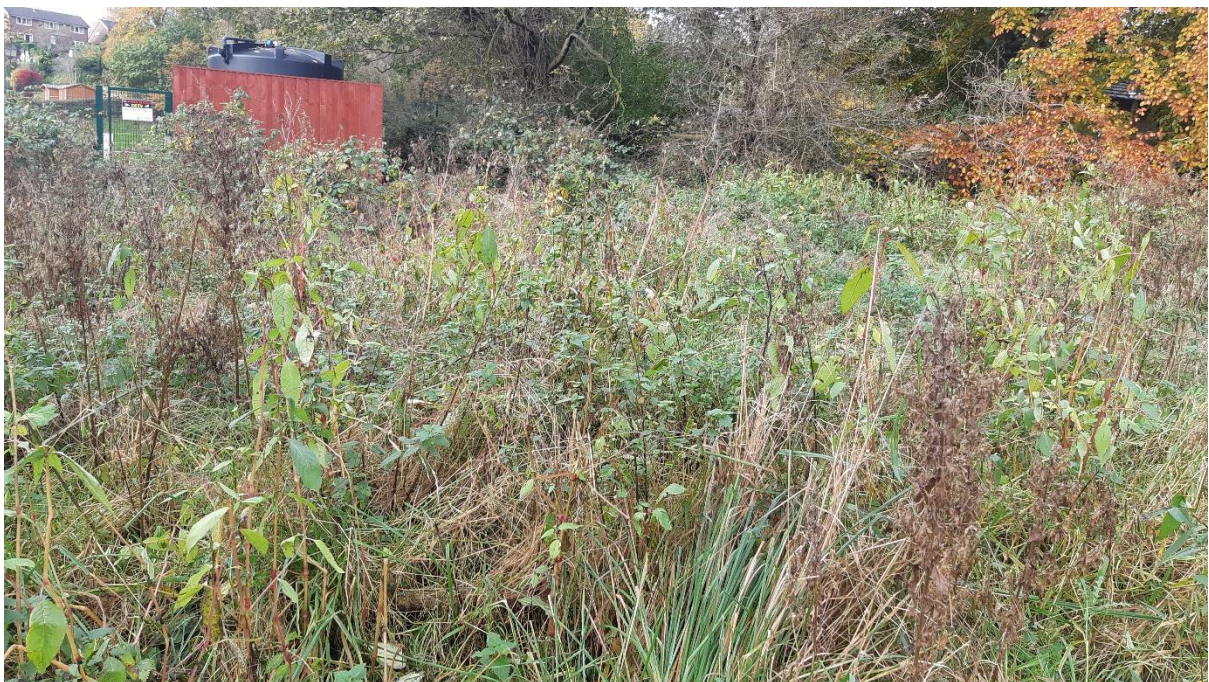
Figure 9: Native vegetation mixed with scattered, individual Himalayan balsam plants.

As with the Japanese knotweed control measures mentioned previously, the club are doing a good job by reducing and controlling Himalayan balsam cover. While in some areas (e.g. directly behind the cricket ground; Fig.9) there are still scattered balsam plants, the benefits to marginal vegetation cover of balsam control are evident (Fig.10).

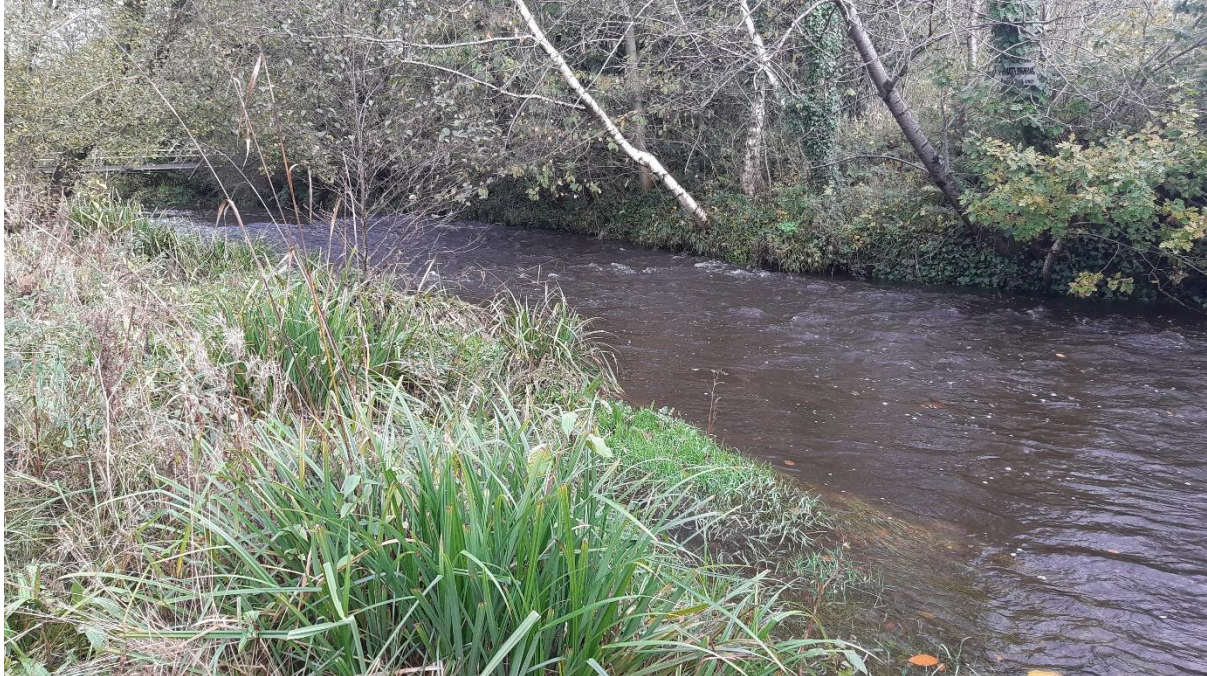
Figure 10: A lack of balsam has allowed native marginal vegetation cover to develop and persist. This helps support healthy aquatic and terrestrial invertebrate populations as well as improving survival of trout fry after they emerge from the gravels in spring.

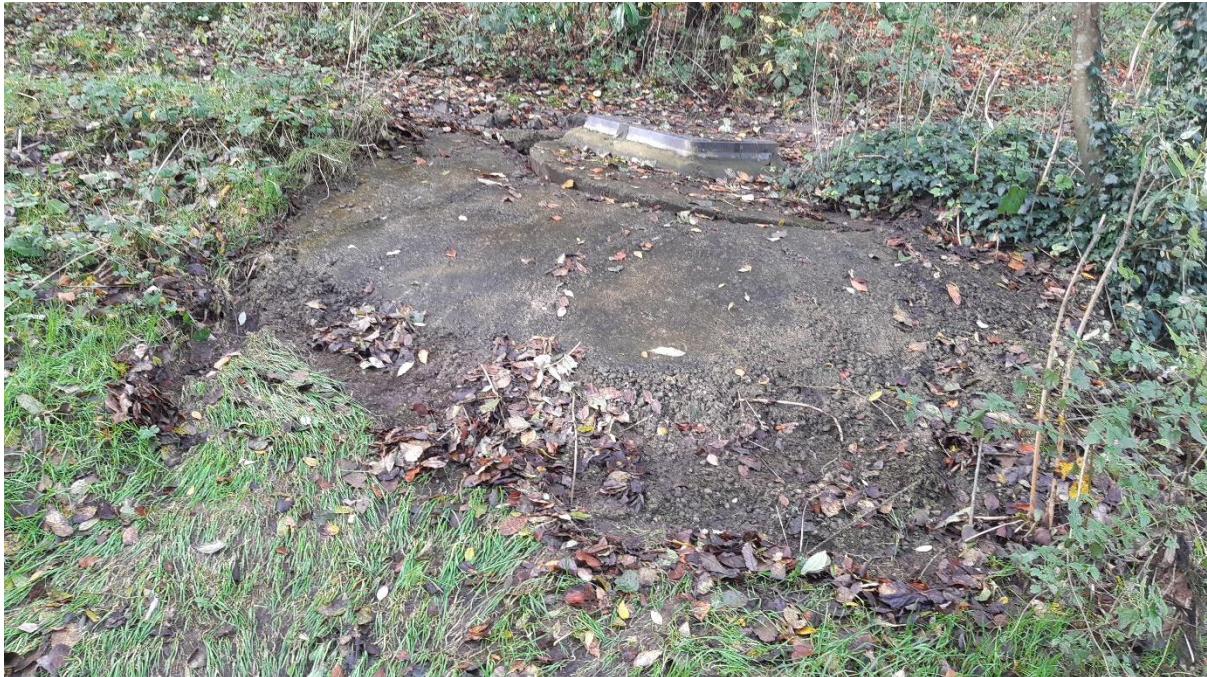
A potential point source of pollution was noted from the previously reinforced drain access shaft shown in Fig. 11. The flattened grass indicated a pathway for overflowing drain material to enter the river and the amount of concrete poured on top of the original structure suggests a known and apparently ongoing problem. If not already known, identifying ownership of this asset and giving the owners an opportunity to fix the leak before seeking a prosecution through the Environment Agency could, potentially, yield a quicker solution. The urgency of any repairs will depend on the nature of material transported by the drainage system. If there is confidence that only surface water with low levels of particulate and dissolved contaminants are ever present in the drainage system, this would have a lower priority compared to severely contaminated material.

However, the ability to confidently rule out contamination is difficult; particularly in cases of intermittent problems and/or unusual pollutant sources.

Figure 11: Raised drain cover with apparent split in the concrete casing. Note flattened grass below the concrete mound indicating a recent overflow into the river (which is just outside the frame, below the lower edge of the picture).

Setting up invertebrate community monitoring (e.g. following the Riverfly Partnership methodology) at comparable reference sites just upstream and downstream of this point-source is recommended. This would provide valuable insights into the likely severity of pollution, without needing to know in advance what substances to try to detect within the runoff.

- Establish invertebrate monitoring stations in an effort to characterize the scale and extent of water quality impacts – particularly around suspected point sources (particularly the overflowing drain shown in Fig. 11)

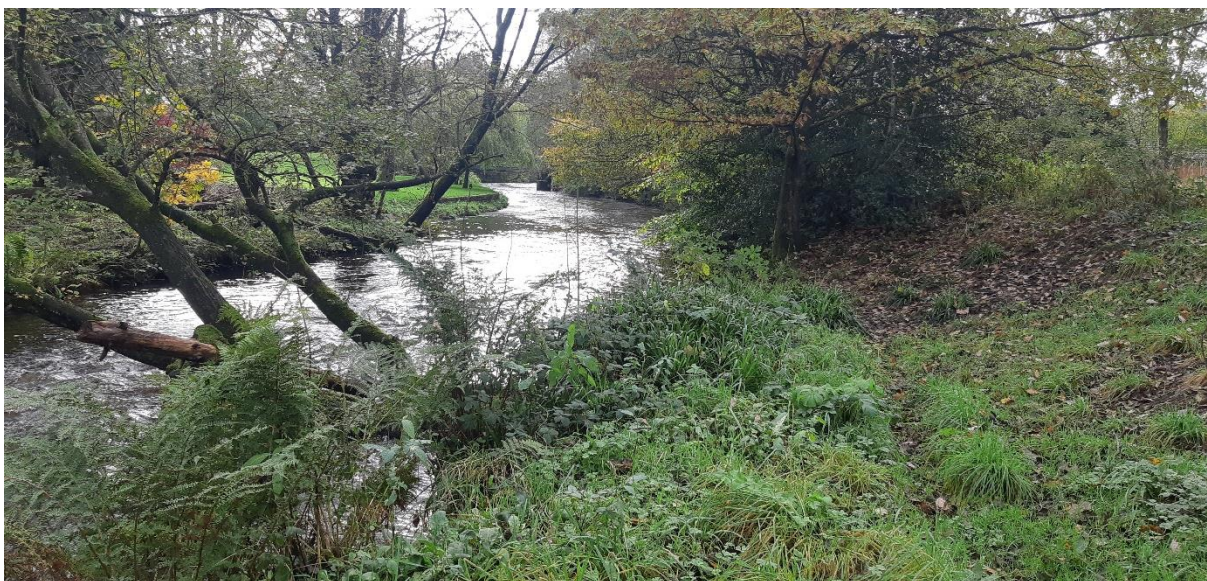
Figure 12: Vertical toe boarding at the edge of a lawn in the background (centre/upper left of frame). The simplification of that section of bank appears to be adequately offset by surrounding, structural complexity on both banks. However, a vegetated buffer would be a positive benefit to wildlife in the garden and on the river.

A short section of riverside lawn and associated vertical toe-boarding represents poorer habitat (Fig. 12). While, in isolation, this isn't a serious ecological impact – it would be far better to allow a vegetated buffer strip to develop. This would avoid the need for revetment, particularly on the inside of a bend, and create a wildlife haven within the garden.

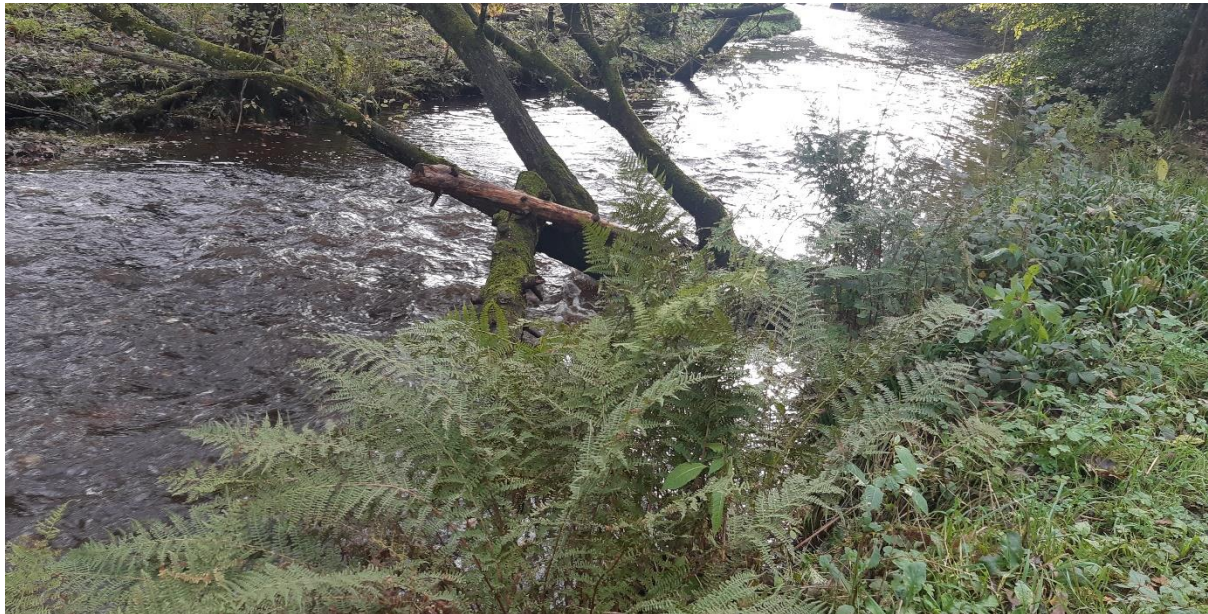
Closer observation of the leaning tree shown in Fig.12 reveals additional complexity and ecological value to this structure (Fig.13). A cluster of large and coarse woody material is complemented by the trailing marginal vegetation resulting in an effective refuge from predation.

Figure 13: Lodged trunks and limbs associated with the rooted, living trees. Under different flow levels these should perform a variety of functions from simple overhead and submerged cover through to flow baffling and shaping the riverbed.

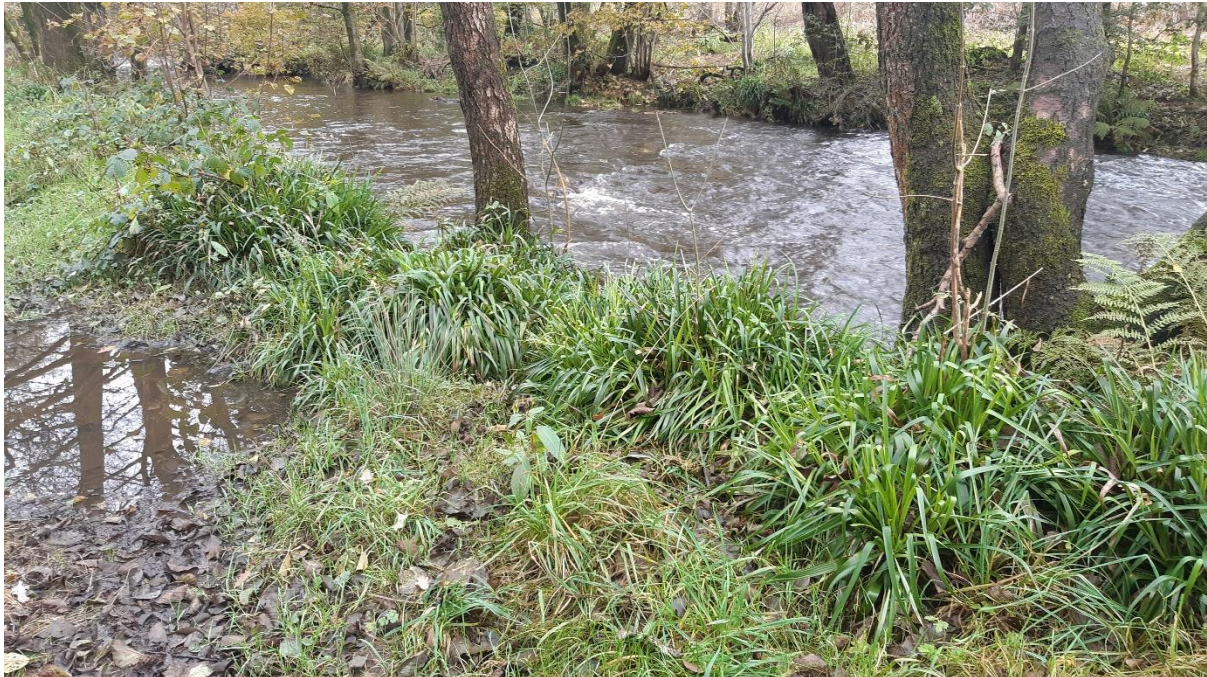
The reduced ground level behind a marginal strip of vegetation in some areas (e.g. Fig.14) may be a result of footfall compacting the ground and inhibiting vegetation growth. Alternatively, this could be the result of scour created during or after high flow events. The marginal plant growth here is, again, providing valuable cover. It appears that, running along the margin of the river, a single row of trees on both banks have quite a uniform age structure. Moving the informal path (or desire-line) further away from the river could be coupled with selective coppicing of a small number of trees. Felled trees could then be wedged (or cabled as required) to create cross-channel trunks – with much of their mass sitting on the riverbanks.

Figure 14: Single row of mature trees lining the near bank (RB) and compacted/lowered area behind the marginal wood rush understory.

The staggered canopy structure along with reduced erosion due to foot fall should allow a wider buffer strip of vegetation to form. Rerouting the usual path a few metres further away from the river could help promote the recovery of understory and wetland vegetation. However, to set expectations, this area may experience episodic flooding and associated scour as water re-enters the channel following flooding. With that said, developing a wider buffer strip over time would make it easier to

accommodate felled tree trunks within revegetated areas without creating an obstacle to riverside walkers. Access for anglers into the river channel could be maintained at the most appropriate points.

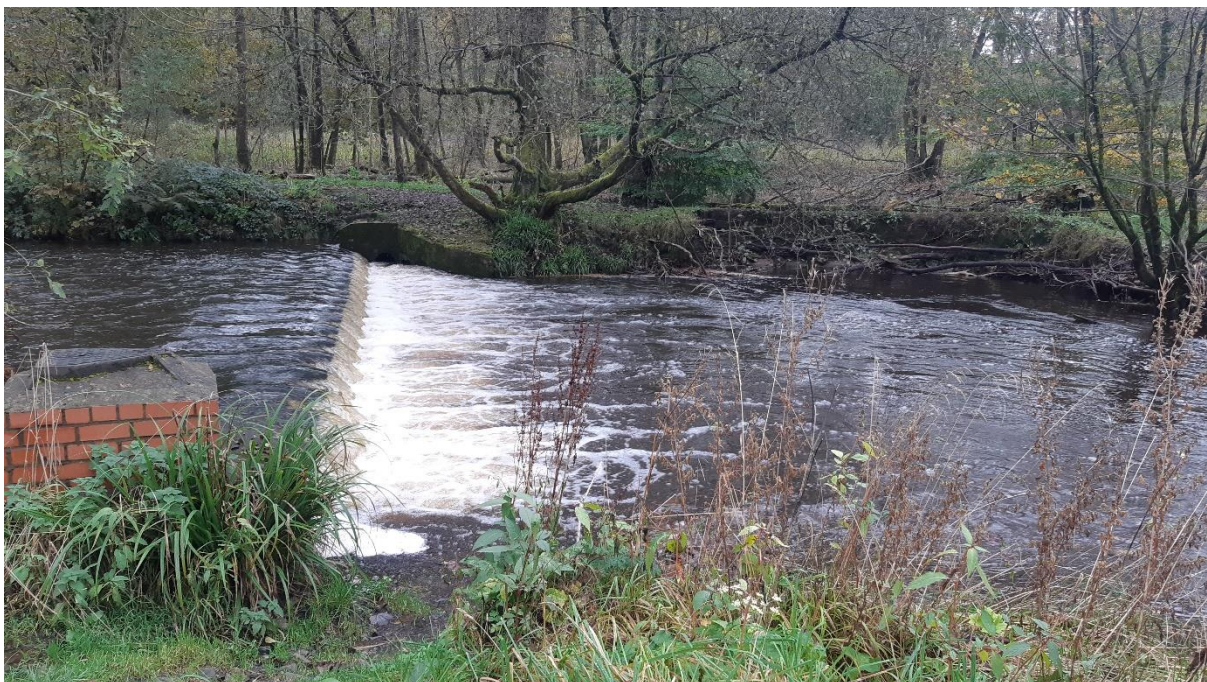
The low weir across the river just upstream from the reach shown in Fig. 14 is likely to represent a complex, negative impact (Fig.15). Although not particularly high relative to many run of river weirs, it will still interrupt both upstream and (equally importantly) downstream movements of fish.

Figure 15: This weir apparently exists to stabilise and protect the services pipe which crosses the river at this point.

Bed scour directly below the weir will promote a slight increase in depth, over perhaps a one to two metre reach length. However, this is still a relatively short vertical swimming depth for fish. In species that are able to leap obstacles, water depth is vital for them to build up enough vertical speed (and hence momentum) to carry them over the obstacle. Consequently, particularly at lower flows, even this low weir is likely to prevent upstream movement of many fish. It may also cause injury or significant depletion of energy reserves for those fish that do make the leap. Even short delays can also lead to increased mortality, since fish accumulate in artificially elevated densities and predators can take advantage.

Any reduction or prevention of free movement up and downstream results in smaller effective breeding population sizes. Trout that would, otherwise, be able to combine their genetic material with particular members of the wider population have their options limited. That reduction in available mates can lead to reduced resilience and adaptability in wild trout populations. It is for this reason that free passage is important for all species of fish that travel between different habitat types to complete their lifecycle (including "resident" trout). Fish migration is certainly not just an issue for iconic marine migratory species such as salmon.

Another, less frequently discussed, impact of run of river weirs is the interruption of riverbed material being transported downstream. The shape and dimensions (bank full width and depth over a range of cross-sectional profiles) of a river channel are set during bank-full spate flows. This is when the shear velocities acting on the riverbed are greatest and when the largest volumes of bed material are shifted and re-deposited. As the spate flows recede, successively finer particles will settle into the overall topography created from deposits of larger gravels, cobbles and boulders.

Initially, installing an impounding structure (e.g. a weir) will create a deeper pool on its upstream side. However, over successive spate events, riverbed material is likely to build up and tends to reduce the average depth of water. As mentioned previously, the turbulent zone just below the weir may create a localised increase in depth due to the focussing of bed scour. Such areas can be known as good fishing hotspots. However, they are typically created at the expense of a much larger area of good fishing that would otherwise exist.

In the case of the Bradshaw Brook, a relatively high longitudinal gradient combines with a fairly wide, shallow channel and low weir crest to limit the "ponding" effect. As long as flow levels are high enough to easily pass over the weir crest, noticeable current velocities are maintained over the full cross section of the channel (e.g. Fig. 15, left of frame). For this specific structure, it is likely that the barrier to free fish movement is the most significant factor. This is not to say that the habitat and bed transport material are not negatively impacted. It would still be better on all fronts

for the weir to be removed. However, in light of the costs of creating an alternative solution for the service pipe crossing the river, the best return on investment is likely to be an intervention that focuses predominantly on effective improvement to fish passage.

Notching the weir and combining with a sufficiently shallow gradient rock ramp on the downstream side (5% slope or less - ideally 1-3%) could be a good compromise if weir removal is unfeasible. Designed correctly, this may also aid in reconnecting at least some downstream transport of riverbed material.

- Continue with the club's excellent policy to retain stable woody and vegetative cover
- Seek a costed design for a stable rock ramp utilising material that closely mimics the natural bed to improve fish passage and reinstate a proportion of riverbed transport at the weir pictured in Fig.15

- Request confirmation of safe limits to the dimensions, location and long-term stability of the notch that may be required to enable successful rock ramp installation and performance

- Obtain a cost for installation under the supervision of rock ramp design contractors
- Establish a very light coppicing regime and utilise arising trees to create stable, secure cross-channel large woody material

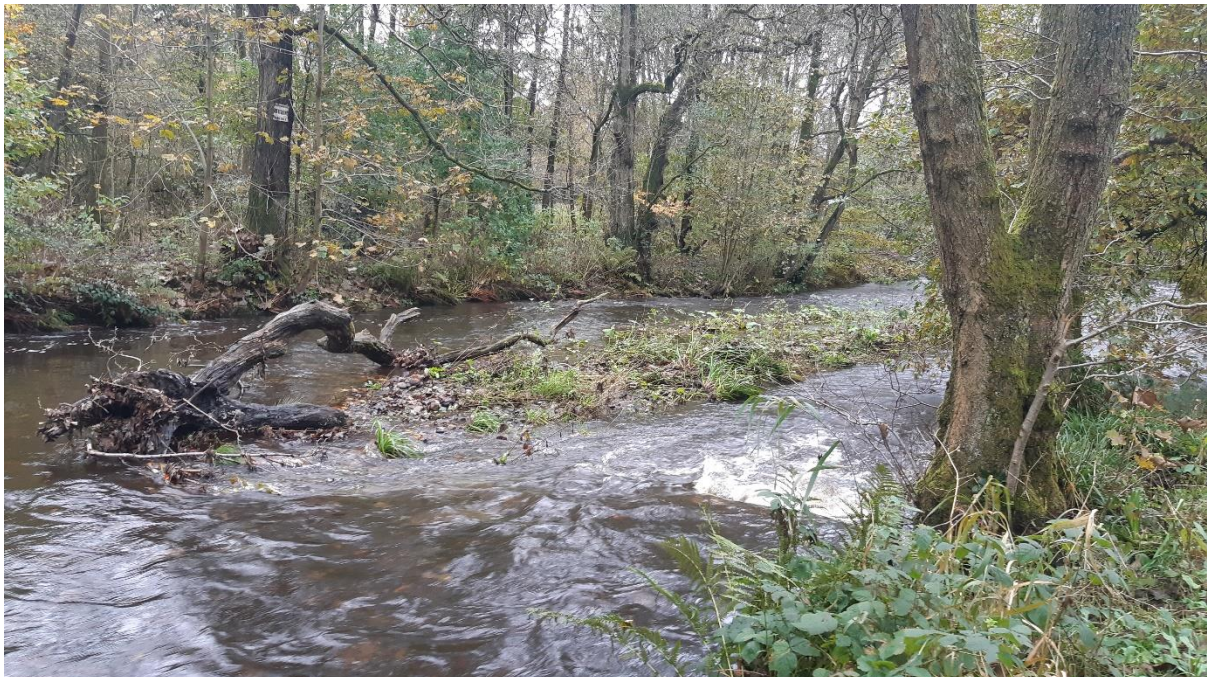
Figure 16: Mid channel cobble bar formed in response to large woody material input.

different locations. Similarly, having the position and size of point bars (e.g. Fig.1), mid-channel bars (e.g. Fig.16) and riffles (e.g. Fig.13) shift in size, shape and location is also a good thing. Note, however, that this is different from situations where an imbalance in land-use in the headwaters of a river can lead to a massive oversupply of, for instance, cobble material. In those situations a river system may struggle to redistribute that oversupplied substrate into complex habitat. This is particularly true if the downstream watercourse has also suffered impacts that simplify a channel. A potential example of this is the likely impact of moorland grips/drains and the supply of cobble material into heavily grazed/unfenced reaches of the River Ure.

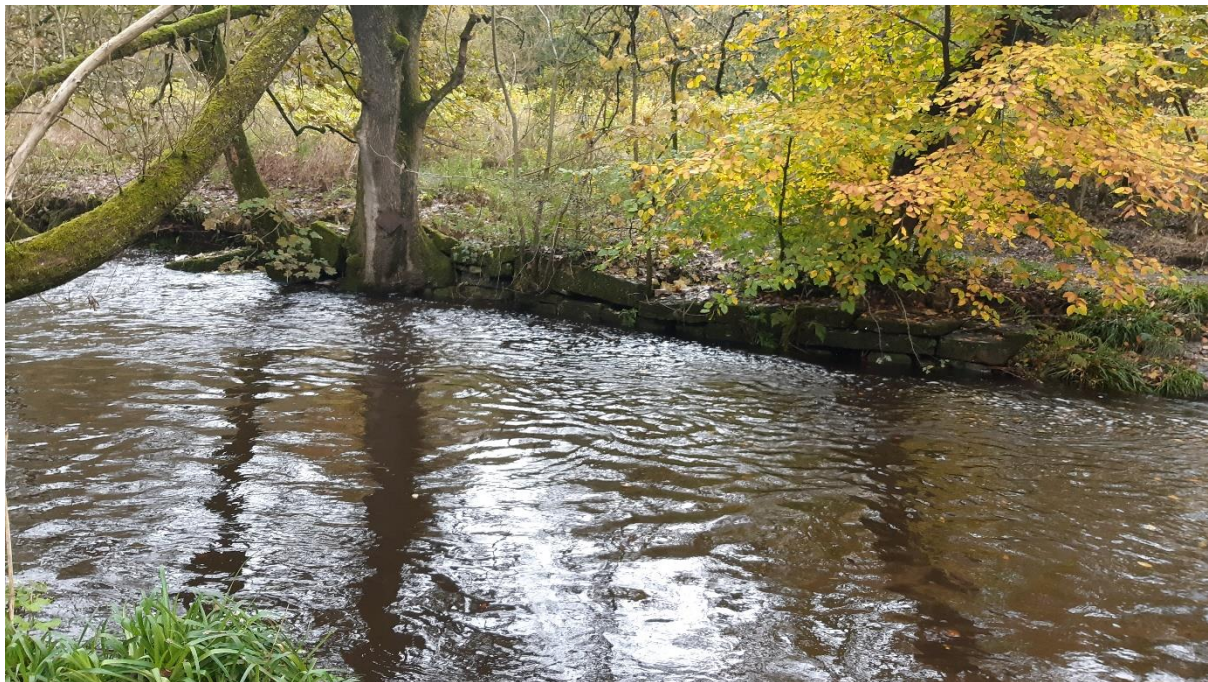
In addition to examples of historic straightening observed further downstream (e.g. Figs.5 and 6), remnants of stone revetment and signs of channel modification were also noted in the upper visited reaches (Fig.17). Consequently, the channel is a little less sinuous than would be expected.

Figure 17: Low blockstone revetment visible on the opposite bank. This will eventually erode away and the growth of bankside trees indicates nature is in the process of colonising these remaining structures.

Retaining a riparian woodland buffer strip around the channel will promote the formation of diverse root structures varying in depth and resistance to erosion. Tree roots, in particular, act to significantly reinforce banks against being washed away. This will help to avoid uncontrolled and rapid erosion associated with the shallow root horizon of short (grazed or mown) grass turf.

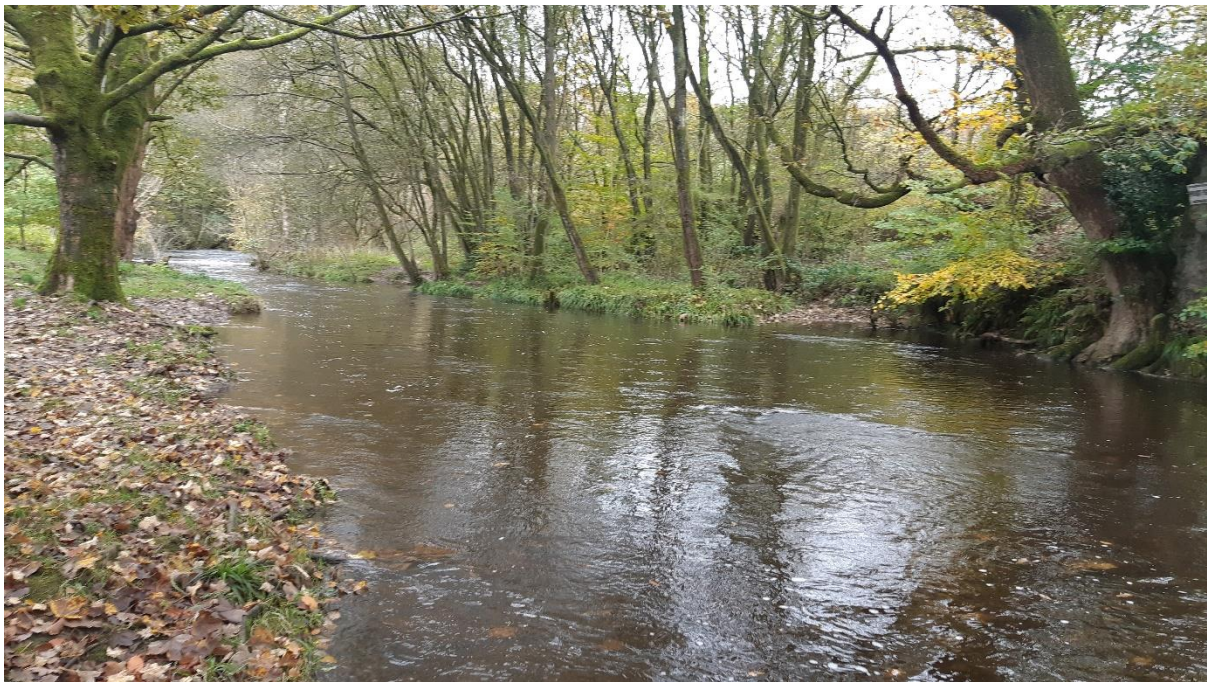
Probably the most significant challenge to overcome will be the degradation in recent years of the riverbed towards the upstream limit of this visit. A shallow gravel and cobble glide area which would otherwise be a potentially valuable spawning area has become clogged with fine silt (Fig. 18).

Figure 18: Cobble and gravel glide which has become clogged with fine silt in recent years.

There is also a lack of low level cover and in-channel large woody material that would be beneficial to reshape the bed and maximise the potential value as spawning habitat. However, the stand of trees on the LB in the background of Fig.18 provides ample opportunity to introduce stable cross-channel tree structures (wedged or cabled in place as required). Although it falls short of a true solution to the problem of eggs being suffocated by silt, large woody material may provide a small amount of mitigation. Undershot flows beneath logs and eddying flows around the edges of structures can create some localised flushing of fine sediment from between gravel particles. Furthermore, even clean gravels may be underutilised for spawning if there is insufficient cover to protect breeding adult fish from the threat of predation.

Consequently, installation of large woody material in this reach should create compounding benefits. With that said, those potential benefits will be relatively superficial if the oversupply of silt cannot be significantly reduced or eliminated. Existing pollution legislation regulates the release of

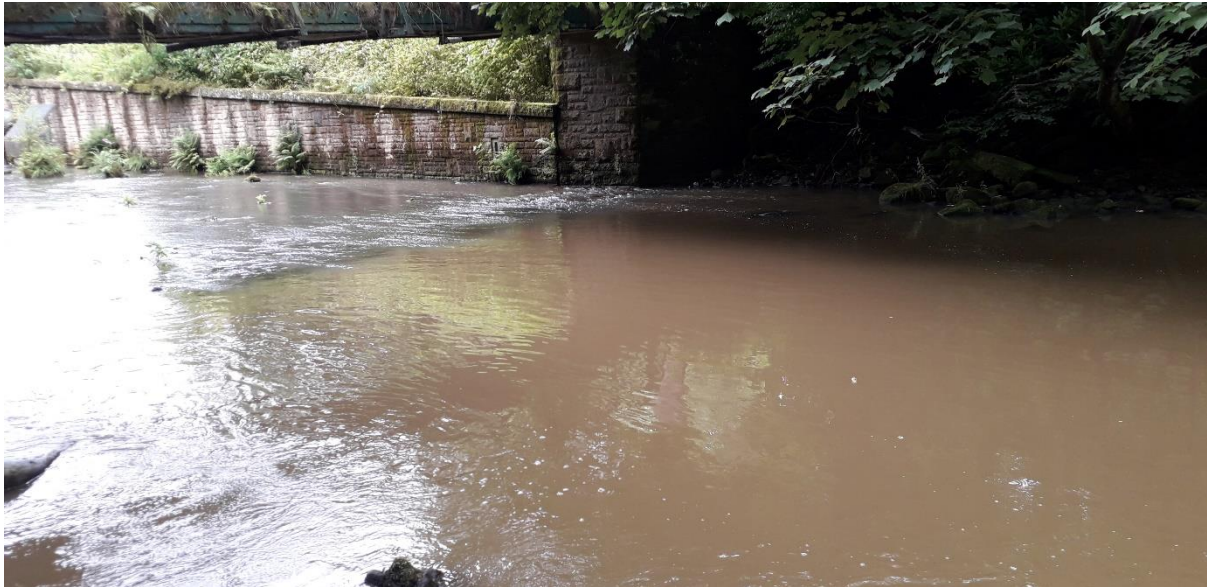
polluting materials into rivers. Establishing whether sediment released from privately owned reservoir assets contravenes legislation an important step. The images shown in Figs. 19 and 20 show sediment releases from Jumbles Reservoir into the Bradshaw Brook during low summer flow conditions. A combination of higher temperatures and also low available dilution is likely to make such releases particularly damaging to the ecology of the river.

Figure 19: Sediment photographed below Jumbles Reservoir dam wall.

Investigation into whether turbidity and/or suspended solid levels, Biochemical Oxygen Demand (BOD) or nutrient levels are covered by (or in breach of) consented levels for this asset is strongly recommended. Information available on the Environment Agency register of discharges to water and groundwater for the area around Jumbles Reservoir do not appear to include the reservoir itself: [Results of searching Discharges to Water and Groundwater \(data.gov.uk\)](#). Confirming whether reservoir silt

releases are currently covered under consented discharge legislation should be coupled with determining whether the release of silt and associated nutrients from water company assets would be covered under The Water (Prevention and Control of Pollution) Act, 1974 and related legislation. This will help to determine the available mechanisms for reducing or eliminating future releases of the material shown in Figs. 19 and 20.

- Determine the legal status of silt releases from Jumbles Reservoir into the Bradshaw Brook including:
  - Whether covered by consented discharge permit

- Whether in contravention of existing water pollution legislation
- Seek proper control or elimination of silt releases – either through voluntary collaboration or enforced legal action

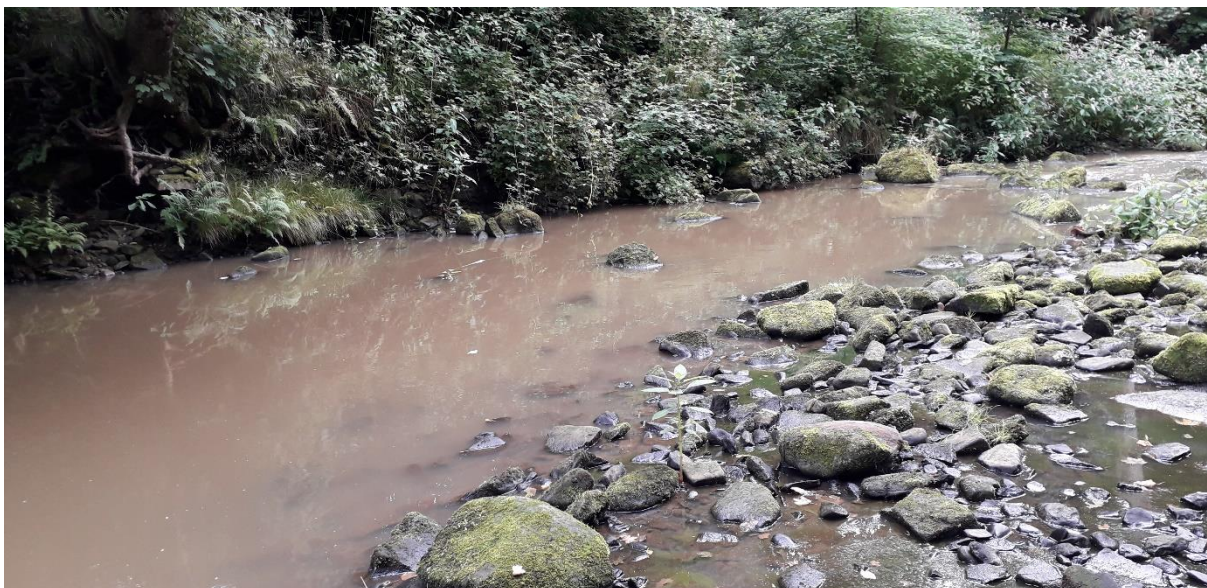
Figure 20: Fine sediment carried downriver in low flow conditions – magnifying likely ecological damage and photographed during summer 2023.

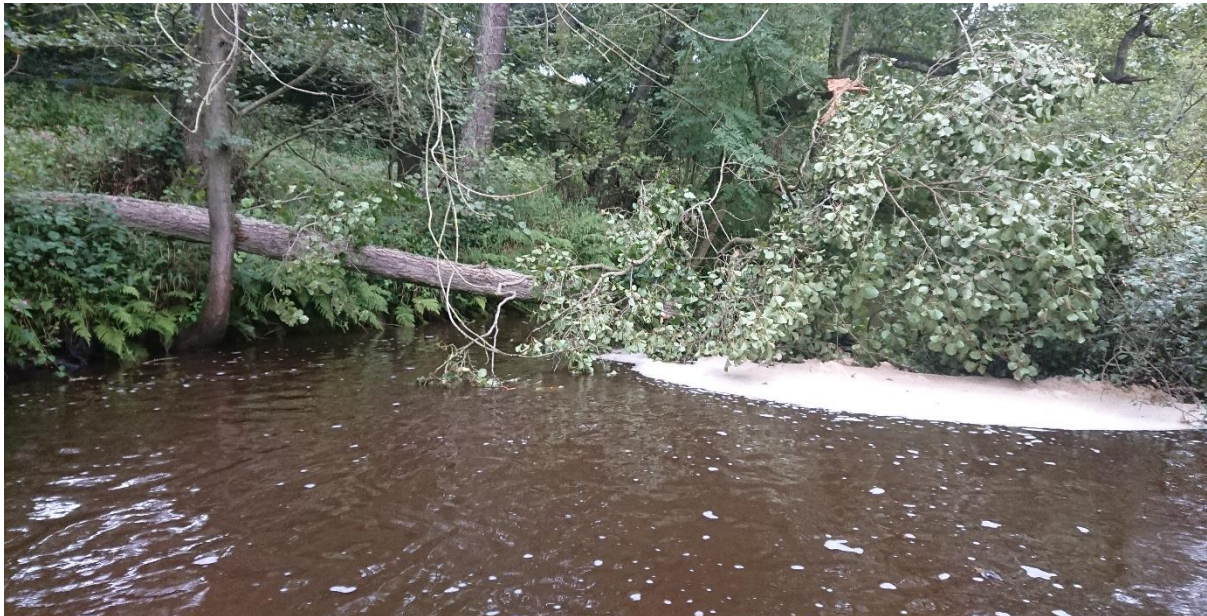
Figure 21: Wedged cross-channel tree habitat feature installed on the River Washburn – note the length and mass of main trunk remaining on the bank, lodged between standing, live trees (left of frame) as well as the space beneath the main trunk to allow flow to pass through for much of the full channel width.

installations (e.g. Fig.21) and/or tree hanger features (e.g. Fig.22) particularly at points mentioned throughout this report
