## Advisory Visit Bradshaw Brook

01/11/2023

<b>River</b>	Bradshaw Brook
<b>Waterbody Name</b>	Bradshaw Brook
<b>Waterbody ID</b>	<a href="#"><u>GB112069064580</u></a>
<b>Management Catchment</b>	Irwell
<b>River Basin District</b>	North West
<b>Current Ecological Status</b>	Moderate (Good for Fish)
<b>U/S Grid Ref inspected</b>	SD73338 12681 (53.610000,-2.4044444)
<b>D/S Grid Ref inspected</b>	SD73499 11877(53.602778, -2.4019444)
<b>Length of river inspected</b>	1.2 km

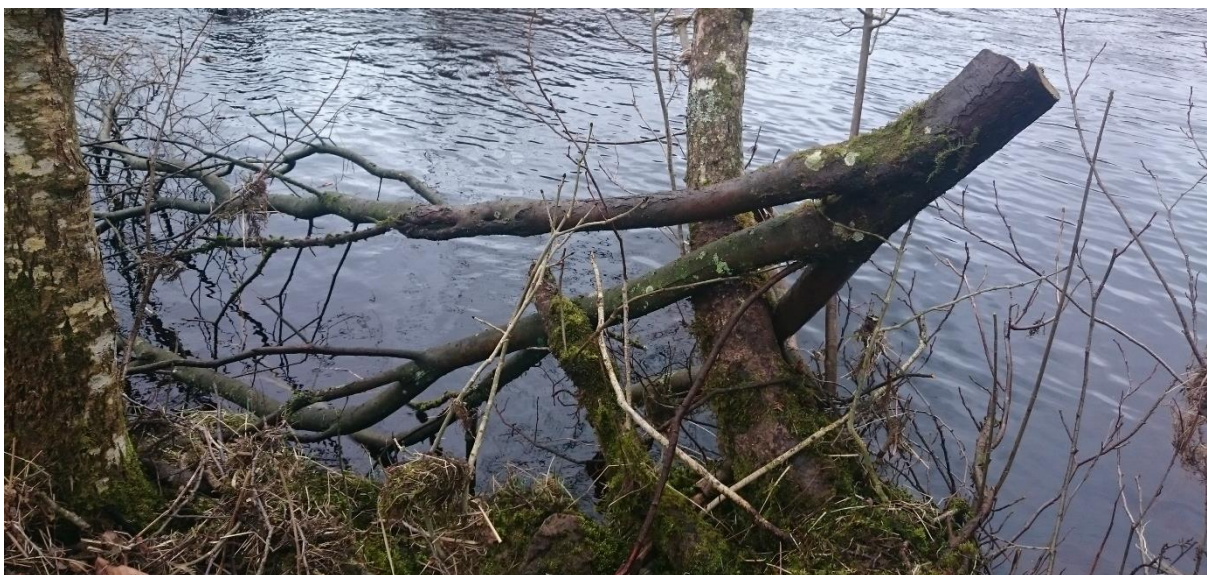
Figure 22: Tree "hanger" with flow travelling from right to left.

installations (e.g. Fig.21) and/or tree hanger features (e.g. Fig.22) particularly at points mentioned throughout this report

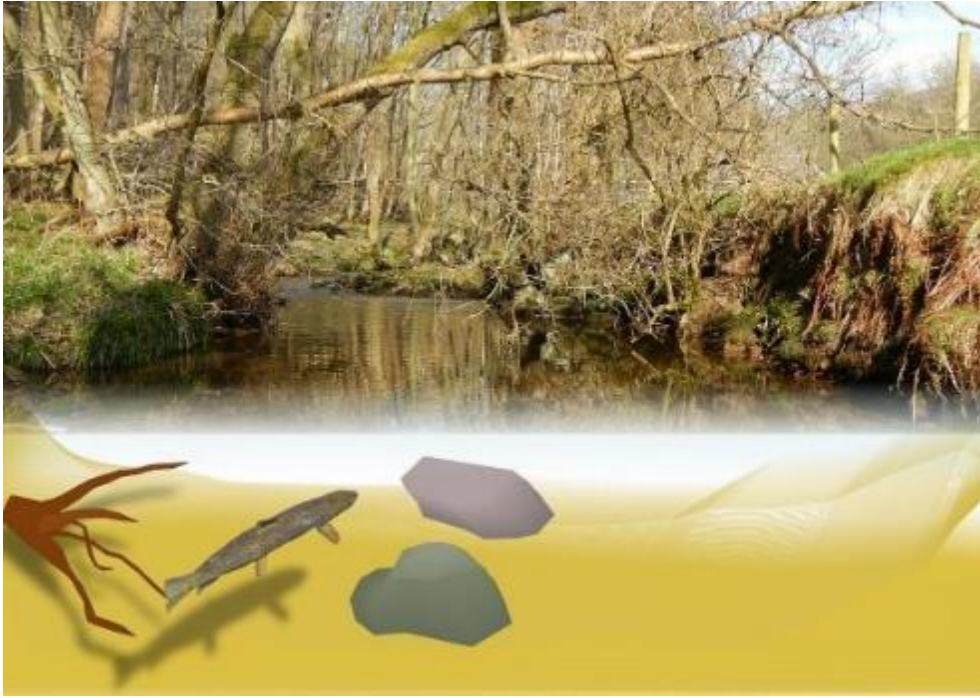
**Figure A4: The availability of deeper water bolt holes (>30cm to several metres), low overhanging cover and/or larger submerged structures such as boulders, fallen trees, large root-wads etc. close to a good food supply (e.g. below a riffle and with prey likely to fall from overhanging tree canopy in this case) are all strong components of adult trout habitat requirements.**
