**Advisory Visit**

**Bradwell Brook (River Noe), Derbyshire**

**11<sup>th</sup> February, 2009**

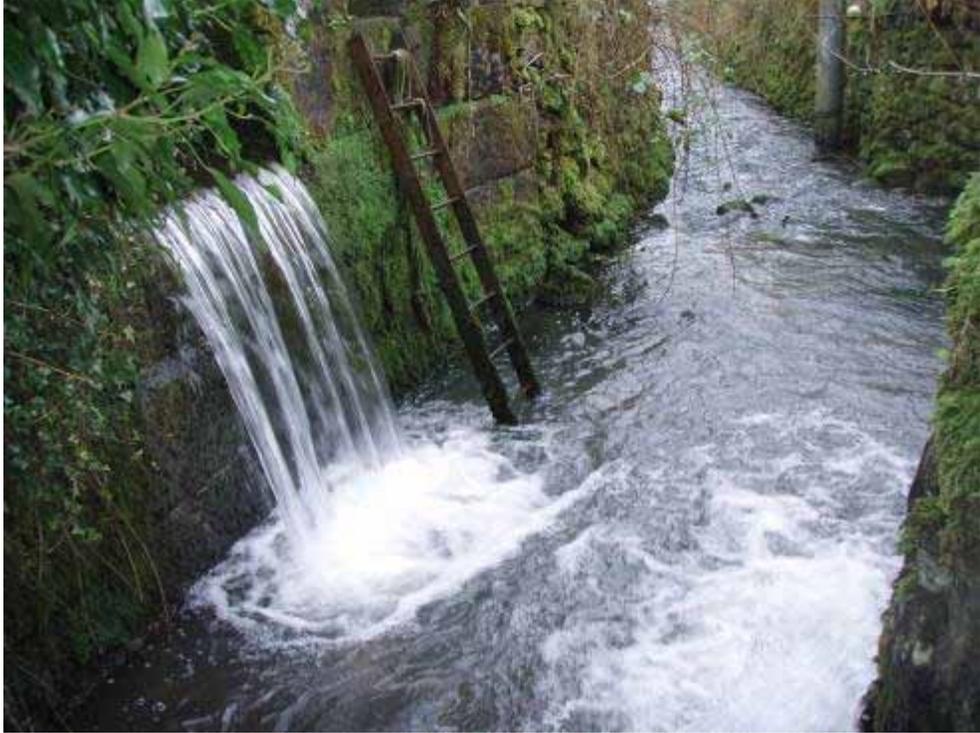
The Bradwell Brook emerges from springs (Photo 1) above the village of Bradwell (National Grid Reference SK 17410 80984). It flows through a walled channel and under several bridges and culverts within the village, and the channel has a uniform width and is shallow, with little depth variation (Photo 2). The bed of the brook is gravel, but this is unsorted and hence not well-suited to successful trout spawning. Generally this would be considered poor habitat for trout, but two factors mitigate against this:

Photo 1 The spring source of the Bradwell Brook

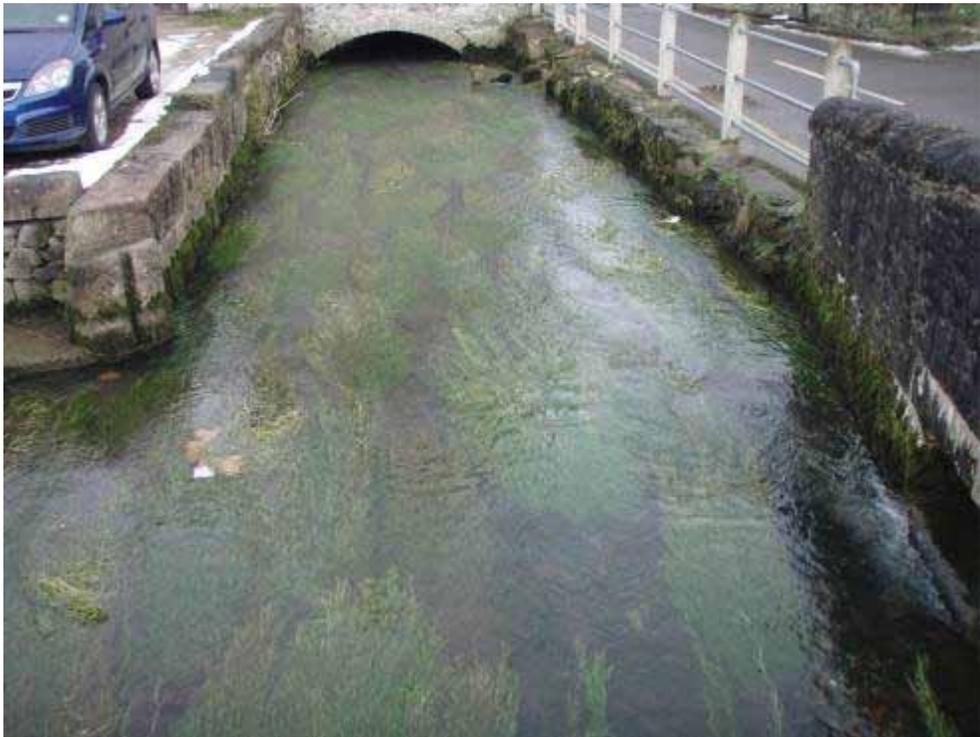
- the abundance of submerged vegetation (water crowfoot *Ranunculus* sp.) provides good cover for juvenile fish and their invertebrate prey. Larger adult fish are known to be present in the few deeper areas with overhead cover (bridges and culverts).
- Being spring-fed, the brook has a high base flow with relatively little variation.

Photo 2 The brook in Bradwell village: wide and shallow with hard banks, but full of water crowfoot.

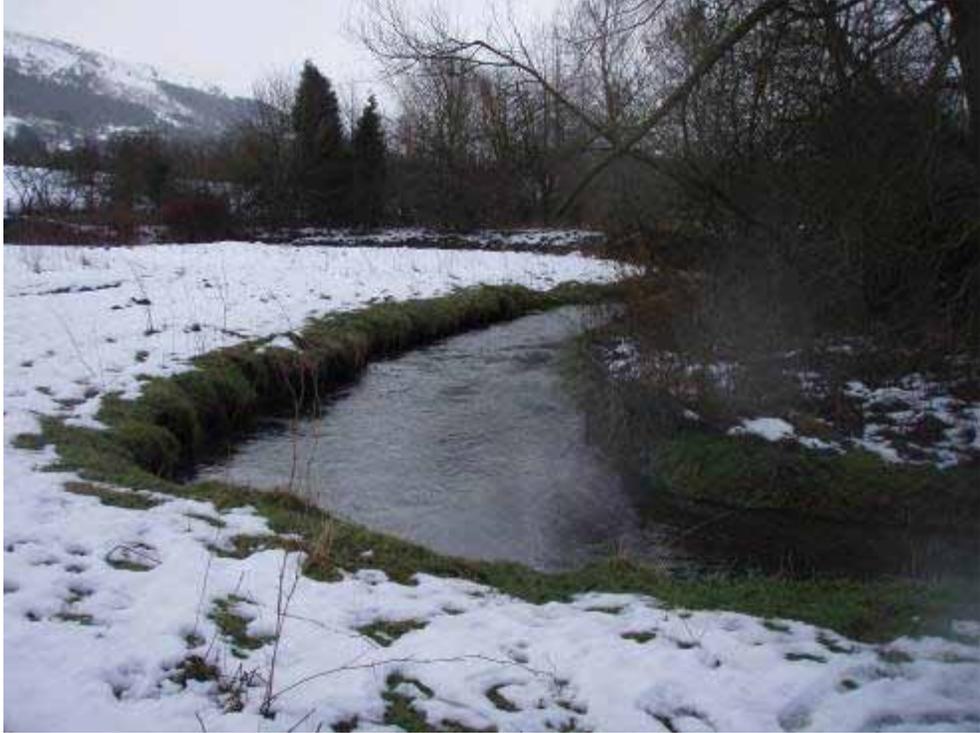
Downstream of the village centre the brook flows through fields (RHB) and the fringes of Bradwell and some houses and factories back onto the brook. The channel is more natural, with a meandering plan-form and a pool and riffle sequence; this promotes greater variation in depths and better habitat for the various life stages of trout. The lateral scour pools on the outside of bends have deeper water suitable for adult fish, whereas the gravel deposited below these areas form shallow riffles suitable for spawning and juvenile habitat (Photo 3).

Photo 3 Below Soft Water Lane – deep pool on the outside of a meander

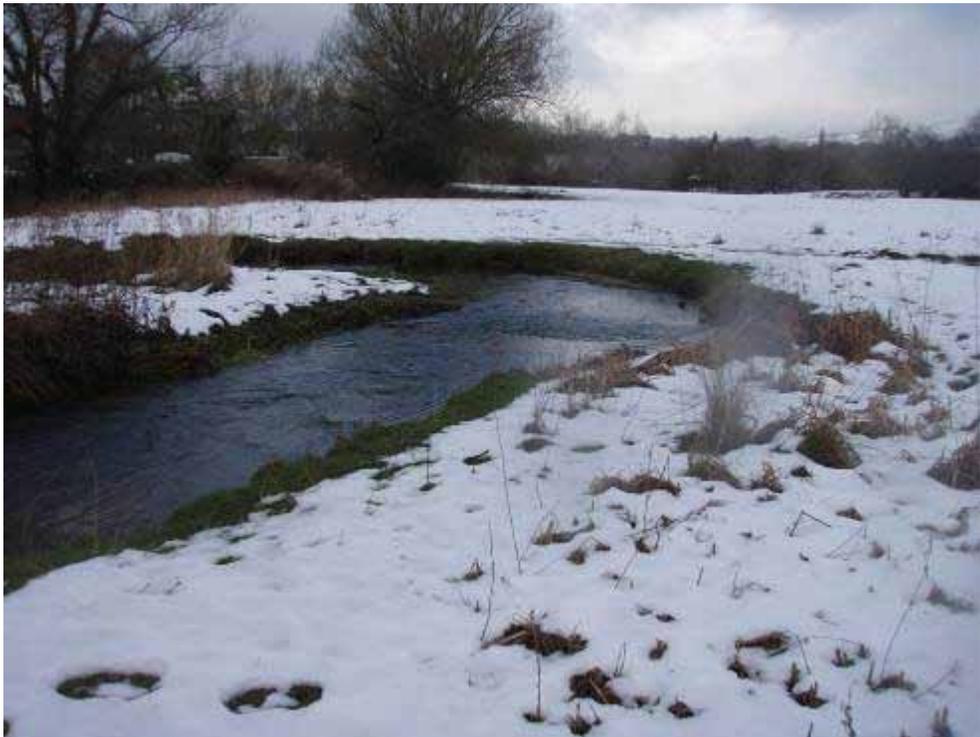
The habitat is generally good in this section, with water crowfoot and gravel present. There is however a lack of low cover over the water which is essential for creating lies favoured by trout; the field on the right bank is grazed but unfenced, leaving the river margin bare and exposed (Photo 4). The left bank has a better margin in places (Photo 5), although grazing animals may be able to wade the river to access this bank, limiting the development of a healthy riparian margin.

Photo 4 Lack of low marginal cover

Protecting the bank from grazing, encouraging the tussocky, over-hanging fringe (as shown in Photo 5), and maybe planting some low-growing bushy trees (such as willows: *Salix caprea*, *S. cinerea*) would benefit this section, and may also improve the habitat for water voles.

- Protect the left bank from grazing livestock on the section between Soft Water Lane and the Old Pond to allow a tussocky margin to develop, along with some low-growing native shrubs (e.g. willows). There may be grants available to fund fencing and livestock watering points, particularly if this would benefit other species such as water vole.

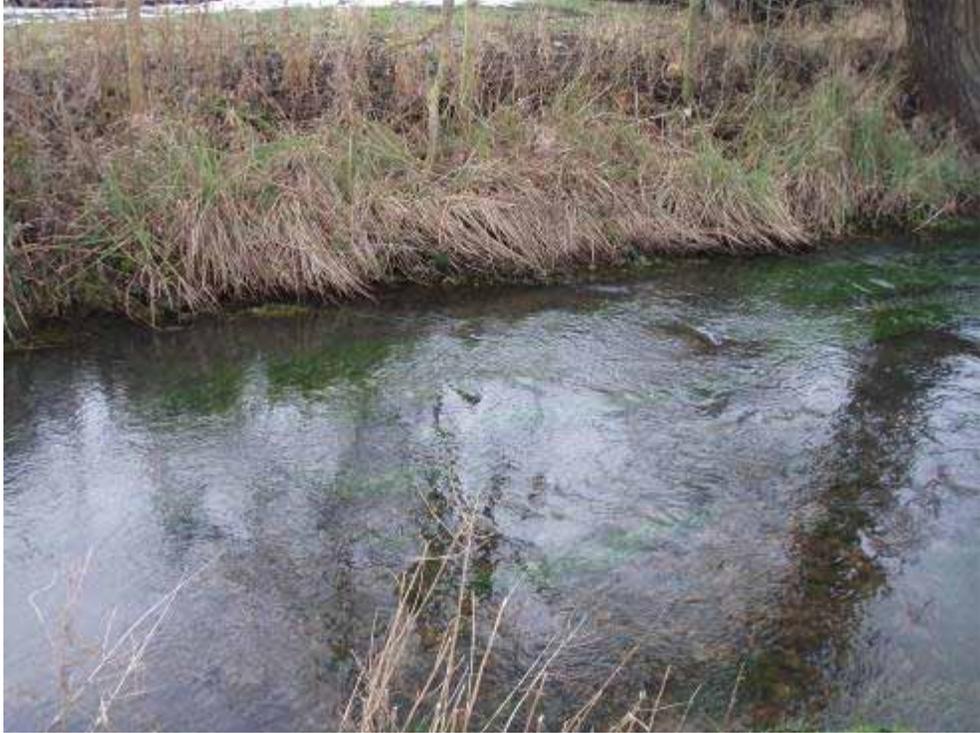
Photo 5 Good marginal cover provided by tussocky vegetation

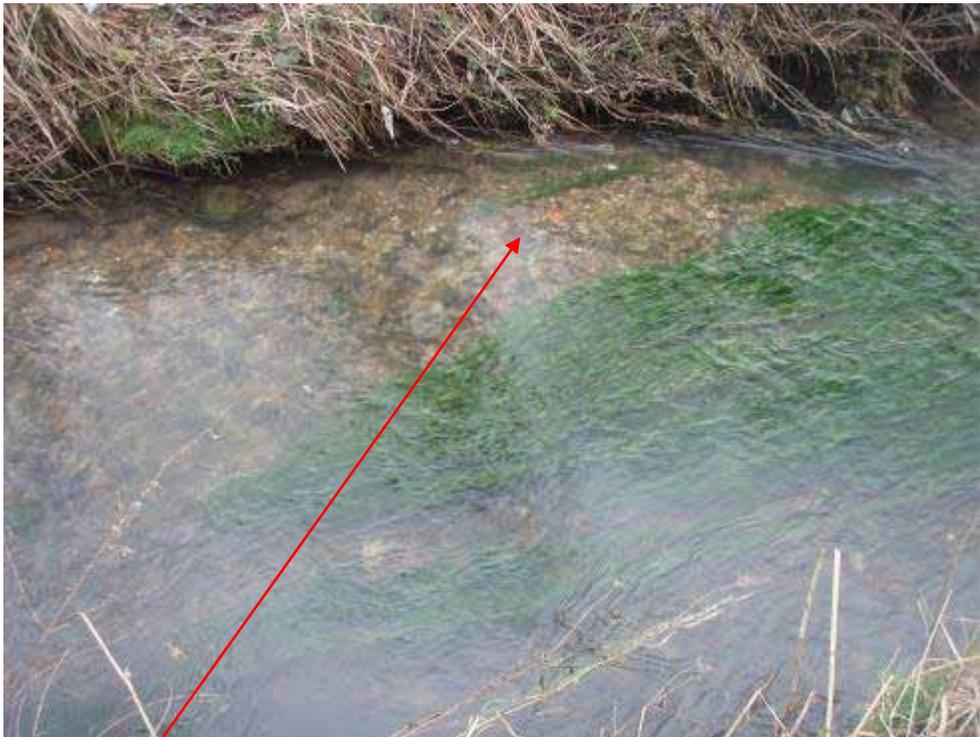
Photo 6 Trout redd cut into gravel where the current is pinched by water crowfoot beds

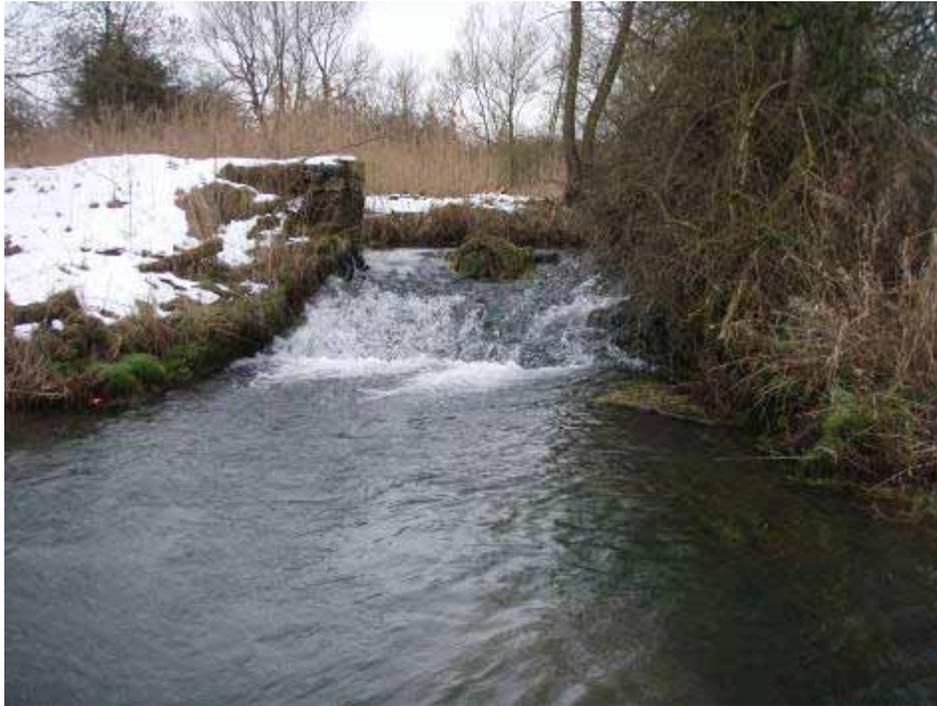
There is an old pond alongside the brook on the right bank. A weir (Photo 7) impounds the brook and the pond was formerly supplied by water diverted from the impoundment. These arrangements are dilapidated and the former pond is now a wet woodland and fen, dominated by reeds, sedges, grasses and willows (Photo 8). The Conservation Service of the Peak District National Park Authority (PDNPA) are working with the club to conserve the wildlife importance of this site which includes the above habitats and the associated plants, invertebrates, birds (warblers, wren, blackcap, bullfinch, kingfisher, dipper and wagtails), mammals (water voles, harvest mice) and fish (bullhead, brook lamprey, brown trout).

In addition to the weir at the former pond, there are additional weirs just downstream. One appears to be a gauging weir (Photo 9), and the other was not inspected but is a more substantial structure associated with Stretfield Mill. All the weirs present barriers to fish movement and fragment populations, limiting access to spawning, feeding and resting habitats. Ideally actions should be taken to improve access for fish over these barriers by either their removal or the construction of a fish pass or easement. It should be noted that the wetland habitat area previously described depends upon the water level behind the associated weir.

Photo 7 Weir alongside old pond

- Start a dialogue with the Environment Agency regarding the improvement of fish passage at the weirs on the Noe and Bradwell Brook. James Finnegan is the Fisheries Technical Specialist at the Nottingham Office, and further information on fish passage can be found in the EA Fish Pass Manual.

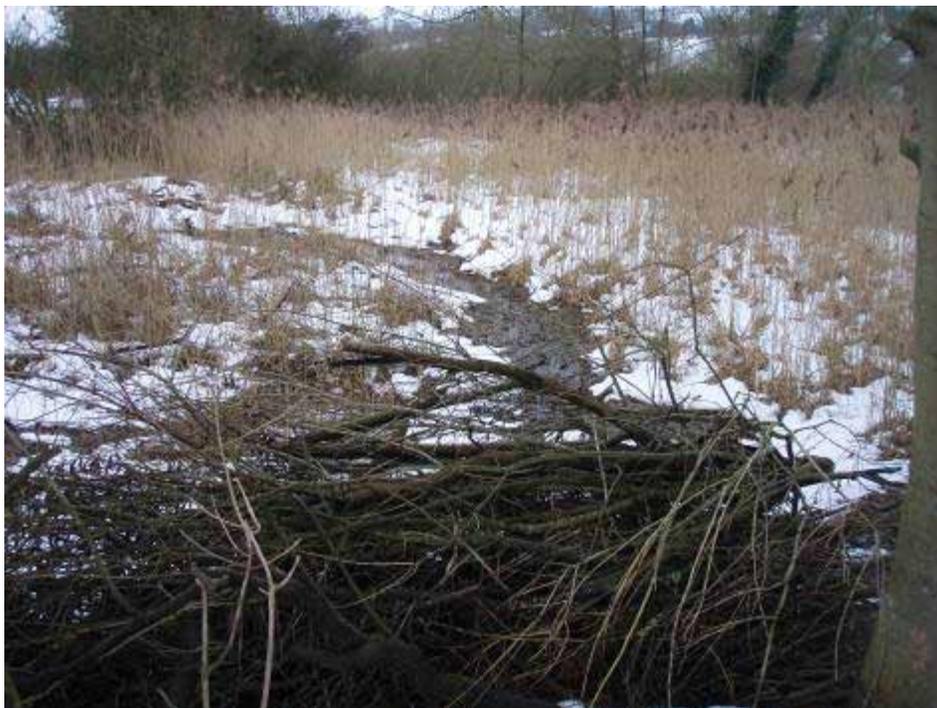
Photo 8 Wetland area on the site of the old pond

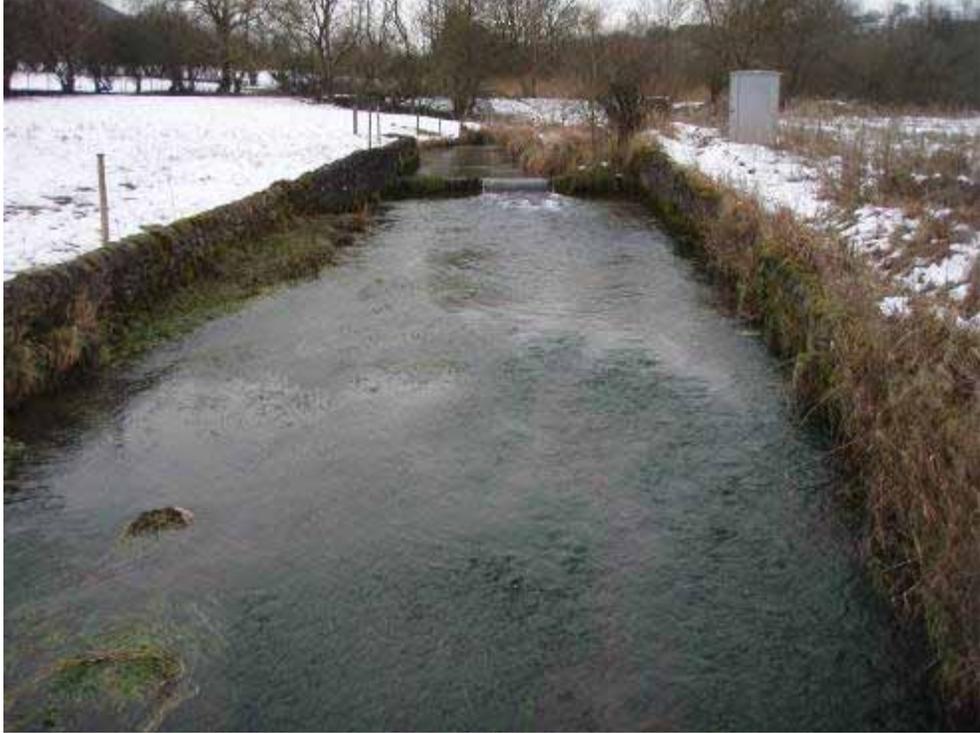
The river channel in the section between the weirs is uniformly wide and shallow, and between stone walls in some parts (Photos 9 and 10). The

habitat is not particularly good for trout, although the abundant water crowfoot affords cover for juvenile fish.

Photo 9 Gauging weir and walled, wide, shallow channel

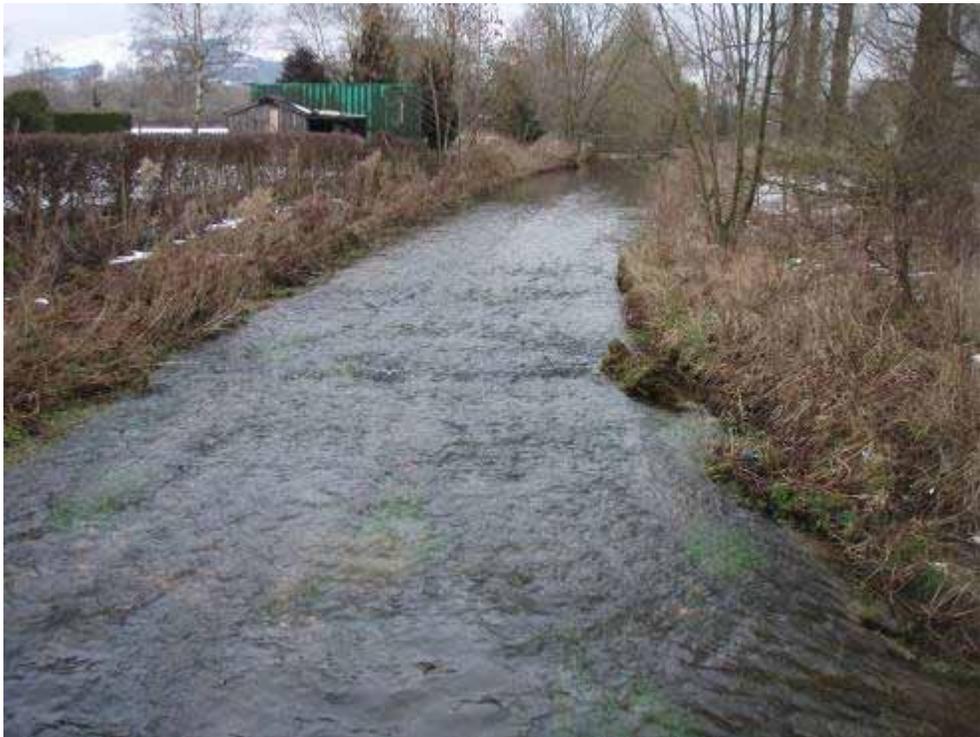
Photo 10 View downstream towards Stretfield Mill

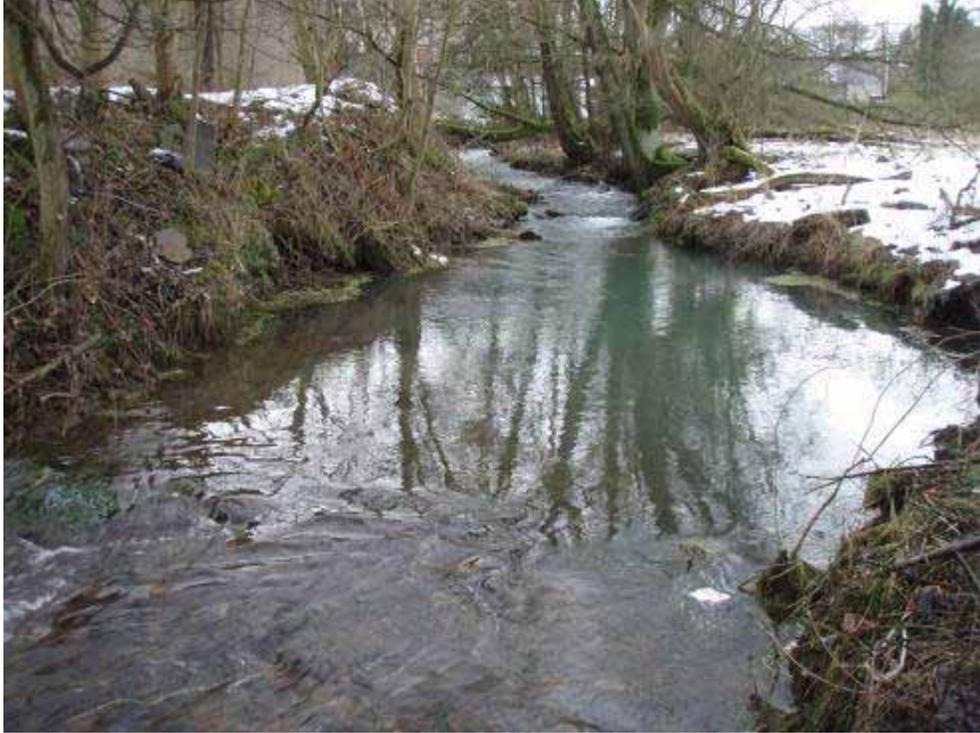
The lower section of the brook has some very good habitat for wild trout. There is a meandering plan-form, a pool and riffle sequence and variation in channel form (widths and depths) (Photo 11). The river margins are largely wooded with some more open areas, and there does not appear to be any grazing of the banks; there are some excellent wet margins with tussocky vegetation ideal for water voles (Photo 12). Water crowfoot is present but in lesser quantities than upstream because of the increased shading of this section. The river bed is predominantly gravel of an ideal size for trout spawning, although there were relatively few areas of really well-sorted gravel that encourage fish spawning and good egg survival (Photo 13).

Photo 11 The lower section of the brook has a good pool and riffle sequence

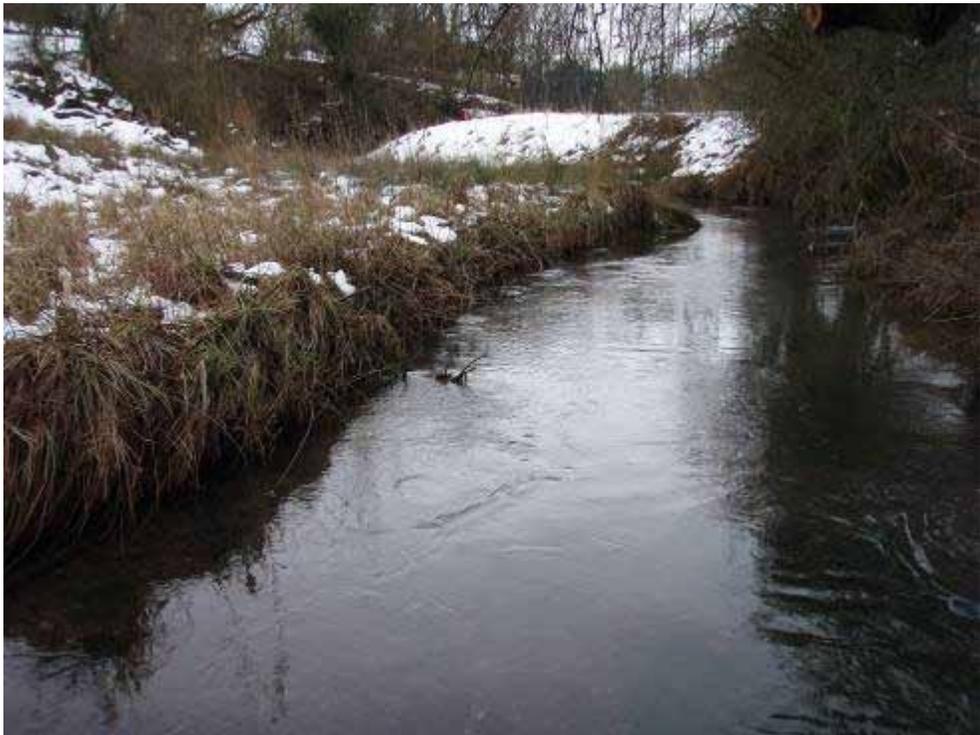
Photo 12 Excellent tussocky, overhanging marginal vegetation

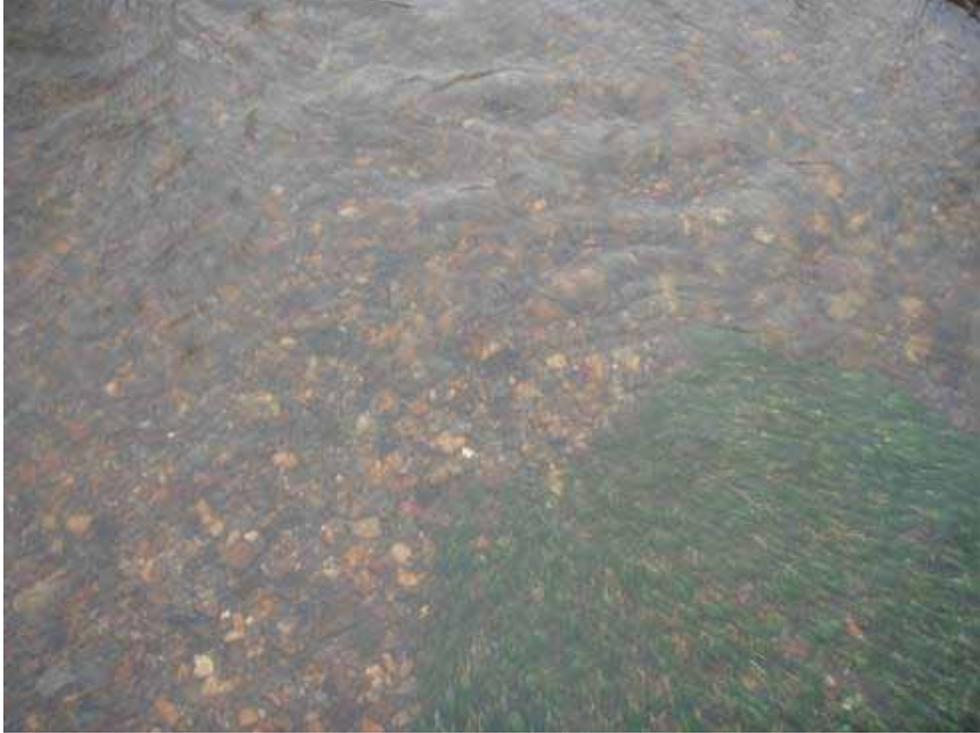
Photo 13 Good spawning gravel, but it would benefit from scouring and sorting by LWD structures

- Continue existing mink control by trapping using the Game and Wildlife Conservancy Trust raft method in partnership with Derbyshire Wildlife Trust.
- Carry out targeted gravel cleaning by raking or jetting. This should be carried out in September or early October prior to the trout spawning season. About 25% of riffle areas should be done annually on a rotational basis. Observation of the river for redds in the winter to see which areas are used by spawning trout can be used as a guide for where to clean gravels in the subsequent year.

Raking is carried out using garden forks to turn over gravel to a depth of 20 – 30 cm. Jetting uses a high pressure water jet or leaf blower to wash fine sediment out of the gravel (Photo 21). Both techniques should be carried out working in a downstream direction.

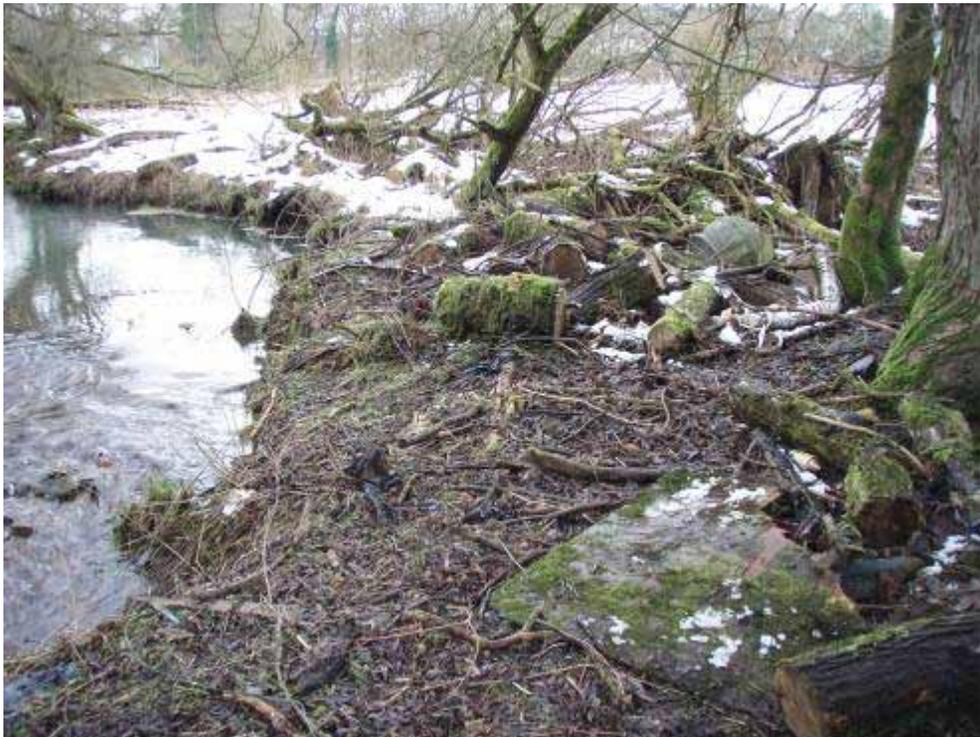
This section of the brook has recently been cleared by the club to facilitate access for angling. During this work, large amounts of naturally occurring woody debris, and also man-made litter and detritus, have been removed from the river channel (Photo 14). On a river like the Bradwell Brook which is fished, there is a balance to be struck between creating access for angling and retaining areas of large woody debris (LWD) essential for healthy fish stocks and stream ecology. In this case the emphasis has been placed on improving access and the river and fishery would benefit from the balance being tipped back in favour of retention of more LWD.

Photo 14 Considerable amounts of LWD have been cleared from the brook

This section of the brook would benefit from a more relaxed approach to the management of LWD, and an acceptance that having some areas of the stream which are not fishable will increase the overall quality of the fishery. This applies equally to the River Noe, because nurturing the potentially high quality spawning habitat in the Bradwell Brook will provide more fish to seed downstream. It would also benefit this section of river in the short to medium term to re-introduce some LWD into selected locations.

· Adopt a policy of retaining some LWD in the river channel. The West Country Rivers Trust provides a useful guide to the management of natural LWD:

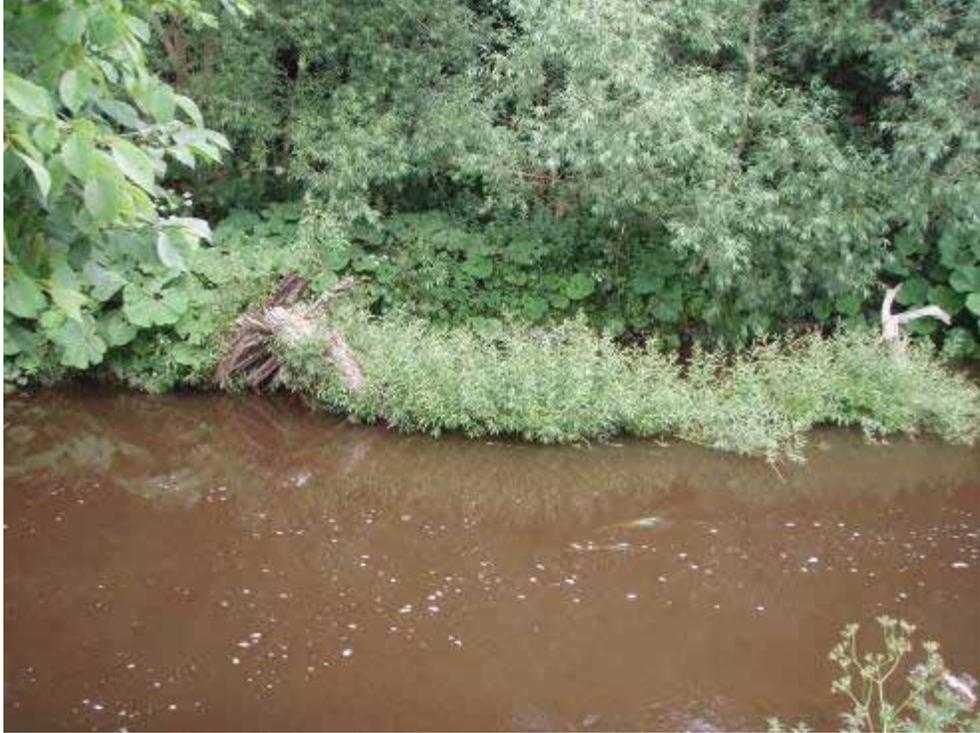
LWD refers to all wood naturally occurring in streams, including branches, stumps and logs; derived from trees within the riparian corridor. Streams with adequate LWD have greater habitat diversity, a natural meandering shape and greater resistance to high water events. Therefore LWD is an essential component of a healthy stream's ecology and maintains the diversity of biological communities and physical habitat (Photo 15).

Photo 15 An example of LWD on the River Dane, Cheshire. The fallen willow is providing superb low cover and creating lies for adult trout

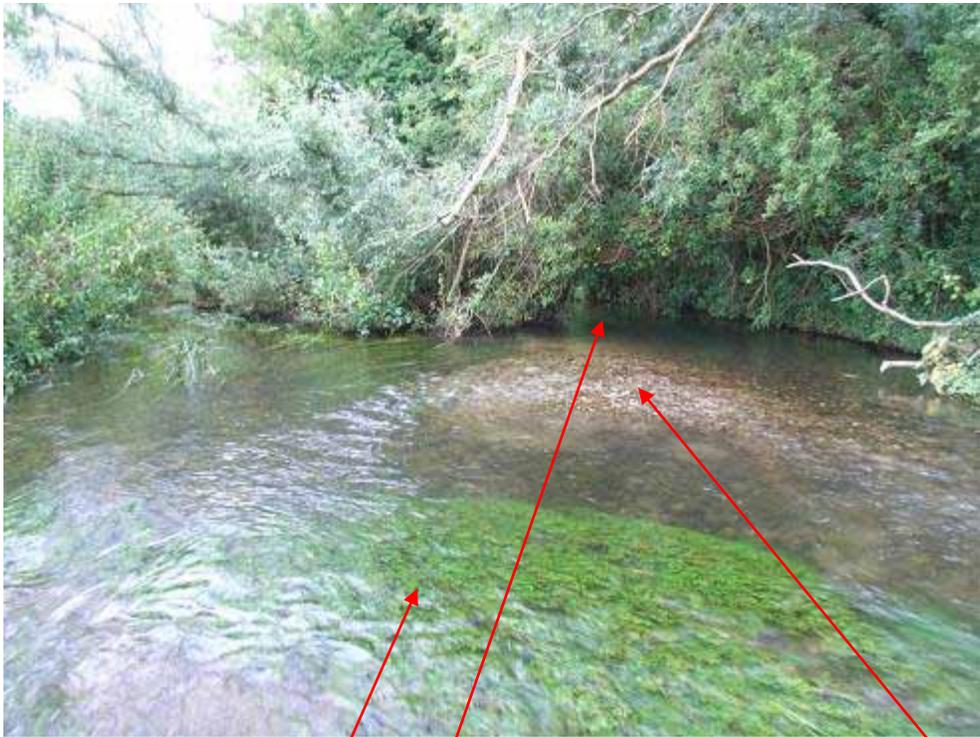
Photo 16 LWD actively creating trout habitat: deep scour (adult holding water), cleaned and sorted gravel (spawning), and in-stream vegetation (juvenile cover). Picture courtesy of Dominic Martyn (EA).

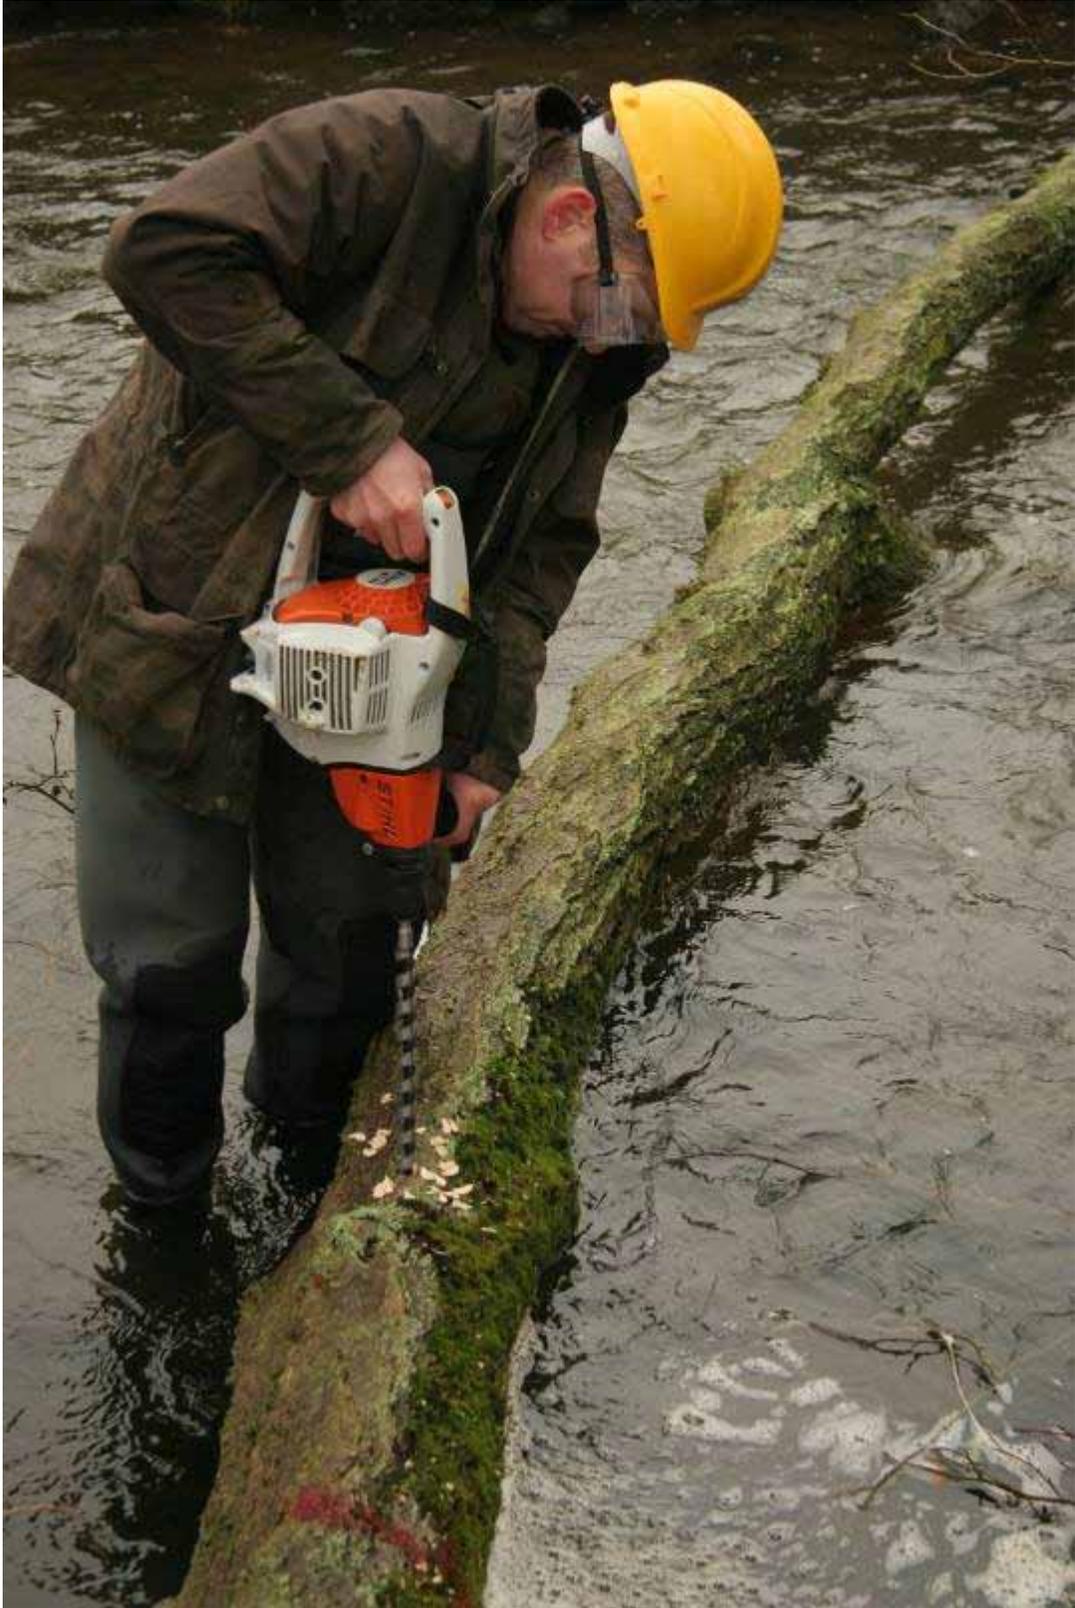
Photo 17 Installing LWD

- Introduce LWD for habitat structure in suitable locations (Photo 17). This can be done in several ways for different reasons:

1. To create deep scour pools and cover for adult habitat (mimicking natural LWD dams).
2. In riffle areas to create gravel scour and low cover to improve spawning conditions, e.g. using upstream facing flow deflectors and hinging trees/boughs into the river rather than removing.
3. In the straightened shallow sections (e.g. Photo 18) to improve flow diversity and cover. Hinging of trees, pinning trunks and root balls to the river bed, and midstream deflectors.

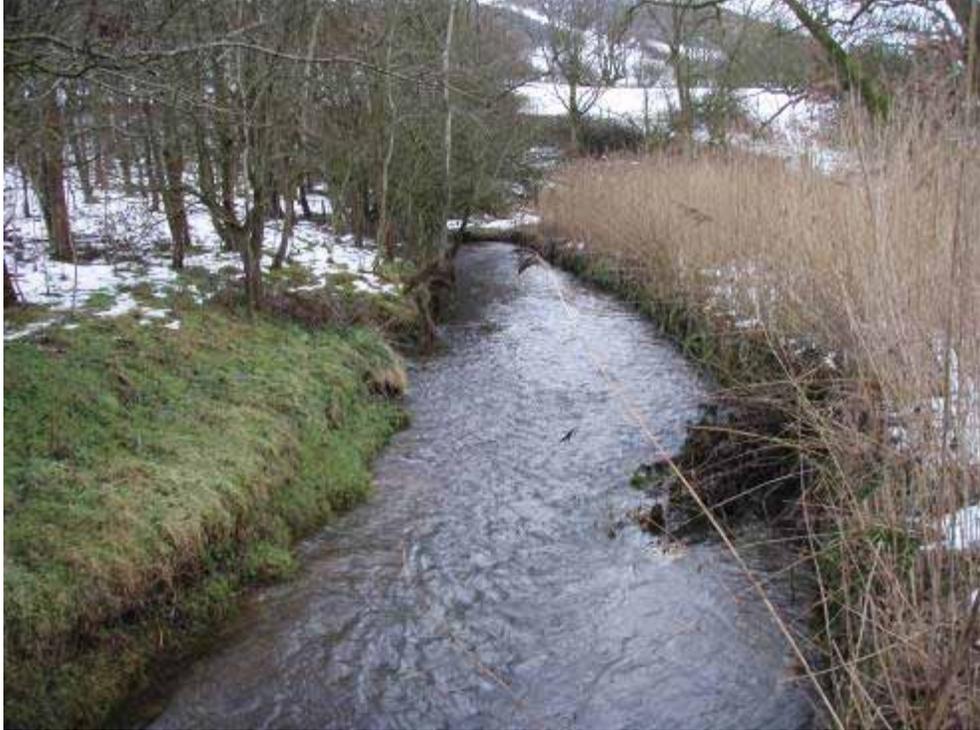
Photo 18 Straightened section suitable for installation of LWD flow deflectors

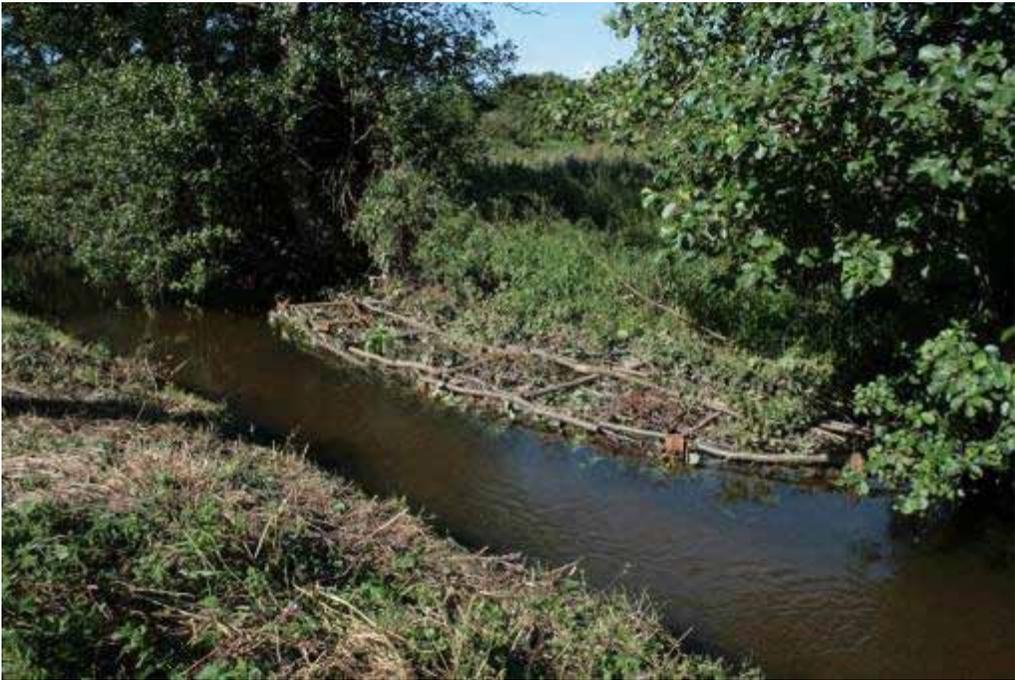
Photo 19 Example of a brushwood mattress

- Introduce LWD and coarse woody debris (brushwood bundles) to provide refuge for fish from predators such as goosander and mink, and to backfill some areas of bank damage (e.g. Photo 19). Brushwood bundles or 'mattresses' can be easily constructed and installed on working parties, and provide valuable cover for most life stages of fish, increasing their survival rate (Photo 20).

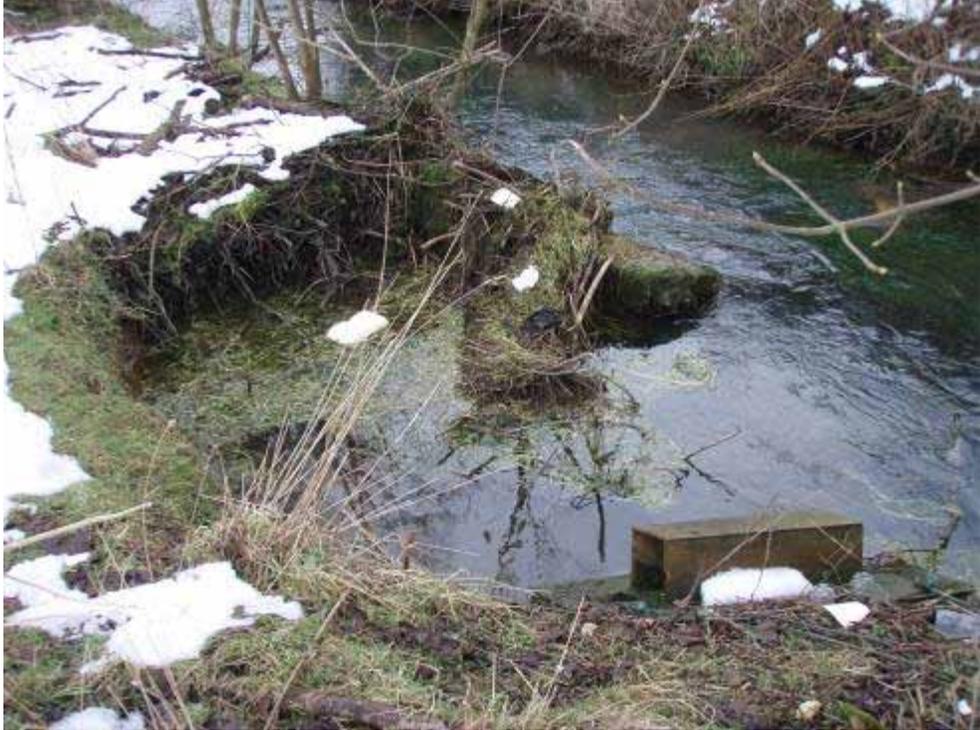
Photo 20 Area suitable for backfilling with brushwood

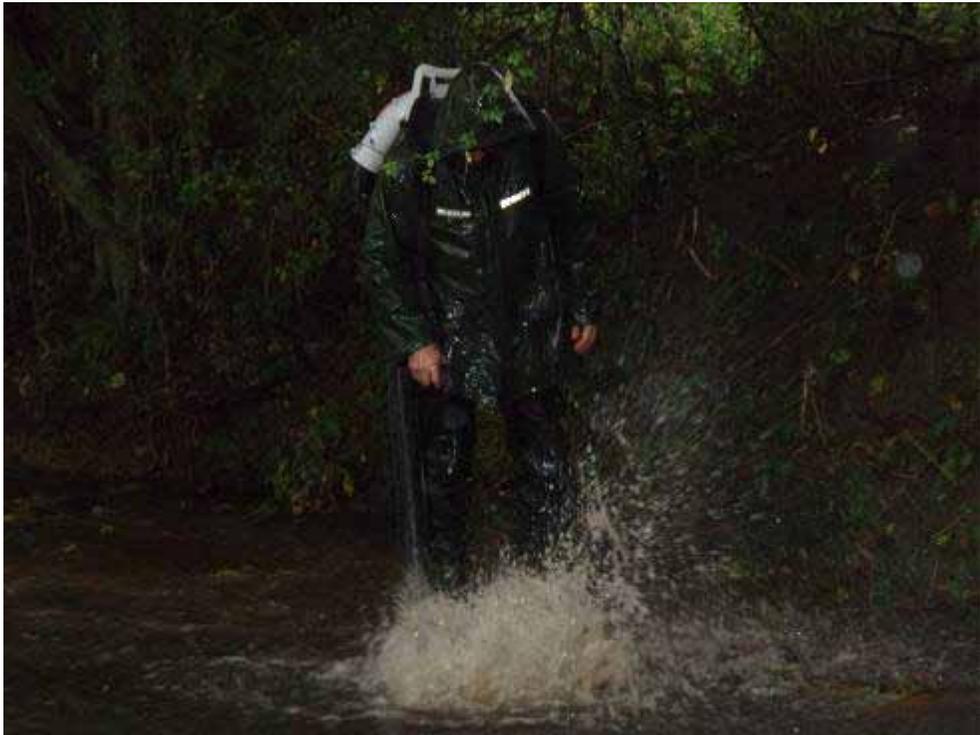
Photo 21 Gravel cleaning with a portable leaf blower
