River Bray – Challacombe Reservoir

An advisory visit carried out by the Wild Trout Trust – June 2008

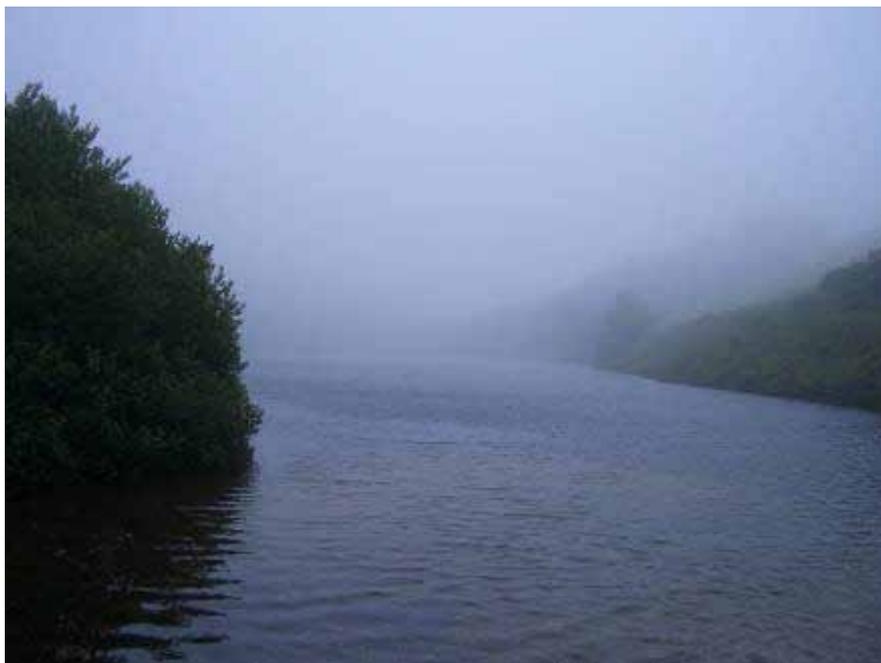
Challacombe reservoir looking towards the dam

Challacombe reservoir is a typical small (1.5 hectares) upland storage reservoir formed by damming the headwaters of the River Bray, which cuts through a steep U-shaped valley. The dam is a substantially engineered structure but the majority of the margins are formed from the naturally steep slopes that feed down from either side of the Bray valley. At the inlet of the reservoir, where the inflowing stream discharges there is a comparatively shallow batter to the reservoir bed and some useful marginal cover by way of some large goat willow or sallow *Salix caprea*. This is the only area where there are substantial shallows, with the majority of the reservoir having very steep margins dropping down to a maximum depth of 9 metres.

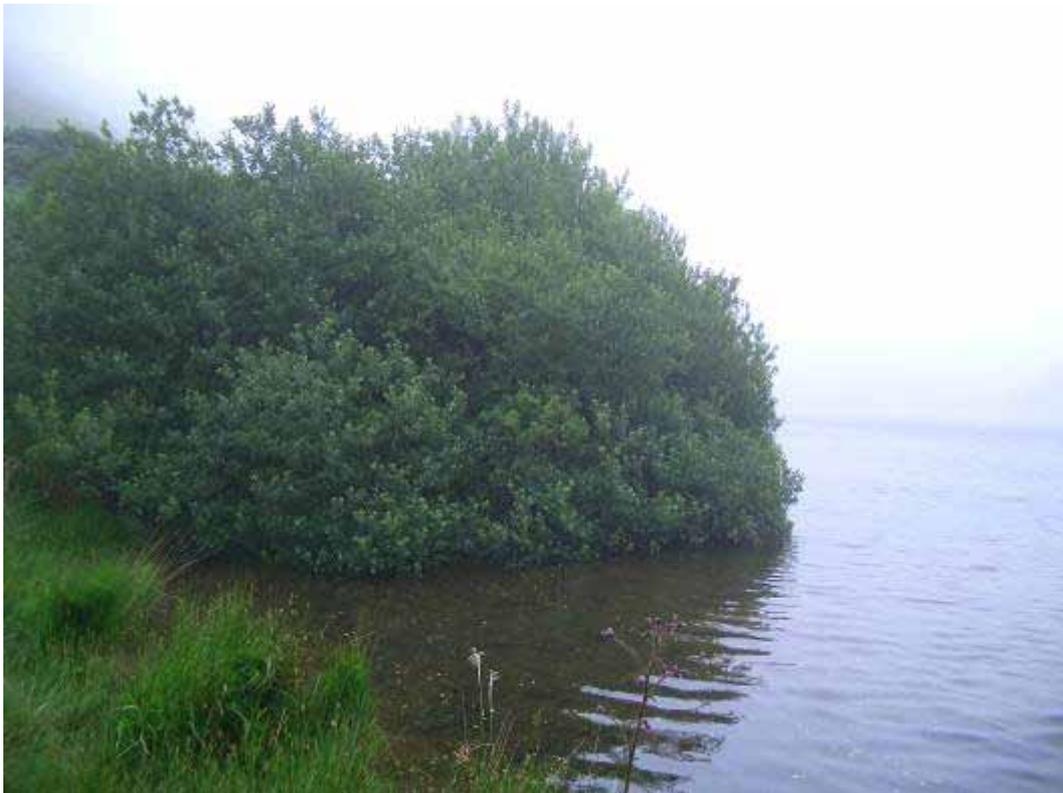
The area adjacent to the inflowing stream undoubtedly has suitable habitat and the overhanging goat willows lining the short section on the left bank will provide additional cover from predators and a source of allochthonous food items. It would be sensible to increase the amount of marginal cover adjacent to these shallow zones to provide as much cover as possible. It is also possible to create further areas of shallow water by creating large marginal shelves, either by re-profiling the existing margins with a large tracked excavator or by importing suitable material to create wide shallow shelves. Environment Agency, Water Company, Natural England and possibly local authority consent would be required for any works of this nature. This work would also be very expensive and not make a significant difference to the bulk of catches made by anglers.

A shallow margin with excellent cover – good wild trout habitat

Further shallow lake margins could be created and should be managed to maintain a mosaic of light and shade, interspersed by cover afforded by marginal trees and shrubs. Large woody debris in the lake margins will also help promote further cover and habitat for invertebrates.

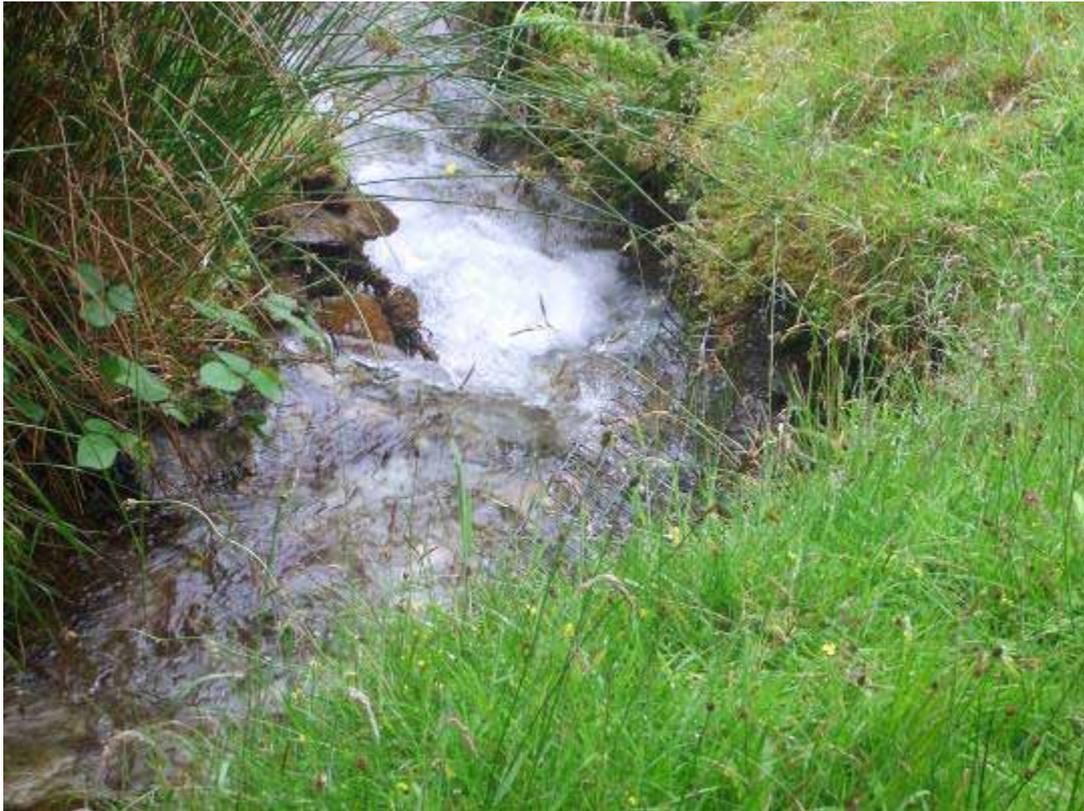
A typical little plunge pool. Note the eroded geotextile on the RH bank.

During the inspection there was evidence of attempts to protect the banks from erosion using plastic geotextile. It is understood that this area is quite heavily used during driven shooting events. To ensure that brown trout production is maximised over this comparatively short section of river, it would seem sensible to ensure that disturbance to banks and bed are kept to a minimum during the peak spawning period - November to February.

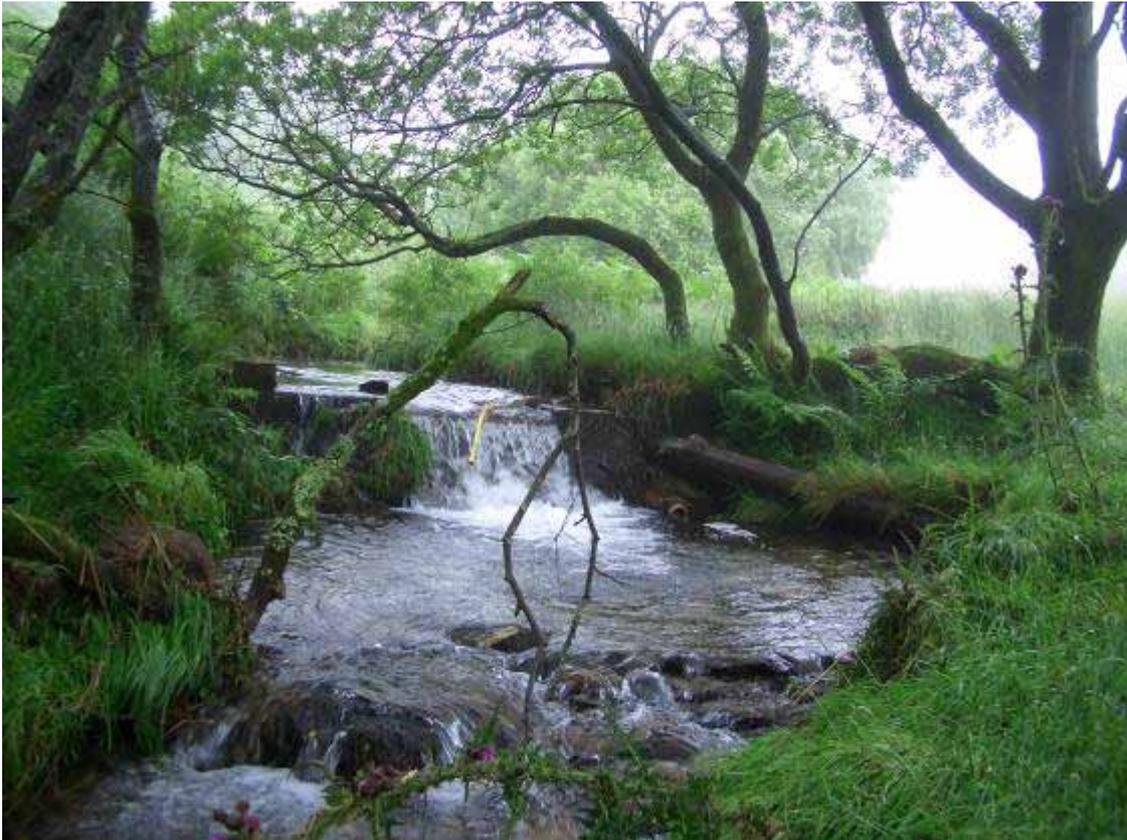
Currently mature trout wishing to migrate to conducive spawning grounds upstream from the reservoir, will only have about 100 metres of channel to utilise before reaching a significant man-made impoundment. The weir was constructed to facilitate the use of an overflow pipe. The pipe was apparently used during the reservoir construction and could also potentially be used if there is a requirement to divert flows away from the reservoir. The height of the head loss covering the downstream to upstream water levels was estimated to be

approximately 750mm. At the time of the visit the stream was flowing strongly but the structure would certainly limit effective upstream migration. It is possible that during a significant spate the tail water level could rise to an acceptable height making free migration possible. It is generally accepted that any jump greater than 300 mm for trout is deemed excessive and will hamper spawning migrations. Retaining the bypass facility may be a necessary part of the infrastructure of the site, so removing the weir may not be a practical option. A possible solution is to reduce the overall head loss by creating a simple timber pre-barrage using tree trunks.

The weir 100m above the reservoir – A possible block to upstream migration

At the tail of the weir pool there is a naturally pinched section where large woody debris (LWD) could be wedged and pinned to create a small debris dam. This will have the net effect of backing up water levels to the weir following a rainfall event and should facilitate easy migration. Debris dams in their own right rarely cause difficulties for migrating fish and fulfil a range of other useful functions, including the trapping of finer gravels and sediments as well as providing a primary source of food items for invertebrates and ultimately trout.

Improvements could be achieved using tree trunks and LWD to reduce head loss at the structure and to stabilise spawning gravels during heavy rainfall events.

- Construct a natural debris dam a few metres below the existing weir to raise water levels and facilitate easier spawning migration.
- Do not remove any woody material from the stream and actively place LWD to help stabilize finer gravels.

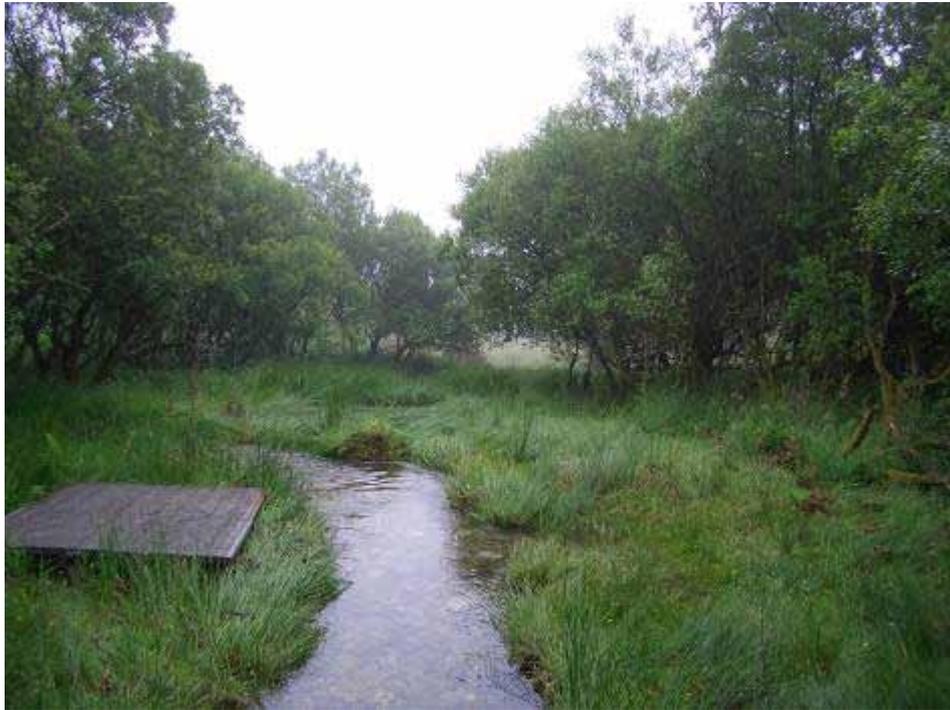
A shooting platform adjacent to a spawning riffle. A bit too close perhaps?

- Raise awareness to the group responsible for managing the shoot to ensure the stream is given as much protection as possible during the important winter spawning period.
- Consider planting more willow on the lake margins, particularly near the shallow top section.
- Do not stock with fertile brown trout and if possible only stock sterile rainbows. Environment Agency consent required.
- Monitor the lake margins following improvements to evaluate presence of small browns.
- Undertake regular monitoring of aquatic invertebrates.
- Consider creating further marginal shelves in the deeper parts of the lake. Note this work will be potentially difficult and expensive and require various consents from EA, NE and your local authority.

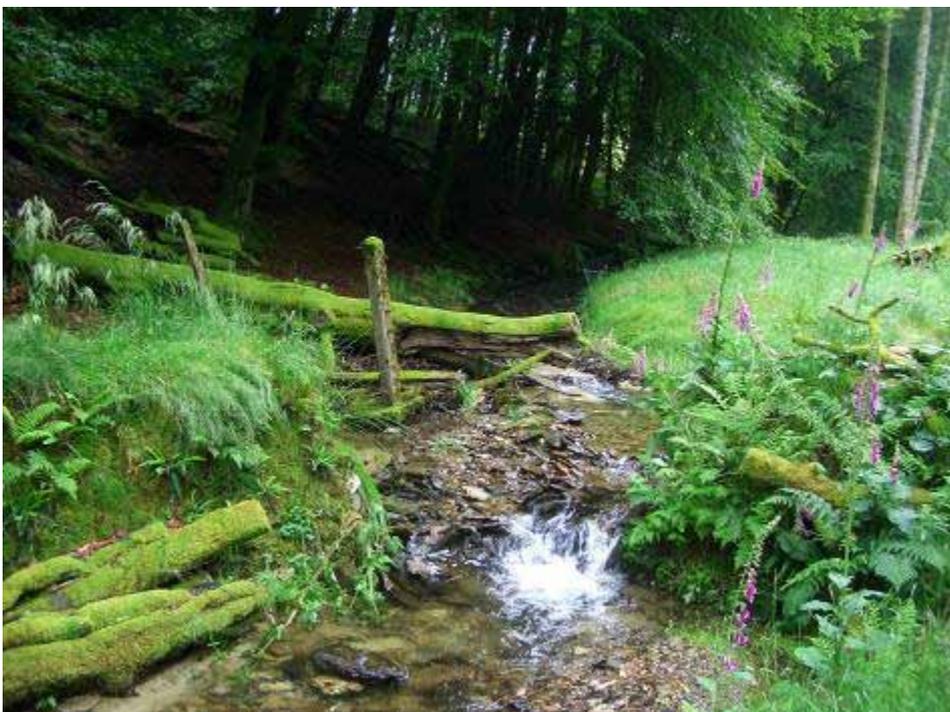
A good example of LWD on the section of stream below the reservoir

In steep catchments, prone to significant spate events, woody debris that slows the rate of flow and traps finer gravels can help to improve and protect spawning habitats. It is recommended therefore, that any fallen timber found is left within the channel and even actively placed there to help stabilize bed material and provide micro pool habitats for spawners. Although there is no suggestion that
