Habitat Advisory visit to the River  
Bride, Co. Waterford and Co. Cork,  
Eire.

Undertaken on behalf of Tallow and  
District Angling Club by Vaughan  
Lewis, Windrush AEC Ltd  
May 2012

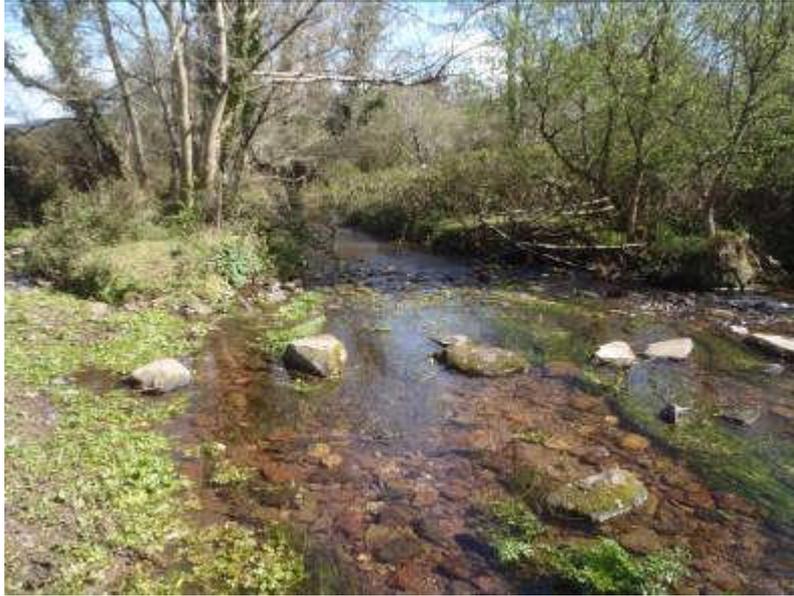
The channel had a generally steep gradient, with a well-developed pool and riffle sequence. The upper section of the reach had a cobble and boulder dominated substrate, with small amounts of gravel suitable for spawning brown/sea trout. The low flows in the river revealed some braiding of the channel, with a dry stony 'island' visible.

In places, there was a well developed fringe of deciduous tree and shrubs. The channel was not however overshadowed, with good stands of submerged vegetation including water crowfoot, water parsnip and water dropwort present in the more open areas.

### **Upper section of the Glenaboy**

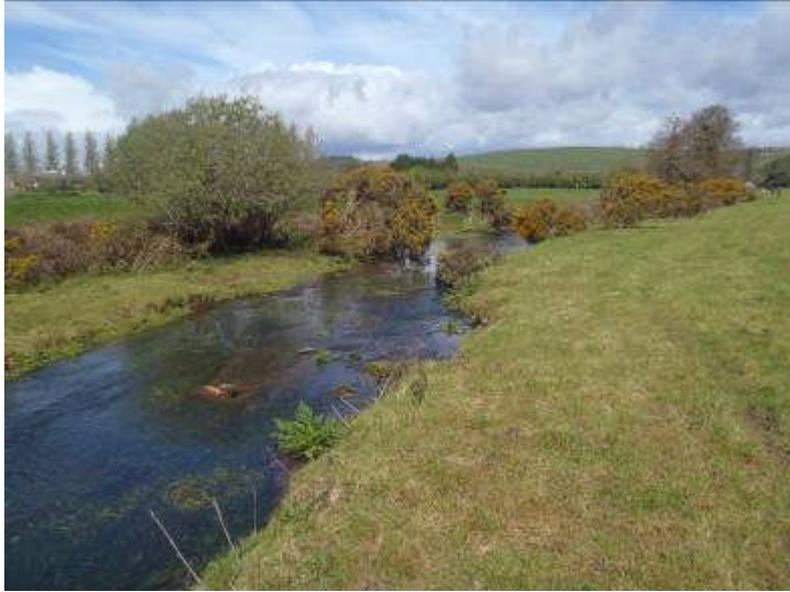
The channel in the lower section was rather more open, with fewer bankside trees and less shading of the channel. Cover in the channel was provided by submerged weeds, over-hanging brambles, gorse bushes and small amounts of Large Woody Debris (LWD). The substrate size remained generally more suitable for salmon spawning, with cobbles and large gravel dominating. There was however an increasing number of small pockets of gravel suitable for trout spawning. The substrate was generally poorly sorted, with significant deposits of fine sediment visible.

**Lower section of river showing its open aspect with limited shade and cover**

- A mix of native deciduous trees should be planted along the more open sections of the reach to increase shading of the channel as they grow. There are increasing concerns that average water temperature is rising in small streams in the face of climate change, with maximum temperatures attained near to lethal levels for salmonids

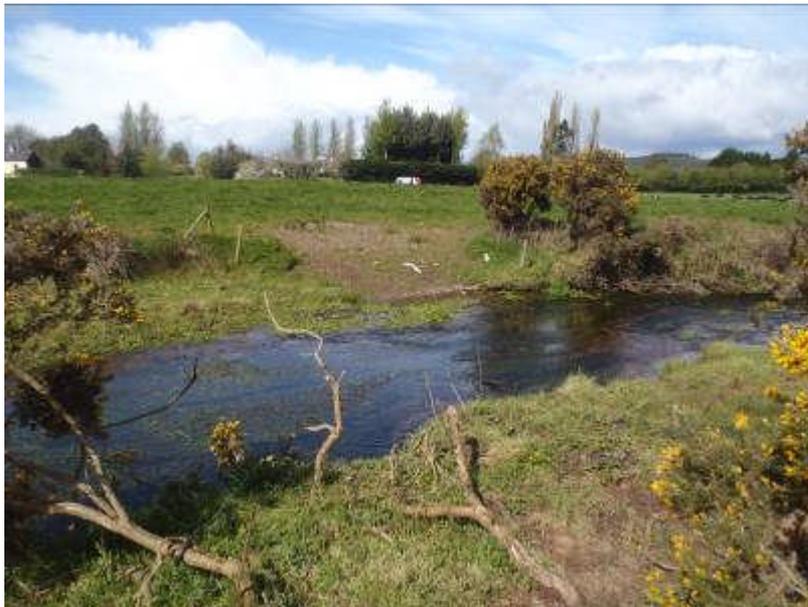
Further downstream, the channel gradient decreased slightly, with land use dominated by intensive grazing, largely for dairy cattle. The land was partially fenced on the LB, but unfenced on the RB. As a consequence, there were some sections of extensive and damaging over-grazing. Lengths of the bank were badly poached, with excessive sediment released into the channel. The long-term overgrazing had also resulted in an overwide and shallow channel cross-section.

**Over-grazed and over-wide channel**

- The damage caused by cattle poaching should be addressed by the erection of stock proof fencing along both banks of the reach where they are presently unfenced. Pressure treated posts with 3 strands of barbed wire should be erected, with cattle drinking areas and access stiles located at suitable locations. The

maximum width possible should be isolated from the cattle, forming an un-grazed buffer strip of coarse vegetation that will reduce run-off of sediment from surrounding land, and allow the growth of fringing vegetation, valuable for the protection of juvenile fish

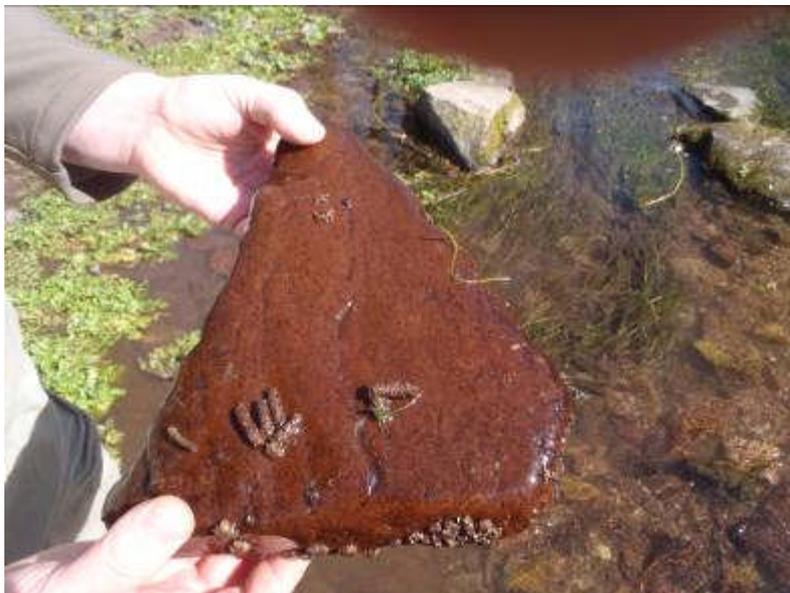
Water quality and macroinvertebrate assessments were undertaken in the Bride catchment by the Environmental Protection Agency (EPA) in 2006. Unfortunately no samples were taken from the Glenaboy. A very quick assessment of the invertebrate fauna was made by stone turning on the day of the advisory visit. There were abundant cases caddis and small Ephemeroptera nymphs present on the stones in the upper section of the reach.

### **Cased caddis on the underside of stones in the upper length of the reach**

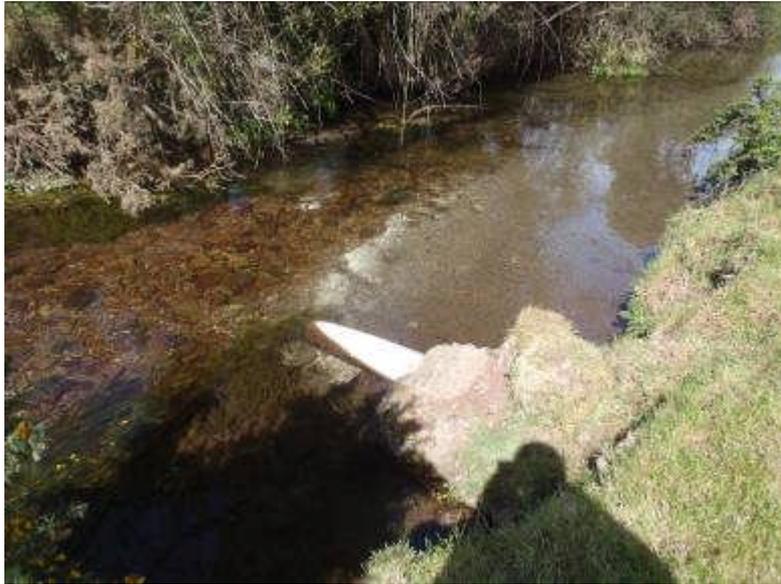
However, the situation at the downstream end of the reach was less satisfactory. There was clear evidence of a poor quality discharge entering on the RB of the river some 200m upstream of the main road bridge. This had obviously been going on for some time, as there was a significant deposit of sediment, sewage fungus and filamentous algae on the bed. The decline in water quality was also obvious in the macroinvertebrate

**RB discharge into Glenaboy....**

- Water quality in the Glenaboy was adversely affected by the poor quality discharge identified from the RB pipe. There was clear evidence of a decline in the macroinvertebrate fauna, with the substrate quality also affected due to the growth of sewage fungus, filamentous algae and deposition of silt. This will have a detrimental impact on trout and salmon spawning, and the subsequent survival of their fry. It is vital that the source of the discharge is located and the poor quality effluent stopped from entering the river

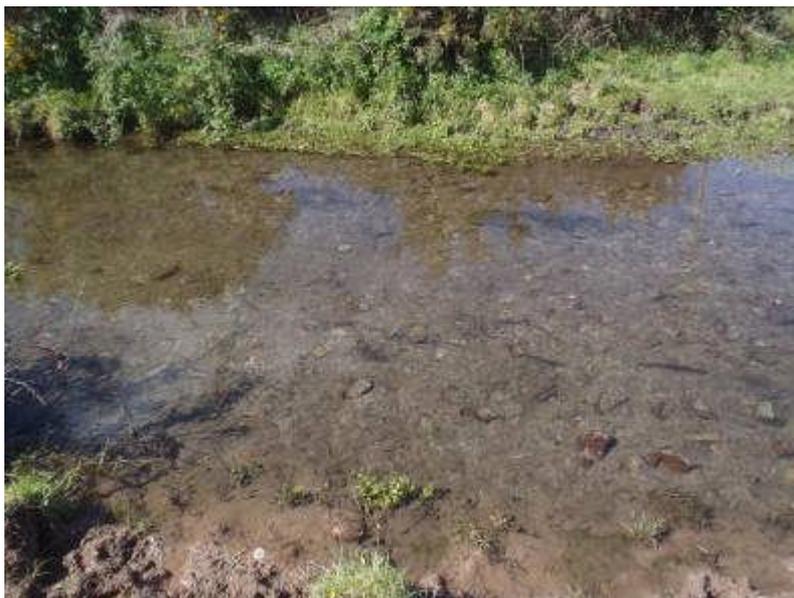
assemblage with the number of Ephemeroidea and caddis dramatically reduced, and a predominance of freshwater limpet (*Ancylus*).

**...And clear evidence of its impact**

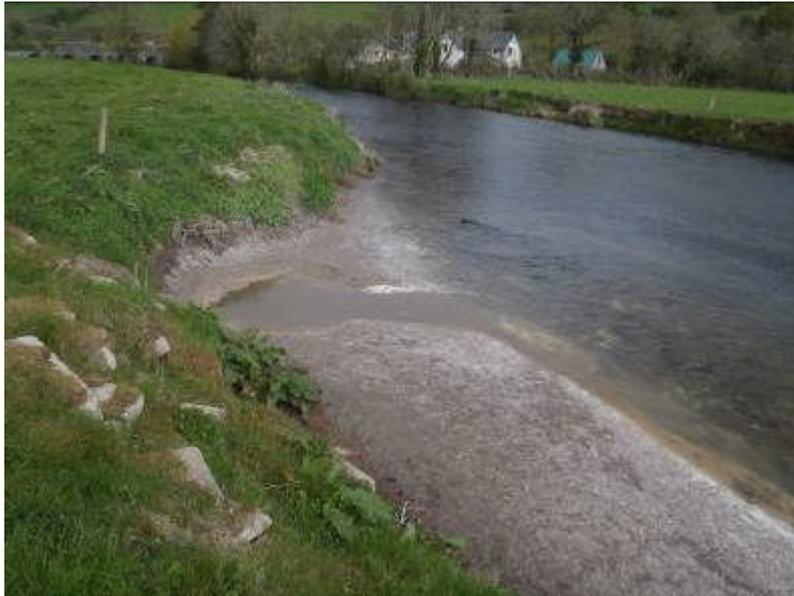
Water quality in the River Bride downstream of the confluence was also far from acceptable, with an appallingly bad discharge from Tallow Sewage Treatment Works entering the main river downstream of Tallow roadbridge. Discoloured effluent was bubbling up from a pipe in the RB, with extensive beds of sewage fungus coating the river bed downstream. It is understood that funding has been allocated to improve this unacceptable discharge into the River Bride SAC. No firm date has however been agreed for implementation of the upgrade.

### **Poor quality effluent discharging from Tallow STW into the River Bride**

- A similar concern exists for the discharge from Tallow STW to the main River Bride. This is a truly dreadful example of poor quality effluent and will affect not only the ecology of the main River Bride, but also the migration of brown trout, sea trout and salmon into tributary streams. It is imperative that a fully funded solution to this issue is agreed and implemented as a matter of urgency, particularly given the River Bride's status as an SAC

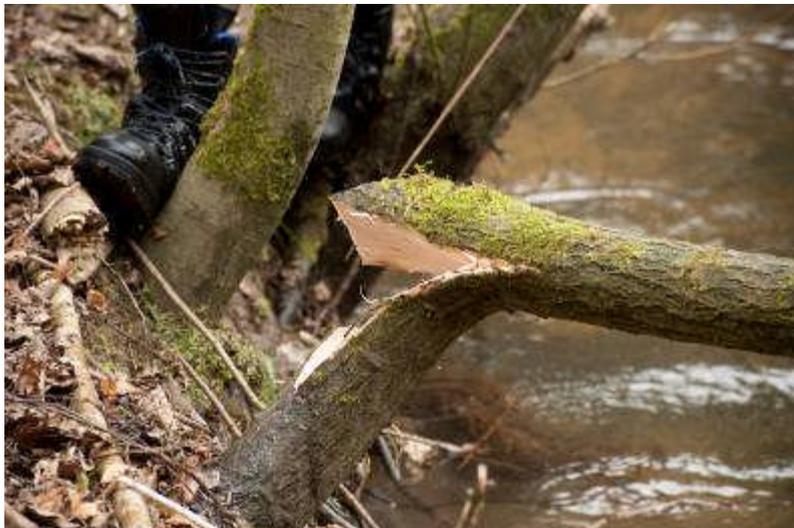
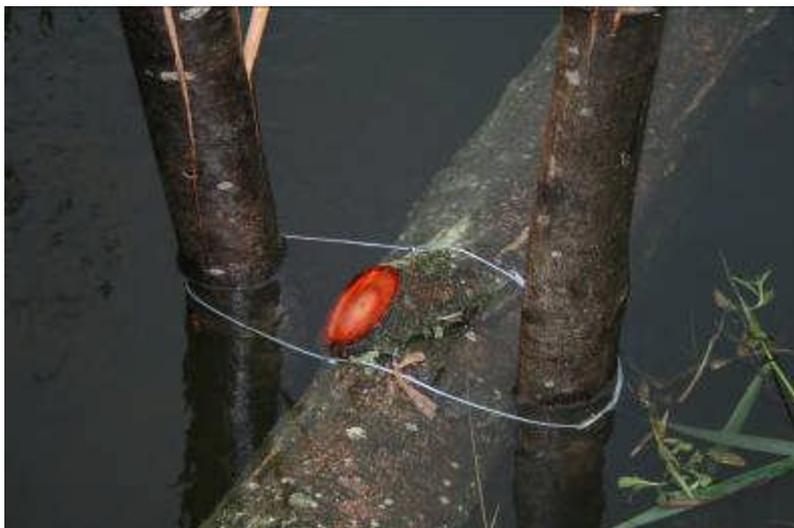
**Hinged timber .....**

**.... And additional fixing using stakes and wire**

- Large Woody Debris introduced to the channel is an excellent way of not only providing additional cover, but also of increasing bed scour, creating deeper pools and helping to sort the substrate. This is important as it will create short sections of silt free gravel at the tail of pools that is ideal for trout and salmon spawning. Ideally, LWD can be introduced by the partial cutting and hinging of bankside trees into the water. This has the advantage of maintaining a secure fixing to the bank and also keeping the hinged trunk alive. The LWD can be further secured using either wooden stakes driven into the bed and wired to the trunk, or by drilling the trunk and driving rebar through it into the riverbed (beware hidden utility service cables and pipes)

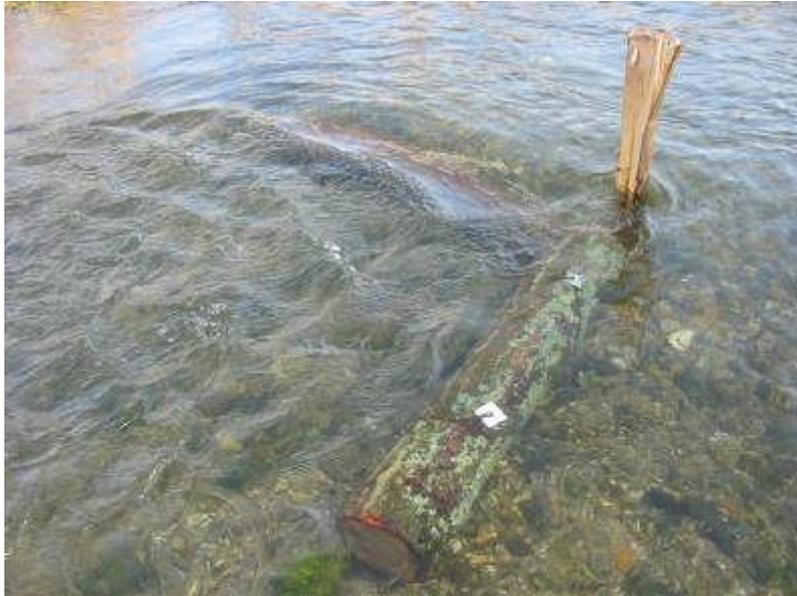
**Paired LWD limbs used to create a 'v' shaped deflector. Note rebar and steel washer fixing**

- Simple mid-stream deflectors can also be constructed using paired upstream facing timber limbs fixed in places with stakes or rebar. Arranged in this pattern, the LWD concentrates flow into the centre of the channel, scouring a small pool and downstream spawning riffle.

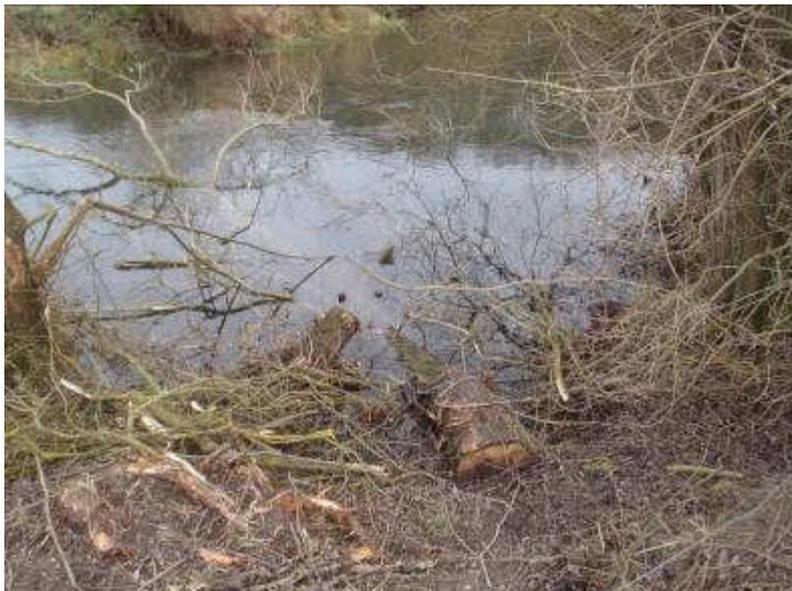
**LWD introduced to a river. Note the steel 'break away' cable attaching the LWD to the tree bole**

- Wherever LWD is used, increased fixing security can be obtained by the use of a cable laid wire 'break away' passed through a pre-drilled hole in the timber and attached to the root bole of a tree or a buried grounds anchor. In the event of a failure of the fixings, the cable prevents the LWD being washed away

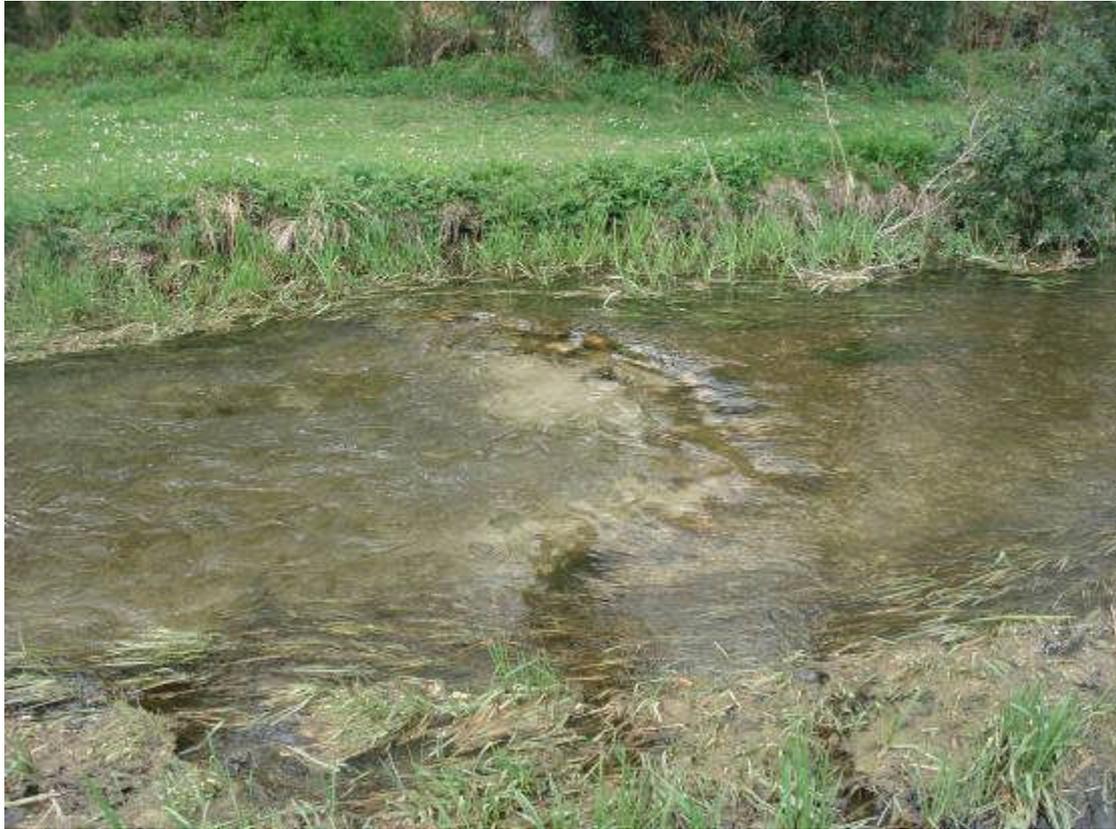
#### **A 'D' shaped deflector in a small limestone stream**

- Increased amounts of cover and bed variation can also be provided by the use of stone deflectors. These comprise of a series of large boulders arranged into a rough upstream facing 'D' shape in the centre of the channel. In combination, they increase water velocity creating scour and cleaning fine sediment away from potential spawning gravel.
