## **Bulbourne - Berkhamsted**

**An advisory visit carried out by the Wild Trout Trust – April 2013**

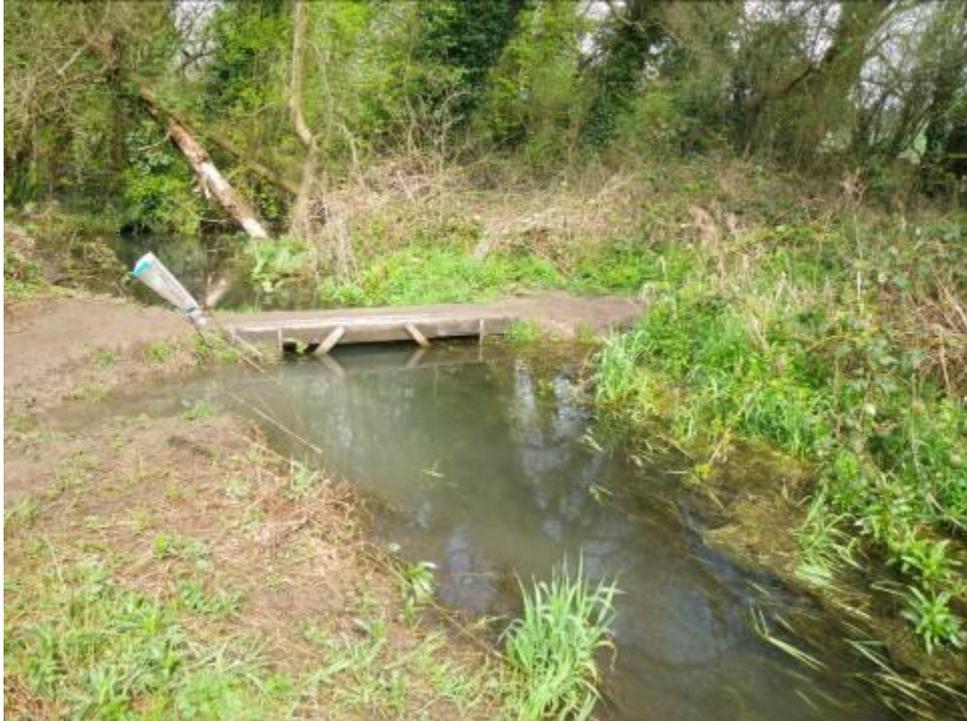
Photo 1. One of the few sections of defined channel at the head of the reach

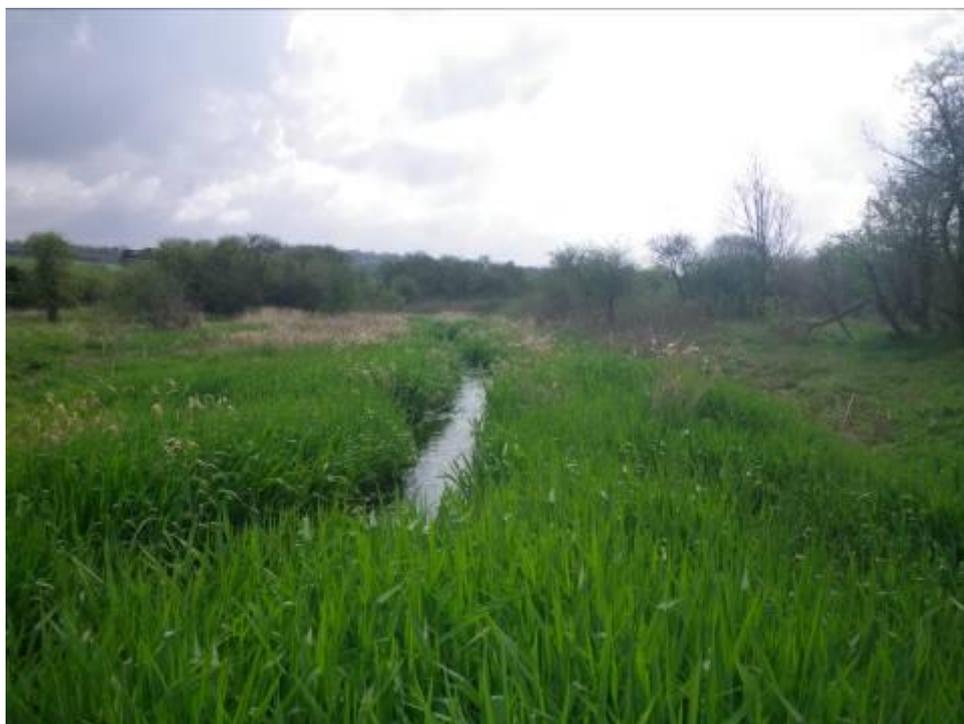
Photo 2 . A typical section of the Bulbourne at Dudswell. where the stream percolates through a dense fringe of emergent wetland plants, mainly reed sweet grass *Glyceria maxima*

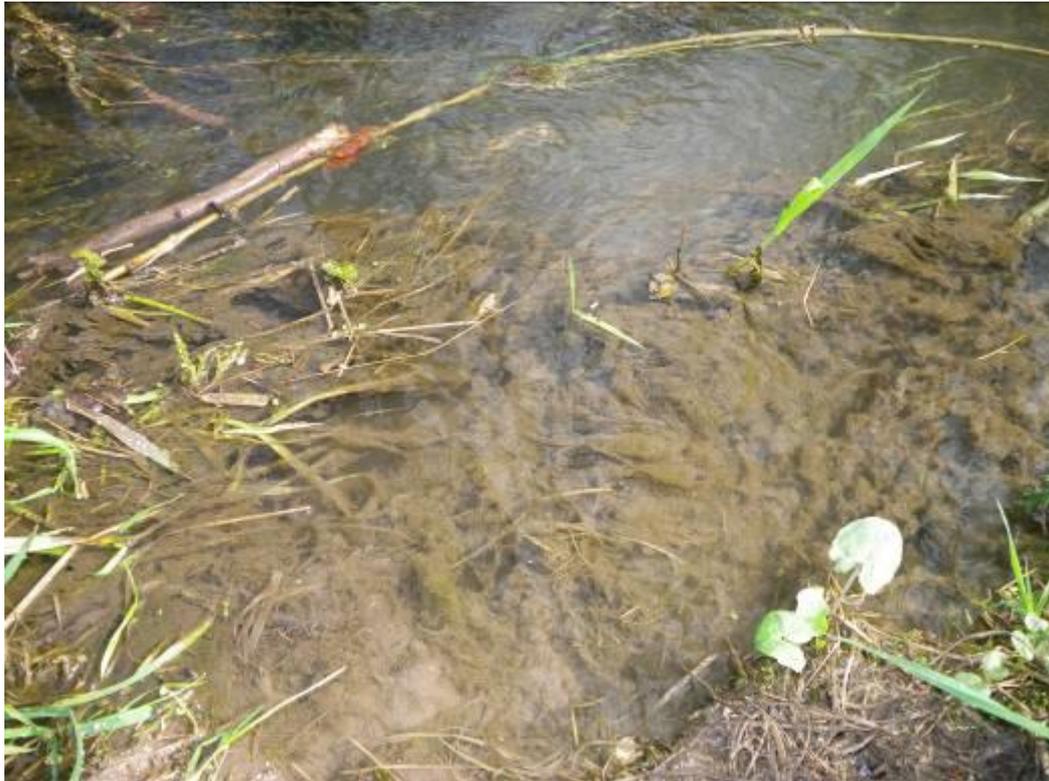
Photo 3. Heavy filamentous algal growth is indicative of high nutrient loads.

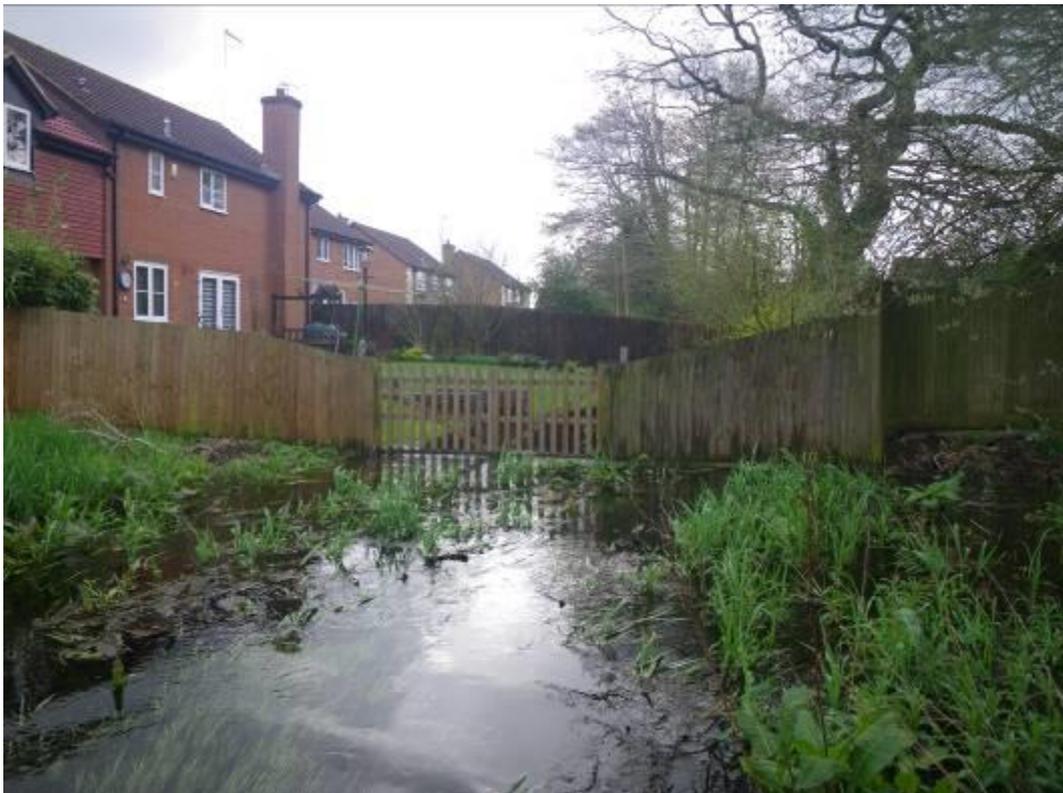
Photo 4. At the bottom end of the Dudswell reach the river runs into a housing development where the treatment of the banks and bed is less than ideal.

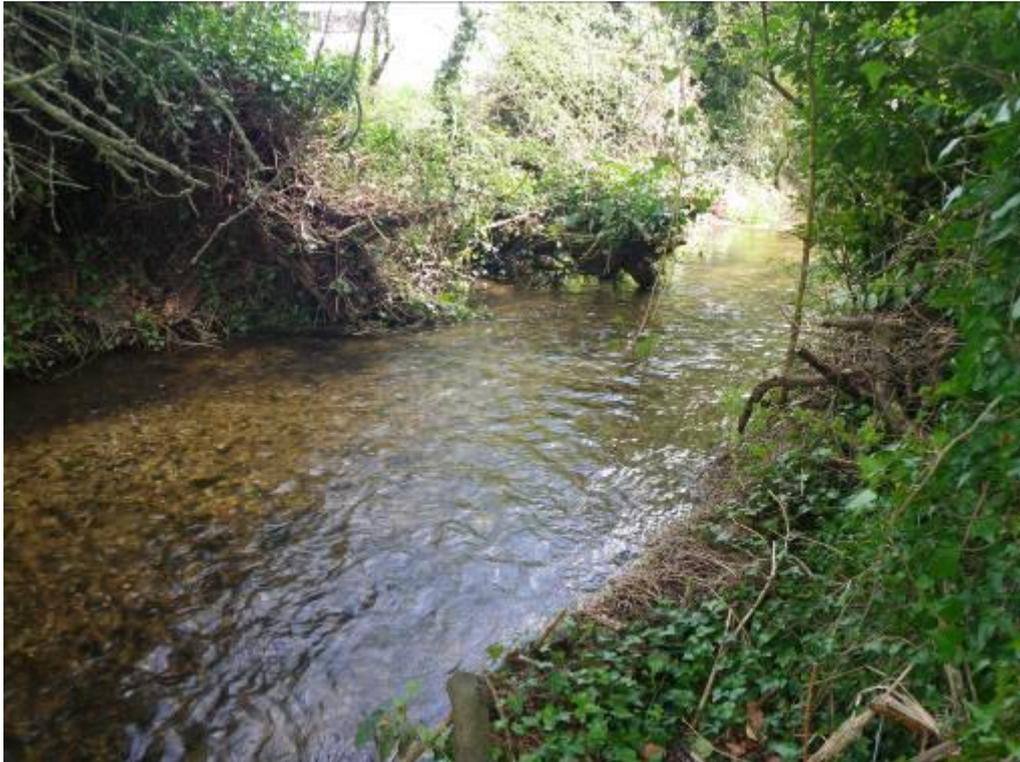
Photo 5. Shallow riffle habitat over a clean gravel bed at Broadway Farm

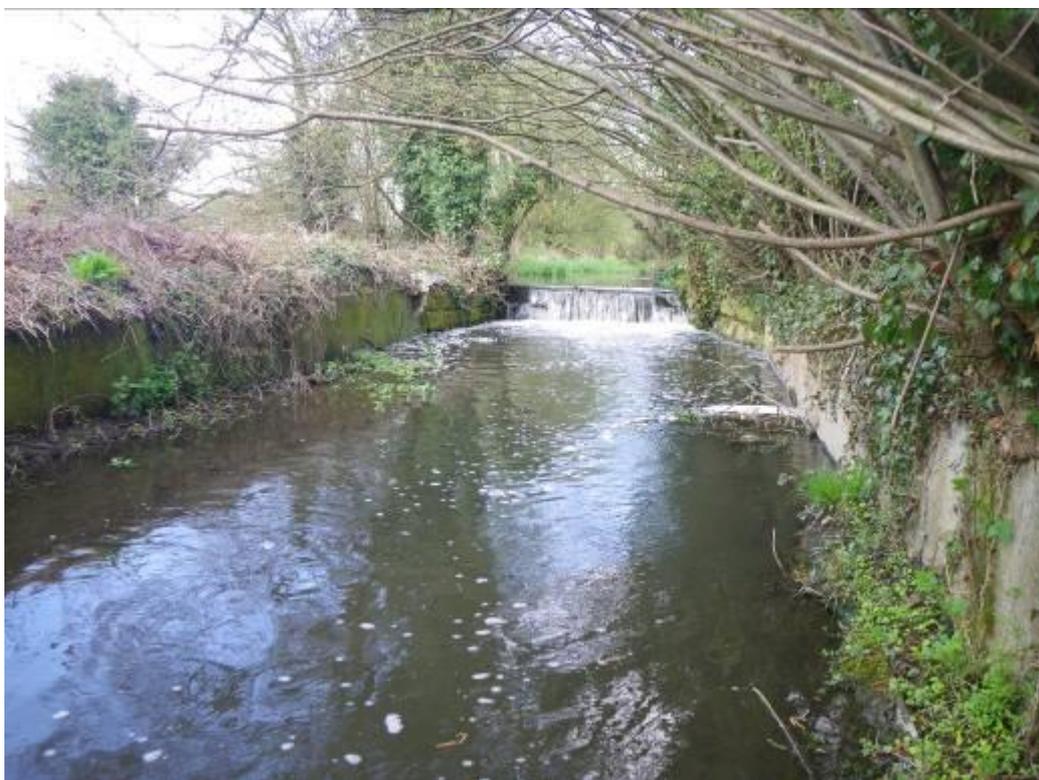
Photo 6. Impounding structure. Fragmenting habitat and restricting access for fish migration.

Of particular significance is the water level control structure shown in photos 6 and 7. It is not clear exactly why this structure was constructed, but it might have been used to manage water levels and therefore flow into the adjacent canal; however, it may be more likely that it was used to raise a head of water to divert flow through the old water cross beds.

Weirs like this, on such a low gradient stream, have a big impact on stream ecology over considerable distances. As well as fragmenting fish populations that might wish to migrate upstream, the weir is 'drowning out' the natural habitat features that would normally be supported by unimpeded flow velocity. The vibrant gravel bottomed riffles and pool habitat evident downstream give way to laminar flow over a heavily silted river bed above the structure.

The weir structures are having a big impact on the habitat quality of the river. Removing, modifying or bypassing the weir will all bring ecological benefit. The construction of a new channel is a particularly exciting proposition and would bring significant ecological benefit over and above simple weir modification. A project of this size and scope will require support from the EA and the local landowners.

- Investigate why the weir was constructed and if it serves any useful purpose.
- Consider the creation of some improved adult holding habitat through the installation of LWD flow deflectors and brushwood shelves on the shallow reach downstream from the weir.

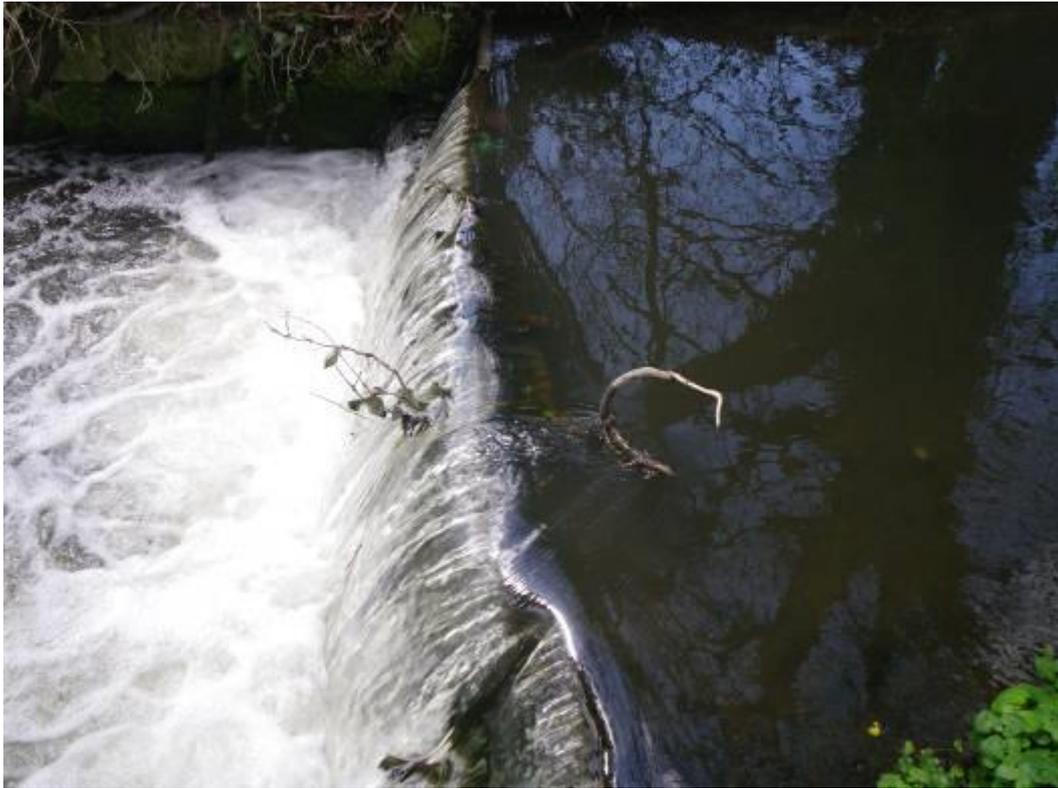
Photo 7. Weir crest could be removed, modified or bypassed.

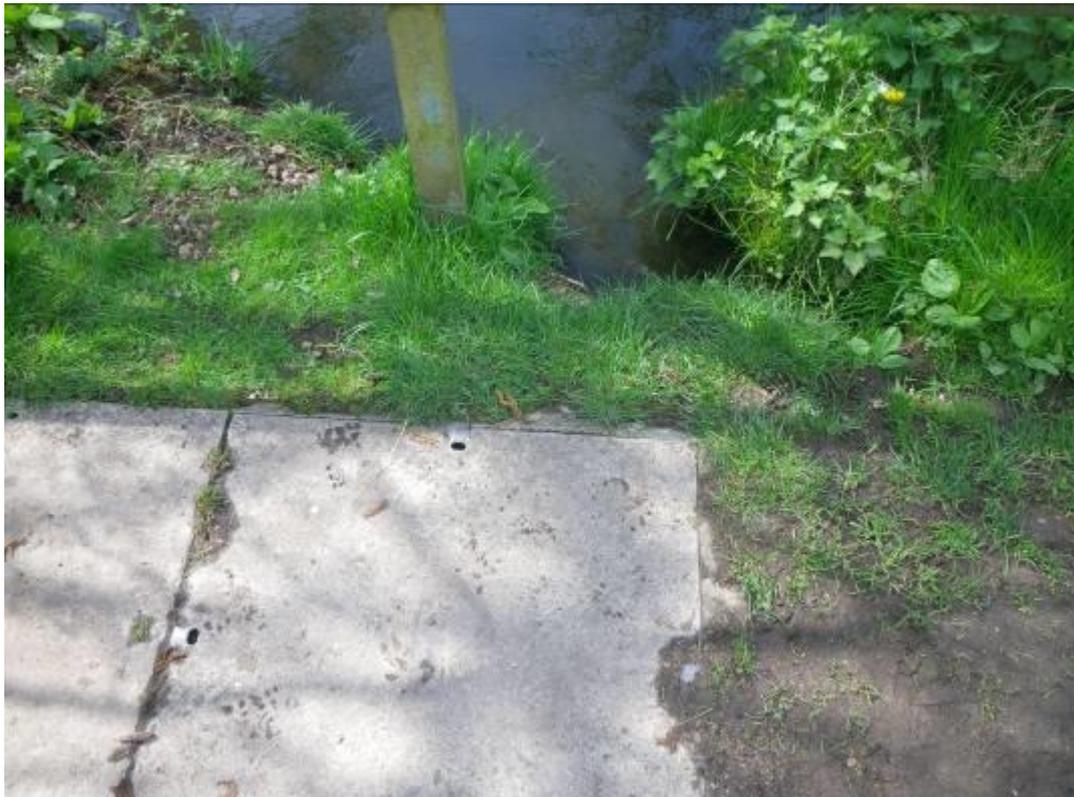
Photo 8. Manhole cover on the canal tow path above a hydraulic connection between the canal and river. The impounding structure in the river may be linked with water supply to the canal, or this may simply be a drain for excess water in the canal pound.

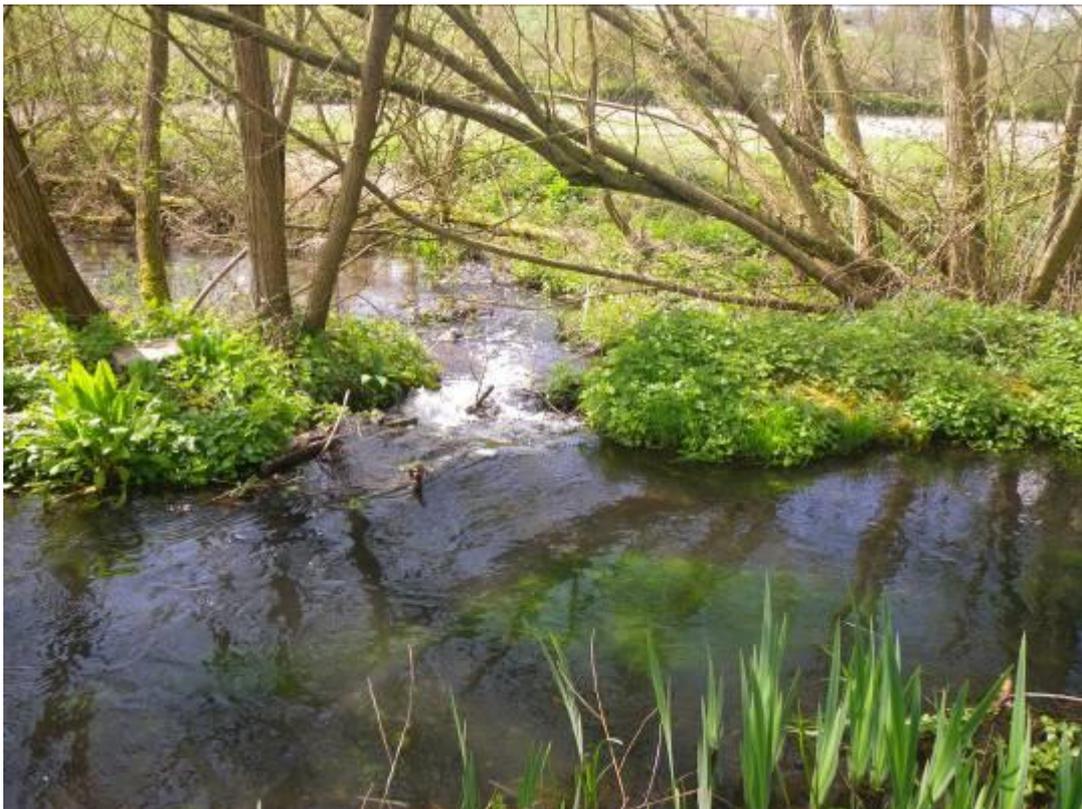
Perching the stream above the valley floor has promoted a bank breach (Photo 9) upstream of the weir and has resulted in the channel braiding. There is sufficient flow here to support a high quality stream habitat but there is not enough water to support more than one formal channel. Constructing a new low level channel to take all of the flow and bypass the weir structure could provide an opportunity to create a high quality stream habitat and potentially move the stream away from the foot of the canal embankment. Encouraging this flow into a sustainable channel width below will bring the most ecological benefit.

Photo 9. Bank breach above the weir. There is no "do-nothing" option here.
