**By Brook – Ford Fly Fishers**

**An advisory visit carried out by the Wild Trout Trust – September 2009**

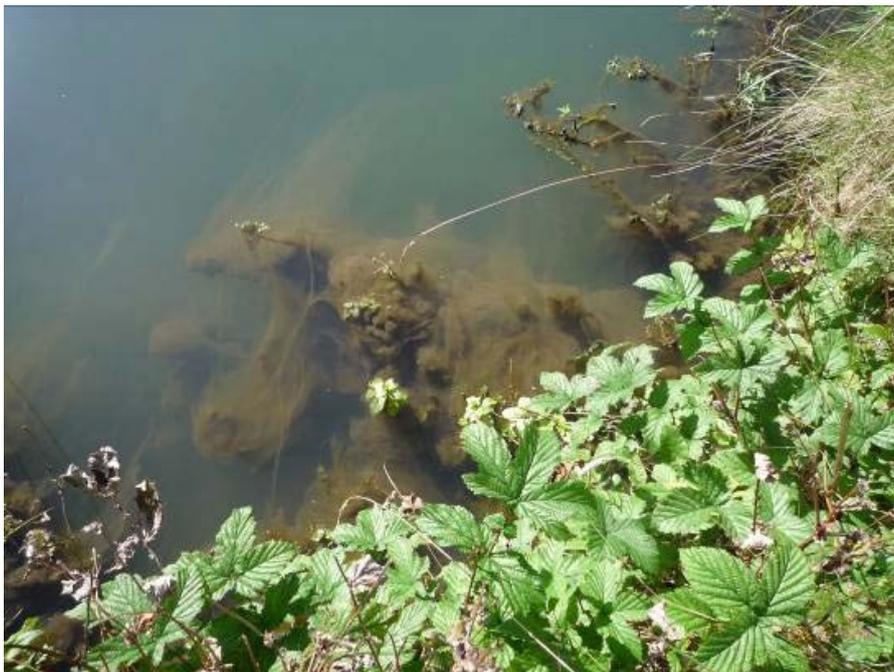
There was considerable evidence of what appeared to be excessive filamentous algal growth, possibly indicative of nutrient enrichment. It was not clear if this is the result of point source discharges or due to diffuse pollution pressures from agricultural practices within the wider catchment. The initial impression of land use within the valley was of light grazing on flood plain meadows with some mixed woodlands on the steeper valley sides, certainly not land use that would normally give rise to immediate concern.

Marginal plants coated with a thick growth of filamentous algae – generally an indication of excessive nutrients

The presence of so much algae is of concern. Are these conditions considered to be the norm for the By brook or are there some underlying water quality issues that need to be resolved? These are questions that should be put to your local Environment Agency teams. Many angling clubs now take part in the Anglers' Monitoring Initiative in order to maintain a close eye on water quality. One excellent method of self monitoring water quality is to link up with the Riverfly Partnership. The Partnership provides simple training and a robust method of assessing fly life through periodic sampling of macro invertebrates. This is a simple and effective way of keeping a close eye on water quality performance. More information can be found at [www.riverflies.org](http://www.riverflies.org)

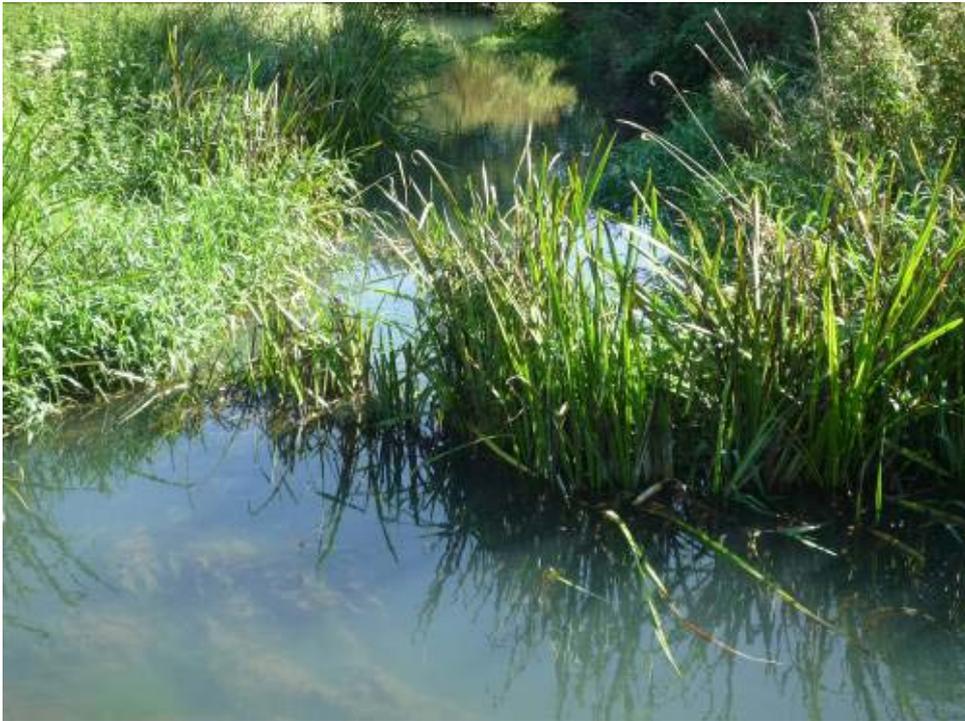
As a direct result of the slow in-channel water velocities, marginal plants such as foals cress (*Apium nodiflorum*) and various emergent reeds such as burr reed (*Sparganium sp*), sweet grass (*Glyceria maxima*) and reed canary grass (*Phalaris sp*) were encroaching into the channel, particularly on those sections with little tree shading.

Burr reed growing right across the channel near the top boundary

On those sections of open channel where marginal plants have encroached into the channel it may help to promote some local shade by planting the occasional willow whip, particularly on the outside of any slight bend or where there is potential pool habitat. Thick fringes of marginal plants should be encouraged but where plants become established in the centre of the channel they should be removed and if possible re-planted where they will help form a margin rather than as a collection zone for sediments in the middle of the channel. The strategic positioning of LWD deflectors will also help to promote local scour not favoured by marginal plants thus maintaining some channel definition.

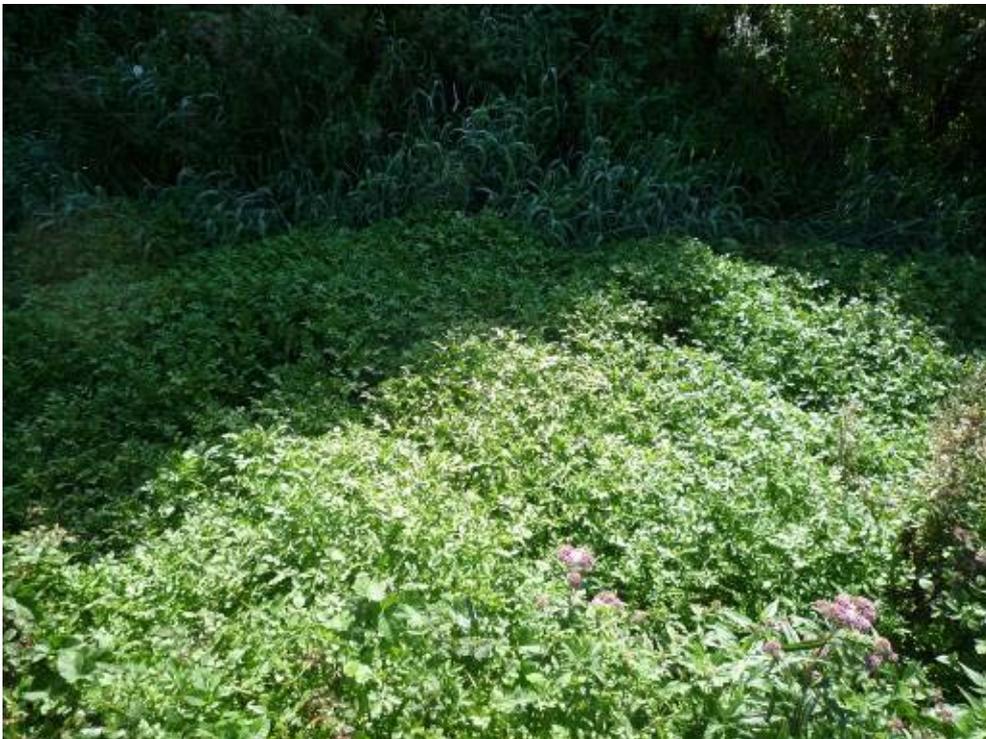
Another silty section choked with foals cress. Plant biomass of this order may have an adverse effect on water quality with possible dips in dissolved oxygen levels.

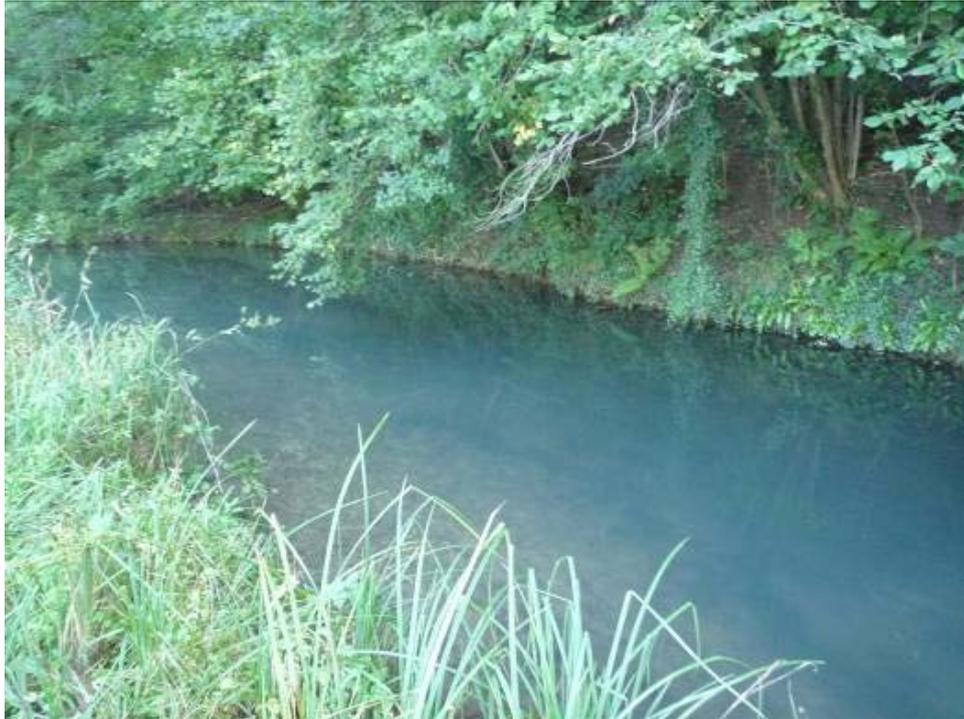
Another section a short distance downstream, where a combination of shade and weed management has provided some reasonable areas for trout to hold.

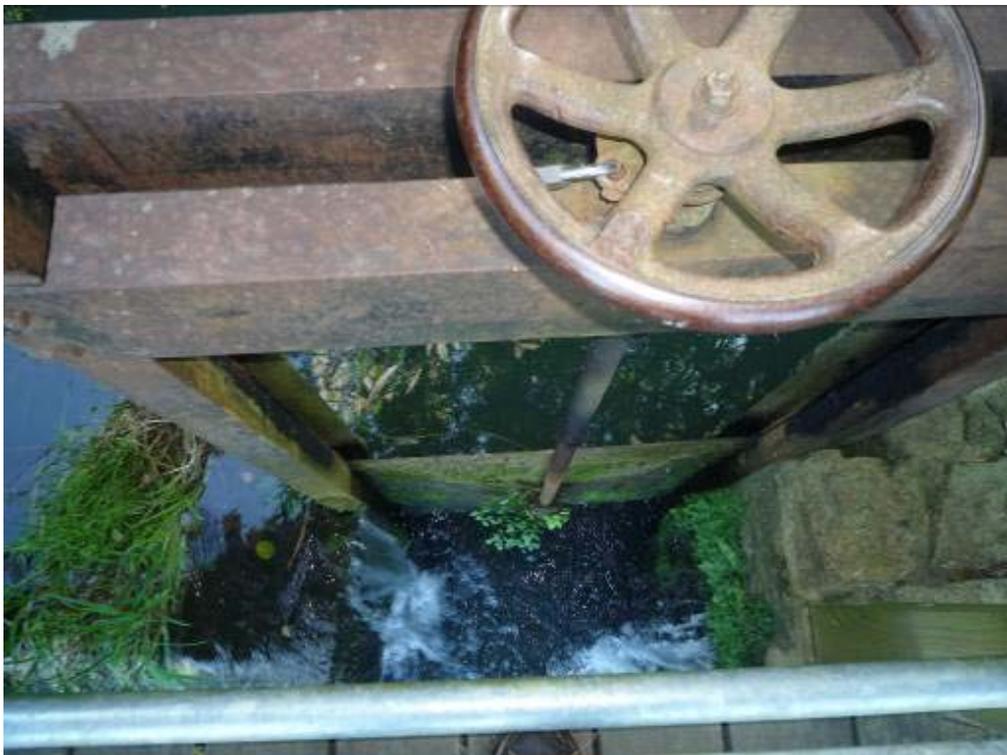
Undershot hatch on the weir screwed down to maintain upstream levels.

A quick inspection of the weir revealed a wide, fixed crest and a single undershot hatch which was screwed down to maintain upstream water levels. Below the weir sill the resultant pool appeared to be very large given the discharge of the river, possibly indicating the flashy nature of this stream following rainfall events. The bank adjacent to the weir is open for public access and this appears to be a popular site for visitors. It is assumed that the weir was originally constructed for milling purposes at this location, or to provide an elevated head of water for pushing elsewhere. This no longer appears to be necessary and tangible benefits to upstream habitats could be achieved simply by removing the hatch gate, or at least leaving it fully drawn at all times. The benefit would be to increase water velocity and allow the river to re-create a natural sequence of pools and riffles which provides habitat for all life stages of trout. The habitat benefits of managing structures in this way were recently well documented as part of the Avon LIFE project where similar gates on a structure on the River Nadder were fully drawn and the subsequent changes in habitat monitored. A summary of the report is attached as an appendix to this report.

- Consider lowering the levels of impounded reaches by pulling boards and lifting hatches wherever possible. It is understood that some depth may be required to support large stocked fish
- Open up a dialogue with the local farmer over the possibility of protecting some banks with new stock fencing and purpose built drinking stations
- Undertake a programme of early autumn gravel cleaning on the sections of shallow glide. Guidelines for gravel cleaning are attached as an appendix to this report. If the bed level drops too much then consider raising the bed to the original depth to reform the riffle using imported angular gravels.
- Remove marginal emergent plants where they appear in the centre of the river to try and re-establish a defined channel.
- Continue the sympathetic programme of tree works to maintain the dappled light and shade regime.

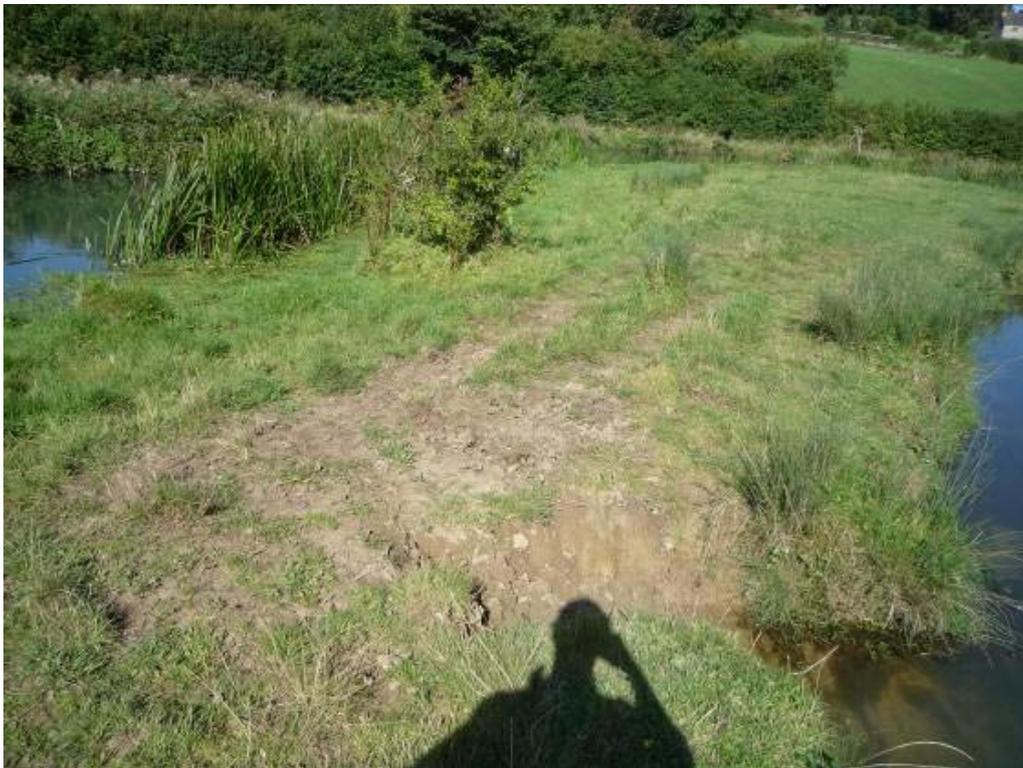
Downstream of the weir the channel embarks on a series of sharp meanders. At one point it looks as though the river may be close to breaking through which could result in the loss of approximately 50m of channel and the formation of an oxbow feature. Although there are some wider conservation benefits in allowing river channels to move, it might be sensible in this particular case to defend the LB margin with some soft engineering techniques such as faggot revetment or perhaps some live willow revetment. The area should be temporarily fenced to prevent further cattle poaching and give the margin time to recover.

A tight meander with evidence of potentially serious bank erosion due to cattle poaching in the foreground

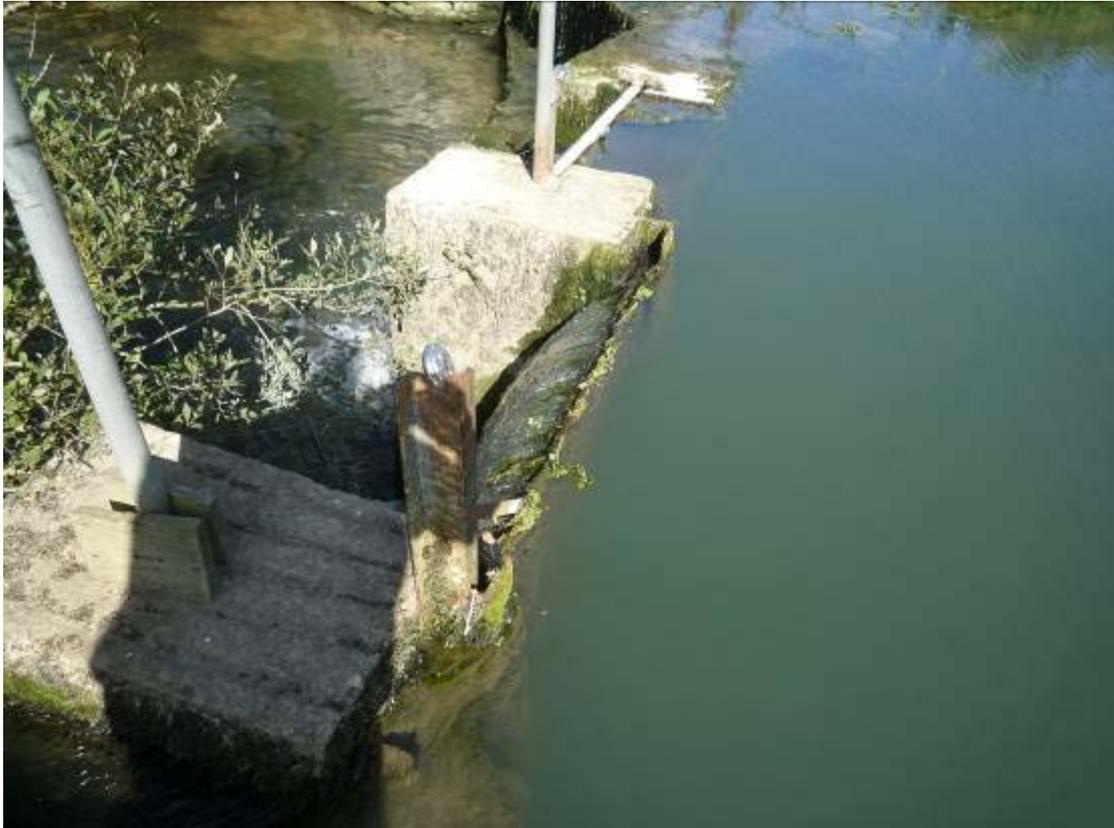
A short distance below the big meander a further structure was inspected. This structure was also having a big impact on in-channel habitat quality. It seems obvious that this section of river was originally chosen for milling because of its steep gradient, which has been drowned out by the numerous steps introduced to harness water power. There is little doubt that prior to the impoundments this section of river would have supported some first class habitat for brown trout.

Another big impoundment which fragments fish populations and restricts habitat recovery

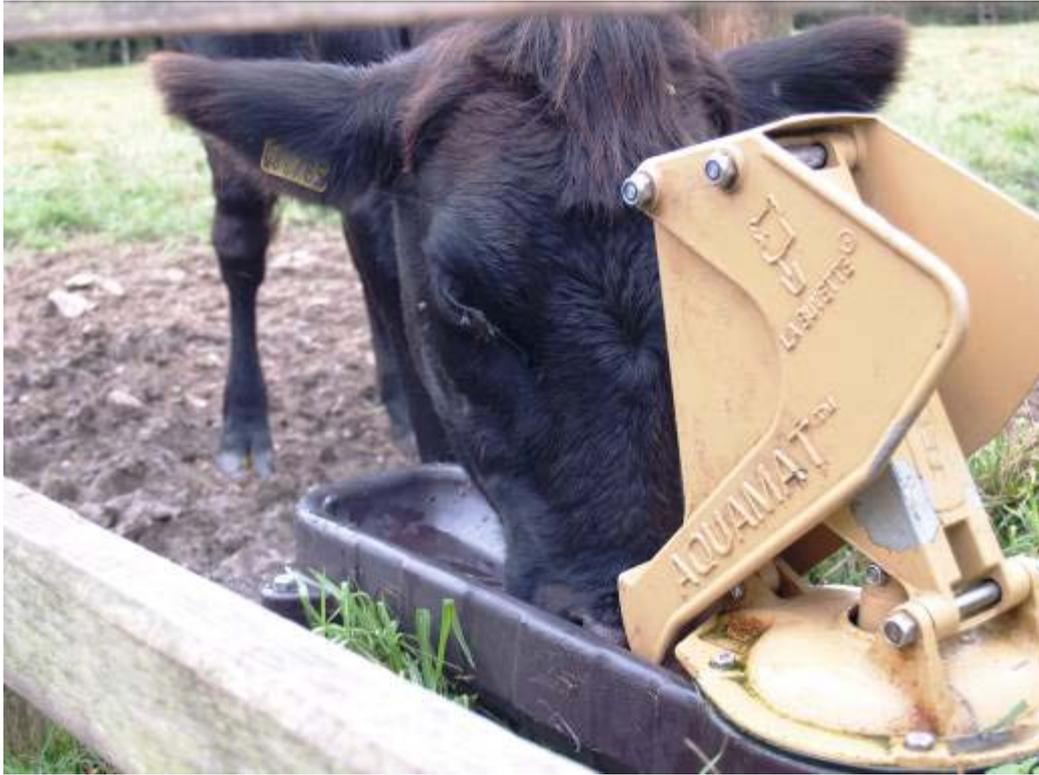
A pasture pump in use next to the River Test.

Further bank damage through excessive cattle poaching was evident on several other sections. Some light trampling of stream margins can provide good habitat for a range of valuable invertebrates but care must be taken to ensure that the river does not become over wide as a result of frequent and excessive cattle poaching. Installing temporary fences to allow some sections to recover is a possible option. If the local farmers are concerned about access to the river for livestock to drink, then the installation of pasture pumps located behind a fence might satisfy demand, particularly in the case of young cattle reared for beef. If fencing is carried out some controlled grazing on the inside of bank-side fencing should also be considered to cut down on maintenance requirements.

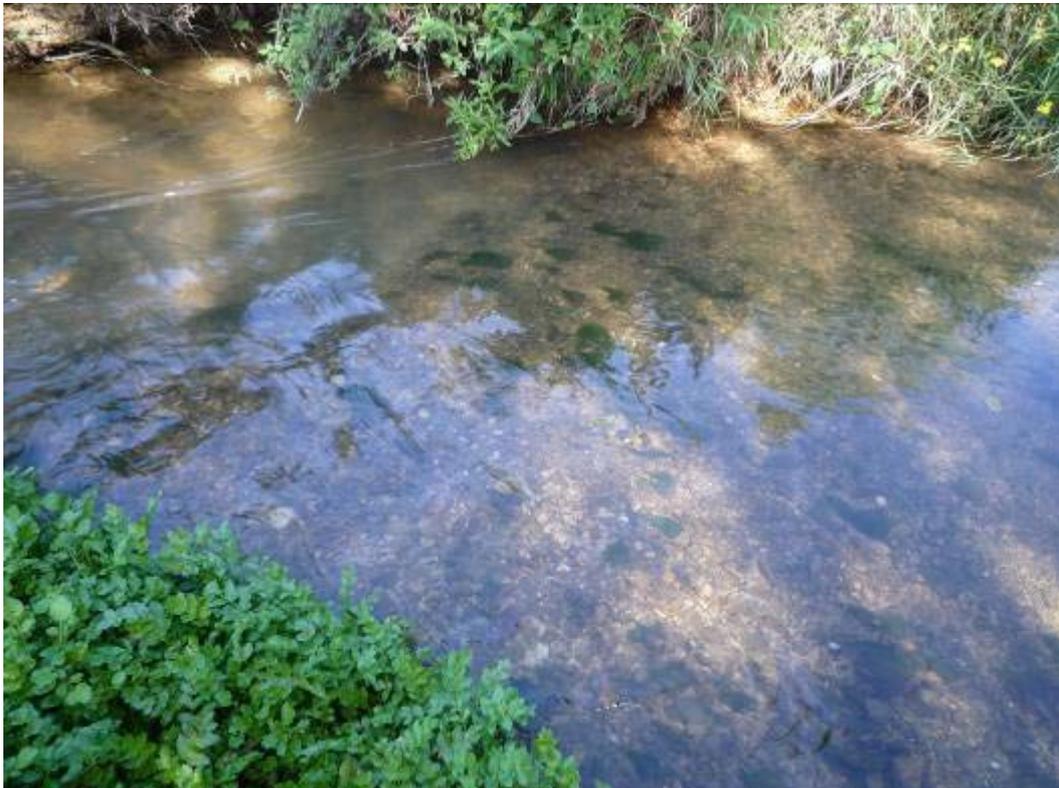
The tail of a glide – potentially an ideal location for trout spawning

At several locations through the middle section there were decent sized areas of potentially good trout spawning and nursery habitat. The gravels did appear to be compacted and, in places, heavily clogged with fine sediments. These areas would benefit from some pre-spawning treatment by breaking up the surface crust of gravels with a spike or rake or possibly undertaking some gravel washing using a high pressure pump or back-pack leaf blower. These and other techniques are fully described in the Wild Trout Trust Chalk Stream Habitat Manual. Some guidance on gravel cleaning is also attached to this report in appendix 2.

Undertaking an autumn programme of gravel cleaning will help to boost trout egg survival rates.

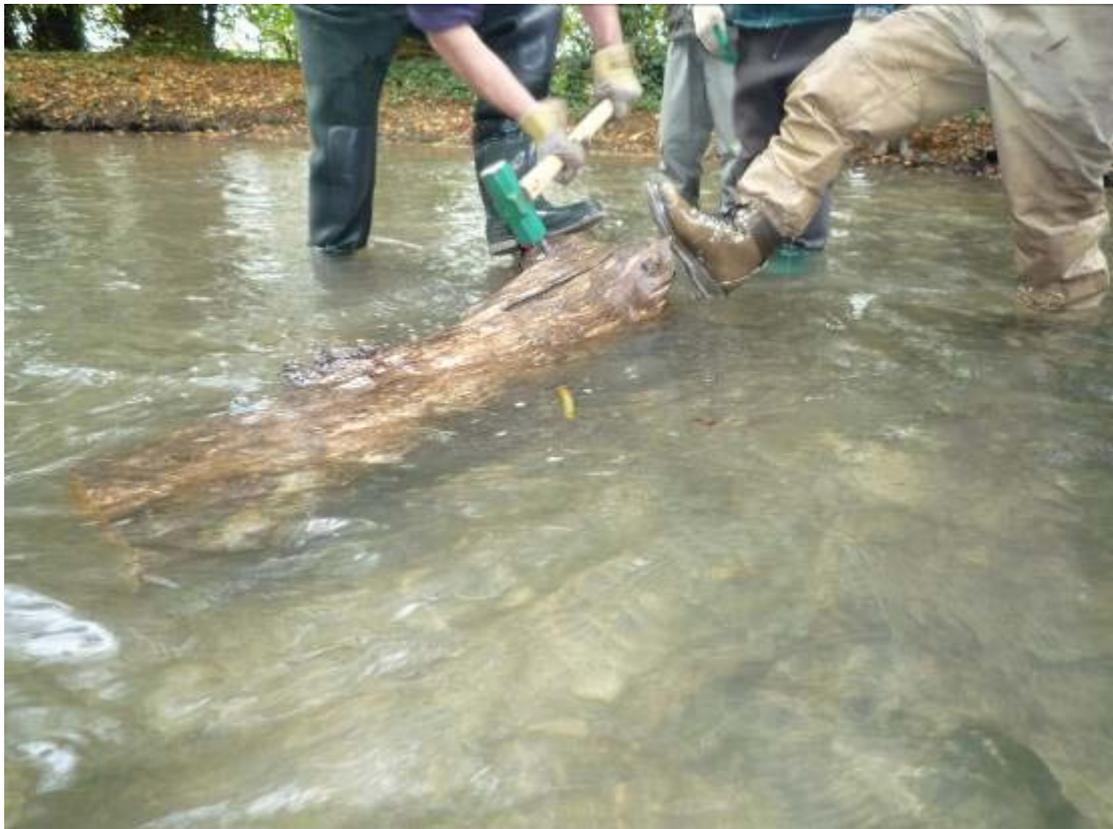
A piece of LWD being secured to the river bed with steel re-enforcing bar. The deflector is configured to encourage bed scour to free up loose gravel for spawning

A good alternative to manually cleaning gravels is to temporarily peg in LWD flow deflectors. These can be configured onto glides to encourage some local bed scour and provide ideal spawning habitat, as well as promoting little pot habitats for holding trout.

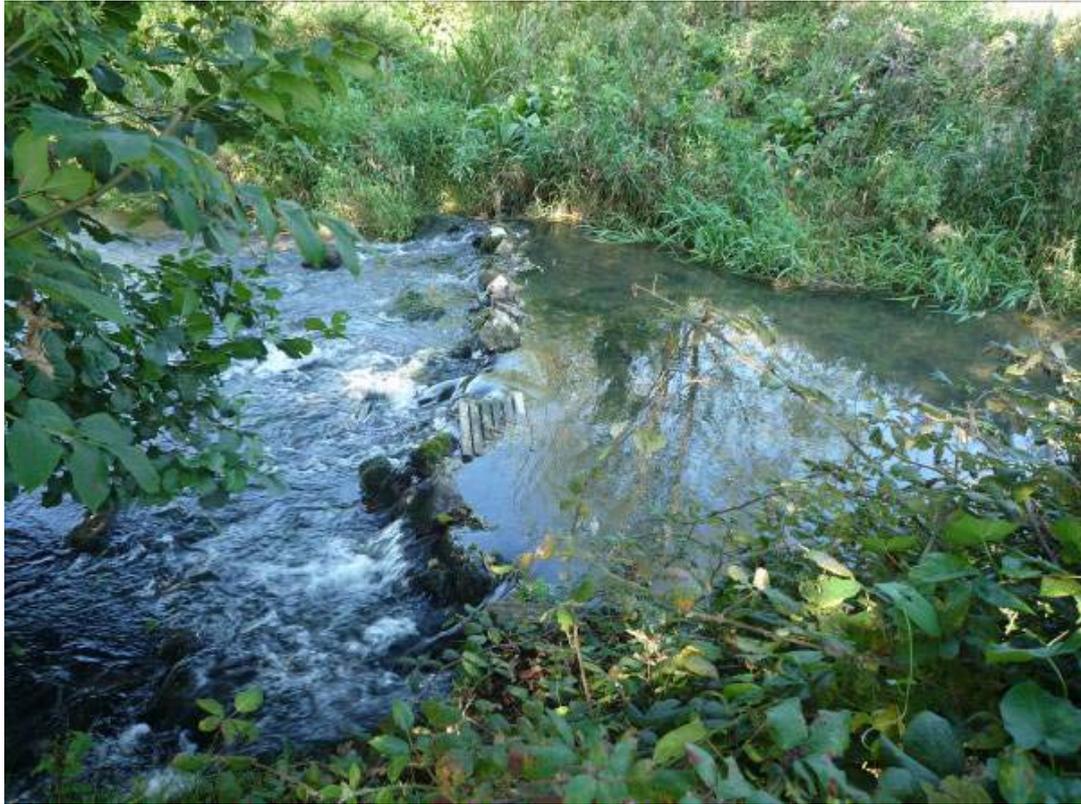
A short distance downstream there was a small weir roughly constructed of stone blocks. This was presumably installed to hold up water levels in the reach upstream. Unfortunately this has slowed down water velocities and encouraged sediments to settle in the reach above. A good compromise would be to remove the central third of the structure, which will still promote an interesting flume but will not significantly impound the water above.

A Low stone weir reducing upstream water velocities. Notching the centre third will help to improve habitat for wild trout in the section upstream

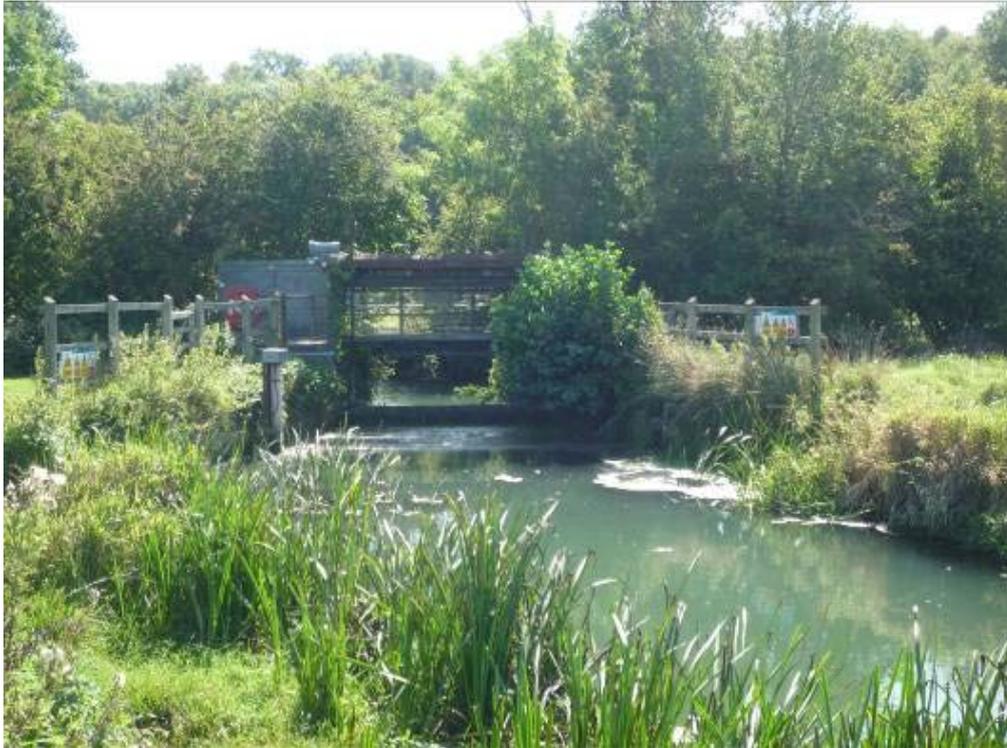
Towards the lower end of the “wild” reach, the channel starts to become much deeper and slower, due to the impounding influence of the large Environment Agency-owned weir. The purpose of this structure is unclear but presumably it was originally designed to provide some flood protection for Slaughterford a short distance downstream. The weir has what appear to be automated sluices but it is understood that these are not operational. Like the weir at the top end of the fishery, this will be a block to fish migration and is undoubtedly having a large impact on local river habitat quality.

Large EA owned structure. The exact purpose and requirements for this structure should be explored as it severely restricts habitat recovery and fragments fish populations

- Open up a dialogue with the Environment Agency over operation and purpose of the large gated weir.

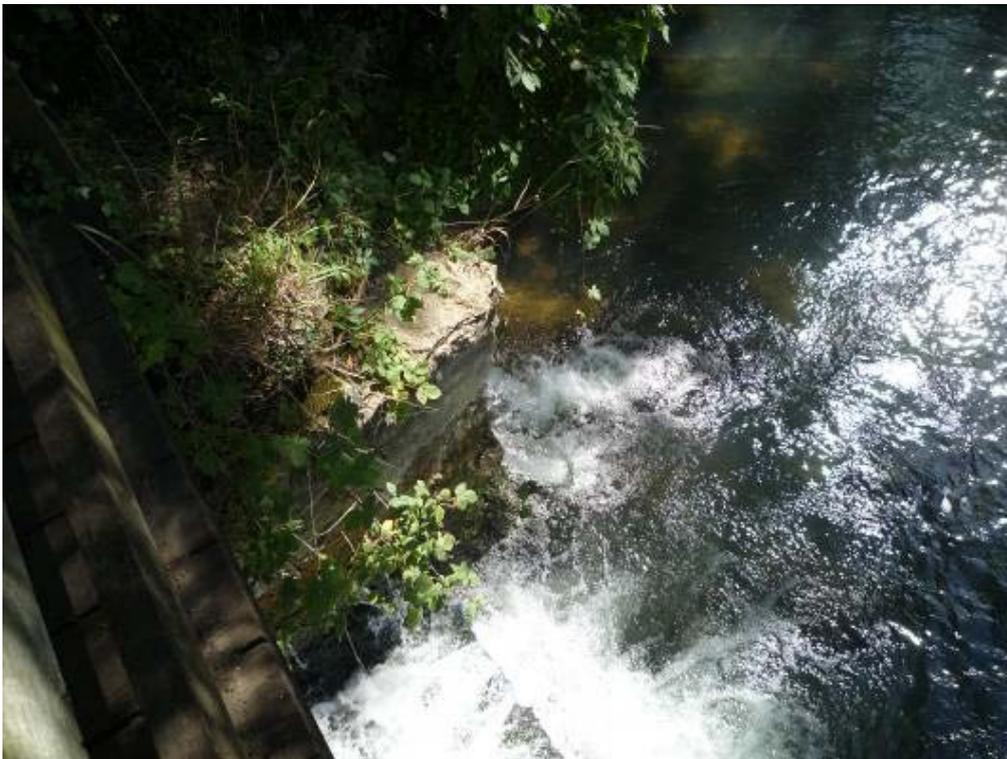
Near to the bottom boundary of the fishery there is yet another old weir (Rag Mill) where the adjacent wing wall is leaking badly. This will require remedial works very soon if the whole bank is not to fail. An alternative solution would be to lower the weir which will have the added advantage of increasing water velocities and providing enhanced habitat for trout.

Rag Mill Weir with the breach in the wing wall evident. Lowering the impoundment will take pressure off the leak and improve habitat.

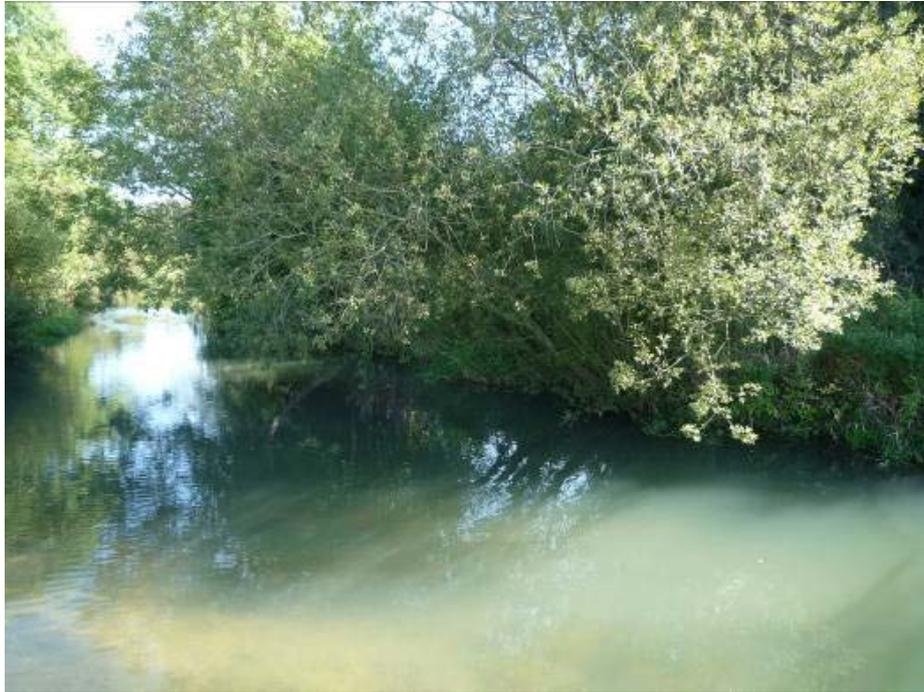
Overall the level of riparian maintenance was felt to be about right with a nice mix of dappled light and shade and plenty of the marginal scrubby cover which is so vital for wild fish. The FFF have managed to get the balance right between access for anglers and cover for fish

A low scrubby willow provides some valuable shade and a source of terrestrial food items.

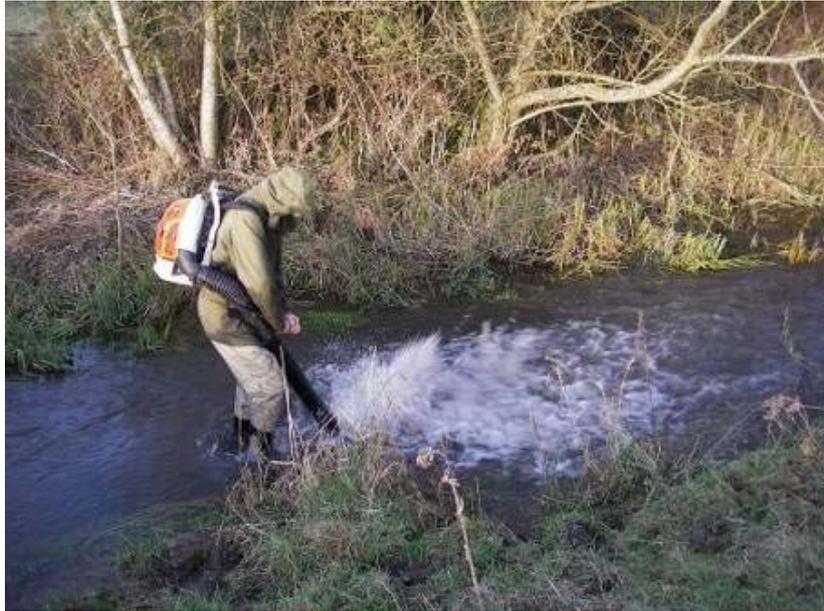
Gravel cleaning using a back pack leaf blower. Cleaning gravels on the very top section is recommended
