**HABITAT ADVISORY VISIT TO THE BYNE
BROOK, SHROPSHIRE.
UNDERTAKEN BY VAUGHAN LEWIS,
WINDRUSH AEC LTD ON BEHALF OF
MIDLAND FLYFISHERS**

APRIL 2007

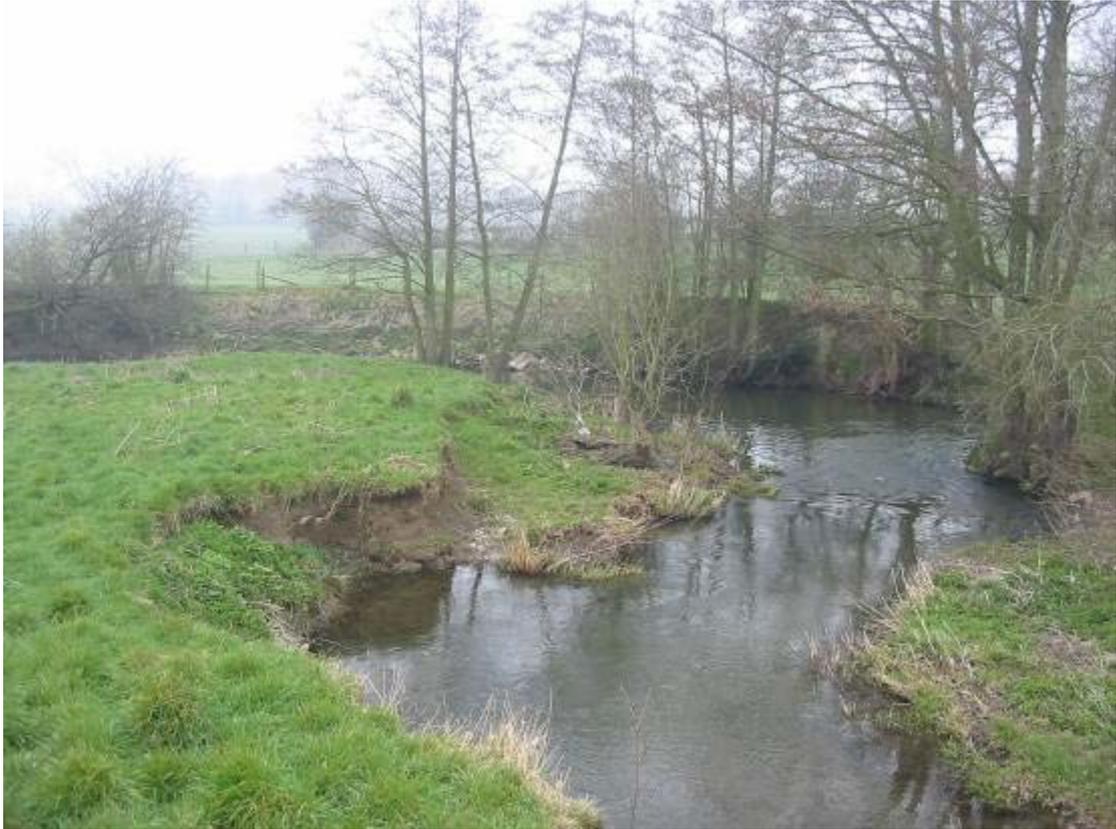
There was fencing along some sections of the fishery, effectively preventing stock grazing and poaching the riverbank. However, other sections remained either unfenced or had fencing that had failed. In these sections, considerable bank damage was apparent, with overgrazed vegetation, and excessive erosion typical. As a consequence, bankside cover was limited. In addition, eroded fine sediment was entering the river to the detriment of the gravel spawning beds.

Overgrazed, unprotected banks with associated excessive erosion and lack of cover

- It is important that the unfenced sections of riverbank should be protected from grazing stock as soon as possible. Without the erection of fencing, damaging erosion of the banks will continue, reducing cover and reducing the hatch rate of deposited trout eggs. Where possible, fencing should be set back at least 5m from the riverbank in order to allow adequate growth of binding vegetation. Without this width of buffer strip, it is quite possible that erosion will proceed more quickly than plants can establish, resulting in failure of the bank and loss of the newly erected fence. There is a clear risk of this happening to the fence erected downstream of the ford.

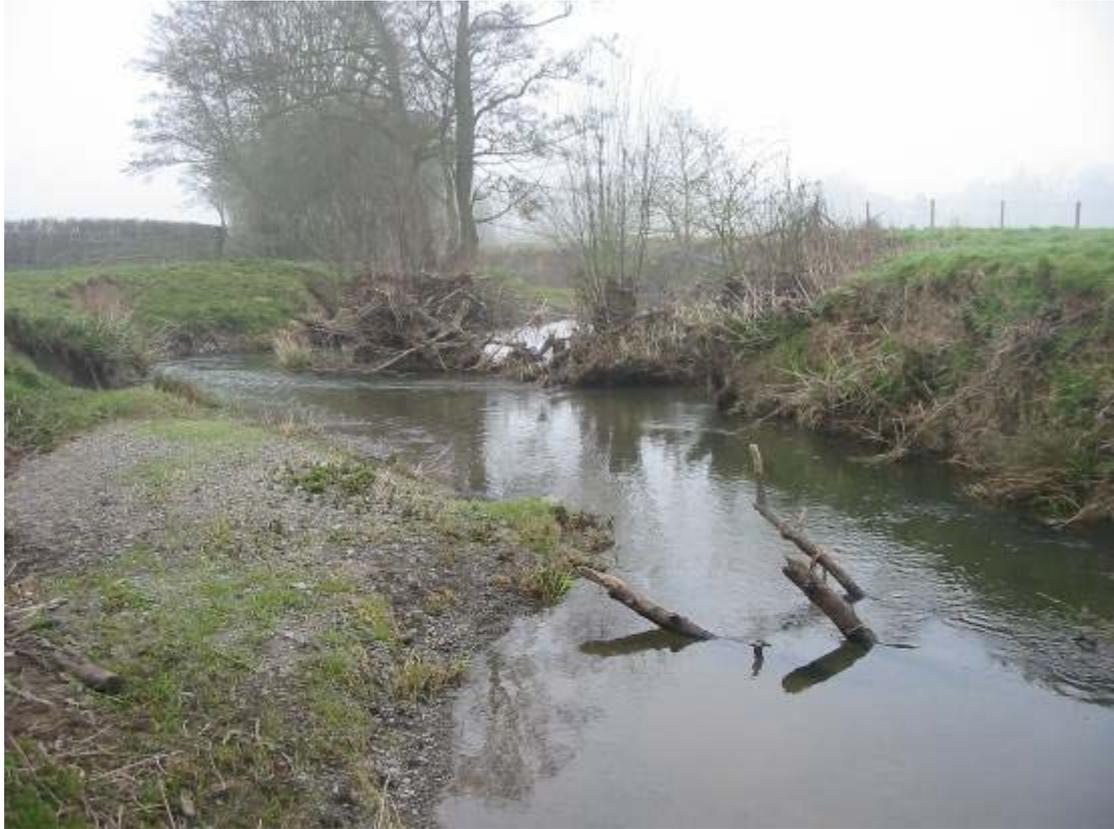
The Byne Brook had generally good instream habitat. Gradient was steep, with an abundance of pools, deep/shallow glides and riffles suitable for all lifestages of brown trout *Salmo trutta*. The river had a meandering course, through moderately wooded banks. There was abundant Large Woody Debris (LWD) in the channel, which in conjunction with undercut banks, extensive tree root systems and deep pools, provided excellent cover for trout and other fish species. Substrate was a mix of cobbles, gravel and sand eroded from the very friable banks.

Typical section of the Byne Brook, with meandering form, LWD, and good variation of instream habitat

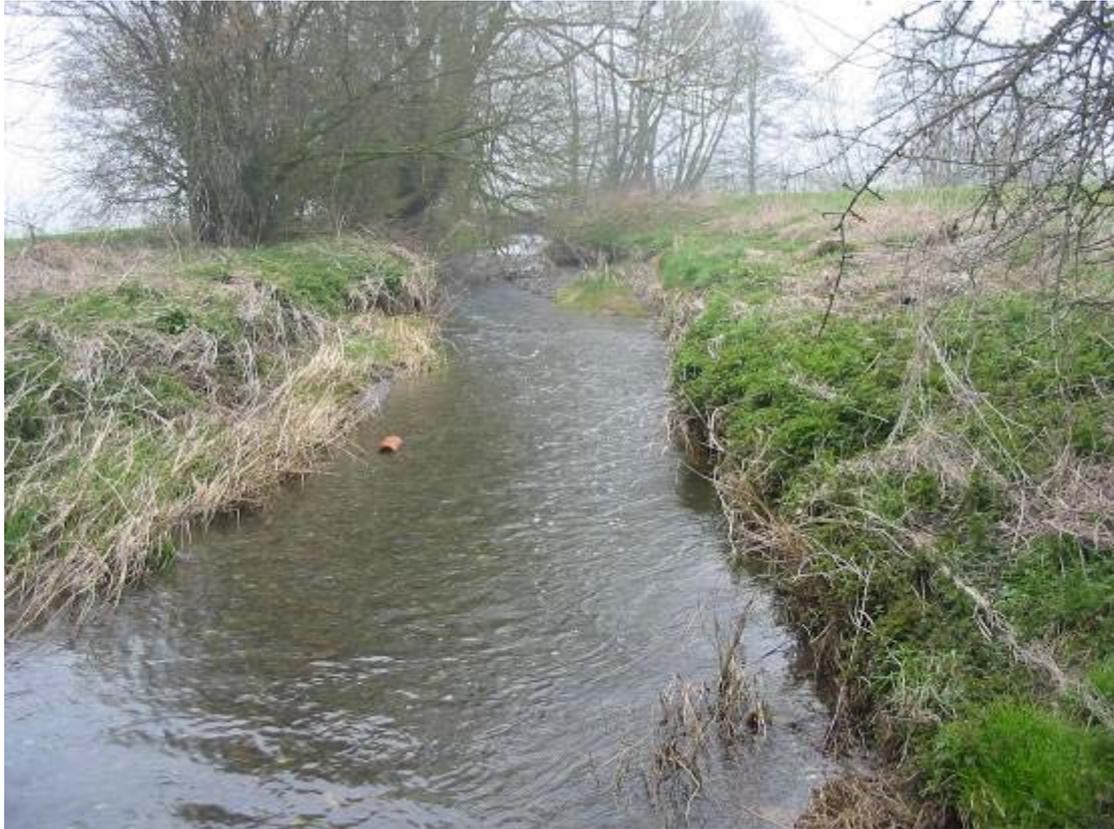
The Quinny Brook joined the Byne Brook towards the upper limit of the fishery. This was a small stream, with an abundance of apparently good quality habitat for spawning and juvenile brown trout. However, as in the main river, there were significant amounts of fine sediment entrained within gravel, potentially reducing the hatch rate of any trout eggs deposited.

The Quinny Brook showing good gradient and gravel substrate suitable for spawning and juvenile trout

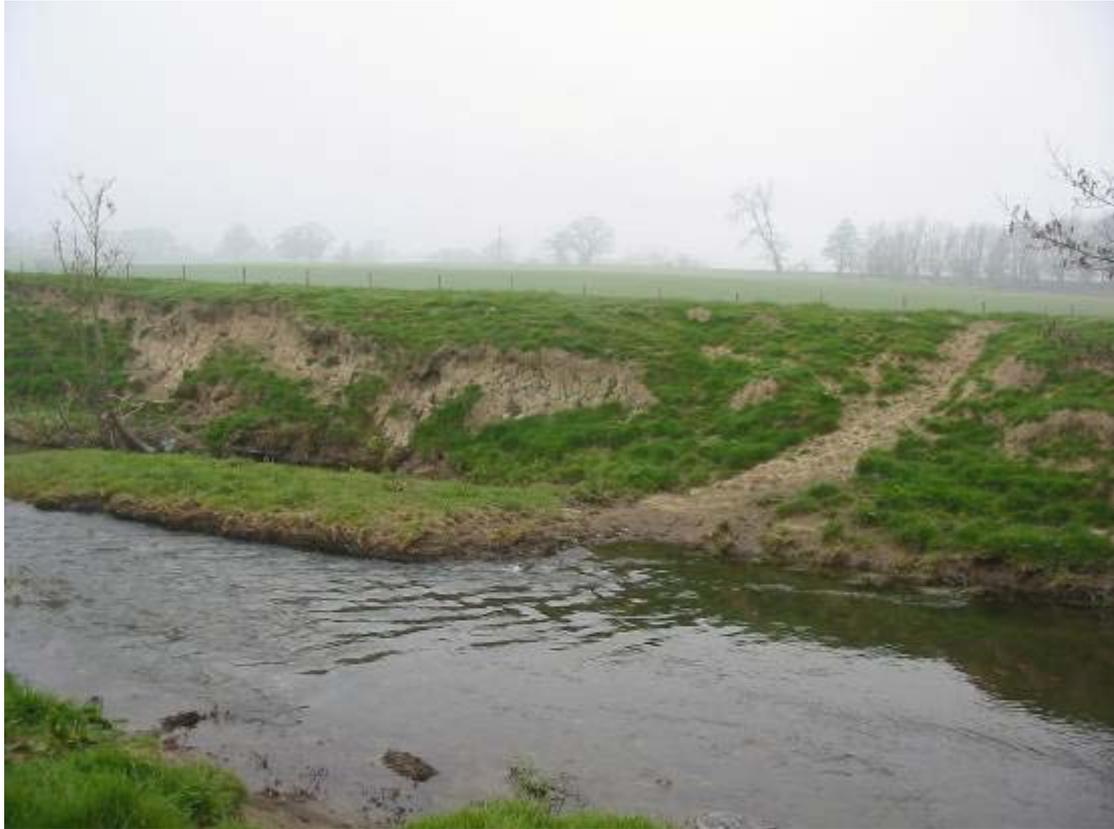
Downstream of the ford, there was an increase in the amount of arable land present. Where this abutted the river, the presence of buffer strips prevented excessive erosion. Some sections of the grazing land adjacent to the river were fenced, preventing erosion due to grazing stock. However, there was significant and damaging erosion in at least one long unfenced section.

Bankside erosion from stock downstream of the ford

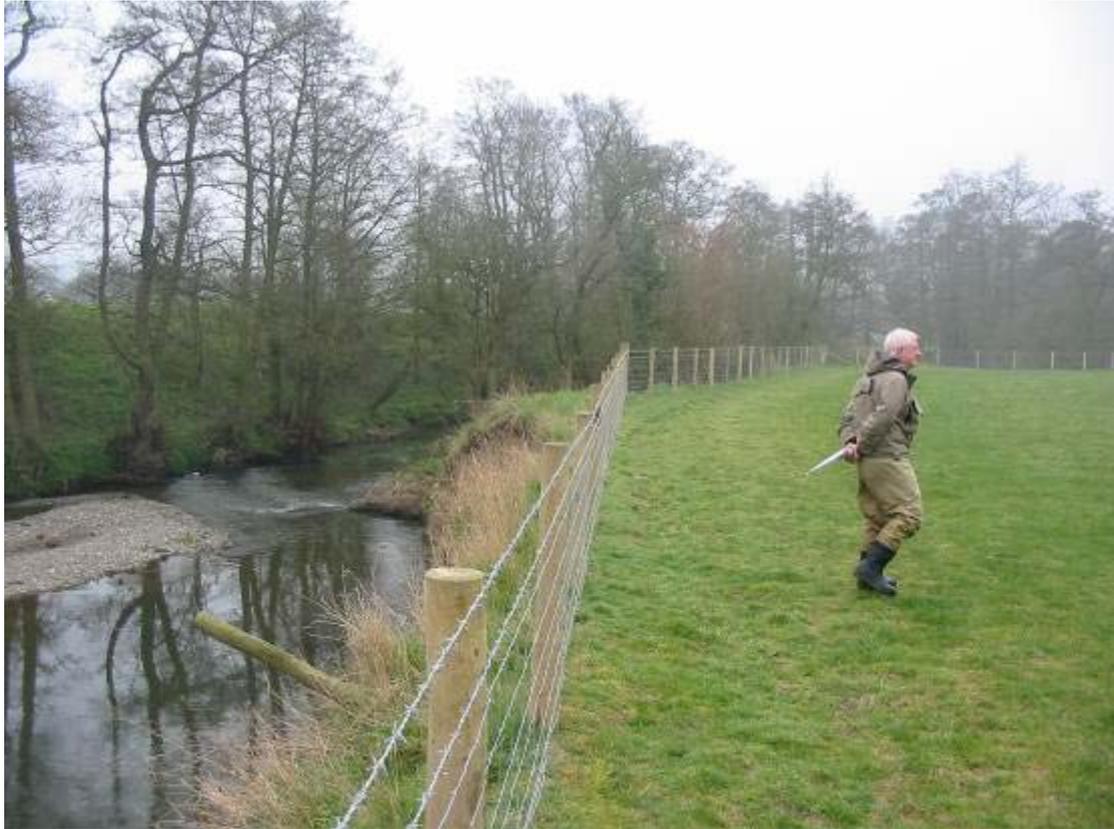
New fence, erected too close to the bank top. It is very vulnerable to rapid erosion and failure of the bank
