Cheselbourne Stream, Cheselbourne, Dorset

Wild Trout Trust report following an Advisory Visit on 6 November 2019

Written by Theo Pike: tpike@wildtrout.org

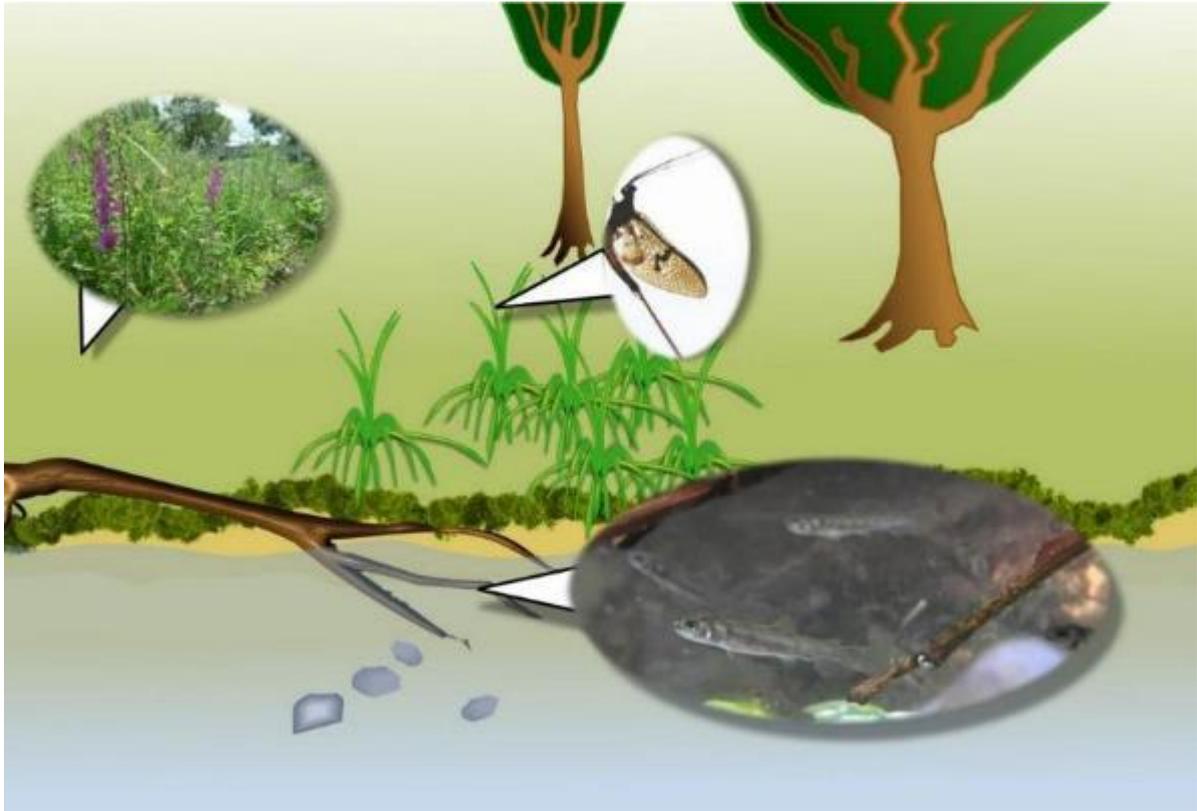
Figure 4: Larger cobbles and submerged 'brashy' cover and/or exposed fronds of tree roots provide vital cover from predation and spate flows to tiny juvenile fish in shallower water (<30cm deep). Trailing, overhanging vegetation also provides a similar function, and has many benefits for invertebrate populations (some of which will provide a ready food supply for the juvenile fish).

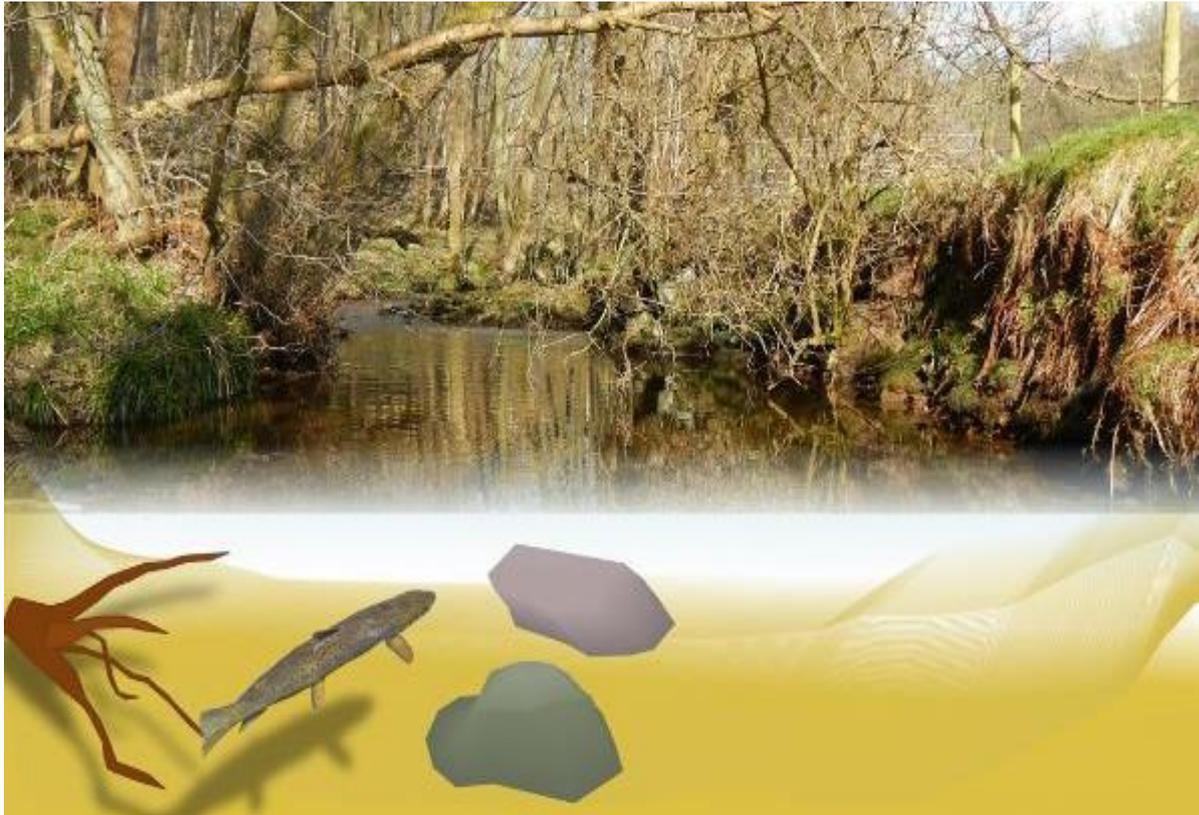
Figure 5: The availability of deeper water bolt holes (>30cm), low overhanging cover and/or larger submerged structures such as boulders, fallen trees, large root-wads etc. close to a good food supply (e.g. below a riffle in this case) are all strong components of adult trout habitat requirements.

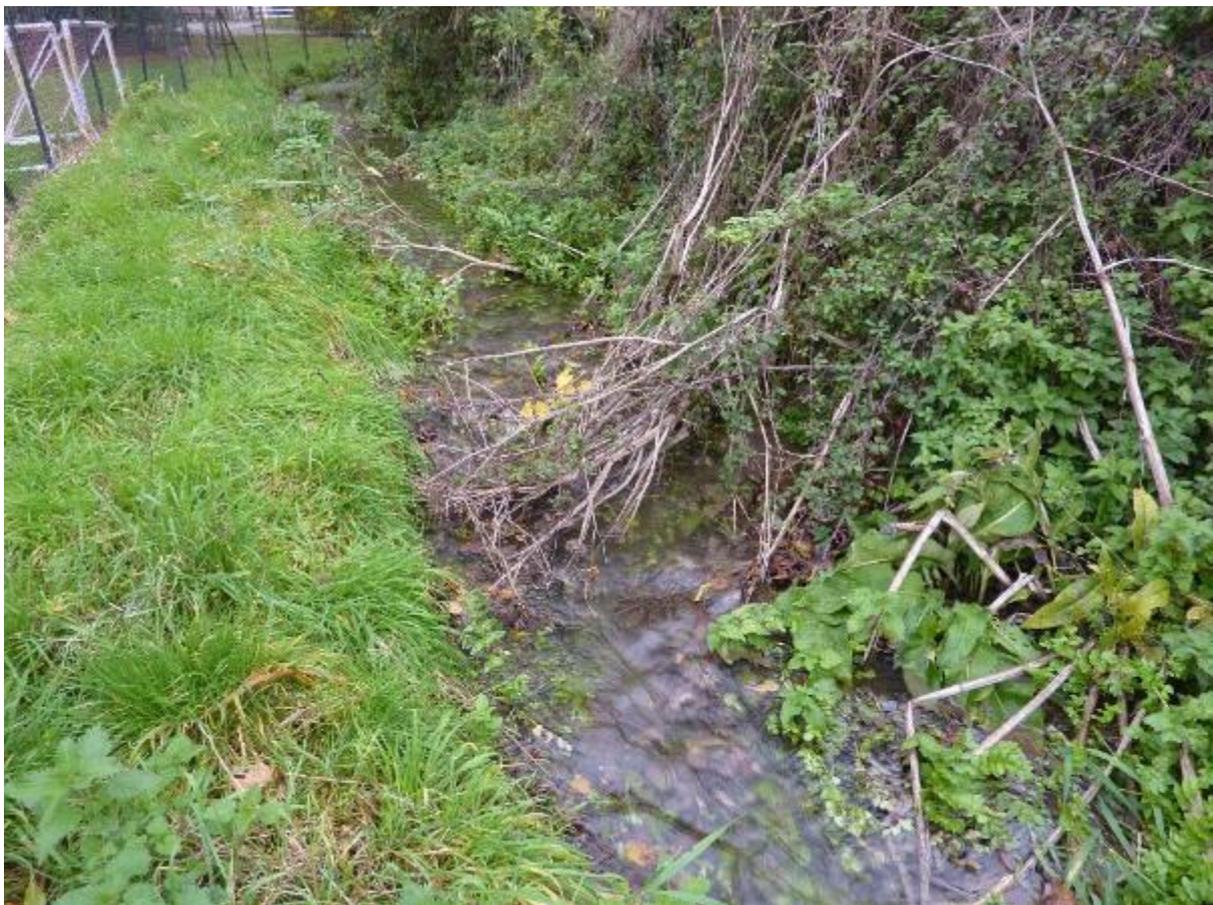
A similarly 'less-manicured' stretch of stream can also be found further downstream, alongside the village school's sports pitch, at approximately ST 76075 00025:

Figure 6: Complex habitat and biodiversity: this stretch of the Cheselbourne offers habitat for many different species

These areas could be seen as near-target conditions for other stretches of the Cheselbourne: rich in macrophytes which are 'reservoirs' for biodiversity, which offer excellent complex habitat for many species of aquatic invertebrates and even fish. The hydrological 'roughness' of the vegetation will also serve to 'slow the flow' very valuably in both high and low water conditions, contributing to flood attenuation for downstream areas on one hand, and maintaining summer water levels on the other.

Stretches of the Cheselbourne such as that near ST 76075 00025 (pictured in Figure 6) could be seen as near-target conditions for other stretches of the stream - with soft, natural, well-vegetated banks that offer excellent complex habitat for many species, and 'slow the flow' of water very valuably in a range of water conditions.

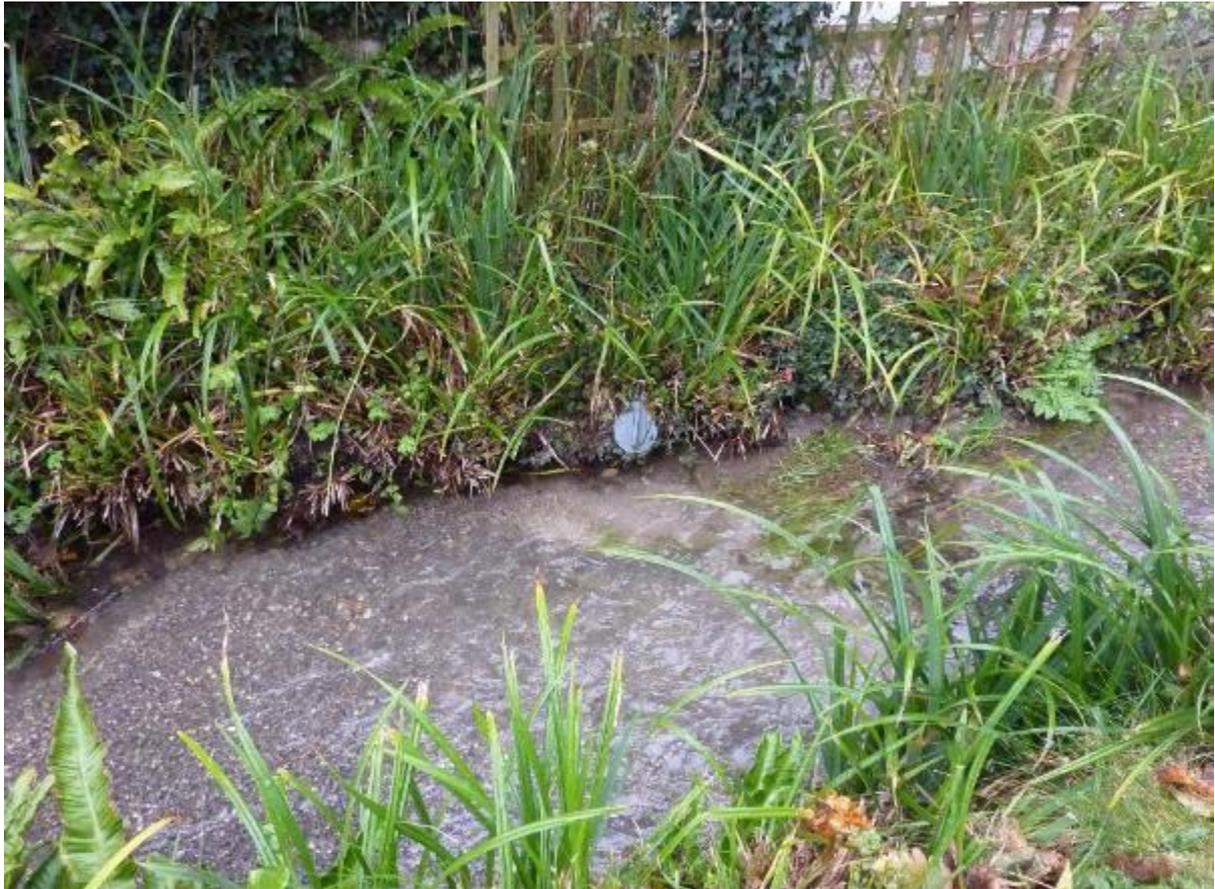
At ST 76027 00103, where the stream emerges from a culvert under a crossroads in a residential area, and approaches Cheselbourne Village School, the stream bed is covered in a large volume of fine sediment, including a variety of small stone chippings which are distinctly different from the typical flint gravel of this area's chalk geology:

Figure 3: Uncharacteristic fine sediment on the bed of the stream at ST 76027 00103

Further investigation upstream suggests that this sediment is a mixture of road runoff down the hill from Drakes Lane, and limestone top dressing from residential driveways, all carried into the stream by a concrete channel from the crossroads to the downstream end of the culvert:

Such large volumes of fine sediment are likely to be very damaging to a small stream like the Cheselbourne: smothering aquatic invertebrates and fish eggs, filling interstices between the stream's natural gravels, and contributing to streambed 'calcretion' as the fine sediments are concreted together by the action of calcium-rich water on silt, creating a uniform layer of tufa on the stream bed. By accumulating in the stream in close proximity to residential properties, the sediment may also increase flood risk.

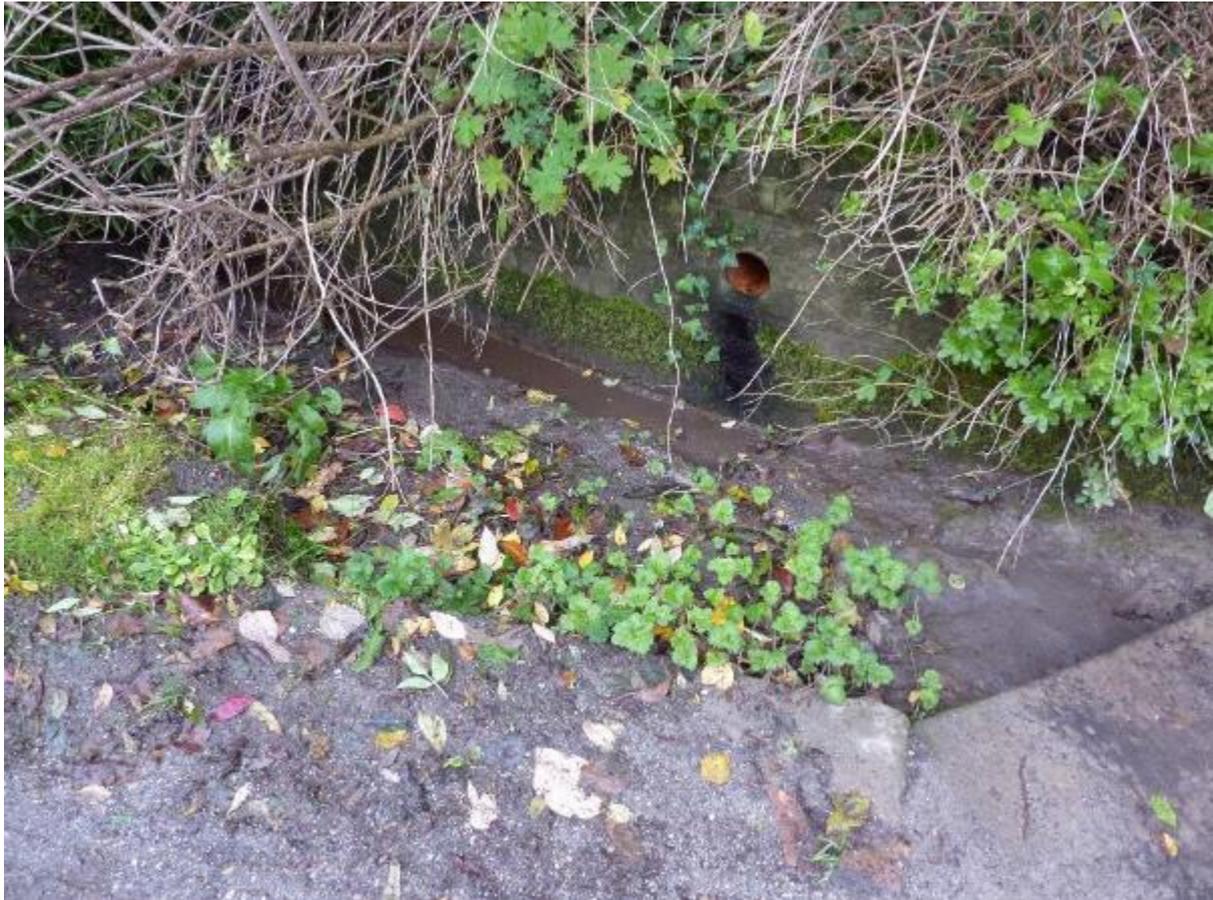
Figure 4: Pollution pathways into the Cheselbourne: fine sediment and possible evidence of leaking heating oil

Also noticeable in this area (and visible in Figures 3 and 4 above) are pipes from nearby properties, which are clearly designed to overspill into the stream. Although no smell was evident at the time of the walkover, the black stain below the pipe in Figure 4 suggests the possibility of heating oil escaping from a cracked line and reaching the stream via surface water drainage. Further investigation would be advised.

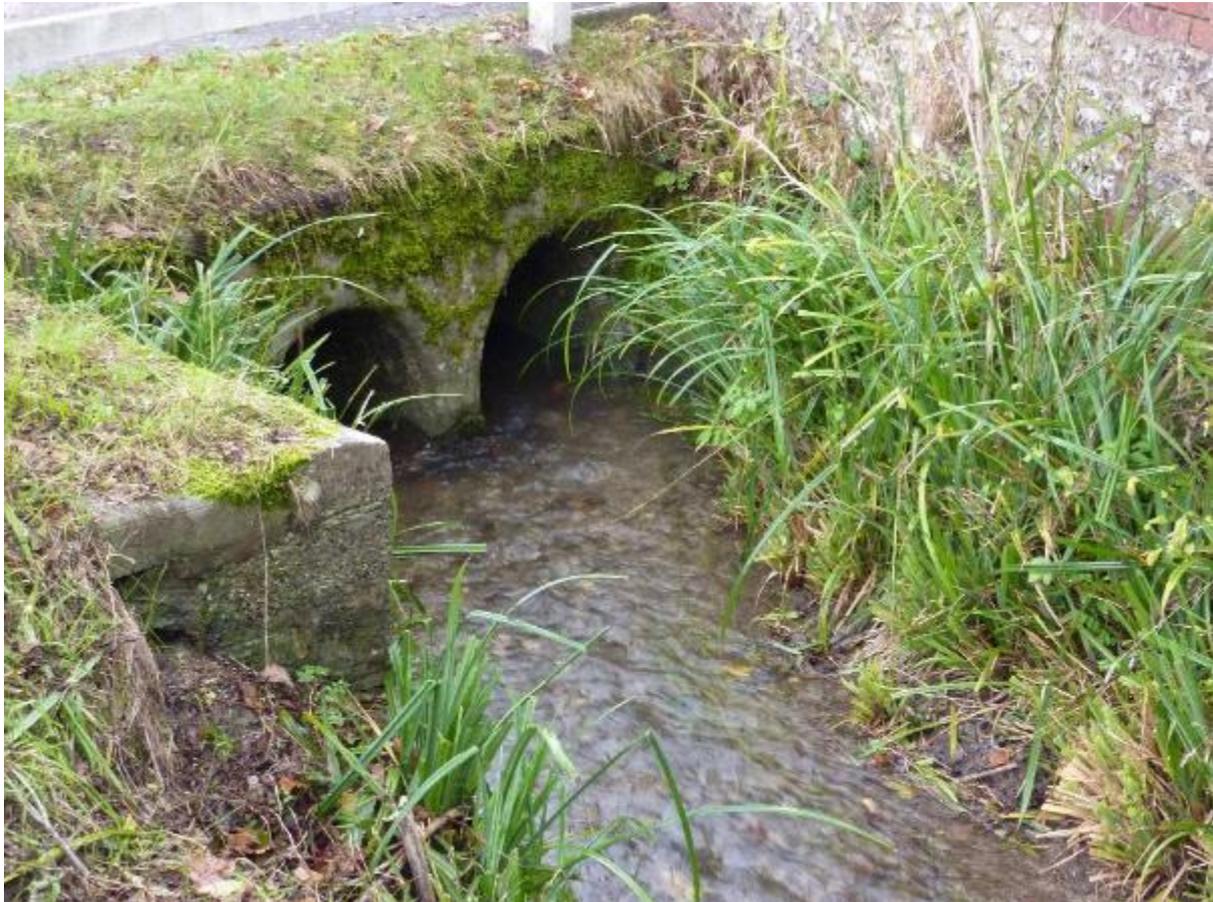
A few metres further downstream, the Cheselbourne flows under the main road, and then under an access road to the Village Hall, in a sequence of double pipe culverts:

Figure 5: Double pipe culverts represent an obstacle to fish passage as well as a local flood risk. (However, the soft and natural bank, rich with pendulous sedge, is very beneficial to this stretch of stream)

Structures like this (which are also present at several other locations in the village) are likely to constitute an obstacle to fish passage, since fish may not willingly swim through long, dark tunnels. These culverts are also noted for increasing flood risk when the relatively small-diameter pipes become blocked with waterborne twigs, leaves and vegetation like watercress when these become dislodged and are carried downstream.

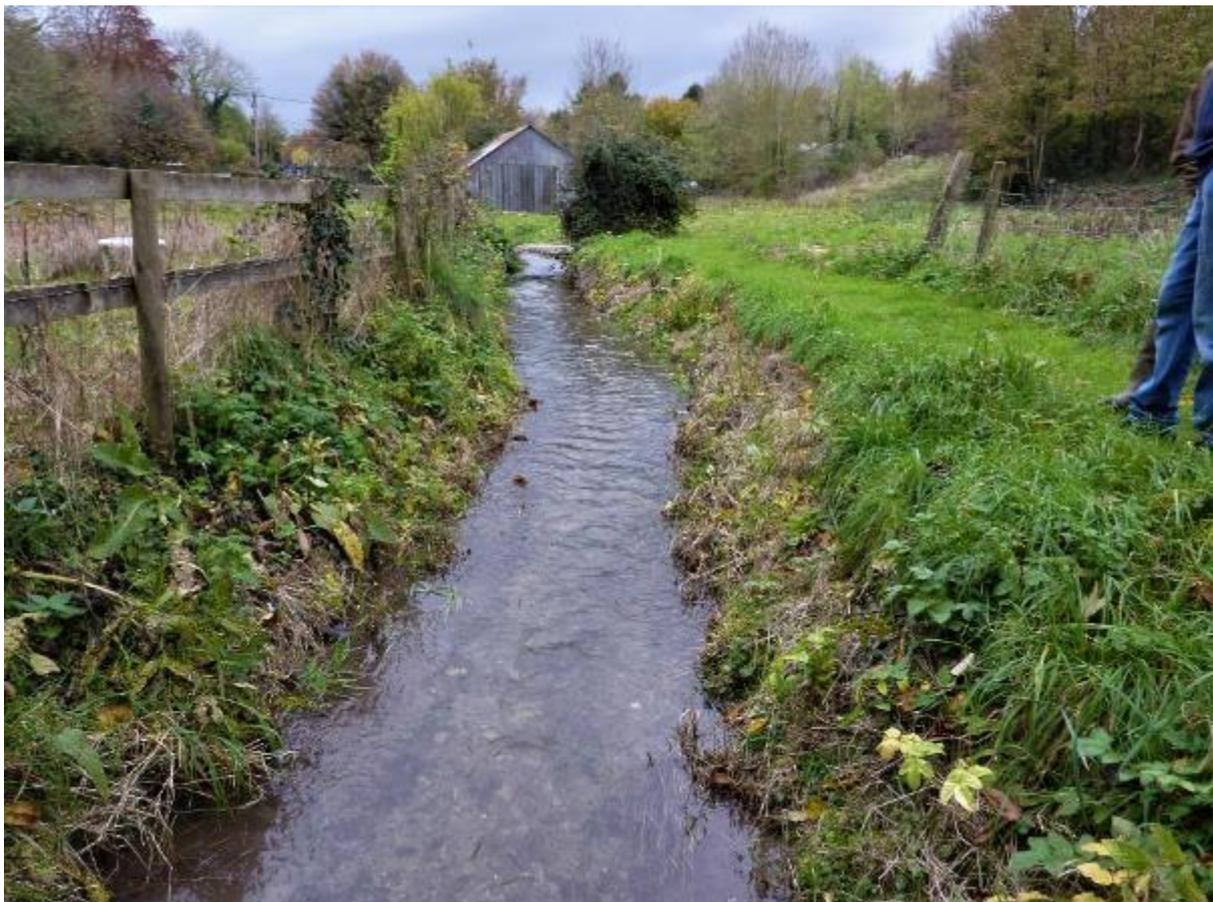
As the stream flows through an area of rough meadow at ST 76099 00009, with a fairly steep slope rising from the LB, it is noticeable that silt is being deposited in the margins on both sides of the stream, and consolidated by the roots of emergent plants, while the gravels in the central channel (where the current runs faster) are scoured clean and silt free:

Figure 6: A healthy, natural stretch of stream, with lateral silt deposition being consolidated by a range of plant species, and a silt-free central channel

This is a beneficial natural process, whereby the stream is accommodating itself to available flows, and should be encouraged. Over time, the silty margins will consolidate: in the meantime, any attempt to remove the marginal plants should be avoided, as this will mobilise silt back into the central gravels, destabilise the new banks, and rob the stream of this vital habitat that connects aquatic and terrestrial habitats. Many aquatic insects, for example, live in the marginal vegetation as juveniles, and climb up it when they emerge into the air as adult flies.

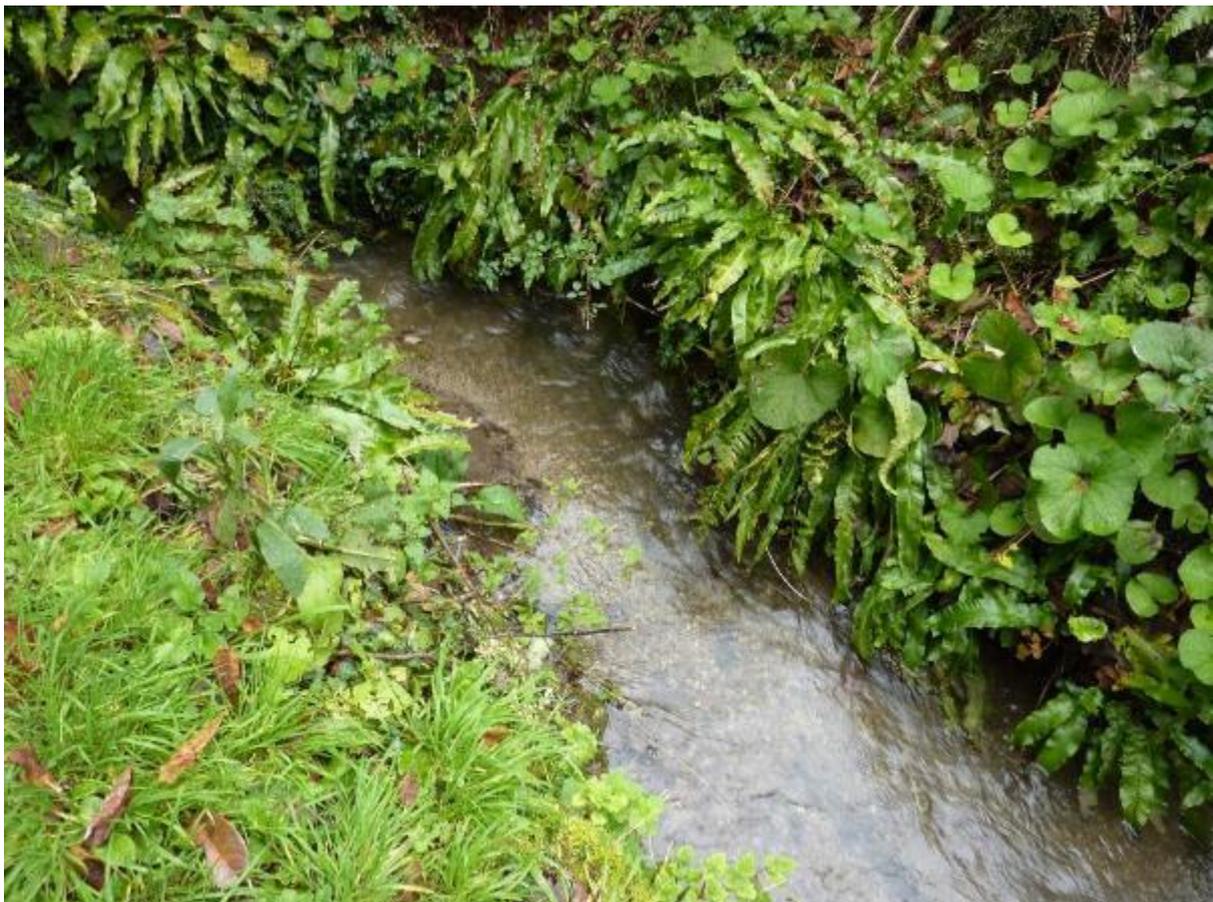
Downstream of this area, the stream runs into an area of private gardens, where some areas of bank host lush growths of hart's tongue and other ferns. This soft, trailing marginal growth offers very beneficial low-level cover for fish and other aquatic species:

Figure 7: Soft, trailing vegetation offers beneficial low cover above a cleanly-scoured corner pool

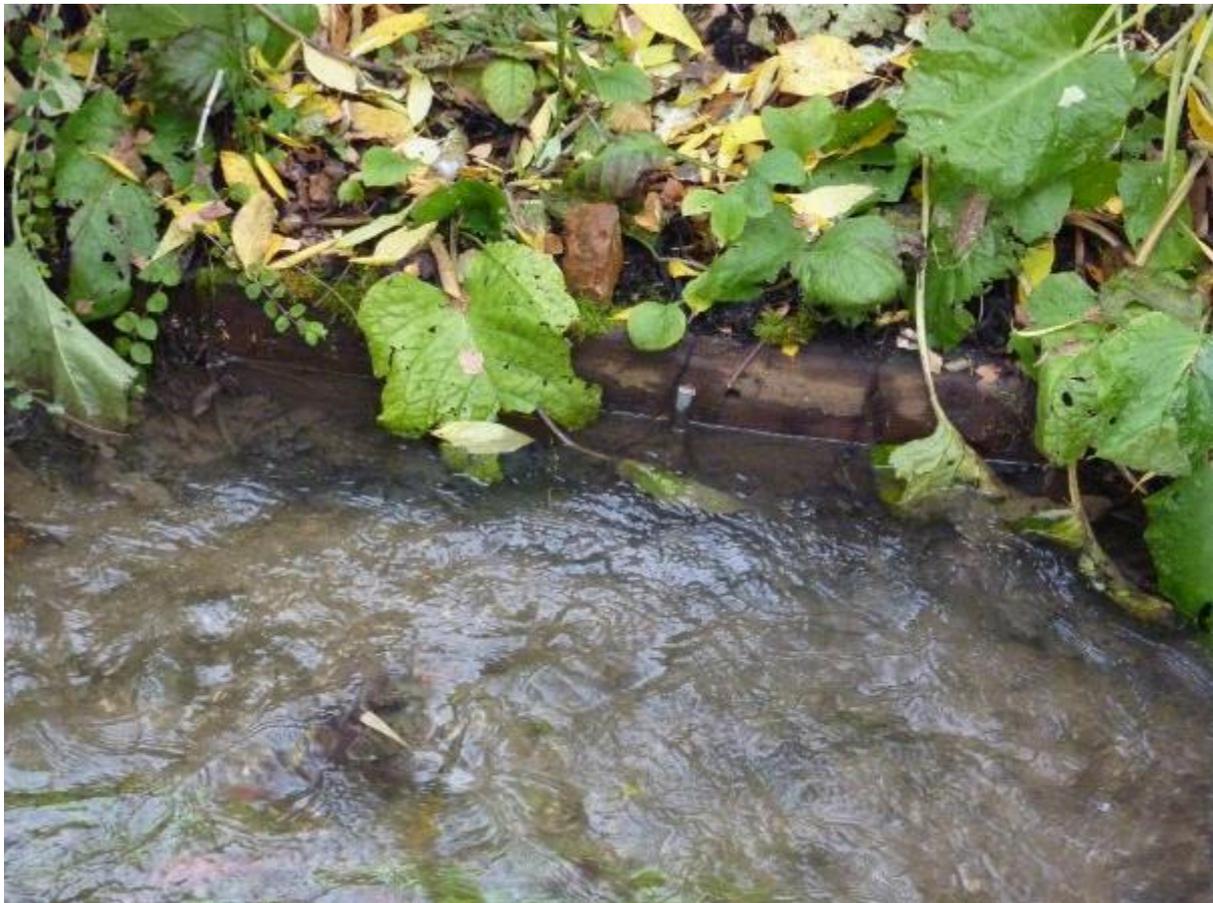
At approximately SY 76272 99770, it was noticed that the stream's banks had been armoured with toe-boards of recycled railway sleepers:

Figure 8: Repurposed railway sleepers can be a significant source of long term chronic pollution as tar-based preservatives leach out into the stream

Railway sleepers have customarily been treated with preservative hydrocarbons such as creosote or tar. When sleepers are repurposed as toe-boards, the toxic hydrocarbons can leach out into the water for many years, with damaging effects on invertebrates. It would be highly advisable to remove these toe-boards as soon as possible, and use brush bundles to restore a soft margin of native plants (in conjunction with tree management to allow enough light for the plants to establish successfully).

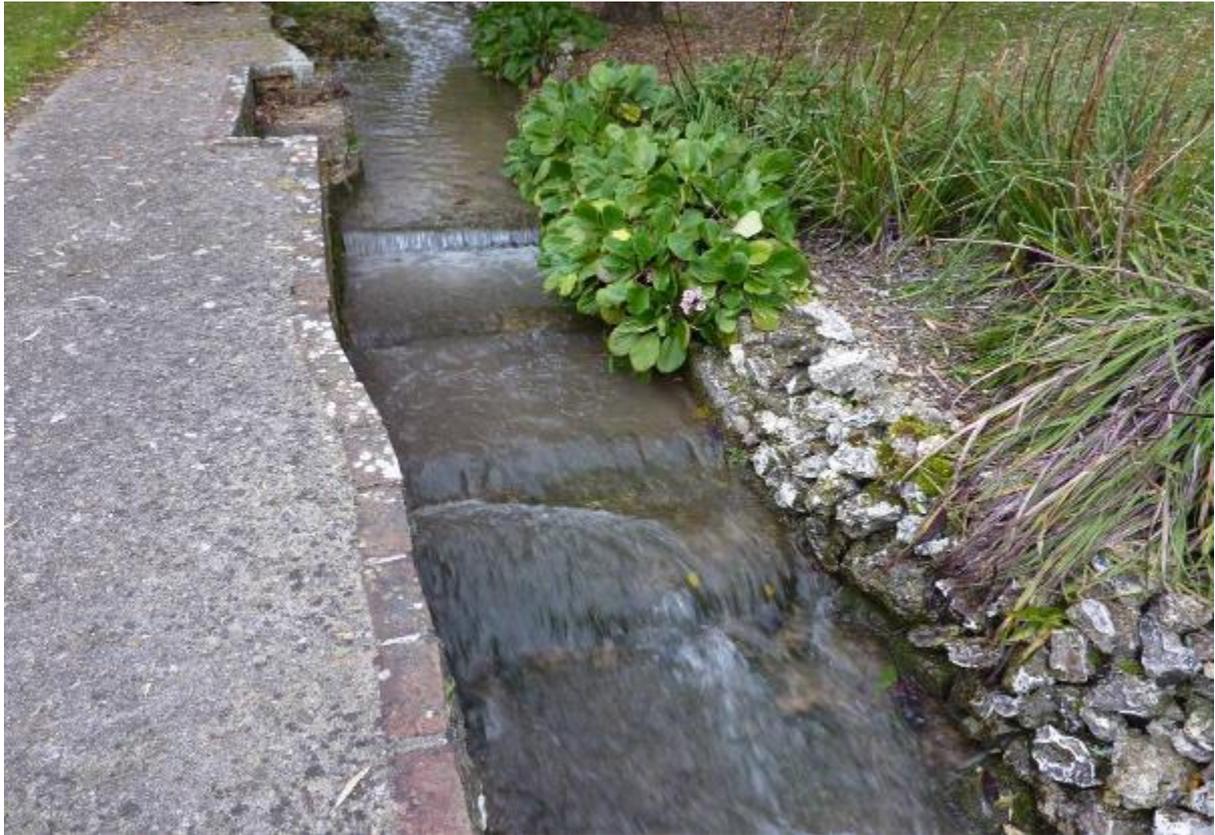
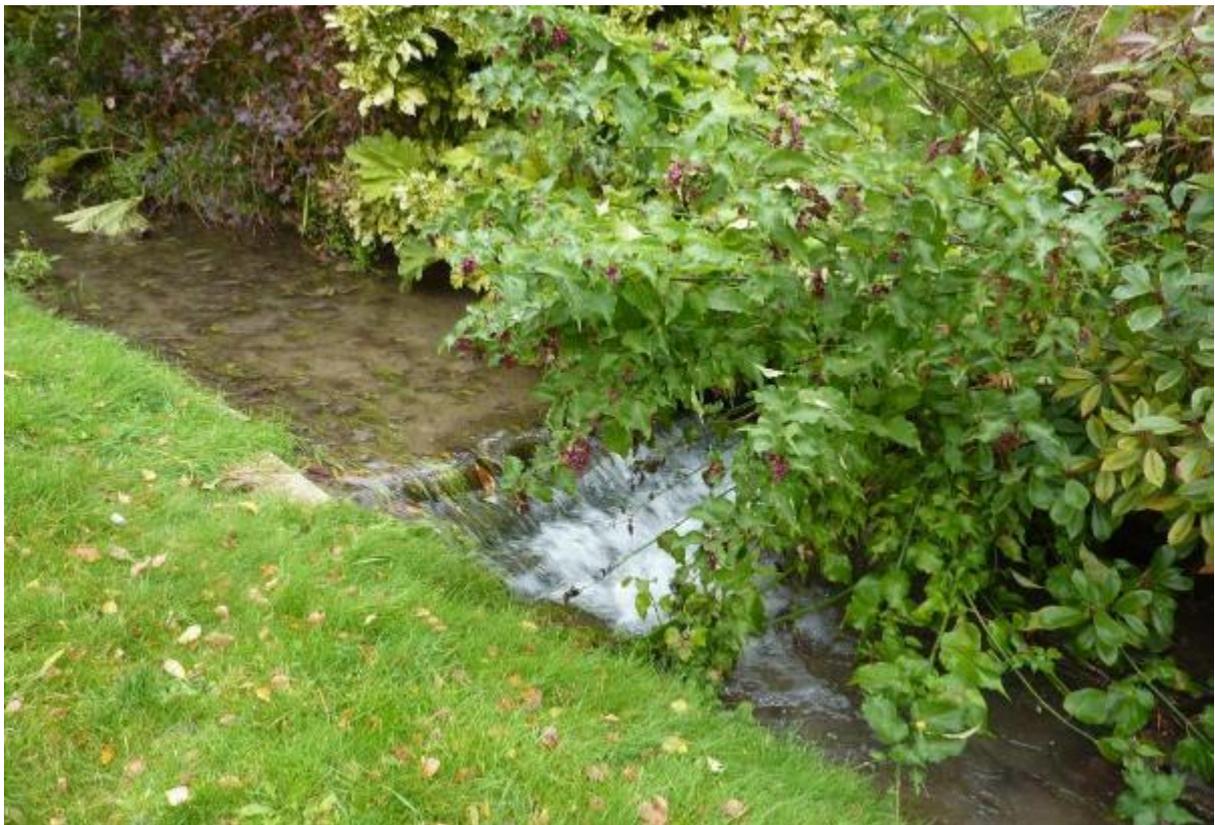
At different points in these gardens, at approximately SY 76198 99900 and SY 76267 99783, the stream has been fragmented by ornamental weirs, perhaps in an attempt to retain water as a feature during periods of low flow:

Figures 9 and 10: Ornamental weirs act as a barrier to fish passage and interrupt the stream's natural processes

Such weirs create long stretches of very slowly-moving water, where sediment carried in suspension drops out of the water column uniformly across the stream bed, and habitat quality and diversity are severely degraded. Such conditions can sometimes provide sufficient deep water habitat for small numbers of adult trout and other species (until the deep water inevitably fills with sediment) but are generally unsuitable for gravel spawning fish, fry and juveniles.

As noted above, weirs prevent fish from migrating within streams and rivers, whilst also degrading habitat by impounding fine sediment in the slow water above the structure.

It would undoubtedly benefit the stream's natural function to reduce or remove the weirs at SY 76198 99900 and SY 76267 99783, regrading the bed of the stream through the head loss in each case, possibly with nature-like rock ramps. At the same time, hard sided channel walls above and below each structure could also be reduced or softened.

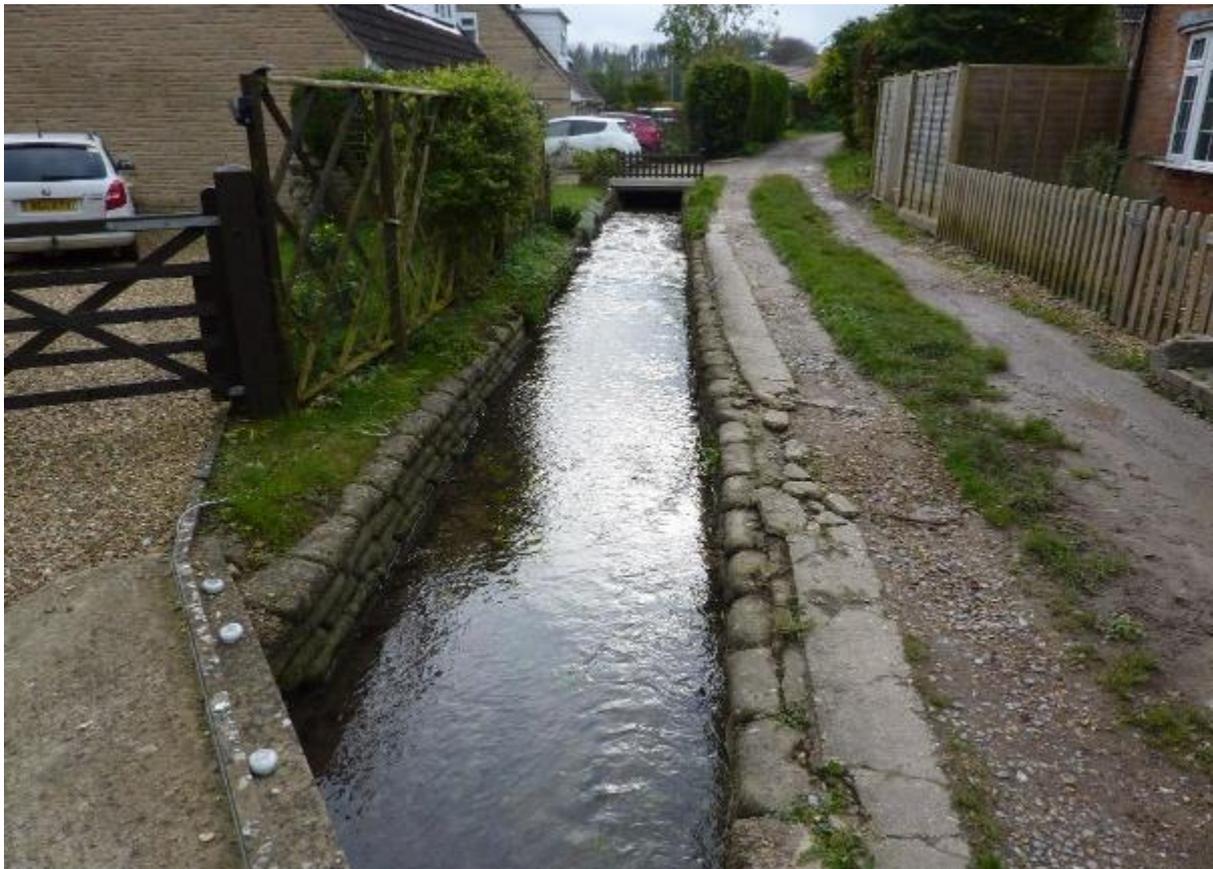
Proceeding downstream, the Cheselbourne passes under the main road once again, and enters another area of private gardens where its course has been straightened and its banks hardened with courses of 'concrete sandbags':

Figure 13: 'Concrete sandbag' flood walls provide very little visual interest or habitat diversity for insects, birds and fish

In areas where the banks of the stream have been hardened with 'concrete sandbags' and other forms of armouring, consideration should be given to breaking these out partially or completely, or at least softening them with a soft green toe of marginal planting, such as staggered stands of iris and watercress, to recreate a sinuous, meandering channel between the hard walls. Low level berms of gravel or loose flints could also be used to define this naturally self-scouring low flow channel: these are likely to consolidate with silt over time. The Wild Trout Trust has recently advised on similar restoration work on the East Meon, a small chalkstream in a village in Hampshire:

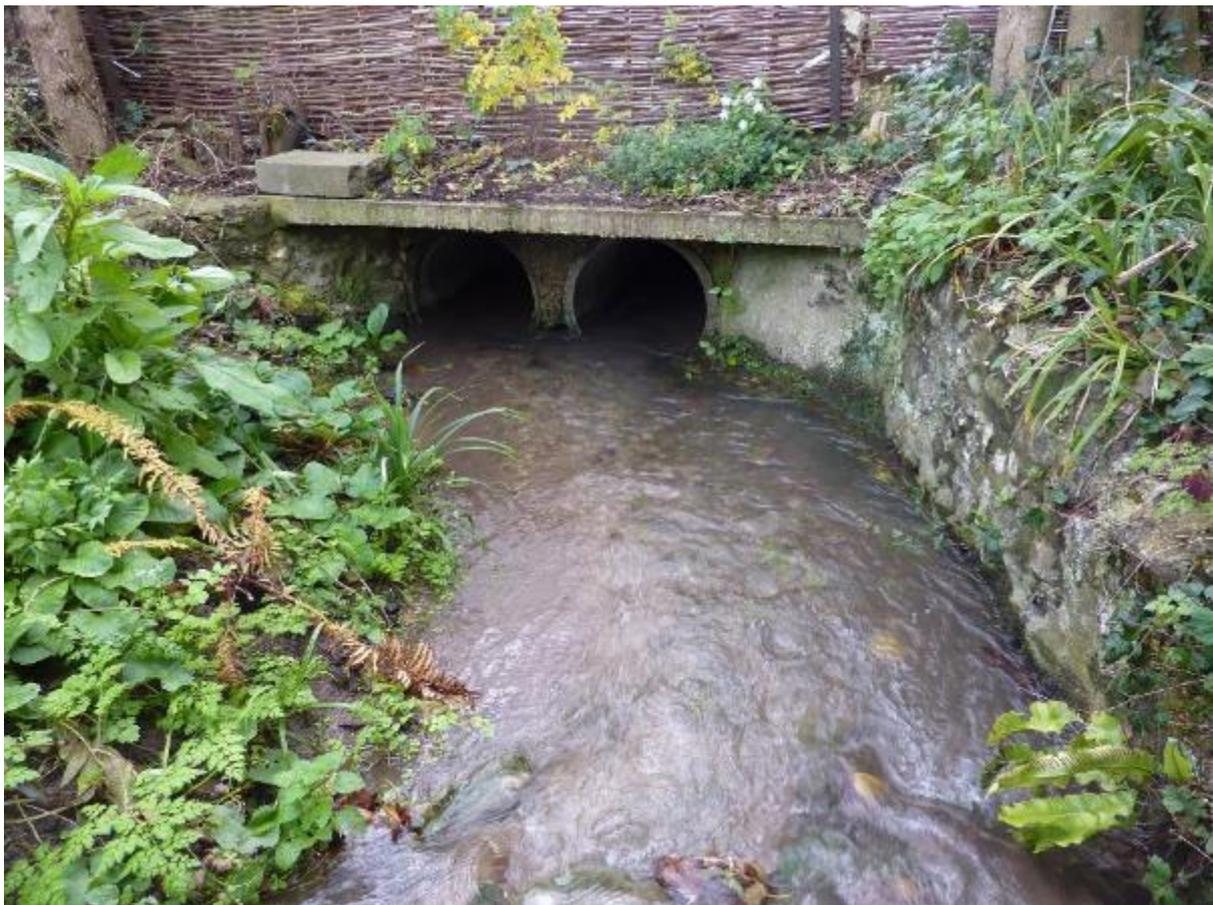
In this area, it is likely that the high, hardened banks have also been necessitated by increased flood risk created by a hydrological throttle just downstream: a double pipe culvert, approximately 50 m long, under Robins Garden at SY 76264 99678:

Figure 14: The upstream end of the culvert under Robins Garden: undersized pipe culverts create flood risk for nearby properties, and could be broken out to make more space for water in this urbanised landscape

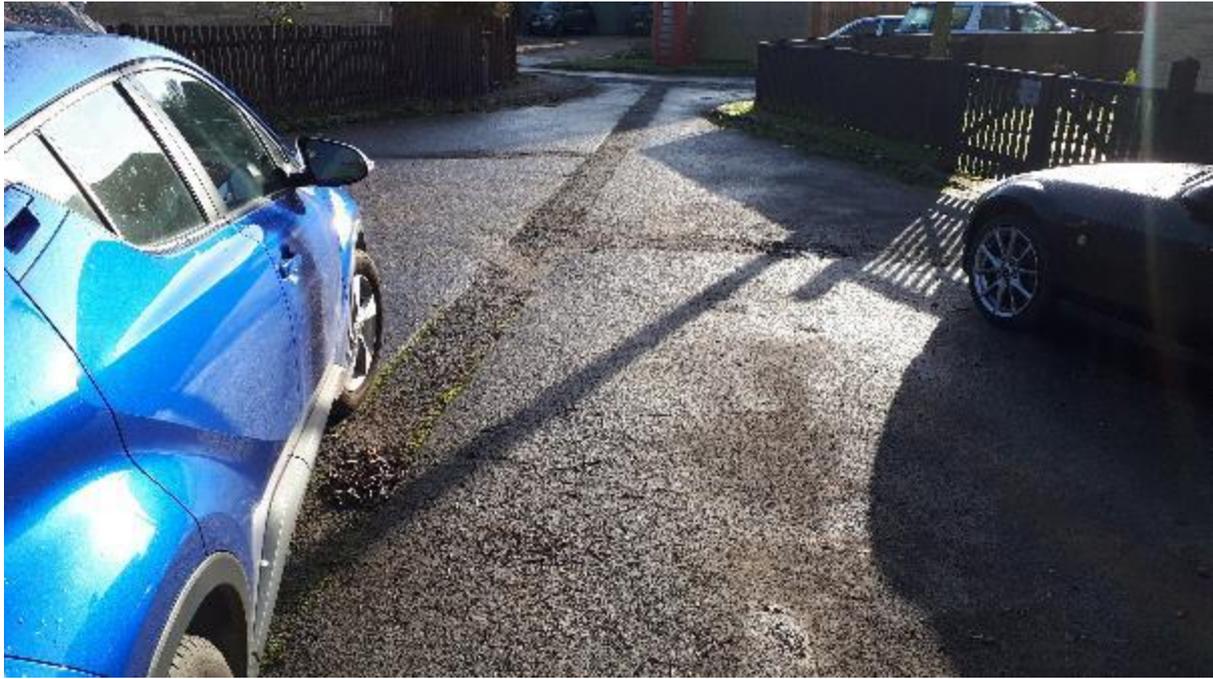
Figure 15: A view of the Robins Garden access and parking area constructed over the top of the culvert itself

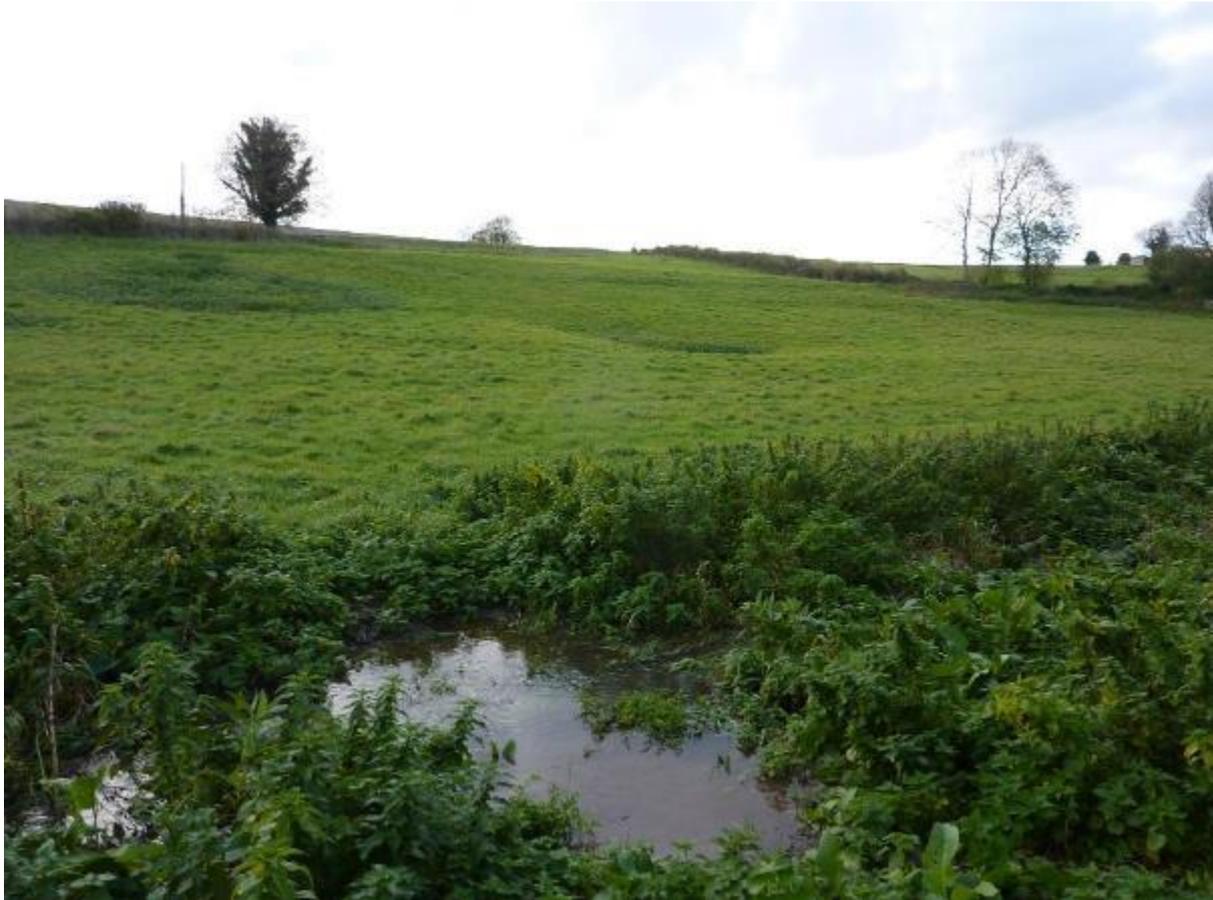
Below Robins Garden, the stream breaks out of the culverts and takes an apparently natural course across Church Field at SY 76267 99620:

Figure 16: The Cheselbourne in Church Field: potentially an area for natural flood management interventions, as well as fencing to exclude livestock from the stream banks to prevent poaching and overgrazing. Similar NFM or remeandering work could also be considered in areas not visited in the course of this survey: for instance, just above the school, and between the Manor House and its withy beds.

At the other end of the scale, Cheselbourne village could become more resilient to high flows by implementing natural flood management (NFM) initiatives, including remeandering the stream (or making it more possible for it to overtop its banks into the floodplain for flood storage and infiltration purposes) in selected areas above or even within the village, such as Church Field.

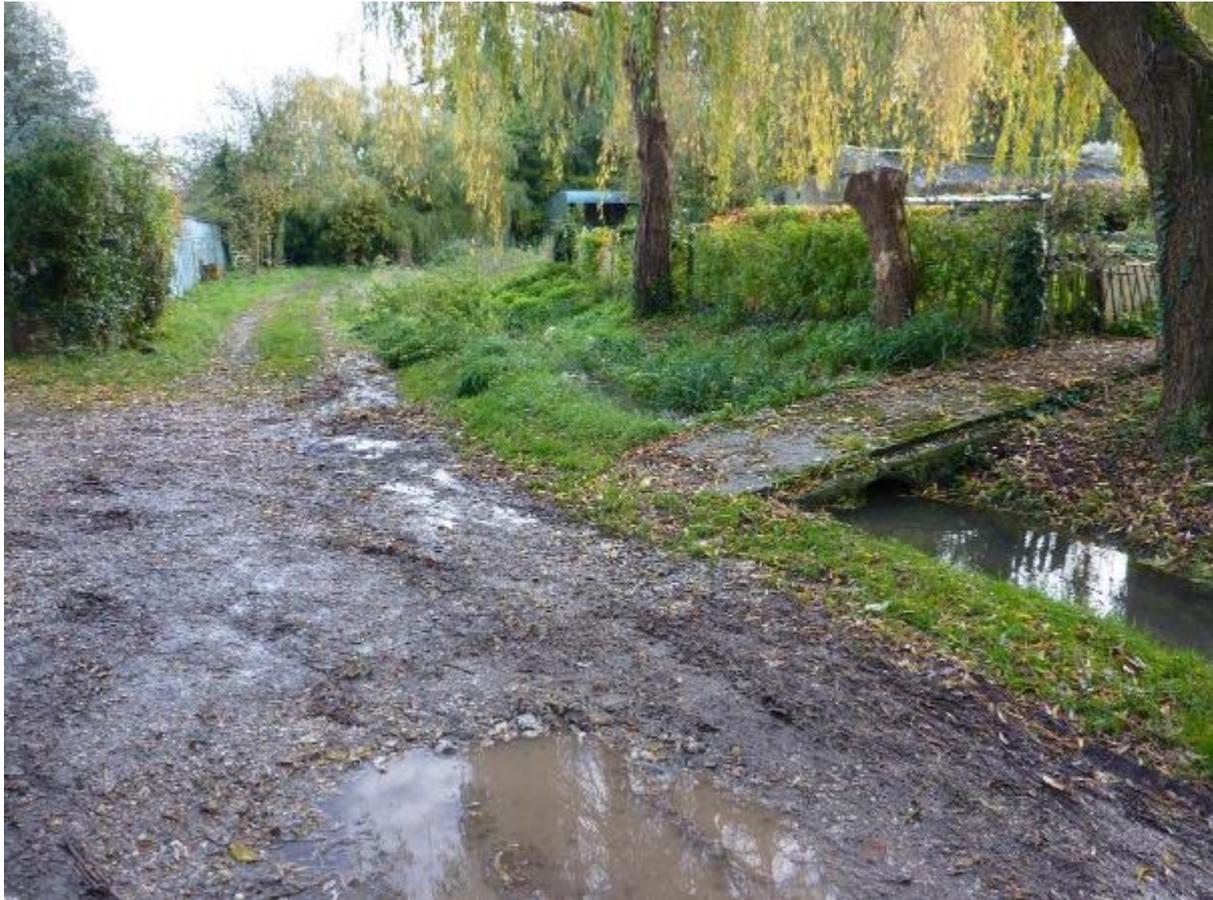
Figure 17: Approaching the ford at SY 76452 99345, possibly along an earlier course of the stream (which now appears slightly perched above the valley floor)

At SY 76452 99345 (and at several other points in and around the village, including SY 76245 99866 and SY 76383 99410) the stream is crossed by a ford. Most such fords in this valley are accessed by steep lanes or tracks which run straight down the valley's sides, serving as sediment pathways channelling runoff (including road washings) directly into the Cheselbourne.

In the case of the ford at SY 76452 99345 as shown in Figure 17, the runoff from the main road is also being piped directly into the stream from a gully pot uphill on the road at SY 76524 99392. This sediment pathway should be urgently intercepted: for example, by breaking out the pipe into an engineered wetland in the verge along the hedge line, or redirecting the flow into a soakaway in the adjacent field.

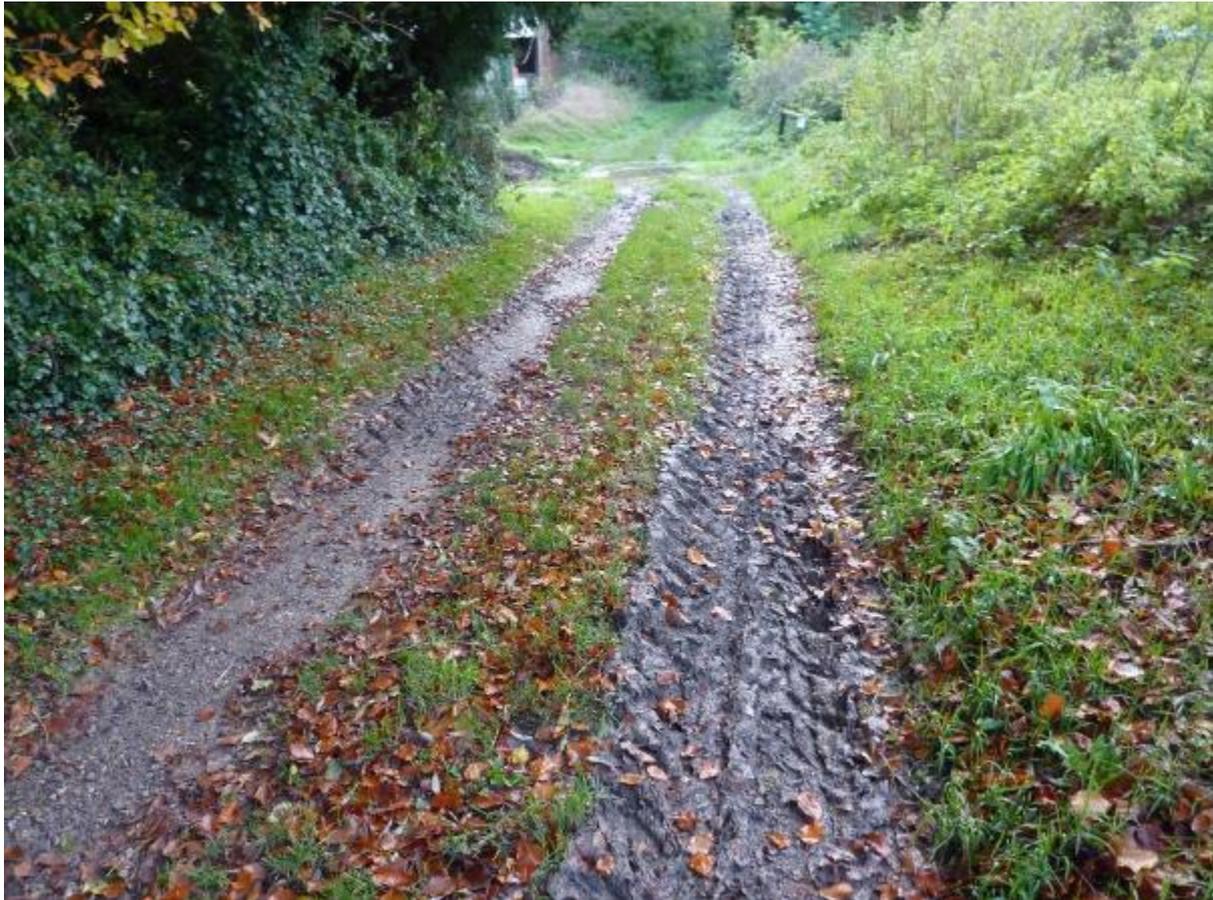
As a result of increasingly heavy farm machinery and associated transport, with tyres which not only carry soil out of fields but also erode the verges of narrow country lanes, the volume of silt pollution from this runoff is clearly very considerable.

Figure 18: A typical sediment pathway into the Cheselbourne, running straight downhill from the main valley road into a ford

In less built up locations, simple cross drains (or even slightly diagonal 'speed humps') could be installed across tracks and lanes to redirect runoff towards soakaways in fields or wooded areas, or into engineered wetlands or reed beds along existing ditch lines. In all of these cases, the objective would be to 'slow the flow' and channel it to other infiltration or sediment-depositing areas before it reaches the Cheselbourne.

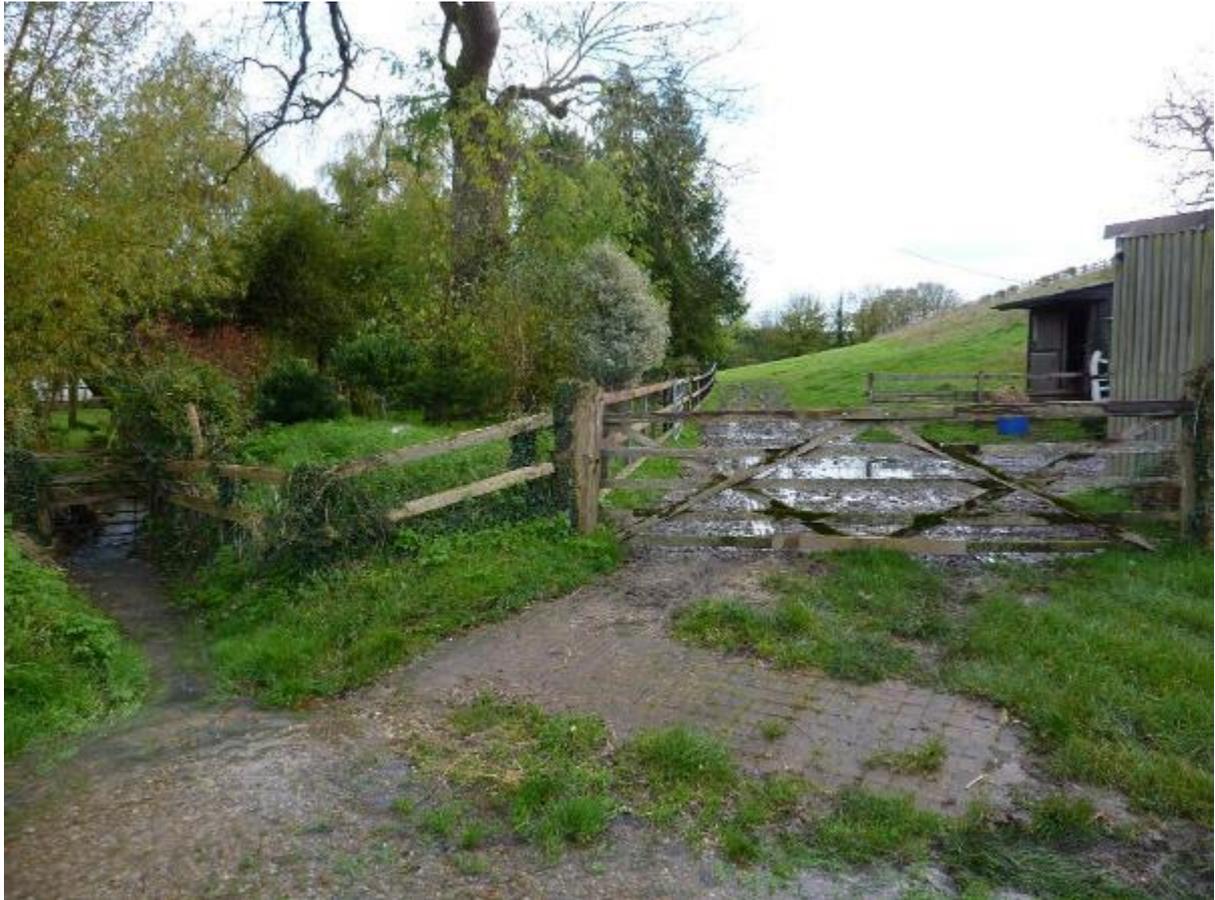
A further source of sediment is present at SY 76452 99345, in the form of runoff from an adjacent stable complex, as shown in Figure 19 below. With a mixture of manure and heavily poached mud entering the stream, this may be in breach of Defra's Farming Rules for Water. The potential impacts of horse culture on streams and rivers (including runoff, bank poaching, soil compaction and over-grazing) are not as widely recognised as those from other farming activities: in this case, engaging with the landowner to discuss options such as permeable paving in a bunded area, plus proper separation of foul and rain water, could be very beneficial:

Figure 19: A source of agricultural pollution from a stable complex adjacent to the Cheselbourne stream
