Cheselbourne Stream, Cheselbourne, Dorset

Wild Trout Trust report following an Advisory Visit on 6 November 2019

Written by Theo Pike: tpike@wildtrout.org

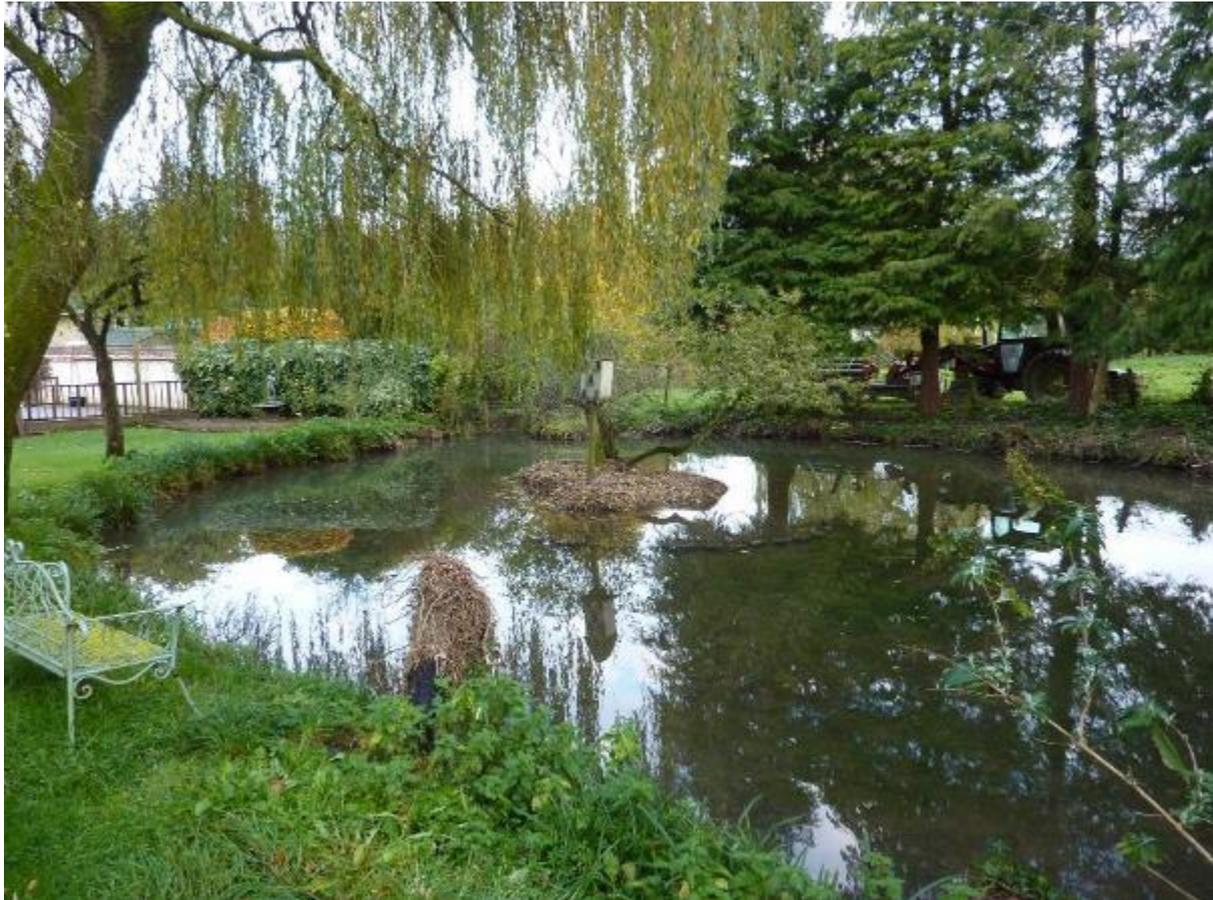
It is likely that much of the resulting sediment is captured by an online pond in the adjacent property: however, this is also causing the pond to silt up more rapidly, necessitating more frequent maintenance by the landowner:

Figure 20: An online pond which is currently acting as a trap for sediment inputs from upstream

No fish passage issues, apart from a temporary fine mesh fence, were noted at the lower end of the pond - although the remains of a sluice gate suggest that an impounding structure may once have been present.

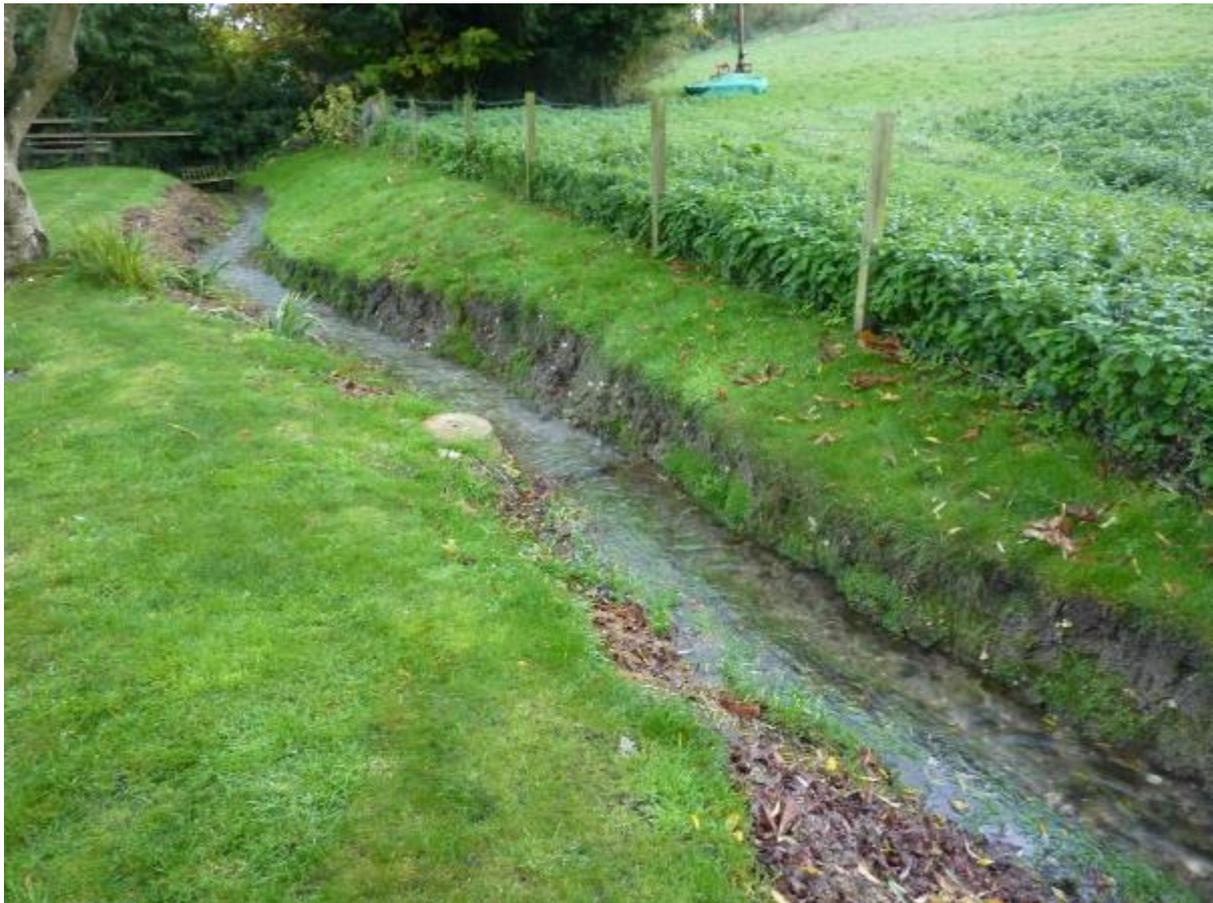
Beyond this point, the Cheselbourne flows through the gardens of several separate properties. In general, its course appears to have been moved to the edge of each property at some past point in history: in some areas this was apparent from eroding vertical faces on the RB. Controlled erosion on the outside of bends is part of a natural stream's processes, liberating new gravels previously laid down in its floodplain, but more general erosion along a failing bankline is likely to deposit damaging amounts of silt into the stream.

Both banks were also heavily mown: such a monoculture of short, shallow-rooted grass can do very little to bind stream banks or support biodiversity. If making more space for the stream on the LB is not possible in this area, stabilising the RB by planting native shrubs such as hawthorn along the bank top, with associated planting of iris and other emergent plants along the bank toe, is suggested. Reed canary grass will also grow out from the toe of the bank in slightly deeper water than iris or sedge, but is less likely to invade mid channel areas than burr reed or club rush. This diversity of plants, with their varied root depths, will help to stabilise the stream banks:

Figure 21: Eroding vertical banks suggest that the Cheselbourne has been moved some distance from its natural course, perhaps across the middle of the garden

Overall, a more relaxed mowing and/or strimming regime is recommended throughout Cheselbourne village's gardens – allowing a fringe of native plants to develop along both banks, stabilising the soil, reducing erosion, and creating attractive wild areas. In practice, this would also have the benefit of reducing the burden of garden maintenance for riparian owners!

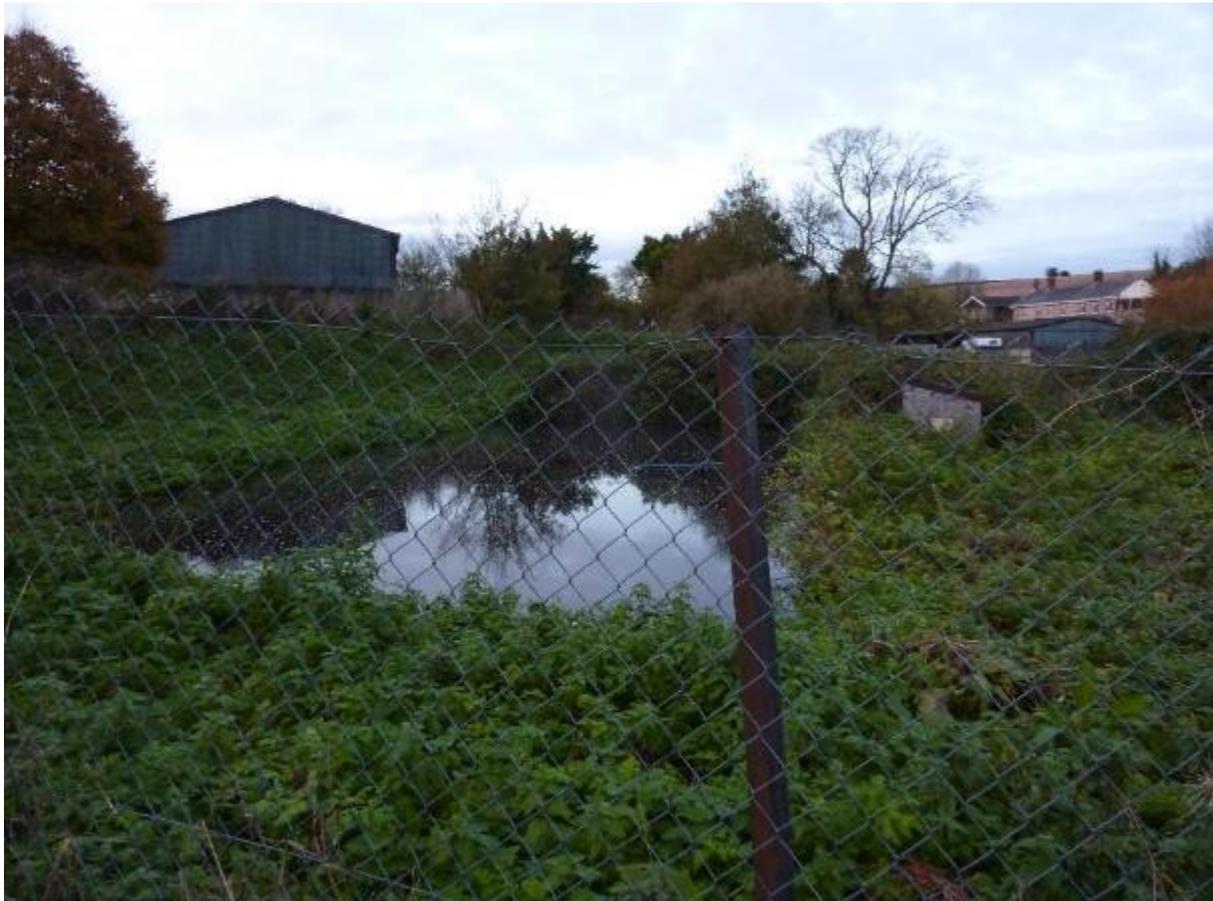
Beyond the farm buildings, the stream continues to follow the boundary lines of the next field. At SY 76549 99103 (pictured below) two large water 'tanks' were observed, with an ancillary structure which may be an automated pump house, perhaps corresponding to an abstraction borehole whose details are available via this link:

Figure 22: A possible borehole site at SY 76549 99103: below this location, flow in the Cheselbourne had virtually disappeared at the time of this walkover

At the time of the visit, the base flow of the Cheselbourne appeared drastically reduced from this point downstream – suggesting either that the area's complex geology is 'sinking' the flow into subterranean channels and cracks in the chalk, or that the cone of depression from an abstraction borehole, such as the one noted above, is similarly taking the water from the surface.

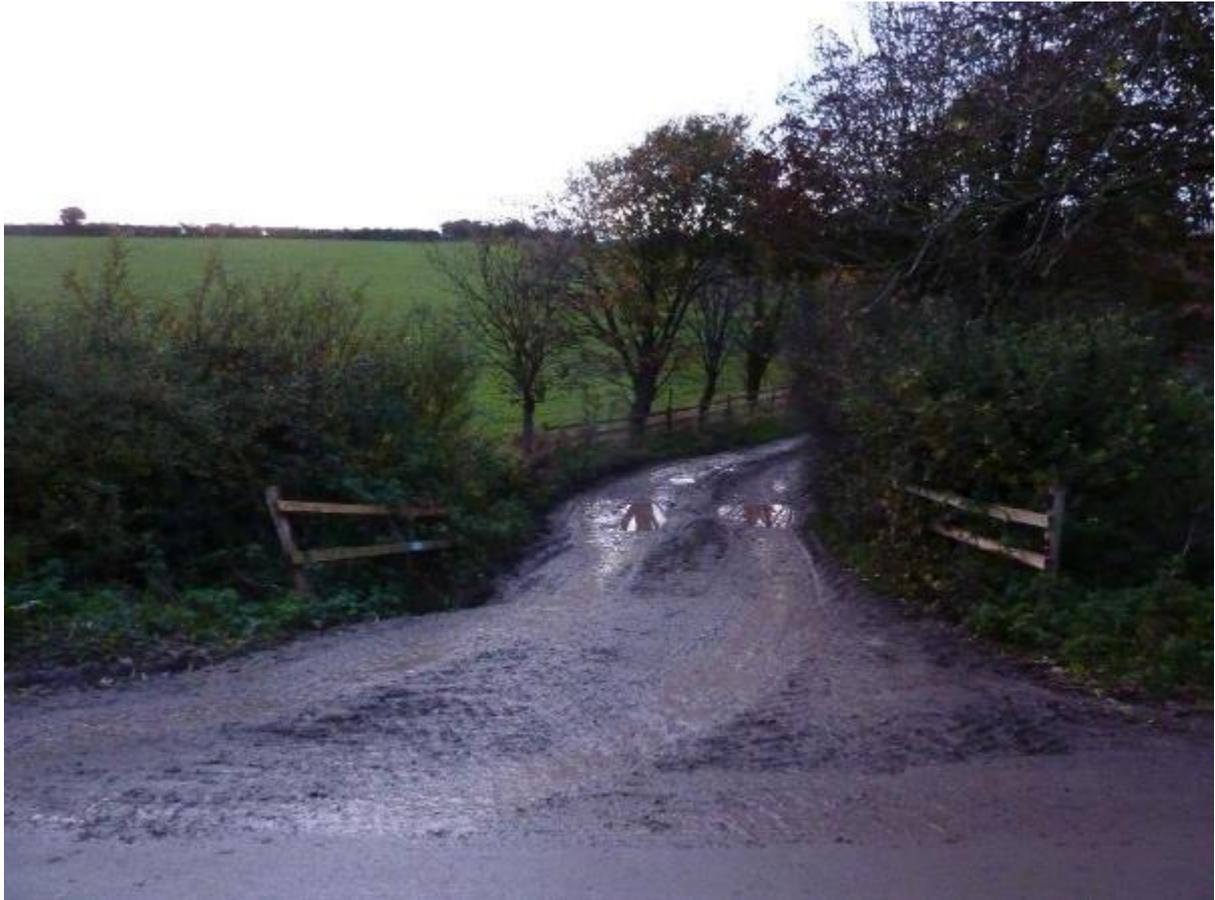
By SY 76559 99042, the furthest downstream point of this walkover, the flow of the stream had virtually disappeared. However, a further sediment pathway into the stream bed was noted from a bridge and farm track off the main valley road:

Figure 23: A further sediment pathway from a farm bridge and track at SY 76559 99042

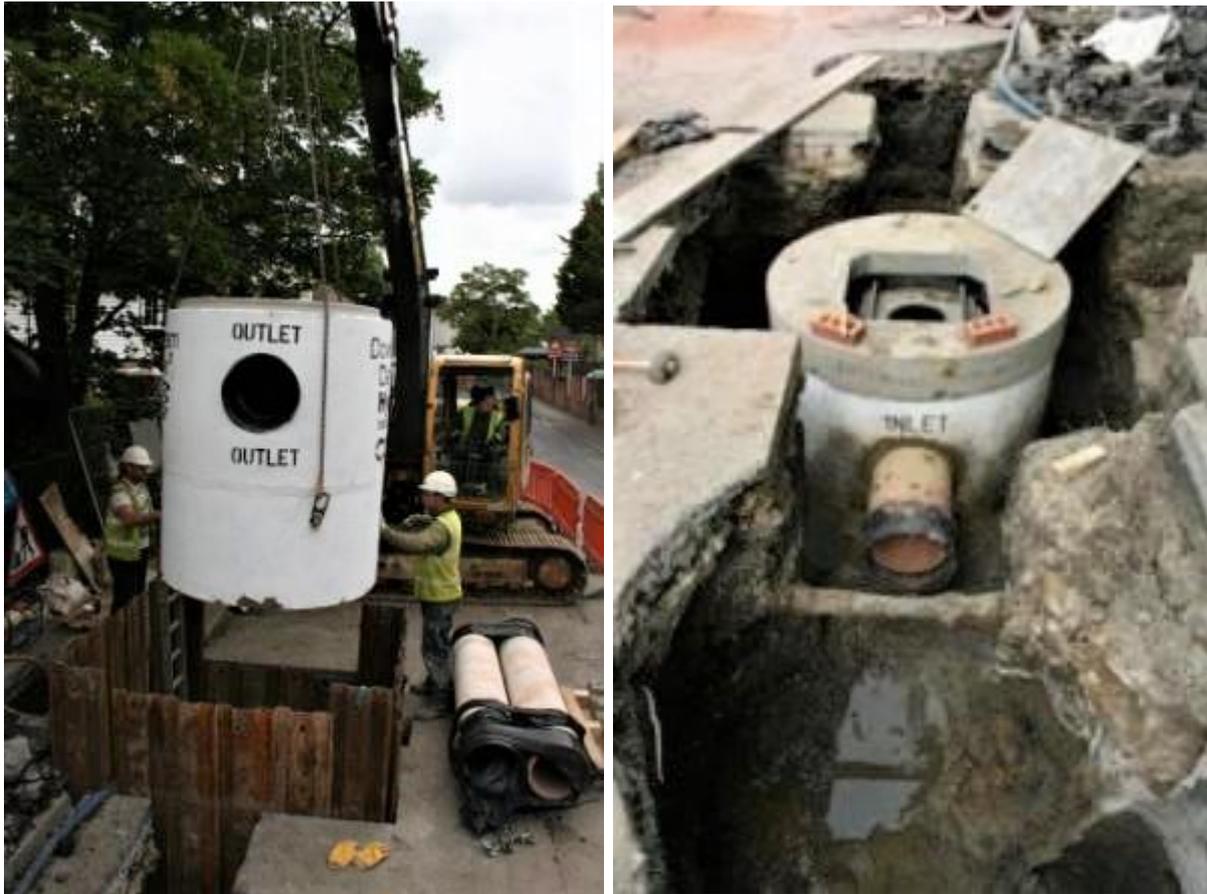
Figure 24: Downstream Defender hydrodynamic vortex chamber silt traps, originally designed for very high volumes of motorway runoff, being installed to intercept sediment in surface water drains near the River Wandle in south London (Photos: SERT)

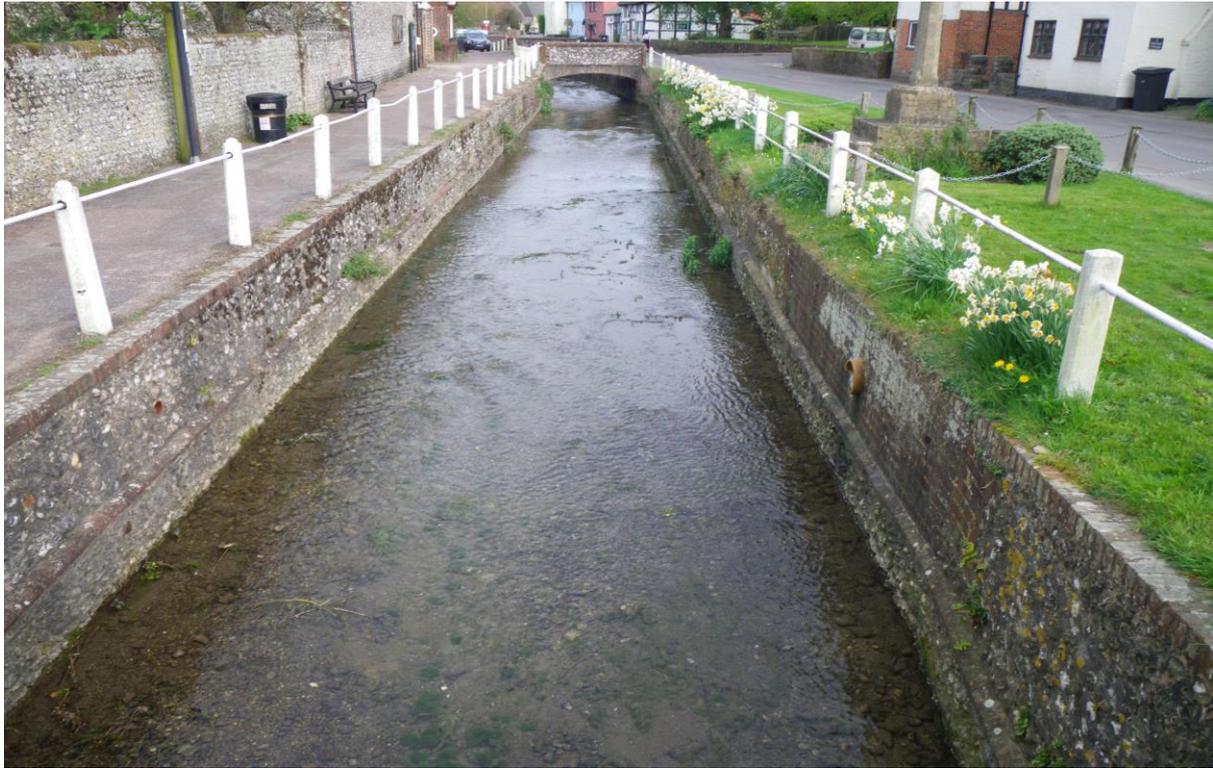
Figure 25: The River Meon in East Meon: an example of a small chalkstream before restoration, in an open culvert through a village similar to Cheselbourne

In areas where the banks of the stream have been hardened with 'concrete sandbags' and other forms of armouring, consideration should be given to breaking these out partially or completely, or at least softening them with a soft green toe of marginal planting, such as staggered stands of iris and watercress, to recreate a sinuous, meandering channel between the hard walls. Low level berms of gravel or loose flints could also be used to define this naturally self-scouring low flow channel: these are likely to consolidate with silt over time. The Wild Trout Trust has recently advised on similar restoration work on the East Meon, a small chalkstream in a village in Hampshire:

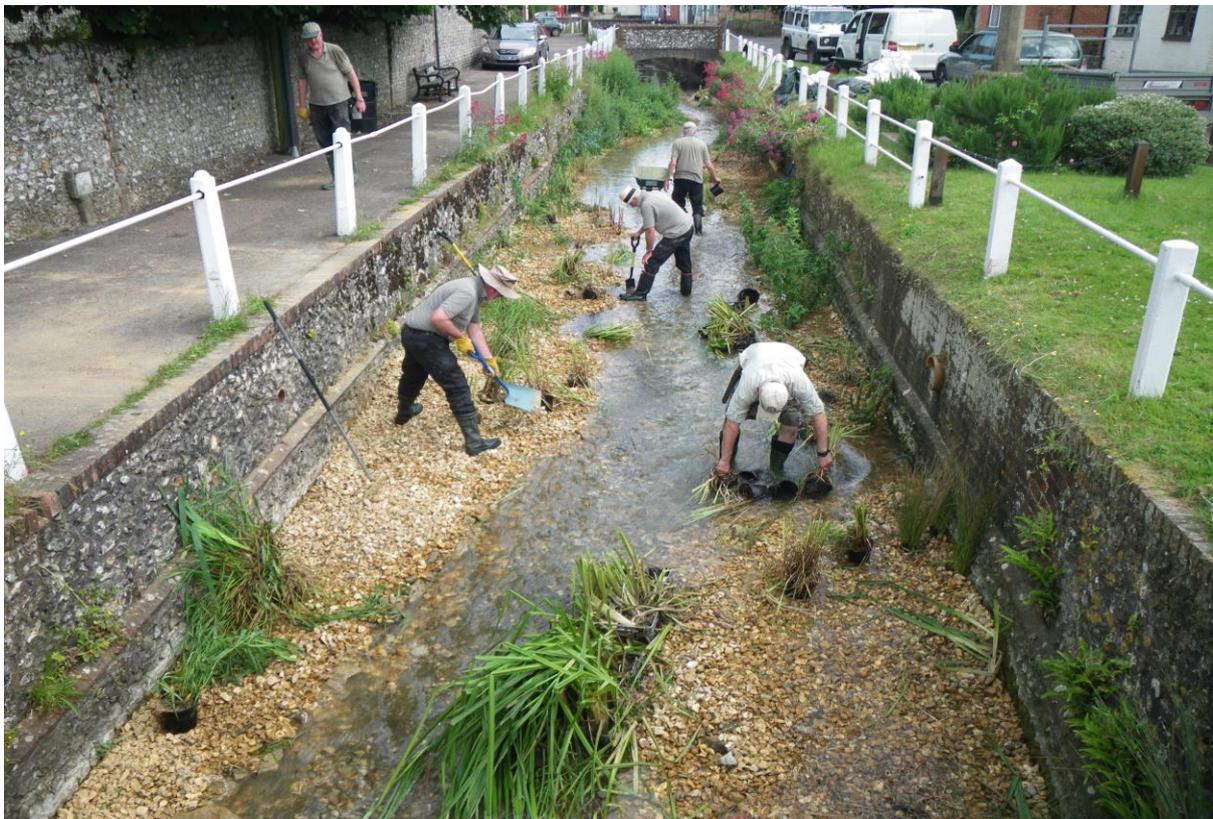
Figure 26: The River Meon in East Meon, during restoration by local residents, with guidance from the Wild Trout Trust

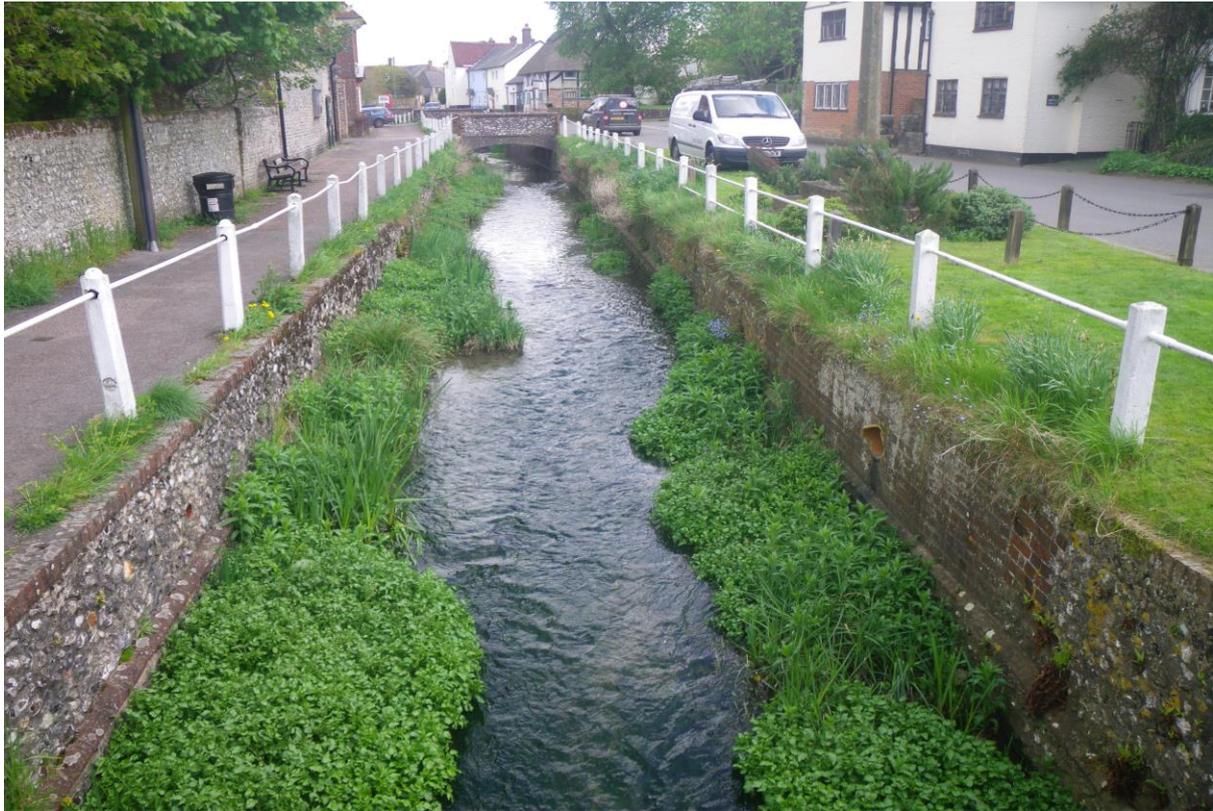
Figure 27: The River Meon in East Meon, with softened banks after restoration. Water voles have now been seen in this stretch – once a sterile stone and concrete drain!

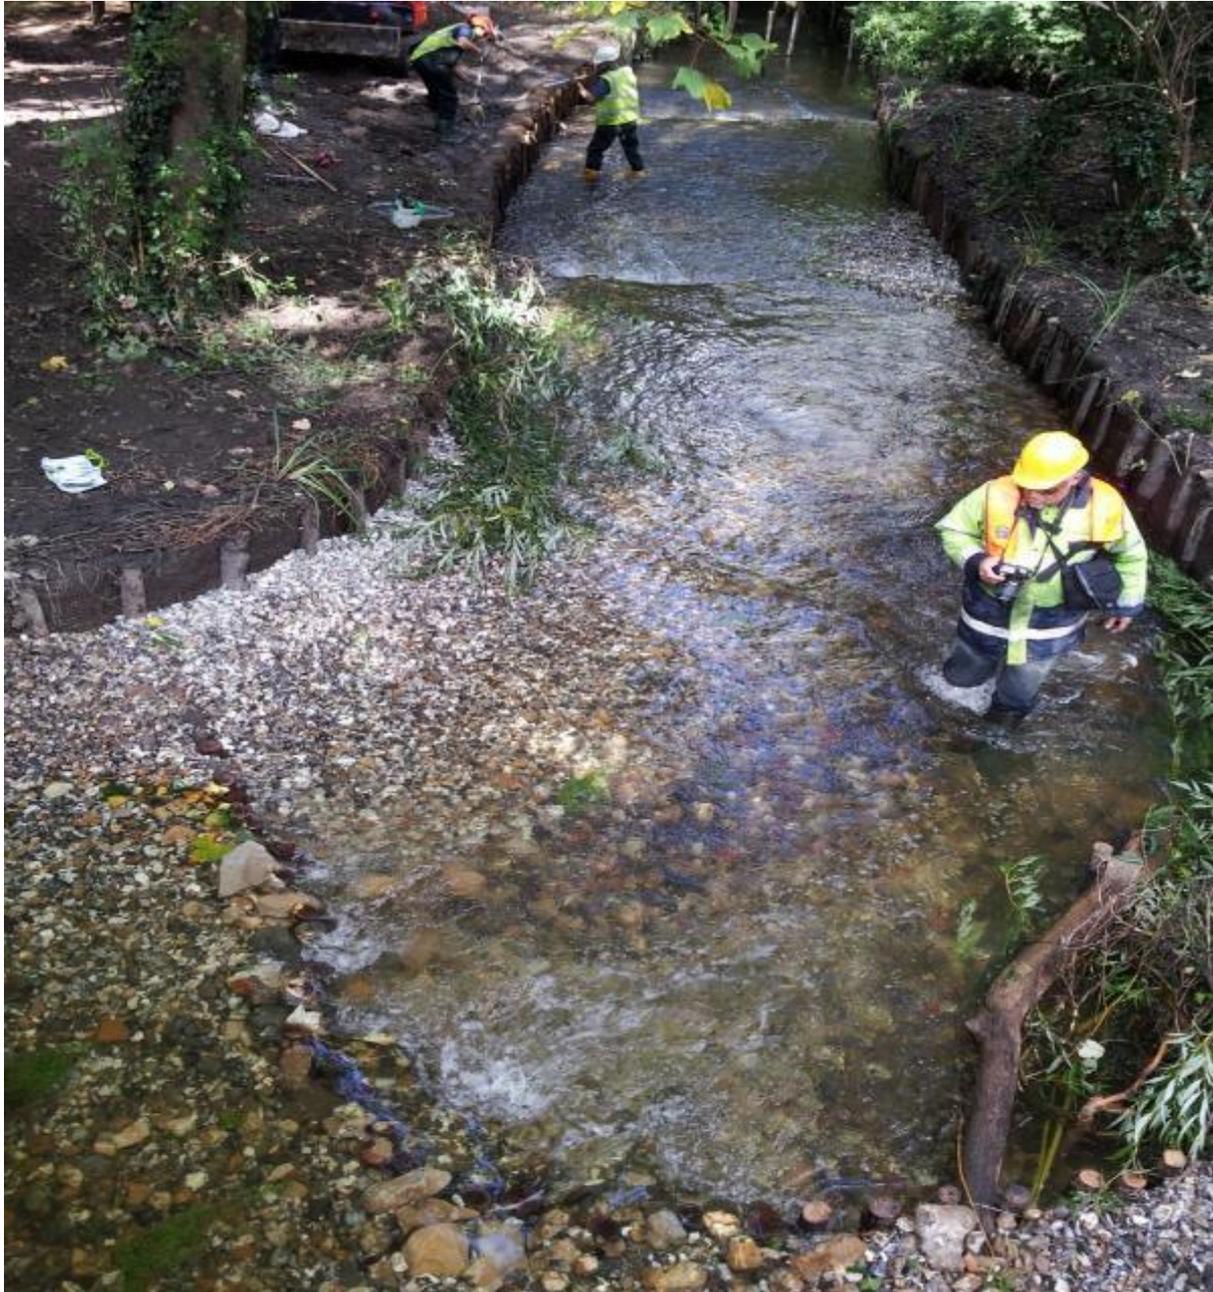
Figure 29: A nature-like rock ramp, constructed to replace a redundant weir on a small side channel of the River Wandle
