Candover Brook – Phase 4 Fobdown

A Project Proposal by the Wild Trout Trust – January 2016

1. Introduction

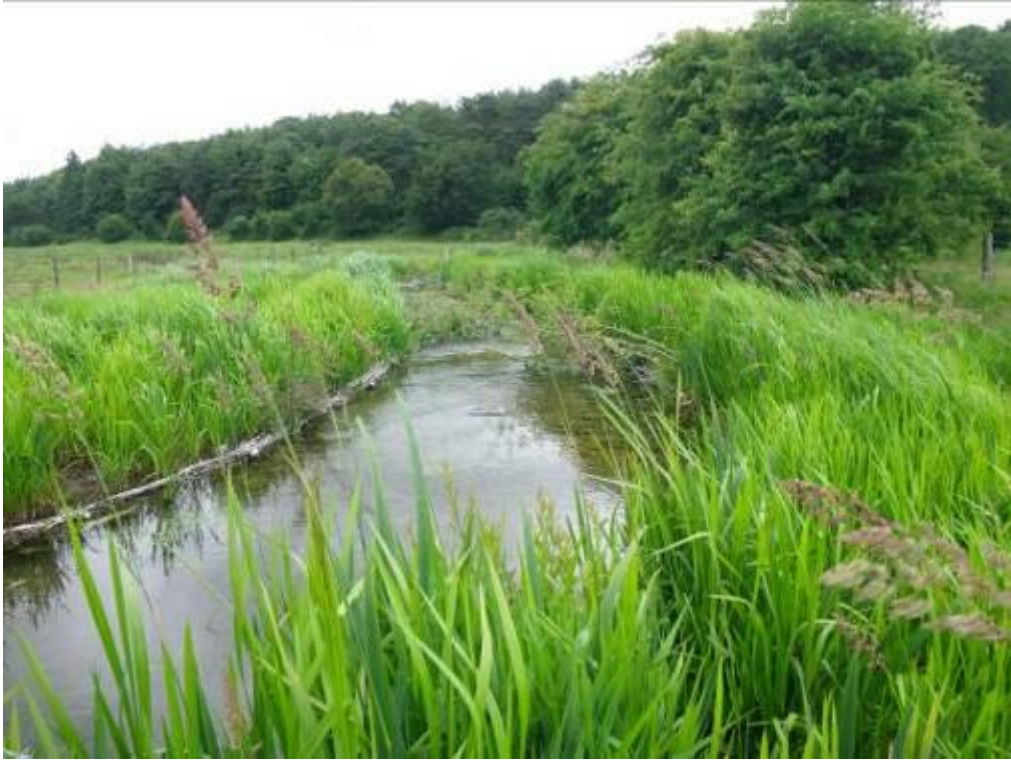
Following the initial WTT AV reports in 2006, several sections of the Candover have been improved via the creation of refuge areas. The channel has been protected from grazing animals with temporary fencing and low marginal cover allowed to encroach into the river, promoting some natural narrowing as well as active pinching of the channel using faggot revetment. Photo 1.

Photo 1. A section of the Candover pinched with hazel faggot revetment, planted with marginal emergent plants and temporarily fenced to promote channel recovery.

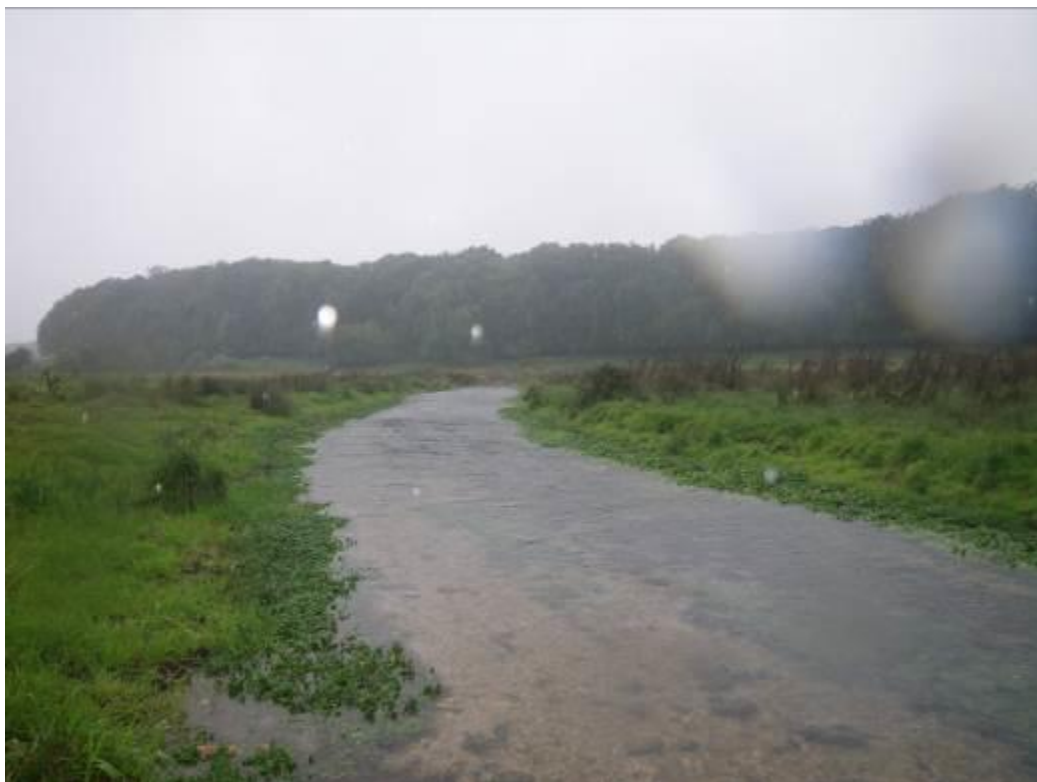
Photo 2. Target site ripe for enhancement. Poorly defined margins and a flat, uniform river bed providing few opportunities for fish and crayfish

The target section of channel shown in photo 2 and 3 is typical of long sections of the upper Candover, where unimpeded access by grazing cattle has, over time, led to the channel becoming excessively wide and shallow. The topography of the bed is flat, the gravels unsorted, with a chronic lack of cover for trout of all life stages. In-channel macrophytes are dominated by water parsnip and cress in the margins, with occasional clumps of water crowfoot located in central channel locations.

The key project objective is to create move diversity in the shape and depth of the river channel. This can be achieved through the re-distribution of existing in-channel bed material using a tracked 360 excavator to create a series of five pools and associated runs and riffles. Pools should not be too deep (1.2m maximum) to be commensurate with pool habitat likely to be found in a chalkstream headwater. Bed material won from each pool excavation is to be side-cast to form a neck, or flume at the upstream end of each pool. Re-shaping the tail of the newly created pools, to form a shallow batter, will also potentially promote new spawning opportunities. Additional material to create pinch points at the neck of the pool runs can be won through the lowering of sections of existing high bank located adjacent to the RB at the upstream end of the target reach. The reach will be inspected for signs of water vole immediately prior to any works. Any areas supporting vole burrows should be clearly marked and excluded from the work area.

The installation of pieces of large woody material adjacent to pool necks and brushwood into shallow riffle margins is recommended, along with a liberal dotting of large flints (found locally on site) into selected areas to create micro habitats for juvenile salmonids and crayfish.

It is proposed to fence sections of river channel, as carried out further upstream. This will help to promote a rapid recovery of plants within the channel and allow a busy riparian fringe of native herbs and emergent plants to rapidly develop. Each section of fenced channel will provide an oasis of cover for small fish and crayfish, potentially enabling the population to build in the reach as a whole.

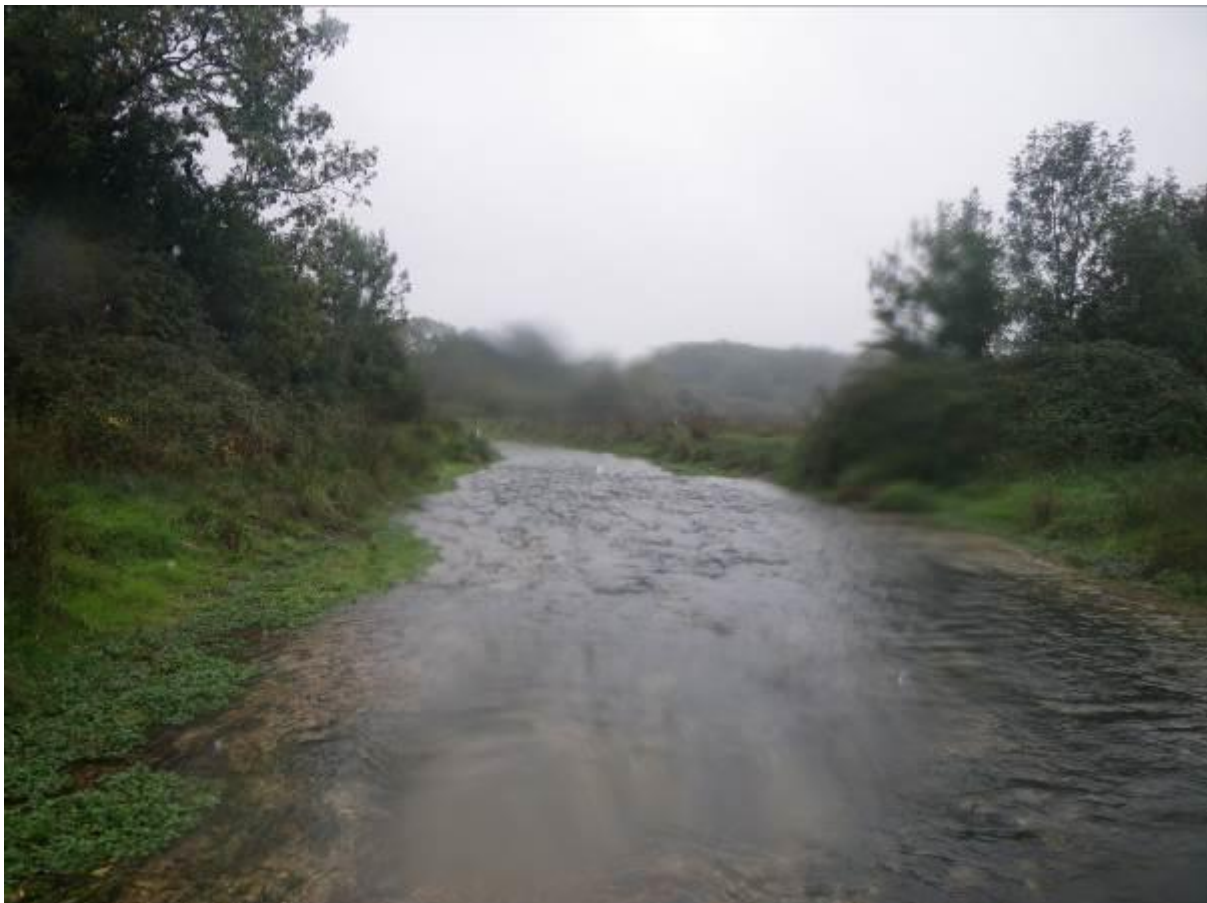
Photo 3. Wide shallow riffle on the downstream end of the target reach.

Creating increased channel heterogeneity within the target reach at this location will provide improved habitat for trout, crayfish, plants and invertebrates.
