**HABITAT ADVISORY VISIT TO THE RIVER CERNE,
DORSET.**

**UNDERTAKEN BY VAUGHAN LEWIS, WINDRUSH
AEC LTD ON BEHALF OF THE GALLIA FAMILY**

APRIL 2008

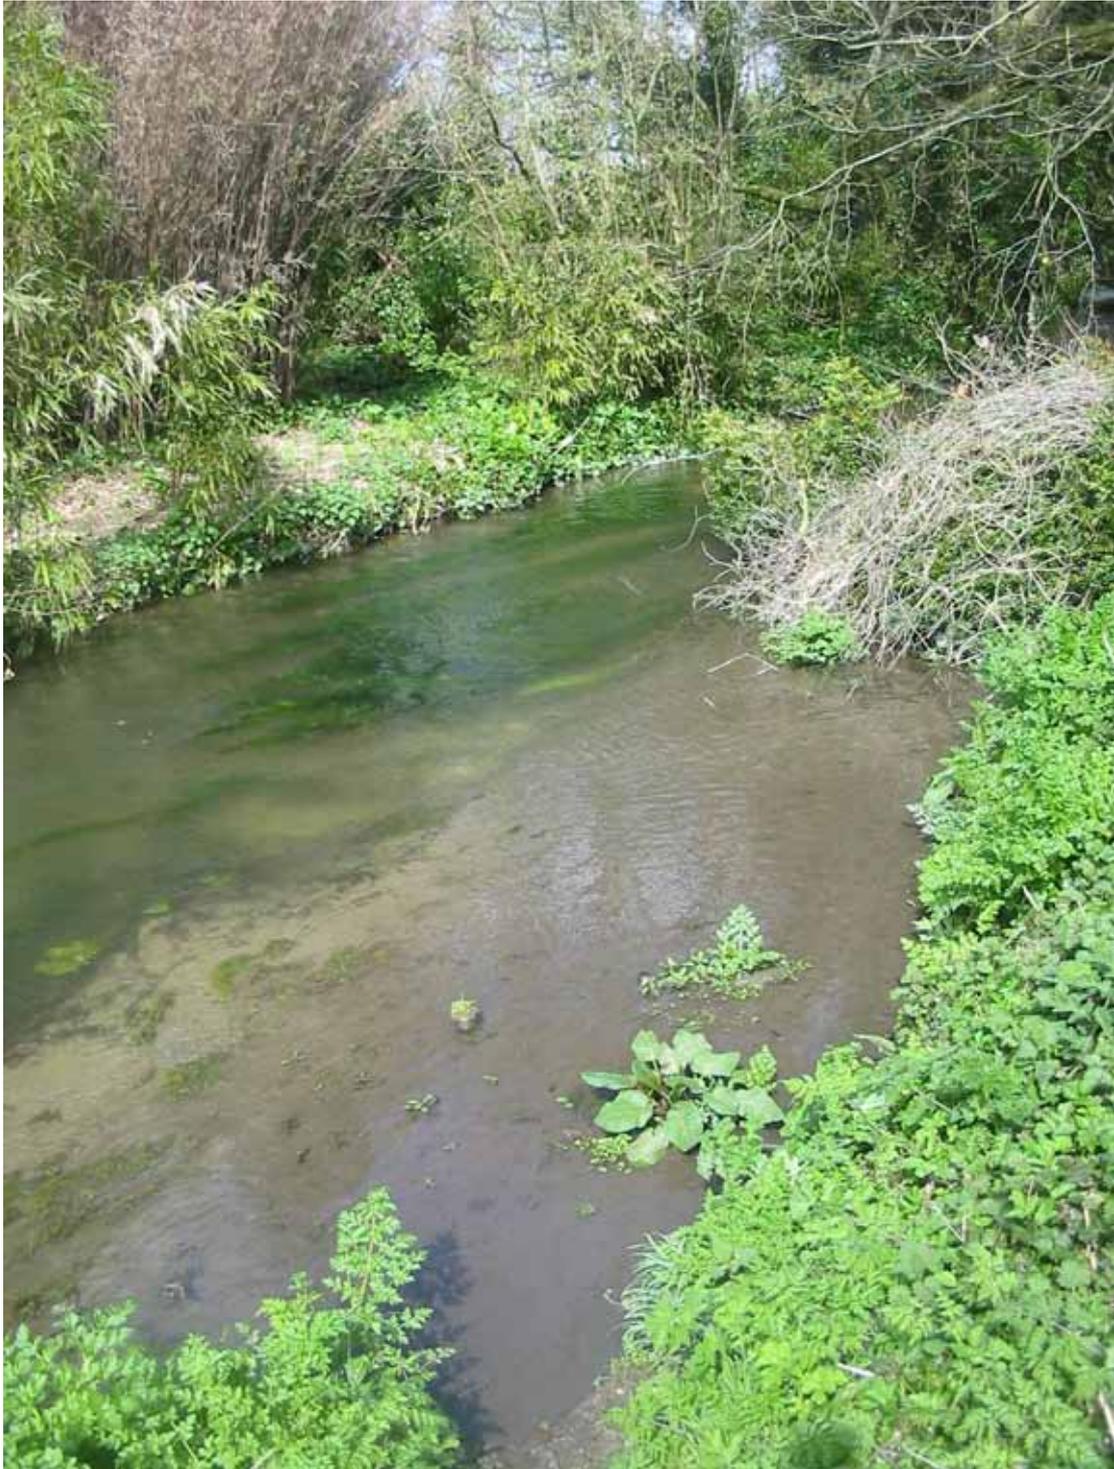
Throughout the fishery, there were sections of over-wide channel. Fine sediment was building up at these locations. Much of this sediment was unconsolidated, with limited growth of binding marginal vegetation present.

Unconsolidated fine sediment in marginal areas

- Sections of overwide channel with unconsolidated sediment in marginal areas could usefully be narrowed by the use of faggot bundles. These should be firmly staked in place along the outer edge of the deposited silt line, with the area behind them backfilled with well secured brushwood. Provided that the site is not too shaded (check and coppice trees locally if it is), colonisation of the brushwood and faggots by marginal plants should be rapid.

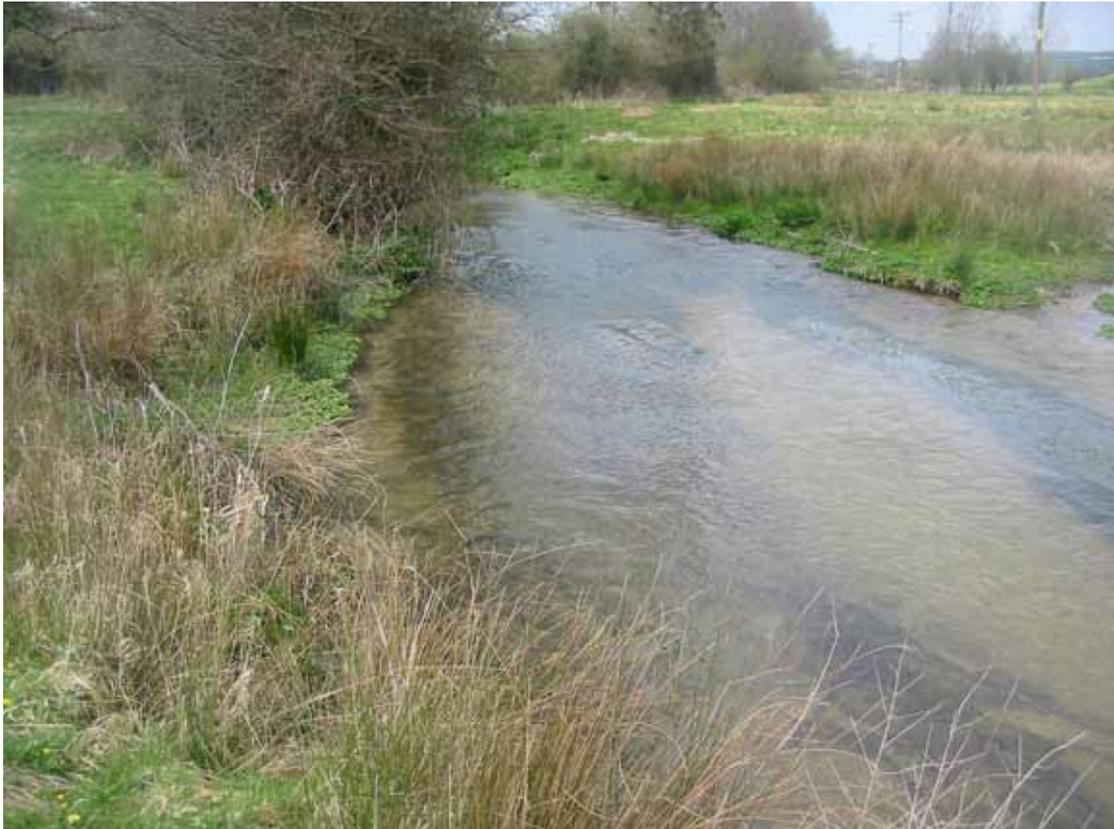
Downstream of the sluice, the channel had generally excellent habitat, although there were sections of overwide, shallow channel, with habitat quality limited by the shallow depth of the water and lack of instream cover.

Overwide section of river in Forston water meadows

- An alternative approach to narrowing wider sections is to construct a series of small mid-stream faggot islands. This is an excellent way of not only reducing channel width but also of creating an alternative habitat type.

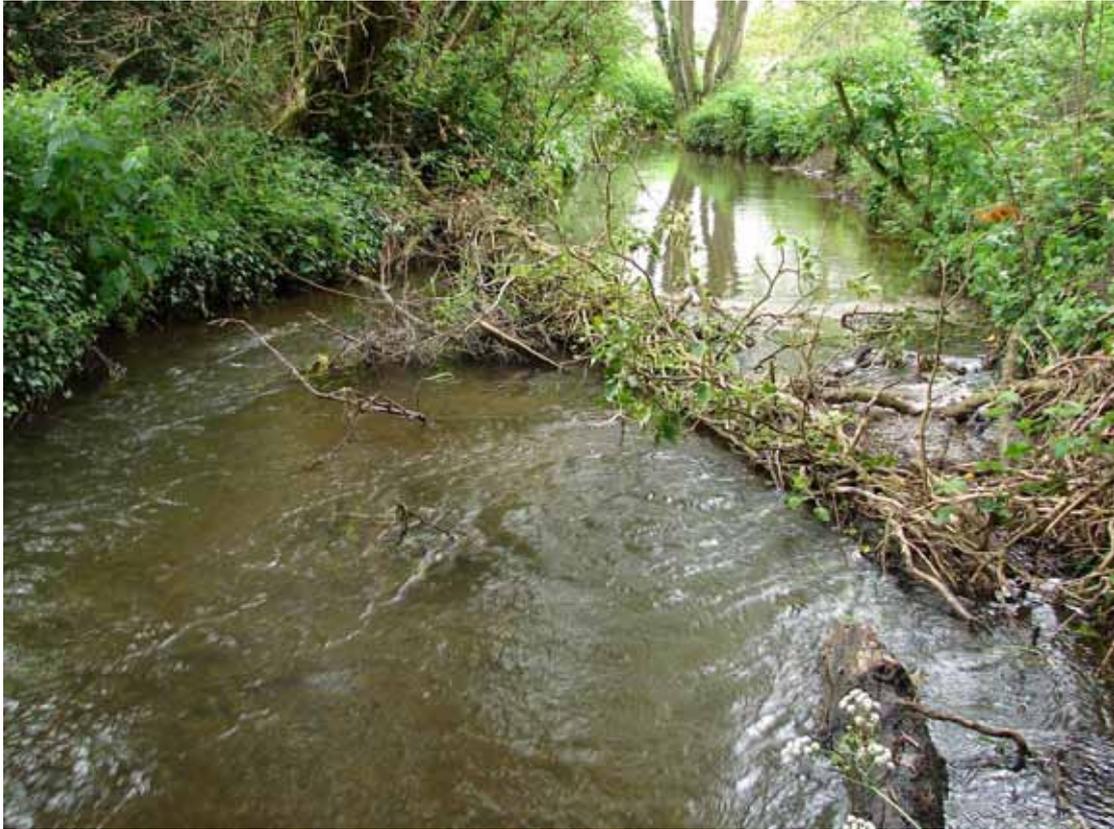
Naturally occurring LWD....

- Where bankside trees were abundant, opportunities exist to increase the amount of Large Woody Debris (LWD) in the channel. This would not only increase cover for trout (particularly important during the winter period when the die back of weed can leave the fishery rather devoid of instream cover) but also would help to scour clean the gravel substrate, improving its quality for spawning trout. By cutting only 75% through the tree trunks and hinging them into the water, they will remain attached to their trunks, anchoring them to the bank and allowing them to continue growing. Additional stability can be provided to the hinged timber by the use of wooden stakes driven into the bed, and high tensile wire. As an alternative, individual large tree limbs or trunks can be fixed using stakes and wire in order to create flow deflectors. A few simple principles should guide any introduction of LWD:

- Ø All timber must be adequately fixed with no risk of it ripping out in high flows.
- Ø Adequate keying in of the timber to the existing bank is essential to prevent erosion. The easiest way to achieve this is to notch the bank out with a spade, introduce the butt of the timber into the bank for at least 1m and then backfill over the top.
- Ø Upstream facing timber tends to scour the centre of the channel, whilst downstream facing timber often results in bank scour (generally not desirable)

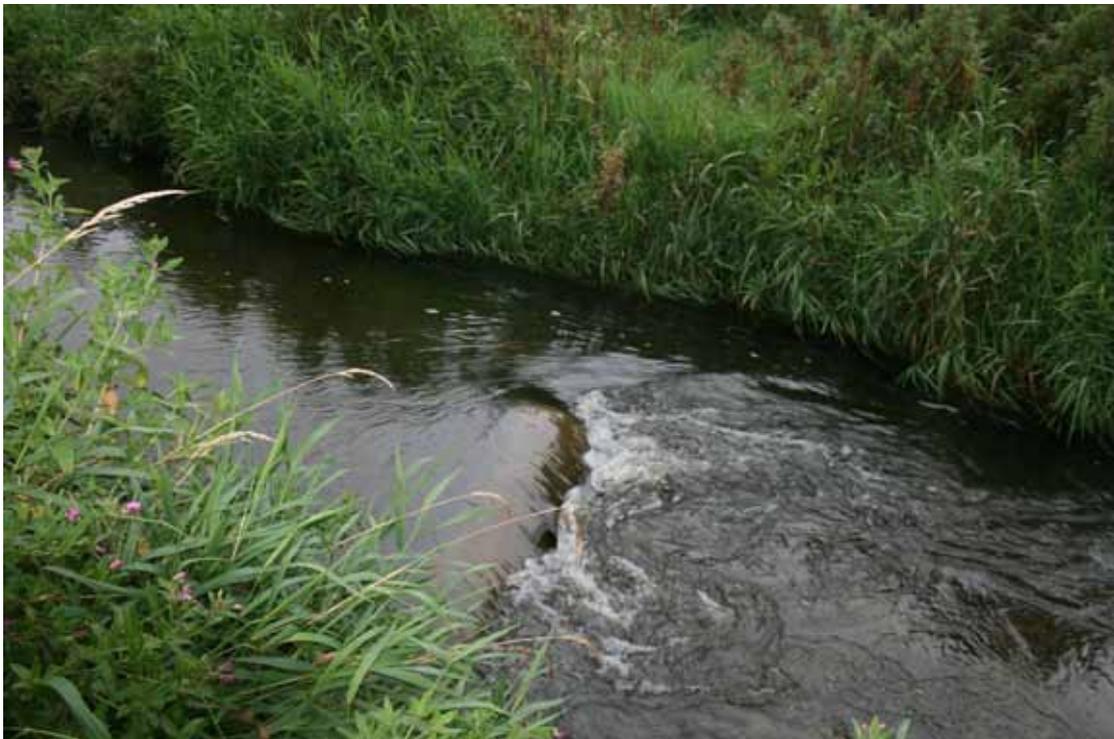
...And introduced LWD

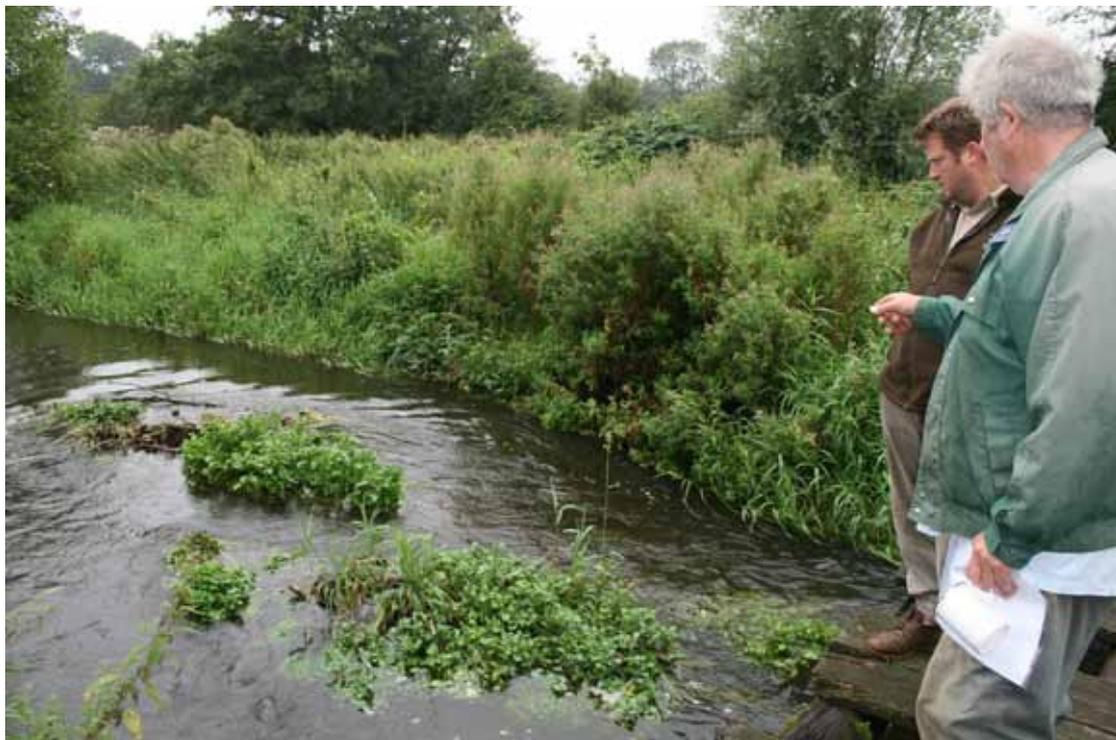
Mid-channel islands constructed from faggot bundles on a small chalkstream
