Chalgrove Brook

A Project Proposal by the Wild Trout Trust - April 2016

1. Introduction

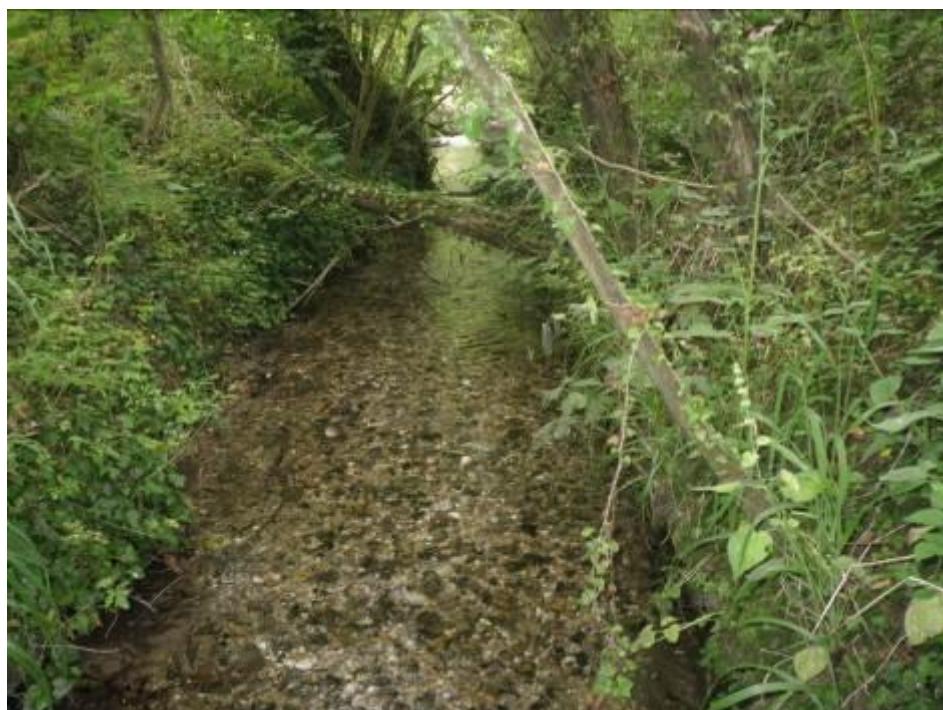
Photo 1. Typical section of the Chalgrove Brook above Cuxham. Shallow gravel riffle habitat providing a good nursery environment for juvenile brown trout. A dearth of deeper pool habitat is an issue that needs to be resolved.

Redoubling efforts to ensure that spawning gravels are well sorted and relatively free of fine sediment could help to promote significant improvements in egg-to-fry survival. This work should be coupled with actions to ensure that adjacent shallow water habitat is packed with complex cover such as coarse woody material, trailing marginal plants and where light penetration permits, submerged weed. Providing more cover in very shallow water immediately adjacent to and just downstream of optimal spawning sites will help to boost survival of juvenile trout. The provision of low-level overhead cover is important, as is the presence of small pockets of deeper water to provide a safe refuge for adult brood stock.

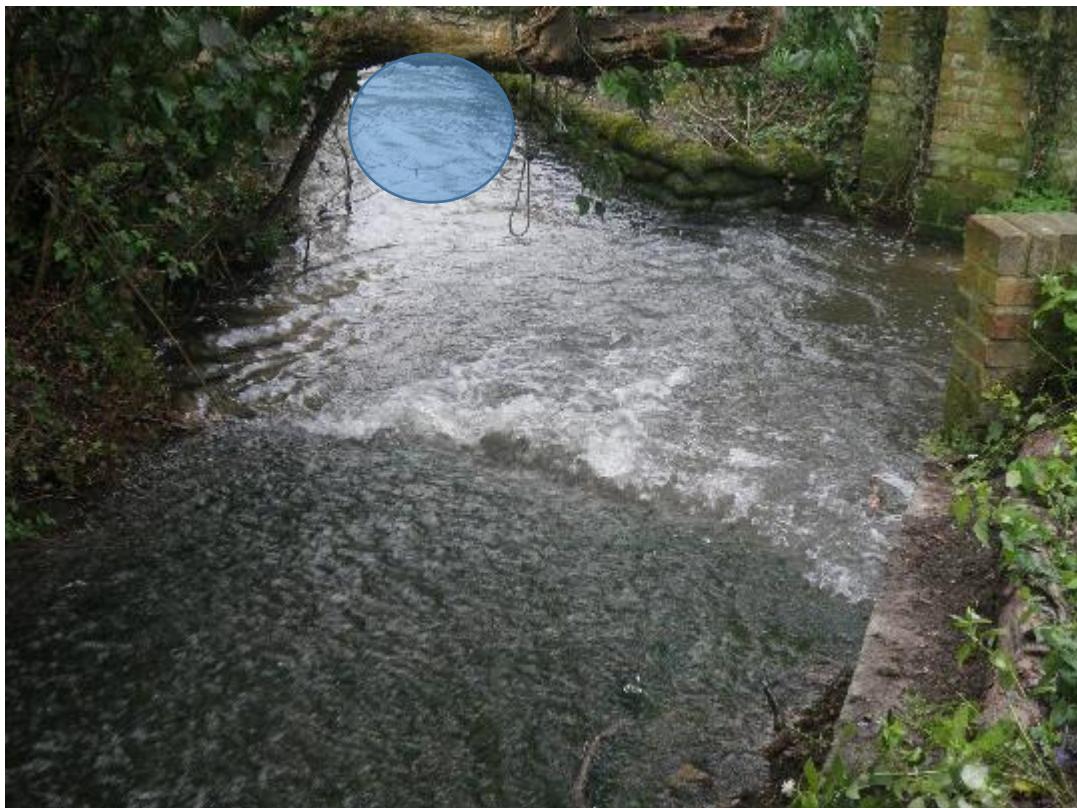
Photo 1. Weir tail. Blue zone indicates approximate location of the stone/gravel pre-barrage.

In order for fish to be able to swim onto the tail of the weir ramp, it will be necessary to raise downstream water levels by approximately 150mm. This can be achieved by building a naturalistic rock/riffle ramp onto the bed of the stream in the location approximately outlined in photo 1.

This area is where the coarse bed material blown out from the plunge pool at the foot of the weir forms a natural hump in the bed. The proposal is to increase the height of the hump by installing a mattress of coarse stone/cobbles and top dressing it with imported 20-40mm flint gravels. It is estimated that approximately 5 tonnes of stone and approximately 10 tonnes of gravel would be required. Access to the site with a small machine would be ideal but if necessary this quantity of material could be imported by barrow.

In addition to slightly raising the water levels, the riffle ramp can be designed to provide further habitat opportunities. No additional flood risks to the mill property are involved due to the high gradient of the channel below.

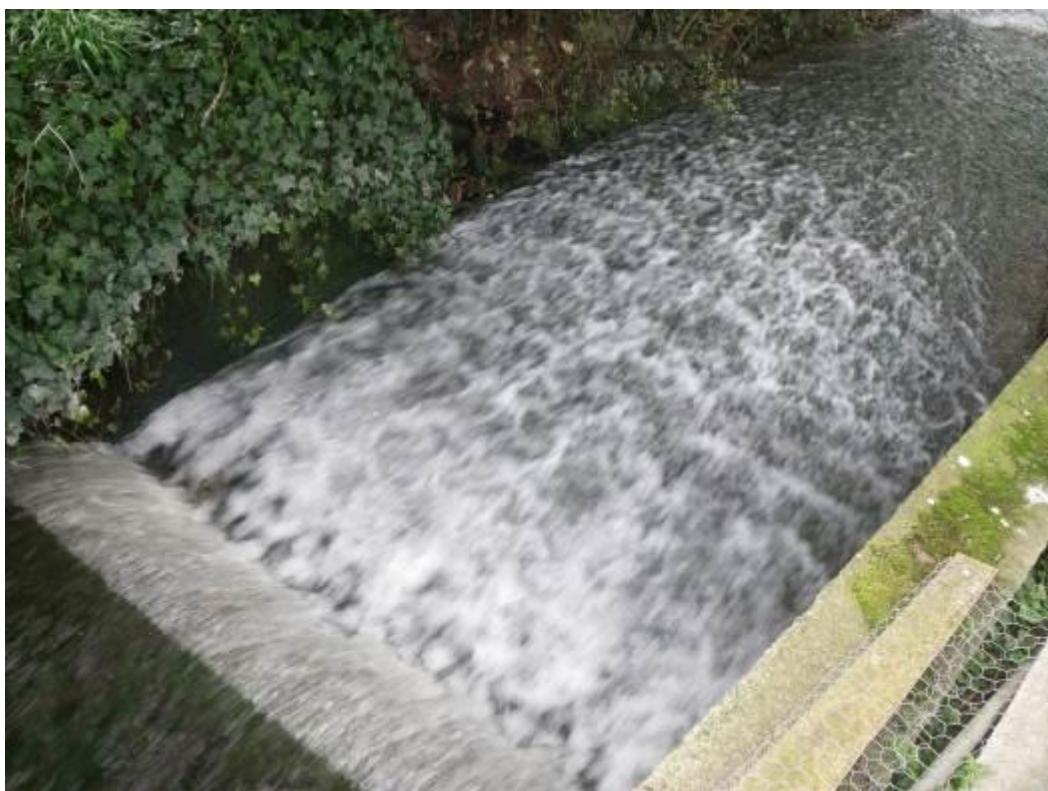
Photo 2. Weir slope.

To enable fish to be able to swim up the existing weir slope (photo 2) it will be necessary to install a series of baffles, these could be constructed of hardwood, or UV stable plastic.

There are numerous configurations possible but the most pragmatic solution is to install a series of off-set baffles. The configuration of the baffles is depicted in photos 3 and 4.

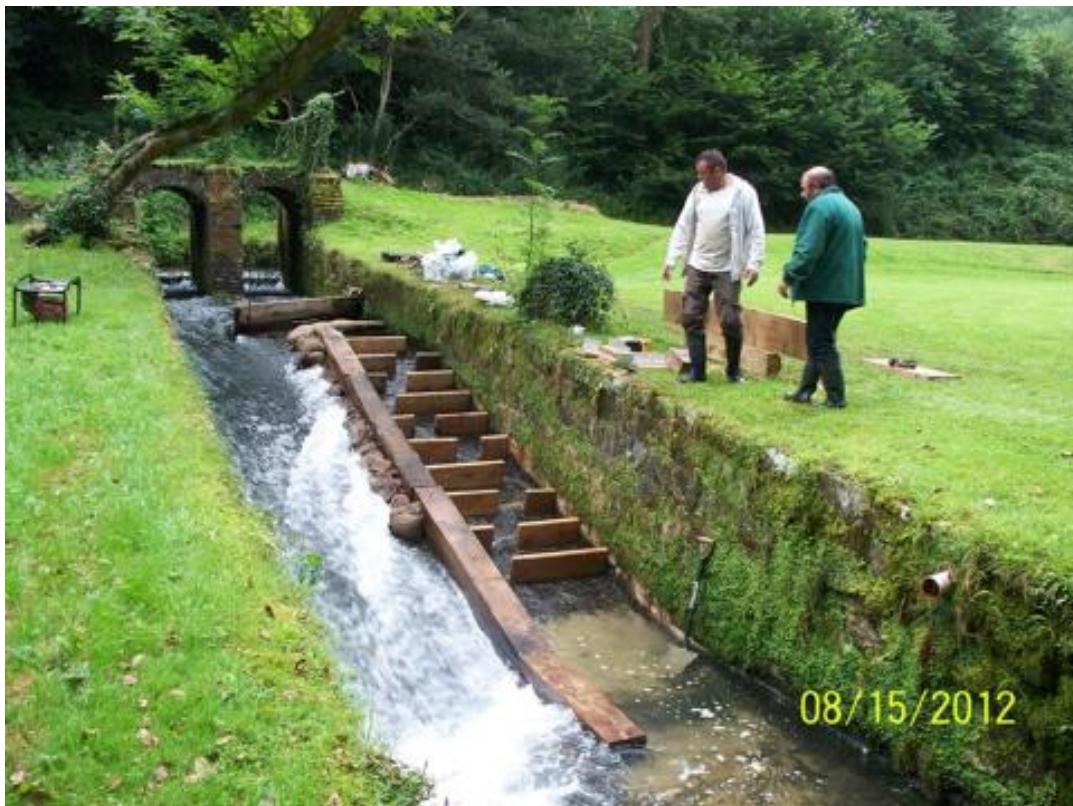
Photo 3. Low cost baffle system constructed in oak on the Costers Brook in West Sussex.

A similar design would work well at Cuxham due to the gradient of the slope. Baffles can be cut to size on site and bonded to the concrete slope by drilling and anchoring with chemi-fixed threaded stainless rod and bolted in place with rebated nuts, or bolted in with right angled support brackets.

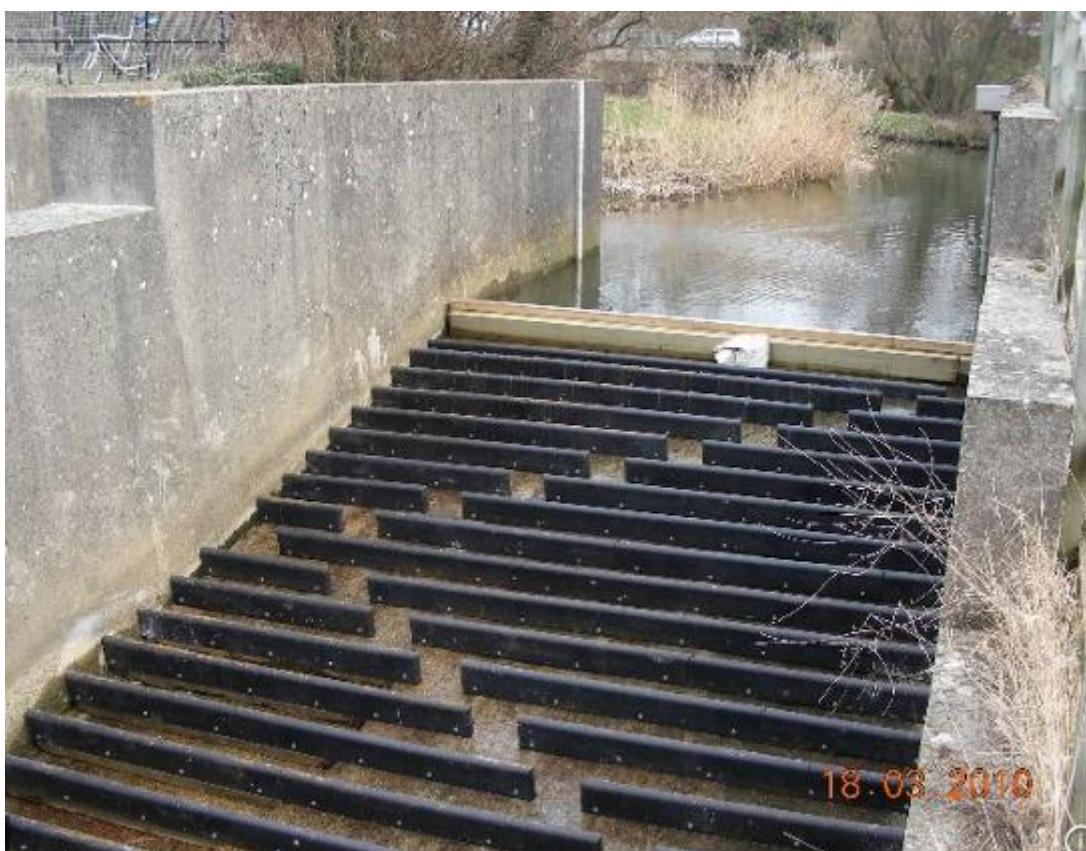
Photo 4. Plastic baffle pass installed on an EA owned crump weir.

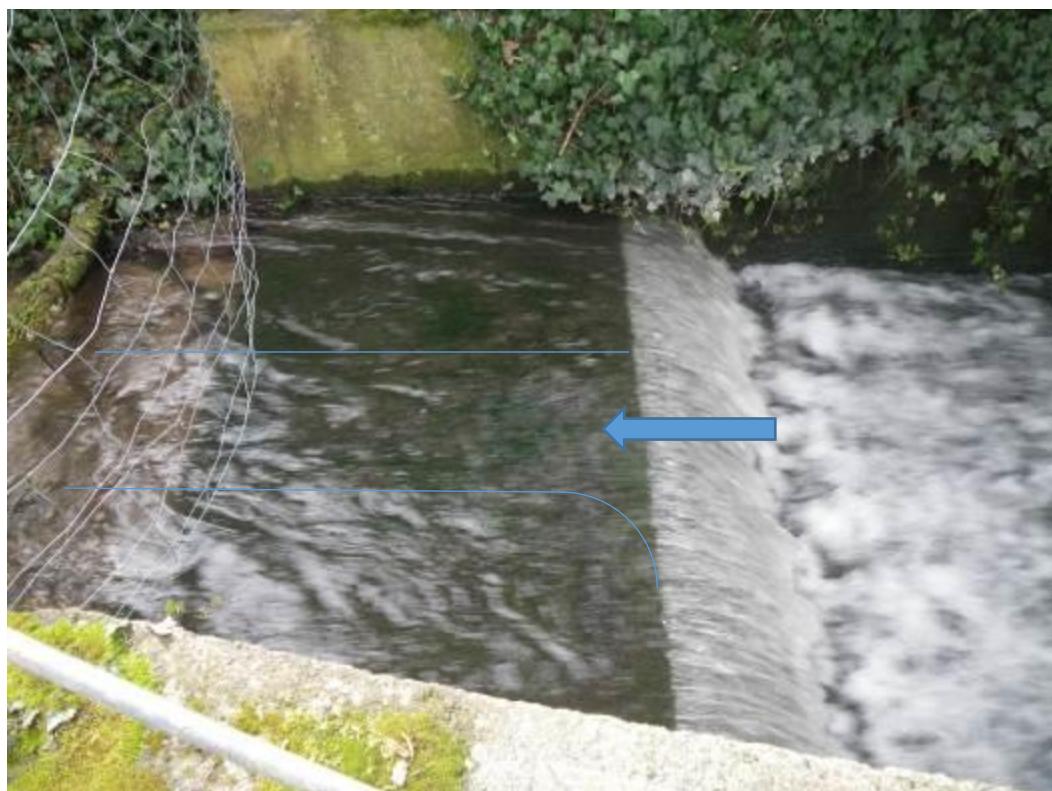
The upper weir apron (photo 5) can be modified to reduce the head loss by cutting a notch through the central section and shaping the downstream face to encourage a laminar plume of water with sufficient depth for fish to be able to swim through the notch.

Photo 5. Combination of notch, shaped exit and baulks to create additional depth.

The width of the notch should be at least 300mm and the depth of the notch needs to be equal to the height of the first downstream baffle for the easement to be effective. The notch can be cut out using a large disc cutter and chiselled out roughly by hand. Care must be taken to ensure the notch is not cut through the entire depth of the concrete to ensure that the integrity of the wing walls is maintained.
