River Cherwell – Steeple Aston

An advisory visit carried out by the Wild Trout Trust – November 2011

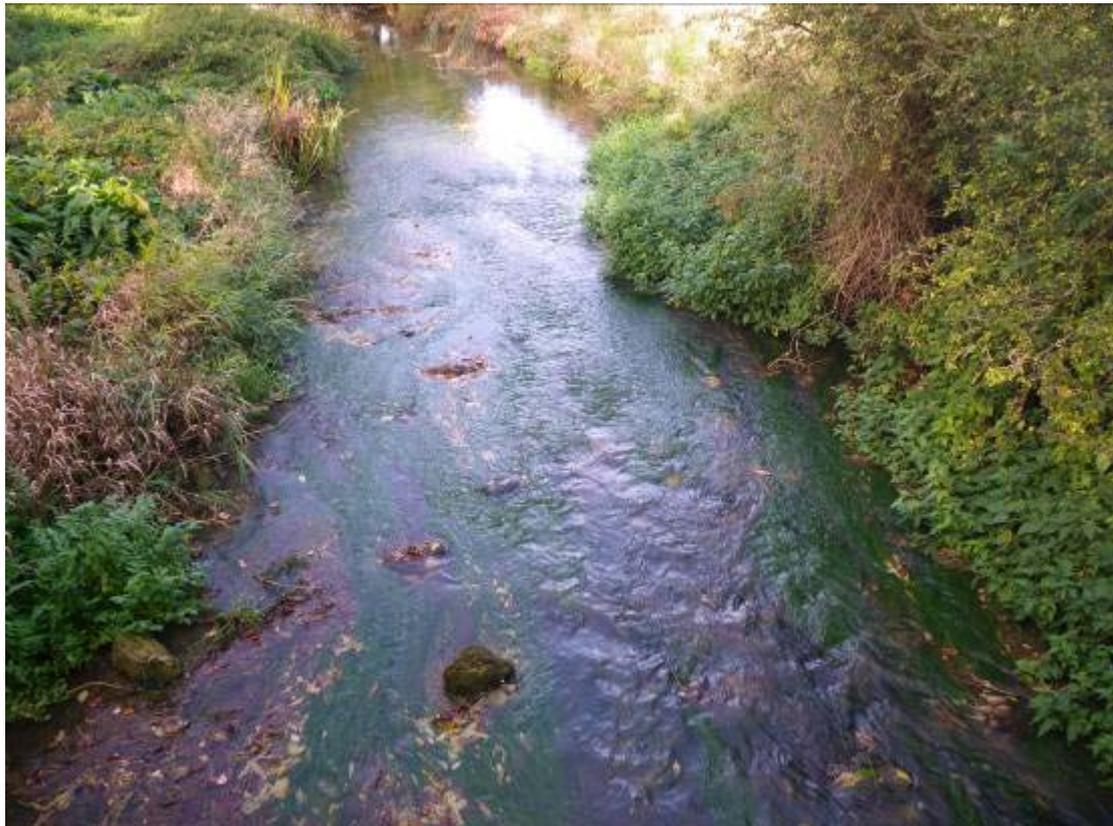
Habitat quality and quantity for brown trout throughout most of the bottom beat is poor, even for adult stocked trout. The channel is wide and deep in places for the average discharge and very uniform in terms of flow variation. The exception to this is the first 100m or so of channel, which does have some potential to comfortably support trout. Here the channel width is pinched and reasonably shallow, with the river flowing over a mixed gravel and silt bed substrate. Water velocities on the top of this section were brisk, promoted by a reasonable slope in the channel gradient. Plenty of in-channel cover was provided by thick beds of fennel pond weed (*Potamogeton pectinatus*).

Upper end of the bottom beat potentially provides spawning opportunities for flow loving fish species including brown trout

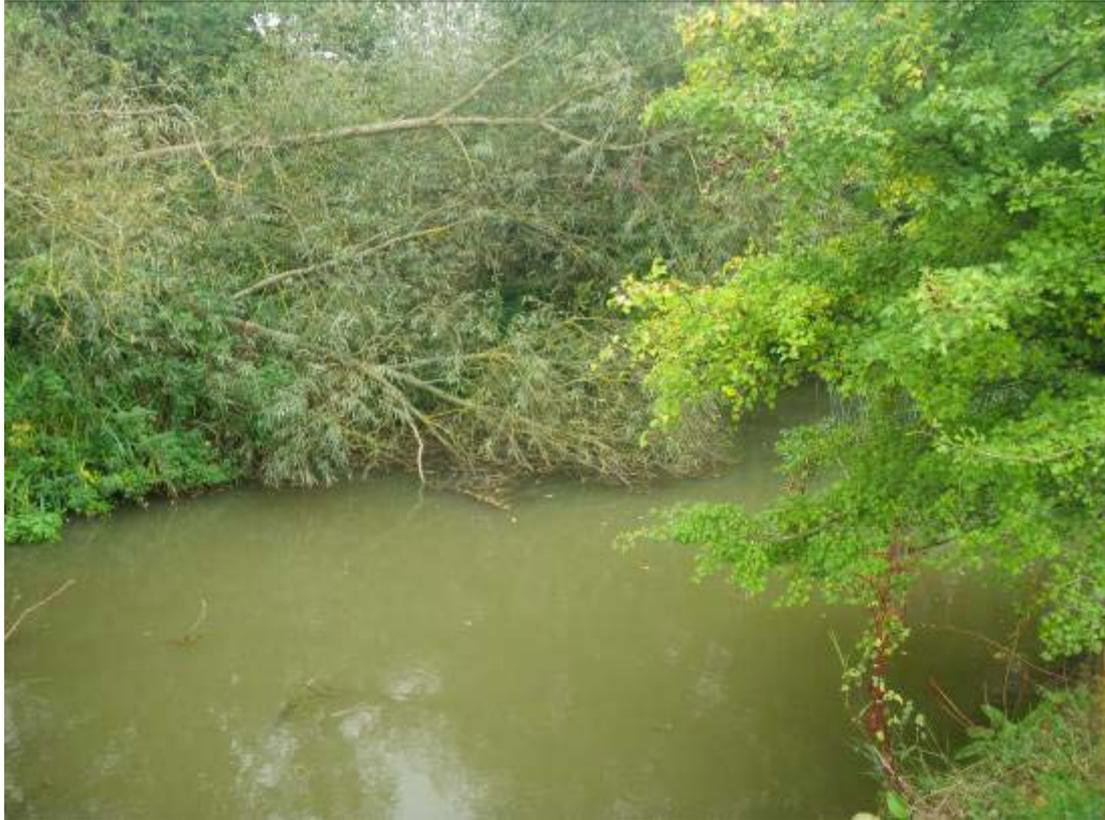
Plenty of marginal cover is provided by numerous low overhanging trees, including willow, thorn and field maple. In several locations fallen and severely leaning trees have dropped into the channel. This is providing some good quality habitat for a range of fish species and will be providing some excellent protection from predatory, fish-eating birds. Where the channel is pinched between fallen woody debris, adult trout could lie up, taking advantage of the local cover and elevated flows promoted by the naturally fallen woody material.

Under normal, or high flow conditions trout may well find the area adjacent to the fallen willow an attractive place to lie.

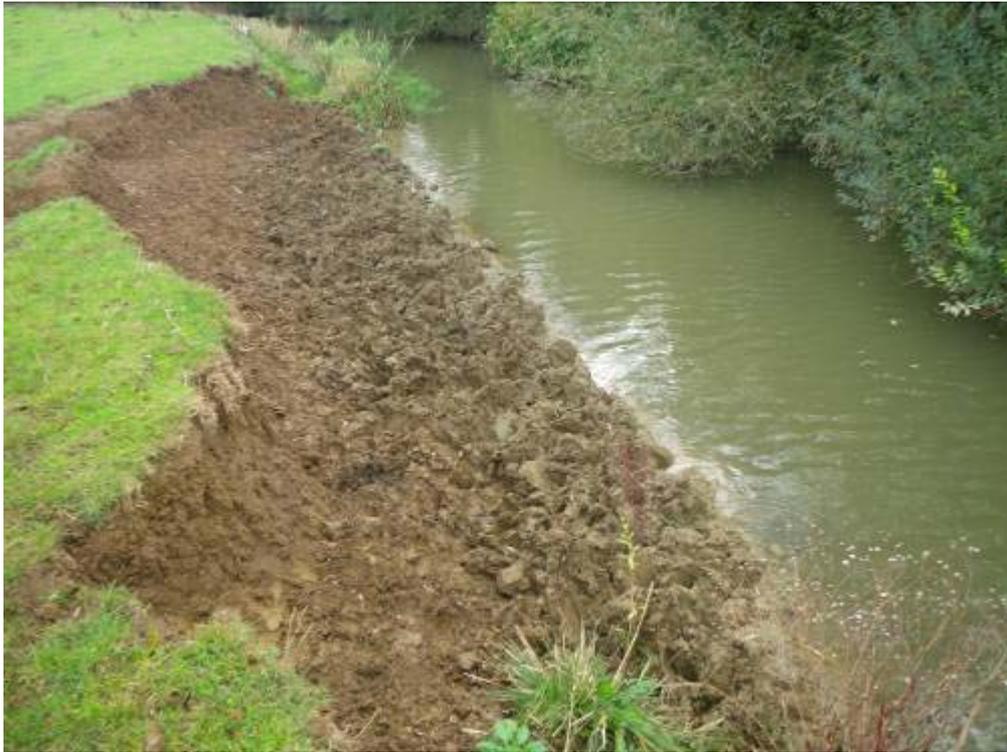
A section of the middle beat where the banks have been severely damaged through cattle trampling. The low shallows on the LB provide good quality habitat for adult fish species. Some light trimming to peg back the channel shading would be required to maintain the balance between fishable water and holding spots for fish.

The priority for the top beat is to avoid any serious bank damage that is prevalent on many of the lower sections. The best solution is to negotiate with the farmer for permission to install some stock fencing. Access for cattle drinking isn't an issue below the railway bridge but in the meadow above the bridge, some access for stock drinking will have to be provided. Purpose built cattle drinks can be constructed by battering back the margin, lining the bay and slope with gravels and installing barriers to stop the cattle crossing, or roaming up and downstream. These drinking bays may also have an additional benefit in being good habitat for juvenile barbell, chub and dace. An alternative is to install a pasture pump which can be extremely effective, especially for beef cattle.

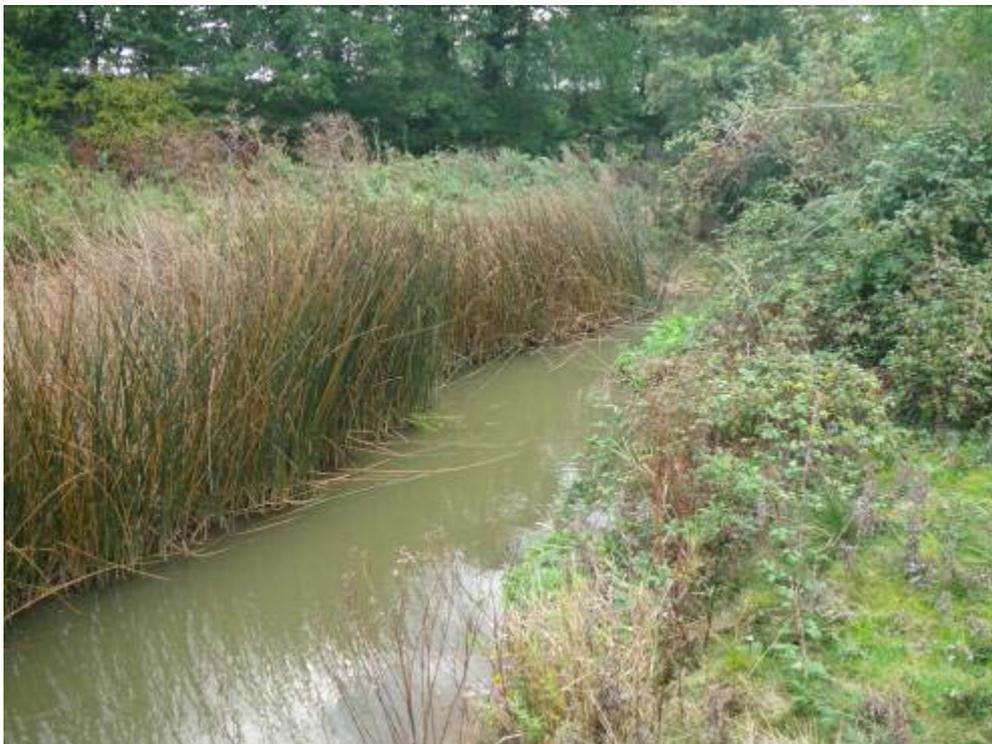
In some locations beds of club rush have pinched the channel width promoting slightly elevated water velocities

In several locations the channel has been squeezed by encroaching beds of club rush. Where the rush grows in the river margins it can help to locally pinch the channel and create some improvement in the quality of habitat for flow loving fish species such as trout. Club rush can, however, also grow in the centre of the channel and have a negative impact by 'backing up' the river and locally slowing water velocities upstream. Managing this plant is difficult but is the key to improving in-channel habit through long sections of the Cherwell.

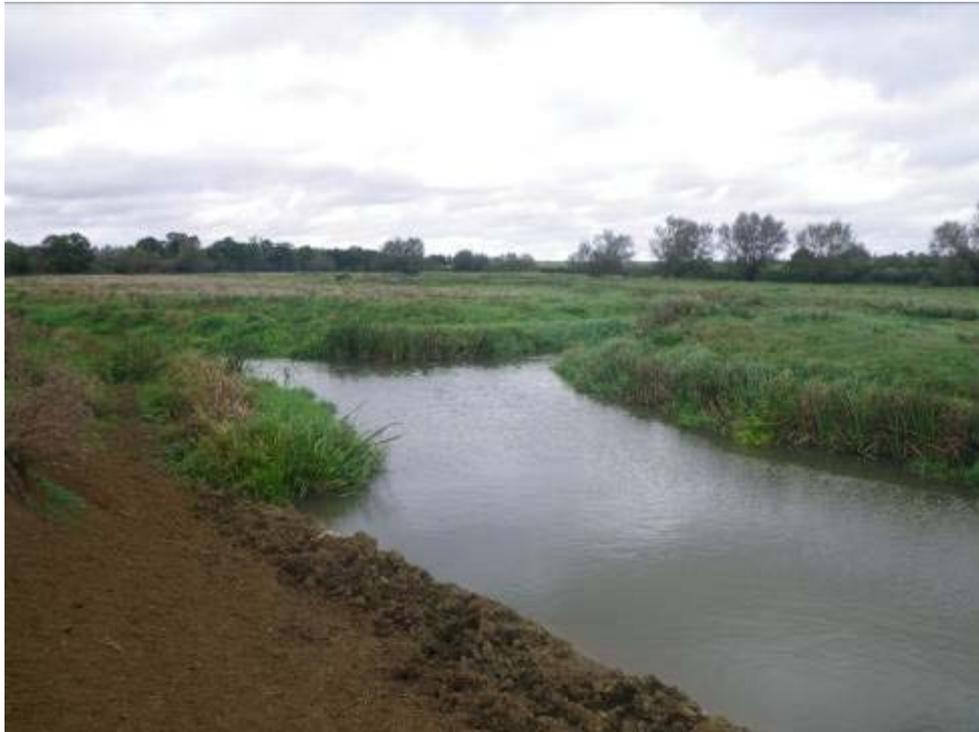
Another section of badly damaged river margin. The lack of any overhead cover and sluggish flow would make this a very unattractive and potentially hostile environment for trout.

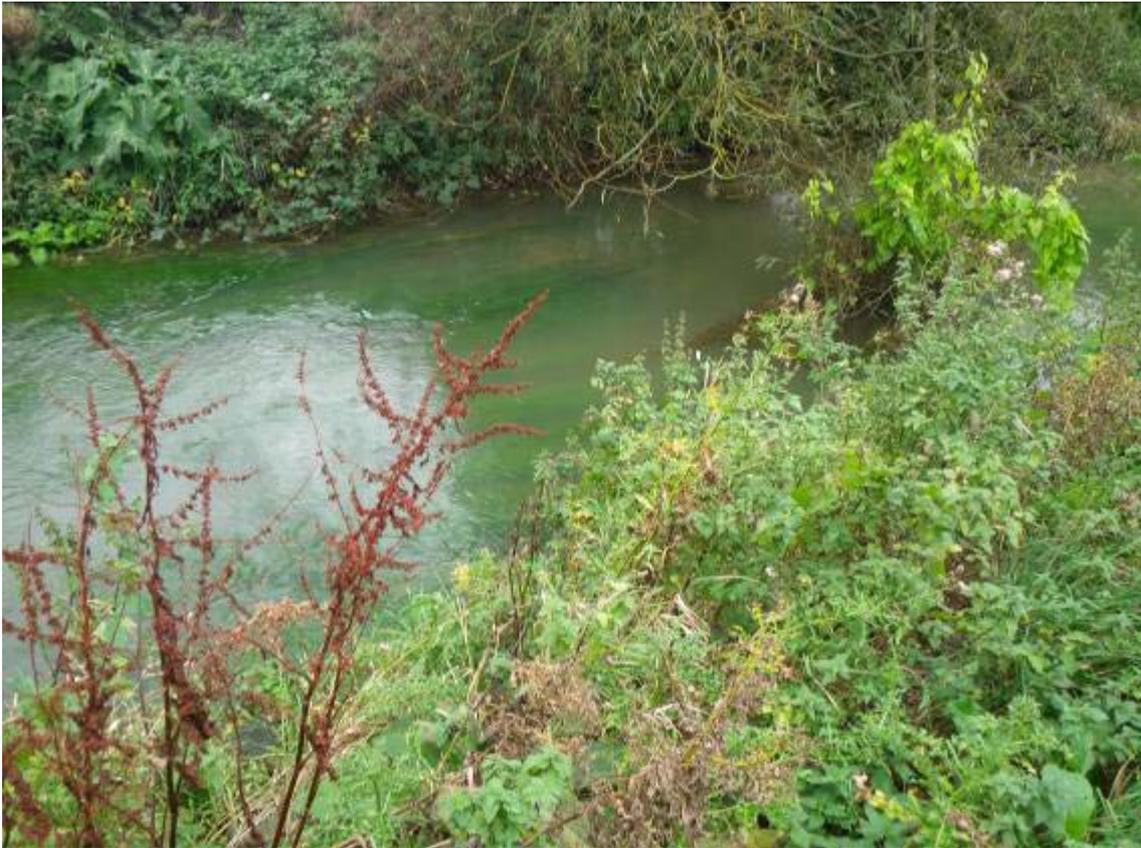
The very top beat, running for several hundred metres either side of the railway bridge, has by far the most potential for supporting trout. The channel here is much more conducive for flow loving fish species and has regained some of its gradient, much of which further downstream is drowned out by the milling impoundment in Lower Heyford. The channel width here is narrower than below and the river (in places) has a much more natural form, with some gentle bends and natural fluctuations in bed topography. Where the channel depth is reduced, beds of fennel pondweed are again evident. Although this plant is not a classic trout stream plant, it does provide attractive cover, where fish may hold comfortably to intercept food items drifting by. The plant also promotes some upwelling within the channel which is attractive to trout because it breaks up the smooth surface glide and potentially provides a safer place to hold station.

A typical section of the top beat. This is habitat capable of holding flow loving fish species.

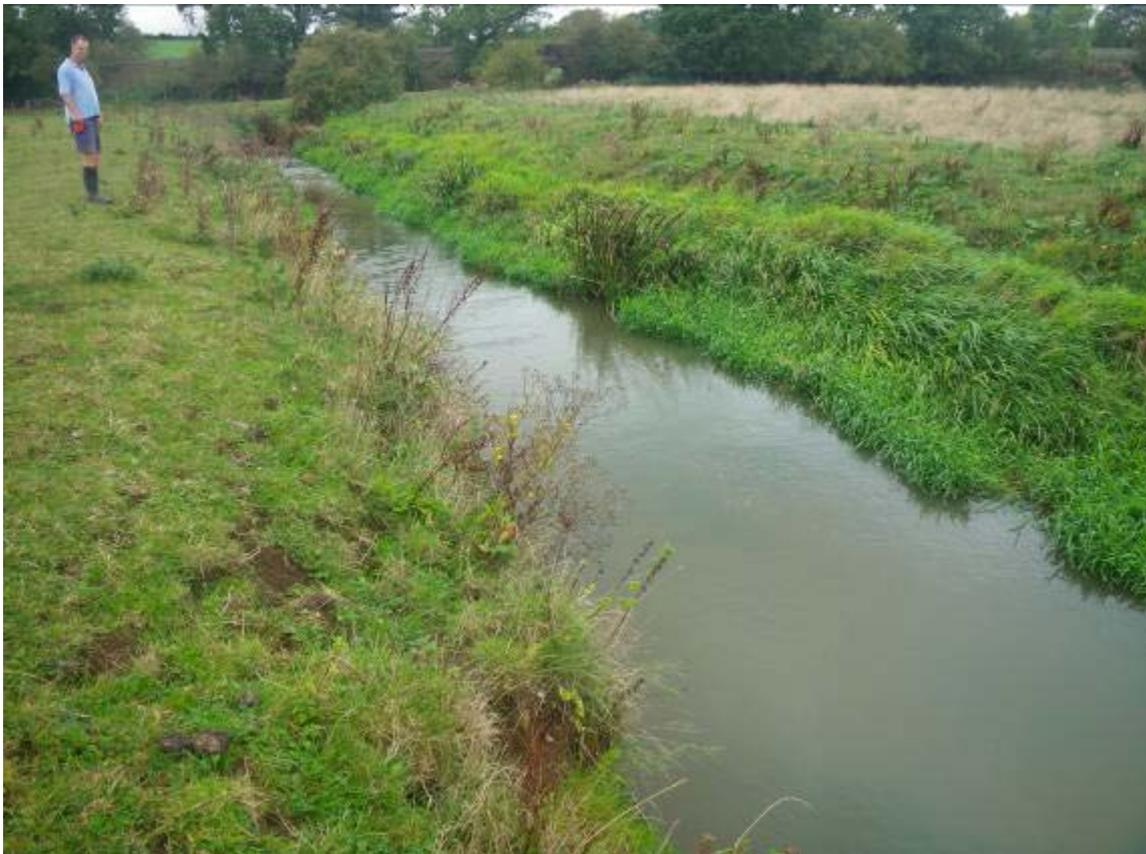
Straight section downstream of the railway bridge could be improved and should hold fish well.

Creating this type of habitat in perhaps the top 100m or so of channel could be achieved but there would be no guarantee of successful trout recruitment. Introducing gravels locally, raising the bed and generally introducing more variation to the channel shape would make it a much more viable fishery. Flow loving fish such as chub, dace and barbel would benefit and it could make the section more attractive for stocked trout to reside as well as for members to fish. If there are viable wild populations residing in the nearby upstream tributaries then there may also be the opportunity to intercept and hold any wild fish that migrate out of the small tributaries, heading downstream looking for good holding water.

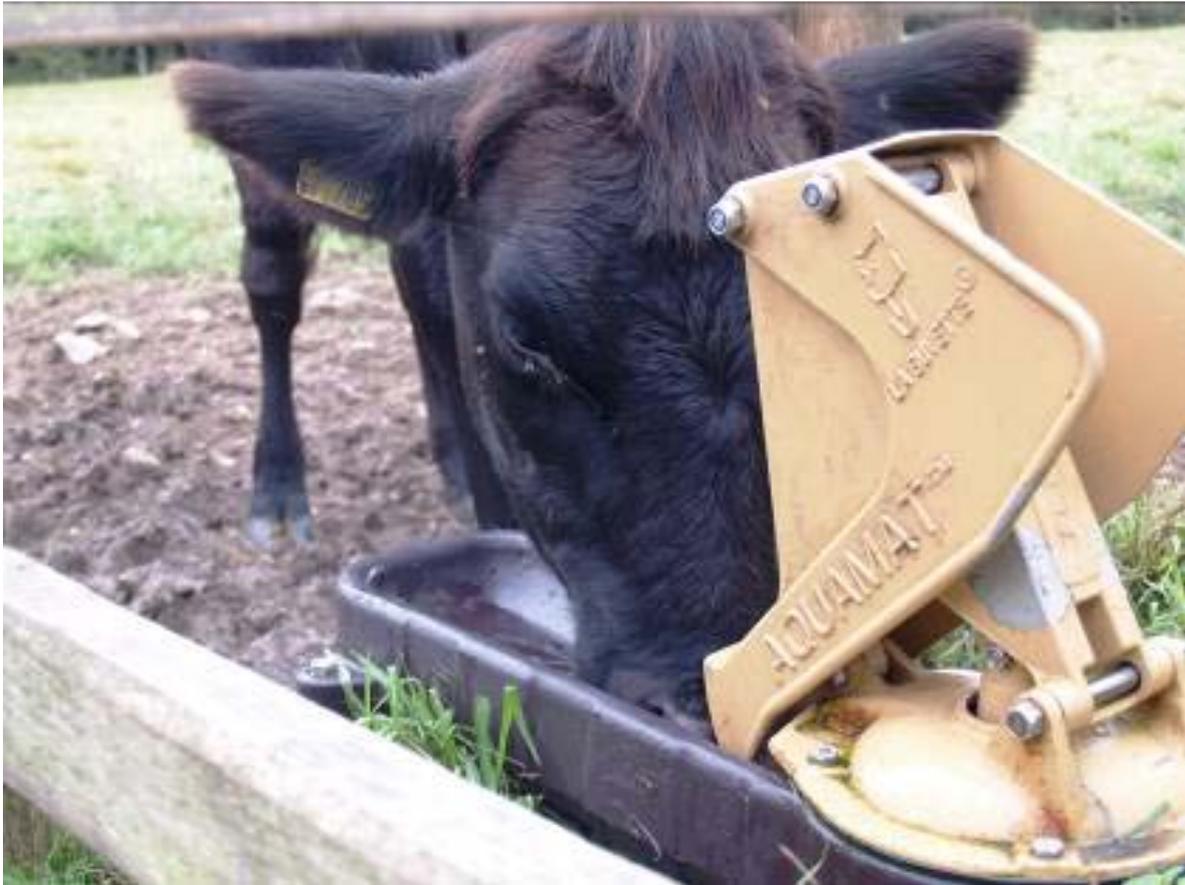
Pasture pumps can be set up behind a fence line. The cattle simply self pump water up from the channel via a pipe.

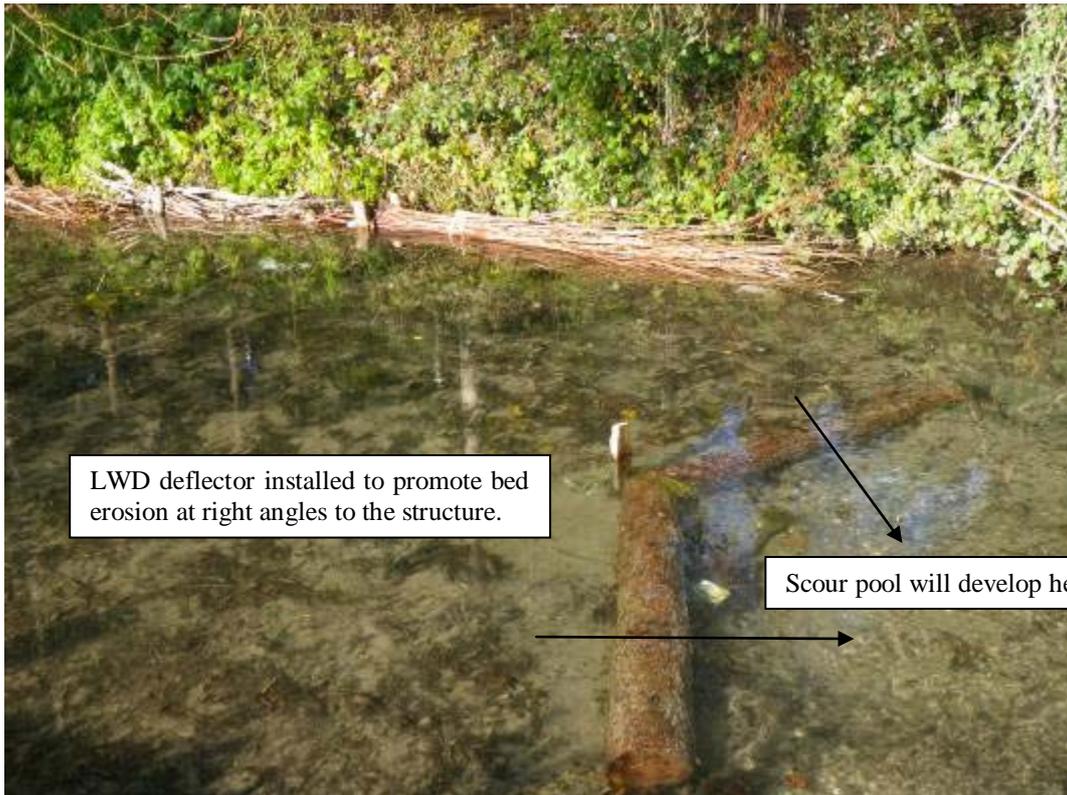
A newly installed flow deflector in the Bucks Wye. Note the brush bundles pegged into the margins to provide improved cover for juvenile fish

Further improvements can be made by importing and pegging in some large woody debris flow deflectors. Care must be taken when installing flow deflectors to ensure that the erosive forces are encouraged to erode the river bed and not the banks. Marginal deflectors must therefore be properly keyed into the bank and configured to kick the flow towards the centre of the channel. Although counterintuitive, the deflectors need to be pointing slightly upstream. Examples of where and how to install woody debris flow deflectors can be found in the WTT Chalkstream Habitat Manual, available either as a CD from our office, or as a pdf download via our website www.wildtrout.org

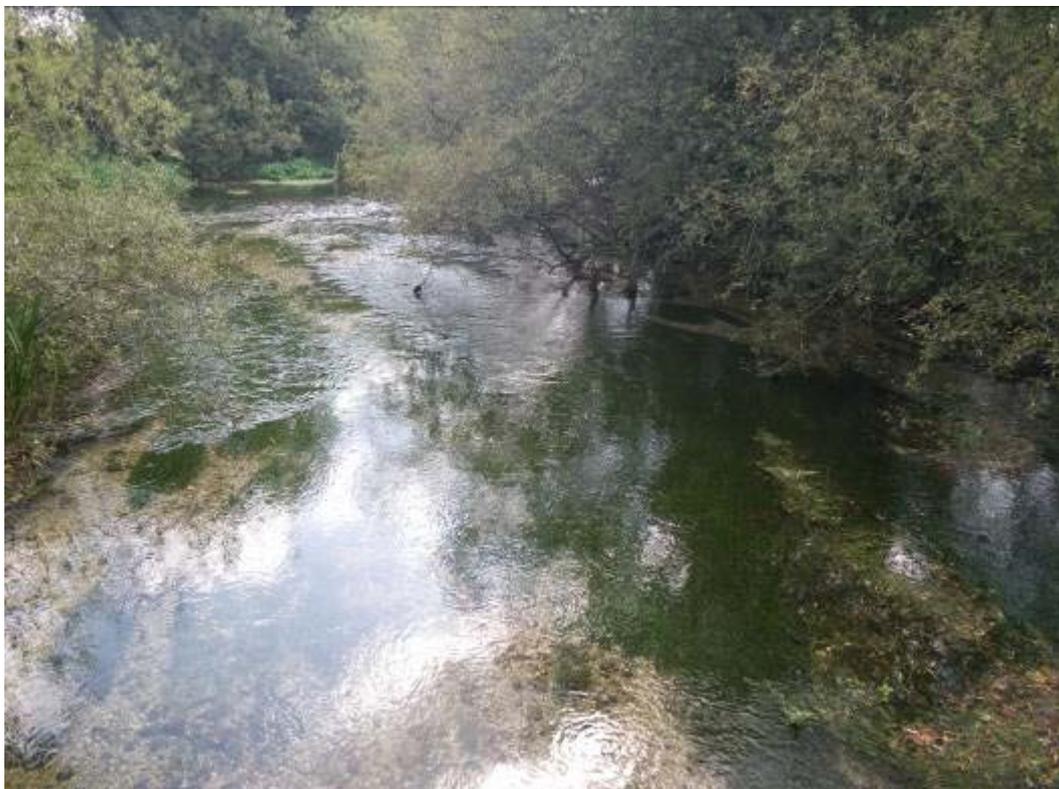
Sallows providing superb cover on a section of the Test. Planting them couldn't be easier.

The introduction of more low, overhanging tree cover is required. The simple solution is to cut small stakes or "whips" from a local willow (*Salix caprea*) and push them into the bank at a 45 degree angle just above the normal water level. This will encourage a low bushy roof to develop and create an ideal lie.
