Advisory Visit
River Churnet, Staffordshire
May 2011

1.0 Introduction

This report is the output of a site visit undertaken by Tim Jacklin of the Wild Trout Trust to the River Churnet near Denstone, Staffordshire, on 12th May, 2011. Comments in this report are based on observations on the day of the site visit and discussions with Paul Deaville of JCB Angling Club.

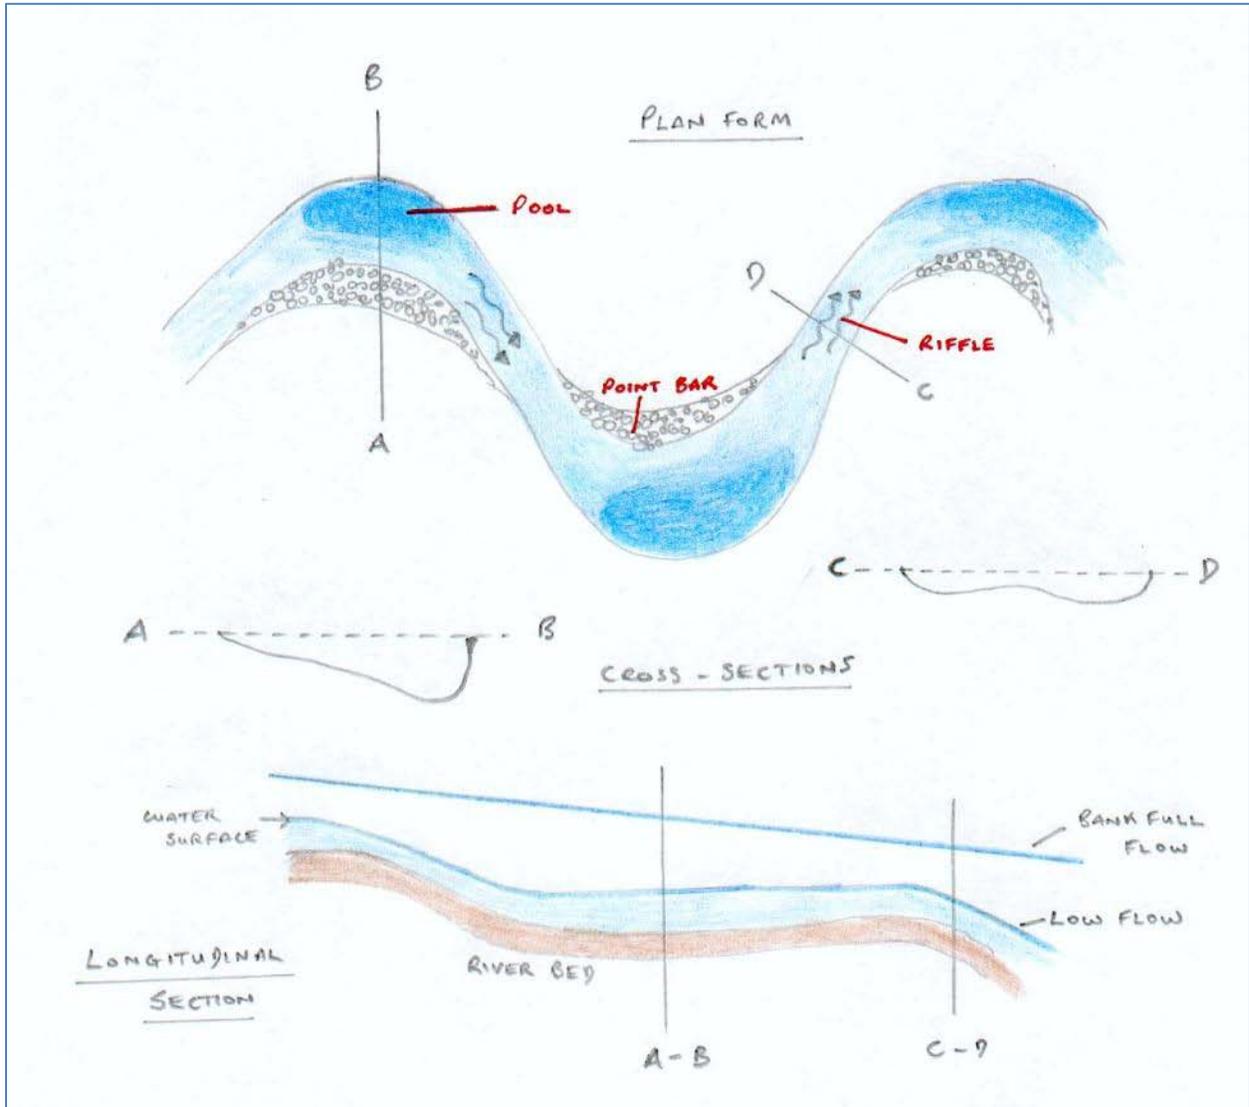
Figure 2 Natural channel morphology in alluvial rivers (adapted from Prof. Richard Hey, 2005)

The plan-form and the natural processes of erosion and deposition form the basis of good habitat within rivers. Meanders, with associated erosion and deposition, form pools, gravel bars and riffles (Figure 2); these in turn

provide a diversity of depth, flow speeds and well-sorted river bed substrate (cobble, gravel, sand, etc.), the physical elements of habitats for aquatic plants, invertebrates and fish.

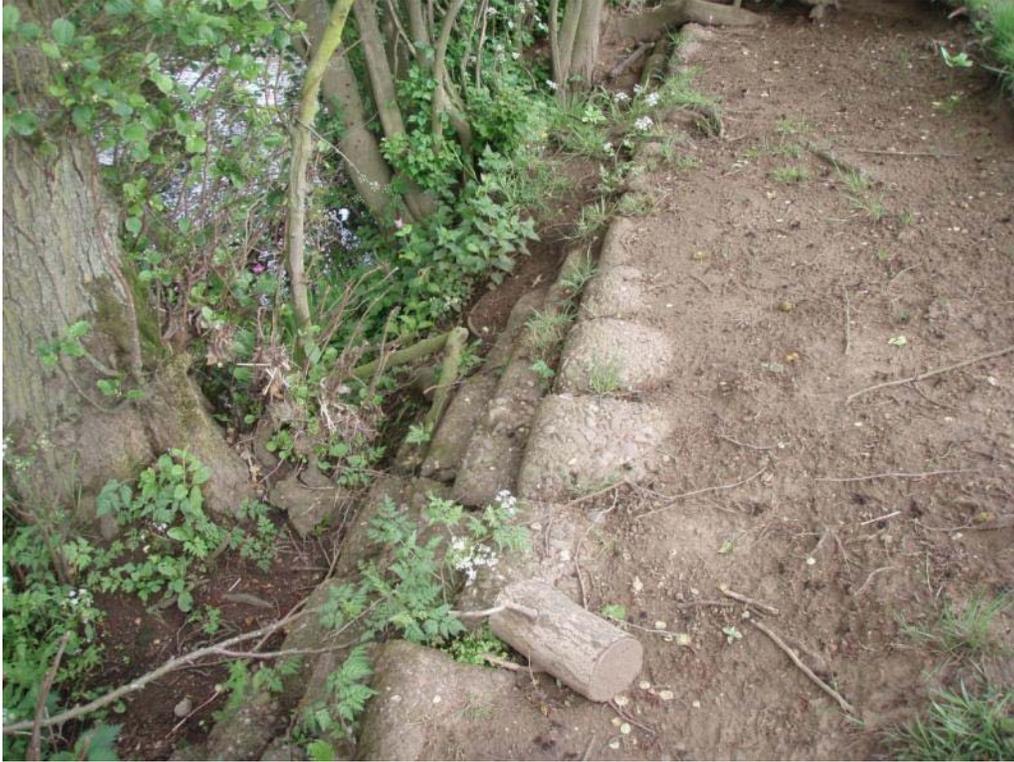
On this reach of the Churnet there are some good examples of a natural plan-form and good habitat on the downstream and upstream sections (above Quixhill Bridge and downstream of Crumpwood Weir), but the middle section has been subject to channel modification which has restricted natural processes and prevented good habitat from developing. The middle section of river is relatively straight and has stone revetment at the toe of the bank

(Photo 1) which has effectively stabilised the river channel in position, preventing the dynamic processes of erosion and deposition from shaping a natural river channel. The revetment has been in place for many years as evidenced by the mature trees growing above and amongst it.

The way land adjacent to the river is managed is a key consideration which affects the rate at which erosion takes place. The bank revetment was undoubtedly installed with the intention of stabilising the river and preventing erosion and 'loss' of land used for agriculture. Yet it is the use of riverside land for agriculture which actually reduces its resilience and increases the rate of erosion (Photo 2). This can be seen by contrasting the rates of erosion on banks grazed right up to the river margin with those where the banks are wooded.

Photo 1 Hard bank revetment on the middle section of the JCB water on the Churnet

- Consider allowing the hard revetment on the middle section of the river to degenerate and the river to move within its floodplain corridor. Discuss this with land managers responsible for adjacent land and the possibility of changing floodplain land use, e.g. to woodland. If a complete land use change is not possible, then consider creating a wide riverside margin and headlands (e.g. alongside the eroding bank in Photo 2) where woodland can be planted. (Photo 15).

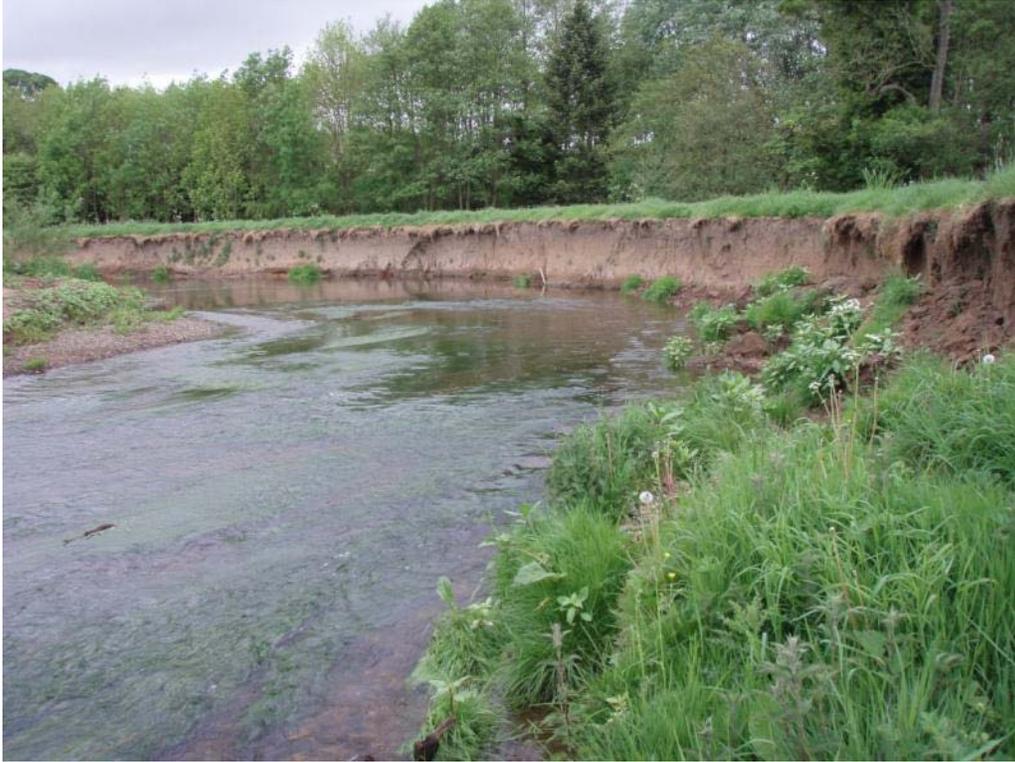
The erosion on the left bank above Quixhill Bridge (Photo 2) is taking place at an accelerated rate and is likely to break through the headland in the field and cut off the meander in the not-too-distant future. Defending the bank against this erosion with hard revetment (like further upstream) would be expensive, have a high risk of failure and would compromise the sand martin colony present in the river cliff. An alternative option would be to temporarily defend the toe of the bank with soft revetment (e.g. log and Christmas tree) to slow the rate of erosion whilst planting the headland with

native trees to create a copse, thus increasing the land's resilience to erosion.

Photo 2 Bank erosion near Quixhill Bridge

- Protect the toe of the eroding bank above Quixhill Bridge (Photo 2) using a soft revetment technique such as log and Christmas trees (Photo 14). This should be done in conjunction with planting the adjacent headland with trees (Photo 15). Consult Staffordshire Wildlife Trust on the implications of this for the sand martin colony in this bank.

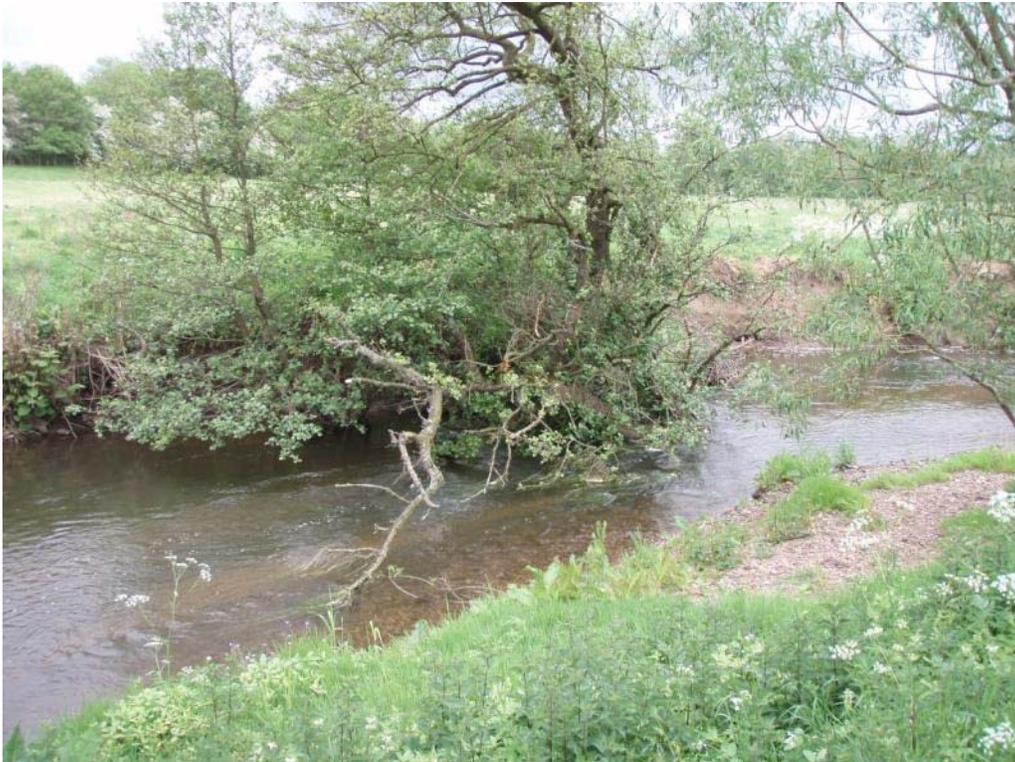
Photo 3 Large woody debris (note the scoured, cleaned gravels suitable for spawning trout in the foreground).

Large woody debris (LWD) is a very important component of a good river habitat. LWD is a general term referring to all wood naturally occurring in the channel including trees, branches, stumps and logs. LWD is generally derived from trees located within the riparian corridor and rivers with adequate LWD tend to have greater habitat diversity, a natural meandering shape and greater resistance to high water events (Photos 3, 4).

It is therefore important that naturally occurring LWD is retained within the river wherever possible. LWD could be deliberately introduced to the river in the form of tree sweepers. These are bankside trees which are felled and fixed to their stumps, mimicking naturally occurring stable LWD.

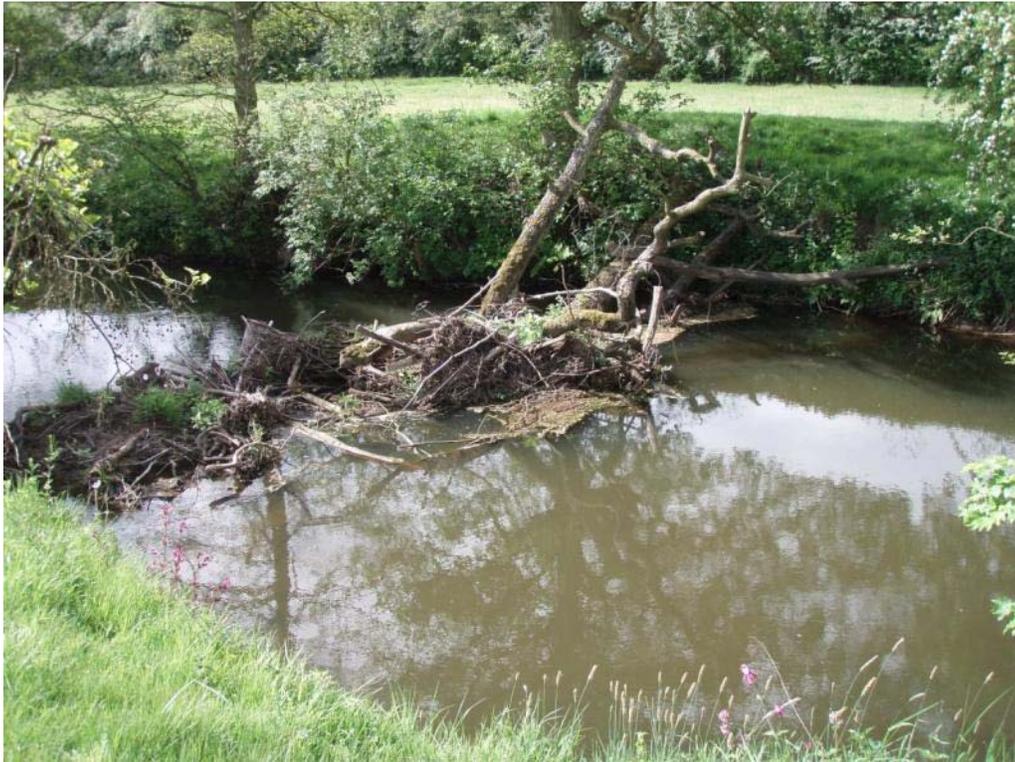
In some places, the stone bank revetment has begun to fail and limited areas of bank erosion are starting to develop (Photo 4). The response to this could be either:

Photo 4 Woody debris log jam – these provide good in-stream habitat and are often the catalyst for changing the river channel shape. Here the river has started to break through the hard bank revetment alongside the log jam; the response to this could be to allow the erosion to continue and start to create some varied habitat, or to remove the jam, repair the bank and stick with the relatively poor habitat.

- To repair the bank revetment and maintain the status quo of relatively poor river habitat in this area;
- Or allow (or encourage) the bank revetment to fail and a more natural river plan-form and better habitat to develop.

The latter option requires an acceptance from land managers that the river channel will begin to move from its current course and create meanders which will encroach on land currently used for grazing / mowing. Consideration should be given to changing land use practices within the river corridor to so that these dynamic natural processes can occur at more natural rates. Creating woodland in fields adjacent to the existing revetment would give time for trees to become established and increase the resilience of the land whilst the revetment is allowed to decay.

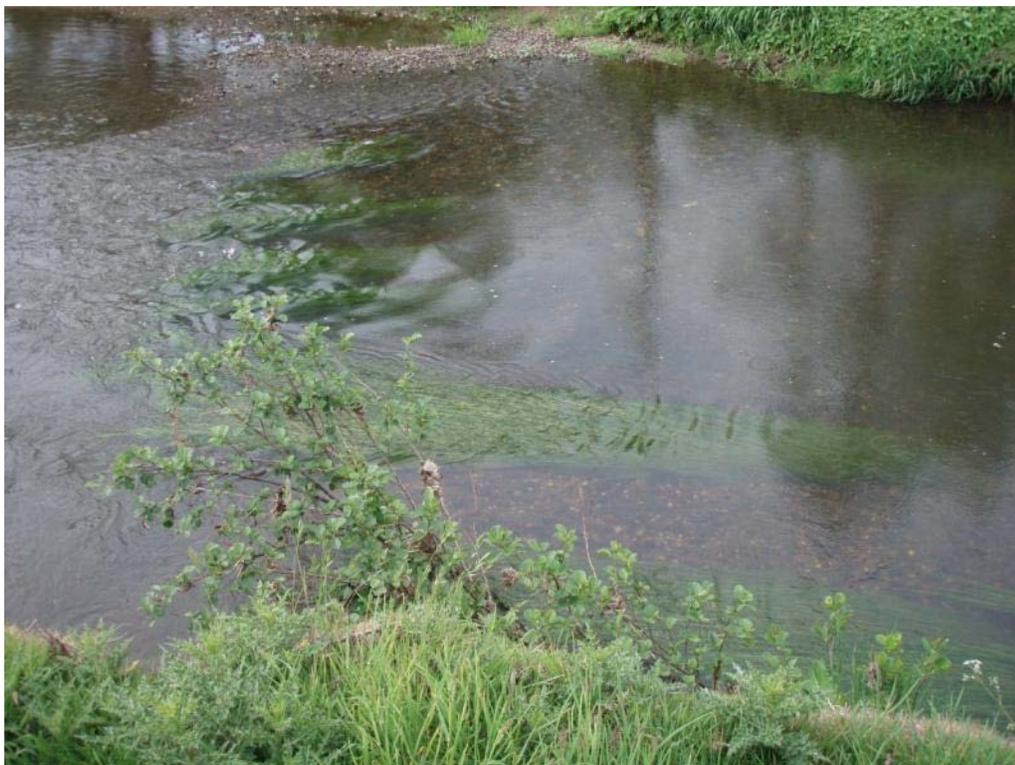
Trout spawning habitat comprises beds of well-sorted, loose gravel in the 5 – 50 mm diameter size range with a flow velocity of around 25 – 75 cm per second (Photo 5). Nearby cover (deeper water, undercut banks, tree roots, etc.) is also important to provide a bolt hole for spawning fish. Because of the sandstone geology of the Churnet catchment there tends to be a large proportion of finer sediments in the river bed substrate; this compromises the survival rate of trout eggs which remain buried for several weeks and require a reasonable flow of water through the spaces between the gravel. The sandy nature of the Churnet is a fact of life and the options for improving trout recruitment are:

Photo 5 The 'glassy' water at the tail of a pool like this is a favoured spot for trout spawning. It could be improved by providing low cover close by as a bolt-hole for spawning fish.

- Retain large woody debris within the river channel wherever possible. Introduce woody debris in the form of tree sweepers (Figure 3), hinged trees and bushes (Photos 12, 13), or brushwood bundles (Photo 14). Target areas alongside potential spawning areas (e.g. Photo 5) and downstream of these where juvenile fish might be protected.

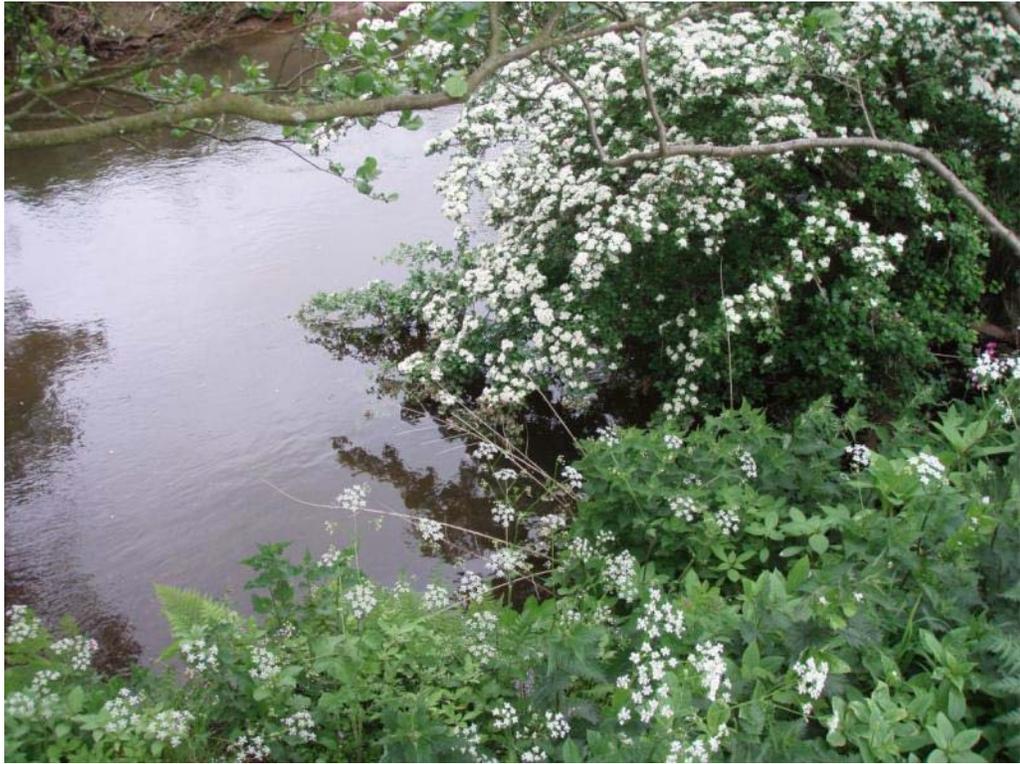
Photo 6 Low cover is excellent habitat for holding fish – don't remove it if carrying out trimming for angling access!

If tree branches are trimmed to facilitate angler access and casting, bear in mind the importance of preserving low cover in or just over the water. There is no harm in trimming the odd twig or branch a few feet above water level, but removing the low cover could well remove the fish holding potential of that area (Photos 6, 7, 8).

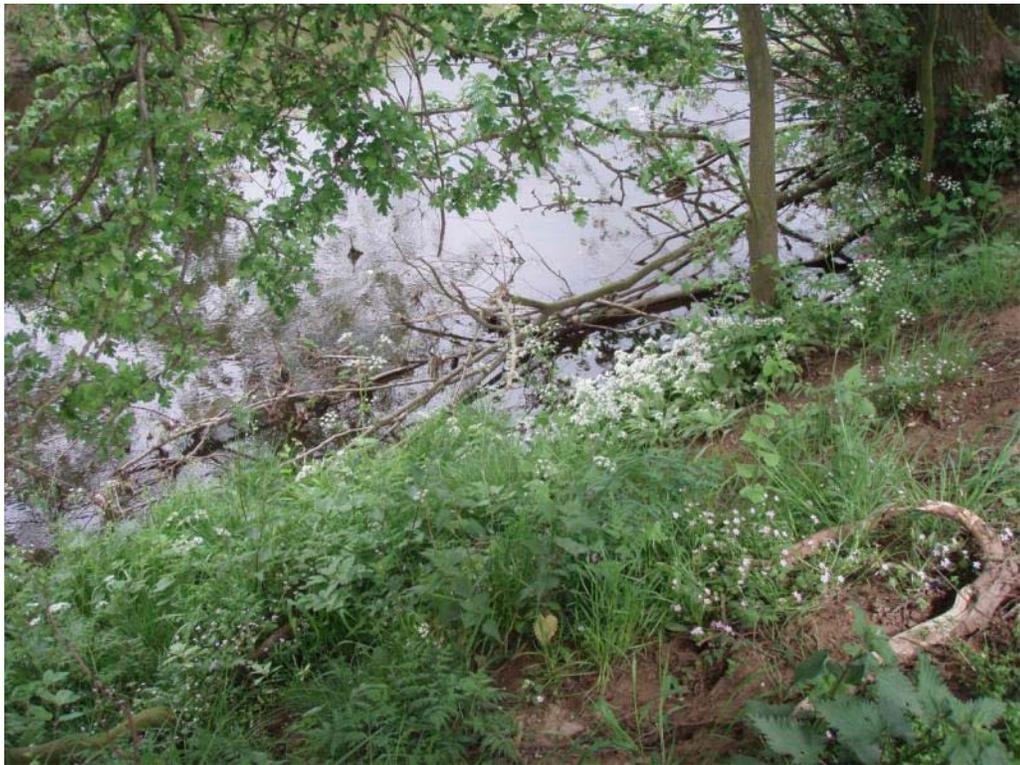
Photo 7 Branches and small trees which have collapsed into the river are superb refuges for juvenile trout. Leave them in place and try introducing a few more.

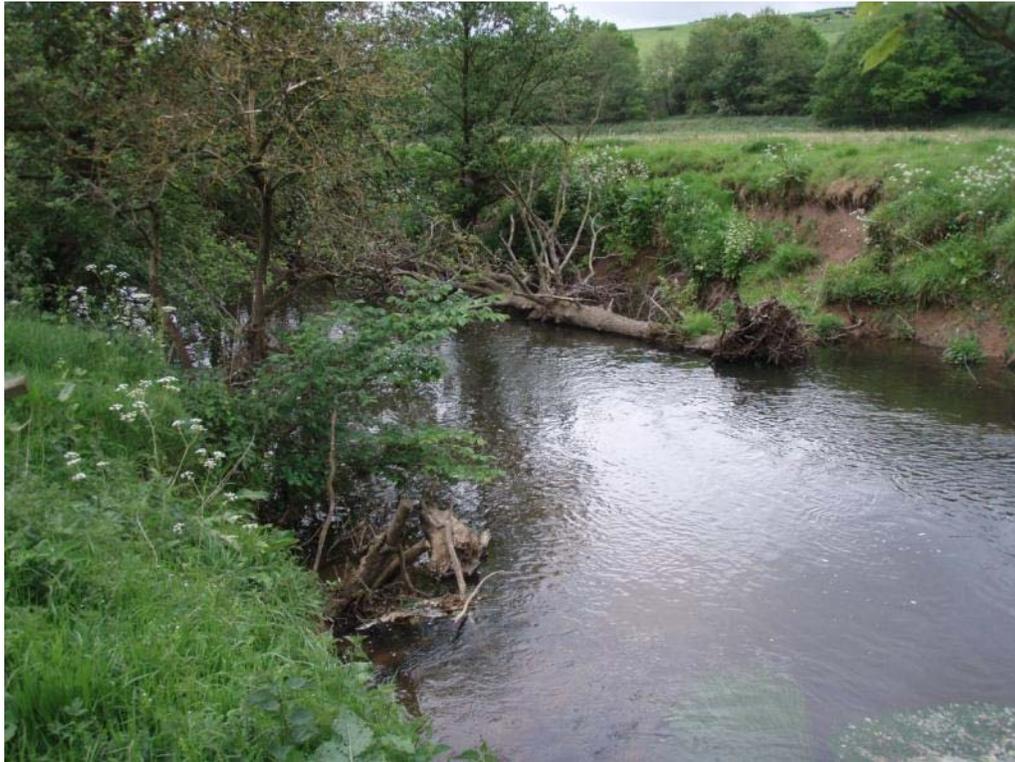
Photo 8 Larger trees also provide excellent cover and great fish habitat. Leave natural ones in place and consider introducing some “tree sweepers”.

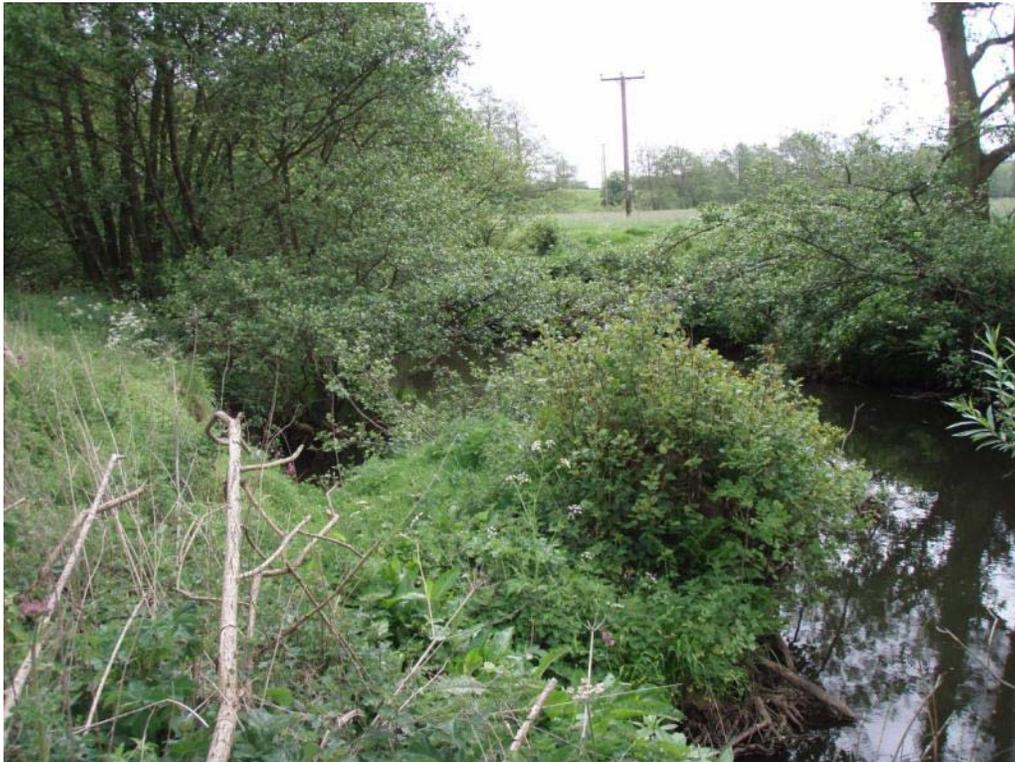
Alder trees can be subject to the disease *Phytophthora* which kills them, accelerating the process of tree loss and bank erosion. Early coppicing of trees showing signs of disease can promote re-growth, preserving the trees root mass and its bank stabilising properties (Photo 9). Any trees which are already dead should be left standing as they are valuable habitats. Creating wide, ungrazed buffer zones and headlands alongside the river or changing floodplain land use to woodland, will allow trees to become established by natural colonisation or planting.

Photo 9 A coppiced alder tree showing re-growth from the stump. In this case the tree has been coppiced because it is under power lines, but it illustrates what can be done to manage riverside alders to increase their longevity. A rotational coppice of ten years or more ensures that there is a good mix of stages of re-growth and channel shading. Coppiced trees must be protected from grazing.

- Assess alder trees for disease and whether they can be preserved by coppicing. Aim for about 60% shading of the channel, with open canopy areas alongside shallow, fast-flowing areas where water crowfoot will grow. Use the arisings from coppiced trees to introduce LWD to the channel.

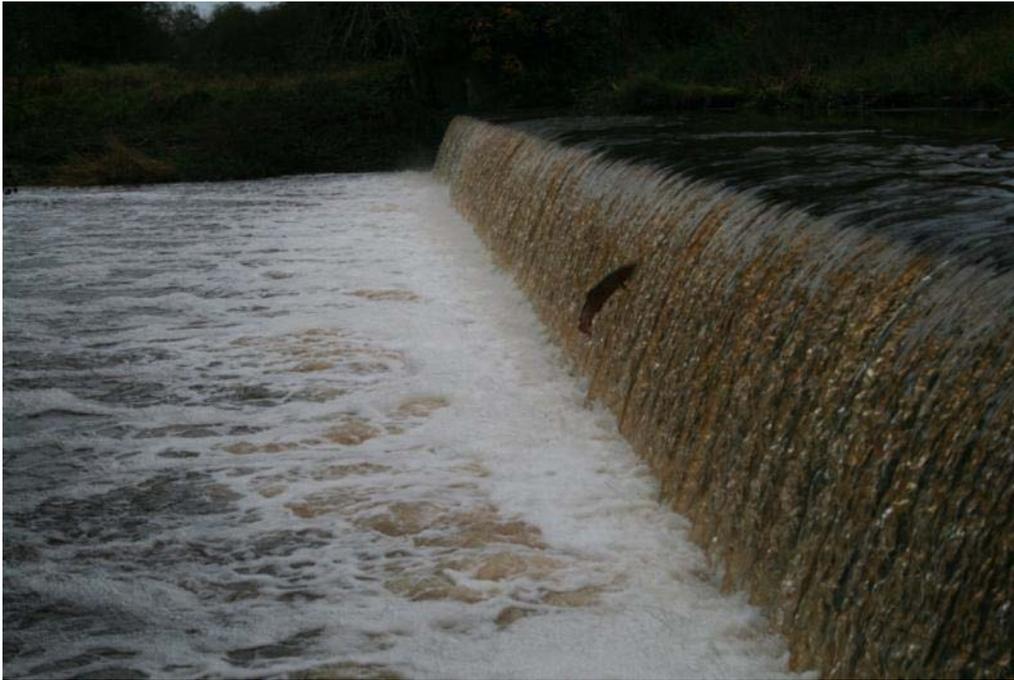
Although Crumpwood weir is not on the JCB AC stretch, it is located a short distance upstream. This structure forms a very significant barrier to fish migration and in recent years salmon have been observed struggling to leap the weir (Photo 11). It is well-known that salmon undertake long migrations between river and sea to complete their lifecycle; what is less well-known is that other species like trout and coarse fish also migrate over varying distances and timescales for spawning, feeding and refuge. For example, trout move upstream and into small tributaries in the autumn in order to spawn and then their offspring subsequently drop back downstream.

Photo 10 A salmon attempting to leap Crumpwood Weir in late 2010 (Picture: Mick Buxton).

- Consider building a partnership to take forward a fish pass construction project on Crumpwood Weir.

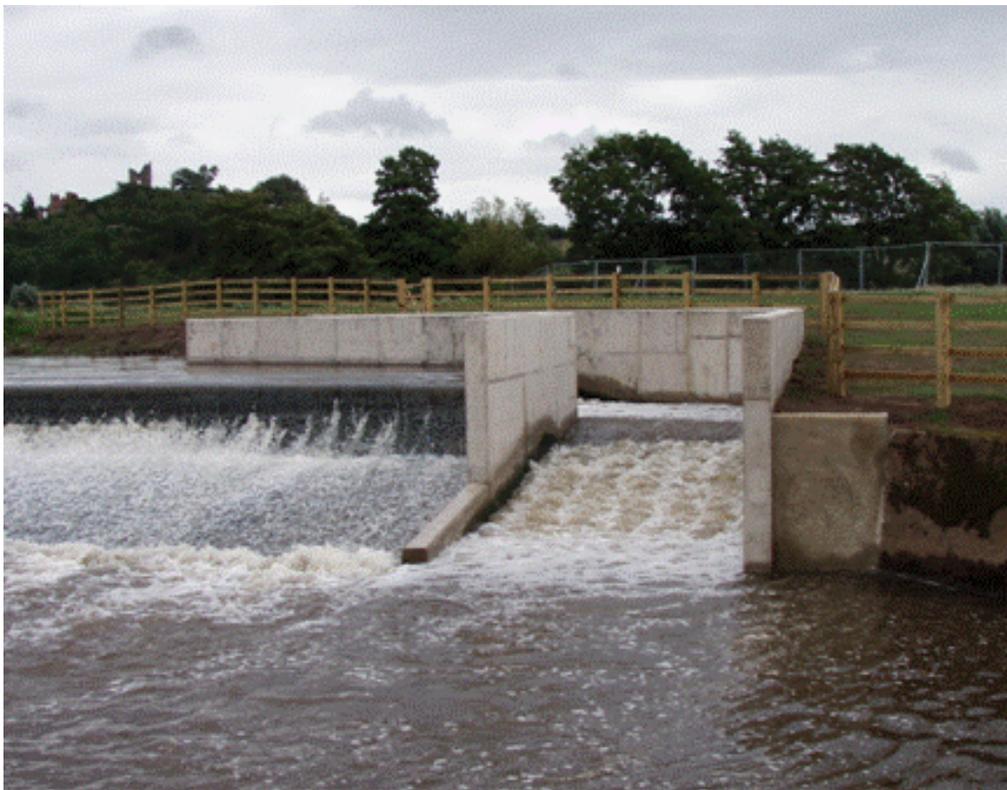
Improving fish passage at structures like Crumpwood has obvious benefits for salmon but would also significantly improve the populations of other species like trout, increasing their abundance and resilience across the catchment. Building a fish pass (Photo 12) at Crumpwood would be an expensive (circa £250K) project but has great potential for good publicity, education opportunities and partnerships between the private (industry), public (Environment Agency) and voluntary sectors (Trent Rivers Trust, Wild Trout Trust).

Photo 11 A fish pass built around Tutbury Weir, River Dove. A similar structure could be built at Crumpwood to be in keeping with the local surroundings and existing stonework.

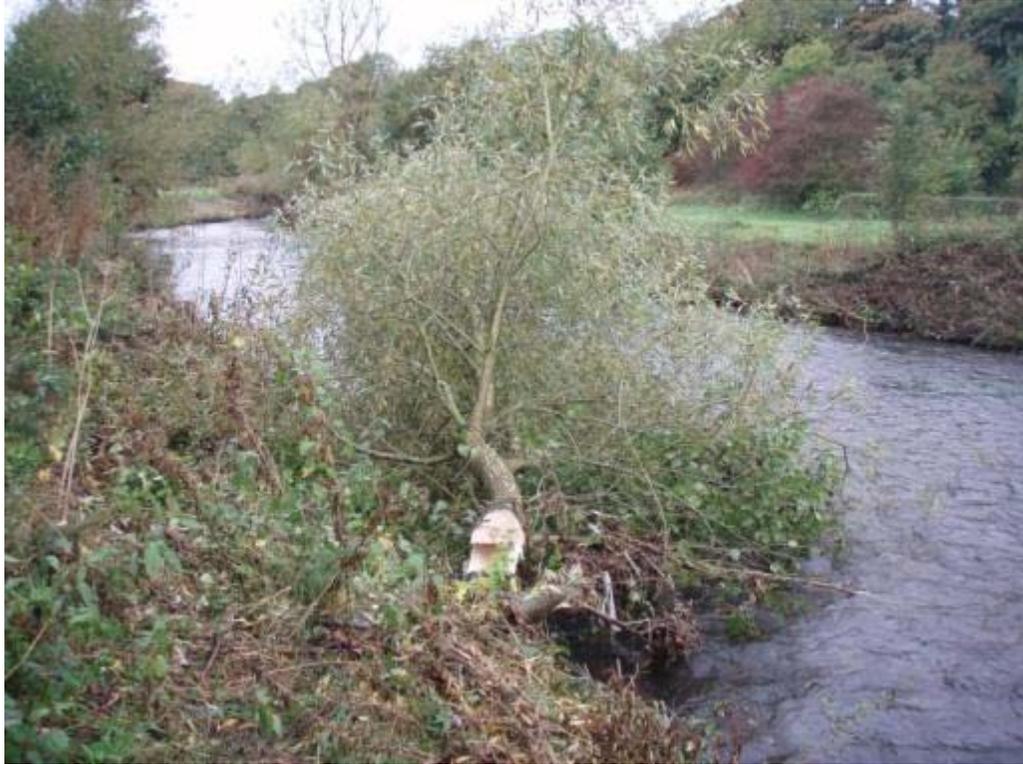
Photo 12 Willow tree hinged into the margins of the River Goyt (Derbyshire). Partially cutting the trunk and pushing over the tree will ensure a firm anchor point. This particular example has been retained through many floods which over-topped the bank.

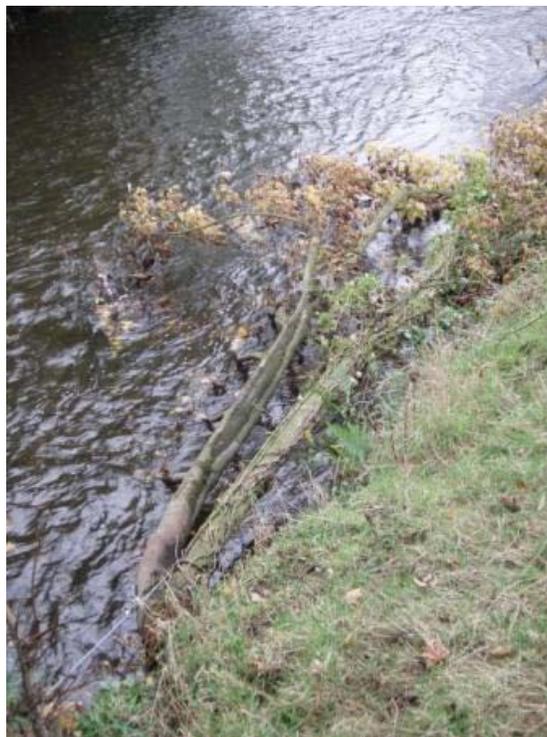
Photo 13 Tree kicker / sweeper. Tree felled and fixed to its stump with cabled wire (River Goyt, Derbyshire).

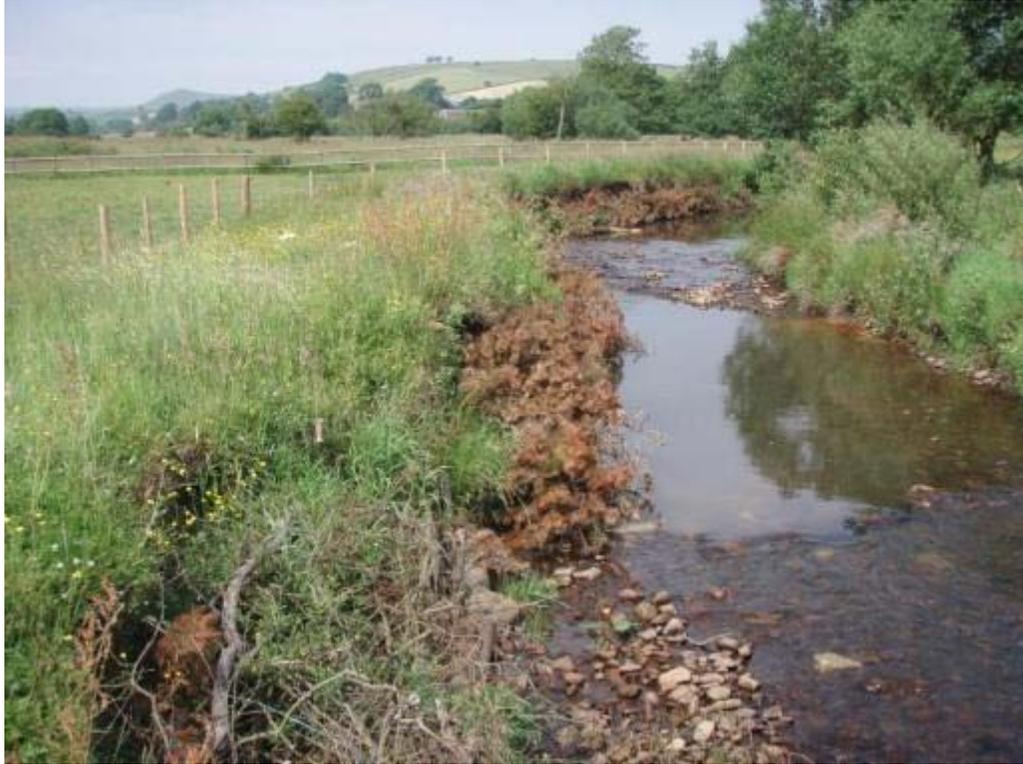
Photo 14 This bank revetment made from conifer brush was installed to reduce the rate of bank erosion, but also proved to be superb cover for juvenile trout (River Manifold, North Staffordshire).

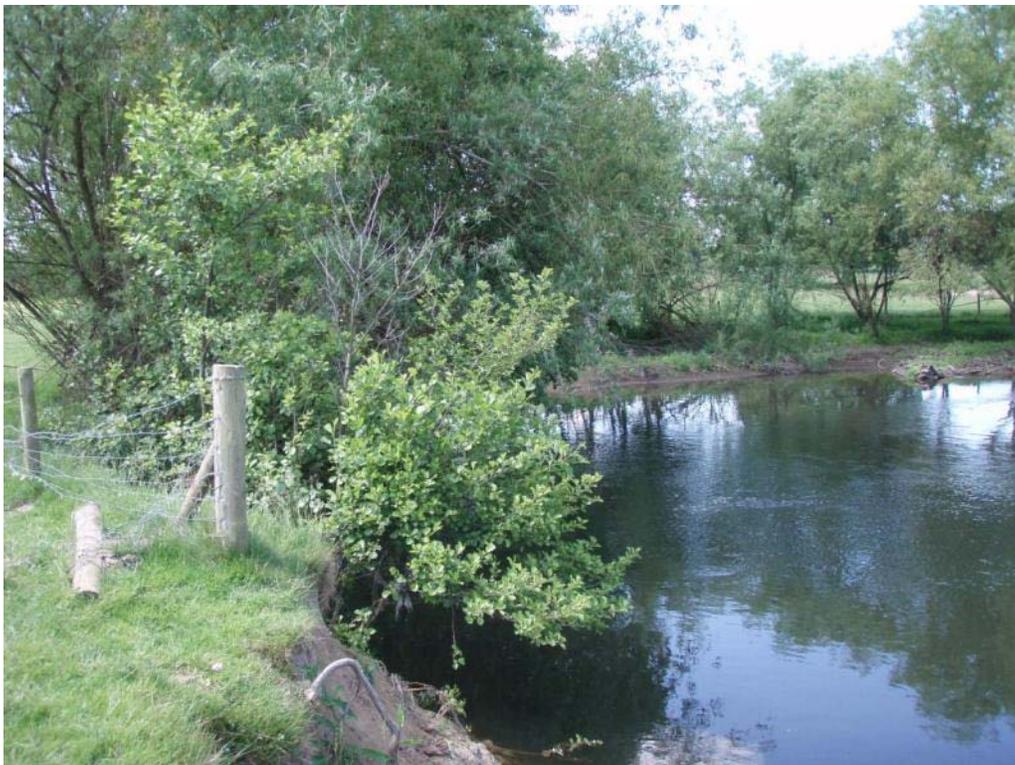
Photo 15 A tree-planted headland which has successfully slowed an excessive rate of erosion, River Clwyd, North Wales.
