Clifton Beck: Advisory Visit for Calder & Colne Rivers Trust

Report by the Wild Trout Trust – 26/02/2016

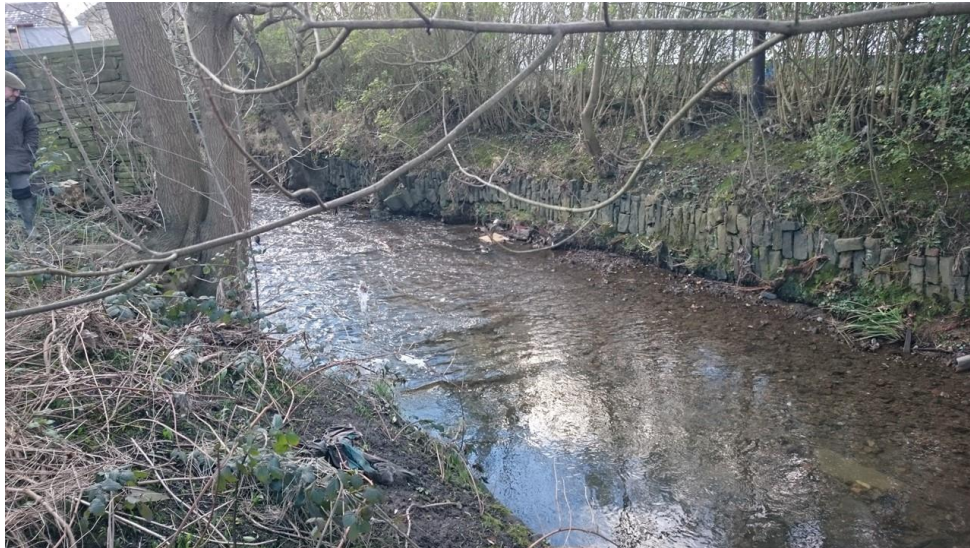
Figure 1: Glide and riffle feature at SE 14913 23119. Varied habitat supporting diverse invertebrate communities

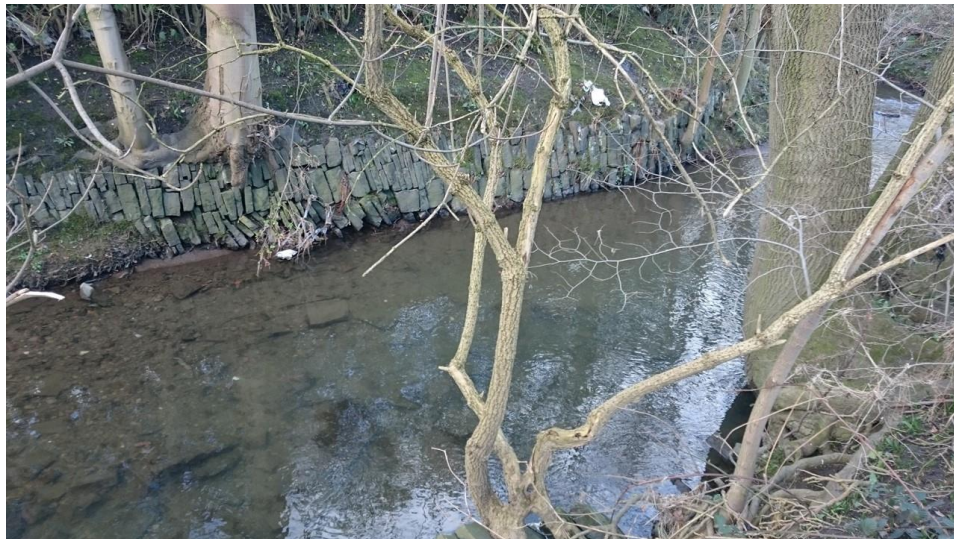
Figure 2: Even though constrained by a wall on the RB, processes of erosion and deposition have created cross-sectional (and longitudinal) variety in depth, velocity and particle size. It is possible that there is an elevated supply of fine (sand/silt) to the channel. If this is derived from improved farmland, this could be a source of the high phosphate concentrations reported in its WFD classification.

Although the channel appears to be capable of re-mobilising and redistributing fine sediment, there appears to be a somewhat elevated supply of sand and silt fractions. This is often associated with surface water runoff washing loose soil into the river (or sometimes runoff from road drainage systems). Land-use in the upstream catchment is reported by AV recipients to include dairy farming and possibly sheep farming. It is possible that, depending on the presence/absence of grazing exclusion to produce vegetated buffer strips, a greater input of fine sediment is derived from agriculture in the upstream catchment.

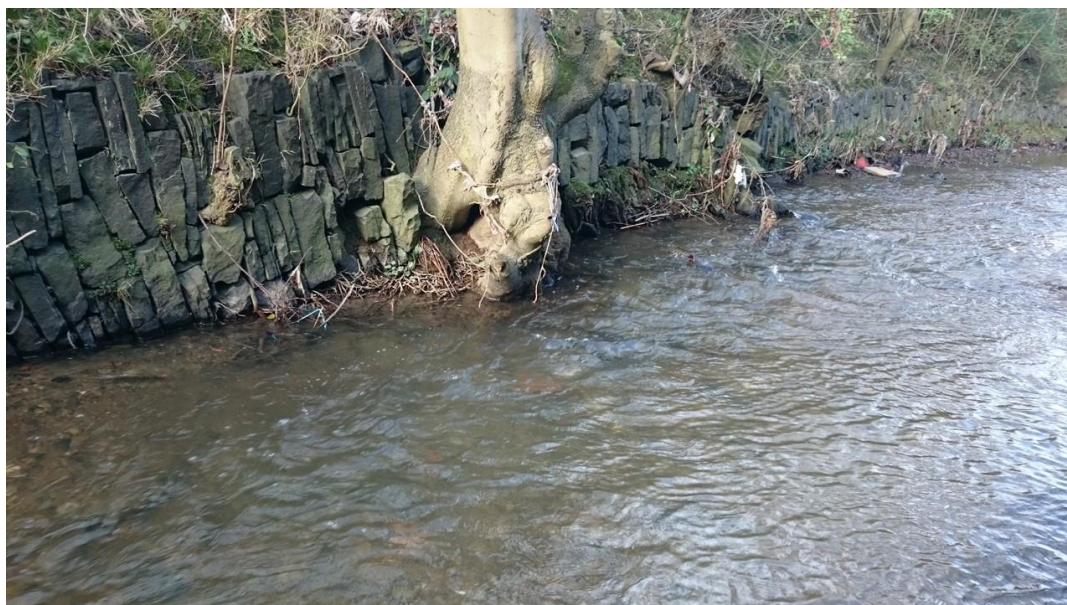
Localised scour and the valuable habitat that results is exemplified by the riverbed morphology caused by the “undershot scour” (i.e. scour resulting from water being squeezed underneath) associated with the curved tree trunk growing outwards and upwards at SE 14920 23120 (Fig. 4). During the visit a significant amount of ad-hoc pruning and lopping of tree limbs with hand saws was observed. The arising branches were discarded haphazardly, suggesting that it was carried out via unofficial channels. This activity should be discouraged where possible due to the potential for unintended consequences for tree health and damage to habitat creation processes (such as those described with reference to Fig. 4).

Figure 4: Scour pool habitat created beneath and downstream of the tree growing out of the wall. During spate conditions the flow diverted underneath and around the trunk has created valuable habitat. Note the speed of the water on the outside of the bend and the slowing of that by the increased depth of the pool habitat (darker water). The slower flow on the inside of the bend (lower right of frame) is associated with deposition of bed material to form a sloping “point bar” – additional structural variety that supports greater biodiversity.

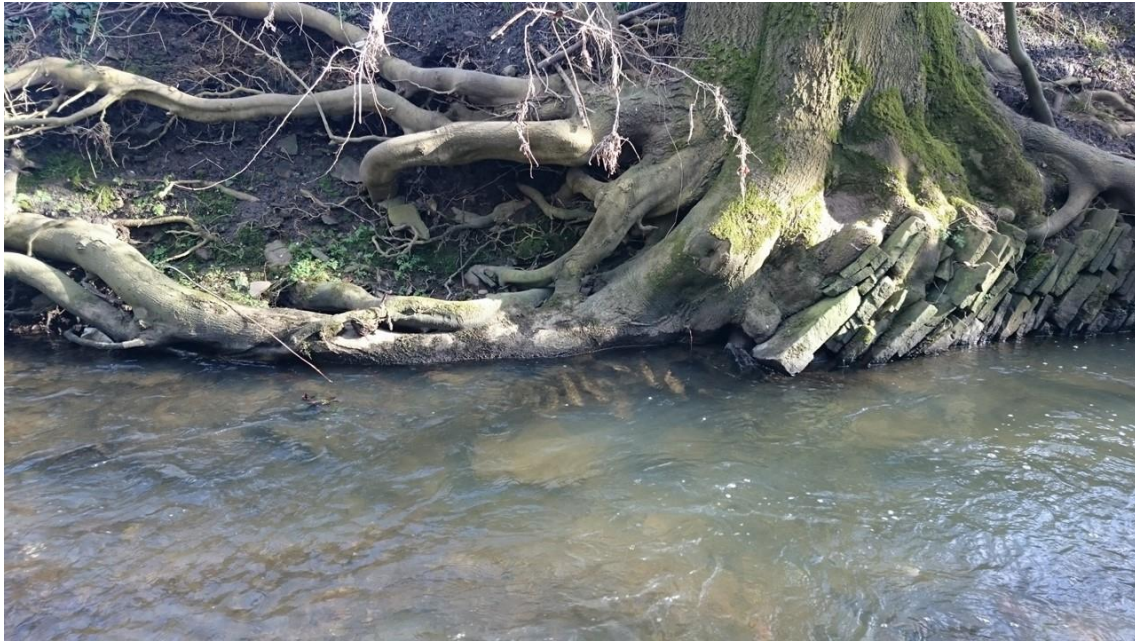
Figure 5: As well as scour-pool creation, the roots of this tree have stabilised and controlled rates of bank erosion after the failure of the stone wall.

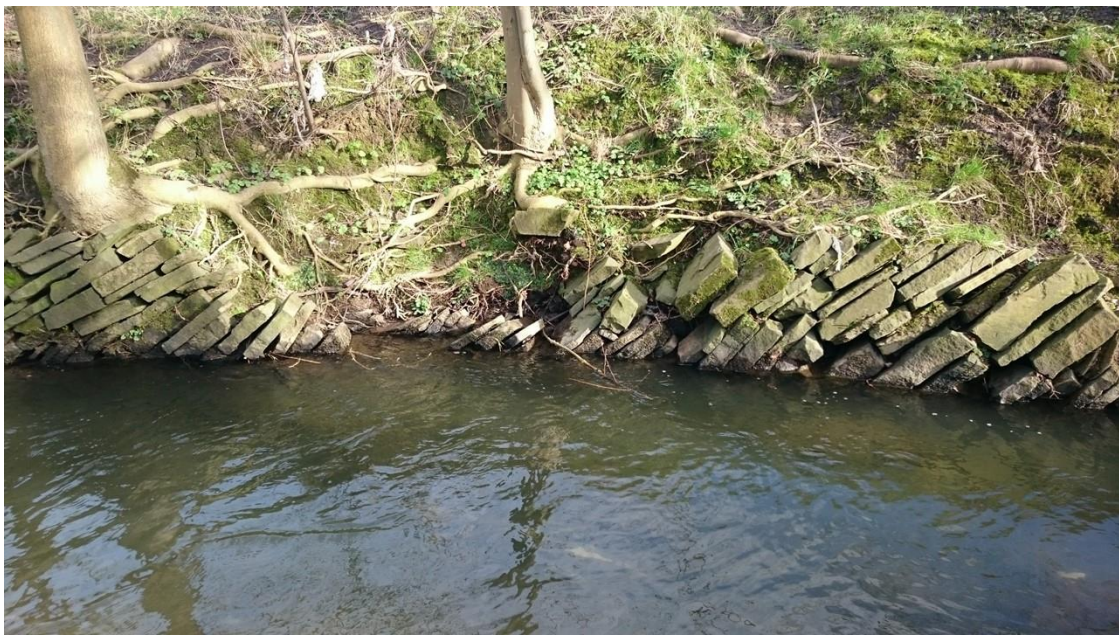
Figure 6: A scour pool of impressive depth formed by a sharp bend on the river. Both the depth and the tight angle of the bend are enabled by the resistance of the banks resulting – not only from the old stonework – but also from the deep root-structure of woody vegetation. Over the longer-term, the self-regenerating living reinforcements (tree roots) will be more reliable than temporary built stonework for ensuring the resistance of banks to lateral erosion.

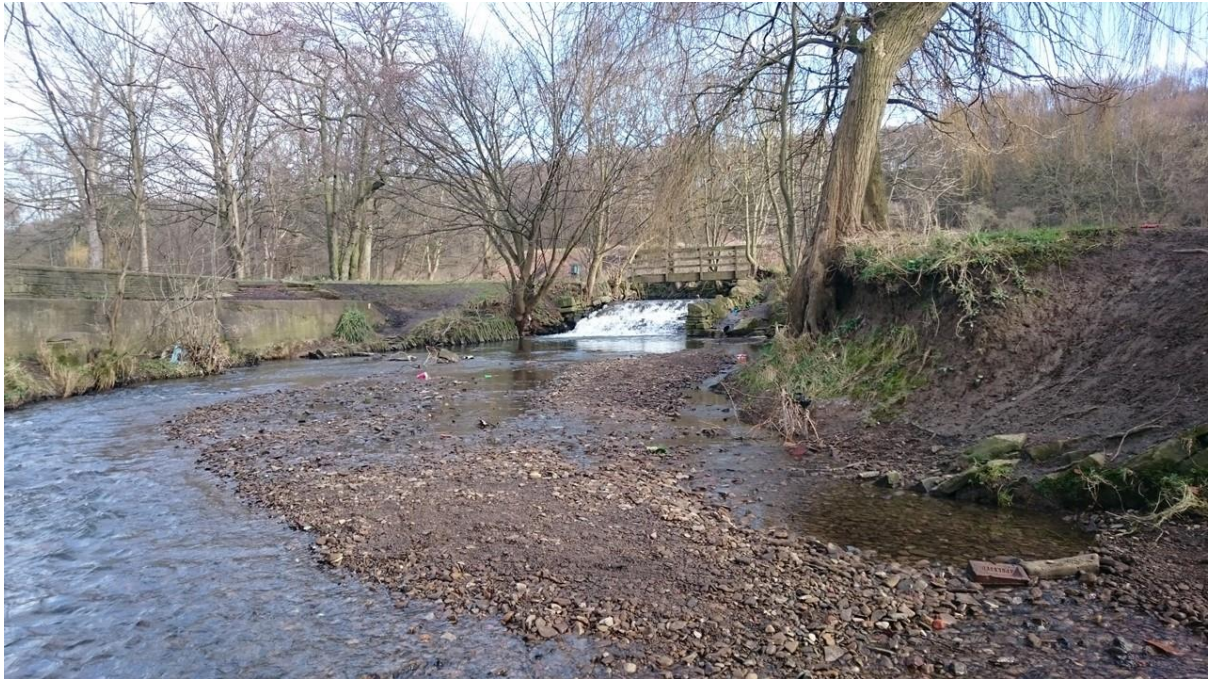
The structurally-diverse habitat is evident up to SE14873 23185. At that point, a weir impounds the upstream watercourse and significantly reduces the variety of available niches. Compare the reach below the weir (Fig. 7) with that directly upstream of the structure (Fig.8).

Figure 7: Despite bank erosion caused by foot-fall and dog-access (right of frame), the deposited gravel and cross-sectional variation in depth and current-speed provides a variety of habitat features.

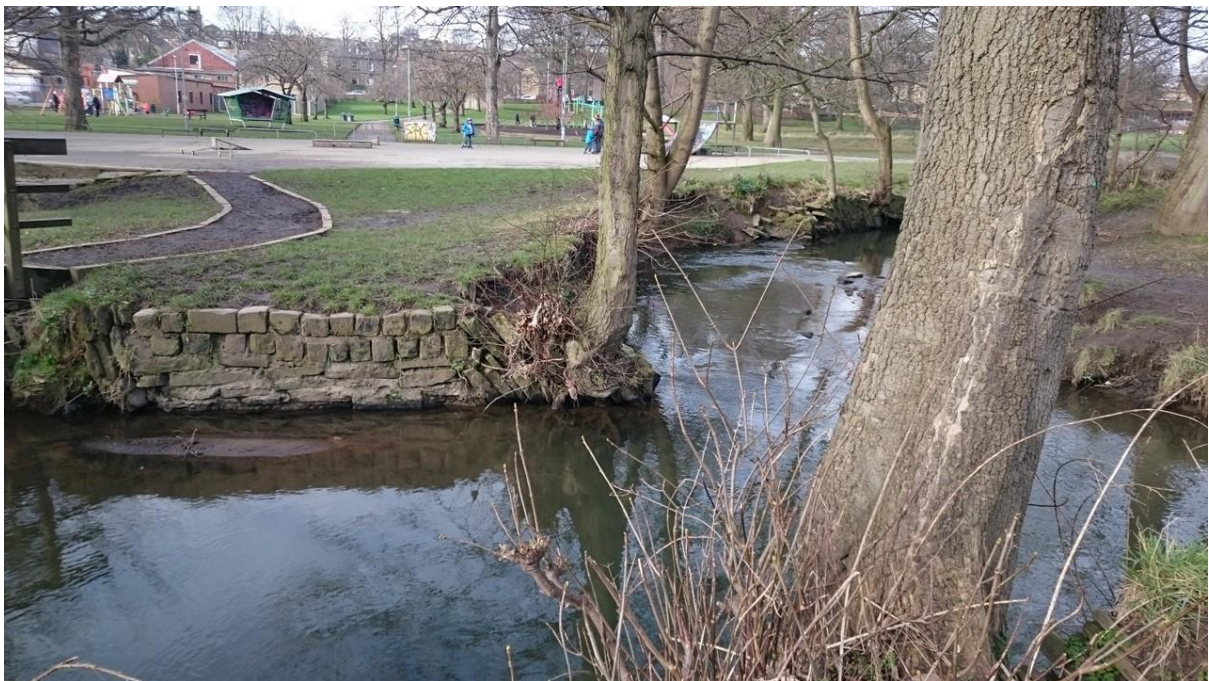
Figure 8: Slow, canal-like flow that extends across the full width of the channel. The substrate is dominated by fine sediment - providing much more homogenous habitat with fewer available ecological niches.

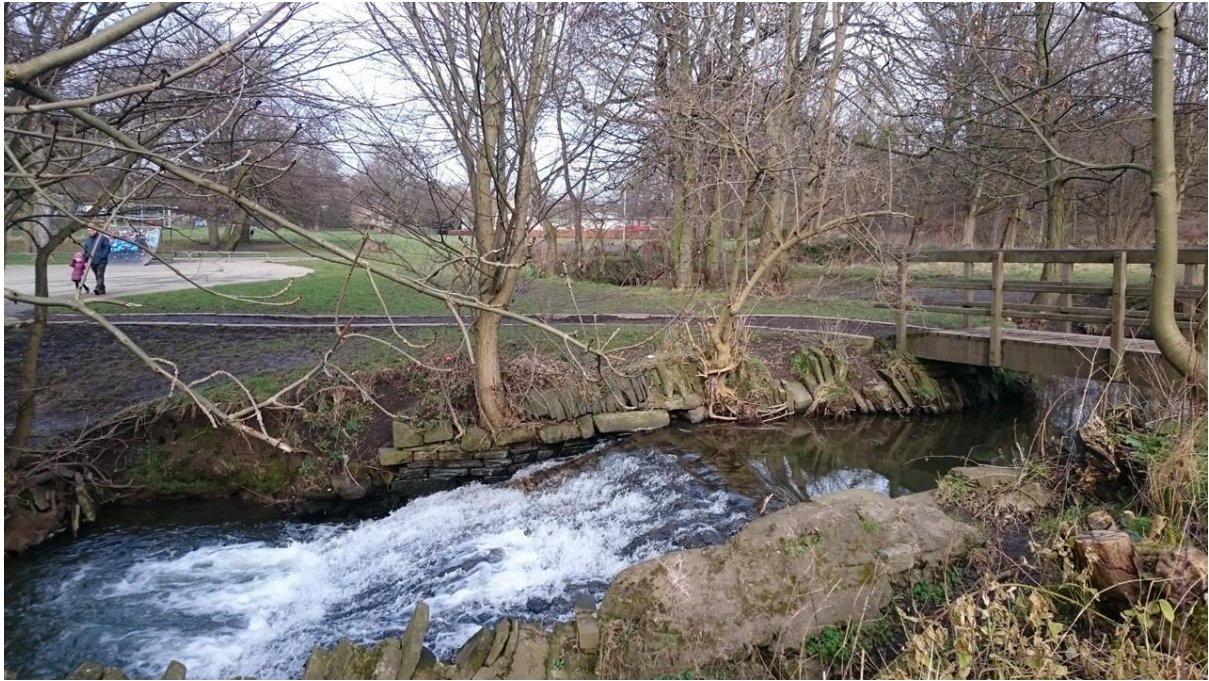
The weir is also likely to be a completely impassable structure to trout (at least in an upstream direction; Fig. 9).

Figure 9: The sloping face of the weir with its shallow, fast flow of water is a complete barrier to upstream migration of trout and other fish. White water indicates the air entrained within the flow that removes the ability of fish to swim.

Although the impounding effect of the weir begins to disappear about 150 metres upstream (shorter as the crow flies, due to meandering planform), this represents a considerable amount of degraded habitat. When coupled with the barrier effect of the weir (and considering the "Not High" WFD status of Hydromorphological supporting elements), there is a strong imperative to remove or bypass this structure.

There are multiple beneficial effects of removing weirs such as the one pictured in Figure 9. However, in this case, there are particular considerations that must be accounted for. Firstly, a general lack of deep root structure has resulted in the river already beginning to cut off the sharp meander upstream of the weir (Fig. 10). Deep roots act a bit like reinforcing bars in concrete and significantly increase the resistance of riverbanks to the process of erosion.

- Removal or bypass of the weir at SE 14873 23185 (likely to require expert geomorphological advice in order to manage the response of the channel – again planting schemes could perform a central role in that management as a means of effectively controlling bank erosion rates).

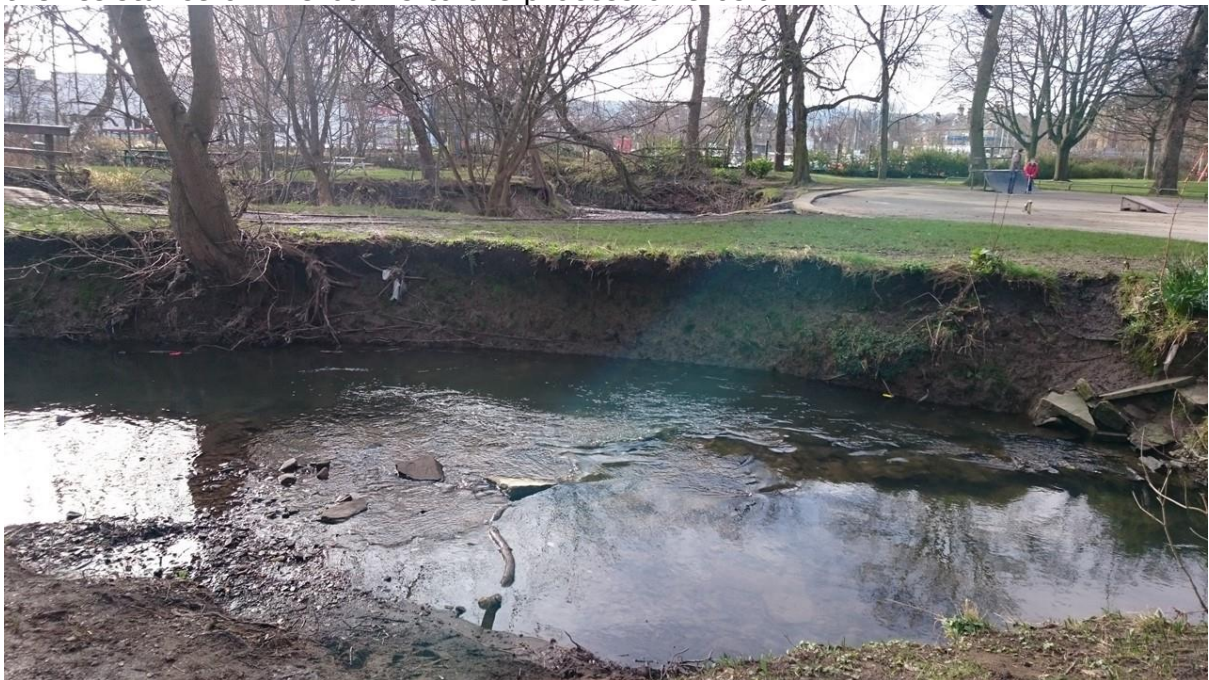
Figure 10: Looking downstream from above the weir, the hand-rail can be seen on the footbridge over the weir top left of frame (also visible in Fig. 9). The shallow root system caused and maintained by mowing of vegetation means that the river is cutting its way around the weir.

Removal of the weir would probably accelerate this process. An alternative view would be that, left to its own devices, the river will eventually bypass the obstruction on its own. Whether this latter approach is an acceptable one will depend largely on the potential for the river to impact on the adjacent playground amenity area. The use of tree planting and vegetated buffer-strip establishment to protect existing amenities is discussed in section 3 "Recommendations".

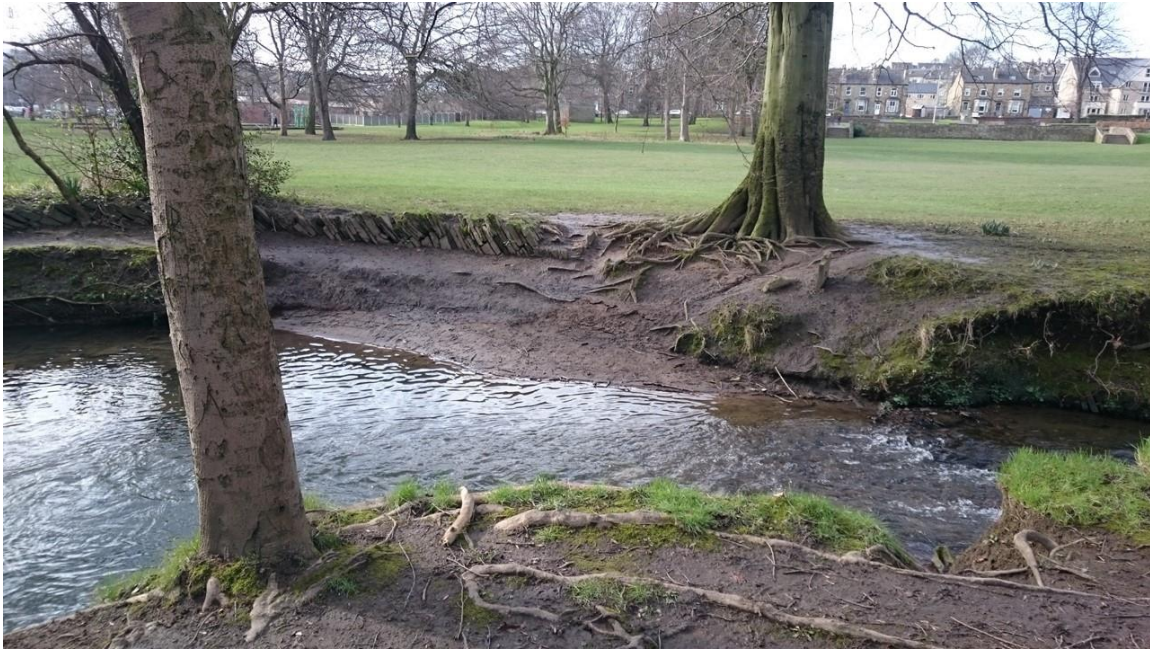
Further examples of the erosion and associated fine sediment inputs arising from shallow root structure were observed throughout the reach (e.g. Fig. 11).

Figure 11: Elevated fine sediment inputs due to lack of riparian vegetation caused by mowing and public footfall at SE 14862 23322.

- Establishment of unmown, vegetated buffer strips in areas that currently lack vegetation (other than shallow-rooted grass turf). This is an excellent opportunity for partnership work between Calder & Colne Rivers Trust and Yorkshire Wildlife Trust to derive and source a locally-appropriate riparian vegetation species mix (see notes above on creating “demonstration” plots with interpretive signage).

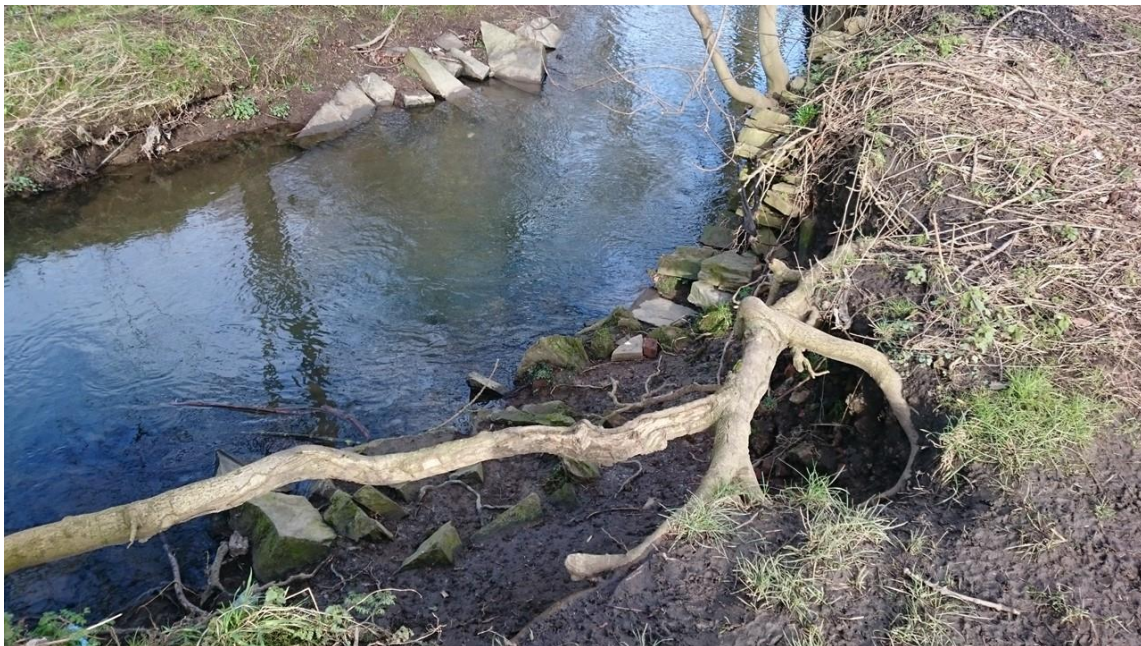
The progressive collapse of the stonework that is used to control the path of the river is, similarly, noted throughout the visited reaches (e.g. Fig. 12).

Figure 12: Gradual collapse of stonework (expensive to maintain) may highlight the desirability of establishing woody vegetation that will automatically regulate rates of bank erosion with little requirement for additional intervention or cost.

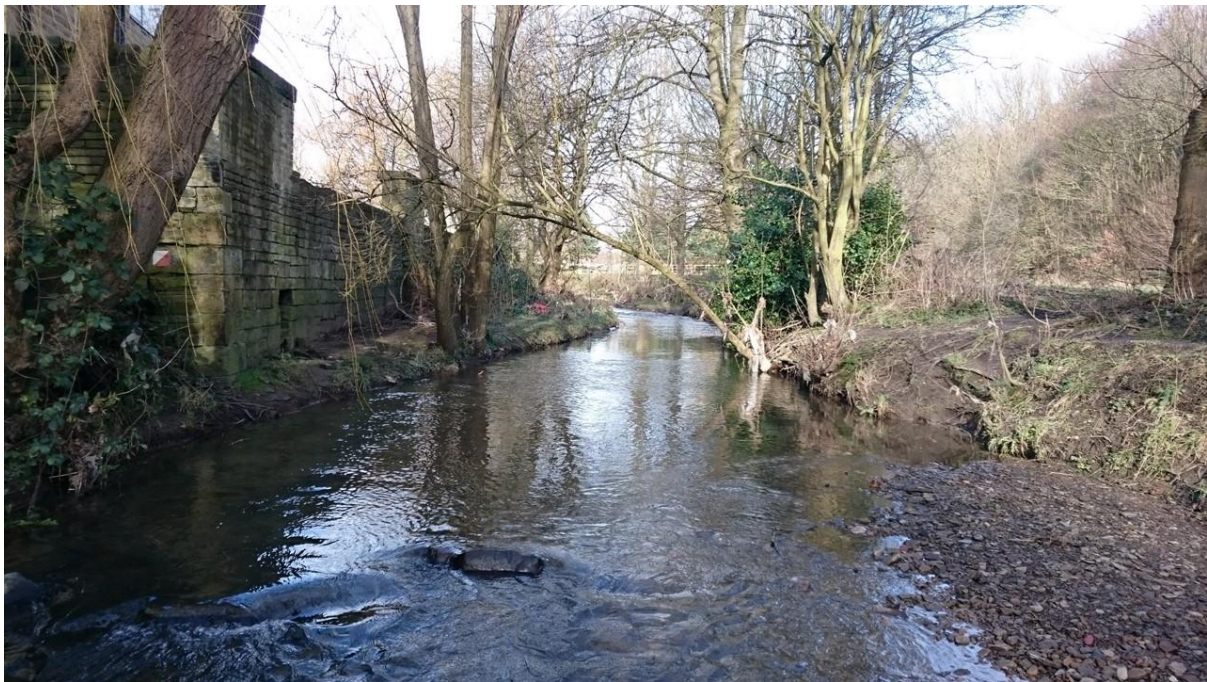
Much of the river channel within the park sits within quite a steeply “incised” channel. In other words, the banks on either side are steep and the surface of the water at normal flow levels is set well below the level of the bank-top. This may reflect the geomorphological processes of the river that, in response to artificial realignment, act over time to re-establish inherent channel dimensions, profile and planform. Steeply incised channels exacerbate problems of erosion due to footfall (whether by walkers or pets). A rare example of the water’s surface being relatively close to the level of adjacent bank and flood-plain features was noted at SE14819 23533 (Fig. 13).

Figure 13: Deposition and vegetation of a point bar on the left of the frame (RB) has produced a bank-top level that is much closer to the normal flow height of the water. Similarly, the opposite bank is also much closer to the level of the water than is typical of the visited reach as a whole.

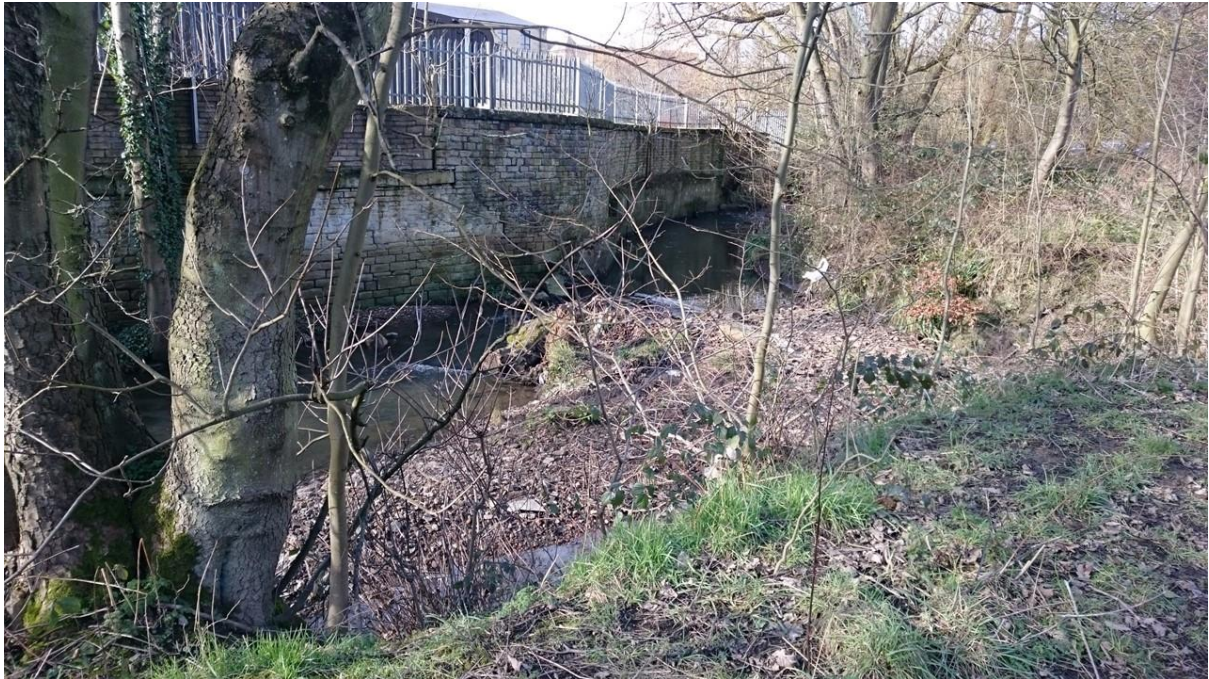
The footings of what was previously an impounding weir structure were visible at SE14818 23585 (Fig. 14). The resultant increase in upstream flow energy (and also the downstream redistribution of material from the weir) has produced valuable habitat. This is an example of the benefits of removing impounding structures for overall biodiversity. There are particular benefits for rheophilic (flow-loving) species such as trout and also the organic-pollution-sensitive stone-clinging mayfly nymphs observed during the visit.

Figure 14: Remains of an old weir and associated gravel-bar depositional feature. At the far bank, the weir structure has washed away so that the original bed level is close to being reinstated. This has restored fish passage and has also delivered habitat improvements upstream and downstream.

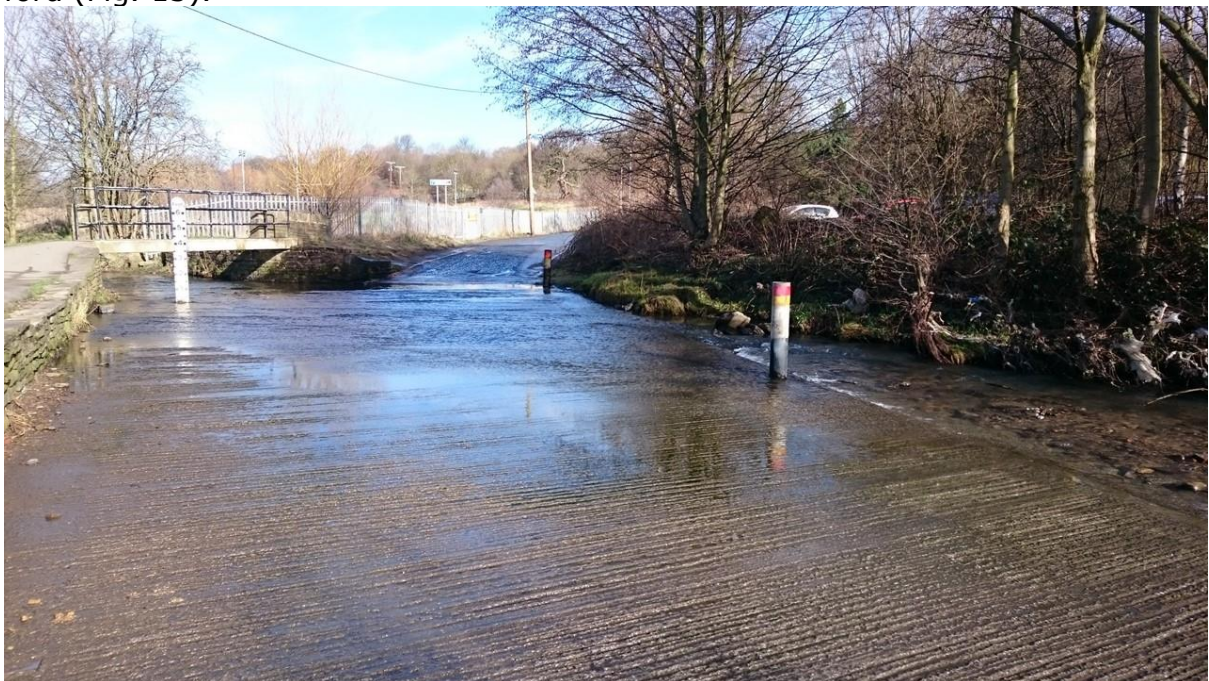
The upstream boundary of the visited reach was marked by a substantial concrete ford (Fig. 15).

Figure 15: Concrete ford at SE14715 23643 – a serious barrier to fish migration.

Although perhaps appearing to be more innocuous than a high weir, this ford is actually a serious barrier to migrating fish. It is also another interruption to the downstream transit of riverbed material. Such transit is an essential process for creation of in-stream habitat structures. The apparent requirement for access means that potential improvements to this situation are likely to be more challenging than is evident to most observers at first sight.

- Engage local highway and council authorities, an EA development control representative and EA fisheries/biodiversity staff to pursue permissions, design and delivery of fish passage easement across the ford at SE14818 23585. Again, Forestry Commission involvement may also be valuable in achieving this aim.

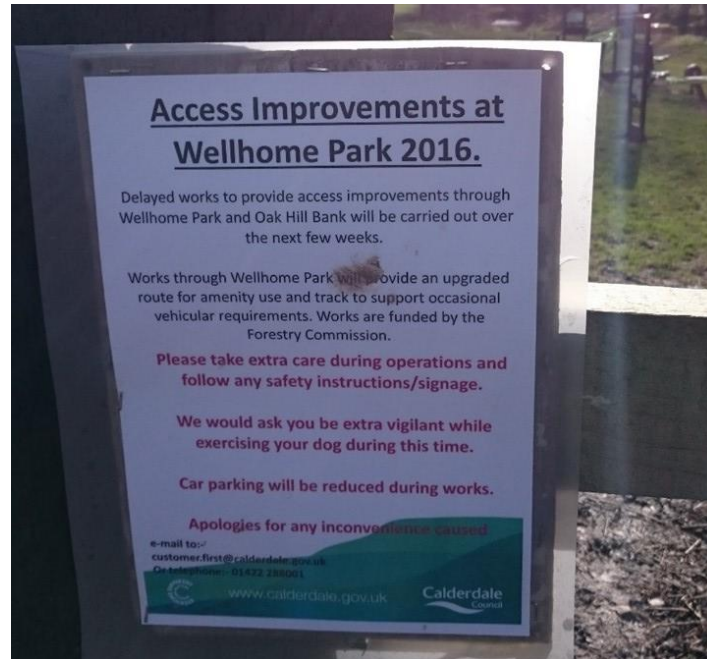
Figure 16: Sign photographed in Wellholme Park during the visit

- Supportive planting of trees (see Fig. 16 for information on existing local Forestry Commission-supported works) and locally-appropriate riparian understory species.

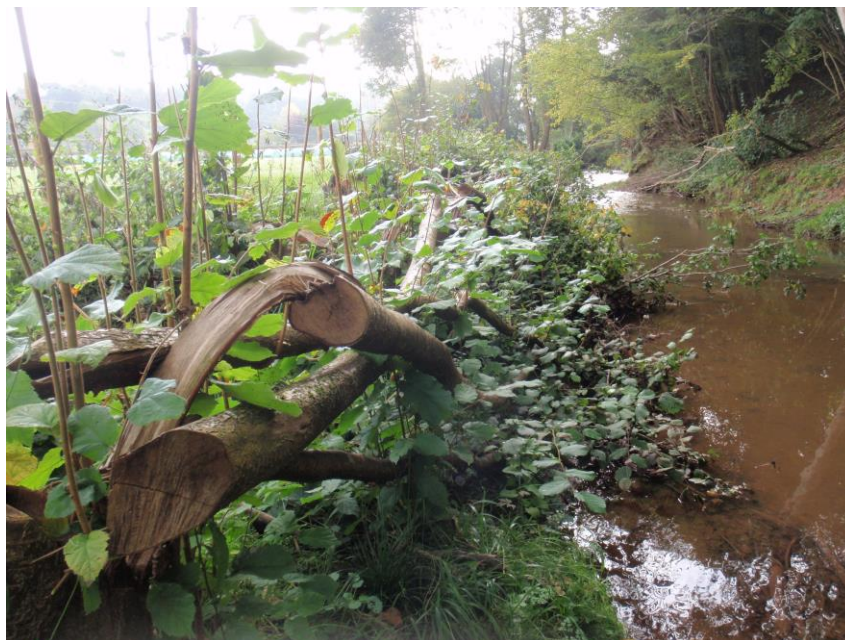
Figure 17: Hinging or laying of saplings to create marginal cover (in this case using hazel – but many suitable species exist)

- Planted trees (or whips) of suitable sizes could also be selectively hinged (or “laid”) into the margins of the beck to provide shelter from predation

and spate flows for juvenile fish (Fig. 17). Some localised bed-scour can also be encouraged by material laid into the margins in this manner.
