**HABITAT ADVISORY VISIT TO THE RIVER
CLUN, SHROPSHIRE
UNDERTAKEN BY VAUGHAN LEWIS,
WINDRUSH AEC LTD ON BEHALF OF
MR CHRIS COOKE**

DECEMBER 2007

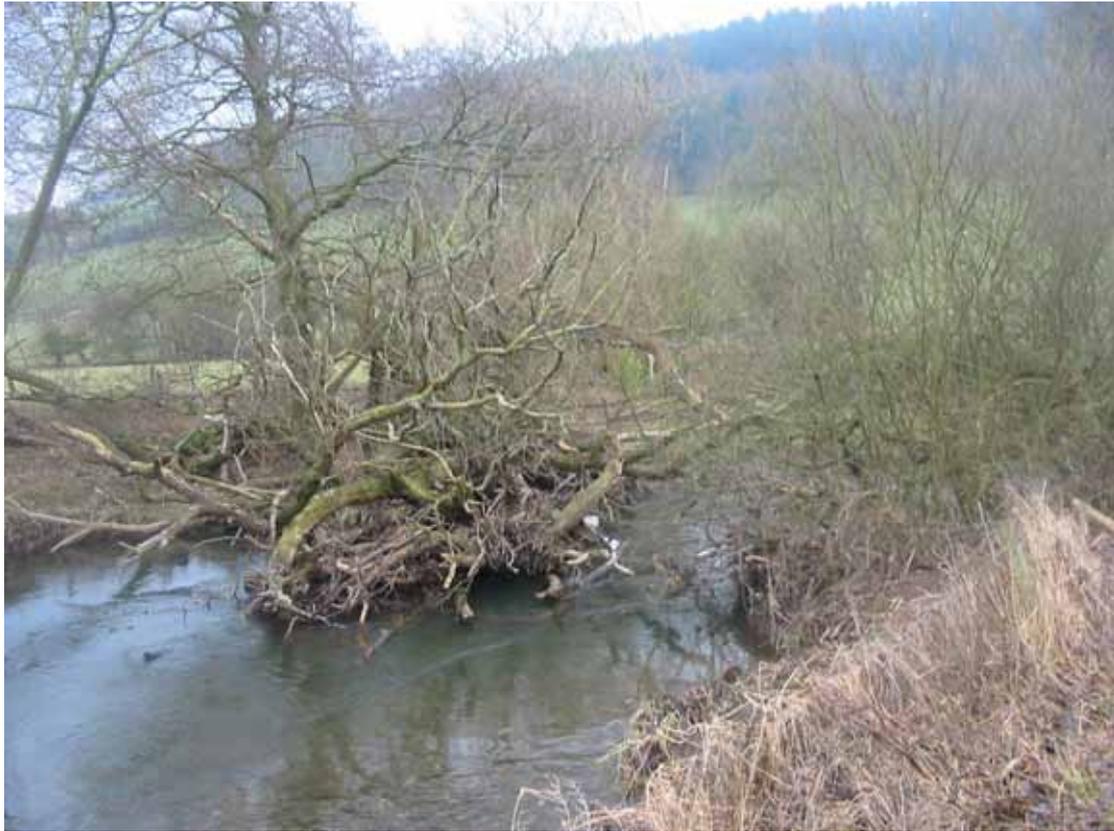
Throughout the fishery, the banks of the river were fringed with deciduous trees, mainly alder *Alnus glutinosa*, ash *Fraxinus excelsior* and sycamore *Acer pseudoplatanus*. The extensive tree root system of these trees provided ample cover for larger juveniles and adult fish, whilst there was an abundance of Large Woody Debris (LWD) in the channel arising from these trees. In places, accumulated LWD had formed extensive dams, with the stream morphology significantly changed downstream as a result.

Typical LWD dam

- The Clun was characterised by a very large volume of LWD over much of its length. Indeed, it had probably the biggest accumulations of LWD in any stream I have recently visited. Generally, the LWD was of great benefit to the river channel, helping to form a diverse instream habitat, scouring the bed, sorting the substrate (there were some excellent examples of clean, recently scoured spawning gravel piles) and providing ample cover for a range of species. Its beneficial impact would be even greater if the banks were fenced, reducing the overall rate of erosion (see below). There should be a presumption in favour of retaining the LWD, removing it only when there is unacceptable erosion to the banks or where it is clear that it poses a significant flood risk.

Current Environment Agency policy nationally is to encourage LWD in headwater streams with an associated low flood risk, in order to slow discharge rate through a reach and encourage out of banks flow during high water events. This provides a degree of attenuation helping to reduce flood risk in more populated downstream reaches. Consultation with the local Environment Agency Flood Risk Management Team would be of benefit in order to establish a management protocol for the fishery with respect to LWD.

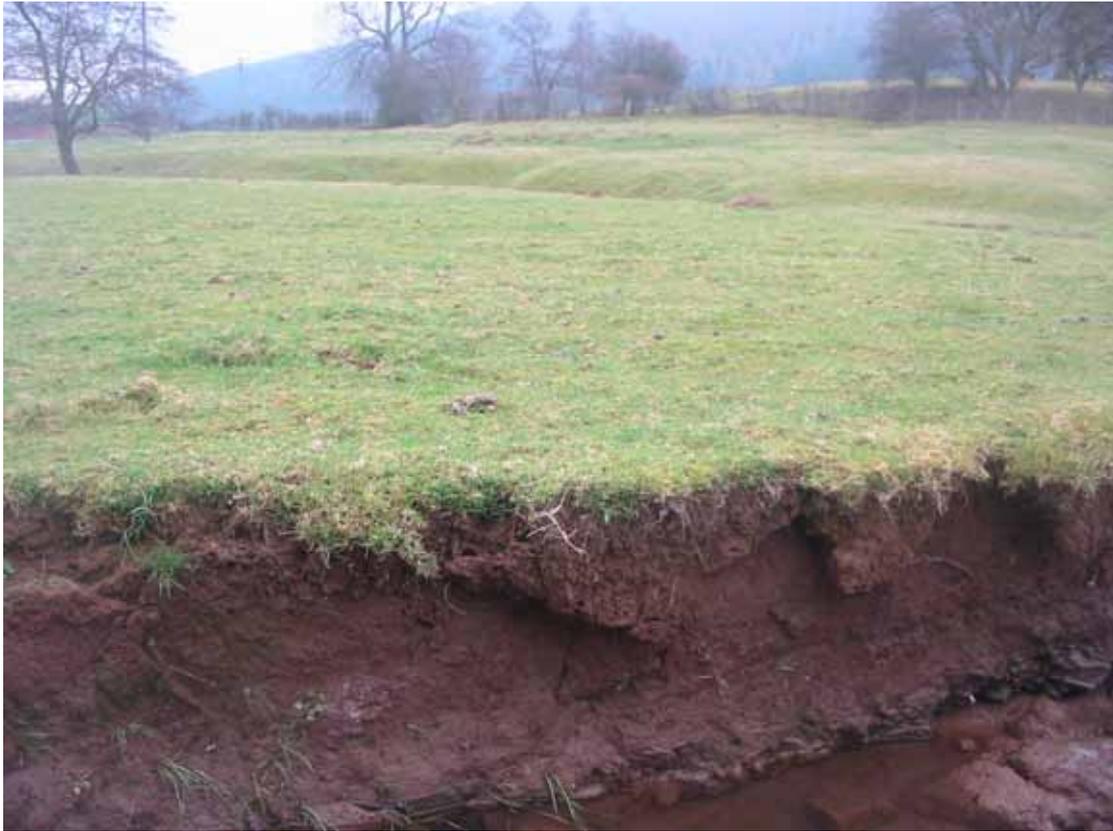
The soft, friable sandstone banks were very vulnerable to erosion. This process was exacerbated by overgrazing by agricultural stock. In places, the bank was almost devoid of vegetation cover, with extensive areas of bare bank. In areas where the bank profile was steep, this had resulted in block failure and the rapid loss of significant amounts of grazing land.

Overgrazed and badly eroded bank

- The most significant issue with respect to this reach of the River Clun was the excessive erosion caused by grazing agricultural stock. The banks were very badly

affected in some locations, with large block failures of bank and destabilising erosion around the base of riparian trees the typical outcome. If the fishery is to be improved, then it is imperative that this issue is addressed. Ideally, a wide ungrazed buffer strip of at least 10m would be created by the erection of permanent or temporary fencing, during periods of grazing. The wide buffer strip is important not only to create a zone of coarse grasses that are effective in capturing sediment and water from overland run-off, but also to allow the development of a strong root zone over time. Without this, erosion will continue at an unacceptable pace, necessitating the continual relocation of any fencing erected. Much of the RB is understood to be in an extant Environmentally Sensitive Area scheme making it possible to obtain partial funding for provision of suitable fencing under a revised conservation plan.

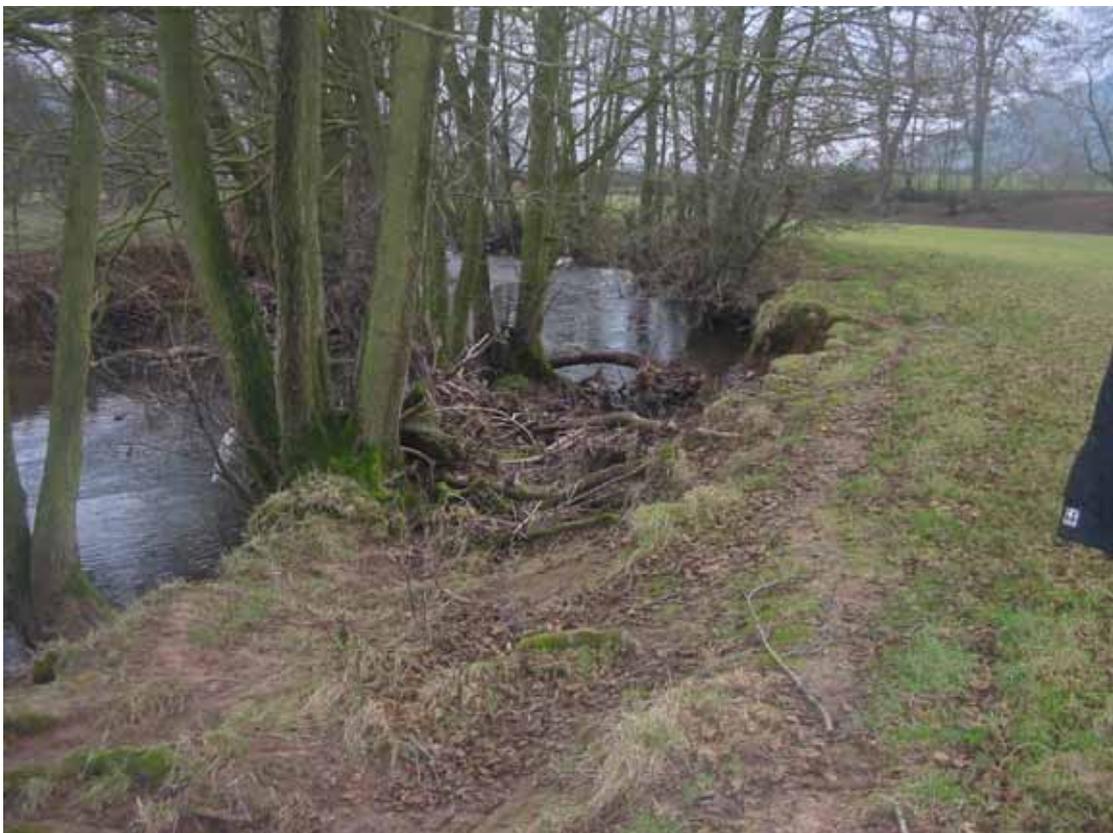
Where the profile was more shallow, constant grazing and trampling, particularly by sheep, had resulted in linear erosion pathways to the rear of riparian trees. Over time, this erosion pattern resulted in the weakening of root holdfasts, with the trees eventually toppling into the river adding to the LWD. Where permanent barbed wire fencing or temporary electric fencing had been erected, the overgrazing was less apparent and the rate of erosion significantly reduced.

Soil around bankside alder trees badly eroded by sheep grazing
