Advisory Visit

River Clun

Pheasant Tail Fly Fishers

23rd October 2008

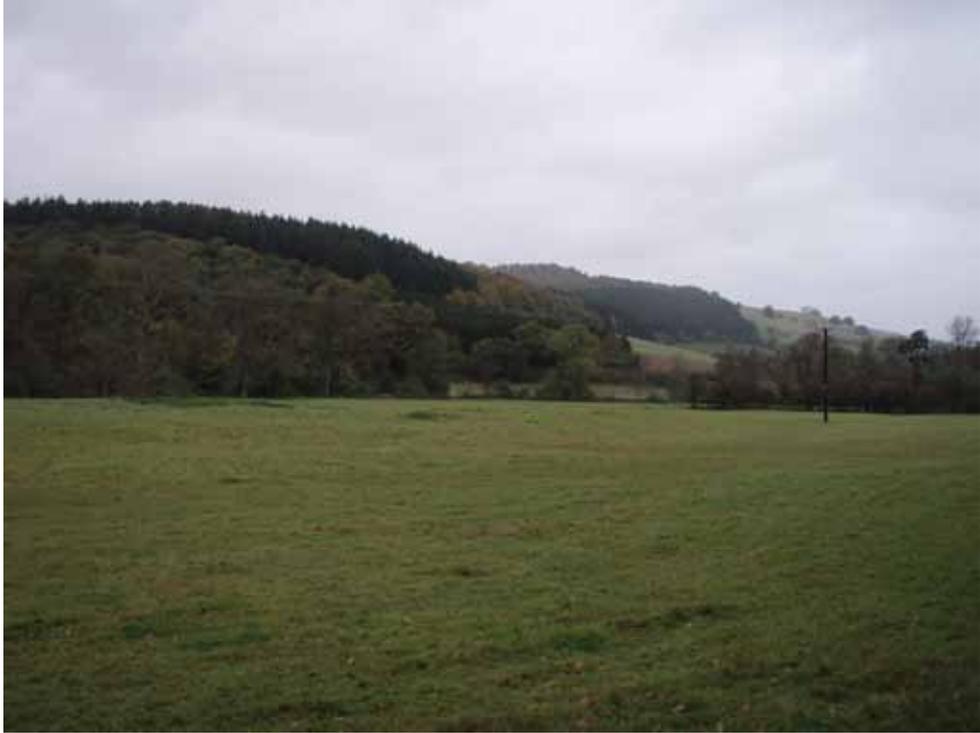
Progressing upstream from the bridge on the right bank, the river has a meandering planform, a relatively steep gradient and a well-developed pool and riffle structure: a great 'baseline' habitat structure for a trout and grayling river. Surrounding land use is mixed farming with livestock in the fields close to the river; there is also some forestry on surrounding hills (Photo 1). The sandstone geology of the catchment means the banks are friable and prone to erosion. In some areas there have been attempts to reinforce the outside of bends with waste concrete and such like.

Photo 1 Land use at Beambridge

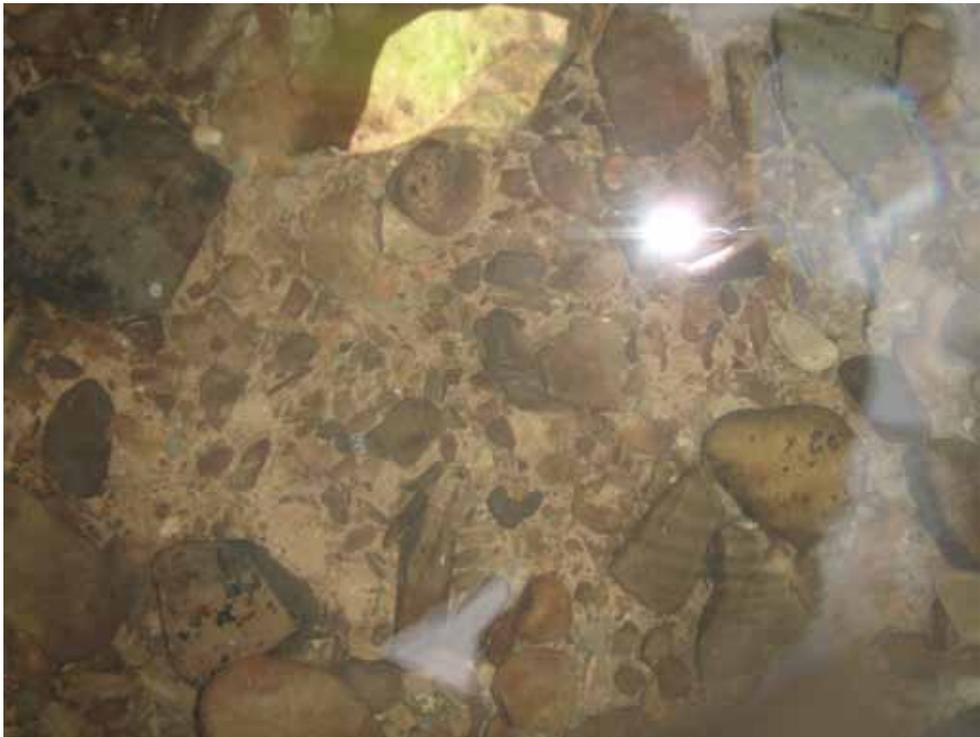
The river has a gravel/cobble substrate which is generally loose and un-embedded (good for spawning fish), but there was a moderate level of fine

Photo 2 A shallow scrape on a typical riffle area shows the fine sediments entrained in the interstices of the gravel just beneath the surface.

sediment entrained within the gravel, which does not favour egg survival (Photo 2).

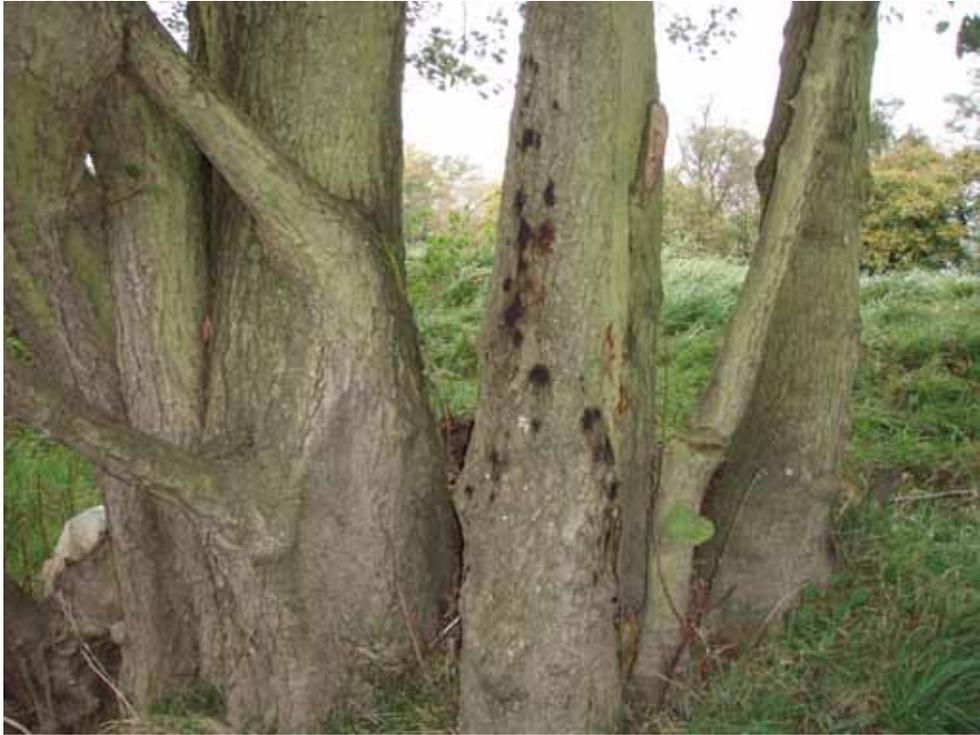
Photo 3 Tarry spots on alder trunks – a symptom of *Phytophthora* disease

The banks of the river are fringed with deciduous trees, mostly alder *Alnus glutinosa*. Many of the alders are suffering from the fungal disease *Phytophthora* (Photo 3) and are in various stages of degeneration, from lightly affected through to dead. On the lower section of this reach in particular, trees have died and been washed out leading to the exposure and rapid erosion of the friable banks (Photo 4).

· The main issue facing these sections of the Clun is the loss of trees and the destabilising effect this has on the river banks. Contributory factors to tree loss include alder disease and erosion of banks which have been overgrazed. These factors have been tackled in some areas by coppicing or singling of alders and fencing out livestock. It is recommended that this is continued and extended, and previously treated areas are re-visited and re-assessed.

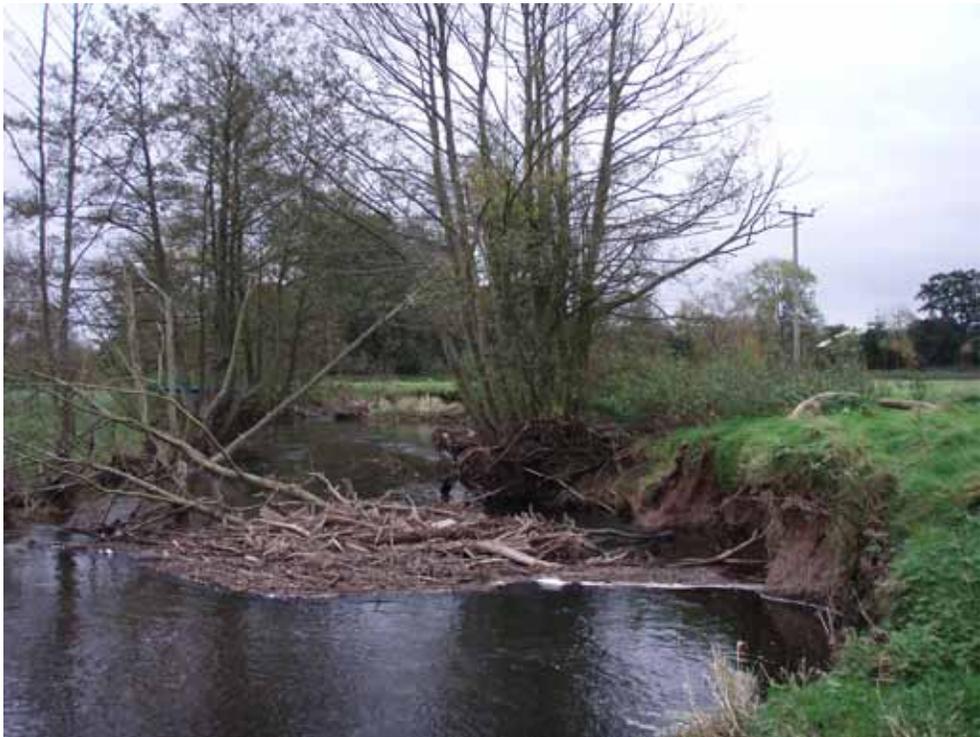
Photo 4 Dead and dying alders being washed out and leaving banks exposed to erosion

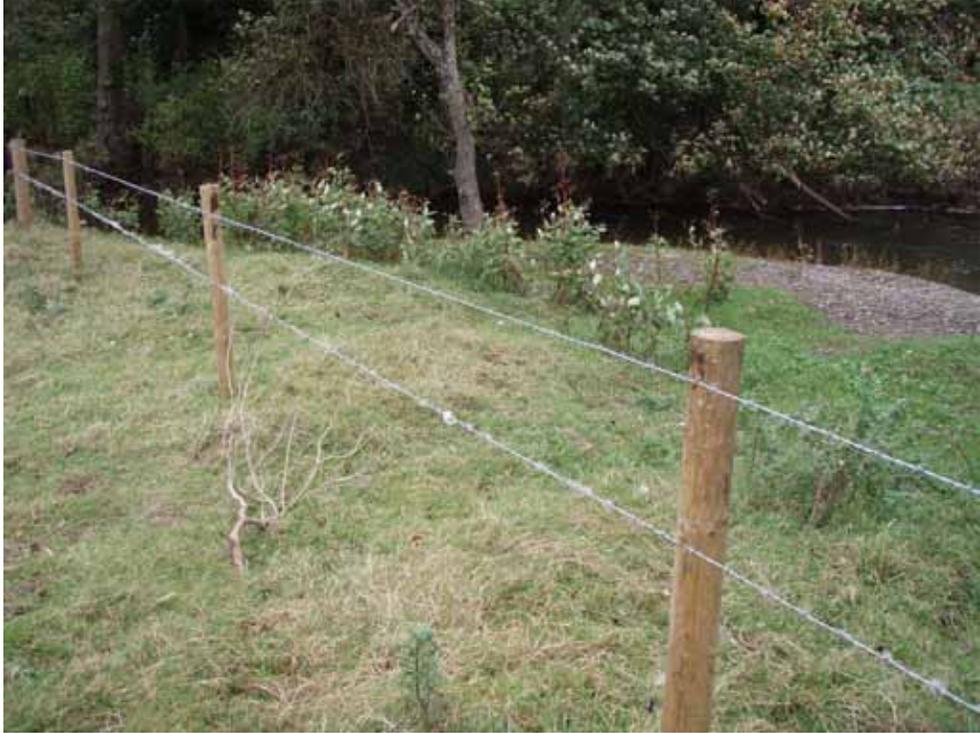
The level of the barbed wire is set high and allows sheep to get underneath and graze the banks. This may be beneficial in assisting the control of Himalayan Balsam, but is restricting the re-growth of the coppiced alder stools in many cases (Photos 5 and 6). Livestock watering points have been constructed, although one of these was incomplete and allowed livestock access to the river side of the fence (Photos 7 and 8). The upper section of the fishery appeared to have less grazing pressure and there were some good river margins developing here (Photo 9).

Photo 5 Barbed wire fencing is allowing sheep underneath to graze the bank – helping to control balsam growth, but...

Limited grazing access appears to be controlling balsam in some sections of the fishery. This could be continued, but needs to be carefully controlled and balanced with preventing overgrazing of desirable species, damage to coppice re-growth or damage to river banks. Access in late spring or early summer before the balsam has flowered would be ideal. In areas inaccessible to livestock, physical or chemical control is recommended.

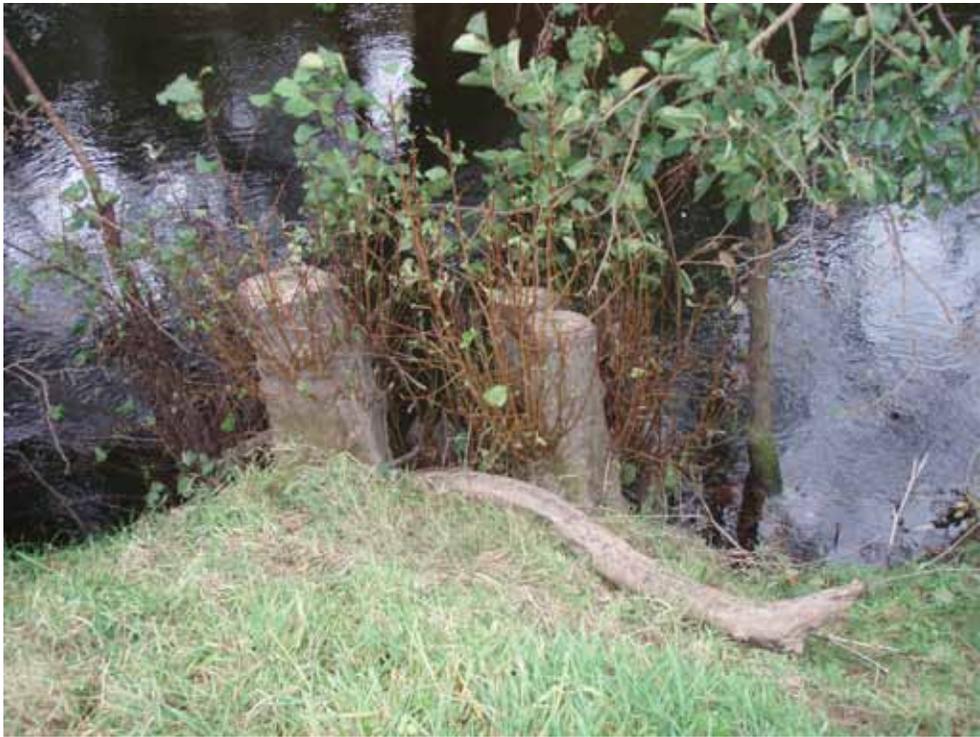
Photo 6 ...affecting the re-growth of coppiced alder.

- The impact of grazing livestock upon the river banks should be reduced. Ideally this should be achieved by reduced stocking levels arising from Single Farm Payments and incentives to farm in a more environmentally sensitive way. Where this is unlikely to be achieved it is recommended that the fencing already present on some sections of the river is extended to limit livestock access and create buffer zones alongside the river; this is essential following coppicing or tree planting.

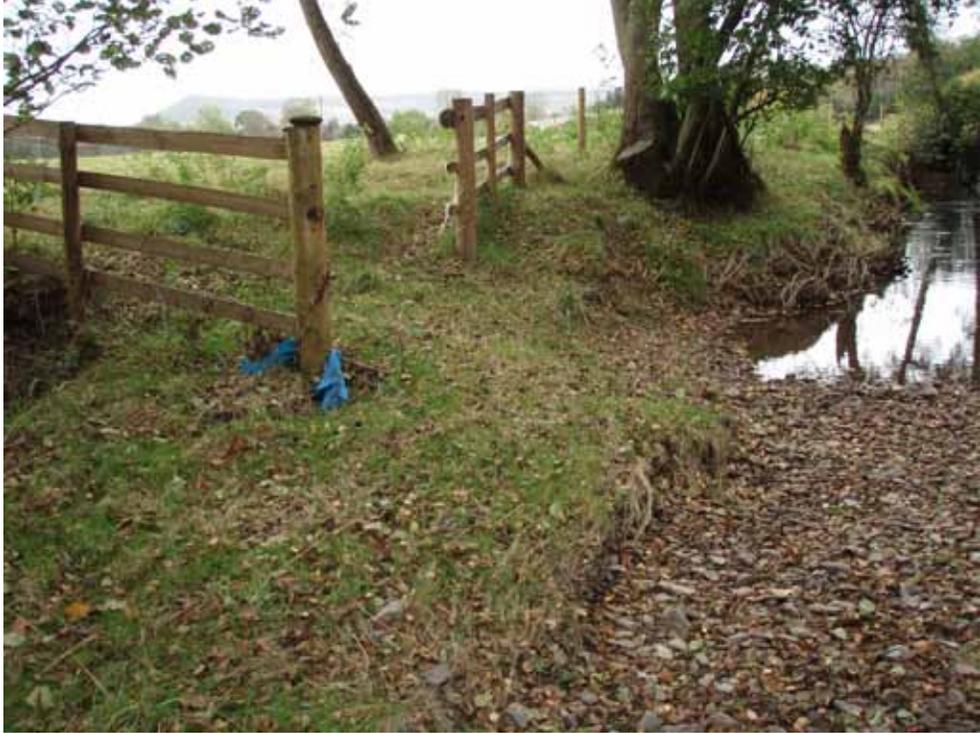
Photo 7 Gap in the fence (drinking point?) which allows livestock behind the fenced area

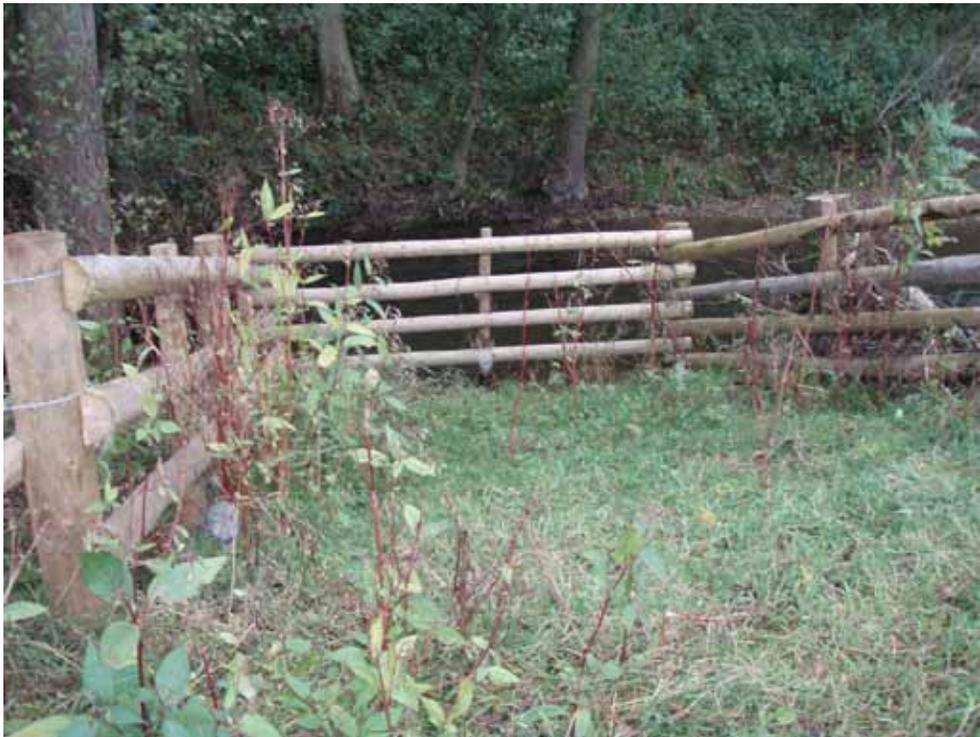
Photo 8 Fenced livestock watering point

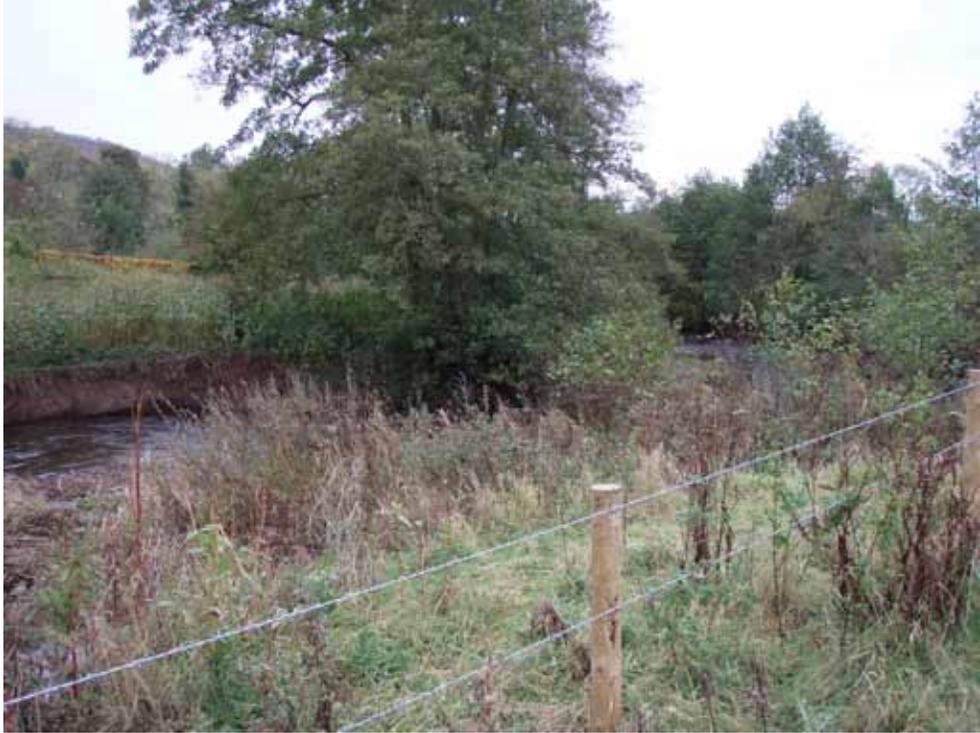
Photo 9 Ungrazed river margin with developing tall vegetation and young trees

Tree planting or the promotion of natural re-colonisation should be encouraged to re-establish a fringe of marginal trees, and provide a succession to those being lost. Critical to the success of this is protection of an un-grazed marginal buffer, ideally at least 10 m wide; Photos 9 and 13 show the type of situation that should be aimed for. Any tree planting should be carried out with native species of local provenance such as oak, ash or willow. Alder should be avoided because of the disease situation.

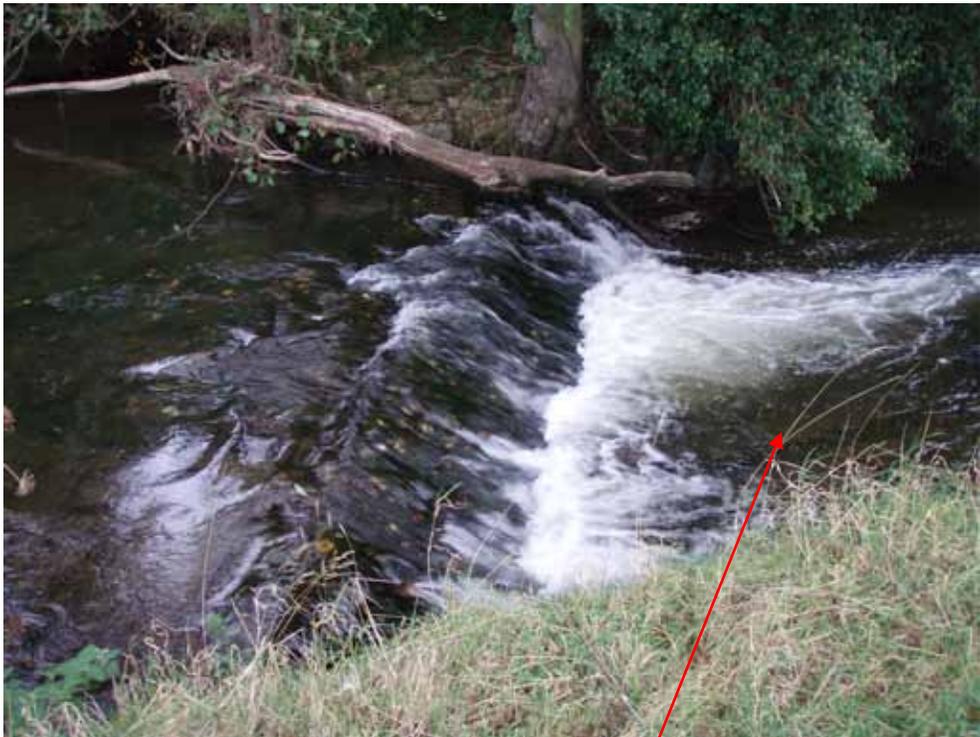
The weir had a head difference of approximately 0.75 m on the day of the visit, and had a cobble base at its toe to prevent bed scour (Photo 10). The weir would be passable in an upstream direction by larger trout (e.g. of spawning size), but it would be more difficult for grayling. The head provided by the weir supplies a mill leat, which also receives the flow of a tributary, the River Kemp.

Photo 10 Weir, with cobble toe

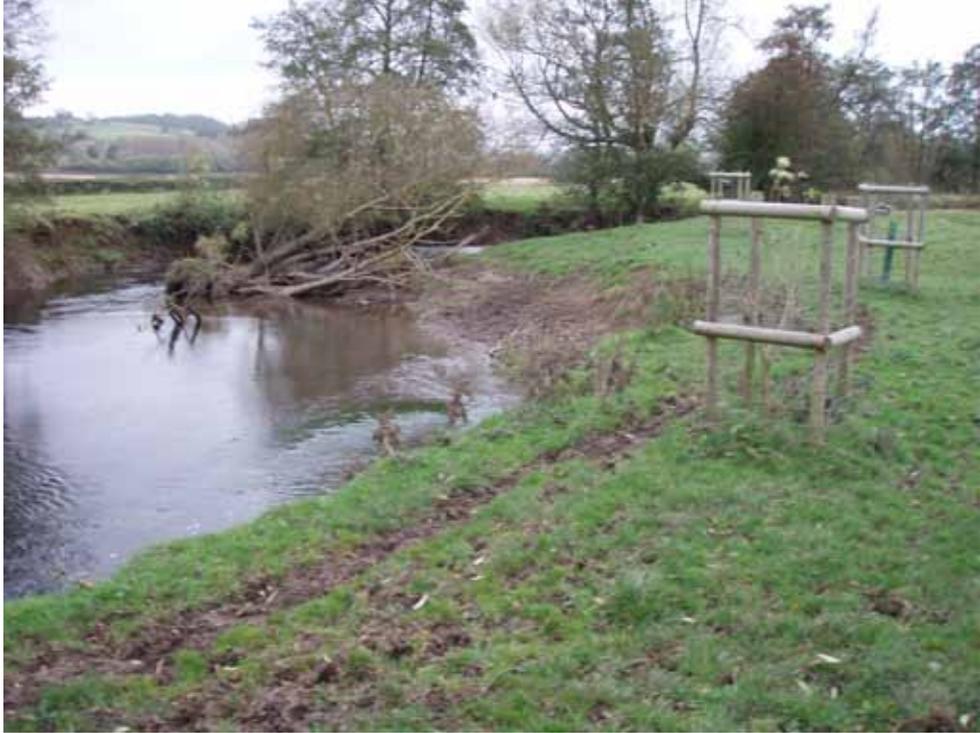
There is less of a pool-riffle sequence here and more of a steady glide; this contrasts with the upstream section which has some nice habitat features (vegetated side bars, pool-riffle sequence). There are some good examples of LWD in the river channel. Some limited tree planting has taken place (Photo 11). Some alders have been coppiced (underneath power lines crossing the river), but grazing is restricting the re-growth (Photo 12).

Photo 11 Tree planting, but enough to replace those being lost?

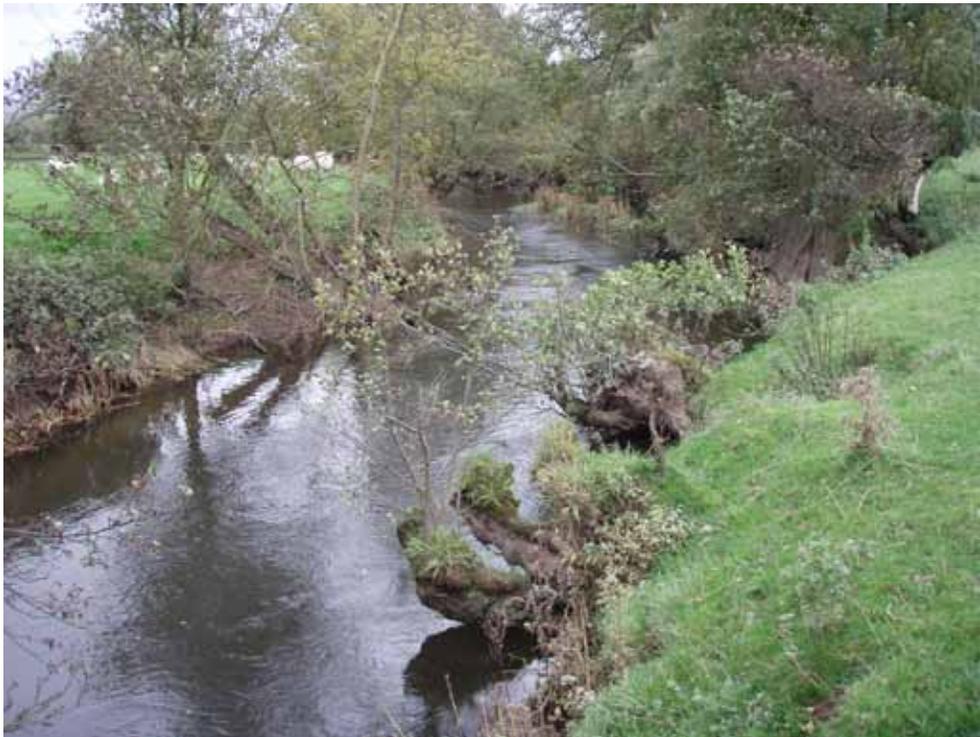
Photo 12 Coppiced alders (underneath power lines); re-growth is restricted by grazing.

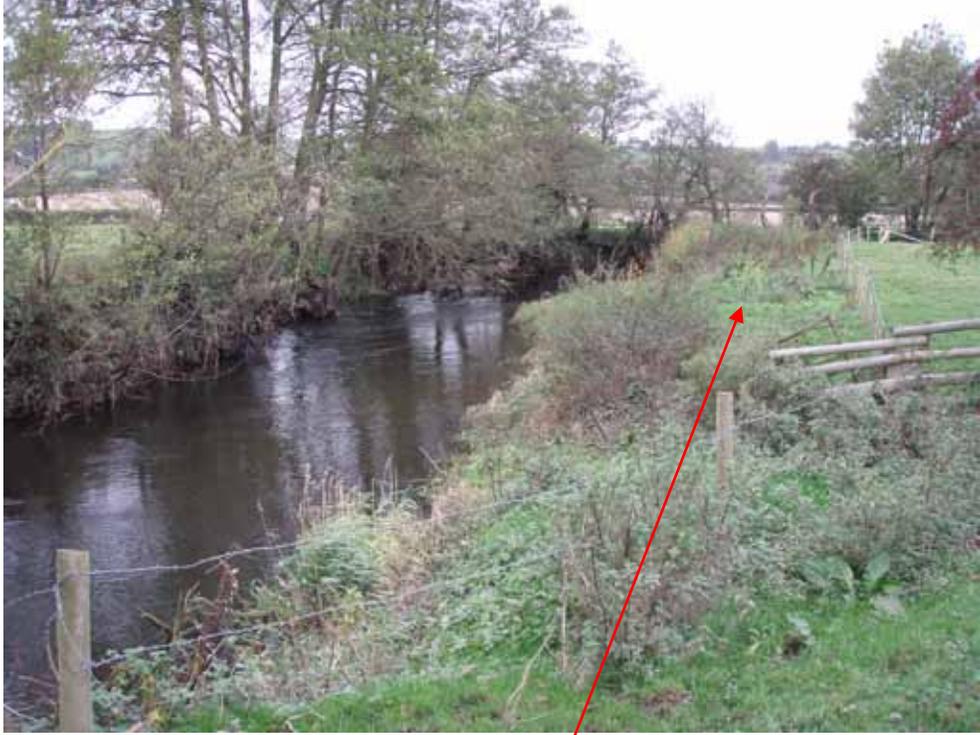
Behind the fence there are some nice areas of marginal vegetation developing (Photo 13), but in other areas livestock have access under the fence and grazing pressure alongside the river continues (Photos 14 and 15). Some coppicing of trees has taken place.

Photo 13 A good width of fenced river margin with tall vegetation developing in the absence of grazing.

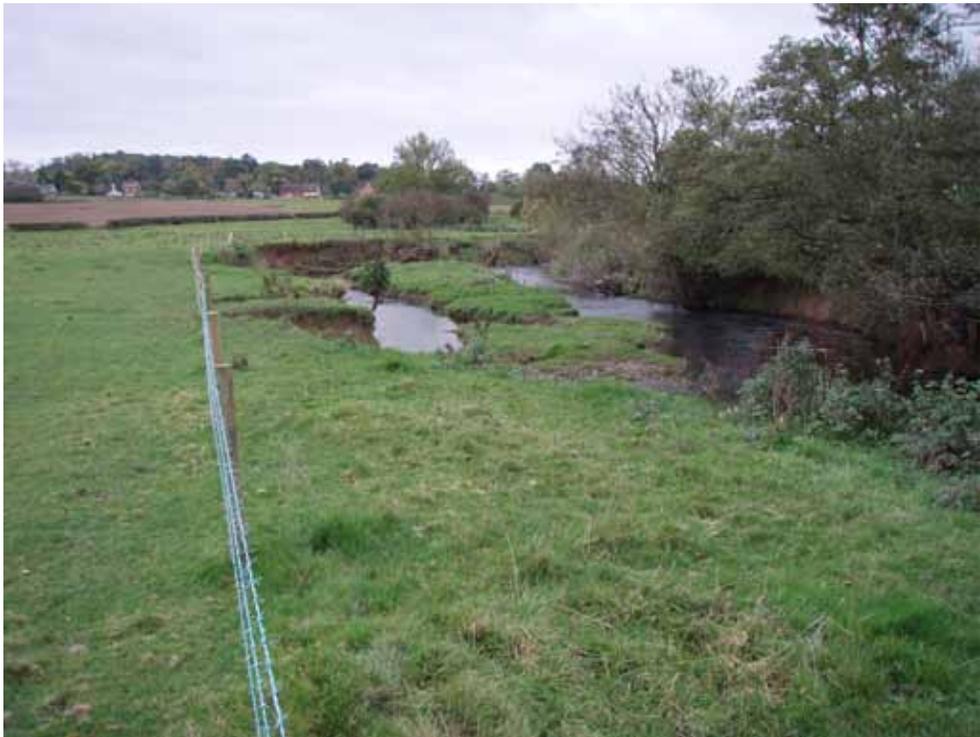
Photo 14 In contrast to Photo 13, the fence is having little effect because livestock can get through it.

1. Just upstream of the midstream island (Photo 14) there is a fallen tree in the river which could be diverting the river down the LH channel, particularly at higher flows (Photo 19), and contributing to the erosion on the LHB bank back towards the new fenceline. This tree could be repositioned to divert flows down the RH channel away from the fence.

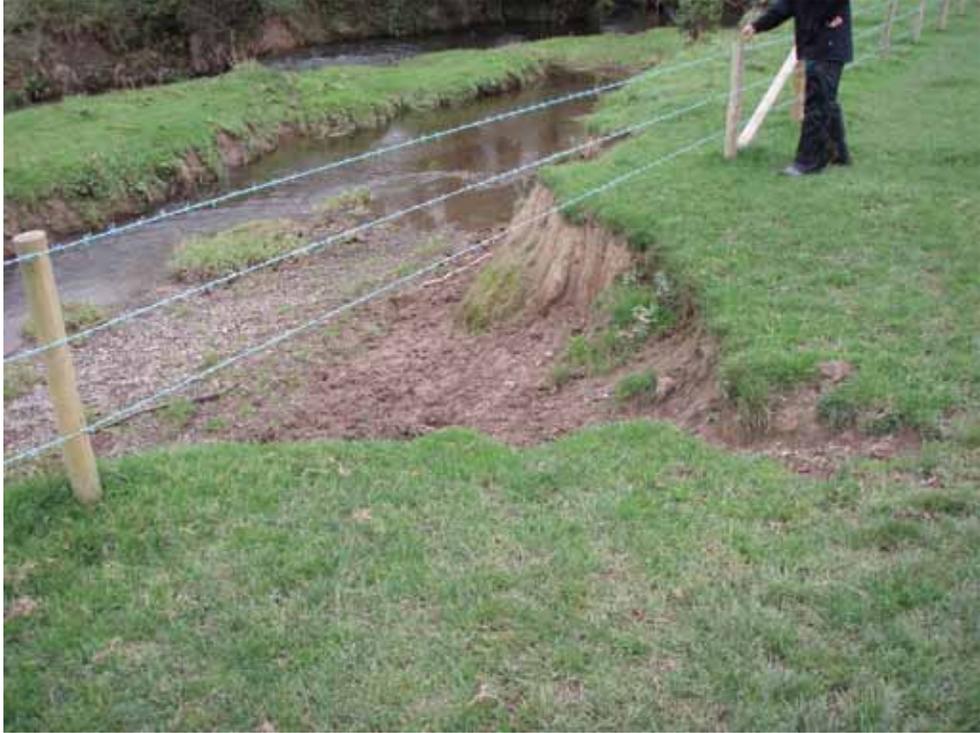
Photo 15 Route under the fence for livestock.

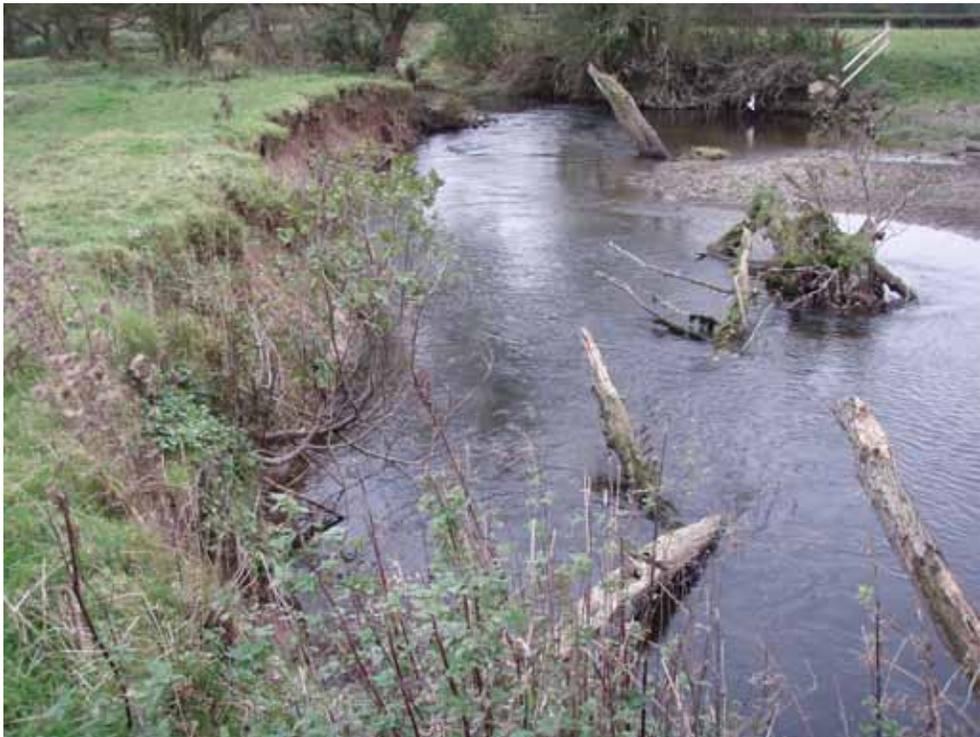
There are some areas of heavy erosion of the soft, friable banks on this section. This process is exacerbated by overgrazing by agricultural stock. In unfenced (or older, inadequately fenced) sections, the bank had poor vegetation cover, with extensive areas of bare bank. In areas where the bank profile was steep, this has resulted in block failure and the rapid loss of significant amounts of grazing land (Photo 16). Where the profile is shallower, constant grazing and trampling, has created areas of poaching and sources of fine sediment input to the river (Photo 17).

Photo 16 Rapid erosion of steep banks (LHB).

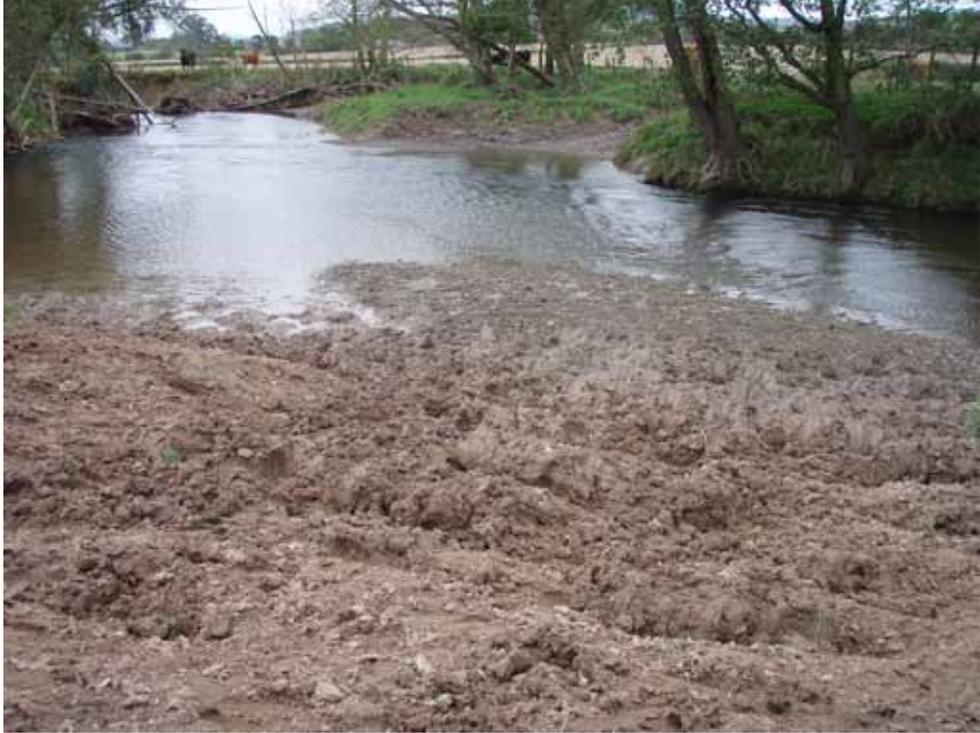
Photo 17 Cattle access on shallow banks causing trampling and ingress of fine sediment

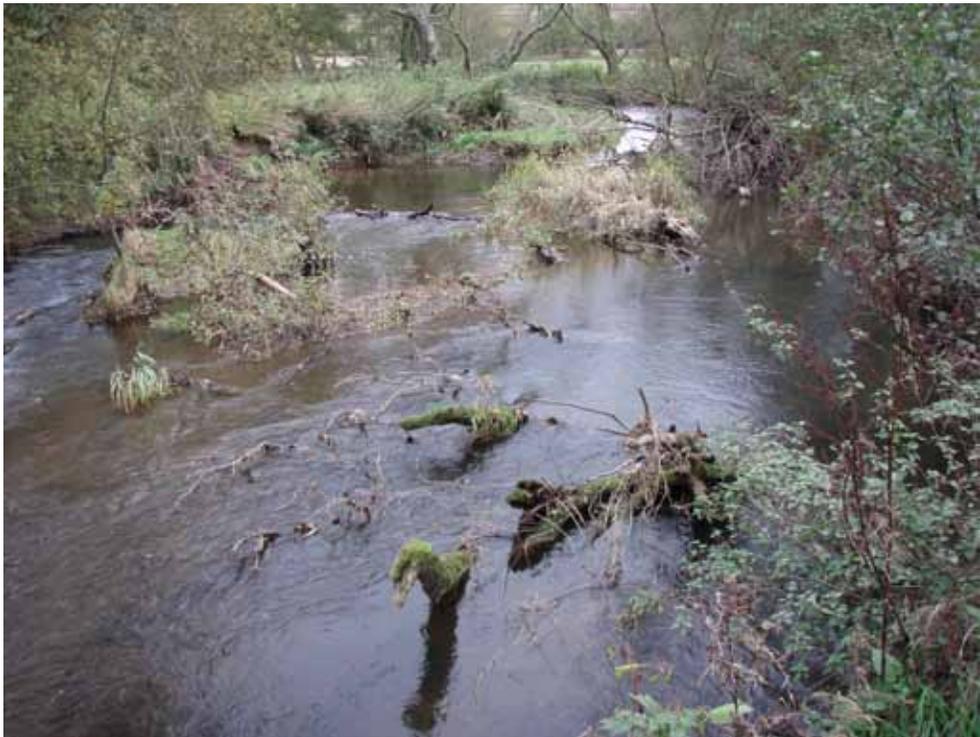
Photo 18 Large Woody Debris contributing to some excellent in-river habitat

There are some good examples of LWD in this section, providing the benefits described above (Photo 18). The LWD may also be providing an additional benefit as a refuge for fish from piscivorous birds – about 20 cormorants were observed flying along the river course during the visit.

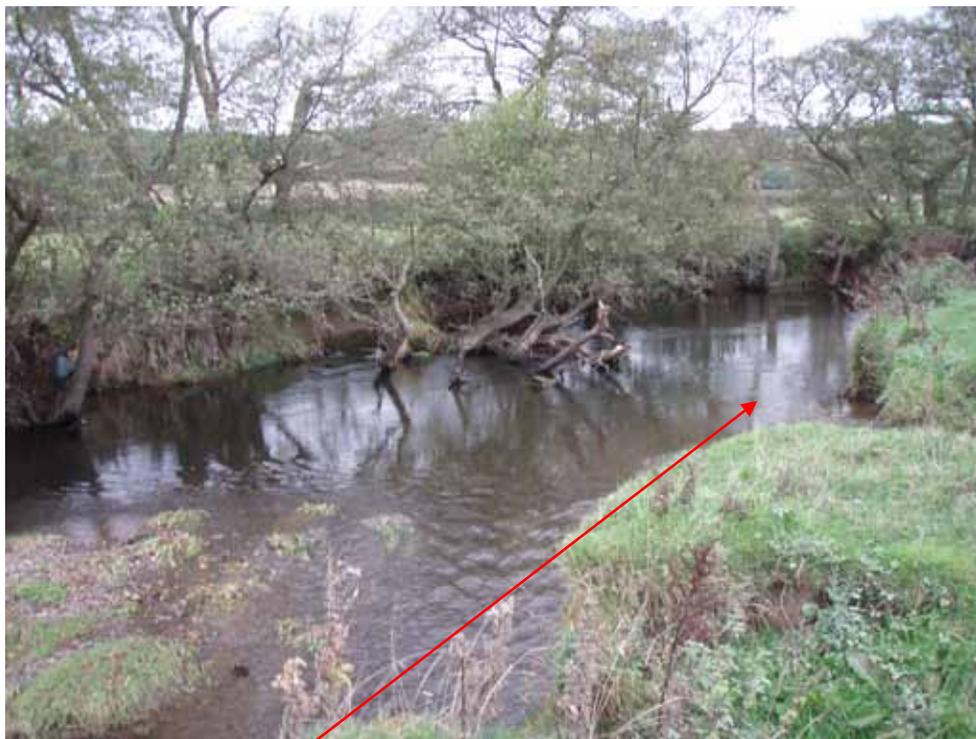
Photo 19 Repositioning this LWD to here could help divert flows away from the near bank where erosion is a problem.

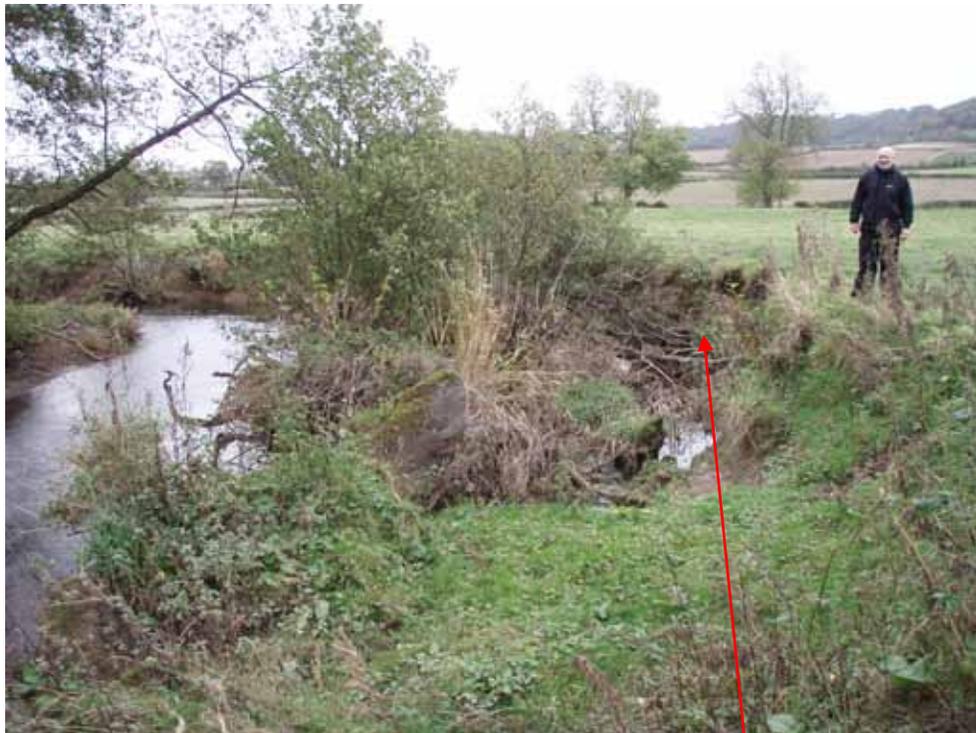
2. Photo 20 shows a fallen alder protecting the LHB on the outside of a bend. The tree is slowing the current and causing deposition and colonisation with vegetation behind it. This could be replicated on other bends. For example on the RHB, some alders have been coppiced on the outside of a bend (Photo 21). This is beneficial as it has taken the weight off root boles preventing them from being pulled out of the bank. However, the flow pattern is still likely to cause

Photo 20 LWD on the outside of a bend, protecting the previously actively eroding bank

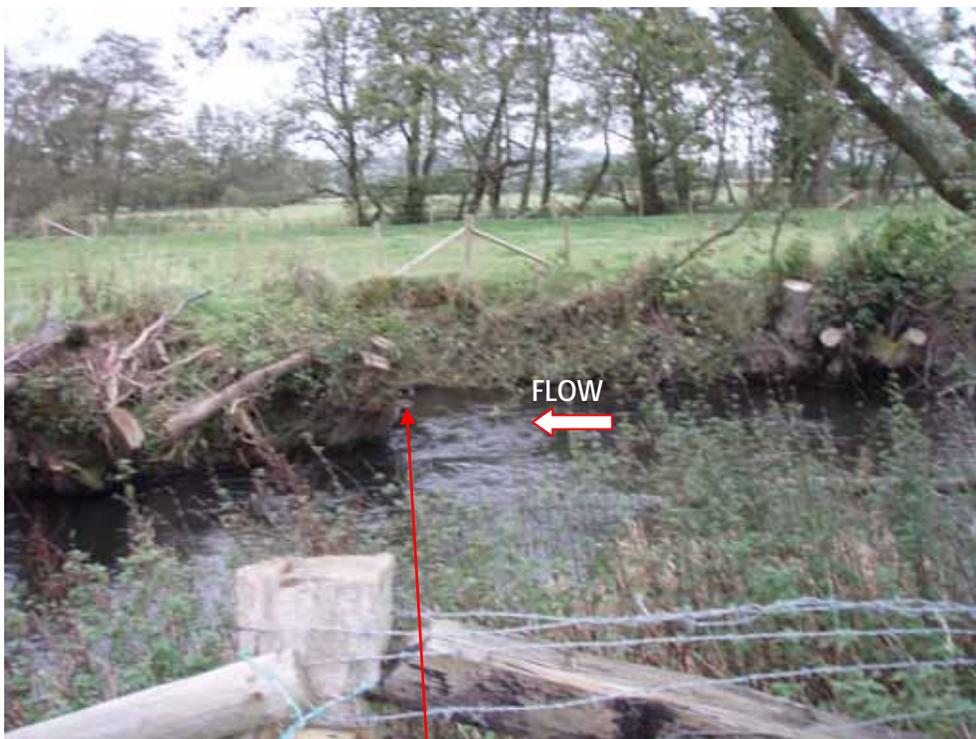
Photo 21 Coppiced alders on the RHB. This gap could be filled with a tree kicker.

erosion behind root boles; this could be prevented by filling the gap with LWD. A “tree kicker” could be used for this (Figure 1).

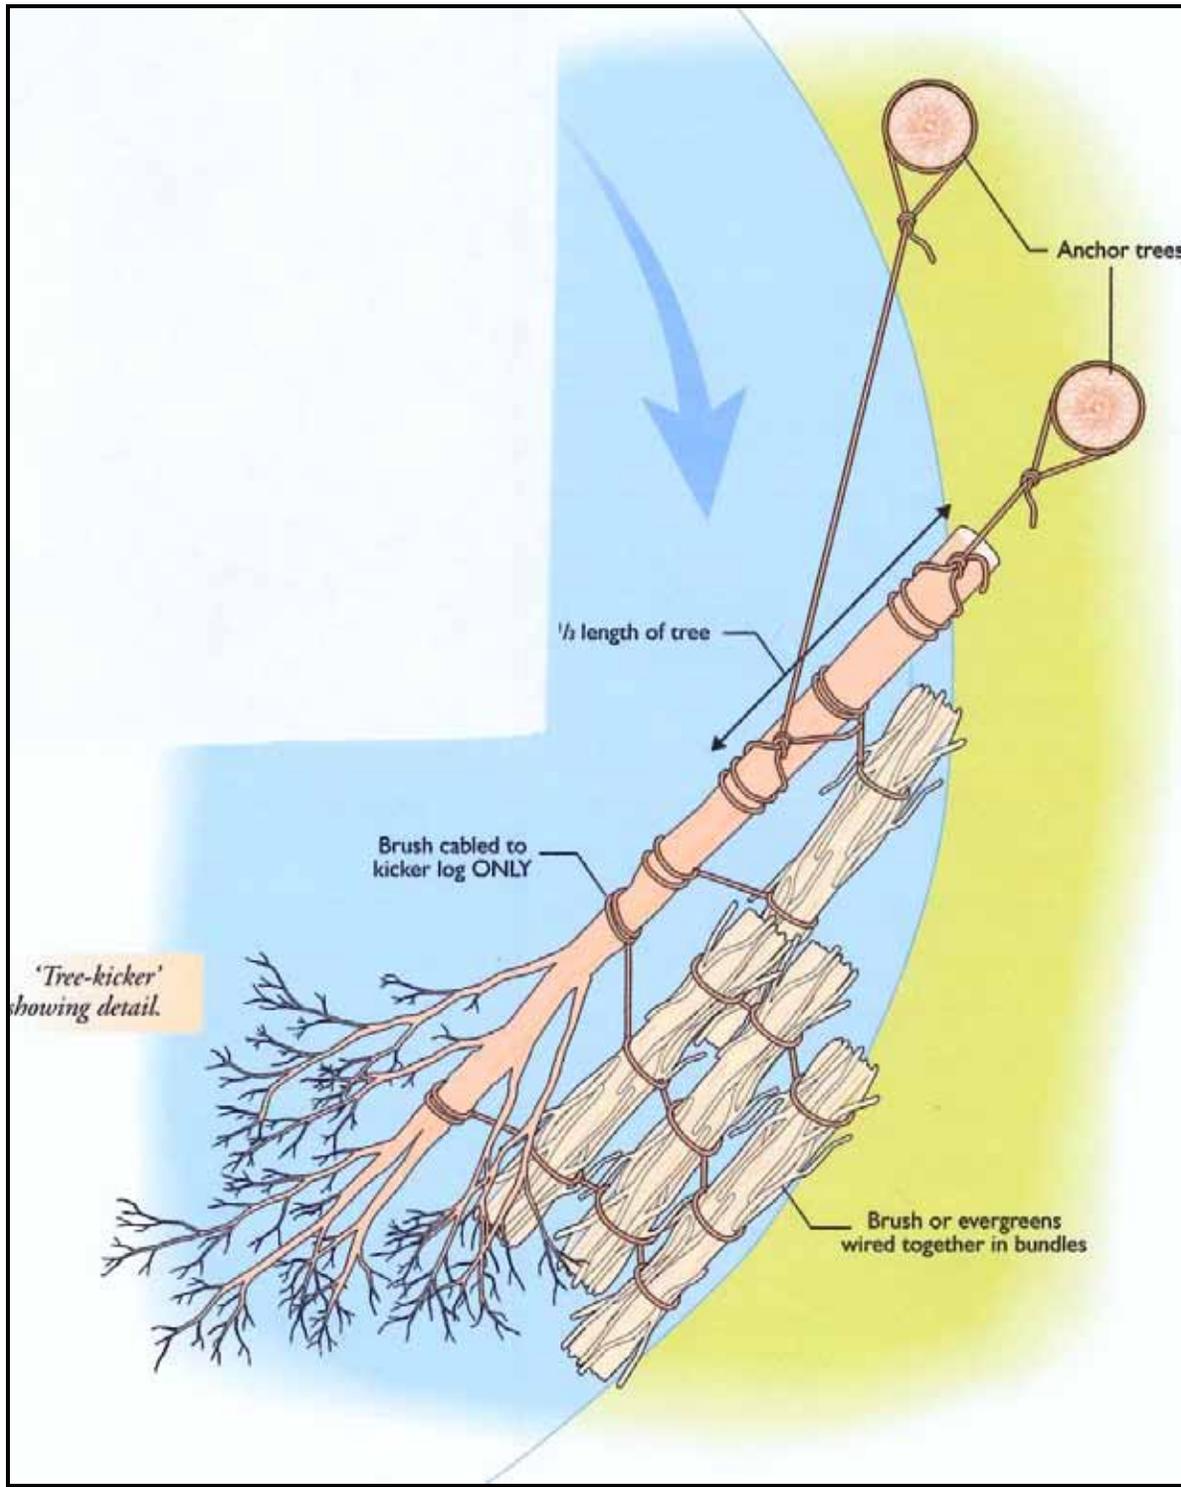
Figure 1 Example of 'tree kicker' erosion protection for high energy streams
