Advisory Visit

Afon Clwyd, North Wales

15th June, 2010

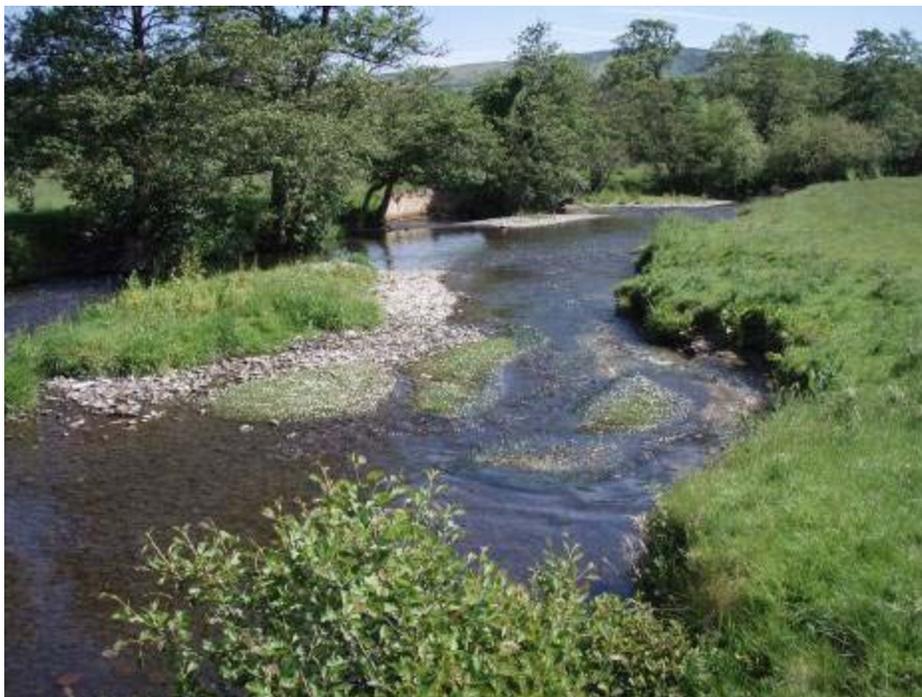
This was the first site visited during the day and we were joined here by landowner Kevin Lydon. The in-stream habitat along this part of the Clwyd is generally very good with a pool-riffle sequence, meandering planform, variety of depths, good marginal cover from trees and their root systems, and natural channel features such as point bars and gravel shoals (cover picture).

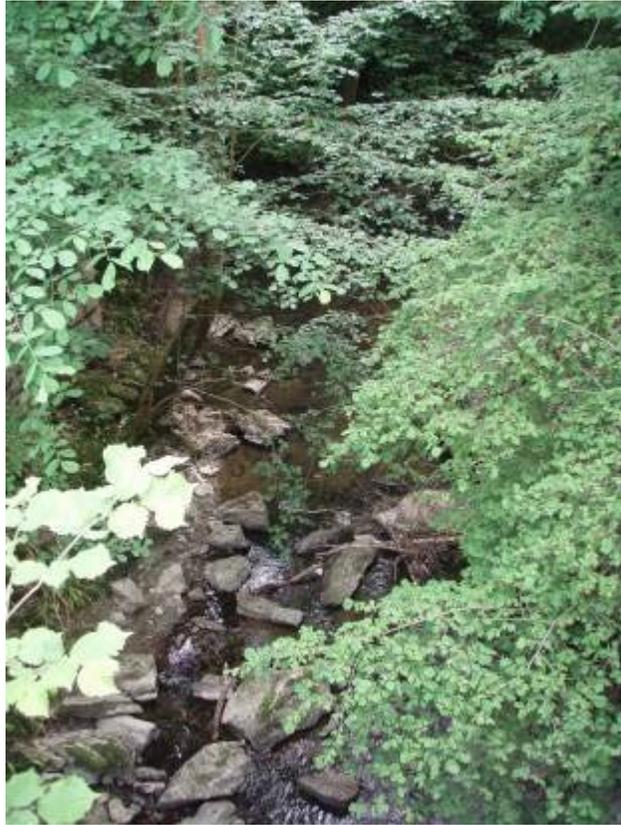
The river here is a relatively small upland river, located in a steep sided channel, with large boulders dominating the substrate in the channel. A tributary (Afon Hesbin) enters on the right bank just upstream of the bridge; it is understood that this tributary is ephemeral. There is an aquifer beneath the Vale of Clywd which is abstracted, and this may have an influence on instream flows.

The river here is heavily shaded by mature trees. It was discussed whether felling some of these to allow more light to reach the channel would be beneficial; in this location, there is probably little to be gained because the steep-sided channel will still limit light penetration. Mature trees also provide a valuable role in regulating water temperatures, keeping them within the limits tolerated by trout and salmon during low water and hot weather conditions.

Photo 1 The Clwyd near Llanfair Dyffryn Clwyd

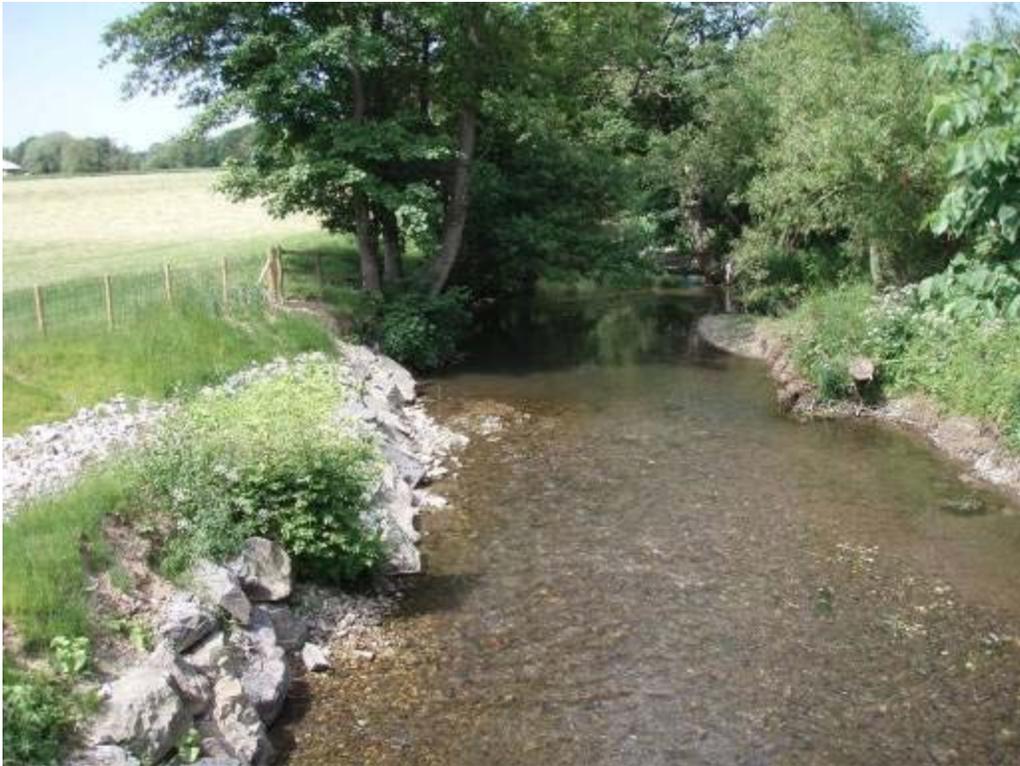
The river here was viewed from the recently re-constructed road bridge. In-stream habitat was good, with a well-developed pool and riffle structure and a good balance of light and shade from riparian trees. Riparian land use was grazing or grass production and there was a good example of well-managed field boundaries alongside the river; these were fenced leaving a wide margin between the river and cultivated land (Photos 2, 3).

Photo 2 A view downstream from the road bridge near Rhewl

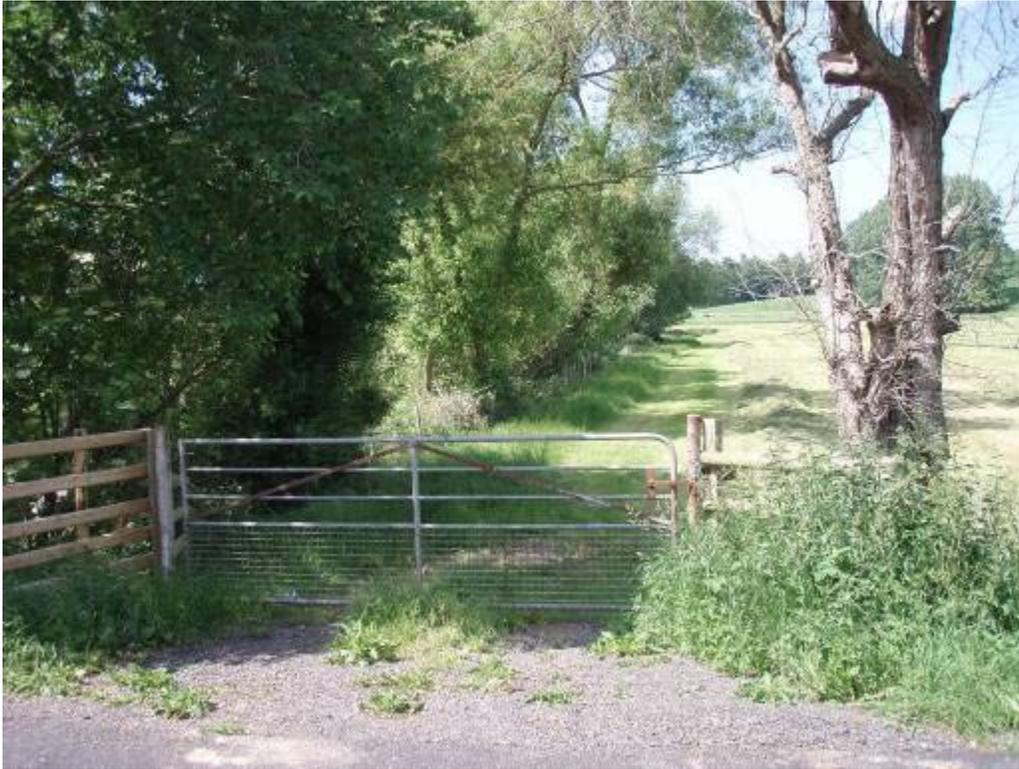
Photo 3 A well-managed river and field margin - Rhewl

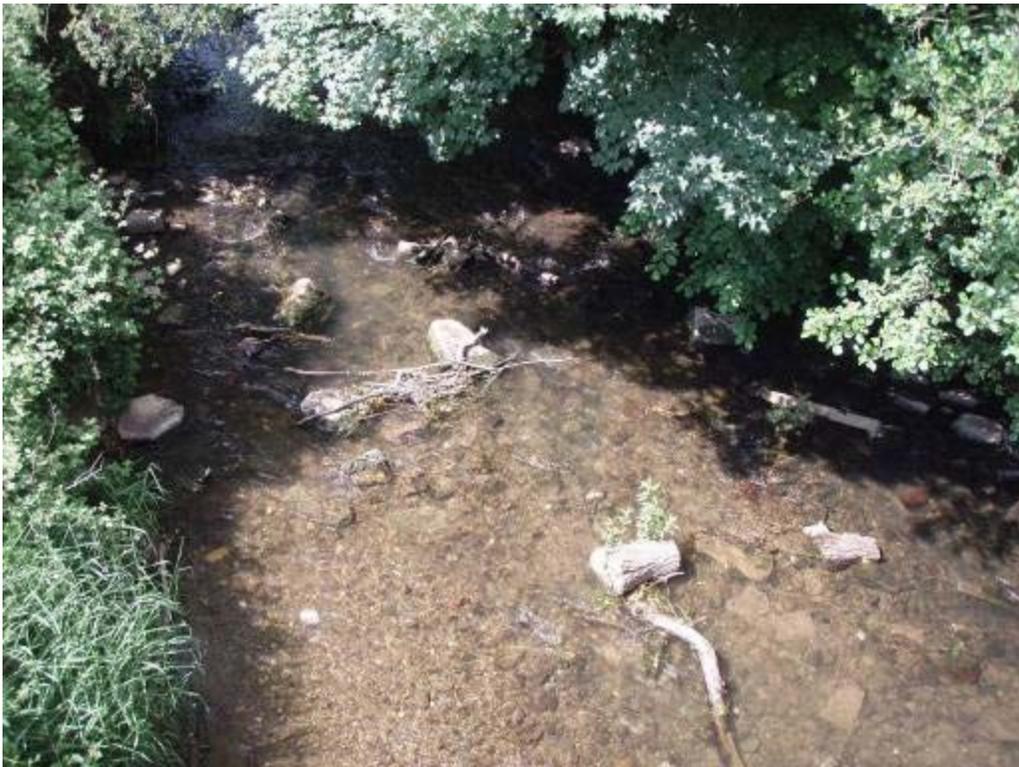
A groundwater abstraction point was located alongside the river on the left bank here; this water is discharged into the river for abstraction further downstream. The river here has good in-stream habitat (pool and riffle structure), and both banks are fenced. The fencing was apparently put in by the farmer in response to the loss of livestock which were perceived to have suffered from drinking contaminated river water.

The channel here is very heavily shaded with willow, sallow, alder and ash. This would benefit from some thinning to provide better angling access, and to open up the channel to more light. Sixty percent shade to 40% light is recommended as a guide. The material arising from this thinning could be used for work on other parts of the river.

Photo 4 Llanychan Bridge – just above the discharge of flow augmentation by groundwater

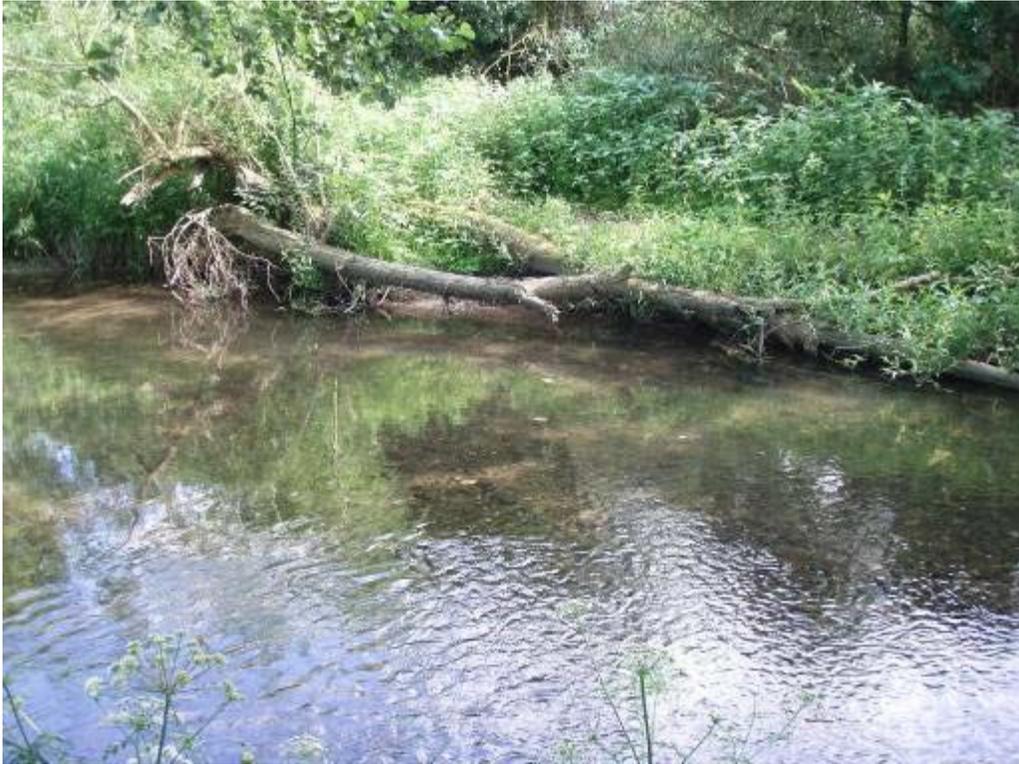
DCAC have carried out some work on the river here recently (upstream of the bridge), clearing out some fallen trees and branches from the river (Photo 5). The management of so-called large woody debris (LWD) is of crucial importance in stream supporting trout and salmon. LWD in rivers is often perceived as a nuisance, causing problems in terms of efficient drainage, flooding (e.g. blocking bridges), and hindering fish migration. However, LWD has been demonstrated to be very important for river ecology in a number of ways:

Photo 5 Large woody debris is an important part of the river's ecology. Retention within the channel is desirable.

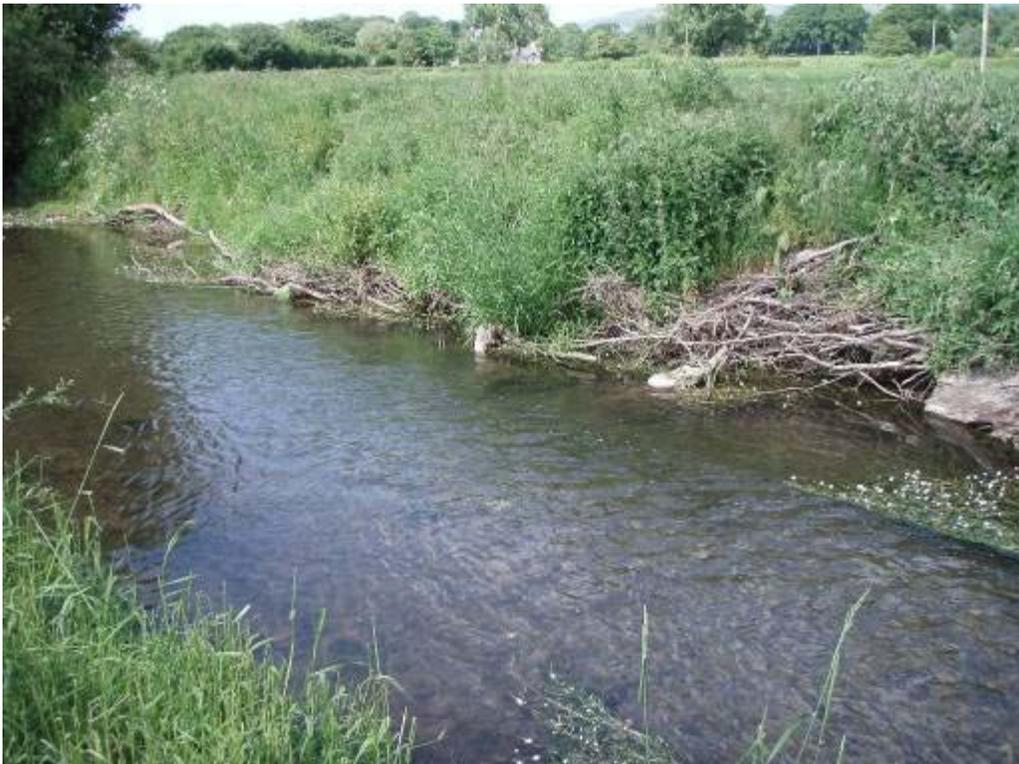
Further upstream from Perfa Bridge there was some good marginal cover on the right bank in the form of trees and bushes growing low over the water, and stable woody debris in the margins (Photos 6-8). Cover on the left bank was less prevalent because of grazing access, but some low bushes were present. The presence of cover overhanging the margins and within the channel is very important for the survival of juvenile stages of trout.

Photo 6 Coarse woody debris along the margins here provides excellent habitat for juvenile trout and salmon. This should be retained and could be replicated elsewhere by introducing brushwood bundles.

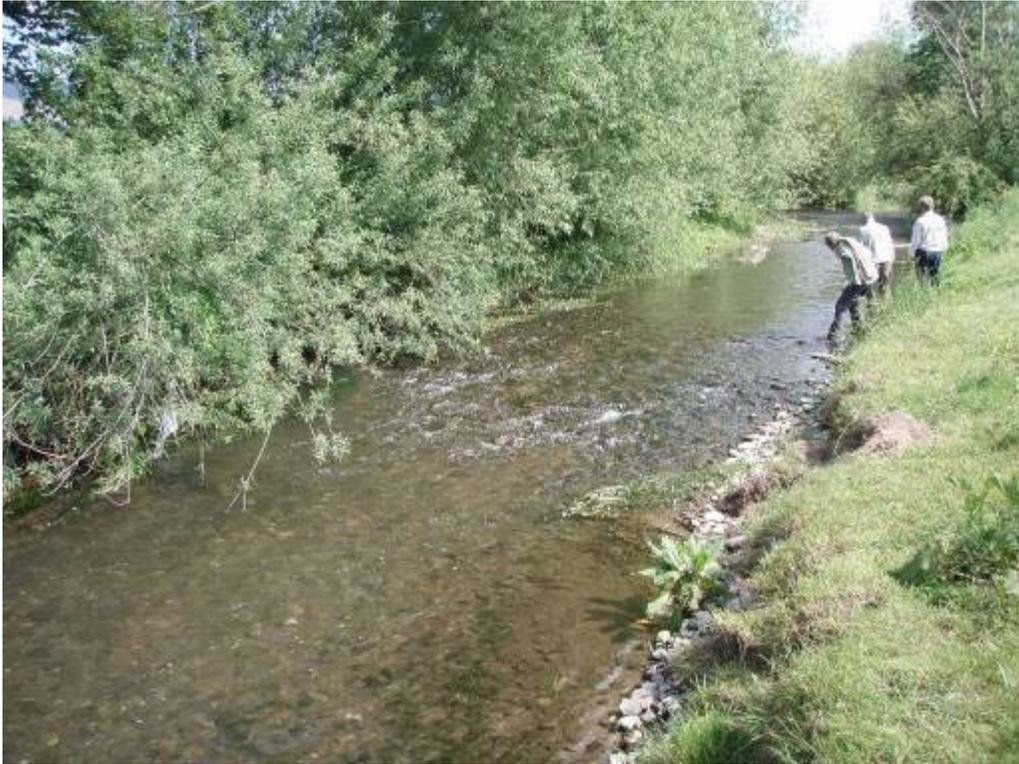
Photo 7 Good marginal cover on the far bank from overhanging willows and ungrazed vegetation.

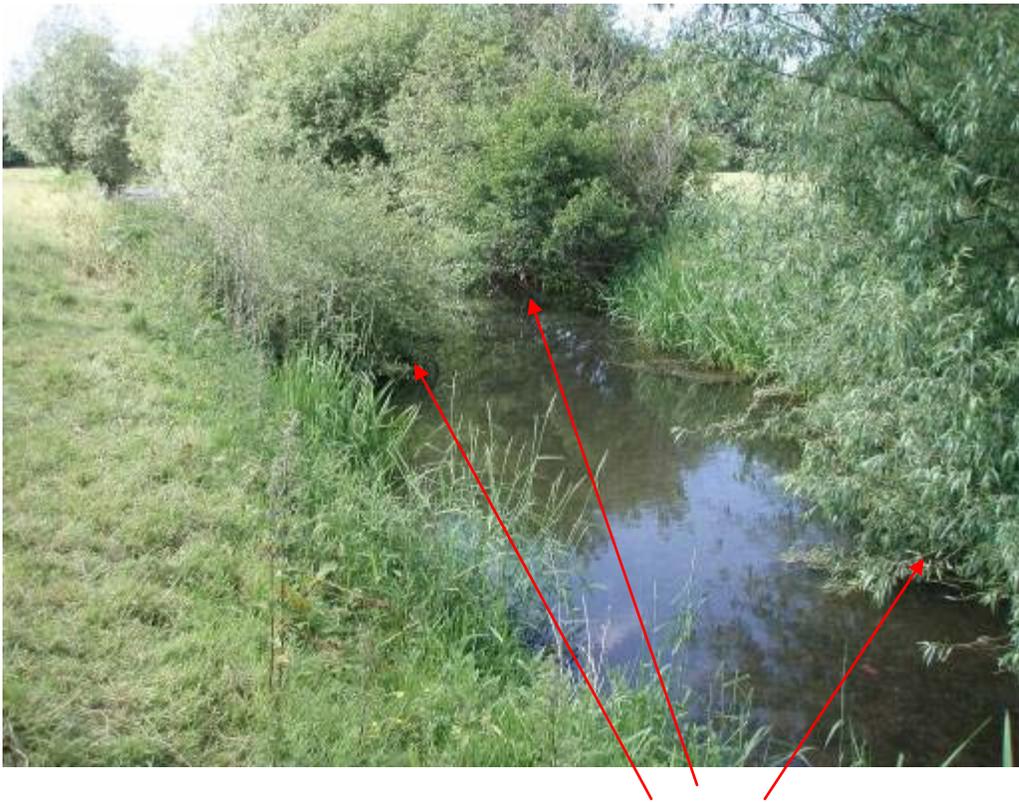
Photo 8 Excellent cover being provided by low-growing willows.

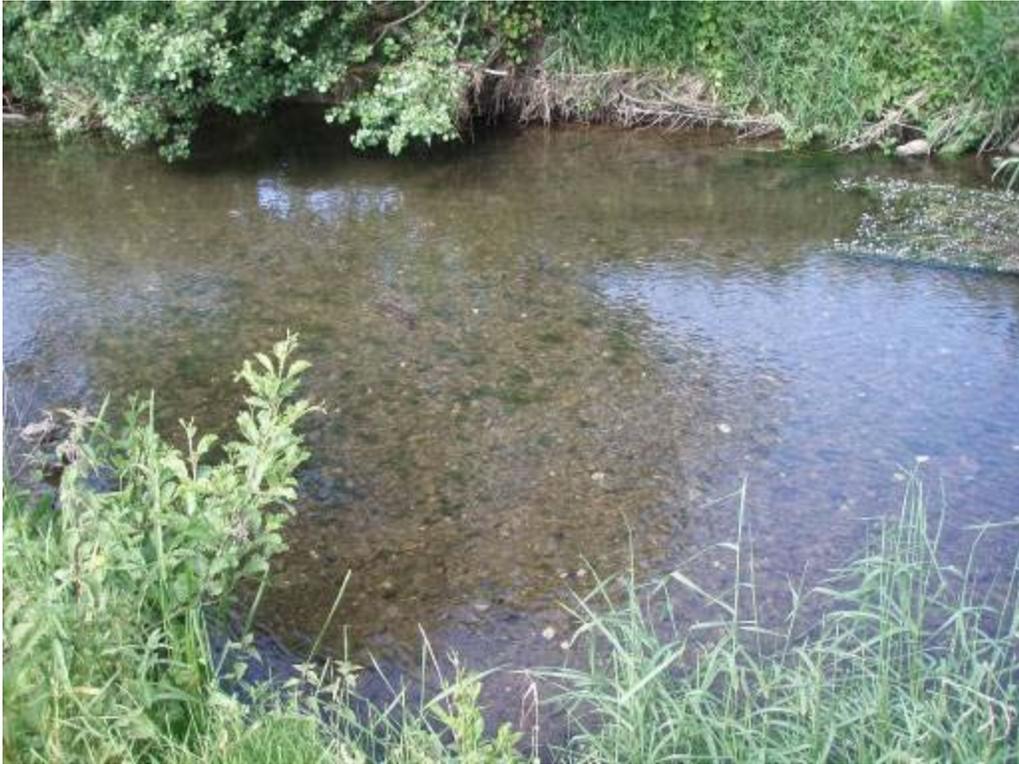
This part of the river channel was relatively shallow and uniform, with little in the way of deeper water for holding fish (Photo 9). There is scope here for the introduction of LWD flow deflectors to promote bed scour and create deeper holding areas. This would create some valuable habitat, particularly if it were tied in with the existing low cover over the water. See the recommendations section for suggestions for this length.

Photo 9 Unfortunately past river modification has resulted in a relatively uniform, shallow channel. Installation of flow deflectors to create bed scour would create better habitat, particularly if combined with the existing low cover.

- Install flow deflectors at Llanynys, associated with the existing overhead cover. Logs and rootwads could be fixed here to create bed scour and varied depths more suitable for holding fish (Figure 2, Photo 22). This would be a suitable site for a WTT Practical Visit to demonstrate techniques, subject to land owner approval and consents.

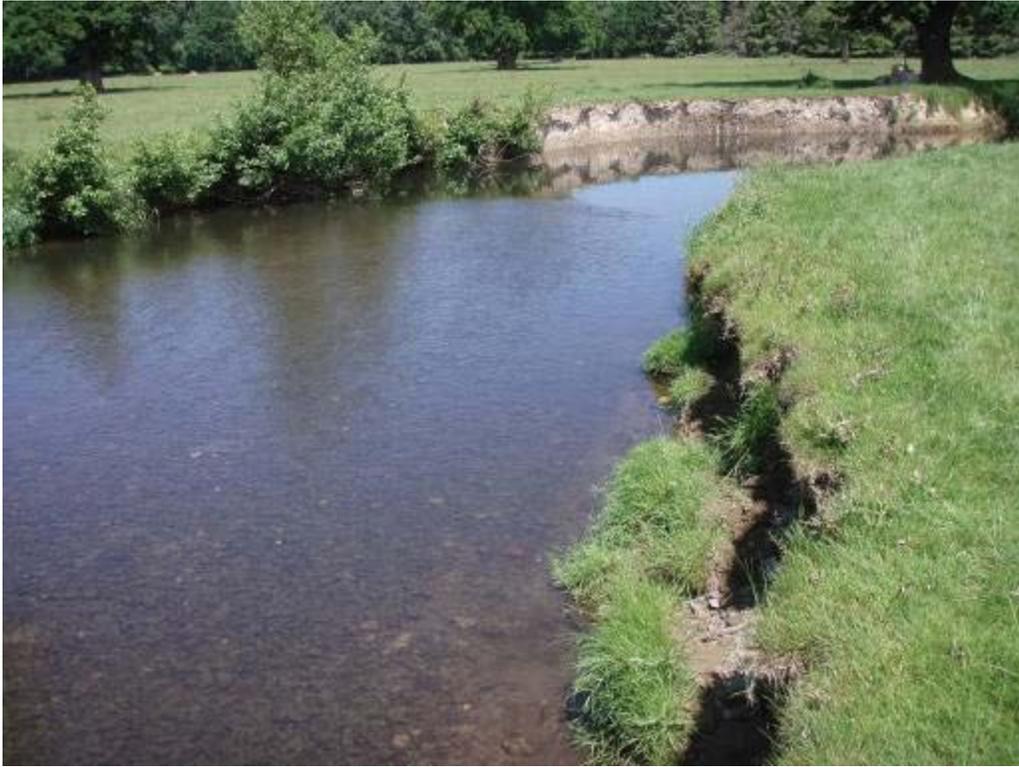
Some concern was expressed over erosion of the banks in some locations. The majority of this section has stable banks which are bound together by tree roots (Photos 11,12) but there are sections where trees have been lost and bank erosion is occurring at an accelerated rate (Photo 10). At the downstream end of the section walked, some bank reinforcement had recently been completed on the left bank to protect the footings of a stock bridge; gabion baskets have been installed and the banks reprofiled (Photo 13). The right bank here has also previously been stabilised with gabions.

Photo 10 Contrasting rates of erosion with differently vegetated banks. Grazing limits the succession of trees which provide good bank protection.

- Downstream of Ystrad confluence. Consider the use of techniques of erosion control outlined in the Upland Rivers Habitat Manual (section 5; www.wildtrout.org/images/PDFs/Upland_Manual/uplands_section5.pdf). The use of rootwads, log and Christmas tree revetment and tree planting would stabilise banks and provide in-stream habitat for fish. It is essential that any revetment works are protected from grazing livestock, so options for fencing should be explored with the landowner.

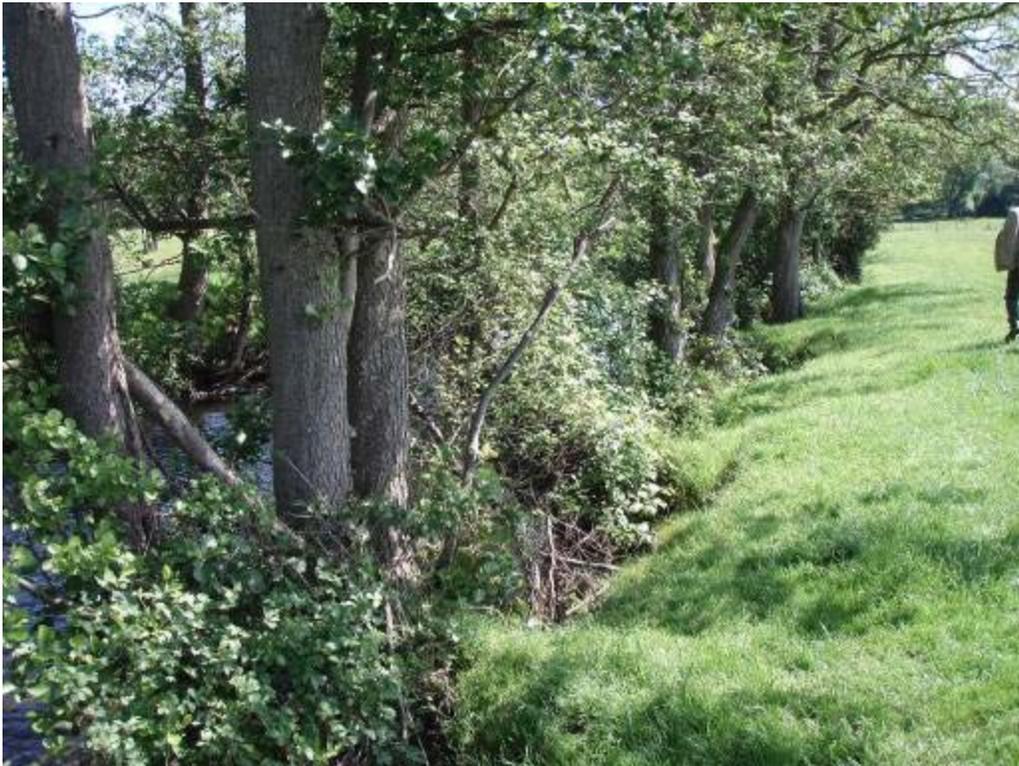
At present, the banks of the river here are largely stabilised by a single line of mature trees, mostly alders (Photo 11). Because of grazing, there is no succession of young trees coming through to replace the mature trees as they are lost. Hence when a mature tree does fall in the river, there is little resilience remaining in the bank and the rate of erosion increases.

Photo 11 Single line of mature trees along the river margin

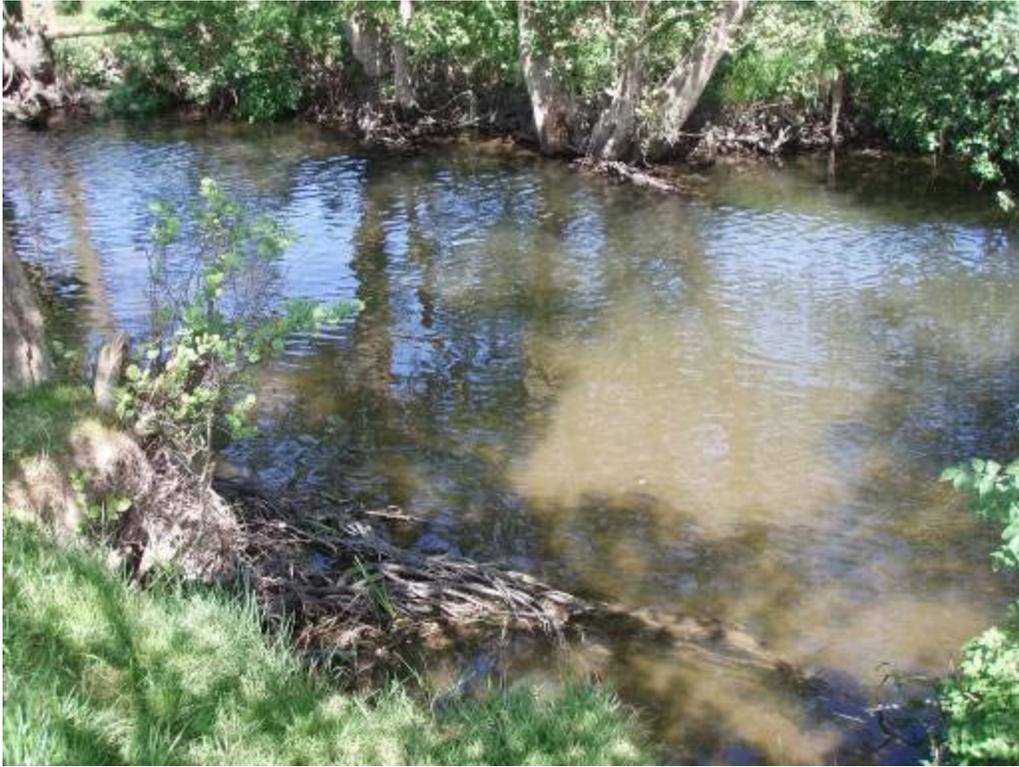
Photo 12 Trees and root systems providing a stable bank and good fish habitat.

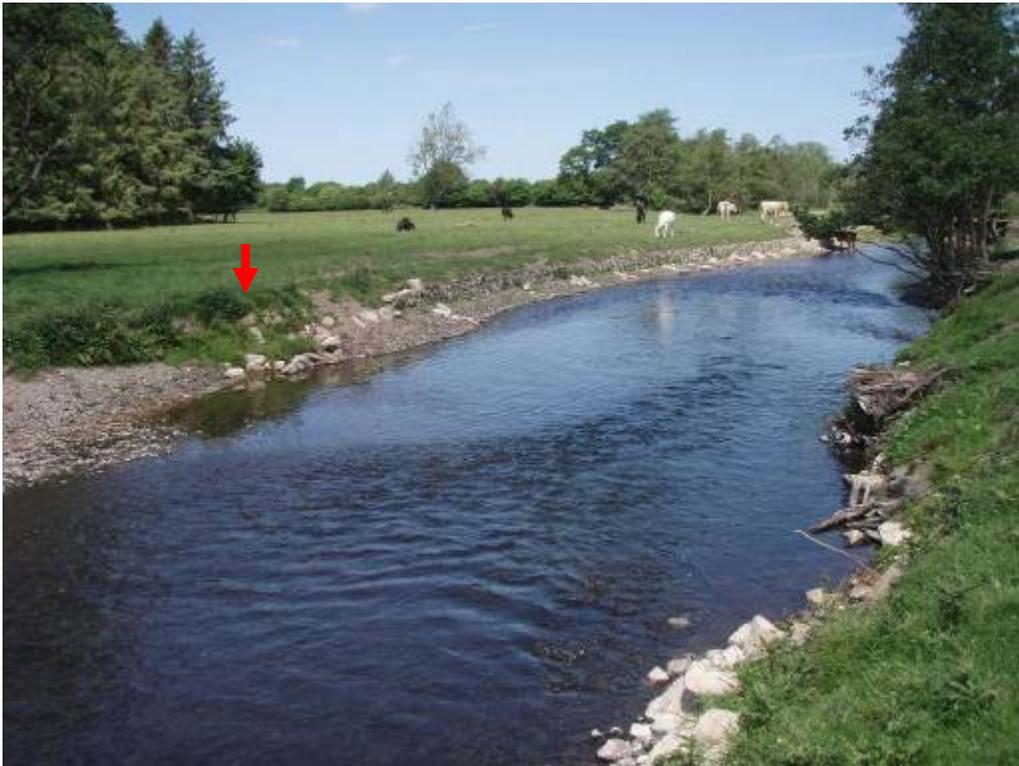
Photo 13 Recently completed bank revetment with gabion baskets. Continued grazing of this area is preventing marginal vegetation establishing which would help further stabilise the bank. High water could cause erosion problems at the upstream end of the gabions (arrow) and get behind them; this area should be inspected after spates and maintained if required.

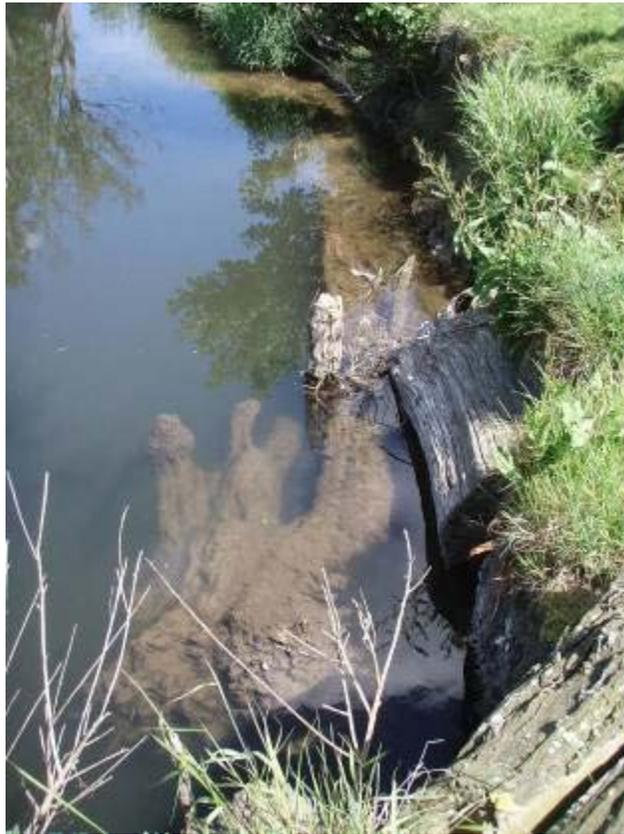
Some previous works to control bank erosion had been undertaken on this stretch of river by the Environment Agency and predecessors. This includes the use of tree trunks to protect the outside of a meander (Photo 14), and the fencing of a section of field and planting with trees (Photo 15). Both have been successful in limiting erosion and have created some good habitat as well. The tree trunks have provided excellent overhead cover for fish alongside a pool.

Photo 14 Tree trunks placed to protect the banks and providing excellent cover for fish.

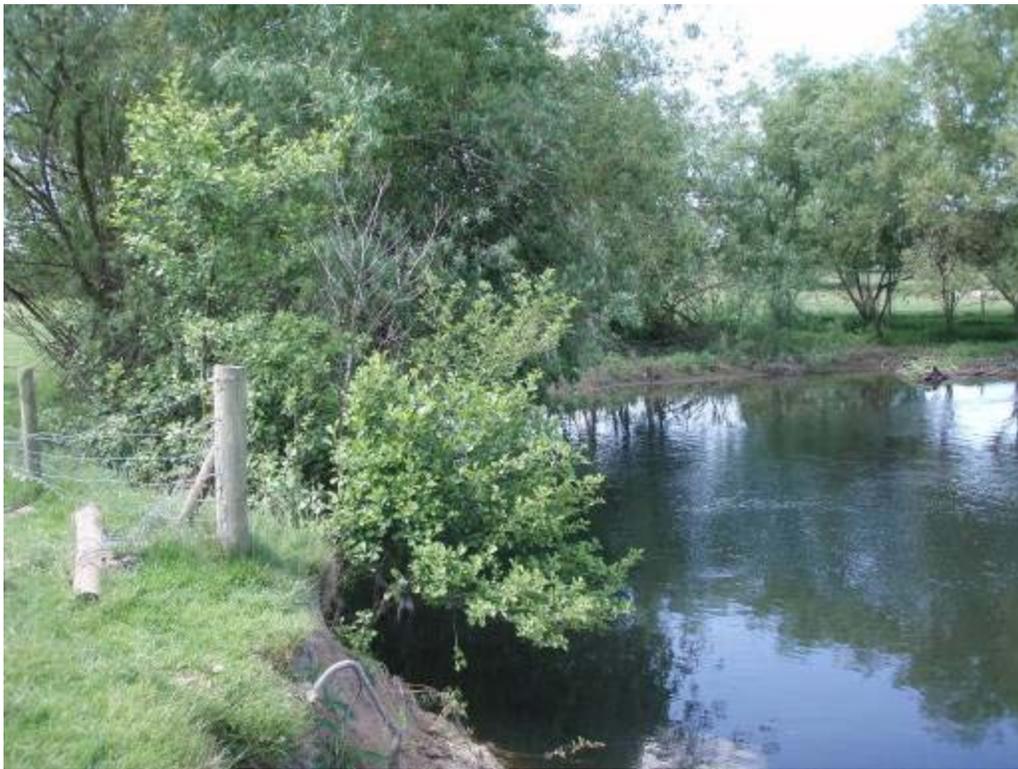
Photo 15 Fenced area planted with willows

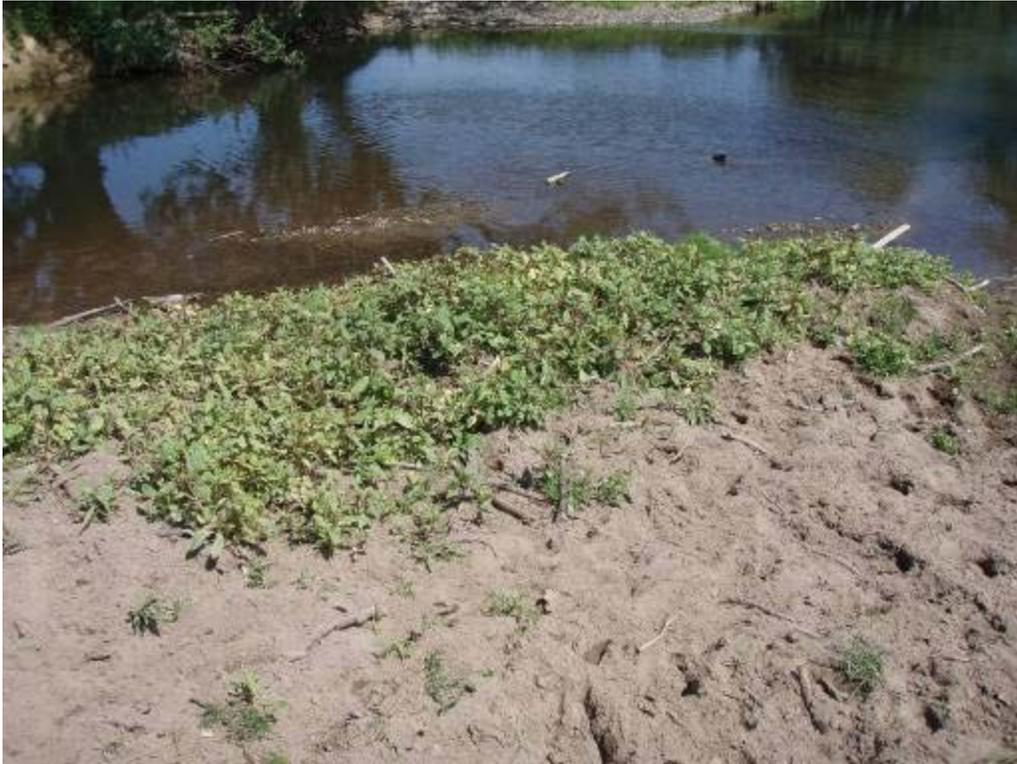
A factor which complicates the idea of fencing a marginal buffer zone along the river is the presence of the invasive plant species Himalayan balsam (Photo 16). This plant proliferates at the expense of native vegetation, dying back in the winter to leave bare banks vulnerable to erosion. It is currently being controlled by grazing, so fencing would create an additional requirement to manage this plant in an ungrazed area, at least until more desirable vegetation became established.

Photo 16 Himalayan balsam

Note the caveat above regarding Himalayan balsam and the need to manage this in fenced areas. This is best achieved by hand-pulling before the plant flowers in late June.

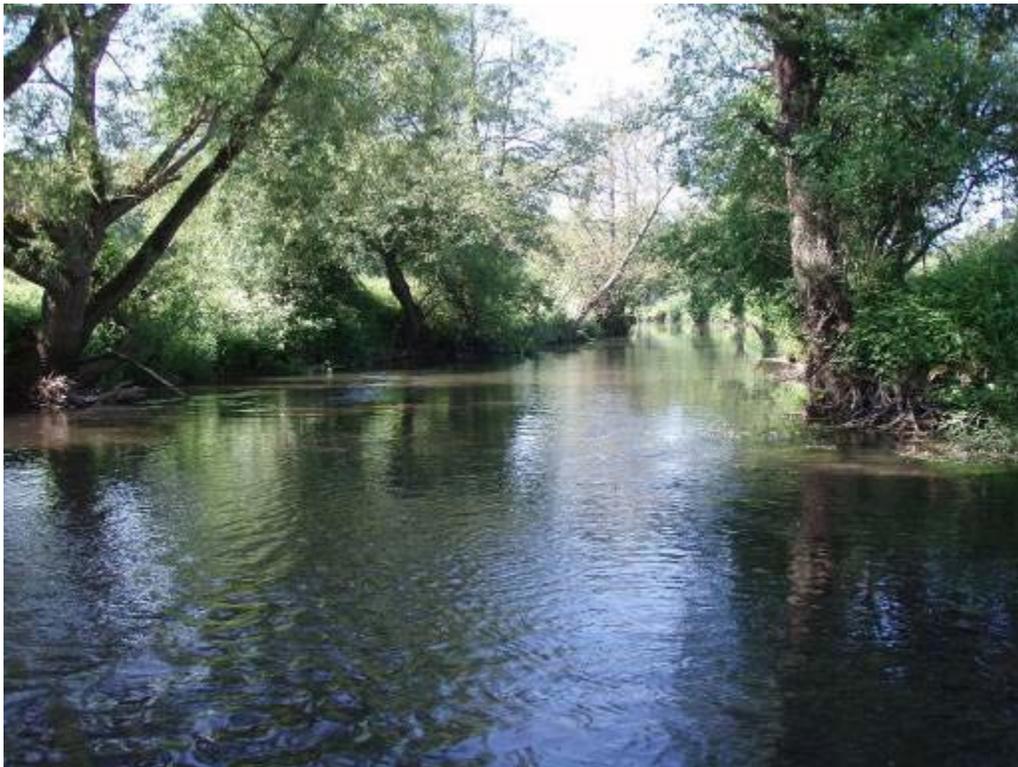
The Bodfari beat is more shaded by trees than Llannerch. A cormorant was observed feeding in the river at Bodfari; this emphasises the importance of retaining woody debris in the river channel as a refuge for fish from predation. The water discharged into the river at Llanychan is abstracted here at Llannerch.

Photo 17 Clwyd at Bodfari

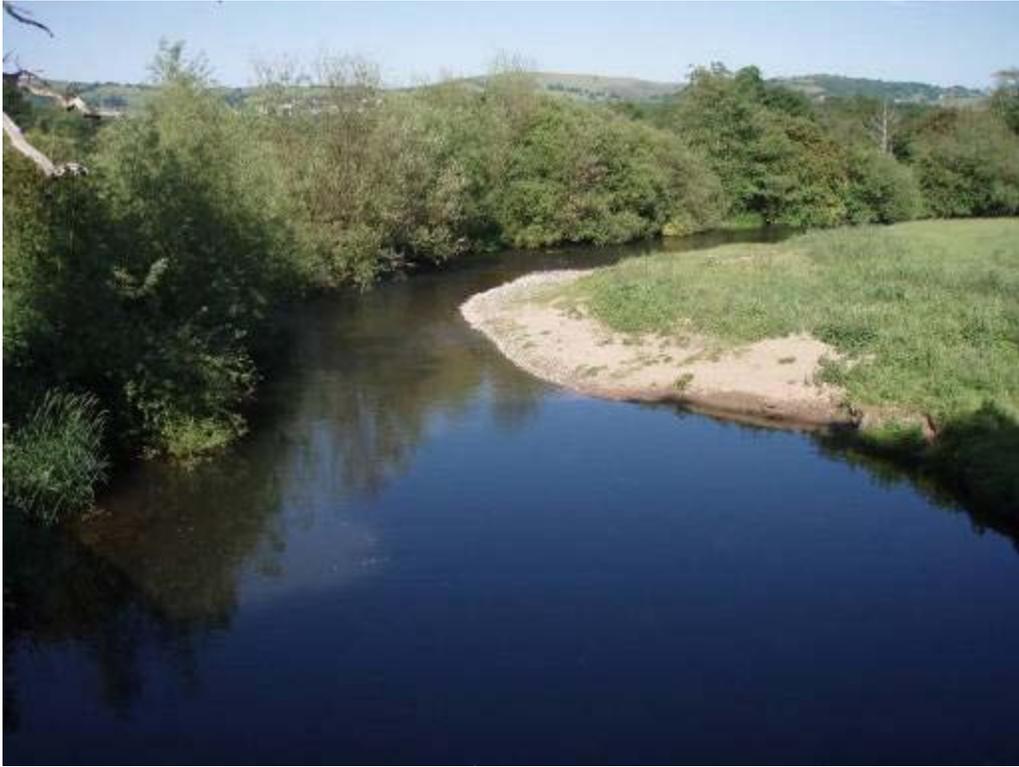
Photo 18 Clwyd at Llannerch Bridge

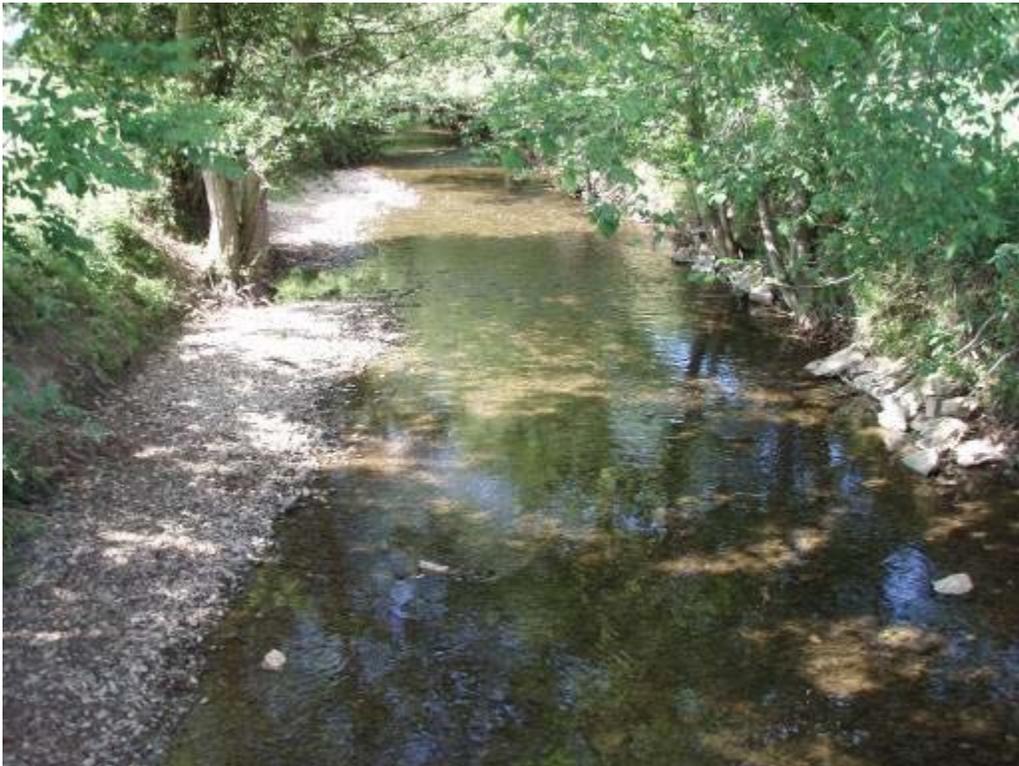
This tributary of the Clwyd was seen at two points, near Llanynys and further upstream towards Rhewl. In both areas it was evident that the river channel had been heavily engineered. The channel was over-wide, uniformly shallow and embanked on both sides. The river bed was stony, but there were few in-stream habitat features such as deeper pools which would hold fish. The river is little fished by DCAC members although it does produce migratory fish following a spate.

Photo 19 Clywedog near Llanynys – an engineered channel which is over-wide and uniformly shallow, providing poor habitat for salmonids.

- Create pool habitat in the Afon Clywedog using channel constrictors and low weirs constructed from stone or wood. It should be emphasised that the design of 'weirs' should be to concentrate and focus flow downstream of the structure to create scour and maintain pool depth; they are **not** intended to impound water upstream of the

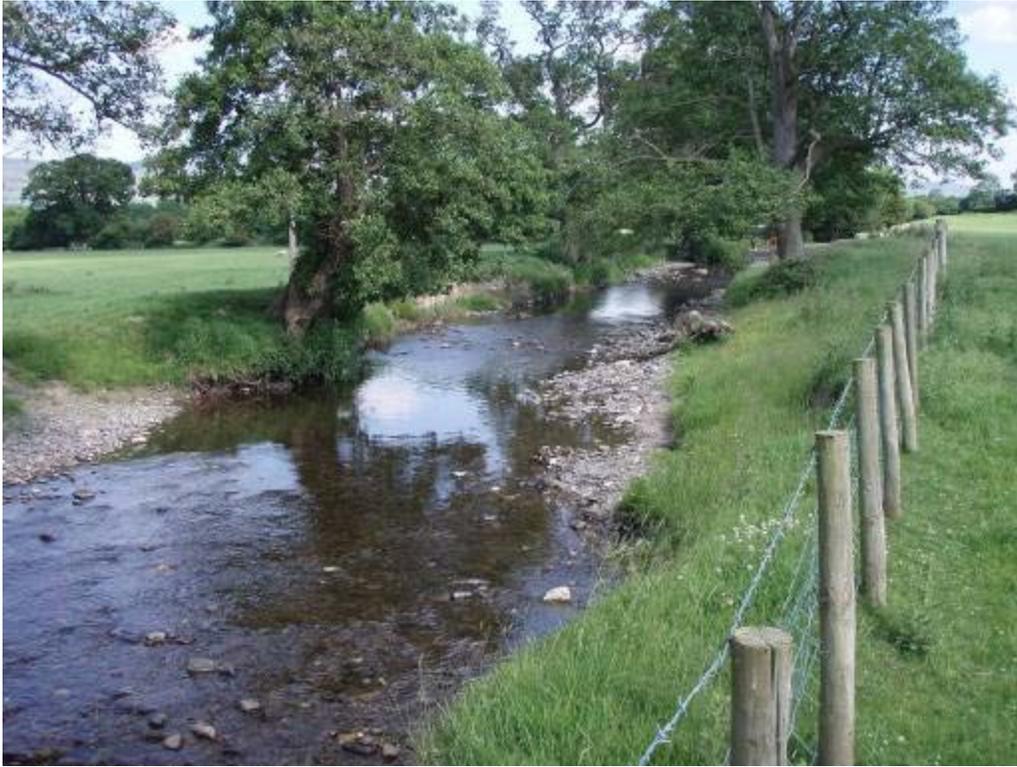
Photo 20 Clywedog near Rhewl – equally impacted by channel engineering which has limited the amount of pool habitat.

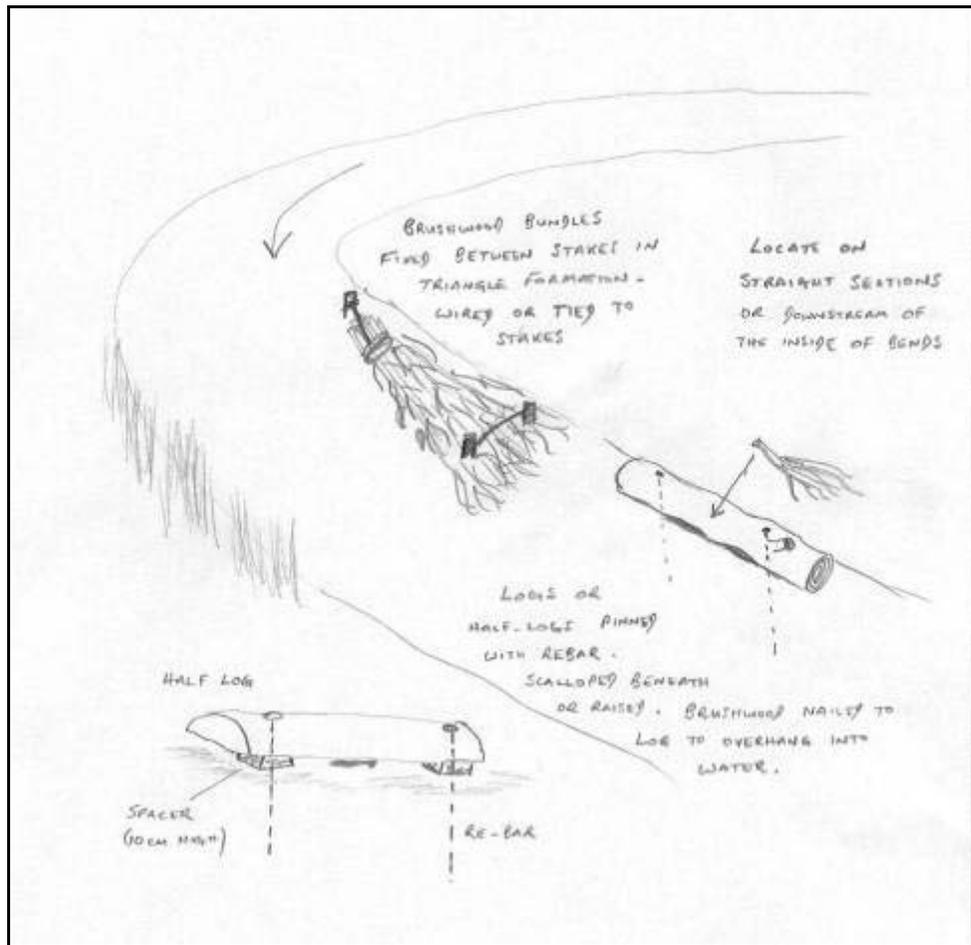
Figure 1

- Retain large woody debris within the channel wherever practical, using the decision matrix provided above (and in the Upland Rivers Habitat Manual).
- Thin out willow growth at Llanychan to achieve a balance of shade and light over the river channel (60:40 ratio). Use the arisings from this work to create brushwood bundles (Figure 1) which mimic the marginal habitat in Photo 6. Note that willow will strike root if installed shortly after cutting, so depending upon the desired effect it may need to be left for a few weeks before use in the river.

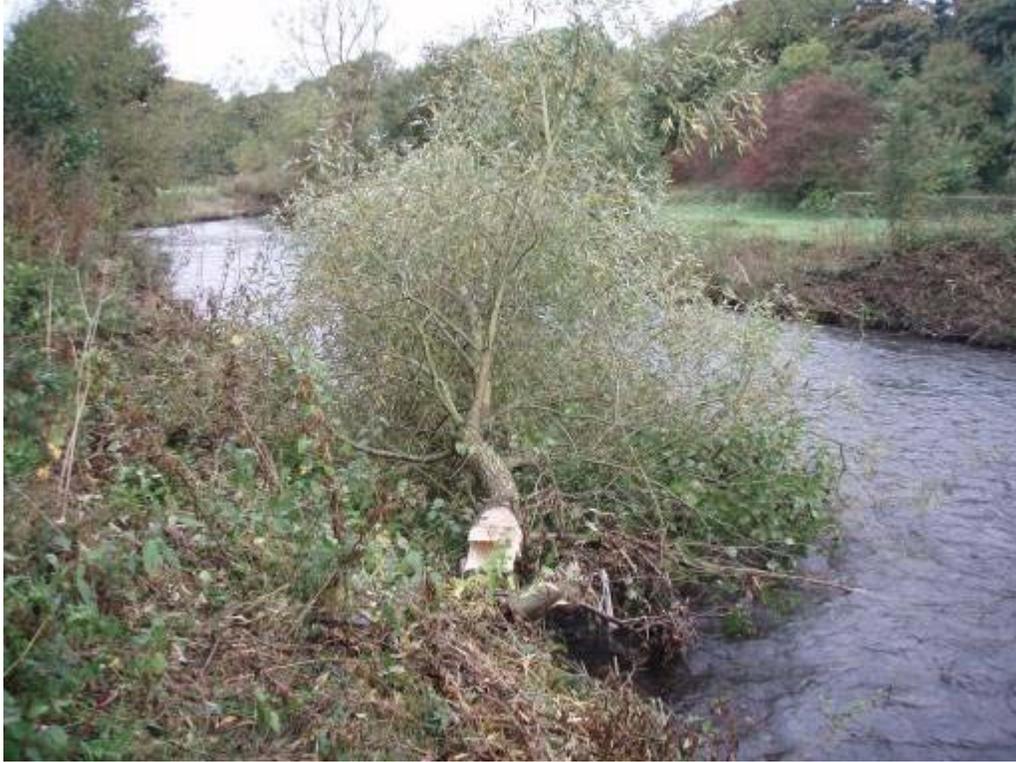
Willows are an ideal species for 'hinging' into the river to create marginal cover (Photo 21). Partially cut through the tree stem (by say two-thirds) leaving a hinge, then bend the tree over into the desired position. This provides a firm anchor which will prevent the tree being washed out in floods.

Photo 21 Willow hinged into the river margins (River Goyt, Derbyshire).

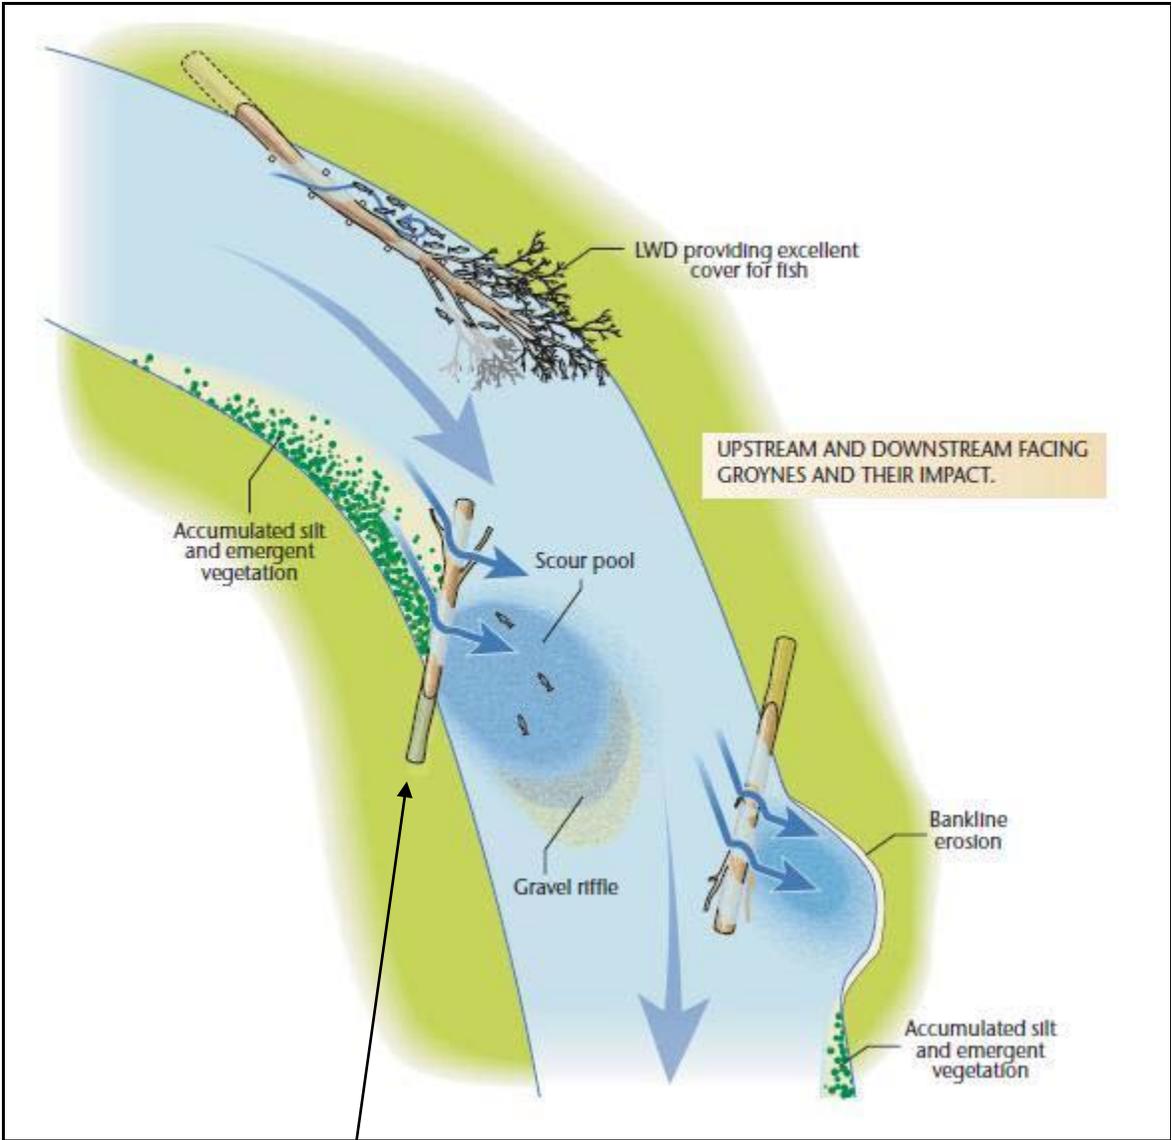
Figure 2 Upstream pointing deflectors will create bed scour and depth variation.

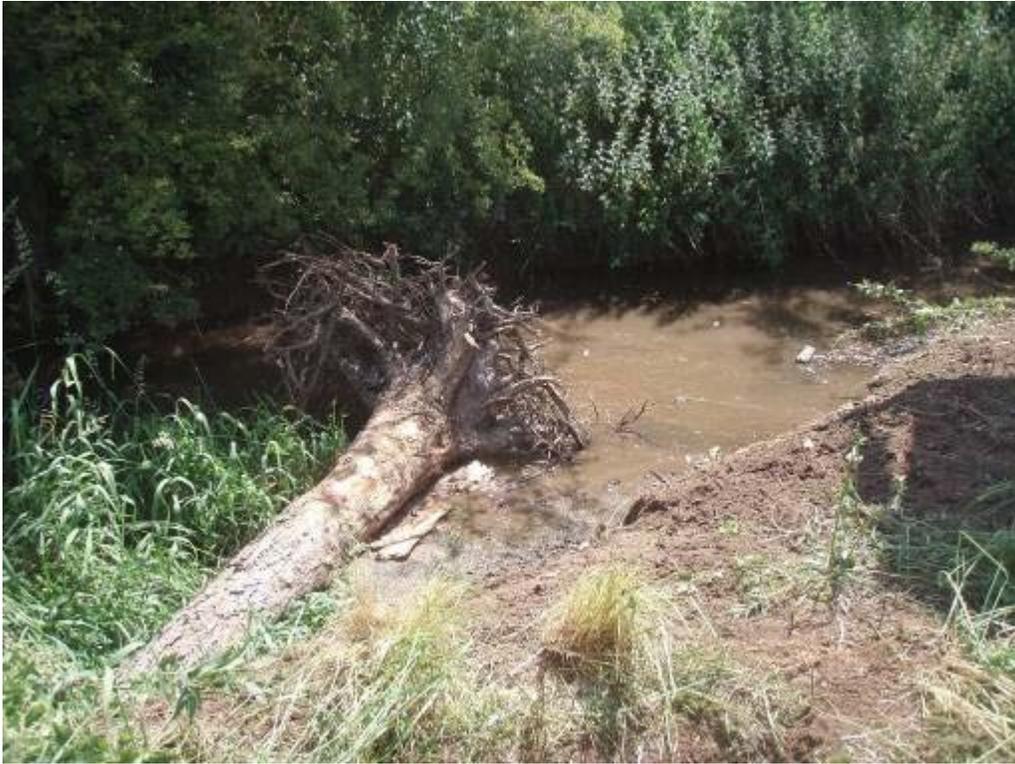
Photo 22 Root wad flow deflector recently installed on a Leicestershire stream
