Advisory Visit

Afon Clwyd, North Wales

15th June, 2010

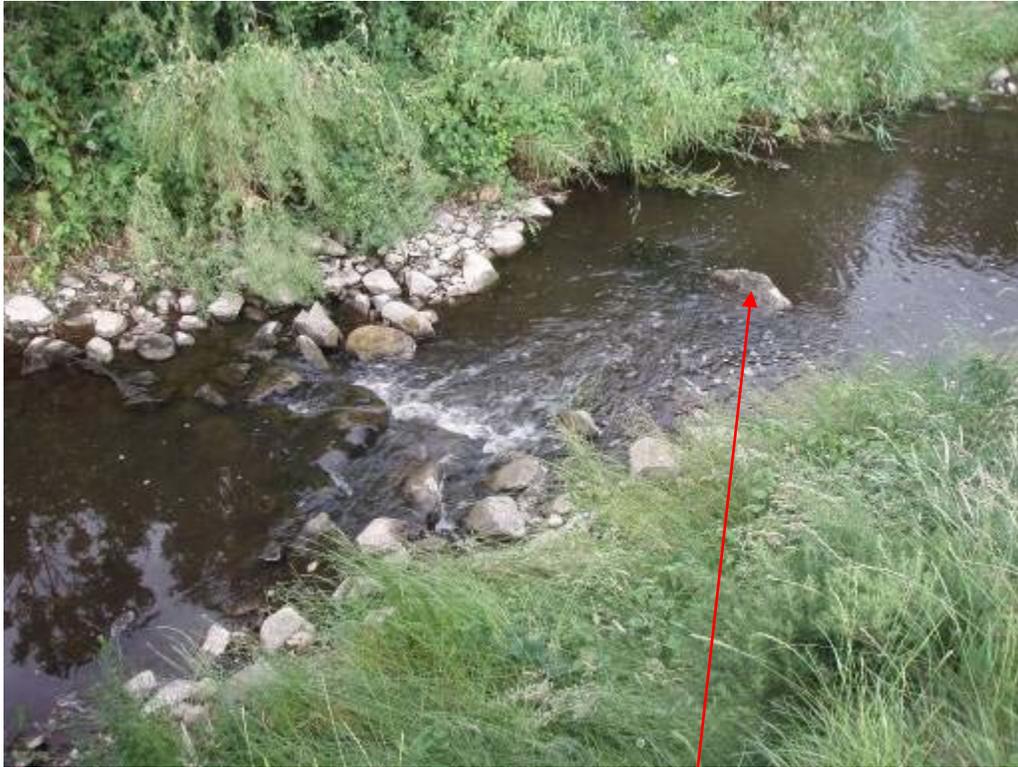
Photo 23 Low weir to focus flows into excavated pool with placed boulder. River Blackwater tributary (Co. Meath, Ireland)

- Create pool habitat in the Afon Clywedog using channel constrictors and low weirs constructed from stone or wood. It should be emphasised that the design of 'weirs' should be to concentrate and focus flow downstream of the structure to create scour and maintain pool depth; they are **not** intended to impound water upstream of the

structure. Various examples are shown in Photos 23 and 24 and the schematic diagrams in Figures 4-6 below.

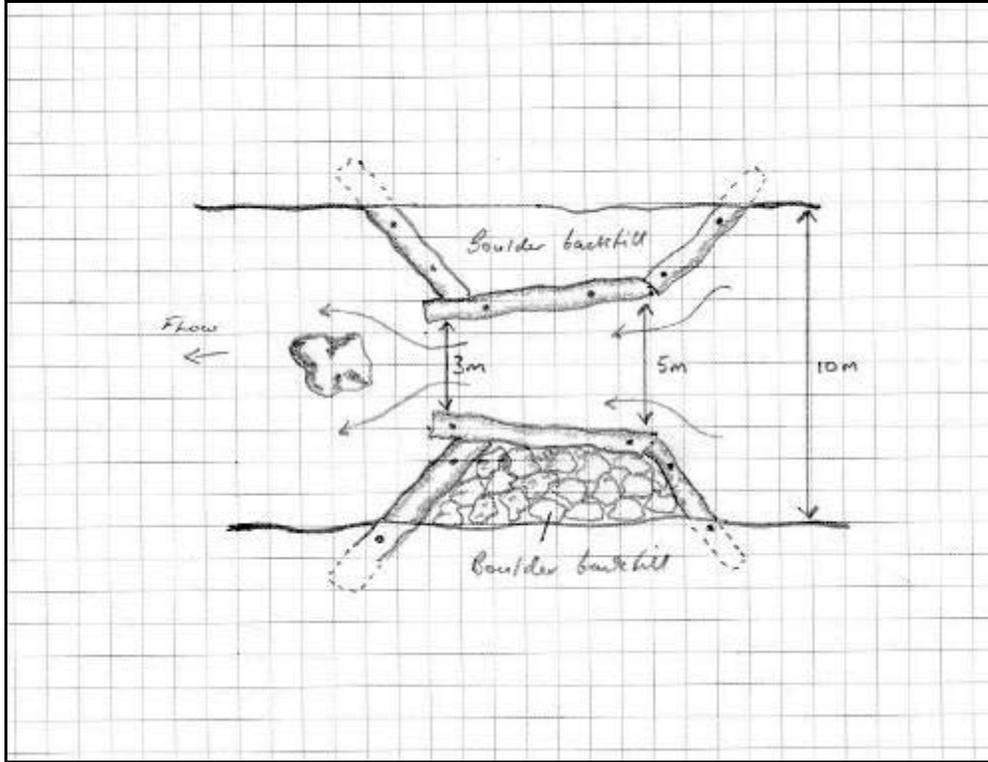
Figure 3 Channel constrictor. Logs not necessary if large boulders are available. Structures can be offset to create sinuous deeper channel.

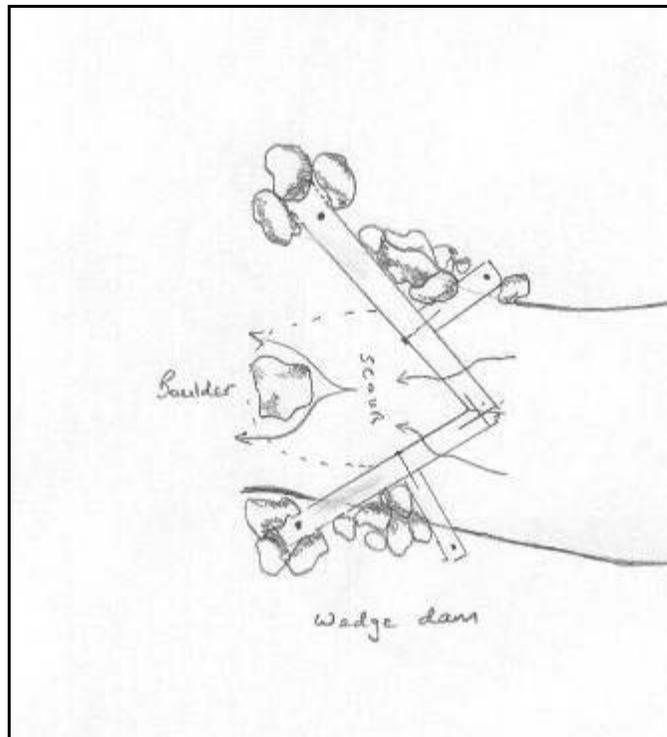
Figure 4 Wedge "dam" constructed from logs and boulders

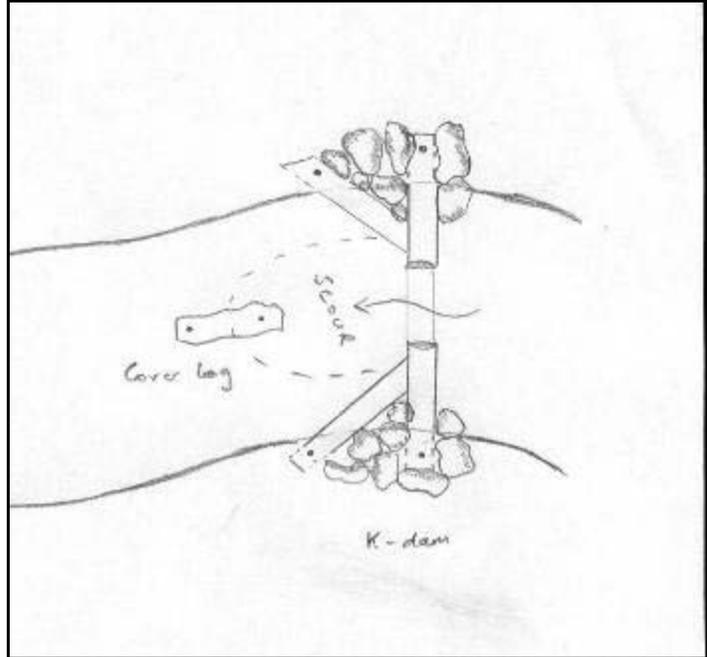
Figure 5 K-dam. Cover log can be substituted with a boulder.

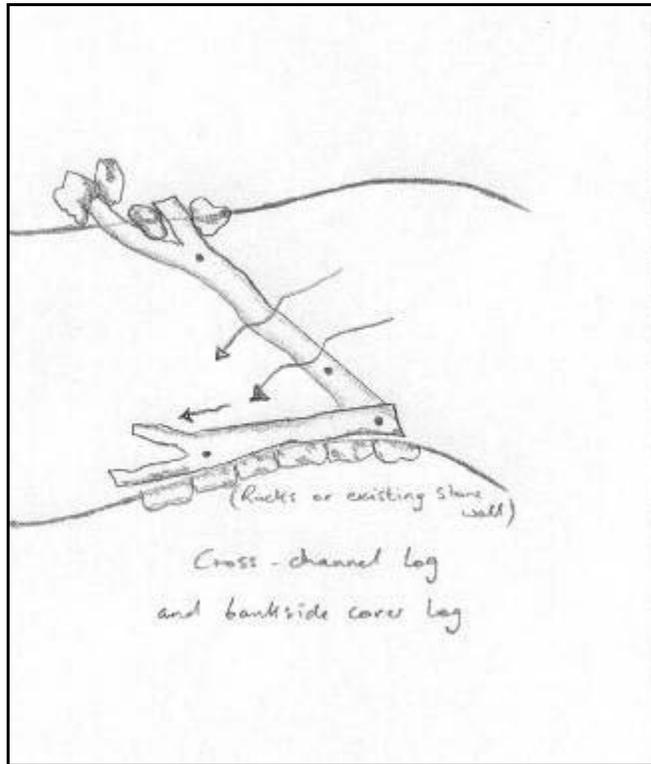
Figure 6 Cross-channel log

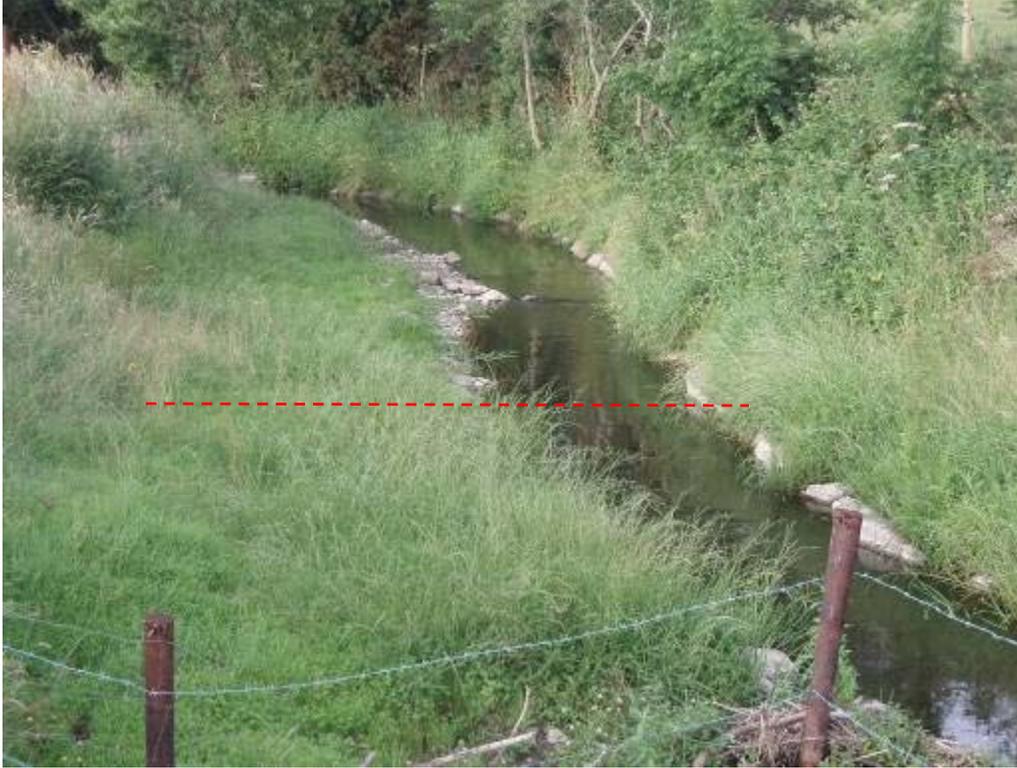
Photo 24 Two-stage channel created to restore an over-wide, engineered channel. The red line indicates the width of the channel prior to restoration.
