The Old Rectory, River Coln

An Advisory Visit by Nick Lawrence for the Wild Trout Trust February 2017

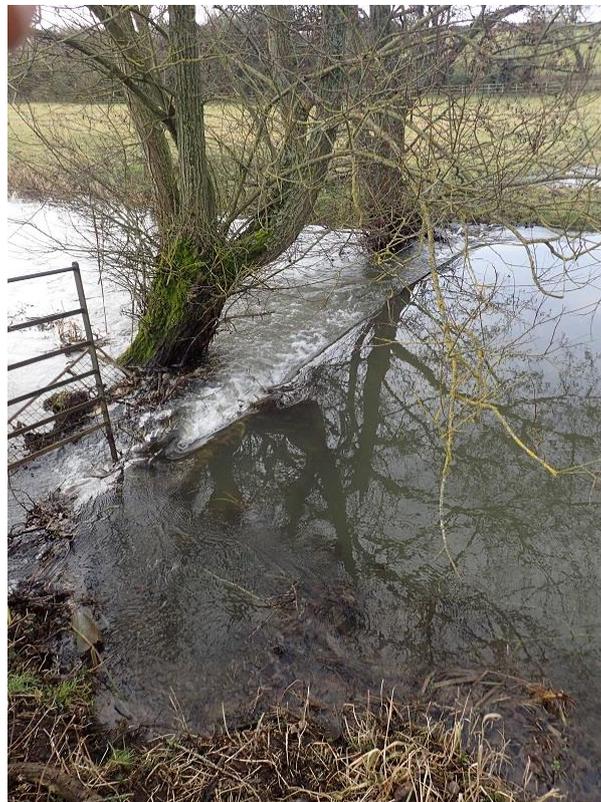
Figure 2: The bottom boundary is blighted by the telegraph pole and reinforcement bar weir that impounds the whole reach of the Old Rectory's water.

As seen in Figure 2, one of the main issues with the reach is the impoundment by the old telegraph pole weir, with this removed it will leave the river 'free'. Even if the weir was notched, to lower the degree of impoundment, this would dramatically change the reach above, which is the area that needs improvement. This will make a marked difference on the flow over the winter, and will pull the silt off the bottom of the river bed upstream. With the addition of some woody habitat features above the river it could be possible to get back some much-needed habitat and flow diversity. A dialogue defiantly need to be opened up with the owner of the RB to discuss the weir, who put it in and will they have an objection to it being removed. But the Wilsons have a right to remove half the weir on their side of the river.

1. The telegraph pole and reinforcement bar weir should be removed as it is impounding the flow upstream and would definitely be interrupting natural sediment transport and could contribute to habitat uniformity and resulting flow diversity downstream. At the very least this should be notched in the middle to pull the flow into the middle of the river utilising the velocity rather than eroding the river bank, and decreasing the impoundment of the reach above. A dialogue should be opened with the owner of the RB, so ensure some joined up management. The issues to discuss with them are taking the weir out, management of the fringes, light grazing or fencing from heavy grazing and tree planting.

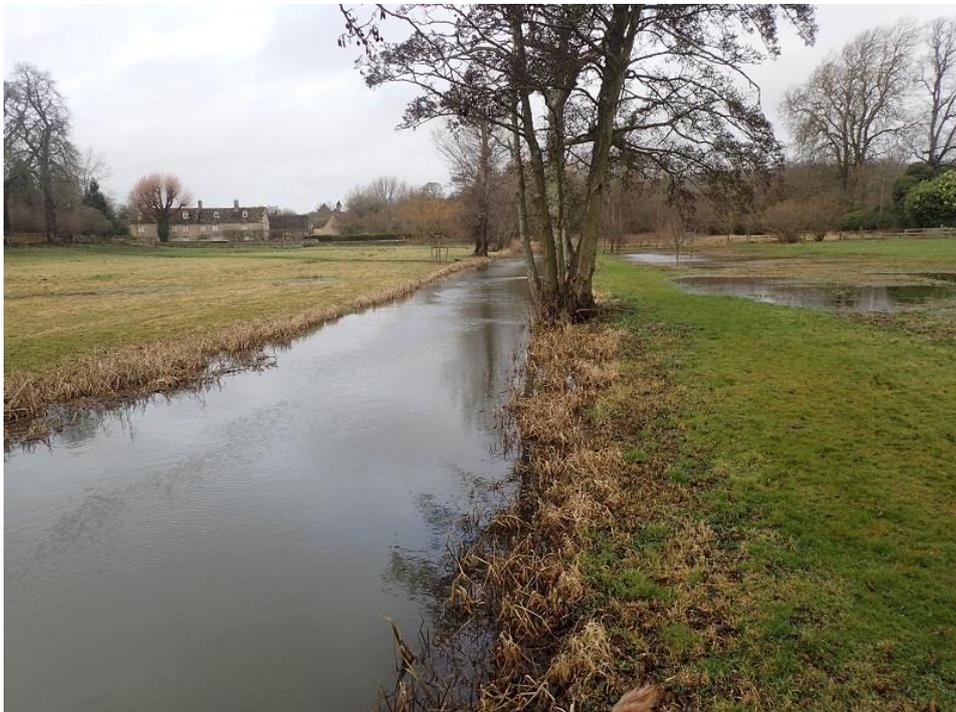
The river has been straightened, as seen in the cover photo and Figure 3. In fact, it is unnaturally straight, probably due to drainage for farming practices. Some sinuosity needs to be restored and this can be done in two ways; either with the addition of woody material (either brushwood berms or log deflectors) or with the introduction of gravel to create hard berms to bounce the flow from one bank to the other. The RB is suffering from grazing pressure and the LB has no grazing.

Figure 3: The middle section looking towards the top boundary, notice unnaturally straight banks and no low cover.

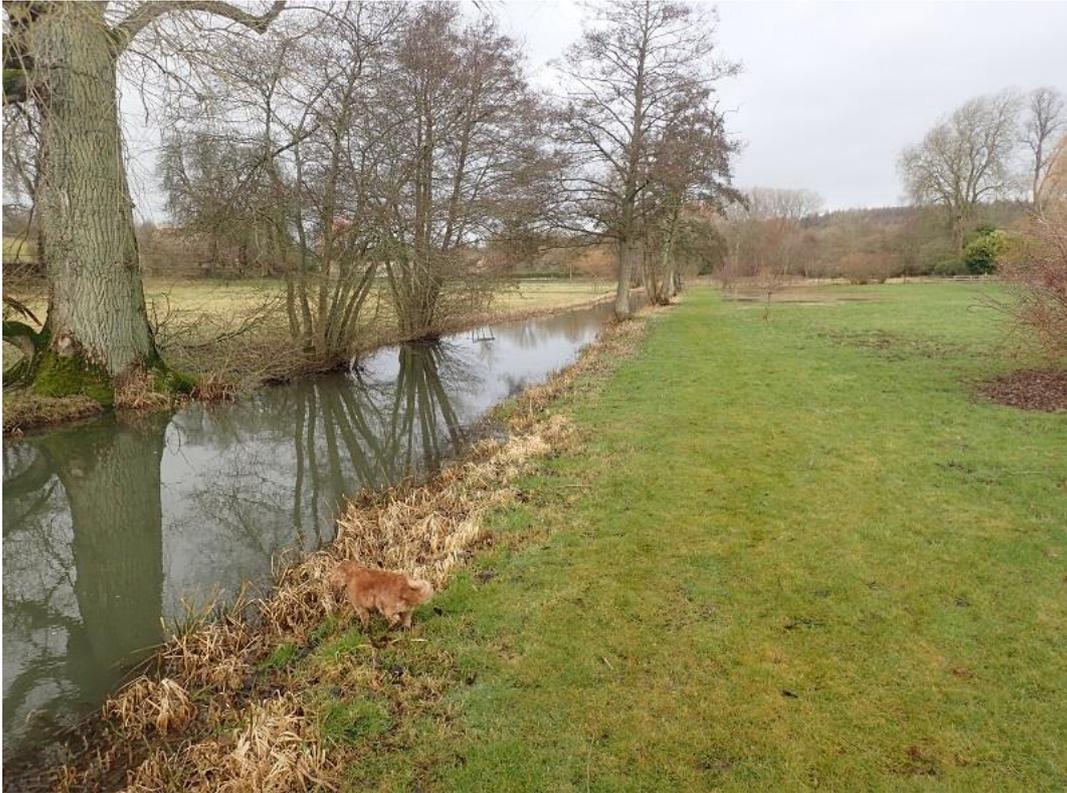
Figure 4: Looking upstream near the bottom of the reach, the two small alder coppice could be re-coppiced to provide useful materials for staggered brushwood structures and the regrowth would provide valuable low cover.

Again Figure 4 shows the straightened nature of the channel and, as mentioned previously, the tree planting is quite uniform. The small alder coppices in the middle of Figure 4 would provide great material for woody structures to introduce some sinuosity to the reach as well as the regrowth from the stools providing low cover for fish in future years.

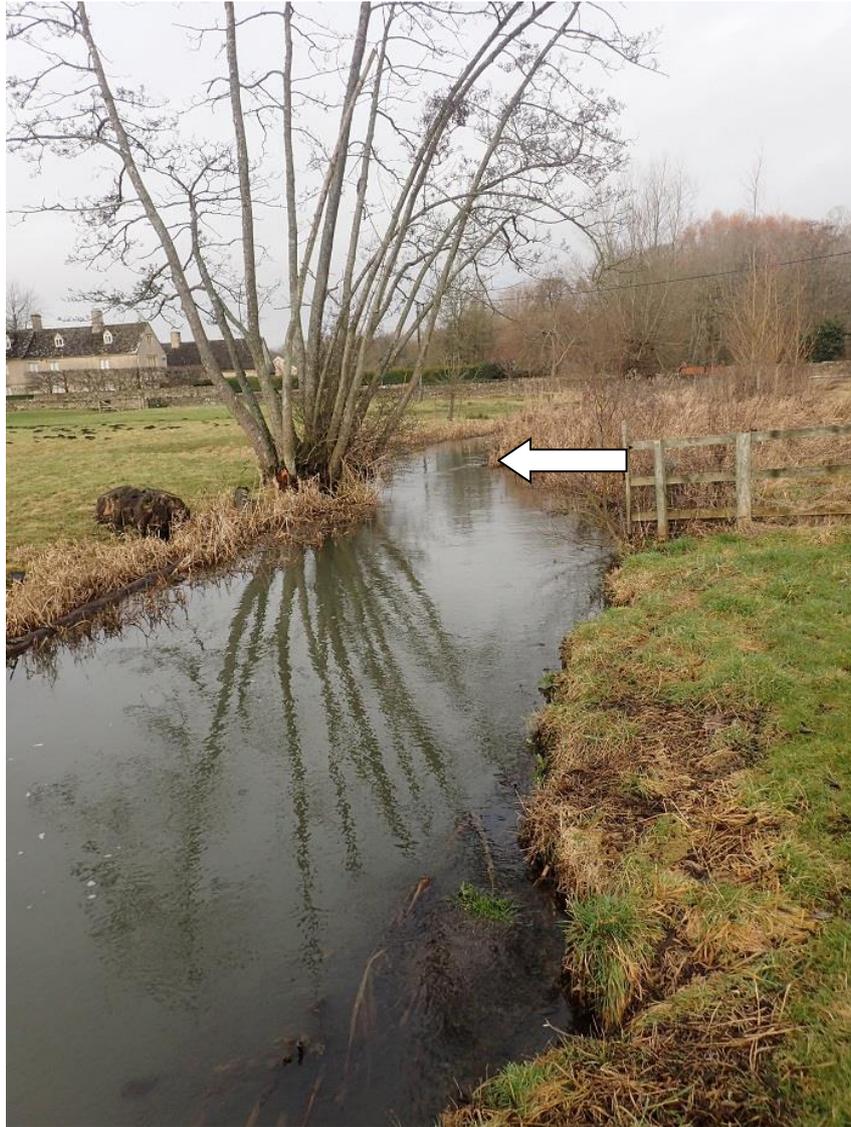
Figure 5: This image illustrates the top of the reach and the difference between a managed bank and a more natural, unmanaged bank on the reach above.

A great example of how a river bank should look is Figure 5, this shows the contrast of a managed bank in the foreground of the picture and an unmanaged natural bank in the background.

Notice how this is the only degree of sinuosity throughout the whole reach! This is by no means luck. It is highly likely this has been allowed to develop because of the lack of maintenance (or careful maintenance and no or limited grazing?) done on the reach above. In particular, the lovely scrubby low marginal cover has been allowed to encroach, thus pinching the river and creating a seam of deflected faster water that can be noticed in the top of the picture (as indicated by arrow). Again, the alder coppice could be used for materials to accentuate the bend, or even some of the back limbs hinged in to provide cover. This is how a

The scallop in the bank in the center foreground of Figure 5 could be caused by hitting the fringe too hard in the autumn thus leaving the river bank unprotected for the winter months.

3. Fringe management was touched upon on the visit as the fringe was noticeably short (Figure 5). Fringes should be kept as long as possible to allow marginal plants to flourish and flower, they will also protect banks in the winter from flooding. Small windows can be cut to allow fishing access and reed beds that get too high can be hedge cut to waist high. If the opposite bank can be fenced from sheep grazing this would in turn benefit the river.

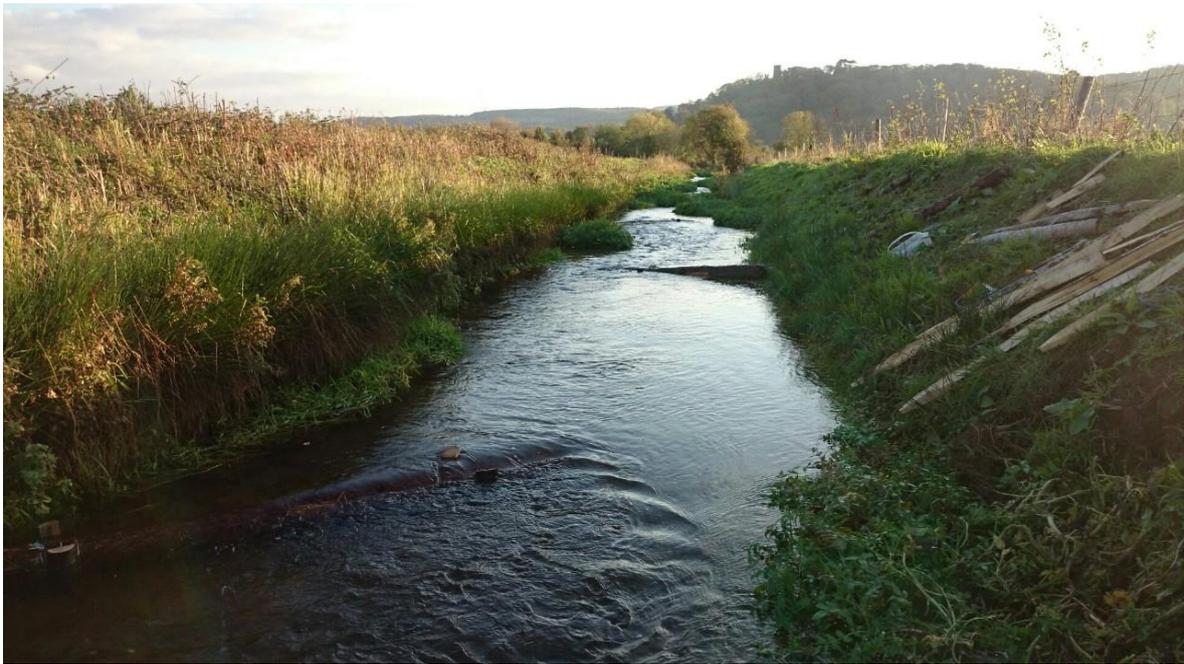
Figure 6: An illustration of how alternating log deflectors could increase sinuosity along a straightened channel.

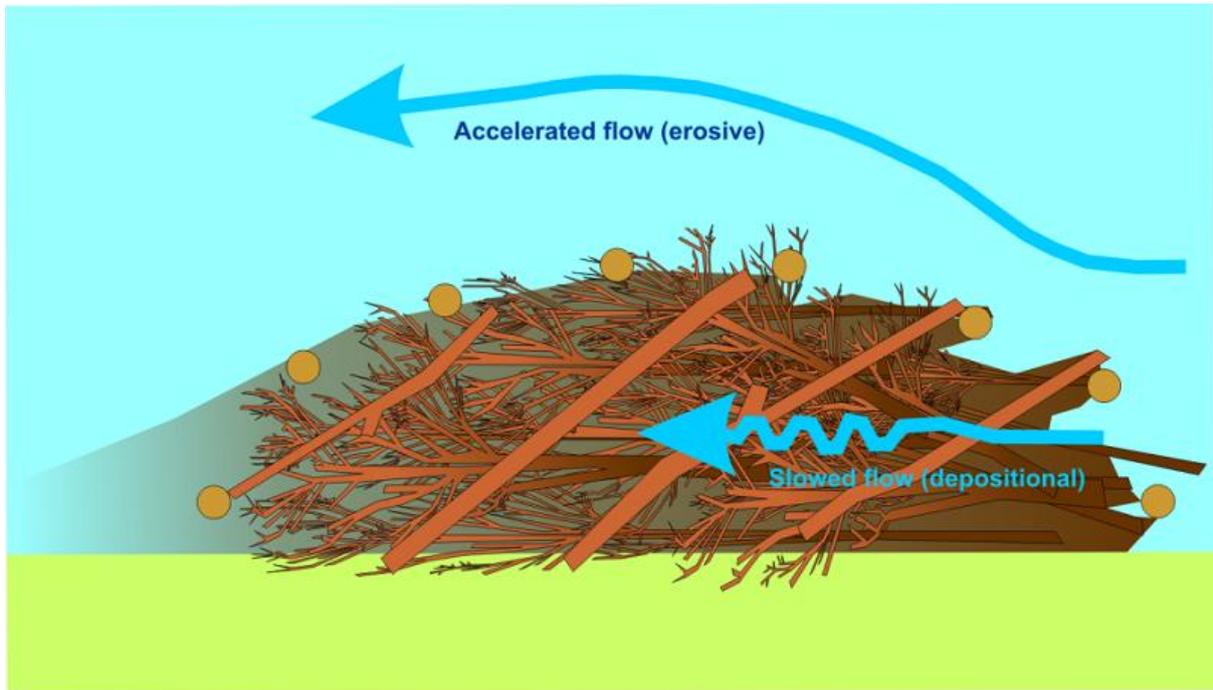
Figure 7: An illustration (plan view) of how brushwood berm structures can help manage in-stream fine sediment

2. The uniformity of the channel upstream of the weir needs to be addressed, once the issue of the weir is solved. Brushwood berms could be staggered in strategic areas to create flow sinuosity and marginal vegetation as well as providing habitat for juveniles. Log deflectors (Figure 8) could be used in this area where the spawning riffles are identified to keep gravels clean and scour out depressions in the river bed. Examples of how staggered deflectors can be introduced to a straightened channel can be seen in Figure 6, and the functions of brushwood berms in Figure 7. Discussions should take place with the owner of the RB so work can be complimentary to both banks.

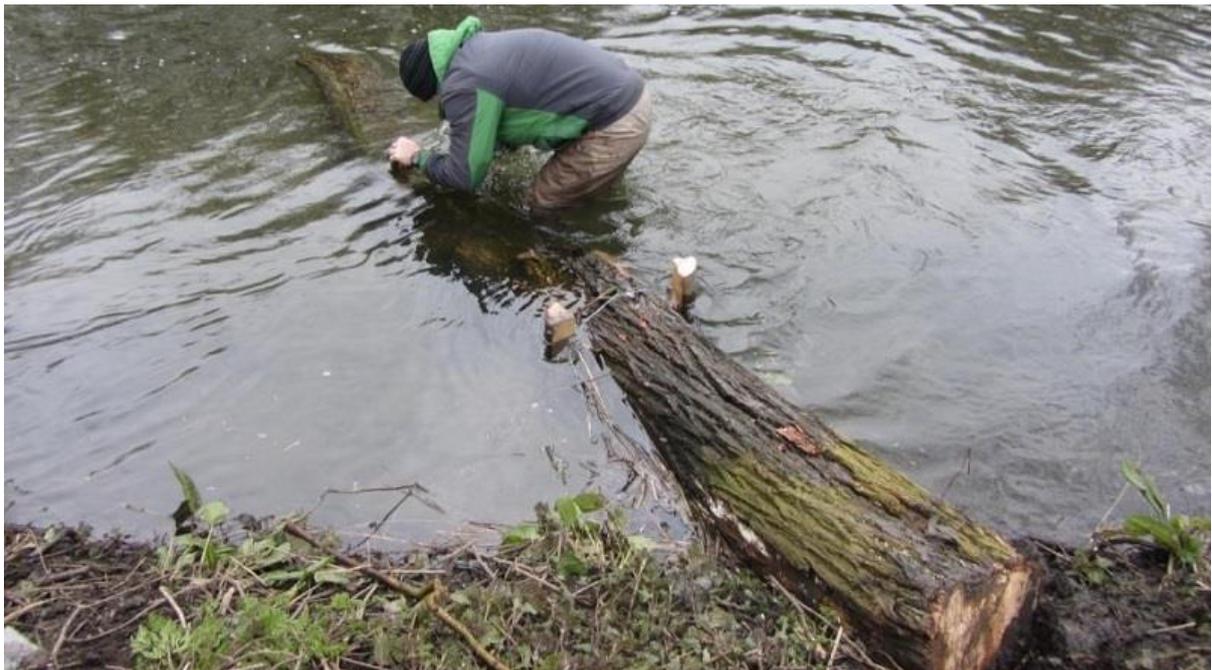
Figure 8: A simple log deflector installed pointing upstream and keyed into the bank will deflect flow out into the centre of the channel, this will help to scour gravels and keep them clean, useful on a spawning riffle. For clarity, the river in this picture is flowing from left to right.
