River Colne – Staines Moor

An advisory visit carried out by the Wild Trout Trust – May 2012

1. Introduction

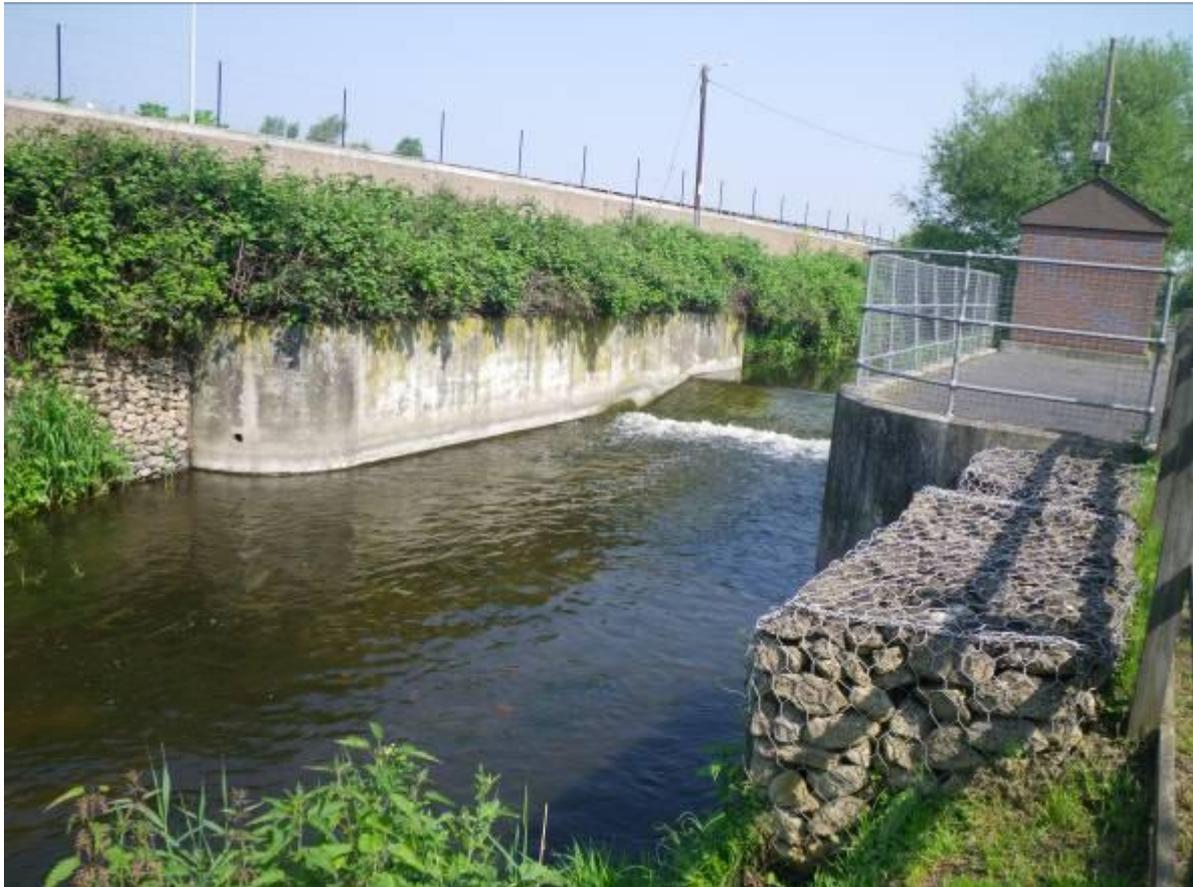
Some good quality habitat for flow loving and gravel spawning fish species was evident on the Wraysbury River. The comparative lack of any significant gradient on both channels is a major limiting factor. This issue is compounded by the presence of substantial weir structures, with a crump-type flow gauging weir

(photo 1) located on the Wraysbury and a large impoundment located on the main Colne downstream of Staines Moor.

Photo 1 EA gauging weir which significantly impacts on fish passage and habitat quality on the section upstream of the structure.

The flow gauging weir is preventing free access for certain fish species and sizes. Ideally the weir should be replaced by the EA with a modern gauging weir that does not require the impoundment. If this is deemed a low priority for the EA then retro fitting a low cost baffle fish pass, including eel bristle mats to the crump weir face is possible. Recent EA R&D research on fish passage through gauging weirs and a stated policy by the EA should eventually lead to some much needed changes at sites like this. Local interest in effecting improvements will help.

- Explore options with the EA for improving access for fish and local habitat quality adjacent to the Gauging Weir.
- Explore options for introducing spawning gravels to key locations on the Wraysbury River and the main River Colne.

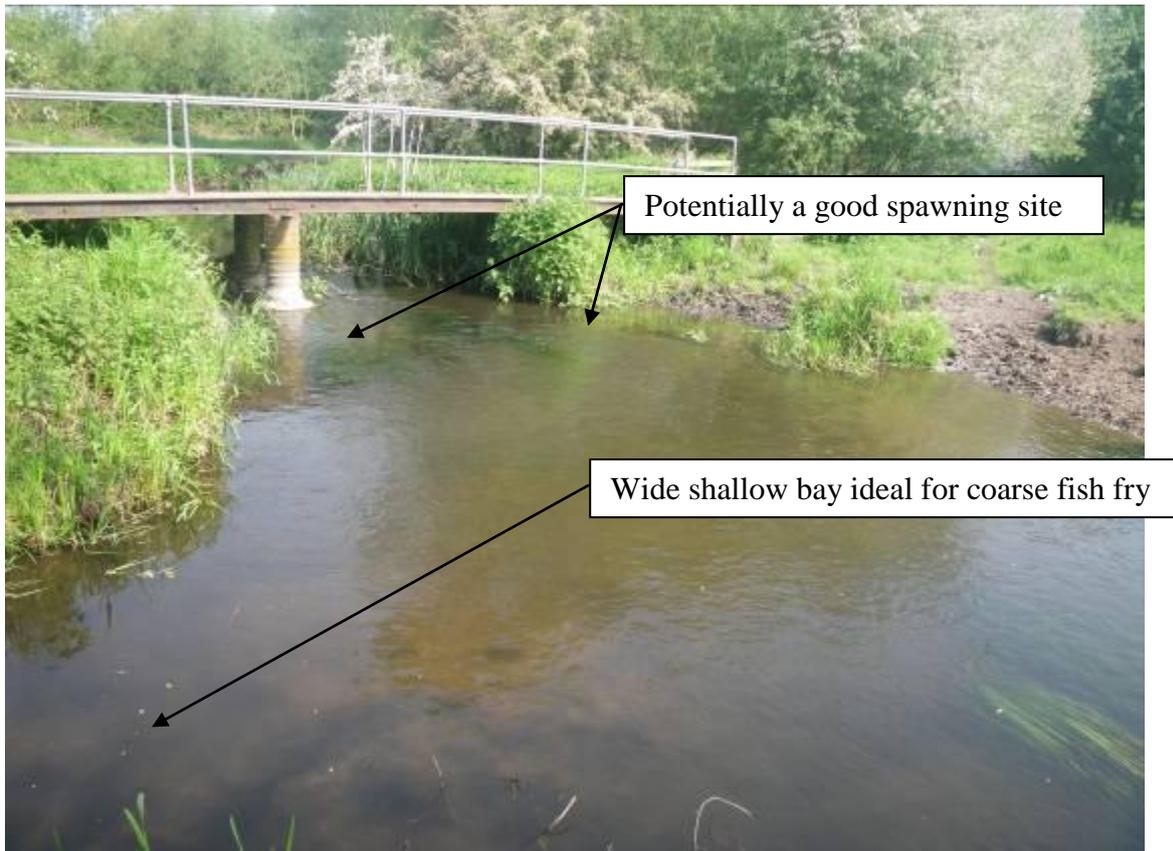
Some good examples of in-channel habitat diversity were evident. One such site was located adjacent to an access bridge on the south side of the Moor, where the channel has been squeezed by foot bridge abutments (photo 2) with a wide, shallow fording bay immediately downstream. The site already provides opportunities for roach spawning on the well established crowfoot beds but could be improved for substrate spawners through the introduction of fresh gravels on the shallow runs immediately above and below the bridge. Sites like this are potentially valuable for coarse fish, especially where there are spawning opportunities immediately upstream of optimum fry habitats. Ensuring that different fish life stage habitat is connected is an area often neglected in river management and maintaining optimum habitat for juvenile fish immediately downstream of potential spawning sites should be a priority.

Photo 2. A wide shallow bay (ford) below a potential spawning site – good habitat for coarse fish

There are some locations where potentially recharging the river bed with imported angular river gravels (10-50mm) could boost spawning opportunities for some fish species. A great site to enhance spawning opportunities would be adjacent to, and just upstream of the footbridge above the ford. Advice and support on how this might be carried out is available from the WTT.

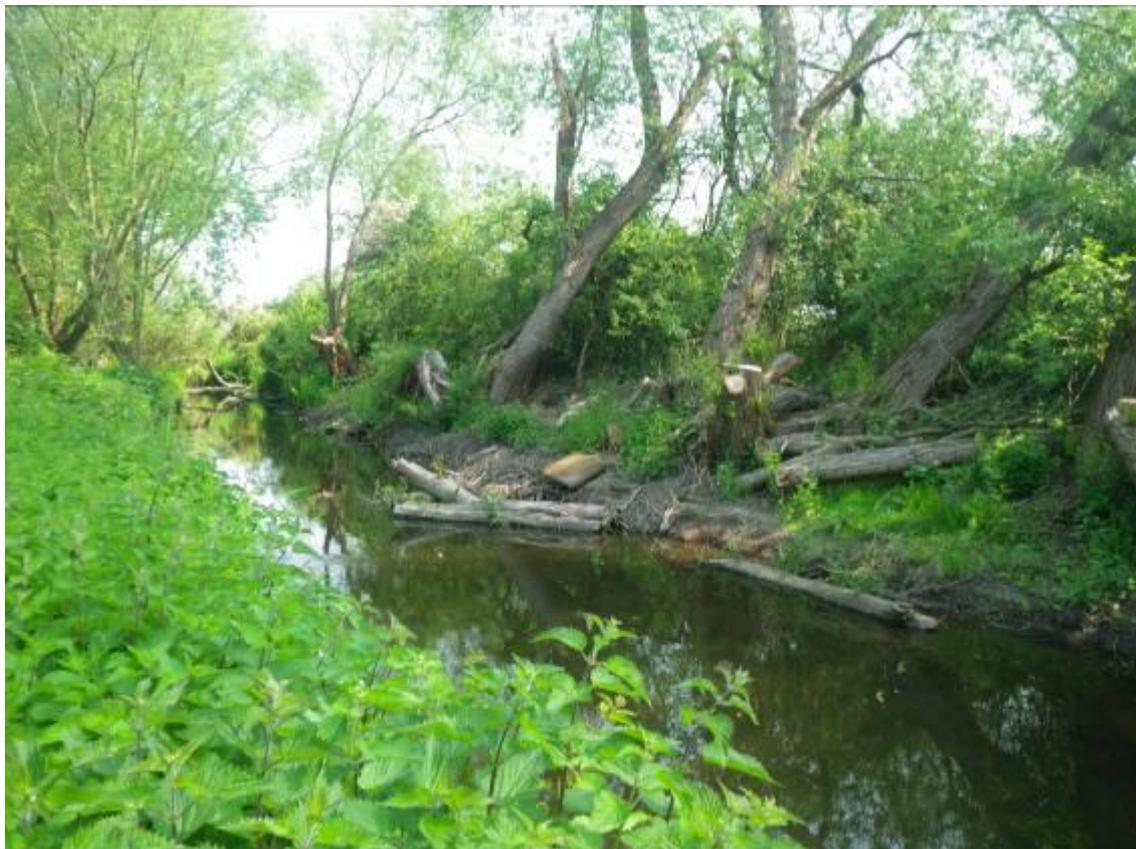
Photo 3. Recent tree works to let in more light. Further opportunities exist to use the woody material to create improved in-channel habitat.

A short distance above the footbridge, work has recently been undertaken to coppice and pollard river margin trees to open up the canopy and allow more light to reach the channel (photo 3). Some of the woody material has been deliberately left in the channel and this has provided some excellent diversity and cover in what would otherwise be an extremely flat and sterile channel. The extra light reaching the channel should in time promote increased in-channel macrophyte growth and provide much needed cover and variations to flow patterns. Large woody debris (LWD) that is currently in the channel should be secured and configured to maximise benefits, both as flow deflectors to promote bed scour and also as parallel shelves, providing a food source for grazing invertebrates and cover for fish.

A programme of sensitive tree works to establish a dappled light and shade regime. Woody material won from tree works should be secured into the channel to promote river bed scour and to provide additional cover.

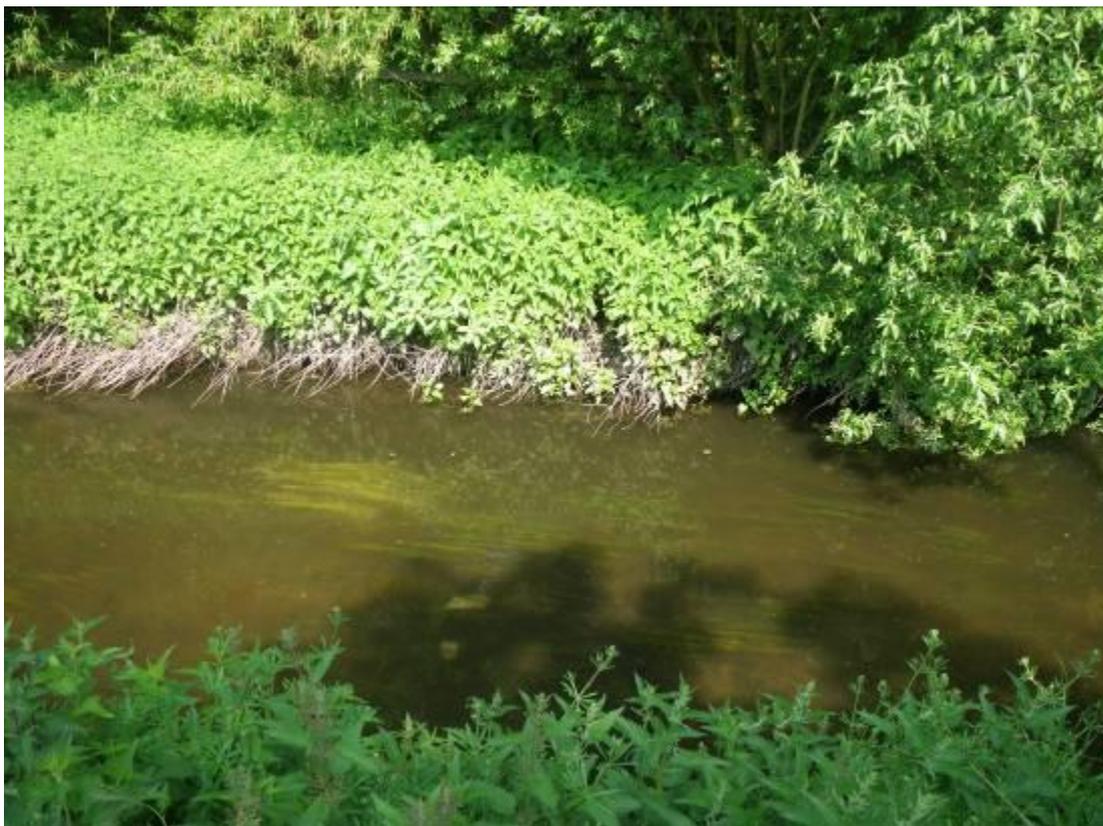
A short distance upstream the channel is more open to direct sunlight and some good habitat is available for coarse fish via low scruffy margins and beds of strap weeds such as the submerged burr reed *Sparganium sp* in photo 4.

Photo 4. Good cover for fish of all sizes from fry in the margins to larger fish in amongst the weed and low overhanging shrubs and trees

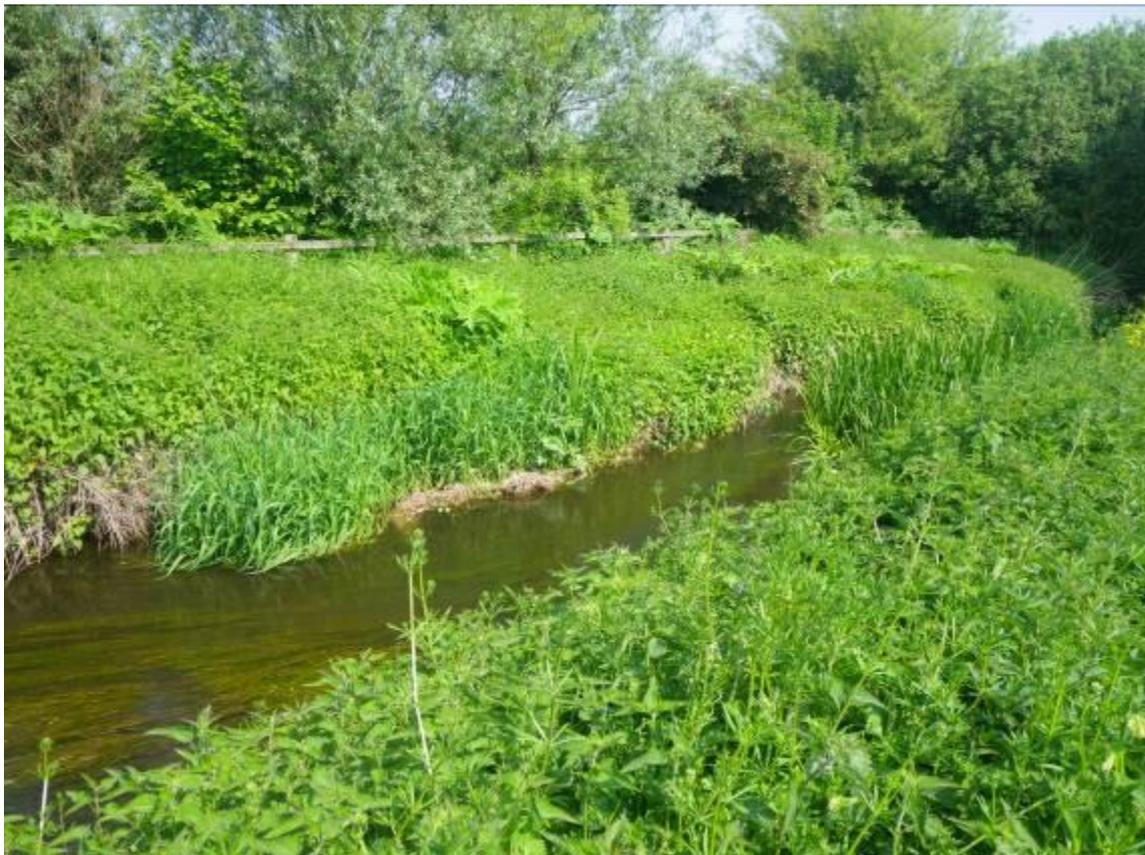
Beds of marginal emergent plants that protect the banks and squeeze the channel help to sweep soft sediments away from central channel locations. Where these reed/rush beds form, they can provide a valuable role in kicking the flow from one side of the river to the other (photo 5). Reeds, particularly the emergent form of burr reed and club rush *Schoenoplectus lacustris* can sometimes grow vigorously in central channel locations, especially on low energy rivers. When this happens there is the danger the channel can become clogged, raising water levels and generally slowing upstream water velocities. Encouraging the plants to grow well in the margins and discouraging them from completely blocking the channel often requires sensitive management intervention.

Photo 5. A bed of emergent burr reed adjacent to the LB and then a bed of reed canary grass *Phalaris arundinacea* below on the opposite bank providing good habitat, particularly for the adult life stages of many aquatic invertebrates and performing a valuable role as natural flow deflectors. Maintaining a balance like this sometimes requires intervention.

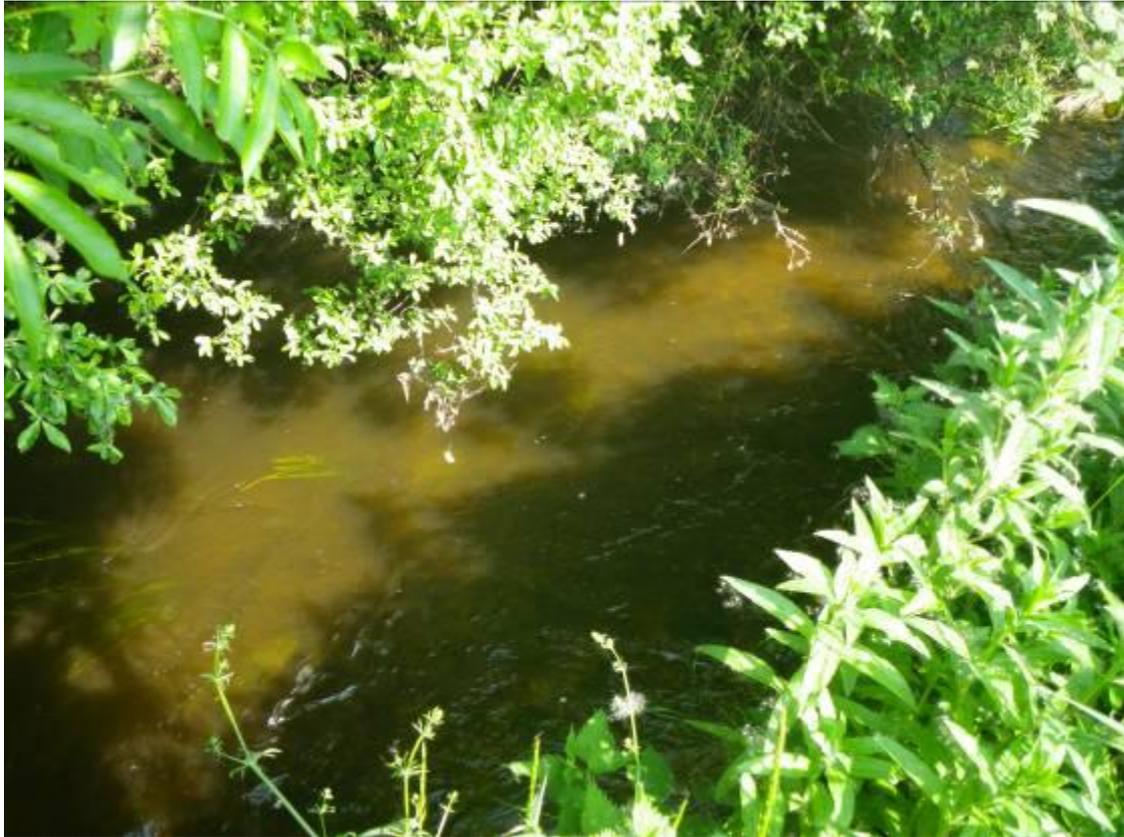
In the reach running downstream from the gauging weir the river supports some excellent habitat for flow loving coarse fish and potentially for trout (photo 6). The gradient in the river at this location promotes some valuable riffle habitat over a mainly clean gravel bed. In places the tree canopy is extremely thick (photo 7) and punching some holes to allow some dappled light to hit the river bed would be beneficial.

Photo 6. Excellent habitat for flow loving fish species including brown trout

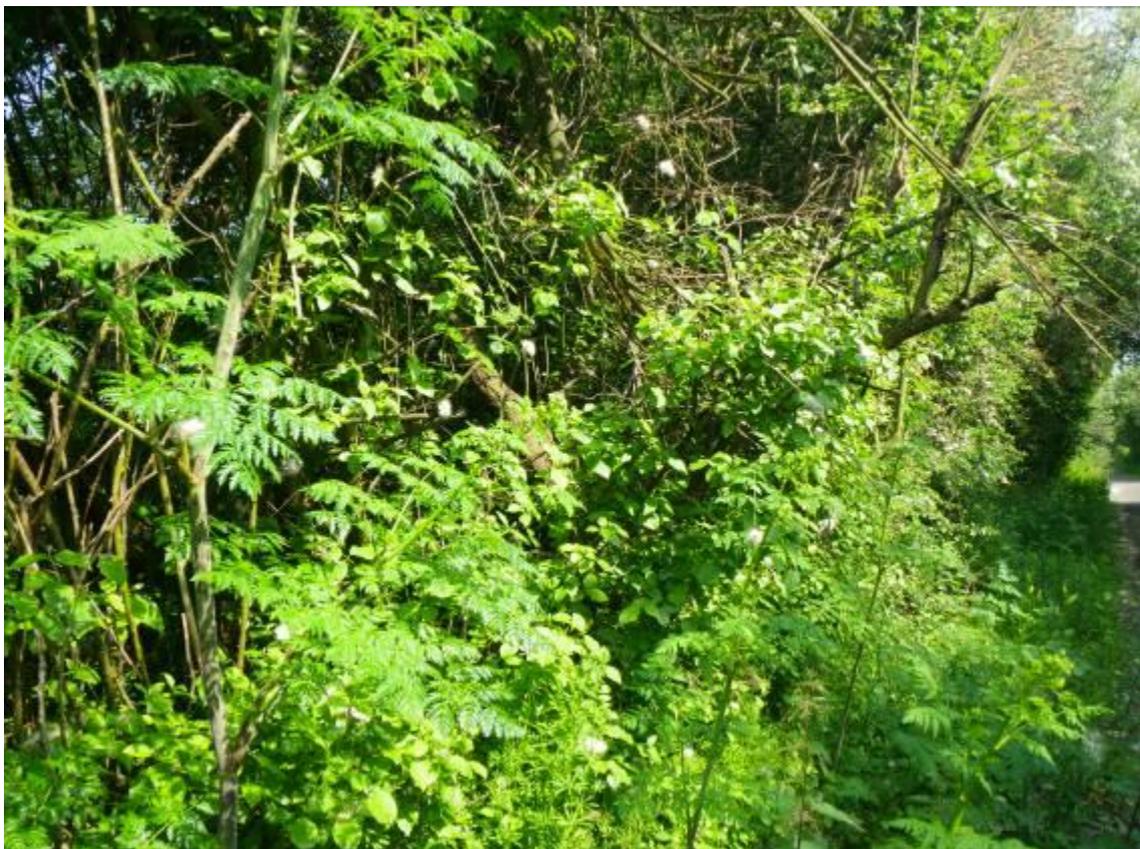
Photo 7. Some "skylighting" is required to let in some light to the channel and provide a valuable habitat like the one pictured above.

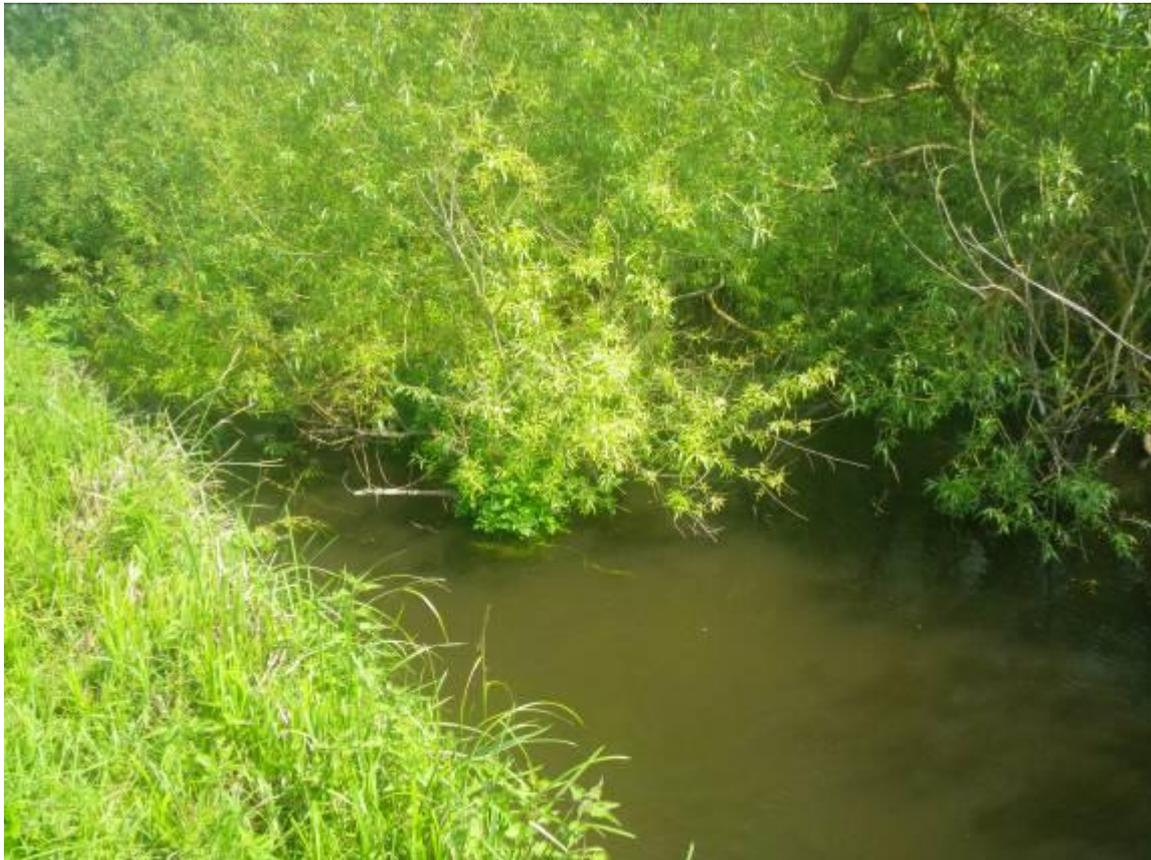
Habitat quality in the main Colne river channel as it traverses the Staines Moor varies considerably. Near the upstream boundary of the site the river channel is comparatively narrow and characterised by dense willow cover down the LB margin (photo 8). It is highly likely that this section of channel has been heavily modified and intensively managed up until the last decade or so and since then has received virtually no maintenance. There is evidence throughout the reach that the river channels have been extensively dredged, leaving a deeply incised channel in places. The encroaching willow cover provides excellent cover for fish from predation pressures but plans need to be formulated to ensure that the upper reaches do not get completely shaded over by willow growth. Cutting back some of the overhanging growth so that 50% of channel is available for light penetration would be a good target to aim for. The willow material that has fallen into the channel and is partially submerged is particularly valuable and should be retained if possible.

(Photo8) Top end of the main Colne at Staines Moor. Some light tree maintenance is required.

Given that some sections of wide shallow water is valuable, an important aspect to ensure that the shallows are packed with juvenile fish is to maximise opportunities for spawning at the upper end of the main channel. Currently there are good opportunities for root and weed spawning species but some light maintenance of the willows adjacent to the LB is required to maintain some weed growth.

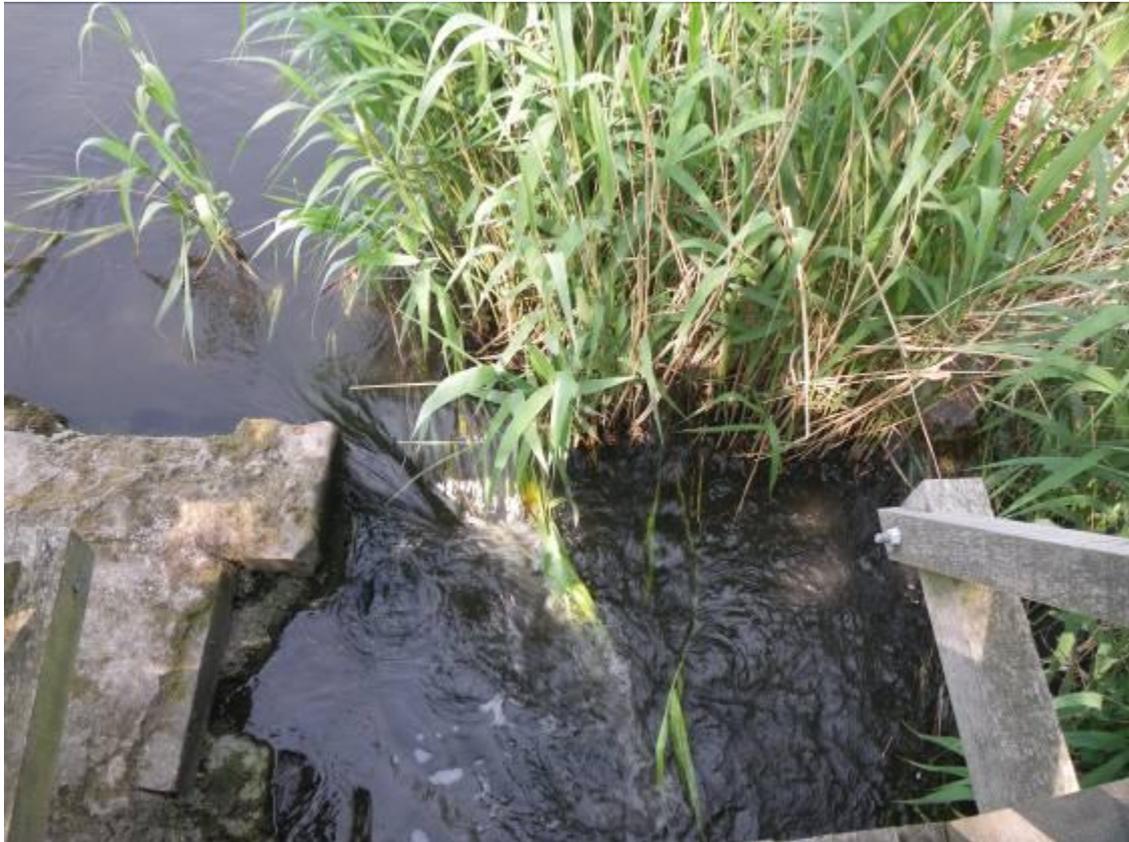
A short distance downstream there is an off-take structure on the LB (photo 9) feeding water into the Bonehead Ditch, which is a small loop off the main Colne taking water around the eastern boundary of the Moor. The water control structure is derelict and has no useable control mechanism. Water appeared to be breaching around the side of the structure and there is considerable risk of complete failure which would result in significantly more flow entering the ditch at the expense of the main channel.

Photo 9 Water bypassing the control structure feeding water into the Bonehead Ditch.

- A temporary repair might be required adjacent to the leaking structure feeding water into the Bonehead Ditch. A long term plan for resource allocation is needed for this site and will influence any permanent repairs to the structure.

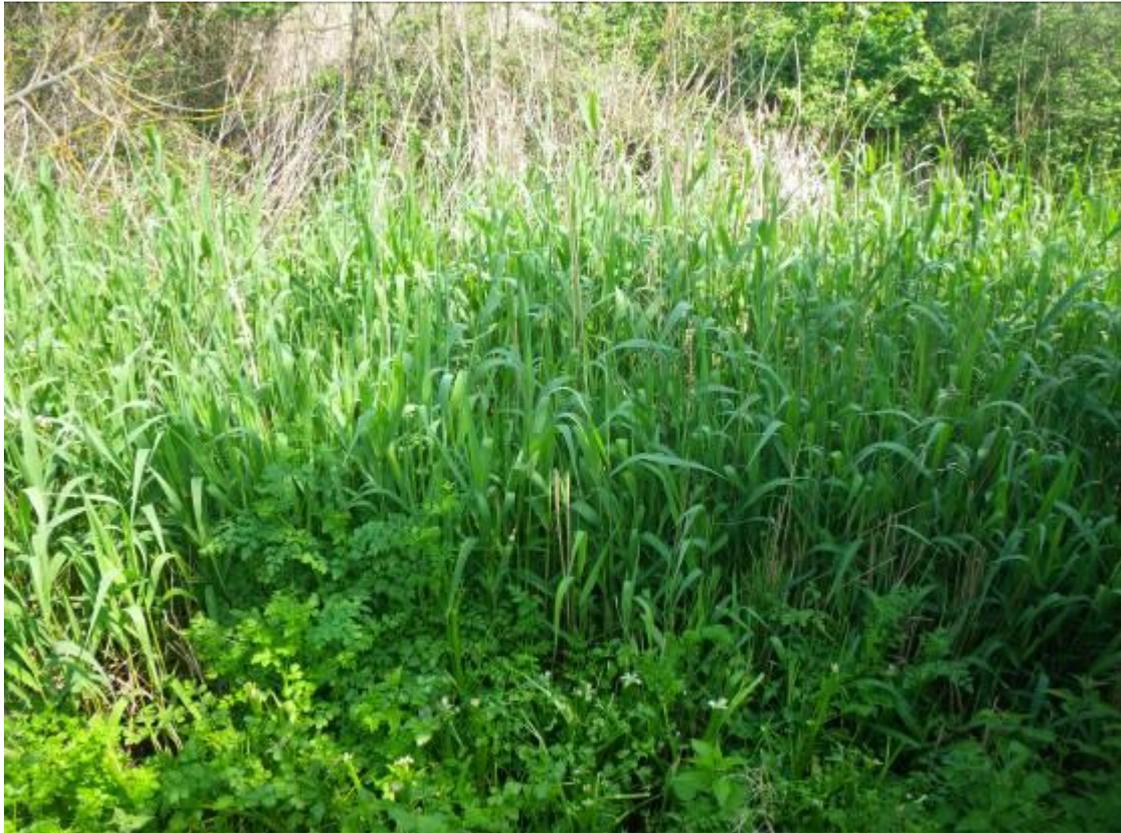
An inspection was made of the Bonehead Ditch and, like the upper reaches of main channel, this channel has been largely unmanaged for a significant number of years. In places, where there is light penetration, the channel is completely clogged with emergent plants (photo 10). In others, the channel is dominated by a tangled mass of willow (photo 11). Additional flows running through this particular environment is unlikely to be rewarded with increases in biodiversity.

Photo 10 A section of the Bonehead Ditch open to light penetration

A huge amount of resource could be put into improving habitat on the Bonehead Ditch. It is recommended that before any work is planned that an assessment of the flow requirements are made. There is a strong argument that the Bonehead Ditch should be managed purely as a ditch and possibly a blind ditch with a series of bunds to maintain water levels, rather than a flowing water course. Flow that is diverted via this route could be valuable in maintaining better quality habitat in the main River Colne. As a series of linear ditches, with

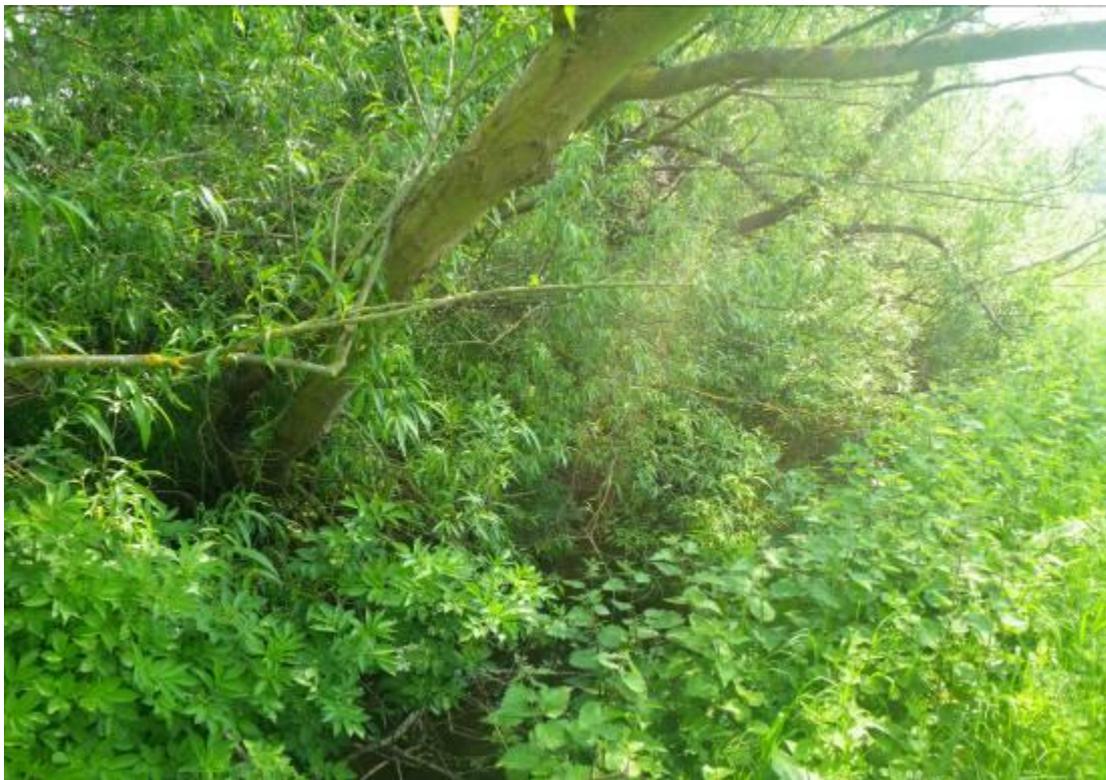
Photo 11. A typical section of the Bonehead Ditch hidden under a thick canopy.

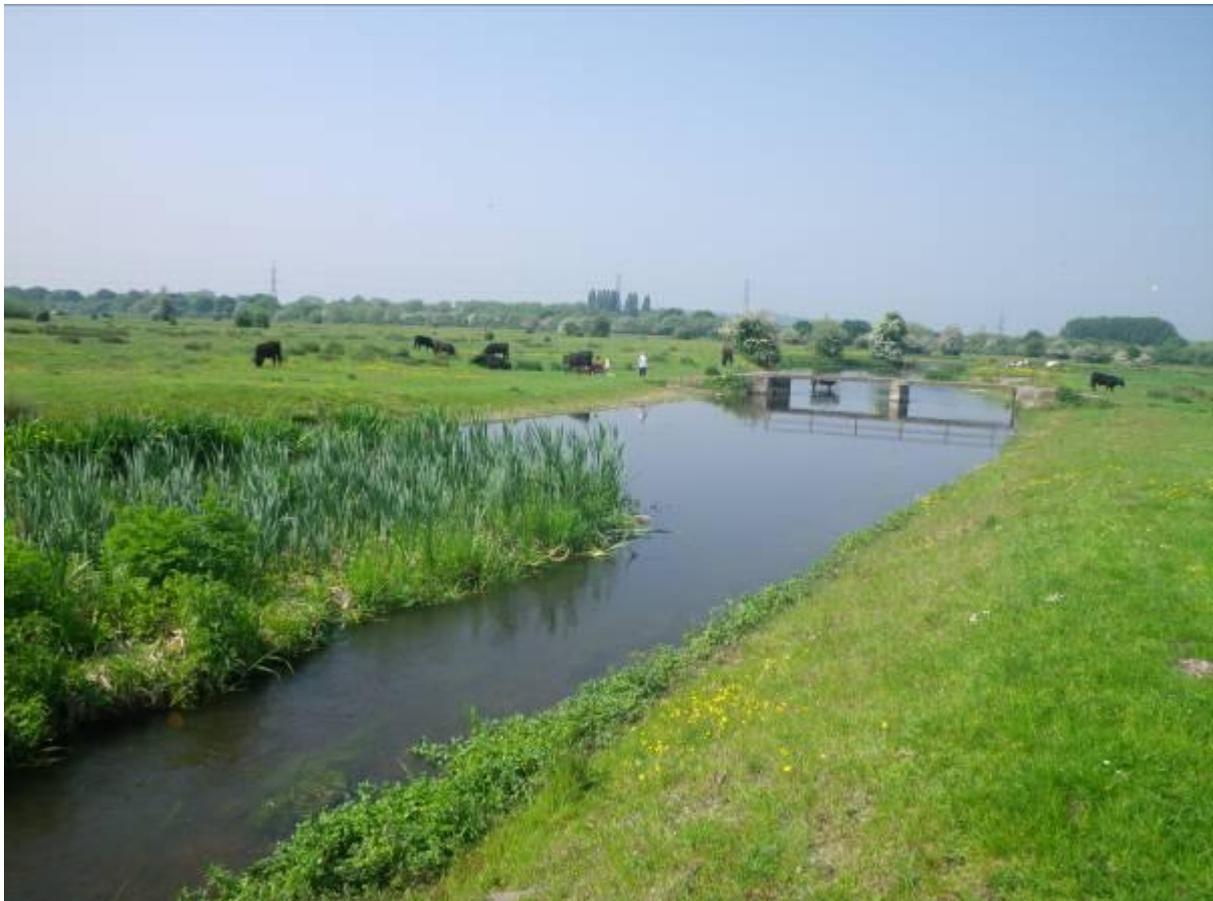
Long reaches of the main river are extremely wide and comparatively shallow and in the upper reaches there are hard bunds on the top of the bank, presumably made up of previously dredged river bed material. This is particularly evident adjacent to the RB, where the river is completely disconnected from the adjacent flood plain for long sections. On one section, the in-channel habitat quality is greatly enhanced by the presence of an island (photo 12) which has provided a valuable habitat in its own right as well as squeezing the flow through two narrow channels either side, providing some much needed diversity in the local flow regime. The remains of the old river bed are clearly visible on the raised bunds on both banks.

Photo 12. A valuable island creating much needed habitat diversity

Another consideration for maximising spawning opportunities is the availability of clean river bed gravels. The sections of channel either side of the island may well provide opportunities for gravel spawning fish species but ensuring that not too much flow is lost to the Bonehead Ditch is also a factor in making sure the upper reaches function as a spawning habitat. Recharging the squeezed sections of channel either side of the island with imported gravel could provide a superb spawning habitat for fish such as dace, chub, barbel and perhaps trout.

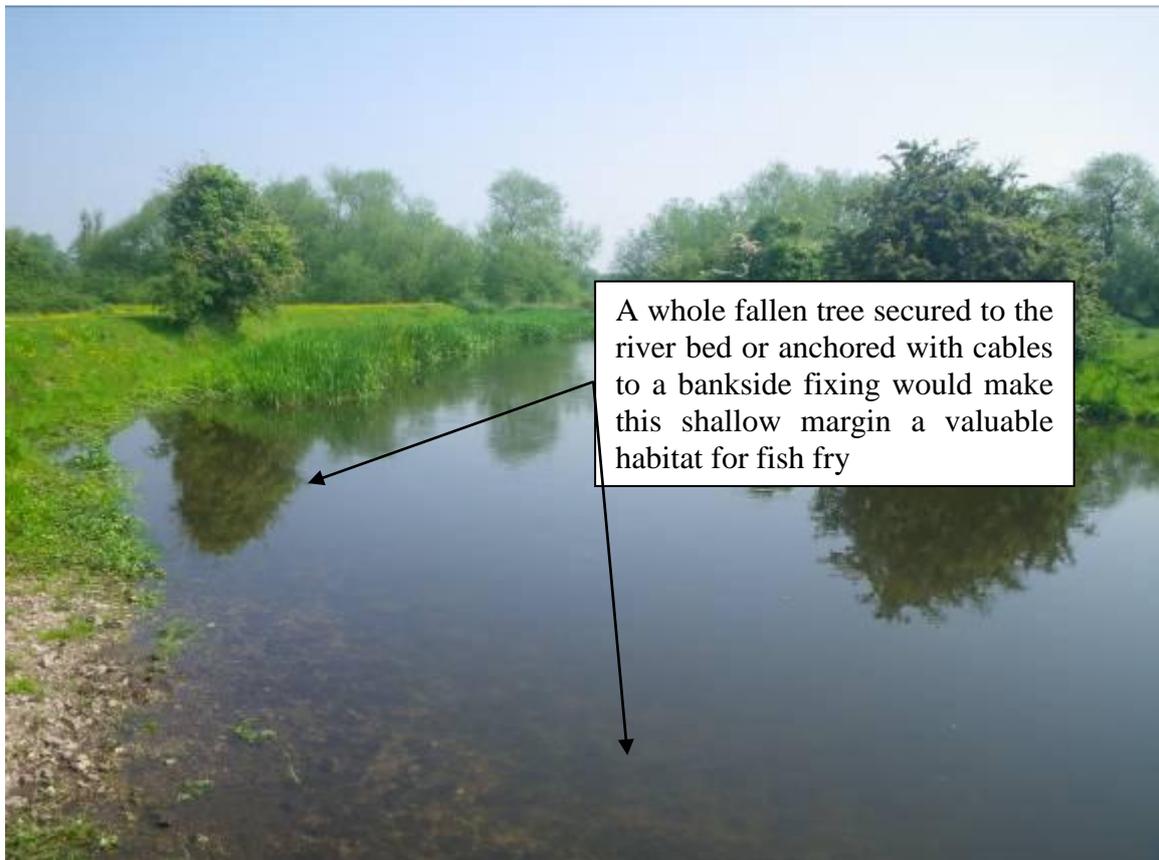
A key characteristic of the river running through the Moor is the wide, open nature of the channel and lack of any significant shading. The lack of any tree shading may be a legacy of the free grazing regime and may also complement the very reasons why the Moor is classified as a rare and important habitat. The lack of any low scrubby cover is problematic for any fish populations wishing to reside within the channel. If tree planting is undesirable then cover could be provided by importing fallen trees, including root balls and branches, and simply dragging them into the channel margins and anchoring them in place. This would be particularly valuable on top of the extensive shallow sections that potentially could provide excellent habitat for coarse fish fry (photo 13).

Photo 13. A long shallow bay in need of structure and cover

To maximise the benefits associated with the wide shallow margins it is recommended that consideration is given to introducing much more large and coarse woody debris. This can either be pegged to the river bed, or tethered to firm fixings (driven posts) in the margins, so that they can freely lift and swing around during spate conditions. Some might suggest that this habitat looks messy and it will collect rubbish but the benefits derived for the Colne will far out-weigh any problems.

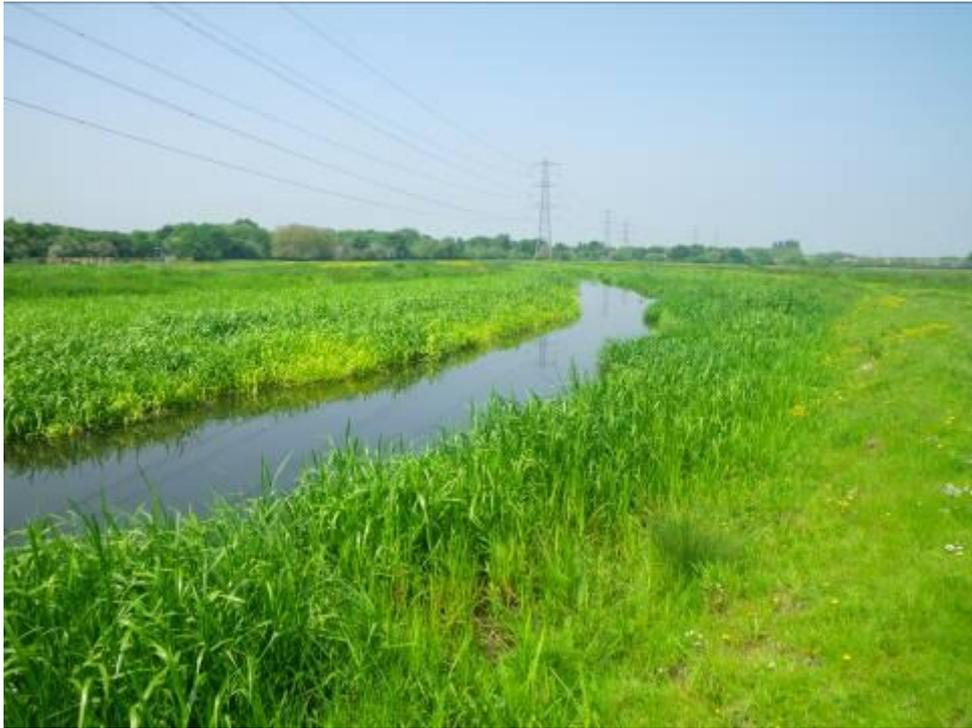
Towards the lower half of the Moor the channel has partially recovered from the past dredging activities and some luxurious beds of marginal emergent plants are well established (photo 14). These provide superb bank protection, habitat and help to elevate mid-channel water velocities by narrowing the channel. Access to the channel for pond dipping or angling is difficult but can easily be overcome by installing some low board-walks to access platforms. An example of a small "adhoc" structure installed by an angler is visible in photo 15. These structures should not damage habitat and this is a simple method for providing some riverside access. Platforms built for anglers do not need to be large, numerous in extent, or extend beyond the line of emergent plants but they are necessary if the water is to be made available for an angling club to rent.

Photo 14. Beds of marginal emergent plants squeezing the channel on the lower section. Good habitat for adult coarse fish.

- Monitor the encroachment of marginal plants right at the bottom of the reach. Intervene if necessary to avoid backing the river up too much.
- Consider some tree planting on the open sections of main channel with low scrubby trees such as willow. These will peg back reed encroachment and provide cover for fish.

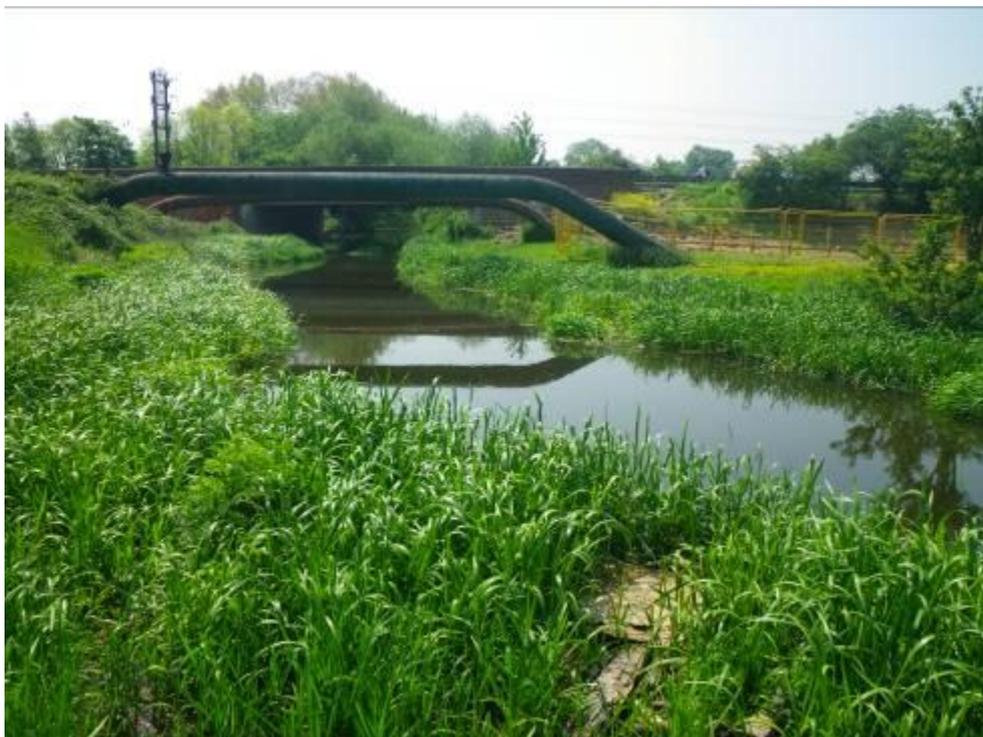
Photo 15. View to the bottom boundary

It was not possible to fully inspect the river channel beyond the bottom boundary of the Moor. It is believed that the flat, impounded characteristics found within the channel on lower section of the Moor are the result of a large weir structure located on the Colne in Staines. It is possible that the A30 road bridge also backs the water up through the reserve, possibly due to a raised

bridge invert although this has not been confirmed with any visual inspection. To ensure that water is pulled through at an acceptable rate, it is advisable to monitor the rate of reed encroachment in the lower sections from the pipe services crossing down to the road bridge. Keeping this section a little wider than the reach above will help to maintain better quality in-channel habitat on the sections running through the Moor.
