Advisory Visit

River Colne, Uxbridge Moor

January 2018

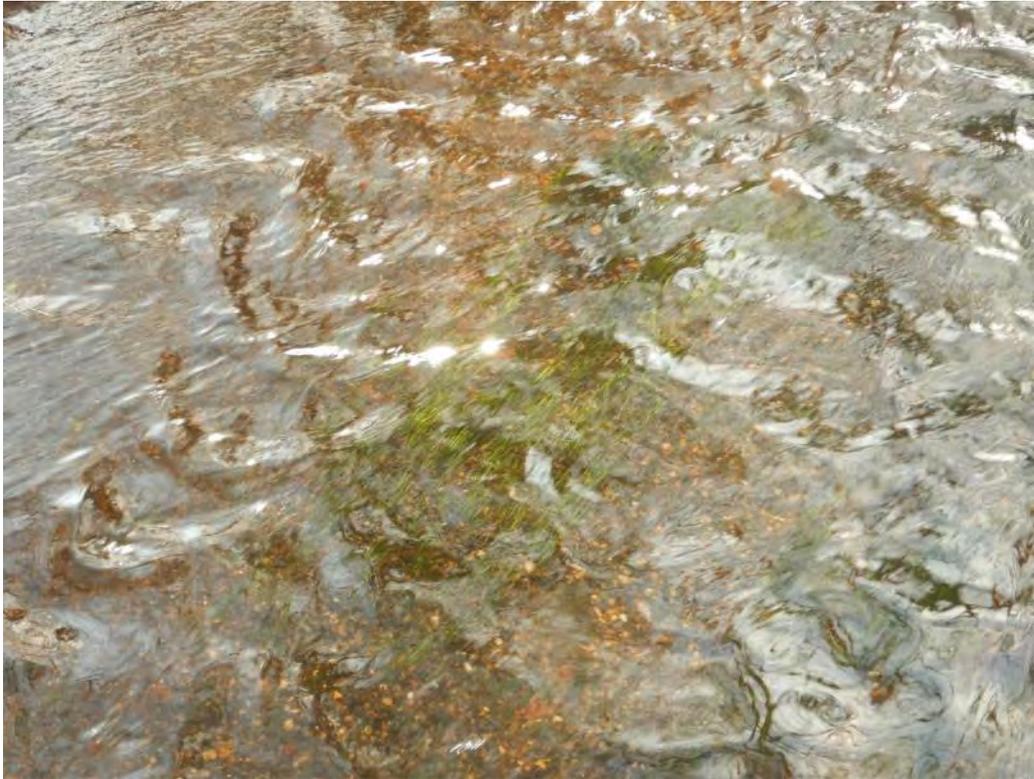
Picture 1 – Water crowfoot growing from the bed of the Sluice. This plant can provide important cover for fish and invertebrates whilst increasing water levels as it holds back flow. The growth of the plant should be encouraged through habitat enhancement techniques that increase flow rate and bed scour.

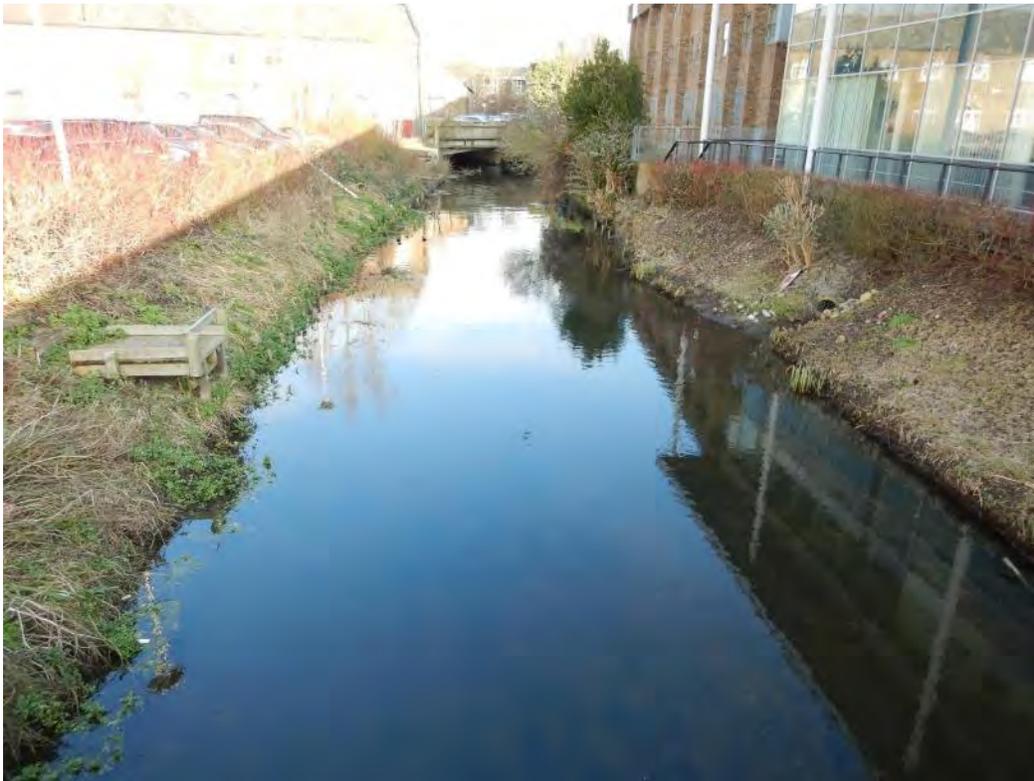
The river at this location did not look very attractive with few marginal plants, no flow diversity, little bed form variation, and dark silt smothering the bed. Burr reed was growing and it is reasonable to assume that, come July, the plant will dominate the channel thereby impeding the flow, giving an appearance of a choked channel (but with water actually finding a pathway through it).

Picture 2 – The Sluice looking upstream from Riverside Way bridge (south). Note the lack of flow diversity illustrated by a smooth water surface. There is also no cover for fish to take refuge as the marginal vegetation has been ‘managed’ and the bed form has little variation. This reach of the Sluice does not offer an attractive setting for the adjacent offices.

Improving the setting of the offices using more sensitive land management techniques could be the key to improving further habitat areas of the Sluice. Engagement with the site owners should be attempted to improve aspects of the channel (flow diversity, appearance and biodiversity) as there is evidence accruing that a healthy ecosystem confers healthier, happier people.

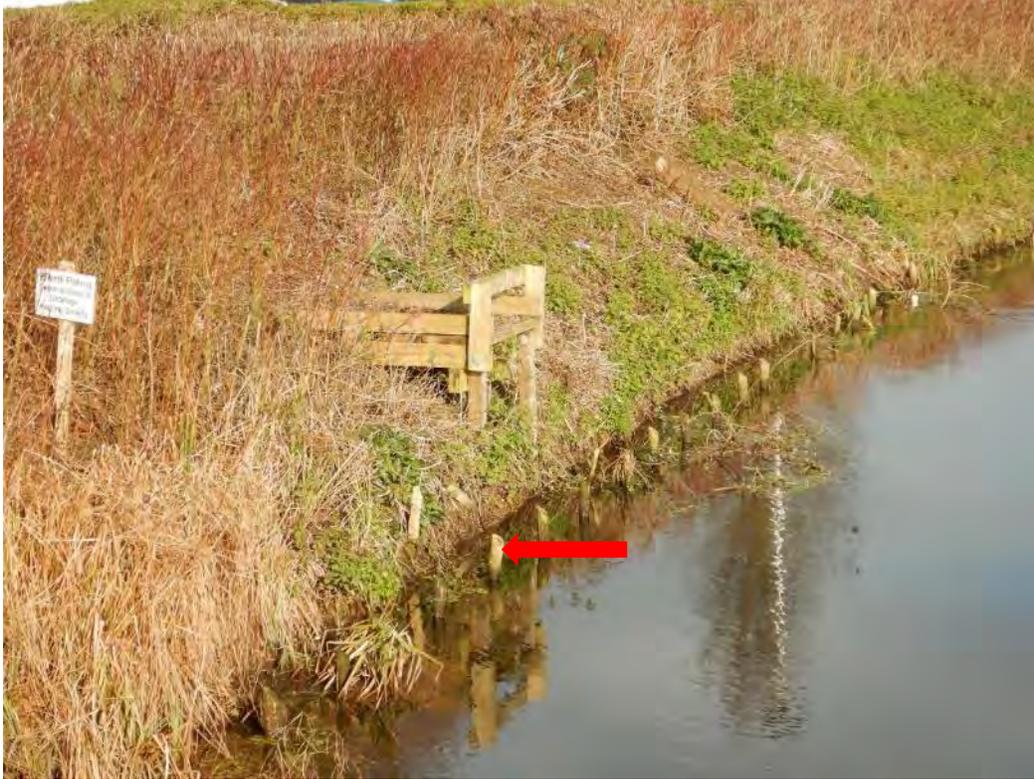
When the Sluice was viewed looking upstream, a number of fishing platforms were apparent. There were also posts that is assumed would have once held coir rolls or some other form of marginal habitat enhancement but that have since degraded to leave nothing of value. The LHB marginal plants had been cut down to water level, **presumably to maintain a 'tidy', kept** appearance in front of the offices. Consequently no standing marginal habitat was present. Removal of standing dead vegetation would have negative consequences for a range of invertebrates as vegetation provides an important food source and as over-winter cover. A reduced abundance of invertebrates may result in less food for fish. Only a very narrow (~0.3m) fringe had been retained on the side from which angling could take place (the RHB). At the time of the visit, the new owner of the offices approached

Picture 3 – Note the posts (red arrow) that would have held habitat enhancement features such as pre-planted coir rolls. Consideration should be given to replacing this features or to seek permission to replace them with something more durable and beneficial to the river.

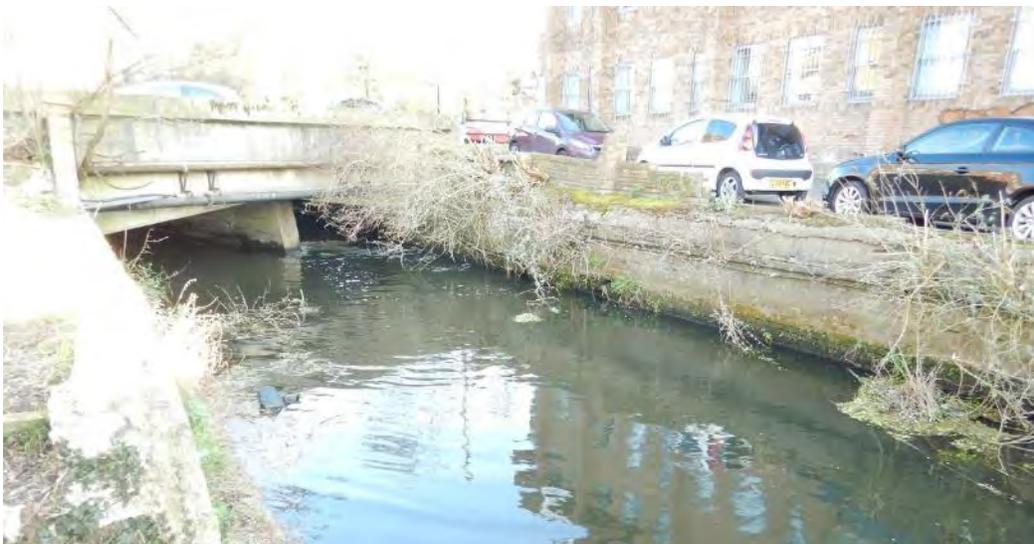
A short distance upstream of the offices, the river was fronted by a hard concrete wall which, except for where it was failing and plants had been able to root, offered no habitat value for fish.

Picture 4 – The concrete wall offers little habitat except where vegetation has managed to root and trails into the water.

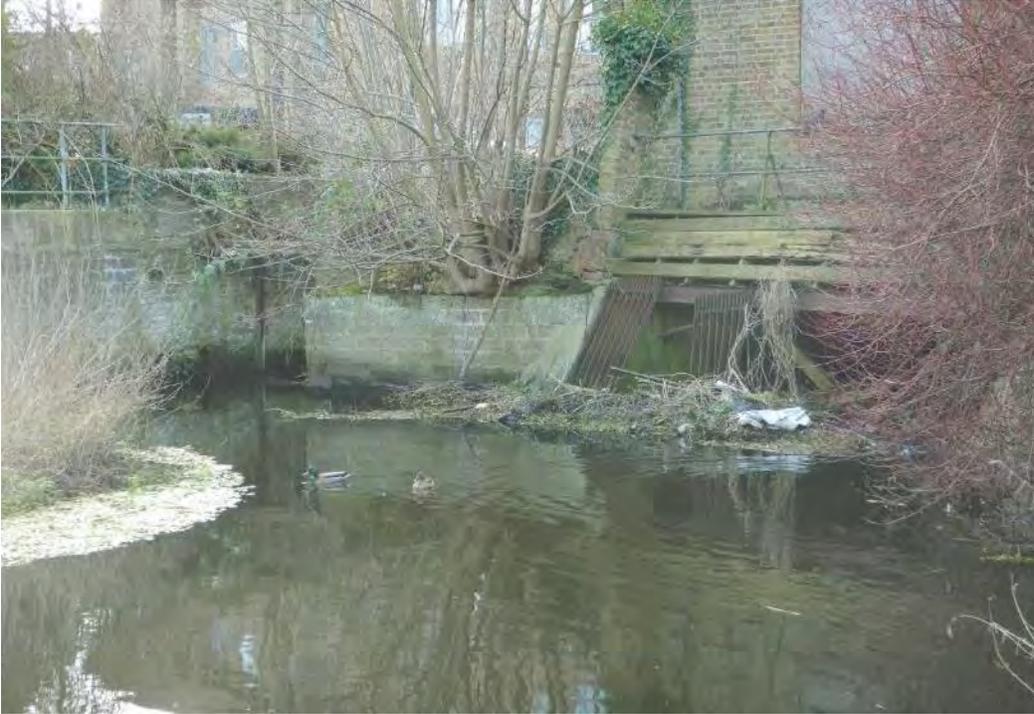
The sluice at the mill is in a poor state of repair (picture 5). The grill preventing debris from washing beneath it is partially damaged and large tree stems were wedged into it. It was not possible to assess the height of the fall. The main flow appears to run around the mill, dropping over a side sluice with a fall of ~0.3m (picture 6) into a narrow channel. The mill and its sluices are considered to present a barrier to the upstream movement of fish.

Picture 5 – Note the trash (which included tree stems) built-up against the mill intake. The side sluice now takes the majority of the flow.

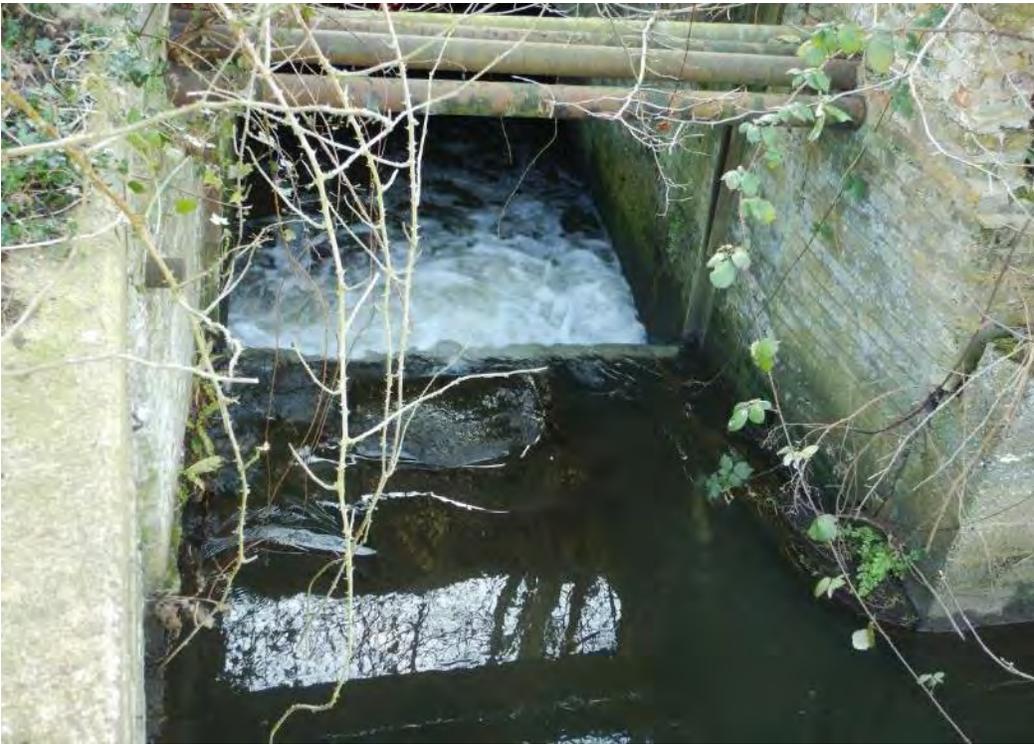
Picture 6 – The side sluice to the former mill (now Government Offices). This structure is considered impassable to most coarse fish species. It may be passable to trout. A lack of access prevented it from being properly assessed.

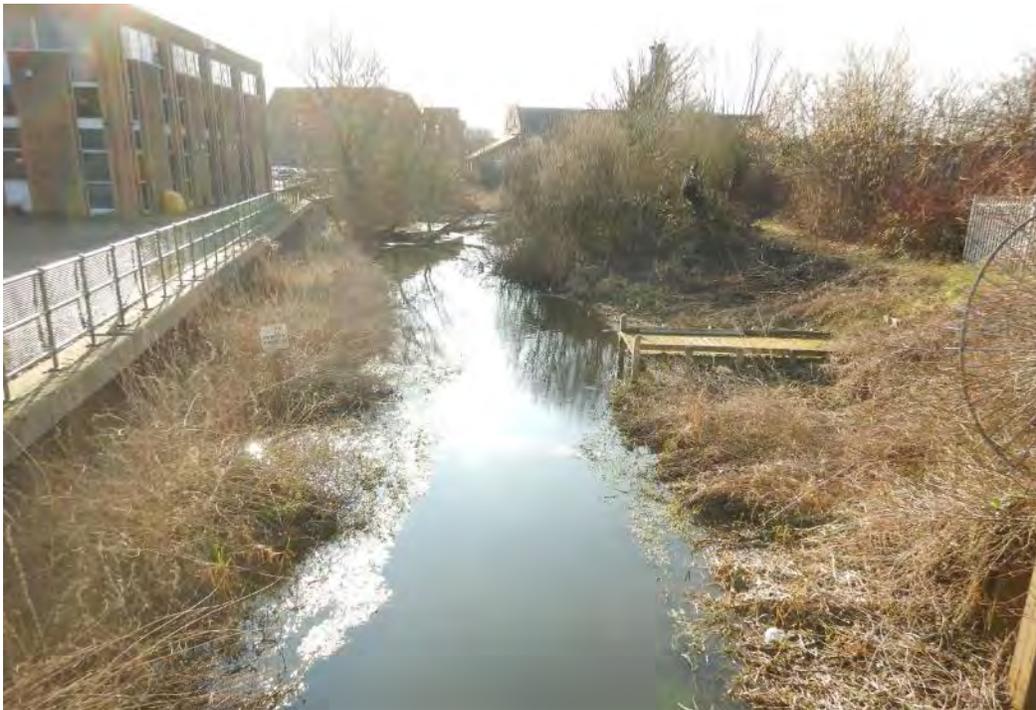
Above the mill, the channel was clearly wider in the past as the mill pond. However, it appears that in recent times the mill pond has become partially silted leading to the development of berms (picture 7) which in turn have become vegetated with reed canary grass and greater willow herb. These vegetated berms present an important habitat as they are providing a gradual transition from water to dry land. The vegetated margins will be providing juvenile fish cover and a diversity of habitats for invertebrates. The flow in the impounded mill pond is slow and consequently silt has settled upon the bed smothering the gravel (picture 8).

Picture 7 – The mill pond which has developed vegetated margins as a result of silt settlement and colonisation by plants. These vegetated berms provide important marginal cover.

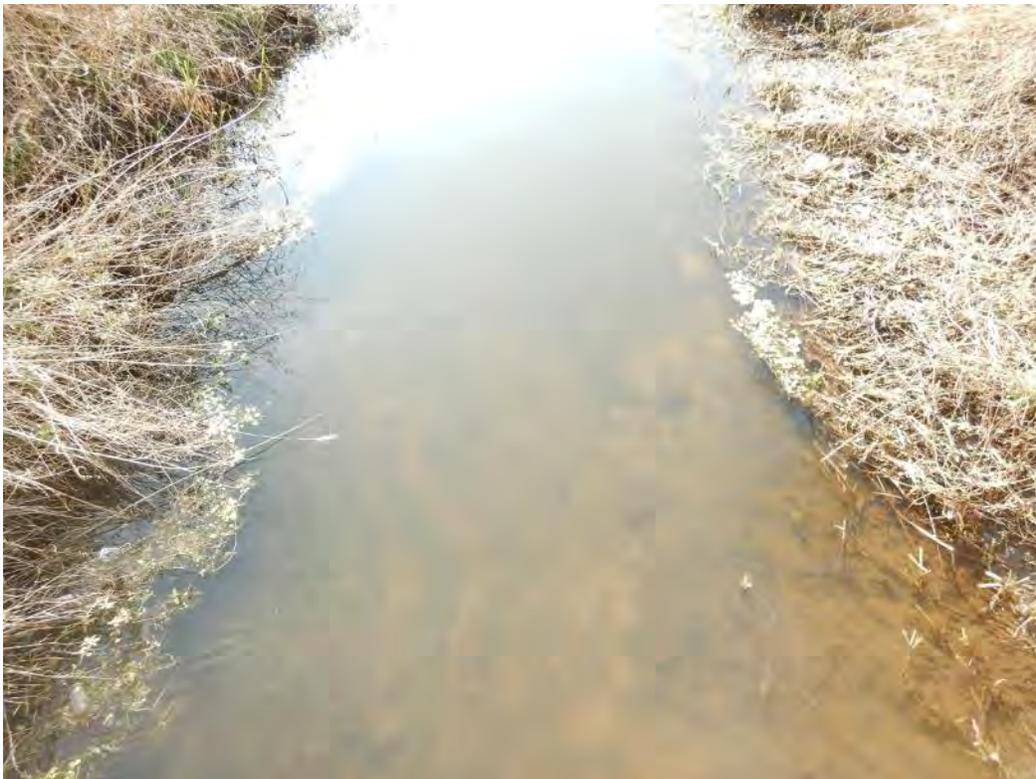
Picture 8 – The bed of the mill pond has a covering of silt over gravel.

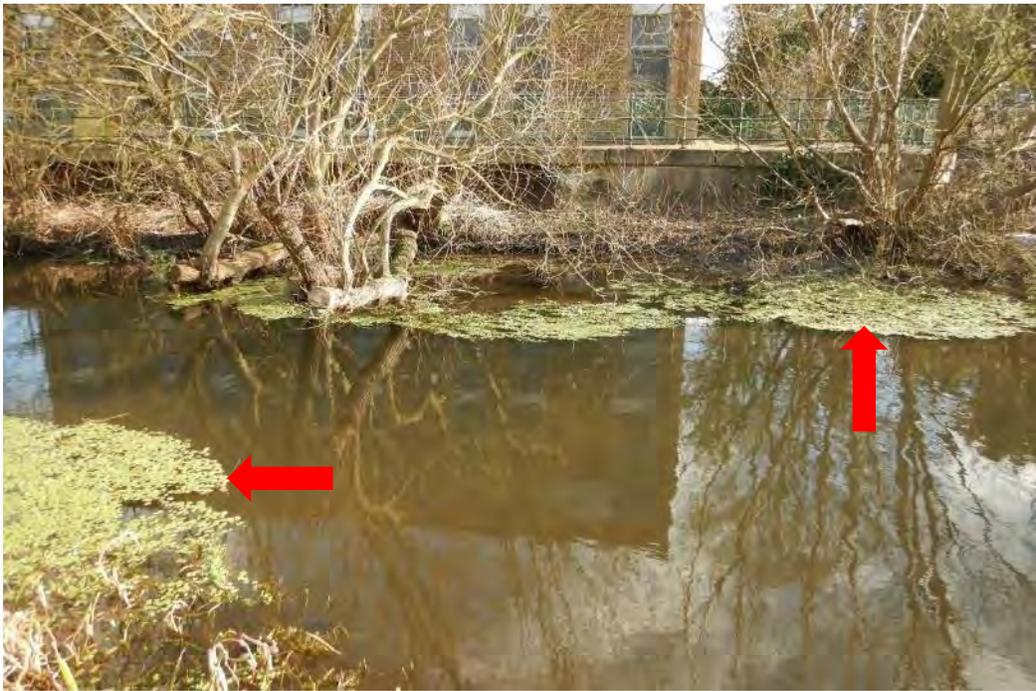
In places, willow trees have fallen into the water. Many trees had been cut back but fortunately trailing branches and roots have been retained (picture 9). Trailing branches further increase habitat for invertebrates and willow root masses provide good cover for freshwater shrimp. Importantly, both these habitats can be used by coarse fish as spawning substrates.

Picture 9 – Willow tree have been cut back but fortunately cover has been retained in the form of trailing branches and roots. Note the rafts of floating pennywort (red arrows).

Floating pennywort is particularly prevalent in the mill pond as the flow is not enough to flush it though, and the trailing willow branches catch small fragments as they drift downstream. This enables the plant to continue growing whilst anchored in the margins from which pieces break away to colonise new areas. The Angling Society are actively removing the plant where possible but their actions only manage to keep up with the growth rather than achieve eradication. Advice should be sought from experts in the EA on the best method of control.

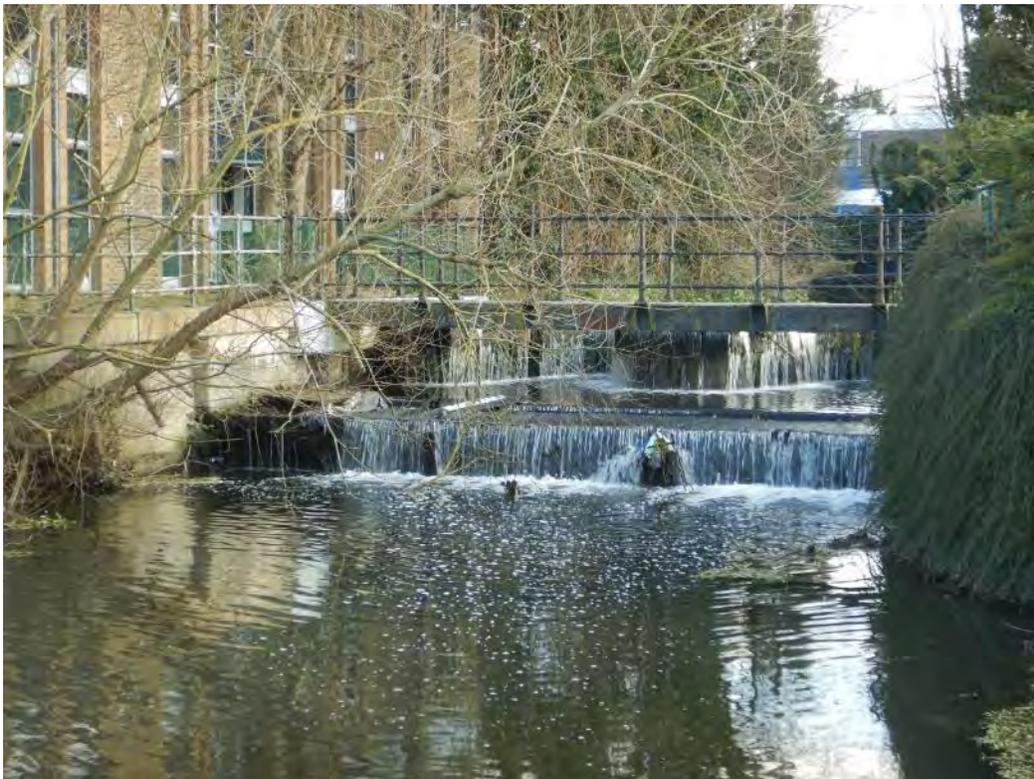
The inflow from the Grand Union Canal enters via a cascade of water (picture 10) which is probably locally important for increasing oxygenation during low flow and/or warm water periods. The canal would not provide habitat for trout so it was not assessed.

Picture 10 – The flow of the Grand Union Canal enters the Sluice by a cascade; whilst this inflow is impassable to fish, it will provide oxygenation of the water received from the canal.

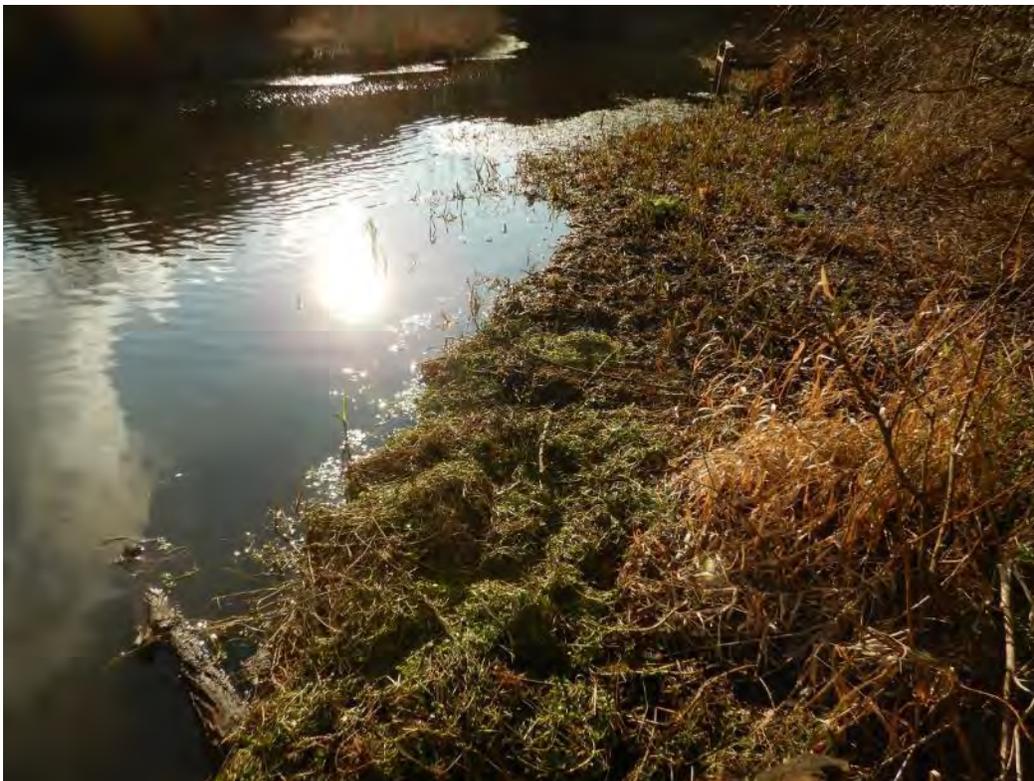
Removal of the pennywort by raking it back is also having a knock-on effect on other marginal plants as they too are being pulled out as a by-catch of the control. The establishment of more strongly rooted plants which grow taller, such as yellow flag iris and lesser pond sedge should be considered in order to retain some native marginal habitat.

Picture 11 – Removal of the floating pennywort is also resulting in the removal of native marginal plants with a negative impact upon both the Sluice and the Colne. A strategy needs to be evolved that sees the removal of the invasive plant but retains the natives. Consideration should be given to planting new native marginal plants such as yellow flag iris and lesser pond sedge both of which are strongly rooted and may not be prone to removal as pennywort is raked to the sides.

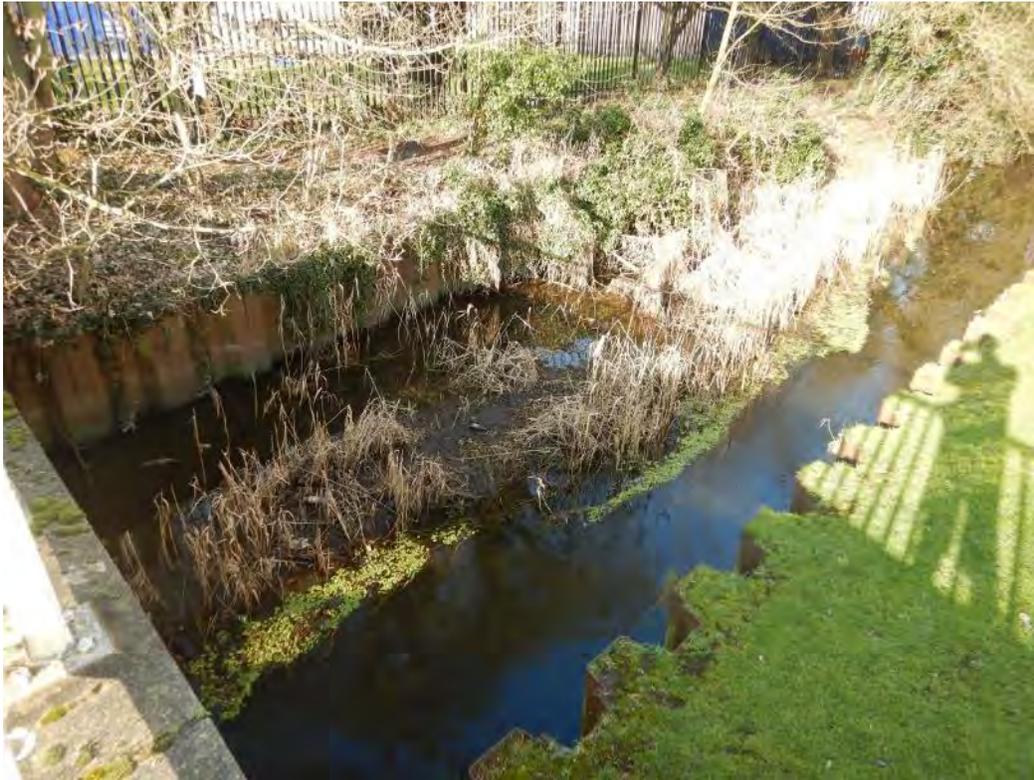
Immediately above the Riverside Way bridge (north), there was a stand of common reed which had narrowed the channel by >50%. This is a good example of a naturally narrowed channel pinching the flow to a width where the flow velocity is sufficient to cleanse silt from the bed and to expose gravel.

Picture 12 – Note that this stand of common reed has been allowed to grow out into the channel presumably without any negative impact upon the channel's flood conveyance capacity.

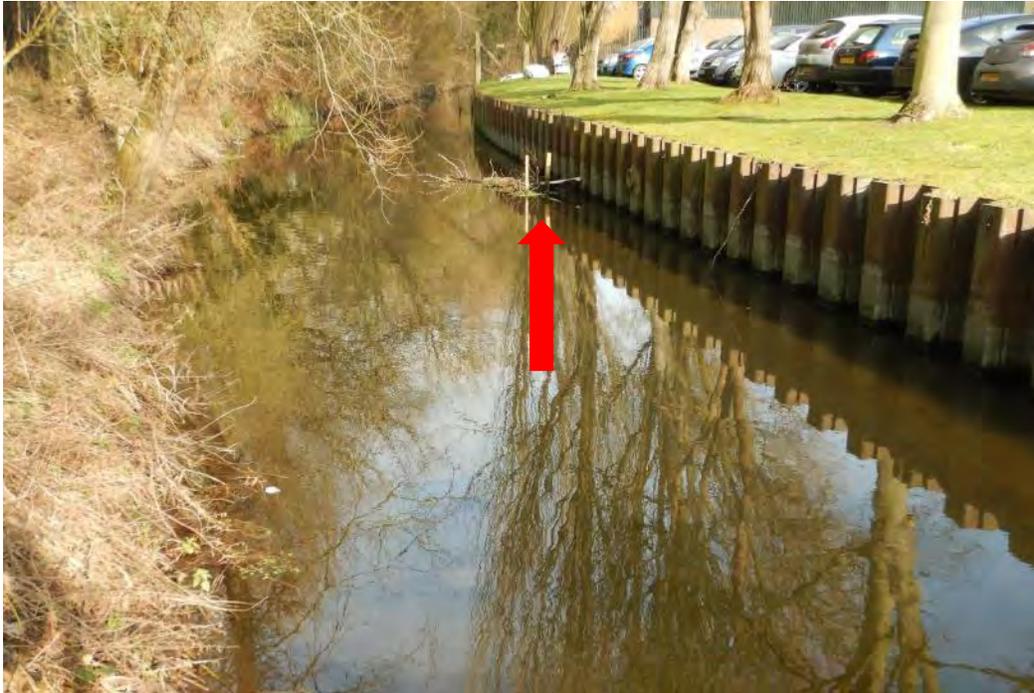
In the locality of the small industrial units, sheet steel piling was present, which presented no habitat opportunities. With the Colne being an urban river, it has largely lost its floodplain connection. This is detrimental to the flow regime of the river and to its ecology. The presence of dark silt upon the river bed suggests that urban run-off is an issue for the river. Without the river having a means to flush silt out of its channel (as might happen in a flood) that silt remains. It could be possible to use habitat enhancement techniques, such as brushwood ledges, to entrain the silt in order to establish vegetated margins.

Picture 13 – Note the hard edge presented by the sheet steel piling which offers no habitat. One low key flow deflector is present (red arrow).

To mitigate the lack of in-channel features within the Sluice, the Angling Society has undertaken some low key interventions in the form of small flow deflectors (pictures 13 and 14). These features generally consist of vertical posts erected to catch material drifting downstream thereby creating a raft. The material creates a small refuge area for fish but has very limited effect on local flow diversity. To have a greater beneficial impact upon the river, all flow deflectors should be increased in size. Flow deflectors are often created up to a size of 50% of a channel width. This local narrowing increases flow velocity to the point where bed scour is created.

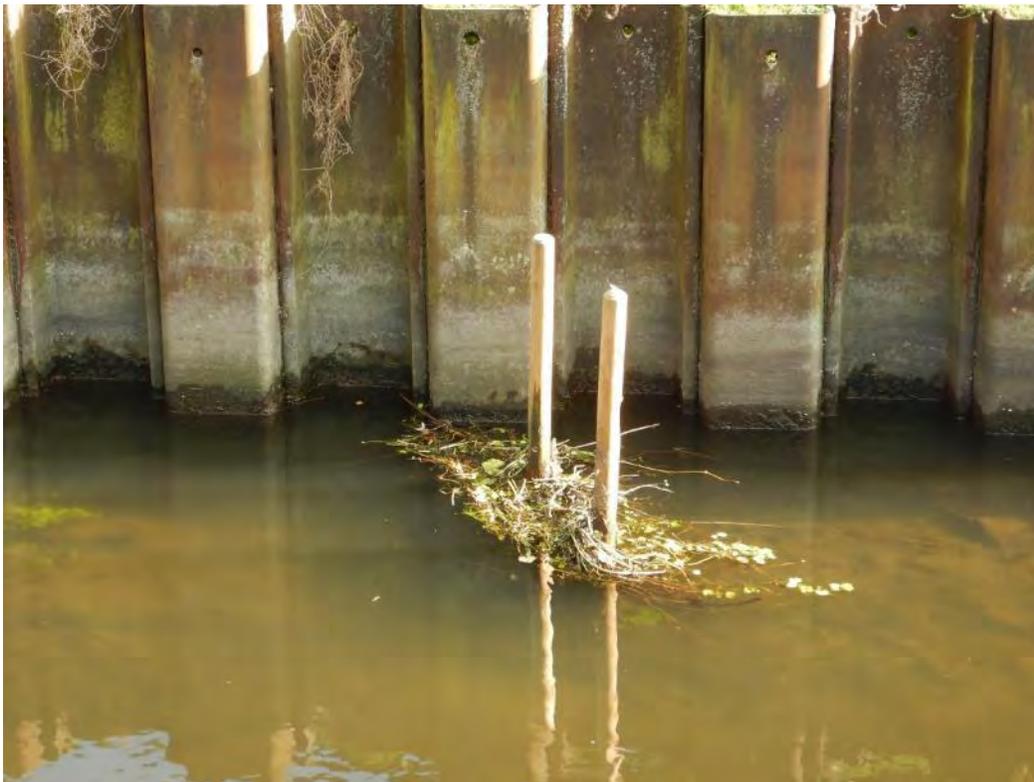
Picture 14 – A close-up view of the flow deflector which is a simple arrangement of vertical posts which collect material drifting downstream. These features should be replaced with structures that are larger in width in order to create a greater scour effect within the channel.

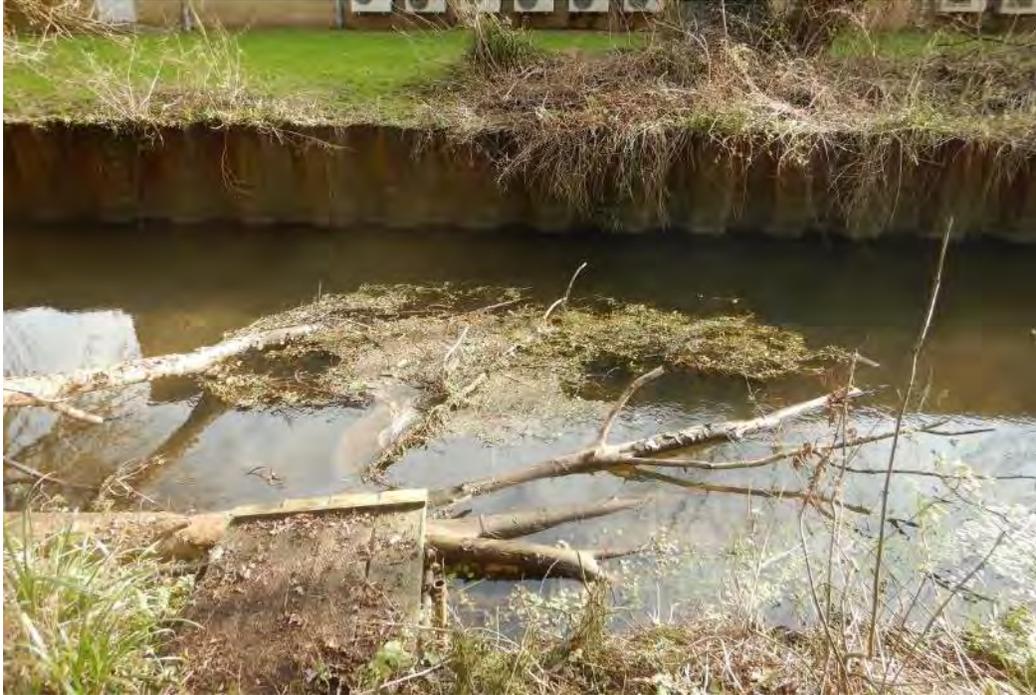
At one location (picture 15), a number of fallen tree branches have been retained within the channel. They provide valuable functions: as fish refugia and as flow deflectors. Ideally, they should be kept in their current location with the angling platform relocated in order to retain important habitat and fish refuge.

Picture 15 – Fallen branches are providing important cover in an otherwise open channel

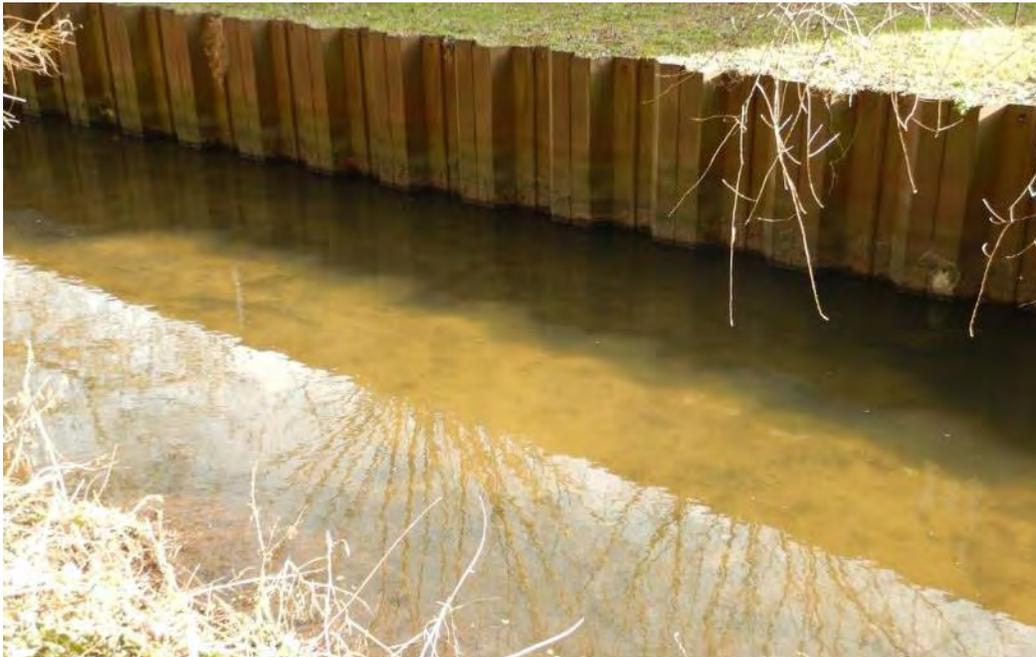
The majority of the Sluice had extremely poor instream and marginal habitat. The highly modified nature of the waterbody means that there is very limited natural bank gradient **at the water's edge** to enable emergent or marginal plants to become established (picture 16). Fish cover was very limited. A large shoal believed to be of roach (and possibly perch) was observed swimming very tightly and rapidly. The fish appeared unsettled and were probably searching for cover. No other fish were seen in the Sluice.

Picture 16 – Note the complete absence of cover for fish and the even smothering of silt upon the bed. The sheet steel piling offers no habitat.

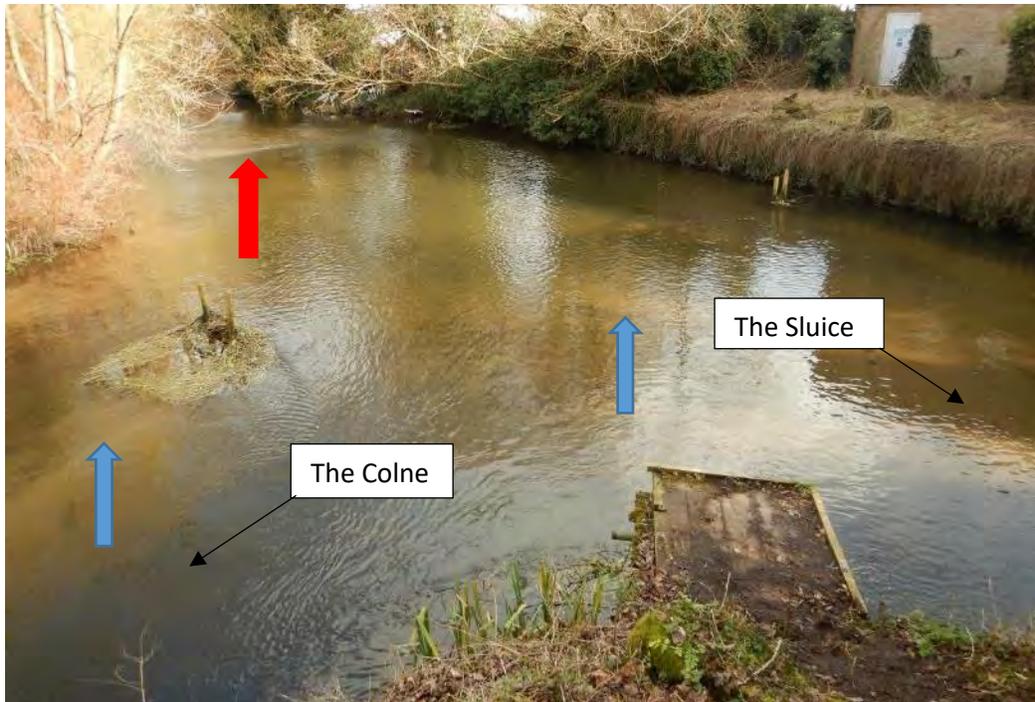
Picture 17 – The point at which the main Colne splits to supply the Sluice. Note the gravel bar (red arrow) and sand bars (blue arrows).

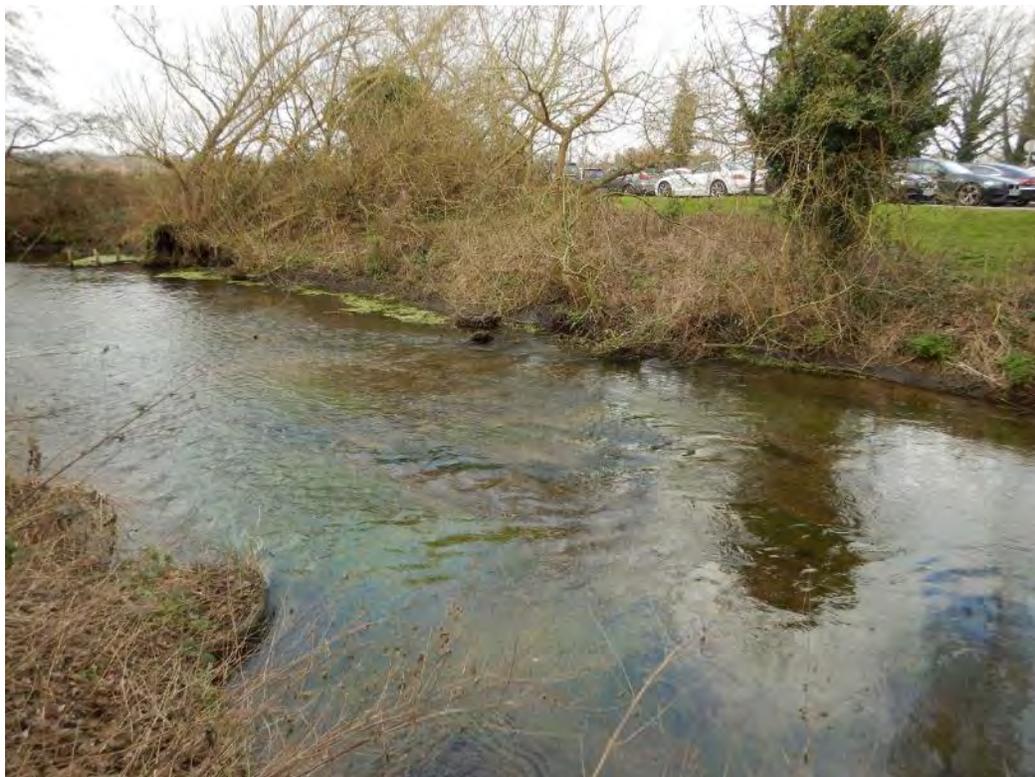
Picture 18 – A riffle within the Colne, an important area for fish spawning and juvenile habitat. Riffles should receive good amounts of sun light in order for good plant growth. Plant growth upon riffles increases the available niches for fish and invertebrates.

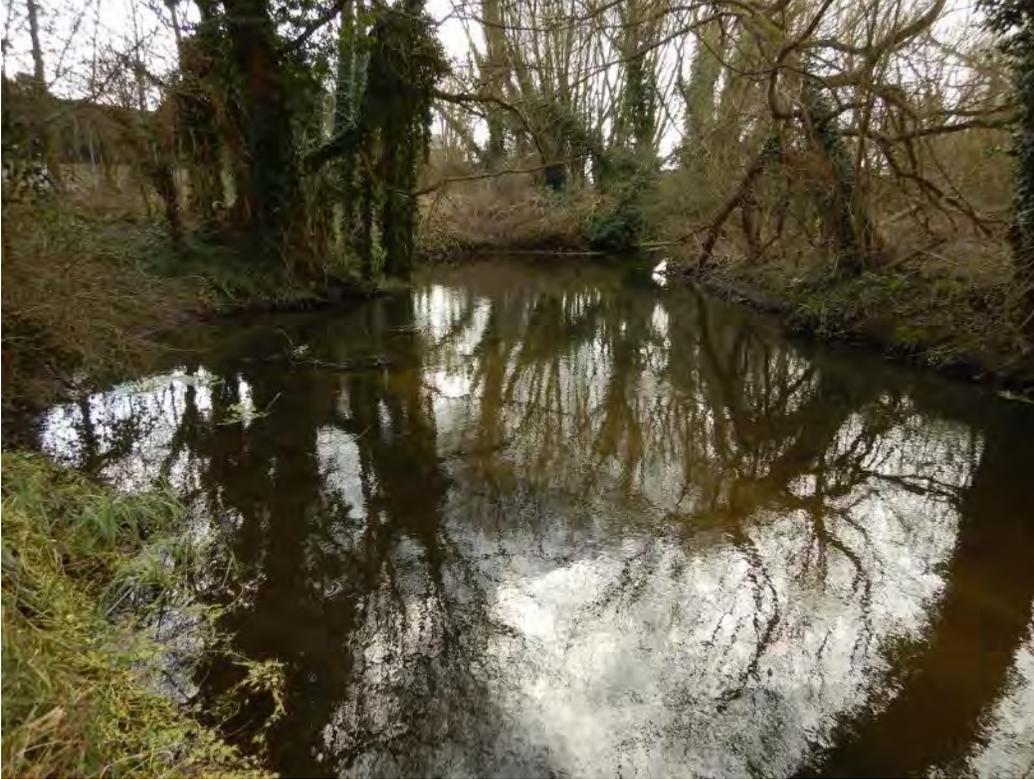
The Colne is lined with mature trees, mainly willow but with some alder and ash also present. The trees cast dense shade over the river. Even though this visit took place in winter, the presence or absence of plants largely corresponded with the tree cover. Shade cast by riparian trees is limiting the extent of both aquatic and marginal plant growth. Consideration should be given to a management strategy to create a mixed age structure of riparian trees. However, due to the site being part of a nature reserve, any such action must be discussed with the London Wildlife Trust.

Picture 19 – The Colne was shaded mainly by willow trees, many of which were a similar age. Tree management could create a better balance of light and shade upon the channel and create age and structural diversity within the tree stock.

Tree management could start with the pollarding of willows as that would retain high cover and allow light to reach the river. However, pollarding trees, by its very nature, will remove the occurrence of collapsed limbs that could provide beneficial habitat. It is possible that a balance could be found where trees are pollarded to sustain their growth and a number of tree limbs or stems are tethered in the water to increase cover.

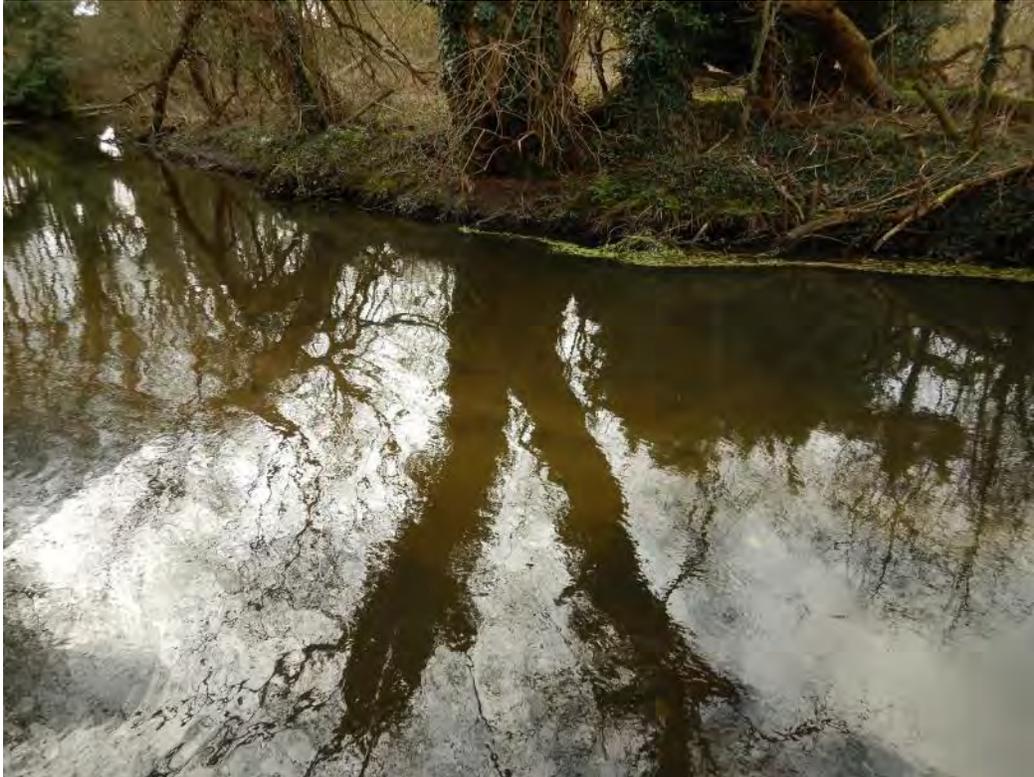
Picture 20 – The Colne was densely shaded (even in winter). Sand was dominant where flow diversity was lacking and it was able to smother the bed.

smother the gravel bed. With a degree of channel narrowing and/or the creation of brushwood margins, the increased flow velocity would transport, sort and deposit the sand in the margins to provide a suitable substrate for marginal plants to colonise and stabilise (provided plants have enough light).

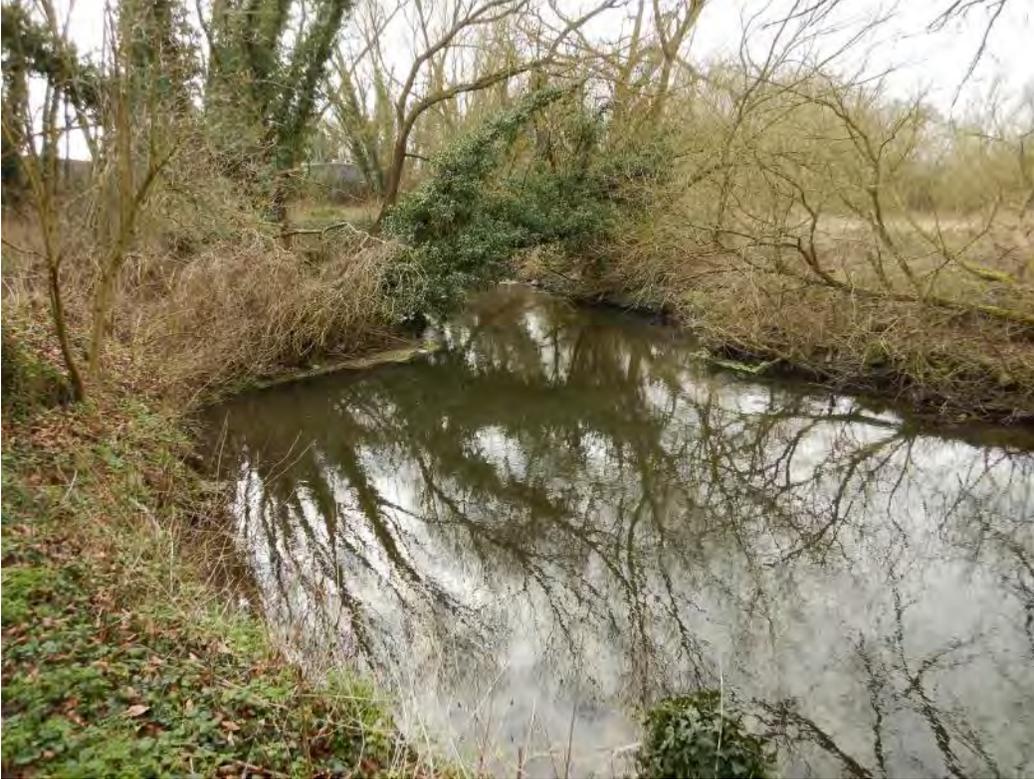
The presence of many fallen trees within the Colne should not be seen as a problem. Trout and chub are commonly associated with such features because they provide food and shelter. Trees also initiate geomorphic processes, such as bed scour, sediment transport and deposition.

Picture 21 – Fallen trees provide important overhead cover for many fish species. Additionally, roach and perch will spawn upon trailing branches.

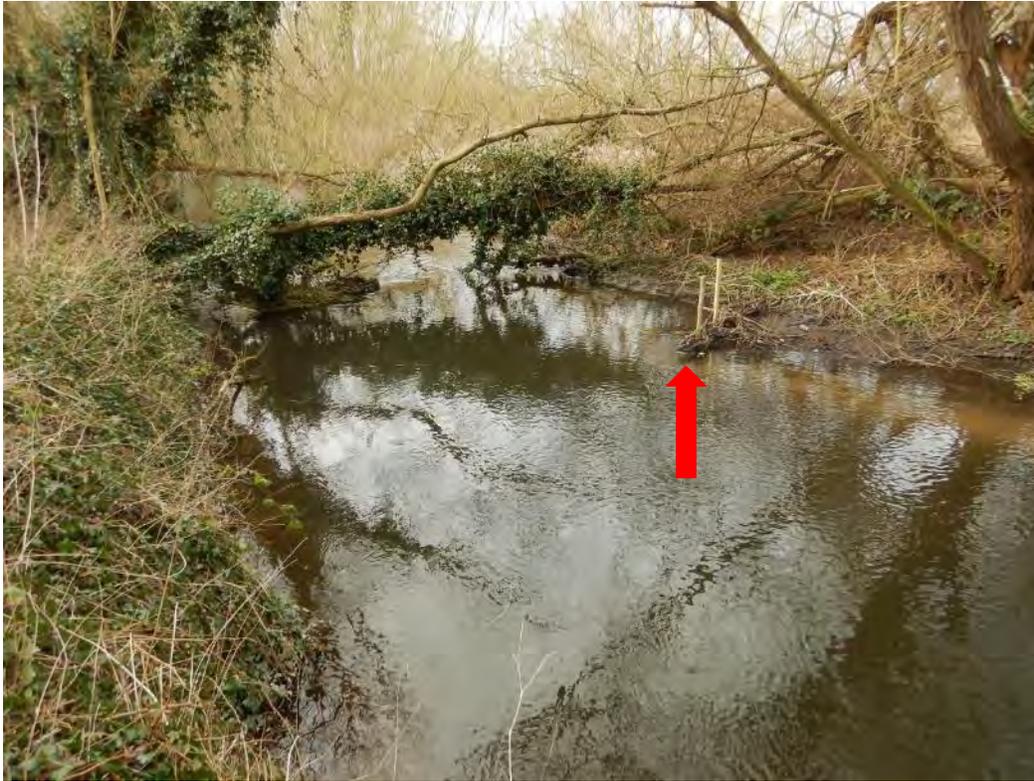
Picture 22 – Fallen trees can be winched and fixed to provide overhead cover at the margins if their adjustment is necessary. Where trees have been in position for many years they may already be providing important habitat features for a wide range of birds and mammals in addition to fish. Note the small flow deflector (red arrow) which is not having any great effect.

The occurrence of fallen trees within the channel can be managed if necessary by winching stems into different positions to lessen an impounding effect upstream, or to enhance a scouring flow. The management of fallen trees does not require EA permission if it is done in a manner that reduces flood risk (such as pulling back protruding limbs and securing them so that they cannot break free and increase flood risk).

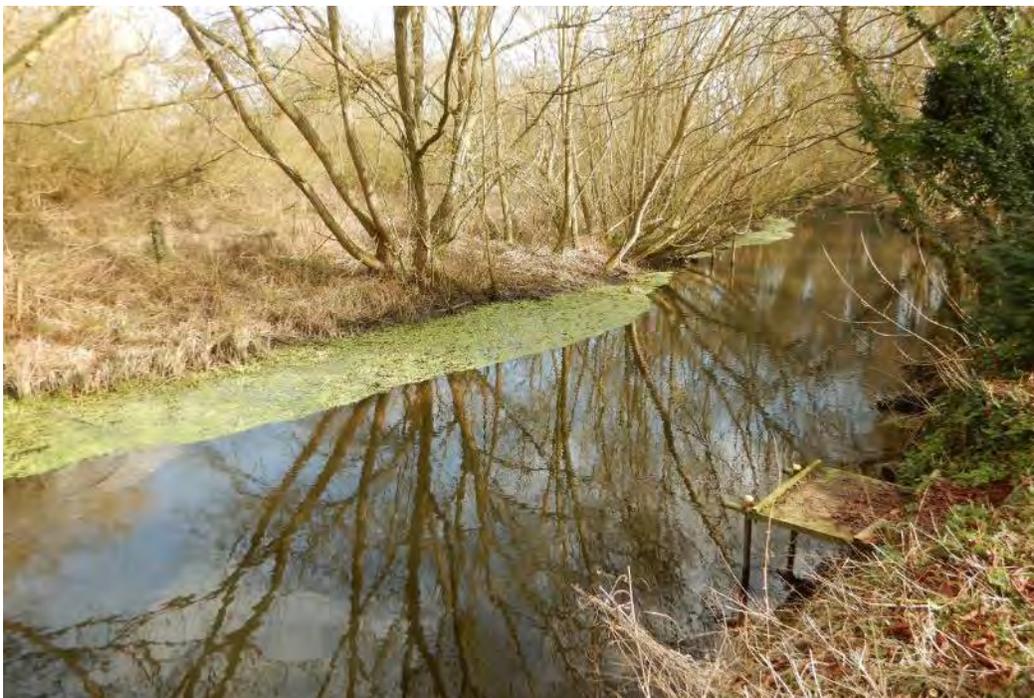
Picture 23 – Note the dense line of willows which are all of the same age having been coppiced in the past. The trees have now grown out over the channel. These trees should be managed to create a varied age structure. Floating pennywort is prevalent on the far bank where it cannot be raked out.

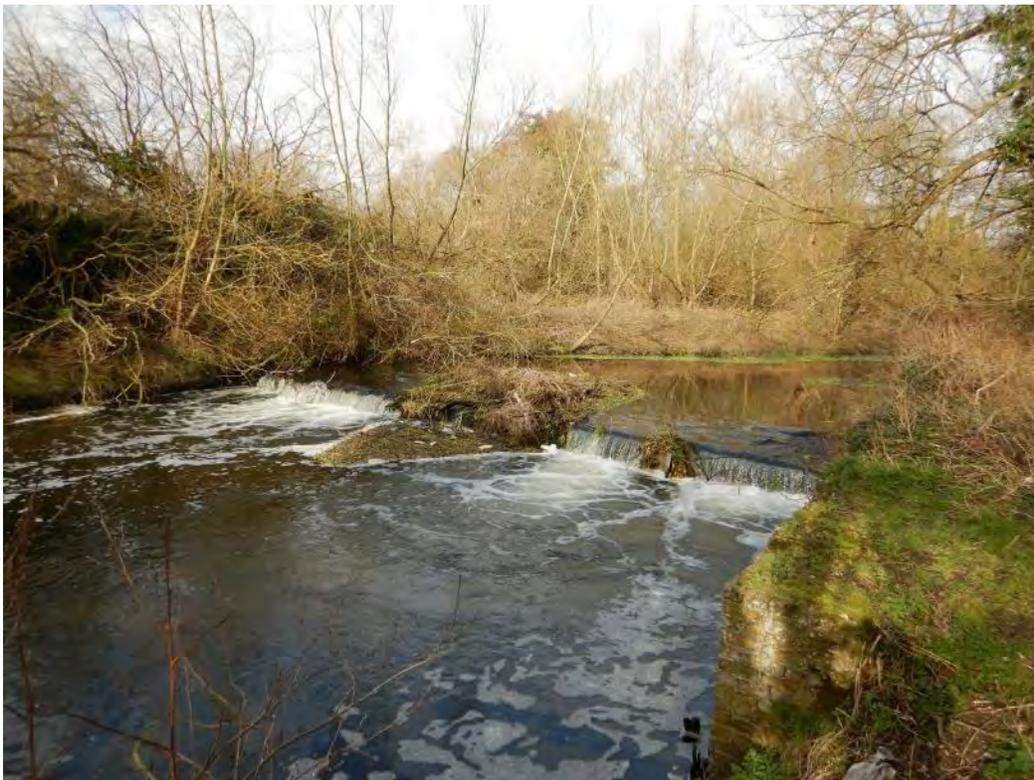
The weir is holding a head of water ~40cm. There was limited depth immediately below the weir due to bed lining, and immediately above it the depth was ~0.1m deep as it ran swiftly over a lined bed for ~1m. Thus it is unlikely that any fish species could easily traverse the weir except in higher flows when the weir is drowned out. But in those conditions the flow may increase too much so as to prevent some species from attempting to traverse the structure.

The weir is creating a barrier to the natural movement of fish: all fish species need to migrate within a river, for feeding, breeding or to escape a pollution event.

Picture 24 – The weir on the River Colne does not appear to serve any purpose and consideration should be given to its removal in order to restore impounded habitat above it and to allow coarse sediment transfer downstream.
