Advisory Visit

River Colne, Uxbridge Moor

January 2018

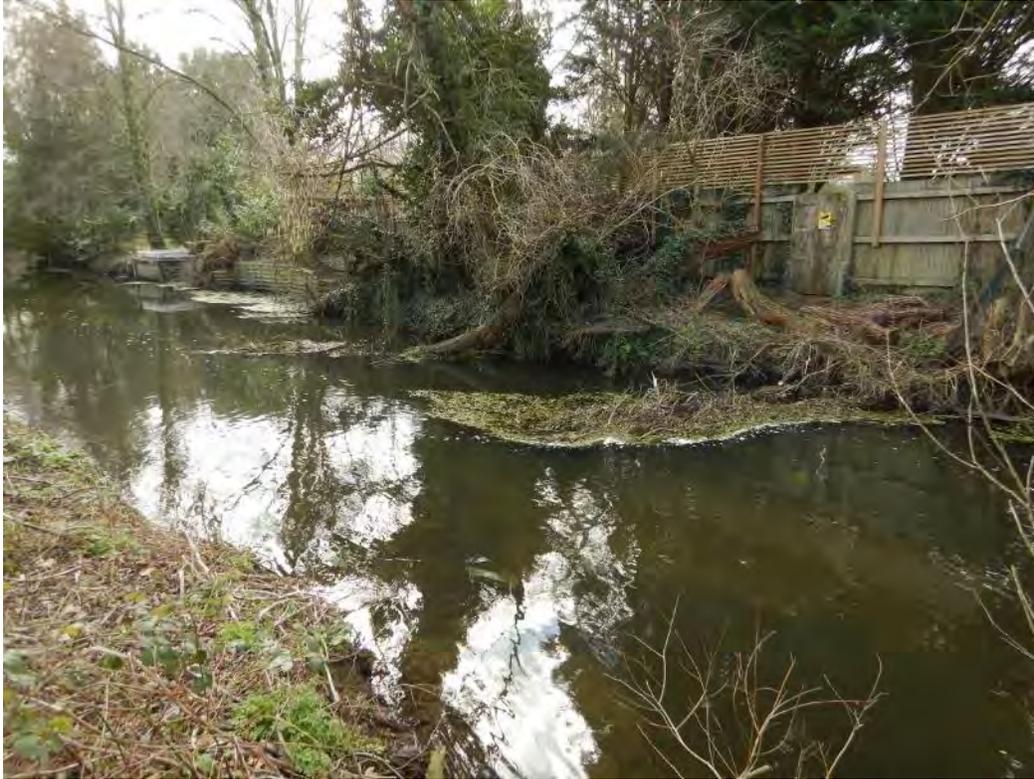
compared to the reach above the weir. It is likely that the weir has trapped coarse sediment and prevented it from being transported downstream. The greater depth downstream is due either to sediment transfer out of the reach or dredging, and the weir has prevented resupply.

Picture 25 – Below the weir, the river ran deep with sand and black silt covering the bed. The presence of trailing LWM offered habitat cover at the margins and should be retained.

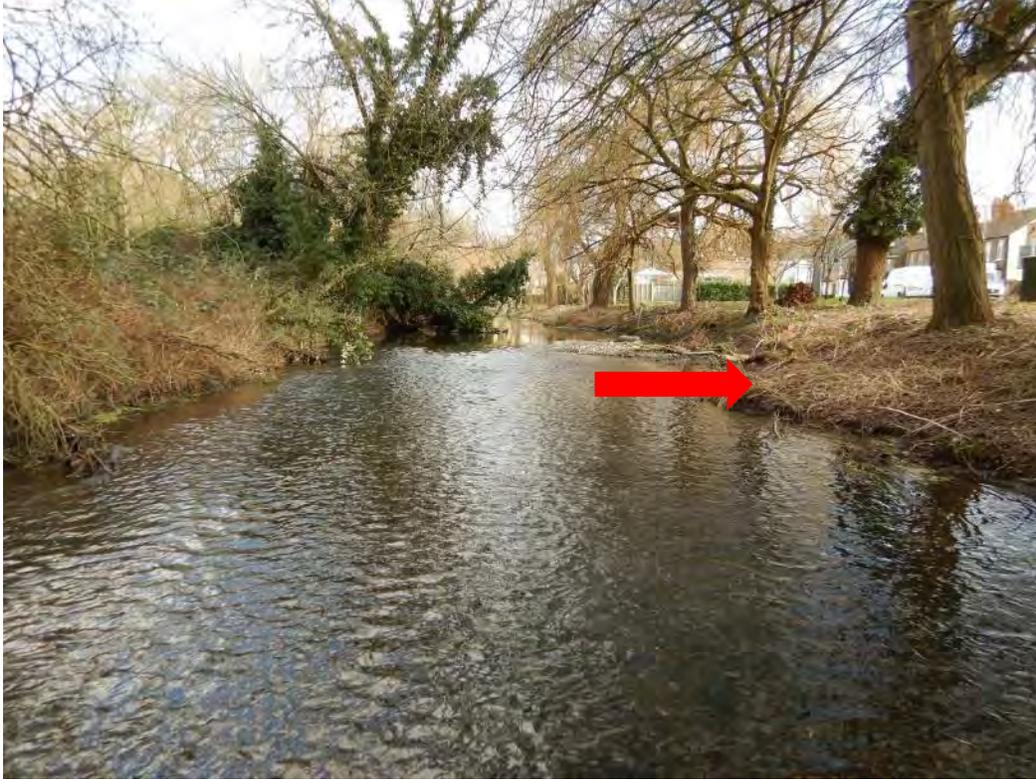
The riparian trees were providing LWM to the channel but it appeared that much of it had been removed as small piles were present on the banks. A similar approach to tree management to that proposed for the Colne could be adopted, i.e. to create a varied age structure.

Picture 26 – The Sluice below Riverside Way bridge (south). The adjacent riverside trees are casting shade over the channel limiting marginal growth. Note the LWM that appears to have been removed from the channel (red arrow). Its retention would have increased cover for fish and habitat for invertebrates.

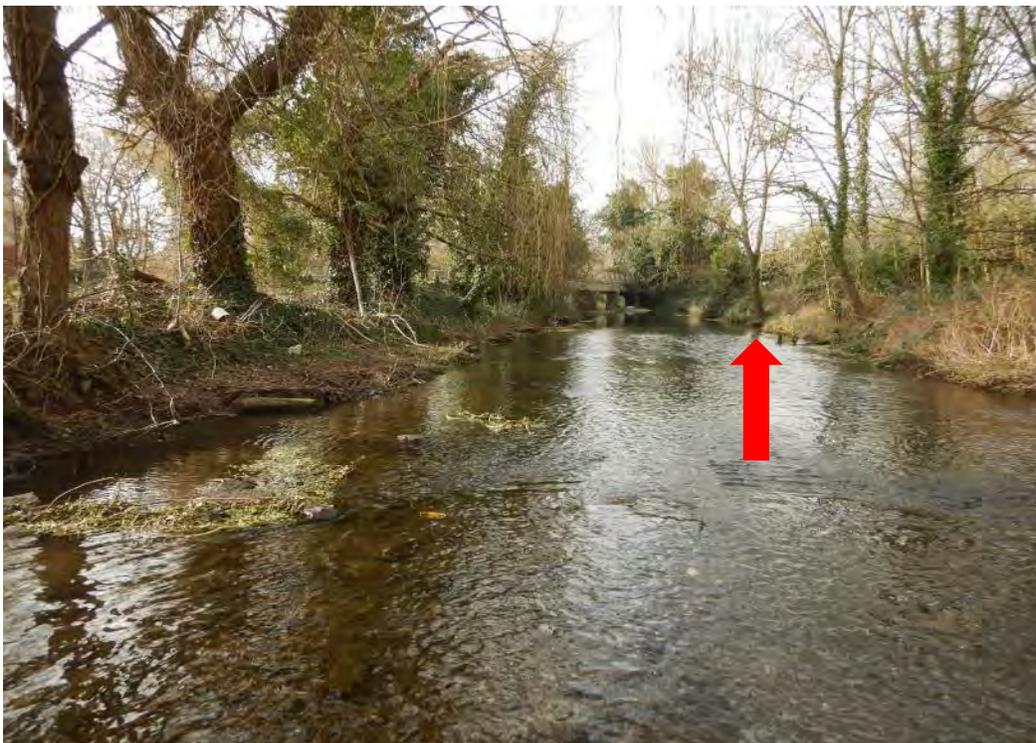
Picture 27 – The trees on the RHB are suitable for hinge-cutting (red arrow) in order to provide flow deflection and over-head cover. They offer a relatively simple and low cost means of diversifying habitat within the Sluice.

It should be noted that many trees are suitable for hinging. In a shallow river, tree hinging would be a very simple and cost effective means of diversifying the flow characteristics and for providing cover.

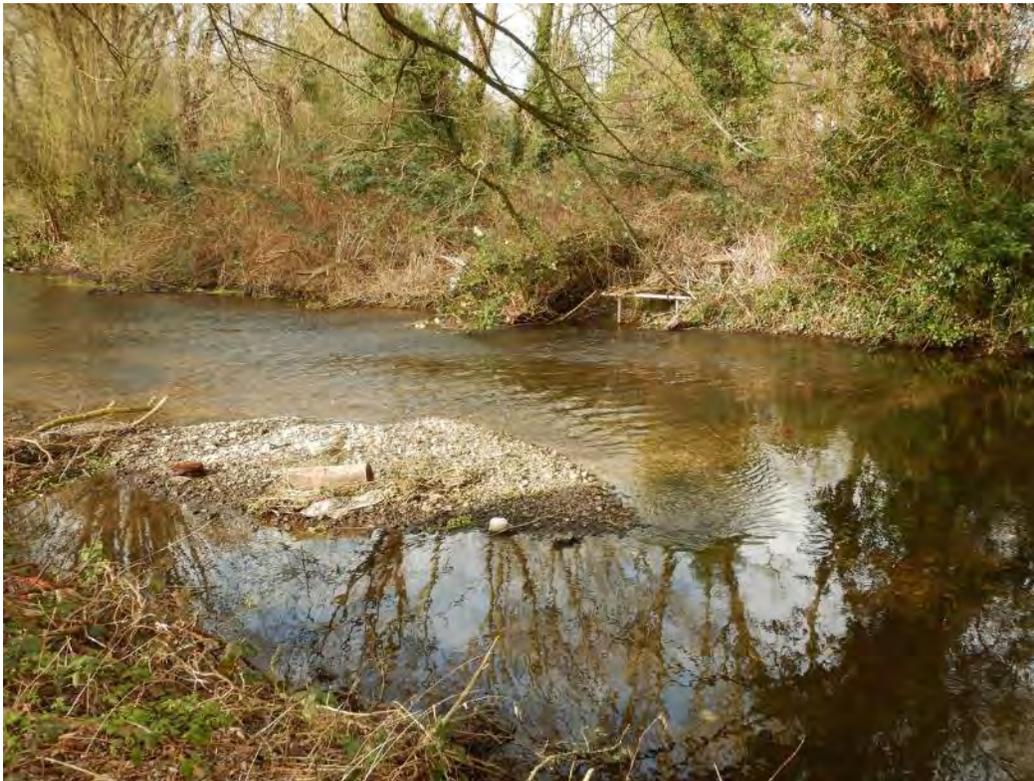
Picture 28 – Note the gravel bar formed as a result of scour. The position of the gravel bar forces water into the middle of the channel where it is gaining velocity and starting to form a new riffle. These types of features are to be expected in a dynamic river and should be retained. The exposed gravel bar will be providing a habitat for invertebrates which was not observed elsewhere during the visit.

The presence of extensive deposits of gravel and a reasonable gradient would enable the **technique of "dig and dump"** to be undertaken. This technique sees existing bed material, usually of a high gravel content, excavated (the dig) and placed to create exposed gravel bars (the dump) funnelling water into the newly created pool.

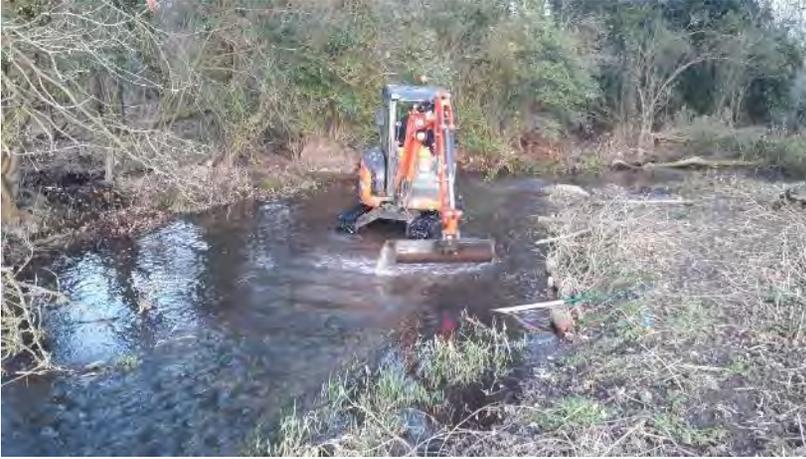
Picture 29 – An excavator is positioned in the river and starts to dig a pool.

An example of the dig and dump technique taken from the River Misbourne at Denham Country Park

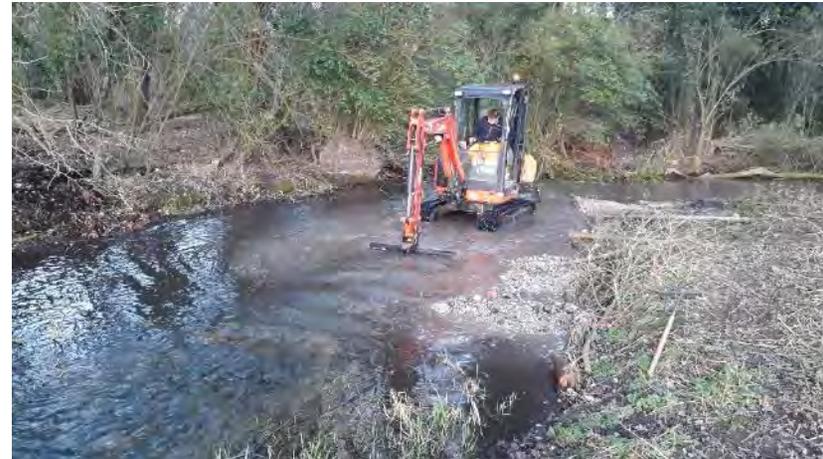
Picture 30 – The excavator places the excavated material at the sides of the newly dug pool in order to enhance flow into it.

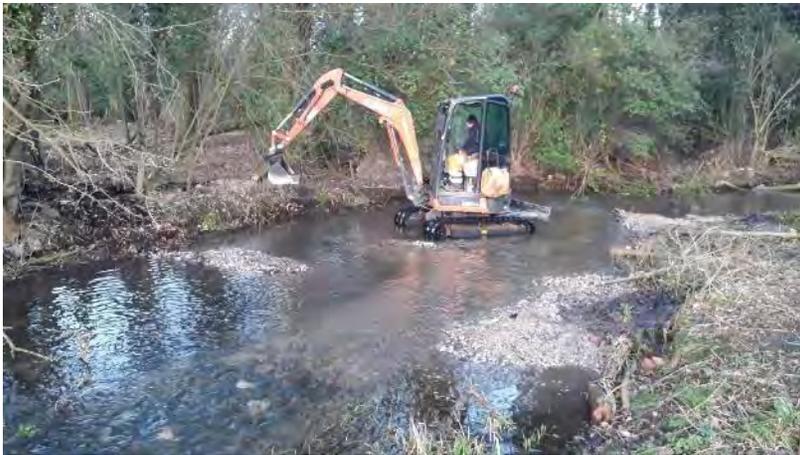
Picture 31 – The excavator places further material either side of the new pool in order to correctly align the flow into it.

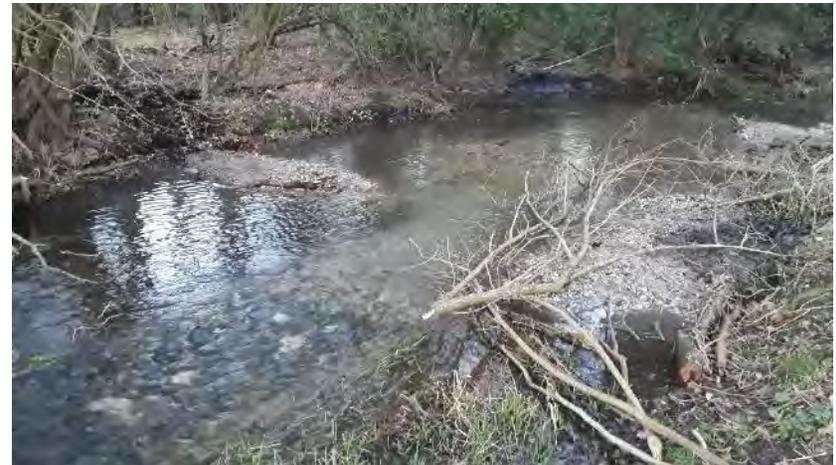
Picture 32 – The bed form is now diverse with a pool created after a shallow riffle thus mimicking the natural pool and riffle sequence that is expected within gravel-rich rivers. LWM can be placed to create instant cover.

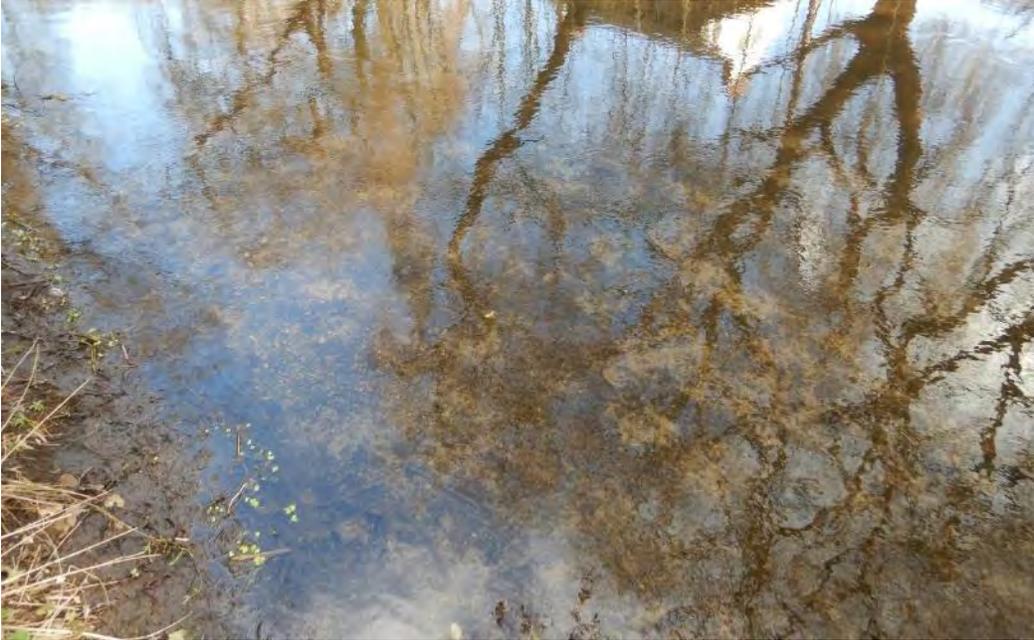
Inspection of the gravel showed it to be compacted and also accreted with calcium deposits. Bed scour is only likely to occur in these areas if the armouring crust can be broken. Gravel rehabilitation can be achieved through water jetting with a high pressure water pump using a lance to direct water into the gravel. The water pressure is able to blast accreted material and fine particles out of the gravel where the water flow carries it downstream. The result is loosened gravel with a significantly reduced content of fine particles (sand and silt). The interstices between the gravel particles can then provide a habitat for invertebrates, and the cleaned and loosened gravel can be used by rheophilic fish species to spawn upon.

Picture 33 – The gravel bed is well compacted and bound by calcium deposits. This gravel could not be moved by fish, such as brown trout, that require loose gravel in order to form a redd (the resting place for fertilised eggs).
