Cornwell brook – Cornwell Manor

An Advisory Visit by the Wild Trout Trust – February 2014

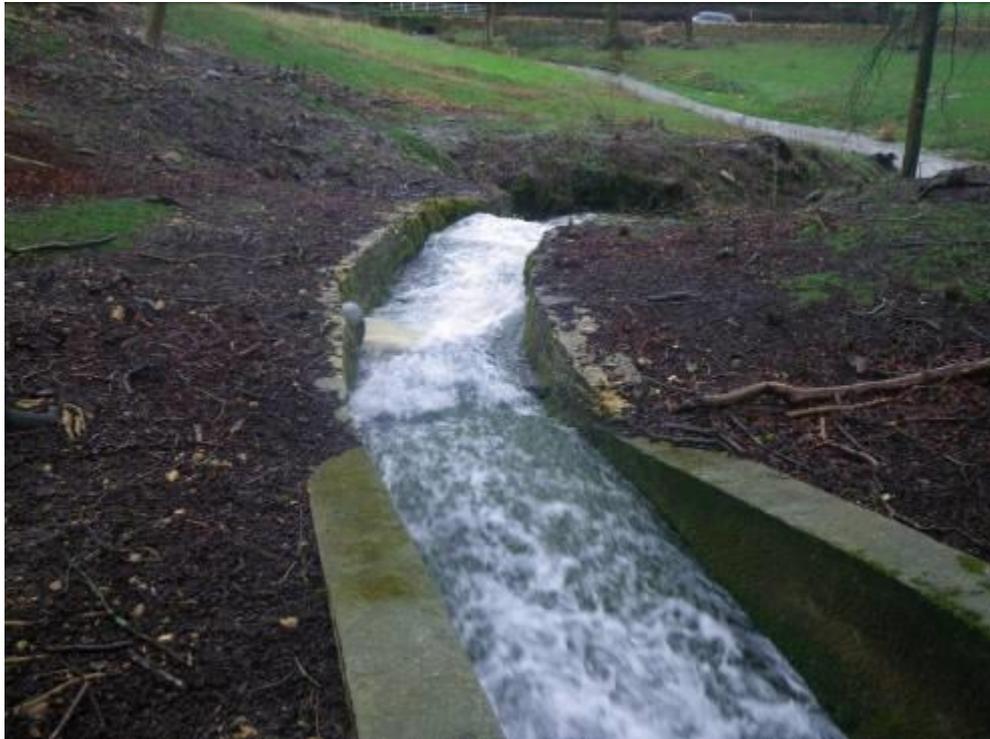
Habitat quality for trout in the main Cornwell Brook immediately downstream of the lakes appears to be good, with the stream flowing down a comparatively steep gradient over a bed of mainly limestone cobbles and chips. Brown trout are known to inhabit this section of stream and are highly likely to use this shallow, fast flowing section as a spawning and nursery site. Unfortunately the dam and outlet channel (Figure 1) of the bottom lake represents a major block for any further upstream migration.

Figure 1. Outlet channel from the bottom lake.

Modifying the outlet structure and channel to facilitate trout migration is possible but would undoubtedly be very expensive and only provide access to approximately 1km of viable channel. If a wild trout population could be established in the reach running up above the lake then there is every chance that some fish will drop back out of the stream and take up residence in the lake and possibly even drop back into the main Cornwell Brook. This would represent the most cost effective method for establishing wild stocks within the lake.

It may not be practicable to provide access for migrating fish from the lower Cornwell Brook, up and through the lake to potential spawning sites upstream. It would be desirable but is likely to be very expensive with no guarantee of success.

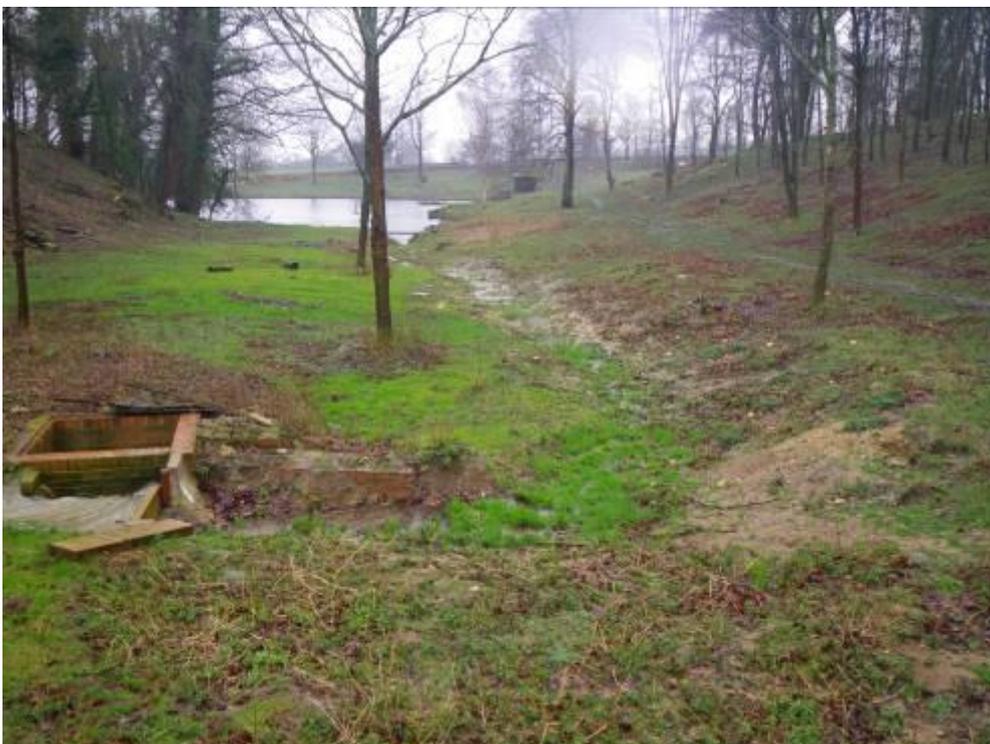
At present, the feeder stream running into the lake has been placed in a long culvert. For wild fish to be able to freely navigate both up and out of the lake for spawning and for juveniles to actively drop back, it will be necessary to take the stream out of the culvert (photo 2) and back into a naturalistic channel.

Figure 2. Inlet channel lost in a culvert.

- Commission a simple electric fishing survey to establish whether or not the stream supports any trout.
- Take the lake inlet stream out of culvert and back into a naturalistic, gently meandering channel.

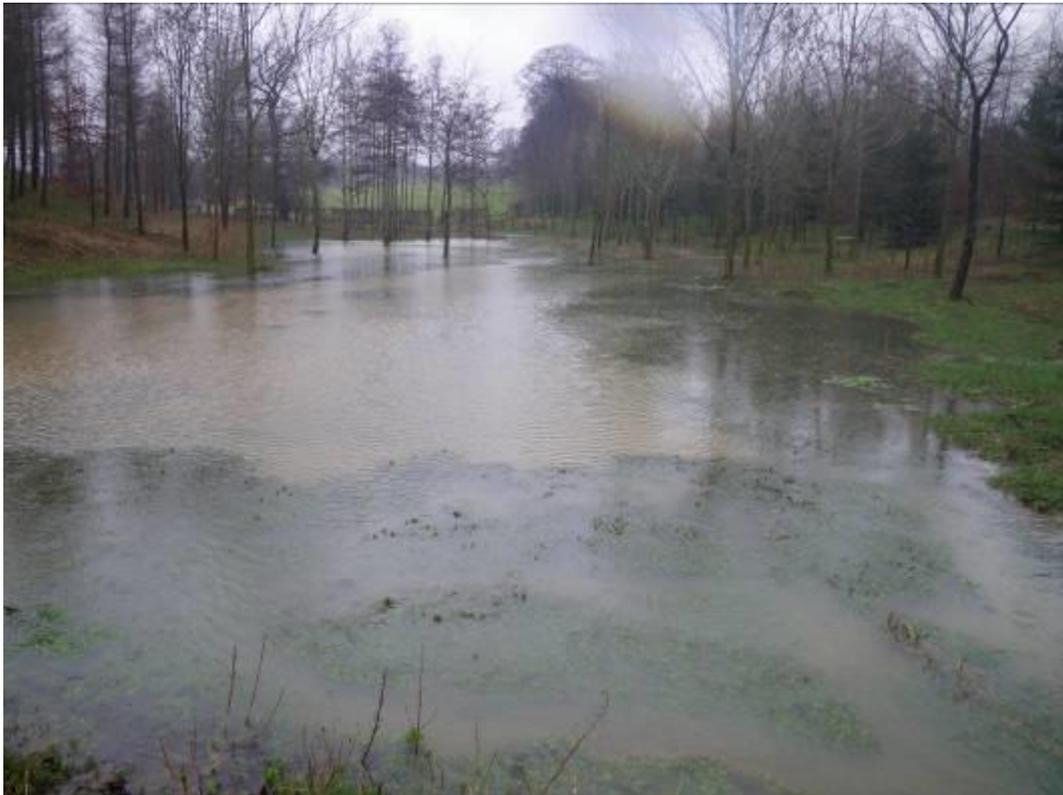
The culverted section of the channel (Figure 3) is also causing problems by backing up the flow, causing local flooding issues and adversely impacting on upstream habitat quality. It is likely the upstream flooding was in part due to some blockage in the culvert. Unless resolved, this issue could lead to the loss of grazing and possibly even some trees if the flooding persists for any significant length of time. Placing the stream back into an open, gently meandering channel will resolve all of these issues and provide an attractive and biologically valuable resource and a suitable access for migrating fish.

Figure 3. Local flooding exacerbated by the partial blocking of the culvert.

Any new channel should be based on the shape and size of sections of functioning channel found further upstream. Ideally any new channel should be designed with a two staged bed profile to allow a self cleansing flow to maintain high quality habitat, even under low flow conditions and also to provide additional capacity via a second stage to accommodate higher flow scenarios. A gently meandering plan form will help to moderate water velocities down what is a relatively steep gradient.

This section will be most valuable as a spawning and nursery site and designing the channel to ensure that there is a variety of depths and channel widths will allow good quality habitat to form. If there is little or no natural gravel available then it is possible to import limestone chips in the 10 to 40mm size range to provide a spawning medium.

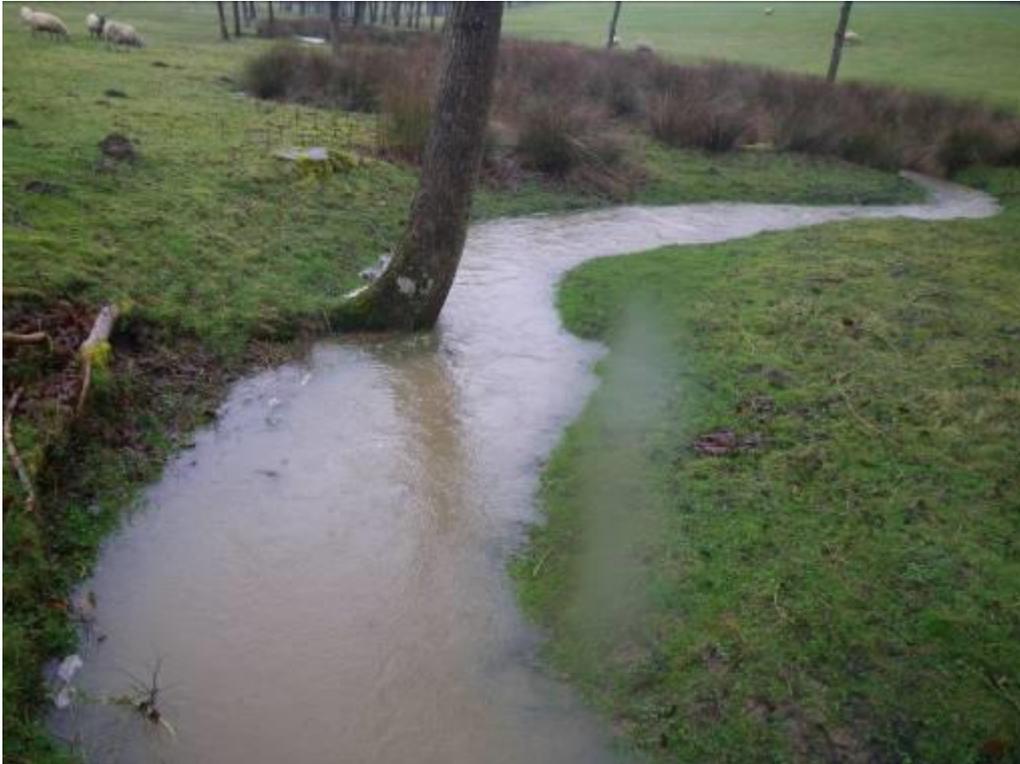
Further upstream above the copse the stream meanders through a grazing meadow. The high flows made an accurate assessment of habitat quality difficult but the shape of the channel looked to be good with the stream flowing through shallow pools interspersed with glides and occasional broken riffles. Here the channel was lacking scrubby cover, possibly due to intensive grazing.

Figure 4. Grazing meadow above the copse. A natural form but lacking in-channel cover.

- Ensure the stream bed is gravel rich and the margins planted with low scrubby cover.
- Consider stock fencing in the reach running upstream to allow the stream margins to develop improved riparian cover.

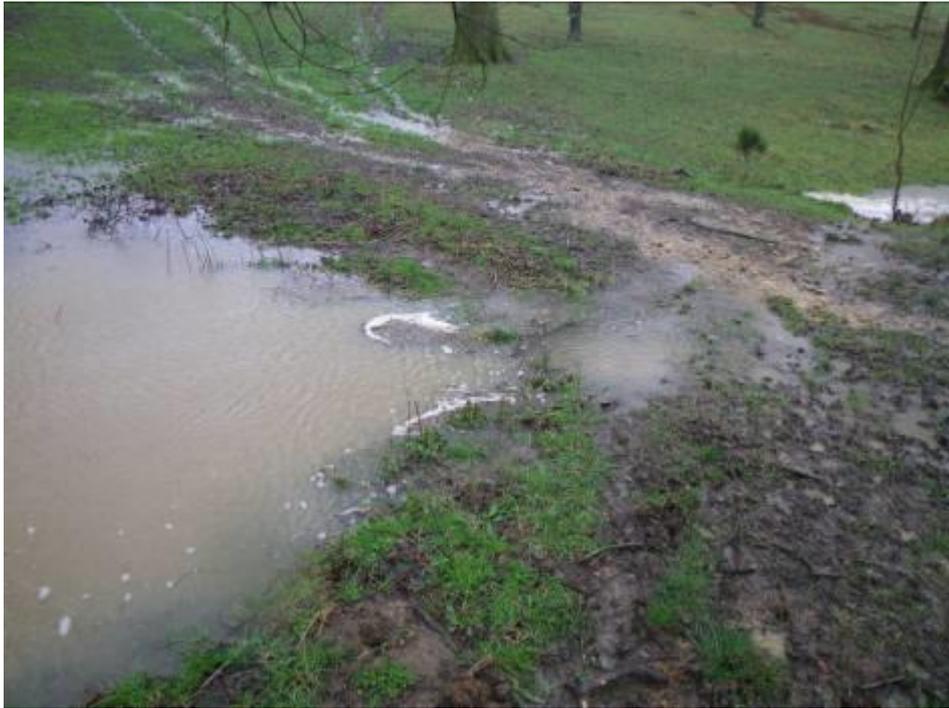
A short distance upstream, the stream passes through another short section of culvert (Figure 5) installed as a crossing point. Again the culvert was partially blocked and was causing the river to back-up. To compound the problem, this culvert appears to be set in on a slope, rendering fish migration even more problematic.

Figure 5 partially blocked culvert causing upstream flooding and sediment deposition.

Even modest sized culverts can cause problems for habitat quality as well as fish migration and replacing this crossing with a free spanning sleeper bridge, or a box culvert would protect upstream habitat and ensure free access for migrating fish. If a box culvert is to be considered then it is essential that the invert of the box is buried well below the downstream bed level and then back filled to existing bed level with natural river bed gravels.

It would be important to consider improving fish passage at this location in combination with removing the inlet culvert. Investing in providing improved fish passage out of the lake without also addressing this issue could be a missed limit the extent of available spawning habitat.

- When creating the new channel, use a section of optimum upstream channel to help with design.
- Replace the culvert crossing with a clear span bridge or sunken box culvert.

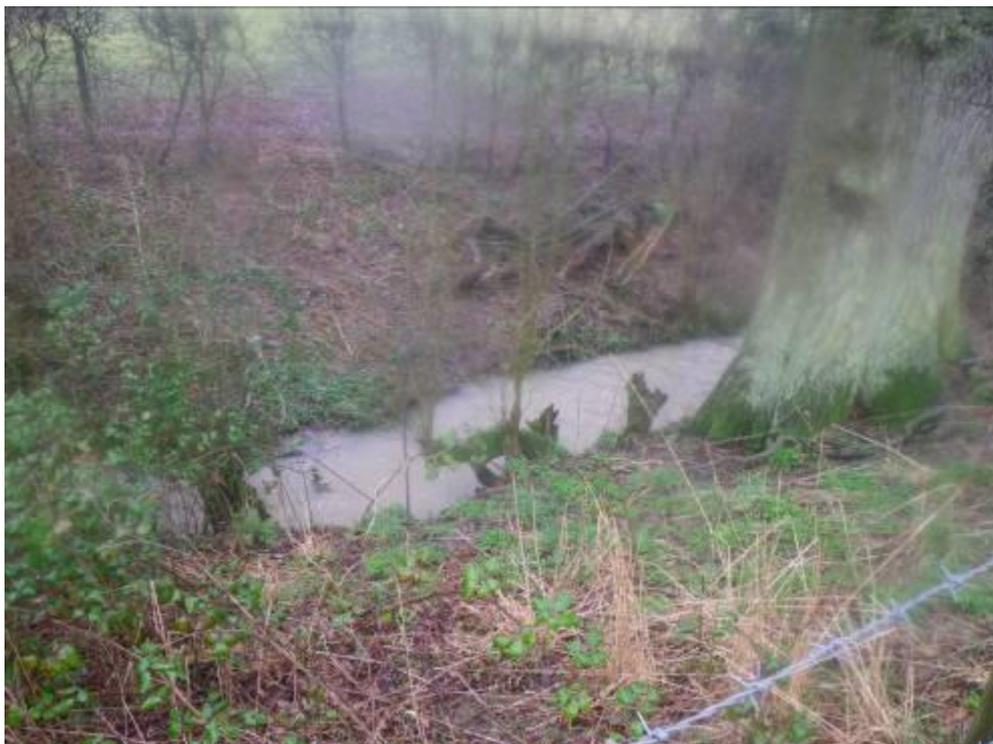
A short distance upstream the stream flows through some arable meadows. A narrow, uncultivated buffer strip had been left and in places the stream has been fenced. This has enabled some scrub to develop which has potentially provides some valuable low level riparian cover (Figure 6).

Figure 6. A fenced section has enabled some low scrubby cover to develop. Ideal for a trout spawning and nursery stream.
