## **River Kennet – Craven Fishery**

**An Advisory Visit by the Wild Trout Trust November 2014**

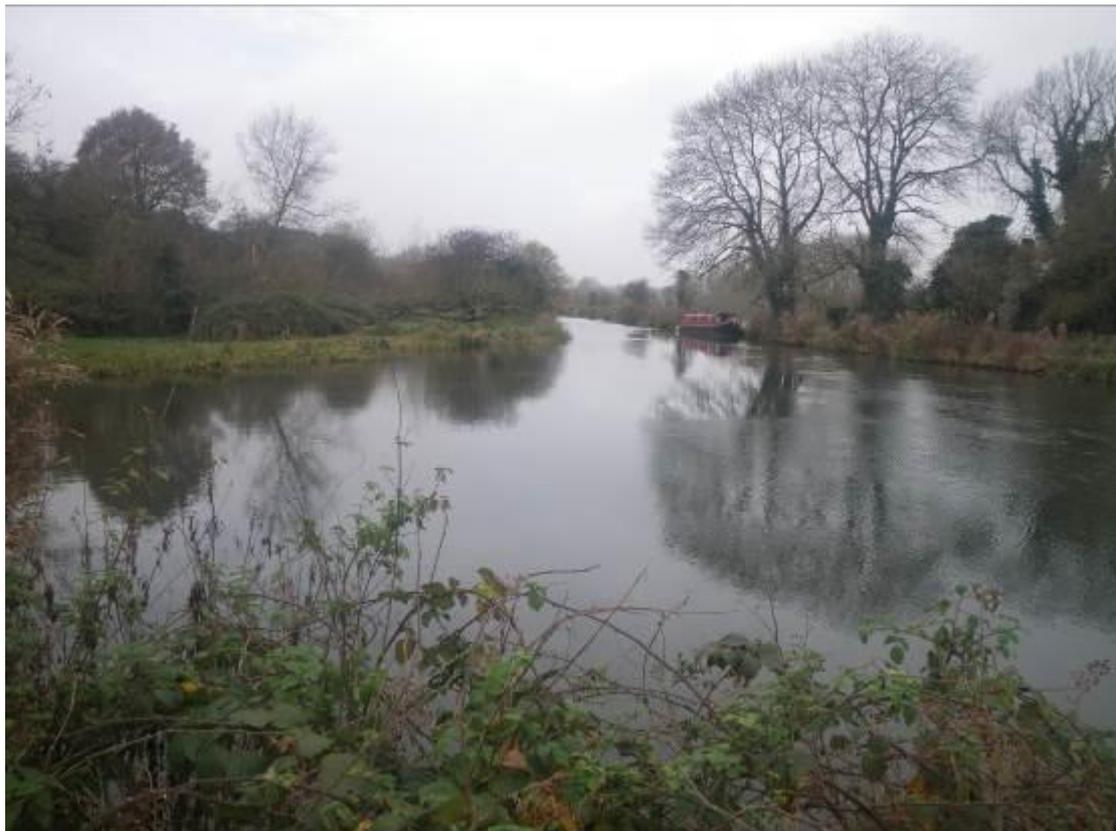
The section of main river channel running through the Craven Fishery can be broadly split into three distinct sections. The top section runs down from the distributary with the Kennet and Avon Canal (photo 1) for approximately 200m where the levels are held up by an old milling structure. A side weir (photo 2) takes the majority of the flow down through the weir and under the Hampstead Marshall road bridge. The milling structure takes flow that is discharged into the carrier channel. The top section of impounded river is not used as part of the main fishery.

Photo 1. The feed into the Craven fishery flows to the left with the navigation channel passing to the right

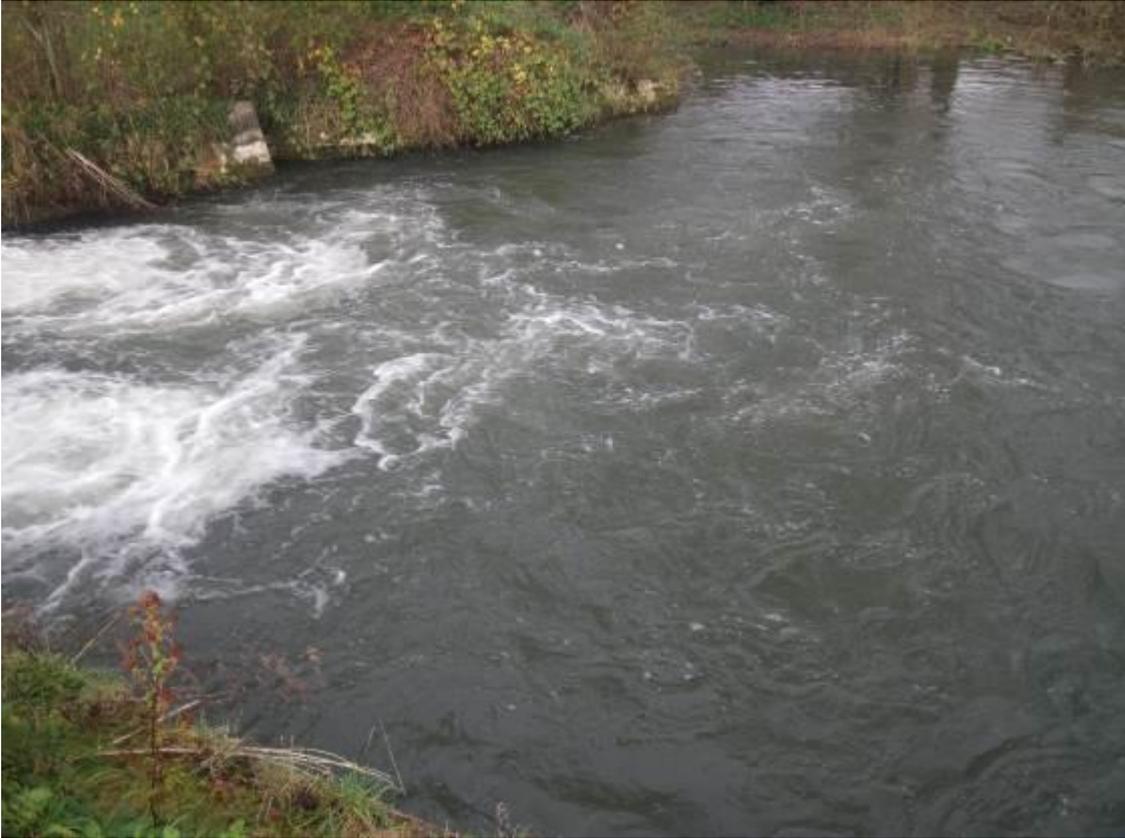
Photo 2. Top weir on the Craven provides the head of water for the mill/carrier channel.

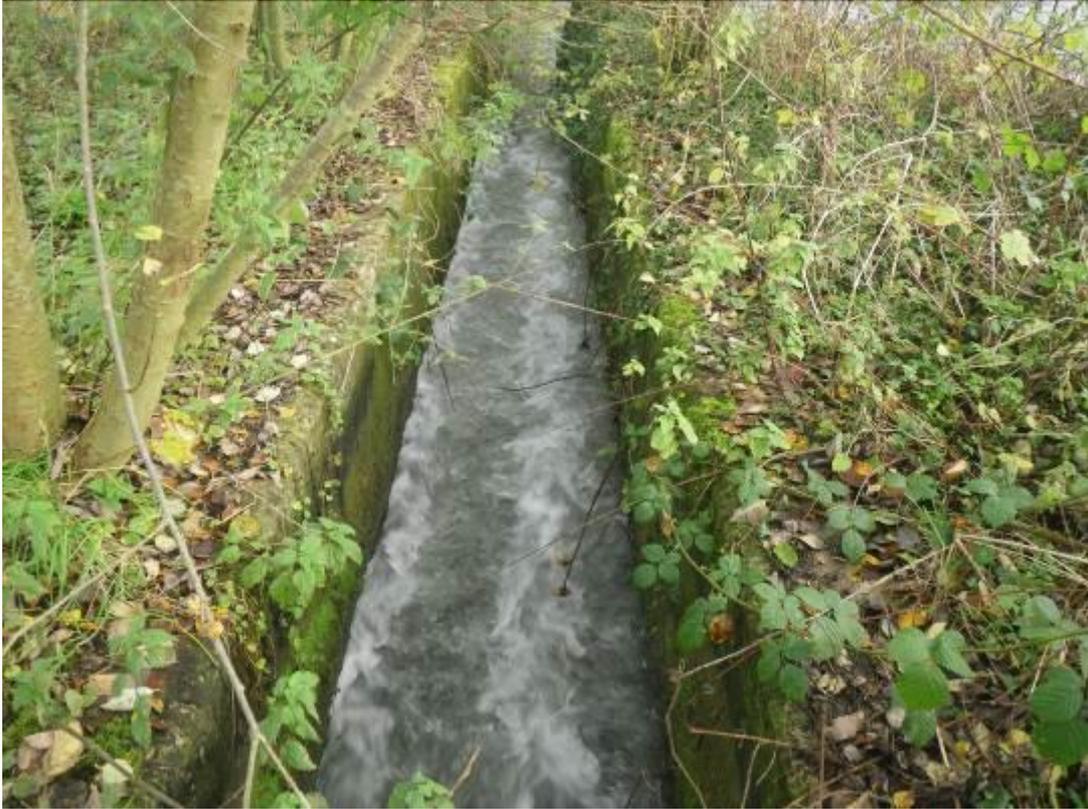
Some of the issues associated with free fish movement have been resolved by a bottom baffled fish pass (photo 3) installed by the Environment Agency. It is thought that this fish pass was constructed as part of the now abandoned Thames Salmon scheme.

Photo 3. Fish pass installed by the EA.

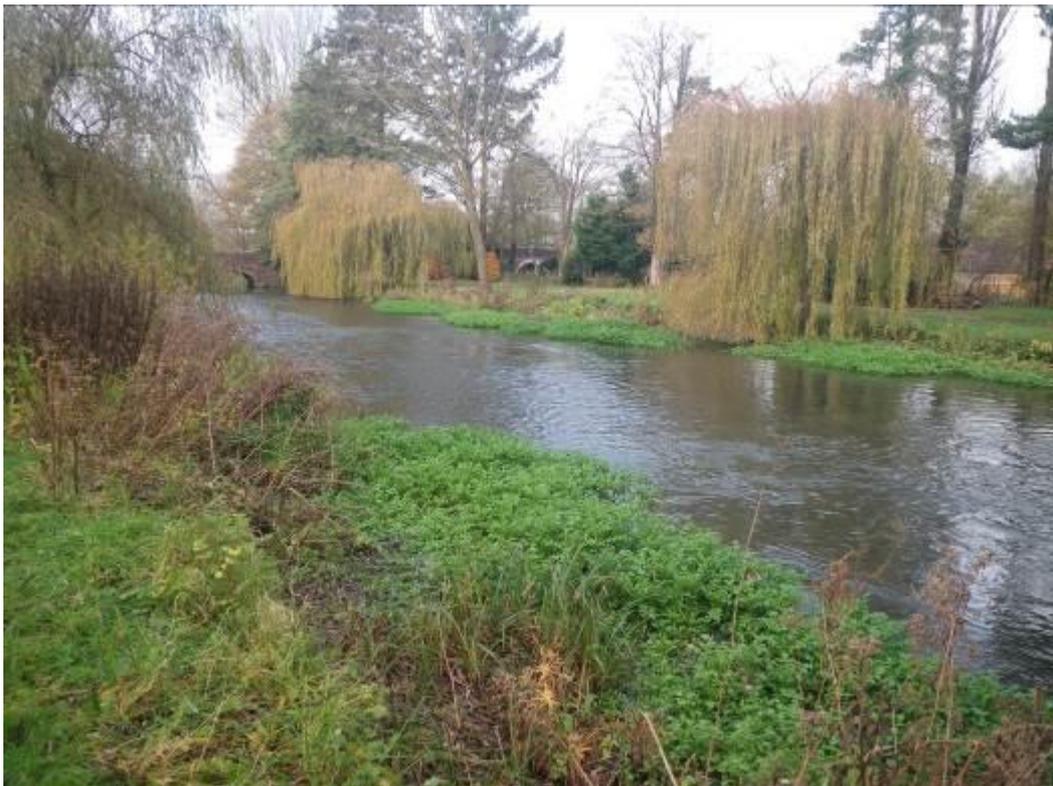
The next section downstream of the road bridge to the upstream weir contains some of the best habitat to be found on the fishery (photo 4). Here the channel has a distinct gradient, with good examples of wide shallow riffle, spawning glides and deeper holding pools.

Some submerged water milfoil *Myriophyllum* sp and water moss *Fontinalis* is present and potentially provides some valuable in-channel cover on the fast shallow runs. Weed growth in general and in particular water crowfoot *Ranunculus* spp, was considered to be very sparse for a chalk stream channel. Both Mr. White and Mr. Trotman confirmed that weed growth has progressively become thinner over recent years and believes that the lack of weed is linked to increased turbidity associated with the water supply via the canal. This would seem to be a logical conclusion but may also be linked to increasing densities of signal crayfish.

Photo 4. Upper section of the main river beat provides opportunities for spawning and good trout nursery habitat.

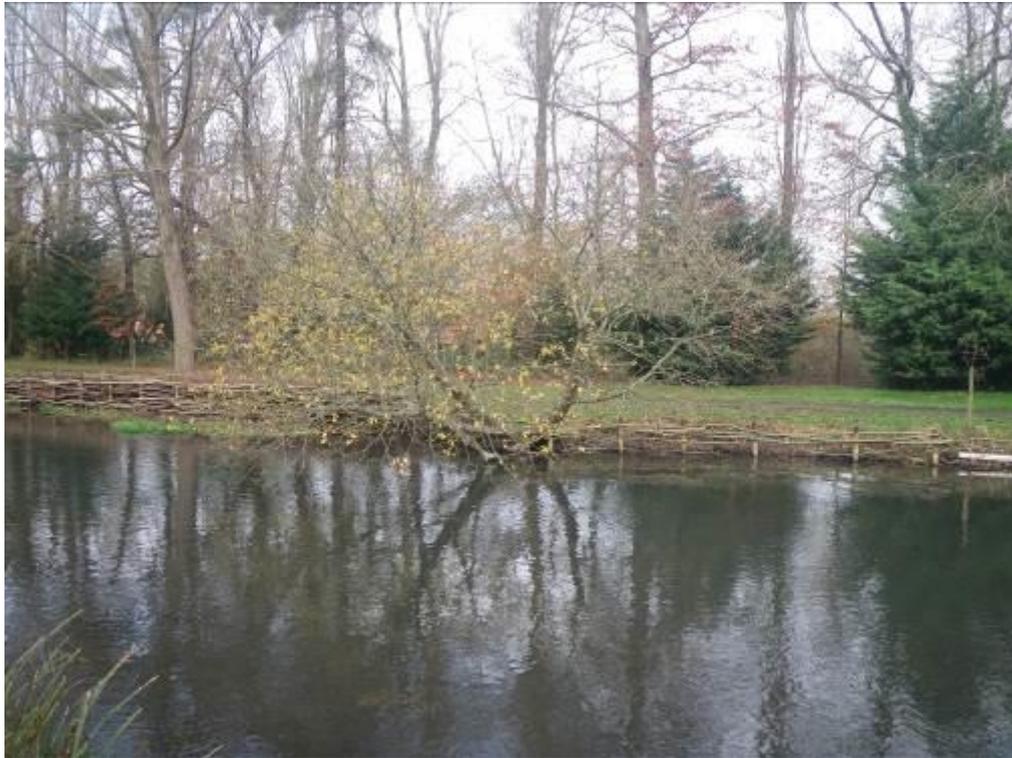
The main access road into the property runs parallel to the LB of the fishery. Some sections of bank have suffered from erosion following the very high flows experienced during the 2013/14 winter. These sections have largely been repaired by Mr Trotman using simple vertically driven poles and horizontally woven hazel laths (photo 5). Some valuable low overhanging tree cover is proved by occasional ornamental weeping willows and salallows.

Photo 5. Left bank erosion repairs.

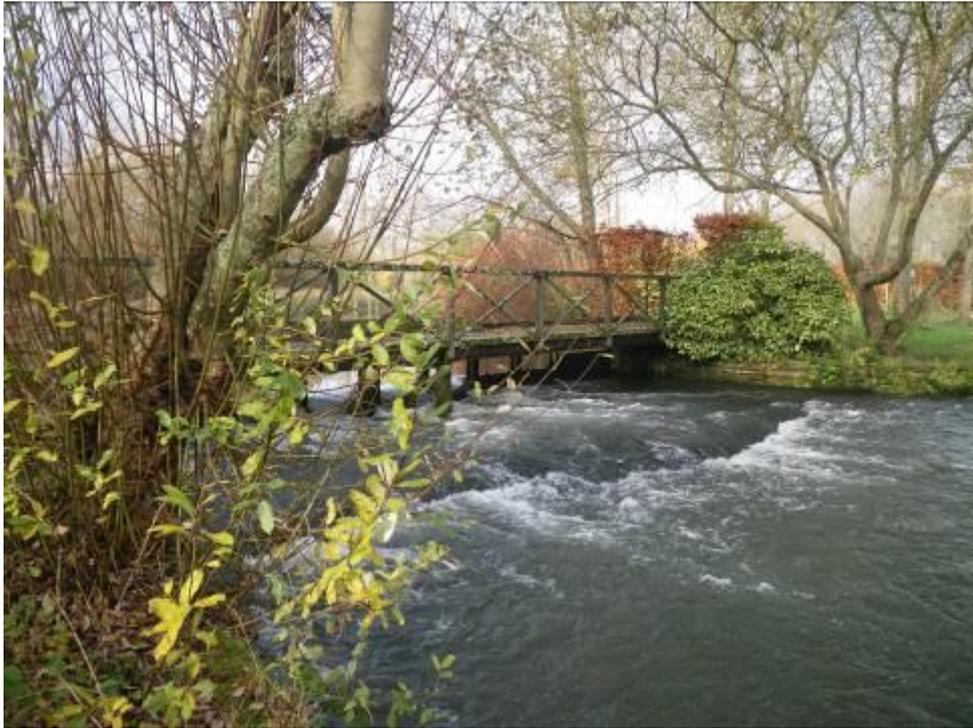
Adjacent to the fishing lodge and keeper's cottage, a second weir holds up levels again. It is presumed that this second weir (photo 6) was installed to provide a head of water for a small off-take in the left bank, which at one time was used to feed water into a series of old, semi derelict stew ponds.

The head loss at this second weir does not pose a problem for fish migration, however the structure significantly drowns out a long section of upstream channel which is predominantly smooth glide habitat flowing over a mainly soft silt bed. Permanently removing all the hatch gates and perhaps even notching out the downstream anti-erosion apron would have a dramatic effect on the upstream reach. By running the river faster and lower, it would be possible to install a series of flow deflectors to create a series of interesting pools and runs, creating a more diverse fishery and certainly an enhanced environment for brown trout. Lowering the structure may limit options for the old stew ponds.

Photo 6. Removing all the hatches and cutting a 3-4 m wide notch in the weir invert would significantly improve habitat quality in the reach above.

The potential for lowering or removing the central weir structure will remove the opportunity to divert water into the old stew system but the opportunity to win gradient and turn a long sluggish section into a vibrant, more ecologically valuable section of channel is within the gift of the fishery owner.

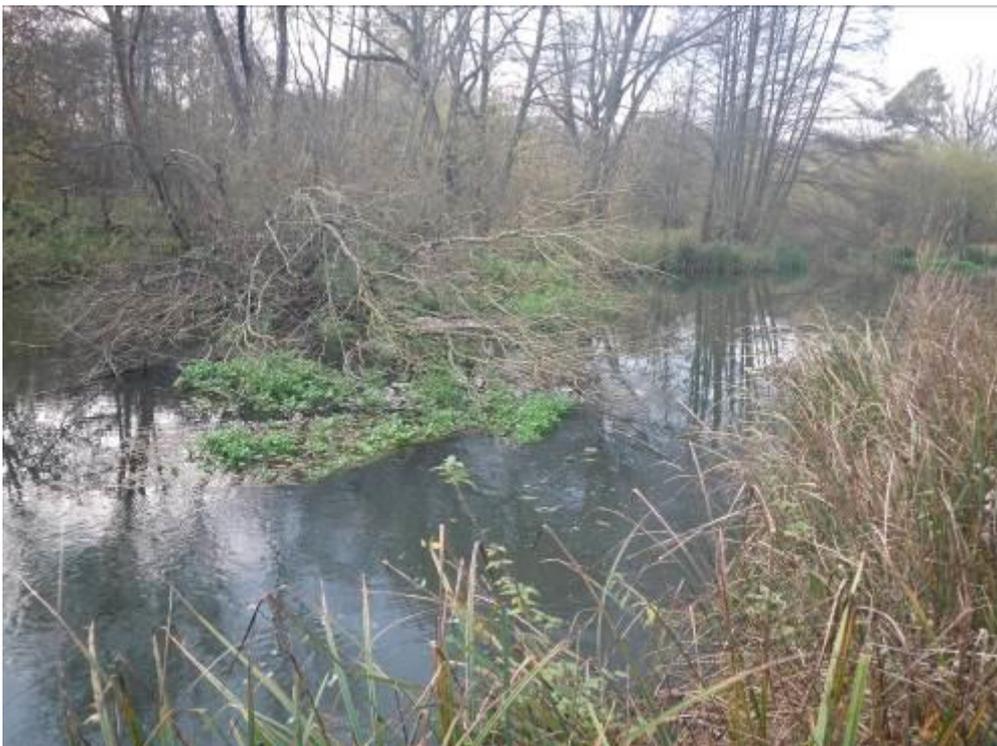
On the lower section of main channel below the second weir there is a very short section of reasonably diverse habitat before the river is again pacified by another impoundment. This lower section of main channel is very wide and slow flowing. Mr. Trotman has been able to create some interest in the channel by leaving

some fallen trees from the RB in situ which has squeezed the channel width and promoted some flow energy (photo 7).

Photo 7. A fallen tree providing valuable cover as well promoting some flow energy adjacent to the near bank.

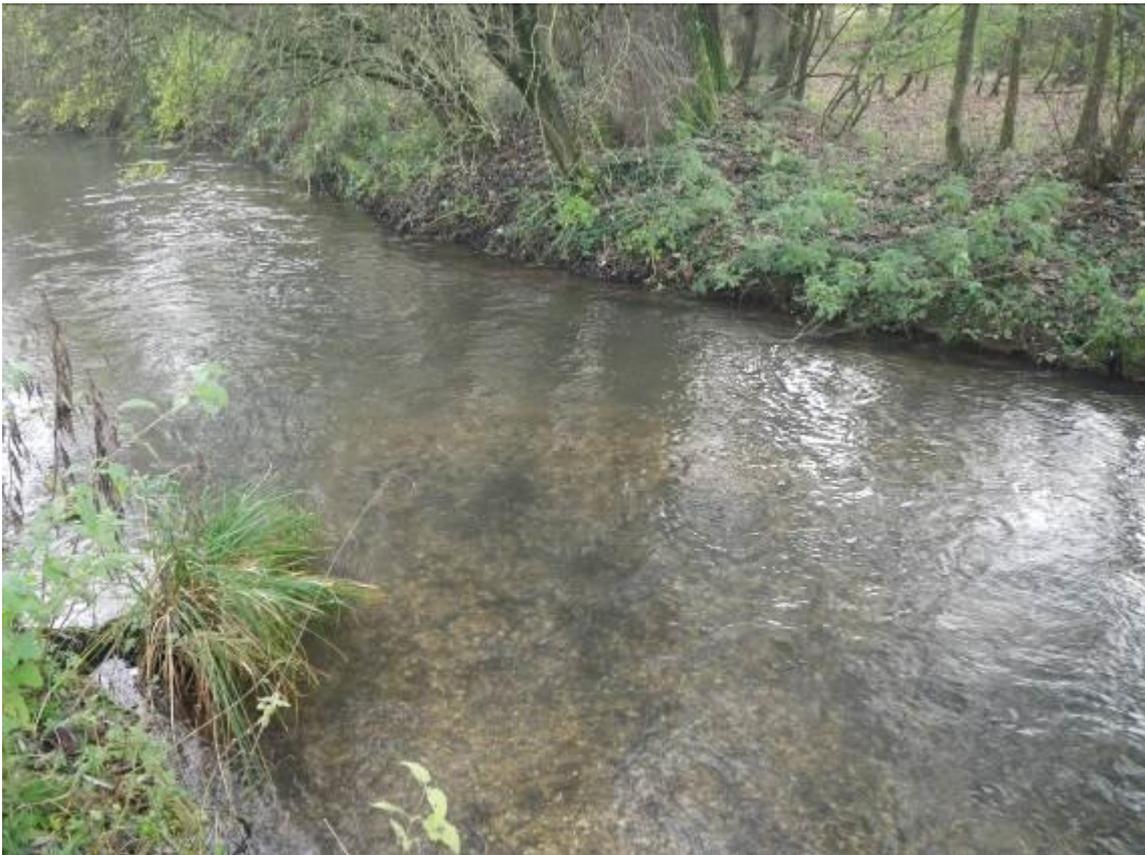
The carrier channel provides some of the best quality habitat for trout to be found on the fishery. Work has been undertaken to extend the length of the channel and provide a natural, sinuous planform. In allowing the carrier to reconnect with the main channel further downstream of the middle weir, as opposed to upstream of the weir, where historically the majority of the flow would have re-joined, the carrier now has sufficient gradient to support good quality chalkstream habitat (photo 8).

The natural pool, riffle and glide sequence provides opportunities for trout spawning, as well as shallow nursery zones and high quality lies for adult trout. The more dynamic nature of the channel has been enhanced further through a sensitive approach to marginal tree and emergent fringe management.

Photo 8. A section of carrier supporting high quality habitats for trout.

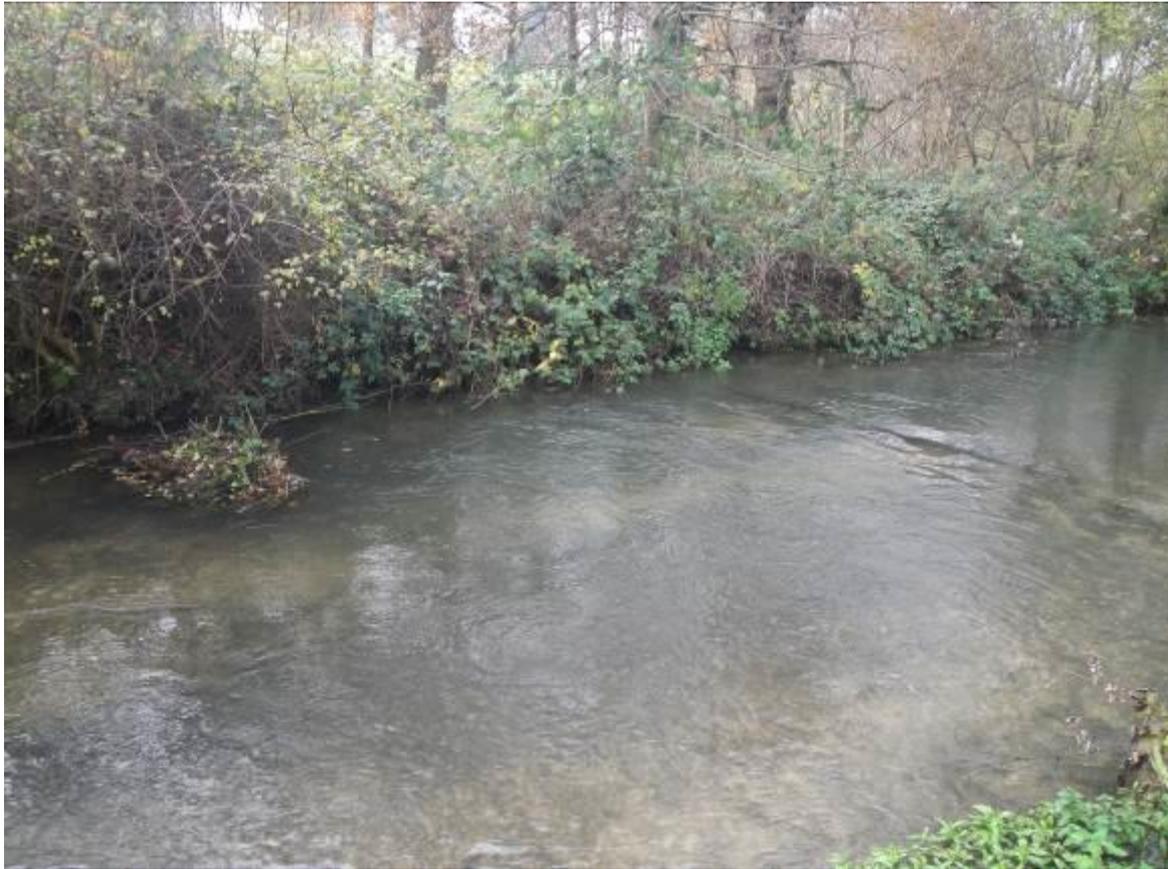
Photo 9. A scrubby fringe and shallow margins provides great cover for juvenile trout when weed growth is poor. Note the line of submerged stones spanning the channel width.

In one section (photo 9) a line of submerged stones forms a low hump in the bed. It is thought that these may have originally been placed into the channel to create a little more upstream water depth. Removing some of the stones to create a central flume will scour the bed and avoid the channel backing up and depositing sediments. Where a gradient in the channel can be utilised to provide an energetic water velocity, the best method for creating improved (deeper) lies for adult trout is to harness the flow energy and drive the bed down and not hold up the level via impoundments.
