Advisory Visit

River Cray, London Borough of Bexley on behalf of
Thames21

11th and 12th August (supplemental visit 17th October), 2008

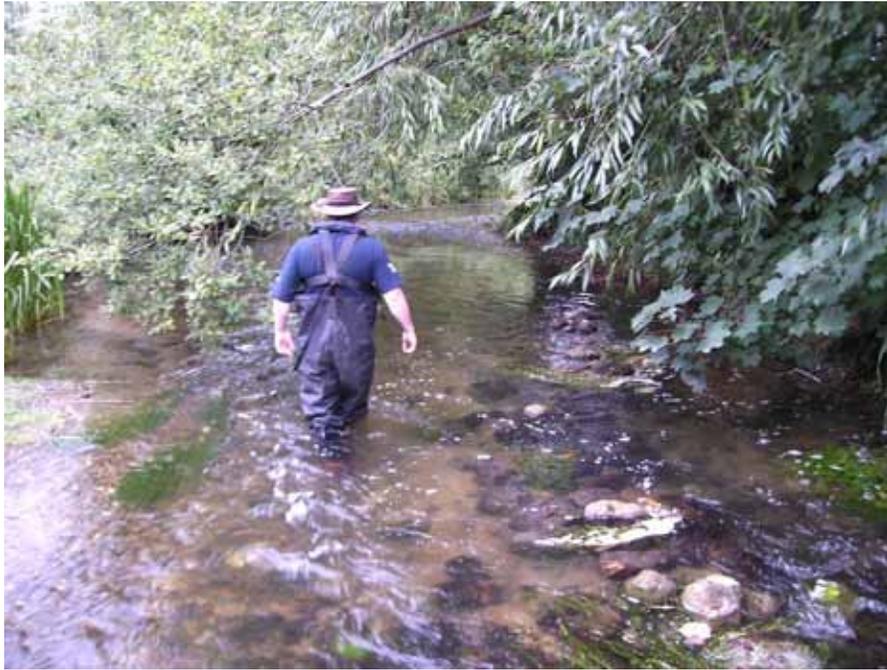
A20 to Five Arches: This section could support good areas of high quality spawning gravels and also displays areas of active geomorphology. This is particularly true in the upper reaches in the region of the Coca Cola factory (photo 1 and cover page photo). Here, there are examples of pronounced scour on the outside and deposition of gravel on the inside of gentle meanders. In addition, there are mid-channel gravel bars and excellent instream submerged macrophyte growth. Even though the stream is a relatively small watercourse at this point, many good sized (1lb plus) chub were shoaled up in scour holes. The instream conditions here have the potential to provide excellent quality spawning, juvenile and adult trout habitat, with some simple instream restoration work.

Photo 1: Varied geomorphology, riparian and instream vegetation

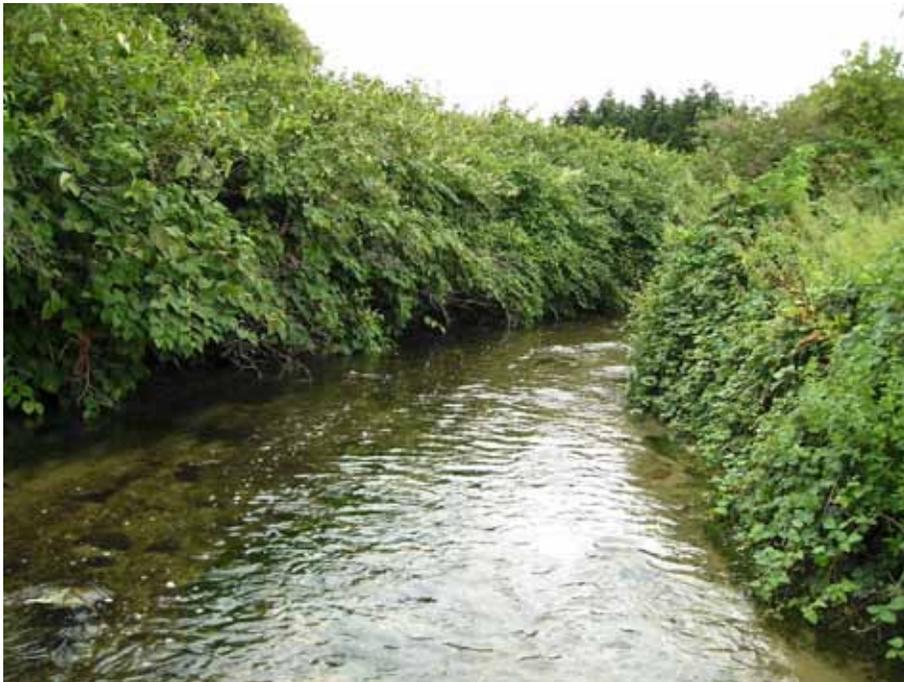
Riparian vegetation is generally varied in the upper (Coca cola factory) region although there was quite a large stand of Japanese knotweed which is earmarked for eradication (photo 2). A mixture of herbaceous, low scrub and

Photo 2: Large stands of Japanese knotweed on LHB and RHB

Continuing control and eradication of invasive plant species is very important. This is particularly true for Japanese knotweed (*Fallopia spp.*) and Himalayan balsam (*Impatiens glandulifera*). These plants out-compete other riparian vegetation and then die back in winter leaving bare soil. This bare soil is highly susceptible to erosion and leads to large inputs of fine particulate material – potentially clogging valuable spawning gravels.

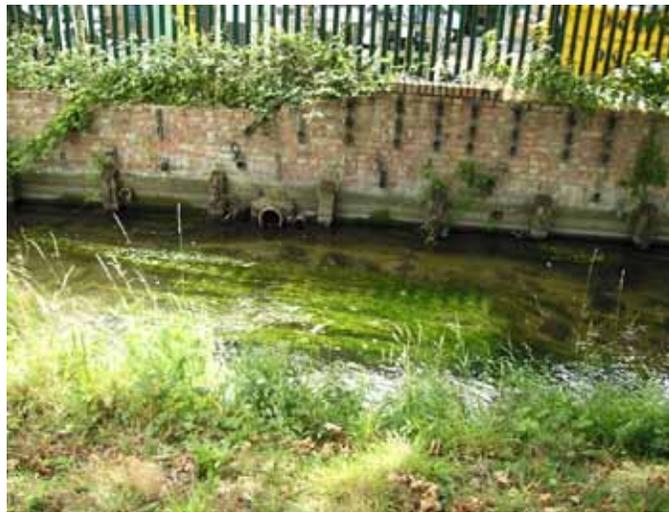
The next accessible section of stream below the uppermost (Coca cola) reach is at the Five Arches business park. Here there is a mixture of shallow riffles and glides; with the latter habitat being generally more extensive. The channel tends to be constrained to a relatively straight course and is walled on the RHB for the length of the business park (photo 3). However, good instream macrophyte growth and mature bankside trees provide juvenile and adult trout habitat (photos 3 and 4). There is less spawning habitat in this reach; although potential for habitat occurs in patches. The main problem being that hard water has caused concretion of potential spawning gravels. Concreted gravels can be physically broken down and cleaned during restoration work. In addition, it would be expected that this reach could be subsidised with fish spawned upstream.

Photo 3: Walled section of RHB along with instream macrophyte growth in Five Arches business park

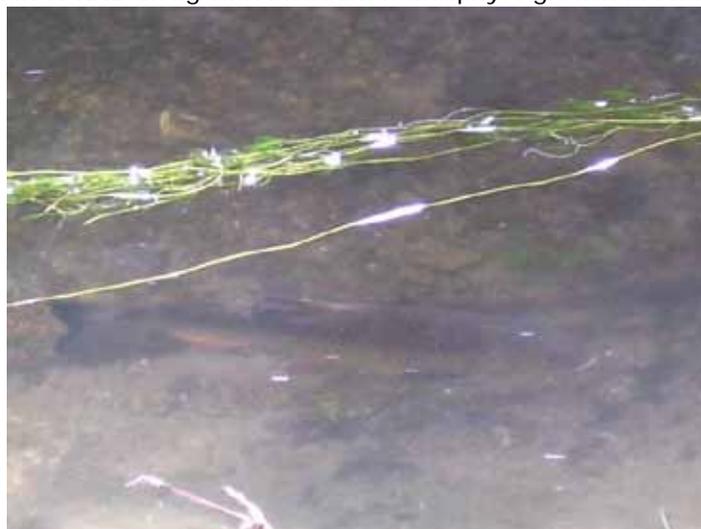
Photo 4: Adult chub sheltering beneath overhanging willow branches in Five Arches business park

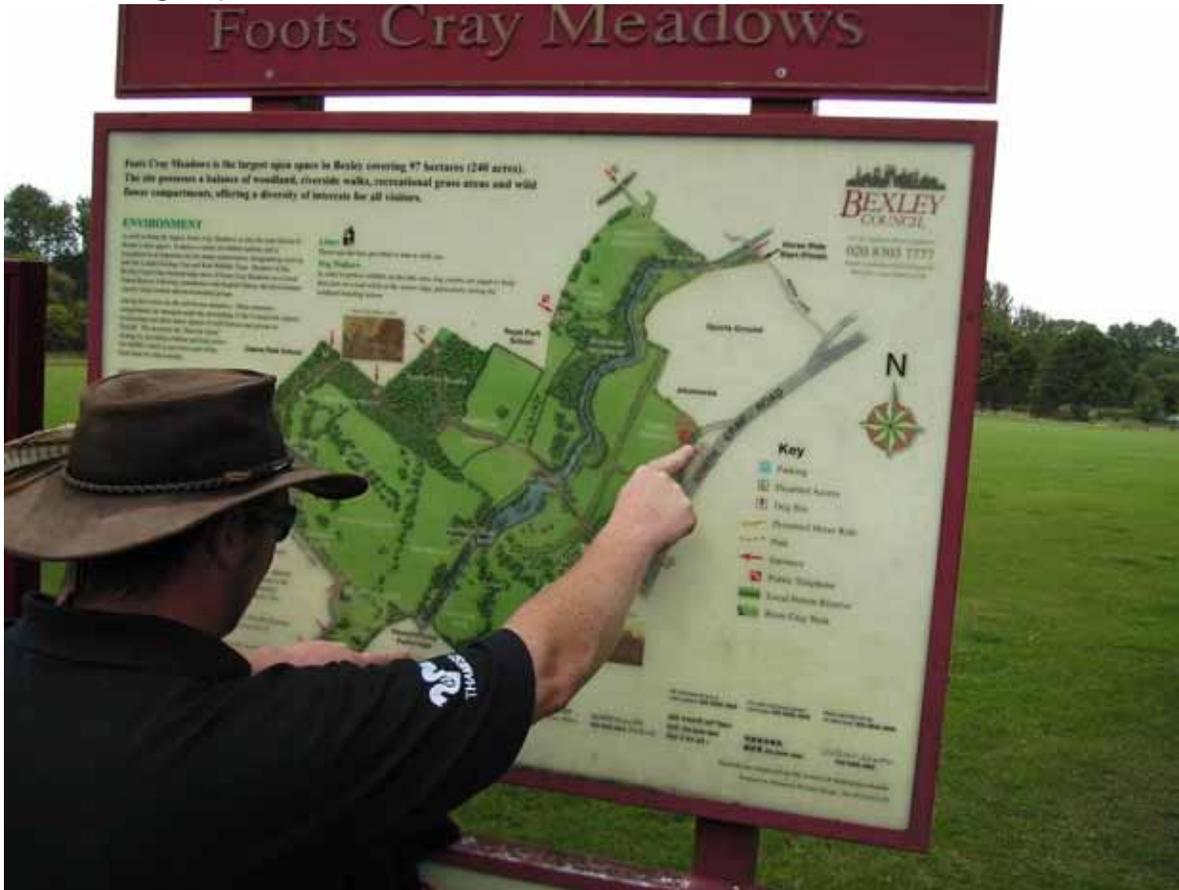
Below the Five arches business park, the river runs through Foots Cray meadows (photos 5) and forms an impounded lake upstream of the Five arches bridge (photo 6).

Photo 5: Fooths Cray meadows nature reserve

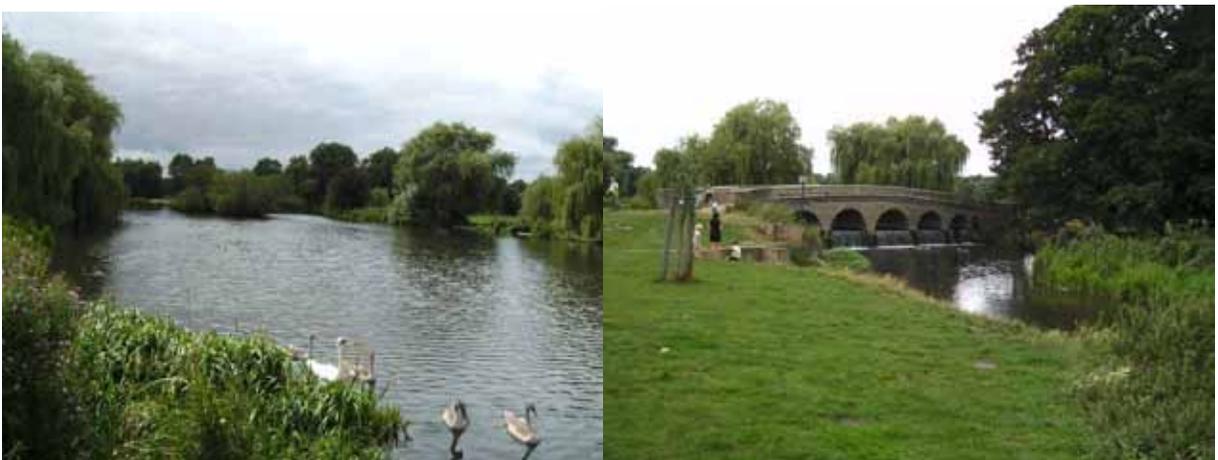
Photo 6: Lake (left) and bridge/weir of Five Arches Bridge (bypass culvert is present in the area where children are playing in the right hand picture)

Refuges are especially important in the lake above Five Arches bridge.

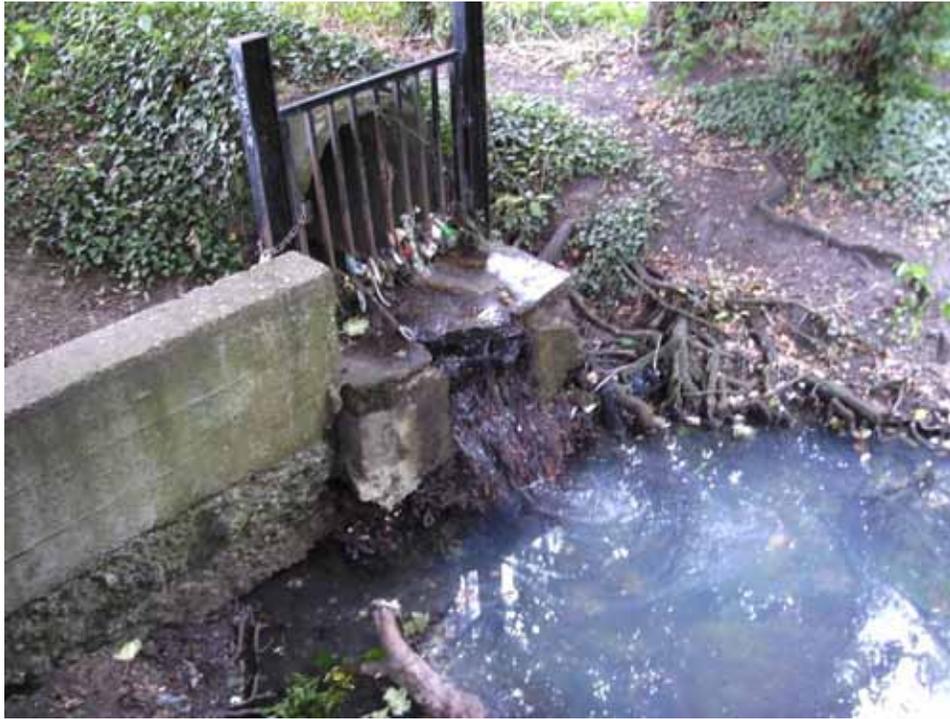
Below the lake, the river continues to flow through Footh Cray meadows before joining section two at the "green bridge". It is at the green bridge that the last remaining potential problem sewage outfall discharges into the Cray (photo 7). However, its influence appears to be confined to a short section of river. Potential may exist for reedbed treatment here.

Photo 7: Last remaining problem effluent discharge on the Cray.

Establish reed-bed to treat problem sewage outfall. Potential funding could be solicited from Thames Water (see also section 5.2). As well as planting the bed, tree canopy would need to be locally thinned to provide sufficient light.

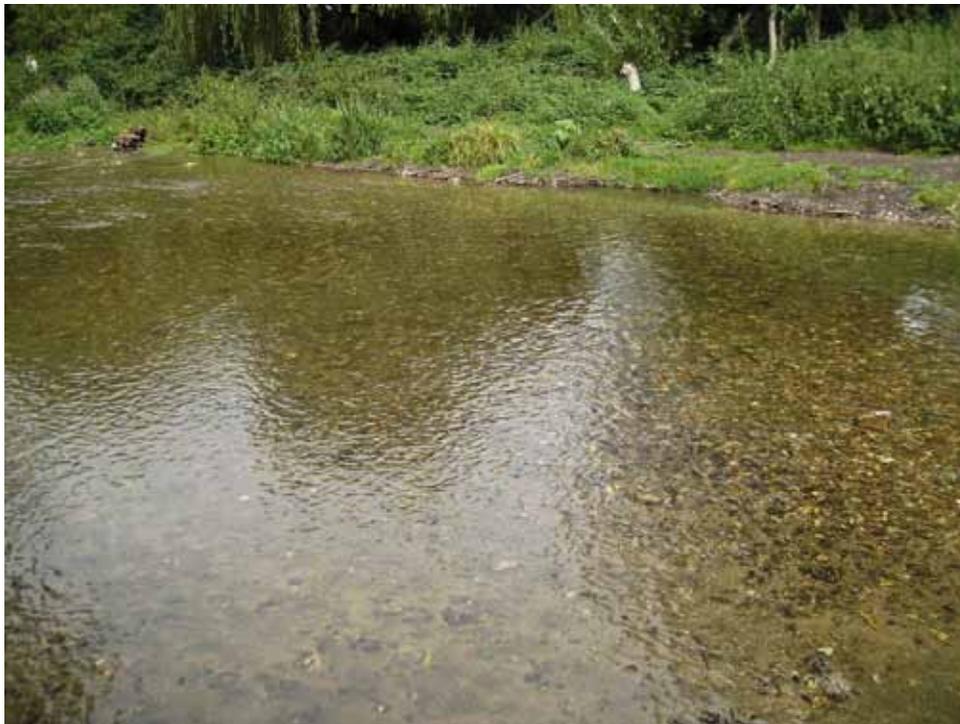
The main river in this section tends to be characterised by long shallow glides of relatively uniform depth (of only a few inches; photo 8). Compared to other reaches, even when light penetration to the stream is ample, there is very little submerged macrophyte growth. This is in contrast to the generally vigorous growth of *Ranunculus spp.* present in the upper half to two thirds of the river. The river is apparently subject to fairly extensive abstraction and the effects of this may be contributing to the lack of geomorphological activity in this reach. It is also possible that the extensive public access to these wide, shallow reaches (coupled with the lower flow and very shallow water) may hinder the establishment of *Ranunculus*. Its general absence is, however, puzzling. There is very little erosion of the banks here from public access and the LHB margin is typically revetted by low woven hazel spiling. Due to the relatively slow and shallow flow, the gravel here suffers in some areas from infiltration by fine sandy material (photo 8).

Photo 8: wide shallow gravelly glides in Foots Cray Meadows. Bankside trees are reflected in the water surface and show the absence of submerged macrophytes in the presence of good light penetration

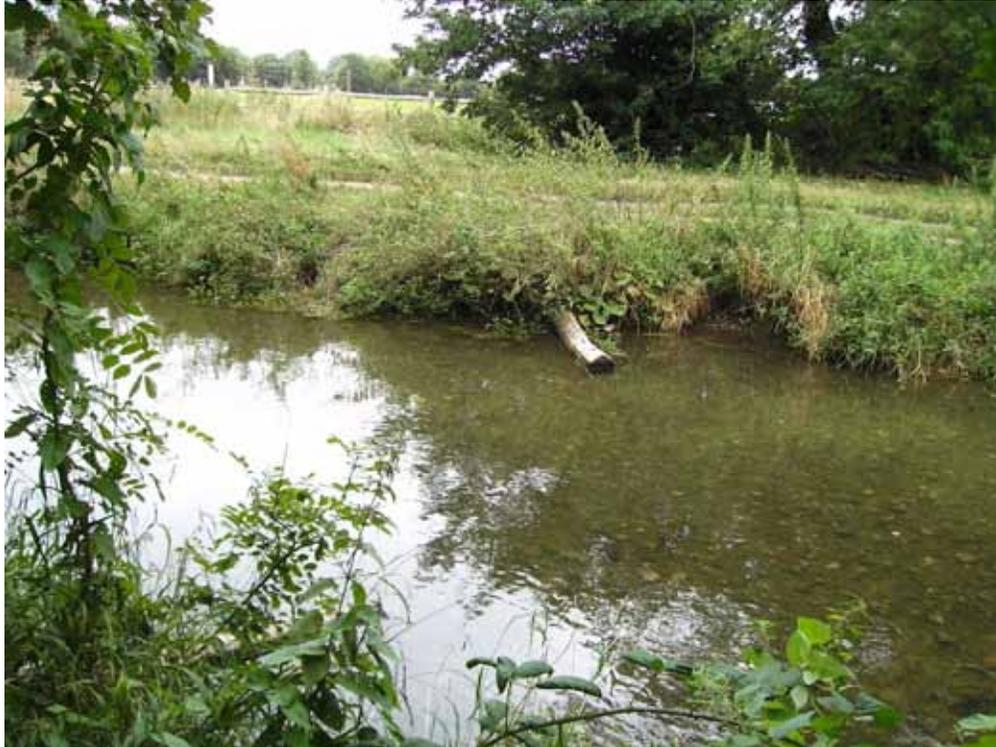
There is also evidence of previous efforts to encourage more variable flow and scour (flow deflector; photo 9). However, such flow deflectors are

Photo 9: Previously installed upstream facing flow deflector (RHB) in Foots Cray Meadows. This particular structure is probably too small to noticeably influence flow heterogeneity and scour.

probably too small to generate much effect. A potentially more effective option may be the installation of longer flow deflectors that are paired together facing upstream. The ideal solution, of course, would be to narrow the channel; although there is likely to be resistance to doing this for continuous extensive reaches of the river. However, locally narrowed pinch points at regular intervals would provide much needed gravel-cleaning flow. Ashe noted, for this reach and others, the problems of having any objects instream that can potentially be moved or removed by the public. Therefore, any measures to introduce more flow heterogeneity must be securely fixed in place.

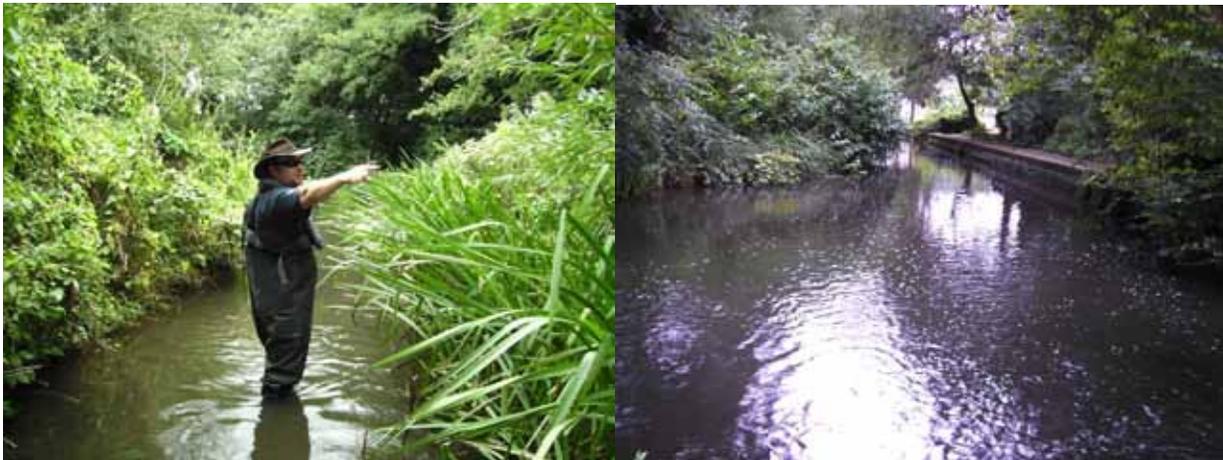
Five Arches to Bexley: Below the green bridge the river narrows, deepens and runs through land belonging to Kelsey's Farm. It is likely that this section has been modified to produce a more deeply incised and narrower channel (photo 10; left). In addition, with the presence of an ornamental pond, the attendant concrete modification and straightening of the channel is evident (photo 10; right). The riparian vegetation is much denser in this section and probably provides a good buffer to high summer temperatures. In the future, some rotational coppicing or pollarding may be appropriate to maintain an appropriate light/shade balance.

Photo 10: Narrower channel (left) and concrete modifications to channel (right)

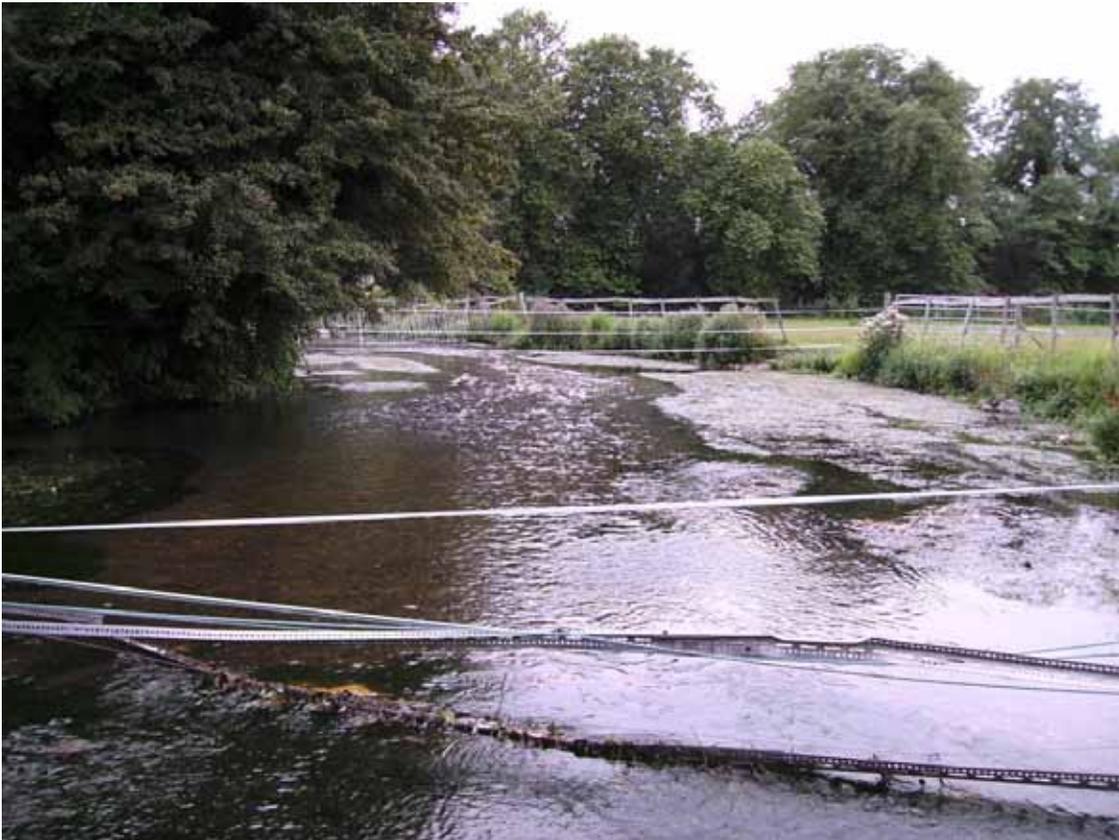
Again, within this reach there is suitable habitat for all brown trout (*S. trutta*) lifestages. The silty/deeper sections would support large adult fish whilst the gravelly/*Ranunculus* dominated sections could be made suitable for spawning, juvenile and adult salmonids with the cleaning of gravel substrate. As with all previous sections, there is a general lack of large woody debris (LWD) in the channel.

Photo 11: Fenced off horse-drink in gravel/*Ranunculus* dominated section

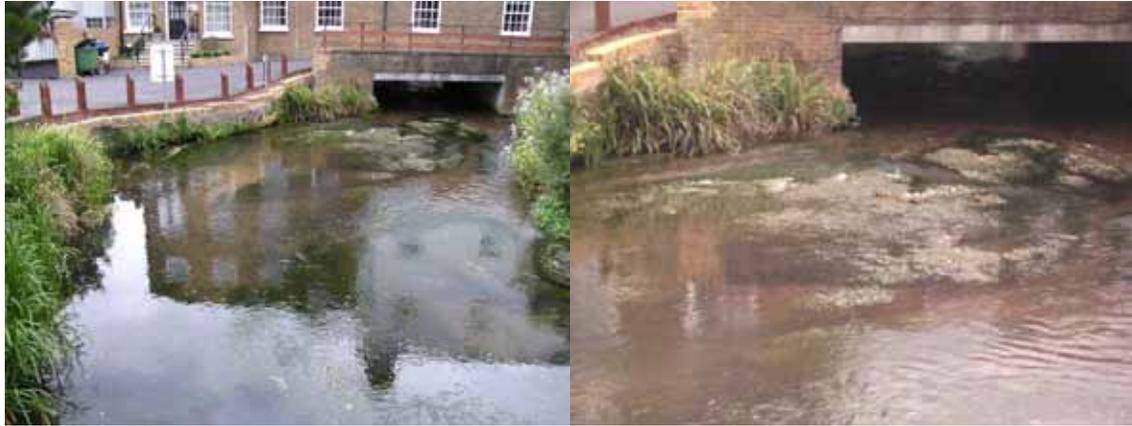
This section then flows into Bexley village at Clarendon Mews (photo 12). Here Ashe reported some sandy sediment accumulation due to building work adjacent to the river. However, in spite of this, dense instream macrophyte growth and a variety of depths and substrate sizes were apparent at this location within the village. The result is a very attractive pool habitat that would be suitable for a wide variety of coarse and salmonid fish.

Photo 12: Varied pool at Clarendon Mews in Bexley village

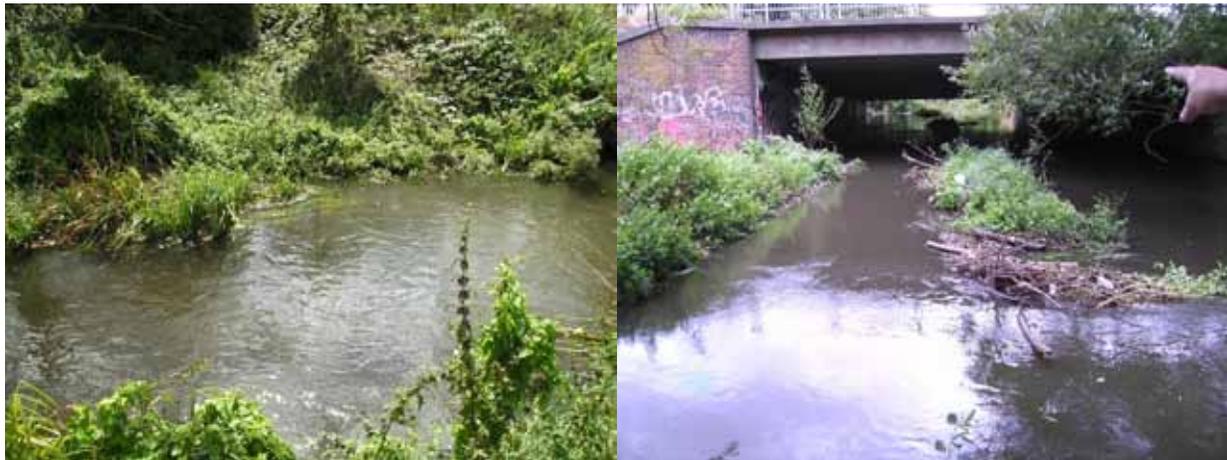
Bexley to Vitbe: In general, below Bexley village, there is an increasing dominance of habitat that is suitable for coarse fish and grayling. Flows tend to deepen and slow and, for the most part, are suitable only for adult trout. For the purposes of this report (which is primarily concerned with potential for wild trout populations) a little less detail is reported for this section as a whole. However, some important aspects in relation to migratory trout and the presence of wild trout in urban centres are highlighted. **It should be noted that all photographs on this section were taken after torrential overnight rainfall and are uncharacteristically coloured and at a higher level.** Below Bexley village the river passes through St. Mary's recreation ground where the average depth increases to around knee-height (photo 13; left). There are sandy inputs into this reach below a quarry and this combines with a more sedate flow to produce typical coarse fish habitat. An example of this habitat is evident at the confluence with the river Shuttle (photo 13; right).

Photo 13: Deeper flow with less submerged macrophyte growth (left) and confluence of River Shuttle and Cray at the A2 road bridge (right).

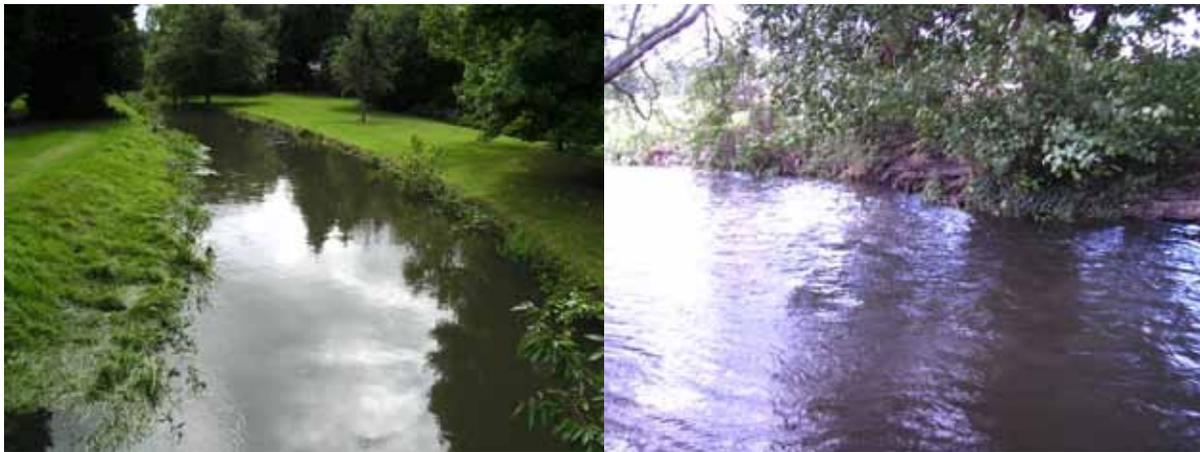
Downstream of the A2, the river passes through Hall Place (Bexley Council and Bexley Heritage). Here the river is extensively modified and straightened as it passes through ornamental grounds. The bank tends to be mown right to the margin of the river (photo 14; left). In addition, an impassable weir is in place on this section. Further downstream, below the heavily modified channel; there is an attractive shaded reach with some varied flow which looks like prime grayling habitat (photo 14; right). Along this section there are some very large and fast growing willows that are actively managed under the riparian owners' instruction.

Photo 14: Modified ornamental section (left) and downstream shaded/more variable section (right)

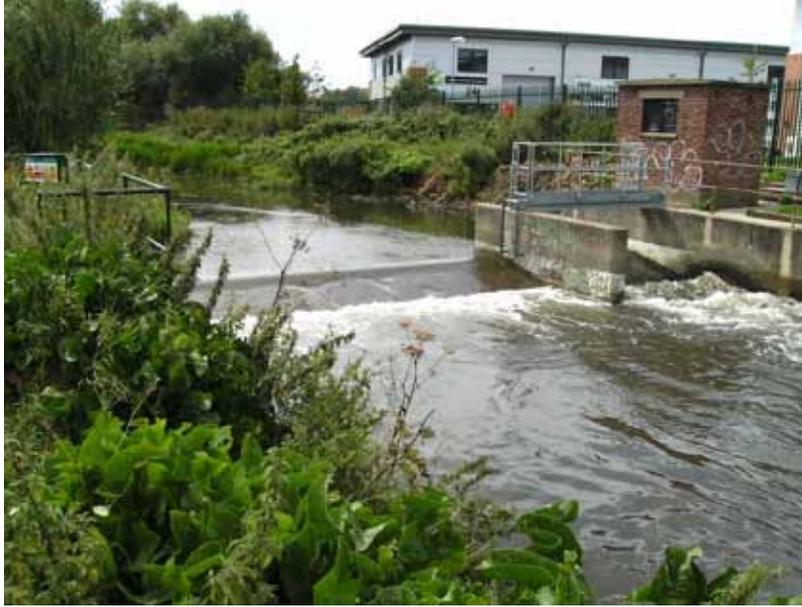
Continuing downstream to Crayford town section; the whole reach is an excellent coarse fishery (and hugely improved from the 1970s and 1980s). A section of land in Crayford close to the old Tannery is owned by Sainsbury's on the RHB. In addition, there are plans for a housing development on the LHB. In terms of salmonid populations, the most significant feature in this reach is the large weir (photo 15) and making this passable would be a very desirable outcome. The housing development and/or Sainsbury's may be a source of funds to achieve this.

Photo 15: Weir at Crayford (in high flow conditions)

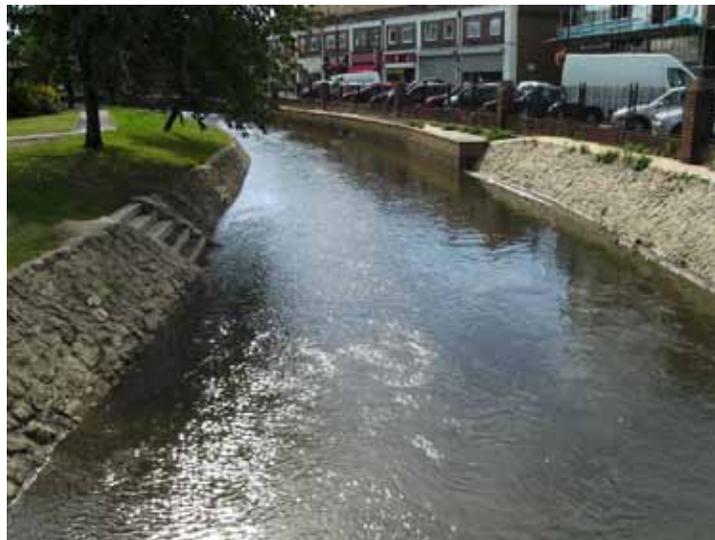
The other significant feature in this reach, with particular reference to Trout in the Town, is the enhancement work already undertaken in the Crayford town centre park. Between the two bridges that delimit the park, Thames21 have installed 120 tonnes of gravel and approximately a ton of rock (photo 16). In combination with their litter removal campaign, this has produced a valuable urban green space with the potential to support adult salmonid fish. It may even be possible for some salmonid spawning recruitment to take place in this stretch. Some possible future improvements are suggested in the Recommendations section that follows.

Photo 16: Crayford town centre park that has already undergone habitat enhancement work by Thames21.

Crayford town park section could benefit from low-level overhead cover provided by secure installation of coir rolls planted with wild flowers. These could potentially be housed within structurally sound baskets bolted to the concrete channel wall to resist vandalism. Again, where possible, LWD (coupled with interpretive signage in the park) should be securely installed in the town section.

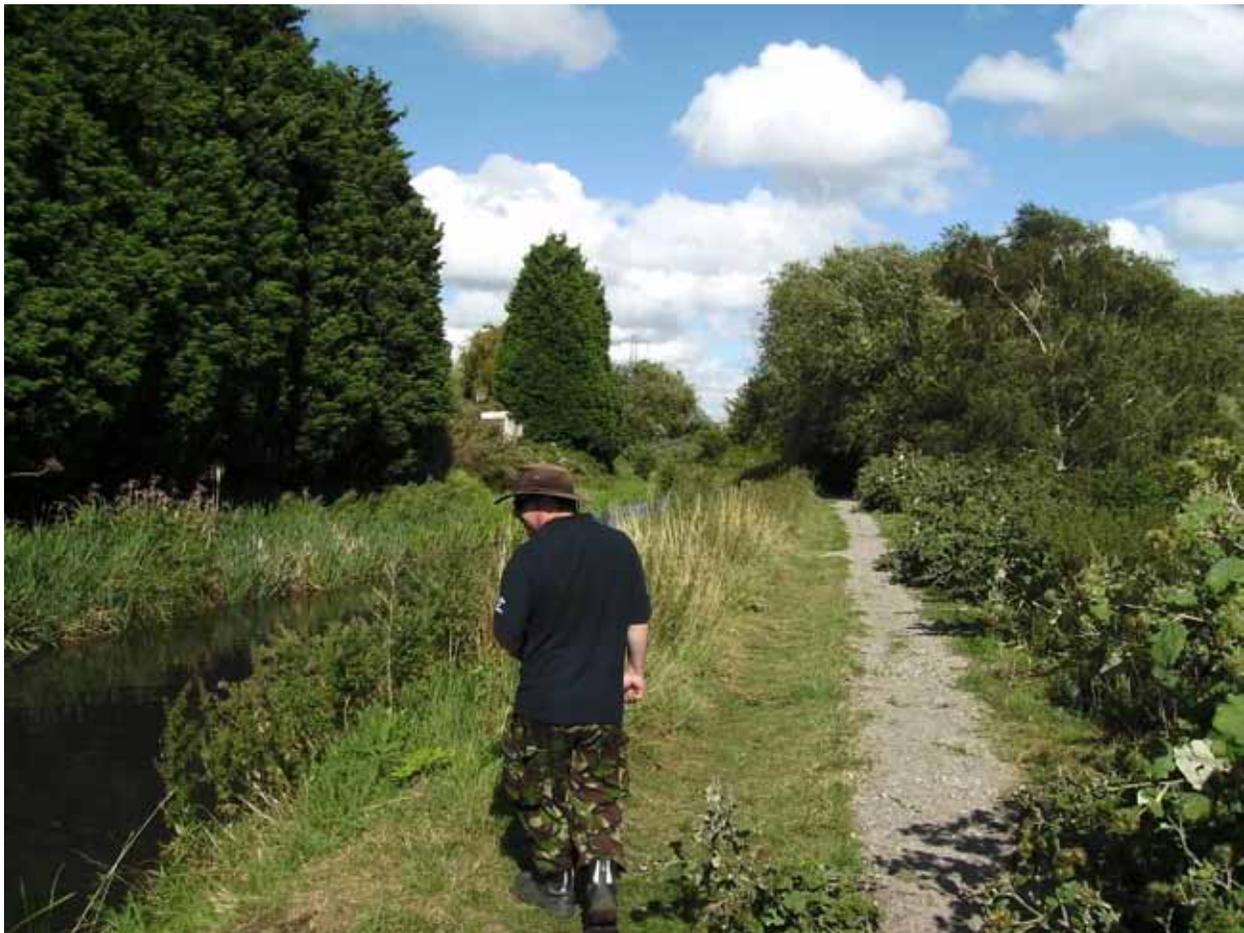
Downstream of Crayford town centre, there is a long canalised reach (photo 17) previously degraded by horrendous amounts of fly tipping and car dumping. The impact that Thames21 and Ashe have had in reversing this scenario is exemplary. This is particularly important in urban areas, where local communities can see that river corridors are valued green space and not landfill.

Photo 17: Section of the Cray that was previously seriously degraded by refuse tipping

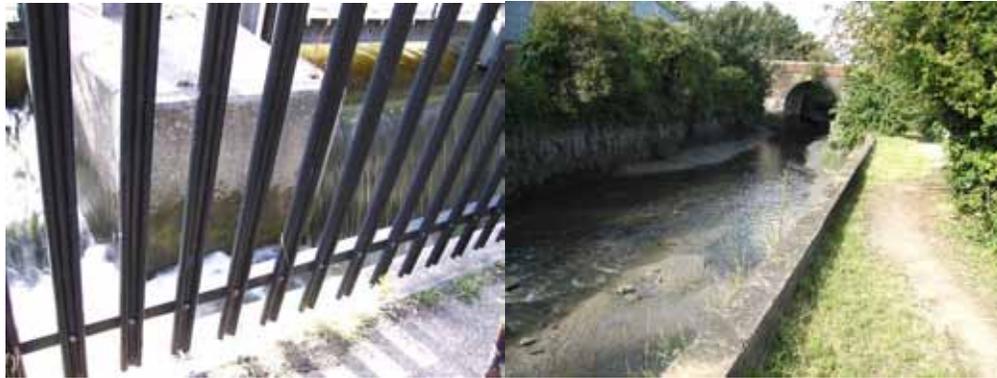
The final significant factor on the lower reaches of the Cray in terms of wild *S. trutta* populations is the large (20 feet high) sluice that determines the current tidal limit of the Cray (photo 18; left). There is some (uncertain) potential for a fish pass to be fitted here. This would be particularly timely as there are now a handful of reports (up to five) of local anglers catching sea trout (*S. trutta*) below the sluice (photo 18; right).

Photo 18: Vitbe sluice (left) and the tidal reaches of the Cray below (right)

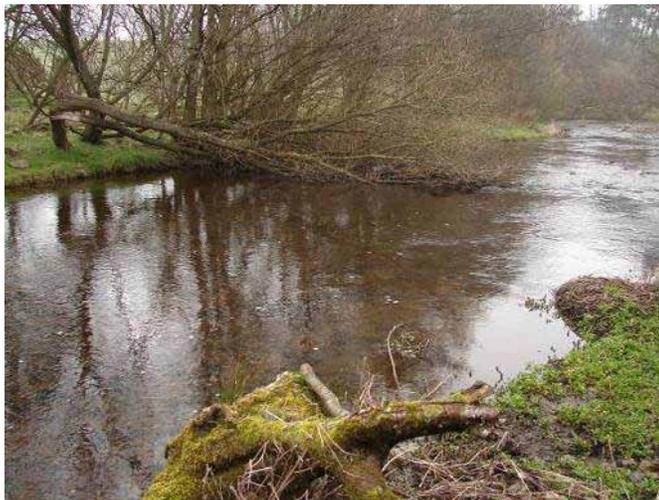
- Pollarding/coppicing trees
- Fixing the arisings in the river channel (trunks or brushwood bundles) using wooden stakes or metal rebar and wire.
- “Hinging” bankside trees into the river channel (trees to be felled should be only cut through for 75% of their diameter and then pushed into the river (Fig. 1)).

Figure 1: Hinged LWD on the River Derwent (Co. Durham)

Hinging maintains a firm fixing to the tree stump and in many cases, allows the tree to continue growing. It may be possible, with landowner permission, to use this technique in areas such as Crayfoot Meadows and Hall Place.

Trees should be fixed into the channel bed at an upstream facing direction or parallel to the bank to avoid scouring of the banks. The secure fixing of all material in the channel is particularly important as a counter-measure to vandalism in urban areas with extensive public access.

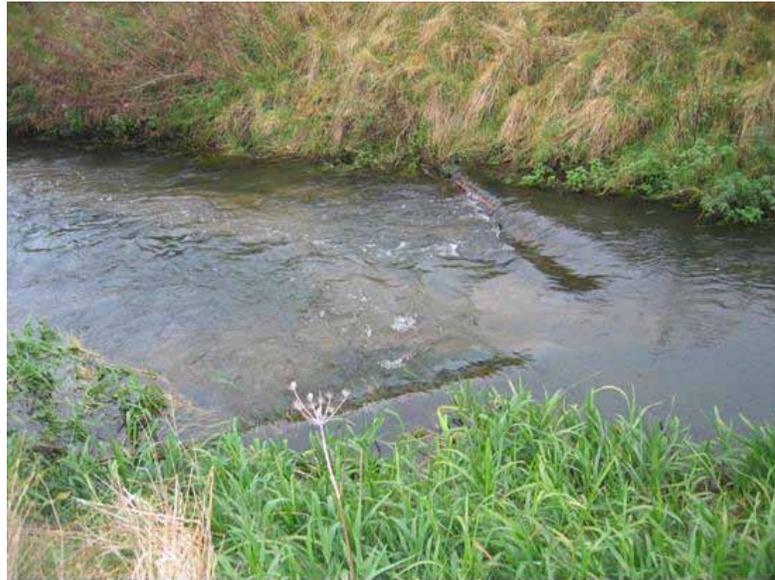
upstream-facing flow deflectors (Fig. 2) should also be considered. These would need to be of sufficient length to produce a “pinching” of the current in the centre of the channel. In this way, scour would be concentrated in the middle of the channel and greater variety in depth would be produced (as well as continual re-sorting of the substrate gravels).

Figure 2: Paired upstream facing flow deflectors generating mid channel scour

Particularly in the section directly below Five Arches Bridge, narrowing as many sections as possible of this reach using felled trees/willow spiling and back-filling with brushings is strongly advised. Paired

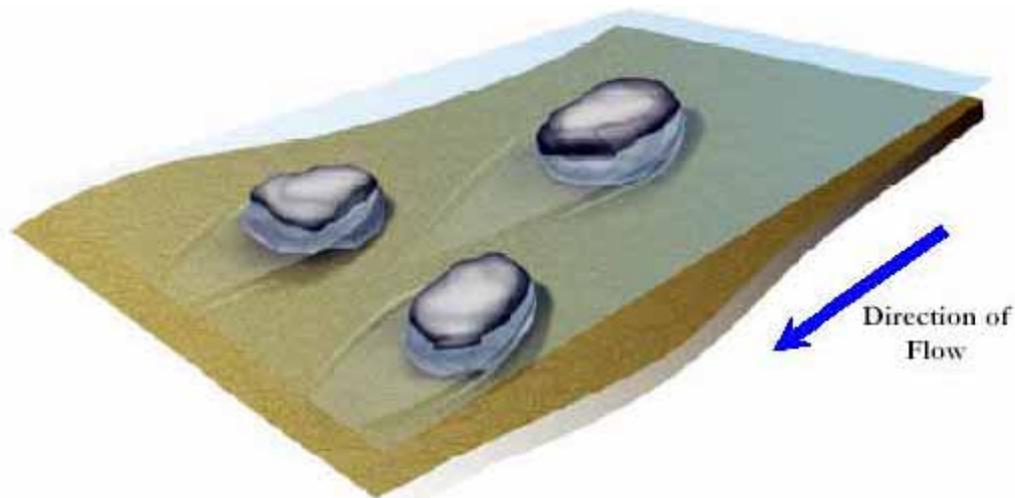
Additional variety could be generated by suitable boulders. It may be possible to install boulders (of sufficient size to resist movement by the public) to produce scour and more varied flow (Fig. 3)

Figure 3: Boulders placed to produce variation in stream bed via localised scour (Copyright Ontario Streams)
