River Wye, Litton Mill Leat & Adjacent River: Advisory Visit

River Wye: Litton Mill to Cressbrook Mill	
River	Wye (Derbyshire)
Waterbody Name	River Wye from Monk's Dale to River Derwent
Waterbody ID	GB104028057820
Management Catchment	Derwent Derbyshire
River Basin District	Humber
Current Ecological Quality	Moderate
U/S Grid Ref inspected	SK1600672973
D/S Grid Ref inspected	SK1707572908
Length of river inspected	1.5 km (plus 330 m of Mill Leat)

Wild Trout Trust Report – Following a Site Visit on 19/10/2017

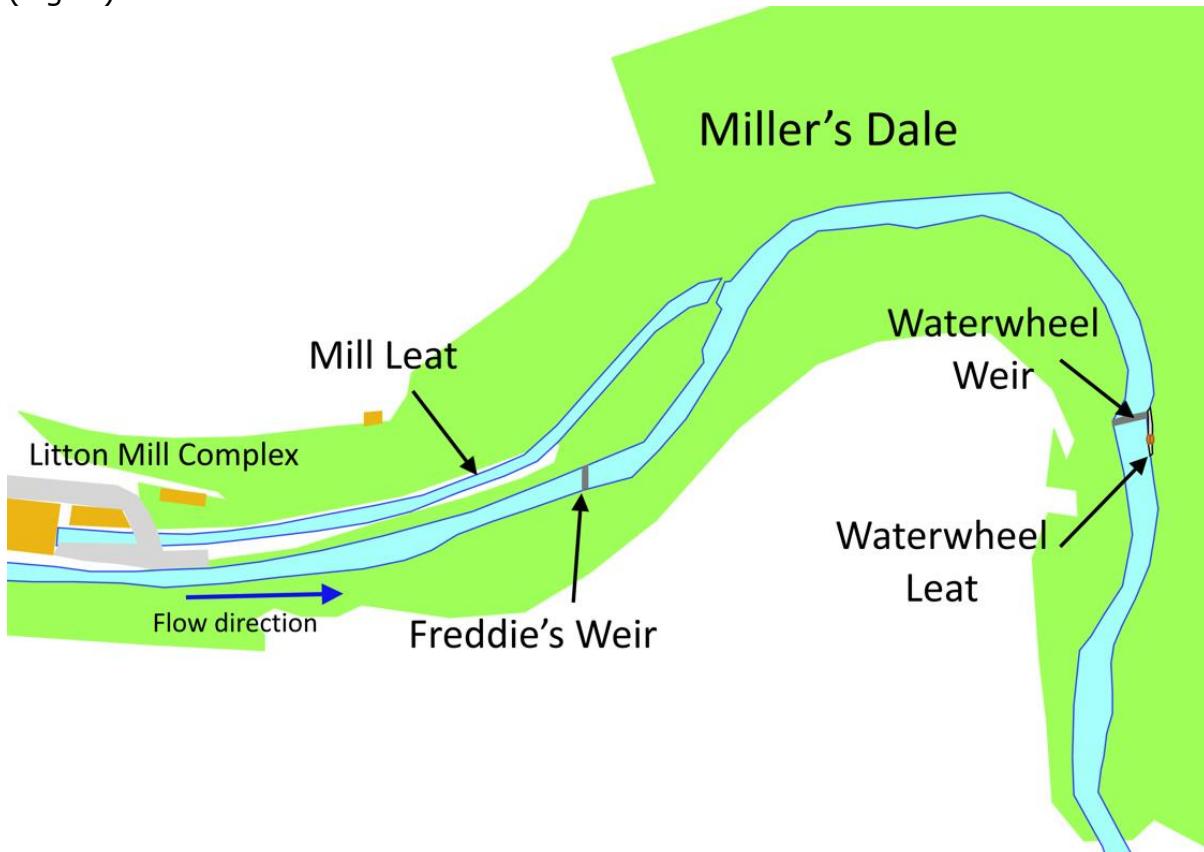
This report refers to a reach between an upstream limit at SK 16006 72973 and a downstream limit at SK 17075 72908. The parallel arrangement of Mill Leat and main river channel mean that it is not possible to list observations in a strictly linear sequence from upstream to downstream (or vice versa). Consequently, named features have been added to a sketch map to aid interpretation of findings (Fig. 1).

Figure 1: Sketch map of main surveyed features

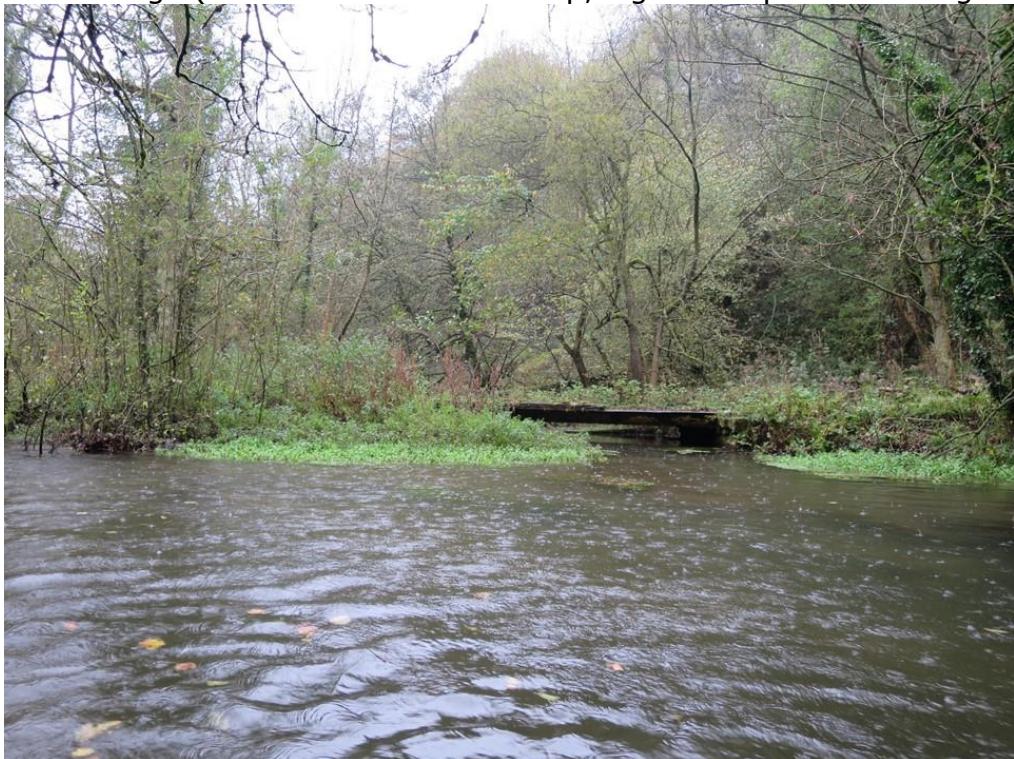
At the upstream limit of this visit the main River Wye is diverted by a sluice through the Litton Mill complex. This feeds an old Mill "leat" (side-channel) which forms a small, wooded valley with a footpath/causeway on its RB and a steep wooded slope along its LB. The footpath/causeway forms the LB of the main river below Litton Mill until the leat rejoins the main river beneath a small, wooden footbridge (visible on the sketch map, Fig. 1 and pictured in Fig. 2).

Figure 2: Footbridge over mill leat where it joins the main river (photographed from centre of main river channel looking up along the course of the leat).

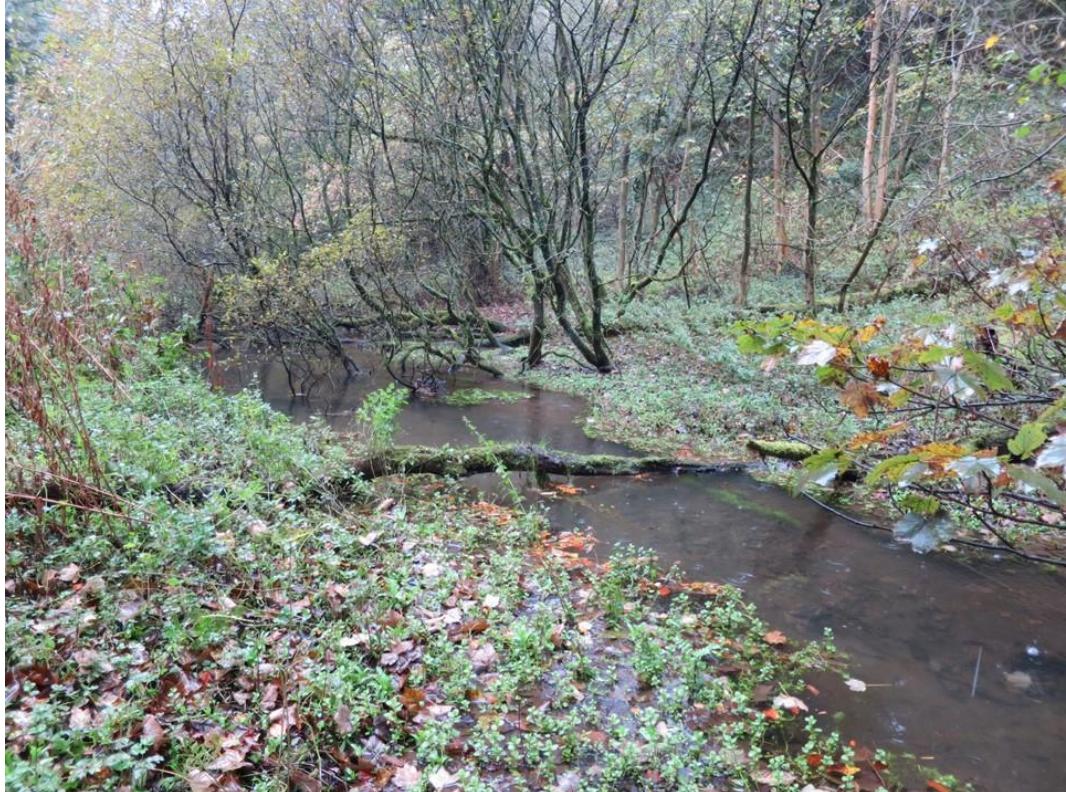
A relaxed attitude to management of woody material in the leat means that some effective backwater refuge habitat has developed (e.g. Fig. 3); however, reinstatement (if it were possible) of a more natural flow regime and gradient would greatly benefit the ecology of the reach, including invertebrate and fish populations.

Figure 3: Typical conditions within the mill leat. The bed is dominated by soft muds and sand – so has little value as a spawning resource or habitat for many of the invertebrates of primary benefit to angling. However, the complex cover formed by fallen trunks and capacity to act as a slowed-flow backwater during spates do provide a useful function as refuge for juvenile and adult fish.

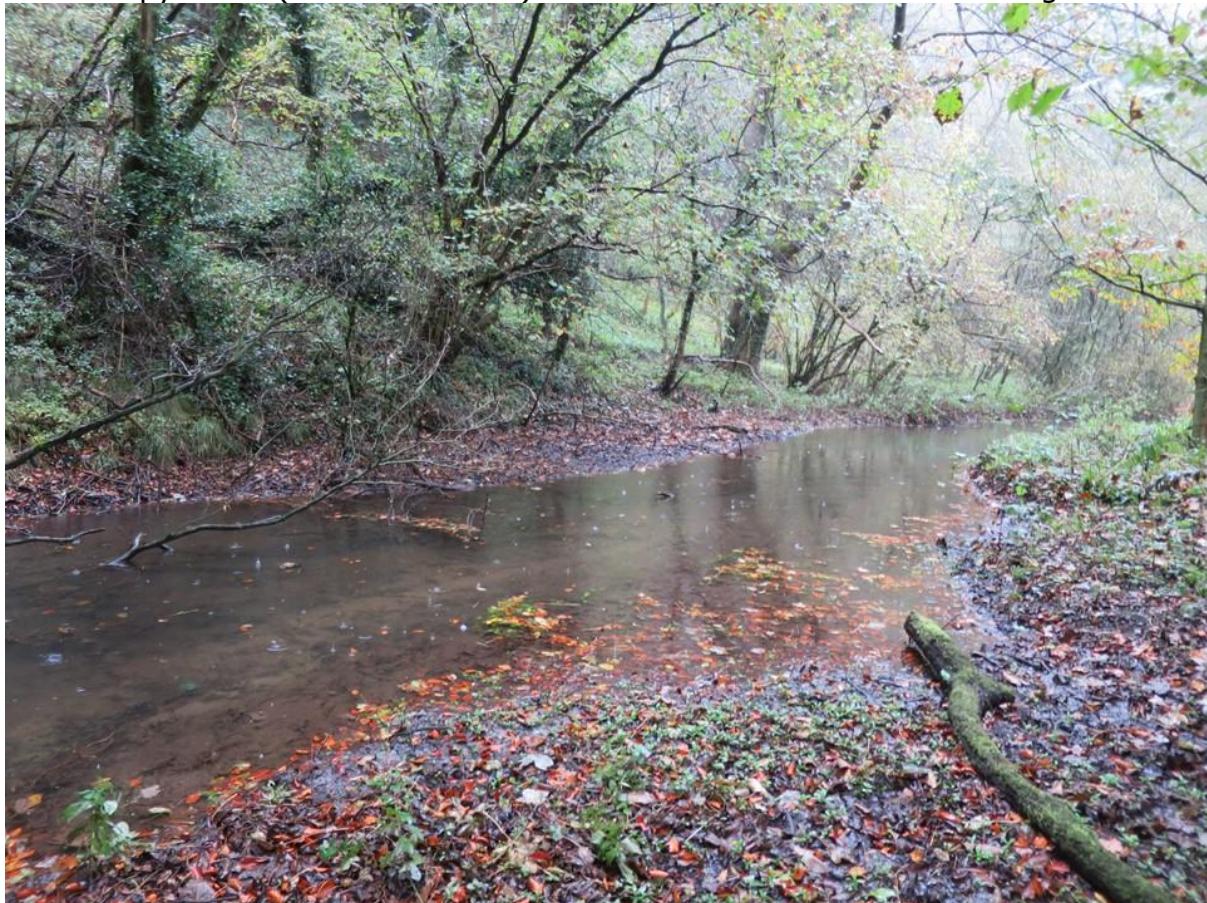
Currently, the dense tree canopy has almost blanket coverage over the leat. Particularly during the warmer months of the year when trees are in full foliage, the artificial channel will be almost completely shaded throughout its full length. The canopy cover (even in autumn) and soft silt bed can be seen in Fig. 4.

Figure 4: Canopy cover throughout the length of the leat upstream of the confluence with the main river. Note also the fine bed material that is at least two feet deep (and possibly more) in many places.

Although some areas of complete shade are a benefit in hot summer conditions, there is also merit in creating both dappled light as well as scattered openings in the canopy. This will promote a more interesting growth of understory species – augmented by the good work carried out by the fishing club to control the invasive Himalayan Balsam. In the absence of such control, the native understory species would be unable to compete and flourish against the rapid growth of balsam. A dual benefit of more varied light/shade regime and also in-stream cover would result from hinging saplings and larger trees (cabling to their stumps if necessary) into the margins of the leat.

The localised increase in available light would promote some passive narrowing of the channel via ingress of understory vegetation. At the same time, the creation of additional marginal “brashy” cover at scattered locations would actively narrow the channel at those points and generate some diversity in flow depth and velocity.

- Undertake light, rotational coppice work (aim to preserve at least 60% of the riverside canopy cover): www.shropshirehillsaonb.co.uk/wp-content/uploads/2010/10/Management-of-Riverside-Trees-Feb-2013.pdf (Natural England should be consulted according to the conservation designations of the site – including that of the Wye Valley Site of Special Scientific Interest: <https://www.gov.uk/guidance/protected-areas-sites-of-special-scientific-interest>).

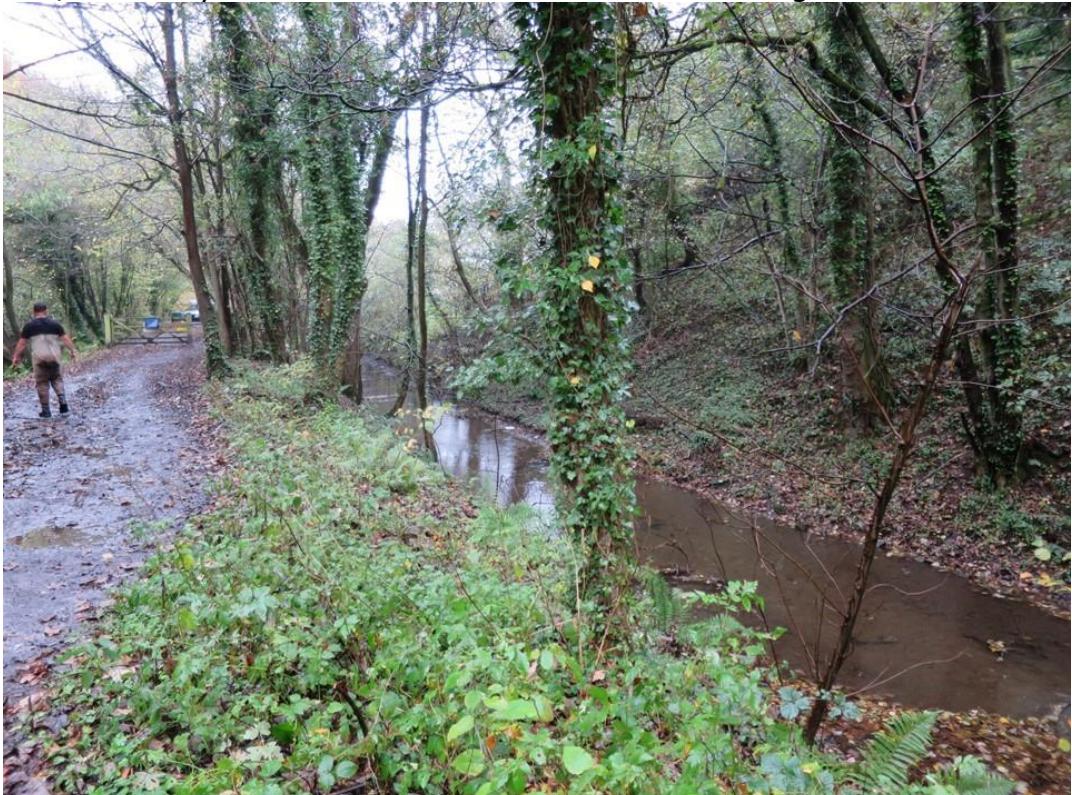
Coppicing a very small proportion (perhaps between 2 and 10 percent) of the trees every one to two years would create more diversity in the age/height/percentage cover of the woodland canopy. This periodic thinning, combined with the coppice regrowth is a simple way to stagger the heights of trees within the woodland. For flora and fauna, structural diversity in the habitat is what creates additional opportunities for biological diversity to thrive. For context, the steep LB and the footpath/causeway on the RB of the leat can be seen in Fig. 5.

Figure 5: Facing upstream the causeway (RB) is to the left of the frame while the steep, wooded slope (LB) is on the right of the frame.

- Extend rotational coppicing to the woodland on the LB of the leat – pending suitably certified forestry workers and any bat habitat surveys that may be required.

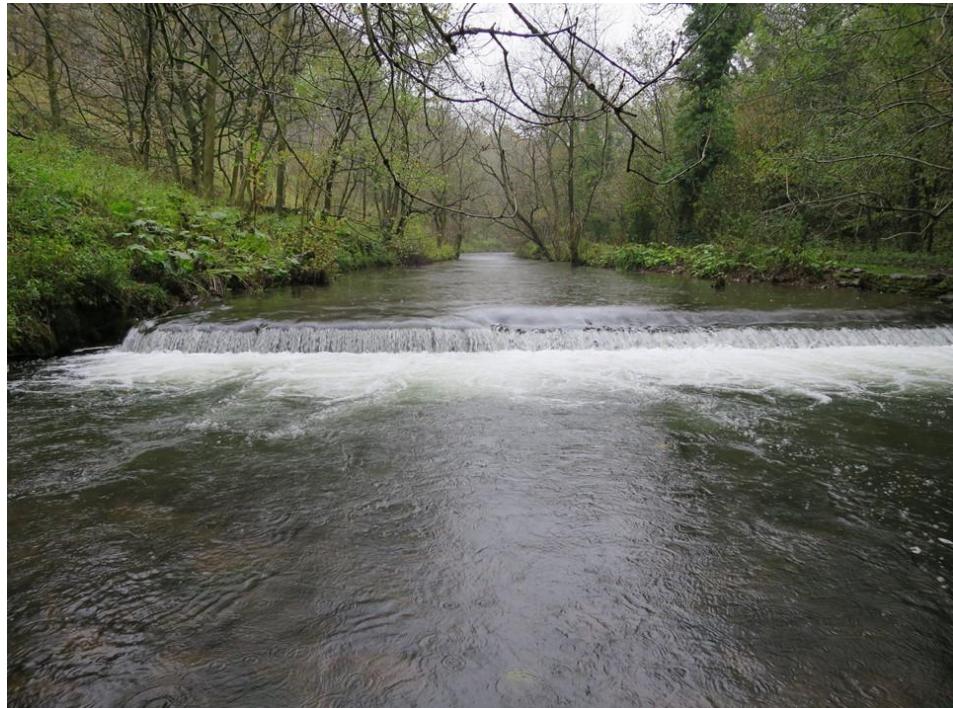
Turning to the main river reaches that were surveyed for this report, a number of interesting conditions were noted. As mentioned in the introduction, although not identified as a “Heavily Modified Waterbody”, the history of mineral mining, milling, associated processing and transport has modified the river channel extensively. Measures have been taken to reinforce the “toe” of the banks (the bottom of the bank where it joins the riverbed) with both stone and also a single line of planted trees. The roots of those trees, combined with stone-work, act to produce a strong matrix that resists erosion (e.g. Fig. 6).

Figure 6: Blocks of limestone and single line of trees planted on RB (left of frame) to consolidate straightened channel, plus "Freddie's weir" that acts to reduce the erosive forces acting on the banks.

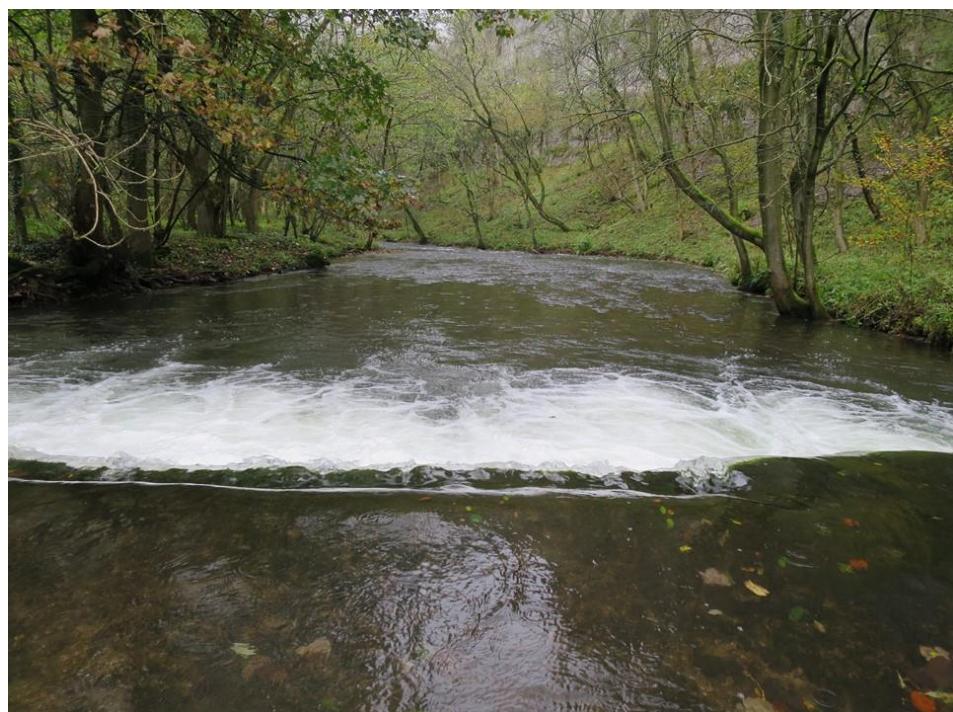
Figure 7: Facing downstream from the crest of Freddie's weir, single line of trees and stonework on RB also visible.

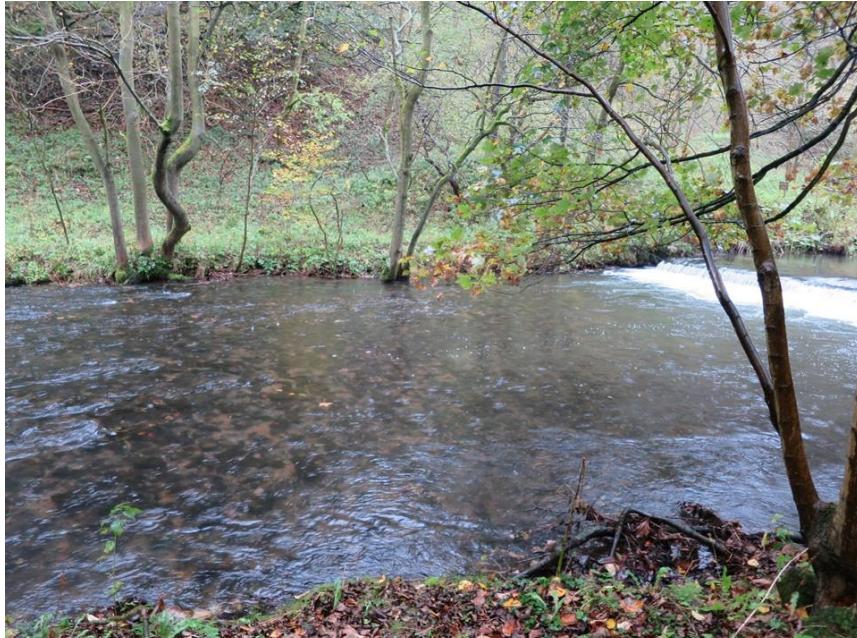
There is evidence of the impacts of reduced gravel input and transport when the bed of the river is examined within the surveyed reaches. For instance, Fig. 8 shows the bed **below** (downstream of) Freddie's weir to be predominantly large cobbles and limestone blocks, interspersed with sandy substrate that has filled the gaps between the rocks. Sand is, of course, more easily washed over the weir

during a spate than the gravel which may become trapped on the upstream side of the barrier, starving areas downstream. At the same time, the high flows that can move gravel will export those chunks and pebbles from below the weir (to be replaced by the incoming sand and silt that drops out of suspension as the flows return to normal/low conditions).

Figure 8: Chunks of (often algae-covered) limestone that are locked into the bed and interspersed with sand. The "gravel" particle-size fraction is notably under-represented.

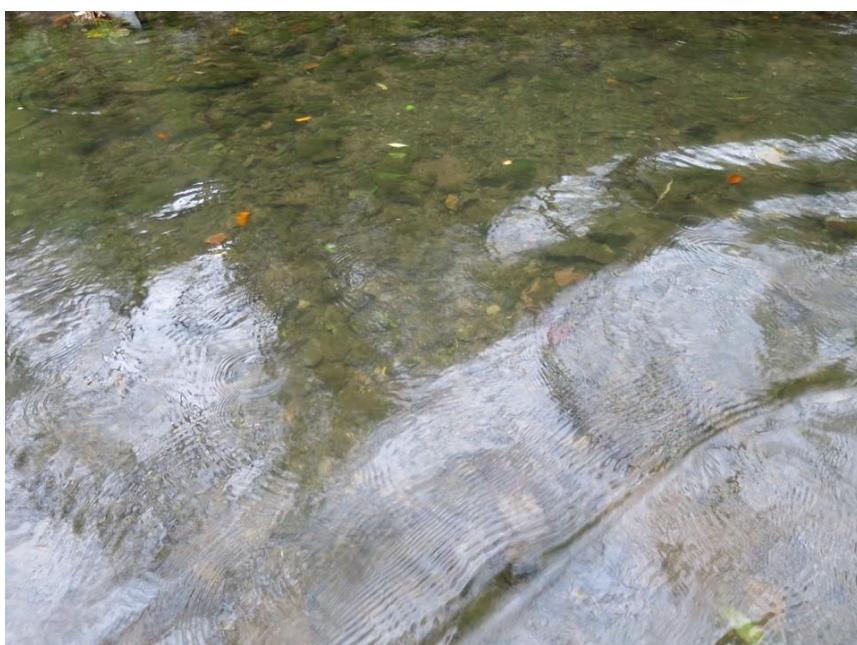
That process will tend to leave the gravels and other material on the upstream side of the weir where it will deposit in a more aggregated (or "unsorted") mass, with the other major unintended consequence of shallowing the pool upstream. This was photographed in Fig. 9 when standing on the upstream side of Freddie's weir.

Figure 9: Behind the lip of the weir on the upstream side, there is a "cake-mix" aggregate of cobble, gravel and sand. The "unsorted" nature of this deposit means that inter-gravel pores are clogged and it is not viable spawning habitat.

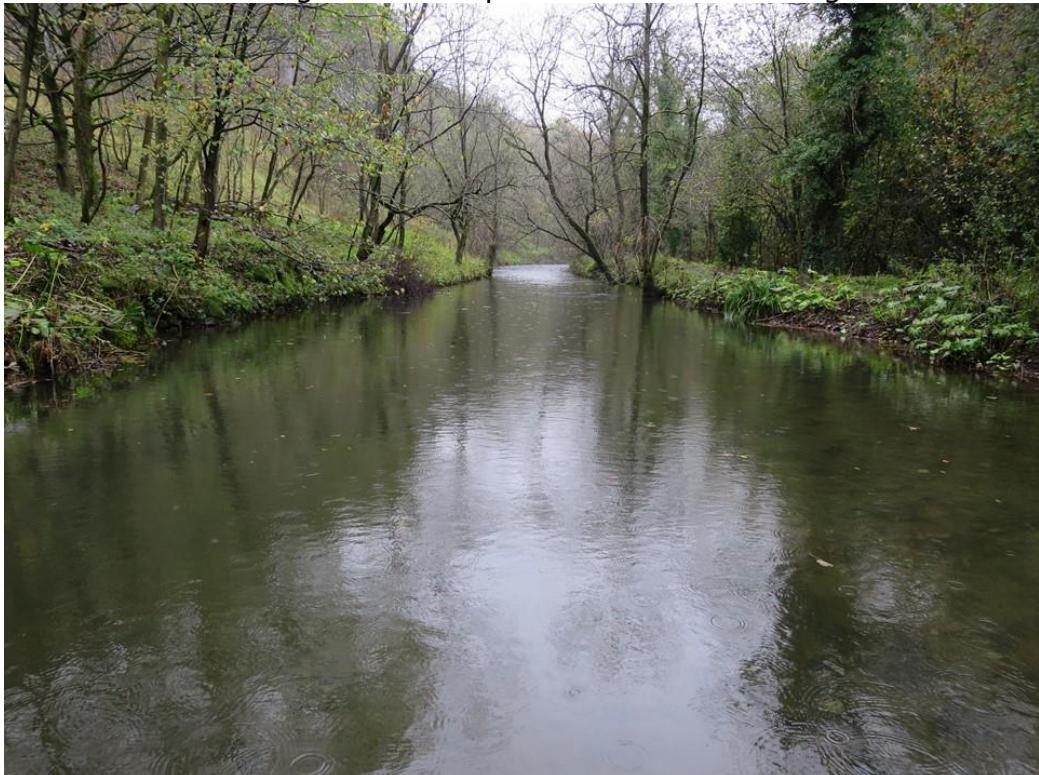
As well as blocking the transport of (already reduced inputs of) gravel, the weir structures also artificially redistribute flow across the channel, with each weir effectively resetting the process. This creates homogenous habitat (e.g. Fig. 10) since there is little diversity in flow velocity across the full cross-section – and hence little variety in associated deposition/erosion of bed material – which is vital to produce a diverse, healthy bed profile of pools and riffles. The greatly simplified and dissipated flows lead also to increased siltation and smothering of the bed with finer sediment throughout the impounded reaches during low flows.

Figure 10: Impounded section above Freddie's weir with little variability in bed profile and reduced opportunity for fish to hide from avian predators.

- Remove sufficient sections of Freddie's weir and Waterwheel weir to reinstate the river's natural gradient, enable improved bed-material transport, reduce siltation and reinstate natural fish passage through the

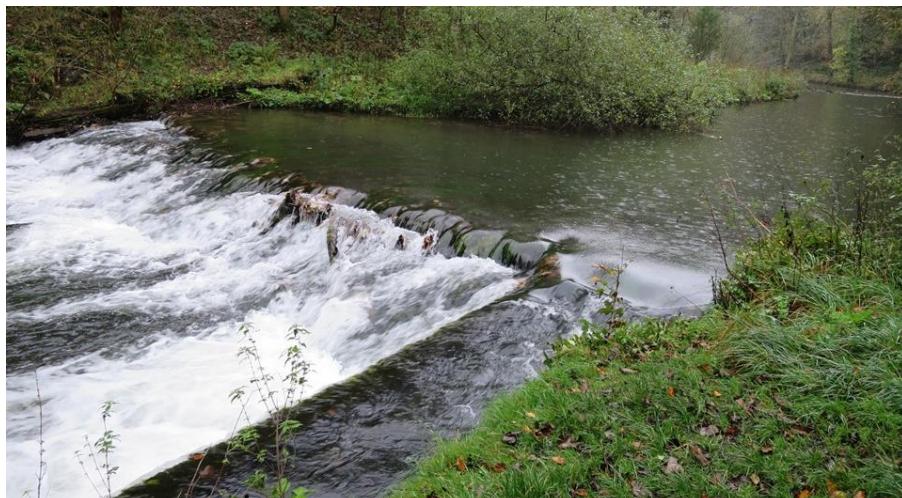
Additionally, wherever “white water” is visible flowing over a barrier (i.e. Figs. 8 and 11) – this indicates a large amount of entrained air within the flow. The physics of a fish swimming through water are radically impacted when air is entrained in the water – since the density and viscosity are vastly reduced. In short, fish’s fins, tails and bodies don’t swim very well in air. Even without lots of entrained air/white water, the flows may be so fast and shallow over the surface of a barrier that it exceeds the maximum swimming speed of migrating fish. Remember, juvenile fish also need to migrate/disperse.

Figure 11: Waterwheel weir (marked on map in Figure.1) – a complete barrier to fish under most flow conditions.

Removing the Waterwheel weir would increase the quality and amount of spawning habitat in the currently-impounded reach (and possibly downstream as well). Both improvements would be extremely valuable. This is an especially important opportunity given the numbers of trout that are restricted by additional weirs in areas up and downstream of the Waterwheel weir. For instance, the area

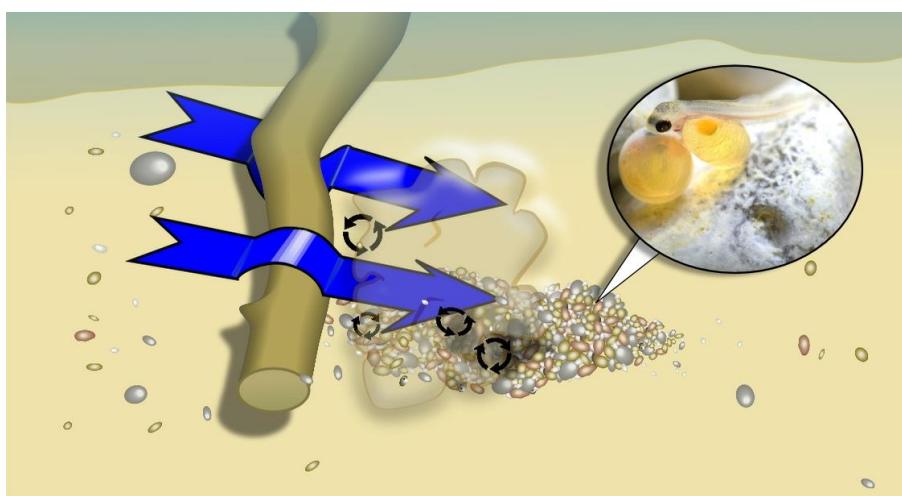
Figure 12: Flow is required under, over and around obstacles to create localised bed-scour which blows silt out from gravel deposits and produces mounds of loose gravel. The loose, silt-free particles can then protect trout eggs and developing juveniles (alevins) that hide in the gaps while being supplied with oxygenated water. Impounded reaches accumulate silt and cannot create the "gravel-cleaning" flows.

- Securely install large woody material to aid sorting and maintenance of spawning gravels both upstream and downstream of the weirs (subject to consent/exemption by the Lead Local Flood Risk Authority: http://www.derbyshire.gov.uk/environment/flooding/ordinary_watercourse_consents/default.asp).

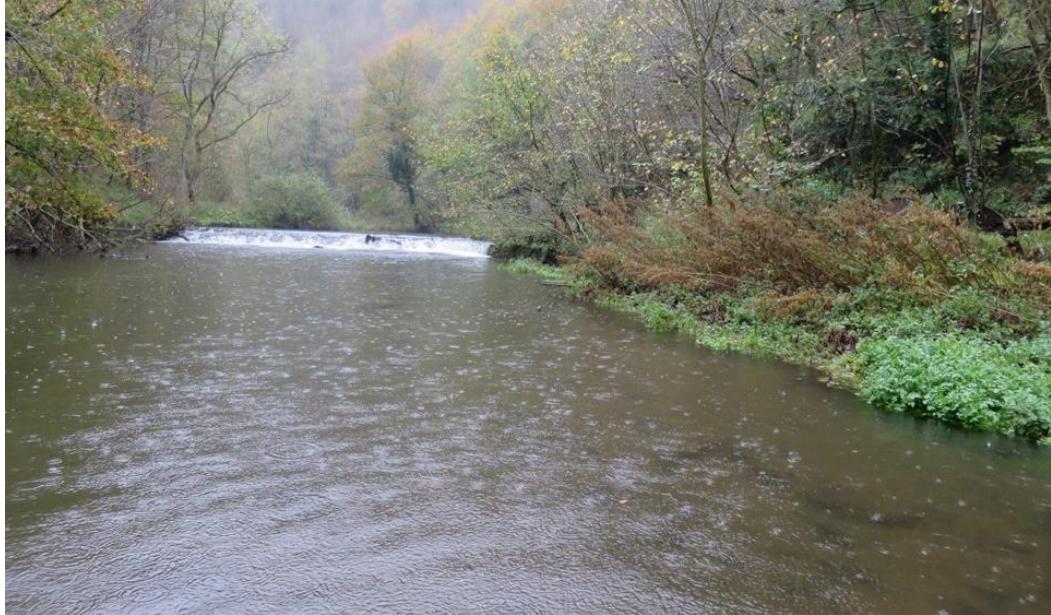
The preceding detail should help with the interpretation of the following observations made at the Waterwheel weir marked on Fig.1. The arrangement of the weir and a narrow stone leat which was used to drive a wheel can be seen in Figs. 13, 14 and 15.

Figure 13: Waterwheel weir - with the narrow leat on the LB (right of frame) obscured by vegetation.

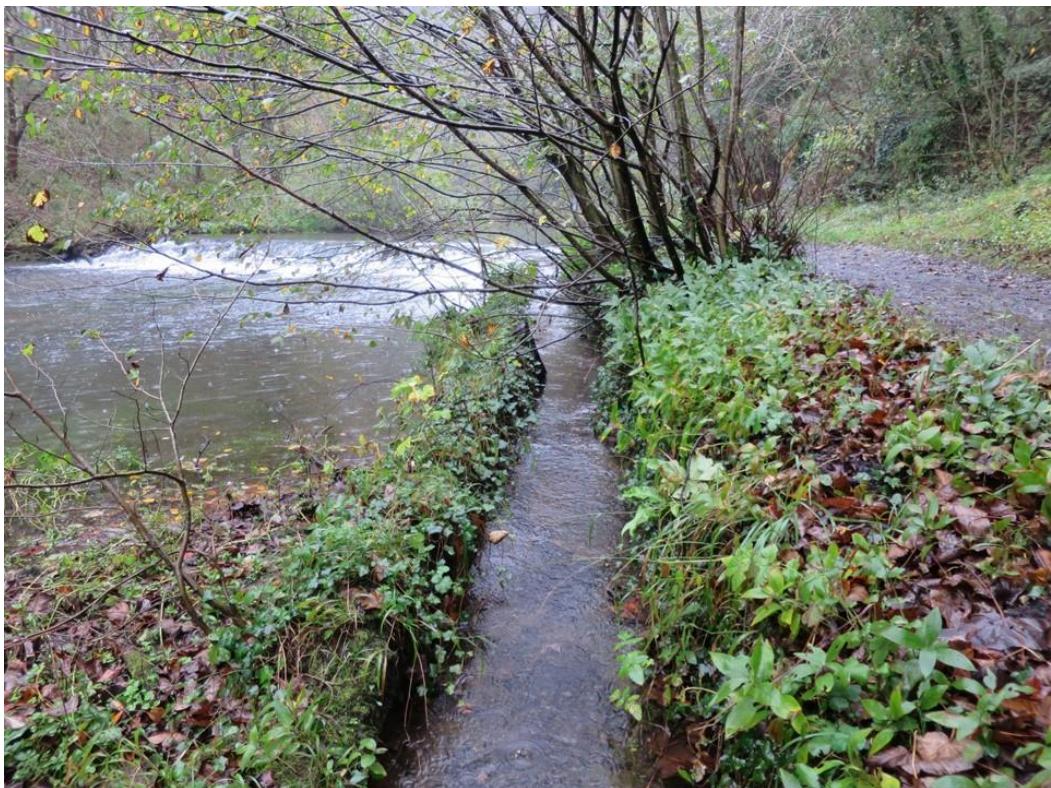
Figure 14: Narrow leat supplied with head of water by the weir.

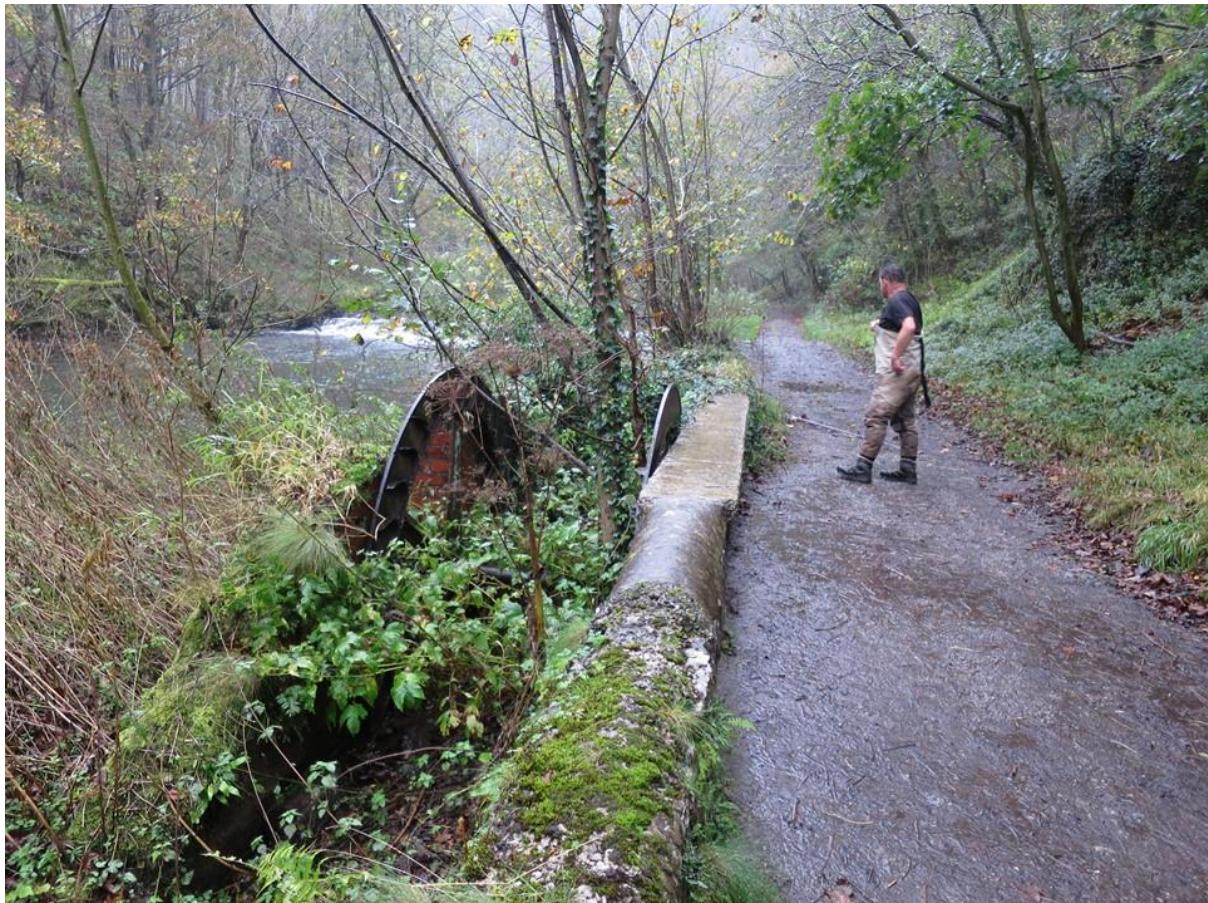
Figure 15: Continuation of leat via derelict waterwheel before disappearing into vegetation.

On the face of it, the leat may be viewed as an opportunity for modification into a baffled fish-passage structure. However, it is difficult to turn it into an effective solution because of a number of factors:

- The location of the downstream entrance would not be easy for fish to find
- The limited flow capacity would not produce very much “attraction flow” (which is also vital for fish to navigate past barriers).
- Fish passes/easements of this nature do not work well for fish trying to migrate downstream (whether juvenile or adults).
- The ability of fish to successfully swim up the leat is very difficult to maximise under a range of different flow levels and for a range of different sizes/ages of fish.
- The vegetated silt bank that currently obscures the downstream entrance would need continual management/periodic removal.

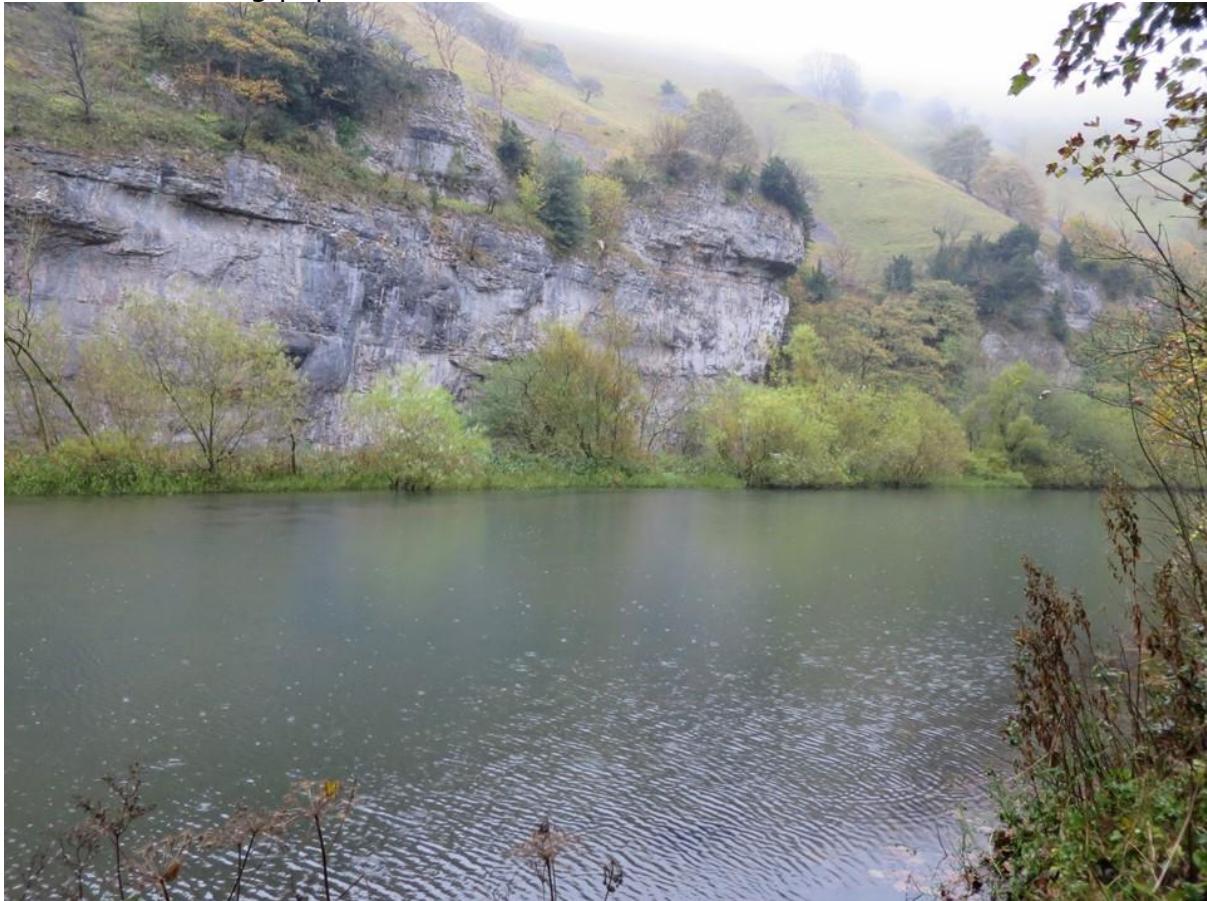
upstream of Cressbrook Mill weir is essentially "lake" habitat (i.e. Fig. 16) with no spawning opportunities and likely to be of limited value to juvenile fish. Given that all trout (whether sea trout or not) migrate from their adult habitat to the habitat that is ideal for spawning – it is fair to say that there is no such thing as a non-migratory trout. By both improving the quality of existing spawning habitat and increasing its accessibility, there is a greater opportunity for the trout living within the river up and downstream of the current obstructions to contribute to a larger effective breeding population.

Figure 16: Impounded lagoon "Cressbrook Lake" photographed from the LB facing slightly up and across stream.
