## Cuckmere – Sussex Piscatorials

An advisory visit carried out by the Wild Trout Trust – July 2008

## 1. Introduction

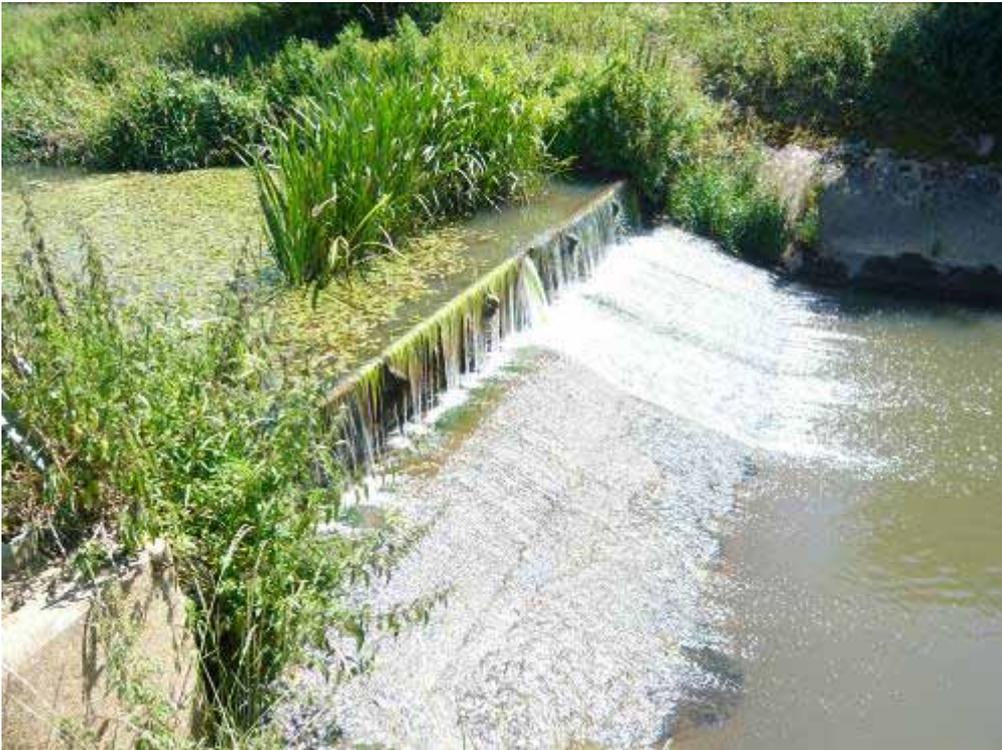
Environment Agency weir near the bottom boundary of the fishery. A barrier to fish migration during low flows

The greatest obstacle to enhancing this stretch is the large weir near the bottom boundary. It is unclear as to what function the weir performs but it is understood that the tilting mechanism is no longer operational and that perhaps the original function is no longer required. It is possible the structure was constructed to facilitate local abstraction or perhaps flood storage. If an adjustable structure is deemed unnecessary then it might be possible to remove or lower the structure and replace any impoundment that might be needed with a series of gravel riffle ramps. The benefit of the riffle ramps will be that it might be possible to create a series of spawning and nursery sites for a range of flow loving species including trout, chub and dace.

- This section of the Cuckmere River could be radically improved if the large impoundment on the bottom boundary was lowered or removed.
- It is likely that any proposal to remove or lower the structure will require detailed modelling and feasibility study. This should be a priority action undertaken by the Environment Agency.

- If current water levels are required to be maintained to facilitate licensed abstraction, or for flood defence purposes, then a series of gravel ramp weirs should be used to maintain the required head and also create spawning habitats for flow loving species.

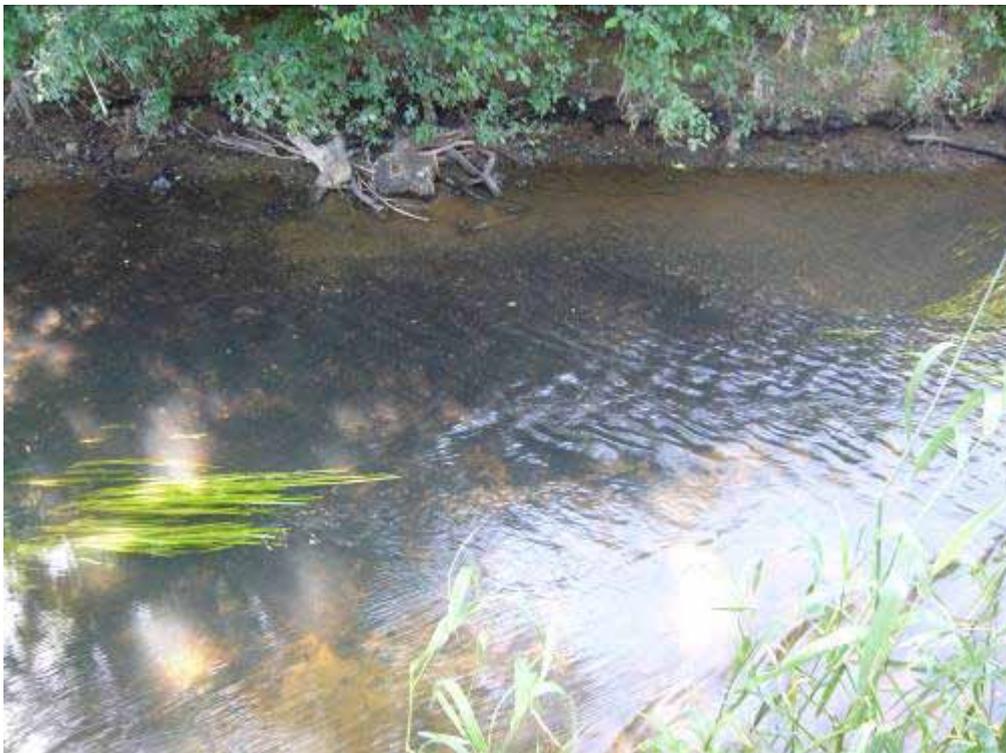
Very little good quality trout habitat was observed, with only one or two very short sections of gravel riffle habitat capable of supporting any spawning activity for reophilic fish species such as trout, dace and chub.

A thin gravel riffle. One of the few spots that could potentially support spawning activity

- On those few sections that have potential for spawning, the substrate could be improved by importing mixed gravel rejects to augment the thin gravels currently present. Advice on riffle design, source of materials and quantities can be obtained from the WTT Conservation Officer.

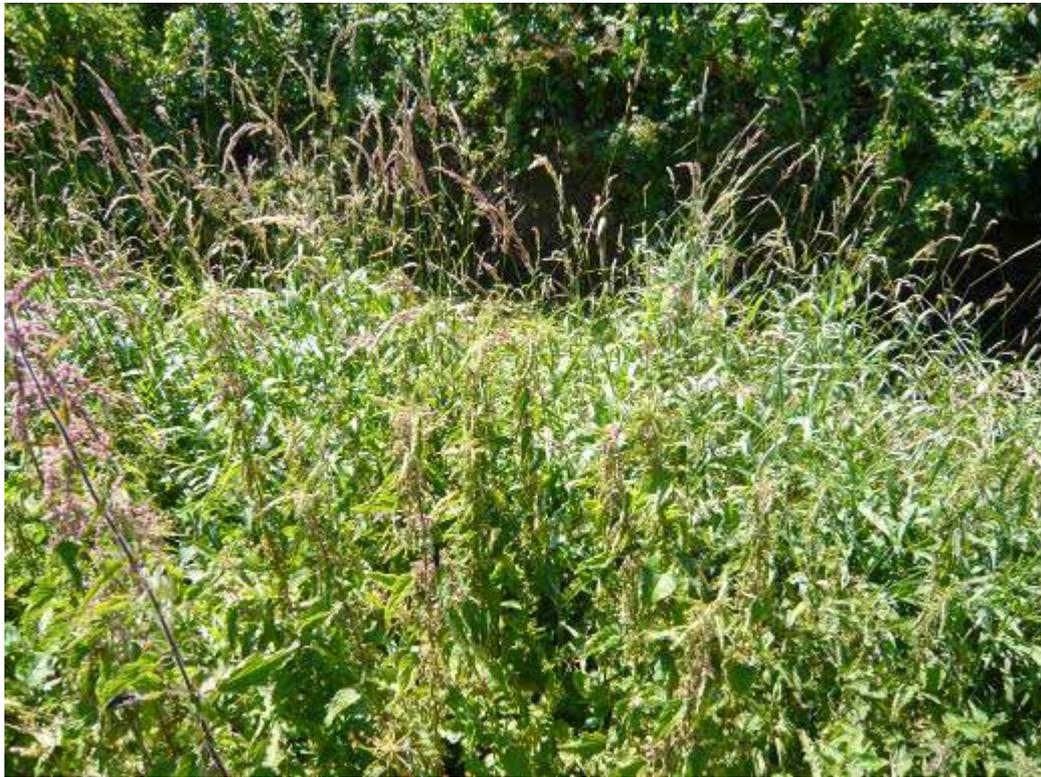
Throughout the whole reach the channel was deeply incised, suggesting previous dredging activity. Many sections were extremely difficult to access for angling due to the steep banks and thick stands of bankside nettle. Some of the banks were eroded suggesting that the Cuckmere can be quite “flashy” in nature with the river responding rapidly following heavy rainfall events. Shallow marginal bay habitat was at a premium and it is likely that this river is a hostile environment for juvenile fish during a significant flood event.

A nettle dominated bank on top of the deeply incised channel.

- Cutting and removal of marginal nettles will help to restore a more natural mix of bankside herbs and plants.

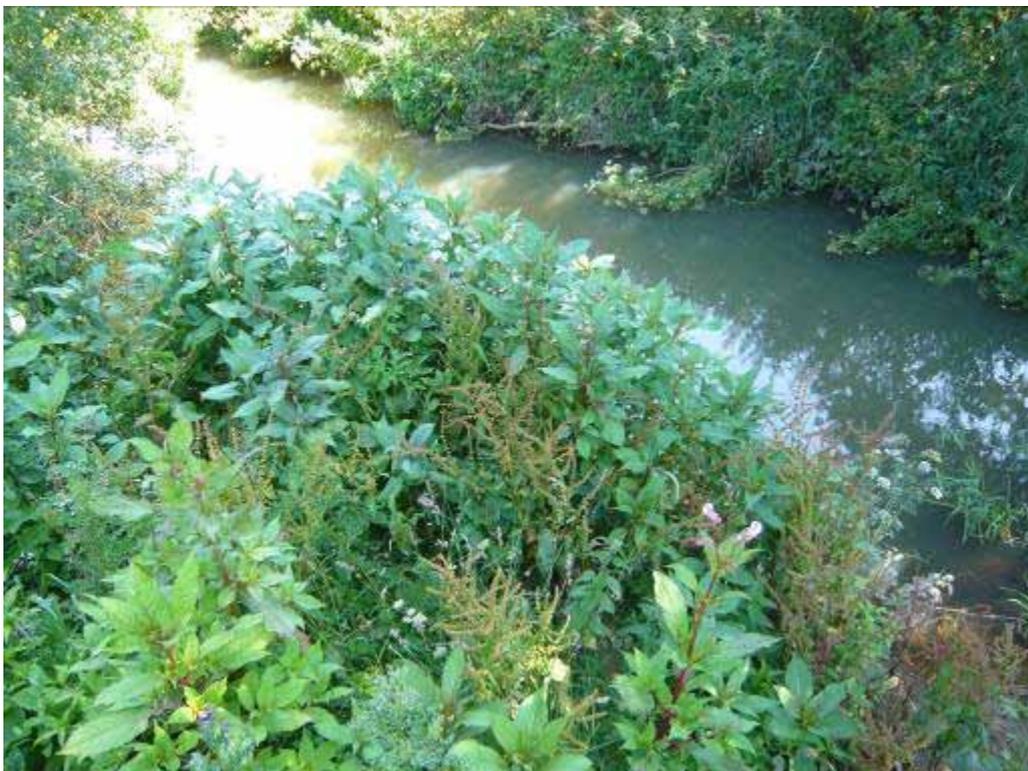
The non native plant himalayan balsam was evident on several sections

An area of potential concern relates to the presence of non native plants. Himalayan balsam (*Impatiens glandulifera*) was observed on several sections of the river. It is a relative of the busy Lizzie and is known by a wide variety of common names, including Indian balsam, jumping jack and policeman's helmet. It is a tall, robust, annual producing clusters of purplish pink (or rarely white) helmet-shaped flowers. These are followed by seed pods that open explosively when ripe, shooting their seeds up to 7m (22ft) away. Each plant can produce up to 800 seeds. Himalayan balsam tolerates low light levels and, in turn, tends to shade out other vegetation, impoverishing habitats. In the autumn, the plants die back, leaving the banks bare of vegetation and vulnerable to erosion.

Currently only very small patches were observed and it is recommended that efforts are made to eradicate the plant before it spreads too widely.

These plants can be easily pulled up by hand or treated with a contact herbicide (Environment Agency consent required).

- Cattle drinking areas could be enlarged and improved to provide off-line refuges for fish fry.
- The angling club should instigate a programme of non native plant control.

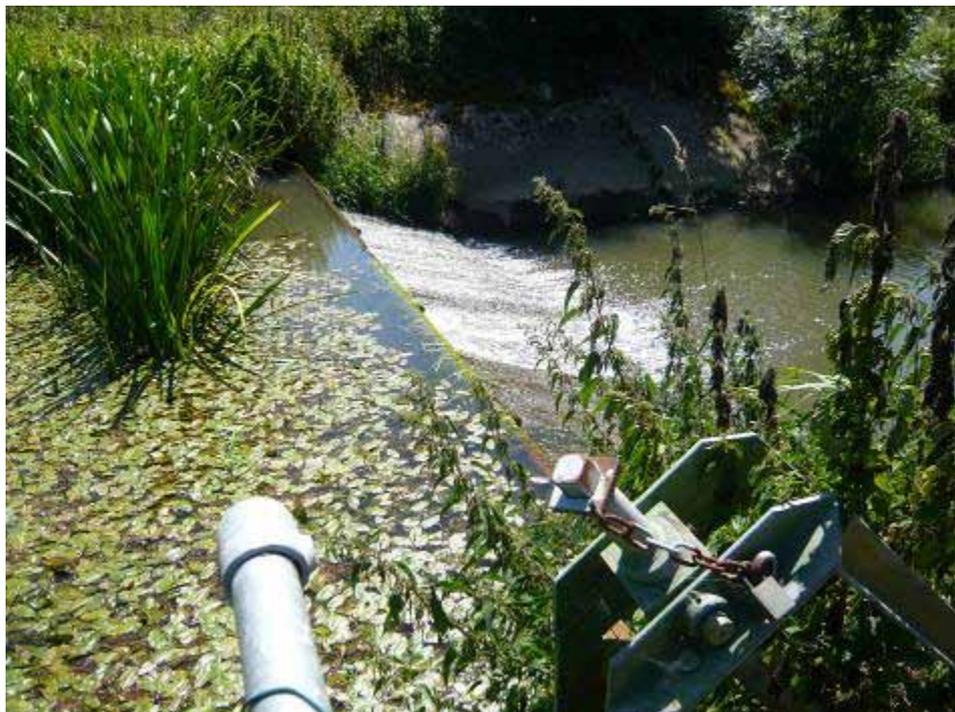
**This old structure holds the key to improving fish migration and habitat quality**
