Dodham Brook, Yeovil, Somerset

Wild Trout Trust report following an Advisory Visit on 14 December 2018

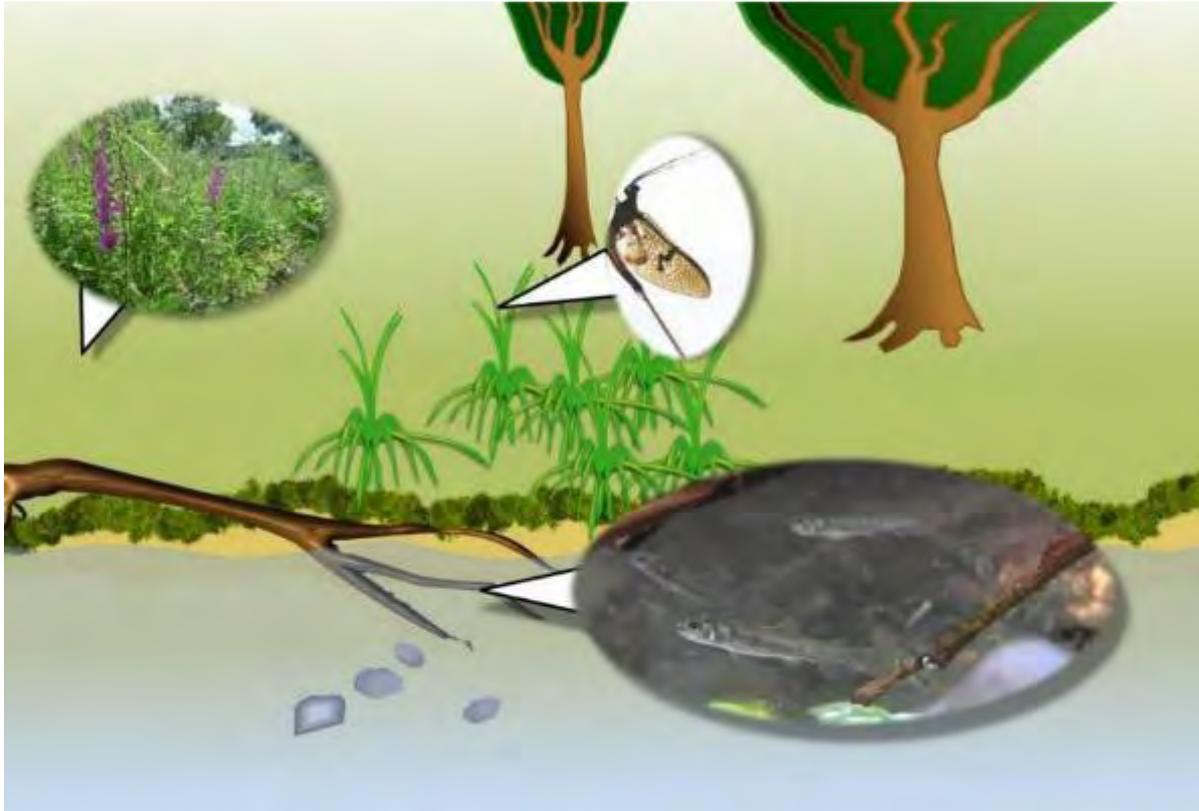
Figure 4: Larger cobbles and submerged 'brashy' cover and/or exposed fronds of tree roots provide vital cover from predation and spate flows to tiny juvenile fish in shallower water (<30cm deep). Trailing, overhanging vegetation also provides a similar function, and has many benefits for invertebrate populations (some of which will provide a ready food supply for the juvenile fish).

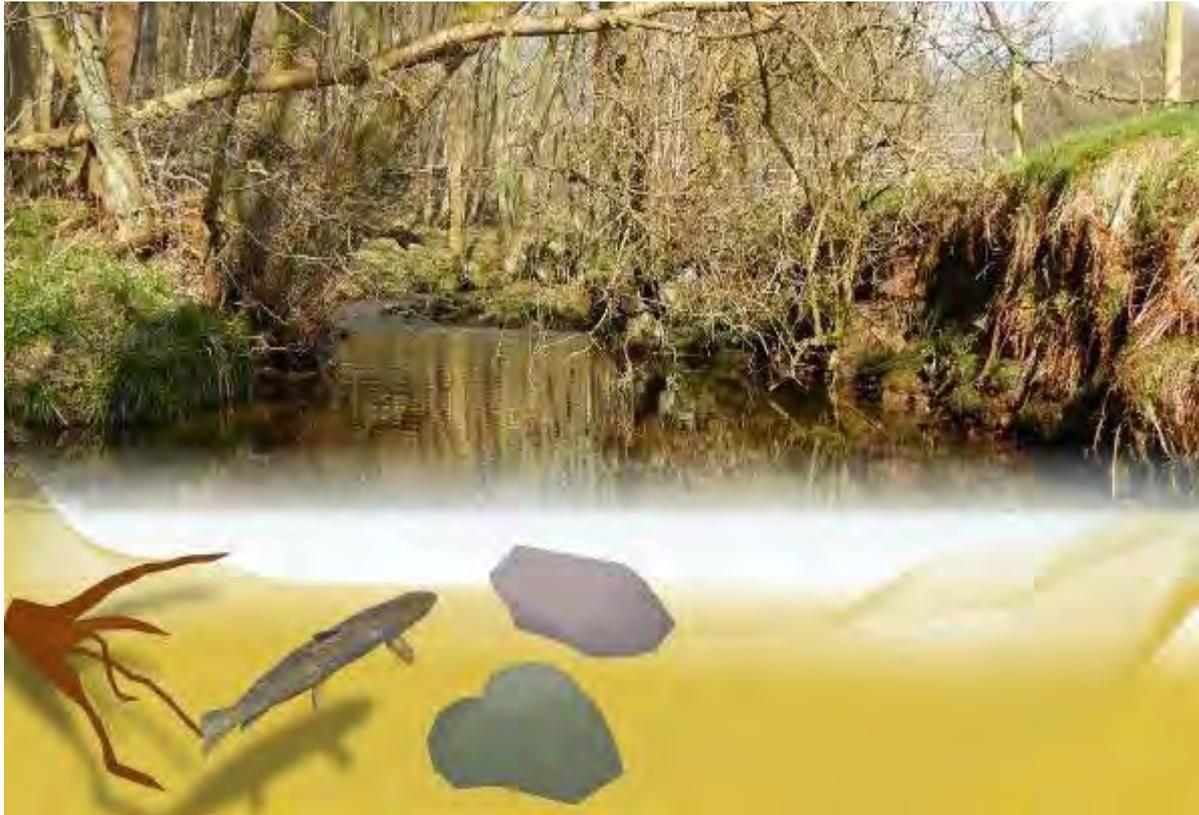
Figure 5: The availability of deeper water bolt holes (>30cm), low overhanging cover and/or larger submerged structures such as boulders, fallen trees, large root-wads etc. close to a good food supply (e.g. below a riffle in this case) are all strong components of adult trout habitat requirements.

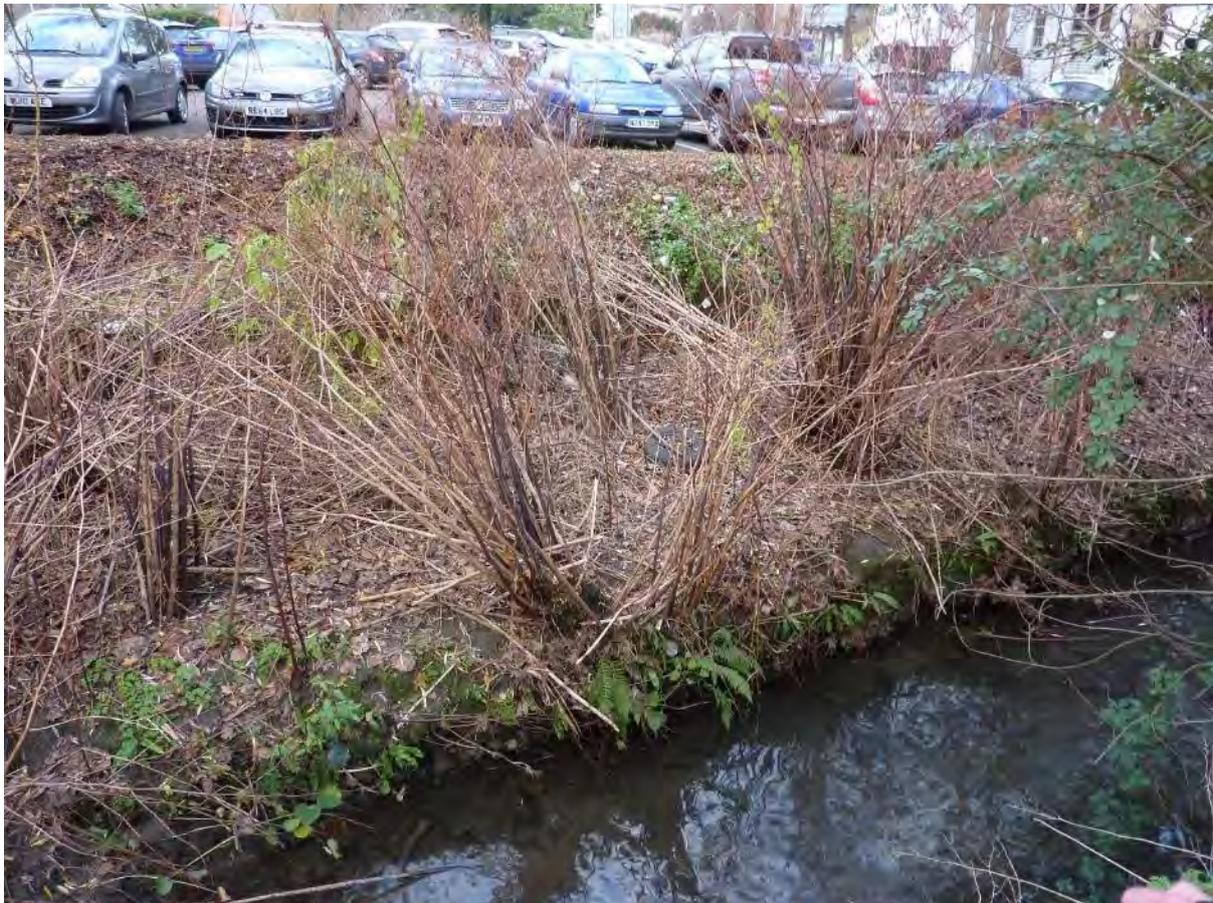
At the upstream limit of this visit, at ST 55298 15440 between the A30 and the access road to Goldenstones Leisure Centre, an extensive 30 – 40m infestation of Japanese knotweed (*Fallopia japonica*) was noted on the LB of the river.

Figure 6: Japanese knotweed on the LB of the Dodham Brook opposite Goldenstones Leisure Centre.

Japanese knotweed is notorious as a highly invasive non-native species (INNS), whose evolutionary history on volcanic islands has adapted it to spread by subterranean rhizomes at a rate of c7m a year, and even grow upwards through concrete or tarmac. It can also regenerate a whole new plant from a fragment as small as a pea. For this reason, cutting or strimming Japanese knotweed is highly inadvisable, and cut or broken fragments are classified as controlled waste.

To prevent the Japanese knotweed noted at ST 55298 15440 from spreading down the Dodham Brook or onto adjoining land, YCRT should approach the local council to take up the issue of eradication with the landowner. Japanese knotweed is probably best controlled by stem injection with glyphosate: due to proximity to the Dodham Brook, Environment Agency consent will be needed for this treatment, as well as appropriate PA1 / PA6 training in safe pesticide use.

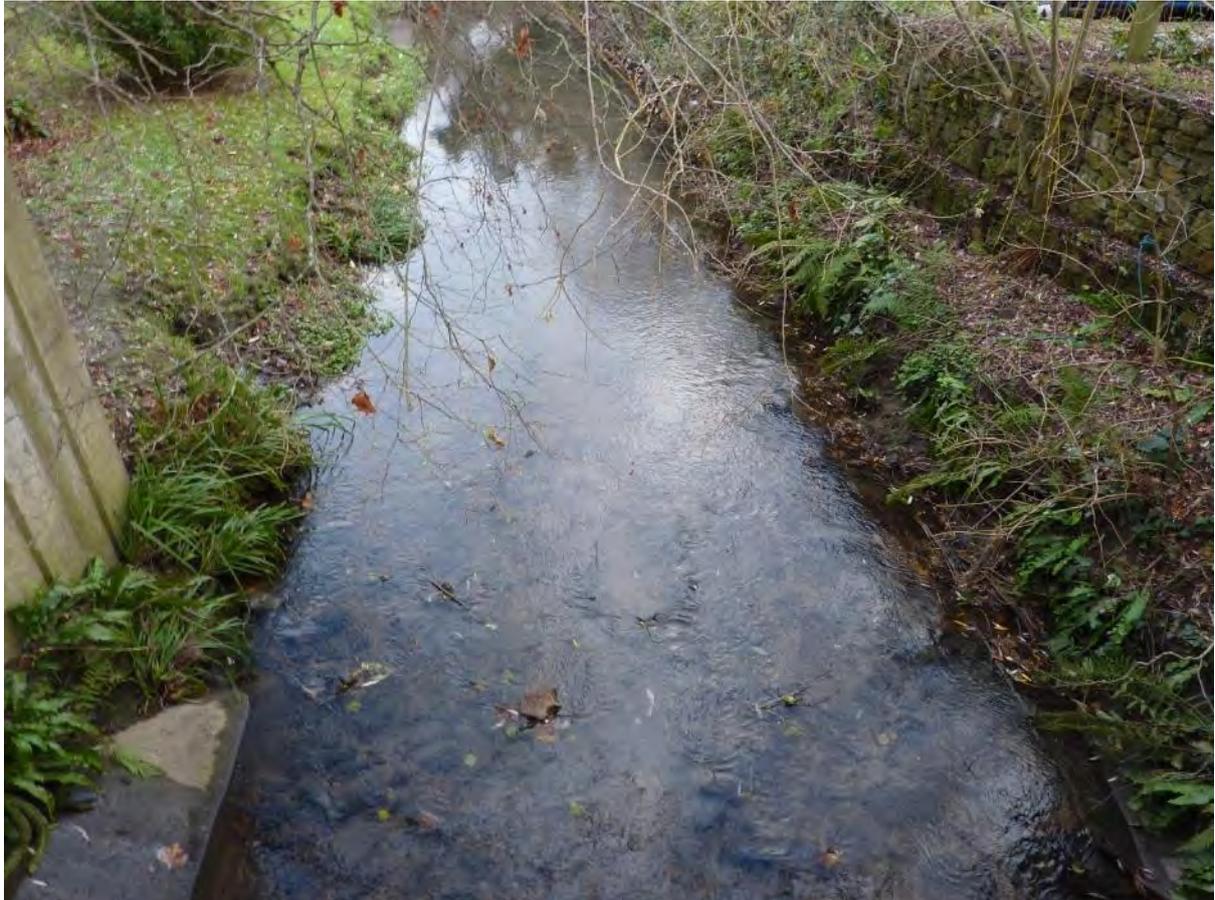
Immediately above and below Goldenstones Bridge at ST 55406 15461, the Dodham Brook is overly straight and wide, but with sufficient gradient and flow that it could be readily improved by a range of simple habitat enhancements. This would create an area of high-quality habitat for fish and other species.

Figure 8: Ripe for enhancement: the Dodham Brook as seen from Goldenstones Bridge.

The long impoundment created by Ninesprings Weir ends a short distance downstream of the access road at Goldenstones Bridge. Together with its high visibility to passing pedestrians and users of the café and leisure centre, this suggests an opportunity to create a 'demonstration site' of high-quality river habitat in this area, and showcase the potential of renaturalising longer stretches in due course.

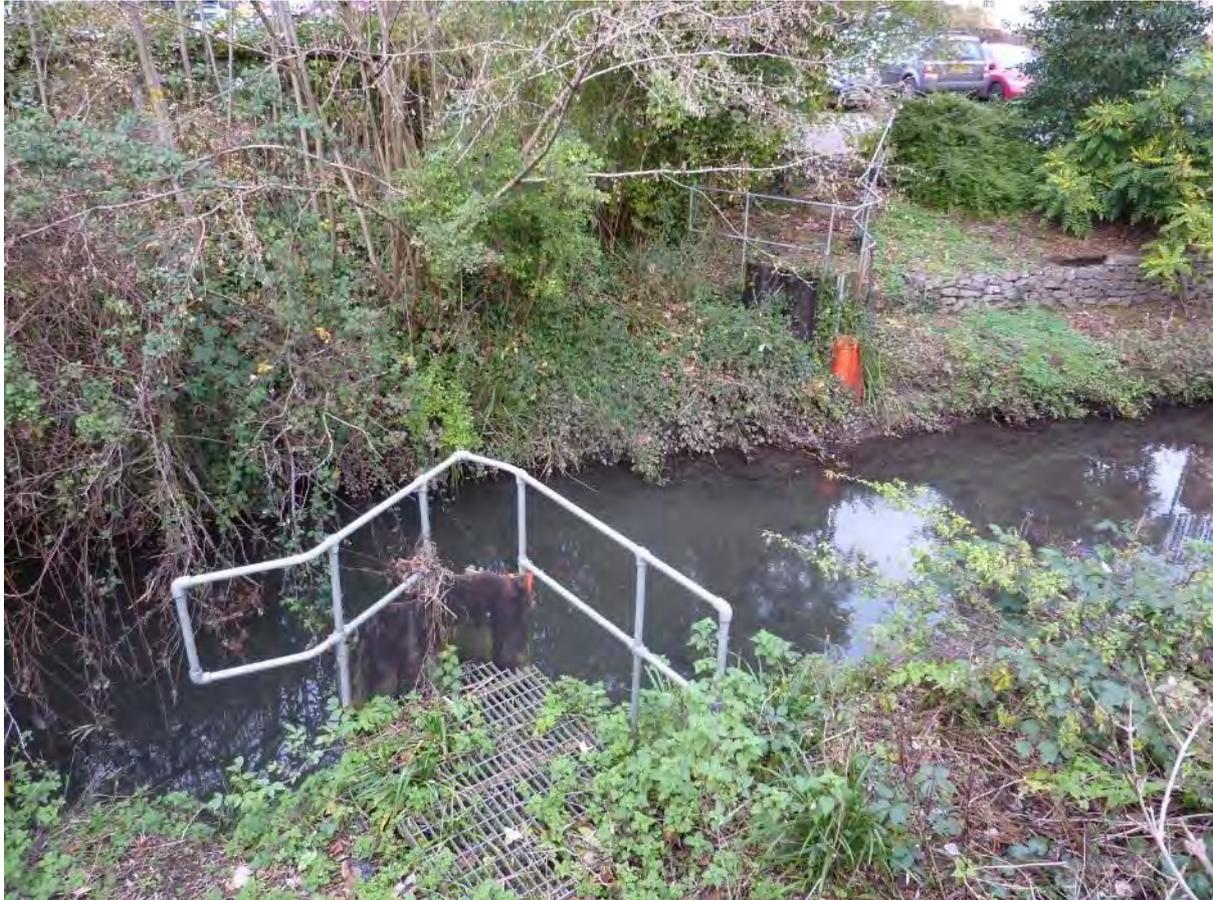
Just above Goldenstones Bridge, metal maintenance platforms were evident on both banks, apparently for stretching pollution-absorbing booms across the river in the event of a discharge from the industrial areas upstream.

Figure 9: River on a knife edge: platforms for deploying pollution mitigation booms suggest that the Dodham Brook has had a significant history of water quality issues. However, this should not discourage strong community efforts to make the Brook as resilient as possible in the future (and help past polluters to understand that future incidents should be prevented at source, not mitigated afterwards).

These emergency provisions serve as an all-too-present reminder that most urban rivers exist on a knife edge – little more than a burst pipe or accidental spillage away from damage by pollution. Being aware of this threat should not discourage urban river restorationists, but make us more determined to increase our rivers’ resilience, and make them better placed to recover from such incidents, as and when they do occur.

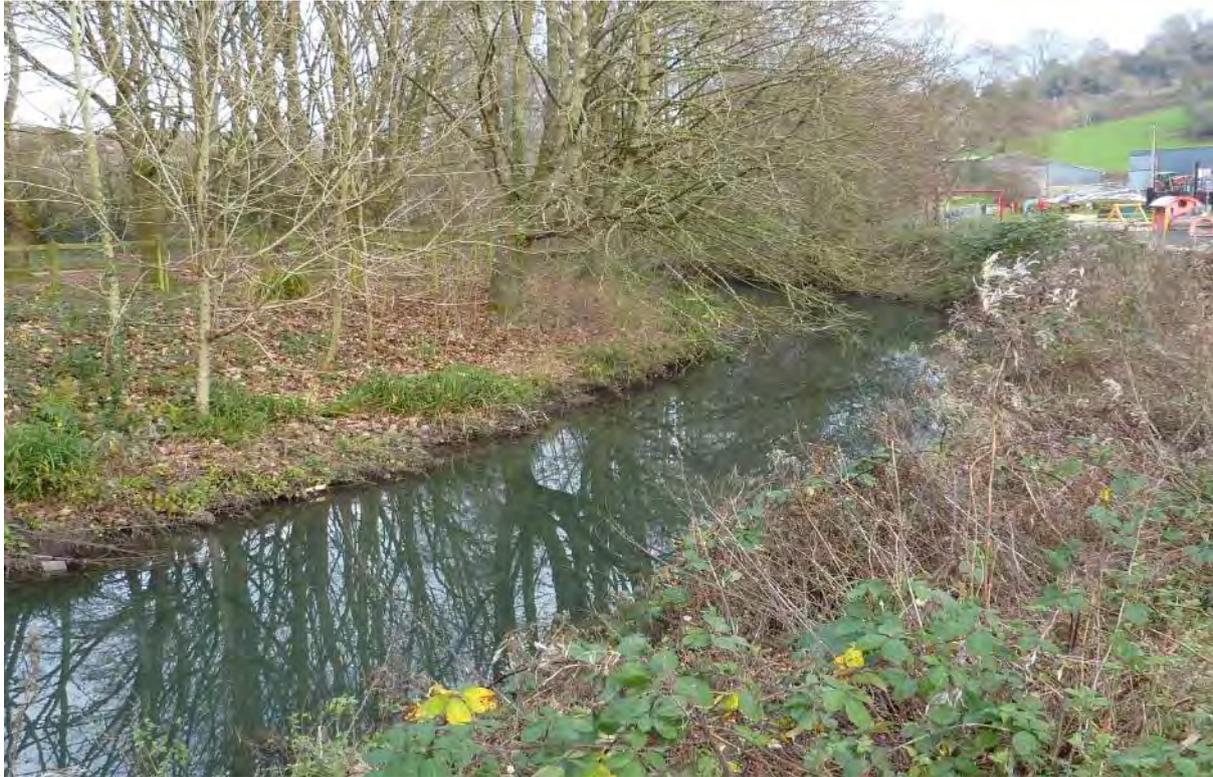
Through most of Ninesprings Park from Goldenstones Bridge to Addlewell Lane, the Dodham Brook is seriously affected by the impounding effect of a large weir at ST 55853 15506.

Figure 10: Impounded water above Ninesprings Weir.

The impact of Ninesprings Weir is evident in the form of a long stretch of very slowly-moving water, where sediment carried in suspension drops out of the water column uniformly across the river bed, and habitat quality and diversity are severely degraded. Such conditions can sometimes provide sufficient deep-water habitat for small numbers of adult trout, but are unsuitable for spawning, fry or juveniles.

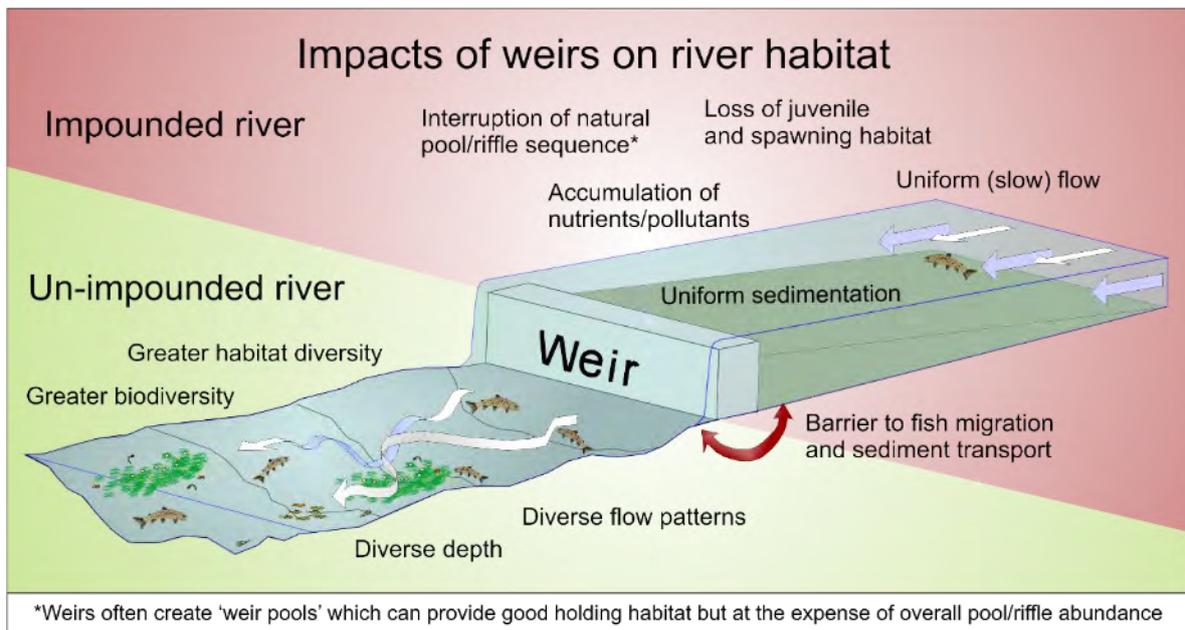
Figure 11: An illustration showing the impacts of weirs on habitat quality.

Weirs are often significant barriers – or even complete obstacles – to fish passage, preventing many species from moving up and down rivers freely to fulfil the different stages of their life cycles. Weirs also interrupt the natural transport of river sediment. This can cause the river downstream to become depleted of coarse sediment, and increase rates of bed and bank erosion in an attempt to compensate for the interrupted supply of suitable gravel and cobbles.

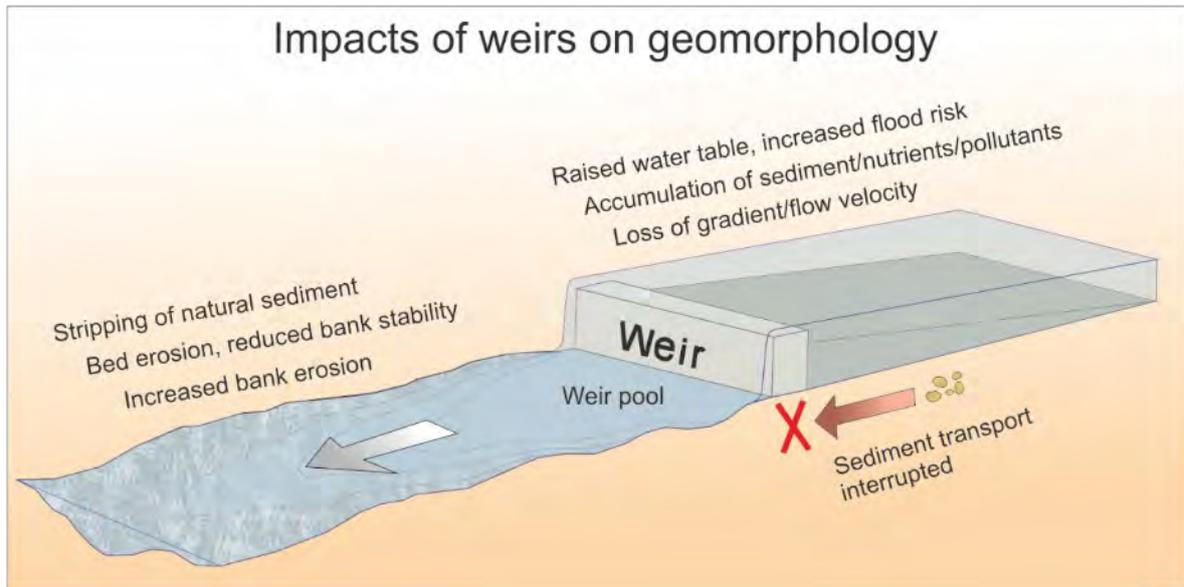
Figure 12: An illustration showing the impacts of weirs on river geomorphology.

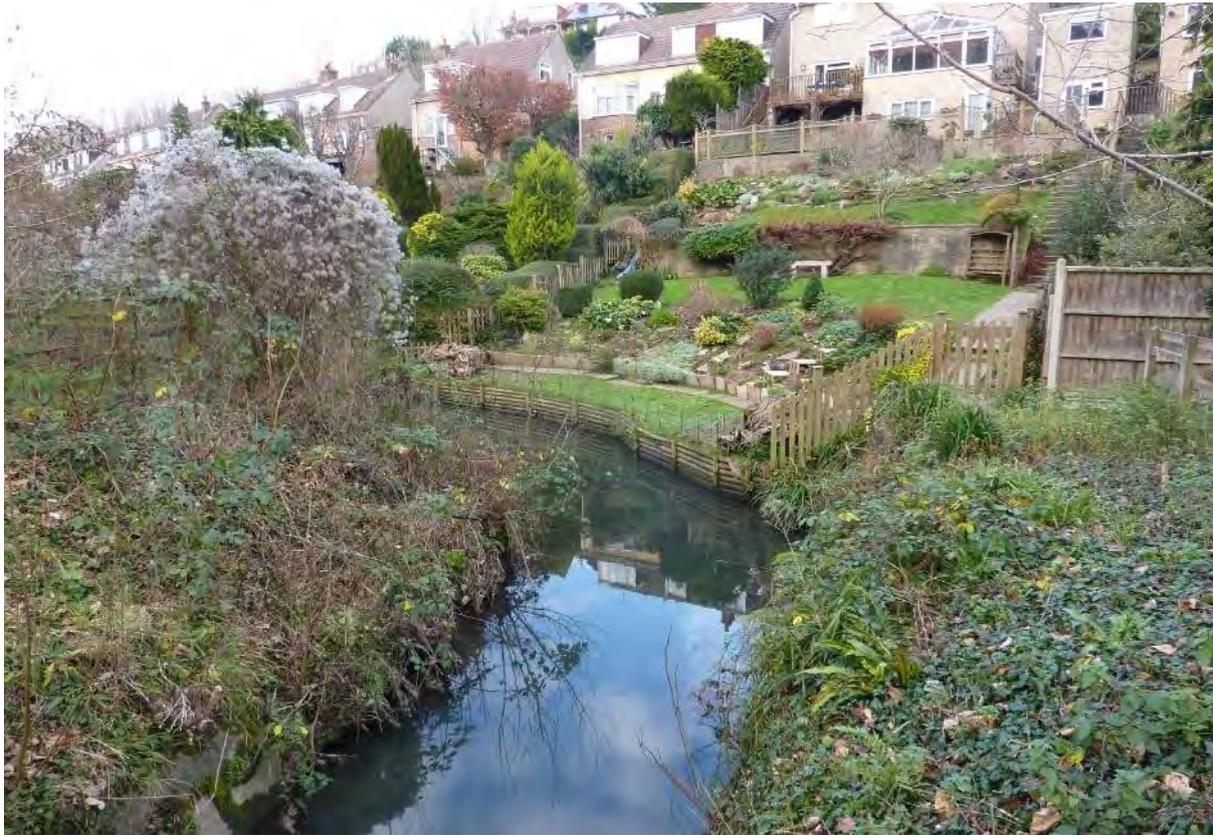
For approximately half of the Dodham Brook's length through Ninesprings Park, the impounded stream forms an unnaturally overwide and over-deep 'wet fence' along the back boundaries of a number of private gardens.

Figure 13: The Ninesprings Weir impoundment extends upstream for several hundred metres, and forms a sluggish, anoxic ‘wet fence’ between the park and a number of private gardens.

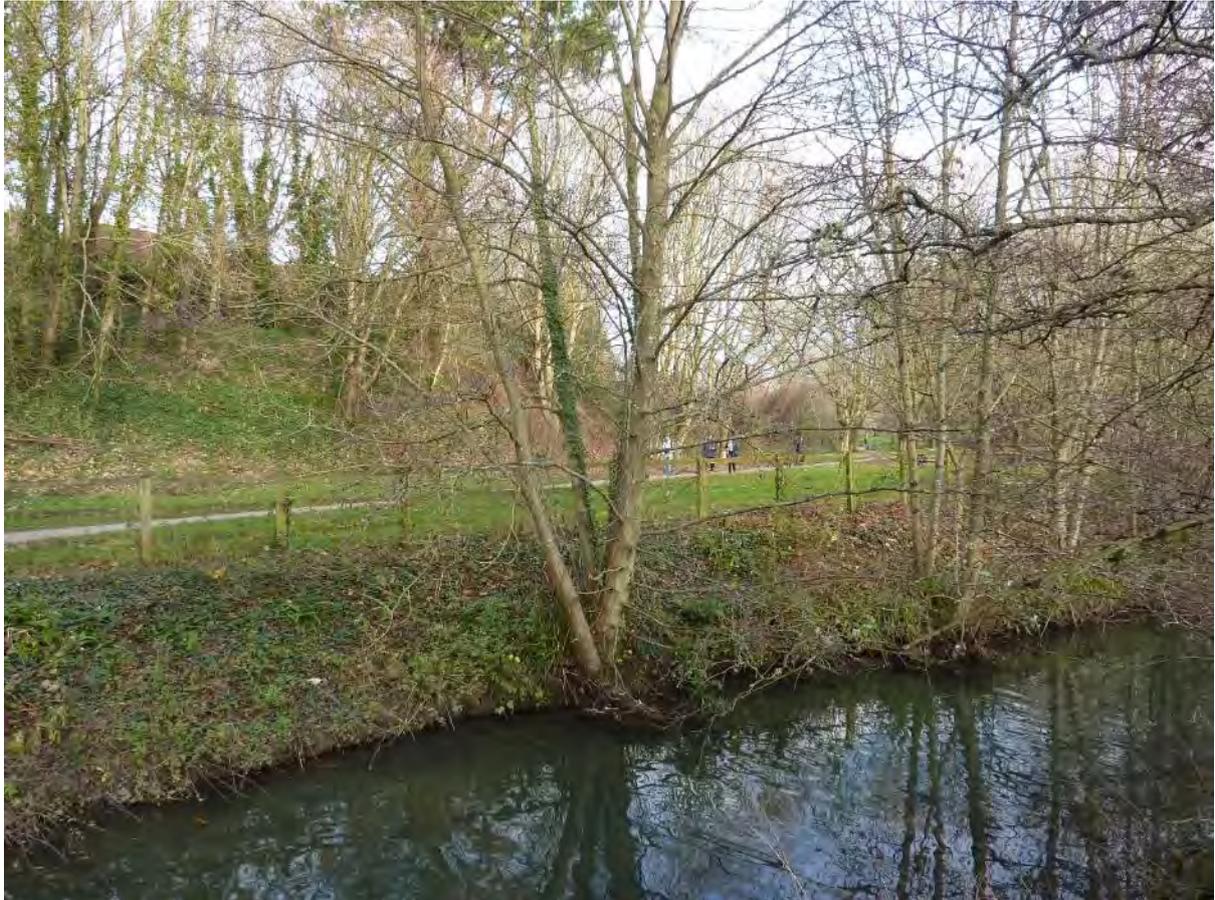
Proceeding downstream through Ninesprings Park, around half of this impounded length of the Dodham Brook is heavily ‘tunnelled’ by trees: mainly alders (*Alnus glutinosa*) of a similar age, which will also be contributing to siltation every year with a subsidy of leaf litter.

Figure 14: Below the footbridge in Ninesprings Park, the Dodham Brook is impounded and tunnelled with alders.

These trees are providing an important area of cool-shade refuge, helping to mitigate the impact of direct sunlight on very slow-moving water in a small stream – this would be beneficial for trout of all ages. In general, however, a less uniformly tunnelled effect would be preferable, with dappled shade and sunlight in an approximately 60:40 ratio, to promote cool water temperatures as well as a healthy diversity of riparian plants. It is also worth noting that the similar age of most of these alders, together with the spread of the *Phytophthora* pathogen, may result in many being lost in a short space of time in the relatively near future. A regime of tree management, through coppicing and supplementary planting, should be initiated in order to establish structural diversity.

On the stretch of the Dodham Brook near Ninesprings Lake, it was noted that the bankside trees were mainly multi-stemmed alders of a similar age and vulnerability to the *Phytophthora* pathogen. In order to maintain the beneficial cooling effect of these trees, consideration should be given to coppicing some of them, encouraging them to re-sprout from their stools, thus prolonging their lives. Replacing some of the alders with a wider range of tree species, including hazel (*Corylus avellana*) and goat willow (*Salix caprea*), would also help to create a more biodiverse riparian zone – allowing other plants to flourish in sunlight and dappled shade.

If it proves possible to reduce the height of Ninesprings Weir, part of the preparations for this work could include hinging some of the alders into the channel, parallel to the bank, secured to their stumps with wire cable if necessary. Such interventions are known as ‘tree kickers’: their complex structure and hydraulic friction will help to hold back sediment mobilised by re-energised flows, prevent undermining of the banks when the water level drops, and help the Dodham Brook to redefine its own more natural channel in this area.

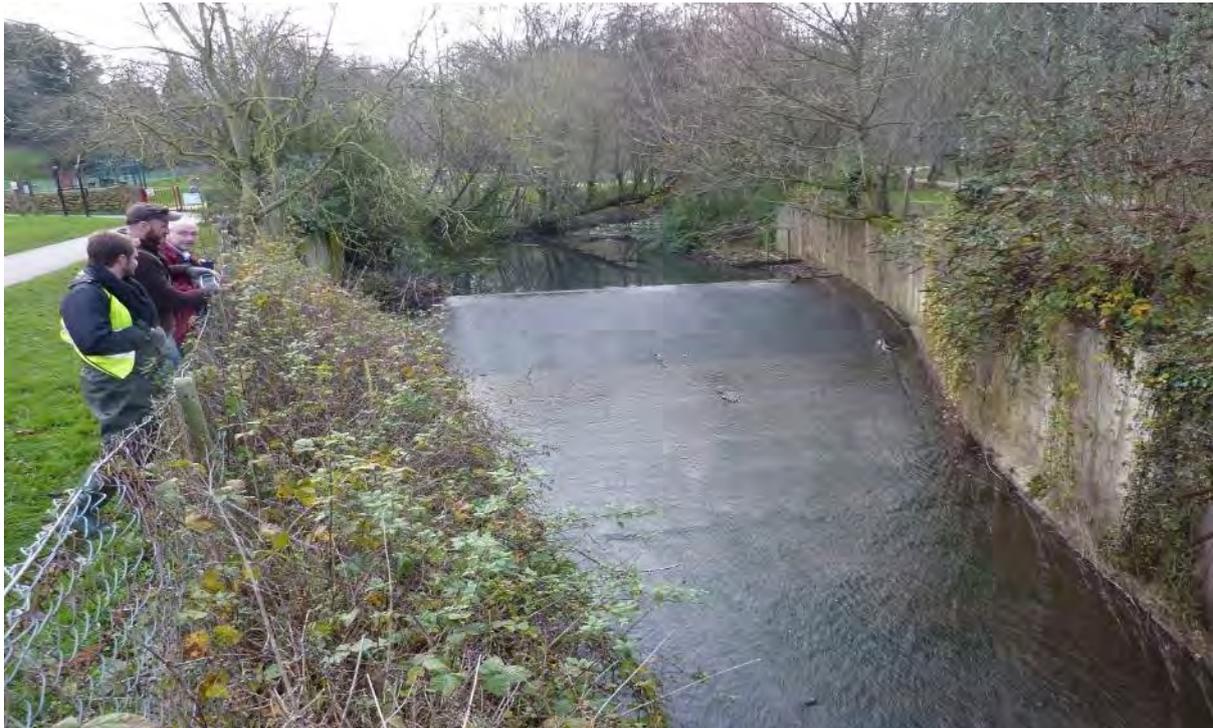
At the lower end of Ninesprings Park, at ST 55853 15506, the source of the long impoundment is finally revealed to be the substantial structure of Ninesprings Weir, whose concrete apron extends beneath the Addlewell Lane bridge.

Figure 15: Ninesprings Weir is completely impassable for fish of all species and age classes.

It is likely that this weir, and / or its predecessor(s), were originally constructed to provide a head of water for factories in the area now occupied by Foundry House and the surrounding retail parks. One of these structures, apparently formed from railway sleepers, is shown in this 1950s postcard image:

Today, apart from supplying water to a short stretch of artificial stream in front of Foundry House (effectively an isolated wetland water feature) with a small volume of flow via a piped offtake, Ninesprings Weir now appears to be a redundant structure. In its current form – a high concrete crest and smooth apron, with laminar flow spread across its full width – it is clearly a total obstruction to fish passage for all species and age classes, including European eels (*Anguilla anguilla*) which are globally threatened.

Possibly rebuilt c1977 when the open concrete culvert downstream was constructed, Ninesprings Weir now seems to be defunct apart from providing a negligible flow of piped water to the perched artificial 'water feature' outside Foundry House. As noted above, the weir is maintaining a large and damaging impoundment, preventing natural processes of downstream sediment transport, and creating a totally impassable barrier to many species of fish.

On a balance of terms of ecological costs and benefits, the aesthetic advantages of retaining the Foundry House water feature are far outweighed by the damage inflicted by the weir's impoundment for several hundred metres through Ninesprings Park. It would therefore be preferable to restore a long stretch of Dodham Brook by reducing the weir's height, and compensating for removing the Foundry House water feature by restoring the Brook's concrete channel to a healthy ecological state, all the way from Addlewell Lane to Newton Road.

In the event that full removal of the weir is not currently feasible, it may be possible to reduce its height by notching the crest, and further ease fish passage with a pre-barrage and / or low-cost baffles fixed to the apron and face of the weir. These should be designed and installed so as to focus available flows and add depth and turbulence for fish to 'grip' in their journey up- or downstream. Under the Eel Regulations, consideration should also be given to providing dedicated eel passage for this threatened species.

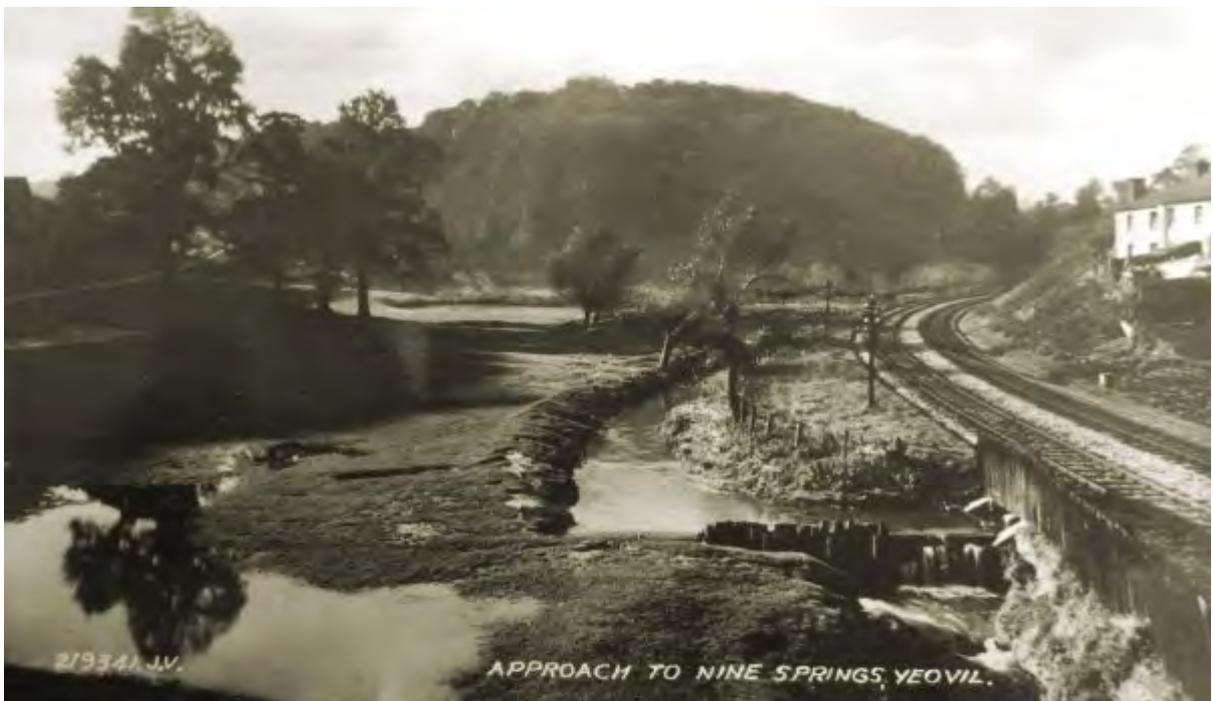
Figure 16: Ninesprings Weir shown in 1950s postcard (Photo: Betty Barber née Bird via <http://www.yeovilhistory.info/dodham.htm>)

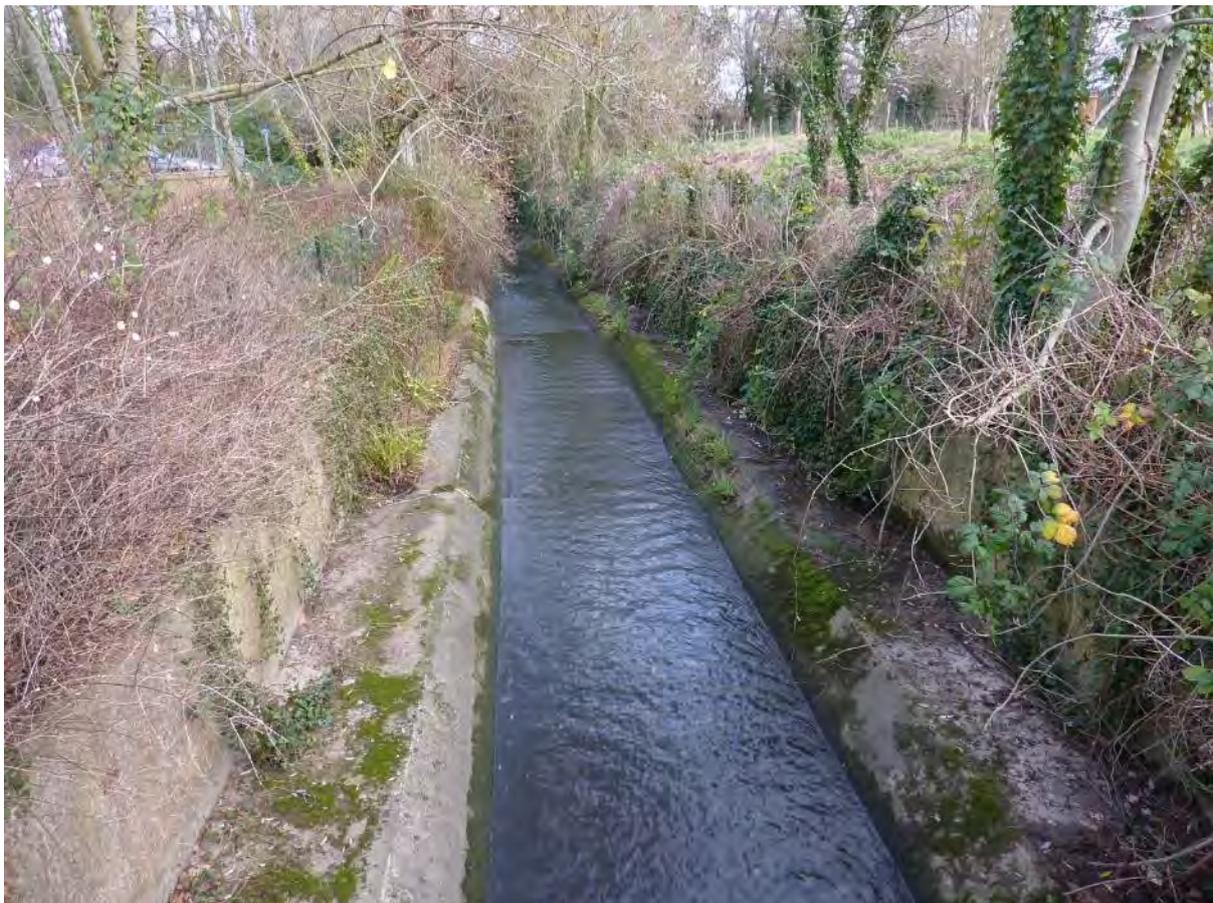
Below Ninesprings Weir and Addlewell Lane bridge, the Dodham Brook drops into a long, straight concrete-lined channel which extends without much variation for several hundred metres down to Newton Road at ST 56347 15857.

Figure 17: The Dodham Brook's dramatically simplified two-stage channel: utterly inhospitable for all forms of wildlife.

This open culvert appears to have been created c1977 as a flood defence measure in the event of the Yeo backing flood water up the Dodham Brook:

It is possible that this armoured channel was also designed to prevent erosion as a result of sediment transport interruption by Ninesprings Weir. However, simplification and over-deepening may also have occurred before this time: for instance, a photograph from the 1930s shows 'unemployed glovers clearing out Dodham Brook' as part of a work creation scheme.

As might be expected, the present simplified concrete channel can be considered exceptionally hostile for aquatic life at all heights of flow - both in terms of habitat and connectivity between more habitable stretches of the Dodham Brook.

From Ninesprings Weir to Newton Bridge, the Dodham Brook flows rapidly through a straight, featureless concrete channel which appears to be hugely over-engineered for its purpose. However, this offers plenty of opportunities to replace it with a functioning stream, with many benefits for a wide range of species – not just creating connectivity between other areas of habitat, but actually providing good quality habitat in its own right.

To make this channel less difficult for fish passage, and less hostile as habitat for all species, it will be essential to add roughness to break up its featureless laminar profile. Existing ideas include breaking small backwaters out of the trapezoidal concrete along each bank. It would also be beneficial to remove the recent concrete plinth to 'daylight' the real channel of the Dodham Brook outside Foundry House: the concrete plate construction should make this quite straightforward.

In the channel, other approaches could include remeandering by breaking out, or otherwise constructing, sinuous alternating berms from the trapezoidal two-stage profile.

Areas of gravel, cobbles and small boulders of local ragstone could also be created, holding some of these rocks in place with bolts and resin to act as bed checks for other rocks to lock against. 'Slowing the flow' in such areas of 'pocket water' may help to mitigate low flows which have been identified as an issue under WFD.

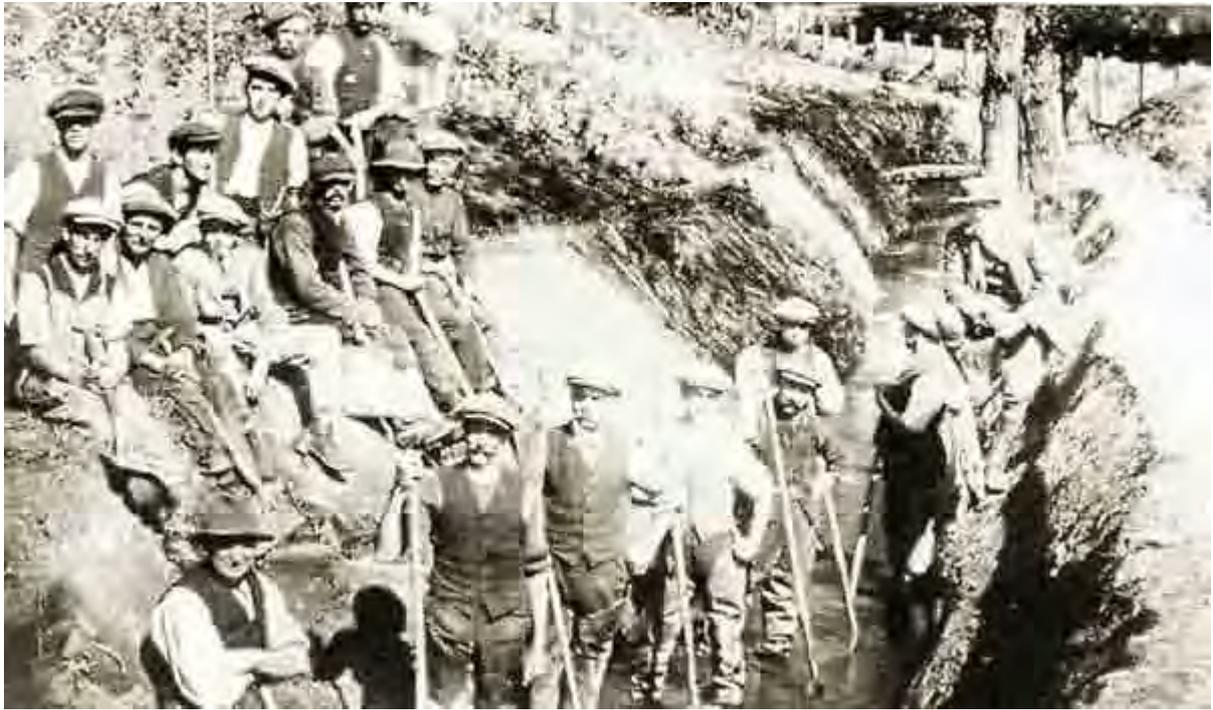
Figure 18: 'Cleaning' an unidentified stretch of Dodham Brook in the 1930s (Photo: Roger McElliott via <http://www.yeovilhistory.info/dodham.htm>)

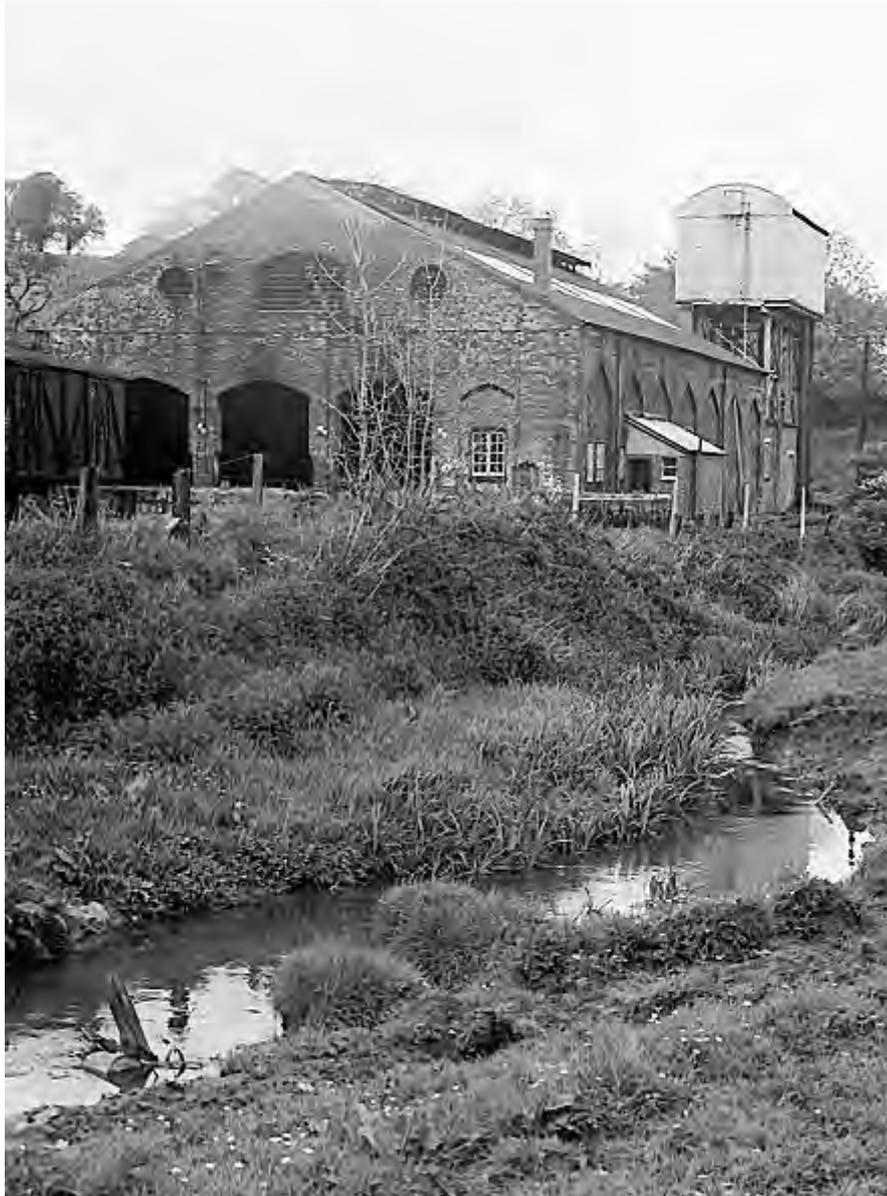
A further photograph appears to provide a 'reference condition' image of the Dodham Brook below Addlewell Lane c1967 before channelisation took place:

Figure 19: The Dodham Brook at Addlewell c1967: meadow banks, emergent plants and natural morphology before brutal channelisation in the late 1970s (Photo: David Perry via <http://www.yeovilhistory.info/dodham.htm>)

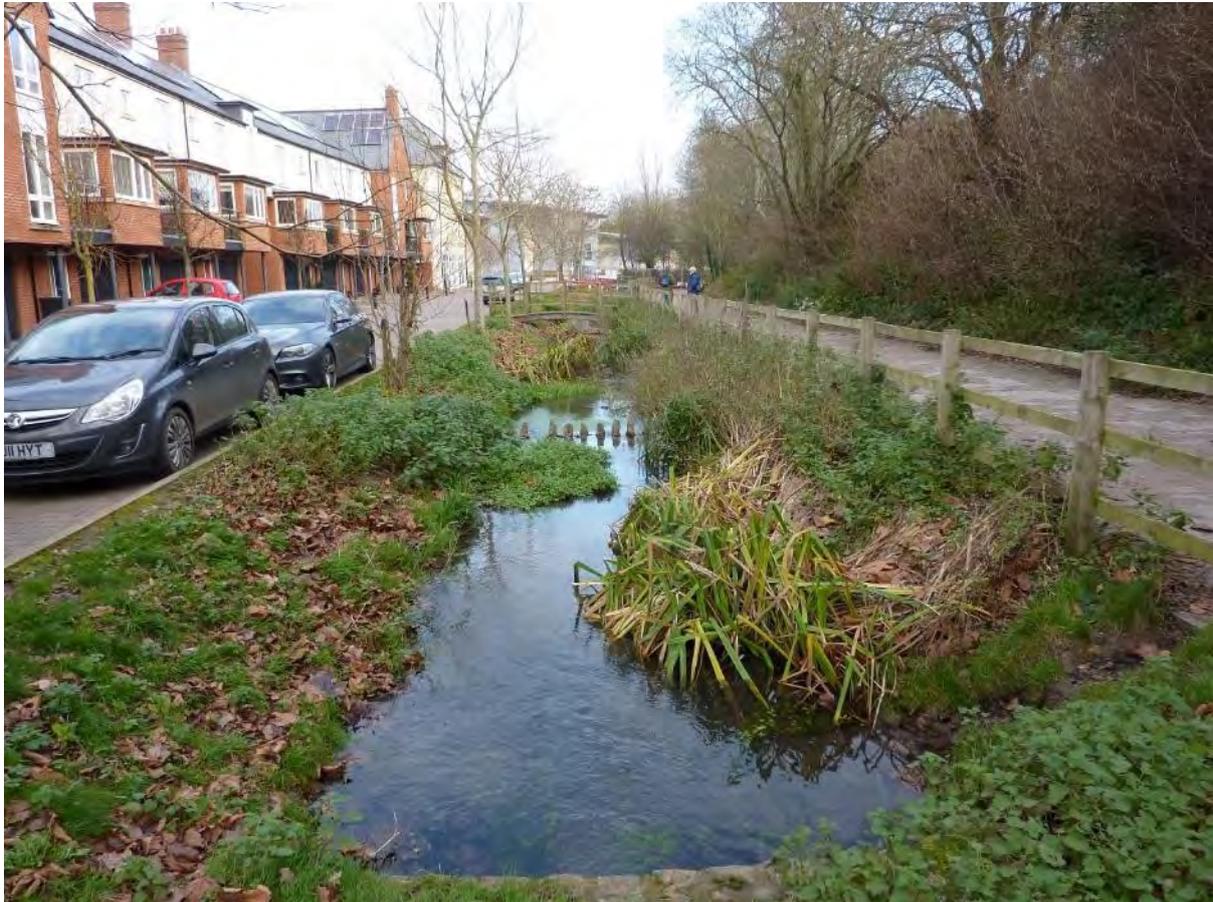
The first is a c75m stretch of stream or wetland, perched high above the current incised channel of the Dodham Brook, apparently supplied with water by a pipe from Ninesprings Weir. This stream displays a range of plants which could be

considered characteristic for a small limestone water body in the local area. A quick rock pick also revealed freshwater shrimp and caddis, indicating reasonable chemical and biological water quality.

Figure 20: The 'water feature' outside Foundry House. The Dodham Brook's real channel has been culverted under the concrete path on the right hand side of this photo.

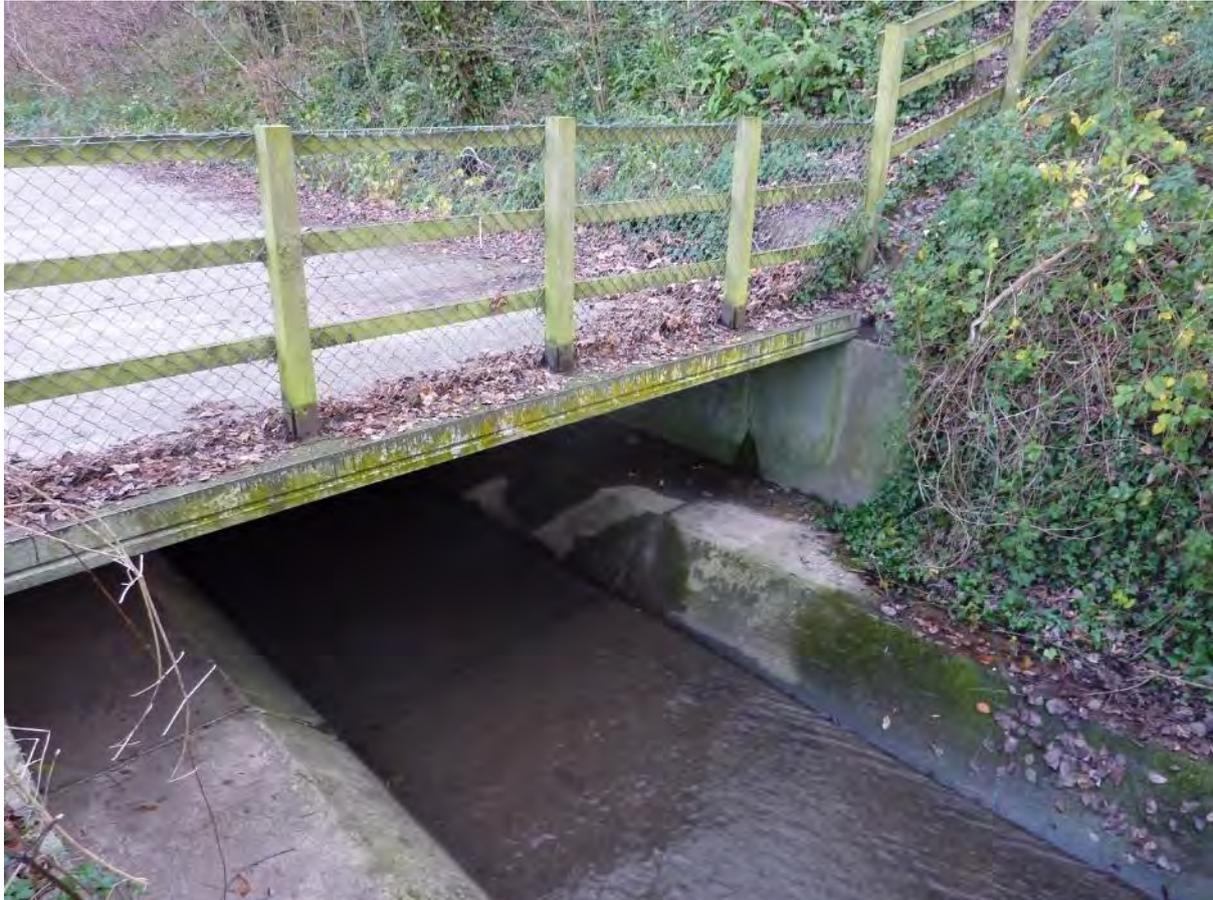
Adjacent to this 'water feature', a similar length of the Brook's concrete channel has been covered with a flat concrete plinth. It is understood that this culvert was installed to divert a public footpath around the Foundry House car parking area, and would have covered an even greater length of the Brook if finances had been available.

Figure 21: The flat concrete plinth over the Dodham Brook opposite Foundry House.

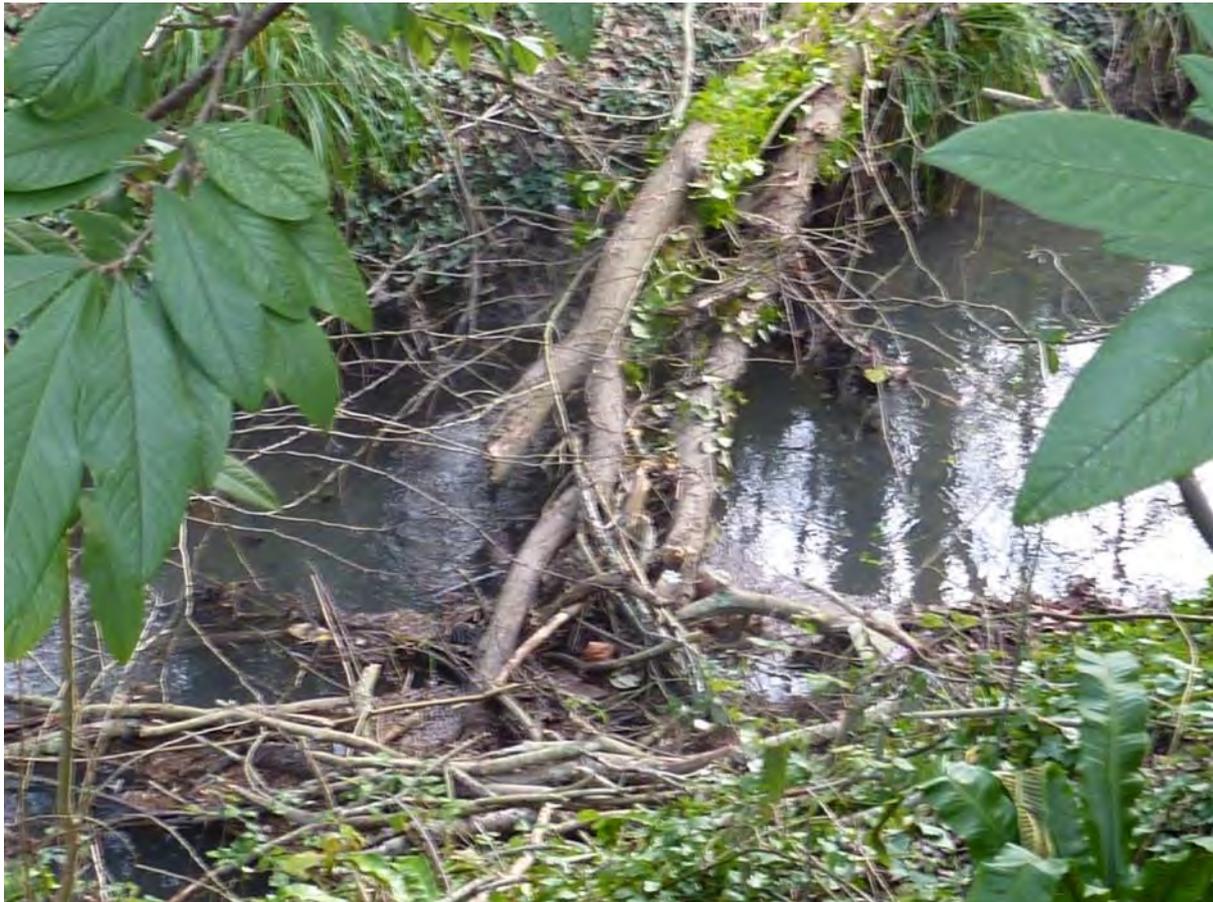
The public footpath rejoins the Dodham Brook at a point where a large surface water outfall brings runoff into the channel. This stretch of the Brook is very deeply incised through dredging, but its inaccessibility (and small likelihood of flood risk) means that the channel has been permitted to accumulate a number of fallen branches and trees.

Figure 22: A natural dam of beneficial 'large woody material' in the Dodham Brook below Newton Road – providing very valuable habitat diversity for many species.

These natural 'large woody material' (LWM) features benefit the Brook by promoting localised scour, deposition and general 'sorting' of the substrate, thus providing microhabitats for a wide range of insects, plants and animals. No fish were observed during the visit, but the LWM in this area, together with unimpeded passage to and from the main River Yeo a couple of hundred metres further downstream, makes it likely that trout of all age classes, as well as other species, could be present in this stretch – ready to migrate upstream when fish passage and habitat improvements are implemented.

Whenever possible, such LWM should be left in place as highly beneficial habitat – perhaps secured with stakes and wire if higher flows are considered likely to dislodge it and risk blocking bridges or other structures further downstream.
