Dodham Brook, Yeovil, Somerset

Wild Trout Trust report following an Advisory Visit on 14 December 2018

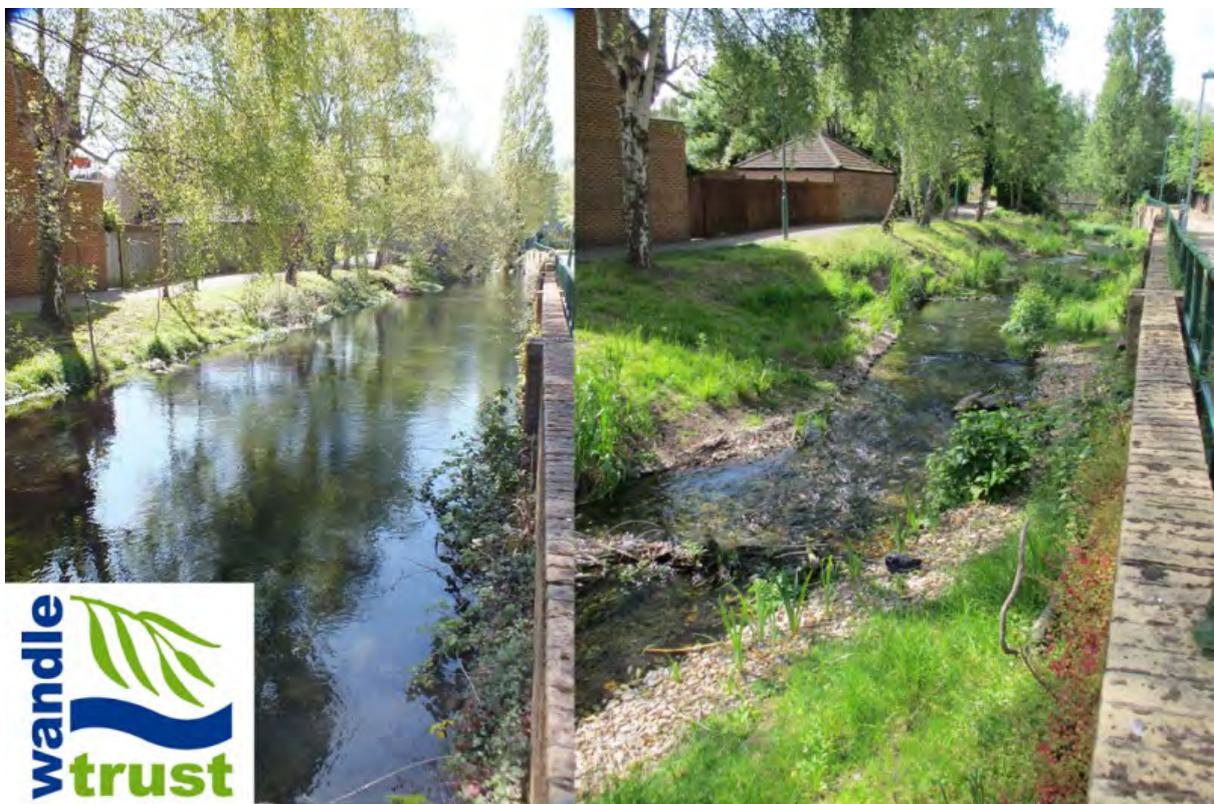
Figure 23: The River Wandle in south London: a similar stretch of urban stream after enhancement (Photo: SERT)

Engagement with at least three landowners is likely to be required: this may be facilitated with artist's impressions or photographs of similar sites.

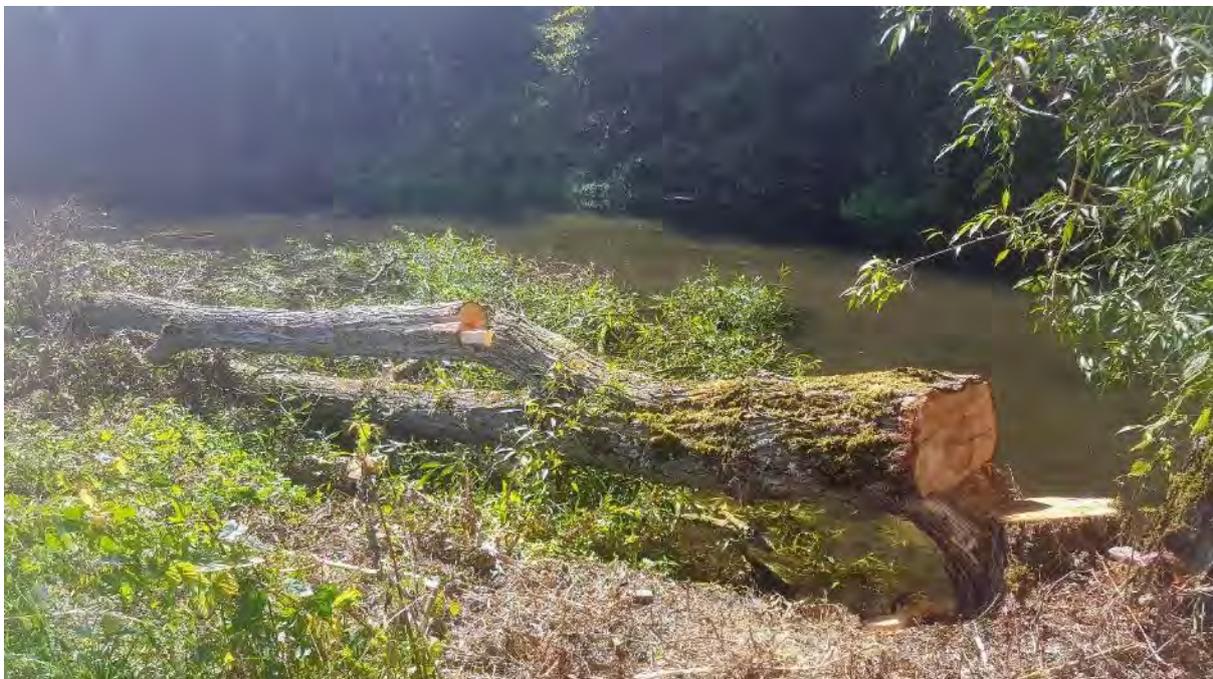
Figure 24: Hinged carefully into the water, a tree kicker can continue to grow while providing much needed structural diversity for a simplified urban river.

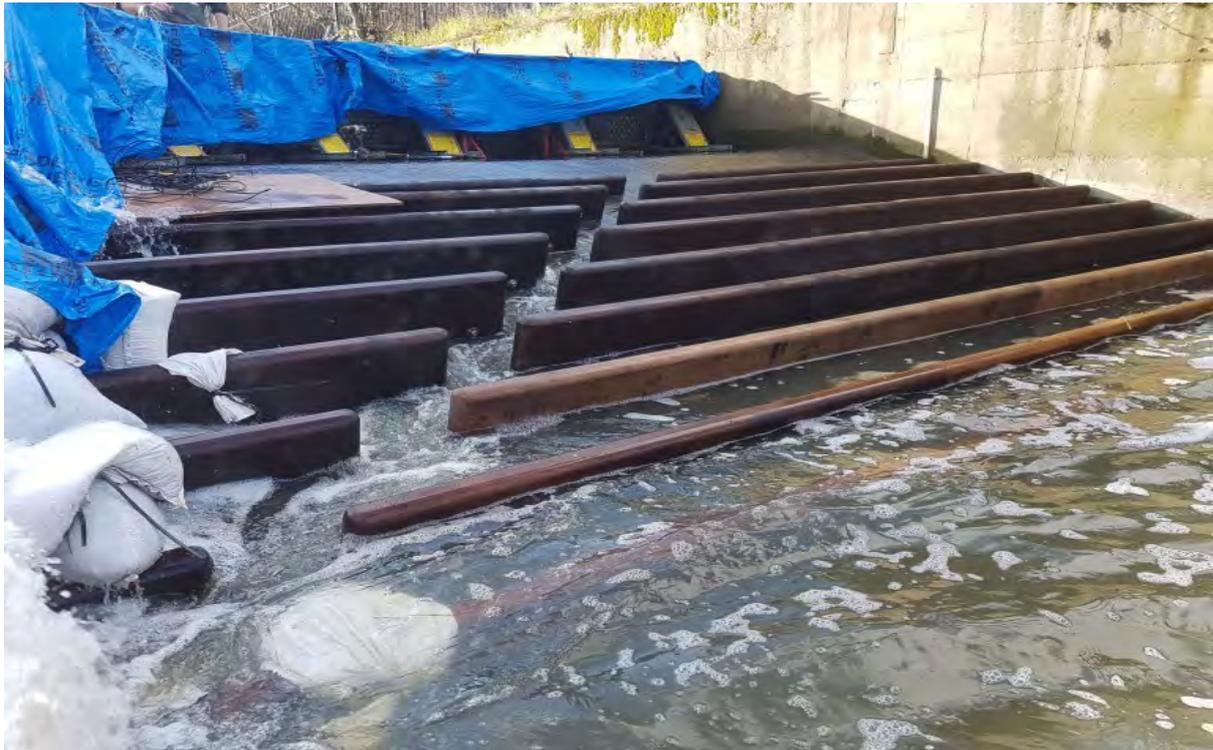
Figure 25: Low cost baffles installed on a gauging weir on the River Hogsmill: see <https://www.southeastrivertrust.org/hogsmill-reconnected-to-the-thames-with-fish-pass-installed-in-kingston/> for the full case study (Photo: SERT)

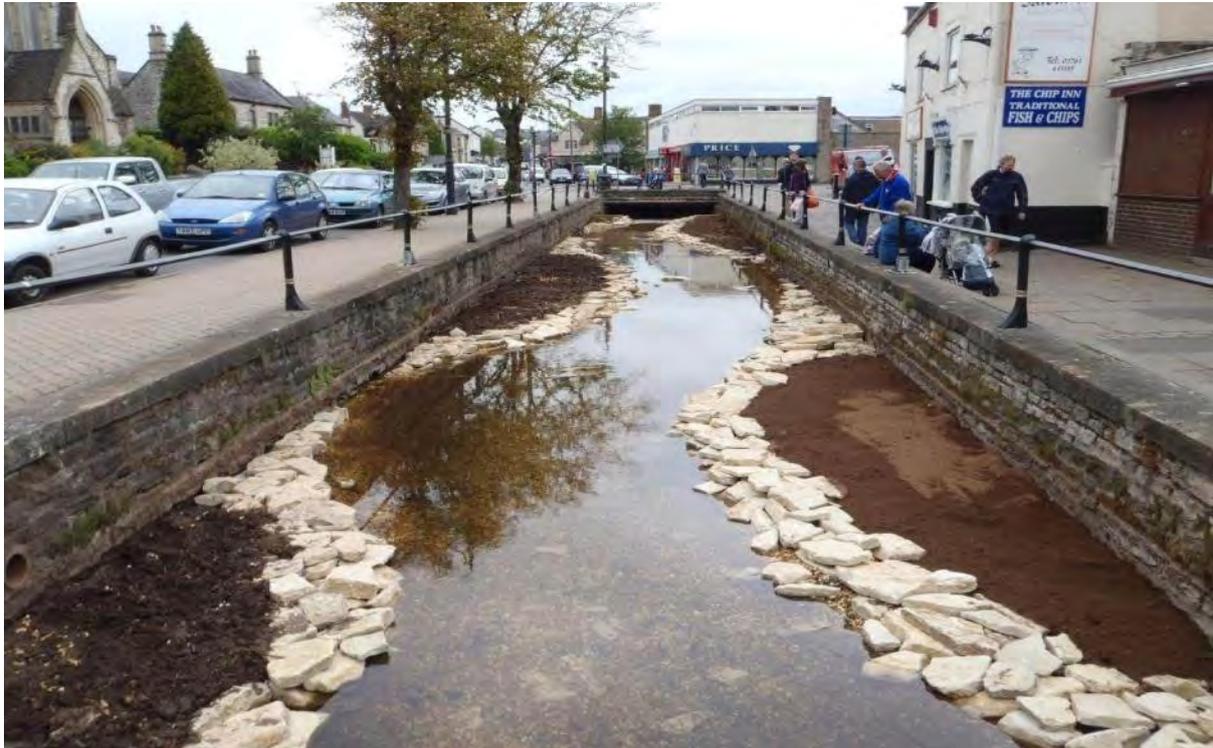
Figure 26: Backfilled rock berms (before planting) create a meandering channel for the River Somer in its open culvert through Midsomer Norton (Photo: Luke Kozak)

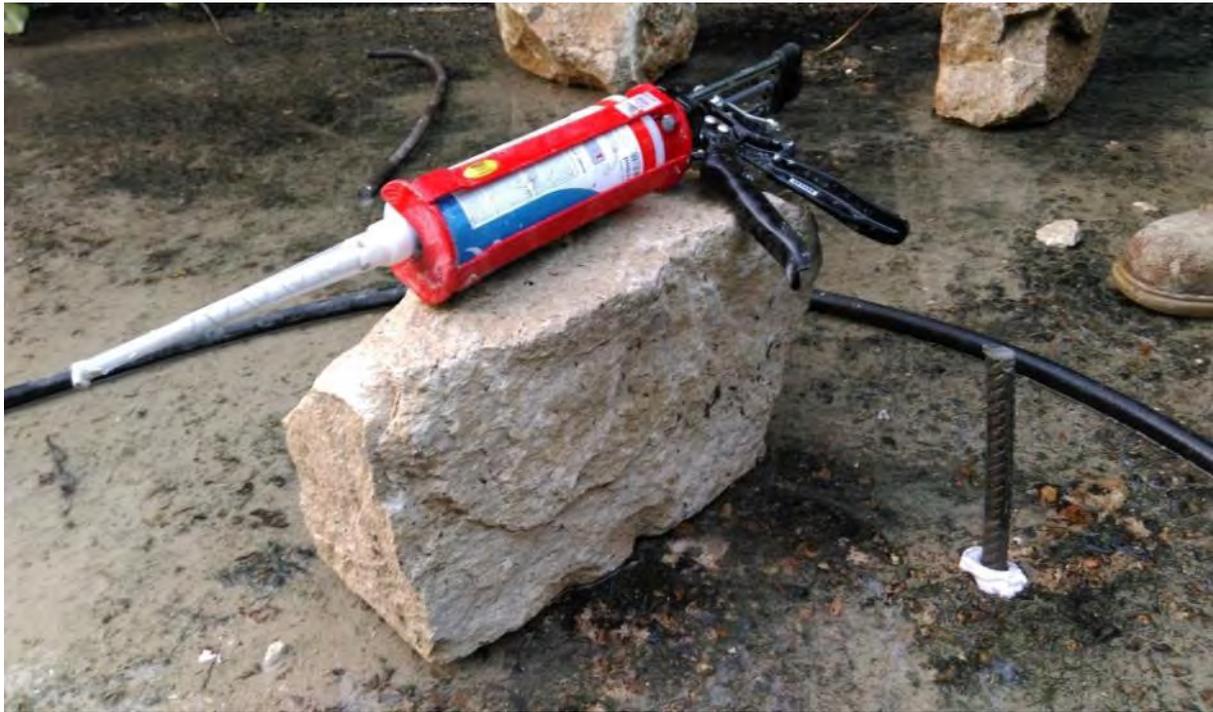
Figure 27: Resin, Purbeck stone and rebar: raw materials for adding roughness to the Hogsmill River in south London: see <https://www.southeastrivertrust.org/first-class-degree-in-fish-passage-at-kingston-uni/> for the full case study (Photo: SERT)

Areas of gravel, cobbles and small boulders of local ragstone could also be created, holding some of these rocks in place with bolts and resin to act as bed checks for other rocks to lock against. 'Slowing the flow' in such areas of 'pocket water' may help to mitigate low flows which have been identified as an issue under WFD.

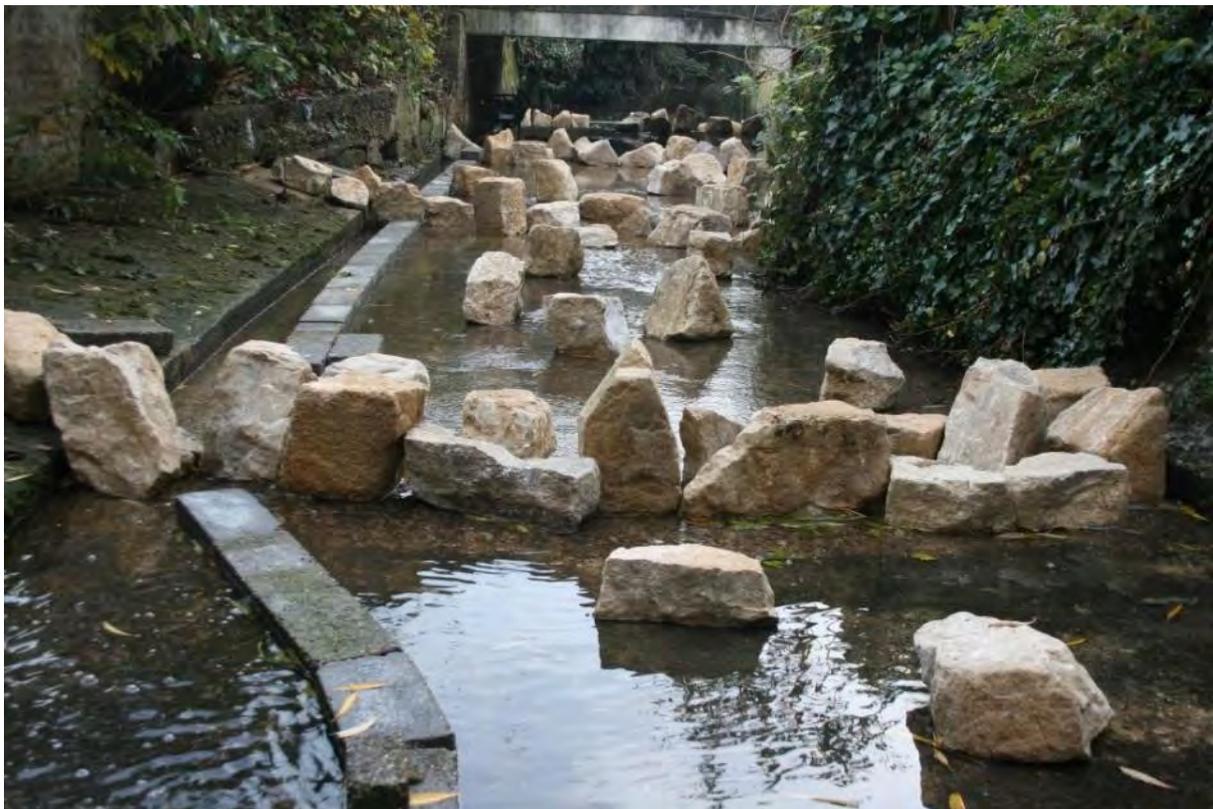
Figure 28: Bed check rocks in position in the Hogsmill River (Photo: SERT)

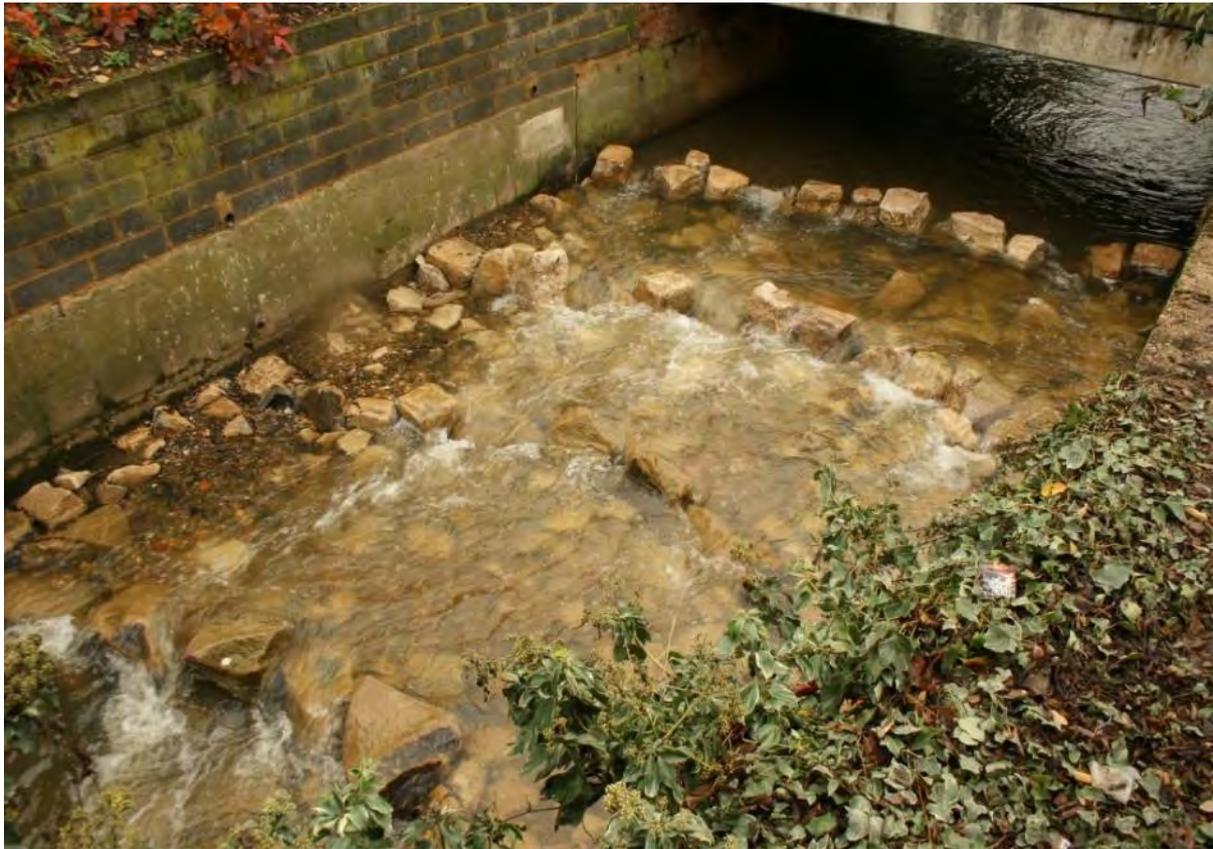
Figure 29: Introduced rocks and gravel create a range of habitats and flow dynamics in what was once a smooth concrete channel in the Hogsmill River (Photo: SERT)
