Advisory Visit

River Dane, Cheshire

Eaton Flyfishers

10th July, 2008

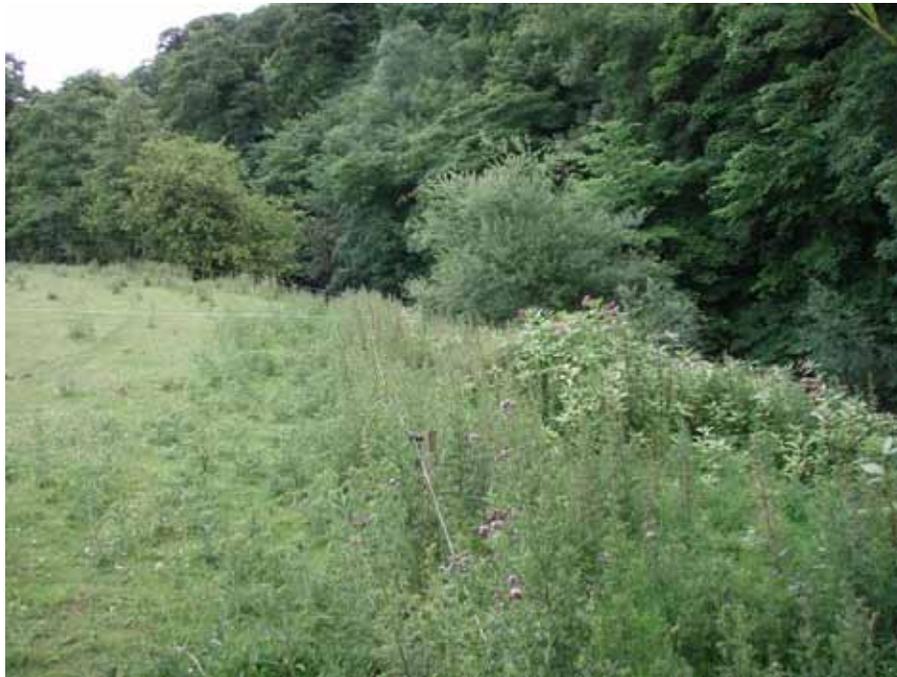
Photo 1 A good width of marginal vegetation protected by an electric fence. Note however the stand of Himalayan balsam (start of beat 2)

The next field upstream (beat 2) had an electric fence along the right bank providing a good riverside margin dominated by nettles, willows and Himalayan balsam (*Impatiens glandulifera*), giving way to dense stands of hazel (which had been coppiced previously) with upstream progress. The fencing ended halfway up this field but the steepening bank prevented livestock access to the river. The opposite bank (left bank) is steep and tree covered (being the start of Madams Wood) and gives excellent overhead cover above the river.

- Control Himalayan balsam. This can be achieved by physical or chemical means:

Physical Control

The main method of control, and usually the most appropriate, is pulling or cutting plants before they flower and set seed. Working parties are the best means of doing this, and Rease Heath College may also be able to provide assistance.

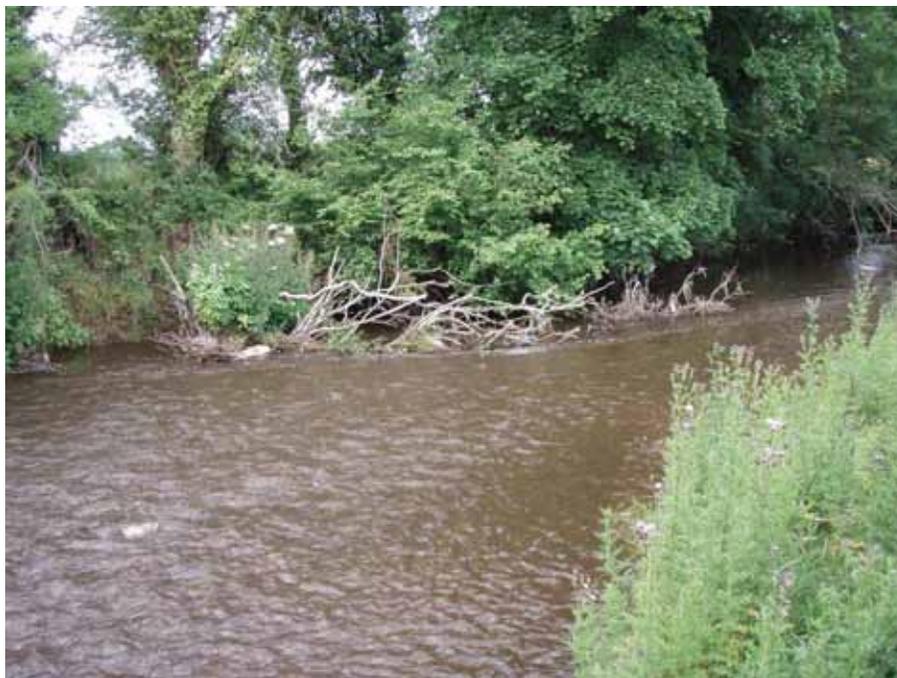
Photo 2 A great example of stable LWD in the river channel

- The club should adopt a policy of retaining LWD in the river channel wherever possible. The West Country Rivers Trust provides a useful guide to the management of natural LWD:

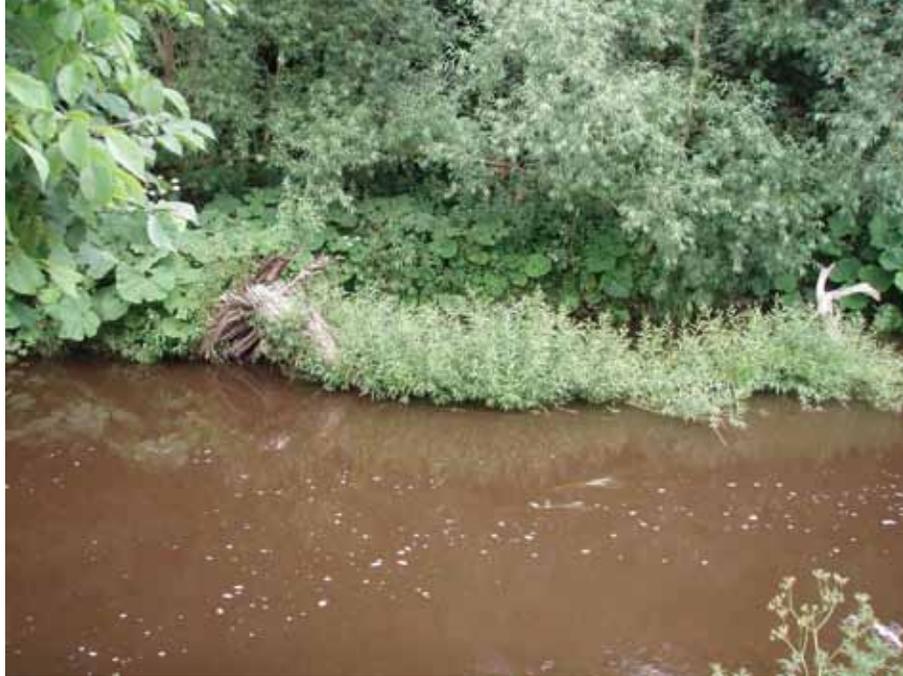
Photo 3 An excellent example of stable in-channel LWD - a willow still attached to its root bole

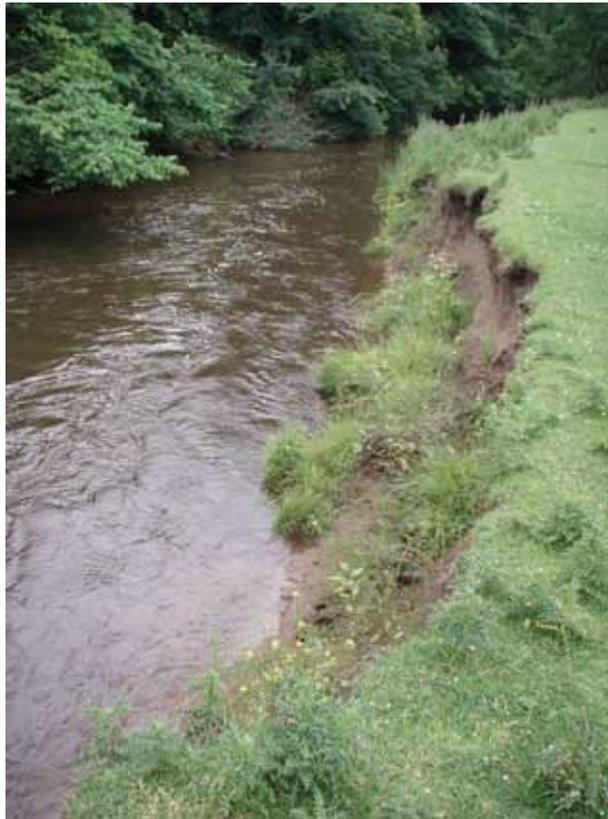
Photo 4 A small section of bank erosion on beat 1

few willows and sycamore trees present on this bank. The first field on this bank is unfenced and is grazed by cattle and horses which have access to the water; the shallow bank gradient means that livestock access is spread out rather than concentrated, so bank damage is light and does not give cause for concern. There is a short area of bank erosion at the upstream end of this field on the right bank where an exposed soil cliff has formed.

The field in beat 1 is the only significant length of river accessible by stock. Erosion is not a major problem here because stock access is spread over a wide area. The club could explore the possibility of fencing this section, ideally in combination with an alternative drinking source because concentrating livestock at a cattle drink in the river would be counter-productive and technically difficult in a spate river. Temporary electric fencing would be the best option in terms of cost, flexibility and controlling balsam (see below).

The eroding section in this field could be controlled by fencing well back from the river (10 metres or more) and planting trees to establish a root network. Protecting the toe of the eroding bank could also be achieved by fixing LWD in that area, possibly in the form of a tree kicker (Figure 1).

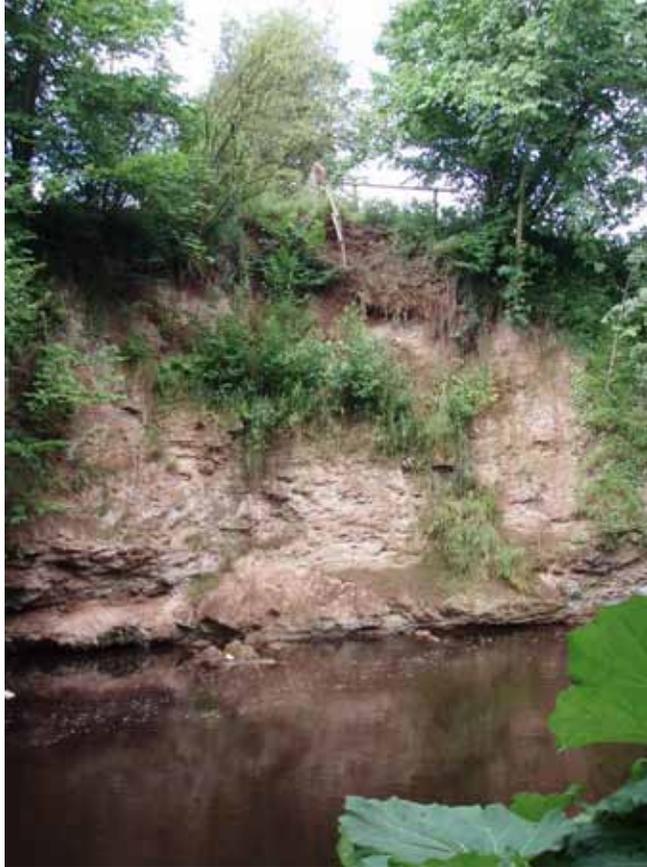
This section was walked starting at beat 7 (SJ 88216 65709) in a field of mowing grass on the right bank. A good margin between the field and the river is present behind the fence. Both banks are quite heavily shaded by trees, with some leaning across the river. There are some steep cliff faces on the left bank.

Photo 5 Example of river cliff

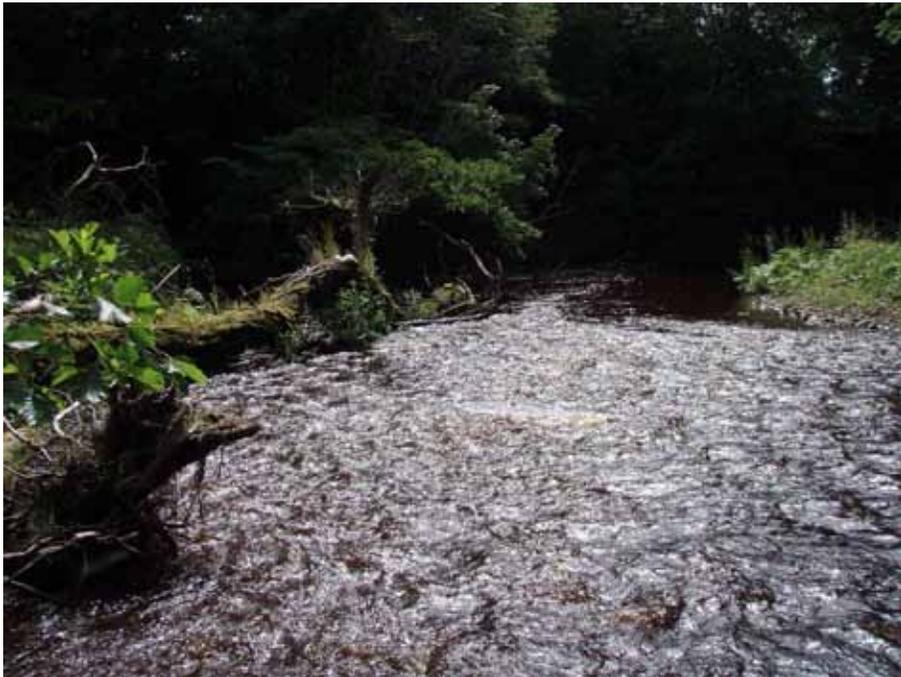
Throughout this section there were many examples of LWD in the river channel, providing excellent habitat and promoting a diversity of flows and channel morphology. A pool and riffle sequence was present throughout the reach.

Photo 6 Riffle, pool and woody debris - an ideal habitat combination.

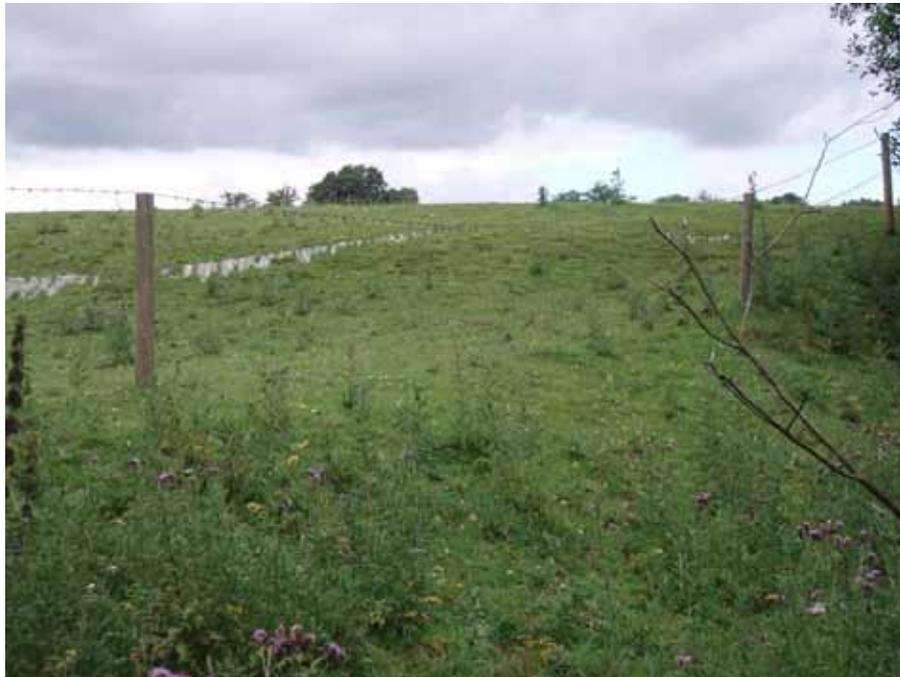
Photo 7 Fences and livestock access to the river bank need to be carefully managed

- Keep a watching brief on the density of livestock in fields on the right bank and their access to the river, particularly where temporary electric fencing is used. The aim should be to maintain as wide a margin as possible, with a good density of tall vegetation.

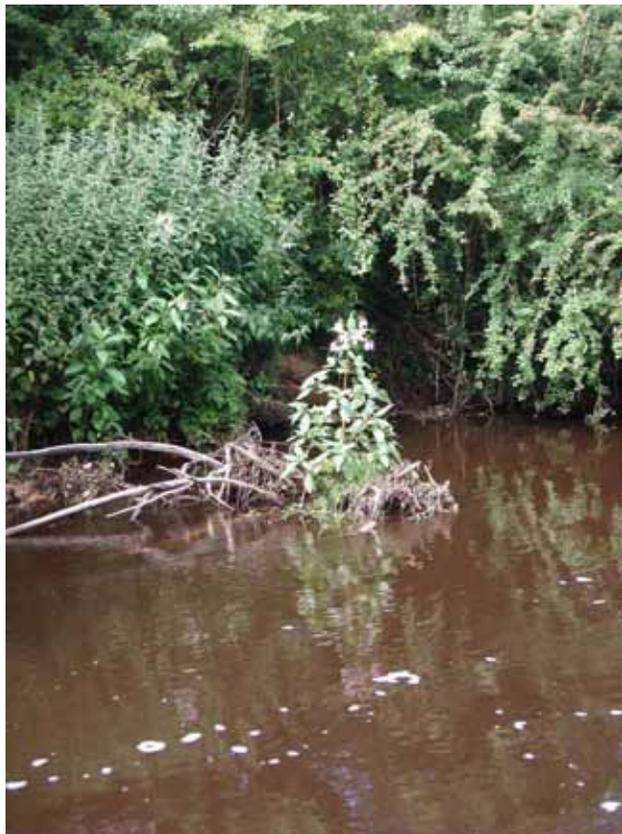
Photo 8 Good and bad! LWD with Himalayan balsam growing on it - leave the former, remove the latter.

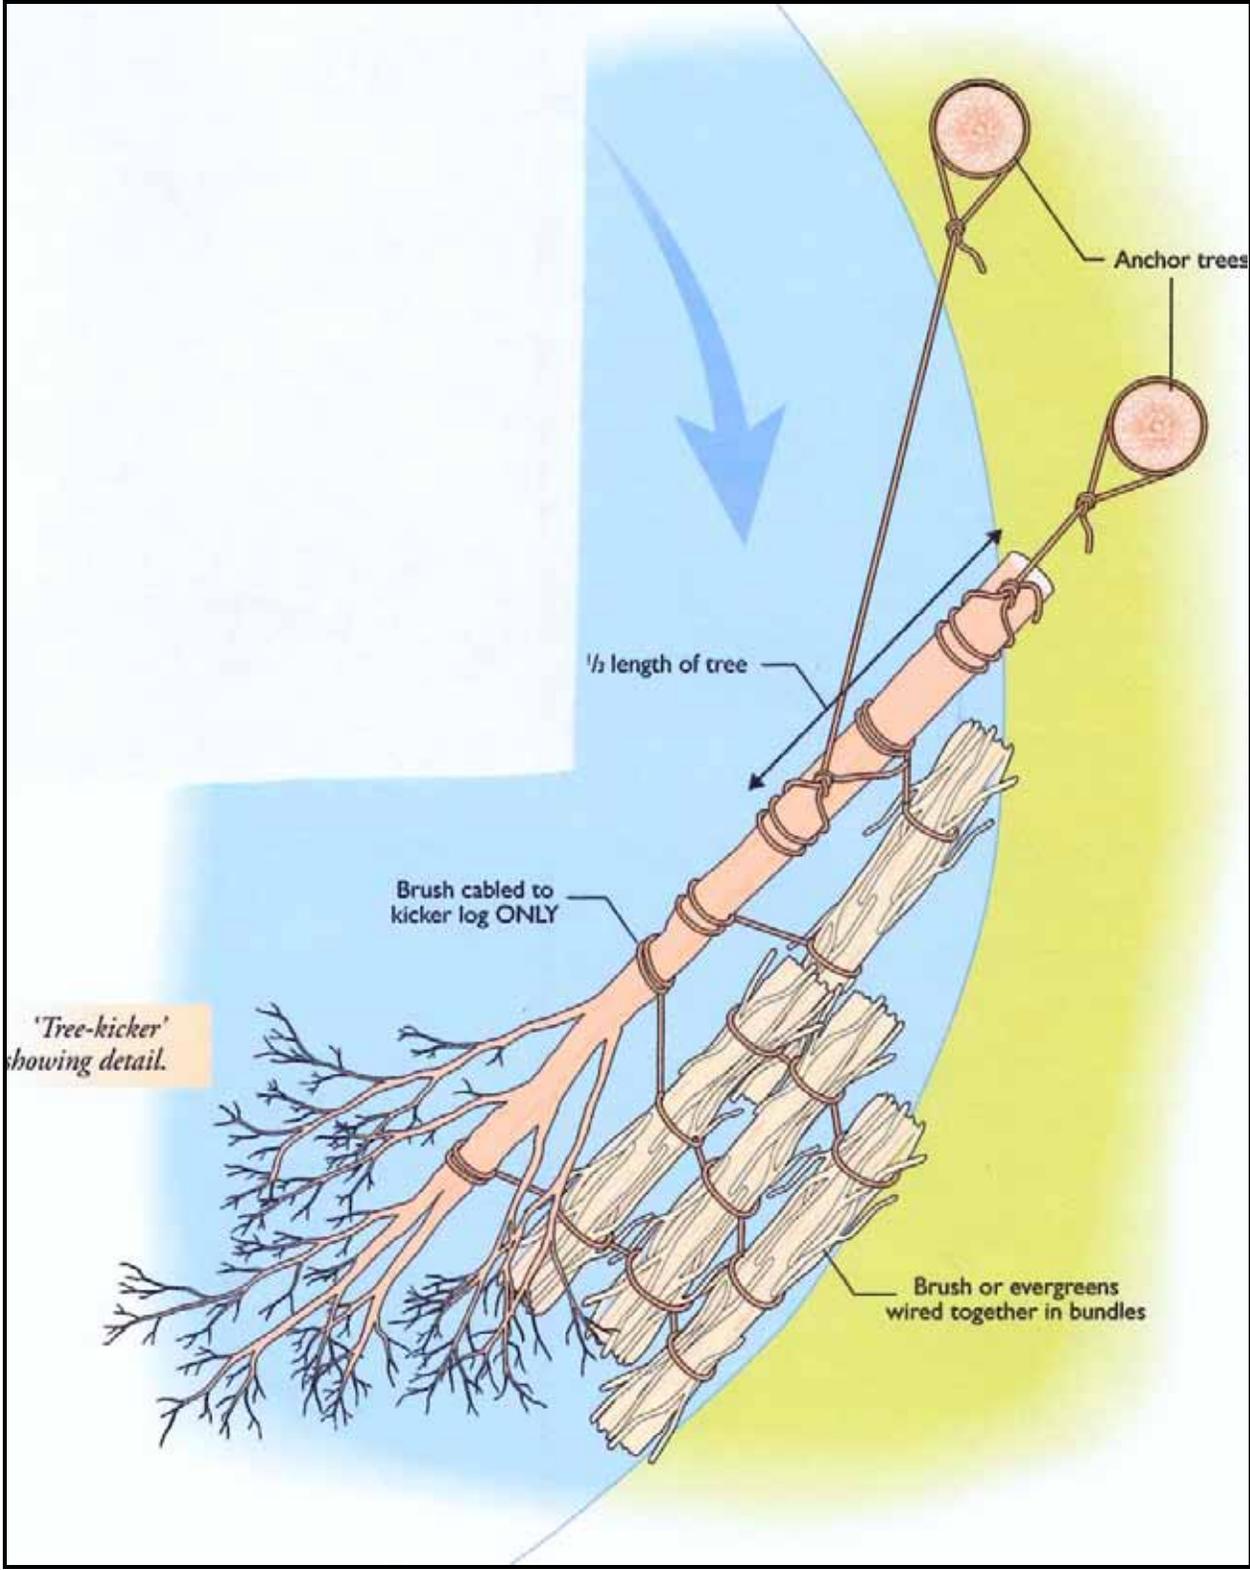
Figure 1 Example of 'tree kicker' erosion protection for high energy streams
