Advisory Visit

River Dane, Hug Bridge

Macclesfield Fly Fishers

2nd October, 2008

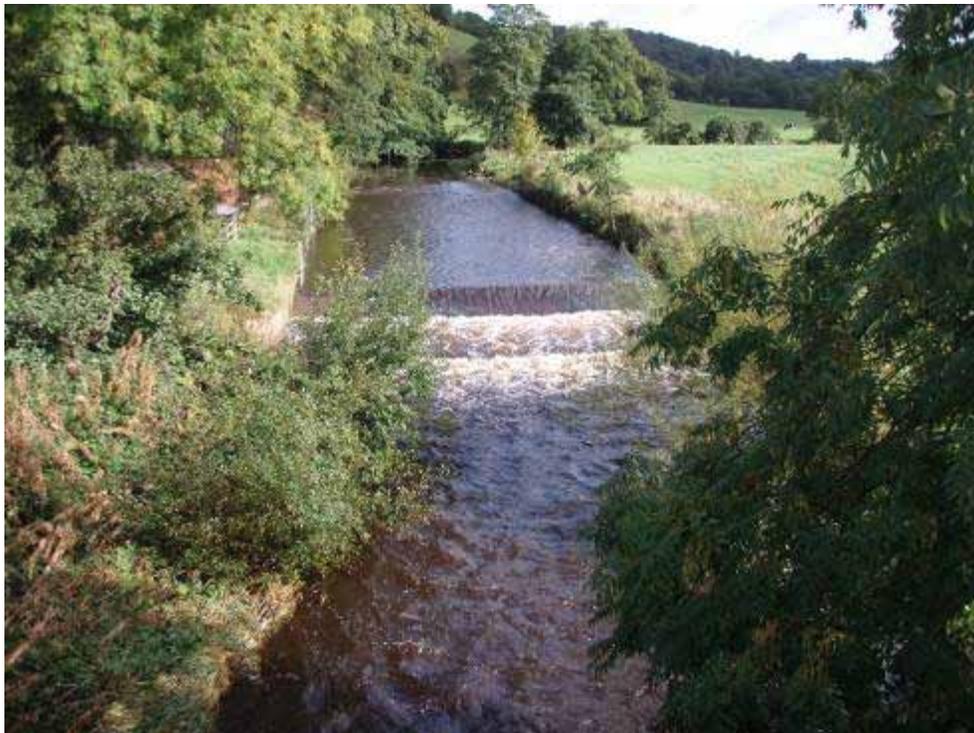
Photo 1 Gauging weir at Hug Bridge

Macclesfield Flyfishers Club has been in existence for 55 years and currently has about 90 members. The club own the fishing rights to the Hug Bridge stretch of the River Dane and it is their longest-held fishery. At the downstream limit of the fishery (SJ 9309 6360) is a United Utilities abstraction pumping station and a gauging weir (Photo 1). The upstream limit some 1.5 km upstream is at the confluence with the Shell Brook (SJ 9413 6388).

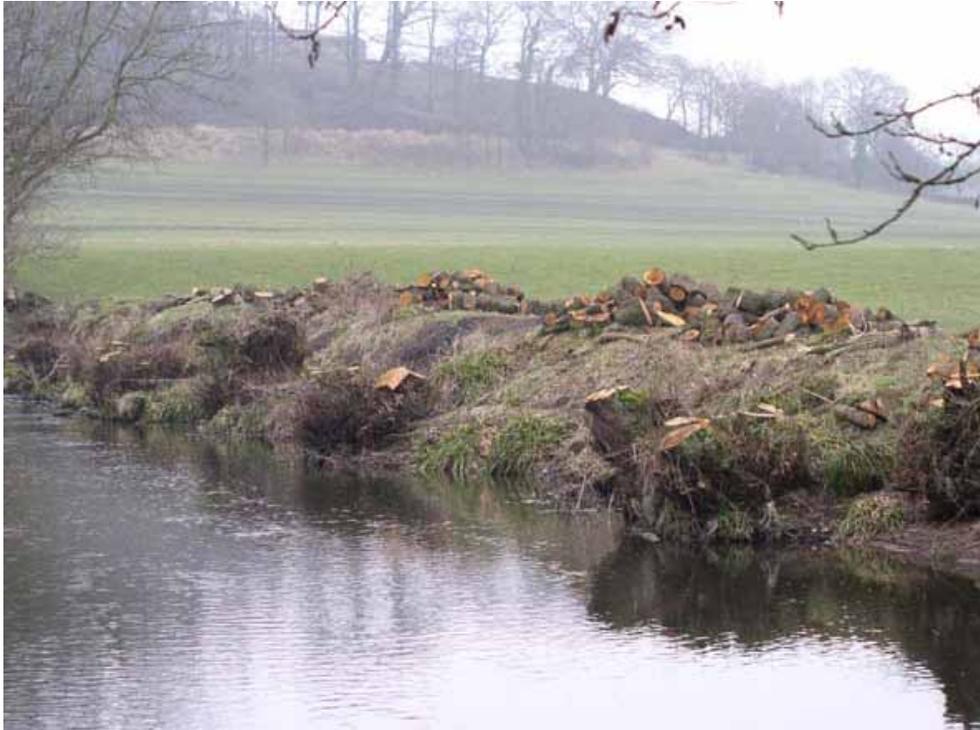
Photo 2 Coppiced trees in 2004 at the downstream boulder placement site (from Weybourne 2006)

In some areas the trees have been coppiced to allow more light to reach the river channel. This appears to have been done alongside the boulder placements mentioned in section 2.0. Re-growth of the coppiced stools has been strong in some areas, but limited in others. (Photos 2, 3 and 4). The restricted re-growth is probably because of damage by grazing livestock (the coppiced areas are not fenced), and the location: the poorer re-growth areas are on the north bank and shaded by tall tree growth on the south bank.

- Further tree coppicing could be carried out in heavily shaded areas to increase light penetration to the river channel and to provide a source of LWD for introduction to the river channel (as tree kickers). It is recommended that selected trees are coppiced on a 7 to 10 year rotation. The aim should be to produce a mix of trees at different stages of maturity, and the trees selected for coppicing should be well spaced, rather than in blocks as in Photo 2. A mix of light and shade at a ratio of 40% to 60% is ideal.

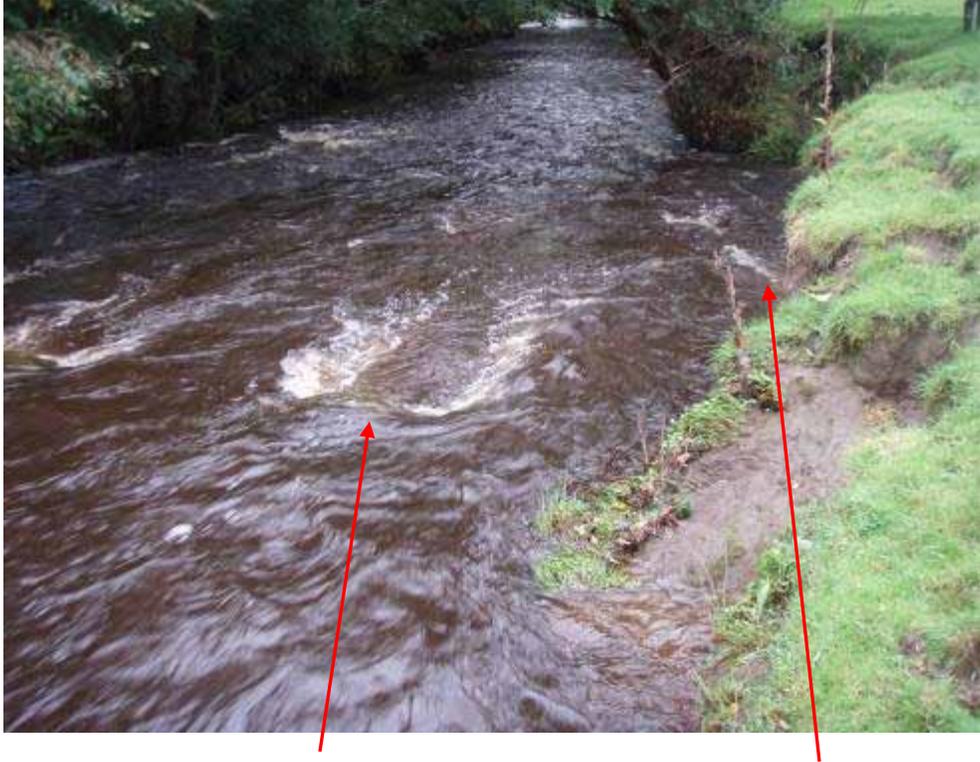
Photo 5 Boulder placed too close to right bank, causing bank erosion

The furthest upstream site for boulder placement is regarded as being the least successful. Here one of the boulders has been placed too close to the

right bank and is causing bank erosion; this was evident in the high flows during the visit and is likely to lead to the loss of the tree immediately downstream (Photo 5).

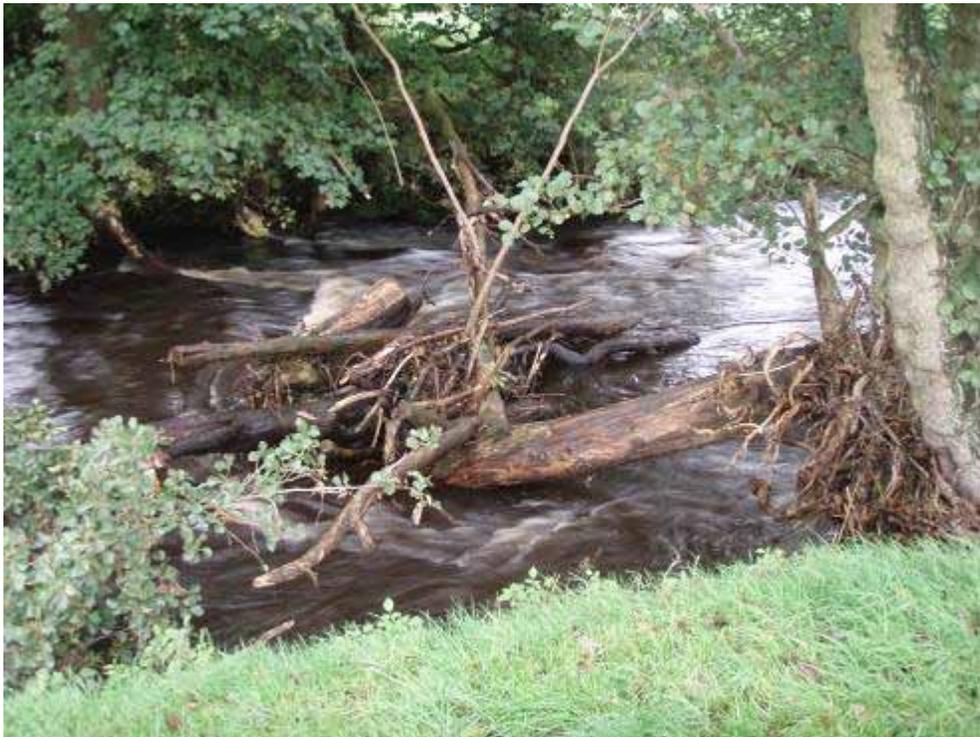
Photo 6 Large woody debris - excellent wild trout habitat

In a spate river such as the Dane, the presence of LWD can be fairly short-lived as it is moved on by floods. However, even ephemeral structures can be beneficial in creating bed scour, cleaning gravel for spawning and providing cover. LWD such as that shown in Photo 6 is likely to be washed out in a flood, but will have created valuable diversity in depths and flows by then. Longer lasting LWD can become established where larger trees become waterlogged and embedded in the substrate, such as shown in Photo 7.

· The club should adopt a policy of retaining LWD in the river channel wherever possible. The West Country Rivers Trust provides a useful guide to the management of natural LWD:

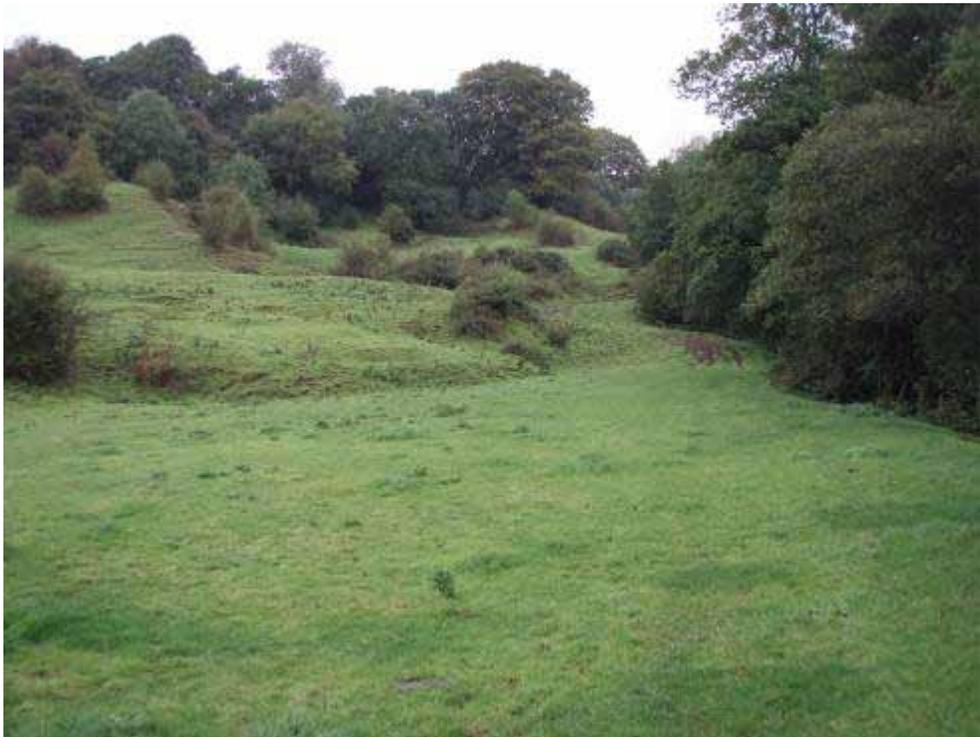
Photo 8 Land use - right bank

Land use on both banks was mostly for livestock, at the time of the visit dairy and beef cattle (Photo 8). Most of the river was not fenced, although cattle access to the river was limited by the steep banks. At cattle drinking areas there was some poaching of the banks (Photo 9), although this was not particularly serious. Generally the banks were in good condition and well vegetated. One field on the LHB was used as a quad bike circuit, and whilst there was some bare earth tracks, there did not appear to be any run off to the river from these.

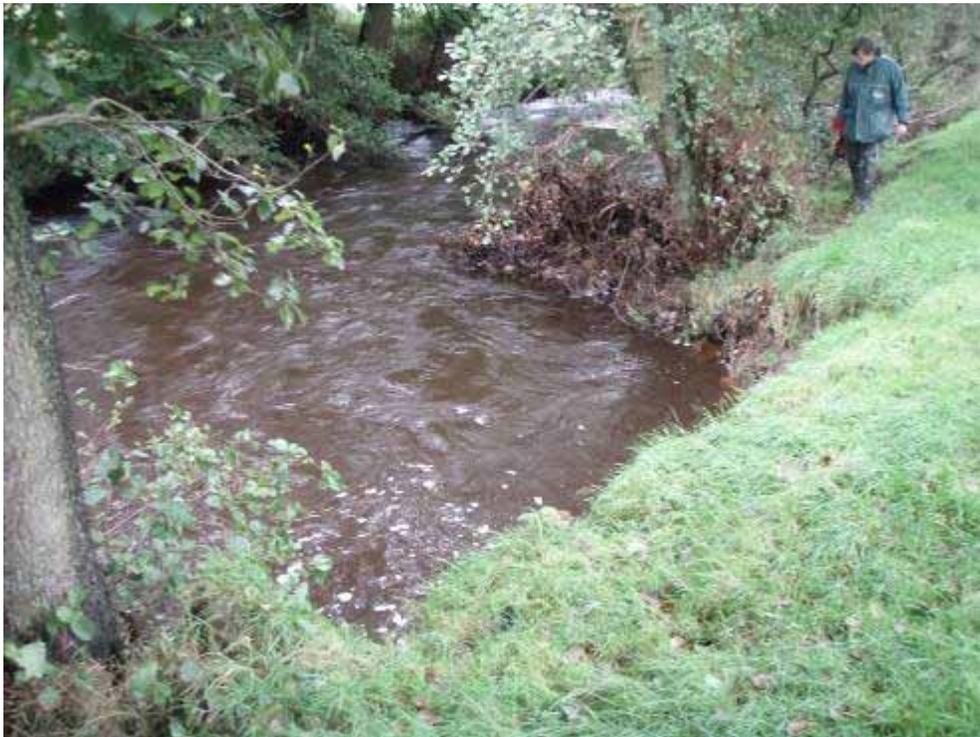
Photo 10 Scalping of the bank between trees

In some areas the bank was scalloped between trees (Photo 10). This is due to the shading out by trees of low-growing marginal plants the roots of which stabilise banks, leading to gradual bank erosion between the root boles of the trees; it can also be caused by the hole left in the bank when a tree falls into the river. This scalloping can lead to further losses of trees as erosion occurs behind the root bole of existing trees.

- LWD could be introduced to the river in selected sections. For example 'tree kickers' could be used to protect the areas of scalloped bank between trees (Figure 1). Tree kickers have recently been used successfully on the River Goyt near New Mills (Photo 15).

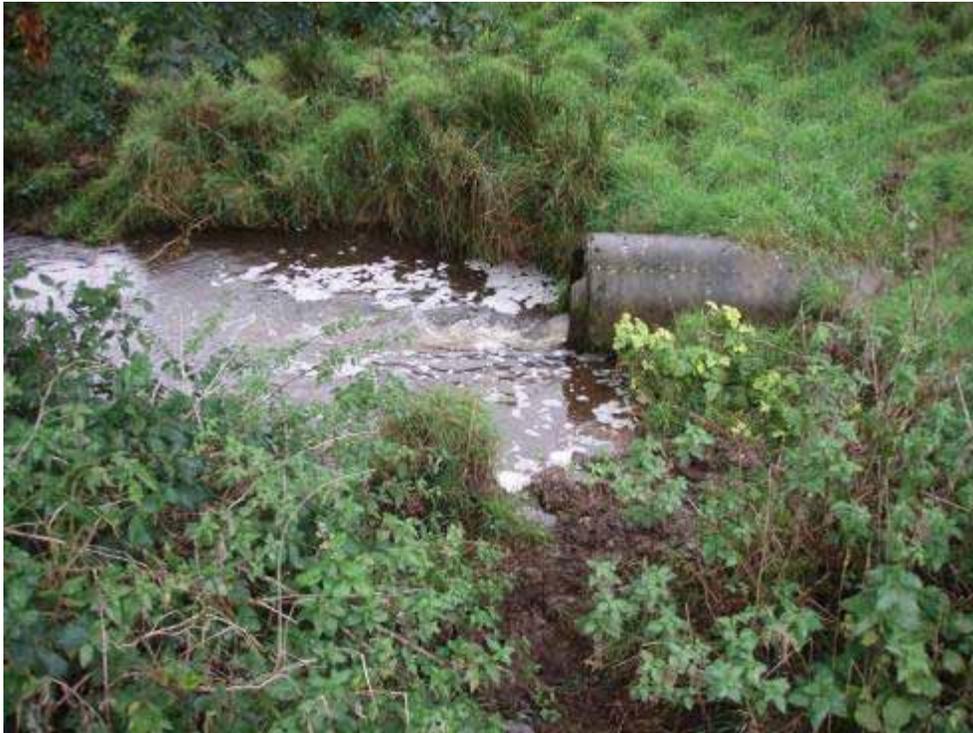
Photo 11 Culvert pipe on small tributary perched above downstream water level making upstream fish access difficult

There are two tributaries entering this reach of the Dane; the Shell Brook at the upstream limit of the MFC fishery, and a small un-named stream on the RHB. These are likely to be used by trout for spawning and nursery areas, and as such it is important to ensure trout have free access into the brooks from the main river. The small un-named tributary had a tractor crossing about 150 metres from the river consisting of a concrete pipe culvert; this had become perched on the downstream side making it difficult for further upstream access for fish (Photo 11).

- The club should check that fish have free access to the Shell Brook for spawning. If there are any obstacles similar to that on the smaller tributary mentioned above, the EA Fisheries department will be able to advise on potential solutions.

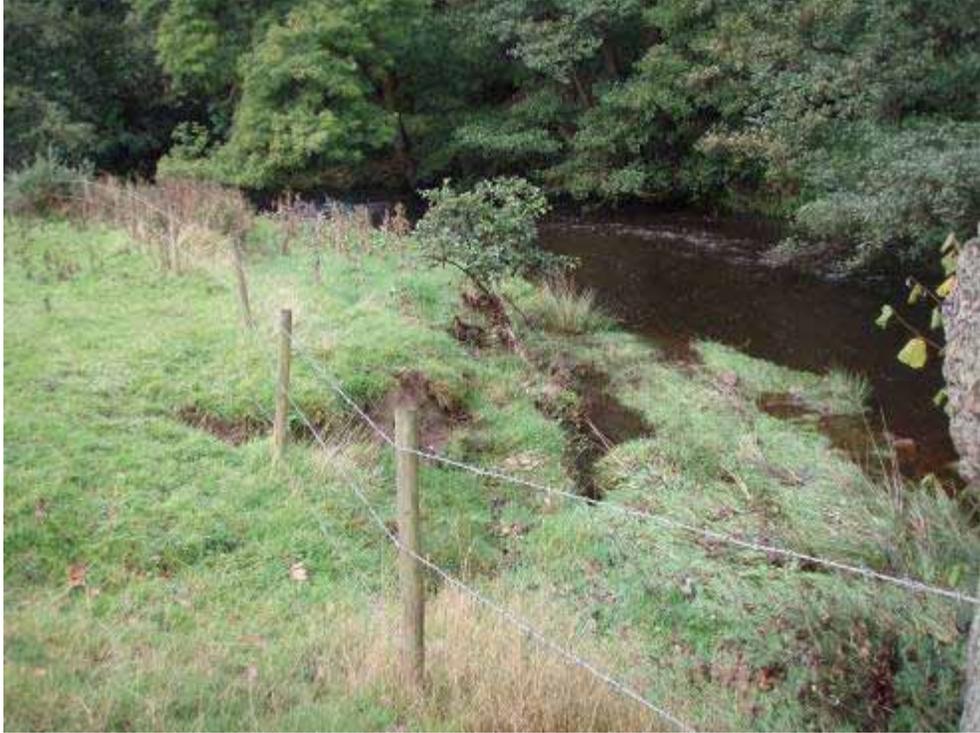
Photo 12 Fenced LHB on upstream section of the fishery

On the upstream section of the fishery the right bank was steep and wooded and the left bank was lower and mostly fenced to exclude livestock. There was generally a generous margin between the fence and the river, and some excellent examples of vegetated side bars and berms alongside the river (Photo 12).

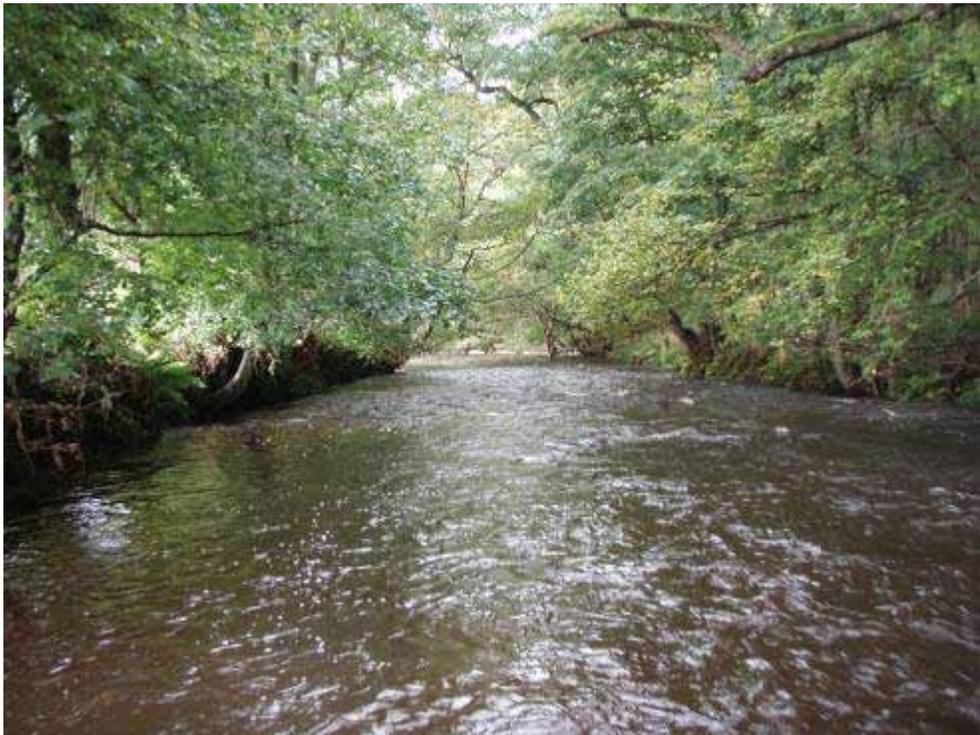
Photo 13 Heavily shaded straight reach

A large part of the upstream section of the fishery consisted of a fast, shallow, straight reach which was heavily shaded (Photo 13). The south

The south bank of the river would be the most advantageous location for tree coppicing to promote increased light penetration. For example the long straight reach at the upstream end of the fishery would benefit from a thinning of trees on the south bank and introduction of LWD to this section. The numerous hazel trees in this area could be used to create brushwood bundles for the tree kickers mentioned previously.

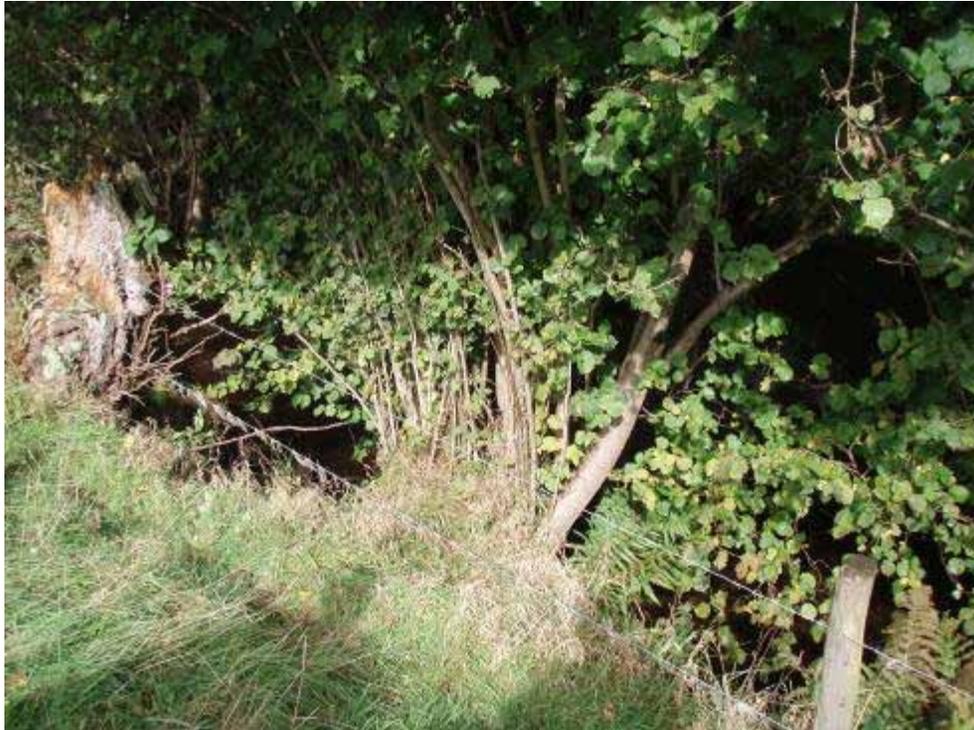
Photo 14 Previously coppiced hazel

bank has a lot of sycamore and previously coppiced hazel (Photo 14), on a low but steep bank with the fence line close to the river.

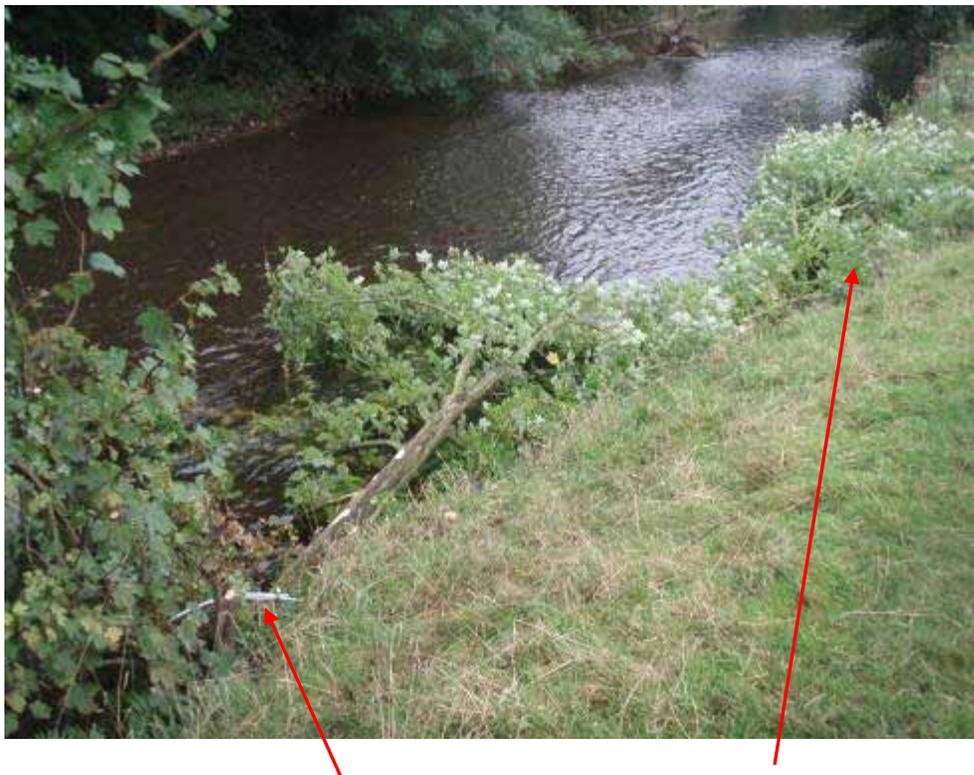
Photo 15 Tree kicker anchored to bankside tree with cable, protecting scalloped bank

The tree kickers on the Goyt have promoted the deposition of fine sediment in the margins of the river. This is valuable habitat for the ammocoete stage of brook lamprey, a species of conservation importance.
