**Advisory Visit**

**River Derwent, Cromford, Derbyshire**

**August, 2012**

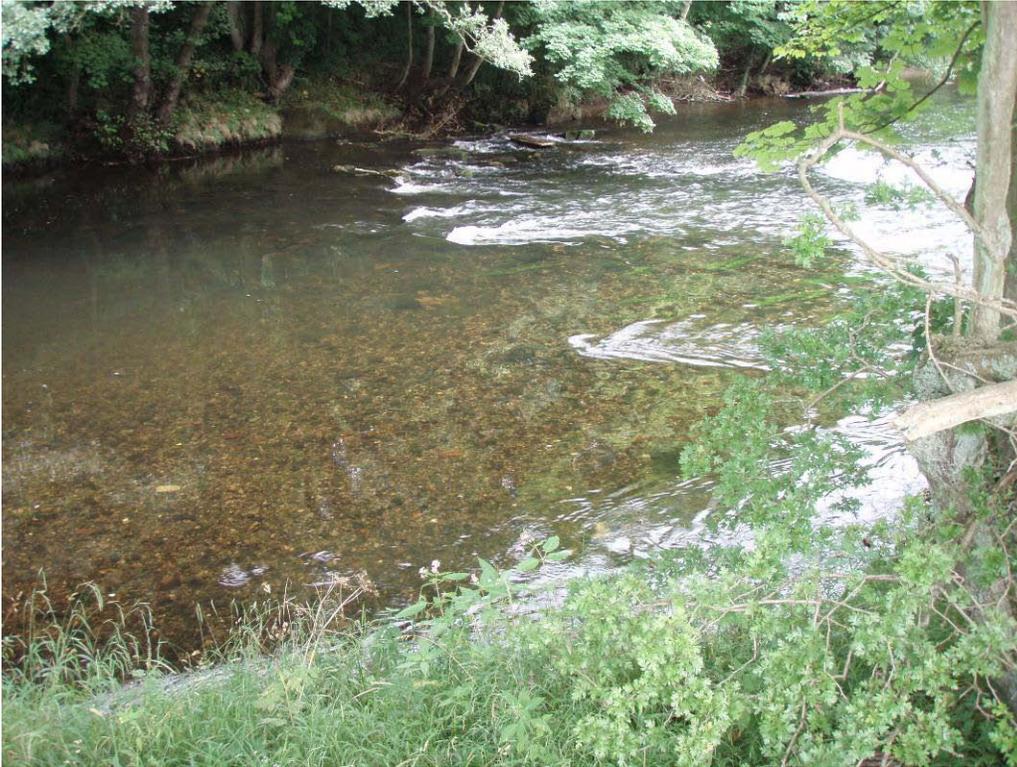
**Photo 1 A diversity of flow patterns and substrate size provides good habitat**

The river was walked from the downstream limit up to Cromford Bridge. In general, the in-stream habitat quality within this section of the Derwent is very good. The river has a moderate to steep gradient and a good diversity of flow patterns and depths provided by the pool, riffle and glide sequence. The river bed substrate is also very varied, ranging from boulders down to sand, with a good proportion of gravel in the 5 – 100mm size range, which encompasses the spawning requirements of fish such as trout, grayling, barbel, chub and lamprey (Photos 1, 2).

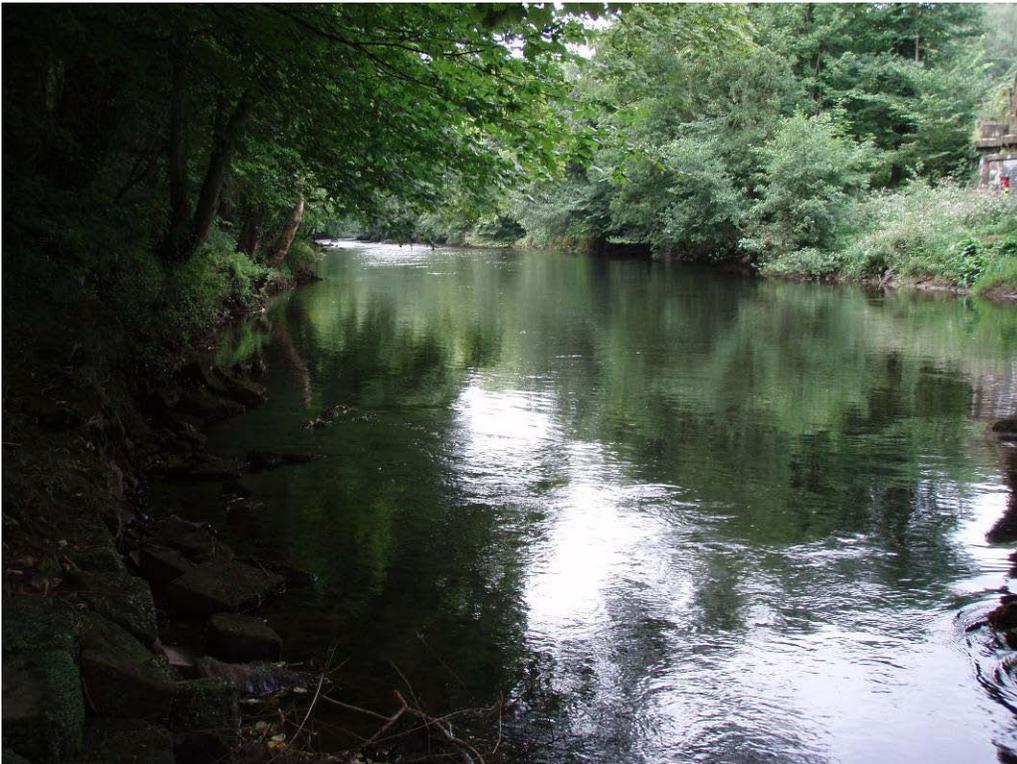
**Photo 2 Steady glide habitat. Managing overhanging trees in these areas should strike a balance between fishing access and cover. Leaving low and trailing branches in place provides excellent holding areas for fish.**

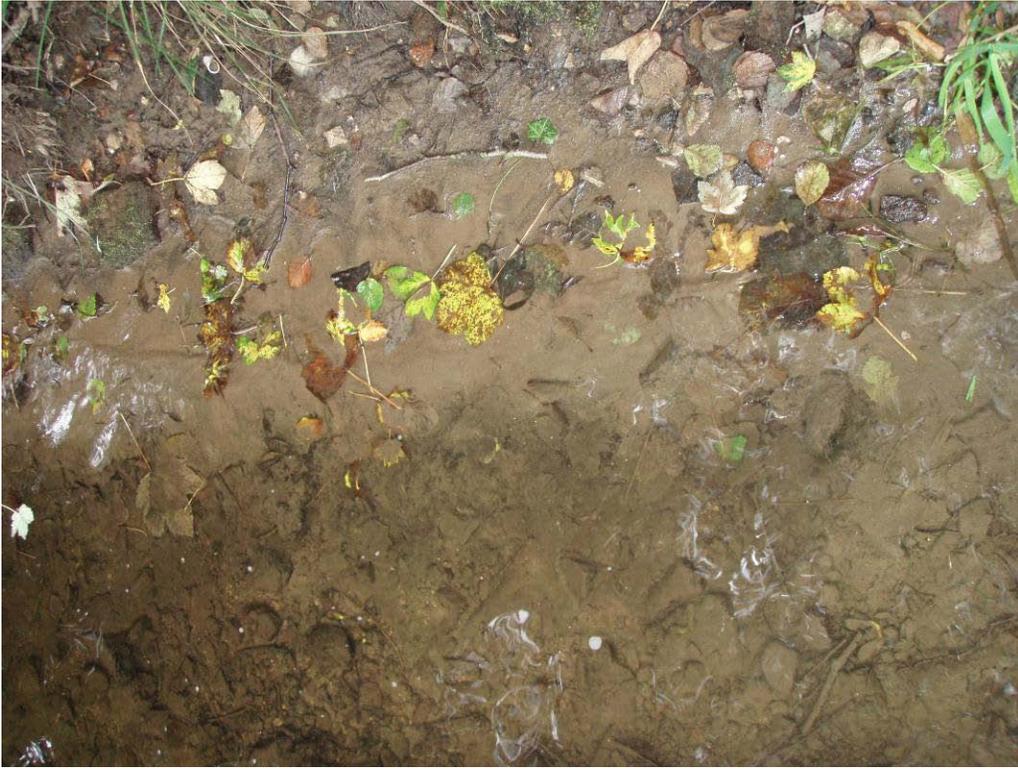
Unfortunately there appears to be a large amount of fine sediment amongst the gravel, which can limit spawning success by suffocating eggs. The presence of the fine sediment may be because of the regulated nature of the flows within the Derwent (fewer spates to wash the sediment through the system); this is known to be a problem on the upper river, closer to Ladybower Reservoir, where the artificial flow regime has even greater influence. This year has however been unusually wet, with prolonged high river levels which might have been expected to flush out finer sediment. There is a possibility that the effects are still being felt of the pollution incident at Stoney Middleton in 2007, where thousands of tonnes of mine tailings (fine sediment) were released to the Derwent; recent untypically high flows could be mobilising sediments which have been settled behind impoundments since the incident (Photos 3, 4).

**Photo 3 Fine sediment deposited in the margins of the river...**

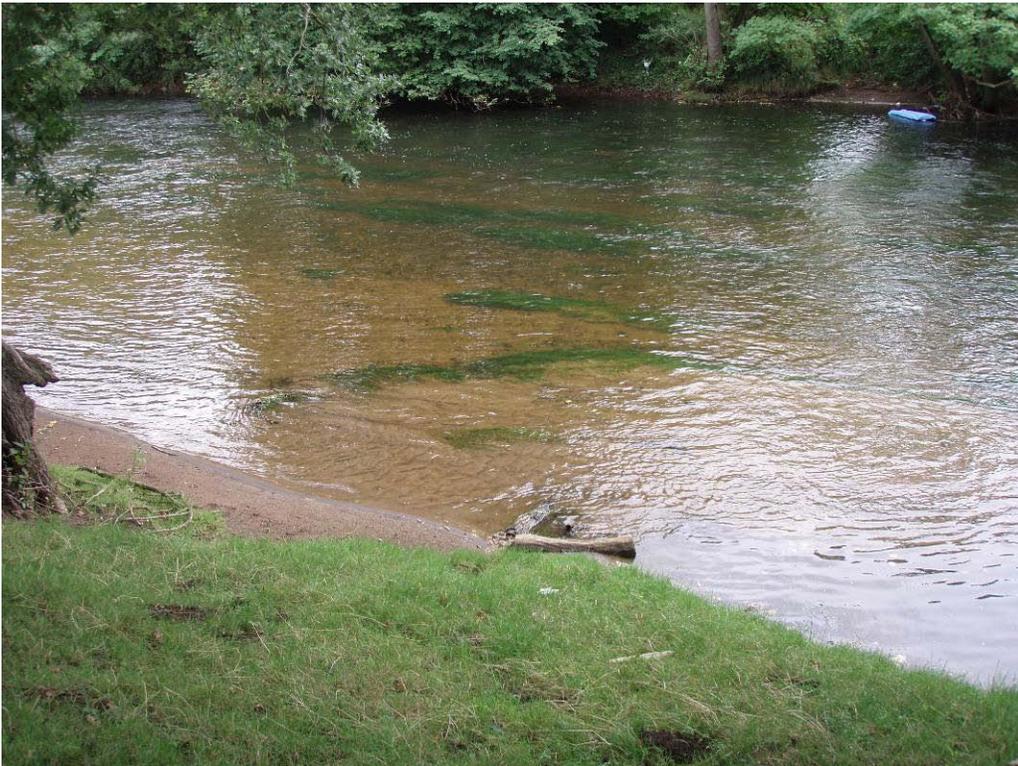
**Photo 4...and across the channel in wider parts of the river.**

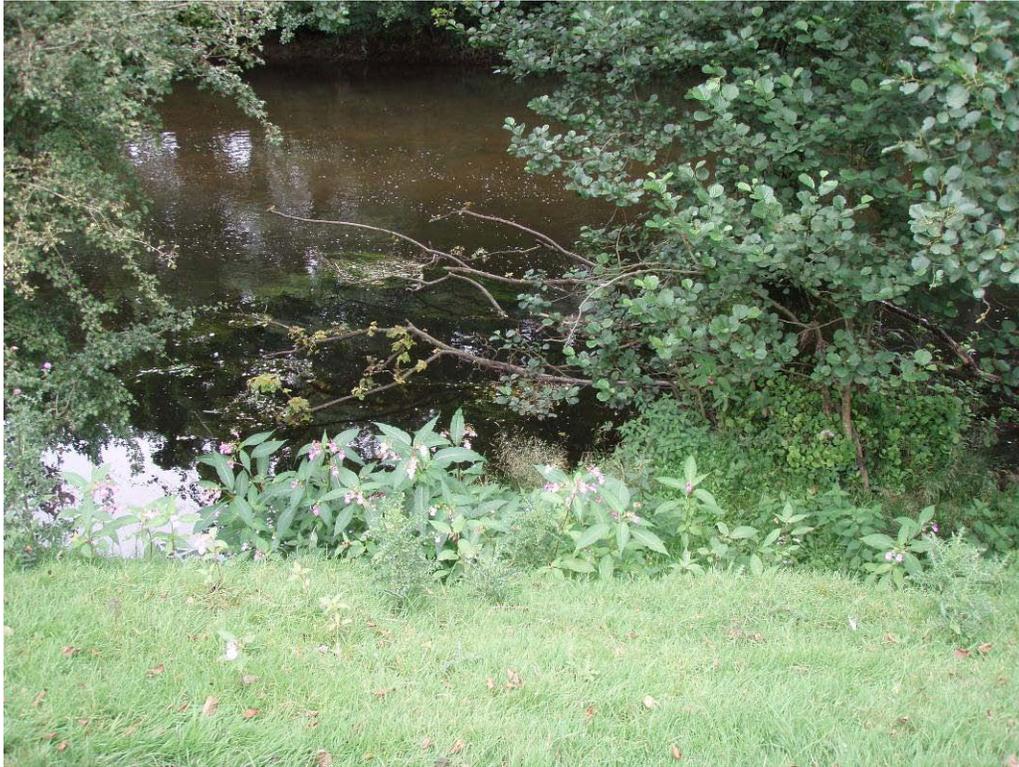
**Photo 5 Naturally occurring large woody debris (in this case a fallen tree) – note the trapped weed and leaf litter which will support invertebrate life and hence trout food**

Often LWD is treated as a nuisance and removed from the river. This may be necessary in some cases (e.g. to reduce flood risk by removal of accumulations from bridges), but very often removal is unnecessary and harmful to stream habitat. Removal of LWD reduces the amount of organic material supporting the aquatic food web, removes vital in-stream habitats that fish will utilise for shelter and spawning and reduces the level of erosion resistance provided against high flows. In addition, LWD improves the stream structure by enhancing the substrate (scouring and sorting gravel) and diverts the stream current in such a way that pools and riffles are likely to develop. The best approach to managing LWD in a way that benefits river habitat is to adopt a default position of leaving it in place unless it poses an unacceptable risk (Photo 5).

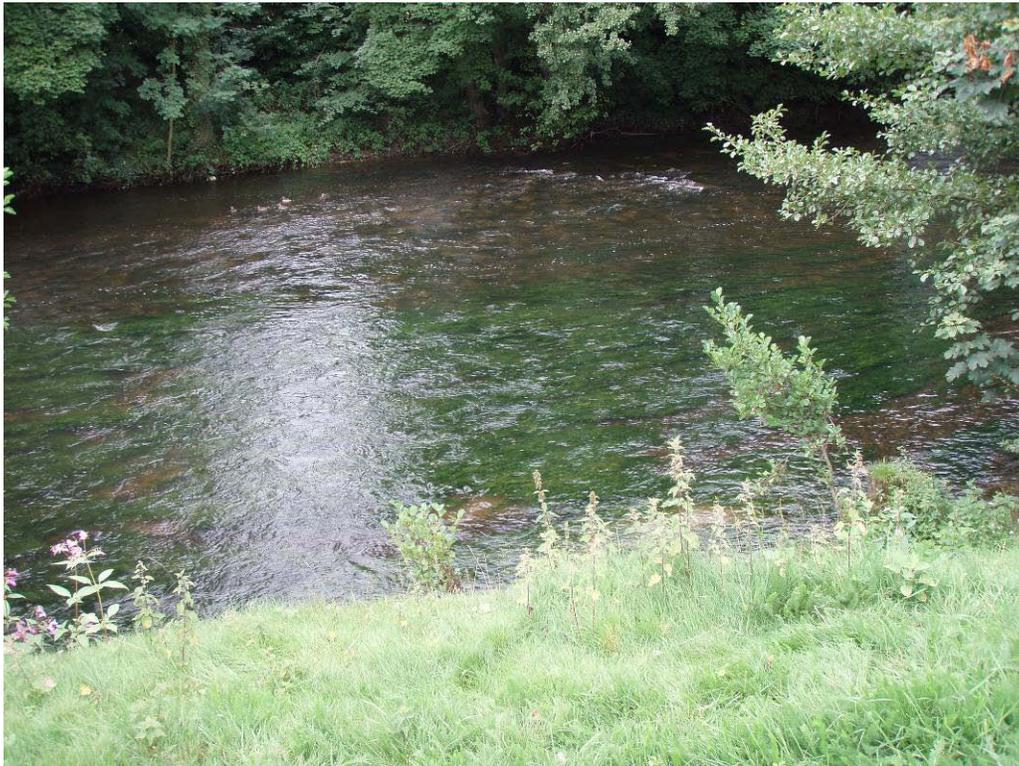
**Photo 6 Water crowfoot growing only on the more open side of the channel**

The idea of "sky-lighting" heavily shaded areas to promote in-stream plant growth was discussed. It was evident that even in more open areas, the growth of water crowfoot was restricted to the side of the river closest to the lower profile, relatively treeless bank (Photo 6). This suggests that even if trees were felled, in some areas the steep valley sides may still limit light penetration and weed growth; careful site selection is therefore required.

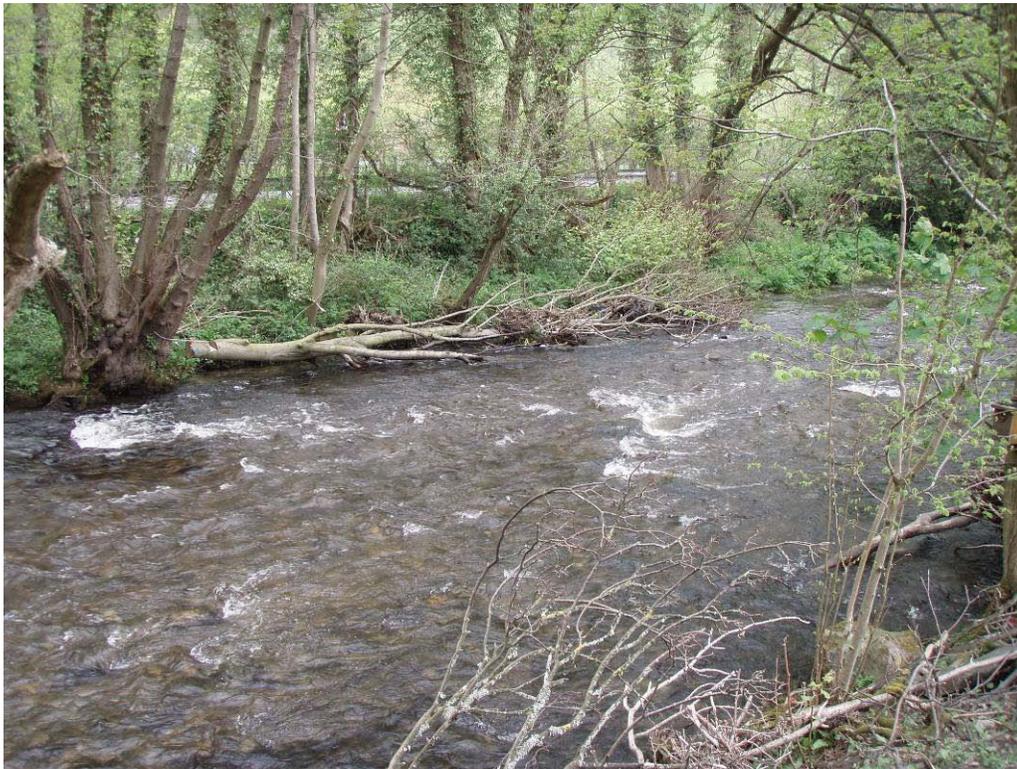
**Photo 7 “Tree kicker” installed on the River Ceiriog, near Chirk.**

The felling of riparian trees gives rise to the opportunity to introduce large woody debris to the river channel using “tree kickers”. This involves anchoring the felled trees closely to its stump using cabled wire and allowing the river flow to push the tree parallel to the bank. Such structures provide habitat advantages similar to naturally occurring woody debris and reduce the labour requirement of logging and removing felled trees. Written consent is required from the Environment Agency for introducing such structures (Photo 7).

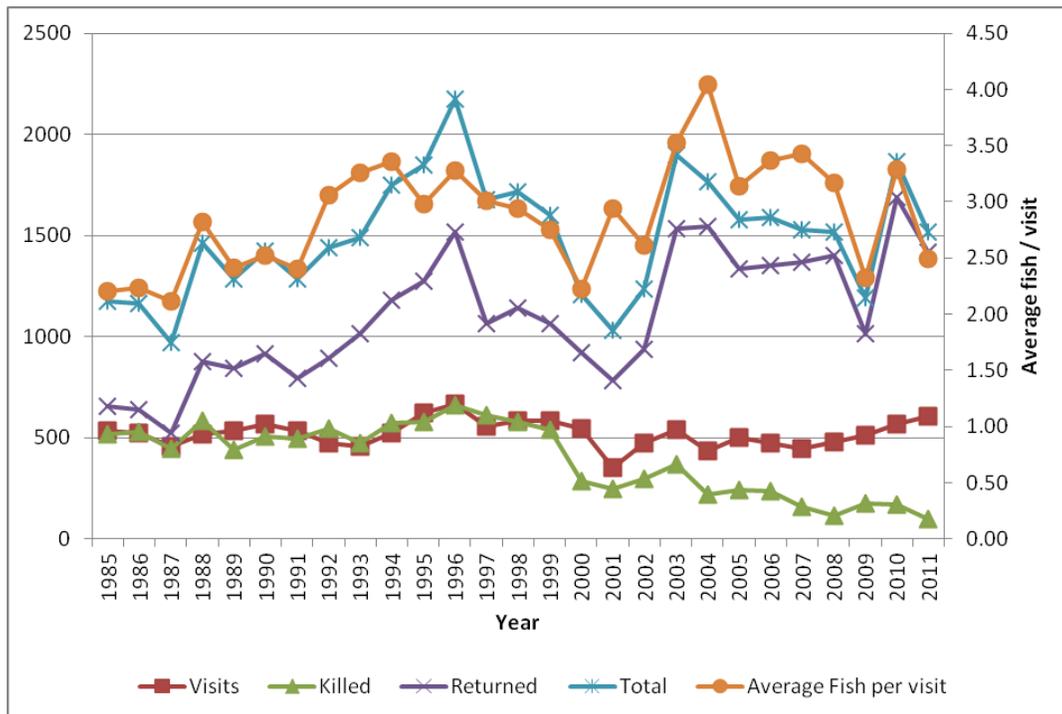
The stocking policy of the club was discussed and catch returns were provided prior to the visit; these are summarised in Figures 1 and 2. The data show a rod average ranging from 2.11 to 4.04 fish per visit, with a mean value of 2.89. The proportion of fish killed and fish returned has changed significantly between 1985 and 2011. The percentage of fish returned has increased from approximately 50% to over 90% (Figure 2).

Figure 1 Catch return summary, Cromford Fly Fishing Club, 1985 – 2011.

Given the large increase in catch-and-release, it would be sensible to reduce the number of fish stocked into the river, on both economic and ecological grounds. This could be done incrementally, reducing the numbers by around 25% each year and using the catch return system employed by the club to monitor changes in catch rate. A number of clubs which have reduced or ceased stocking (as catch-and-release has increased) have seen catch rates maintained or increased, probably as a result of reduced competition between stocked and wild fish and an increase in the numbers of the latter.

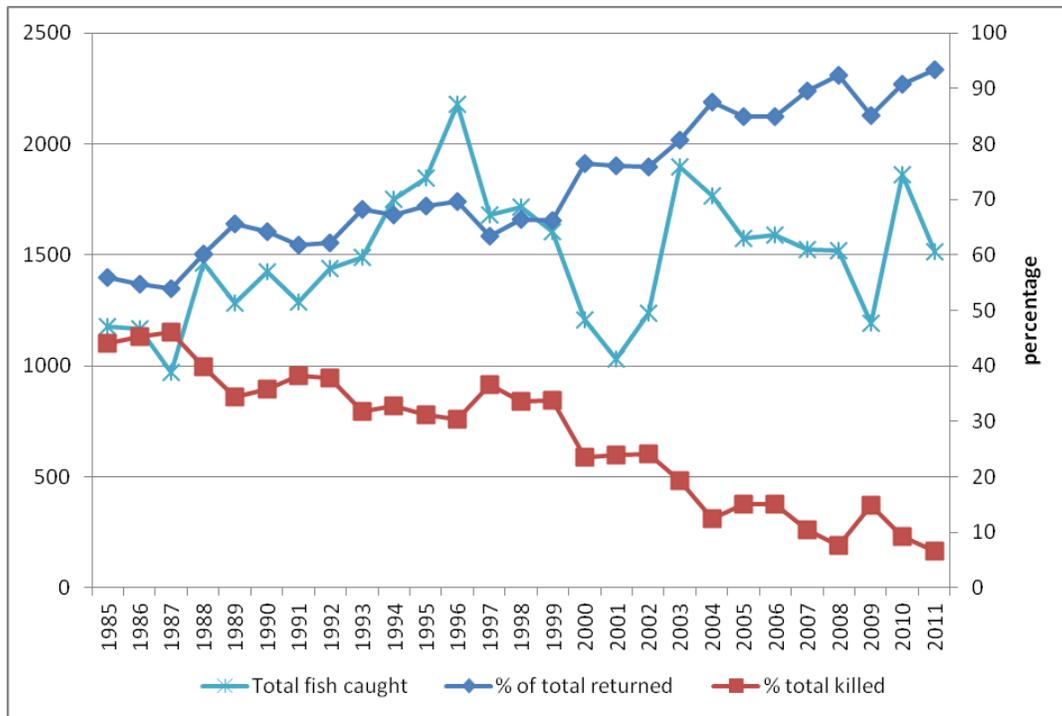
**Figure 2 Proportion of total catch killed and returned by year.**
