Advisory Visit
Dibney River, Co. Down
2nd July, 2010

1.0 Introduction

3.0 Habitat Assessment

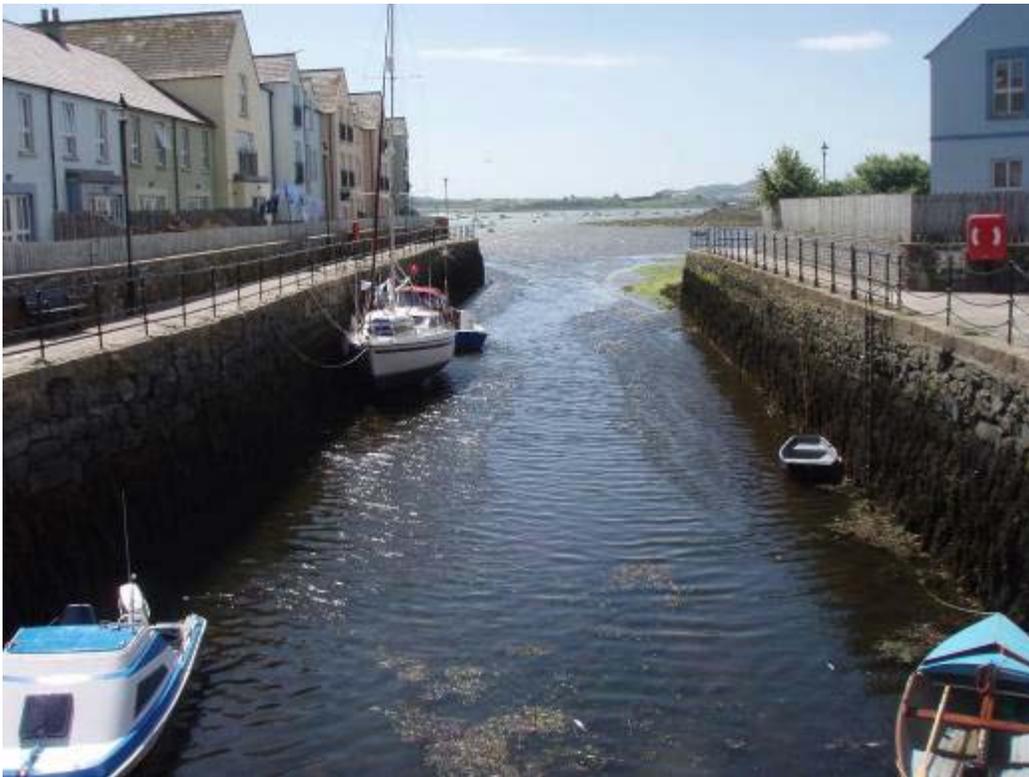
The river enters Strangford Lough through the old coal dock which has recently been re-developed as a residential area (cover picture); the river is tidal for a short distance upstream of this point. There are no obstructions to the free passage of sea trout into or out of the river at this point (Photos 1, 2).

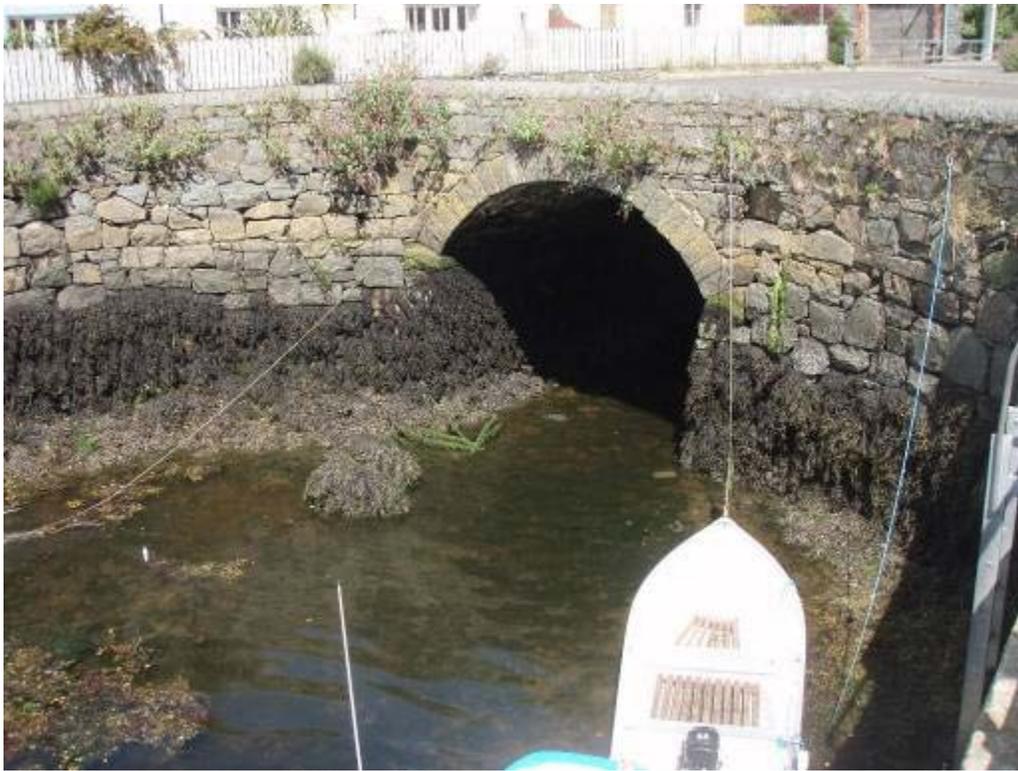
Photo 1 Outflow of Dibney River

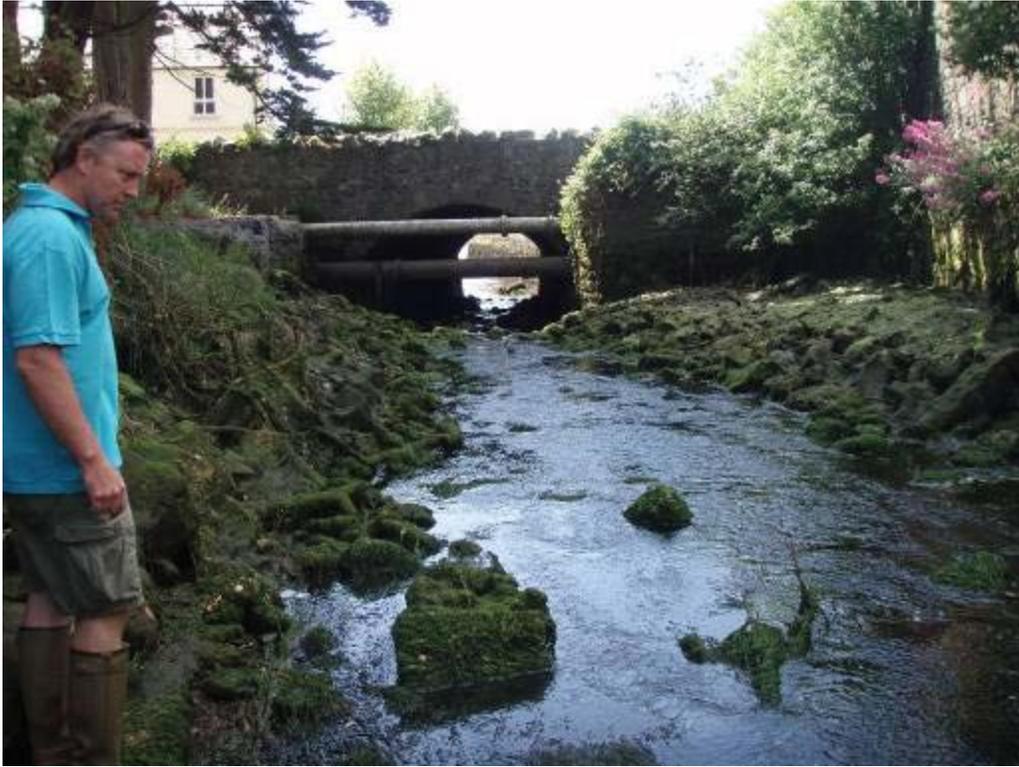
Photo 2 Tidal section of Dibney River

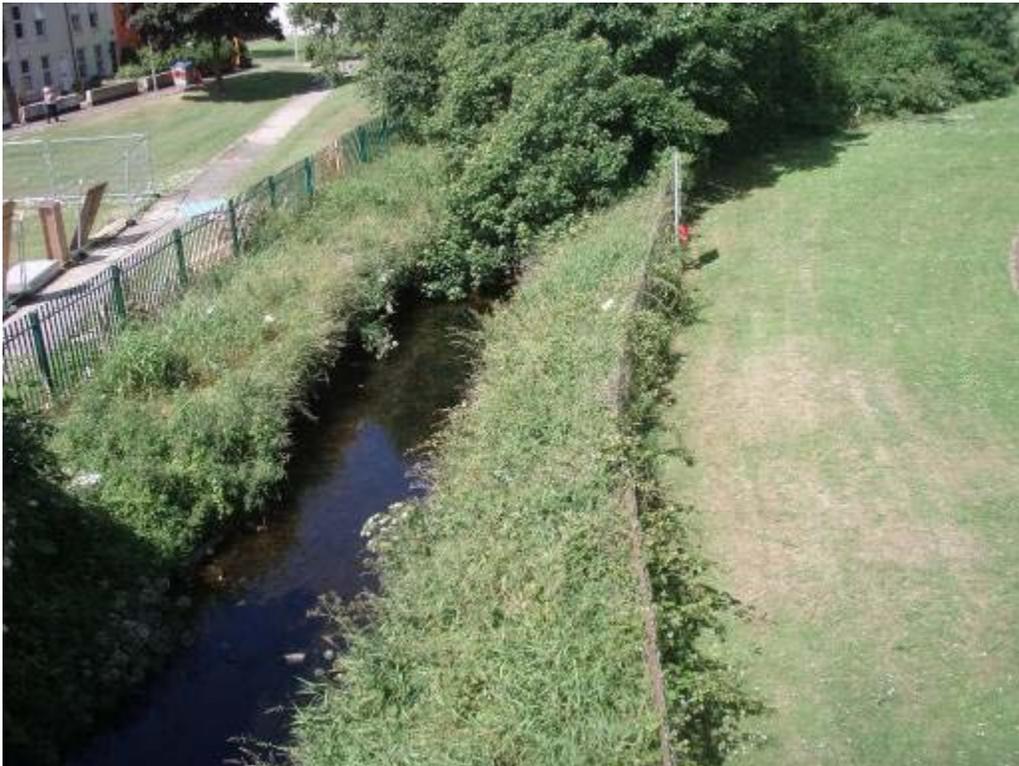
In Killyleagh, the river flows through a riverside park close to the Bridge Community Centre and some playing fields. A chain-link fence and railings prevent close access to the river here and throughout the riverside walk prominent health and safety notices are displayed (Photos 3,4). There is a considerable amount of fly-tipping within the river channel (Photo 5).

Photo 3 Riverside Park, Killyleagh. Access to the river is discouraged by fencing and...

- Discuss options for improving the river in Riverside Park, both for the local community and wildlife, with Down District Council and seek advice from bodies such as the River Restoration Centre.
- Consider making a more formalised riverside walk - perhaps using low wooden fencing to delimit pathways. The route should encompass both sections that run close to the riverbank and sections some yards away from the river and could also include cheap, easily replaced interpretative signage.
- Incorporate robust barriers to traffic at any access points to the walkways (using materials that have no scrap value – e.g. boulder placements) to prevent fly tipping from vehicles

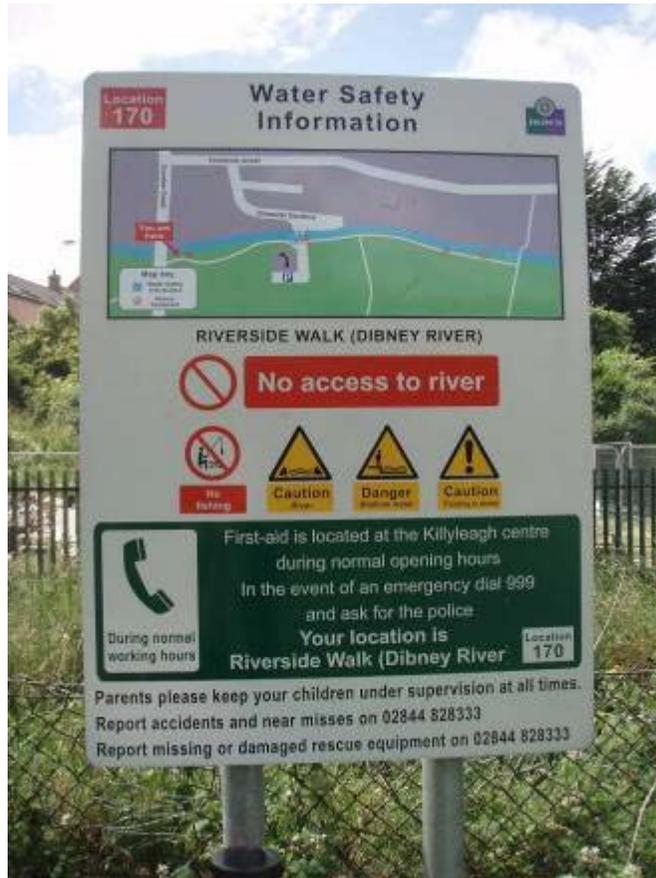
Photo 4signs.

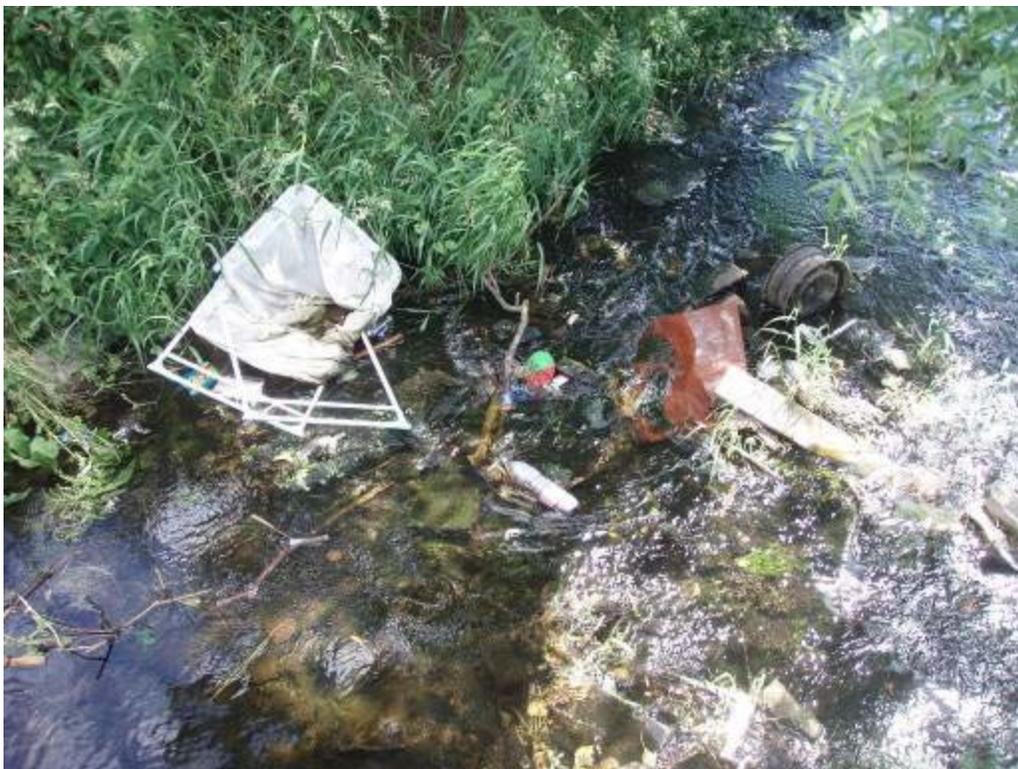
Photo 5 Fly tipping is common in the river here – a sign it is not valued.

- Continue river clean-up activities and involve the local community as widely as possible. Putting the schedule of planned trash clean-ups and other events (nature trails for kids and their families with a ticklist of wildlife species) on the BBC Breathing Places website is a great way to get new volunteers and as a useful reminder of dates and times for existing volunteers

Regular trash clean ups tackle the problem on two levels – firstly the simple benefit of rubbish removal, but secondly (probably more importantly) the visible presence of working volunteers is a deterrent to future fly tipping. Sending out a public message of this sort also helps to secure future volunteers and to introduce local communities to the value of healthy rivers.

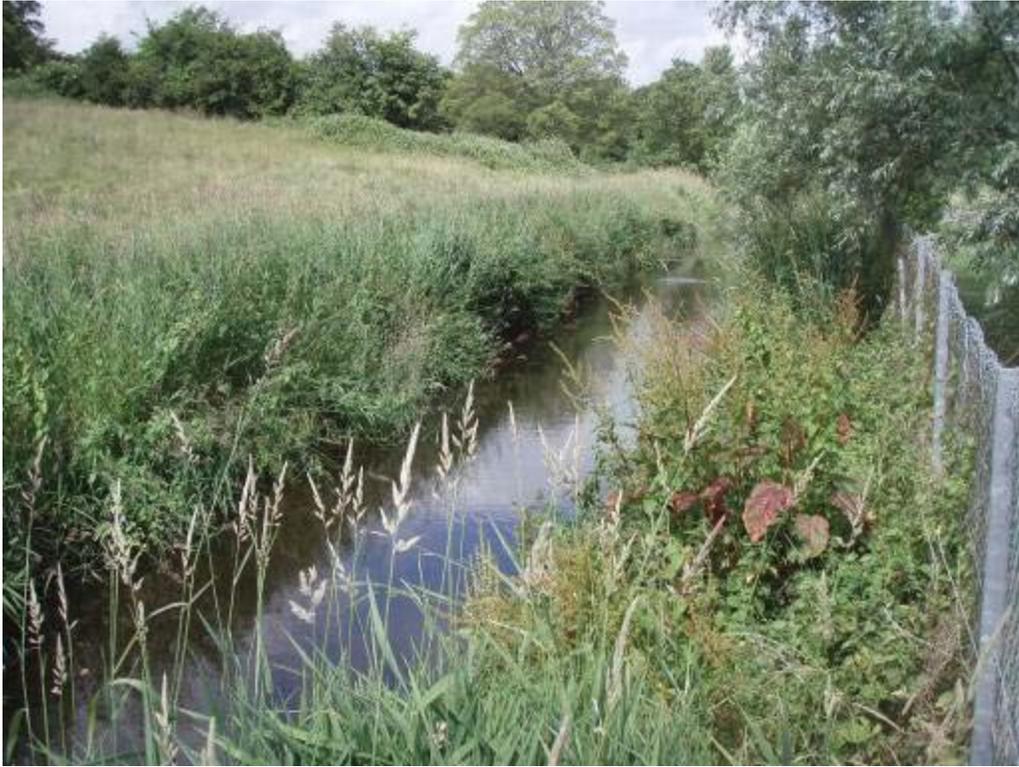
The river channel has previously been straightened or its course altered, leaving a predominantly homogenous, canal-like, slow-flowing section of river (Photo 6). The channel is relatively low gradient and where bridges are present, these form high points on the river bed impounding water upstream and creating short areas of faster flows downstream (Photo 7). In these latter areas, the river bed tends to be comprised of cobbles and gravel and some flow-loving plants such as water crowfoot (*Ranunculus* sp.) are present. In the slower flowing areas fine sediments dominate the river bed and floating sweet grass (*Glyceria* sp.) is present. Marginal vegetation is very good along this section, probably because of the limited access to the river, and is comprised of long grasses, meadowsweet, dock and bindweed interspersed with the occasional young alder, willow and ash. This lush,

Overall the in-stream habitat here is moderate to poor. The channel lacks variety in that there is no pool-and-riffle sequence, and the depth is very similar throughout the reach; the depth is however suitable for holding trout beyond the juvenile stages and this is complemented by the good marginal vegetation. The river bed contains some gravel, but this is unsorted and unsuitable for spawning.

Photo 6 Straight, slow-flowing section of river alongside the playing fields. Poor in-stream habitat but a good “shaggy” marginal fringe of vegetation.

- On the meandering sections of river, for example in the wood upstream of Shrigley, re-create lateral scour pools by the re-distribution of material from the riverbed and embankments (see Photo 24). Lateral scour pools are the deeper areas which occur naturally on the outside of meander bends.
- On straight sections of river, pools could be created by building channel constrictors or specialised weir structures. It should be emphasised that the idea of these is to create depth **not** by impounding water upstream, but by focussing flows downstream of the structure to create scour. Guidelines for construction of these structures are given in O'Grady (2006). Figures 1 – 3 show some examples.

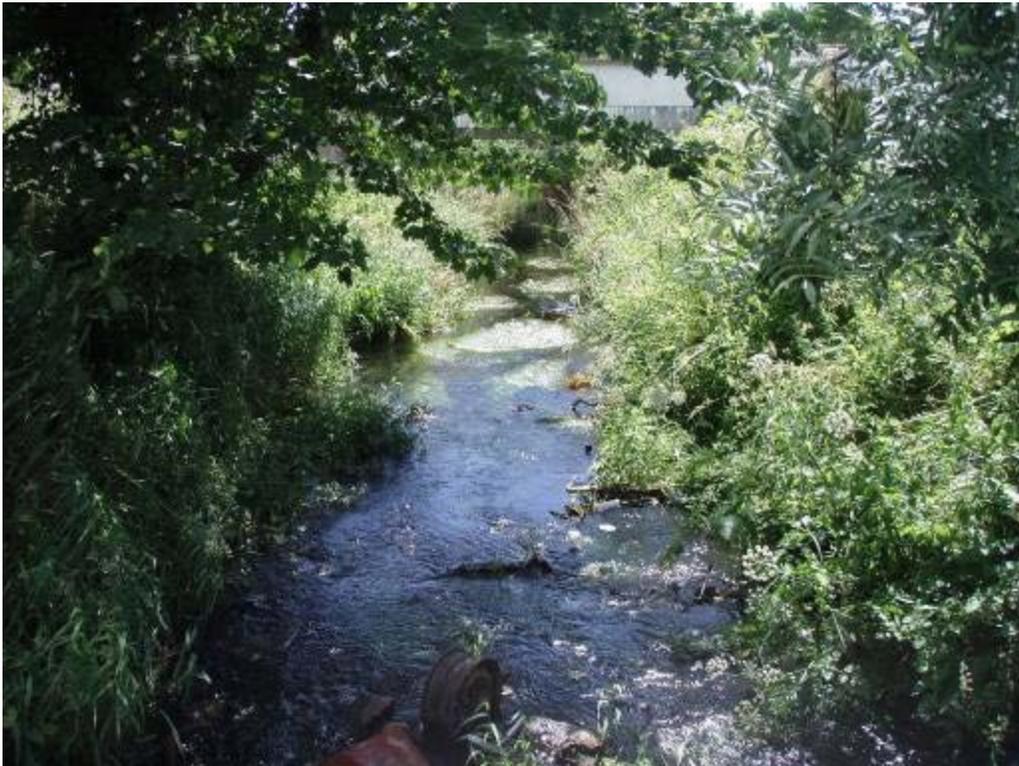
Photo 7 Short sections of faster flowing water are present downstream of bridges.

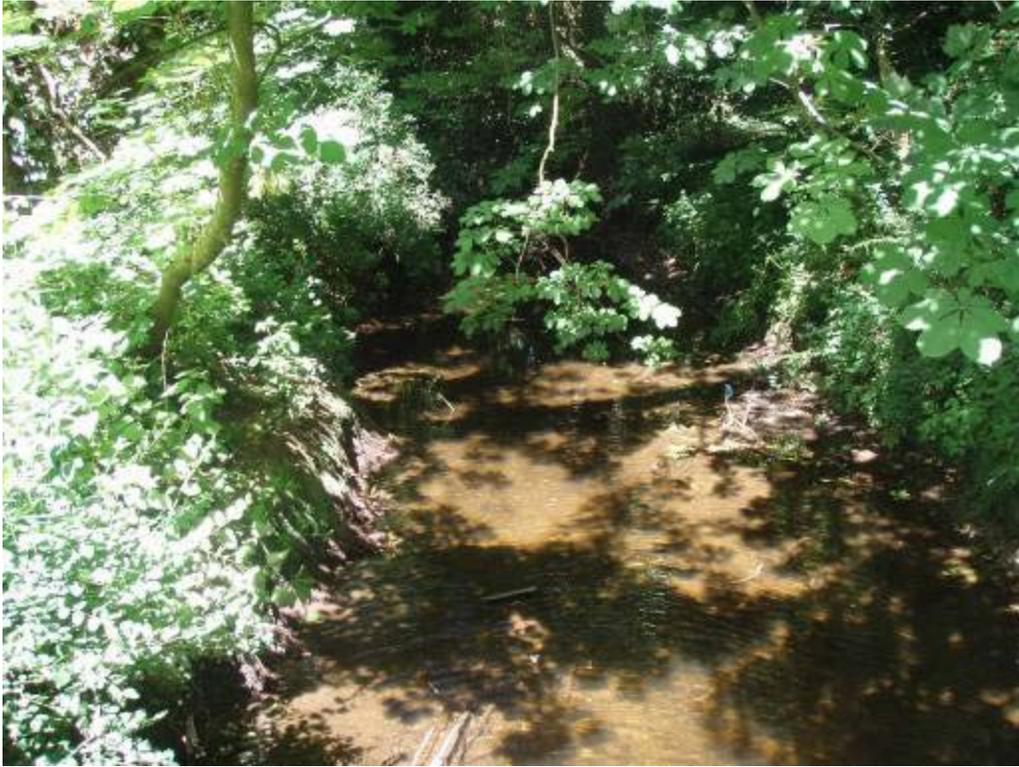
The river here remains straight and slow-flowing and is lined by poplars on the left bank. The two bridges present again form high points in the river bed, impounding water behind and creating faster flows downstream; trout were observed holding station alongside the faster flowing areas. A large eel was also observed in this area.

Photo 8 River upstream of Broad Meadows Lane

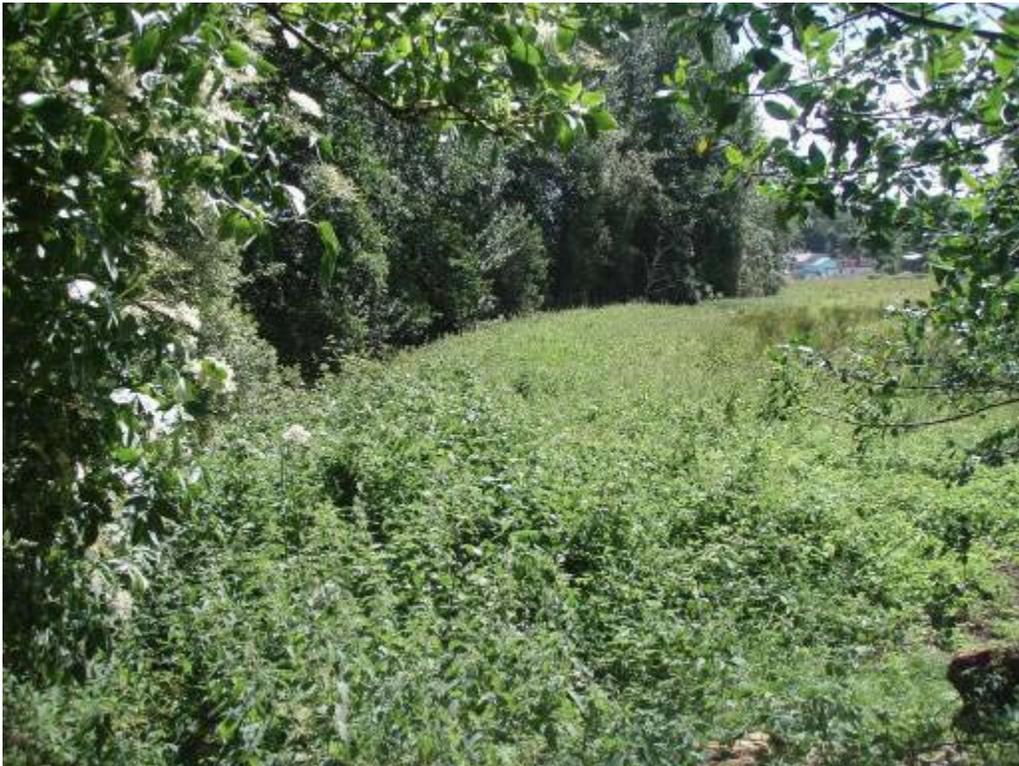
Photo 9 View downstream from public footpath near Broad Meadows Lane

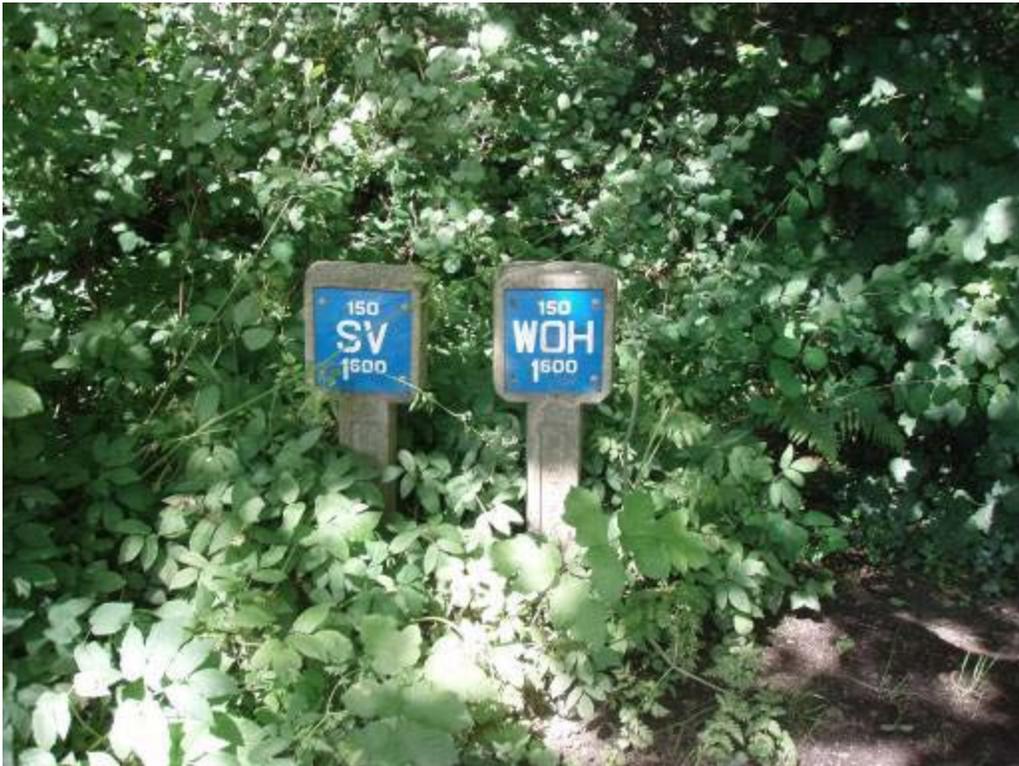
Photo 10 Services are present along the right bank here – appropriate checks need to be made before any works are carried out.

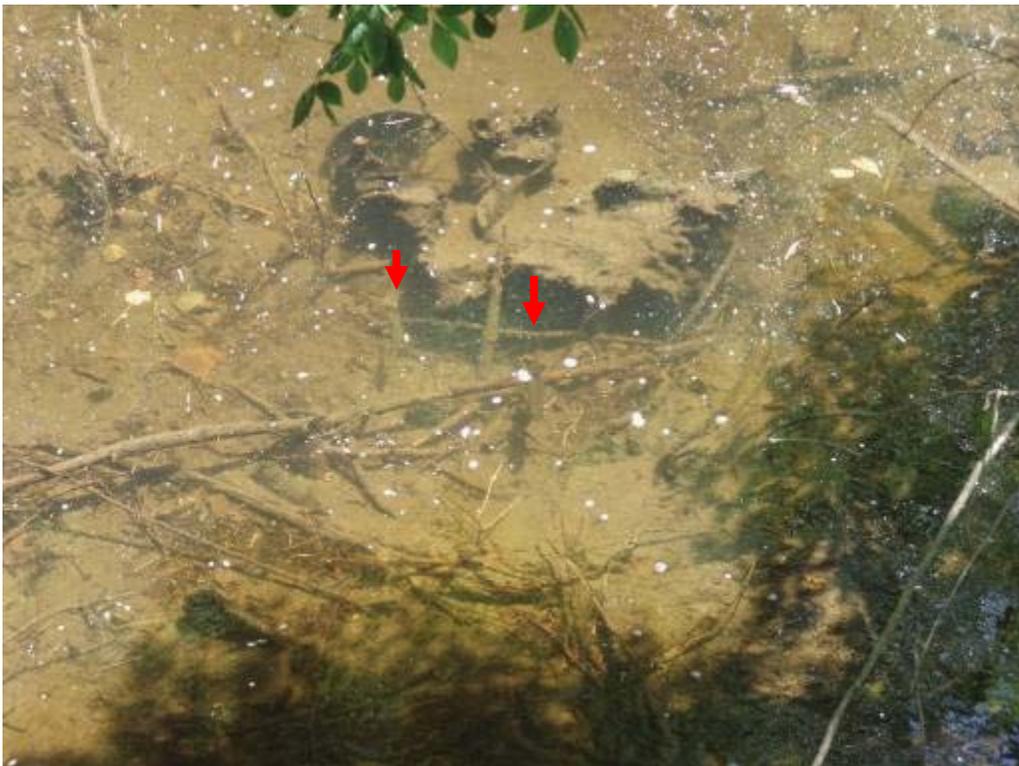
Photo 11 Small trout downstream of the footbridge

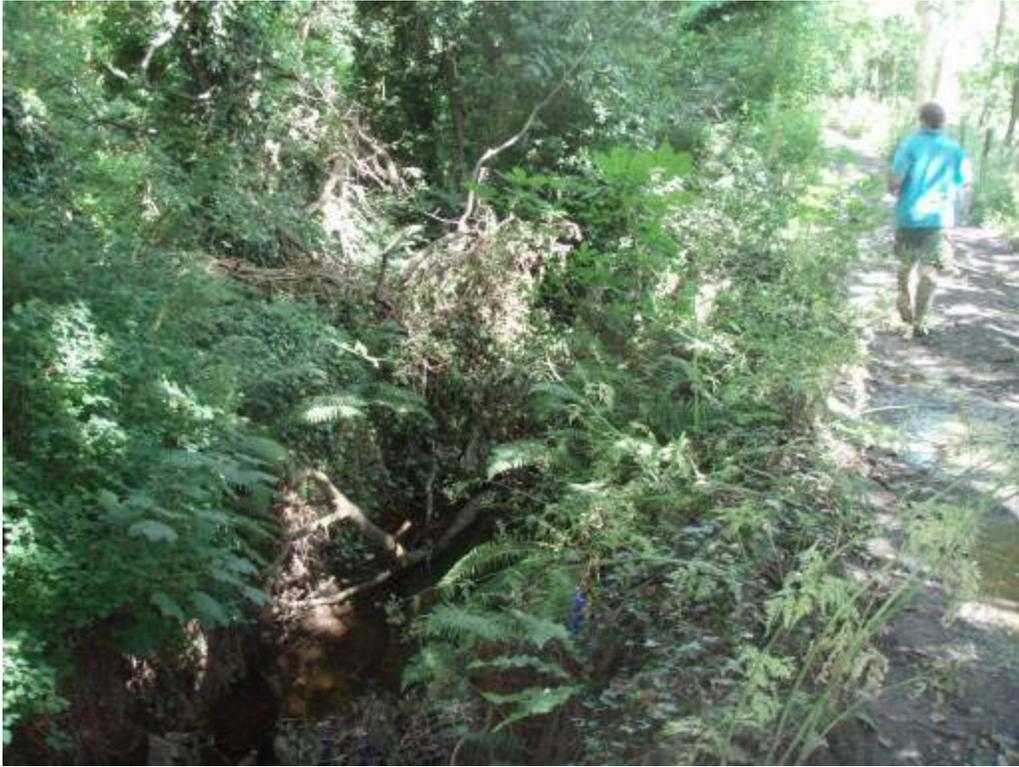
A small tributary enters the river on the left bank here; there is a good flow and reasonable gradient although the channel is straightened (alongside the public footpath). Water quality appears to be good with freshwater shrimp (*Gammarus pulex*), olive nymphs (Baetidae) and caddis present. There is a reasonable amount of gravel on the bed, although some fine sediment is accumulated in places (upstream of debris blockages). This stream could be used by sea trout for spawning and it would be worth walking its length, removing any blockages to access and enhancing spawning potential by introducing structures to scour and sort the river bed. These might include paired boulders and log deflectors (see recommendations).

Photo 12 Small tributary alongside footpath

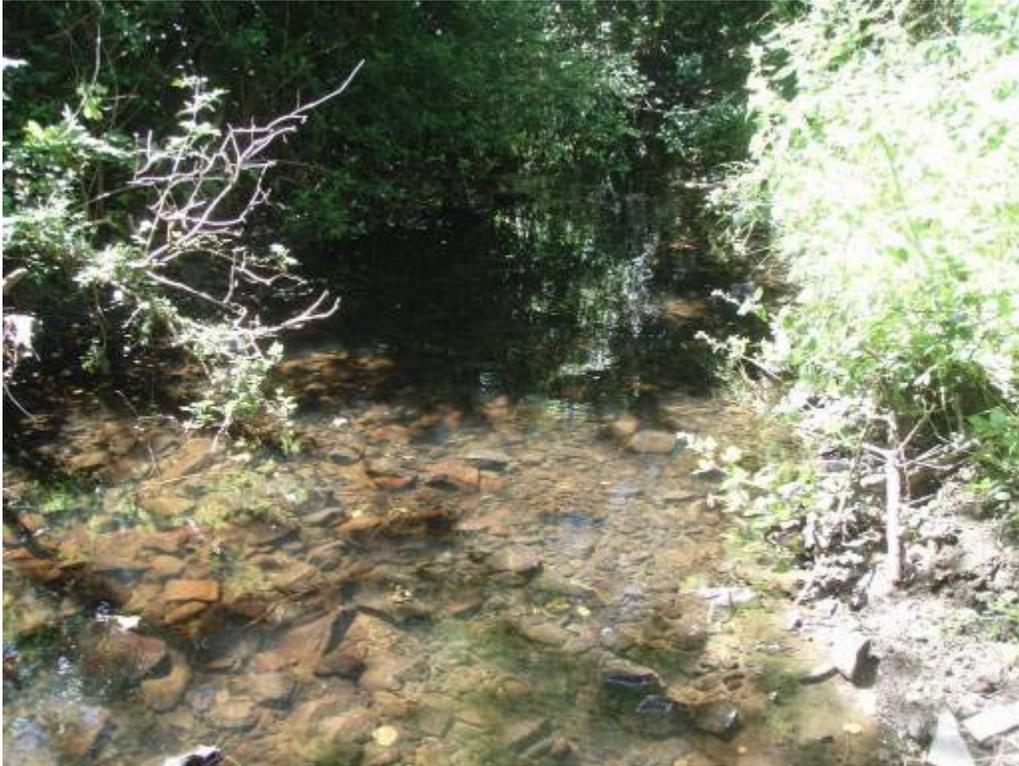
This section of river flows through a wooded area. The river has a meandering planform which contrasts with the straightened channel downstream. The river bed substrate is good quality for trout spawning, comprising approximately 10% boulder, 40% cobble, 40% gravel and 10% sand. Invertebrates present include blue-winged olive, olive nymphs, freshwater shrimp, caddis and prolific growths of freshwater sponge.

Photo 14 The river has a steeper gradient and better bed substrate composition upstream of Shrigley

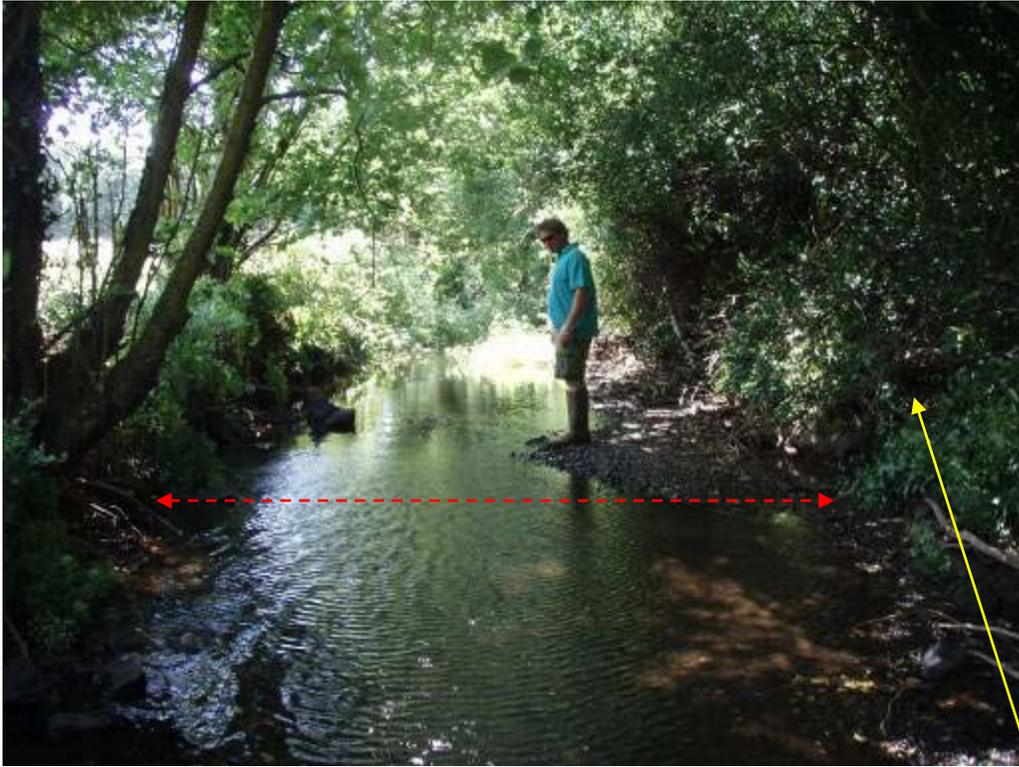
With progress upstream it becomes evident that the river channel has been modified at some point in the past. The left bank is embanked and the channel is wide and very shallow – largely ankle deep and totally lacking in deeper pool habitat. The substrate also becomes finer (10-40 mm gravel dominated), but remains reasonably good quality for spawning.

The presence of mature trees on the embankments indicates that the channel modification took place some decades ago; however the effects are still evident today. There are some exposed areas of bedrock within the channel and in places there have been some attempts at building small dams and groynes from stone. DRCT indicate the latter may have been constructed to facilitate the poaching of adult sea trout, but it again highlights the lack of deeper water habitats along this section.

Photo 15 With progress upstream it is evident the channel has been modified; it is overwide, shallow and embanked (left bank – picture taken looking upstream).

This section of the river has great potential for habitat improvement to create deeper holding areas and to improve the quality of gravel available for spawning – see recommendations.

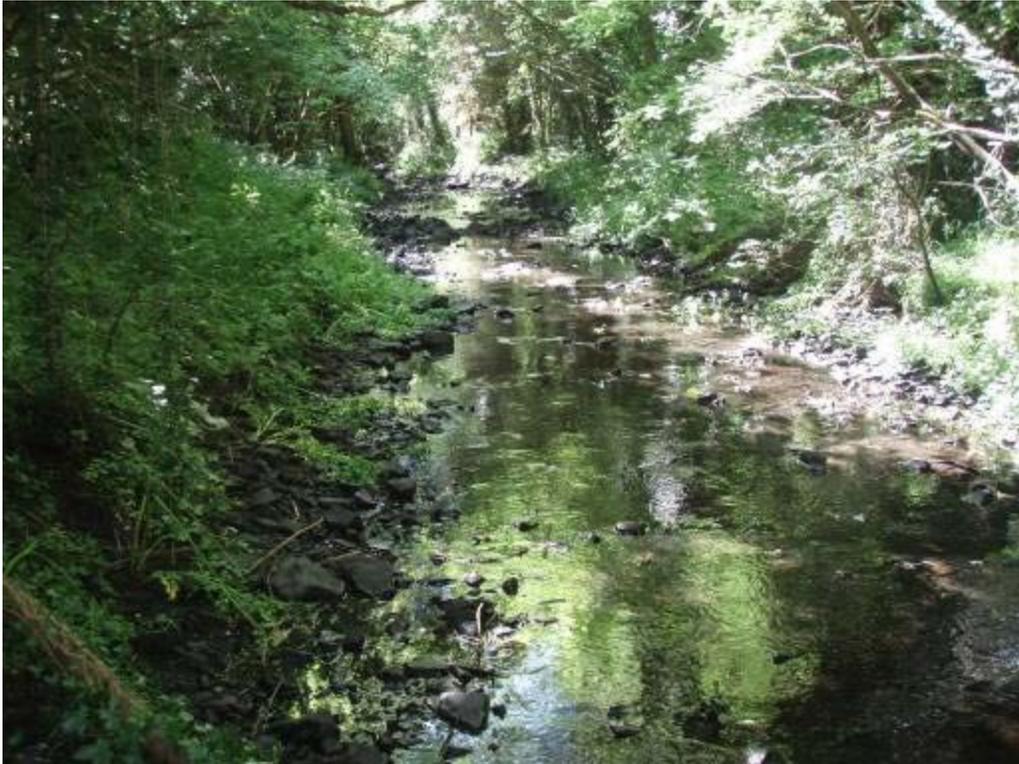
Deeper water is necessary for holding adult fish when they run to spawn and for juvenile stages to grow to a size when they can become smolts and head down to the sea. Very few small trout were seen in this section, and most of those were young-of-the-year (0+) fish. This begs the question whether there is sufficient juvenile habitat available to allow trout to grow to a size and age when they can become smolts.

Photo 16 Wide, shallow channel – no pool habitat.

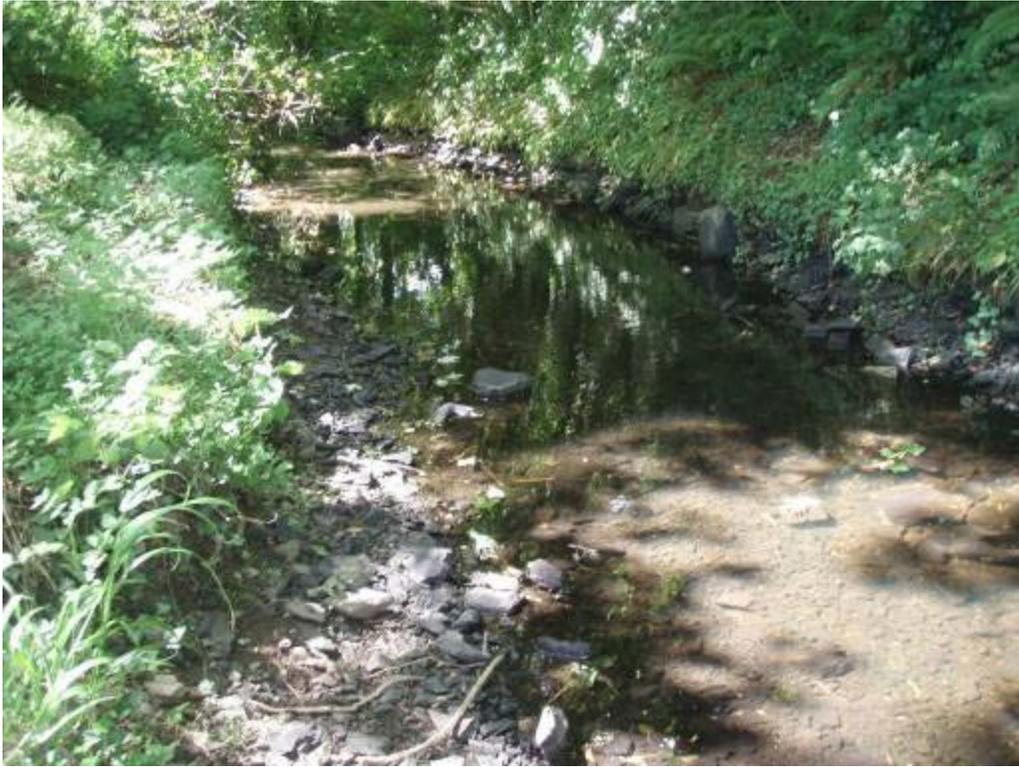
Photo 17 Typical section of river in the wooded area – ripe for the creation of pools.

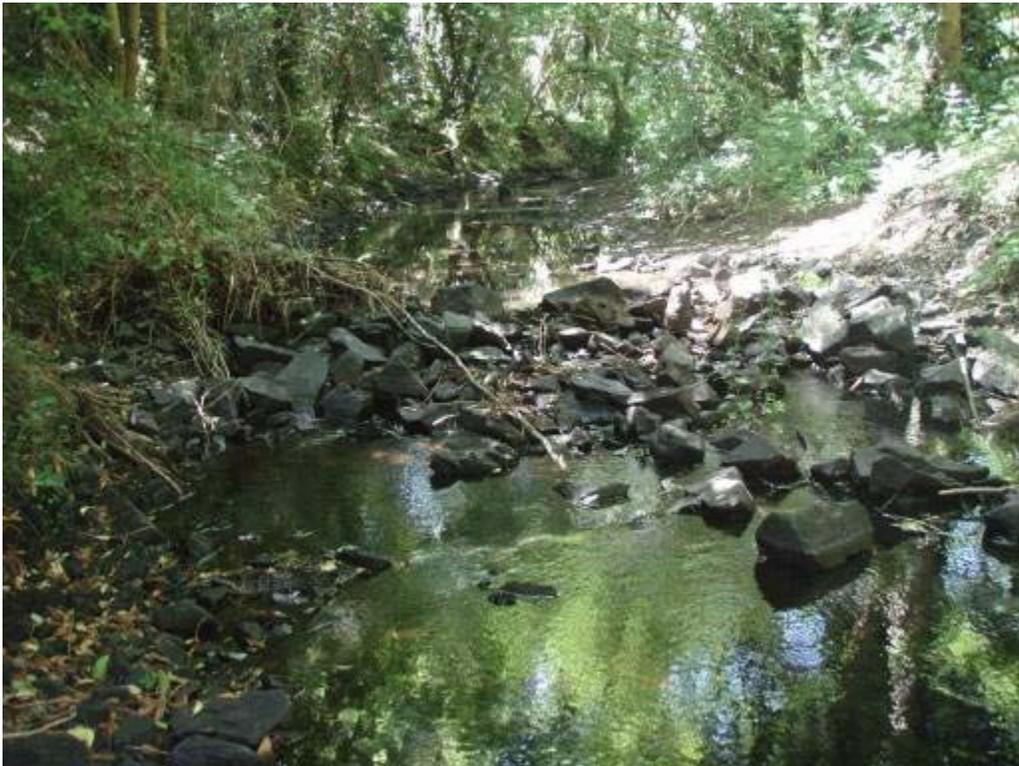
Photo 18 But not like this! A dam probably constructed to assist poaching.

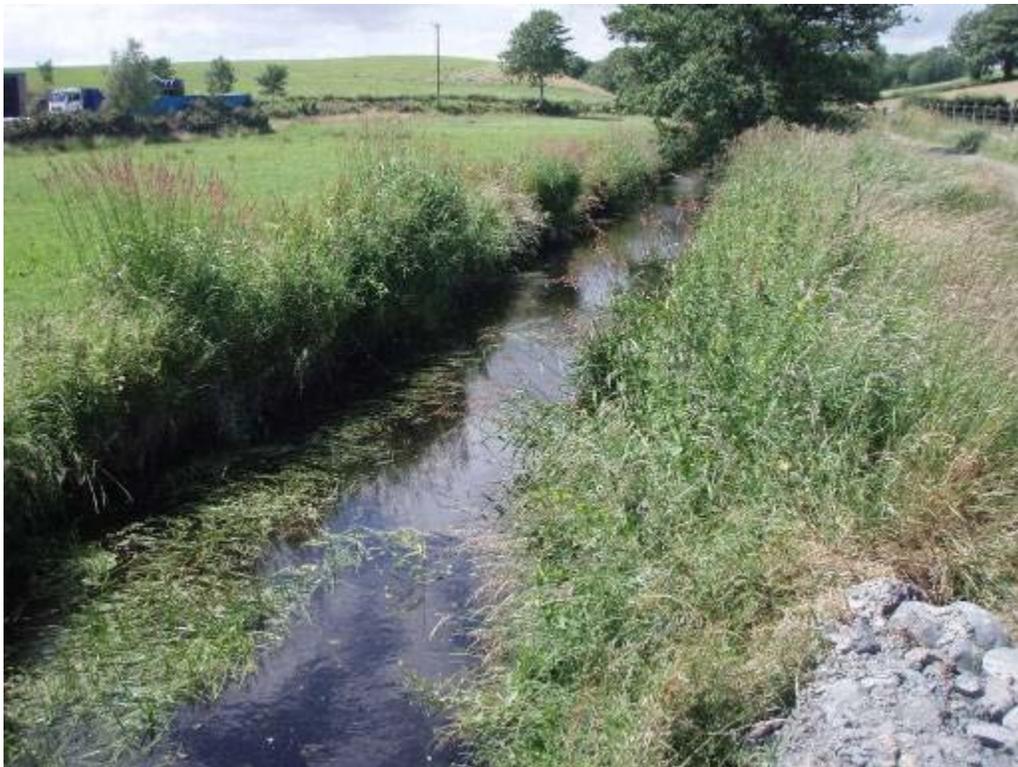
Upstream of the road bridge the river channel has been dredged and is straight and slow-flowing. The channel is open (few trees or bushes) and aquatic plants typical of still or slow flows are present (Canadian pondweed *Elodea canadensis* and duckweed *Lemna minor*). The river bed is composed of fine sediments until the farm track which runs parallel to the channel on the left bank ends; beyond this point gravel substrate becomes evident. It appears the river bed has been dug out and the gravels used to surface the track. This is very damaging to in-stream habitat, but fortunately has been carried out over only a short length of river.

Photo 19 Upstream of Crossgar Road – the bed has been dredged from the river here.

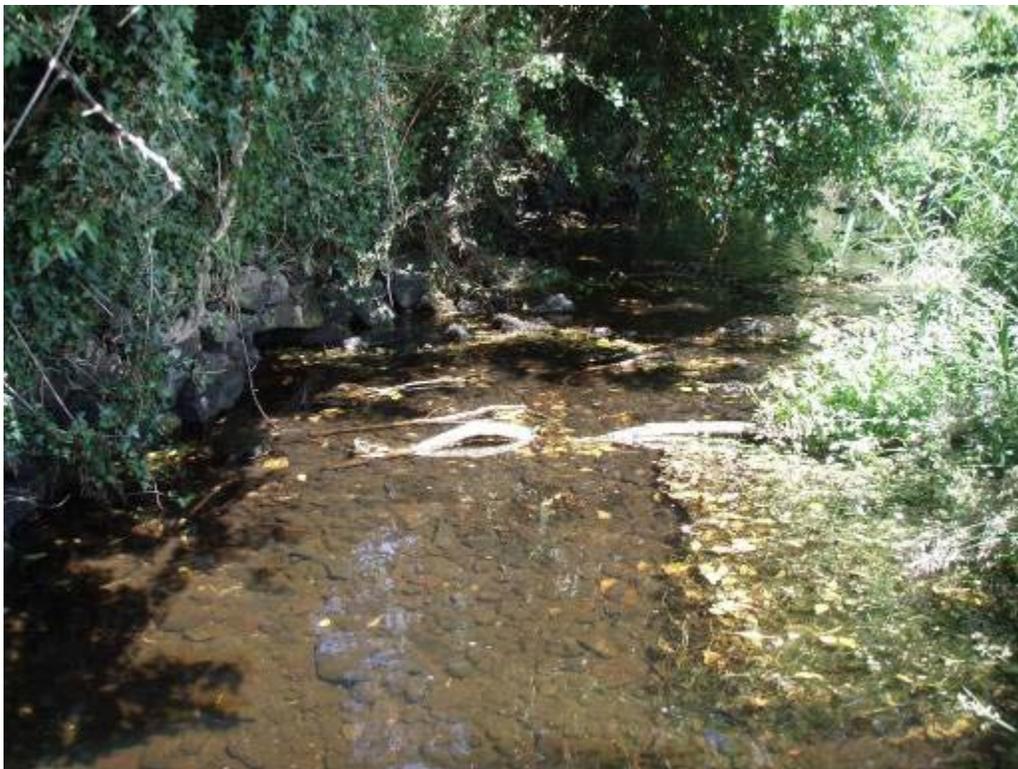
The left bank of the channel downstream of the bridge is a built stone wall, and the channel is predominantly shallow and lacking pool habitat (Photo 20). Some 0+ trout fry were observed but no larger fish.

Photo 20 Downstream of Jericho Road – channel is walled on the left bank and generally shallow.

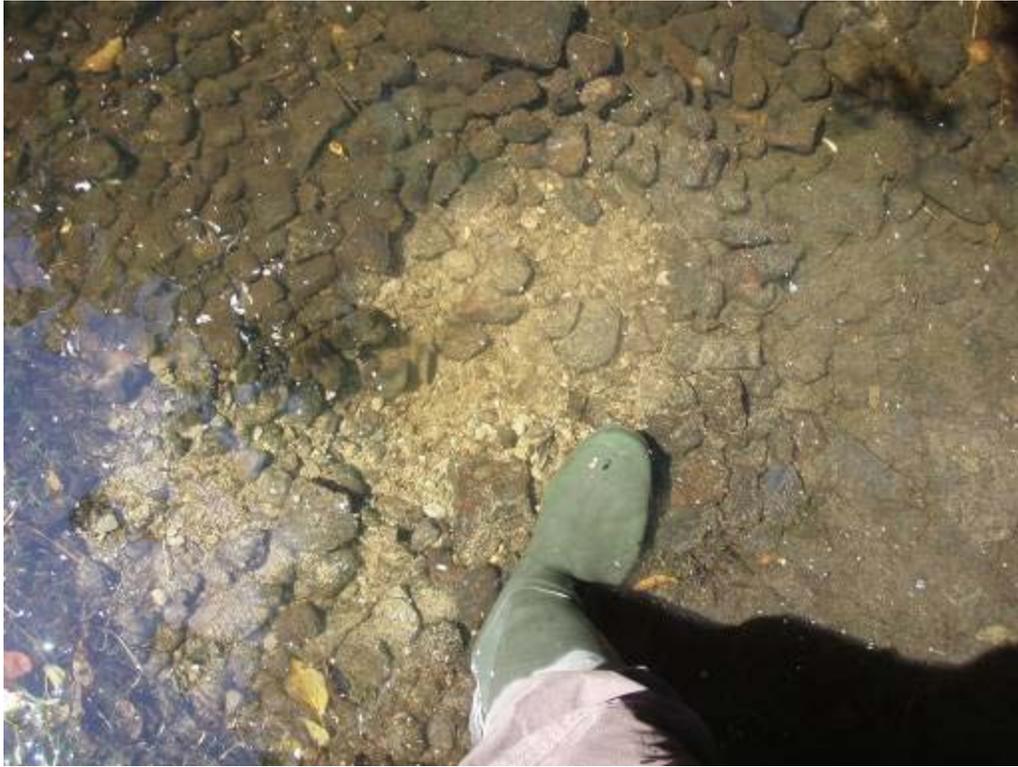
The river channel here has a moderate gradient with a gravel dominated river bed and water crowfoot (*Ranunculus* sp.) present. However, the gravel layer is a thin, armoured layer on the surface and a quick scrape revealed fine sediments underneath (Photo 21). This is not good quality spawning habitat because the gravel layer is too thin; a depth of at least 30 cm of gravel is recommended for trout spawning (more for larger sea trout).

Photo 21 The gravel substrate is thin here and overlays fine sediment– not good for spawning.

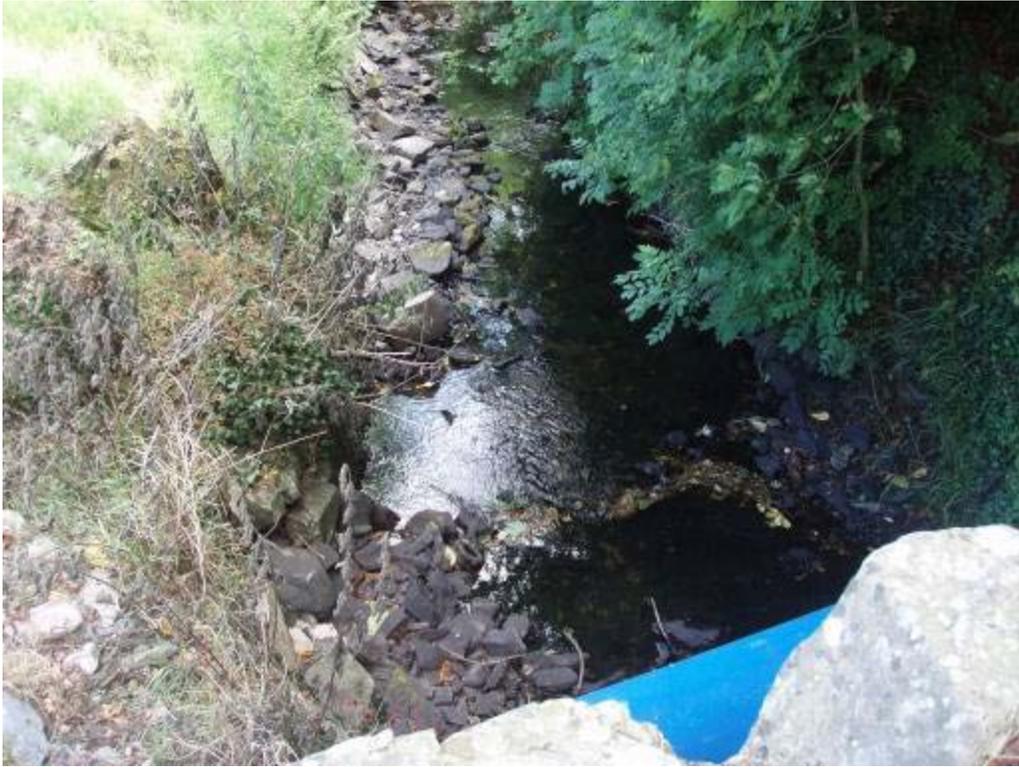
Photo 22

Access to the river here was difficult so only short sections were inspected close to the road bridges. The channel here is heavily shaded by trees and bushes (hawthorn, ash, gorse – Photo 23) along both banks; beyond this strip are fields mostly with beef cattle or mowing grass. The bridge culverts have very shallow water depths flowing over them; this could be a barrier to fish movement at low flows (see Scottish Executive guidance on culverts – references). The river bed comprises large cobbles and gravel (Photo 22), but the channel is quite incised suggesting the bed may have been lowered for drainage in the past; lack of pool habitat may again be a limiting factor for trout populations here (juvenile habitat bottleneck).

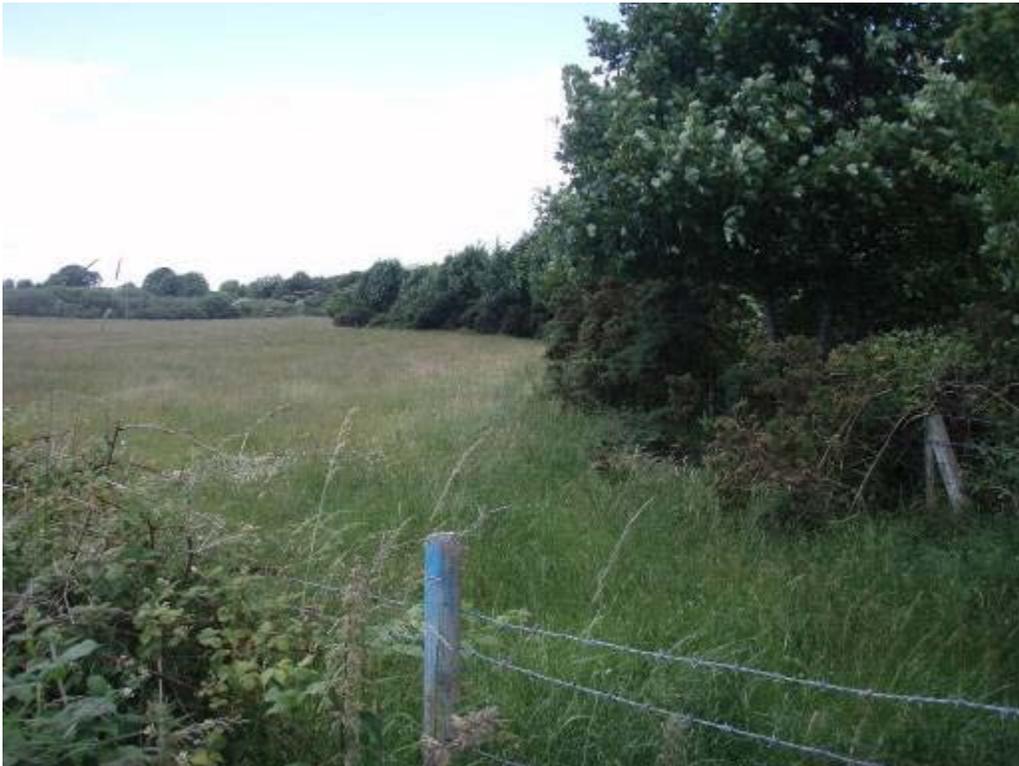
Photo 23 River channel is to the right of the tree line

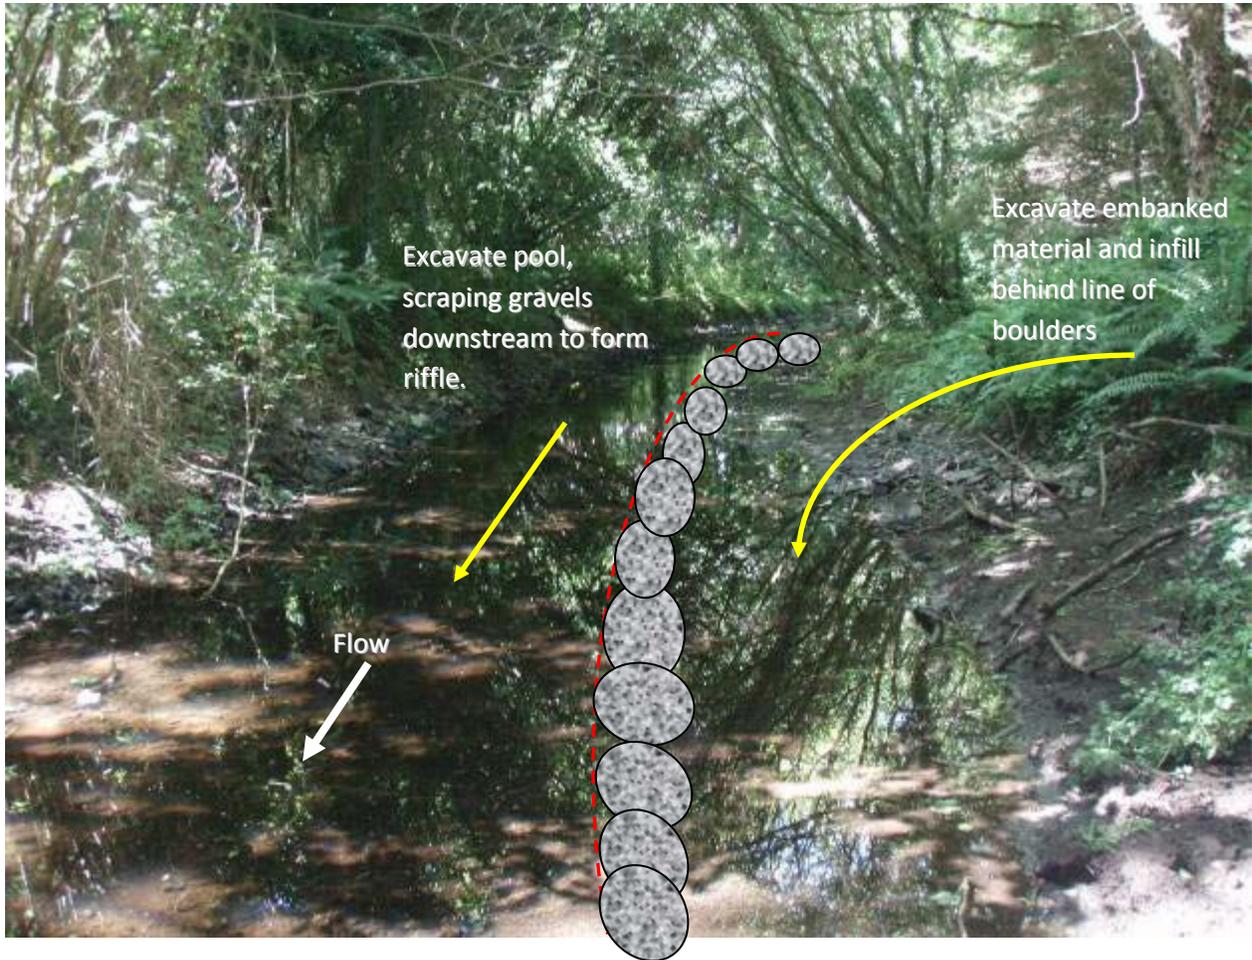
Photo 24 Creation of lateral scour pool on the outside of a bend

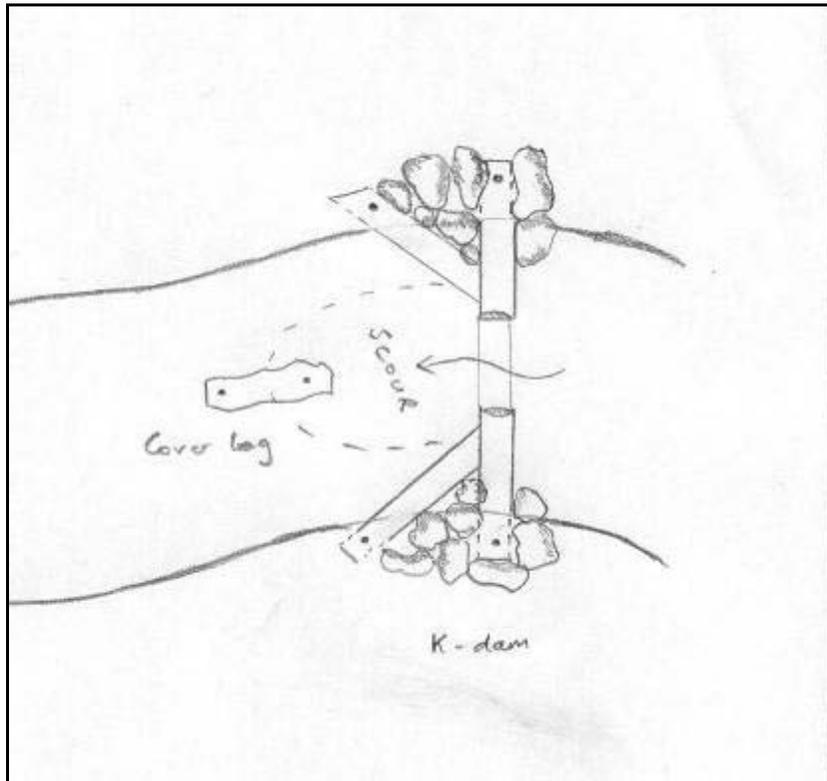
Figure 3 Cover log can be substituted with a boulder
